Implementation of an Improved Shear Key Detail in the Buffalo Branch Bridge

Final Report VTRC 20-R4

FINAL REPORT

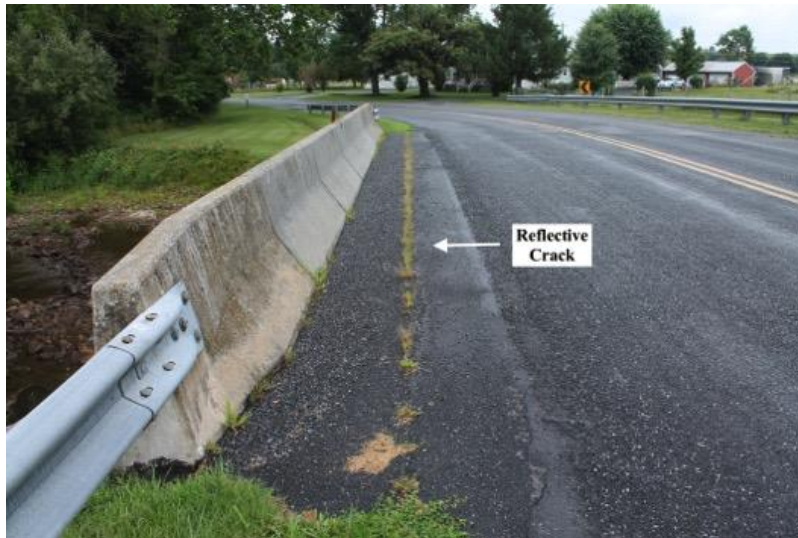
However, over time, the traditional grout shear key tends to deteriorate, causing reflective cracking to propagate through the deck and into the wearing surface, as shown in Figure 1. These reflective cracks allow water and corrosive agents, such as deicer salts, to penetrate down into the joints, an example of which can be seen in Figure 2, which is the underside of the joint in Figure 1. If left uncorrected, chloride-laden water can eventually cause the reinforcing and prestressing steel in the precast members to corrode. This corrosion leads to the need for bridge repair or replacement well before the end of its anticipated design life, negating the assessed economic value of the adjacent member system.

Figure 1. Reflective Cracking

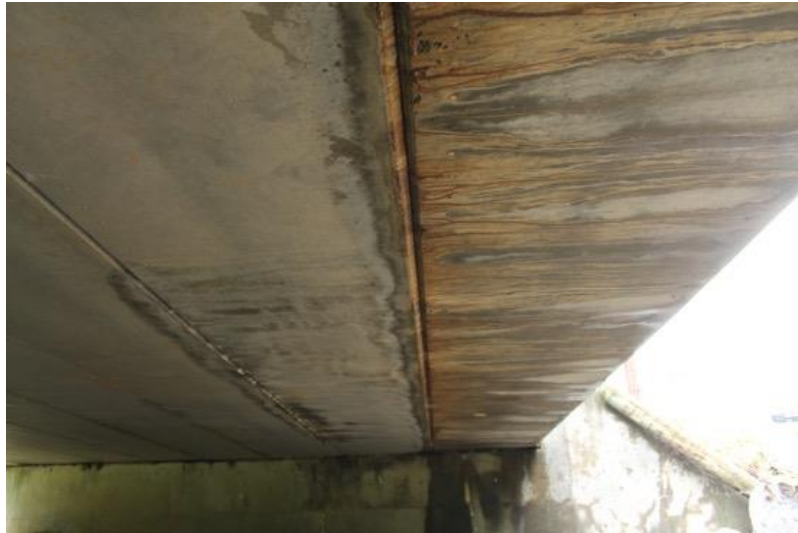
Figure 2. Leaking Joint

of leakage was also seen on the second downstream joint and the furthest upstream joint within 6 ft of the abutments. The leaking downstream joint is shown in Figure 2. The plan and transverse views of the bridge plans are shown in Figure 5 and Figure 6. The 55-ft span bridge consists of nine simply supported adjacent box beams with transverse ties at the third points.

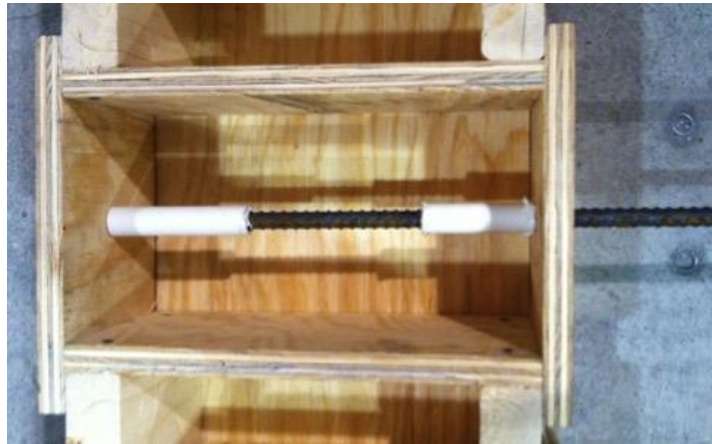
A modified version of the pull out tests presented in Johnson (2010) was performed to determine the bond of the VHPC mixes with reinforcing steel. The tests performed in this study were simplified with slightly smaller blocks and No. 4 reinforcing steel embedded at the center of the blocks, as the only objective was to measure if the reinforcing steel slipped out of the concrete or yielded. To prevent the reinforcing steel from pulling out the top section of the block in a cone failure, the top of the reinforcing steel was debonded using PVC pipe in the bottom 4 in and top 3 in of the block, leaving 5 in of the reinforcement bonded in the middle of the concrete block, as shown in Figure 9.

Figure 9. Bonded versus Debonded Reinforcing Steel for Pull Out Specimen

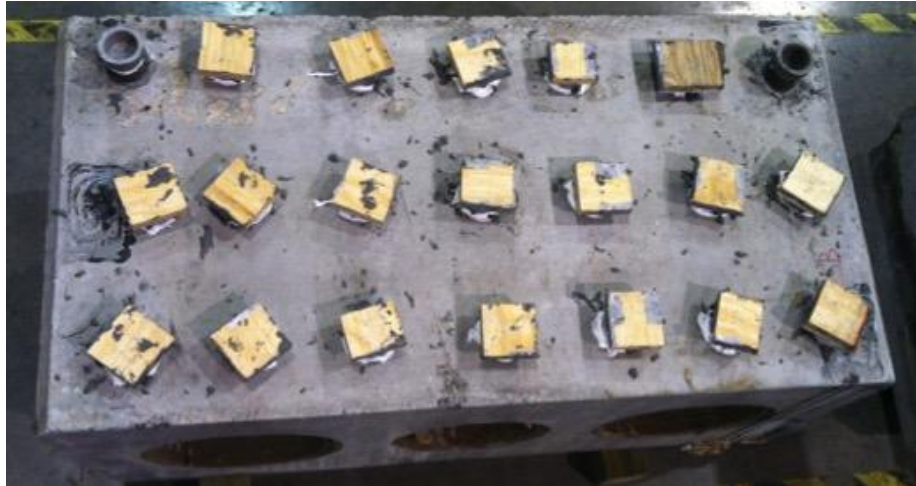
Figure 12. Bond Test Specimens

preparation could also be assessed, such as sand blasting and surface dryness. The bottom of the precast member offered a large surface area for many pucks to be cast, yet had the same smooth surface as the shear key due to metal formwork. The pucks were cast on a horizontal surface because it was not practical to cast them vertically. These test results were compared to specimens tested by Joyce (2014), which were cast in an identical manner. An overview of multiple VHPC pucks being cast on the bottom of a precast member is shown in Figure 12.

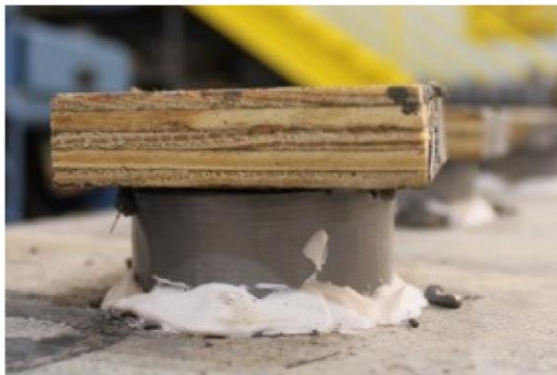
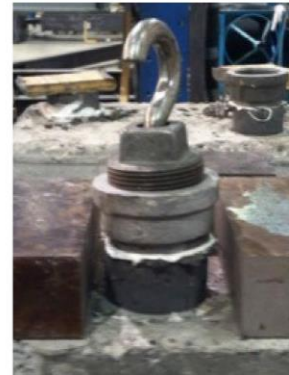
Figure 13. (a) Bond Puck with Wood Top and (b) Bond Puck with Hook Attached

Ordinarily, a skin-like layer starts to form at the surface of VHPC immediately after being placed. In order to epoxy a threaded metal cap used to apply the tensile force, a piece of duct-tape covered wood was set on the surface of the puck to prevent the skin-like layer from forming on the surface. A threaded metal cap was typically epoxied to the top of the pucks 12 to 24 hours before testing and is also shown in Figure 13. A hook was screwed into the metal cap and attached to a tension load cell, with load being applied by twisting a load jack. The test set-up is shown in Figure 14.

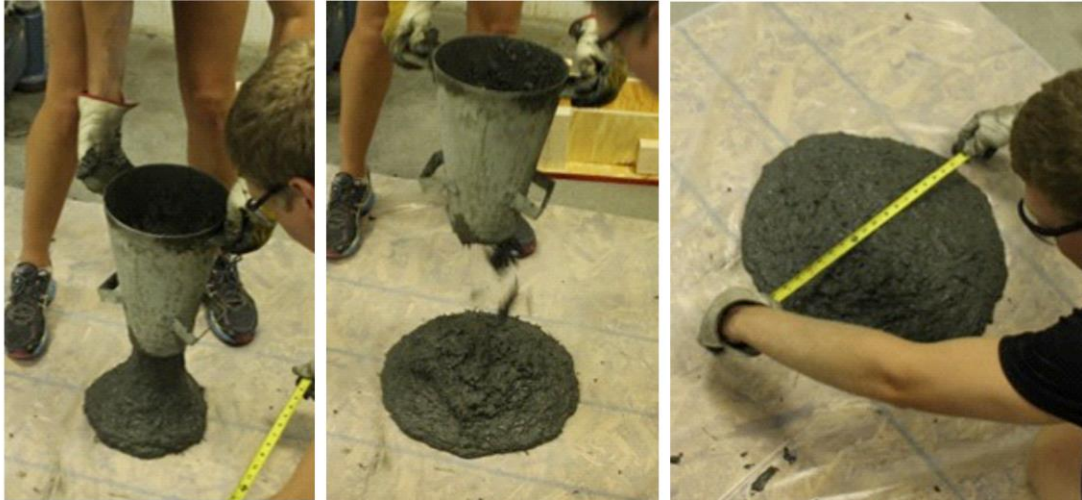
Figure 15. Inverted Cone Slump Testing

One way of quantifying workability is in accordance with ASTM C1611 (2014c), as shown in Figure 15. In this research, the spread was measured at different times during the mixing procedure to investigate how rapidly the flow changes.

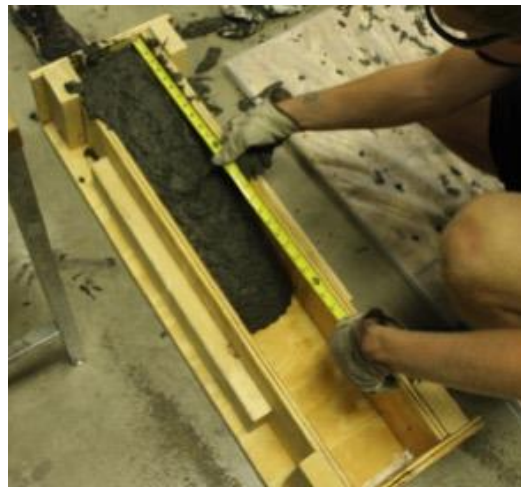
In addition, the flow was measured using unconventional methods to simulate field conditions. A 6 in x 6 in x 5 ft box test was built to mimic a closure pour and determine the distance the VHPC-Large could reasonably be expected to flow. After placing six large scoops of the VHPC-Large into one end of the box, the researchers recorded the distance the material had flowed after 15 sec. The test setup is shown in Figure 16.

Figure 16. Box Test

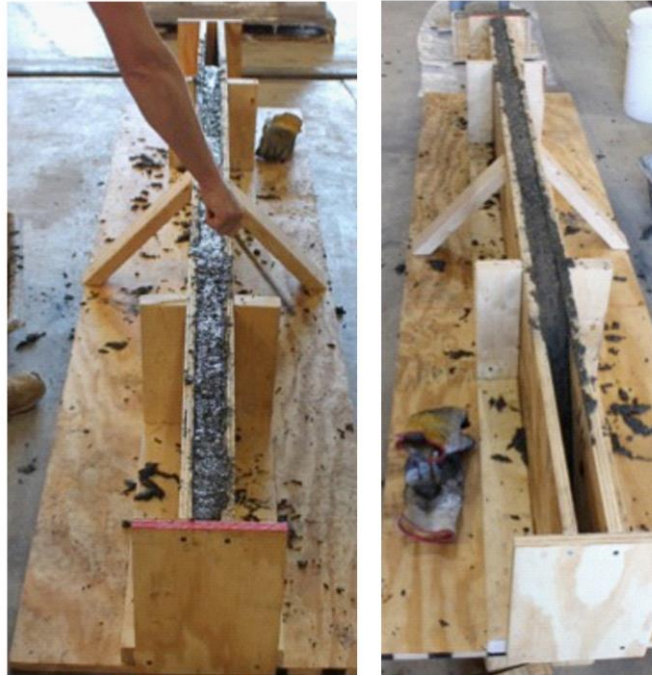
The shear key slope flow test was designed to replicate the depth and slope of the shear keys along the length of the Buffalo Branch Bridge to determine if the shear key at the low end of the bridge would need to be covered to prevent the VHPC-Small from overflowing. A 1.5 in x 12 in x 8 ft box was made and initially placed on supports at the same 0.8% grade slope as the bridge. The VHPC-Small was placed in the top of the slot starting at the low end and moving to the high end. Because the VHPC-Small did not overflow on the low end after 5 min with continued tapping on the sides to agitate it, the elevation difference was changed to 5 in to represent the full elevation change of the bridge. This resulted in a 5% slope for the box. The shear key slope flow test is shown in Figure 17.

Figure 17. Shear Key Flow Test

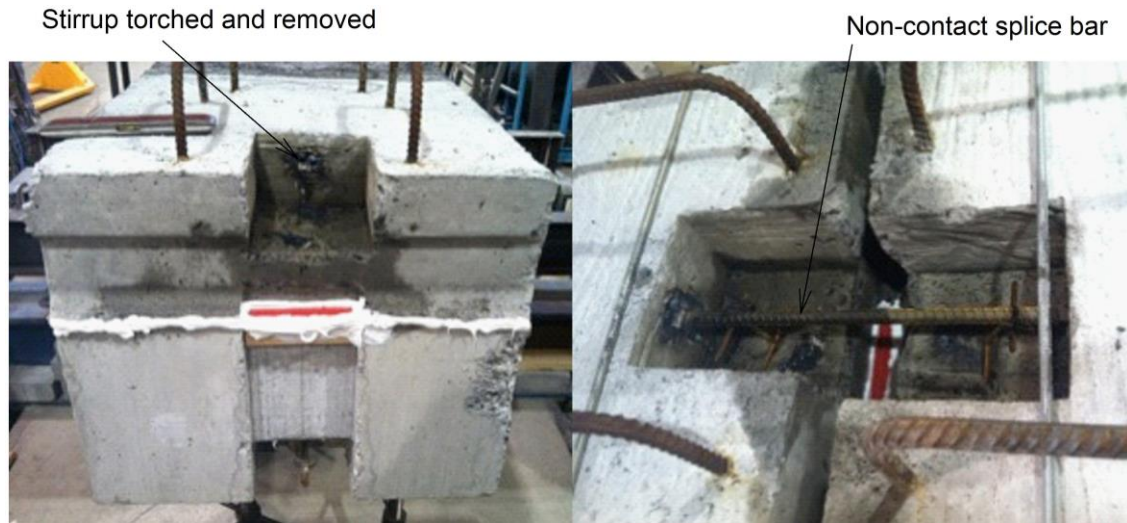
Figure 20. Non-Contact Voids Slab Connection

Halbe (2014) and Joyce (2014) worked to develop durable adjacent member shear key details for new construction using blockouts that exposed part of a transverse bar in adjacent members, which could be tied together by a splice bar across the longitudinal joint (as suggested in Figure 4). At the conclusion of Joyce's work, there was one extra sub-assembly of voided slab sections remaining and this specimen was used to investigate the non-contact lap splice connection. The specimen was modified by cutting the exposed transverse bars and placing a short piece of reinforcing steel in the otherwise empty blockout. This created a non-contact lap splice between the drop in bar and the nearest stirrup approximately 4 in away, while otherwise maintaining the conventional shear key. This modification represented the detail to be used in the retrofit of an existing structure designed with adjacent box beams. A schematic of the sub-assembly and test set-up is shown in Figure 19. The joint and shear key were filled with VHPC-Large. The connection pocket can be seen in Figure 20 with a non-contact splice bar in place.

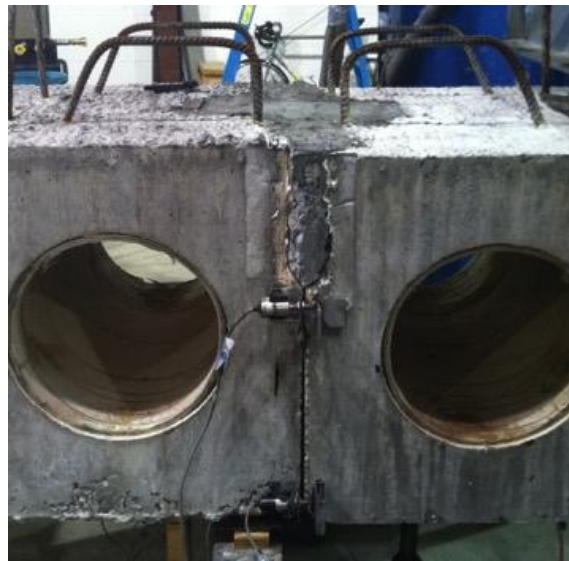
Figure 21. Joint Instrumentation

Joyce's finite element modeling of both a representative voided slab bridge and the sub-assembly helped to determine that the transverse tensile stresses in the shear keys of the bridge system subjected to an AASHTO design truck loading could be replicated by imposing a vertical displacement of 0.03 in on the sub-assembly specimen supported by W8x15 beams. The sub-assembly was instrumented with LVDTs at the bottom of the shear keys on both sides of each joint, which can be seen in Figure 21. The purpose of the LVDTs was to monitor the joint opening during the testing.

Testing began with an initial static test in which the center voided slab was lowered to a vertical displacement of 0.03 in and then raised back up by 0.03 in so that the specimen returned to its initial "zero point." After the initial static test, cyclic tests began by lowering the specimen by 0.015 in and then cycling the deflection between 0.03 in and the "zero point" at a frequency of 3 hertz. Static tests were performed after each group of cycles, with the groups being 10, 100, 1,000, 10,000 cycles, and then every 100,000 cycles until the test reached 1,000,000 cycles.

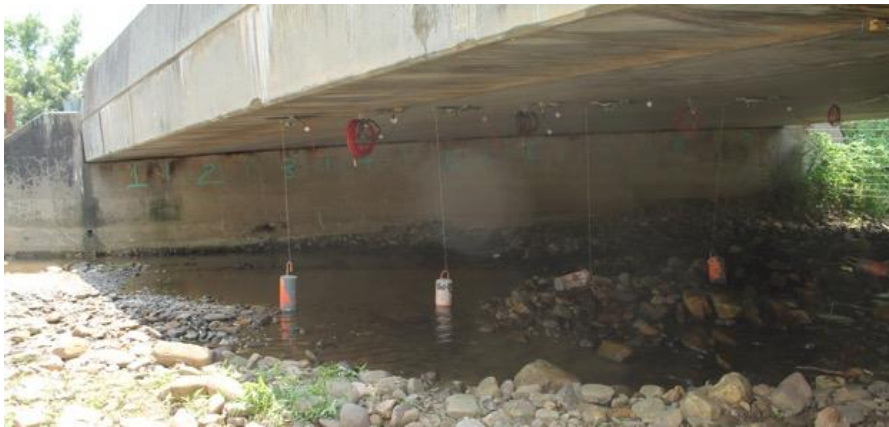
Figure 23. Concrete Cylinders Weighing Down Wires Used for Pre-deflection

the deflection, the deflectometers were calibrated in the lab by correlating recorded strain values with known deflections of the end of the cantilever. In the field, the deflectometers were attached to the bridge by gluing the metal feet to the box beam members. The end of the deflectometer cantilever was pre-deflected using a high-strength wire tied down to a concrete cylinder sitting on the ground, as shown in Figure 23. In this way, when a truck load was applied and the bridge deflected, the deflection of the cantilever tip was reduced, which reduced the strain recorded by the gauges.

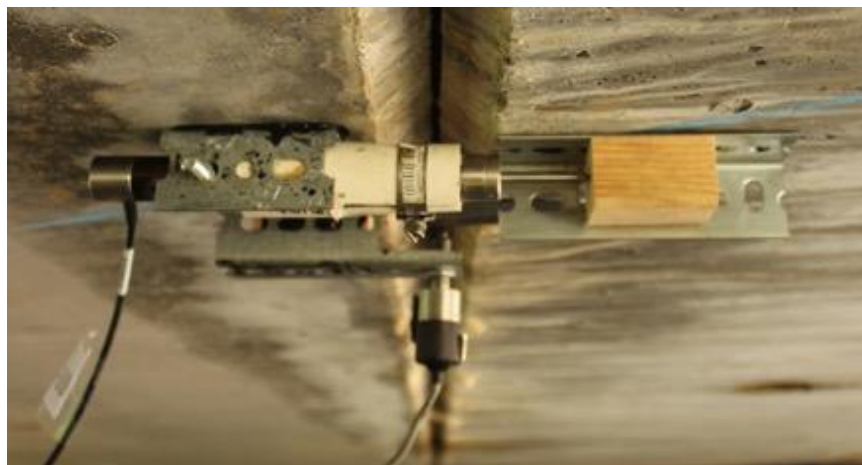
Figure 24. Horizontal LVDT

LVDTs were used to measure the horizontal and vertical relative displacements of adjacent box beam members, and were strategically placed at the location of the highest expected relative girder displacements. The horizontal LVDT was glued to the bottom edge of a box beam and a wooden block was glued to the bottom edge of the neighboring box beam so that the LVDT measured differential horizontal movement between the two box girders. Likewise, the vertical LVDT attachment was glued to the bottom edge of a box beam and a piece of steel was glued to the bottom edge of the neighboring box beam such that the vertical LVDT was in contact with the plate at the center of the joint. See Figures 24 and 25 for the horizontal and vertical measurements setups, respectively.

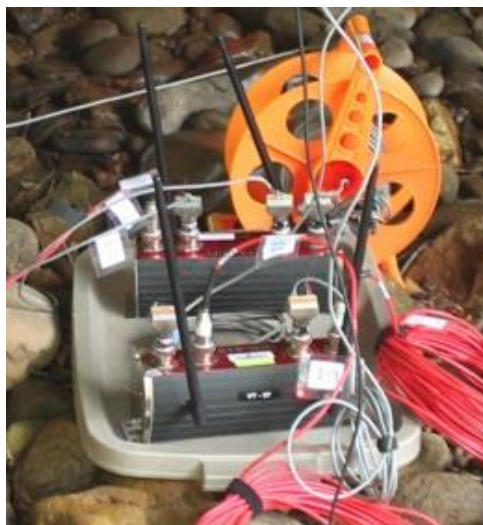
Figure 28. BDI Nodes

The data acquisition system (DAS) and software used was the Structural Testing System (STS) by BDI. The STS consisted of three main components: the computer software, DAS base station, and nodes. The sensors were wired directly to the nodes, shown in Figure 28. Each node was capable of connecting to four sensors. The BDI nodes transmitted the data wirelessly to the computer through the DAS base station.

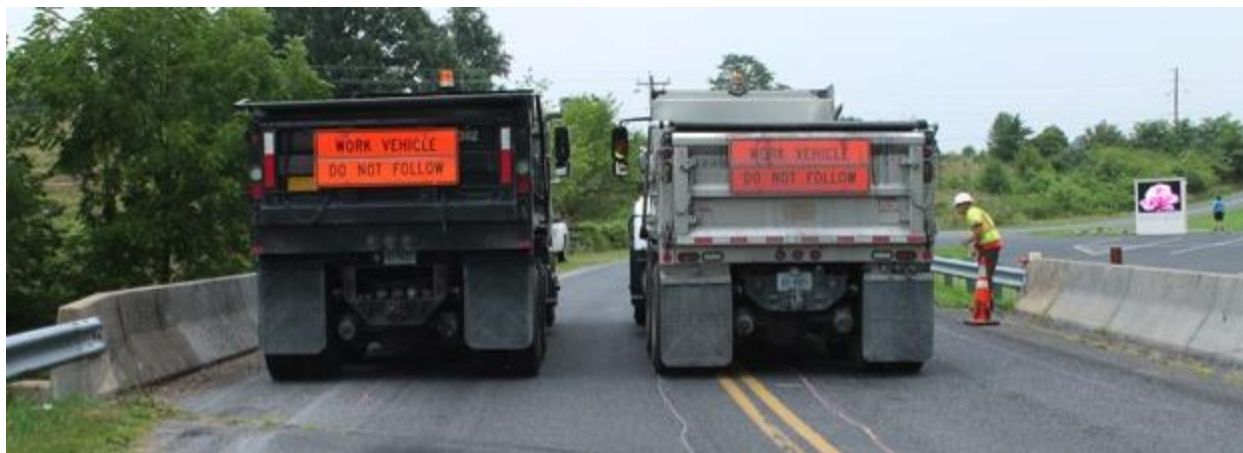
Figure 29. Marking Location of Truck(s)

A total of six quasi-static load cases were tested, each in three separate runs. Brightly colored chalk lines were drawn on the bridge deck at the joints, marking the outside edge of the front left tire of the load truck(s), which traversed the bridge at the slowest possible speed of two to three mph, as shown in Figure 29.

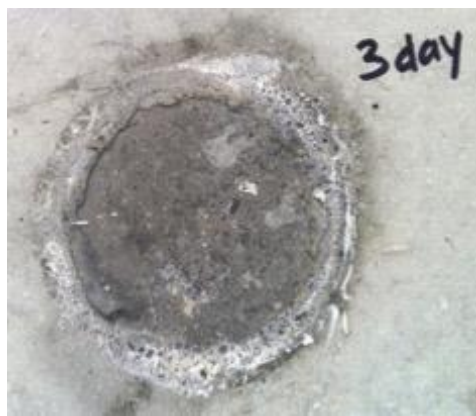
The typical failure mode observed in the VHPC at two days to five days was substrate failure B, in which the bond failed at the cement paste but was not strong enough to fracture the aggregate, as depicted in Figure 58.

Figure 58. Typical VHPC 2-Day to 5-Day Failure

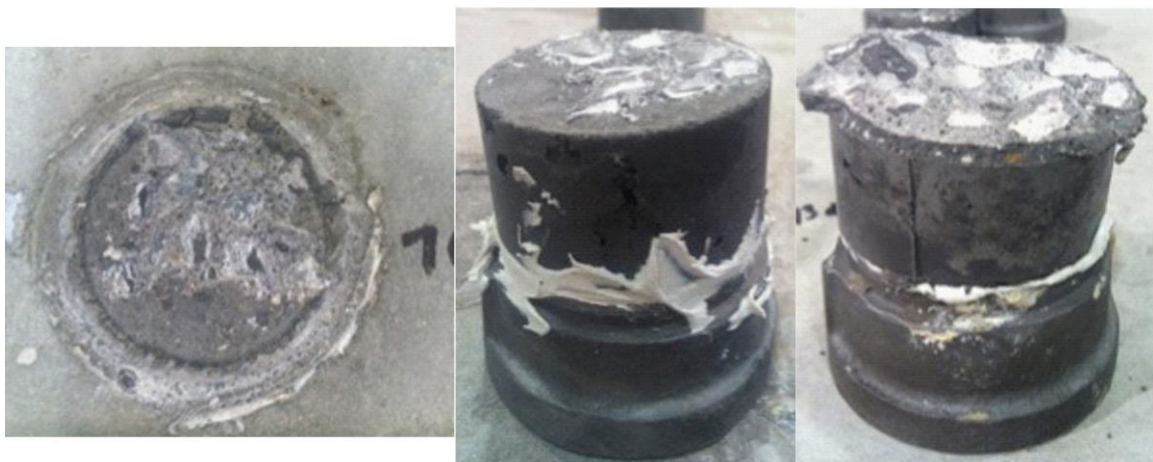
The typical failure mode observed in the VHPC at seven days and older was substrate failure A, in which the bulk of the cement paste was detached along with fracturing the aggregate inside the precast concrete member. This failure type is shown in Figure 59, where the left two pictures were taken at seven day tests and the picture on the right was taken at 28 days.

Figure 59. Typical VHPC 7-Days and Older Failure

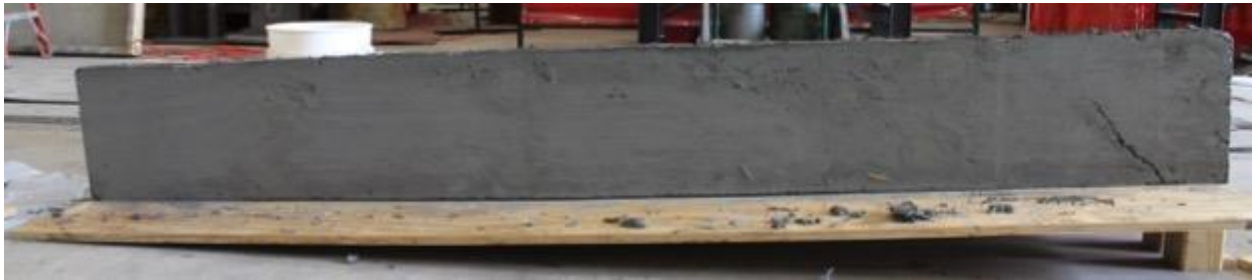
Figure 62. Shear Key Flow Test Overall After Removing the Formwork

The results from the shear key flow test with the VHPC-Small mixture are shown in Figure 62. Placing the VHPC-Small began in the low end and moved toward the upper end. The majority of the shear key was continuously placed; however, the upper end was placed after a fifteen minute break. The transverse slope of the geometric cutouts was also found to not cause the VHPC to overflow on the low end. A picture of this is shown in Figure 62 where the VHPC-Small is still level after being placed on an incline.

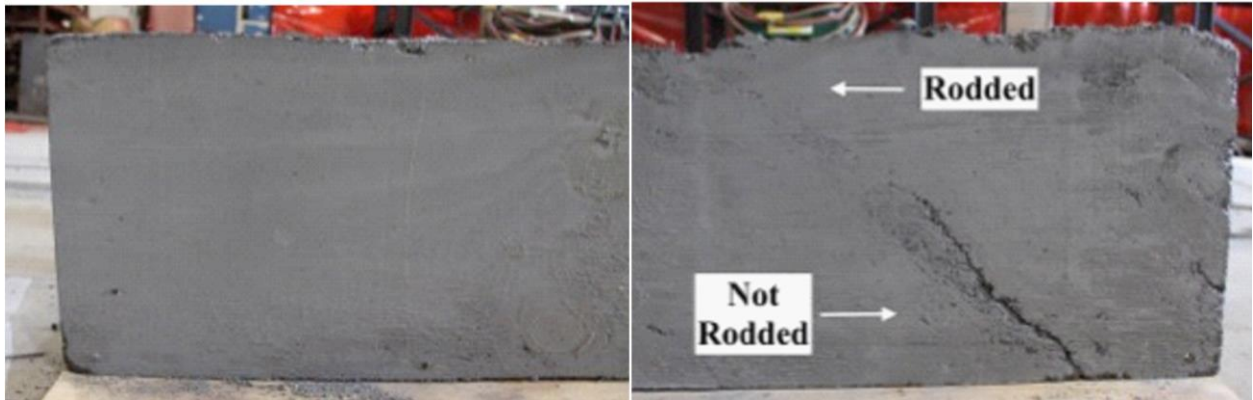
To examine what happened when two batches were placed next to each other, the top half of the joint was rodded while the bottom half was not. The results of this are shown in Figure 63. As can be seen, a cold joint formed on the bottom half of the upper end where the two batches were not rodded together.

Figure 63. Shear Key Flow Test Lower End (Left) and Upper End (Right)

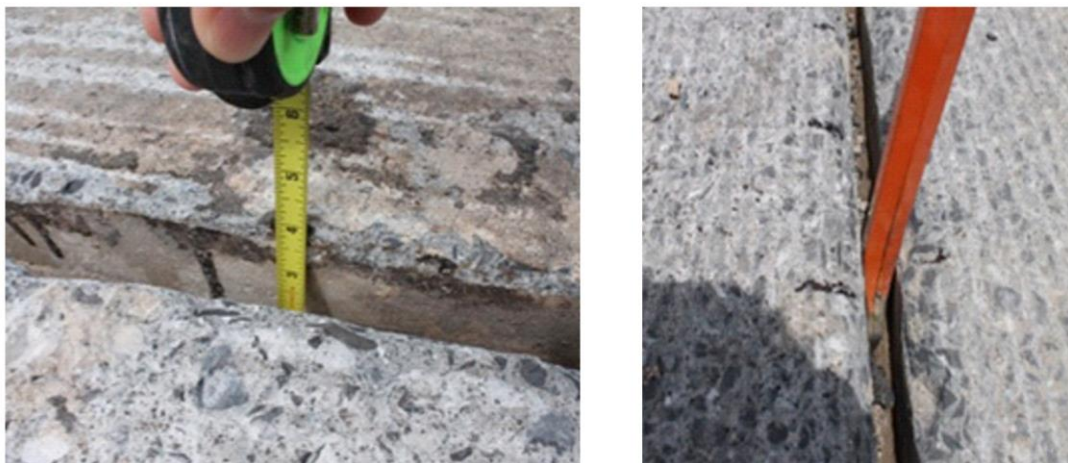
Figure 91. Typical Depth of Cleared Joints and Removing Grout from Joints with (a) Bonded Grout and (b) Deteriorated, Sandy Grout

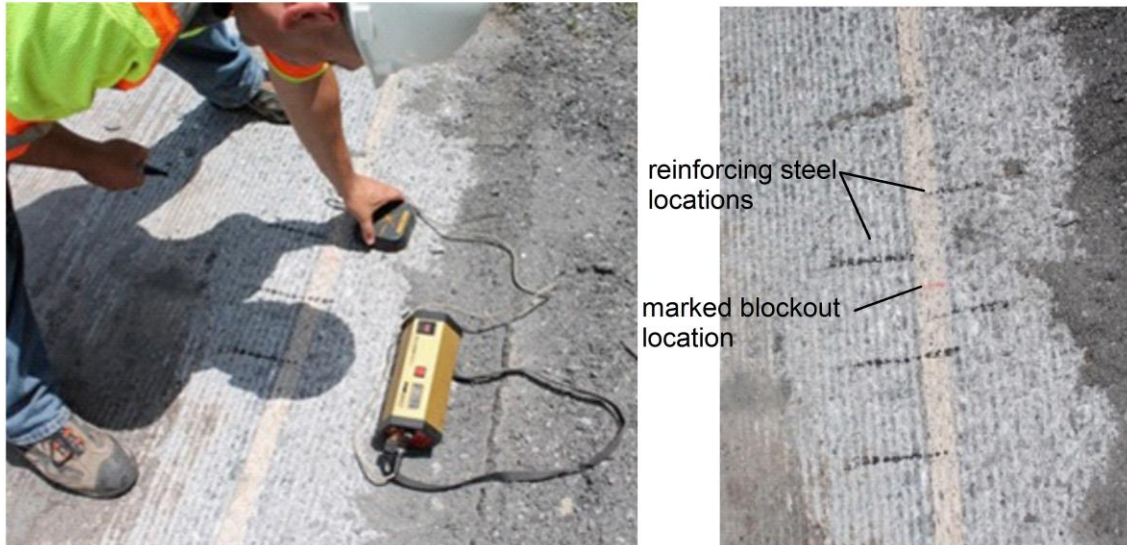
Figure 92. Locating Steel with Pachometer and Marking

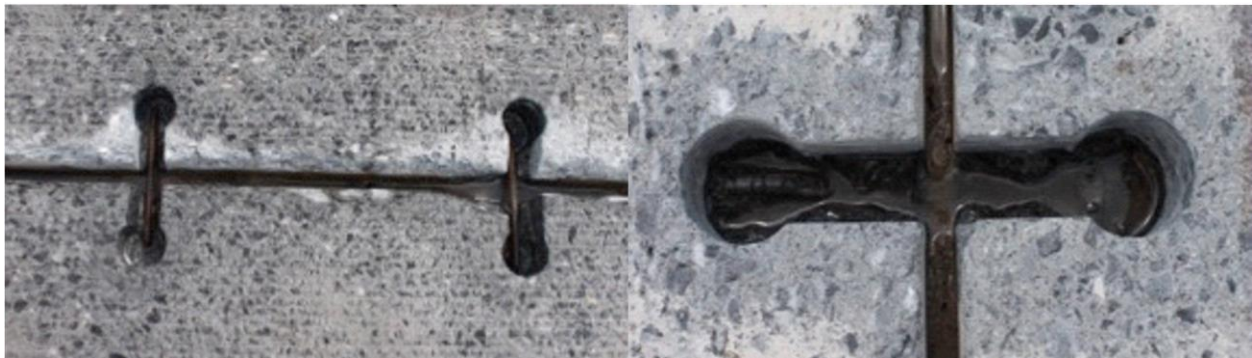
Figure 93. Dog Bones

Cutting the dog bones took approximately 20 minutes each, starting with coring both ends of the shape using a 3-in core drill. Next, the contractor cut the middle portion of the dog bone with a circular saw blade, chiseling out the concrete remaining in the shape. Completed dog bone cutouts are shown in Figure 93.

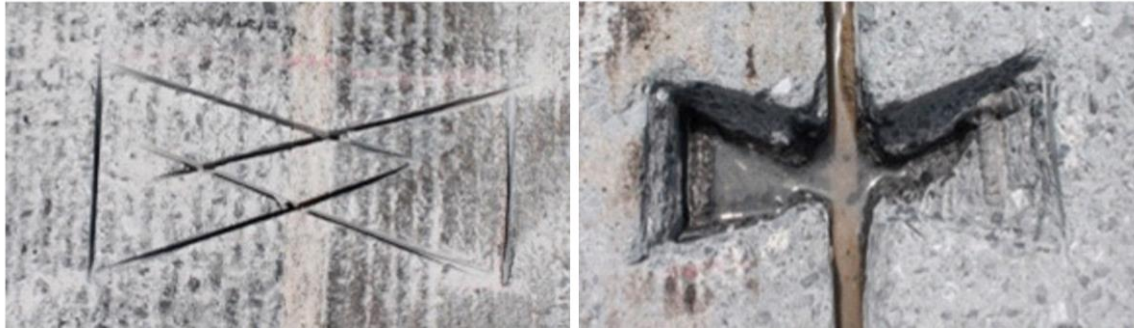
Figure 94. Bowtie Joint

The contractor did attempt to cut one bowtie shape at midspan of Joint 7, shown in Figure 94. Although the cutting took about the same amount of time as the dog bone, the contractor deemed that this shape was too cumbersome because the crews needed to chisel out more concrete in order to avoid cutting completely through the reinforcing steel in the precast concrete member. Thus, the rehabilitation plan was changed to using only the dog bone-shaped cutout for the non-contact splice locations. Furthermore, the plan was changed such that no additional cutouts would be made in Joint 7, and the spacing for the dog bones at Joint 8 was changed from 2 ft to 4 ft. Figure 95(a) shows Joint 1 with dog bones spaced at 2 ft and Joint 2 with dog bones spaced at 3 ft, as specified in the proposed rehabilitation plan except using dog bones instead of bowties. Figure 95(b) shows Joint 7 with only a bowtie at midspan and Joint 8 with dog bones spaced at 4 ft. Note that after cutting the pockets, the joints were sand blasted and sprayed with a hose to create a clean, SSD condition immediately before placing the VHPC.

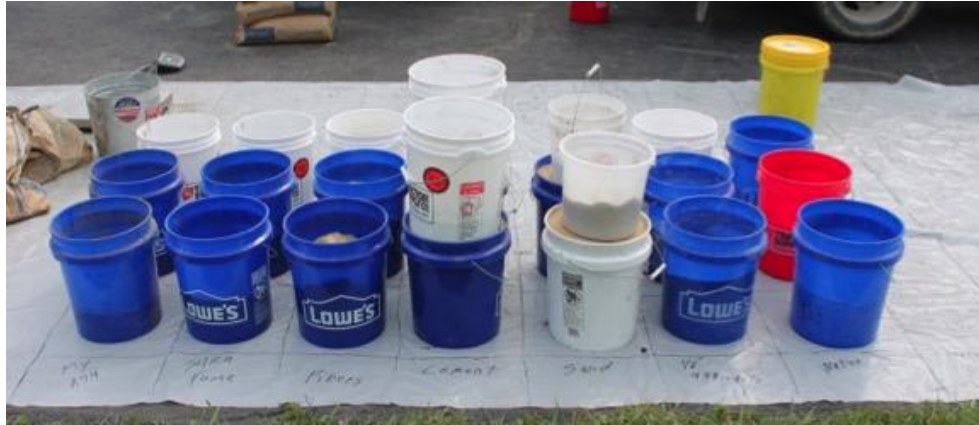
Figure 96. Materials Pre-Weighed

On the first day of placing, the contractor began mixing the first batch of VHPC at 9:30 am, with the hopes of mixing the VHPC before the ambient temperature increased to the point of affecting the working time of the VHPC. Before mixing, the contractor weighed out the required amount of each material in buckets and aligned them on a tarp with a chart outlining the materials and batch number, shown in Figure 96. Doing so allowed for the mixing process to start smoothly.

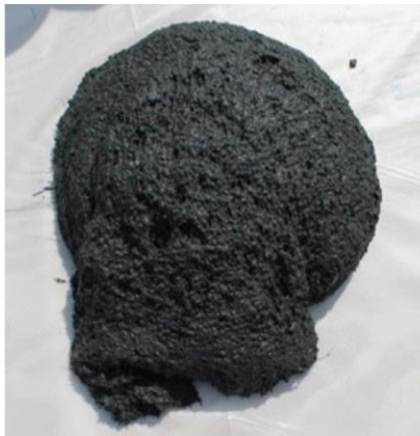
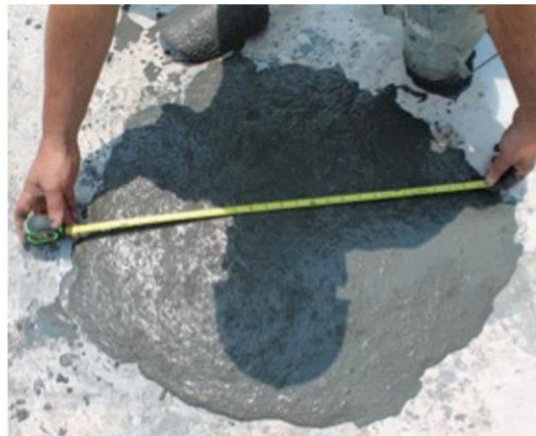
Figure 97. Slump Test, VHPG Too Stiff

After the VHPC was adequately mixed, the inverted slump test was performed to measure the spread. The original slump test from the first batch on day one of placing is shown in Figure 97(a). With a spread of 12 in, the VHPC was too stiff to place, and thus was returned to the mixer with more HRWR and some retarder added to improve the workability of the

VHPG. On the other hand, the original slump test from the first batch on day two of placing had too large a spread at 27 in. Along with the large spread, Figure 97(b) shows evidence of a mortar “halo” surrounding the VHPG. After noticing this halo effect, the materials were examined more closely. Apparently, the sand was not properly covered up overnight, when enough rain had fallen for the sand to be handled into the shape of a ball. The moisture content was determined to be 6.0%. After the amount of mix water was adjusted to compensate for this moisture, the slump tests were in line with the target spread of 18 in to 20 in, as shown in Figure 98.

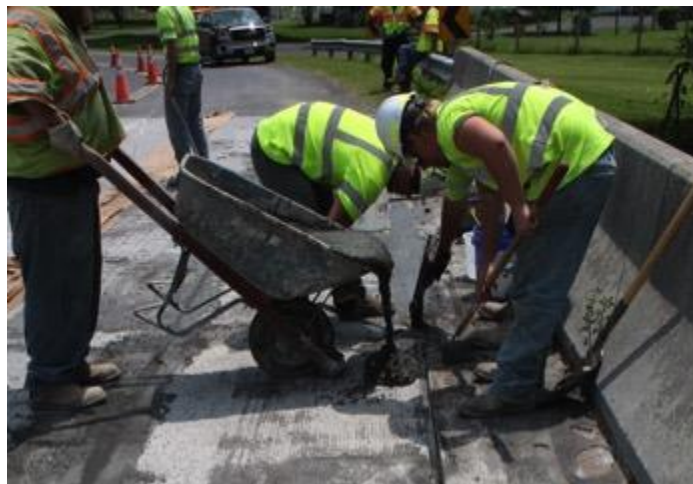
Figure 99. Dumping VHPC from Wheelbarrow

After the workability of the VHPC was determined to be adequate, the wheelbarrow was filled and the VHPC was dumped at the joint, shown in Figure 99.

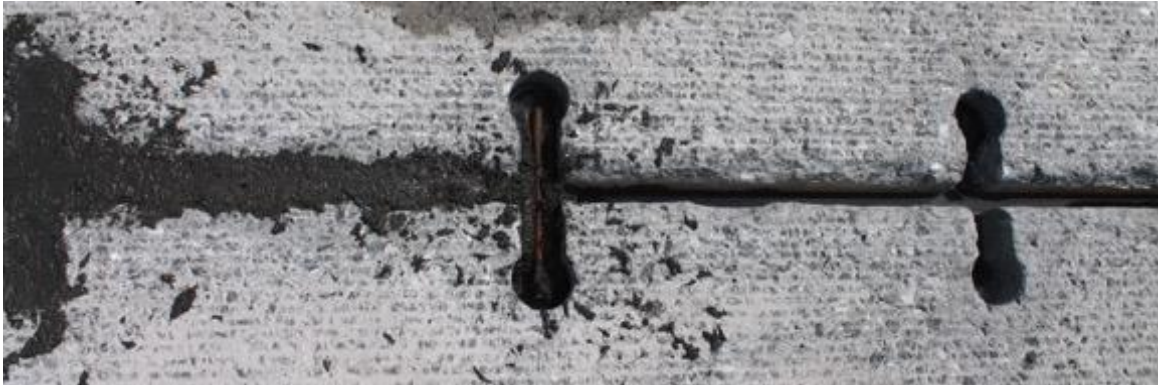
Figure 100. Reinforcing Steel in Dog Bone

Because the contractor did not have chairs on which to support the reinforcing steel above the existing concrete, approximately 1 in of VHPC was placed in the dog bone before the reinforcing steel was set on top of the wet concrete. The contractor then placed more VHPC up to the top of the beams, as shown in Figure 100. To prevent cold joints from forming in between batches, the construction crews rodded the VHPC where the two batches met. After placing VHPC in the entire length of the joint, the construction crew covered the joint with wet burlap for moist curing. As with conventional adjacent member bridge rehabilitation, the joints were allowed to cure overnight while the bridge was open to traffic.

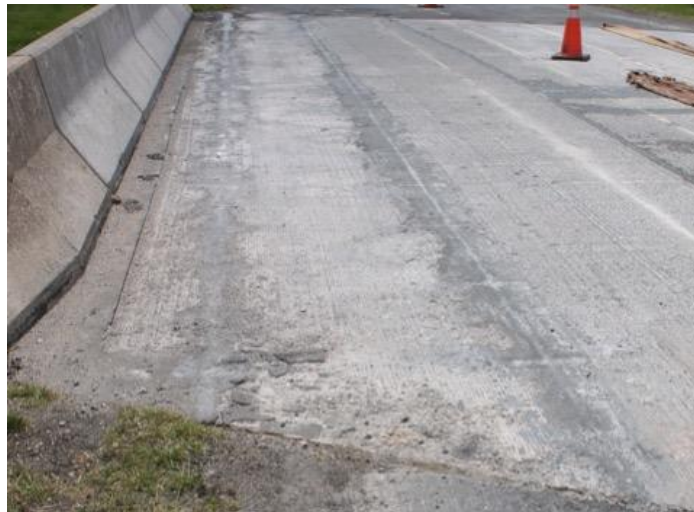
Figure 101. Completed Joints

On day one the downstream joints were completely placed by 12:00 pm and on day two the upstream joints were completely placed by 1:00 pm. At 5:00 pm each day, the traffic lane traveling over the newly placed joints was opened back up. Therefore, the VHPC was allowed to moist cure for five hours on day one and four hours on day two before traffic was directed back on it. Figure 101 shows the downstream joints that were placed on day one after being driven on

from 5:00 pm to the following morning. The joints did not show visual signs of damage due to exposure to traffic this soon after placing the VHPC.
