Use of Surface Treatments to Extend Pavement Life: A Case Study on US 301, Sussex County, Virginia

Final Report VTRC 20-R26

The purpose of this study was to assess the performance of pavement preservation treatments through a highly controlled field trial on US 301 in Sussex County, Virginia. This report documents the installation of a microsurfacing application, a cape seal with a conventional modified single chip seal base, and a cape seal that incorporates a fiber-reinforced (i.e., FiberMat) chip seal base.

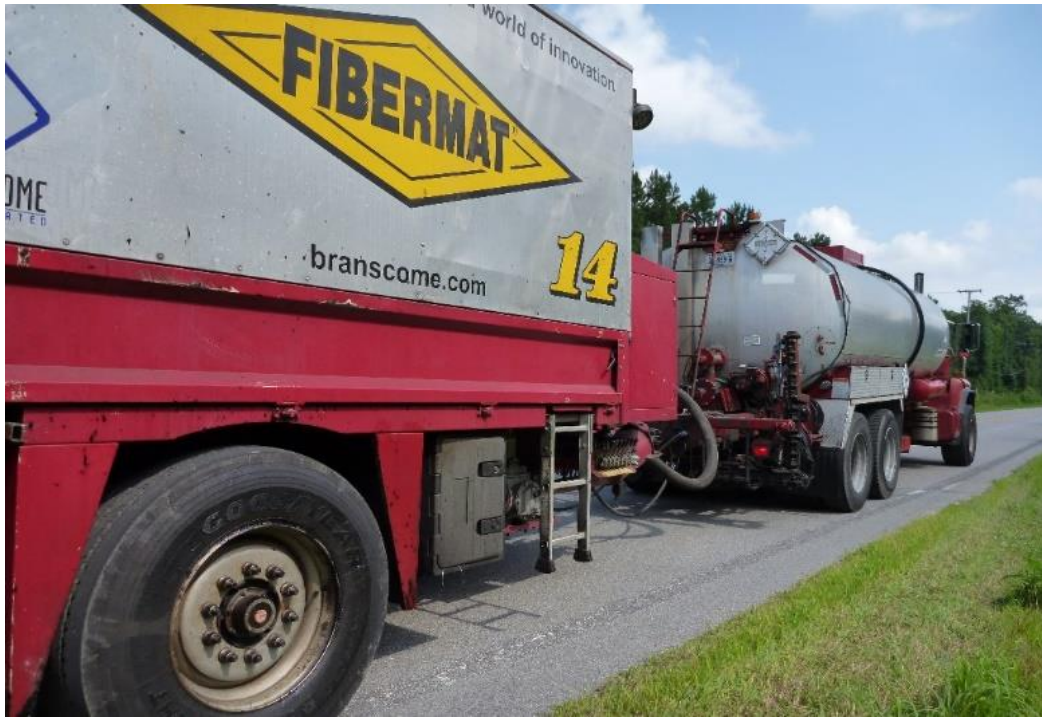
Figure 1 shows the equipment used to apply the FiberMat. It consists of a truck with an emulsion tank and a fiber storage unit. The equipment uses two spray bars with nozzles to spray the emulsion. It also has cutting units between the spray bars, which cut and distribute the glass fibers on the initial emulsion layer (FiberMat, n.d.). The second layer of emulsion encapsulates the fibers into a single membrane layer. Figure 2 illustrates the process of spraying polymer-modified asphalt emulsion and glass fibers on the existing pavement using rows of spray nozzles. Figure 3 depicts the fibers used for the process. The asphalt emulsion used provides the waterproofing membrane, and the glass fiber strands increase its ability to withstand stresses and enhance the tensile properties. Fibers are applied at a nominal rate of 2 to 3 oz/yd², depending on the severity of the cracking. The asphalt emulsion is applied in two simultaneous applications that total 0.4 to 0.6 gal/yd² (Midland Asphalt Materials Inc., n.d.).

Figure 1. Fibermat Placing Equipment

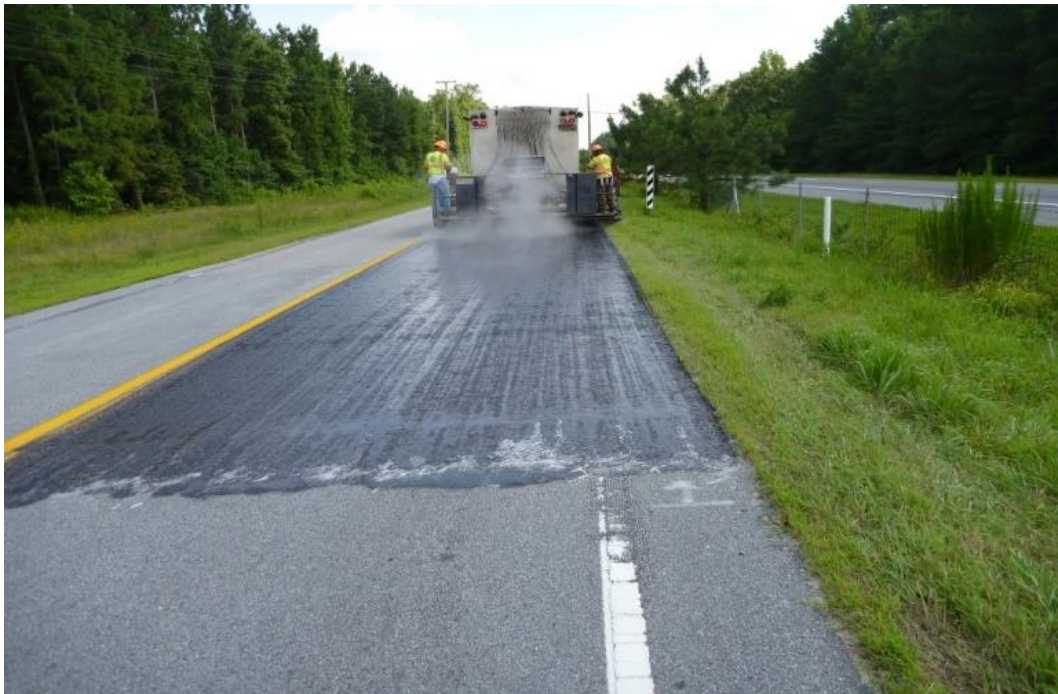
Figure 2. Placement of Fibers and Emulsion

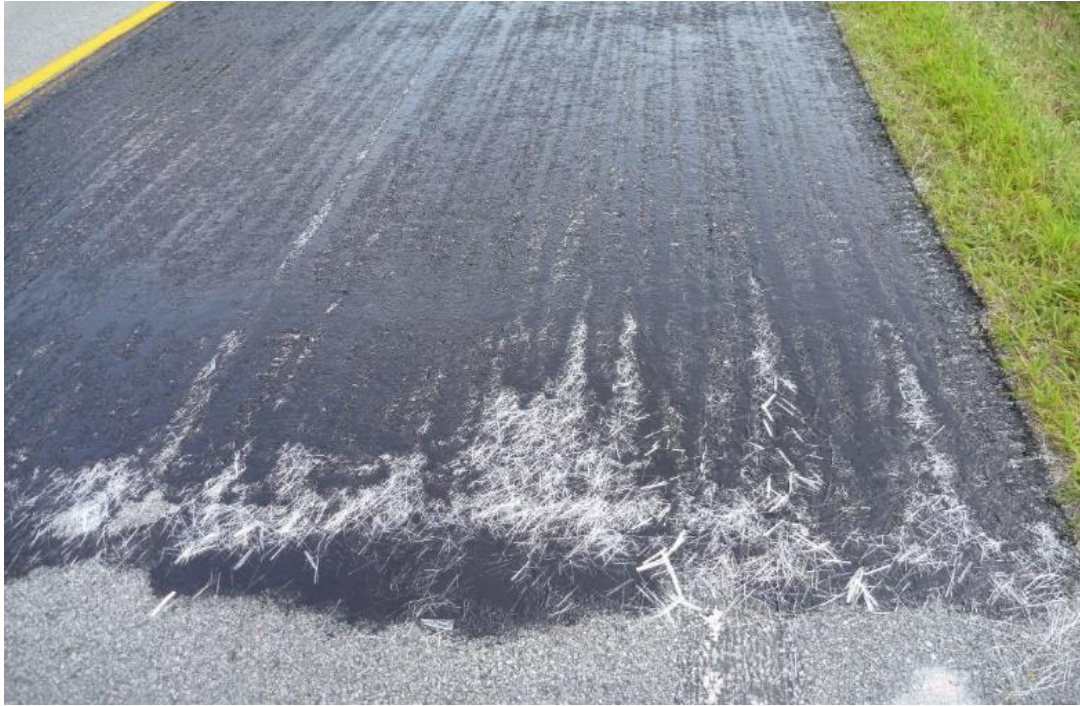
Figure 3. Placement Showing Fibers at Beginning of Section

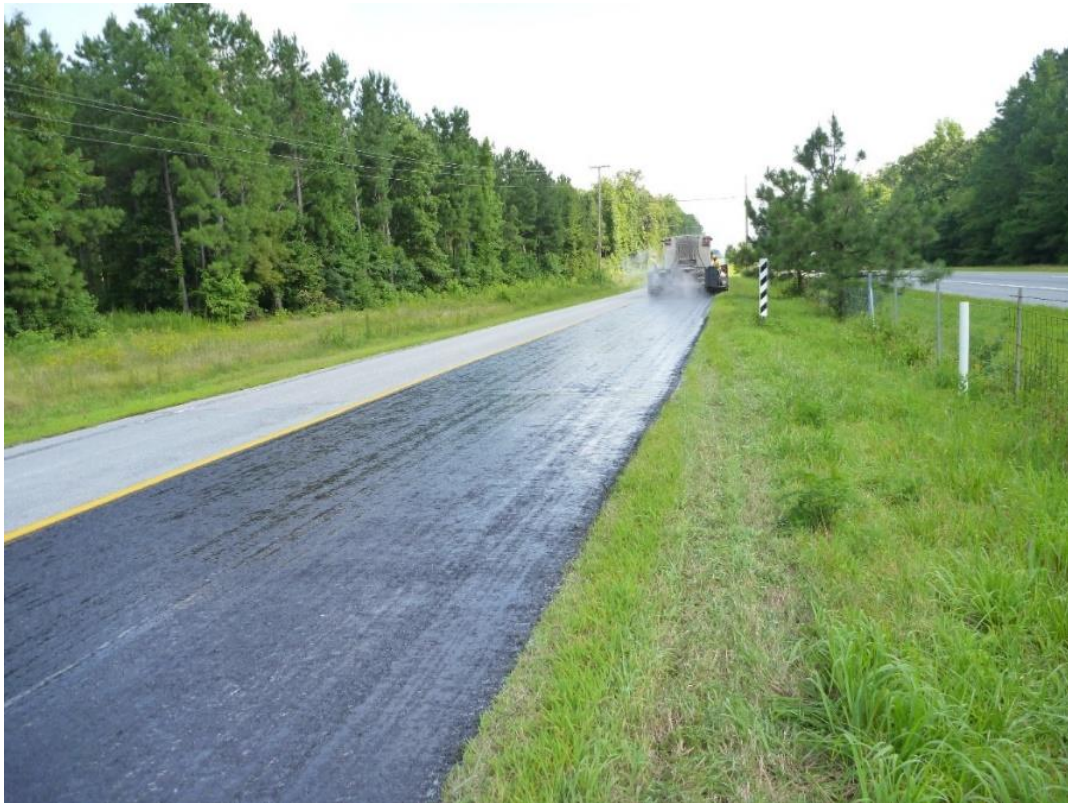
The final step in the process includes the application of an aggregate layer. Figures 4 through 6 show the intermediate application of emulsion with fibers, final surface aggregate spreading, and static compaction using steel rollers, respectively. A typical aggregate application rate of 17 to 25 lb/yd² was used (FiberMat, n.d.).

Figure 4. Emulsion With Fibers in Between

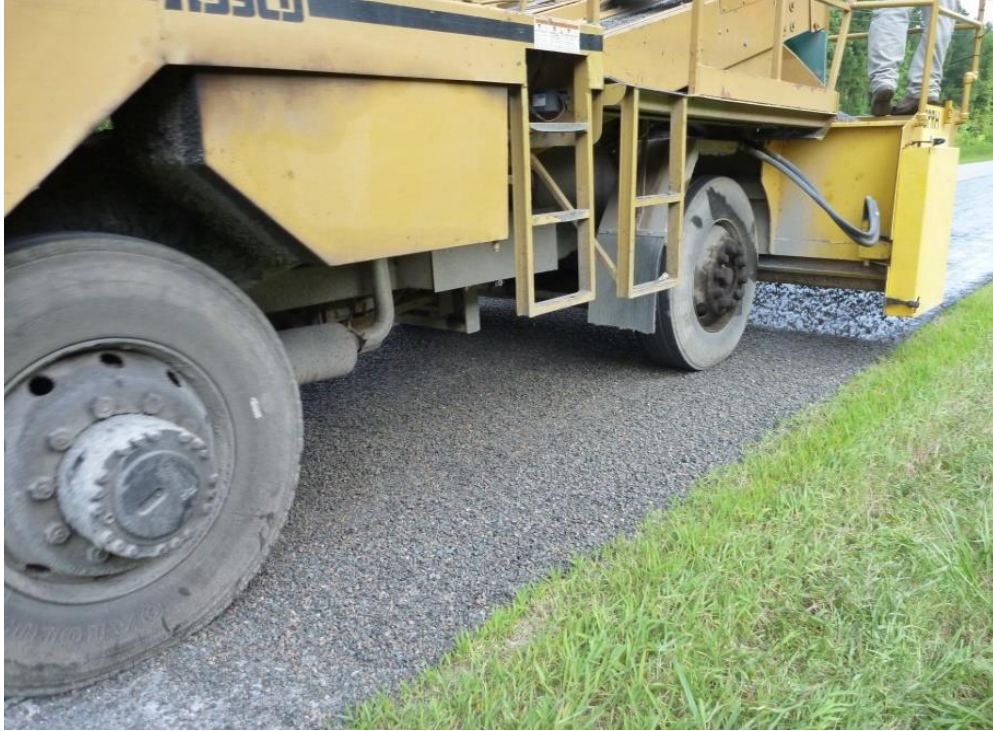
Figure 5. Aggregate Spreading

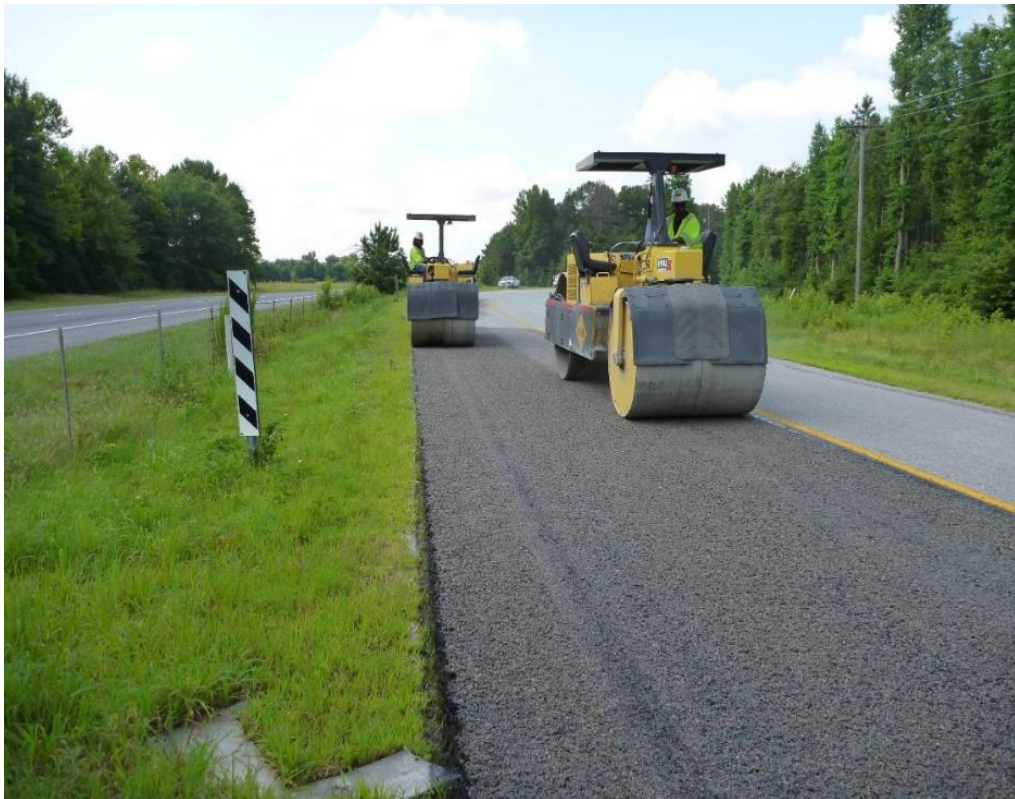
Figure 6. Compaction Using Steel Rollers

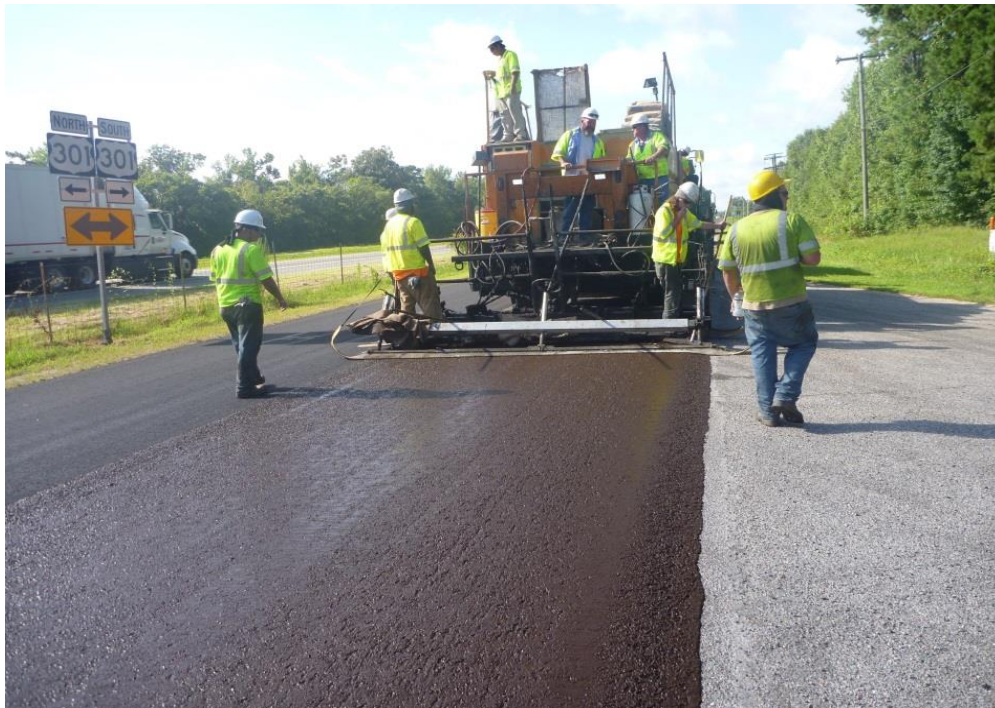
Two weeks after the FiberMat and modified chip seal placement, microsurfacing was applied over the entire pavement test section, providing a consistent final wearing surface for all three subsections. As mentioned earlier, the 0.3-mi section (Section 3, MP 12.12 to 12.42) received only a microsurfacing treatment with no underlying chip seal. Figures 7 and 8 show the microsurfacing placement.

Figure 7. Microsurfacing Placement

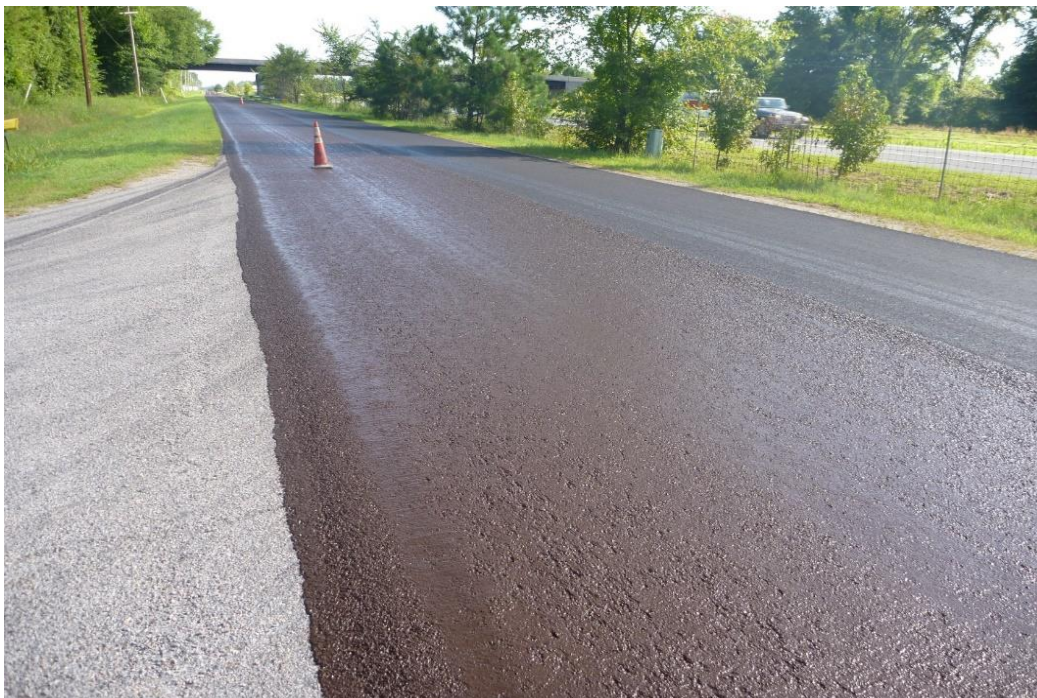
Figure 8. Microsurfacing Before Opening to Traffic

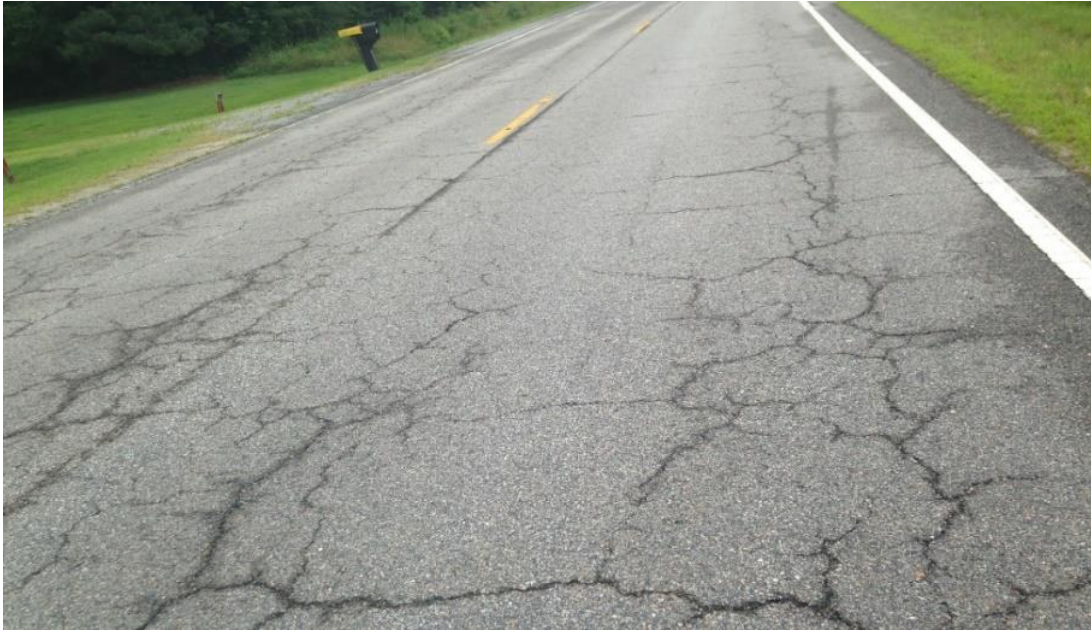
A visual distress evaluation was conducted before treatments. Figures 9 through 11 show the existing pavement surface with different levels of cracking. The majority of the cracks were transverse cracks, longitudinal cracks (both on the wheel path and outside the wheel path), and some localized alligator cracks.

Figure 9. Section With Large Amount of Cracking

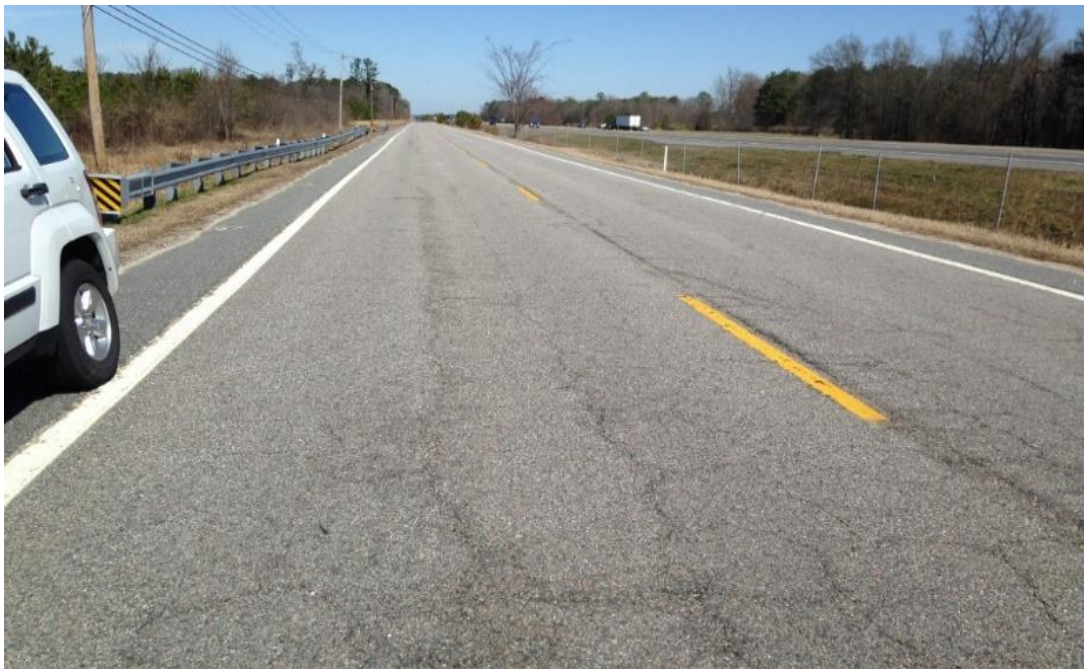
Figure 10. Section With Moderate Amount of Cracking

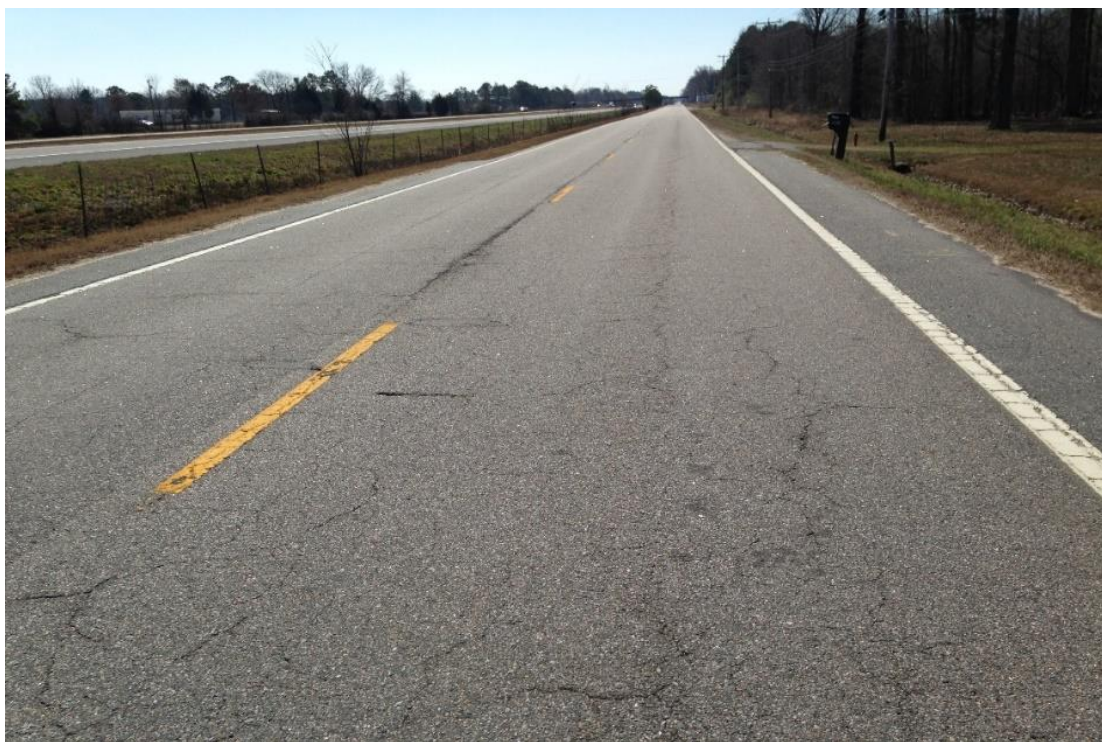
Figure 11. Section With Lower Amount of Cracking

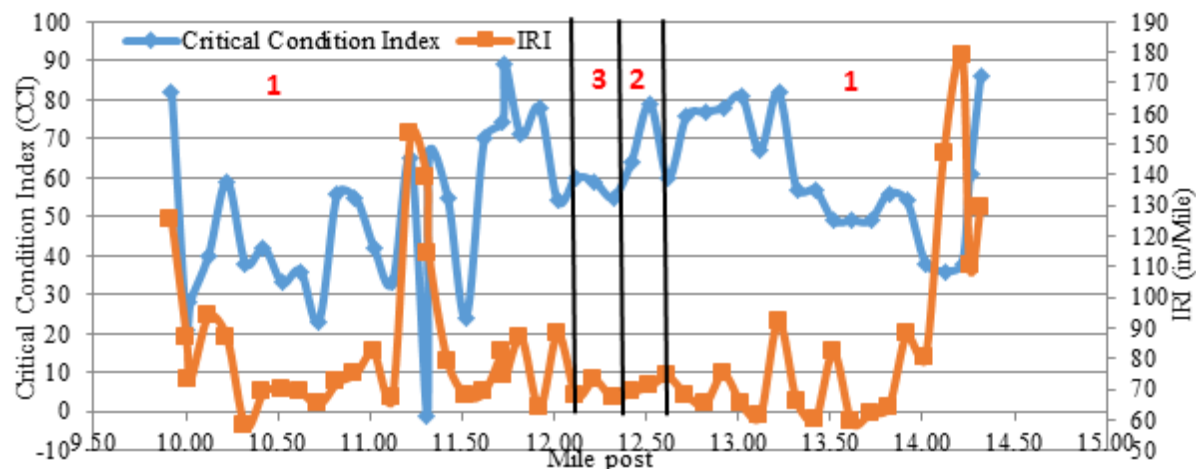
Figure 12 shows CCI and IRI values for the entire section before treatments. In general, IRI values were less than 75 in/mi, indicating relatively smooth pavement. CCI values varied considerably along the entire section. Some sections had values less than 50 (ranging from 20 to 50), and other sections had values in the range of 60 to 80. The majority of the distress identified included alligator cracking and transverse cracking. The average rut depth before treatment was 0.09 in.

Figure 12. Distress Data Before Treatments. Section 1 = fiber-reinforced cape seal; Section 2 = conventional cape seal; Section 3 - microsurfacing.

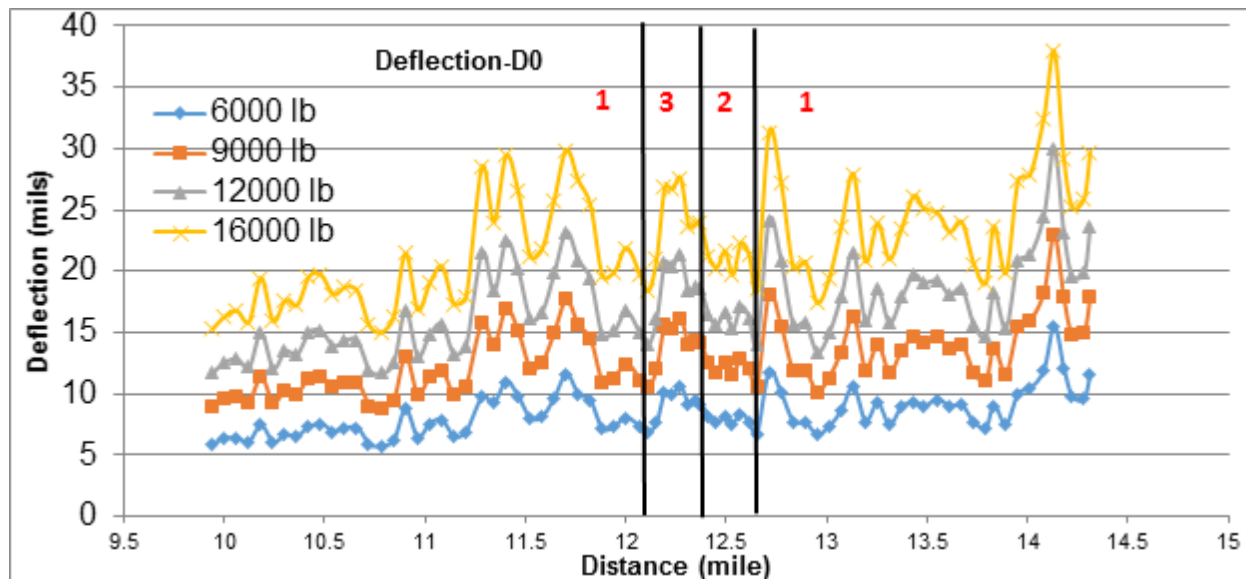
FWD deflection data for the first sensor (D0) and the last sensor (D72) for different load levels are shown in Figures 13 and 14. D0 denotes the deflection at the loading plate, and D72 denotes the deflection at a distance of 72 in from the loading plate. The D0 parameter is an indicator of the overall structural capacity of the pavement system, whereas the D72 parameter is an indicator of the quality of the pavement foundation (subgrade).

Figure 13. Deflection Results From FWD Testing. FWD = falling weight deflectometer; D0 = deflection at loading plate; Section 1 = fiber-reinforced cape seal; Section 2 = conventional cape seal; Section 3 = microsurfacing.

The results in Figure 13 also show the deflection of D0 to be uniform from Station 0 to approximately Station 1.2, with an average of approximately 10 mils (using a 9,000-lb load level), and a bit higher from approximately Station 1.2 to Station 4.4, with an average of approximately 13 mils. Earlier studies showed that these deflection values indicate a strong structural pavement (Diefenderfer et al., 2019; Pierce et al., 2017). Station 4.2 showed high deflection compared to others (23 mils), showing a weaker pavement structure compared to the rest of the pavement. The results in Figure 14 show the pavement foundation to be stiff and uniform with a deflection of approximately 2.2 mils when 9,000-lb loading was used.

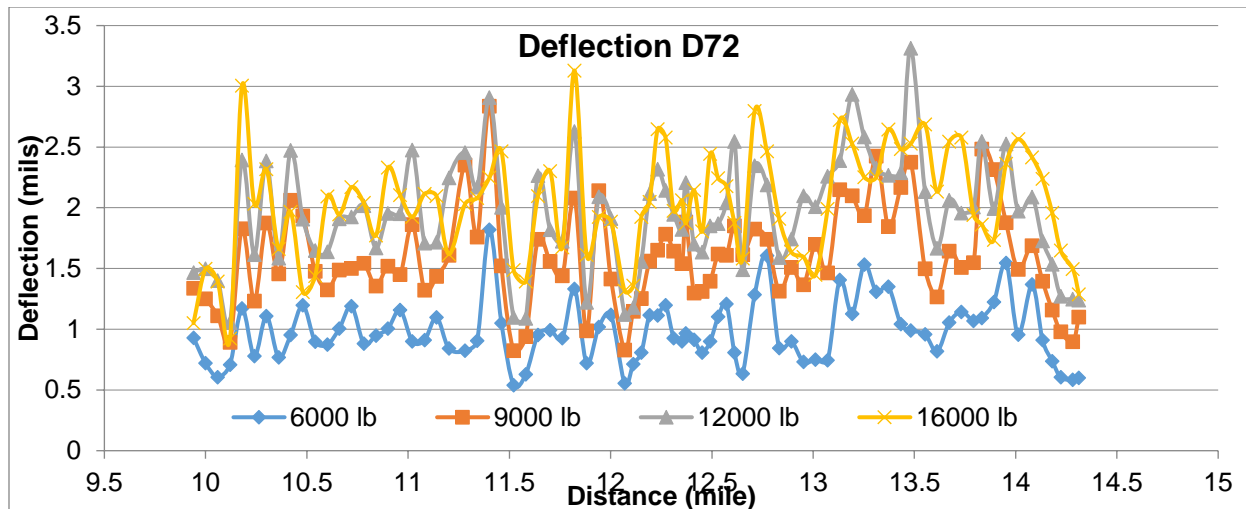
Figure 14. Deflection Results From FWD Testing. FWD = falling weight deflectometer; D72 = deflection at 72 in from loading plate.

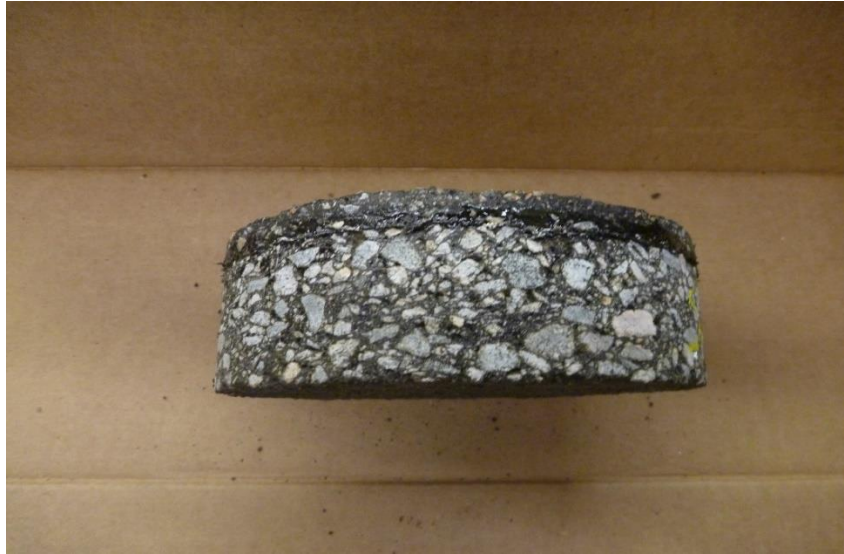
Figures 15 through 17 show cores obtained from fiber-reinforced cape seal, regular cape seal, and microsurfacing sections, respectively. From Figure 15, a clear interface is seen between the existing top asphalt surface and the FiberMat because of thicker emulsion with fibers. Figure 18 shows a surface picture of microsurfacing treatment after curing. Four full-depth cores were collected from the north end of the section, and Figure 19 shows a full-depth asphalt core. Full-depth cores had an average asphalt thickness of 7 in. All full-depth cores were intact (no delamination).

Figure 15. Core Showing FiberMat + Microsurfacing Surface Above Existing Asphalt Top Surface

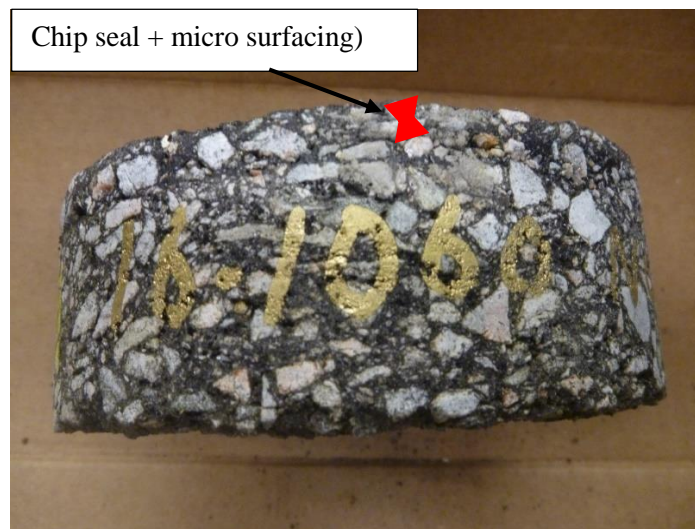
Figure 16. Core Showing Chip Seal + Microsurfacing Above Existing Asphalt Top Surface

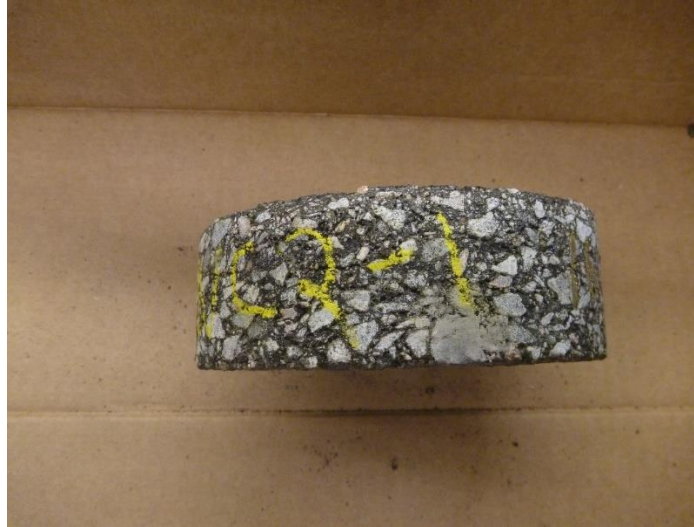
Figure 17. Core Showing Microsurfacing Above Existing Asphalt Top Surface

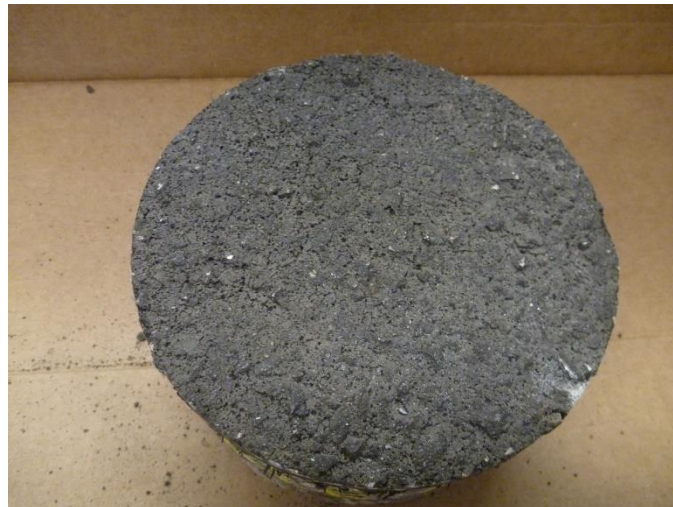
Figure 18. Final Pavement Surface With Microsurfacing

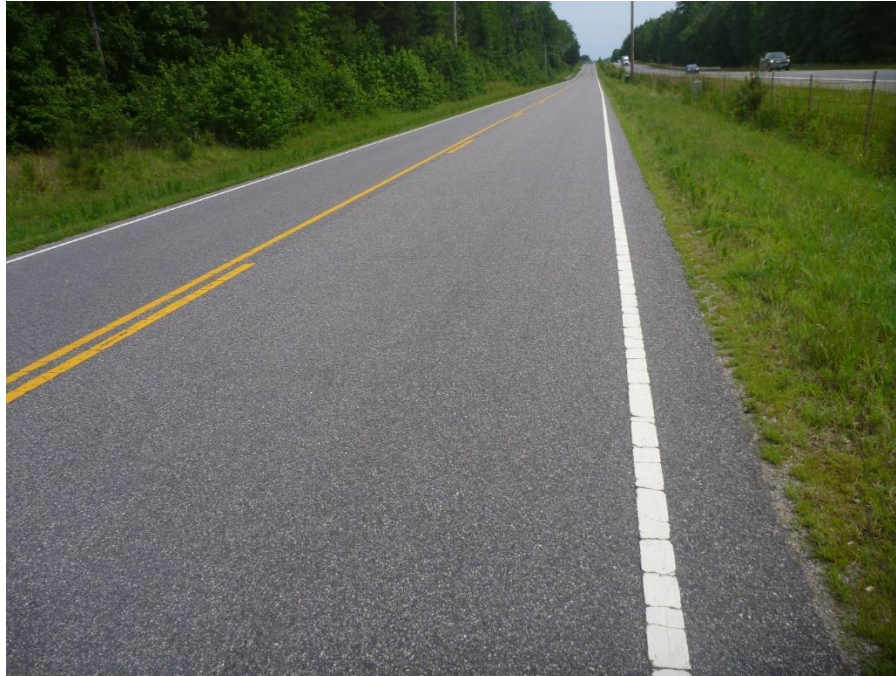
Several visual evaluations were conducted over the first 3 years in service. The annual average daily traffic for US 301, Sussex County, was 612 in the southbound direction and 715 in the northbound direction. Overall, the fiber-reinforced cape seal section (Section 1) is performing well with very little reflective cracking (mostly transverse cracks). Figure 20 shows the fiber-reinforced cape seal surface after 3 years. Figure 21 shows a close-up view of the surface texture of the fiber-reinforced section.

Figure 20. FiberMat With Microsurfacing After 3 Years

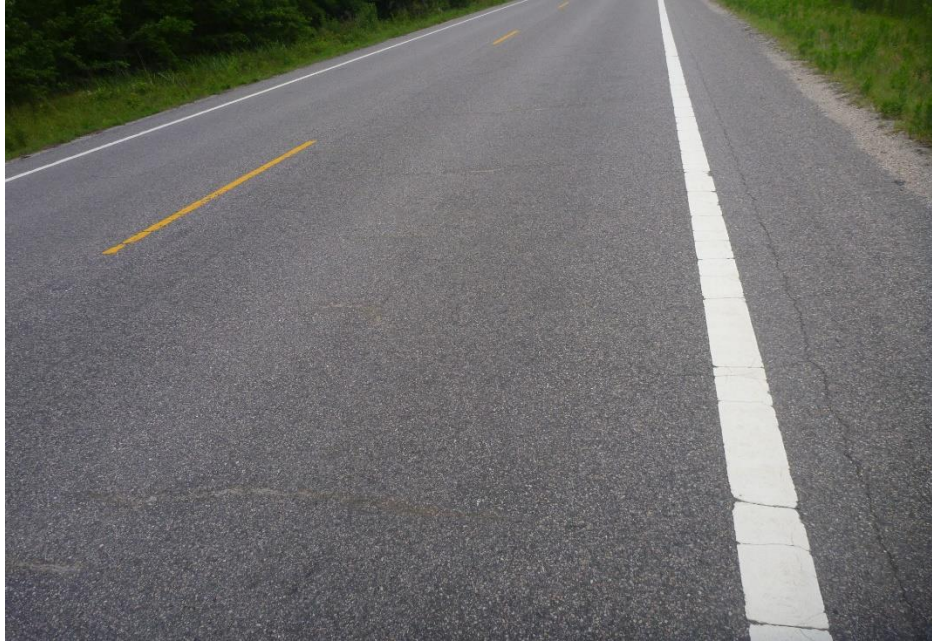
The regular cape seal section (Section 2) was also performing well, but reflective cracking was higher compared to the fiber-reinforced cape seal section (Section 1). Figure 22 shows the modified single seal with microsurfacing after 3 years.

Figure 22. Modified Single Seal With Microsurfacing After 3 Years

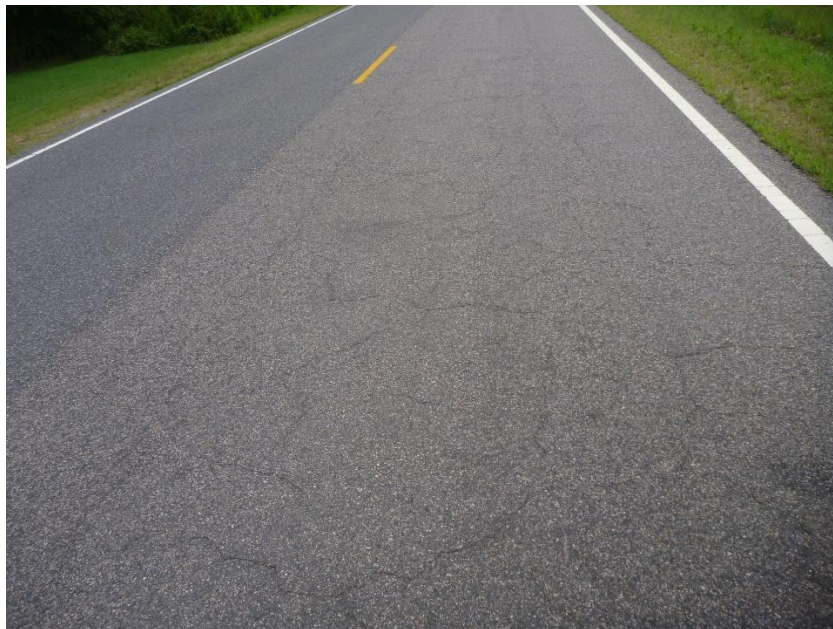
The section with microsurfacing alone showed the largest amount of reflective cracking. Delamination of the microsurfacing was also found in several places. Figure 23 shows the microsurfacing section (Section 3) with considerable cracking.

Figure 23. Microsurfacing Section After 3 Years

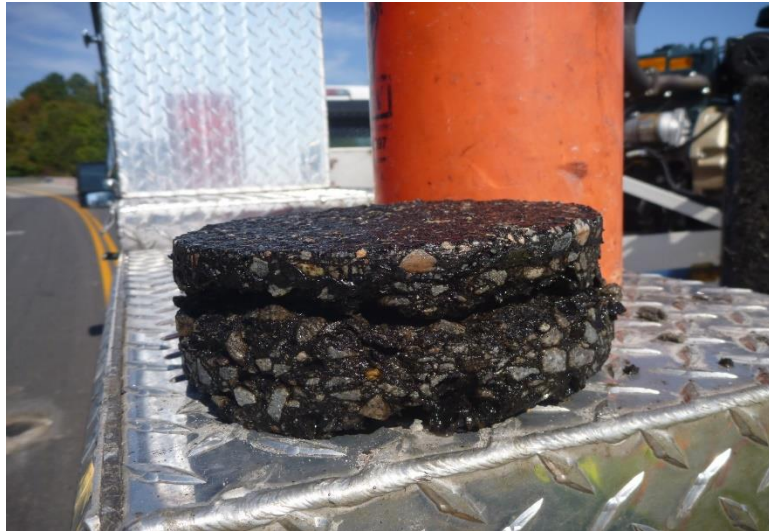
Four months after the treatments, a segment near the end of the northbound FiberMat cape seal section (200 ft long, approximately at MP 14.2) began to exhibit early cracking. FWD testing showed higher deflections in this segment, and a forensic investigation revealed moisture damage and delamination in the underlying asphalt layer, as shown in Figure 24. If subsurface drainage of the pavement is inadequate, moisture and/or moisture vapor can move upward

because of capillary action and saturate the asphalt courses. An impermeable layer on top (such as a microsurfacing treatment) can accelerate the existing moisture damage. The damaged section was removed and patched with new asphalt concrete.

Figure 24. Core Showing Moisture Damage and Delamination

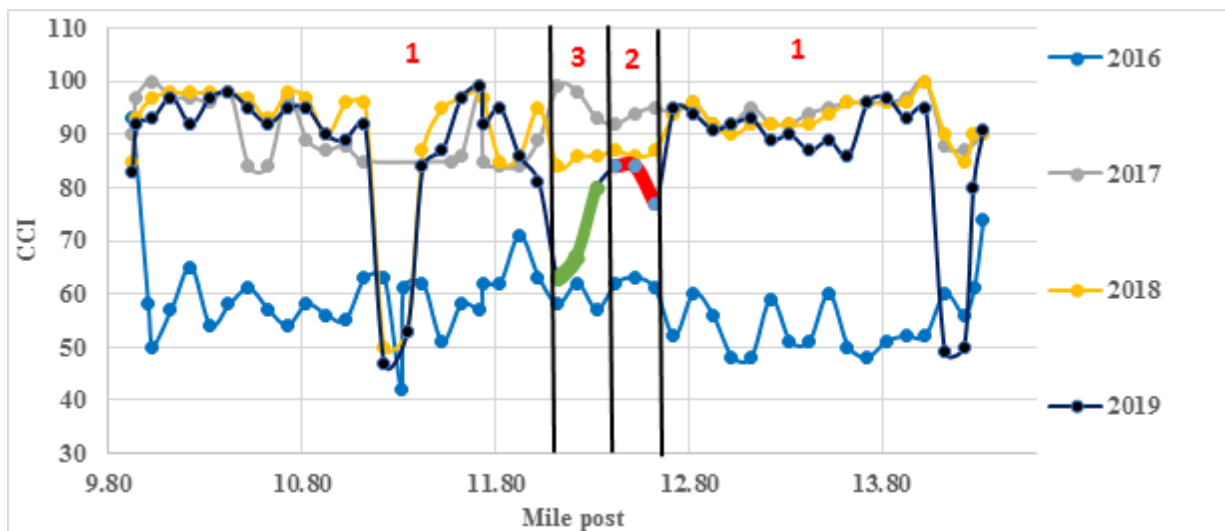
Distress data were collected from VDOT's PMS for 3 years; CCI values are plotted in Figure 25 (2016 data reflect condition state before treatment). It can be seen that, overall, the fiber-reinforced cape seal was performing well, with CCI values above 85 (based on 2019 data). It can also be seen that the CCI for the section with microsurfacing alone had dropped below 80 based on 2019 data. Average rut depth for all sections in 2019 was 0.15 in, and most of the cracks were transverse reflective cracking.

Figure 25. VDOT's PMS Distress Data. Green color in 2019 data indicates microsurfacing-only section, and red color indicates regular cape seal section. Section 1 = fiber-reinforced cape seal; Section 2 = conventional cape seal; Section 3 = microsurfacing.

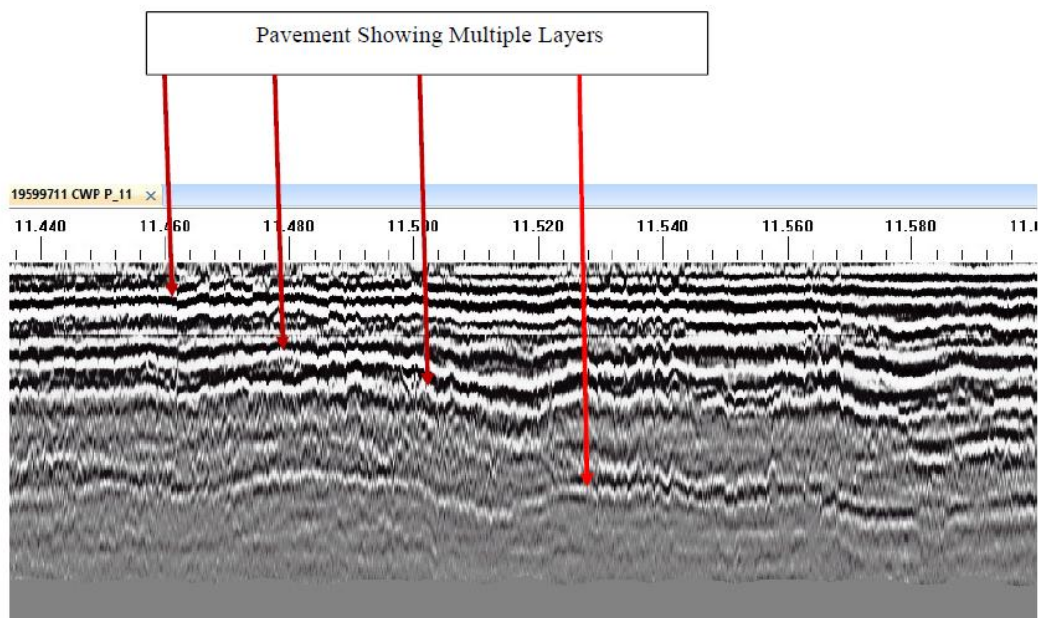
The primary objective of the GPR testing was to measure the thickness of the pavement layers. The layer thickness was summarized by using the average of the data taken at 0.01-mi (52.8-ft) intervals. The data represented by each point is 0.005 mi on either side of the testing point. Multiple layers were observed in the RADAN 7 images. The layer interface at the bottom of the scan image was marked. An example of the processed image with multiple layers was shown in Figure 26.

Figure 26. Sample of GPR Images With Different Layers in Processed RADAN 7 Images. GPR = ground penetrating radar.

Multiple layers were observed in processed RADAN 7 images, and only two layers were marked for this analysis. Layer 1 was assumed to be the bottom of the asphalt concrete, and Layer 2 was assumed to be the bottom of the base (aggregate layer based on construction history). The pavement thickness graphs for 0.01-mi sections were plotted in Figures 27 and 28 for the northbound and southbound sections. On average, the asphalt thickness was 12 in, with an aggregate layer 6 to 7 in thick. As mentioned earlier, limited full-depth cores showed an average asphalt thickness of 7 in; hence, further coring is needed to confirm the thickness.

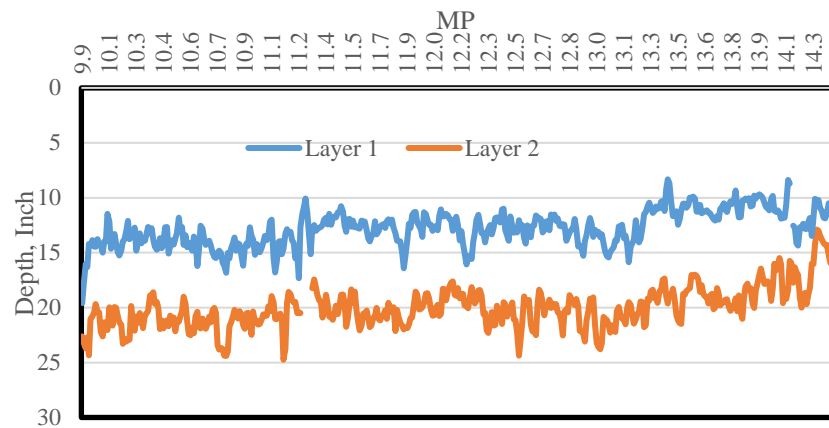
Figure 27. US 301 Northbound Center Line Pavement Thickness Plot

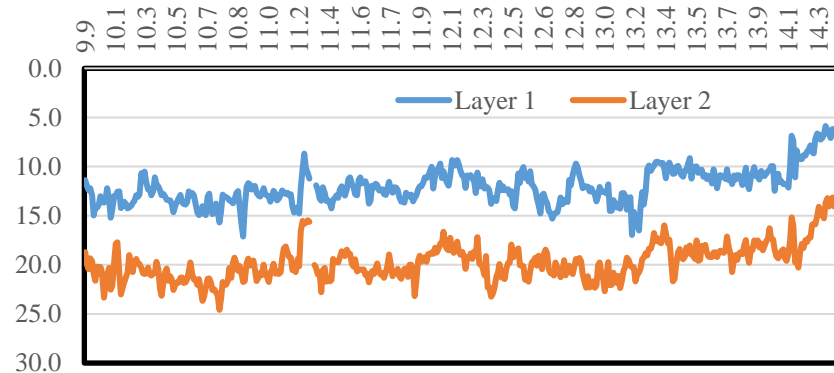
Figure 28. US 301 Southbound Center Line Pavement Thickness Plot

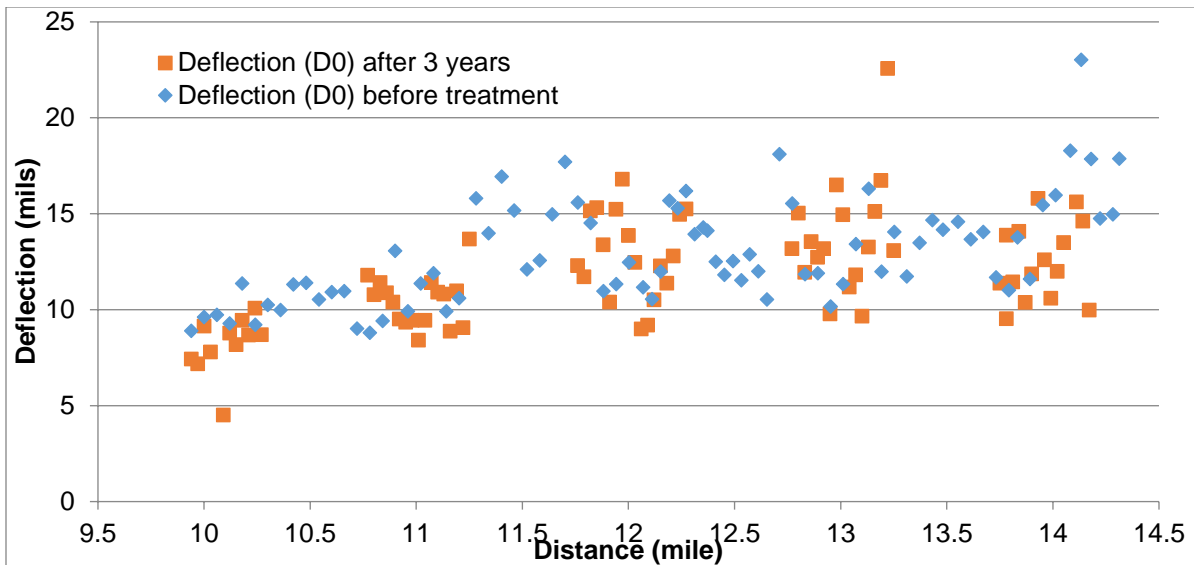
FWD testing was conducted 3 years after treatments. Figure 29 shows D0 deflections before treatment and 3 years after treatment for the sections using the 9,000-lb load. In general, the deflection values were less than 15 mils. When compared to D0 values before treatment, changes in deflection values were not large, indicating the structurally strong section remains in a similar condition as previously tested.

Figure 29. FWD D0 Deflection Data (9,000-lb Load) Before Treatment and 3 Years After Treatment. FWD = falling weight deflectometer.

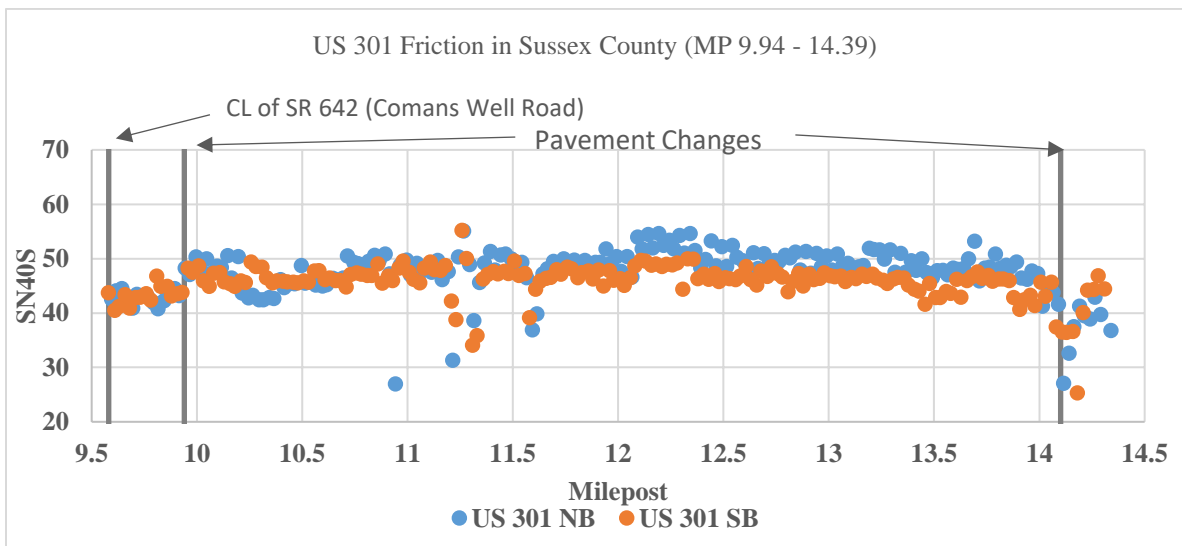
Skid testing results after 3 years are shown in Figure 30. In general, values ranged from 40 to 55. In Virginia, when SNs are less than or equal to 20, measures are usually taken to improve friction. The values were higher than 20, indicating good friction.

Figure 30. Skid Testing Results. SN = skid number; CL = closing line; NB = northbound; SB = southbound.

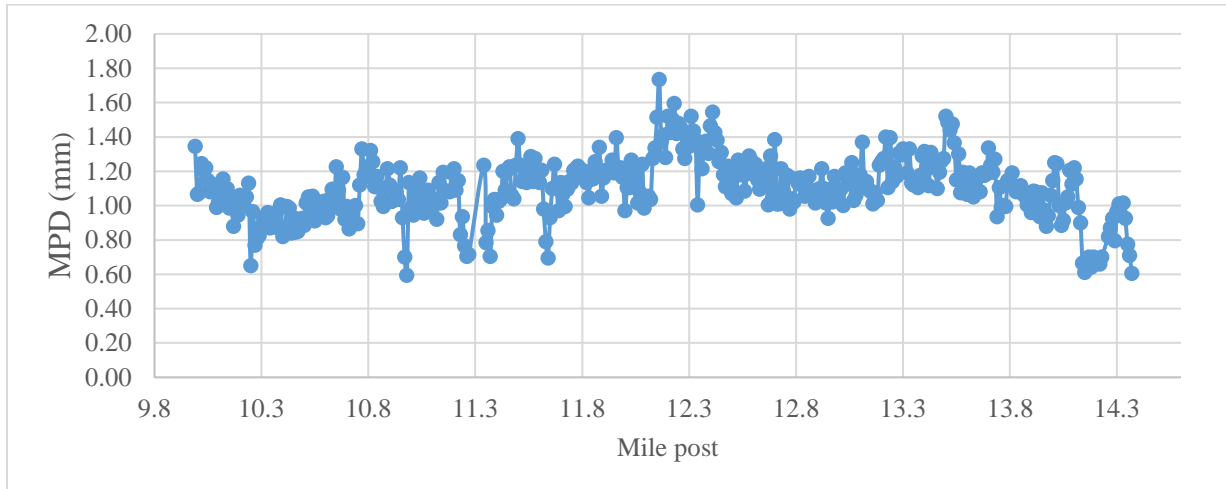
MPD values relate to macrotexture; testing results after 3 years are shown in Figure 31. In general, average MPD values of 1 mm were observed, which is comparable to typical values for asphalt pavement surfaces. The higher SNs obtained were consistent with the adequate macrotexture, as indicated by these MPD values.

Figure 31. MPD Testing Results. MPD = mean profile depth.

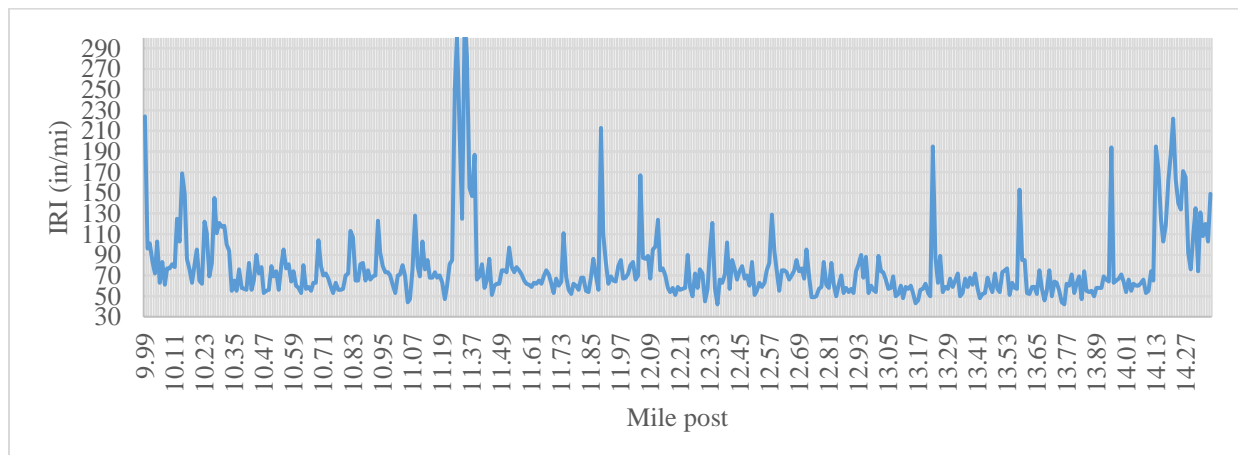
Figure 32 shows ride test results after 3 years. The average IRI value was 70 in/mi. In general, IRI values less than 70 in/mi indicate smoother pavement. The IRI values did not increase after the surface treatments. The higher ride value for Section 11.37 was due to the concrete bridge deck.

Figure 32. IRI Testing Results (at every 52.8 ft). IRI = International Roughness Index.
