Field Monitoring of Erosion and Sediment Control Practices and Development of Additional Iowa DOT Design Manual Guidance

**Final Report
April 2020**

Sponsored by
Federal Highway Administration
Iowa Department of Transportation
(InTrans Project 18-654)

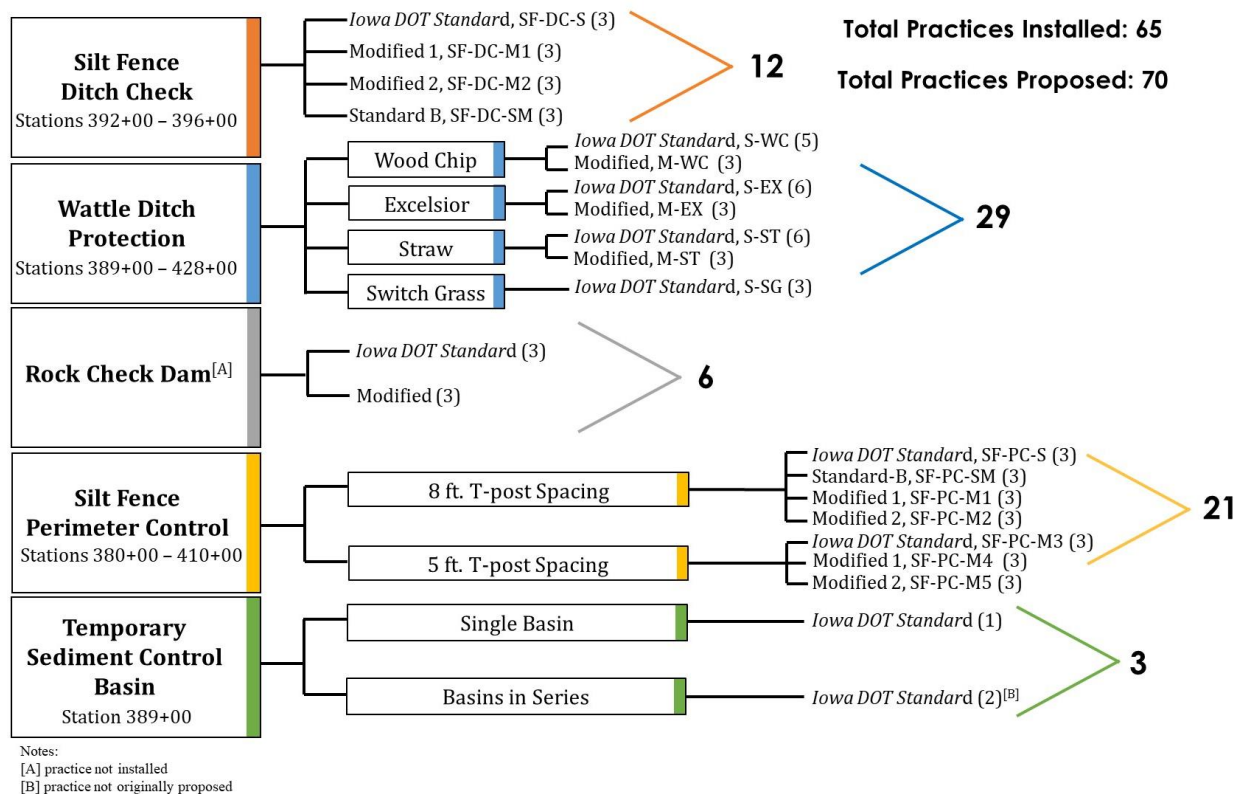
E&SC practices evaluated in this research study are categorized in one of the following (1) ditch checks, (2) sediment barriers, or (3) detention practices. Figure 3.1 illustrates all installed practice types.

Figure 3.1. Installed E&SC practices on Tama US 30

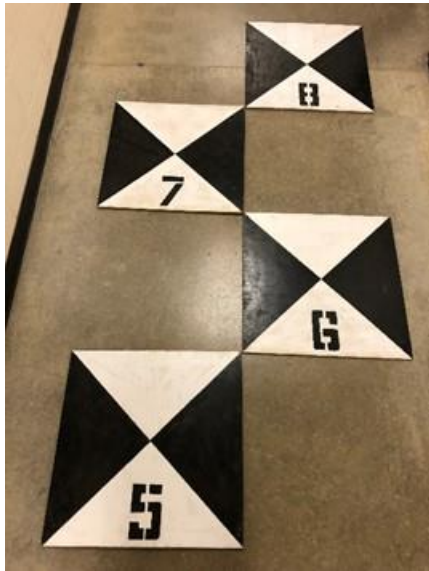
Figure 3.8. GCP and RTK unit

During the 2019 construction season, over 15 flights were conducted on the site at different locations, taking georeferenced images for photogrammetric applications. Each automated flight captured over 700 images that were used for developing two-dimensional (2D) maps and three-dimensional (3D) models of the Tama US 30 site. Ground Control Points (GCP) contributed the photogrammetry development by correcting uncertainties in the image geolocation. Eight GCPs were prepared for this study by creating 2 ft by 2 ft (0.61 m by 0.61 m) plywood markers and painting with black and white triangles. Numbers were assigned and painted on each GCP marking for matching surveying results with the initial model. GCP markers were spread across the flight path, and a real-time kinematic (RTK) unit was used to obtain northing, easting, and elevation information of the GCP markers. The RTK unit and GCPs are shown in Figure 3.8.

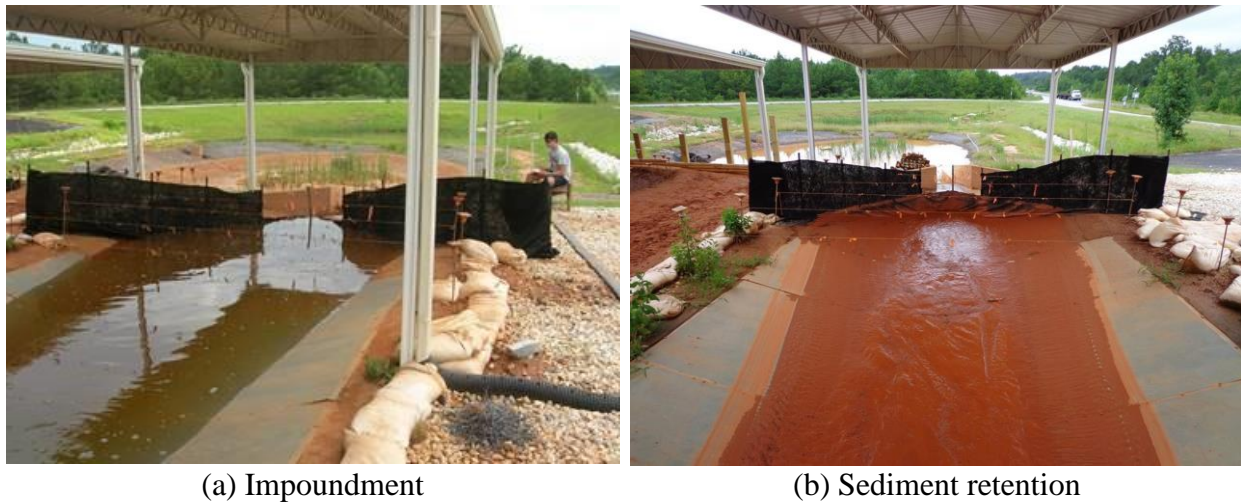
The ALDOT standard exhibited scour at the middle post in low flow conditions and was therefore not evaluated in the higher-tiered flow conditions. Testing indicated that the dissipaters did not aid in structural performance of the ALDOT standard and experienced similar failure; however, the #4 stone dissipater delayed erosion patterns and forced them to occur farther downstream. The TDOT enhanced silt fence ditch check reached full-channel length impoundment without failure but exhibited the need for a downstream splash pad. The enhanced ALDOT pinned installation was configured to minimize undercutting of the splash pad, exhibited by the TDOT installation. The enhanced ALDOT pinned installation performed best in large-scale testing and was installed in field for longevity testing. Over the course of six tests, the installation retained 90% of the sediment introduced with no obvious failures (Donald et al. 2015). The enhanced ALDOT pinned installation is shown in Figure 4.3a and b.

Figure 4.3. Longevity evaluation of pinned silt fence ditch check

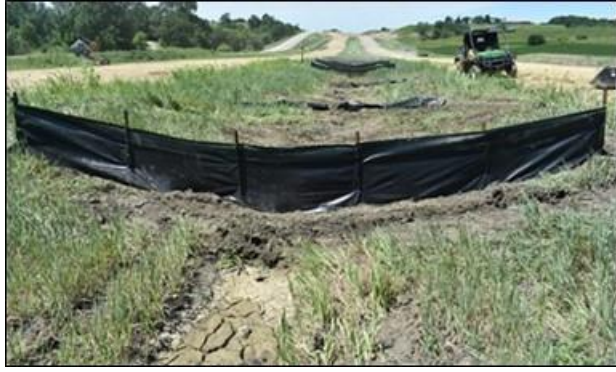
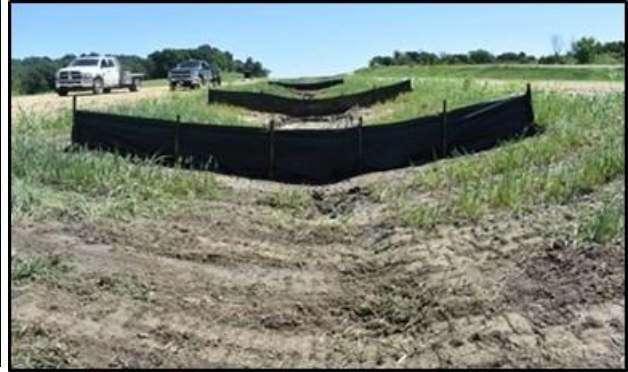
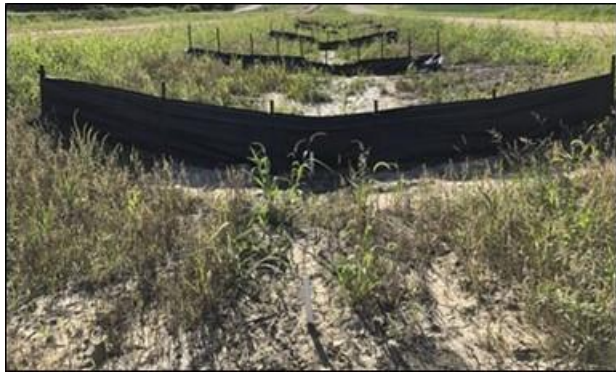
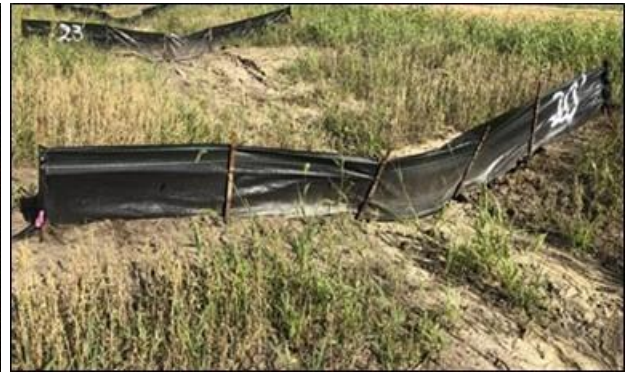
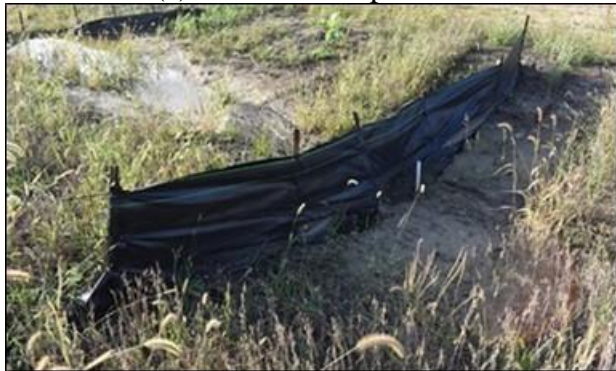
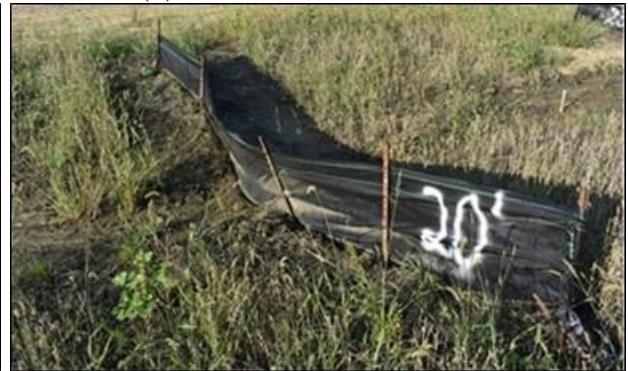
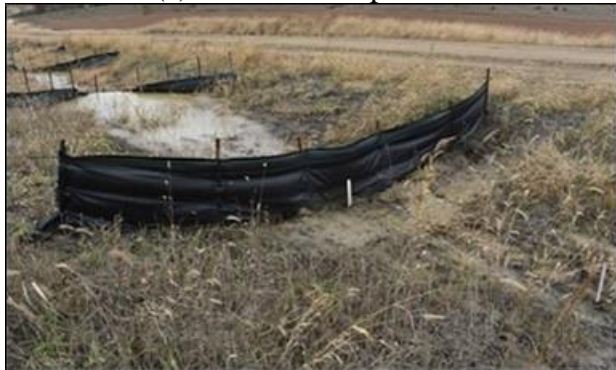
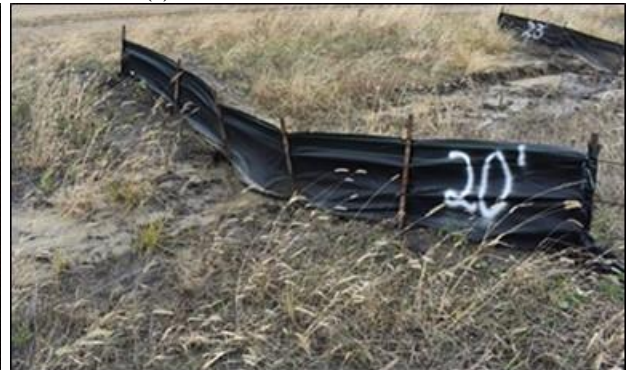
Figure 4.7. Silt fence ditch check- standard (SF-DC-S)

Two of the Iowa DOT standard silt fence ditch checks, SF-DC-S-1, started to experience post deflection within a month of installation after 2.99 in. (7.59 cm) of rainfall, Figure 4.7 (SF-DC-S-2 and S-3), and the third exhibited undercutting and downstream scour after 5.5 in. (13.97 cm) of rain.

Lack of sedimentation upstream and erosion patterns in the channel indicated undercutting on all of the three monitored standard installations. After nearly two months and 11.82 in. (30.02 cm) of rain, there was still no evidence of sedimentation and further channel erosion; however, the posts did not seem to deflect much further.

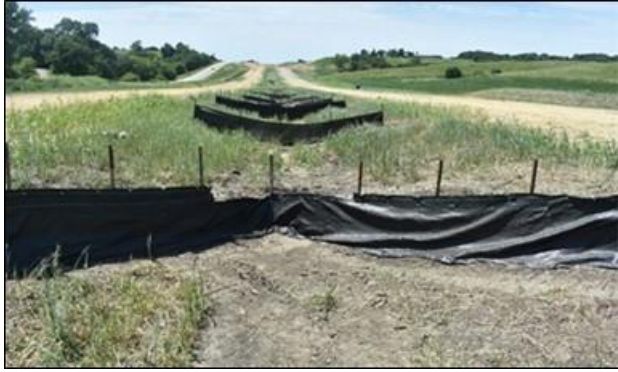
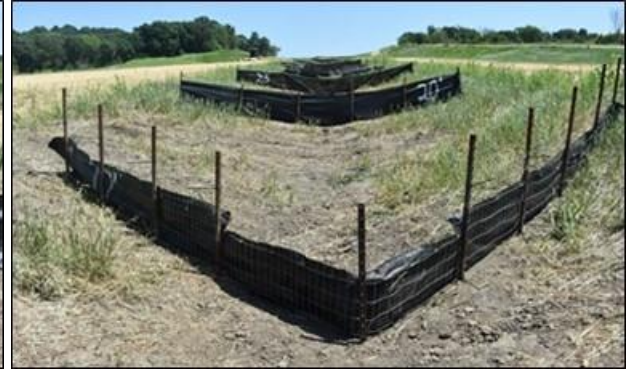
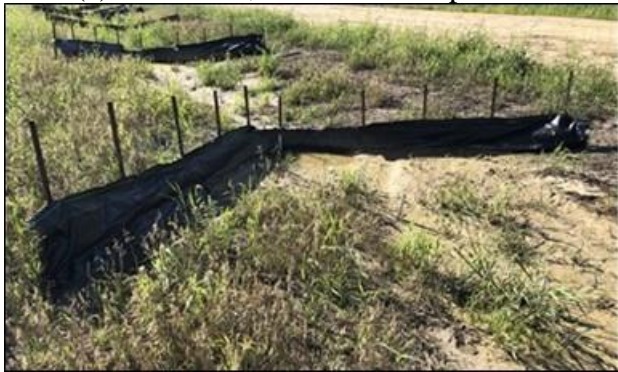
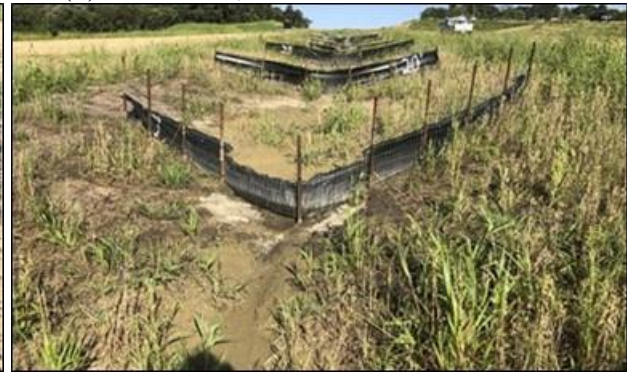
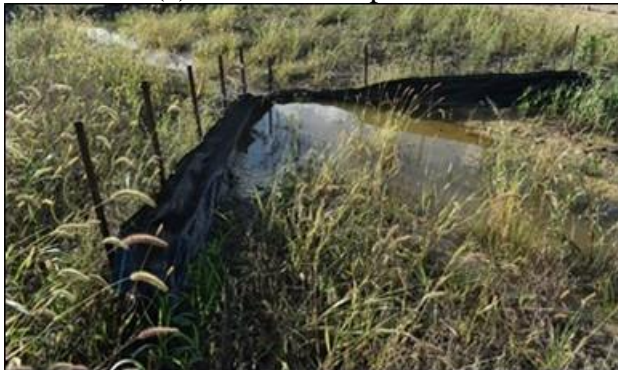
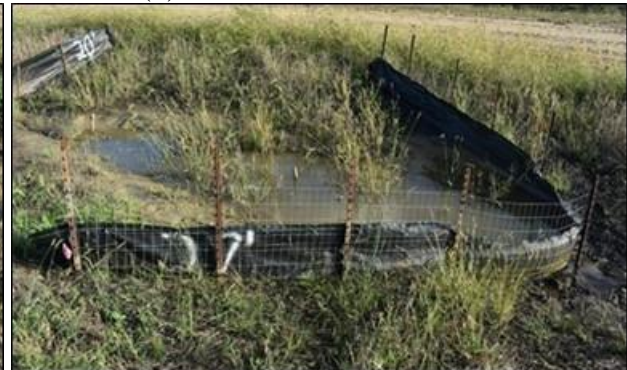
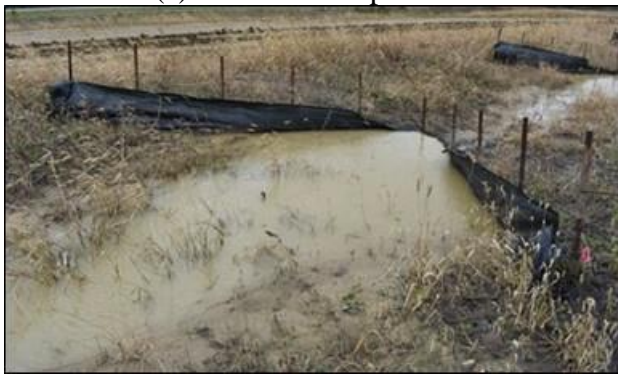
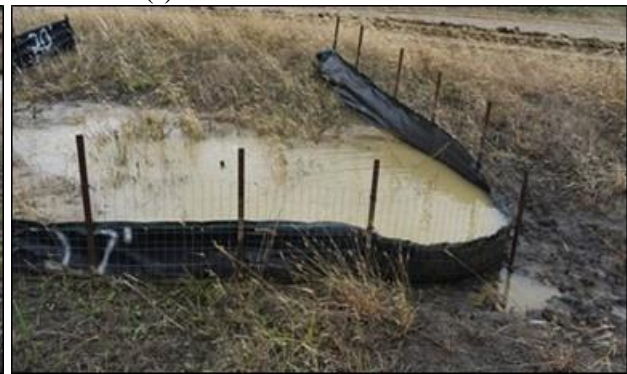
Figure 4.8. Silt fence ditch check - Modified 1, SF-DC-M1

All of the Modified 1 installations, SF-DC-M1, exhibited sedimentation and signs of impoundment after 2.99 in. (7.59 cm) of rainfall (Figure 4.8).

There was no evidence of channel erosion or post deflection. SF-DC-M1-1 had accumulation reach 50% height after 9.4 in. (23.88 cm) of rain, requiring sediment removal. SF-DC-M1-2 and SF-DC-M1-3 had accumulation up to full height after 11.21 in. (28.47 cm) of rainfall. By the third and fourth inspections shown in Figure 4.8c and d, there was evidence of channel flow overtopping the weir on the first two installations (SF-DC-M1-1 and SF-DC-M1-2), particularly on SF-DC-M1-2. The downstream photo on the fourth inspection, Figure 4.8h, displays erosion just downstream of the weir, indicating overtopping flows scoured the earthen channel. While a special ditch control mat was intended to reduce the occurrence of scour at the weir discharge, a higher level of armoring may be needed in future installations. A geotextile pinned to the channel bottom may provide adequate scour resistance. Without proper armoring, the scour point may extend toward the upstream face of the ditch check, eventually compromising the integrity of the installation.

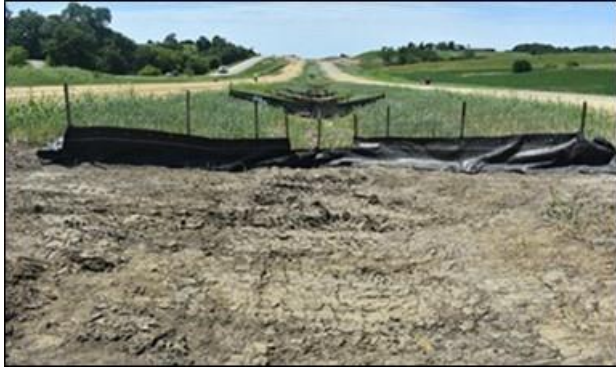
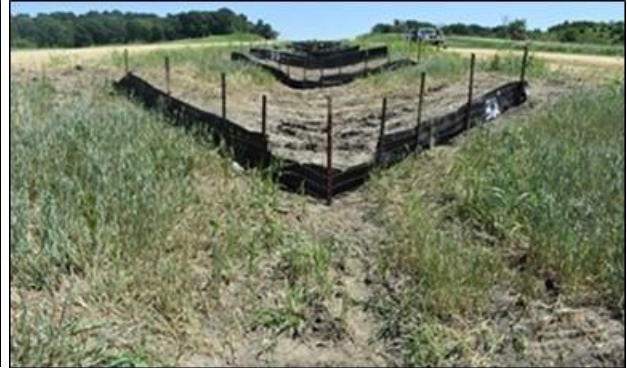
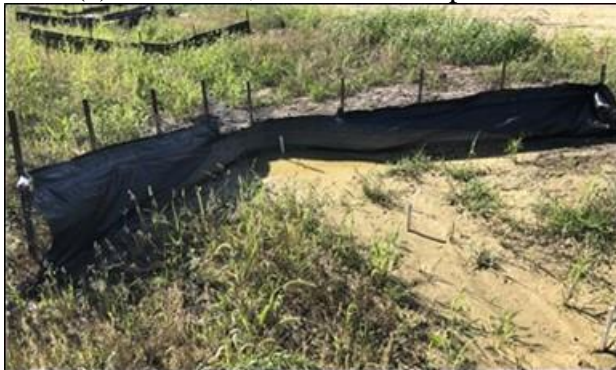
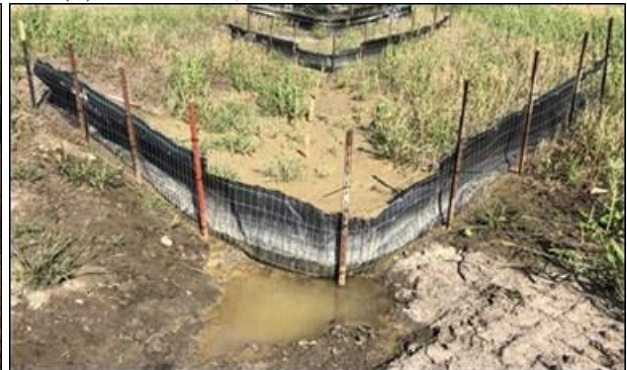
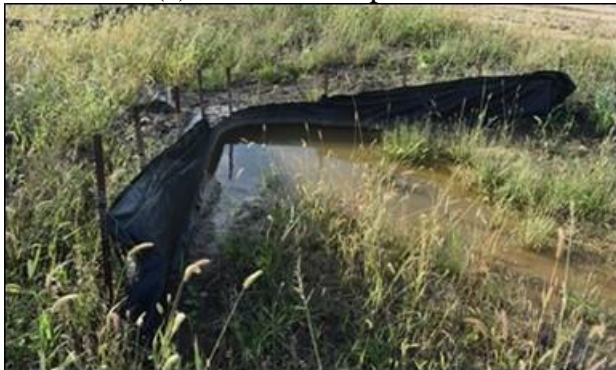
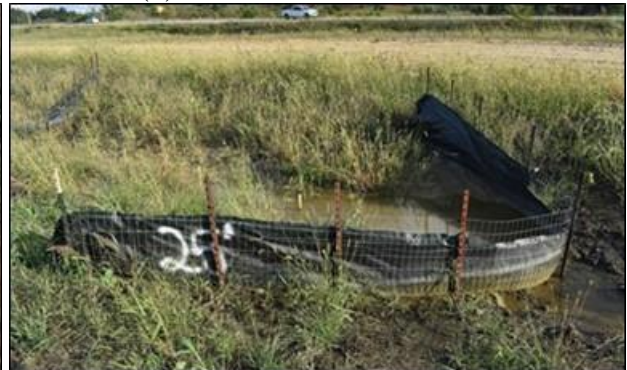
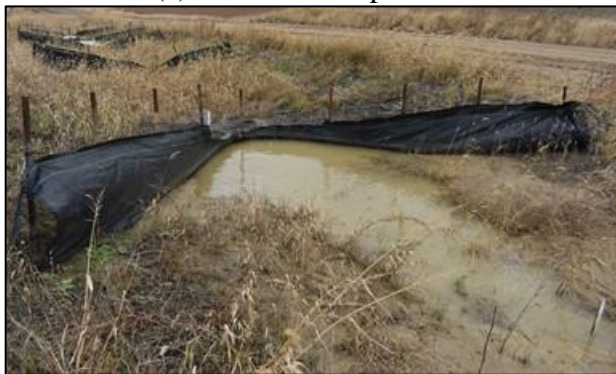
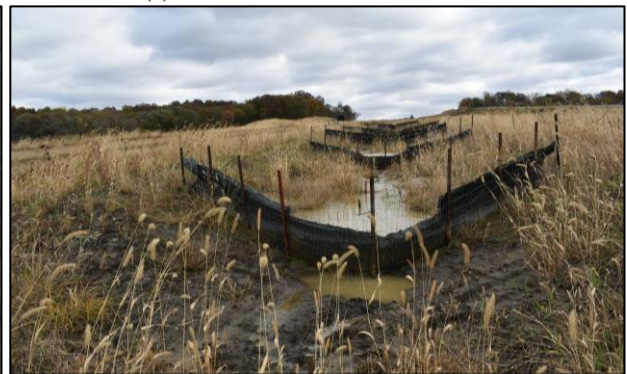
Figure 4.9. Silt fence ditch check - Modified 2, SF-DC-M2

Similar to SF-DC-M1, all SF-DC-M2 installations exhibited sedimentation and impoundment after 2.99 in. (7.59 cm) of rainfall. There was also evidence of flow overtopping the weir causing erosion of the channel immediately downstream. Erosion downstream of the weir increased in the third and fourth inspections but did not seem to compromise structural integrity. Photographs are shown in Figure 4.9.

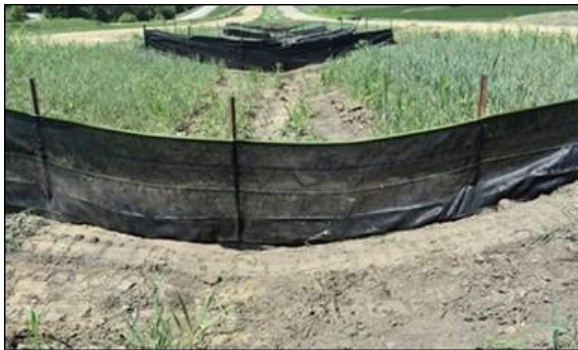
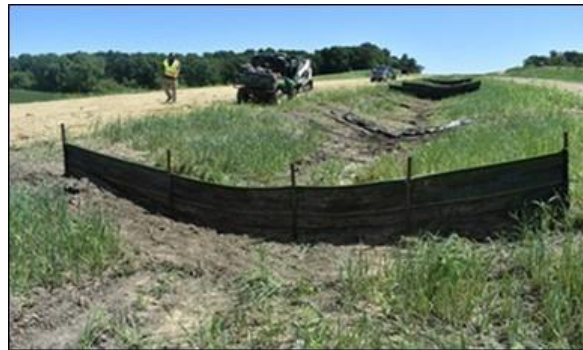
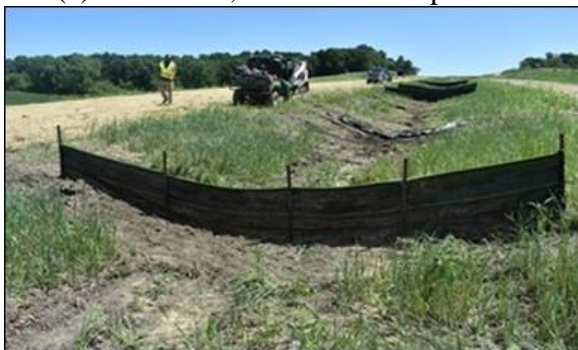
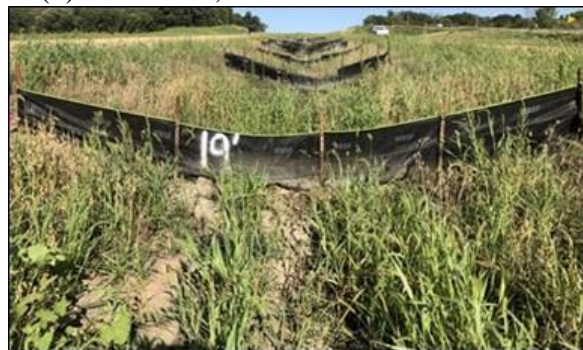
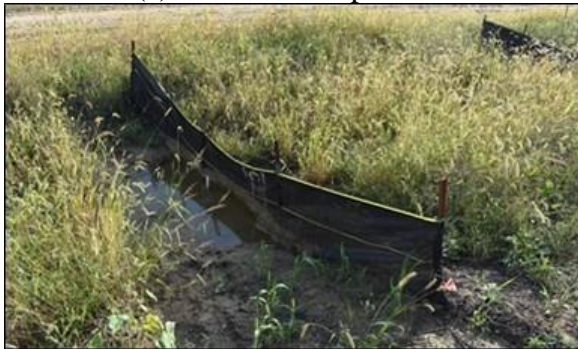
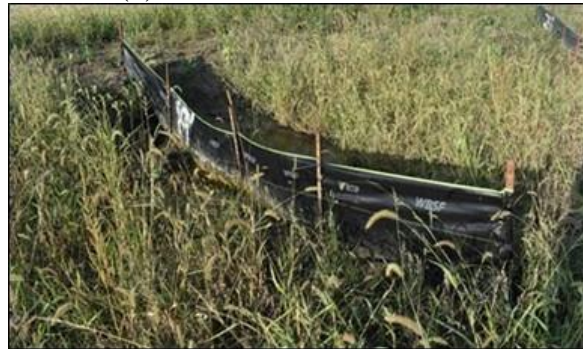
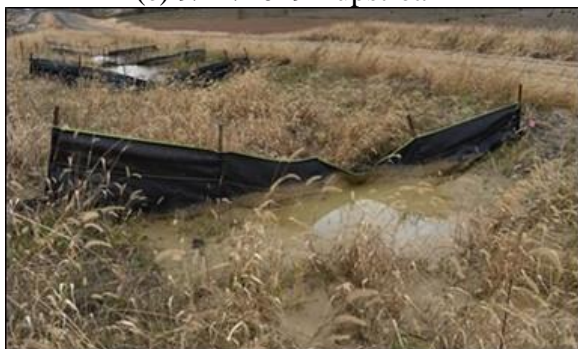
Figure 4.10. Silt fence ditch check – Silt Saver WBSF, SF-DC-SM

The SF-DC-SM employed a standard installation technique with the SiltSaver WBSF material. Inspection photographs are shown in Figure 4.10.

In the Figure 4.10e and f, captured during the third inspection, there is evidence of some sedimentation with high water markings on the fence. SF-DC-SM-1 and -2 exhibited a high water mark by the second inspection but did not show signs of sedimentation upstream. This could be due to the apparent opening size, allowing quicker dewatering and less sedimentation. However, flow patterns indicate scour upstream of the practice, leading to undercutting. This was less obvious than undercutting observed on SF-DC-SM-3. Although the installation did not exhibit post deflection until the fourth inspection, there was obvious undercutting by the third inspection. Runoff had eroded a significant portion of the channel directly upstream the ditch check. The geotextile was dislodged from its original slice. By the fourth inspection, the silt fence had failed and overtopped due to post deflection. This material has much larger apparent opening sizes than the DOT standard geotextile (US sieve #30), allowing runoff to pass through more quickly and easily. Due to the flow velocity within the channel, there was evidence of erosion with little evidence of upstream sediment deposition.

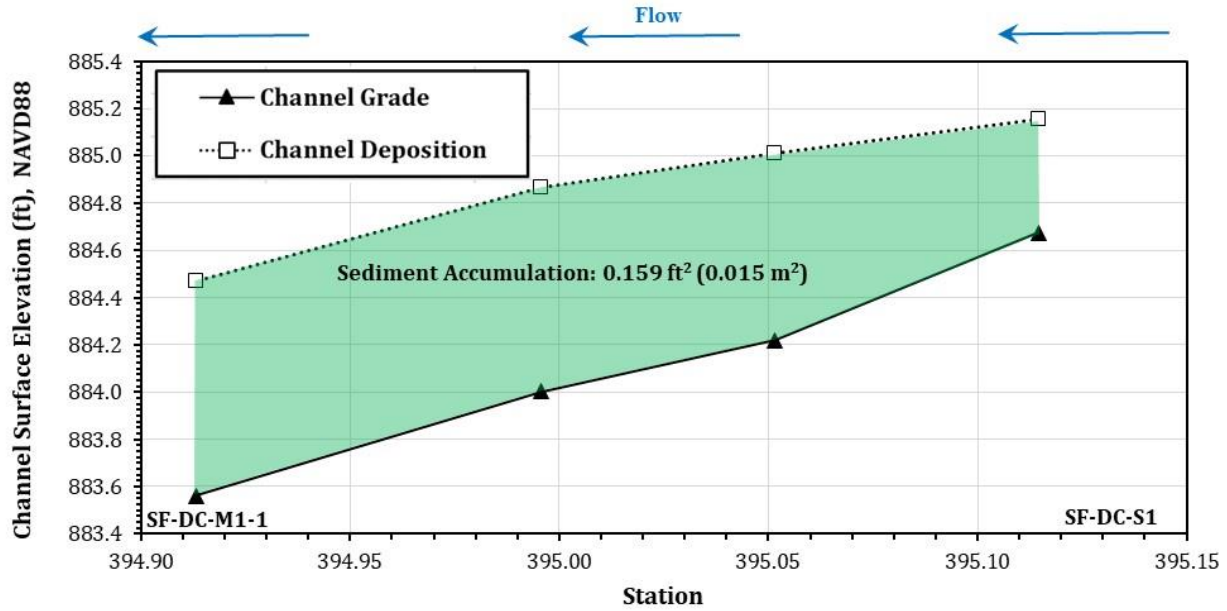
The surface profiles of SF-DC-M1-1, which exhibited the most sediment accumulation, and SF-DC-S-2, which exhibited the most channel erosion, are shown in Figure 4.12a and b, respectively. Surface profiles for each individual practice can be found in Appendix E.

(a) SF-DC-M1-1 profile

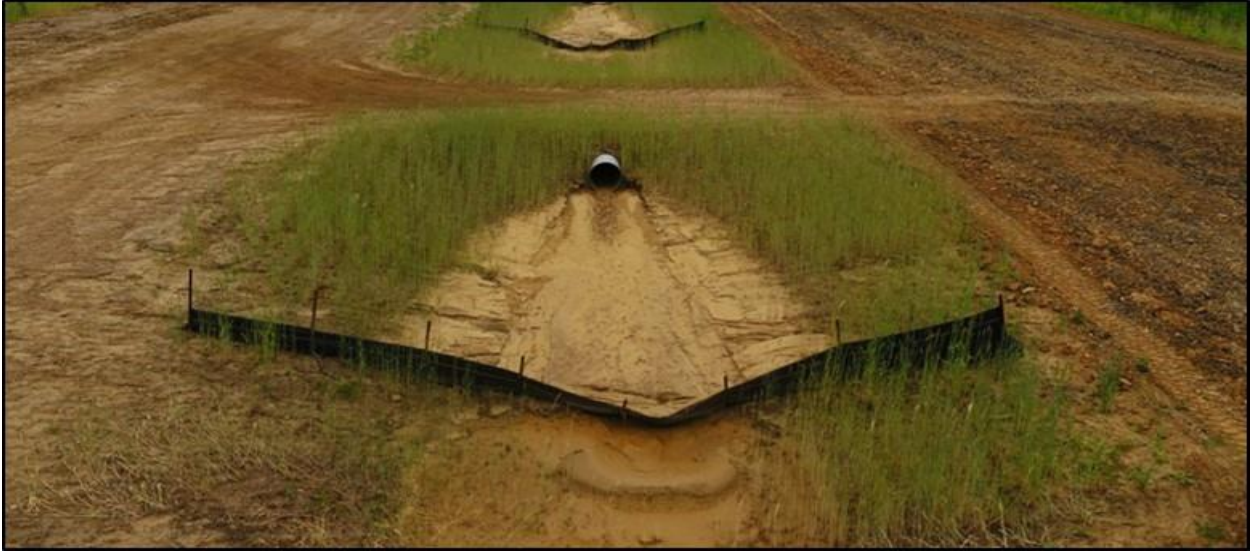
Common silt fence ditch check failures observed on-site included T-post deflection, leading to overtopping, undercutting, and flow bypass. These failures can be seen in Figure 4.13 and Figure 4.14. These failures were not observed when monitoring the modified practices.

Figure 4.13. Silt fence ditch check overtopping due to T-post deflection

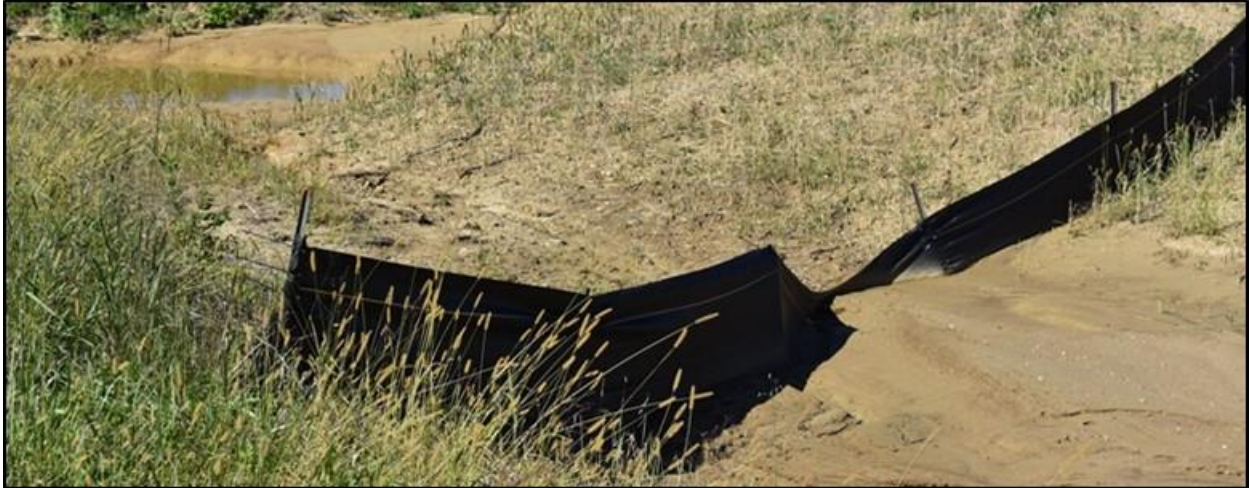
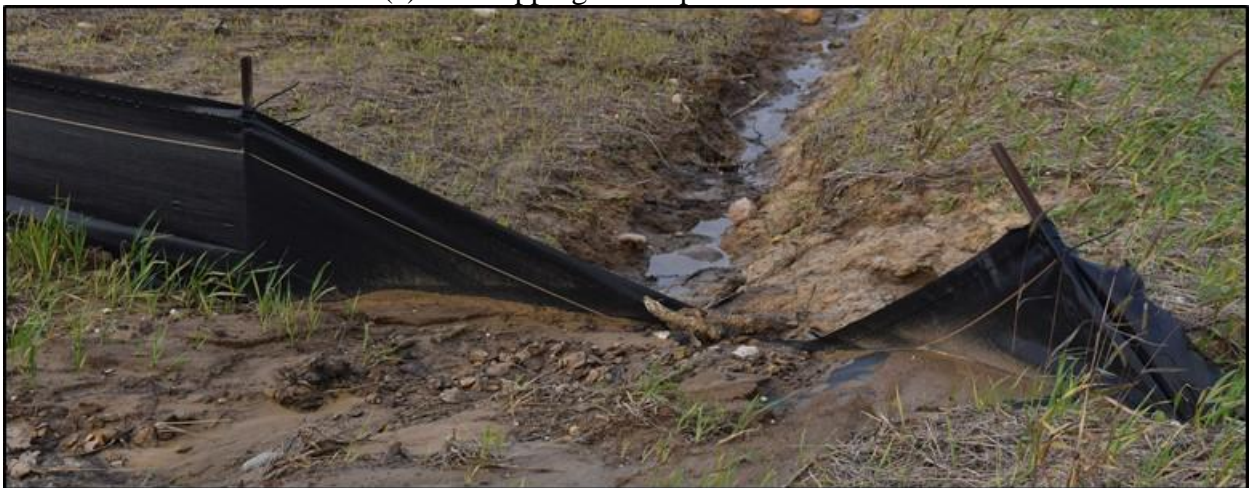
Figure 4.14. Silt fence ditch check failures

(a) Overtopping and T-post deflection

(b) Overtopping

Based on field monitoring and results, Modified 1 would be recommended to adopt with the addition of a geotextile splash pad at the vertex to avoid downstream scouring during dewatering. While field results provide a basis for practice adoption, it would be advantageous to test and compare the installations in a controlled setting to compare performance using controlled flow and sediment rates descriptive of expected field drainage areas, flow conditions, and sediment loading.

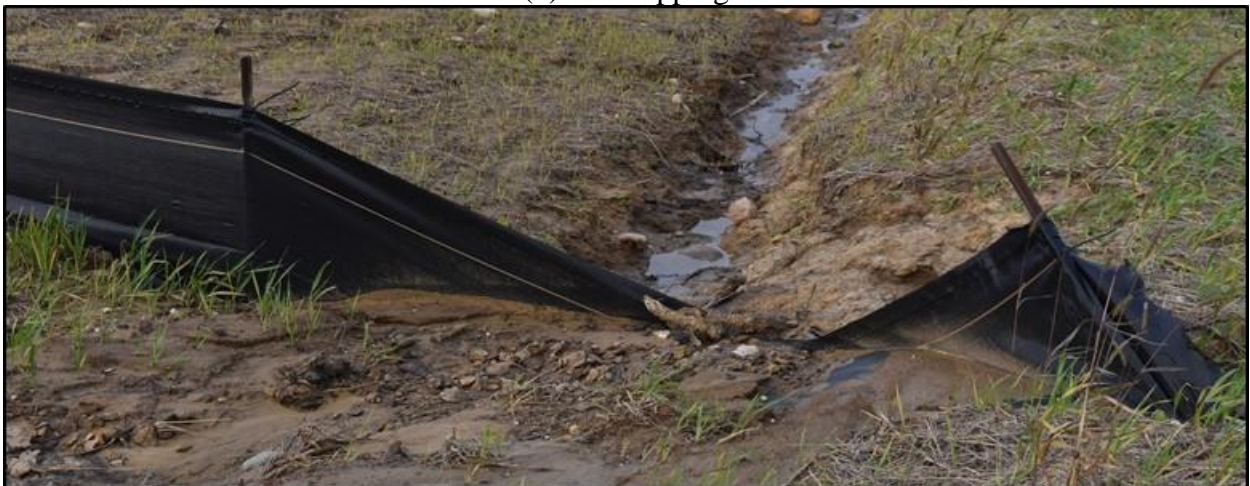
(c) Flow bypass of silt fence ditch check

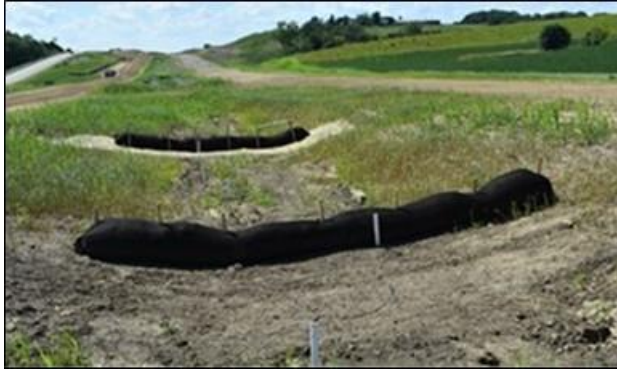
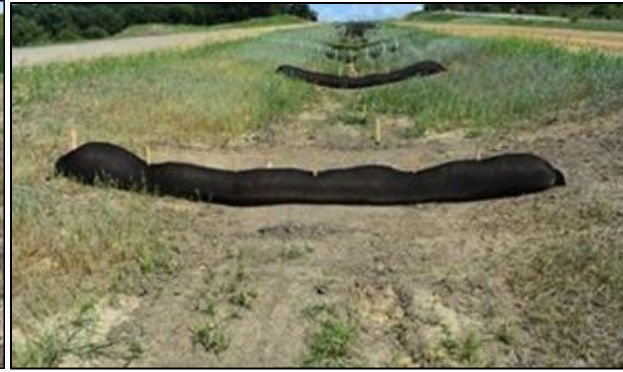
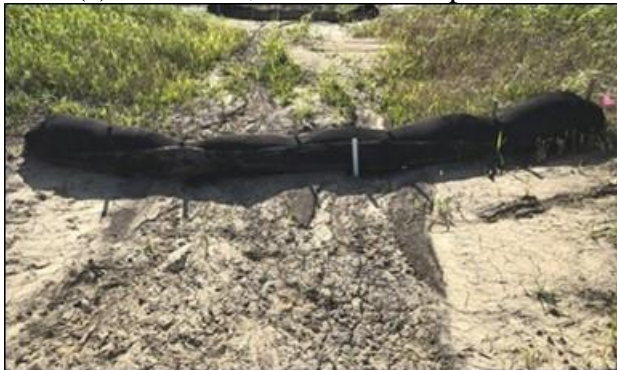
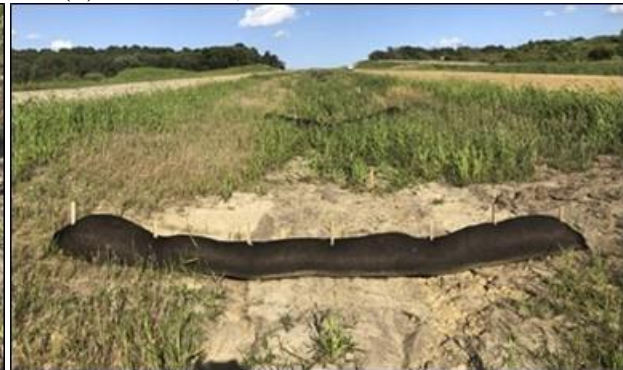
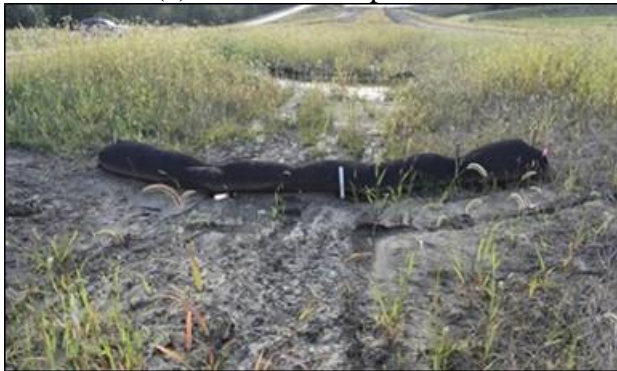
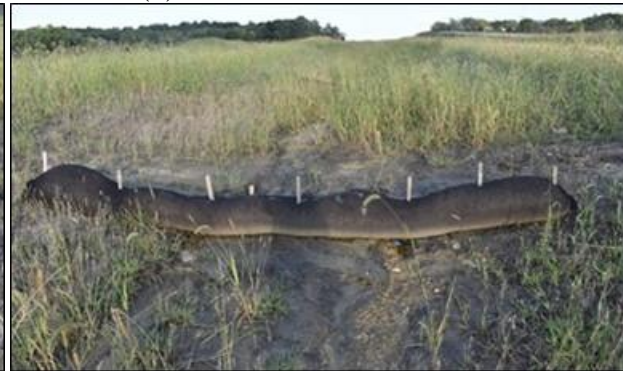
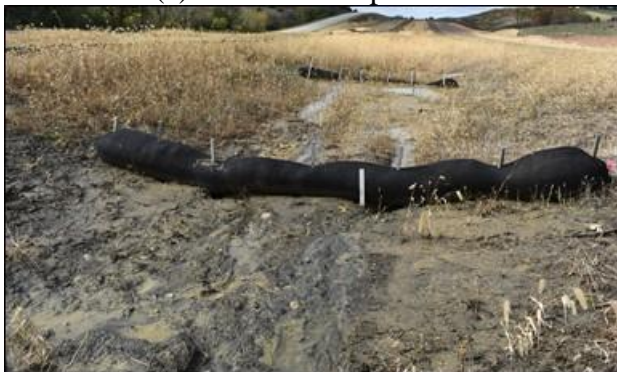
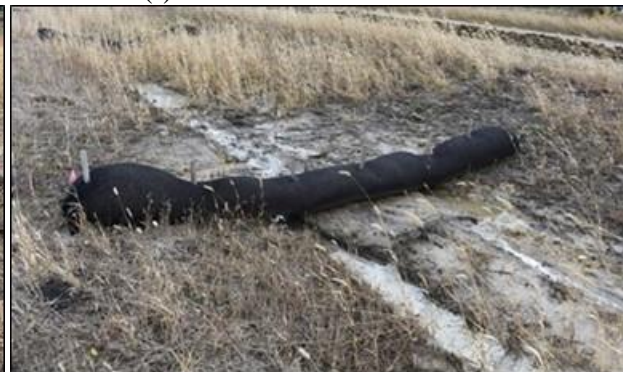
Figure 4.18. Wood chip wattle standard installation, S6

Within the first month, there was evidence of undercutting for the standard installed wattle. When compared to the modified installation, there was no evidence of impoundment or high-water mark on the wattle netting. By the fourth inspection, there was deep channel erosion under the standard wattles, whereas the modified wattle exhibited sedimentation within the channel and runoff reaching the full wattle height and overtopping. All five standard wattles exhibited significant undercutting and had no signs of overtopping or upstream sedimentation. By the final inspection in December, all of the standard installations had experienced undercutting. Of the five standard installations, three of the wattles exhibited undercutting after 1.68 in. (4.27 cm) of rain, and two exhibited undercutting after 2.99 in. (7.59 cm) of rain. Two of the modified installations had evidence of scour downstream of the wattle and flow bypass starting due to the high sedimentation and impoundment. Of the modified installations, WC-M1 exhibited flow bypass after 11.21 in. (28.47 cm) of rain and WC-M3 had evidence of downstream scour after 5.5 in. (13.97 cm) of rain. Researchers would recommend extending the wattle further up the side slopes of the channel. In addition, it would be expected that the channel and wattle be maintained. Sedimentation patterns started to cause flow bypass on the first and third modified installation.

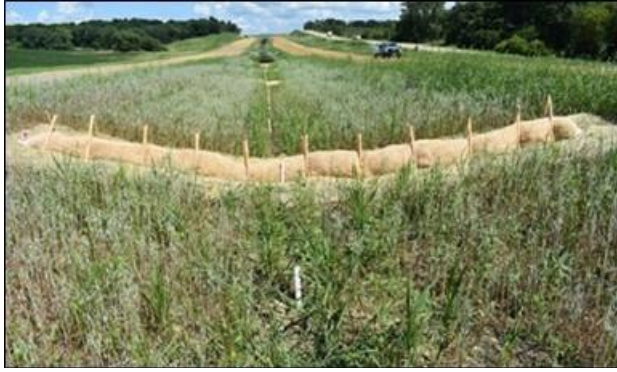
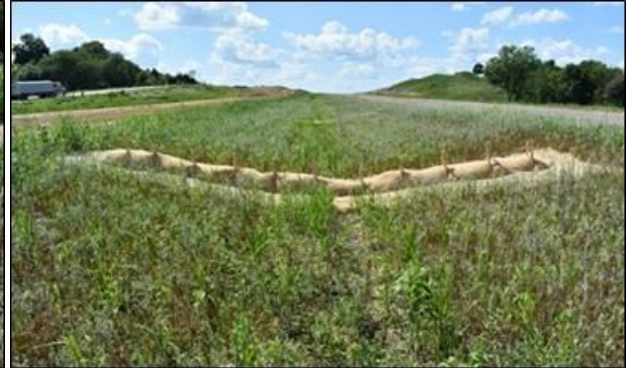
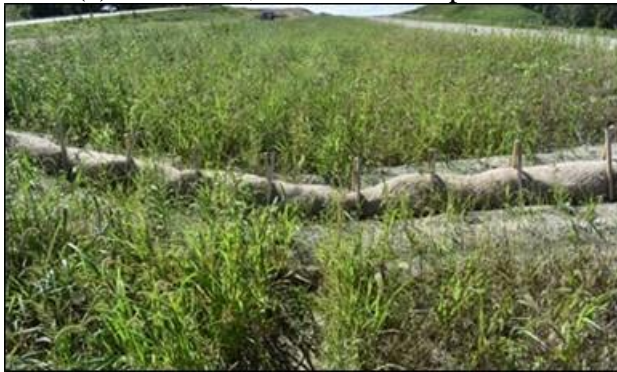
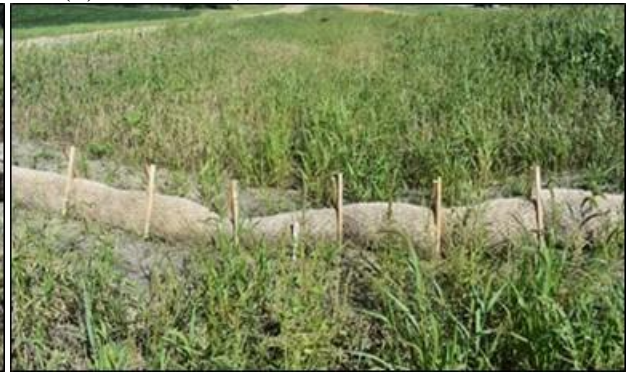
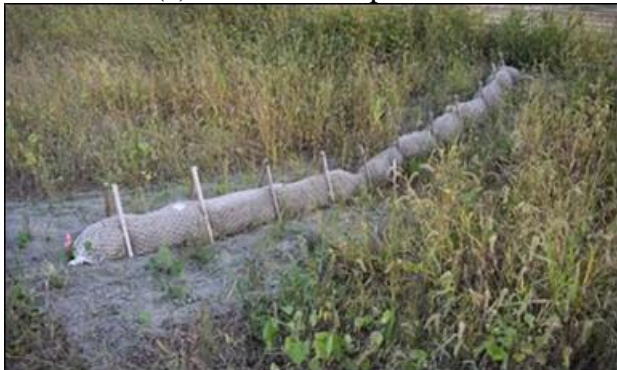
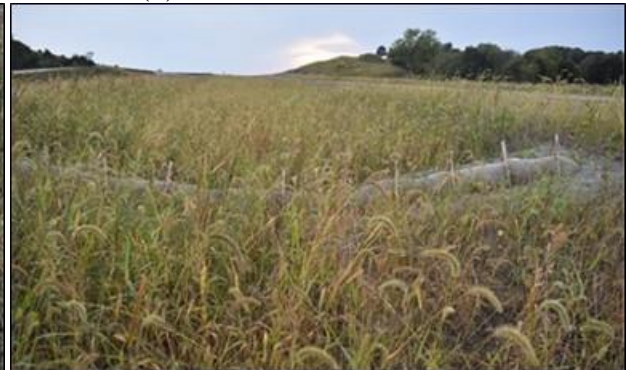
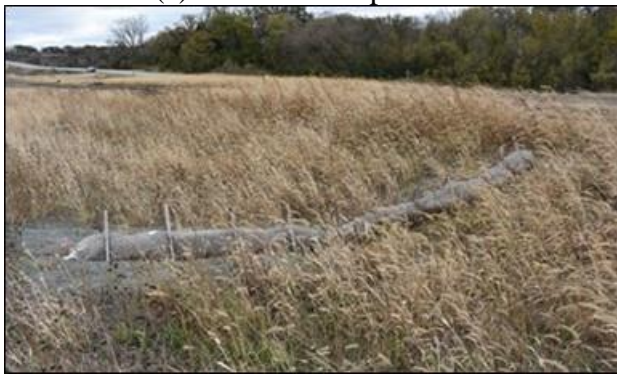
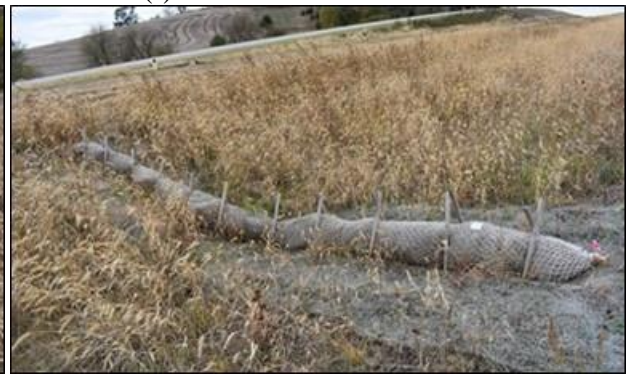
Figure 4.23. Excelsior wattle modified installation, M2

(a) 7/26/2019, installation - upstream

(b) 7/26/2019, installation - downstream

(c) 8/27/2019 - upstream

(d) 8/27/2019 - downstream

(e) 9/24/2019 - upstream

(f) 9/24/2019 - downstream

(g) 10/22/2019 - upstream

(h) 10/22/2019 - downstream

Figure 4.20 and Figure 4.21 include inspection photos of the standard and modified installations of the straw wattles, whereas Figure 4.22 and Figure 4.23 include the excelsior-filled wattles.

Figure 4.24d starts to show evidence of undercutting, which is continually exhibited in Figure 4.24e through h. Due to extreme vegetation in both the straw and excelsior channels, it is difficult to view differences in inspection photos. There is some evidence of impoundment by the fourth inspection; however, there is little to no shown sedimentation. From field observations, researchers conclude that both wattle channels are following similar patterns as the wood chip shown in Figure 4.18 and Figure 4.19. The modified installation of each product has evidence of high water marking and upstream sedimentation. Due to the vegetation, LiDAR scans could not accurately capture the channel surface; however, researchers measured sedimentation on the upstream stakes of each practice.

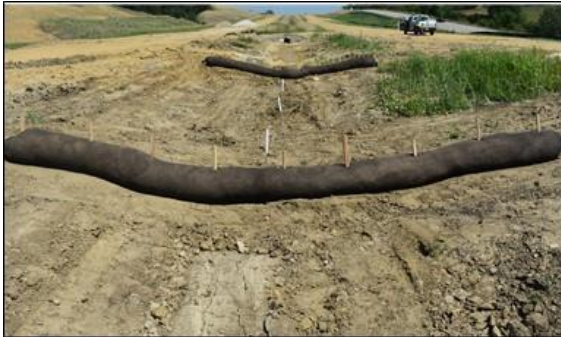
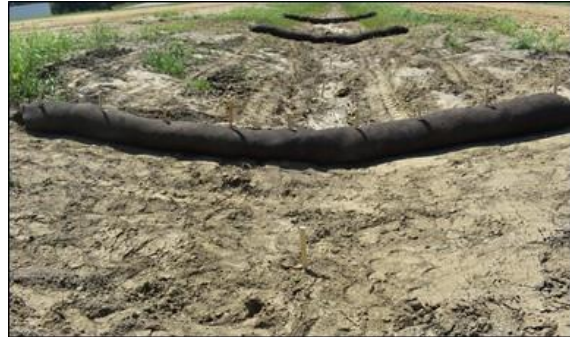
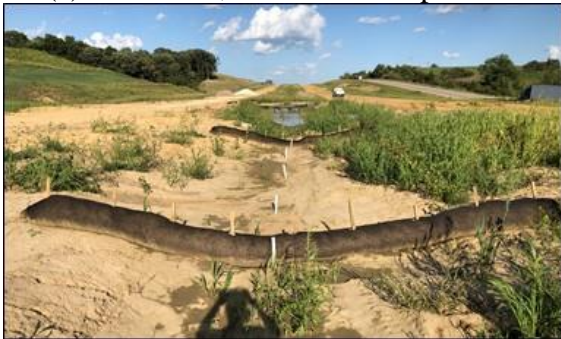
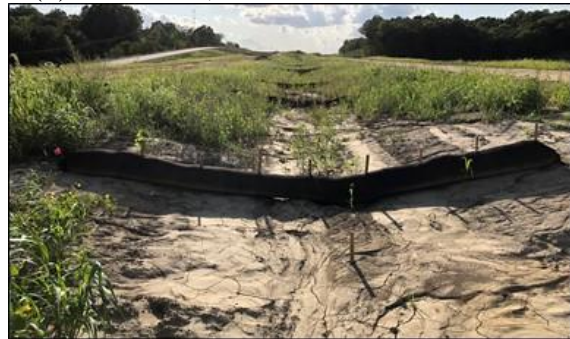
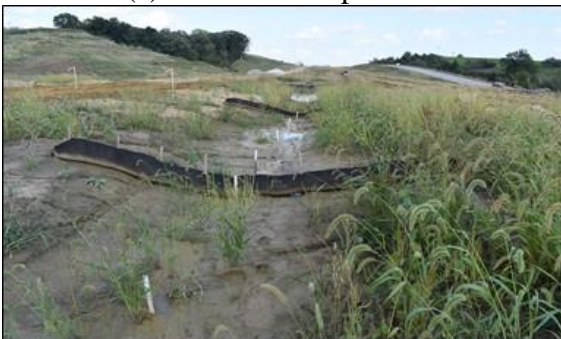
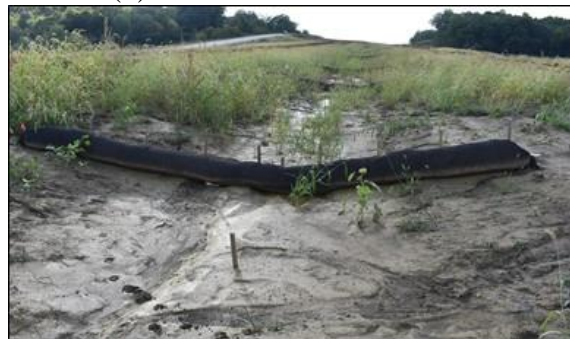
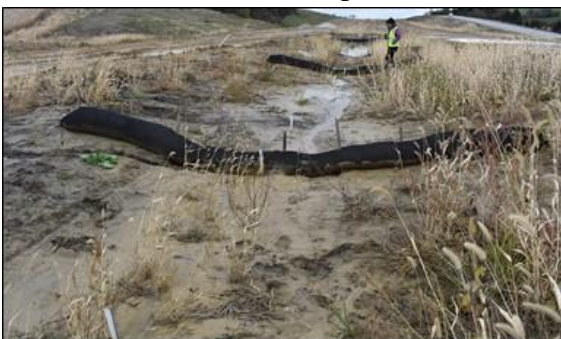
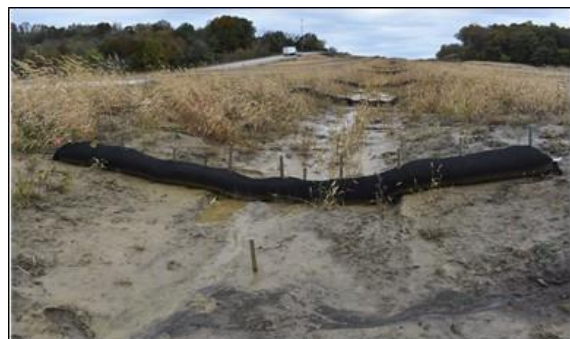
Figure 4.24. Switch grass wattle standard installation, S1

Figure 4.24 shows the standard installation of the switch grass wattles. The modified installation including the teepee staking, underlay, and sod staples was not completed for the switch grass wattles.

(a) 7/26/2019, installation - upstream

(b) 7/26/2019, installation - downstream

(c) 8/27/2019 - upstream

(d) 8/27/2019 - downstream

(e) 9/24/2019 - upstream

(f) 9/24/2019 - downstream

(g) 10/22/2019 - upstream

(h) 10/22/2019 - downstream

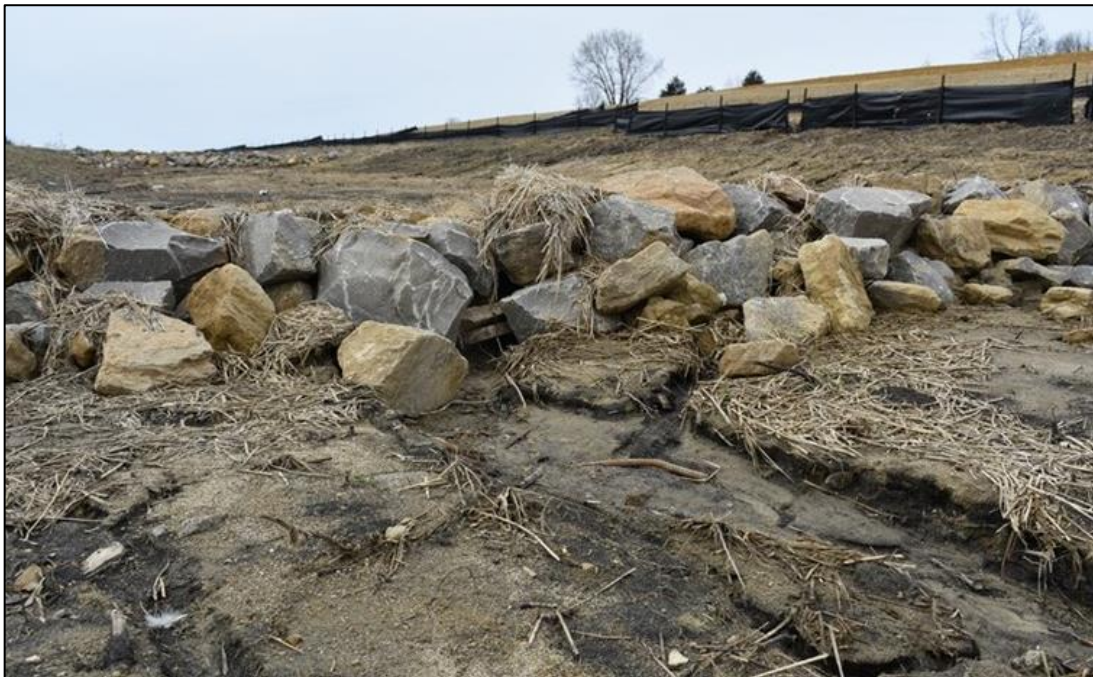
Although rock check dams were not installed for field monitoring, several previously installed rock check dams were observed and photographed during site visits, such as the one shown in Figure 4.30.

Figure 4.30. Rock check dam undercutting
