Field Monitoring of Erosion and Sediment Control Practices and Development of Additional Iowa DOT Design Manual Guidance

**Final Report
April 2020**

Sponsored by
Federal Highway Administration
Iowa Department of Transportation
(InTrans Project 18-654)

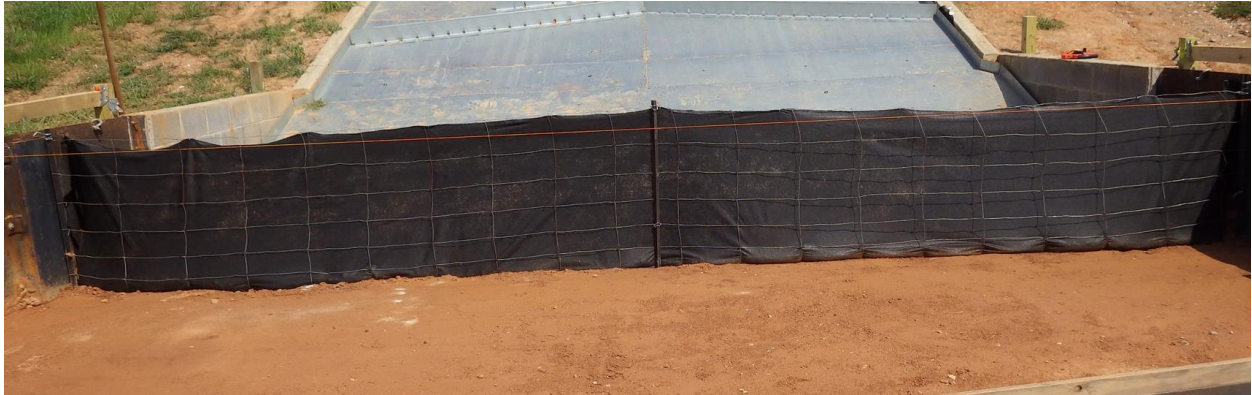
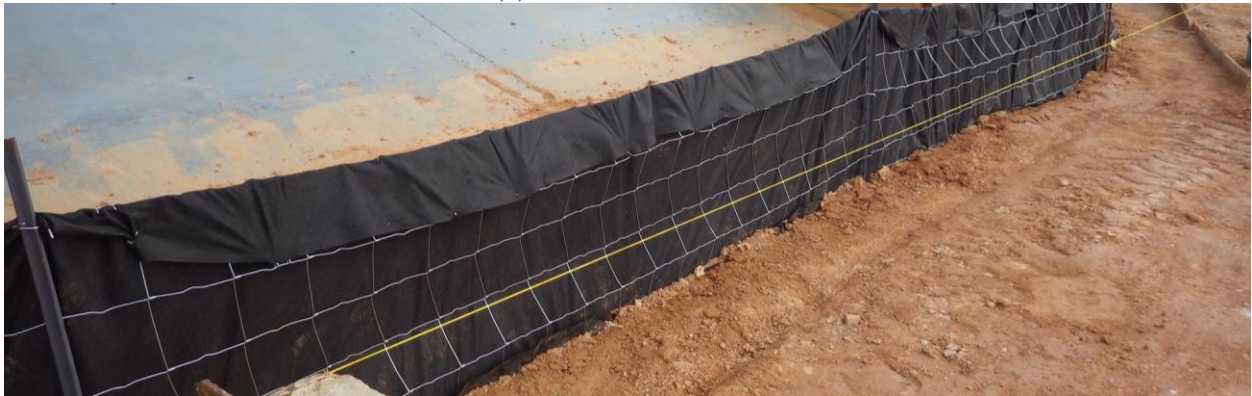
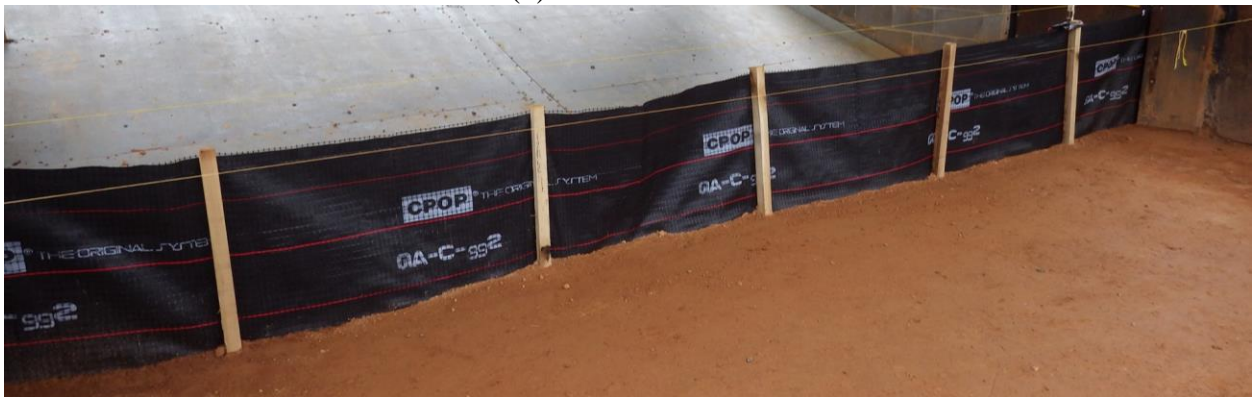
Figure 5.2. Alabama silt fence configurations

Bugg et. al (2017b) conducted large-scale performance-based evaluations at the AU-ESCTF on ALDOT silt fence installations, including a manually trenched and sliced installation of a wire-reinforced geotextile. In addition, an Alabama Soil and Water Conservation Committee (AL-SWCC) detail was tested, which included a woven, polypropylene-reinforced silt fence. The study at AU-ESCTF aimed to test the structural integrity and sediment retention of each design's installation. ALDOT details, for trenched and sliced installation, include a 5 ft (1.5 m) tall steel post, spaced 10 ft (3.05 m) on-center. A nonwoven geotextile with a weight of 3.98 oz/yd² (135 g/m²) is specified. For the trenched installation, a 6 in. (15.2 cm) wide by 6 in. (15.2 cm) deep trench is dug to bury the wire reinforcement and fabric, fulfilling the requirement of placing the reinforcement and fabric at least 6 in. (15.2 cm) below the ground surface. In the sliced detail, reinforcement was shown to be buried at least 8 in. (20.3 cm) under the ground surface. The AL-SWCC describes a 2 in. (5.1 cm) by 2 in. (5.1 cm) hardwood stake configuration, spaced 4 ft on-center. The stakes should be buried at least 12 in. (30.5 cm), while maintaining a height of 24 in. (61 cm) above surface. A woven geotextile is to be buried at least 4 in. (10.2 cm) deep and attach to the mount between 18 in. (45.7 cm) and 24 in. (61 cm) above ground, with compacted soil in front of the trench (Bugg et al. 2017b). The configurations are shown in Figure 5.2.

(a) ALDOT trenched

(b) ALDOT sliced

(c) AL-SWCC

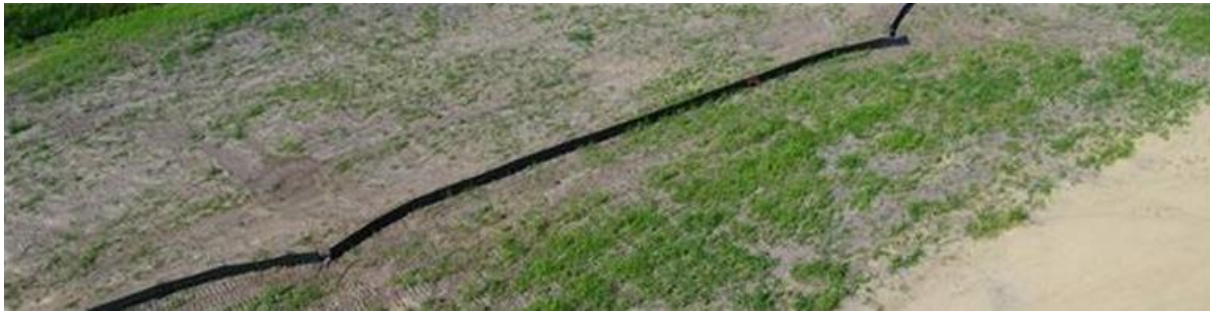
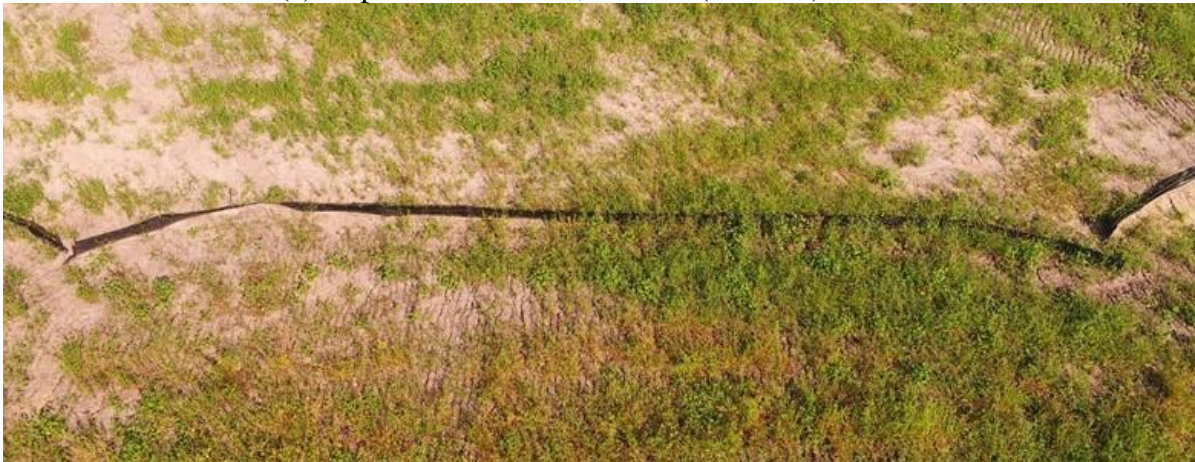
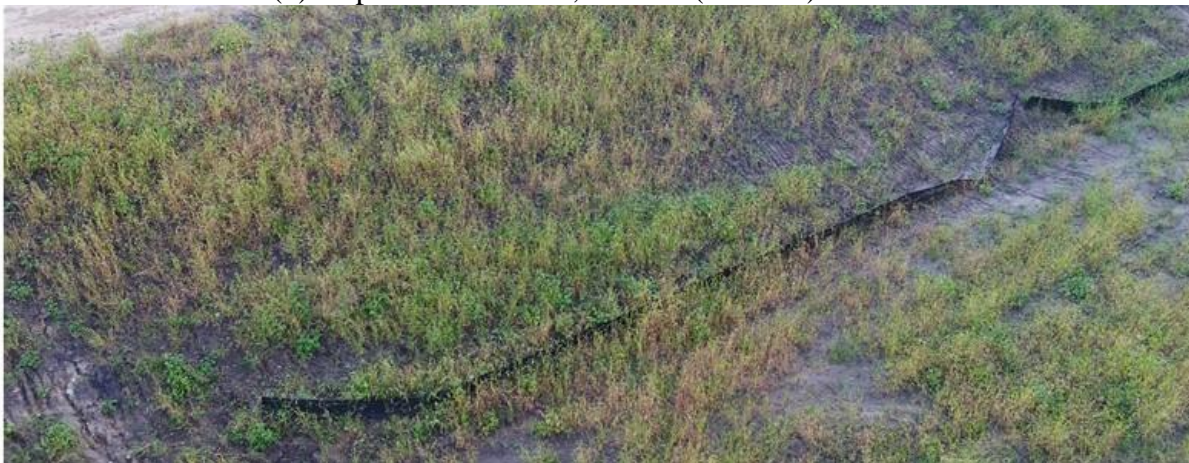
Figure 5.7. Standard silt fence perimeter control aerial inspection photos

Weekly inspections were conducted to understand the performance of the standard and trial modifications of silt fence perimeter control. Inspections were conducted with UAS and documented with photographs. The aerial inspections provided the full view of the silt fence run to illustrate sedimentation patterns. The images in Figure 5.7 consist of periodic aerial photographs during field monitoring.

(a) Inspection 8/6/2019, 0.33 in. (0.84 cm) rainfall

(b) Inspection 9/5/2019, 3.53 in. (8.97 cm) rainfall

(c) Inspection 9/24/2019, 6.78 in. (17.22 cm) rainfall

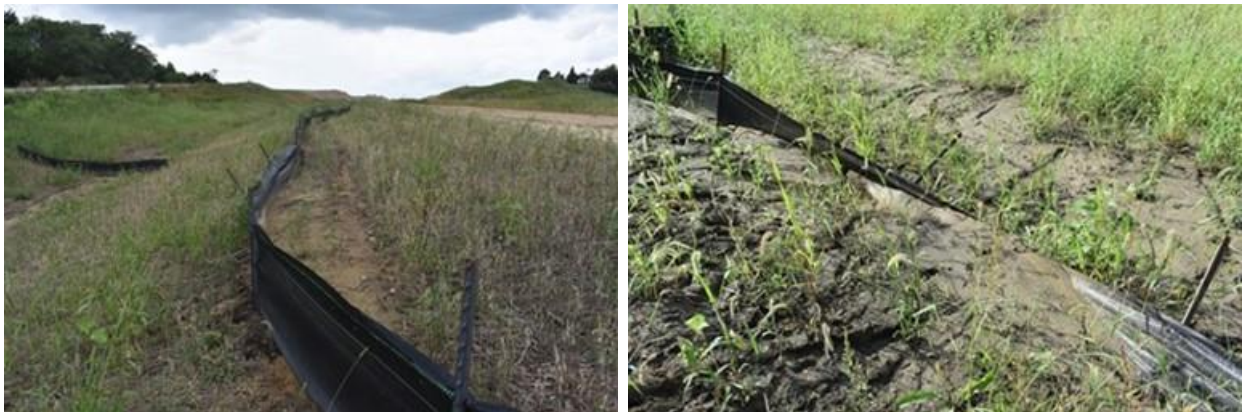
Figure 5.8 shows the post deflection on two of the three standard installations after 3.53 in. (8.97 cm) of rain.

(a) Post deflection on SF-PC-S1 (9/5/2019) (b) Post deflection on SF-PC-S2 (9/5/2019)

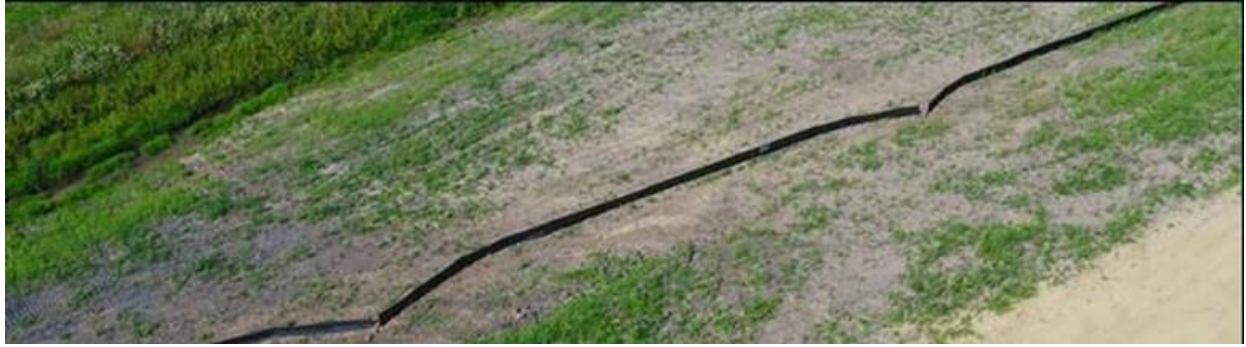
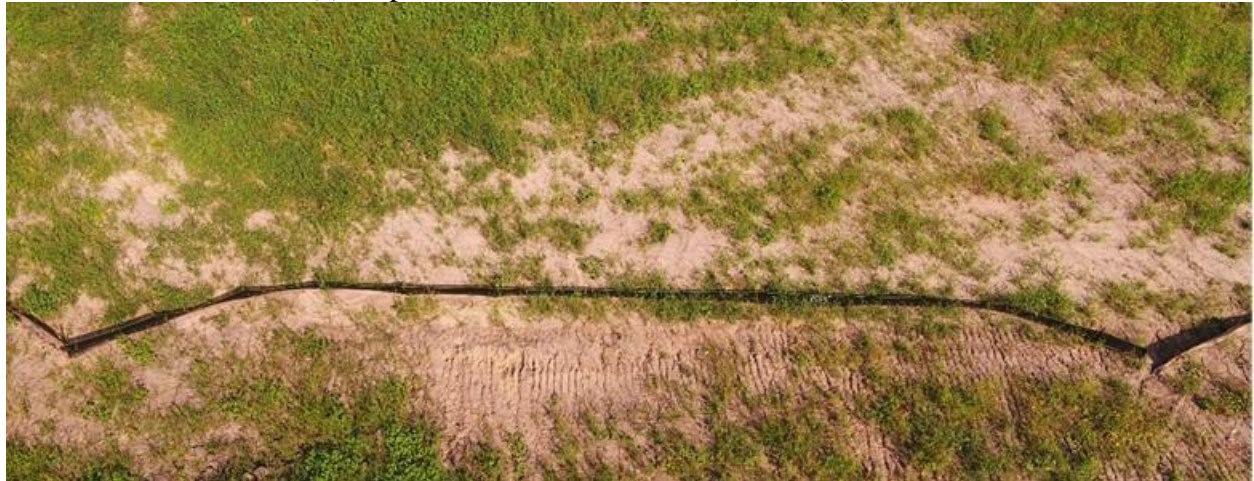
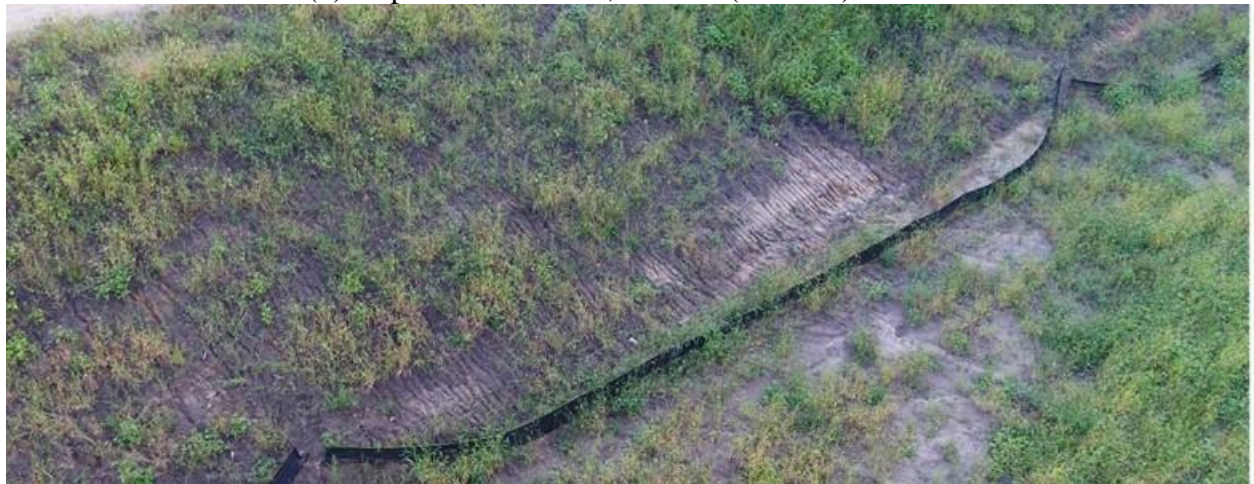
Figure 5.9. SF-PC-SM aerial inspection photos

Figure 5.9 and Figure 5.10 show periodic aerial photos during field monitoring for the SF-PC-SM and SF-PC-M1 sites.

(a) Inspection 8/6/2019, 0.33 in. (0.84 cm) rainfall

(b) Inspection 9/5/2019, 3.53 in. (8.97 cm) rainfall

(c) Inspection 9/24/2019, 6.78 in. (17.22 cm) rainfall

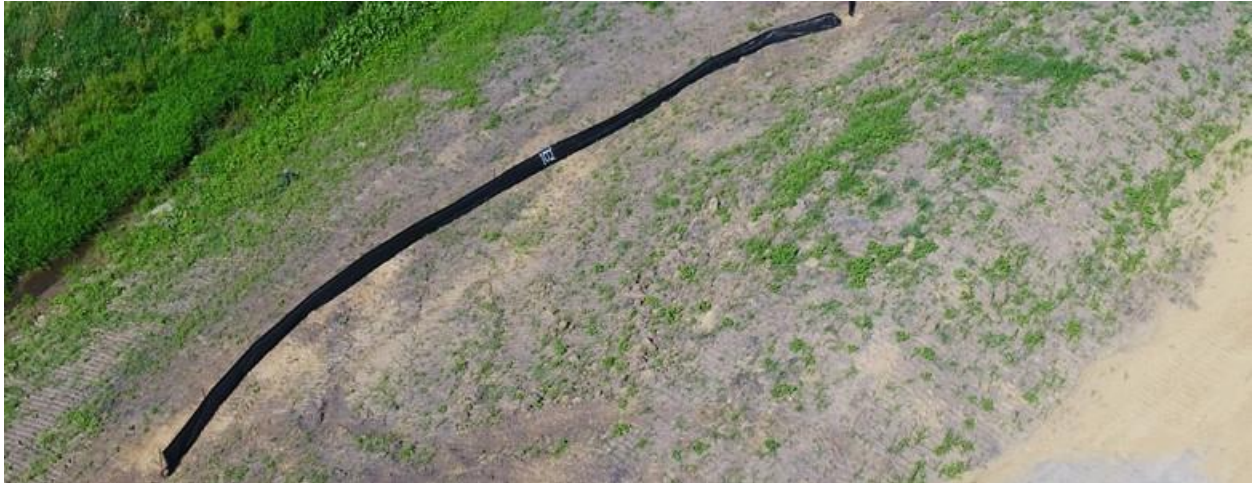
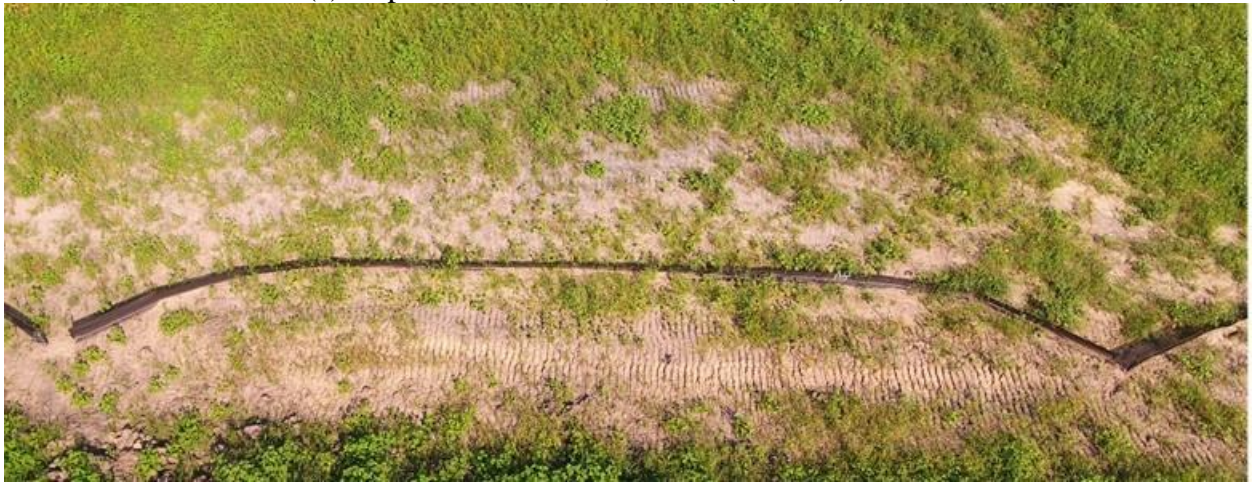
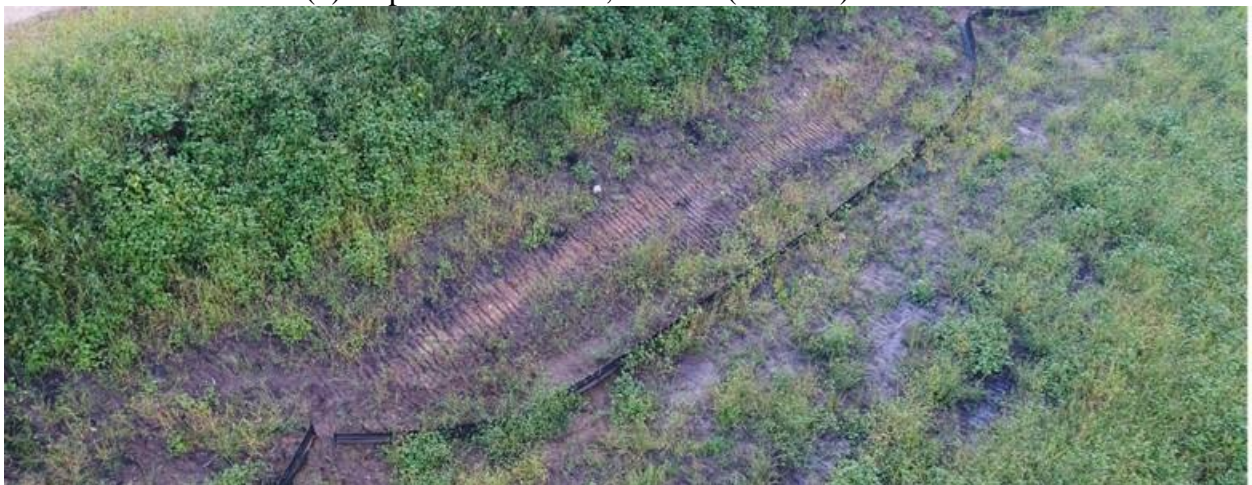
Figure 5.10. SF-PC-M1 aerial inspection photos

(a) Inspection 8/6/2019, 0.33 in. (0.84 cm) rainfall

(b) Inspection 9/5/2019, 3.53 in. (8.97 cm) rainfall

(c) Inspection 9/24/2019, 6.78 in. (17.22 cm) rainfall

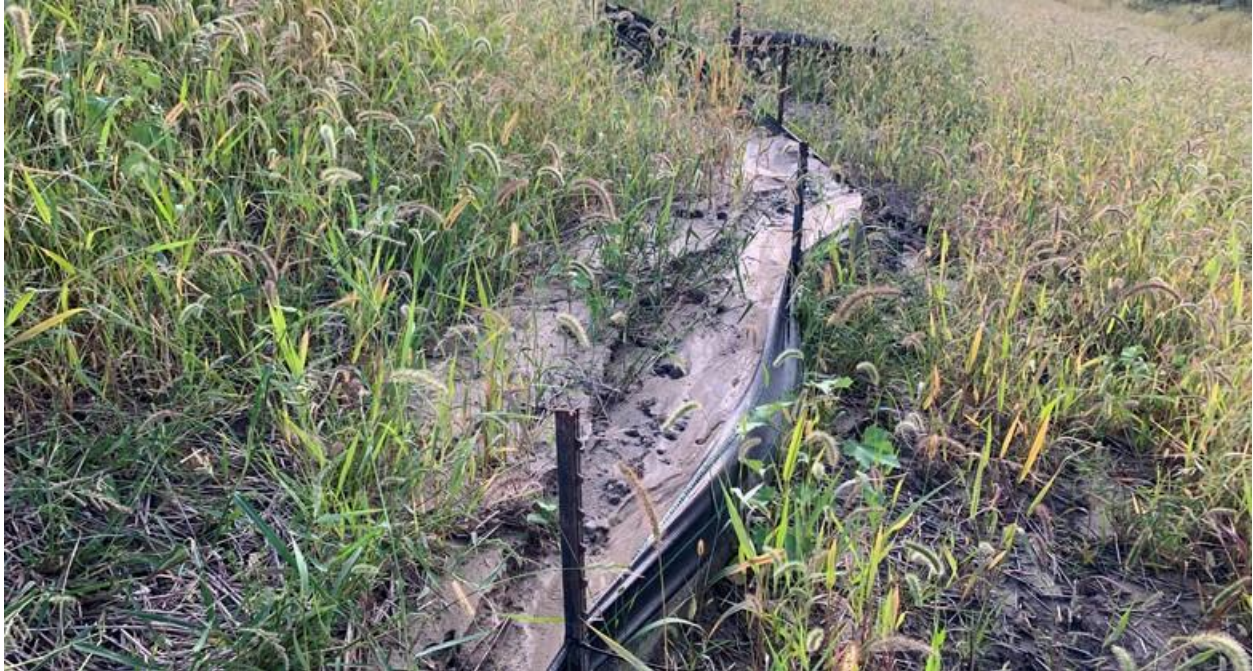
Figure 5.11 shows the overtopping of the third run of the SF-PC-M3 installation. Overtopping occurred due to sedimentation to full height of silt fence. No T-post deflection was observed.

Figure 5.11. SF-PC-M1 overtopping

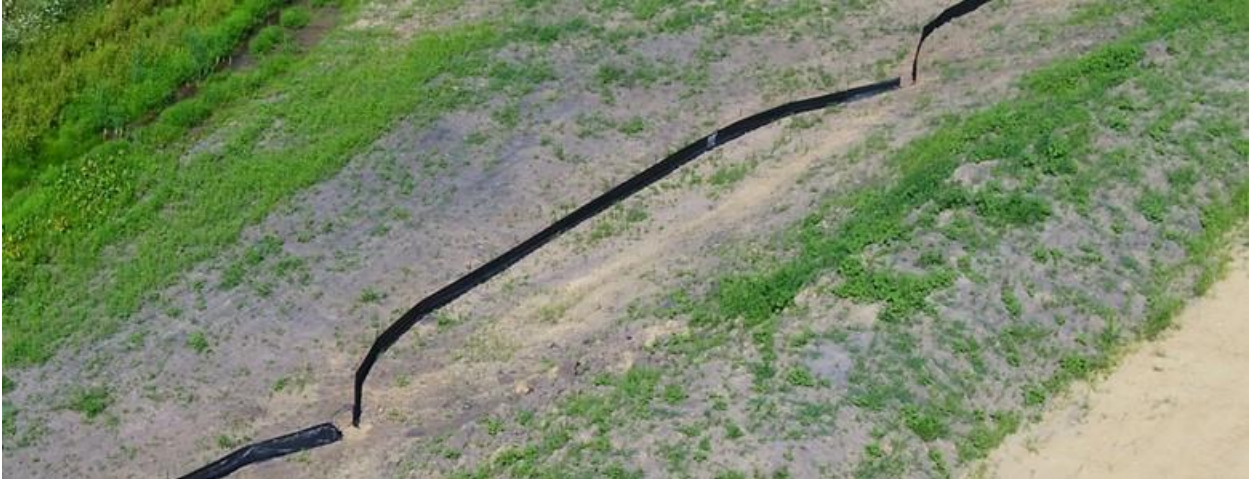
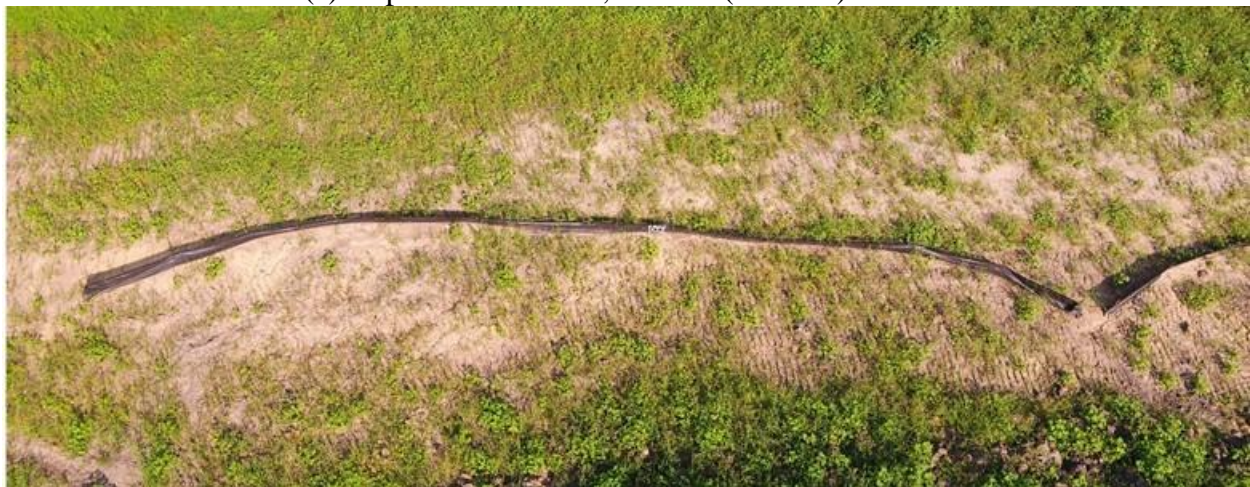
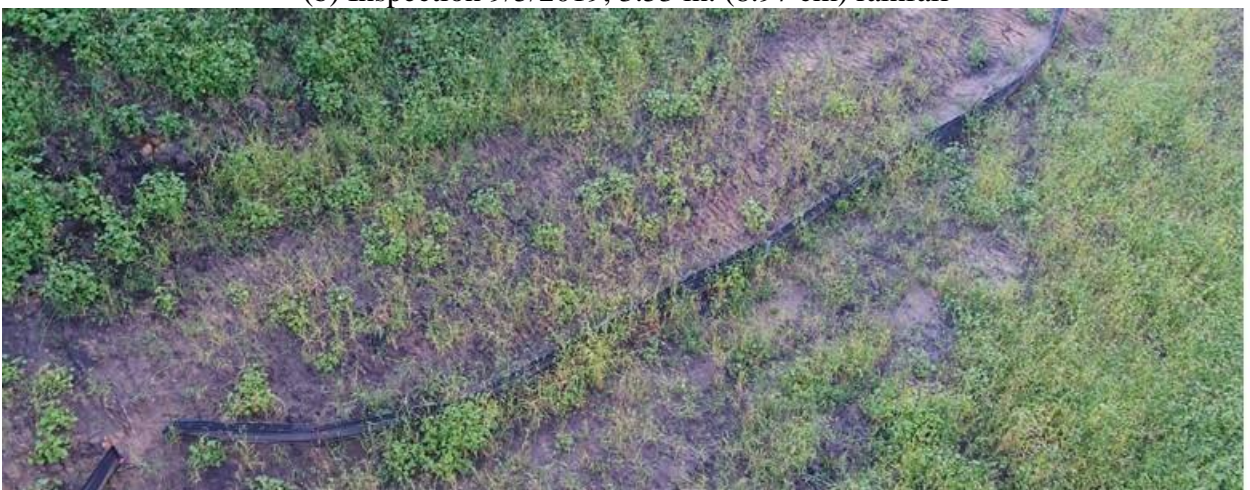
Figure 5.12. SF-PC-M2 aerial inspection photos

Figure 5.12 and 5.13 show periodic aerial photos during field monitoring and the sedimentation, respectively, at the SF-PC-M2 site.

(a) Inspection 8/6/2019, 0.33 in. (0.84 cm) rainfall

(b) Inspection 9/5/2019, 3.53 in. (8.97 cm) rainfall

(c) Inspection 9/24/2019, 6.78 in. (17.22 cm) rainfall

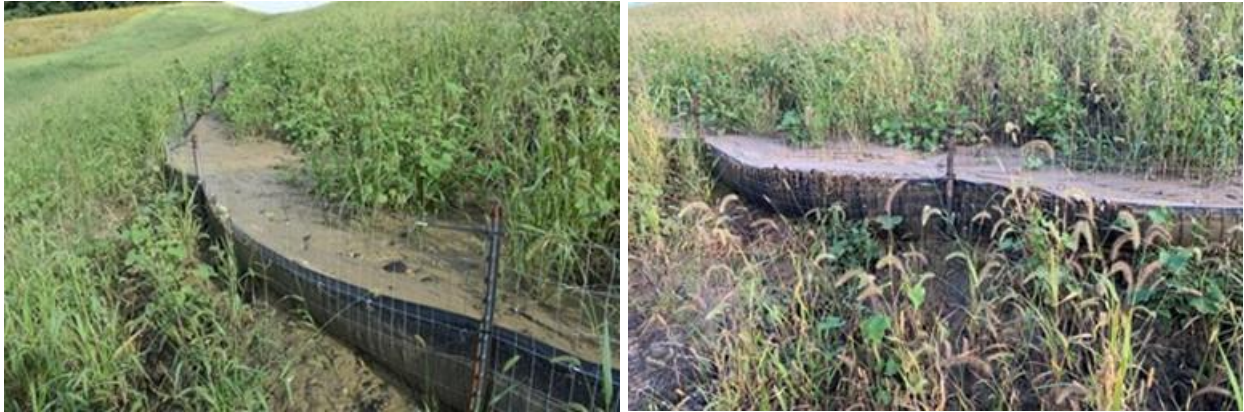
Figure 5.13. SF-PC-M2 sedimentation

(a) Full sedimentation, no deflection (9/5/2019) (b) Overtopping due to full height sedimentation (9/24/2019)

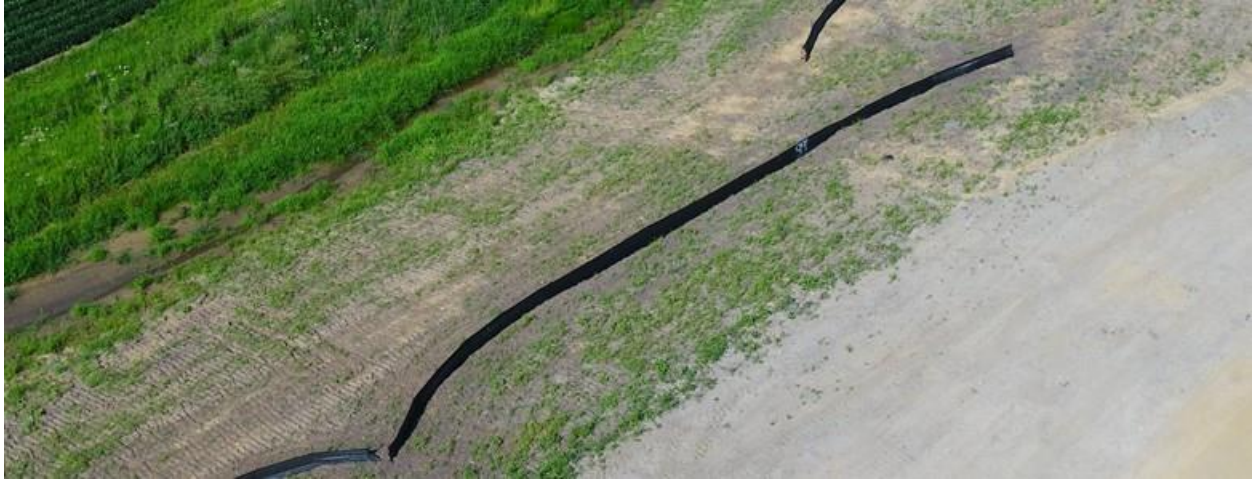
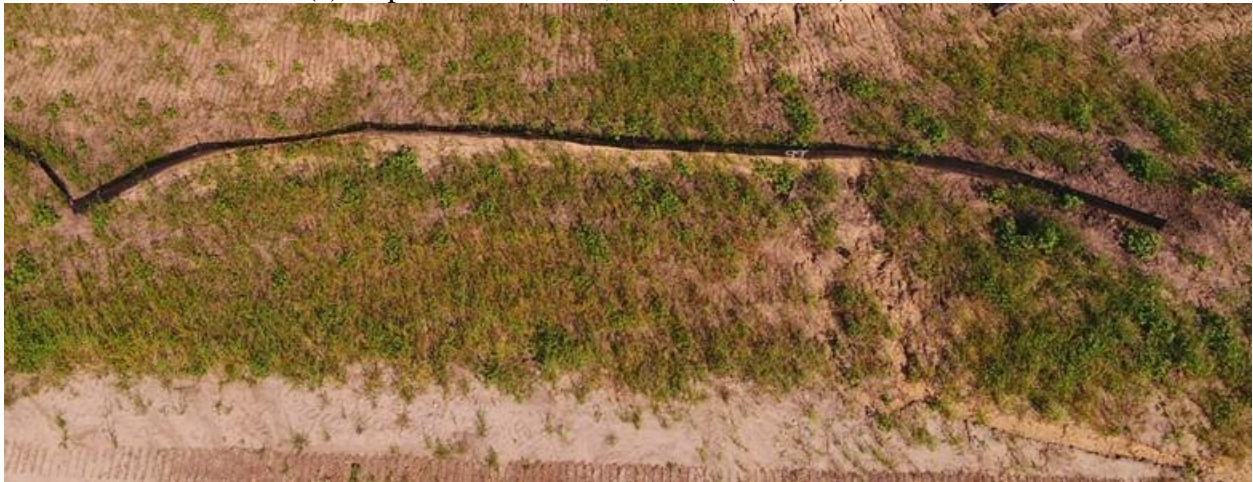
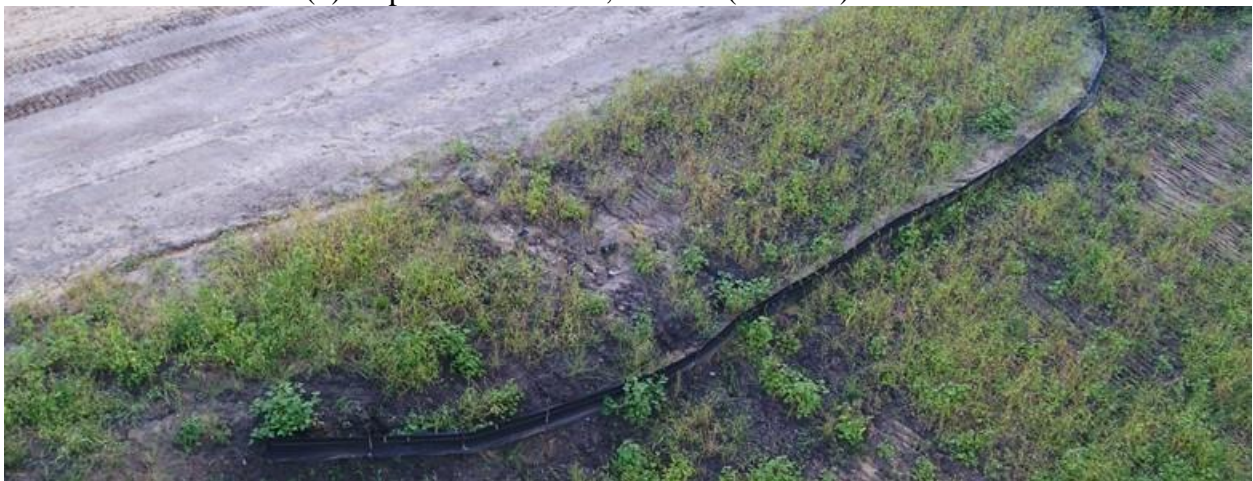
Figure 5.14. SF-PC-M3 aerial inspection photos

Figure 5.14 through Figure 5.16 show periodic aerial photos during field monitoring of the SF-PC-M3, SF-PC-M4, and SF-PC-M5 sites.

(a) Inspection 8/6/2019, 0.33 in. (0.84 cm) rainfall

(b) Inspection 9/5/2019, 3.53 in. (8.97 cm) rainfall

(c) Inspection 9/24/2019, 6.78 in. (17.22 cm) rainfall

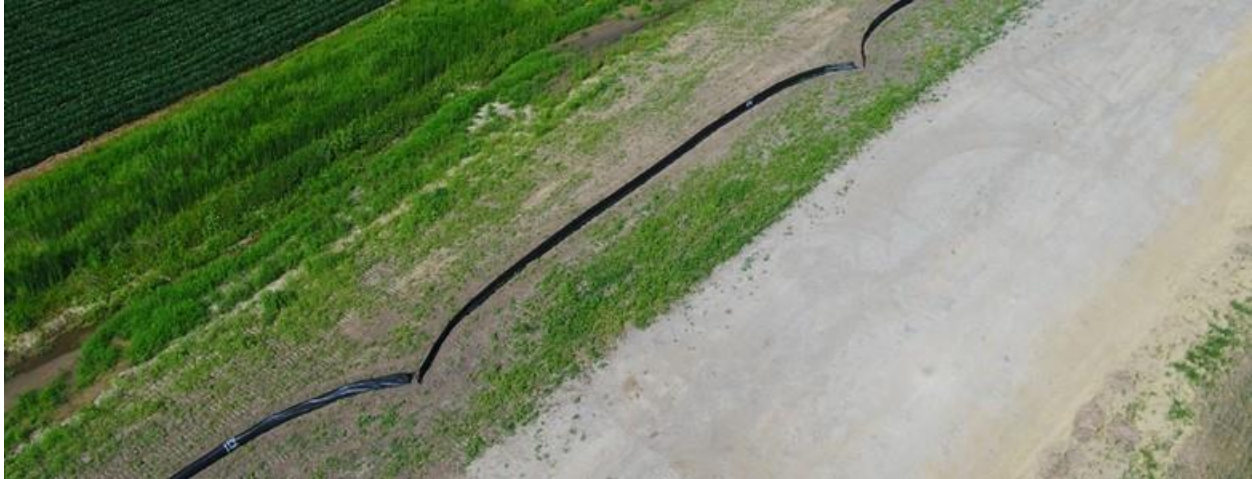
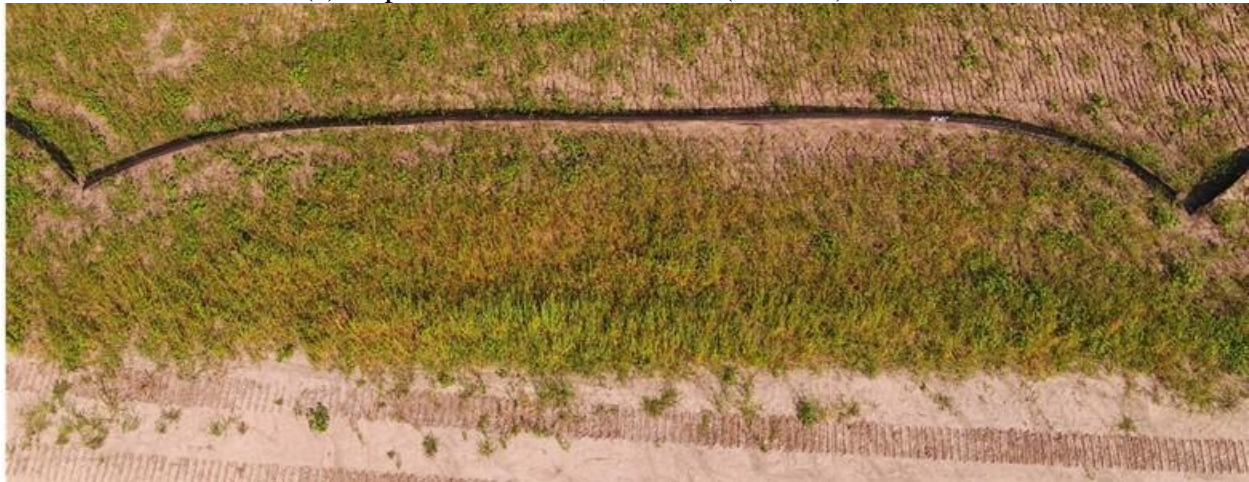
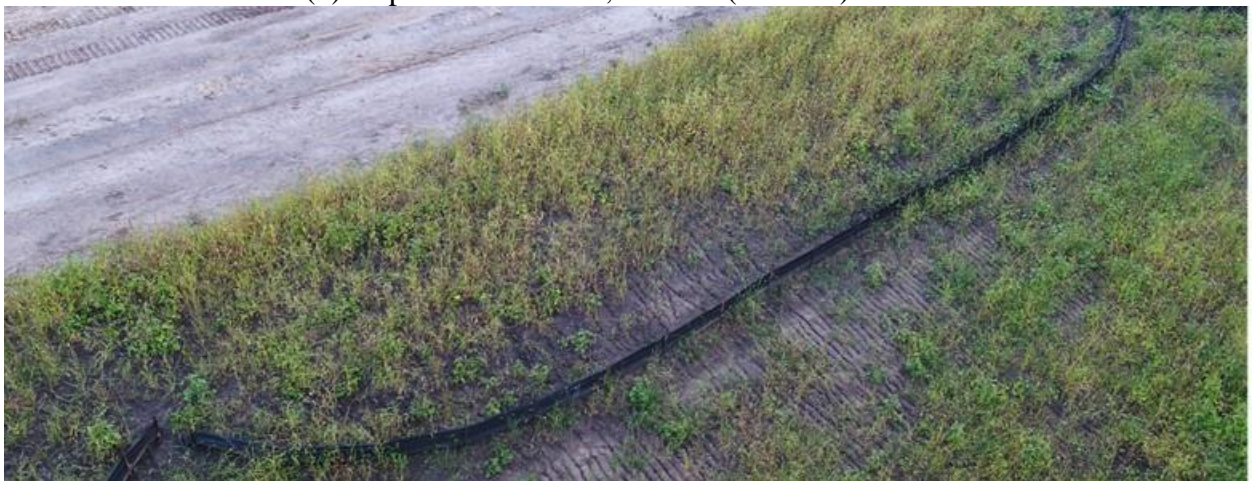
Figure 5.15. SF-PC-M4 aerial inspection photos

(a) Inspection 8/6/2019, 0.33 in. (0.84 cm) rainfall

(b) Inspection 9/5/2019, 3.53 in. (8.97 cm) rainfall

(c) Inspection 9/24/2019, 6.78 in. (17.22 cm) rainfall

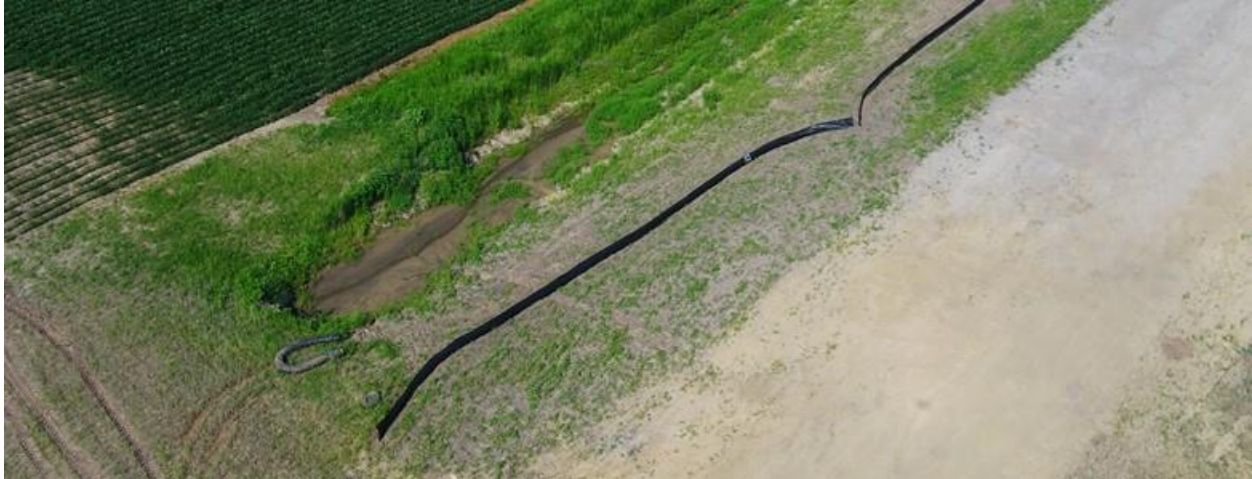
(a) Inspection 8/6/2019, 0.33 in. (0.84 cm) rainfall

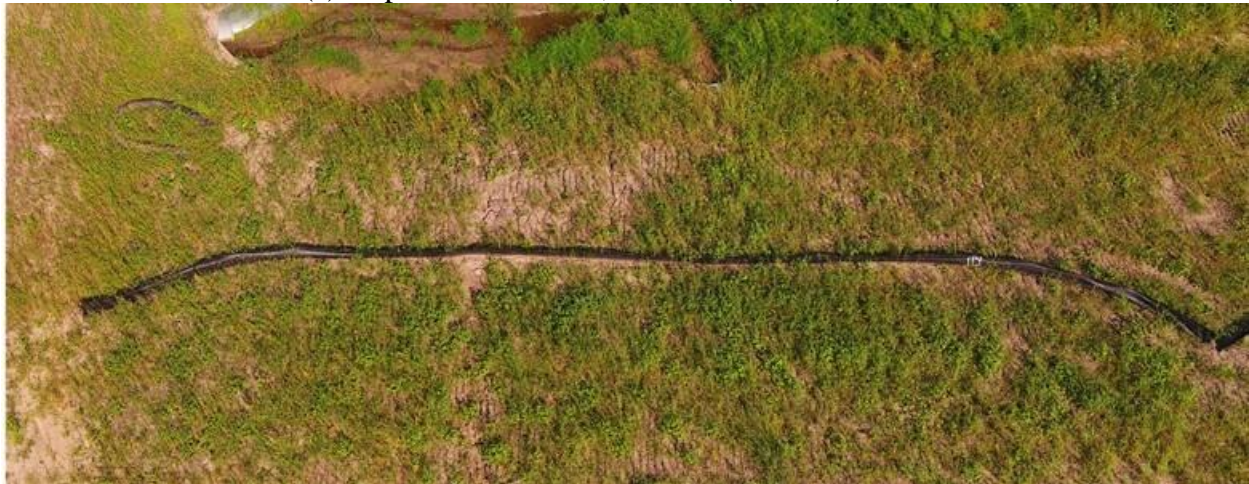
(b) Inspection 9/5/2019, 3.53 in. (8.97 cm) rainfall

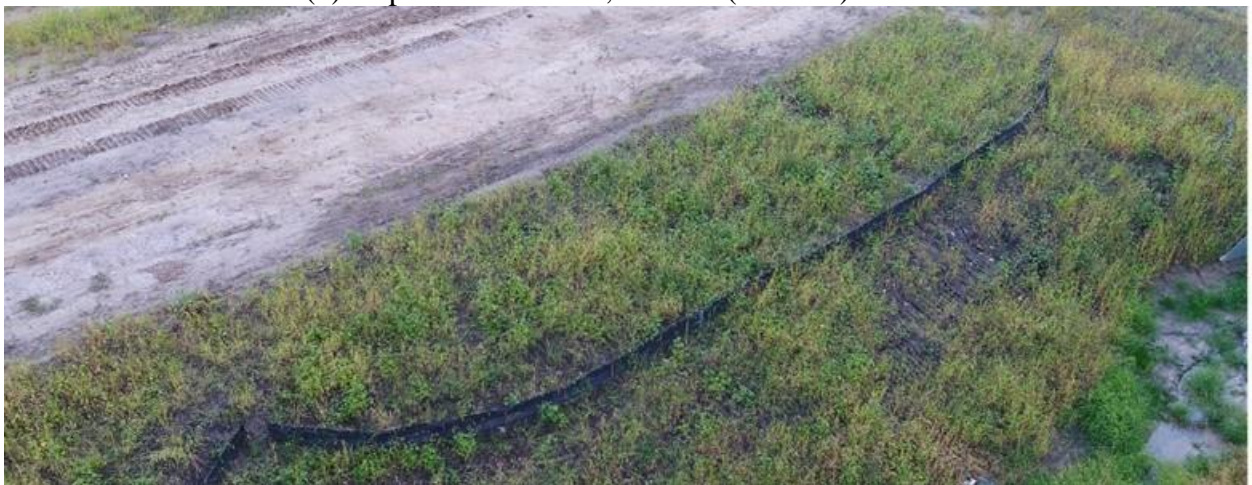
Figure 5.16. SF-PC-M5 aerial inspection photos

(c) Inspection 9/24/2019, 6.78 in. (17.22 cm) rainfall

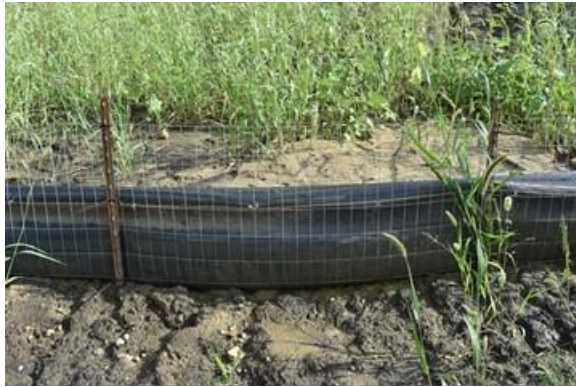
Figure 5.17 illustrates the full height sedimentation encountered by the second installation of the Modified 5 and sustained structural integrity.

(a) Full height sedimentation (9/5/2019)

By the second inspection, two of the three standard silt fence installations had failed due to T-post deflection causing overtopping. Similarly, the standard installation with manufactured, belted material had two of the three installations fail due to post-deflection. One of the failures led to undercutting and the other led to overtopping and downslope erosion. Modified 2 and 5 held back a large quantity of sediment with no observed structural change. The difference in the two installations was the T-post spacing. Modified 1 and 4 did not have any observed failures, but more sediment was observed behind Modified 4. It is believed that the closer spacing aided in maintaining the structural integrity.

Based on these observations, it would be recommended that adopting either the wire reinforcement at 8 ft (2.4 m) spacing or decreasing spacing to 5 ft (1.5 m) aids in the structural integrity. Both of these practices had an offset. Since the offset is no additional cost to the DOT and seems to aid in structural integrity, it is recommended to adopt the offset. Based on cost comparison and observed performance, decreasing post spacing is recommended. In addition to the recommendations from this field study, researchers suggest testing the performance of a wooden stake system to replace the steel T-posts to decrease cost. However, it would be advantageous to test representative runs of the standard and modified installations in a controlled environment to ensure similar conditions for comparison. In addition to these modifications, it is recommended to decrease the length of the silt fence segments and implement J-hooks or C-configurations to reduce the load on low points of the silt fence.

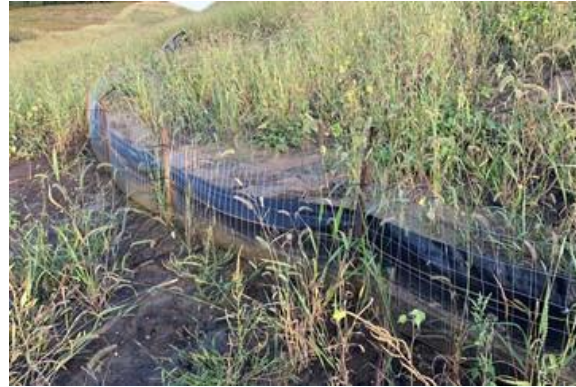
Figure 5.17. SF-PC-M5 sedimentation

(b) Sedimentation (9/24/2019)

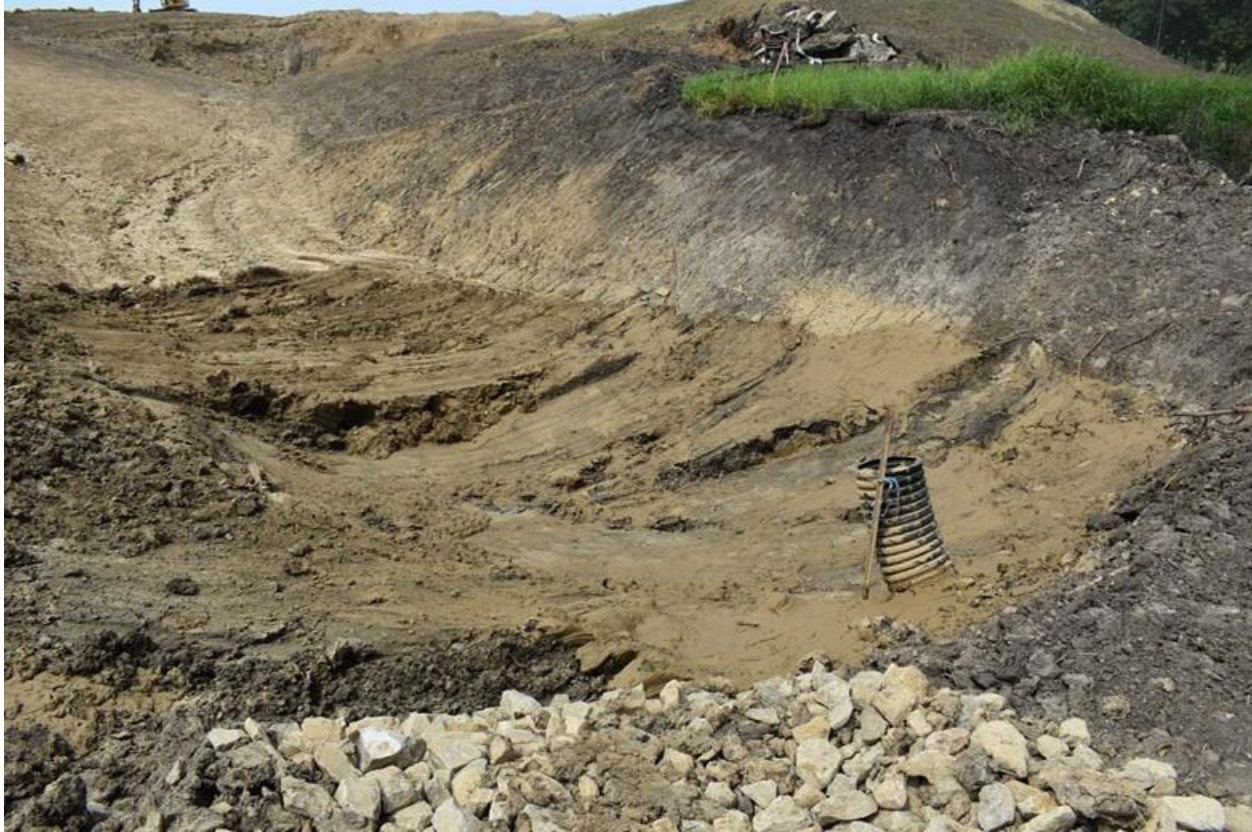
Photographs from field-installed sediment basins are provided in Figure 6.2.

(a) Basin (downstream perspective)

The Iowa DOT standard sediment basin detail is designed to create temporary detention within the typical channel environment. The basin is constructed by excavating an additional 12 in. (30 cm) and using the material to create an earthen berm. The berm has a 4 ft (1.2 m) top width and is 4 ft (1.2 m) high at the midpoint of the berm. Side slopes are 1:2 (H:V). Situated along the berm, a 4 ft (1.2 m) wide by 6 in. (15 cm) deep spillway allows for runoff to bypass the sediment basin when the volume capacity is exceeded. The spillway is armored with erosion stone to prevent scour during overtopping events. A 4 ft (1.2 m) erosion stone apron extends beyond the toe of the berm along the downstream face of the sediment basin. A 12 in. (30 cm) diameter corrugated riser pipe is installed through the berm. The upstream face of the dewatering pipe is turned upward at a 90 degree bend to create a riser structure at the end of the sediment basin. The top of the riser pipe is drilled with three 1.0 in. (2.5 cm) holes spaced 2.0 in. (5 cm) along the top of the pipe. Typically, a riser structure has about 12 perforations. The Iowa DOT temporary sediment control basin detail EC-601 is represented from profile and cross-section views in Figure 6.1a and b, respectively (Iowa DOT 2018).

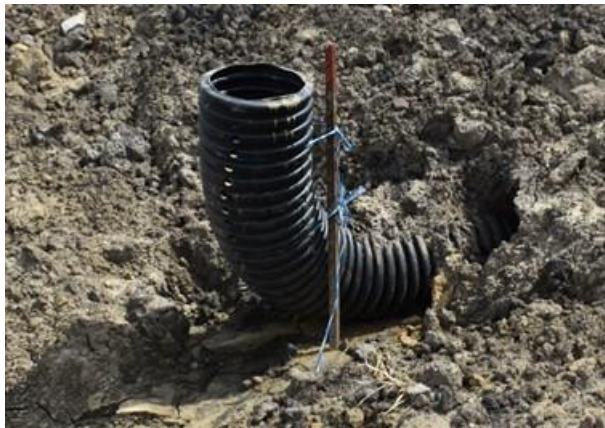
(b) Riser pipe structure

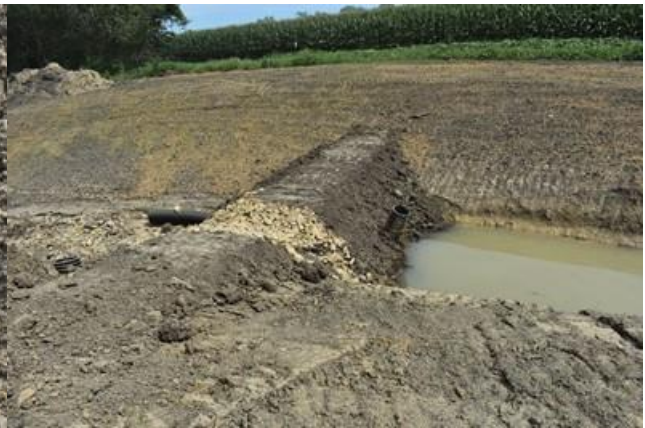
Figure 6.2. Typical sediment basin installed in Tama US 30

(c) Spillway

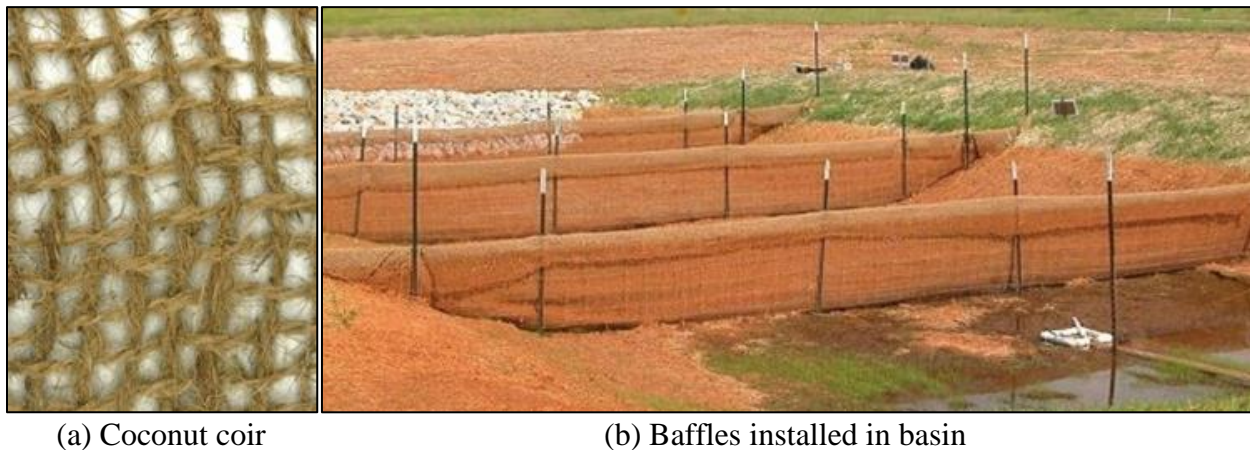
Figure 6.3. Sediment basin baffles

Figure 6.3a shows a sample of coconut coir typically used as a sediment basin baffle. Figure 6.3b shows a series of baffles installed within a sediment basin.

Several DOTs have adopted flow baffles or energy dissipaters including the Alabama and North Carolina DOTs (ALDOT 2020, NCDOT 2015).

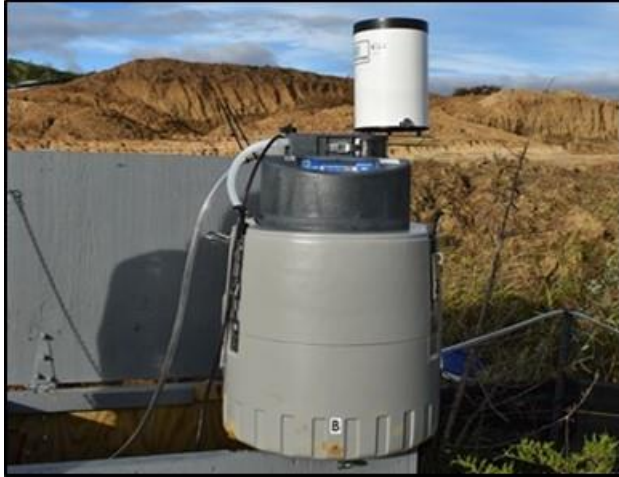
To evaluate water quality performance of the monitored sediment basins, automated water samplers were deployed to collect samples at the inflow and discharge of sediment basins. Teledyne ISCO 6712 full-size portable samplers were selected for sampling the basins. This sampler could be programmed based on several parameters such as time, flow, level, or rainfall, with the necessary attachments. A Teledyne ISCO 674 rain gauge was connected to one of the samplers, measuring the depth of rainfall observed on-site. An ISCO sampler is shown in Figure 6.7a.

(a) Sampler system

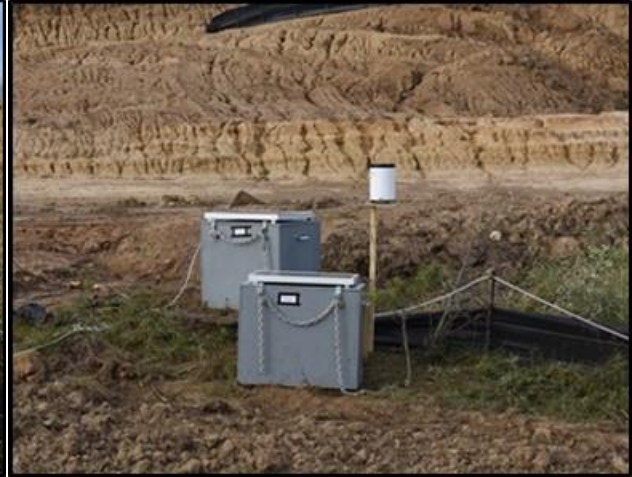
(b) Secured lock boxes w/ solar panel and rain gauge

To protect the samplers from theft and vandalism, samplers were housed in a constructed 5 ft long by 2 ft wide by 4 ft high (1.52 m long by 0.61 m wide by 1.22 m high) plywood lock box. The lock box was secured to a ground anchor with chain and locked with a pad lock as shown in Figure 6.7b. A 12V deep cycle marine battery was placed inside the box and was used to power the ISCO sampler. To keep the battery charged, a 36 cell, 50 watt solar panel (32.69 in. high by 21.13 in. wide by 1.97 in. diameter [32.69 cm high by 53.66 cm wide by 5.00 cm diameter]) was mounted to the top of the lock box housing, Figure 6.7c. Samplers were programmed to take 25 oz (0.75 L) samples from the basin at 12 hour sampling intervals. Each sample was collected in a single ISCO 33.8 oz (1.0 L) pie-shaped bottle. The ISCO 6712 auto samplers can hold a total of 24 pie bottles at a time, as shown in Figure 6.7d.

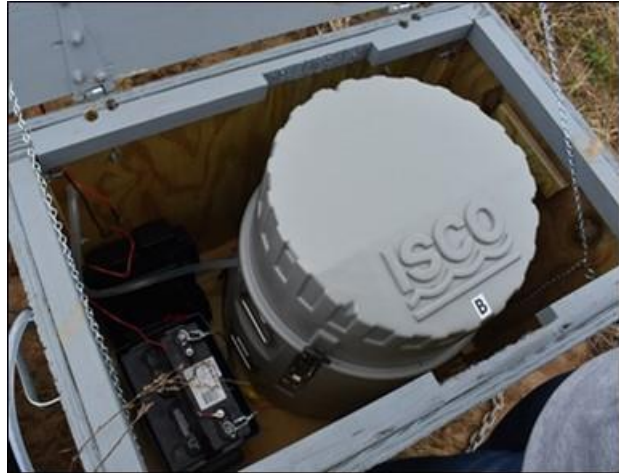
(c) 12V marine battery

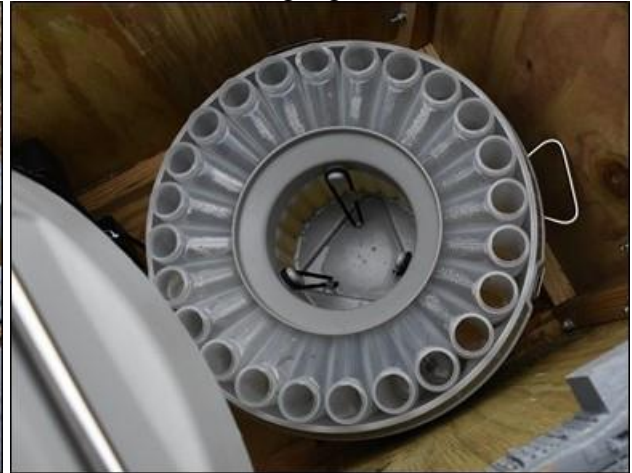
Figure 6.7. Automated sampler apparatus on Tama US 30

(d) Sample bottle array

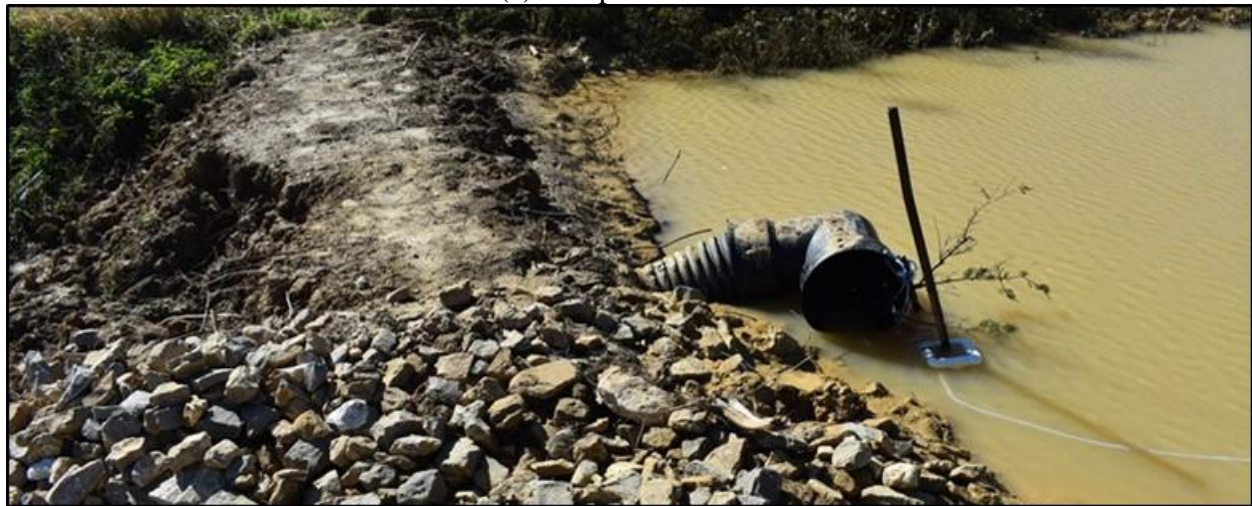
Figure 6.8. Single sediment basin sampling locations and dewatering system

(b) Sample float system at discharge

A set of basins in series was identified and monitored between May and September of 2019. The basins were located at station 390+00 and had a drainage area of 6.56 ac (2.65 ha). The first basin had a flow length of approximately 75 ft (23 m) from inflow to discharge and served as pre-treatment. The second basin had a flow length of 100 ft (30.48 m). The riser pipe from Basin 1 inflows to Basin 2. Four automated samplers were deployed between the two basins. Samplers A and B were used to sample the first basin at inflow and discharge, respectively. Samplers C and D were used to sample the second basin at inflow and discharge, respectively. Sampler B collected at the discharge of the first basin, which then discharged to the inflow at Sampler C. All samples were collected from the surface of the water column using floating sampling devices as shown in Figure 6.8b. Sampling locations of the basins in series are shown in Figure 6.14.
