Field Monitoring of Erosion and Sediment Control Practices and Development of Additional Iowa DOT Design Manual Guidance

**Final Report
April 2020**

Sponsored by
Federal Highway Administration
Iowa Department of Transportation
(InTrans Project 18-654)

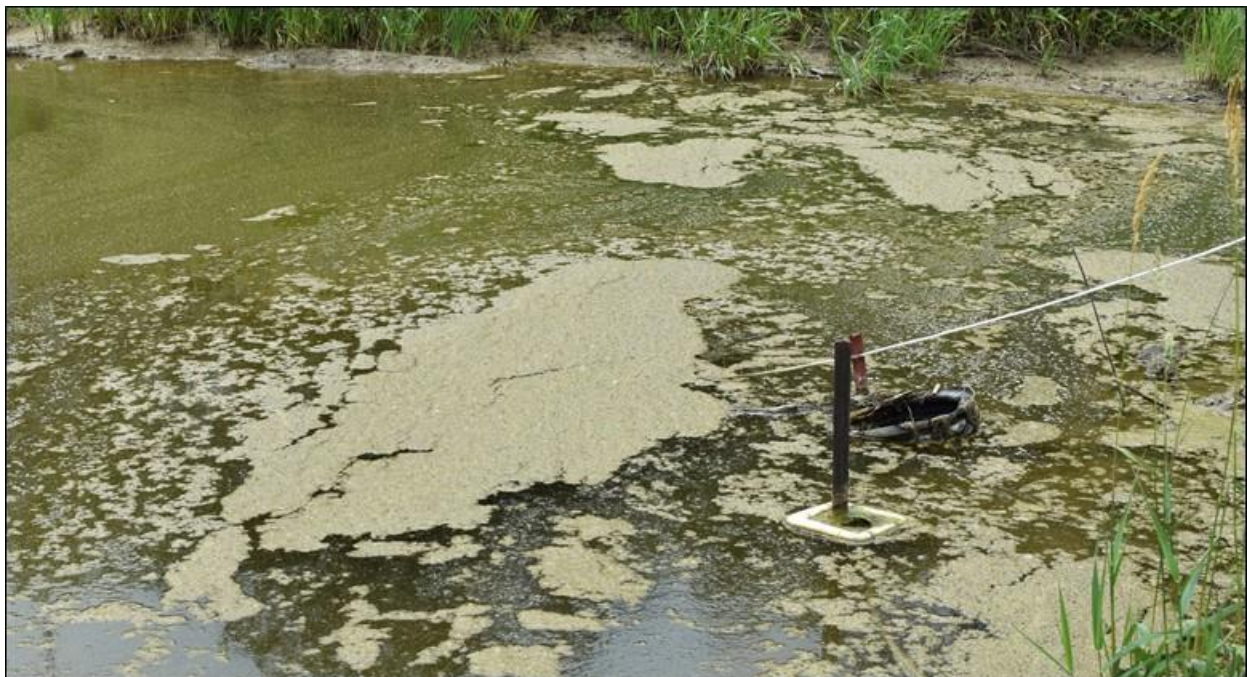
The sampling season had a high number of algae, plant materials, and gastropods contaminating samples as shown in Figure 6.15.

Figure 6.15. Algae growth in basin

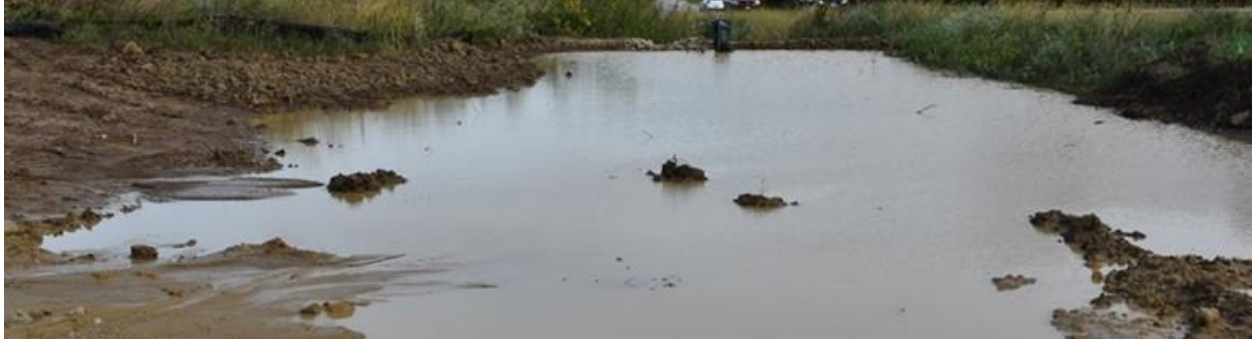
The basins did not have defined inflow channels and received sediment-laden flows from several directions due to lacking sediment barriers along the site perimeter. The channels that existed eroded with each storm, contributing to the incoming sediment load. As the basins dewatered, there was progressive widening due to sloughing of the basin walls and which minimized the length-to-width ratio of the basin. Additionally, materials from the sloughed walls would suspend with captured runoff. Due to lack of maintenance, there was accumulation of sediment in the basin, which exceeded the dead storage available, consequently decreasing the available live storage volume during subsequent storm events. In the single basin system, the riser pipe's buoyancy eventually caused the anchoring T-post to be dislodged from the basin ground. The basin was not dewatering via the riser pipe but overflowing and washing out the auxiliary spillway, shown in Figure 6.8b. Erosion stone was washed out, transferring flow shear stress to the earthen berm beneath it, causing erosion. Washout from the earthen berm was not captured, as discharge samples were taken proximal to the discharge pipe. It is likely turbidity and total solids concentrations were higher than captured by the sampler. Common sediment basin deficiencies captured on Tama US 30 are shown in Figure 6.21.

(a) Side wall sloughing and no defined inflow channel

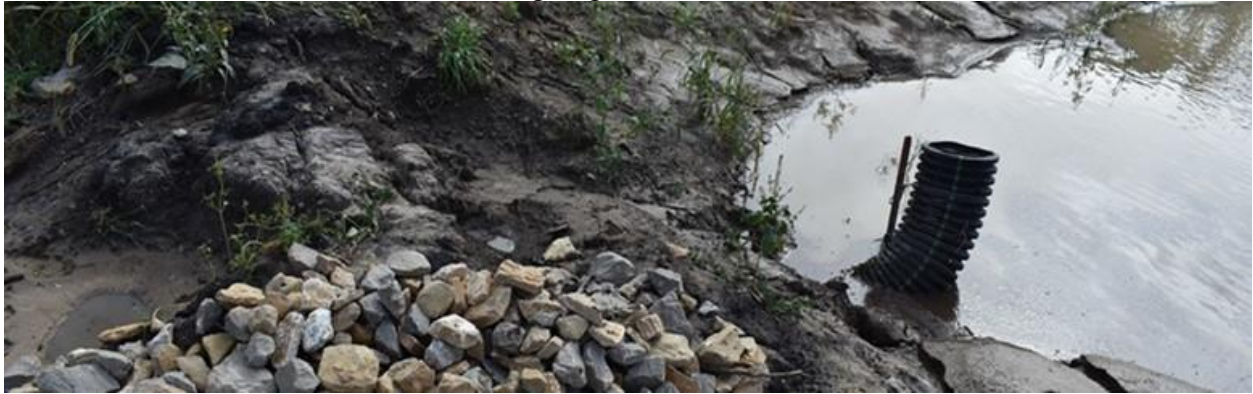
(b) Erosion of overflow berm

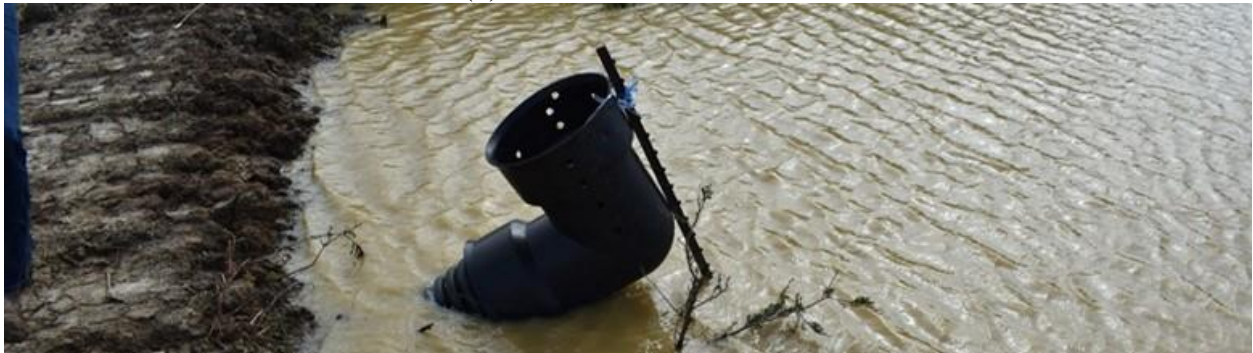
(c) Buoyant riser pipe dislodged from basin bottom

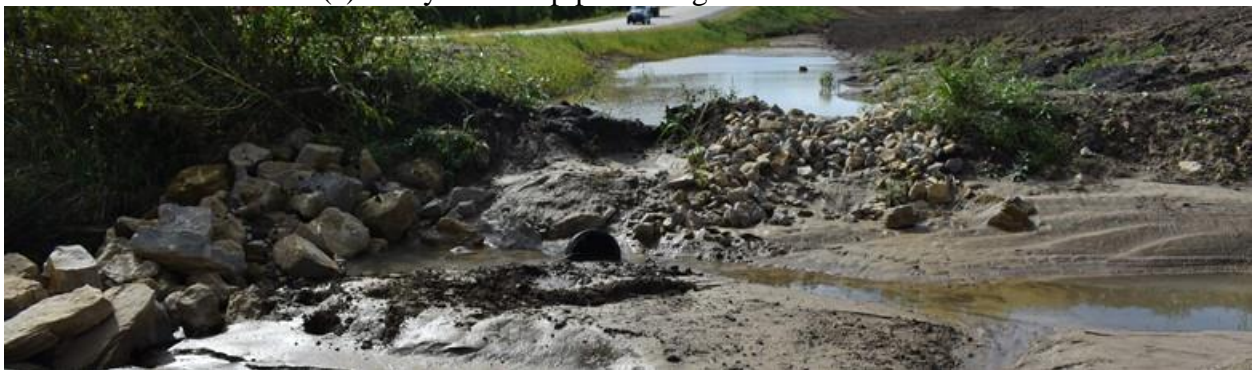
(d) Washout of berm, riser pipe discharge elevation higher than inflow, sedimentation prior to dewatering

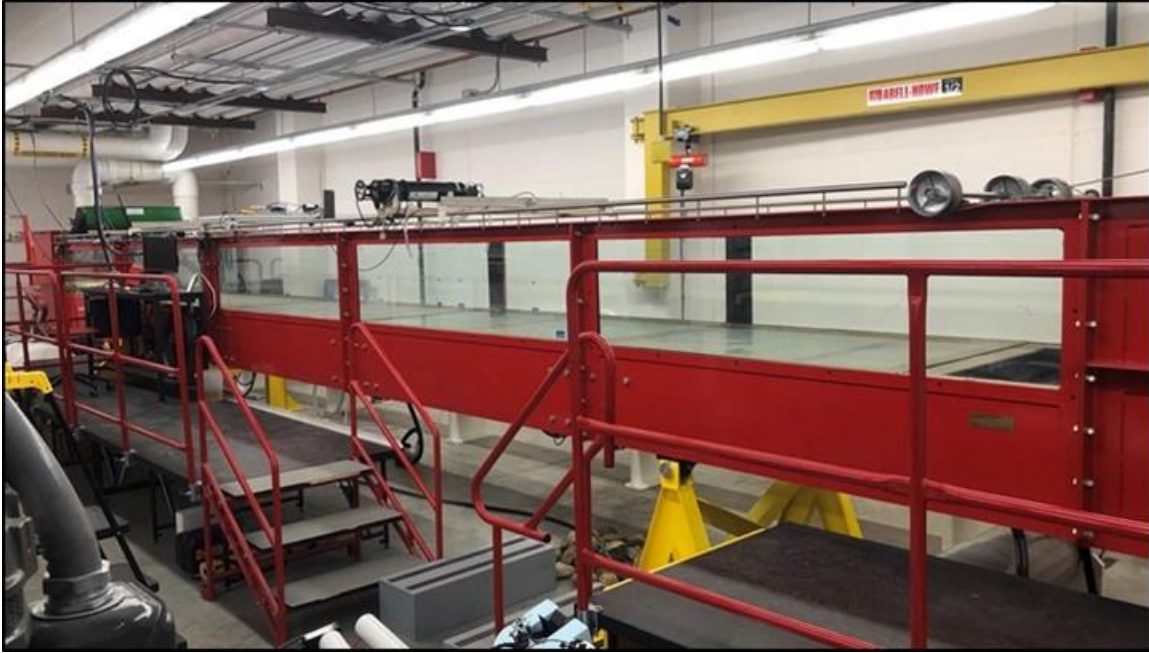
Figure 7.1. Test apparatus

The state-of-the-art flume system used during this study is shown in Figure 7.1a.

(a) Iowa State University flume

Wattle evaluations were conducted using a tiered slope and flow regime that introduced clean water at 0.25, 0.75, 1.25, and 2.00 ft³/s (0.007, 0.021, 0.035, and 0.057 m³/s) at slope grades of 3.50%, 4.25%, and 5.00%. Flow duration for each tier was approximately 3.5 minutes or until flow equilibrium (i.e., constant subcritical flow length measured from wattle center to hydraulic jump) was achieved within the flume. This evaluation process was selected to allow wattle performance to be analyzed with respect to slope and flow rate. As shown in Figure 7.1b, nine cross-sectional (CS) locations were established prior to testing for data collection, seven upstream and two downstream of the installed wattle. Cross sections were spaced 3 ft (1 m) apart, measuring from the upstream and downstream face of the installed wattle. These cross sections were used to obtain water depth measurements during testing.
