Evaluation of the Effectiveness of Wildlife Guards and Right of Way Escape Mechanisms for Large Ungulates in Arizona

Arizona Department of Transportation Research Center

SPR-729

September 2020

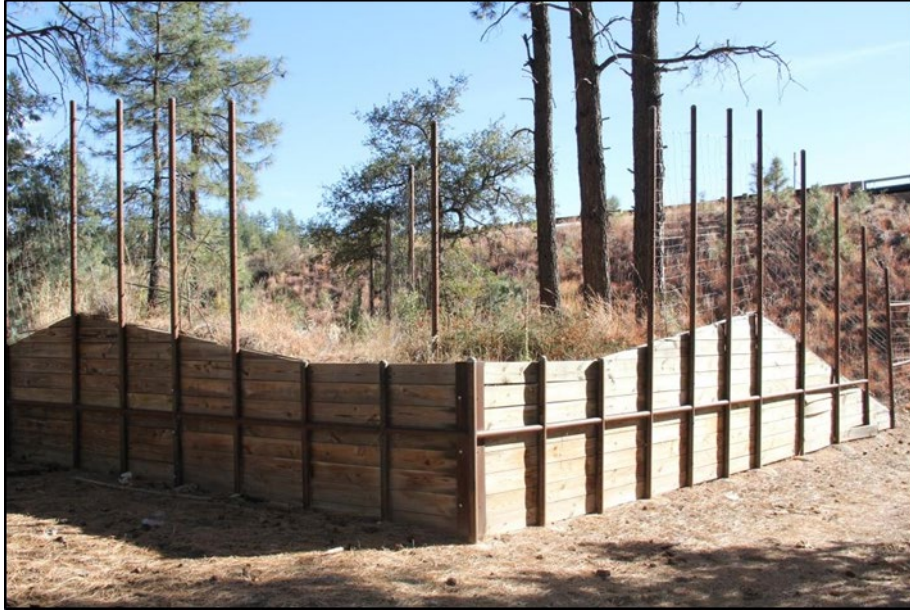
Figure 1. Wooden Escape Ramp

Wooden plank escape ramps used on the first phase of SR 260 presented maintenance issues as boards warped, allowing ramp fill material to erode and compromise the structure. These maintenance concerns prompted AGFD to work with ADOT to modify the escape ramp design, ultimately leading to a robust concrete retaining wall design that was implemented for the next phases of SR 260 and have so far withstood erosion. However, the effectiveness of these concrete structures as one-way escape mechanisms for elk and deer has not been evaluated.

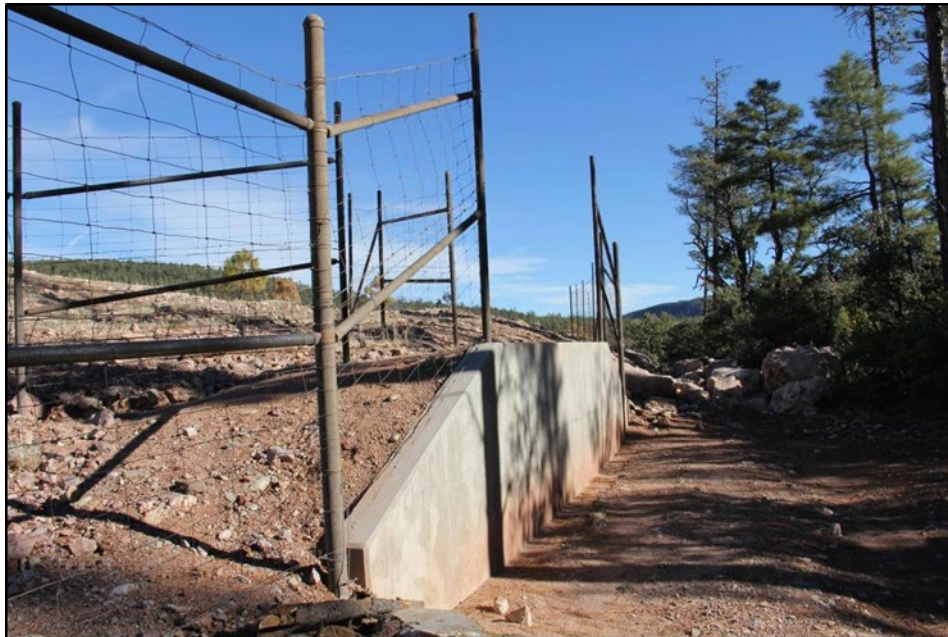
Figure 2. Concrete Escape Ramp

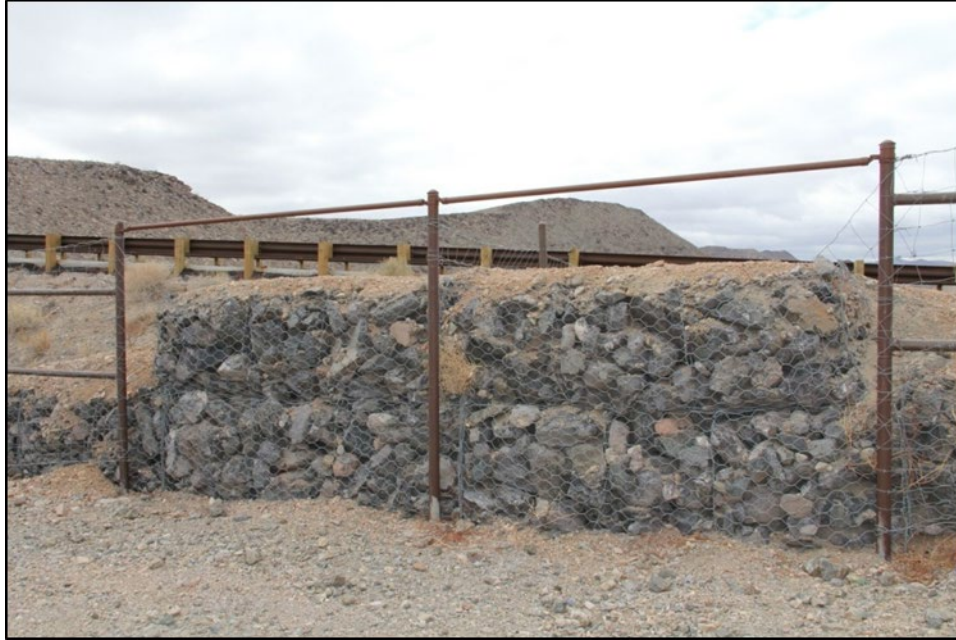
Figure 3. Gabion Basket Escape Ramp

In 2003, ADOT began experimenting with gabion basket escape ramp structures as an alternative to costly concrete designs along U.S. 93 (McKinney and Smith 2007). Gabion basket escape ramps consist of stacked wire mesh baskets filled with rocks (see Figure 3). Although the first gabion baskets were inexpensive, preliminary data indicated that the escape mechanism design was inadequate for preventing bighorn sheep from accessing the ROW, and researchers recommended increasing the ramp height in the future. The heightened versions were installed as escape mechanisms for bighorn sheep on U.S. 93 and for elk and mule deer on I-17. At both locations, soil retention partially failed, exposing the wire mesh along the leading edge of the ramp. This presented a maintenance problem and posed a danger to ungulates as their legs could become caught if they attempted to use the deteriorated escape mechanism (Gagnon et al. 2016, Gagnon et al. 2017a). To address soil retention issues, the gabion basket escape ramps installed on SR 260 in 2013 used a revised design to prevent backfill from sloughing off, incorporating fine wire mesh and landscape fabric into the approved design drawings. The installation was completed in fall 2013, and the updated design has yet to be evaluated.

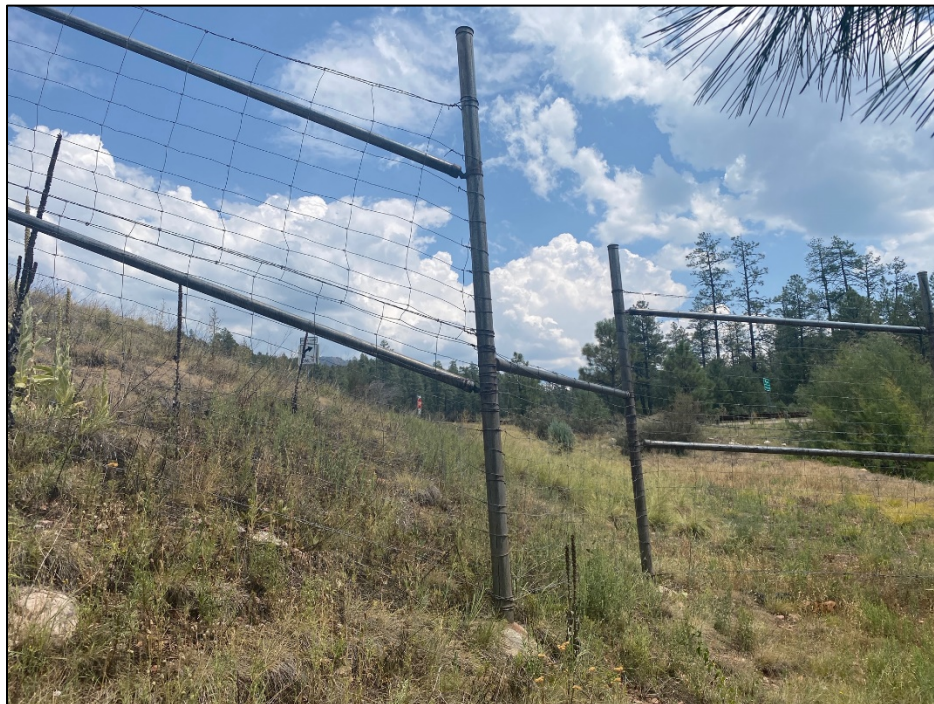
Figure 4. Slope Jump Escape Mechanism

a slope with the uphill side of the slope jump toward the highway and the downhill side away from the highway (see Figure 4). The premise of slope jumps is to take advantage of existing topography where physics would easily allow a deer or elk to jump down the slope (over a lowered segment of fence) and out of the ROW, but where the animal would have difficulty gaining enough momentum to jump up the slope (over the fence) and into the ROW (Gallagher et al. 2005). Presently, there are no empirical data regarding slopes and heights that effectively prevent ungulates from entering the ROW via slope jumps or using them to escape. The slope jumps along Arizona highways (SR 260 and I-17) are the first of their kind to be implemented; as such, they provide an opportunity to test the effectiveness of this design and determine its utility for future ADOT projects.

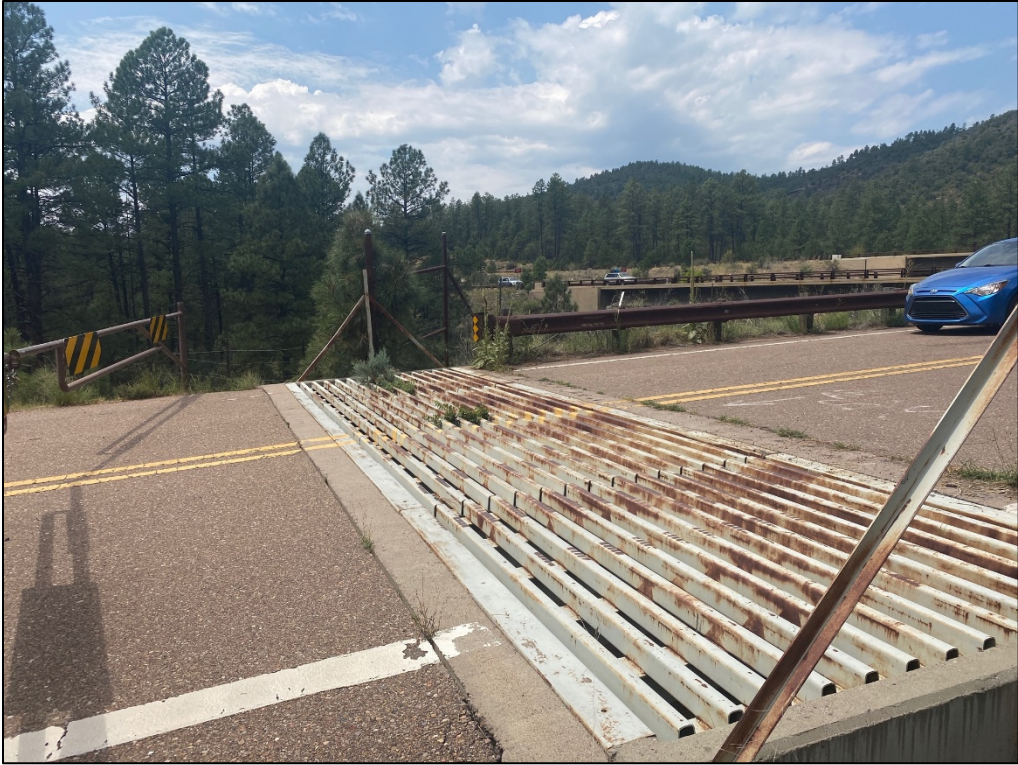
Figure 5. ADOT Standard Cattle Guard

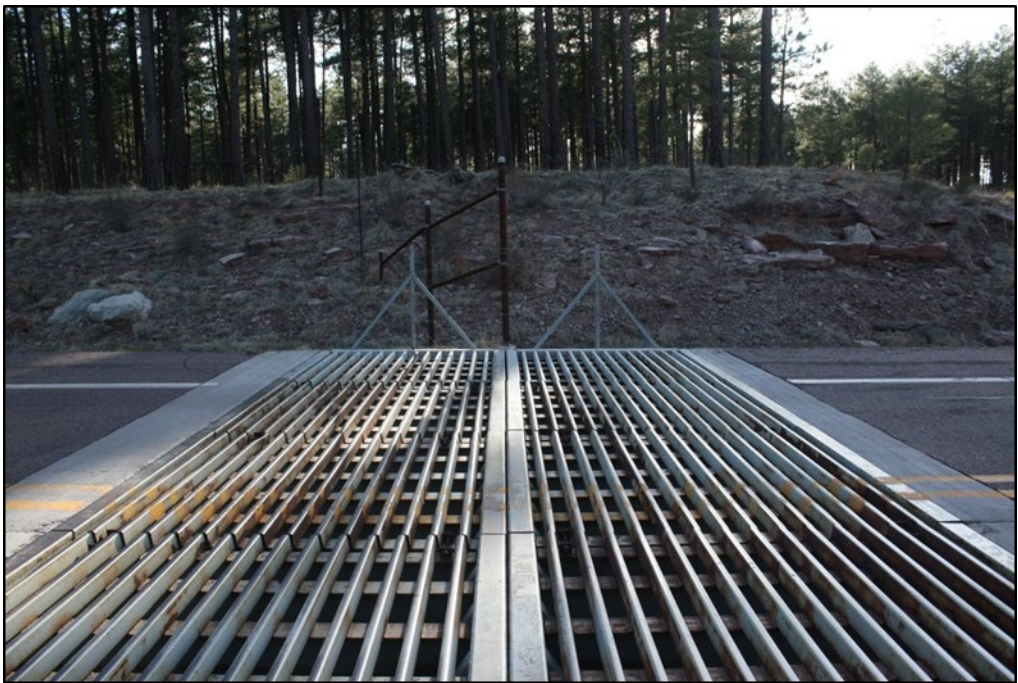
Figure 6. Two ADOT Standard Guards Installed Side-by-Side to Create a Double Cattle Guard

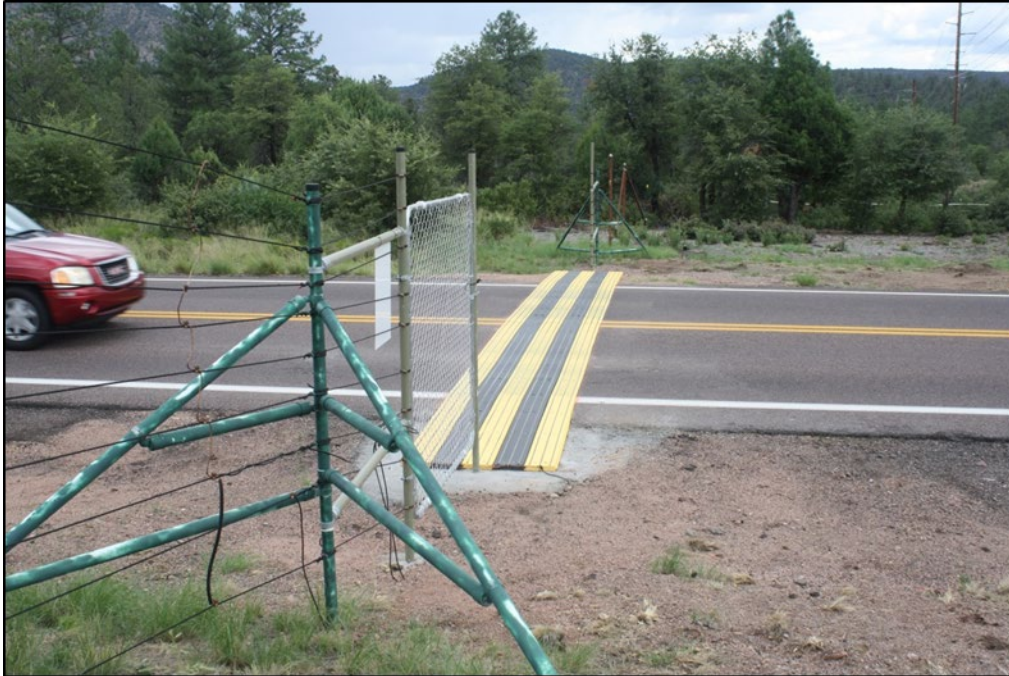
Figure 7. Electrified Mat

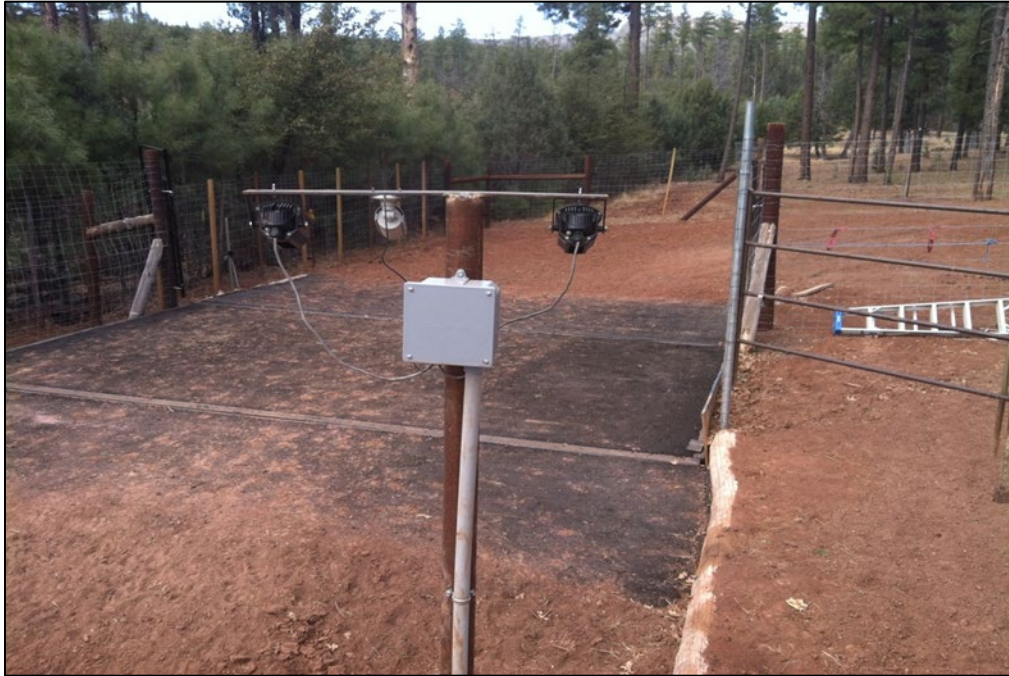
Figure 10. Video Surveillance Camera Orientation at a Wildlife Guard Treatment

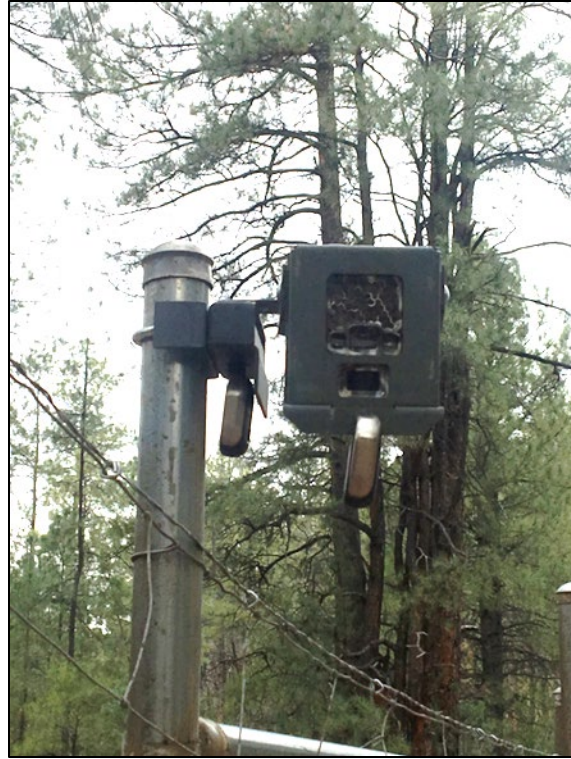
Figure 15. Camera Box Mounted to Wildlife Fencing

Researchers used Reconyx HyperFire still cameras, which use a motion sensor to detect animals and have a night vision feature to capture images in low lighting. Cameras were positioned to begin capturing images as animals approached the escape mechanisms from either inside or outside of the ROW (see Figure 16). Once an animal was detected, the camera captured a burst of three images each second until the animal left the camera's field of view. Because of the limitations of battery life and image storage capacity, cameras were checked approximately every six weeks to replace batteries, collect image data, verify that camera orientation was correct, and ensure that vandalism or theft had not occurred. Images were backed up twice to avoid loss in the event of storage equipment failure. If a camera was stolen or vandalized, researchers replaced the camera as soon as possible to minimize disruption in data collection.

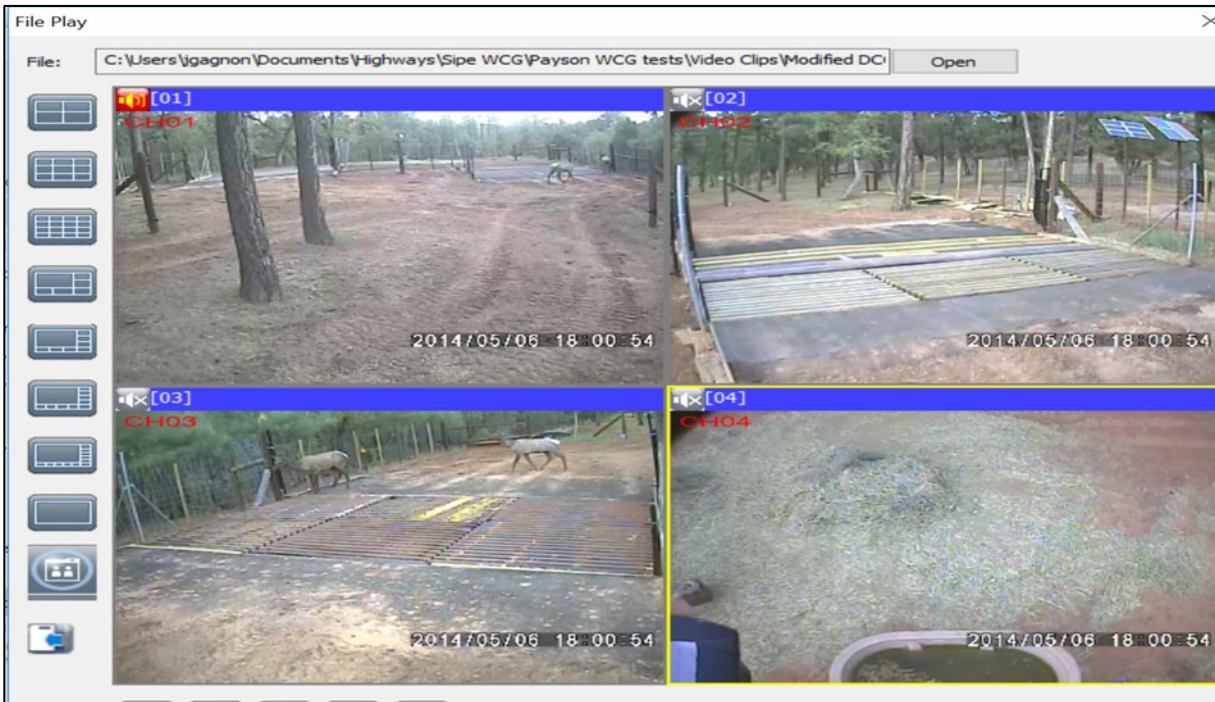
Figure 18. Video Camera Orientations Showing, top to bottom and left to right, (1) Entry Point into Test Site, (2 and 3) Wildlife Guard Treatments, and (4) Bait and Water

Four cameras were oriented to collect video when elk entered the test site and to document interactions with wildlife guards within the enclosure as elk attempted to reach bait and water on the other side of the wildlife guards at the back of the enclosure (see Figure 18). Infrared illuminators were activated via photocell to allow researchers to document elk activity during nighttime and low-light conditions. Cameras continued to record activity while elk were present and for two minutes after they left the enclosure. Cameras were checked approximately every two weeks to ensure correct camera and photo-beam orientation and to switch out the digital video recorder for image review.

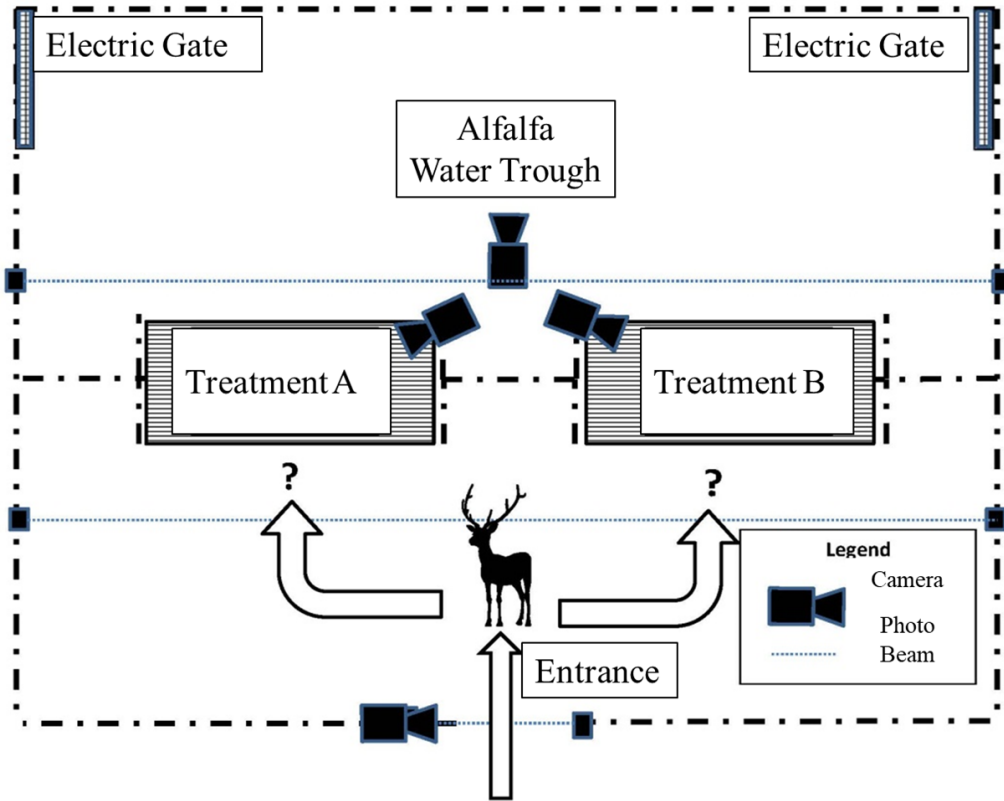
Figure 19. Layout of the Elk Wildlife Guard Test Site and Video Cameras at Risser Ranch

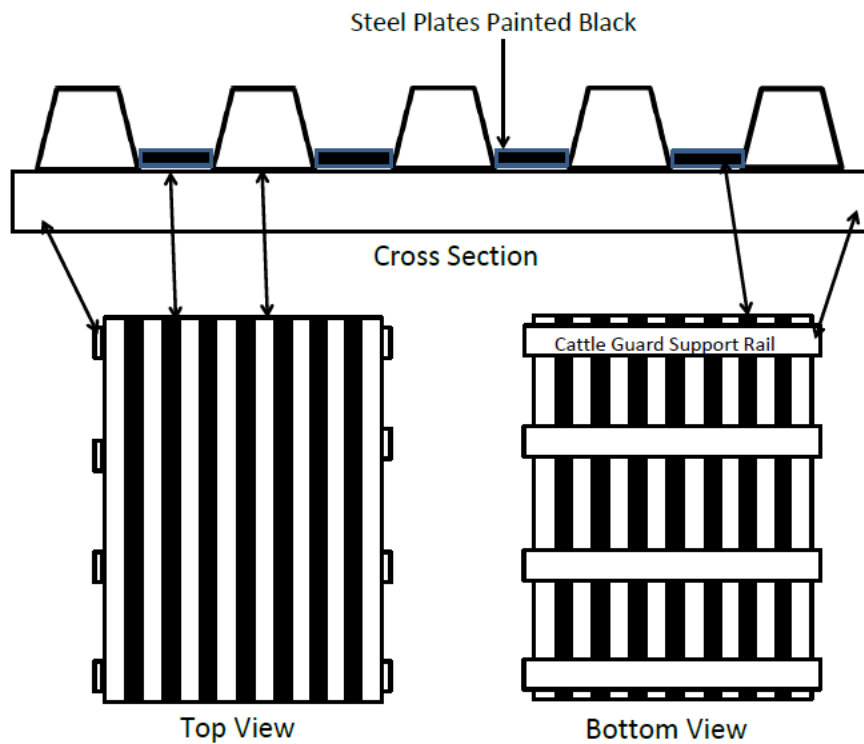
Figure 20. Cattle Guard Modified to Prevent Elk Injury, Showing Cross Section, Top, and Bottom Views

The evaluation and comparison of various combinations of wildlife guard types ended up being limited by the difficulty in implementing potential modifications to the guards and asphalt at the test site; thus, only selected comparisons were made. In addition, the test site evaluation of ADOT standard single and double cattle guards used modified versions of the guards created by CrossTek LLC. In these modified guards, welded black plates were placed inside the cattle guards to keep elk from falling all the way through the grates (potentially leading to injury) while still visually mimicking a cattle guard (see Figure 20).

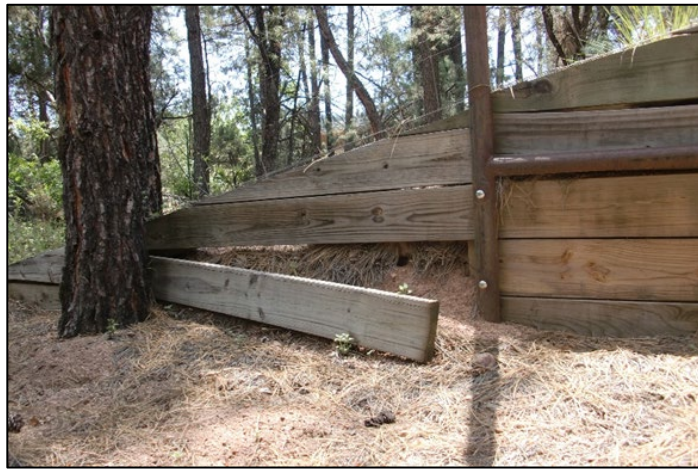
Figure 21. Escape Mechanism in Need of Maintenance

The research team collected photographic examples of maintenance and design concerns associated with various escape mechanisms and wildlife guards used in Arizona. One example is shown in Figure 21. In addition to maintenance and design issues, the research team also sought out examples of escape mechanisms and wildlife guards from other states. These examples were combined and used to help inform current maintenance decisions and recommendations for possible future design changes that would maximize wildlife use and minimize maintenance needs. These issues are discussed in detail in Chapter 4.

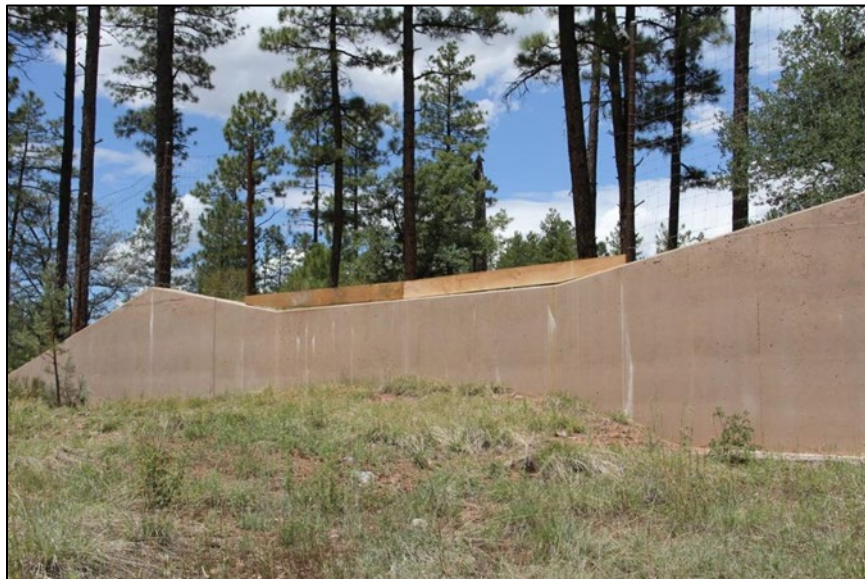
Figure 23. Board Added Along the Top of an Escape Ramp to Increase Its Height

In seven locations, researchers modified the height of existing escape mechanisms during the study. These locations included areas where elk had been documented to easily enter the ROW via an escape mechanism (see Figure 22) or where heights of escape mechanisms appeared too low (less than 60 inches) to effectively preclude elk from entering the ROW. The research team made modifications that included adding boards along the top edge of the escape mechanism (see Figure 23) or removing dirt mounds at the base of the escape mechanism to increase the height an elk would have to jump to enter the ROW. Three of these locations were on SR 260 and four were on I-17. After the modifications, monitoring was resumed at the new heights. In some instances, multiple modifications were made to the same escape mechanism to find the optimal height that would allow elk to escape the ROW relatively easily but discourage them from entering the ROW.

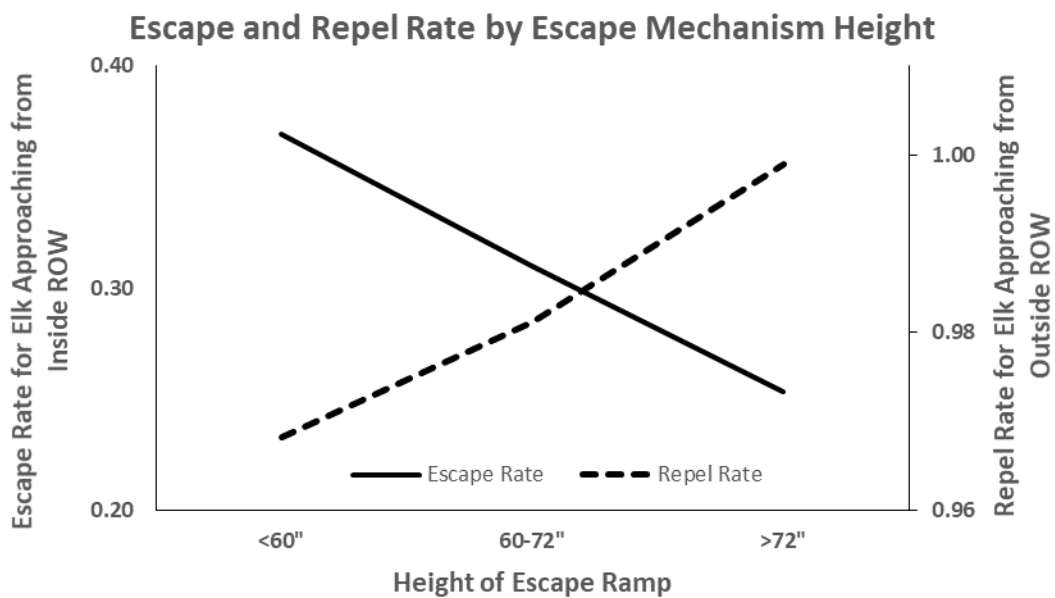
Figure 24. Comparison of Elk Escape Rates and Repel Rates by Escape Ramp Height

Escape Ramp Height (inches)	Approaches from Inside ROW	Escapes	Escape Rate	Approaches from Outside ROW	Times Repelled	Repel Rate
< 60	712	263	0.37	2545	2464	0.97
60-72	129	40	0.31	903	886	0.98
> 72	158	40	0.25	928	927	1.00

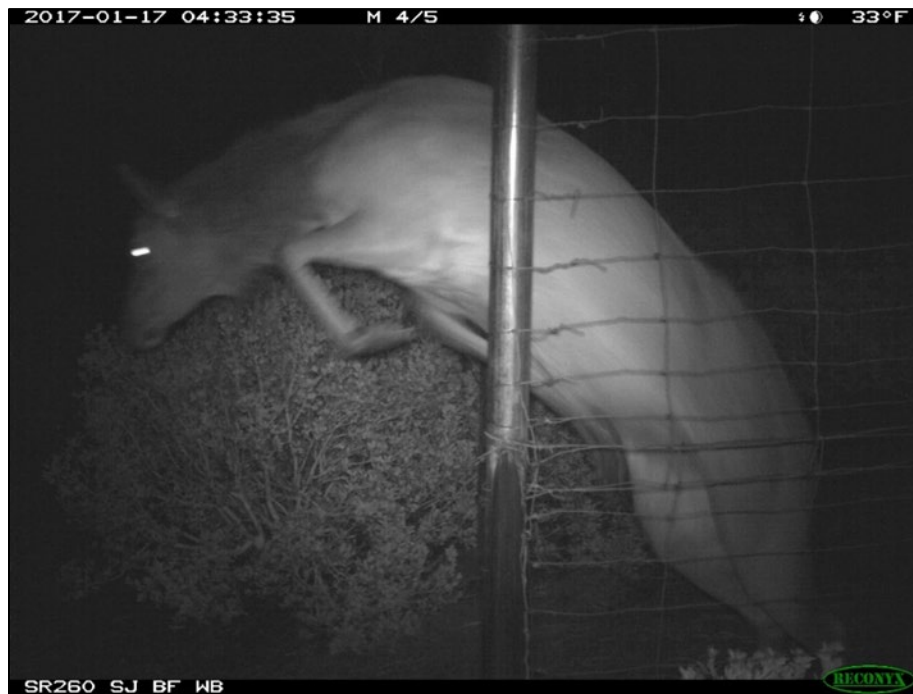
Figure 25. Elk Successfully Exiting the ROW Using a Slope Jump

Slope Jumps. The research team documented 24 elk escapes from the ROW out of 278 approaches to slope jumps within the ROW (see Figure 25), which is a 0.09 escape rate. Of 1289 elk that approached from outside the ROW, four entered the ROW and 1285 were repelled, for a repel rate of 1.00. Since 23 of the 24 escapes occurred at a single slope jump where the slope was minimal or nearly flat and only one escape occurred at a slope jump with a slope, the research team did not have enough data to determine an optimal slope. Although the slope jumps deterred elk from entering the ROW, they did not sufficiently facilitate elk in exiting the ROW. The lack of elk use of slope jumps led the research team to discontinue monitoring slope jumps after March 2018.

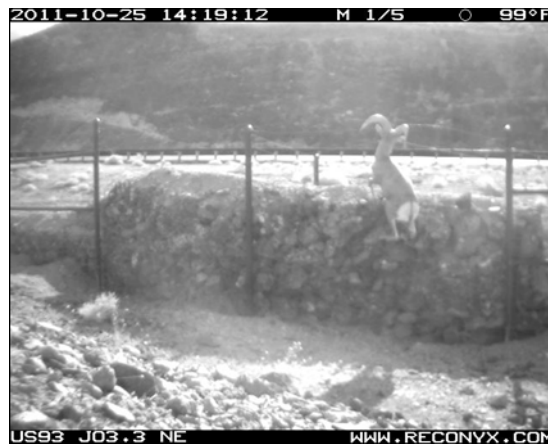
Figure 30. Wire Preventing Bighorn Sheep from Using an Escape Ramp to Enter the ROW

Modifications were made to escape ramps between 2011 and 2015 to determine the impact on the ramps' effectiveness. During the bighorn sheep crossing project along U.S. 93 from 2011 to 2015, the research team noted the presence of sheep in the ROW as well as unexpected sheep-vehicle collisions (Gagnon et al. 2017a). The team suspected that sheep were entering the ROW via escape mechanisms and installed cameras at select escape mechanisms to record these entries. After confirming that sheep were accessing the ROW at these locations (see Figure 28), the research team stretched wire across the opening of the ramp to deter sheep from jumping into the ROW while still allowing sheep to exit the ROW by passing under or over the wire (see Figure 29). Continued monitoring of the escape ramps with wire showed that sheep still tried to jump up and were stopped by the wire, presumably because they could not see it (see Figure 30). To help accentuate the wire, the research team added polyvinyl chloride (PVC) pipe to the wire (see Figure 31). The research team presented these preliminary findings to ADOT, and ADOT Maintenance staff added an adjustable horizontal metal crossbar to the escape ramp in place of the wire/PVC (see Figure 32).

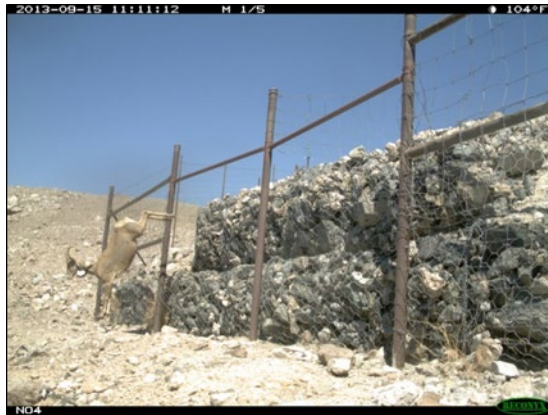
Figure 32. Bighorn Sheep Using an Escape Ramp with a Bar

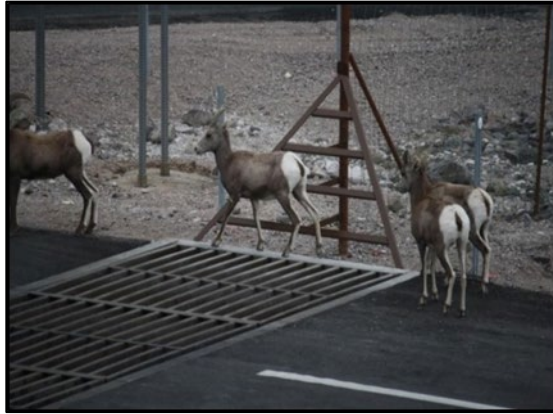
Figure 33. Bighorn Sheep Walking a Cattle Guard Ledge at Kingman Wash TI

From 2011 to 2015, the research team and ADOT Maintenance staff noted that sheep were entering and exiting the ROW via the single cattle guards (a non-ADOT standard cattle guard) at the on- and off-ramps of the Kingman Wash traffic interchange (TI) by either jumping the cattle guard or walking the ledge along the edge of the cattle guard (see Figure 33). In an attempt to reduce access to the ROW by sheep, ADOT painted stripes on the ROW side of the cattle guards to mimic a double cattle guard and discourage sheep from jumping over the cattle guard and onto the painted stripes (see Figure 34). The research team added cameras to two of the cattle guards in 2012. A previous study conducted by the research team on bighorn sheep along U.S. 93 found that these painted stripes did not deter sheep from crossing the single cattle guards (Gagnon et al. 2017a; see Figure 35).

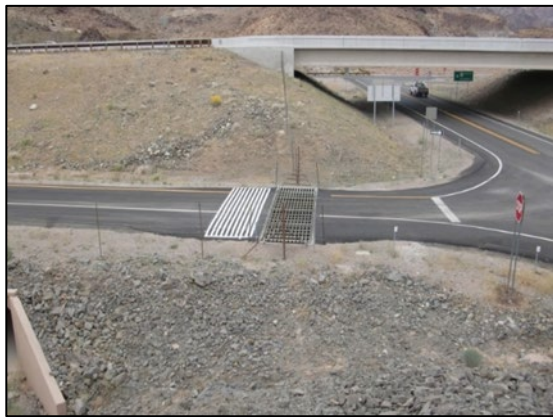
Figure 34. Painted Stripes Mimicking an Additional Cattle Guard

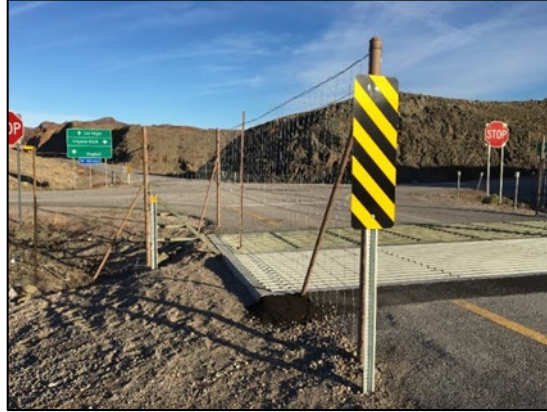
Figure 36. Double Cattle Guard with Fencing

In 2015 ADOT modified the wildlife guards at the four on- and off-ramps at Kingman Wash TI, installing a second single cattle guard alongside the initial cattle guard to create a double cattle guard (like those used for elk along SR 260) and added a fence to block access to the ledge that the sheep had used to cross the cattle guard (see Figure 36).

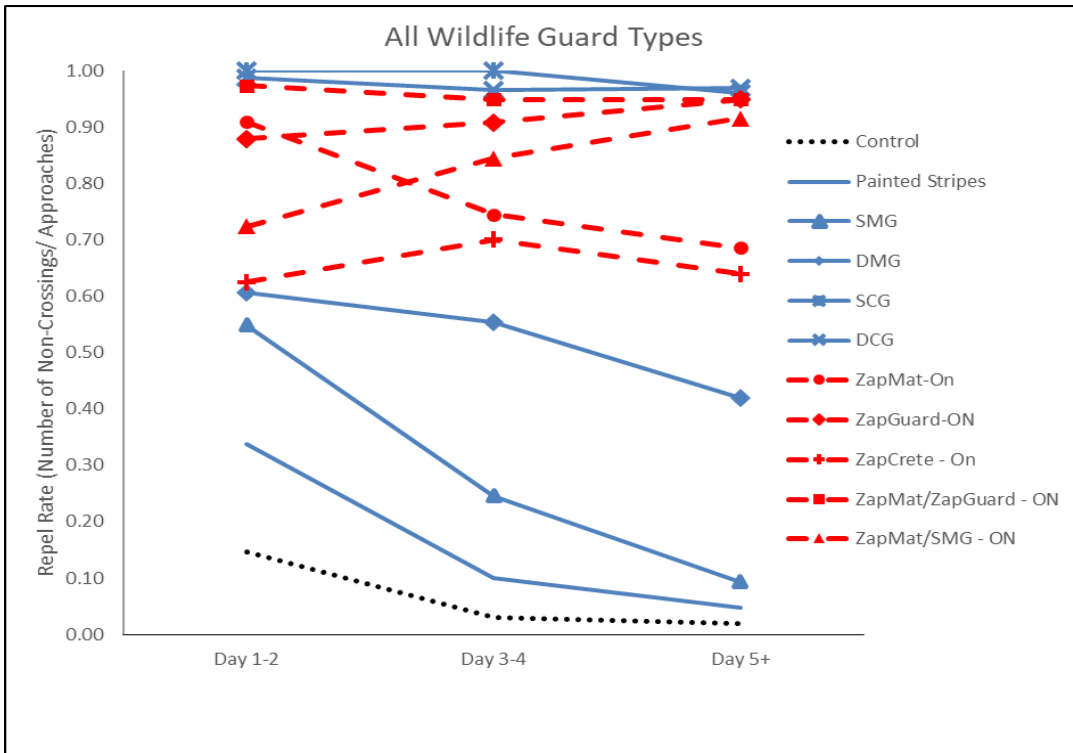
Figure 37. Elk Repel Rates Over Time for Wildlife Guards at the Controlled Test Site

Researchers analyzed the effectiveness of each wildlife guard type over time (days 1 to 2, 3 to 4, and beyond) (see Figure 37). The electrified wildlife guards had higher repel rates in most instances than the nonelectrified versions (see Figure 38). Of the nonelectrified wildlife guards (see Table 14), the single and double cattle guards maintained a consistently high repel rate over time, while the painted stripes and single modified cattle guard showed a reduction in repel rate to less than 0.10 within four days (see Figure 39). All types that included electrified components (see Table 14) achieved a repel rate greater than 0.60, and in some cases these types increased in effectiveness over time. The most effective electrified configuration over time was the ZapMat combined with the ZapGuard. Both the ZapGuard alone, and the ZapCrete and single modified cattle guard combined, increased the repel rate to more than 0.90 (see Figure 40).

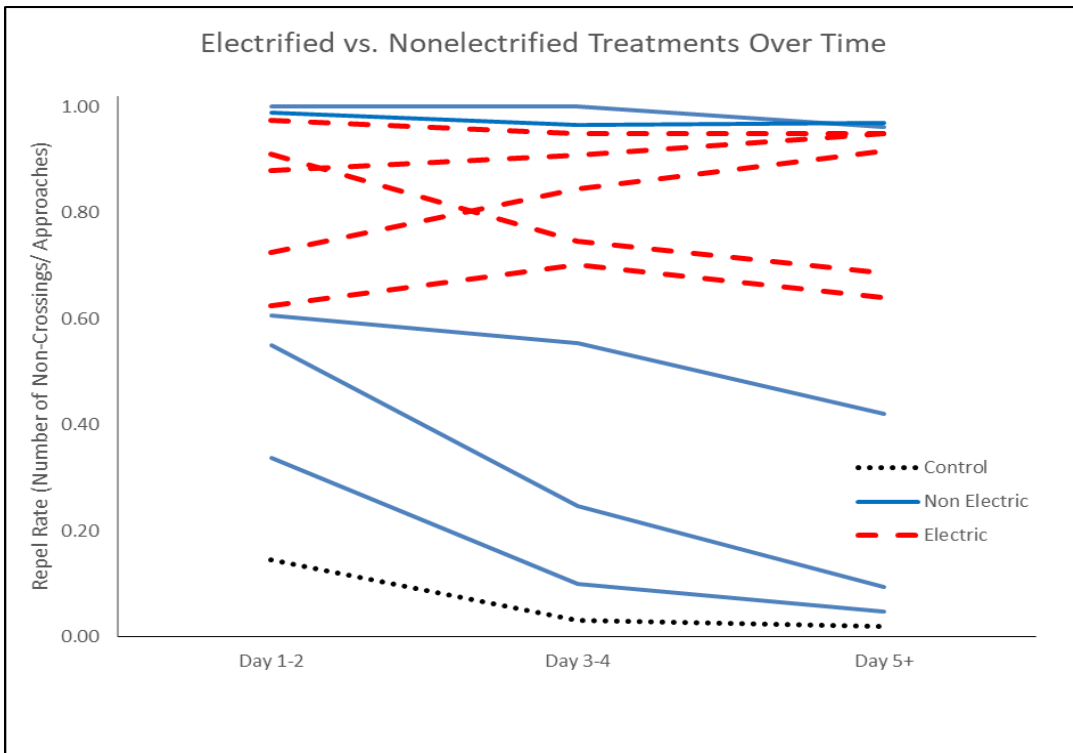
Figure 38. Elk Repel Rates Over Time for Electrified and Nonelectrified Wildlife Guards

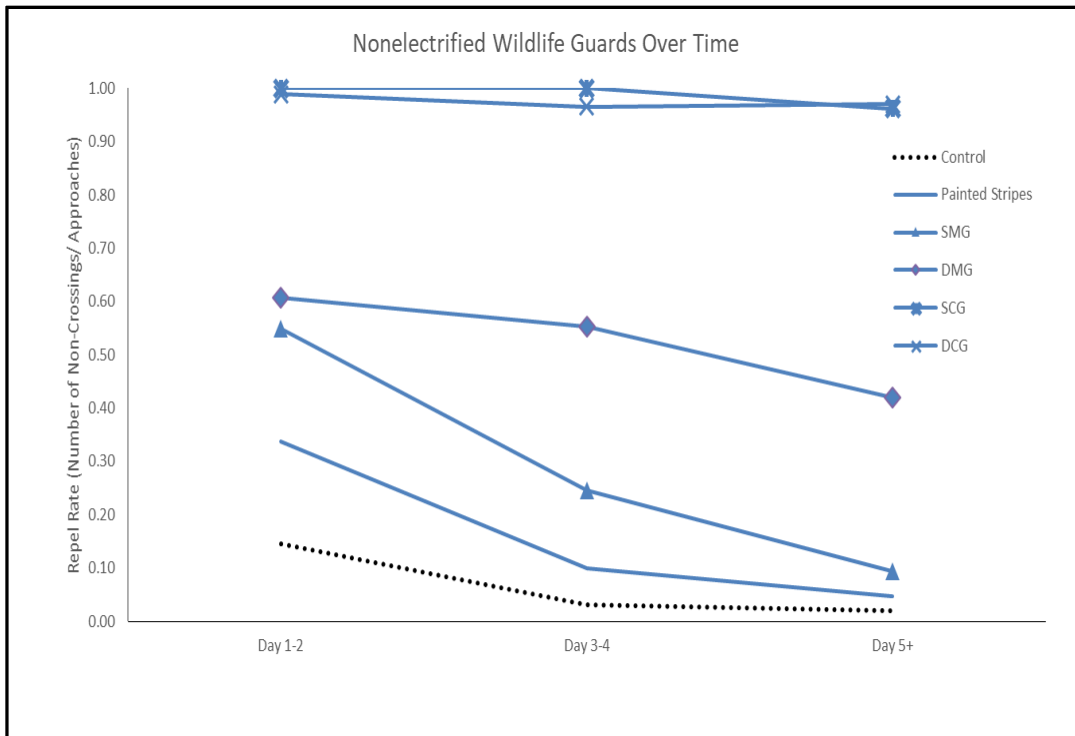
Figure 39. Elk Repel Rates Over Time for Nonelectrified Wildlife Guards

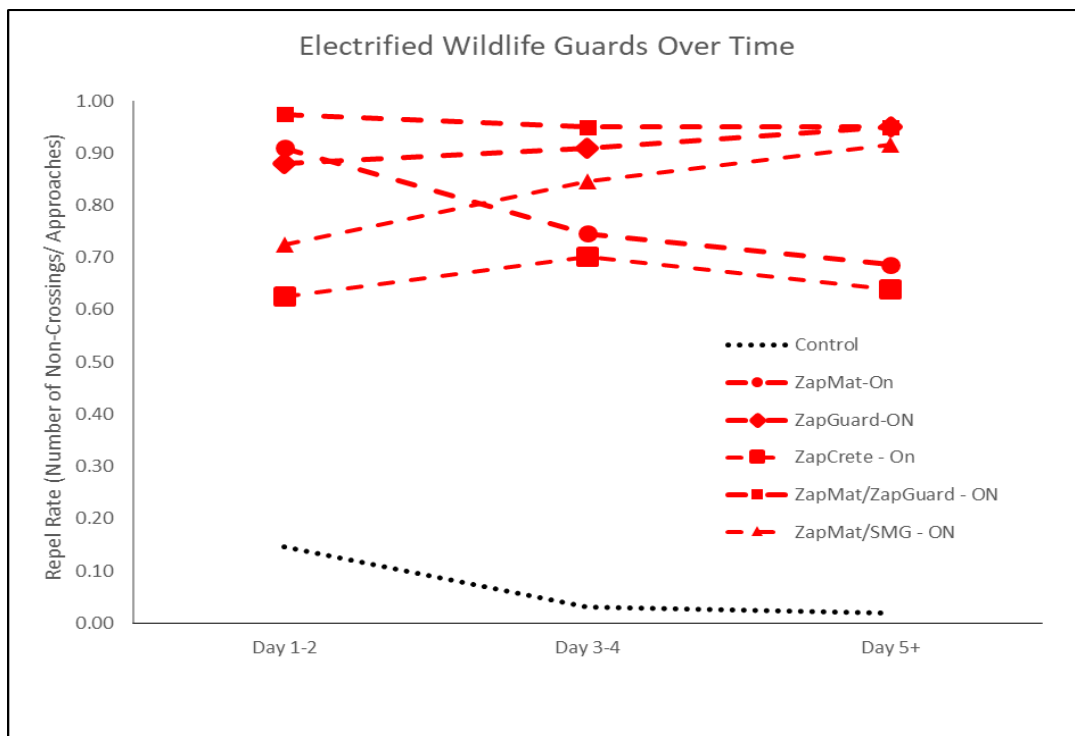
Figure 40. Elk Repel Rates Over Time for Electrified Wildlife Guards

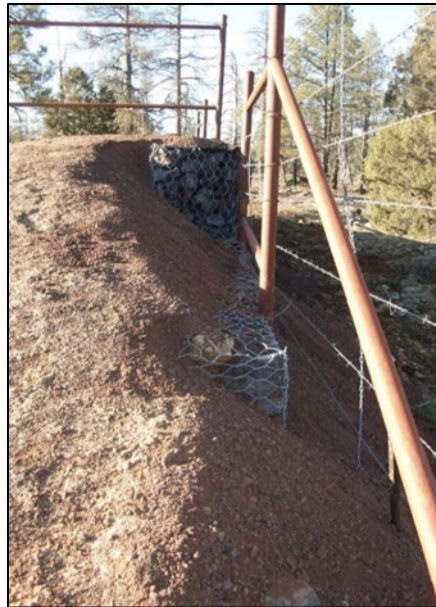
Figure 41. Escape Ramp with a Noncompatible Substrate and No Soil Retention Method

For escape mechanisms, a key maintenance concern was inadequate soil retention. Causes included no method of retaining soil, retention failure due to excessively porous soil, failure of soil retention material, noncompatible substrate on the ramp surface, and soil and debris buildup at the base of a ramp from flood events. Design concerns included ramps short enough to allow wildlife to easily enter the ROW, and obstacles that may hinder wildlife use of ramps (see Figures 41 to 47).

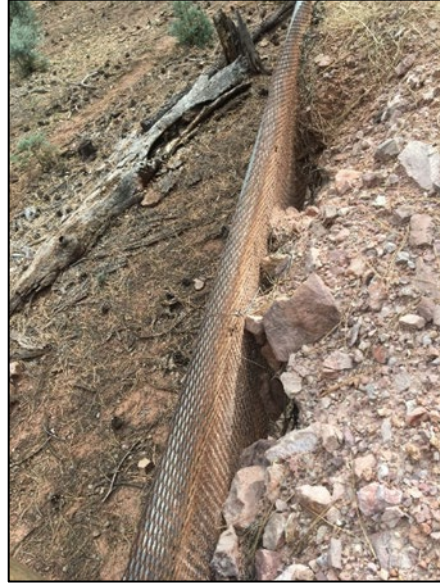
Figure 42. Soil Loss Around an Expanded Metal Mesh Retainer

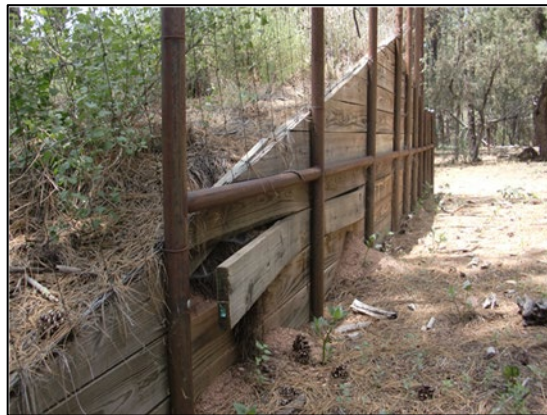
Figure 43. Soil Loss from Failing Wooden Plank Retaining Wall

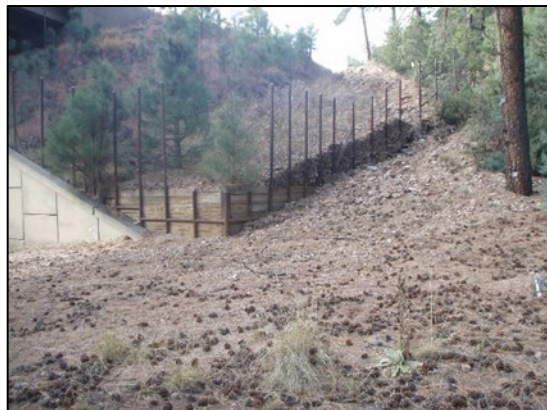
Figure 44. Ramp Placed Near Drainage, Allowing Buildup of Water-Deposited Sediment

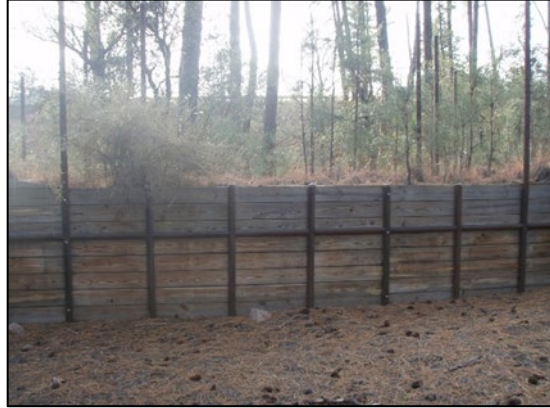
Figure 45. Retaining Wall Too Short to Keep Elk from Entering the ROW (Height Less Than 48 Inches)

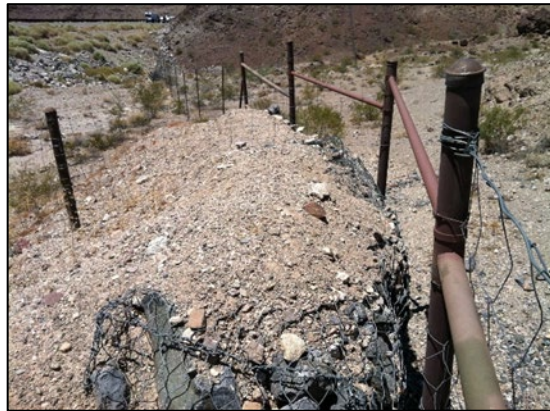
Figure 46. Erosion, Lack of Soil Retention, and Short/Buried Guide Fence

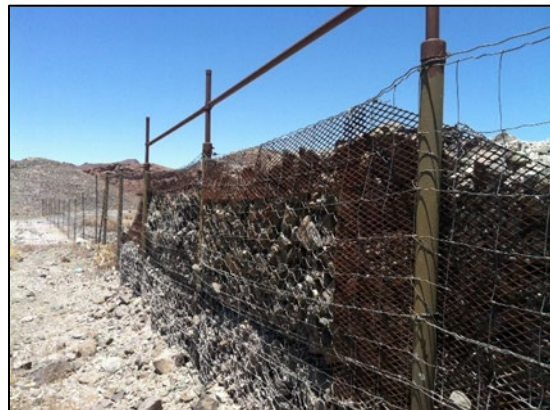
Figure 47. Retaining Mesh Above Lip of Ramp, Creating Potential Escape Obstacle

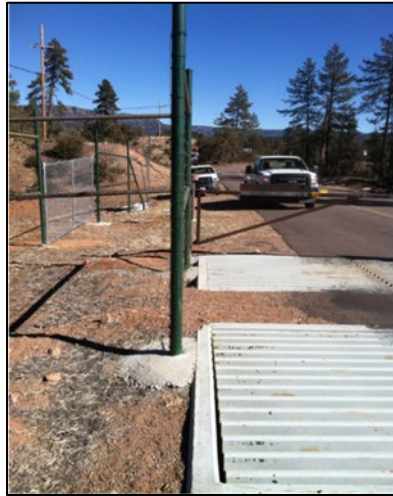
Figure 48. Large Distance Between Double Cattle Guards and Short Fence

The research team also documented maintenance and design concerns regarding wildlife guards during field visits in Arizona. These concerns included excessive spacing between the two cattle guards in a double cattle guard; areas within the wildlife guard where animals could walk, either related to design or to dirt filling the cattle guard; and materials unsuitable for heavy traffic (see Figures 48 to 51).

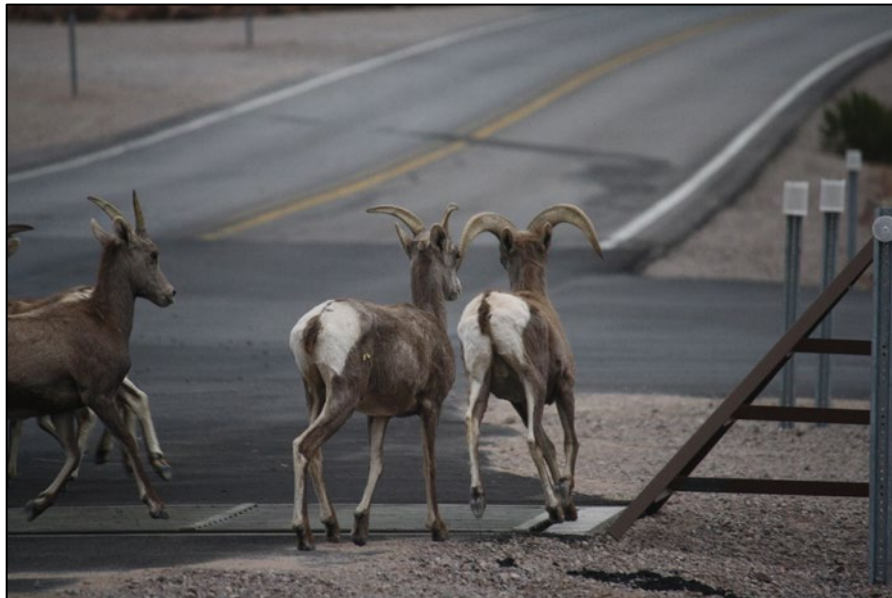
Figure 49. Ledge Allowing Animals to Access the ROW via a Wildlife Guard

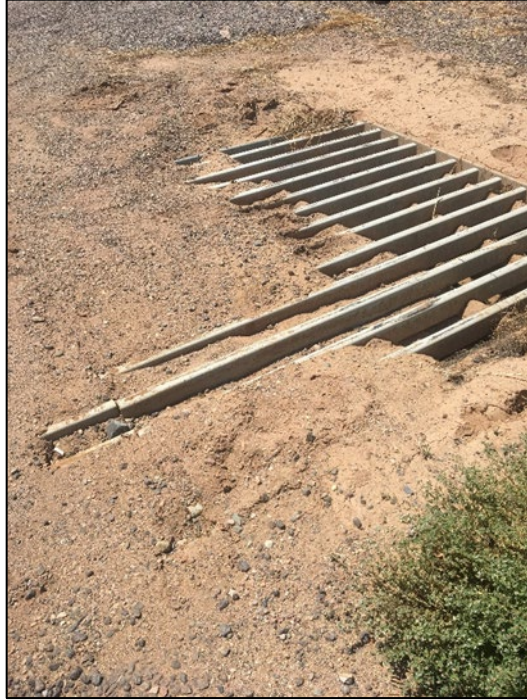
Figure 50. Cattle Guard Partially Filled in with Dirt

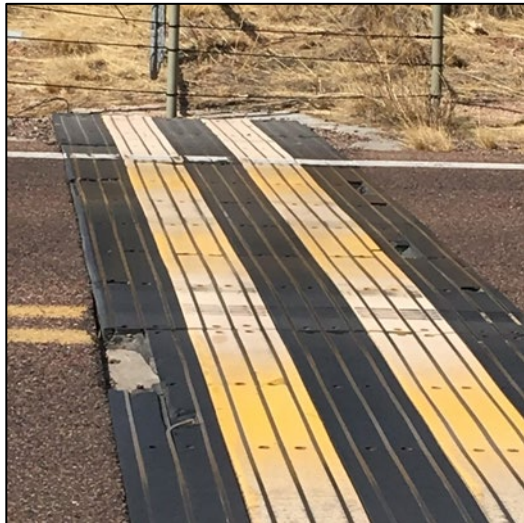
Figure 51. Electrified Mat Material Damaged by Traffic Over Time

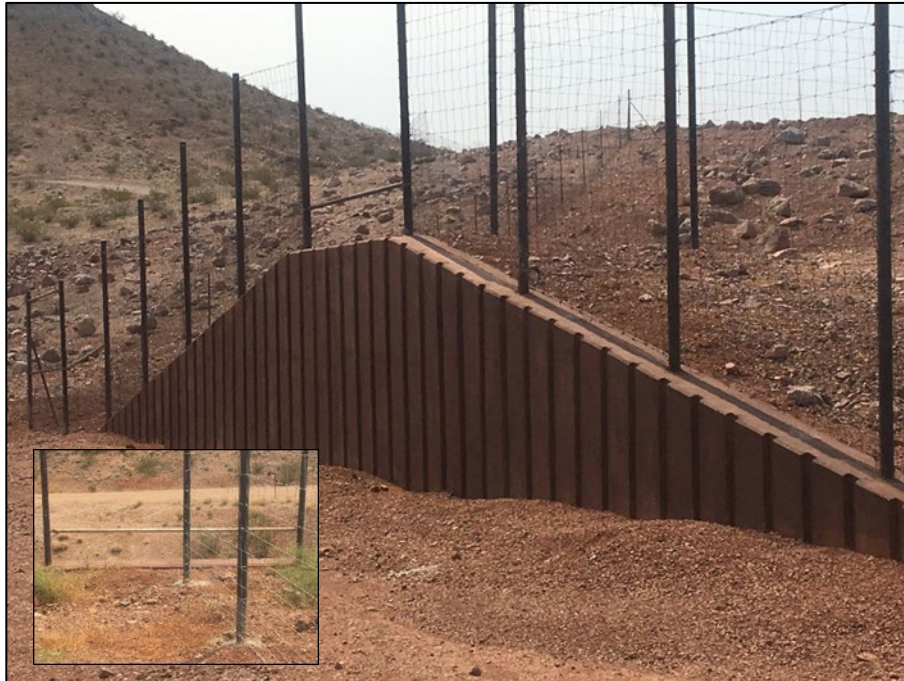
Figure 52. Escape Ramp with Horizontal Bar to Limit Bighorn Sheep Access from Outside the ROW; Inset Photograph Shows Horizontal Bar Detail

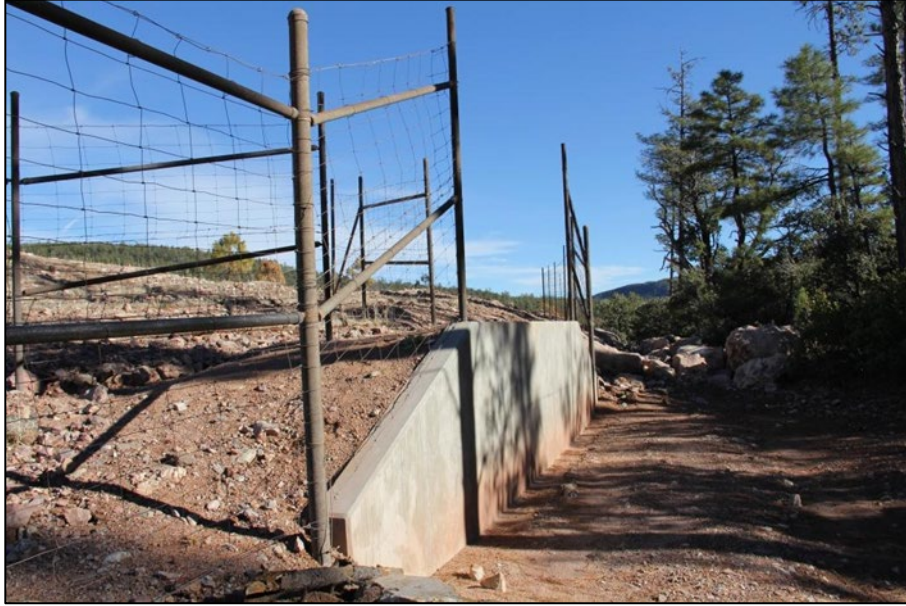
Figure 53. Escape Ramp Using Concrete to Retain Soil Along State Route 260 in Arizona
