Investigating the Optimum Performance of Snowplowable Reflective Pavement Markers

Research Report No. FHWA-ICT-19-013

ICT PROJECT R27-151

Illinois Center for Transportation

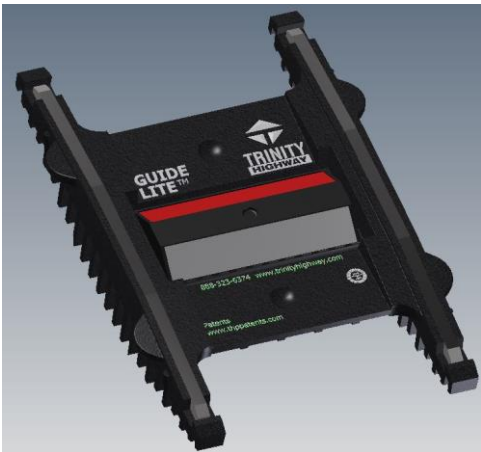
By 2016, all six markers were installed in six test sections. Details about the test sections are provided in Section 1.3. At the time this study began, Trinity Industries began development of a new marker called the Guide Lite. The Guide Lite, shown in Figure 3, is made of lightweight, high-impact grade polymeric material cast in an “H” shape similar to the traditional snowplowable markers. It also has a section of hardened steel embedded through the center of the rails. Similar to traditional cast-iron markers, Guide Lite is placed in a groove and bonded to the pavement with an epoxy adhesive.

Figure 3. Guide Lite snowplowable raised pavement marker.

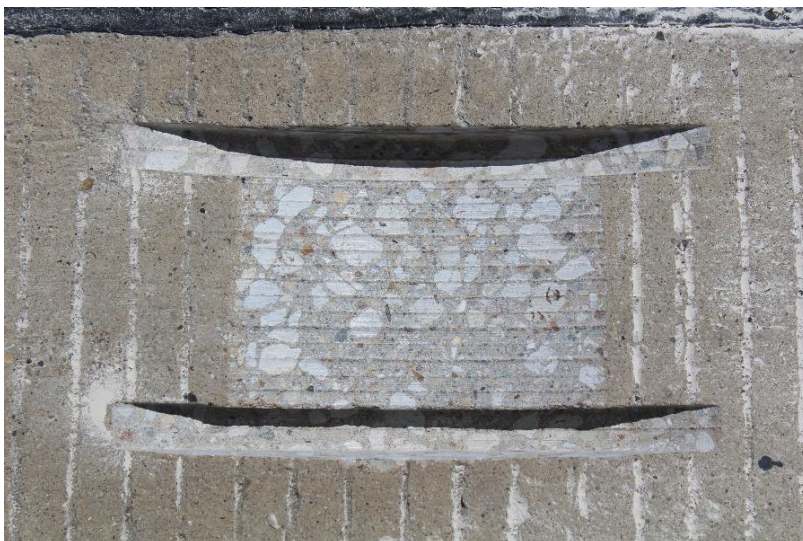
Figure 6. Completed cut for SRPMs with rails.

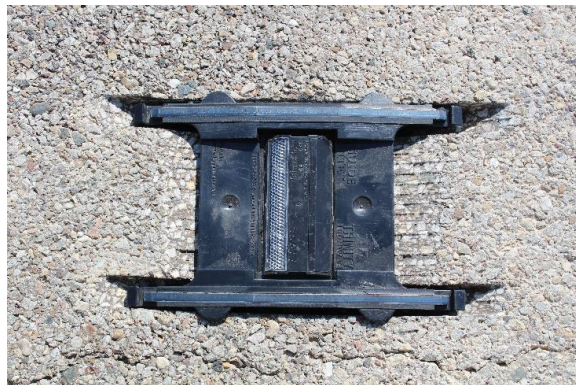
The next step is to check that the marker fits in the groove and the leveling tabs rest on the pavement surface, as shown in Figure 9. Figure 10 shows epoxy adhesive being poured into the groove and then more epoxy being poured after the marker is in the cut. The first pour filled the cut to within

Figure 9. Marker placed in dry cut (no adhesive) to verify leveling tabs rest on the pavement.

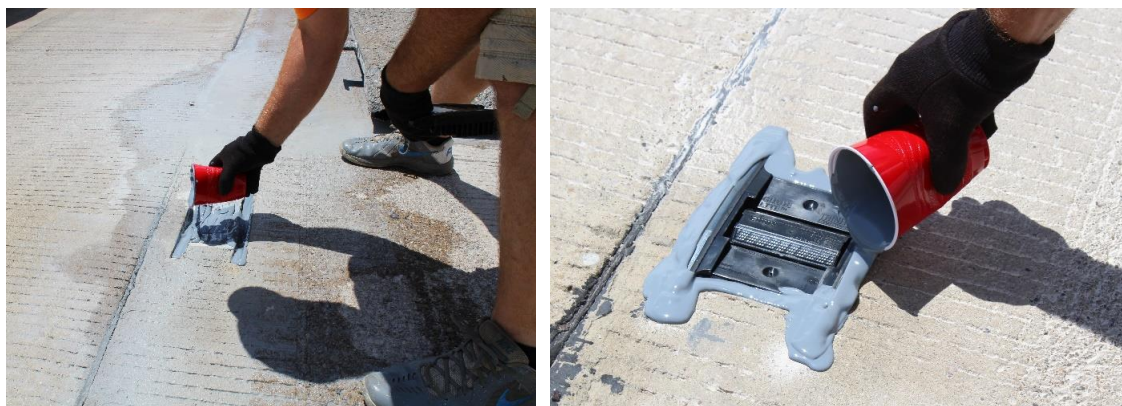
approximately 3/8 in. of the pavement surface, and the second pour is common practice to help seal all the edges of the marker.

Figure 10. Epoxy adhesive being poured before and after the marker is placed in the cut.

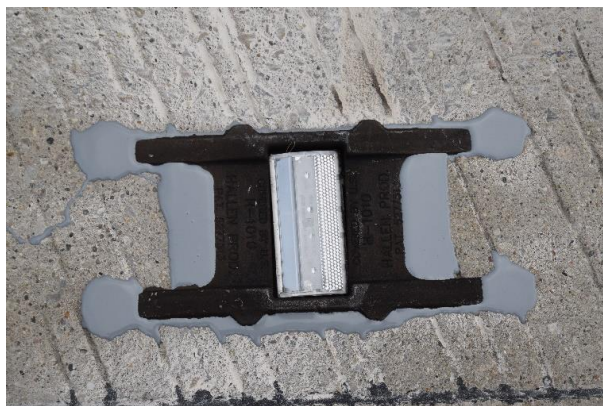
The photos taken by the ARA researcher after installation served as a baseline reference for future comparisons to assess marker conditions. Figure 11 is an example of an installation photo of an H1010 on the I-70 test section.

Figure 11. Example installation photo of an H1010 marker on I-70.

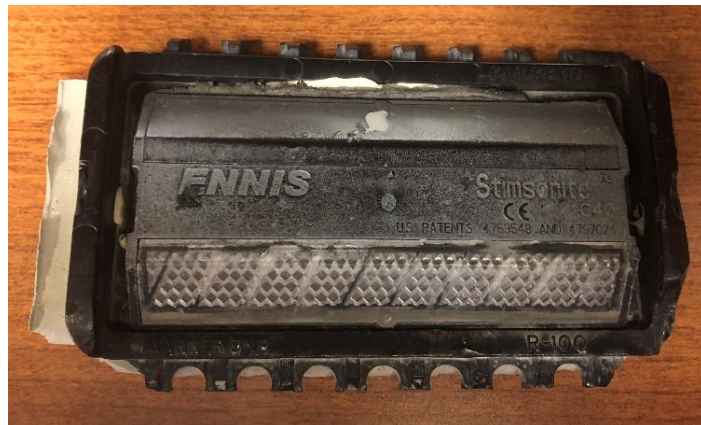
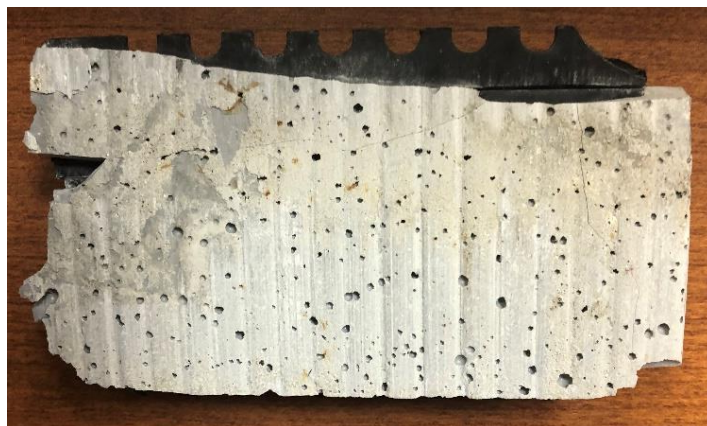
Figure 16. Dislodged R-100 with epoxy still bonded to it.

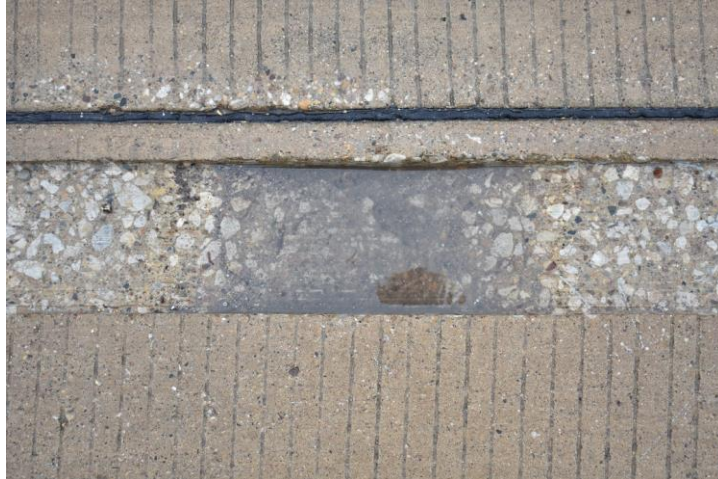
Figure 17 is a photo of the empty “banana cut” where an R-100 used to be. As seen in the photo, water is now “ponding” in these cuts. Water ponding on the pavement surface that freezes can cause pavement deterioration issues. Figure 18 is a photo of the location where an R-100 is now missing from an asphalt-surfaced site. The entire marker, all of the epoxy, and some of the asphalt pavement overlay are gone. The epoxy used for the R-100 markers was the same epoxy as used for all other markers at the test site.

Figure 17. Missing R-100 on IL-8 (central PCC site).

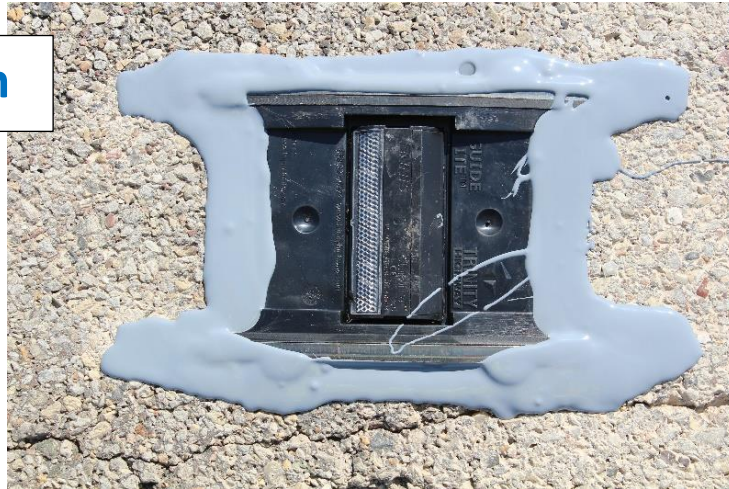
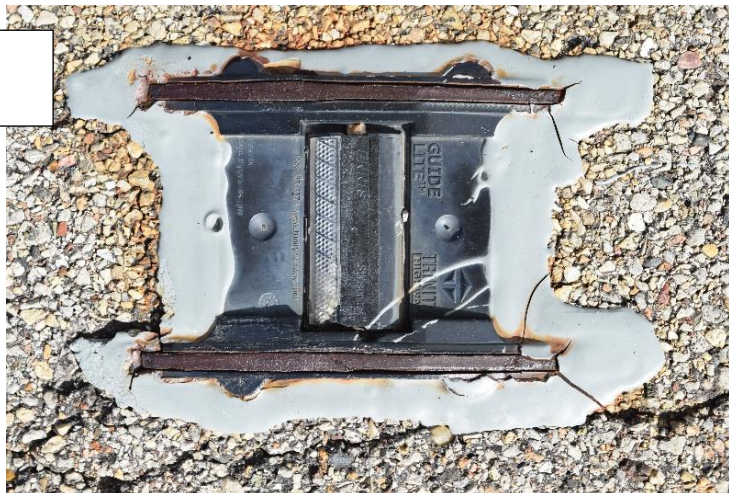
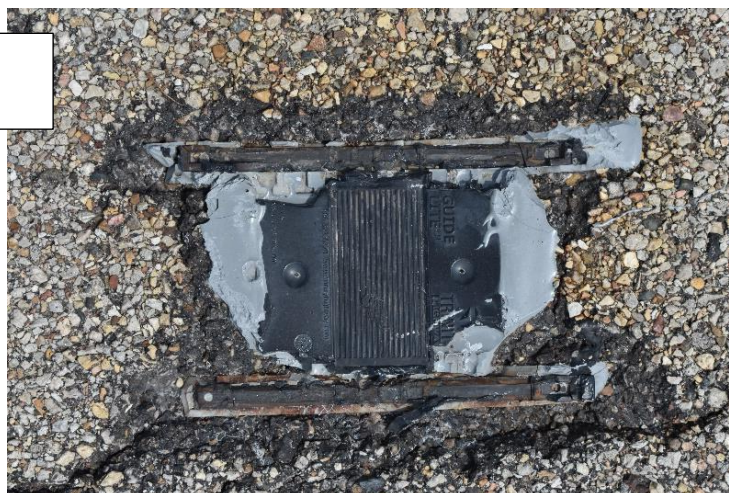
Figure 20 is an example of a Guide Lite on I-155 (central HMA site) with a missing lens after two years. The figure includes the installation and Year 1 photos to show the progressive condition. The Year 2 photo also shows damage to the marker itself. Of the markers with three years of service, R-100 has

Figure 20. Guide Lite with no lens after two years of service on I-155 (central HMA site).

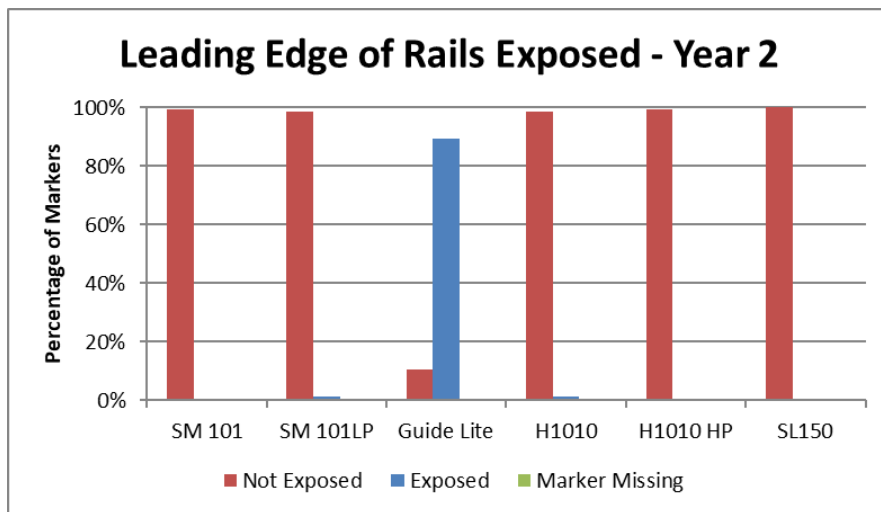
Figure 22 reports the percentage of markers with the leading rails exposed after each year. Keeping the leading edge covered with adhesive and below the pavement surface will help keep water from infiltrating the groove and snowplows from shearing or removing the marker. Because R-100 does not have rails, it is not included in these figures. As shown, the five SRPMs with rails installed in 2016 are performing well. However, nine of the 57 Guide Lite markers had exposed rails after the first year, and nearly 90% had exposed rails after the second year. This is likely due to the marker floating up in the epoxy at installation. However, the leading edge of every Guide Lite was still below the pavement surface. Figure 23 is an example of a Guide Lite marker on I-155 that has a leading edge exposed after one year of service. Some damage to the steel rail can also be seen after one year.

Figure 22. Percentage of markers with leading edge of rails exposed after each year.

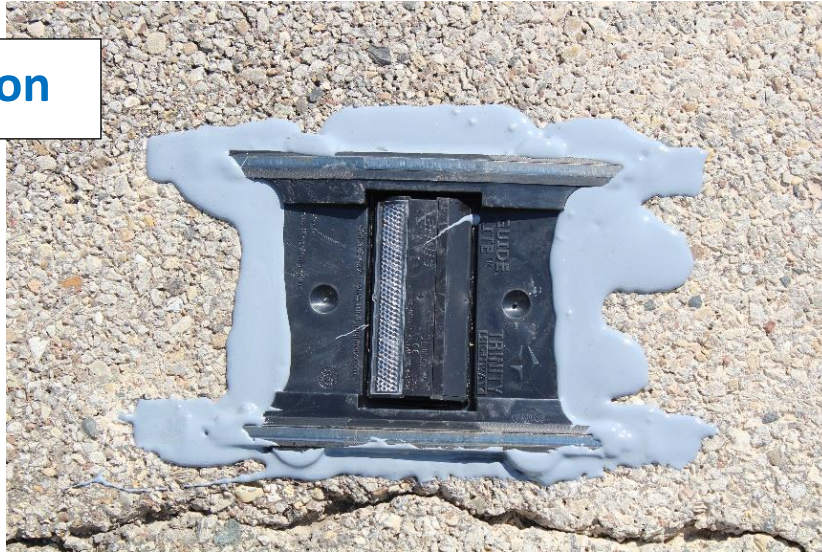
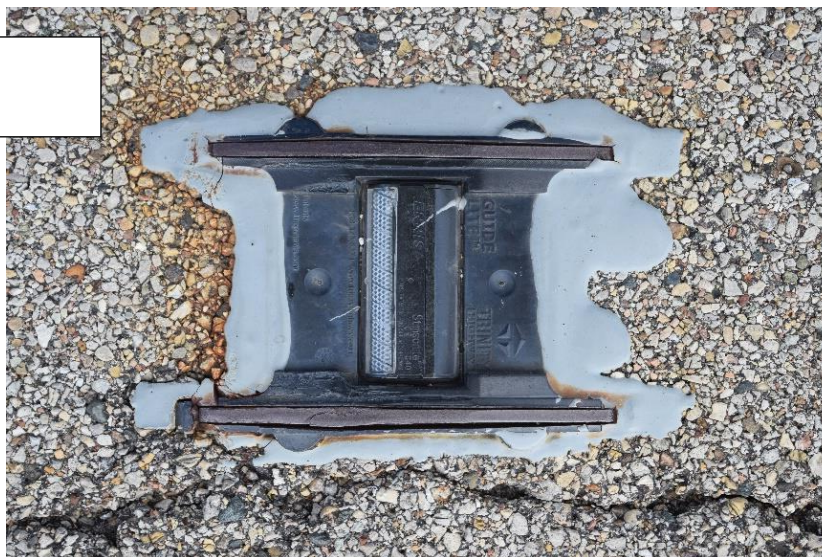
Figure 23. Example of Guide Lite with leading edge of rail exposed after one year.

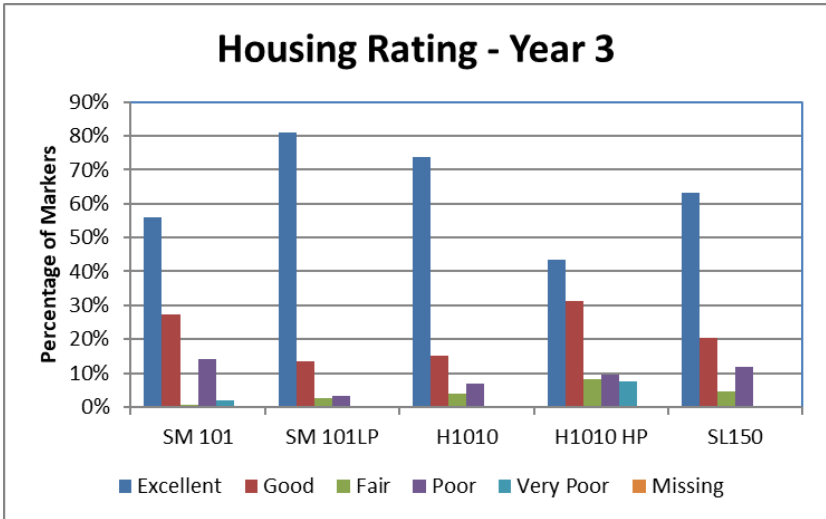
Figure 26 provides each year’s results of the overall marker housing condition based on the NTPEP rating scale, as described in Section 1.4.2. Because the NTPEP scale is based on traditional SRPM housing, this assessment does not include R-100. After one winter, the Guide Lite experienced the most damage. The traditional cast-iron markers exhibited more damage after Year 2, but a majority of the markers were still in excellent condition. The Guide Lite marker housing was in the worst condition, with over 60% of the markers in poor or very poor condition. After Year 2, the two high-profile markers, SM 101 and H1010 HP, were the first of the traditional markers to have a few markers (2% and 4%, respectively) in very poor condition. After the third winter, these two high-profile markers were still the only traditional markers to have a few in very poor condition (2% and 8%, respectively). The higher profile means that the markers are in greater contact with snowplows, which explains the higher rate of damage. After the third winter, H1010 HP had the lowest overall housing condition ratings, with 25% in fair to very poor condition. SM 101 had 17% in fair to very poor condition, and 17% of SL150 were in fair to poor condition. SM 101LP had the highest overall housing condition rating, with 94% in good to excellent condition, and H1010 had the second-highest rating, with 89% in good to excellent condition. The lower profile marker design affects the longevity of the marker condition.

Figure 26. SRPM housing condition rating after each year.

3.1.6 Marker Housing Condition Rating

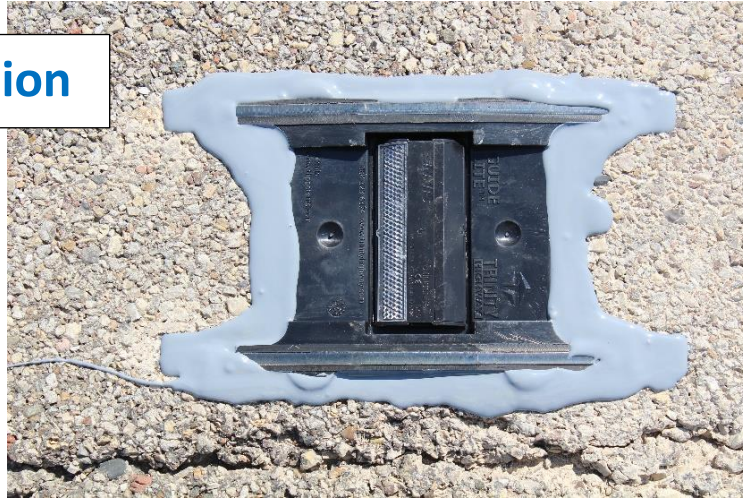
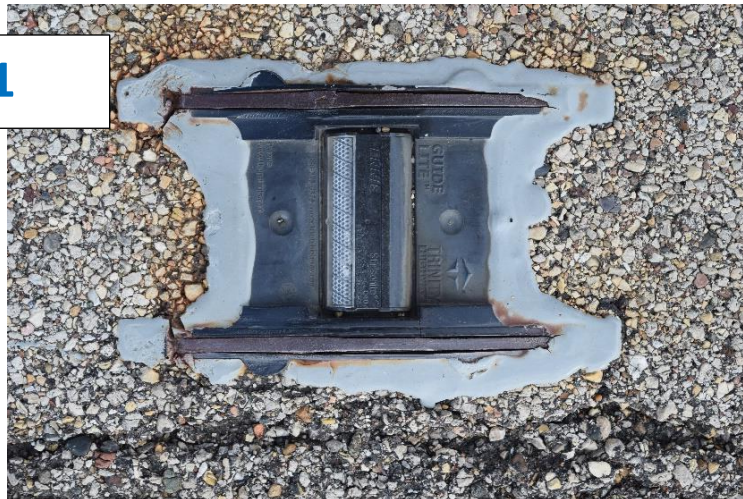
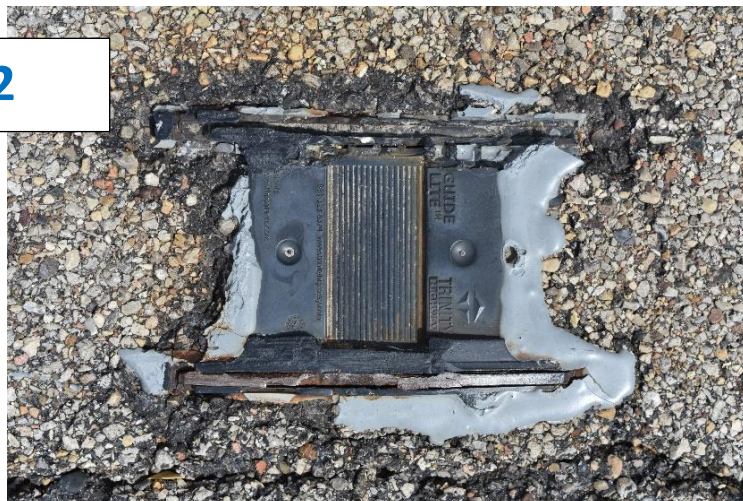
Figure 27 is an example of the deterioration of a Guide Lite marker on I-155 (central HMA site) after two years of service. The marker exhibits severe damage, and the damage shown is representative of the other markers in poor to very poor condition. The rail component of the markers sustained the most damage. The plastic rails and the steel inserts are often either cracked or broken. As previously mentioned, the pavement condition surrounding the I-155 Guide Lite markers was mostly in fair or poor condition, but the IL-8 Guide Lite marker locations were almost entirely in good condition. However, 85% of the IL-8 Guide Lite marker housings were in poor to very poor condition, and 54% of the I-155 Guide Lite markers were in poor to very poor condition. Therefore, the pavement condition did not contribute to the Guide Lite markers’ performance.

Figure 27. Guide Lite marker in very poor condition after two years of service on I-155.

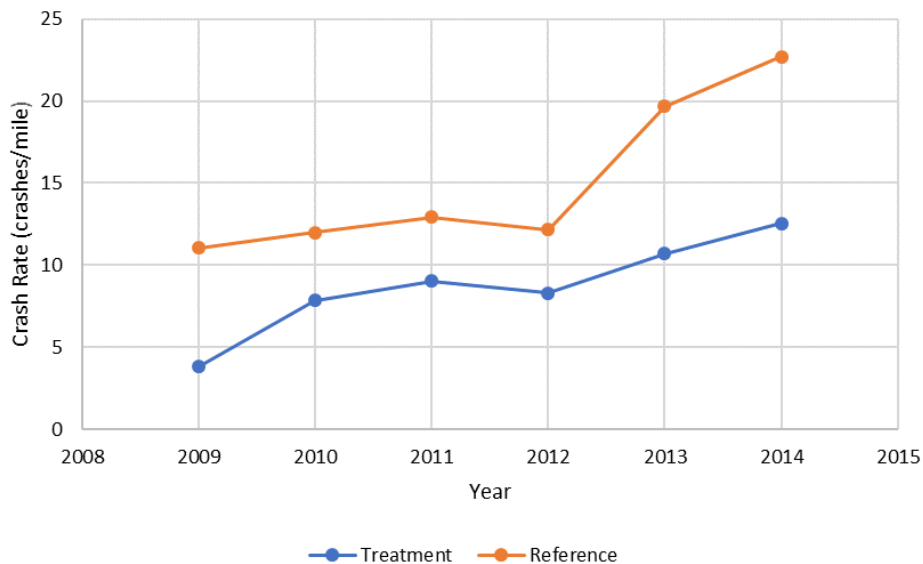
Figure 28 provides a graphical representation of total crash rate per year for treatment and reference sites (from 2009 to 2014). The graphics for fatal and injury and lane departure crashes are quite similar to total crashes. From Figure 28, it appears as though the reference sites adequately mimic the trends in the treatment sites prior to installation. Further, the test of suitability provides a reliable, scientifically rigorous method for determining if the reference sites are sufficient. The test of suitability computes odds-ratios from year to year for treatment and reference sites and determines if the odds ratios are significantly different from 1.0. If 1.0 is within the 95% confidence interval, then the null hypothesis cannot be rejected. (The null hypothesis is that the two groups have the same trends.) Based on the test of suitability, the 95% confidence interval for total crashes was 0.77 to 1.33 for total crashes (with a mean of 1.05), 0.54 to 1.60 for fatal and injury crashes (with a mean of 1.07), and 0.57 to 1.47 for lane departure crashes (with a mean of 1.02). Therefore, there is sufficient evidence to suggest that the reference group is suitable for identifying annual factors for the treatment group.

Figure 28. Annual crash rates for treatment and reference groups.

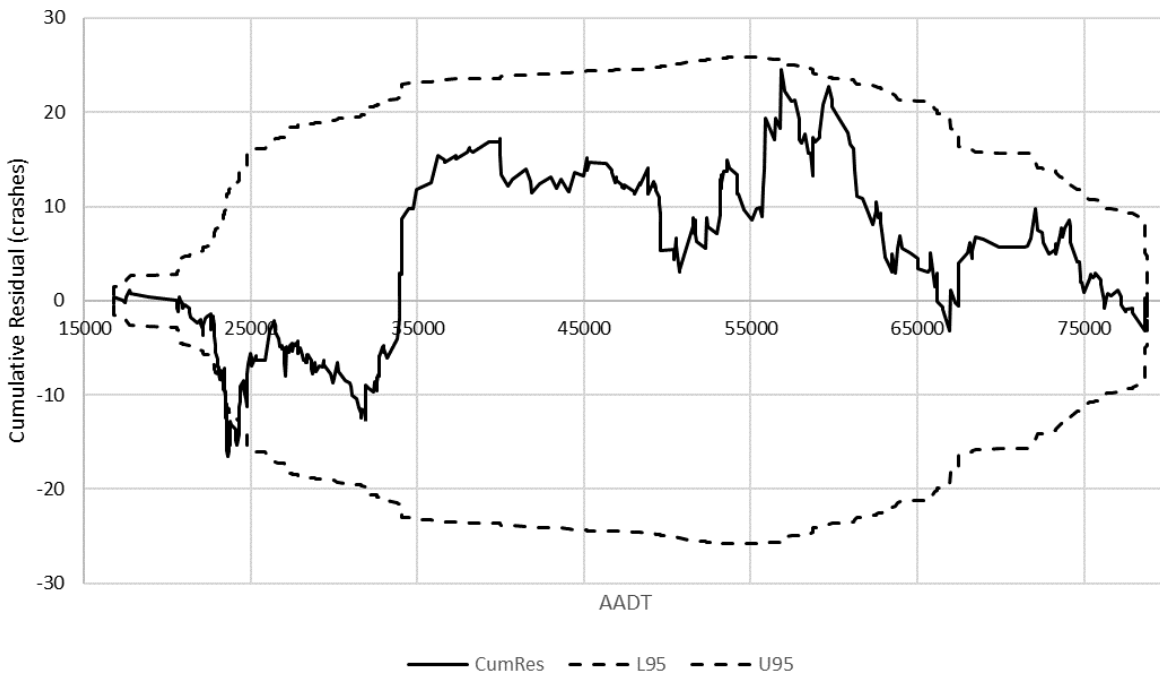
Figure A35. CURE plot for fatal and injury lane departure crashes.

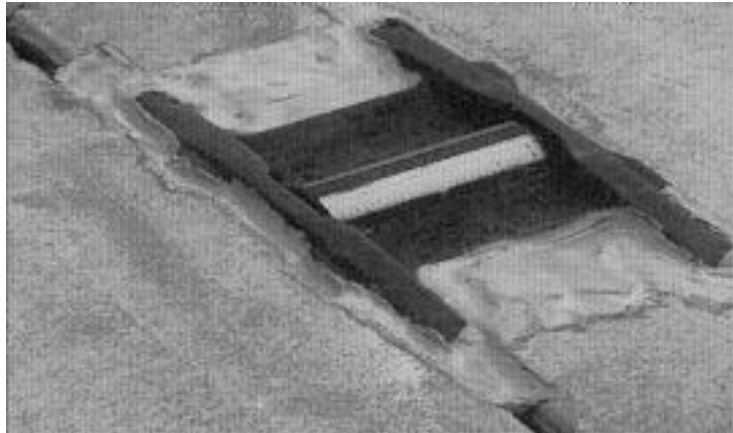
Marker is installed in a pavement joint

- Results in a weaker bond than installation in a complete saw cut, possibly leading to de-bonding and pavement joint degradation.
