Rapid Retrofit and Strengthening of Bridge Components

Report Number: KTC-19-07/SPR13-465-1F

Research Report
KTC-19-07/SPR13-465-1F

July 2019

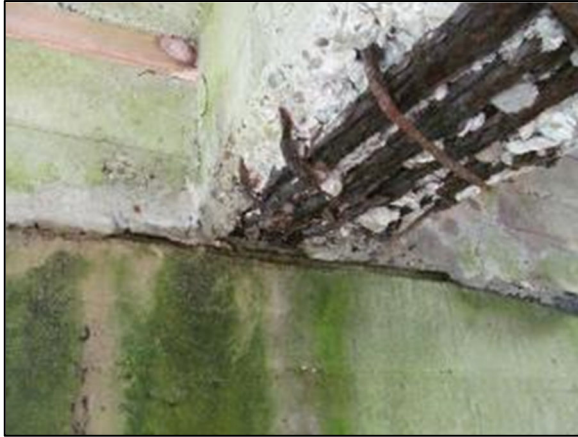
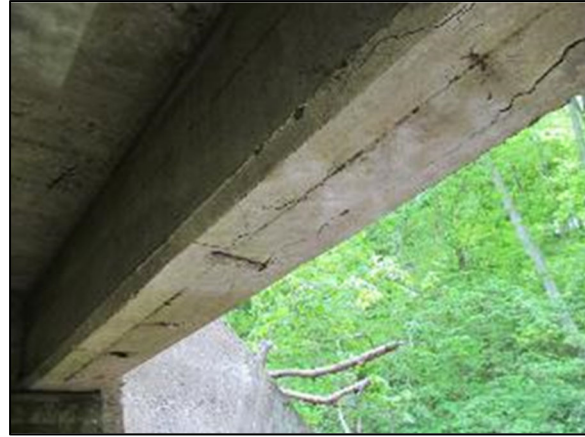
Fig. 5. Typical damage to concrete girders

The initial damage observed was spalled concrete and corroded reinforcement near one end of Girder G2 (Fig. 5(a)). Over 50% section loss was observed in several rebars. Longitudinal cracking was also observed on the bottom of other girders (see Fig. 5(b)), indicating the rebar within them may be corroded. During the initial retrofit construction, it was found that the remaining girders also had section loss due to corrosion and required strengthening.

(a) Damage observed in girder G2

(b) Longitudinal cracks in girder G1

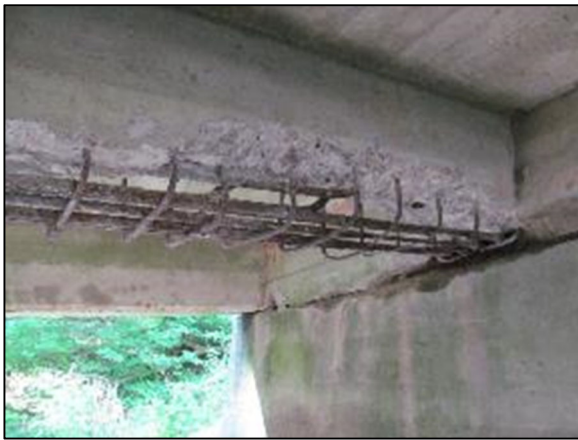
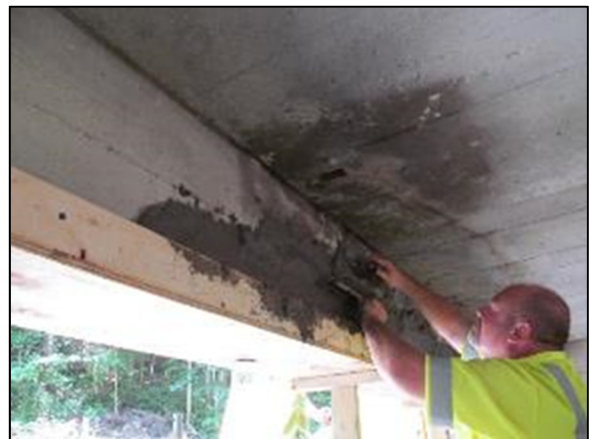
Fig. 7. Repair Process of KY 55 over Major Run Creek

KYTC District 06 bridge maintenance personnel carried out the retrofit in June 2013. Initially, all loose concrete was removed from cracked regions of the girders. Crew members used pneumatic chipping hammers to remove the material and expose at least one inch of non-corroded reinforcing steel (Fig. 7(a)). The steel was then sandblasted to remove rust, and a zinc primer was applied with a brush after wiping it with a solvent (Fig. 7(b), (c)). Wooden forms were erected to ensure the repair mortar cured appropriately to provide the original shape of the beam (Fig. 7(d)). The forms were removed once the repair mortar had cured. A mechanical grinder was used to remove any in-plane variations between the repair mortar and pre-existing concrete.

(a) Concrete removed to expose rebar

(d) Wood framework and repair mortar application

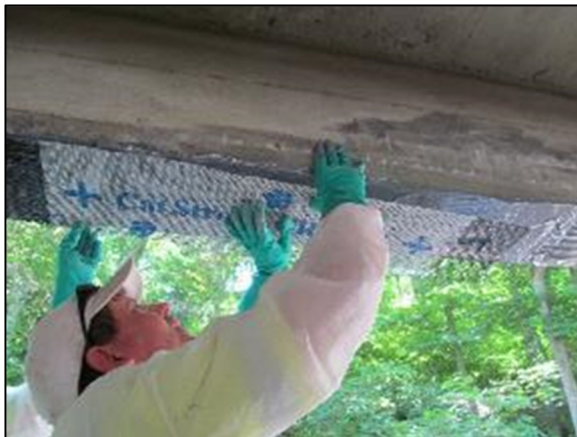
Fig. 8. CRP and TCF application on KY 55 over Majors Run Creek

A two-part epoxy was applied to the clean concrete and the CatStrong CRP 070 was placed over the epoxy and pressed into it by hand (Fig. 8(a)). This was carried out in a modular fashion, moving from one panel to the next. Each panel was connected to the next using the finger joint connection. Once rod panels were in place along the vertical and bottom faces of the girder, additional epoxy was applied over the finger joint area all the way to the top of the girders, and the CatStrong TCF 012 was placed over top of the CRP 070 using a dry layup process. All air pockets and irregularities were smoothed out of the fabric with laminating rollers (Fig. 8(b)). Fig. 9 depicts the bridge following the completed retrofit. The retrofit underwent periodic inspections in the three years following the construction — no defects were observed.

(a) CRP 070 applied with epoxy

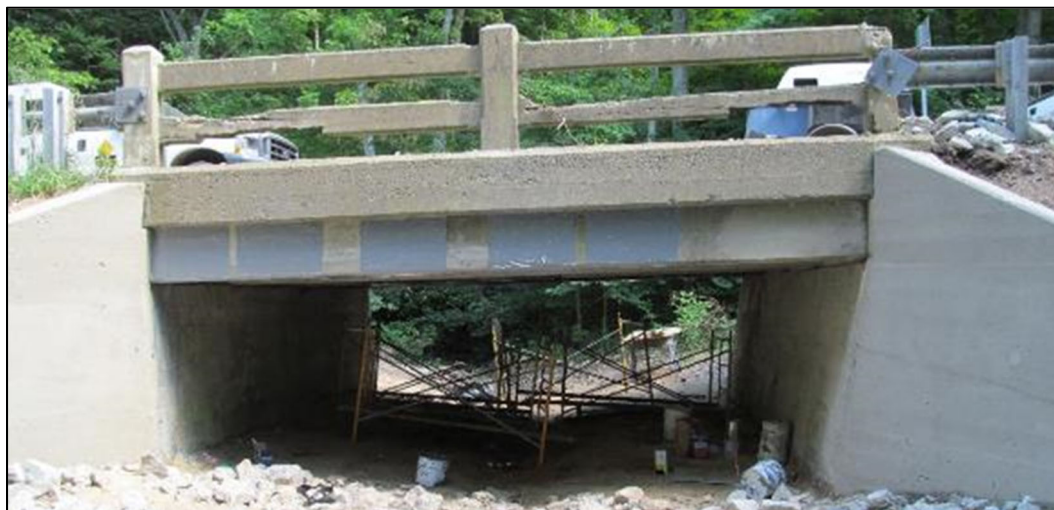
Fig. 9. Repairs complete on KY 55 over Majors Run Creek

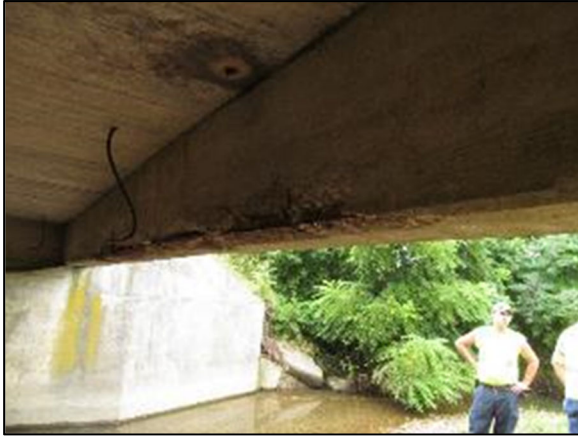
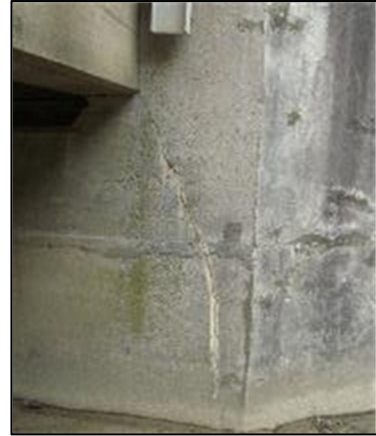
Fig. 12. Damage to concrete girders and abutment

The primary damage observed was spalled concrete and corroded reinforcement along the length of Girder G1 (Fig. 12(a)). In addition, two vertical cracks (Fig. 12(b)) were observed on the abutment walls.

(a) Damage to girder G1

(b) Damage to abutment wall

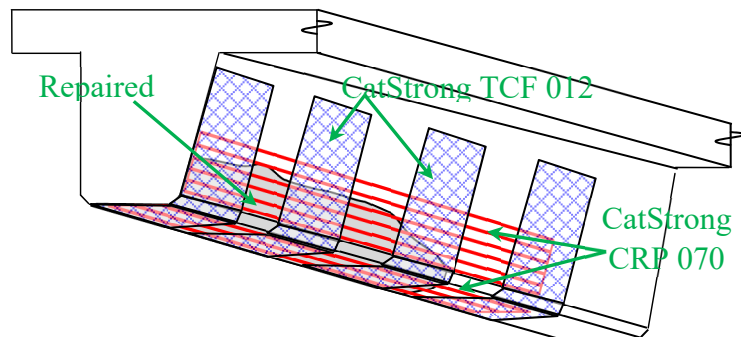
Fig. 13. Retrofit diagram of KY 11 over Cat Creek

The general retrofit plan for the girders was similar to the KY 55 bridge in KYTC D06. The primary retrofit material was 10 in. wide CatStrong CRP 070 panels. Panel width was restricted to 10 in. due to the width of the bottom surface of the exterior girder. The panels were applied to the bottom and sides the girders. CatStrong TCF 012 fabric U-wraps were applied over the CatStrong panel finger joints to provide anchorage. Additional details on the girder, as well as the abutment retrofit design, can be found in Appendix B.

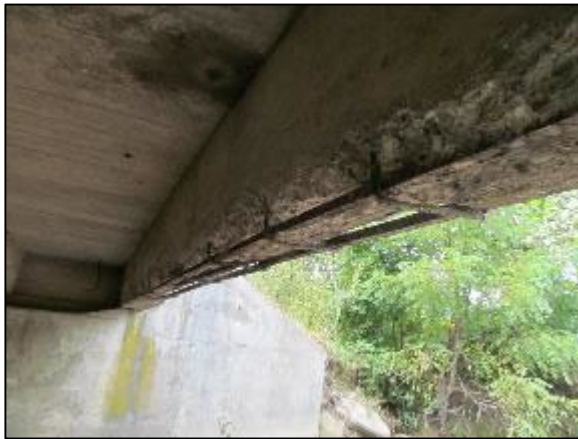
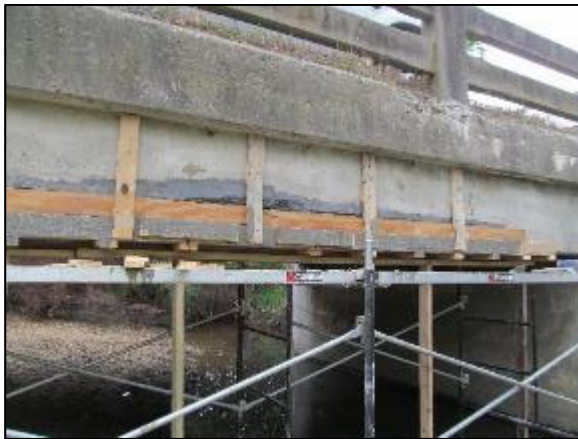
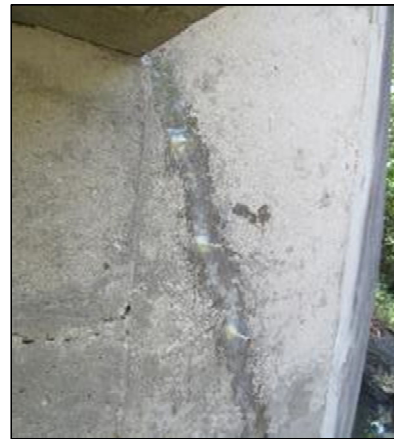
Fig. 14. Repair process of KY11 over Cat Creek

The retrofit was carried out by the KYTC District 10 Bridge Maintenance personnel in September 2013. Initially, all loose concrete was removed from the damaged regions of the exterior girder. Crew members used pneumatic chipping hammers to remove the material and expose at least one inch of non-corroded reinforcing steel (Fig. 14(a)). The steel was then sandblasted to remove rust, and a zinc primer was applied with a brush after wiping it with a solvent (Fig. 14(b)). Wooden forms were erected to ensure the repair mortar cured appropriately to provide the original shape of the beam (Fig. 14(c)). The forms were removed once the repair mortar had cured. A mechanical grinder was used to remove any in-plane variations between the repair mortar and pre-existing concrete.

(a) Concrete removed to expose rebar

(c) Wood formwork and repair mortar application

(d) Repair of abutment crack

Crack injection ports were mounted, and the exterior of the abutment cracks was covered using a trowel-grade epoxy (Fig. 14(d)). Following the exterior epoxy's curing period, a crack-injection

epoxy was introduced, starting from the bottom-most port and gravity fed in to the cracks. After the crack-injection epoxy had cured, the crack injection ports and excess epoxy over the cracks were ground off.

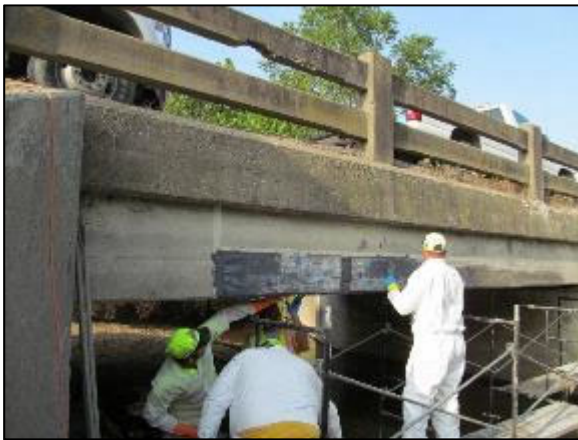
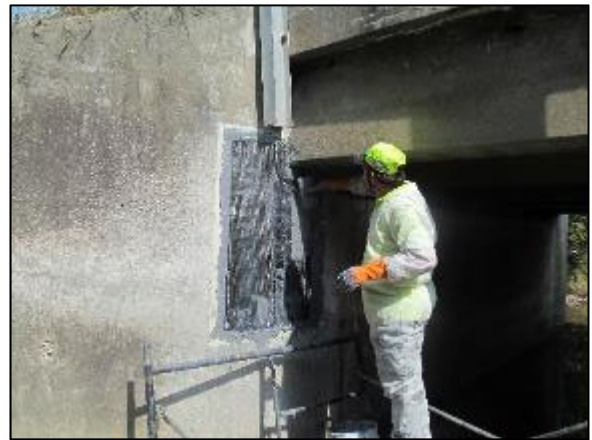
Fig. 15. CRP and TCF application on KY11 over Cat Creek

The same two-part epoxy used on the KY 55 bridge in KYTC District 06 was applied to the concrete; the CatStrong CRP 070 was placed over the epoxy and pressed into it by hand. This was carried out in a modular fashion, moving from one panel to the next (Fig. 15(a)). Each panel was connected to the next using the finger joint connection. Once rod panels were in place along the vertical and bottom faces of the girder, additional epoxy was applied over the finger joint area to the top of the girders, and the CatStrong TCF 012 was placed atop the CRP 070 using a dry layup process. The same epoxy was applied over the cracks in the abutment, and 13 in. wide CatStrong TCF 012 fabric was centered over the cracks (Fig. 15(b)). Fig. 16 shows the bridge following the completed retrofit. The retrofit underwent periodic inspections in the three years following the construction — no defects were observed.

(a) CRP 070 applied with epoxy

(b) TCF application over abutment crack

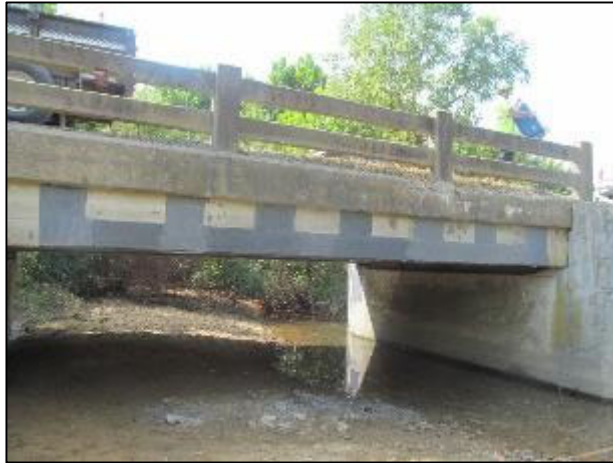
Fig. 16. Completed repairs on KY11 over Cat Creek

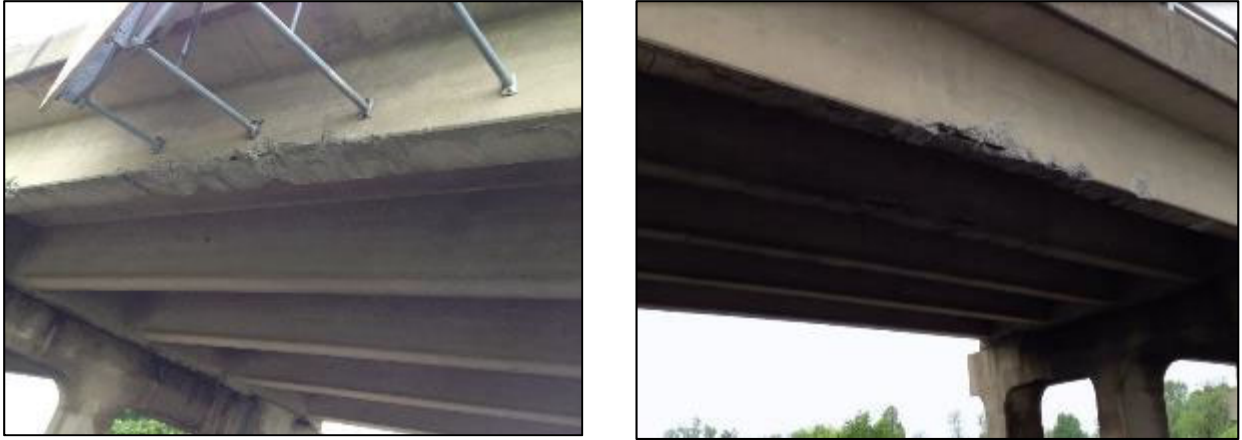
Fig. 19. Damage to concrete girders

The exterior girders on the north side of the southbound and northbound lanes of I-69/Purchase Parkway suffered damage from over-height truck impacts. The impacts damaged rebars and led to concrete spalling. Several of the interior girders also exhibited concrete spalling and minor rebar damage from the over-height impacts.

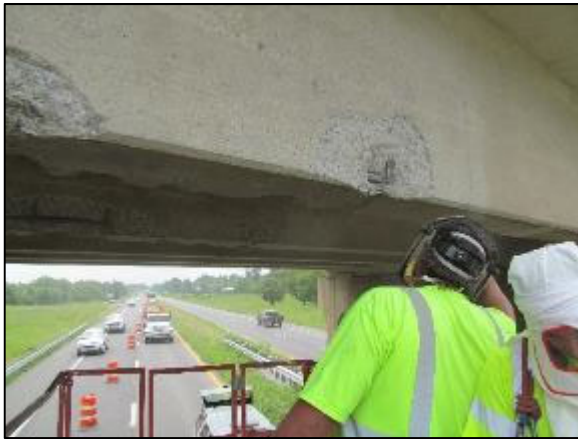
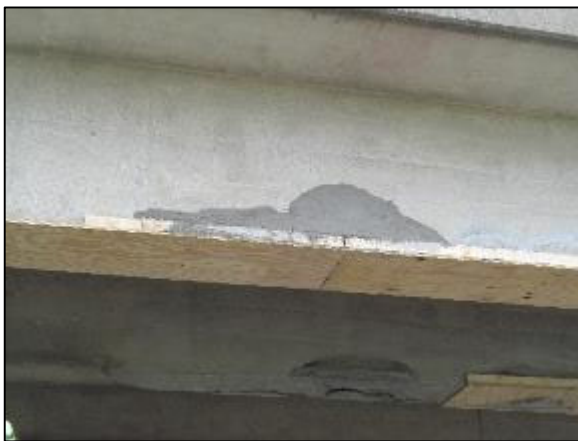
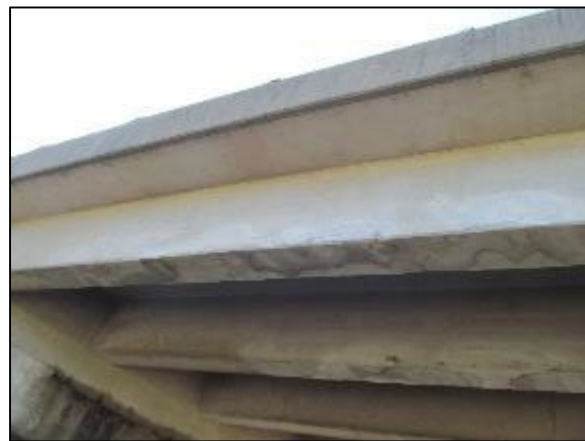
Fig. 21. Repair process of KY 80 over I-69

KYTC District 01 Bridge Maintenance personnel carried out the retrofit in August 2013. One lane of the two-lane north and south bound interstate was closed during construction and the damaged areas were accessed via a scissor lift. Crew members used pneumatic chipping hammers to remove

loose material and expose at least one inch of non-corroded reinforcing steel (Fig. 21(a)). The steel was then sandblasted to remove rust, and a zinc primer was applied with a brush after wiping it with a solvent (Fig. 21(b)). Wooden forms were erected to ensure the repair mortar cured appropriately to provide the original shape of the beam (Fig. 21(c)). The forms were removed once the repair mortar had cured (Fig. 21(d)). A mechanical grinder was used to remove in-plane variations between the repair mortar and pre-existing concrete.

(a) Concrete removed to expose rebar

(c) Wood formwork and repair mortar application

(d) Bridge girder with applied repair mortar

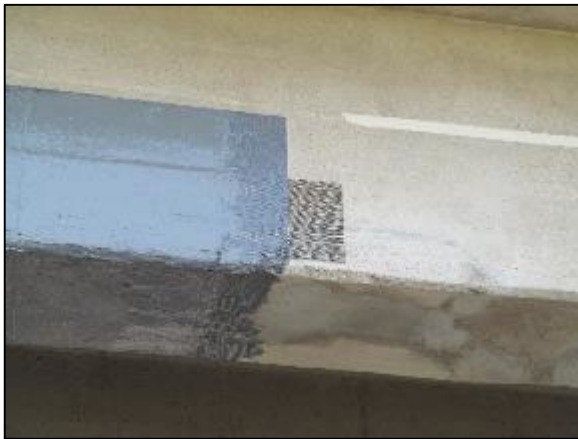
Fig. 22. CRP and TCF application on KY 80 over I-69

A two-part epoxy was applied to the concrete; the CRP 070 panels were placed and pressed into the epoxy by hand. Construction proceeded in a modular fashion with the application of one panel after the other; the scissor lift was moved after the application of each panel. Because the impact-damaged section spanned both lanes of the northbound I-69/Purchase parkway, the last CRP panel applied near the centerline had the finger joint left void of epoxy (Fig. 22(a)). This allowed the

crew to shift traffic and start construction on the adjoining lane the following day. Once the rod panels were in place along the vertical and bottom faces of the RC girders, the CatStrong TCF 012 CFRP fabric was placed atop the CRP 070. Air pockets and irregularities were smoothed out of the fabric with laminating rollers. The completed retrofit of two girders over the northbound lanes is shown in Fig. 23.

(a) Finger joint of CRP 070 left void of epoxy

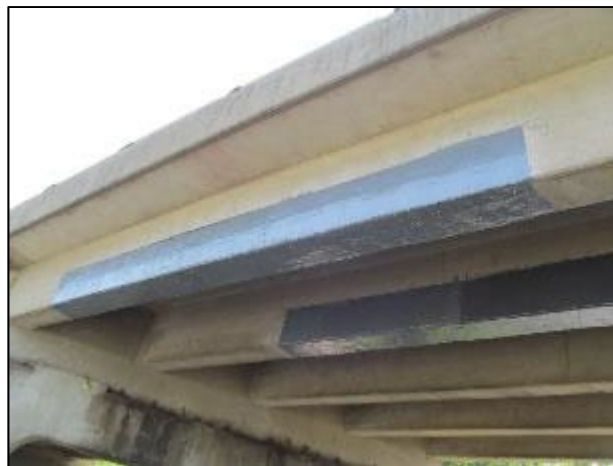
Fig. 23. Completed repairs on KY 80 over I-69 with UV protective coating

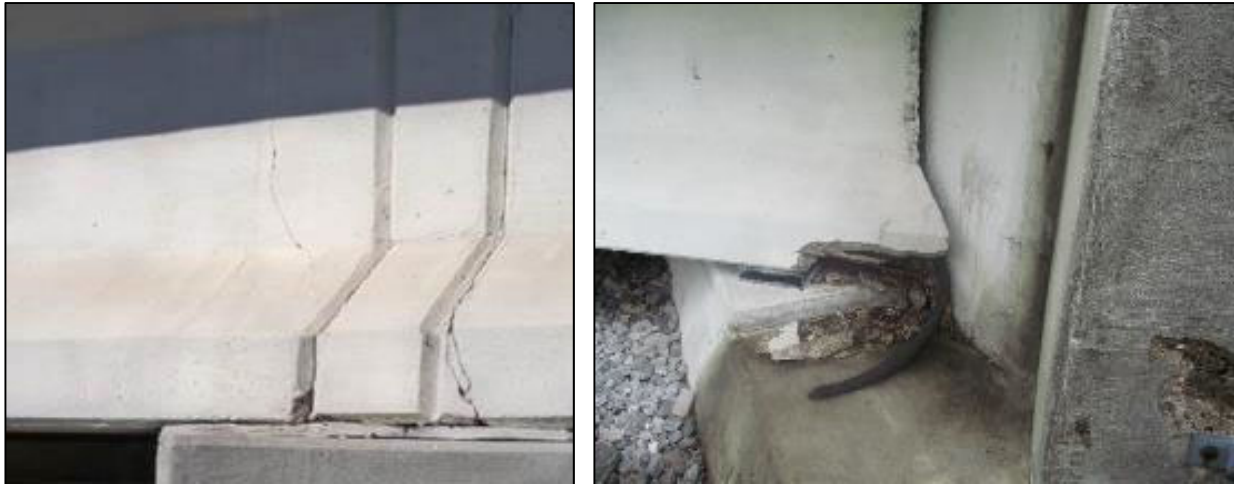
Fig. 26. Damage to beam ends and cracks in beams

The observed damage to the AASHTO Type IV PC girders included cracks at the girder ends at 10 locations, similar to Fig. 26(a). The cracks were primarily located at the ends of the girders within the center span. In addition, concrete spalling and exposed prestressing tendons were identified at the girder ends at six locations over the two abutments, similar to Fig. 26(b).

(a) Cracks at PC girder ends

(b) Damage to PC girder ends over abutment

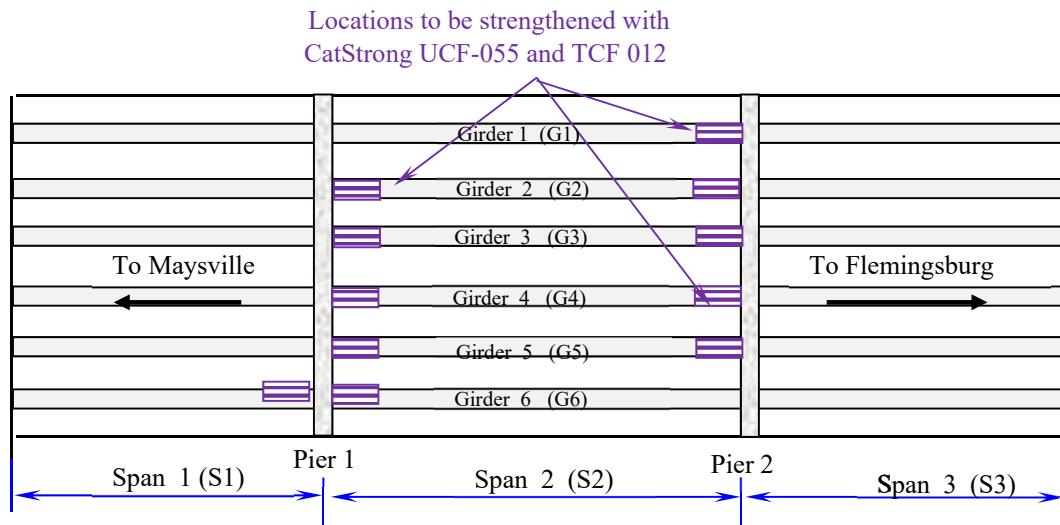
The retrofit plan included the use of CatStrong UCF 055 CFRP and fabric strips and TCF 012 CFRP fabric U-wraps for strengthening the PC I-girder ends (Fig. 27). Additional details regarding the girder retrofit design can be found in Appendix D.

Fig. 27. UCF-055 and TCF-012 retrofit locations on KY 11 over CSX Railroad and Strodes Run Pike

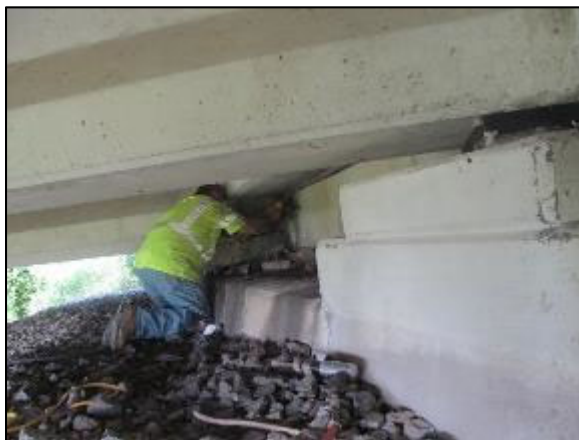
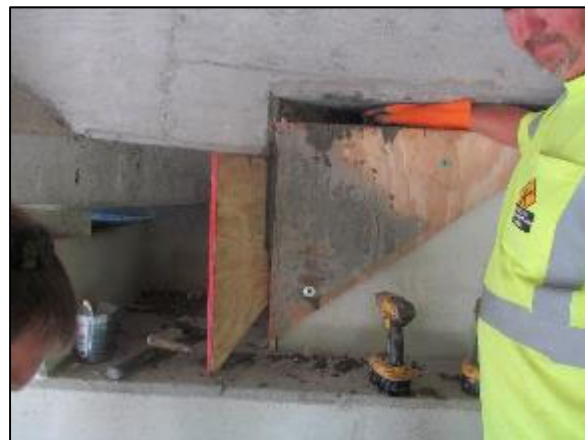
Fig. 29. Beam end repair process

KYTC District 09 Bridge Maintenance Personnel carried out the retrofit during July and August 2014. Loose concrete was removed from the damaged end regions of the PC I-beams over the abutments. Pneumatic chipping hammers were used to remove additional concrete and expose at least one inch of non-corroded prestressing steel. They were cleaned of rust using a mechanical brush (Fig. 29(a)). Wooden forms were erected to ensure the repair mortar cured appropriately to provide the original shape of the beam ends (Fig. 29(b)). Forms were removed once the repair mortar had cured.

(a) Cleaning damaged areas of PC beam ends

(b) Wood formwork and repair mortar application

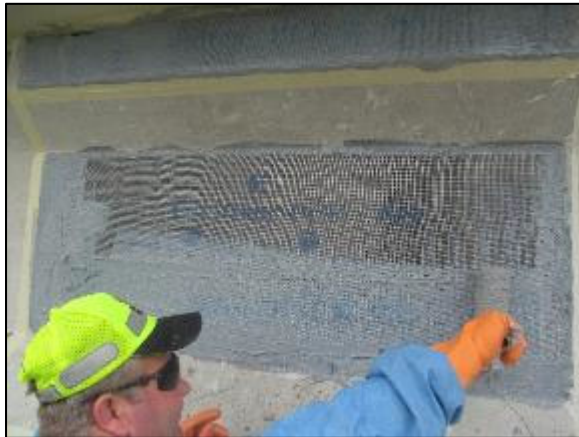
Fig. 30. CRP and TCF application on KY 11 over CSX Railroad and Strodes Run Pike

The cracks at the PC I-girder ends were too small to be injected with crack filling epoxy. The ends were blast cleaned using a pressure washer and, once dried, the CatStrong UCF 055 and/or TCF 012 application was carried out. A two-part saturating epoxy was used to impregnate the fabric prior to the application. Once the UCF 055 was applied, the TCF 012 U-wraps were placed over them. Small strips of UCF 055 were used as anchor strips for the TCF 012 U-wraps. For several girders on which the cracks were quite small, the CatStrong TCF 012 U-wraps were the primary strengthening material. After the epoxy had cured, a UV protective coating was applied over the retrofit areas on the exterior girders.

(a) Modular CRP application process

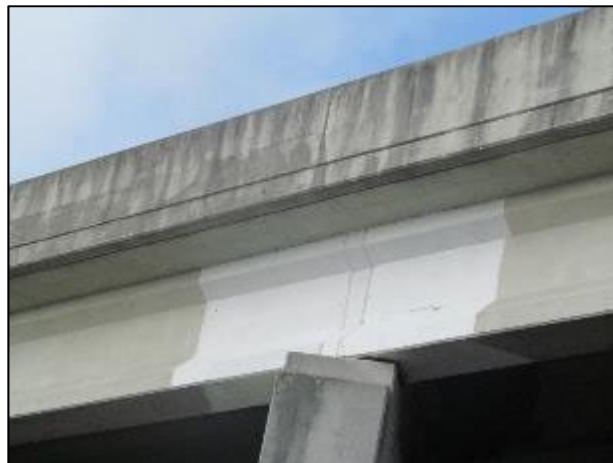
Fig. 31. Completed repairs on either side of Pier 1 following application of protective coating

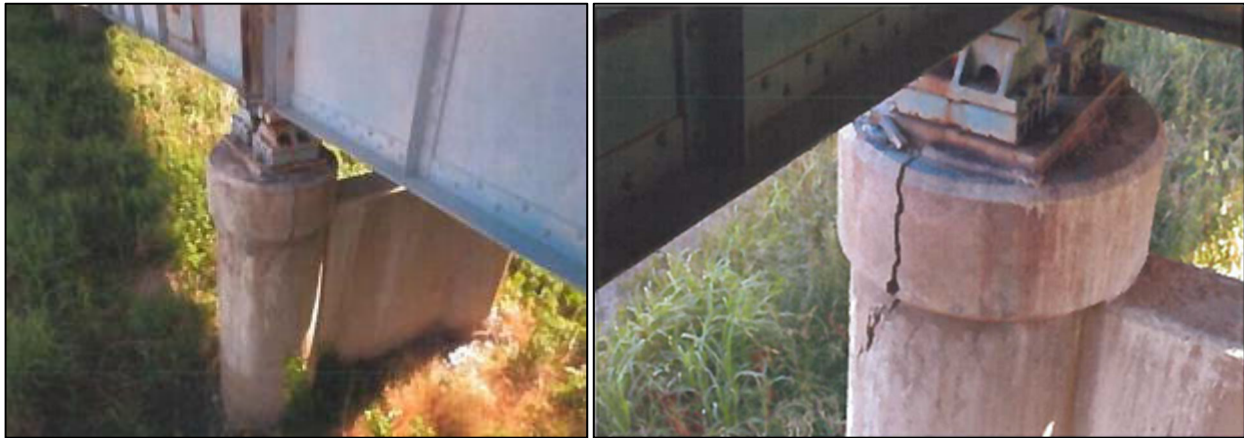
The pier cap on one of the approach span piers had a large vertical crack (Fig. 34). The crack originated under the bearing plate, propagated down the pier cap, and extended into the pier column. Several smaller cracks were seen on the opposite side of the pier cap.

Fig. 34. Typical damage to pier cap in US 60 bridge over Cumberland River

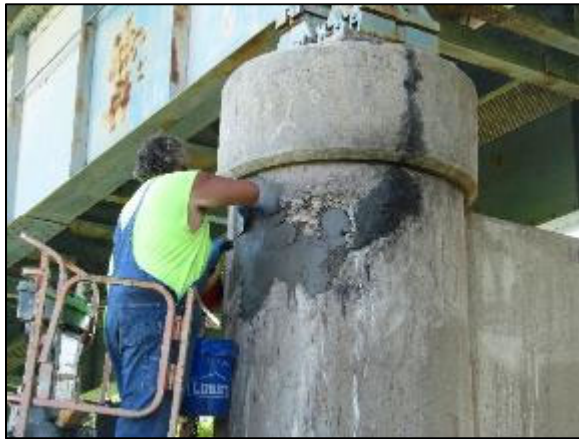
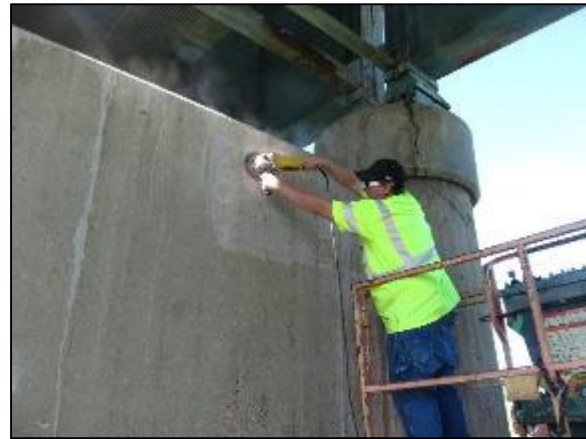
Fig. 36. Repair process of KY 60 over Cumberland River

The retrofit was carried out by the KYTC District 01 bridge maintenance crew in April 2016. Loose concrete was removed and the crack filled prior to the CatStrong carbon fabric application. The damaged area was filled with repair mortar to return the column to its original shape (Fig. 36(a)). Once cured, the repair mortar was ground to remove in-plane variations between the repair mortar and pre-existing concrete. In addition, the CatStrong fabric bond surfaces were cleaned using a mechanical grinder to provide a good bond surface.

(a) Repair mortar application

(b) Surface preparation for CatStrong UCF 115

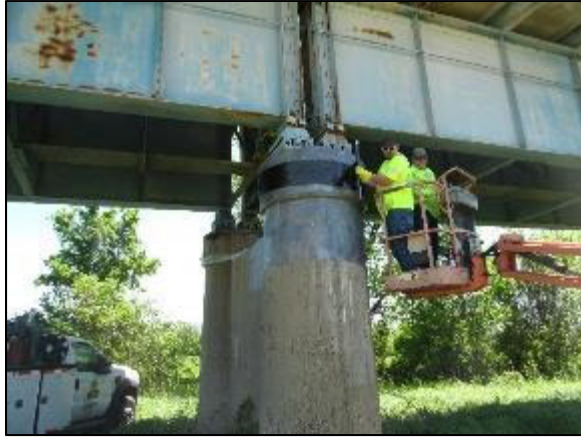
Once the surface was ready for carbon fiber application, a primer coating was applied to the concrete surface to prevent the saturated carbon fabric from sliding under its own weight. The CatStrong UCF 115 was impregnated with a two-part saturating epoxy and wrapped around the pier cap (Fig. 37(a)) and column (Fig. 37(b)). All air pockets and irregularities were smoothed out of the fabric with laminating rollers.

(a) Wrapping UCF 115 around column

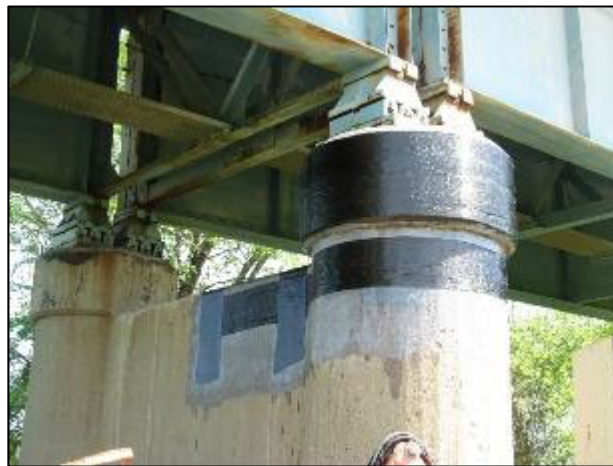
Twelve inch wide CatStrong UCF 023 anchor strips were applied over the CatStrong UCF 115 carbon fabric at the termination point as well as the transition point between the Pier column and Pier wall. The completed retrofit following the application of the UCF 023 anchor strips is shown in Fig. 38.

Fig. 38. Completed repairs to US 60 over Cumberland River bridge pier

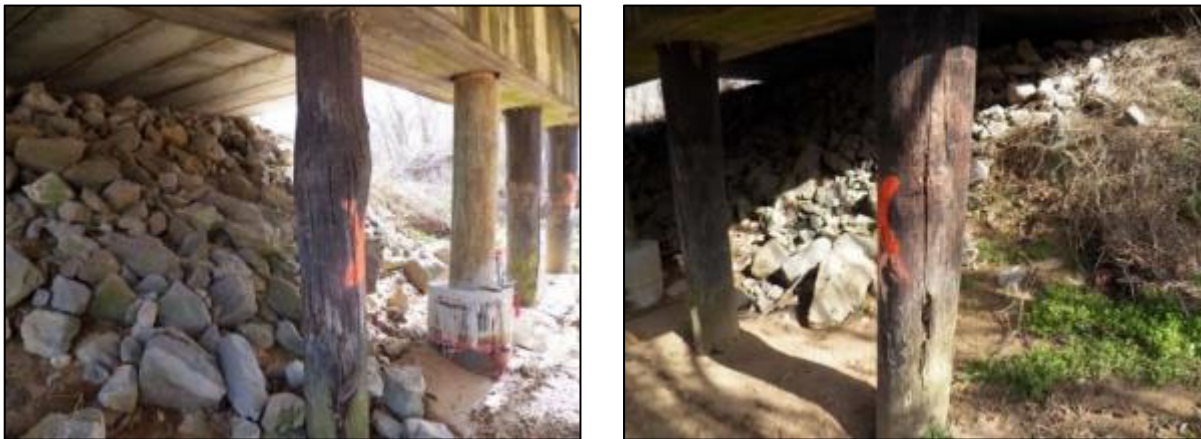
Many of the timber piles had deteriorated, especially near the splash zones from normal stream flow levels. Several piles had been spliced previously by KYTC bridge maintenance personnel using concrete cast around the joint between the new pile section and the old pile protruding above the ground.

Fig. 40. Typical damage to KY 339 timber pile supports

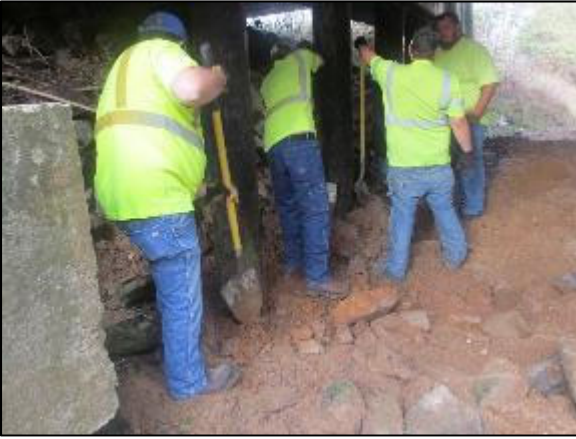
KYTC District 01 Bridge Maintenance personnel carried out the retrofit in November 2015. Earth surrounding the base of the damaged timber was cleared with shovels (Fig. 42(a)). Spacers were attached into the timber pile (Fig. 42(b)) to maintain 2 in. of spacing between the timber pile surface and the CatStrong TCW 012 to accommodate the epoxy mortar. As seen in Fig. 42(c), the CatStrong TCW 012 overlap was coated in a structural epoxy, wrapped around the spacers, and secured with adhesive tape. Epoxy mortar was then mixed and placed between the timber pile and the TCW 012.

(a) Clearing area around base of timber piles

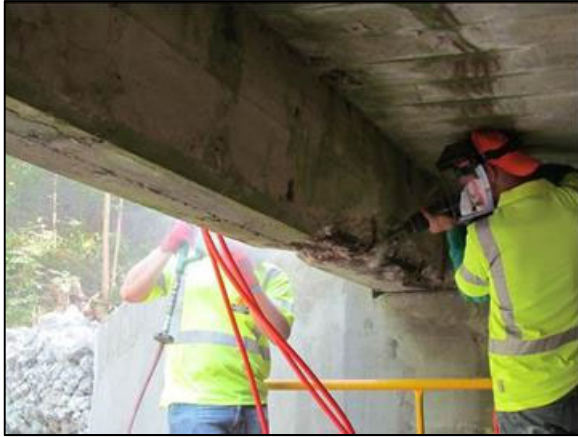
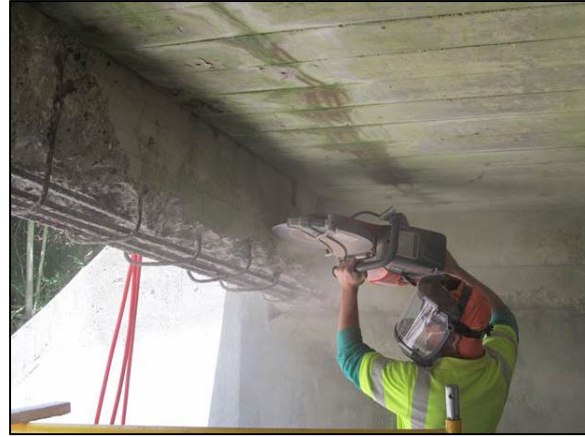
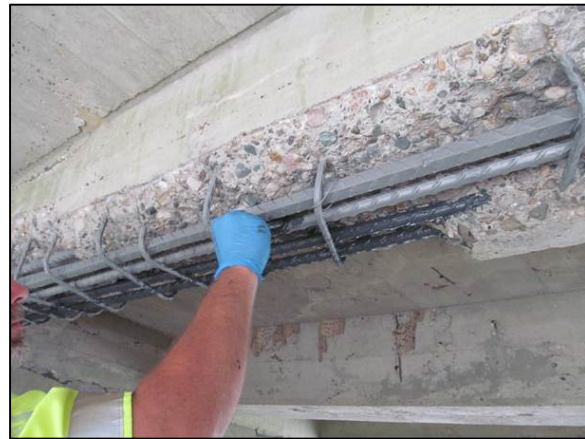
1. Remove all loose concrete and debris from damaged area. A pneumatic or electric chipping hammer can be used to remove all loose concrete.
2. For irregular shapes, use a concrete saw to cut a simple geometric shape to repair.
3. If steel is exposed to the elements, at least one inch of non-corroded reinforcing steel must be exposed. Sandblast the steel to remove rust and apply a zinc primer with a brush or spraying equipment.
4. If required, new rebar can be spliced or damaged rebar replaced.

(a) Removing loose concrete

(b) Saw cuts to create simple geometric shapes

(c) Sandblast exposed steel rebar

(d) Constructed wooden formwork

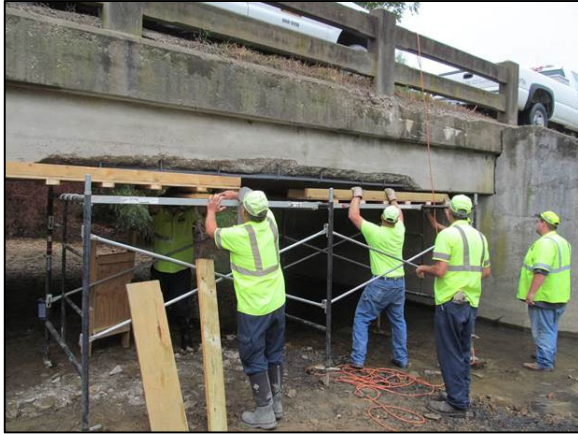
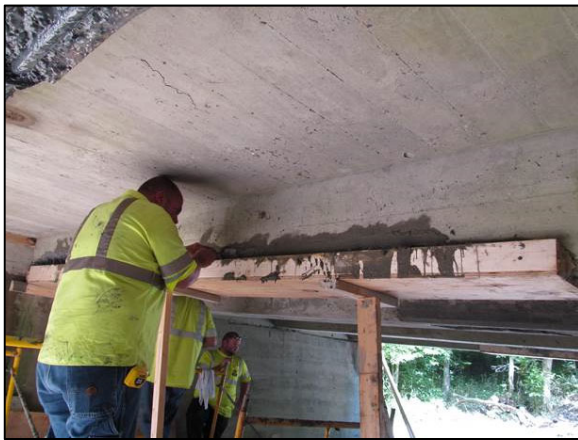
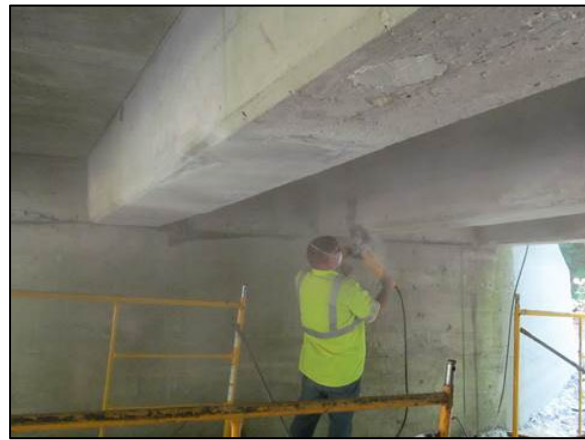
5. If needed, construct wooden formwork to facilitate the application of repair mortar. A bonding agent may be beneficial for overhead applications. Apply repair mortar to return the damaged area to its undamaged state. Vibrate the mortar to prevent voids.
6. Once the mortar sets, grind away excess mortar to remove any in-plane variations between the mortar and pre-existing concrete to a precision of 1/32 in.

(a) Setup formwork

(c) Application of repair mortar

(d) Grinding excess repair mortar

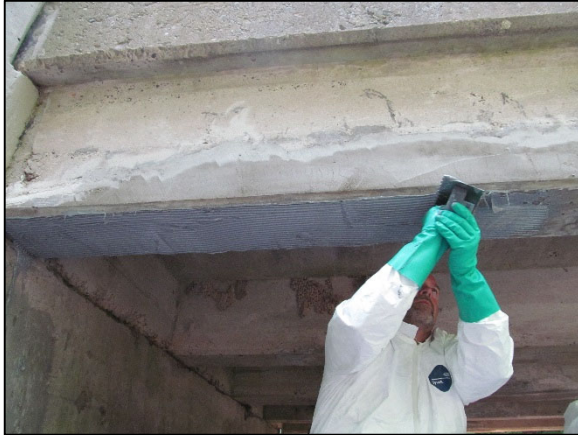
(a) Applying coat of epoxy to concrete surface
