Research Report

EVALUATION OF LANDSLIDES ALONG ALABAMA HIGHWAYS

The Alabama Department of Transportation

AUGUST 2019

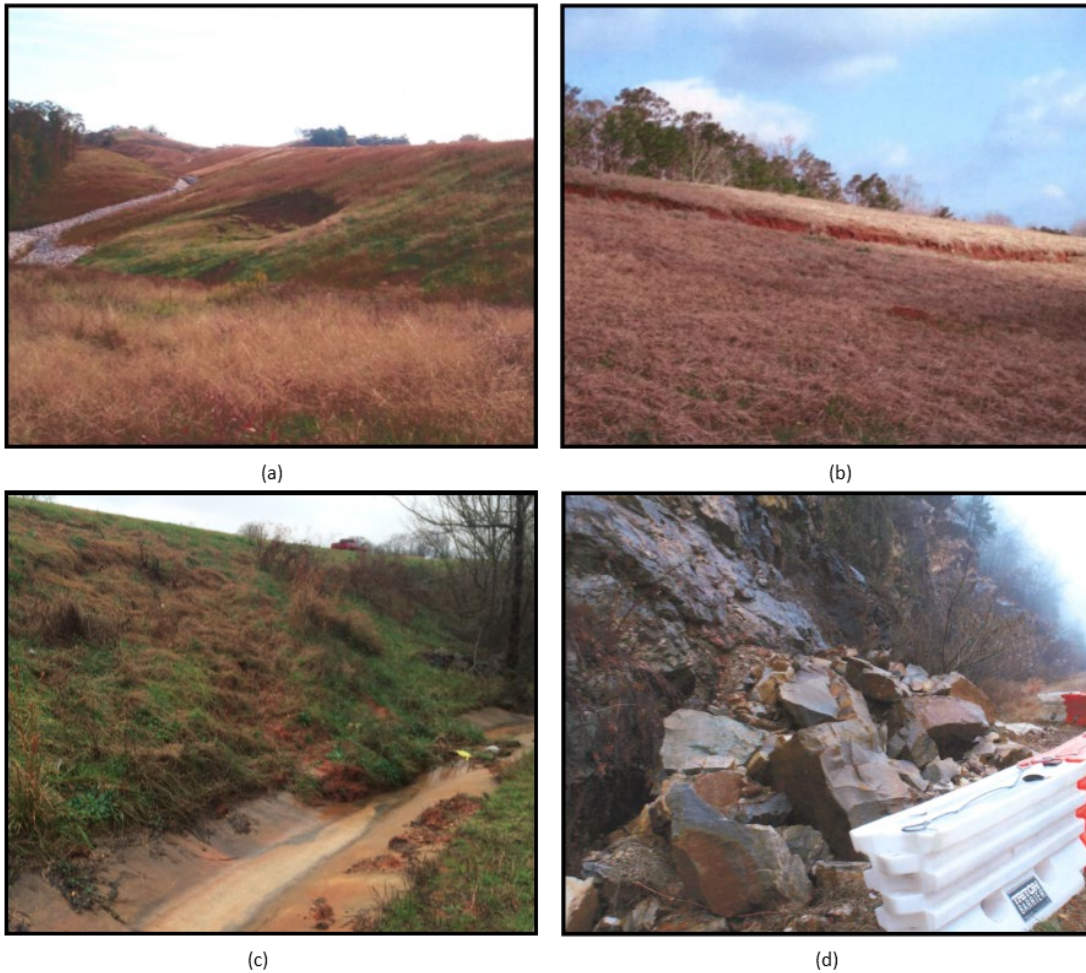
Figure 1-1. Different types of landslide movements observed along Alabama highways including: (a) an earth rotational landslide (b) an earth translational landslide, (c) a surface erosion (creep) failure (d) a rock fall.

Landslides along roadways (e.g., Figure 1-1) are a significant concern for state and federal transportation agencies, leading to large direct repair costs as well as indirect costs, such as traffic disruption, driver inconvenience, commercial losses, road closure, and secondary maintenance. Landslide repairs and related maintenance are estimated to cost the United States between \$2.1 and \$4.3 billion annually (Klose 2015). However, fewer estimates are available for costs due to landslides along highways. Walkinshaw (1992) estimated state highway departments spend \$106 million annually (1992 dollars) on landslide repairs, although the author suggests that this is likely only a fraction of the total annual costs.

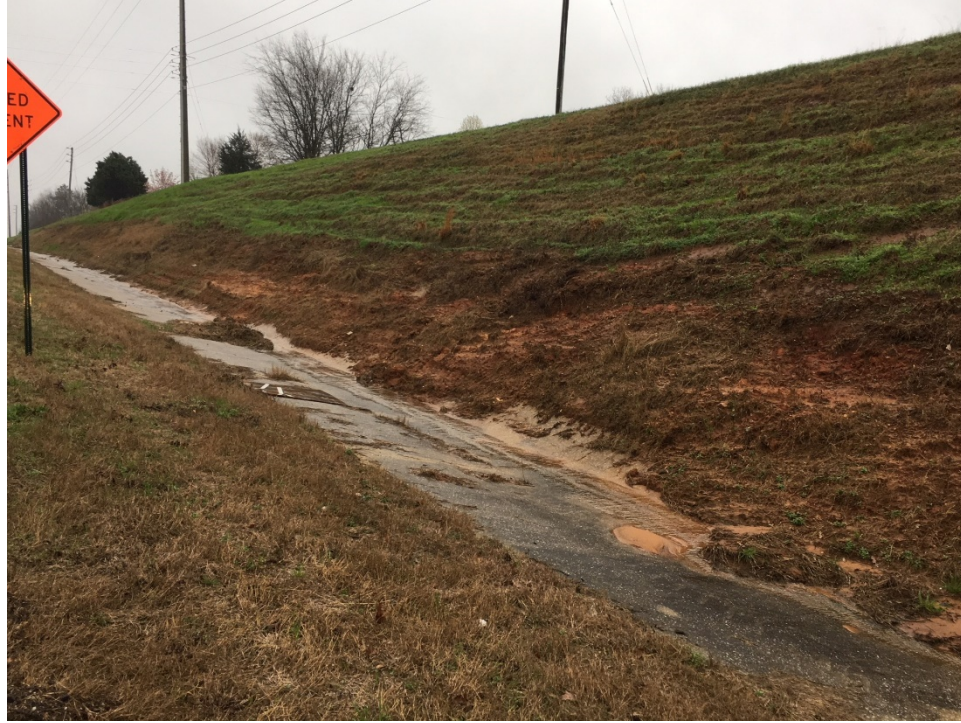
Figure 2-5. Shallow slope failures caused by rutting from mowing activities along Highway 69 near mile post 137.7 (photo provided by Jacob Hodnett, ALDOT).

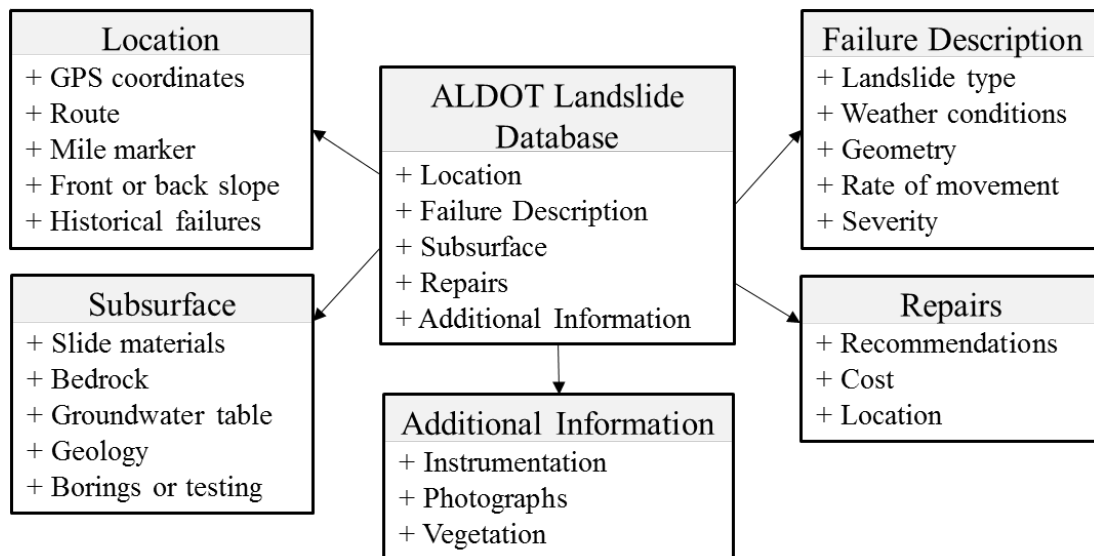
Figure 3-2. Data model for the ALDOT landslide database. Each box shows a tab within the model which group together similar attributes of both the roadway and the slide.

Knights (2018) originally developed two databases to deal with the different levels of detail in each of the data sources, but the information has been combined into a single database in this study (Figure 3-2). The current database collects information on the location of the landslide, the soil conditions, the weather around the time of failure, the landslide type (following Varnes 1978), measurements of the landslide geometry, repairs, and effects of the landslide on the roadway. If available, information is also collected on the rate of movement, groundwater, subsurface conditions, previous landslides in the area, vegetation, and availability of additional data (i.e., photos, instrumentation, borings, and laboratory tests). These attributes are further described in Table 3-2.

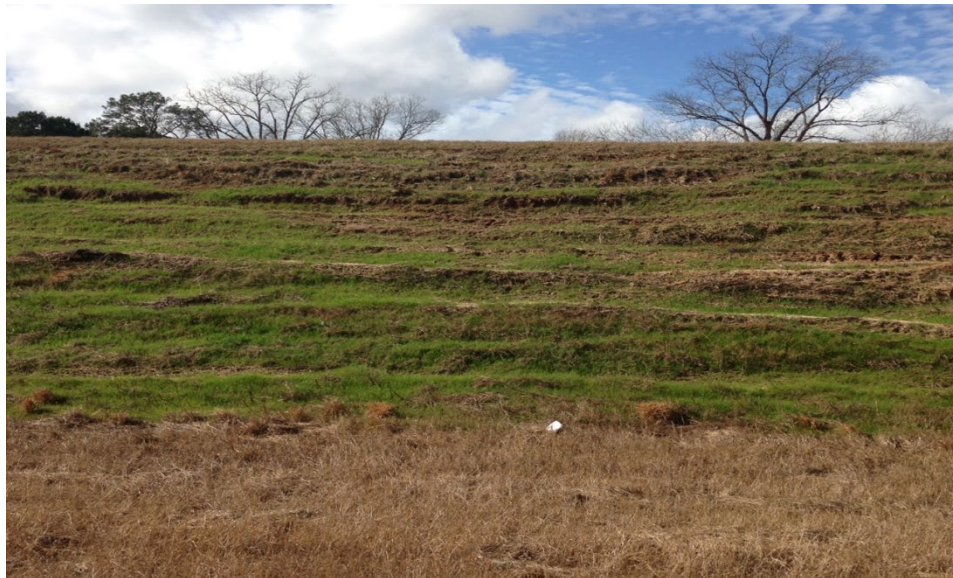
Figure 3-5. Rutting along the face of a slope due to mowing activities (photo provided by Jacob Hodnett, ALDOT).

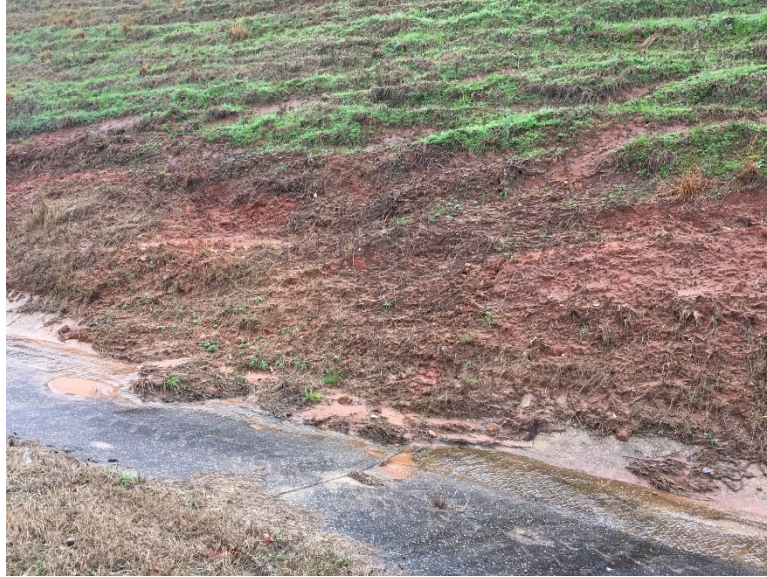
Figure 3-6. Shallow slope failures caused by rutting from mowing activities along Highway 69 near mile post 137.7 (photo provided by Jacob Hodnett, ALDOT).

events (Figure 3-6). If left unrepaired, these surficial failures may lead to larger stability problems. These types of surface erosion failures are not reported to the Materials and Tests Bureau or FHWA and so were not included in the reports collected for the database described in the previous sections. Repairs of these failures are typically handled by local maintenance forces and commonly involve cleaning failed material out of ditches or other drainage structures and possibly placing top soil to fill in the eroded area. These repairs are often considered part of “ditching activities”, which can also include repairs to drainage features, constructing a new driveway or entrance onto a state route, and beaver dam removal. While it is not possible to track the exact amount of money spent on repairing surface erosion failures, ALDOT spent more than \$13.7 million on ditching activities between 2014 and 2018. Surface erosion from slopes likely represents a significant portion of these repair costs.

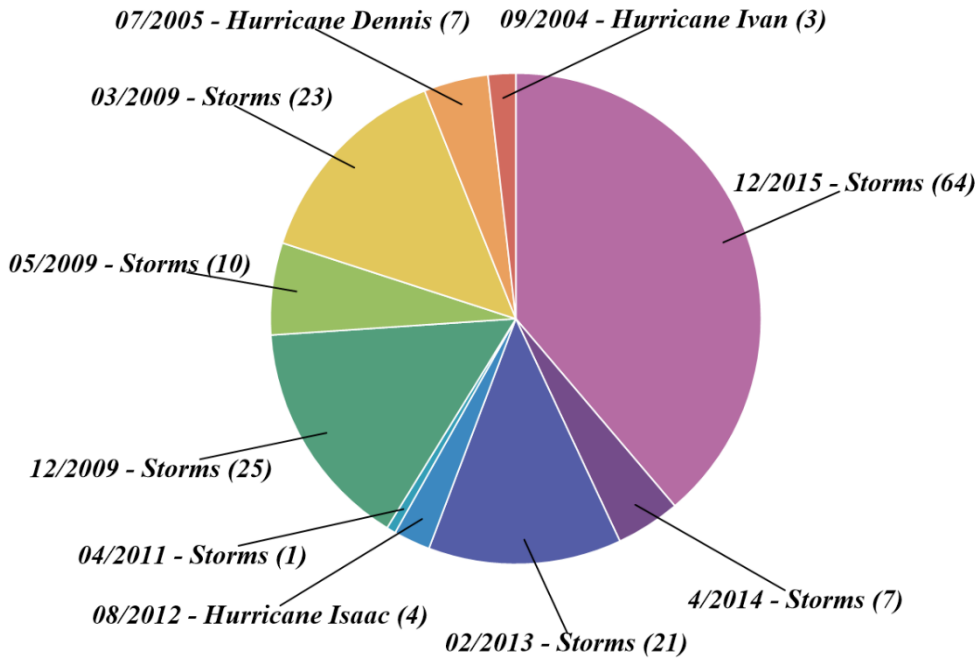
Figure 4-3. Distribution of emergency relief slides by event. The number in parenthesis indicates the number of landslides attributed to that event.

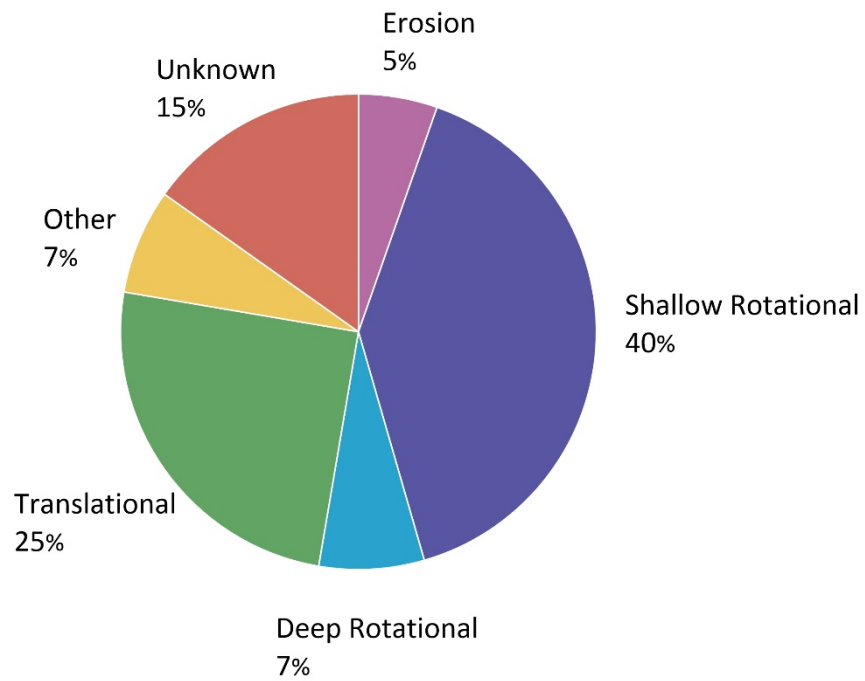
Figure 4-5. Landslide categories for the landslide reports within the database.

The number of landslides within each failure category is presented in Figure 4-5 and Figure 4-6. The charts represent the number of times the failure categories appear within the database, allowing landslides to be counted more than once if it experienced multiple failure types. Figure 4-5 shows the majority of landslides within the landslide reports database are classified as either shallow rotational failures (40%) or translation failures (25%). Figure 4-6 shows the majority of the emergency relief landslides were classified as either translational (40%) or erosion failures (17%). The increase in erosion-related failures within the emergency relief slides is expected as these slides are driven by heavy rain which can overwhelm drainage structures.

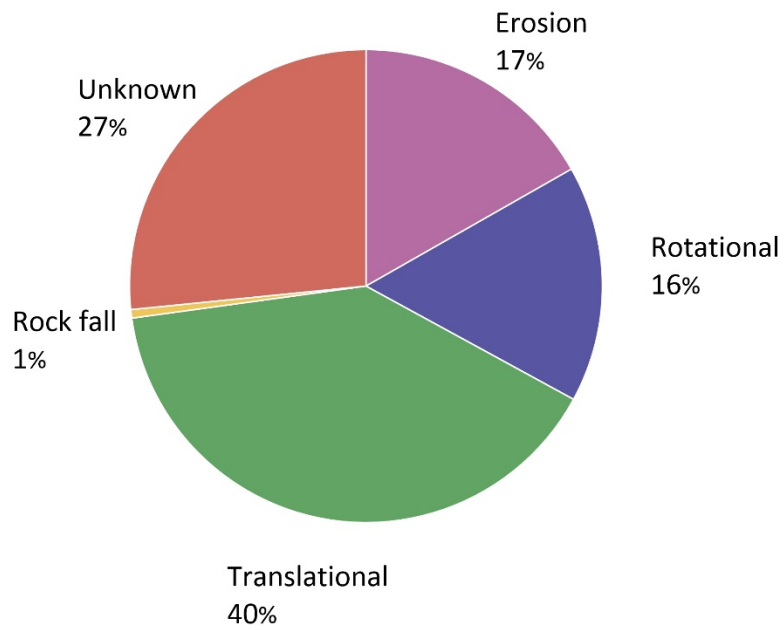
Figure 4-6. Landslide categories for the emergency relief slides within the database.

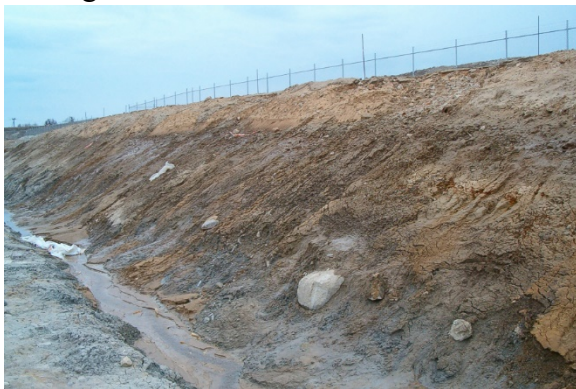
Surface Erosion: The upper few inches to foot of soil is eroded by moving water leaving an area of bare soil behind.

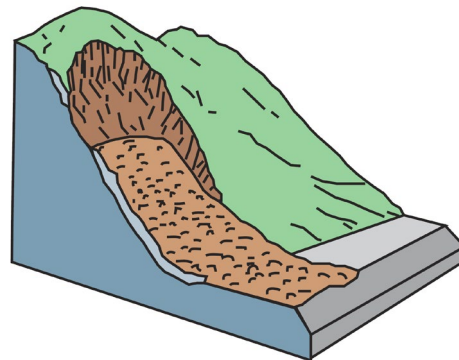
Flow: Flows are landslides that involve the movement of material down a slope in the form of a fluid. The failed mass does not usually have a well-defined structure.
