Platform Track Intrusion Detection System Evaluation for Los Angeles County Metropolitan Transportation Authority

MARCH 2021

FTA Report No. 0189
Federal Transit Administration

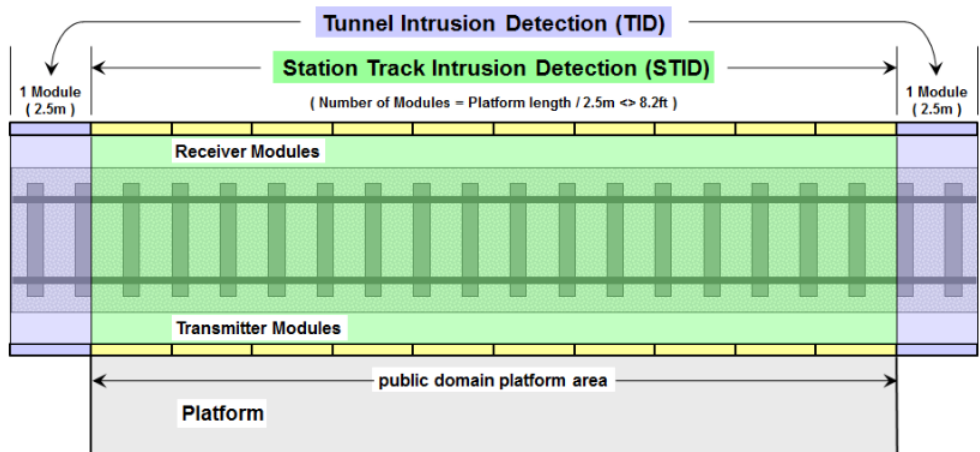
Figure 1-1

STID and TID detection zones

This system monitors the track area in front of the platform through a row of transmitter and receiver sensor module pairs on each side of the track. The plane between the transmitter and receiver modules is set to a reasonable height below the platform and above the top and rail. An object is detected by the STID function when it falls through this plane and interrupts the radar signal between the transmission modules and corresponding receiver modules. Software algorithms are then used to filter unwanted detections, including the train.

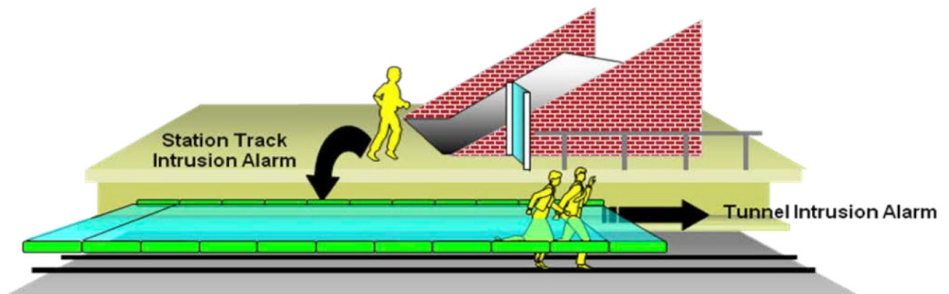
Figure 1-2

STID and TID alarm zones

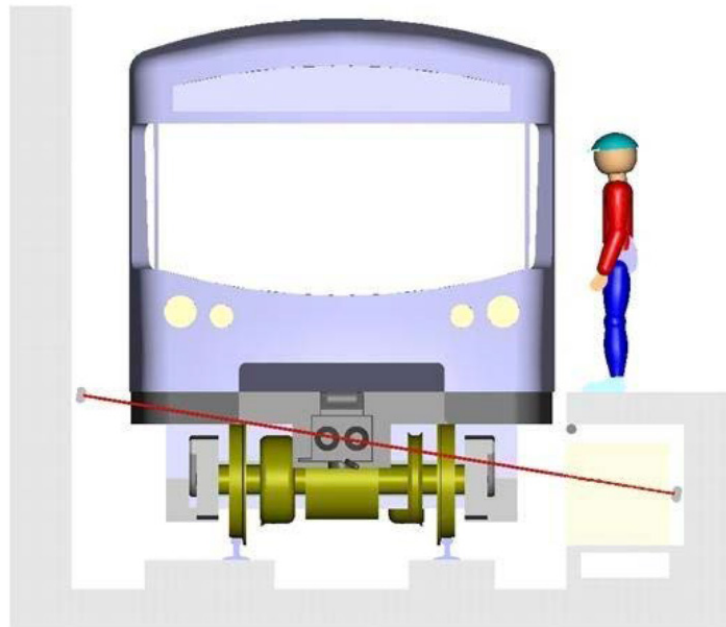
Figure 1-3

Typical arrangement of STID and TID transmitter and receiver modules

Additional module pairs are also installed beyond each end of the platform. These modules are used for the TID function and are responsible for detecting a person leaving the station track area and entering the tunnel area. An alarm also is triggered if an object falls through these module pairs just as it would for the other modules used for STID. Figures I-1 and I-2 depict the module detection zones for STID and TID.¹ Figure I-3 illustrates the typical arrangement of the transmitter and receiver modules in relation to the platform.

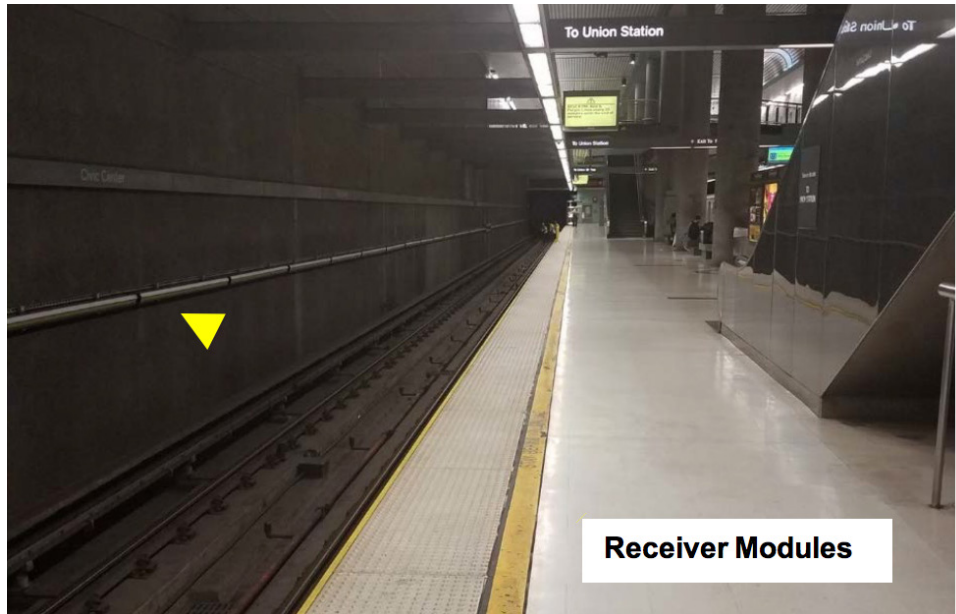
Figure 2-2 shows the platform with a yellow arrow pointing to the row of receiver modules mounted along the wall.

Figure 2-2
Civic Center platform

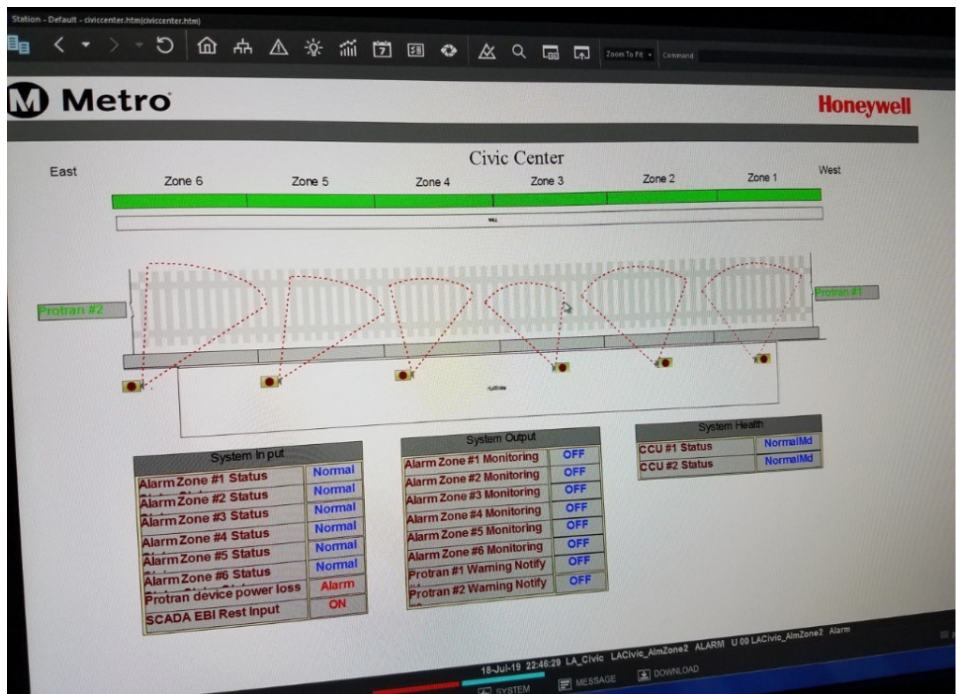
The site consisted of six alarm zones spanning the length of the platform (approximately 450 ft) for STID. The two end zones, Zones 1 and 6, extended beyond the platform into the tunnel area for TID. Figure 2-3 is an illustration of the alarm zones as shown on the PTIDS maintenance computer in the Train Communications Center (TCC).

Figure 2-3
Screen shot from maintenance computer showing alarm zones

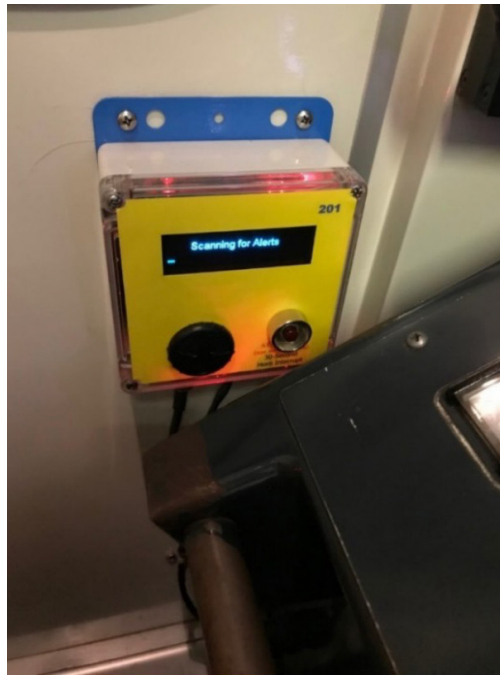
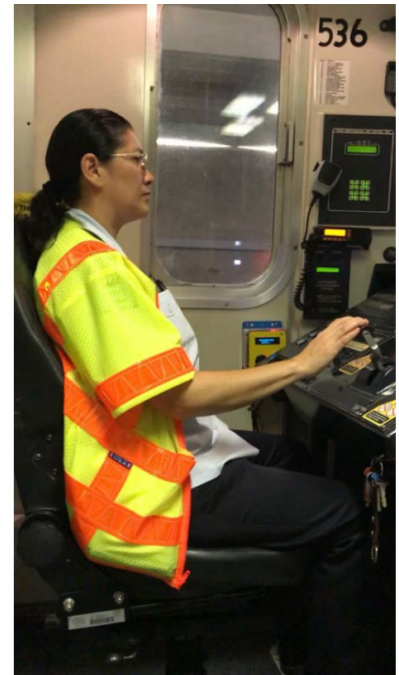
Figure 2-4

A secondary system by Protran Technology called an Intrusion Warning Device was also installed.² The Intrusion Warning Device provides local and remote indications that an unauthorized triggering event has occurred and alerts an operator within 800–1,200 ft of the PTIDS through an RF signal. The platform area also is alerted by way of visual and audible alarms, providing a warning to people in the area of the potentially dangerous situation (Figure 2-4). This system was available only for observation for some of the testing and was connected to the PTIDS status indicator at the platform, which included a strobe light and siren that would alert the platform area of an intrusion.

Protran intrusion warning device

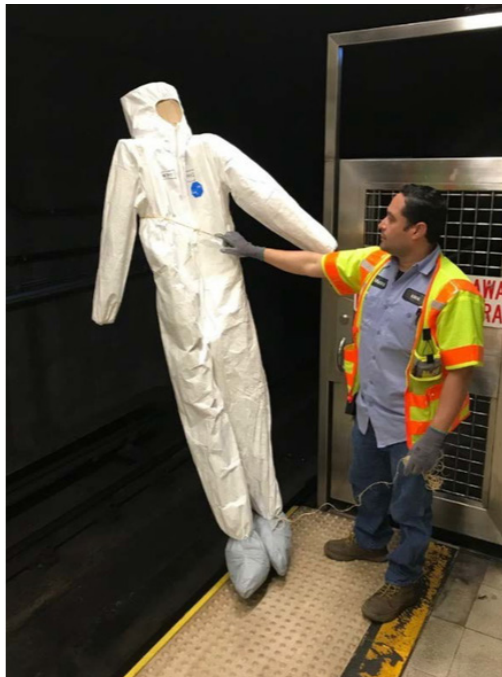
Figure 2-15

The second part involved a test body being thrown from the platform into each alarm zone of the PDZ 10 times. The test body used for this testing was a pair of coveralls with a cardboard cutout of a person inside (Figure 2-15).

Test body
