**Federal Railroad
Administration**

Conventional Coupling Test Between Coach Car and Passenger Locomotive

13. ABSTRACT The Federal Railroad Administration (FRA) sponsored Transportation Technology Center, Inc. (TTCI) in conducting impact tests between a Budd M1 Car and a F40 locomotive to evaluate the performance of both vehicles under dynamic conditions. This set of impact tests were performed on November 18 and 19, 2015, at the Transportation Technology Center (TTC) in Pueblo, CO. The M1 car was impacted by the locomotive at 1.89, 3.86, 5.67, 7.89, 9.95, and 11.86 mph. The most substantial damage that occurred during the tests was inflicted upon the M1 car, with the F40 locomotive sustaining no noticeable damage. The most significant damage to the M1 was the buckling and cracking of the side sills, but the draft pocket and draft gear did show deformation after these tests.

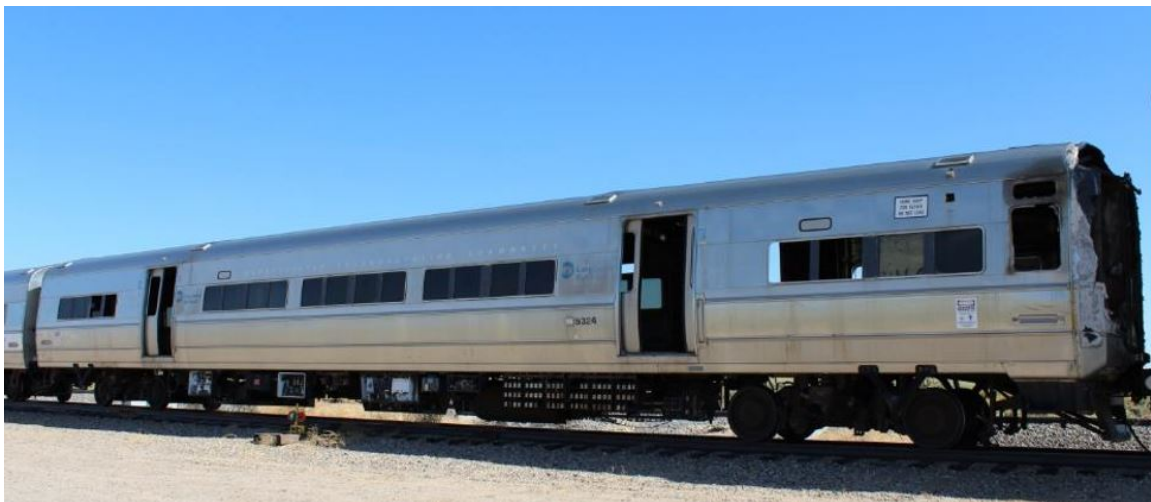
Figure 1. M1 Car 9324

The M1 car is an electric multiple unit vehicle, built by the Budd Company for the Long Island Railroad. The testers chose M1 car 9324 to serve as a stationary passenger car. The weight of this car was 73,325 pounds. This car suffered previous fire damage on the cab end. Some of the composite material used outside and inside of the cab was burned; however, inspection showed there was no significant damage to the car structure. All interior equipment including floor, seats, and side wall panels was removed before the testing, and the car's asbestos contamination was abated. [Figure 1](#) has a picture of M1 car 9324. Missing traction bars were replaced with 1-inch diameter solid steel rods.

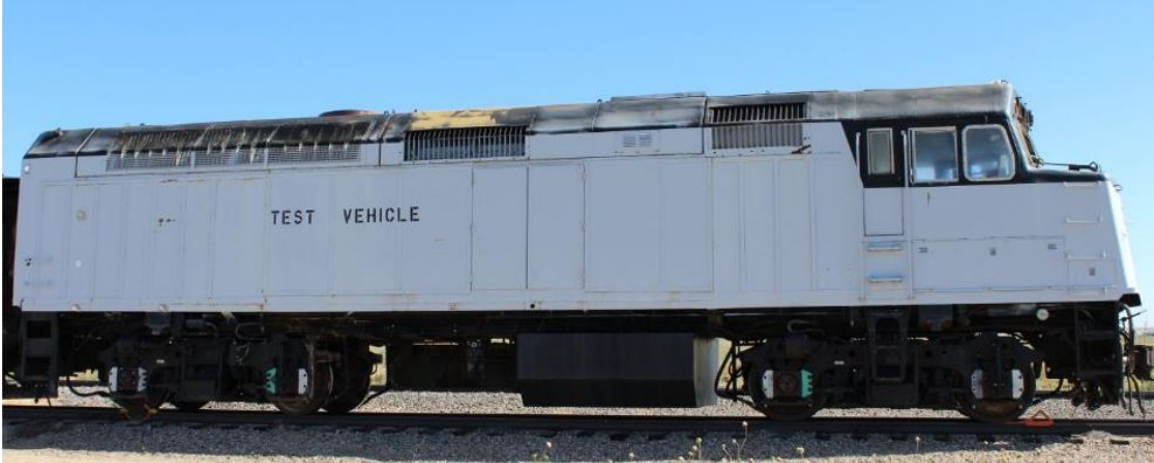
Figure 2. F40 Locomotive

The F40 locomotive was a four-axle diesel electric locomotive intended for use in passenger service. These tests used F40 locomotive 202 as the impacting vehicle. The weight of this locomotive was 245,800 pounds. [Figure 2](#) has a picture of F40 locomotive 202.

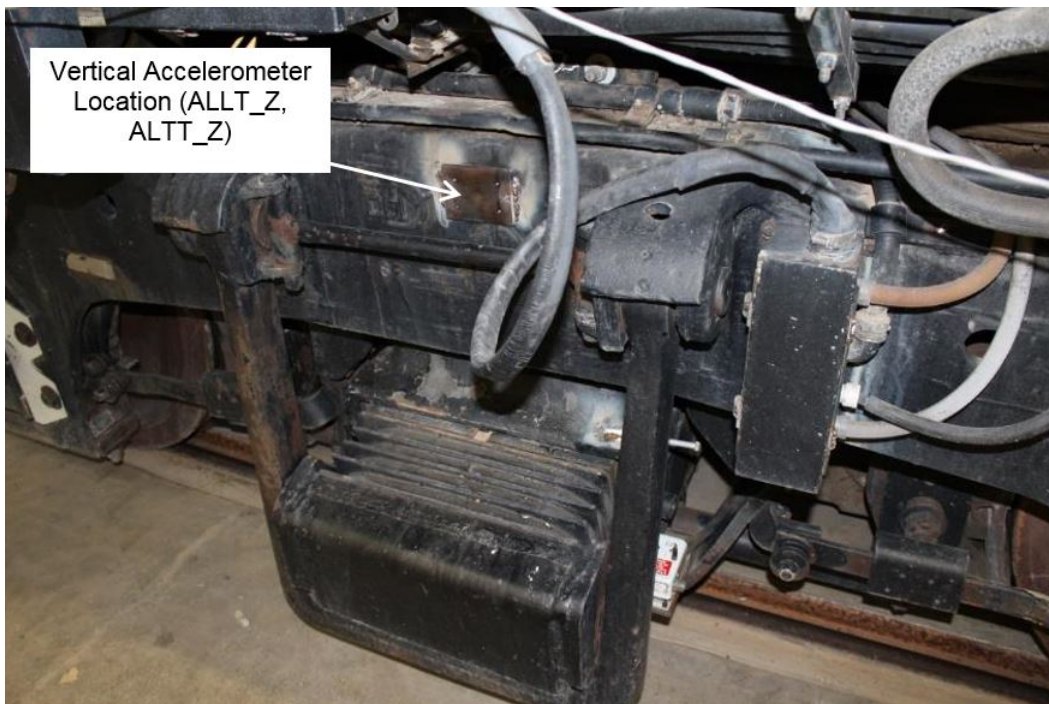
Figure 4. Locomotive Truck

Tri-axial accelerometers were placed at the two ends and the center along the locomotive center line. The locomotive had longitudinal and vertical accelerometers placed on the left and right sides of its underframe at its longitudinal center. Each locomotive truck was equipped with a vertical accelerometer. The locomotive's coupler was fitted with two longitudinal accelerometers, one on the left side, and one on the right. The typical scale factor calibration error for the accelerometers used was 2 percent. In addition to these accelerometers, the locomotive was instrumented with string potentiometers across each truck's secondary suspension. String potentiometers were also fitted to the coupler of the locomotive to measure the up/down and left/right displacements of the coupler. The underframe of the locomotive was fitted with a string potentiometer near the coupler to measure longitudinal displacement. This instrumentation plan is summarized in [Table 2](#) and [Figure 3](#) through [Figure 7](#).

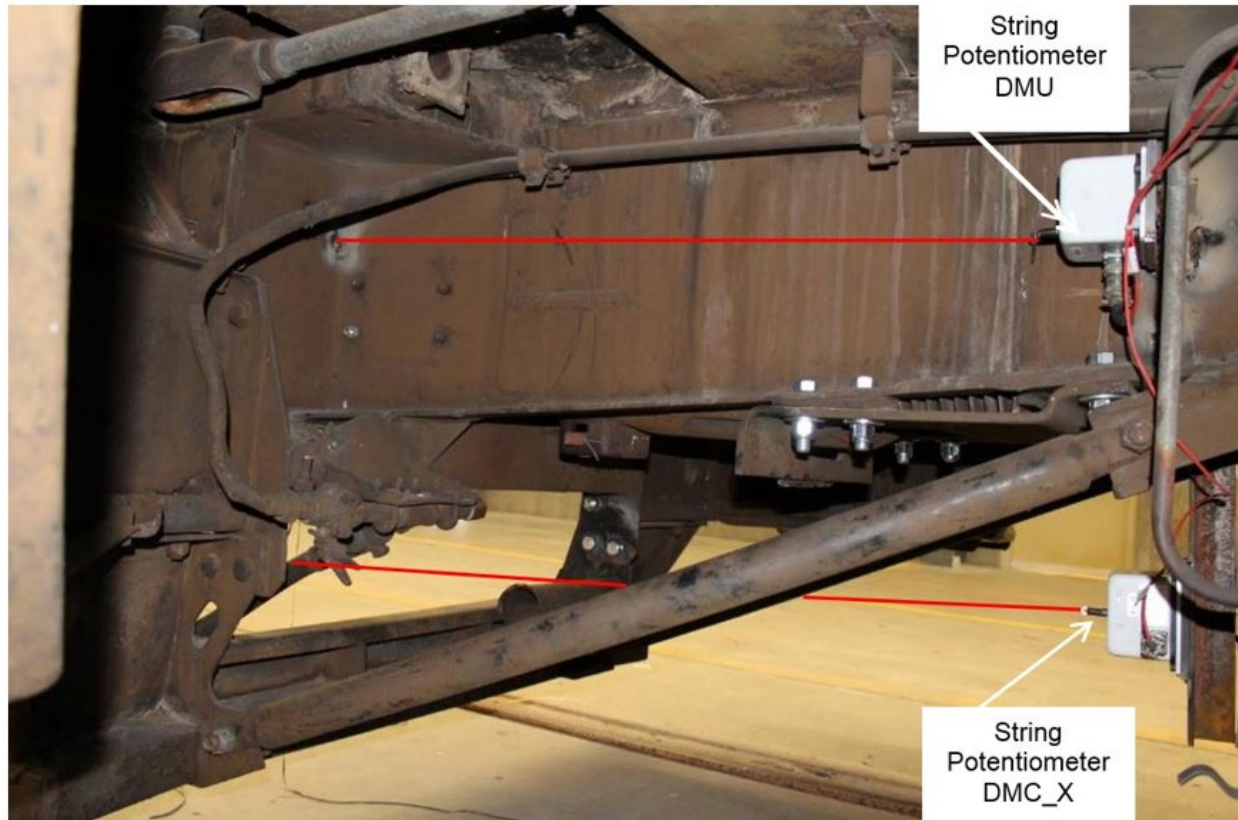
Figure 11. M1 Underframe

Tri-axial accelerometers were placed at the two ends and the center along the car center line. The car had longitudinal and vertical accelerometers placed on the left and right side of its underframe at its center. Each truck was fitted with a vertical accelerometer. The car's coupler was fitted with two longitudinal accelerometers, one on the left side and one on the top. The typical scale factor calibration error for the accelerometers used was 2 percent. In addition to these accelerometers, the M1 car was fitted with string potentiometers across each truck's secondary suspension. String potentiometers were also fitted to the coupler of the M1 car to measure the up/down and left/right displacements of the coupler. The underframe of the car was also fitted with a string potentiometer near the coupler to measure longitudinal displacement. This instrumentation plan is summarized in [Table 3](#) and [Figure 8](#) through [Figure 11](#).

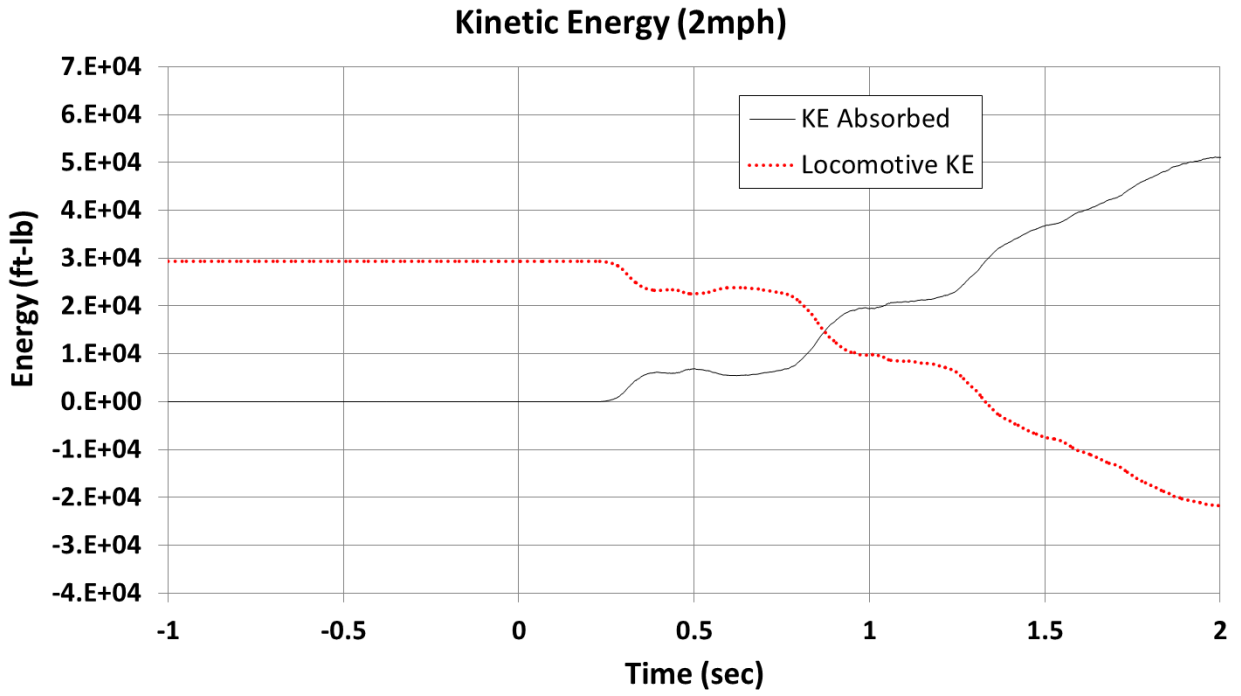
Figure 25. Impact Energy at 2 mph

Integrating the acceleration history yields the velocity history for each trial run. Impact energy was then calculated using the velocity histories and the mass of the locomotive. Figure 25 through Figure 30 are graphs of the energy absorbed and the energy of the locomotive during each impact. The kinetic energy of the locomotive was calculated by subtracting the absorbed kinetic energy from the locomotive's maximum kinetic energy. The maximum kinetic energy was based on the locomotive's speed just before impact, as measured by the speed traps, and it is shown in Table 5. Theoretically, the kinetic energy of the locomotive should approach zero because all the energy the locomotive contained before impact would be dissipated by the time the locomotive came to a stop. The negative kinetic energies for the 2 mph through 8 mph runs occurred because the impacts took place on an incline, and the locomotive and M1 car had to move various distances before coming to a stop.

Thus, energy was added to the locomotive after each impact occurred, and that energy cannot be taken into account when the maximum kinetic energy of the locomotive is calculated without knowing the distance the locomotive traveled after impact. During the 10 mph and 12 mph runs, the locomotive energy did not reach zero, because data recording stopped before the locomotive came to a complete stop.

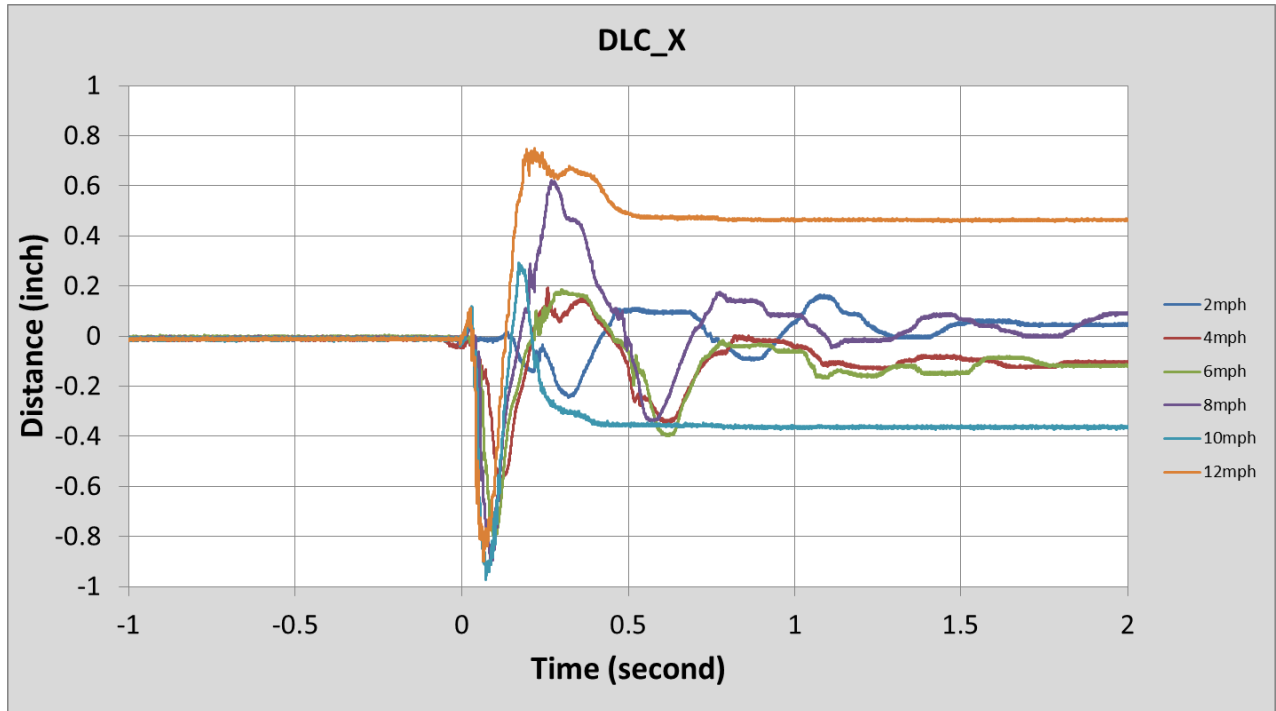
Figure 31. Locomotive Coupler Displacements

The primary string potentiometer measurements measured the displacement of the M1 car coupler and the locomotive coupler. [Figure 31](#) and [Figure 32](#) show these displacements. For both the car and the locomotive, the coupler moving into the draft pocket is reported as a negative

displacement. These figures show that for most of the test runs, the coupler on the M1 car showed much more displacement than the locomotive coupler. For example, at 8 mph the locomotive's coupler displaced approximately 0.8 inch into the draft pocket, while the car's coupler displaced approximately 1.6 inches. This shows that the locomotive's draft gear was stiffer than that of the M1 car. During the 10 mph and 12 mph test runs, the displacements did not exhibit the same behavior as during the lower speeds because the locomotive and car did not couple during these runs and impacted multiple times.

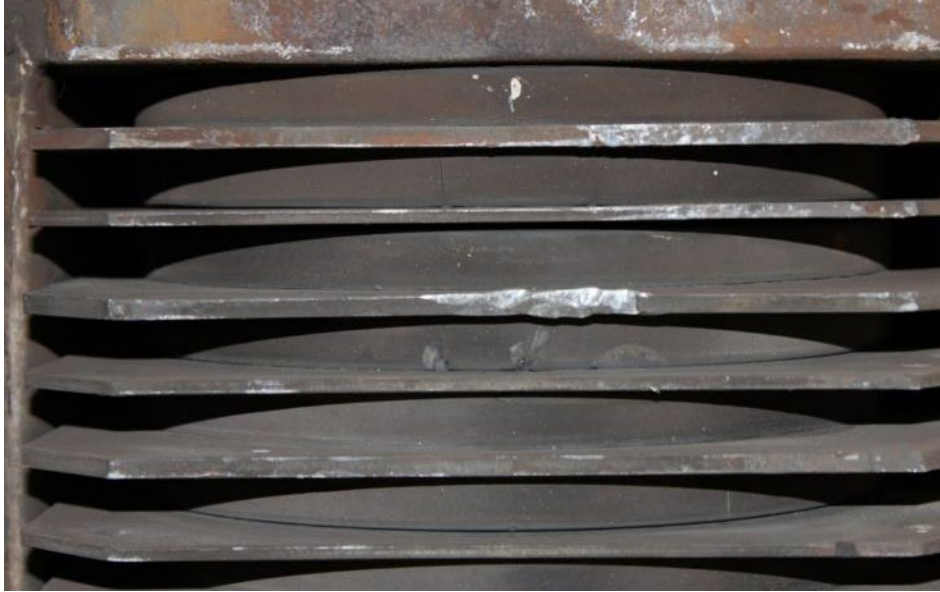
Figure 33. Chipped Draft Plate

The draft gear assembly in the M1 car consists of a series of rubber pads attached to metal plates; some plates were housed within the yoke and some were placed behind the yoke within the draft pocket. This assembly did sustain some damage during the test. [Figure 33](#) shows a plate within the yoke that was chipped along its outer edge. These plates were not accessible during testing and this chip was not discovered until the draft gear was removed from the M1 car. Thus, it is not known at which speed the plates were chipped.

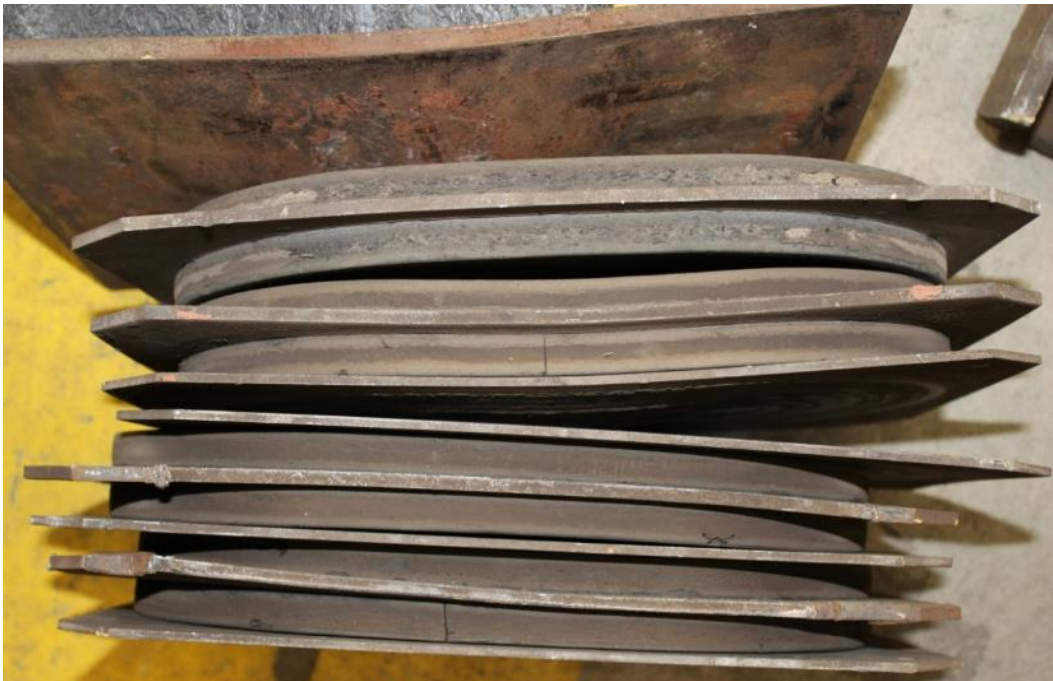
Figure 34. Bent Draft Plates

The plates in the draft assembly that were placed behind the yoke were also damaged during the test. [Figure 34](#) shows several of these plates that became noticeably bent. During the test, these plates were not accessible, and it is unknown how the damage progressed during each test run.

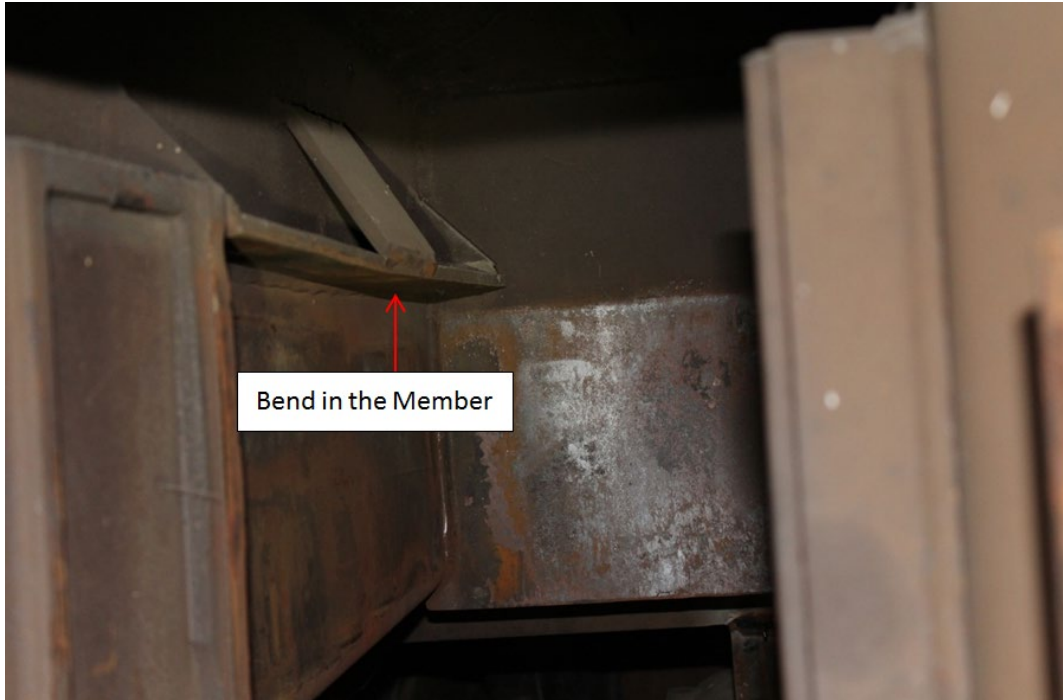
Figure 35. Bent Draft Pocket Member (right)

The M1 car's draft pocket sustained damage during the test. The interior of the draft pocket contains two structural members that run longitudinally, along the length of the pocket. These members were slightly bent ([Figure 35](#) and [Figure 36](#)) compared to the pre-test inspection. The visual inspection indicated that this deformation began during the 10-mph run and increased during the 12-mph run.

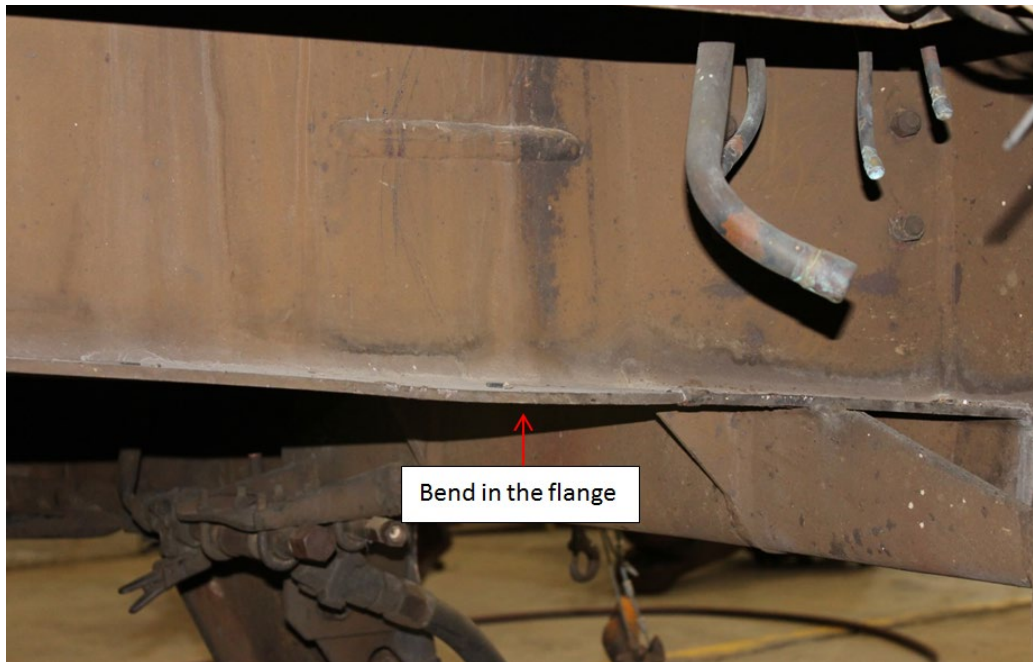
Figure 37. Exterior Bend in Draft Pocket, Right Side

The exterior of the draft pocket also shows a small bend. This bend can only be seen on the lower flange of the draft pocket exterior, which is located on the right side of the M1 car (Figure 37). This bend is similar in magnitude to the bends of the structural members on the interior of the draft pocket. As with the bent draft pocket members, this damage first appeared during the 10-mph test run and increased during the 12-mph run.

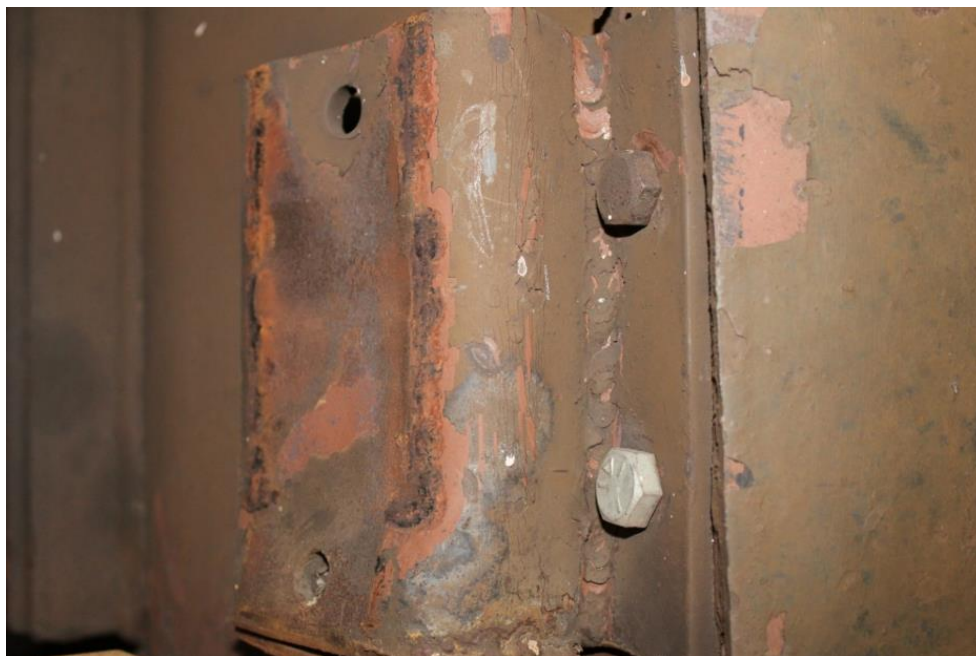
Figure 38. Damaged Buff Stop

One of the bump stops located at the opening of the draft pocket also received substantial damage (Figure 38). This stop was significantly impacted by the M1 coupler casting during the 10-mph impact and partially collapsed as a result.

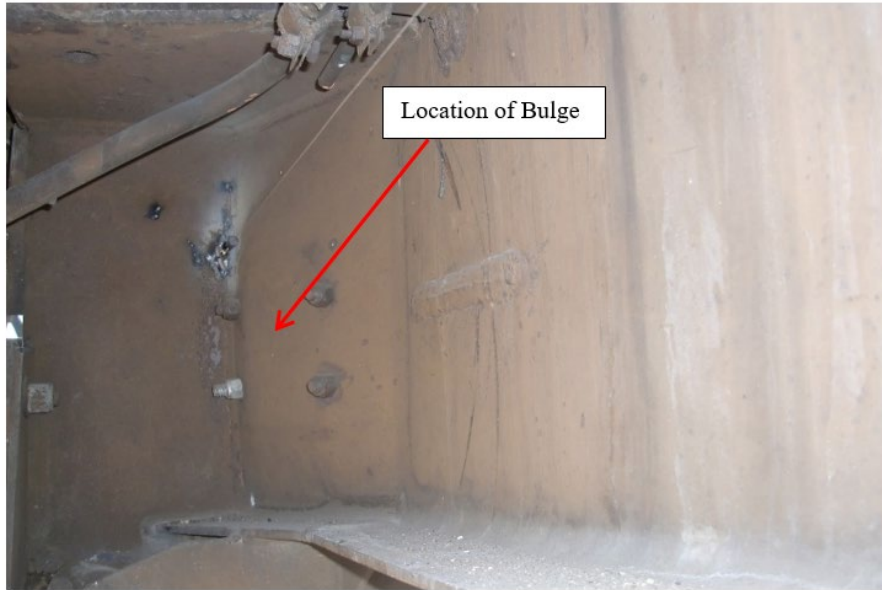
Figure 39. Draft Pocket Side Wall Bulge

The coupler impact that damaged the bump stops also caused the draft pocket walls to bulge outward at the location of the bump stops. This damage occurred in the bellmouth of the draft pocket (Figure 39). This damage also occurred during the 10-mph test run.

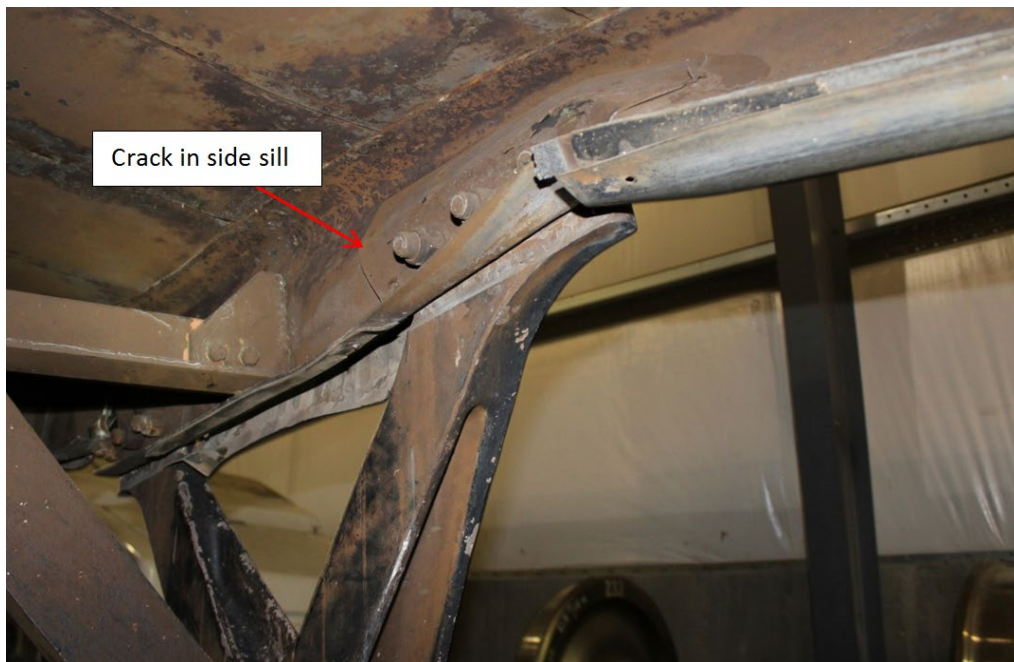
Figure 40. M1 Left Side Sill

The M1 car's side sill sustained substantial damage during the test. The side sills are connected to the truck bolster via traction rods. During the impacts, the force that was transferred from the M1 car body to the trucks, through these rods, caused the side sills to buckle on the car's left side and crack on both sides. This buckling began during the 10-mph test run and continued during the 12-mph run, while the cracks appeared after the 12-mph test run. The car's left side sill is shown in [Figure 39](#). The right-side sill is shown in [Figure 40](#).

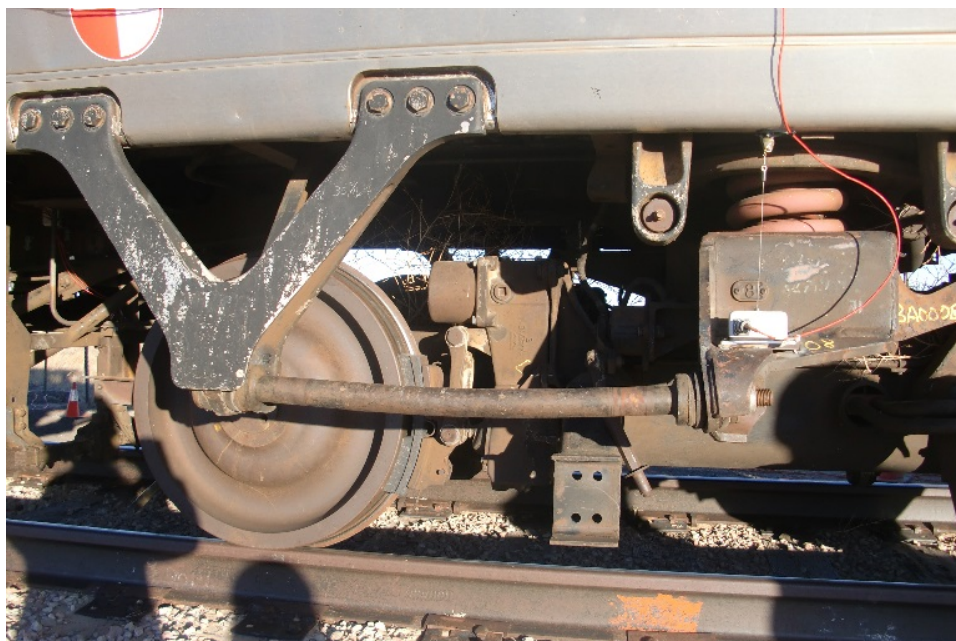
Figure 42. Bent Front Left Traction Bar

The force that was transferred from the M1 car body to the trucks, through the traction rods also caused one of the traction rods to bend. The front left traction bar bent during the 8-mph run (Figure 42). This bend did not seem to increase during the subsequent runs (10 mph and 12 mph).

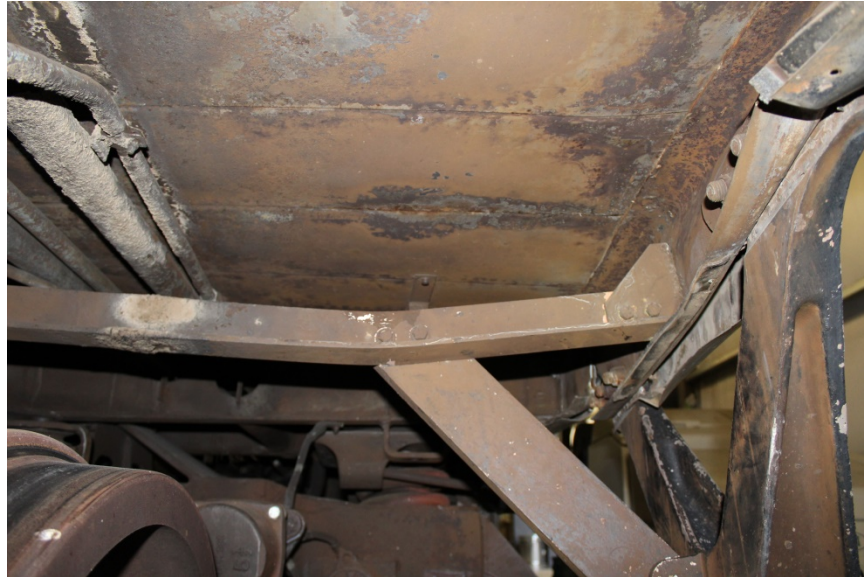
Figure 43. Bent Underframe Member

A structural member in the M1 car underframe also exhibited damage during the test (Figure 43). This lateral member on the right side of the car's underframe was bent during the 10-mph run.

This bend increased during the 12-mph run. This bent member is located near the buckled side sill on the right side of the car.

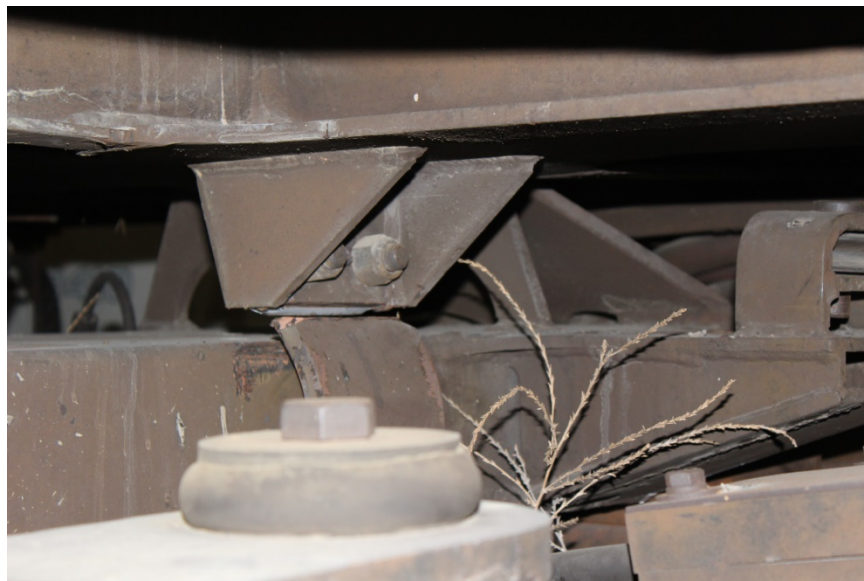
Figure 44. Severed Front Truck Belt Loop

The belt loop on the front truck was severed during the test (Figure 44). This damage was observed after all test runs had been completed. Thus, it is unclear during when this damage occurred.

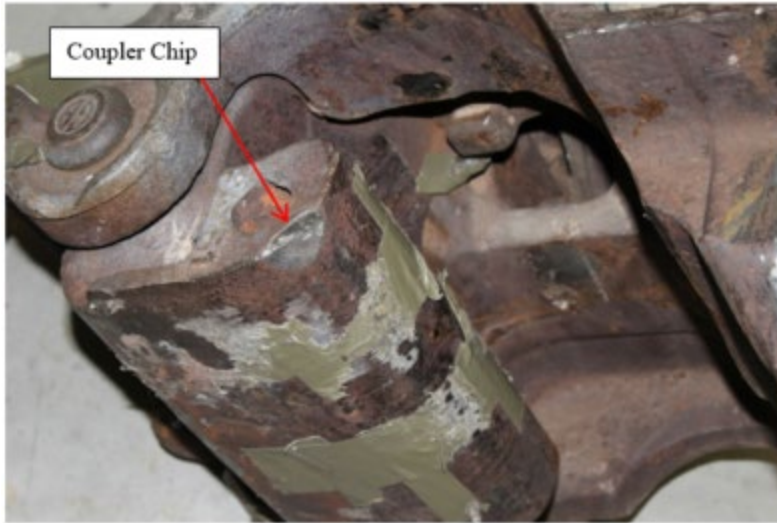
Figure 45. Chipped Locomotive Coupler

In addition to the damage that was observed on the M1 car, the F40 locomotive sustained minor damage on its coupler. The coupler knuckle was chipped during a secondary impact on the 12-mph test run (Figure 45). This damage was minor, and did not affect the coupler's operability.
