# Precast Concrete Bridge Barriers for Accelerated Bridge Construction

**Final Report**  
**October 2018**

IOWA STATE UNIVERSITY  
Institute for Transportation

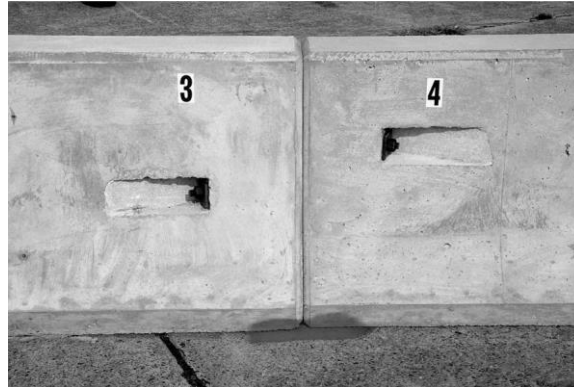
The purpose of the study was to design a portable concrete traffic barrier with the minimum dynamic deflection that could also be easily inspected and repaired. The connection was studied using full-scale crash tests (Bligh et al. 2005a). As seen in Figure 2.11, the connection uses two threaded rods across the joint.

**Figure 2.11. X-bolt test specimen**

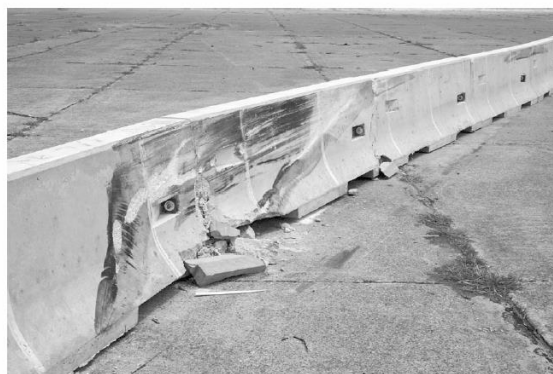
The barriers had a standard F-shape profile and were 32 in. in height. The cross bolts used a 7/8-in. diameter threaded rod and were 25-1/4 in. and 29 in. in length. The cross-bolt barriers were tested under TL-3. There were two crash tests conducted. One test consisted of 20, 10-ft long concrete barrier sections for a total test installment length of about 200 ft. A 4,960 lb pickup truck was used for the crash test. The resulting damage is shown in Figure 2.12. Some permanent deformation of the connection bolts was noticed when disassembling the barrier. The barrier system experienced 27.0 in. of maximum deflection.

**Figure 2.12. Damage to 10-ft long prefabricated barrier with X-bolt connections**

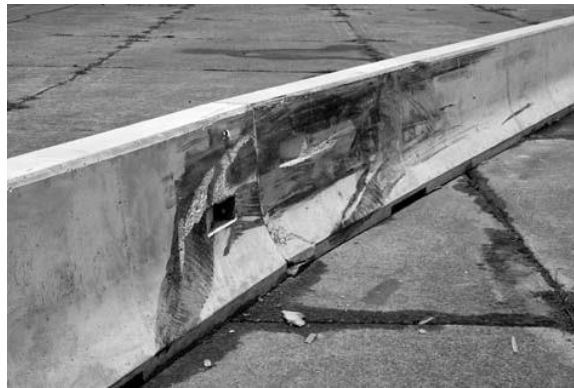
The second test had the same barrier and connection details, but the test installment included seven 30-ft barrier segments for a total length of about 210 ft. The pickup truck used for this experiment was 4,531 lbs. The damage resulting from the vehicle impact is shown in Figure

2.13. After the test, the connection bolts could easily be removed and possibly reused. The maximum deflection experienced by the system was 19.0 in.

**Figure 2.13. Damage to 30-ft long precast barrier with X-bolt connections**

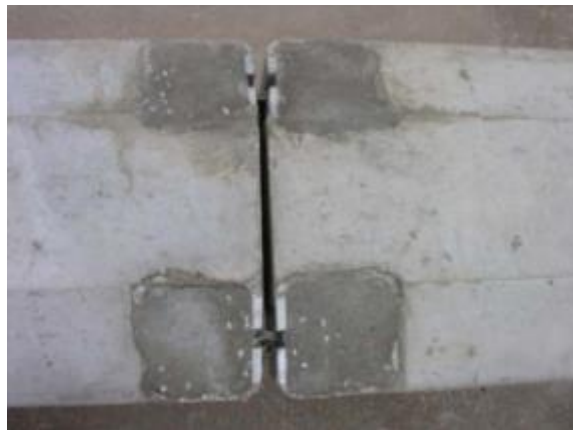
**Figure 2.16. A plan view of MWRSF I-shaped rail connection**

During the test, the joint failed and the rail segments completely separated. The connection was able to resist a force of 143 kips, exceeding the design forces needed for TL-4. The test connection and the failure of the connection are shown in Figure 2.16 and Figure 2.17, respectively.

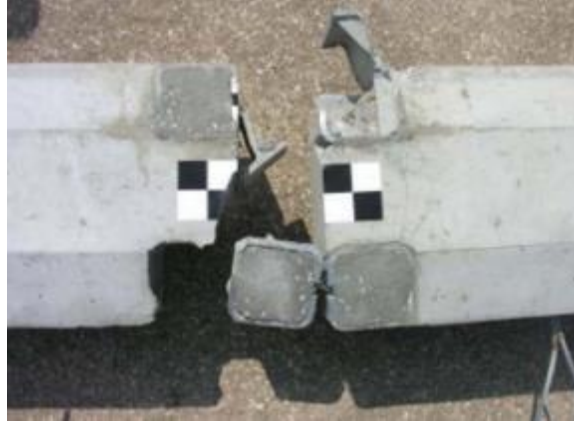
**Figure 2.17. Failed MWRSF I-shaped rail connection**

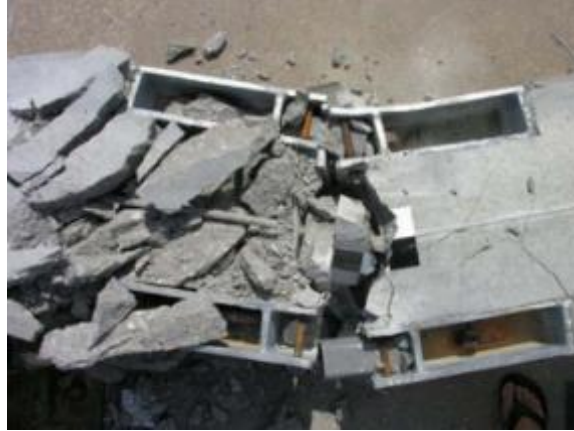
The second tested connection used two bolts and two shear tubes to connect the adjacent rails. During this test, the rails stayed connected, but the joint was severely damaged. The concrete between the steel pockets completely broke apart. The connection was able to resist a force of 102 kips, exceeding the design force of 54 kips needed for TL-4. The test connection and the failure of the connection are shown in Figure 2.18 and Figure 2.19, respectively. After these experiments were conducted, the results were analyzed, and they were redesigned according to their failures.

**Figure 2.19. Side bolt and shear tube connection failure**

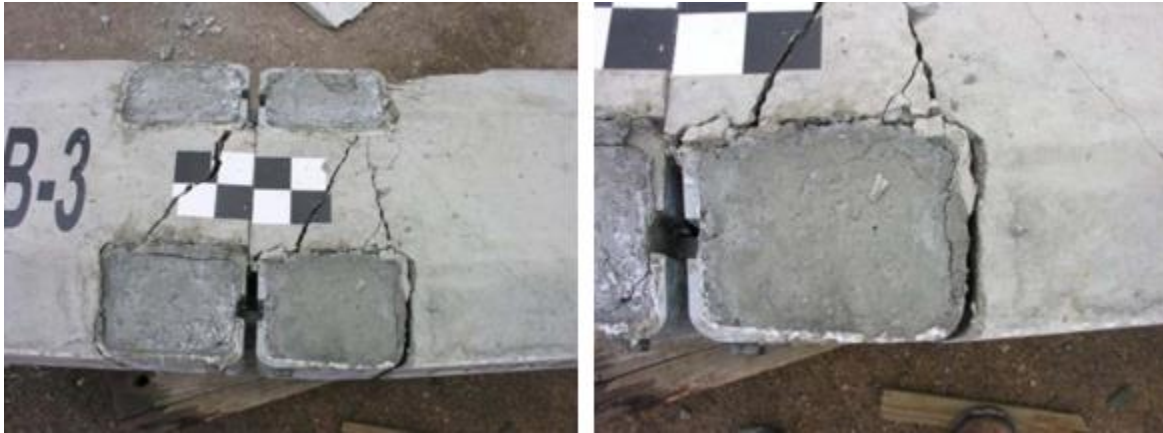
This joint held up to an approximate load of 100 kips, exceeding the design impact force of 62 kips. The joint also sustained minimal damage. The resulting damage is shown in Figure 2.21.

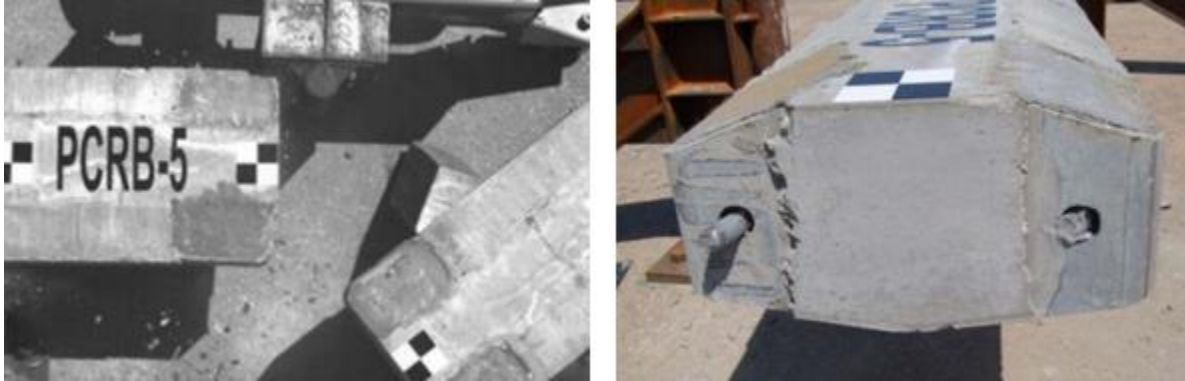
This joint sustained a load that averaged over 100 kips and absorbed slightly more energy than the grouted I-shaped joint. However, the specimen suffered much more damage from concrete spalling and cracking. Damage after testing is illustrated in Figure 2.23.

**Figure 2.23. Alternate redesign I-shaped rail connection failure**

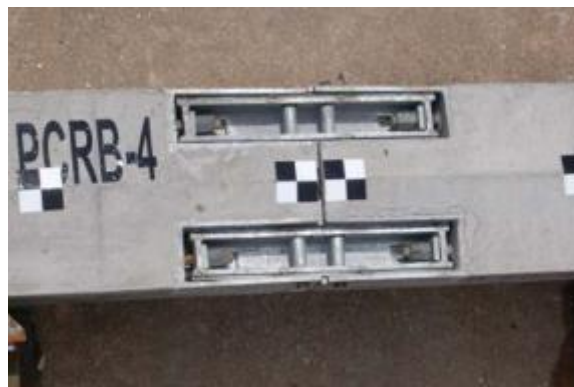
The side bolt and shear tube connection were modified in a similar fashion. The longitudinal steel size was increased to a threaded no. 8 bar, the steel tubes were cut to form U-shaped pieces, the size of the joint pockets increased, and shear bolts were added. See Figure 2.24.

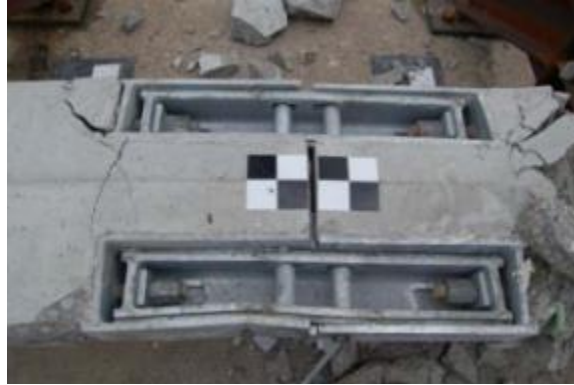
The testing results of this joint proved that the connecting threaded rods were too weak and failed at a load just over 60 kips. Resulting damage is shown in Figure 2.25.

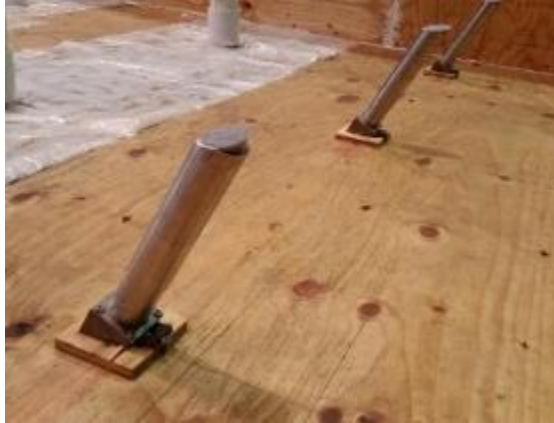
**Figure 4.7. Connected inclined receiving end piece to the deck formwork**

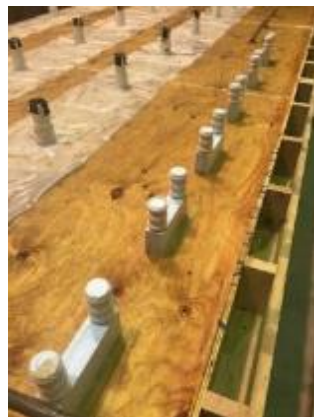
As noted, the U-bars for the PBU connection were inserted from the underside of the overhang into pockets in the bridge deck. Cutouts were made, and proper blockage was established before pouring the deck concrete. The block outs of these access pockets are shown in Figure 4.8.

**Figure 4.8. Deck block outs to facilitate U-bar installation**

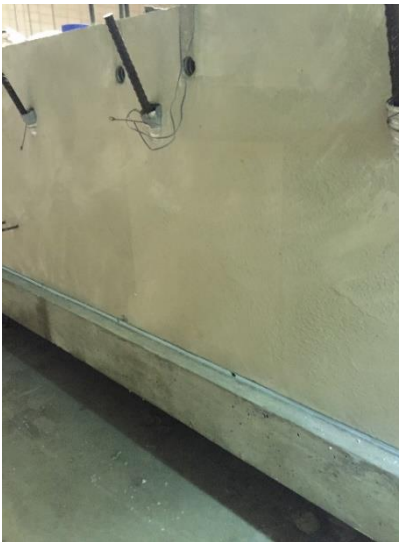
After the bars were in place, the grout pad between the overhang and the barrier was poured. In this case, the grout pad had a depth of  $\frac{3}{4}$  in. Also, a foam pad was placed under the barrier  $\frac{3}{4}$  in. from the backside to limit the damage to the barrier during the push test, shown in Figure 4.21.

**Figure 4.21. Foam added to grout pad to minimize damage cover concrete**

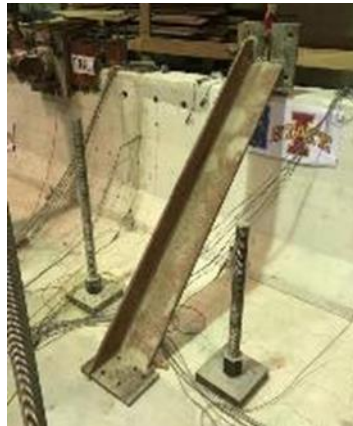
**Figure 5.2. Brace beam**

conducted at the center barrier-to-barrier connection, was tested to the desired target force of 54 kips, followed by an additional load step of 6 kips to further evaluate the connection performance. In order to avoid any more damage occurring to PBU during Test 4, which was conducted on the PBI side of the barrier-to-barrier connection, a brace beam was added to the test unit to limit the deflection of PBU (Figure 5.2). This explains the increased stiffness seen in Test 4 in Figure 5.1.

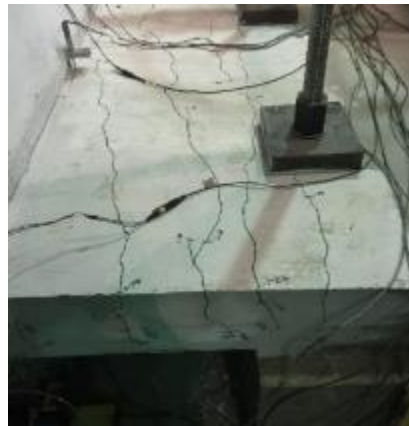
The loading block and actuator were set up to apply the load at the center of PBI at the top of the barrier over 3.5 ft length. The first two load increments produced no visible cracks on the test unit. The deck began to crack as the applied load approached 18 kips. The initial flexural cracks were noticed on the bridge deck overhang, as seen in Figure 5.4; three somewhat uniformly spaced flexural cracks formed on the deck overhang and they were visible along the entire length of PBI. The lateral deflection at the top of the barrier was 0.105 in. after applying 18 kips.

**Figure 5.4. Test 1: Formation of flexural cracks on the deck overhang**

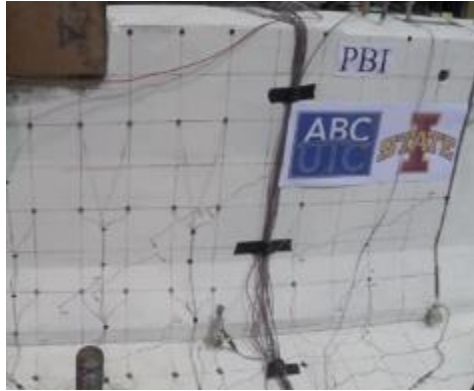
As the load was increased, the flexural cracks extended along the overhang and over the side of the bridge deck. At 24 kips, cracks also began to develop along the grout pad that was placed between the barrier and the top of the deck. At 24 kips, the barrier deflection reached 0.215 in. When the load was increased to 30 kips, there were only minor crack extensions on the deck and on the side of the bridge deck. The measured deflection was 0.317 in. At 36 kips the cracks on the deck extended over to the other side where PBU was located. There was no crack extension on the side of the bridge deck, but a new crack developed behind PBU near the barrier-to-barrier interface. This crack was due to testing the barriers individually without connecting the two. At this point, lateral deflection of the barrier at the top was 0.426 in. The load was then increased to 42 kips, which led to small deck crack extensions and crack widening. The deflection corresponding to the 42-kip load was 0.536 in. It was not until the load reached 48 kips that diagonal, hairline cracks began to develop on the barrier near the barrier-to-barrier interface (Figure 5.5), at which point the deflection was 0.67 in.

**Figure 5.5. Test 1 (PBI middle) barrier cracks**

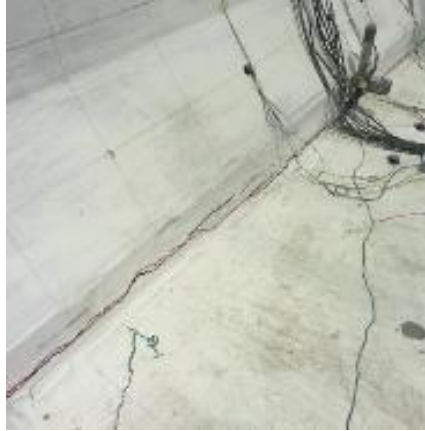
**Figure 5.12. Crack at the barrier-to-deck interface in PBU during Test 2**

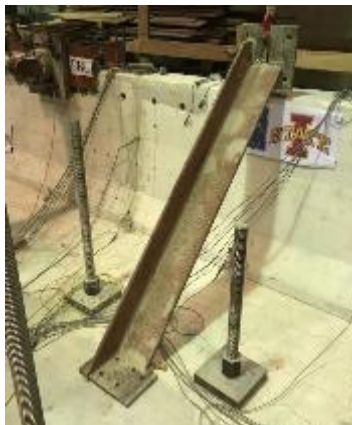
**Figure 5.24. Beam used to brace PBU with respect to the deck during Test 4**

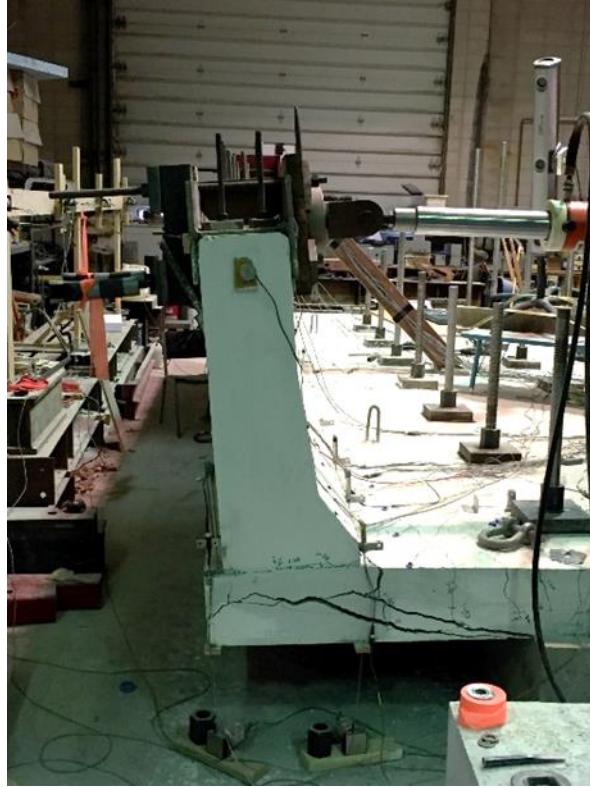
**Figure 5.33. Final barrier deflection and cracking in bridge deck during push direction loading in Test 5**

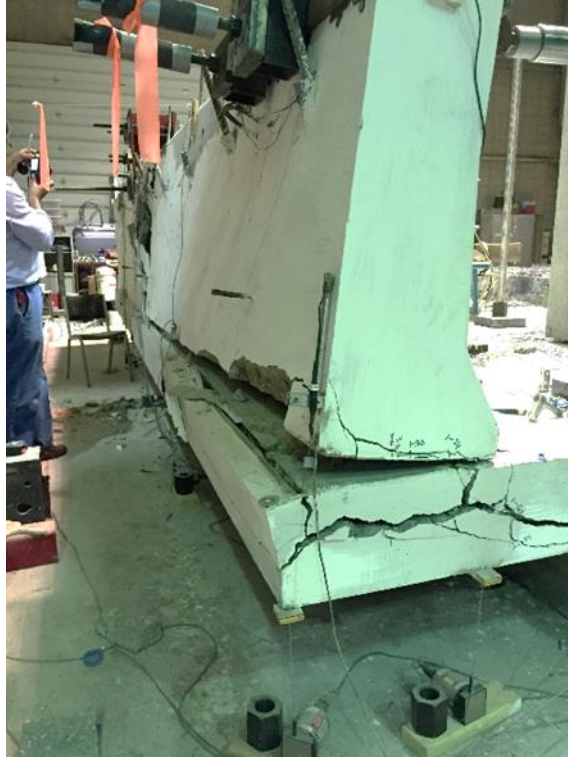
**Figure 5.34. Damage to barrier and deck after Test 5 pull test**

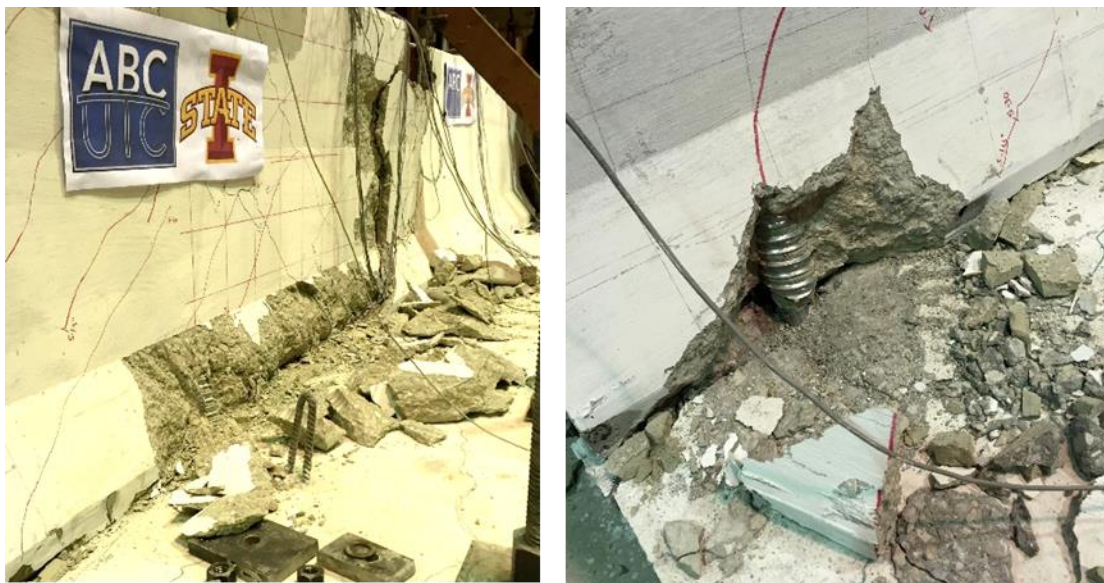
**Figure 5.36. Concrete spalling on front of PBI at deck interface and barrier-to-deck connection**

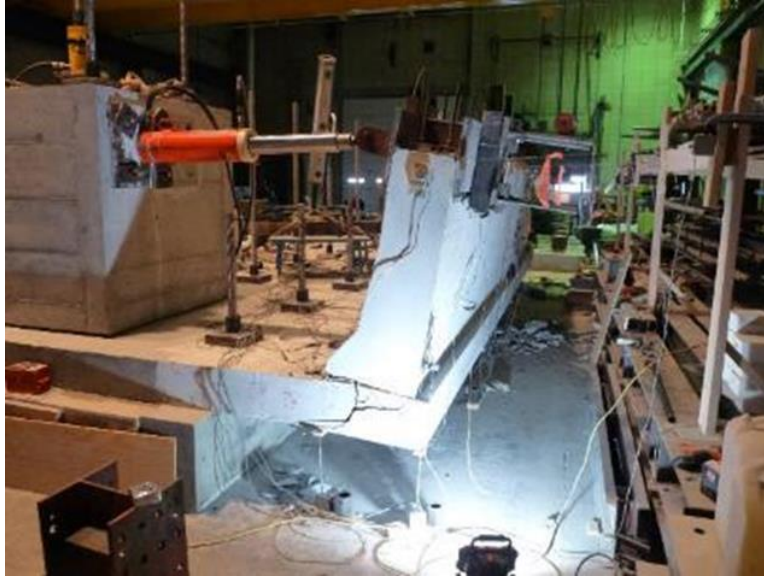
**Figure 5.40. Final barrier deflection and the corresponding damage to the bridge deck during Test 5**

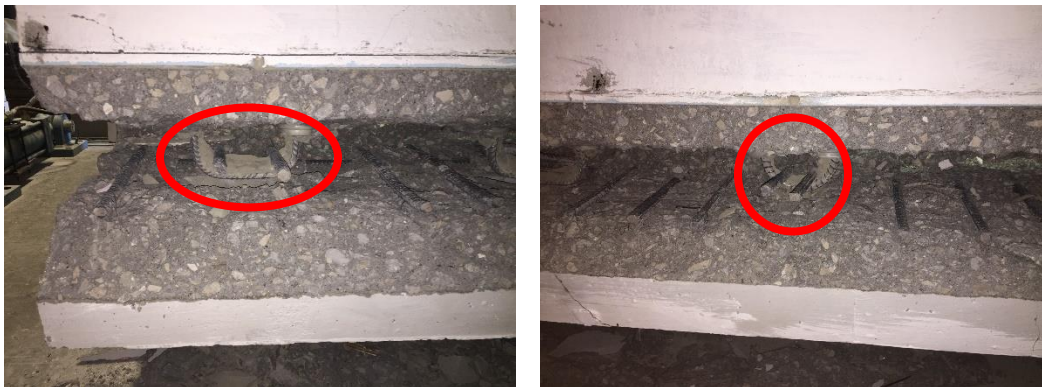
**Figure 5.41. Top mat of the bridge deck reinforcement after the Test 6 pull test**
