Test Report No. 608331-4-6  
Test Report Date: March 2020

## **MASH TL-3 EVALUATION OF 2019 MASH 2-TUBE BRIDGE RAIL THRIE BEAM TRANSITION**

**State of Alaska Department of Transportation and Public  
Facilities and North Dakota Department of Transportation**

### **TEXAS A&M TRANSPORTATION INSTITUTE PROVING GROUND**

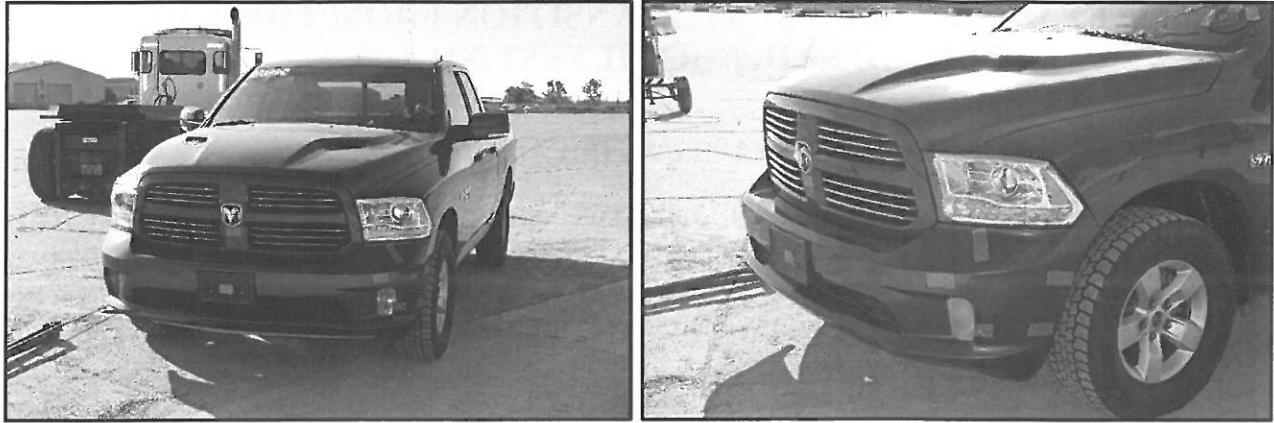
Figure 6.2. Test Vehicle before Test No. 608331-01-5.

Figures 6.1 and 6.2 show the 2013 RAM 1500 pickup truck used for the crash test. The vehicle's test inertia weight was 5050 lb, and its gross static weight was 5215 lb. The height to the lower edge of the vehicle bumper was 11.75 inches, and height to the upper edge of the bumper was 27.0 inches. The height to the vehicle's center of gravity was 28.25 inches. Tables E.1 and E.2 in Appendix E1 give additional dimensions and information on the vehicle. The vehicle was directed into the installation using a cable reverse tow and guidance system, and was released to be freewheeling and unrestrained just prior to impact.

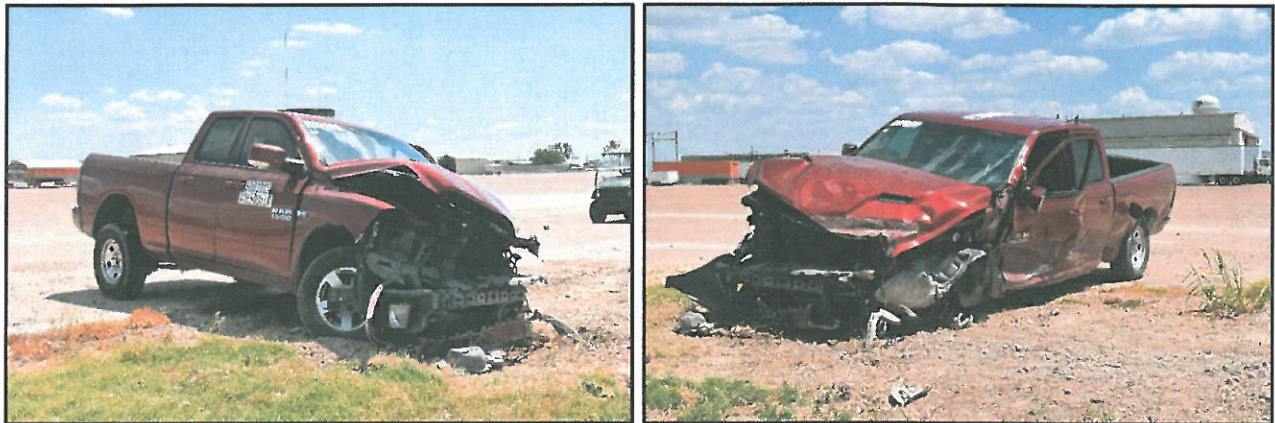
**Figure 6.4. Test Vehicle after Test No. 608331-01-5.**

Figure 6.4 shows the damage sustained by the vehicle. The front bumper, hood, grill, radiator and support, left front fender, left front tire and rim, left upper and lower A-arms, left front door and window glass, left front floor pan, left rear door, left rear cab corner, left rear exterior bed, left rear rim, and rear bumper were damaged. No fuel tank damage was observed. Maximum exterior crush to the vehicle was 15.0 inches in the side plane at the left front at bumper height. Maximum occupant compartment deformation was 4.0 inches in the left side kick panel. Figure 5.5 shows the interior of the vehicle. Tables E.3 and E.4 in Appendix E1 provide exterior crush and occupant compartment measurements.

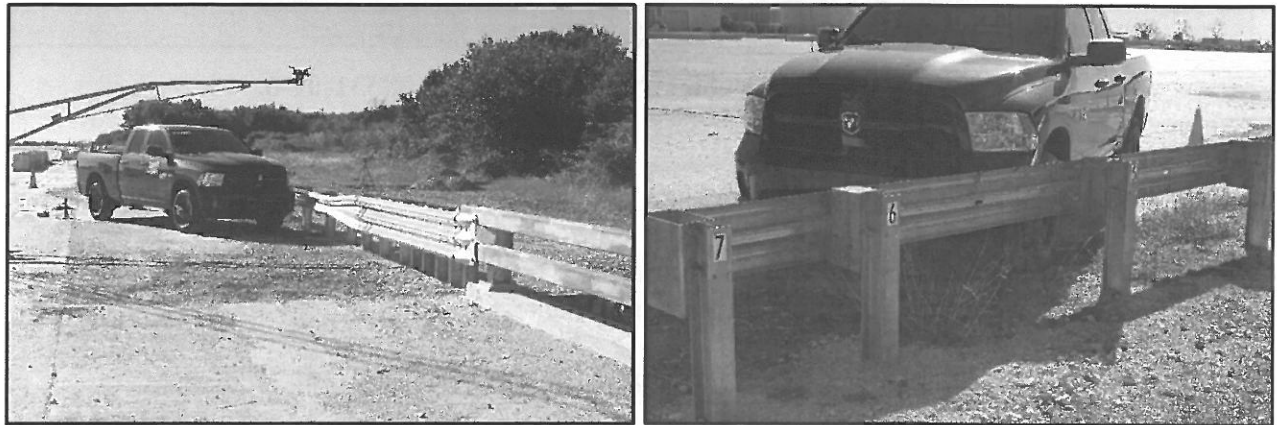
Figure 7.1. Transition/Test Vehicle Geometrics for Test No. 608331-01-6.

*MASH* Test 3-21 involves a 2270P vehicle weighing 5000 lb  $\pm$ 110 lb impacting the CIP of the transition at an impact speed of 62 mi/h  $\pm$ 2.5 mi/h and an angle of 25°  $\pm$ 1.5°. The target CIP for *MASH* Test 3-21 on the 2019 *MASH* 2-Tube Bridge Rail Thrie Beam Transition was 7.3 ft  $\pm$ 1 ft upstream of the centerline of post 7. Figure 7.1 depicts the target CIP.

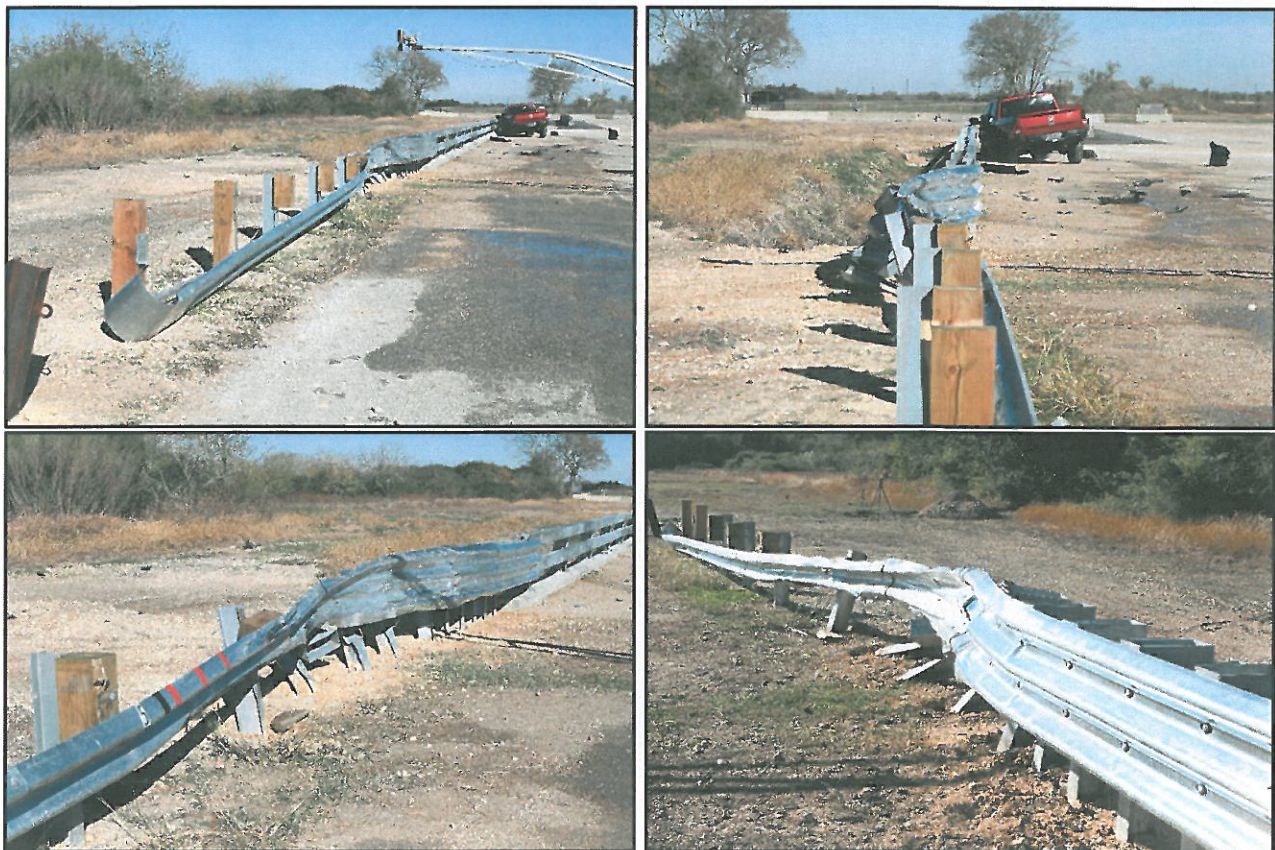
**Figure 7.3. Transition after Test No. 608331-01-6.**

Figures 7.3 through 7.5 show the damage to the transition. The metal rail element released from posts 1-5 and 7-10. Post 1 was pulled downstream 0.75 inch and post 2 was split.

Post 5 was leaning toward field side  $88^\circ$ , and there was a gap between the soil and post of 0.5 inch on the field side and 1.0 inch on the traffic side. Post 6 was leaning toward field side  $76^\circ$ , and there was a gap between the soil and post of 1.5 inches on the field side and 6.0 inches on the traffic side. Posts 7 through 9 were pushed toward field side and downstream. Post 10 was leaning toward field side  $80^\circ$ , and the gap between the soil and post was 3.0 inches on the field side and 0.75 inch on the traffic side. Post 11 was leaning toward field side  $84^\circ$ , and the gap between the soil and post was 3.0 inches on the field side. Post 12 was leaning toward field side  $87^\circ$ , and the gap between the post and soil was 0.13 inches on the traffic side and 1.5 inches on the field side. Post 13 was leaning toward field side  $88^\circ$ , and the post was pushed toward field side 0.75 inch. Post 14 was pushed toward field side 0.5 inch, and the soil around post 15 was disturbed only. Working width\* was 44.7 inches, and height of working width was 61.8 inches. Maximum dynamic deflection during the test was 33.6 inches, and maximum permanent deformation was 28.0 inches.
