BRIDGE STRUCTURAL INSPECTIONS USING BRIDGE INFORMATION MODELING (BrIM) AND UNMANNED AERIAL VEHICLES (UAVs)

Yelda Turkan, Ph.D., Assistant Professor
Yiye Xu, Graduate Research Assistant
School of Civil and Construction Engineering
Oregon State University, Corvallis, OR 97331

Sponsorship
Pacific Northwest Transportation Consortium

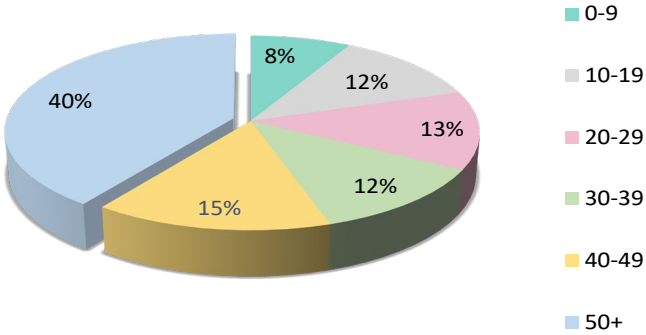
Figure 1.1 America’s bridges by age (Source: ASCE, 2017)

need for major maintenance or rehabilitation. In addition, 9.1 percent of bridges were classified as structurally deficient in 2016 (ASCE, 2017). Structurally deficient bridges are not necessarily unsafe or likely to collapse. However, their critical load-carrying elements are in poor condition as a result of deterioration or damage, so they need more frequent monitoring to eliminate possible and potential collapse. Although the federal government has increased investments to fix bridges in recent years and the number of structurally deficient bridges is decreasing, the budget available for bridge rehabilitation and repair is limited, and the backlogged budget has reached \$123 billion (ASCE, 2017). In summary, because of the U.S.’s aging and deteriorating road and bridge systems and limited budget, there is an urgent need for an efficient and cost-effective bridge inspection and management process that can reduce or even prevent structural failures.

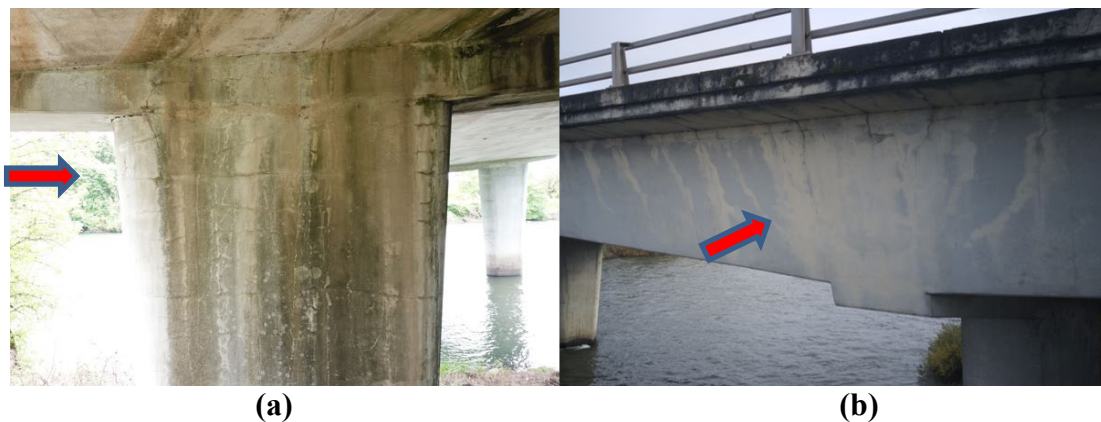
Figure 5.1 (a) Hairline shrinkage cracks on a column; (b) Hairline flexure cracks with efflorescence on the sides of boxes

During overall image collection, 74 high-resolution images of the bridge were collected. The bridge elements containing defects were identified from the overall images visually, and more detailed images, a total of 260, containing defects such as cracking, efflorescence, spalling, and joint leakage were collected in the next step. Figures 5.1 through 5.3 present some of the defects identified from the detailed images. The total flight time per data collection was approximately 40 minutes, which was significantly less than the amount of time typically needed (several days) to collect data with the traditional inspection methods detailed in the introduction.

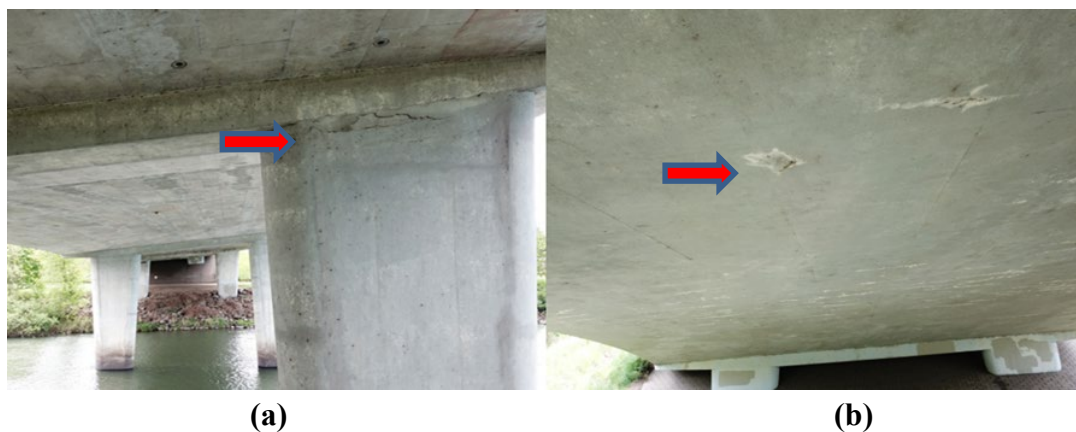
Figure 5.2 (a) Sacking is falling off of a column; (b) Spalling at the bottom of the girder box

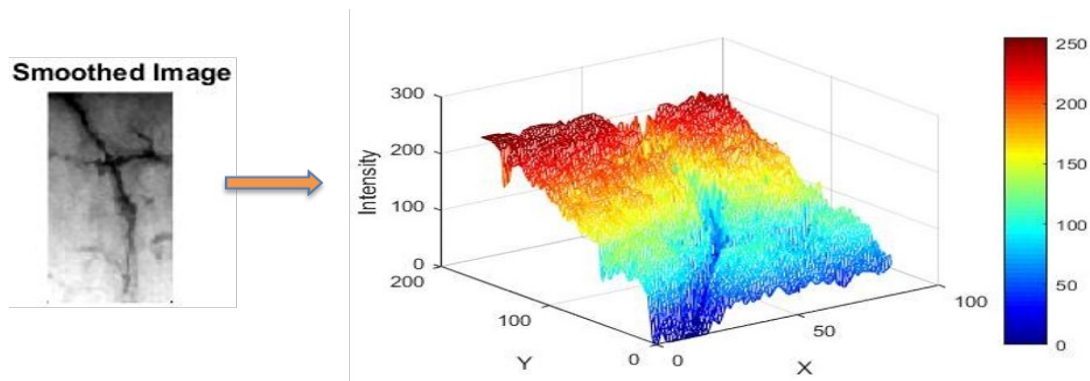
Figure 5.5 3D representation of the sample gray level image

First, all RGB color format images were converted into grayscale images for further processing. The gray scale values were stretched to fill the entire gray-level range (0-255) by applying a mean filter to the high-resolution images. Figure 5.4 shows both the original and adjusted image histograms of a sample image. The grayscale adjustment resulted in a higher contrast, i.e., larger differences of pixel intensity, between the background and the cracks, making the cracks darker and the background brighter. However, the crack edges on the concrete surface were complex and could contain holes or material deficiencies. Contrast enhancement also highlighted these small deficiencies around the cracks. Therefore, the mean filter smoothed the gray values of the pixels, which discarded the unnecessary details of material deficiencies without affecting the shape and detail of the cracks. Through image enhancement and filtering, the contrast between the crack and background became more evident. As shown in figure 5.5, a 3D representation of the sample image after preprocessing, the gray levels of the crack were significantly lower than those of normal regions; therefore, a bottom hat transformation was performed to extract these dark regions of interest. However, some dark regions that were not cracks were classified in the same group as cracks at the end of the previous step. Therefore, threshold segmentation was applied to separate the cracks from those dark regions. However, at

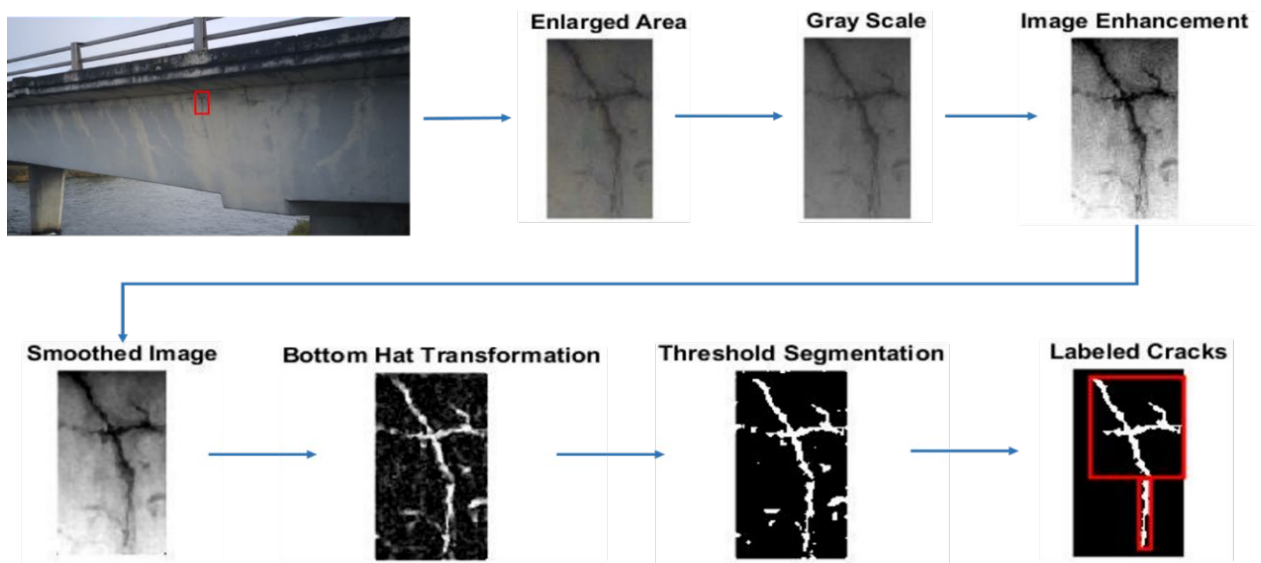
Figure 5.6 The processing results of a sample image using the proposed method

the end of this step, some smaller regions and noise still remained in these images that were misidentified as cracks, which can be seen in the threshold segmentation image in figure 5.6. Therefore, morphological area opening was applied to remove these connected isolated small areas that were misidentified as cracks. Finally, the cracks were automatically detected and labeled on the images. The workflow used for crack detection is shown in figure 5.6. All of these processes were performed automatically on every high-resolution image collected with the UAS by coding for loops in MATLAB.

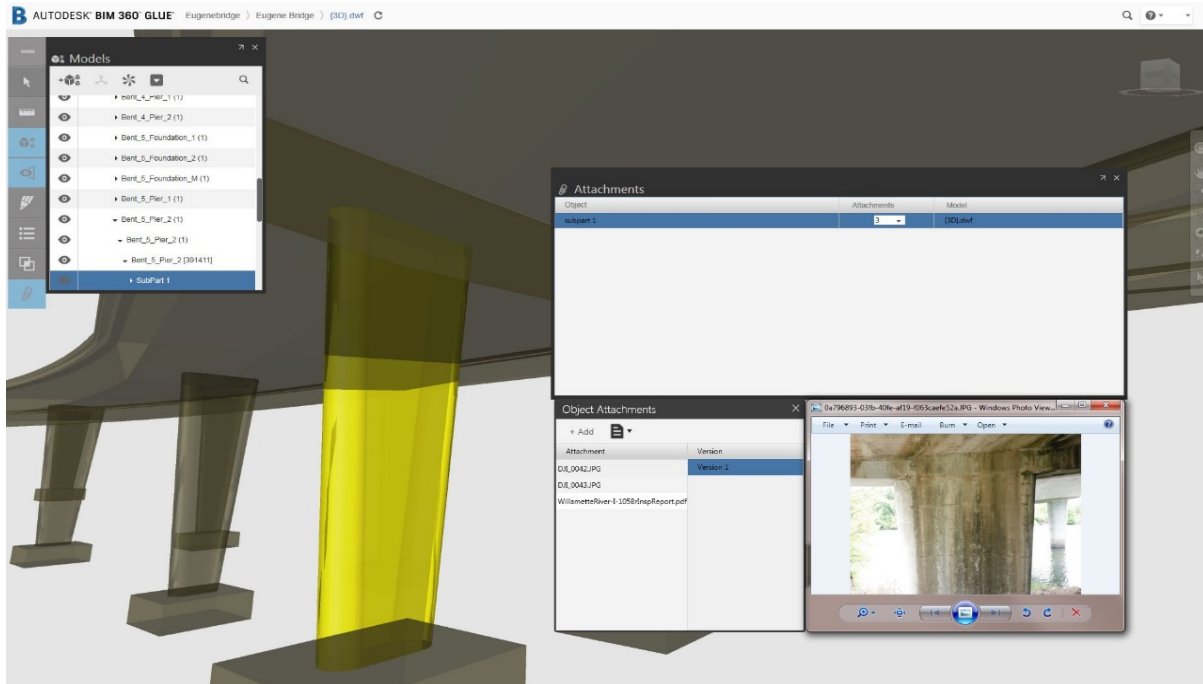
Figure 5.9 Bridge information management using Autodesk BIM 360 Glue

For data management, BIM 360 Glue was used to store the integrated model containing the defect information along with original UAS images and the historical inspection data (figure 5.9). With this program, different colors could be used to represent different severity levels based on the severity of the defect of a specific element, as in traditional inspection reports (figure 5.9). BIM 360 Glue would also enable access to the model along with the bridge inspection information that could be accessed and updated using mobile devices. This would enable effective and real-time communication between on-site personnel, e.g., inspectors and engineers, and decision makers in the office regarding inspection data.

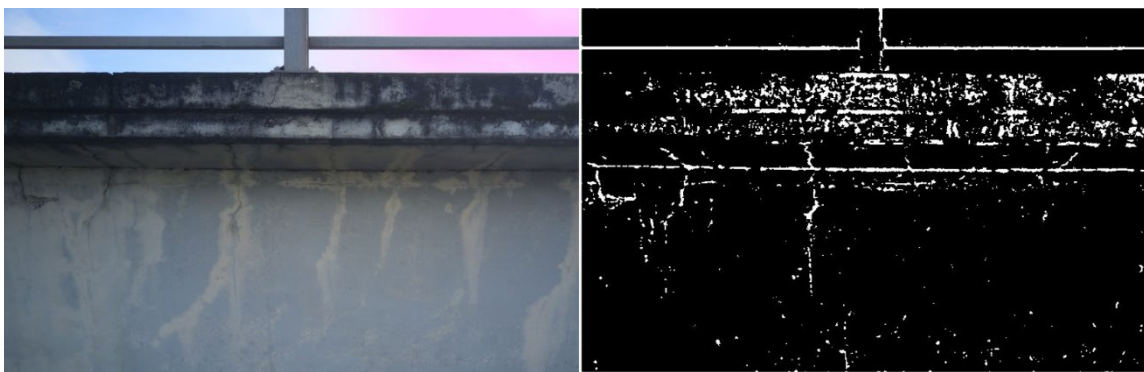
Figure 6.1 (a) Original image; (b) Corresponding binary image

Although cracks could be automatically detected by coding for loops in MATLAB, obvious edges of bridges and other objects (e.g., rivers) in overall images would affect the crack detection results adversely. The image processing algorithms used in this study analyzed the gray level of each pixel. However, edges are usually larger and more obvious than cracks. Therefore, it would be difficult to detect cracks without also detecting edges using the image processing method proposed in this study. For this reason, the detailed images had better crack detection results than overall images (detailed images did not contain as many edges and covered smaller areas around a defect/crack). This is why only detailed images were used for crack detection, and the precision and recall values were calculated by using the results obtained processing those detailed images. Figure 6.2 shows an example of crack detection results obtained by processing an overall image. In addition to the real cracks, the algorithm also identified the river, as well as the edges and railings of the bridge as cracks.
