# Methods to Ensure Appropriate Installation and Prevent Loosening of Anchor Nuts on Ancillary Highway Structures

**MATTHEW H. HEBDON, Ph.D., P.E.**  
Assistant Professor

Final Report VTRC 20-R30

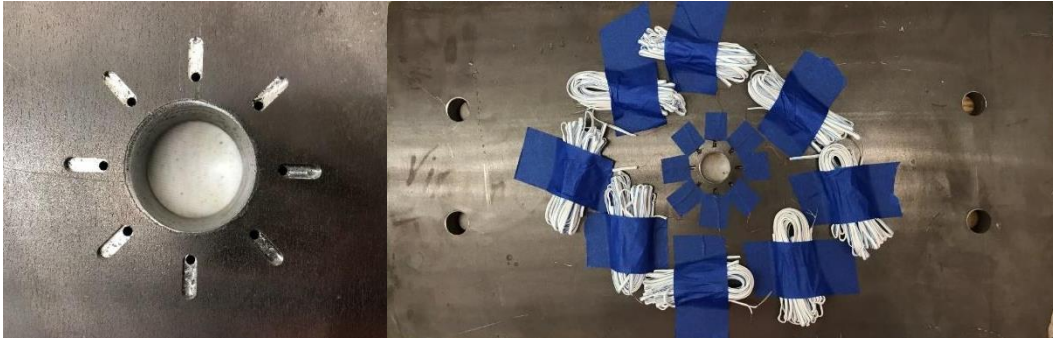
**Figure 1. Drilled strain gage holes (left) and base plate with instrumented eight bolt strain gages (right)**

mid-thickness of the base plate. This was done to effectively measure the maximum compressive strains in the base plate during tightening.

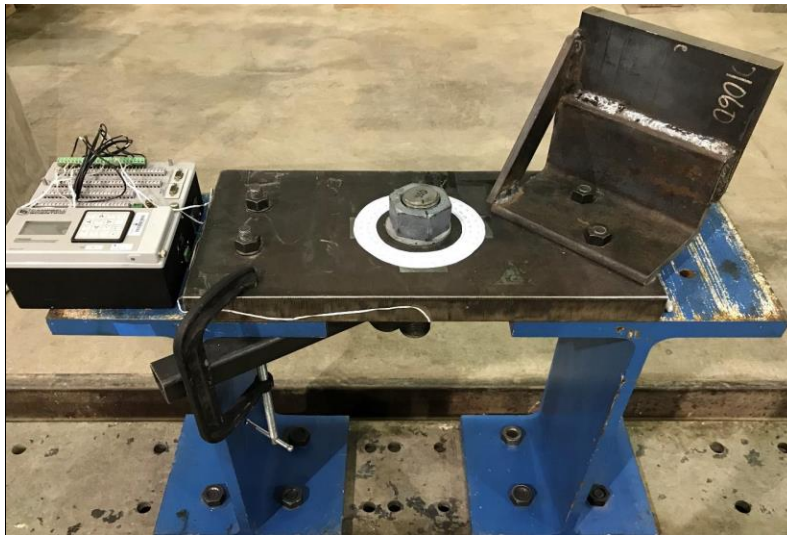
Base plates were fastened to the top flanges of two I-shaped beam stubs (W27x217) using 0.875 in diameter ASTM A490 bolts, as shown in Figure 2. Three calibrated manual torque wrenches with capacities of 300 ft-lbs, 600 ft-lbs, and 1500 ft-lbs were used for tightening the anchor rods. Two torque multipliers with an output capacity of 2000 ft-lbs and 8000 ft-lbs and multiplication ratios of 3.6:1 and 4.6:1, respectively, were used for increasing the output torque. The torque multiplier was allowed to react against a 6 in x 6 in x 3/4 in steel angle. A 360° circular gauge with 1° markings around the anchor rod hole was used for measuring nut rotations.

**Figure 2. Test-setup for tightening anchor rods**

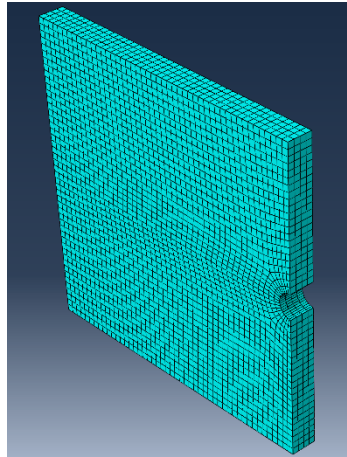
was chosen along with creation of 40 local nodes at the anchor rod hole for mesh refinement (see Figure 3). The average percentage difference between the calibration results and FE results was found to be less than 10%. Since tension in the anchor rod must be equal to the compression in the plate during tightening, the calibration curve was further used to calculate the effective tensile stress in the anchor rod. This was done by dividing the calculated force applied on the plate during tightening by the tensile stress area of the rod.

**Figure 3. Mesh at the anchor rod hole for the half symmetric finite element model of 1 in plate**

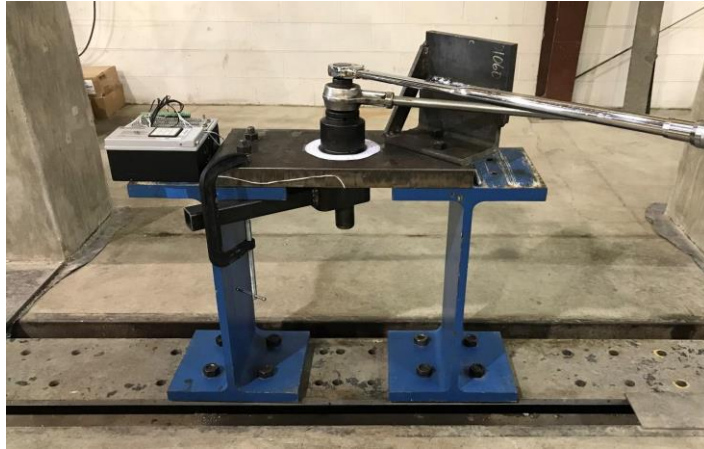
9. A manual torque wrench and torque multiplier was used to turn the top nut beyond snug-tight condition.
10. Torque was applied incrementally, and the corresponding pretension in the anchor rods and change in nut rotation was recorded.

**Figure 4. Anchor nut tightening performed on a 2 in anchor rod**

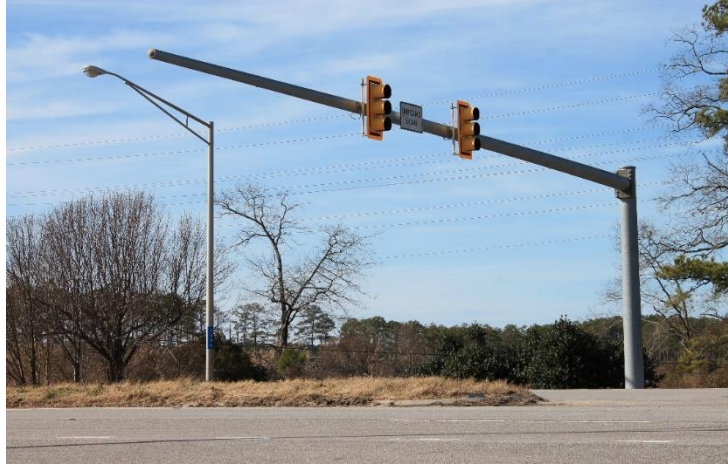
Two ancillary structures were instrumented and monitored for four months in a high wind speed region near the east coast of Virginia. Two different structure types—one aluminum luminaire and one overhead galvanized steel traffic signal located near the James River Bridge in Carrollton, Virginia, were field monitored from April 2018 to July 2018 (see Figure 5). The structures were instrumented with accelerometers, a wind monitor, and strain gages. The sensor data history was collected over the four months and used to analyze and determine observed vibration loads and stress ranges on these structures, relative to specific wind speeds and wind direction. Similar loading conditions were simulated in the large-scale experimental testing program. The other purpose of the field monitoring was to determine the dominant modal frequencies and the structural behavior under vibrations.

**Figure 5. Instrumented luminaire and traffic signal near the east coast of Virginia**

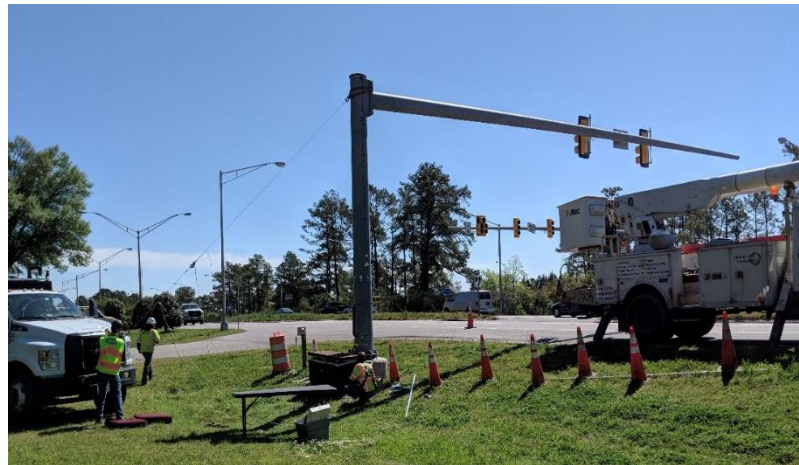
Pluck tests were performed on the individual poles to quantify their dynamic characteristics (see Figure 6). Pluck tests were conducted by pulling the top of the poles laterally using an instrumented cable, and then the cable was released. One end of the cable was tied to the top of the pole using a sling, and the other end was tensioned using a come-along attached to the trailer hitch. The cable was released using a quick-release shackle. Pluck tests were done to induce free vibrations in the poles. The resulting vibration data was further used to calculate the natural frequencies and damping ratios of each of the modes of the two poles.

**Figure 6. Pluck test performed on the overhead traffic signal**

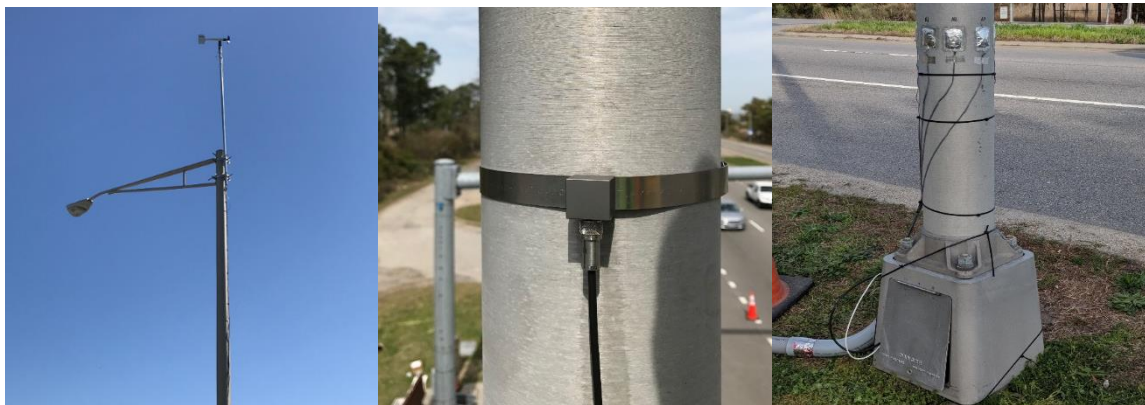
Eight temperature compensated strain gages were installed on each pole near the base plate to record the stresses corresponding to the wind forces. The strain gages were installed  $45^\circ$  apart to measure the bending stresses induced due to pluck tests and ambient wind vibrations. The strain gages were installed 2 ft above the base plate of the luminaire and 2 ft above the hand-hole of the traffic signal. This was done to avoid any stress risers due to sharp geometric discontinuities around the hand-hole. A K-type thermocouple with a separate data logger was also installed near the job-box to measure the change in temperature of the ambient conditions every 5 minutes throughout the duration of the monitoring. All the instrumented sensors are shown in Figure 7.

Figure 7. Wind monitor (left), accelerometer (center), and strain gages (right)

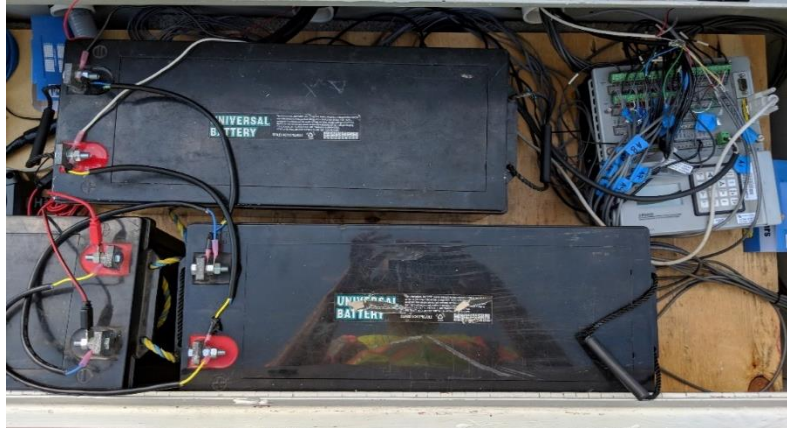
charged by a 7.5A – 12V smart battery charger for approximately 8 hours during each night when external power was supplied to the luminaire circuit. The sensors, batteries, data acquisition system, and modem were enclosed in a weather-proof job-box at the site.

**Figure 8. Parallel battery connection for charging datalogger**

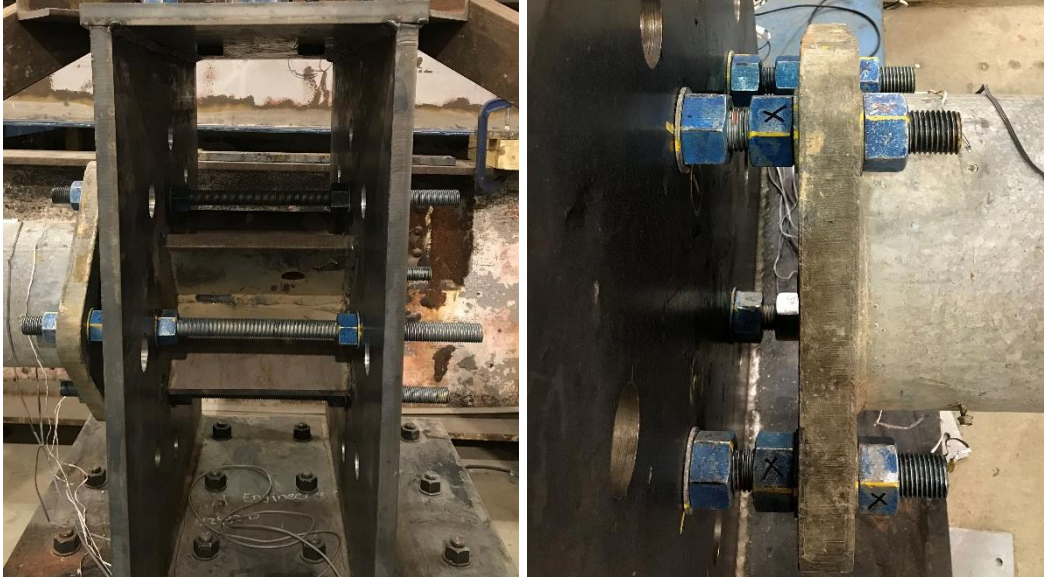
reaction box fixture. The traffic signal pole was fastened to the anchor rods on the front side of the reaction box fixture using a double-nut moment connection. The same anchor rods were then fastened to the vertical plates of the fixture block. This was done to ensure that the connection simulated the same fixed boundary conditions as with a concrete foundation in the field. Cross stiffeners were welded on the inside of the fixture block to increase the stiffness of the fixture block.

**Figure 9. Reaction box fixture for large-scale testing**

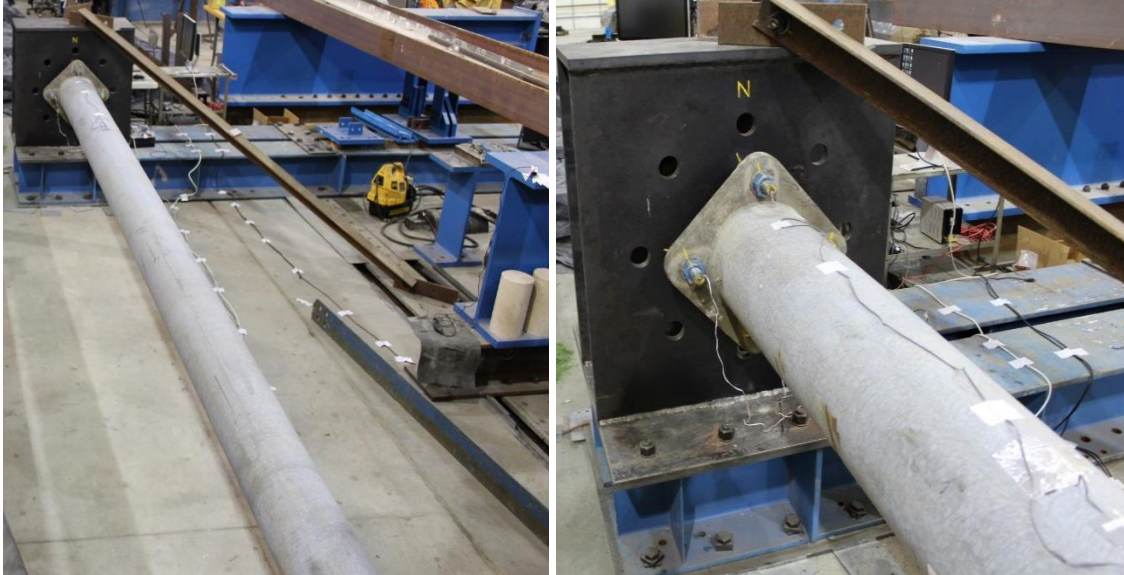
The fixture block was fastened to two W14x99 sections. The W sections were fastened to the strong floor of the laboratory at three locations, eight ft apart (see Figure 10). Plates were connected to the W sections on the top and bottom to make the beams a closed section. This was done to increase the torsional capacity of the beams and prevent any twisting during the induced vibrations.

**Figure 10. Complete view of the test-setup for large-scale testing**

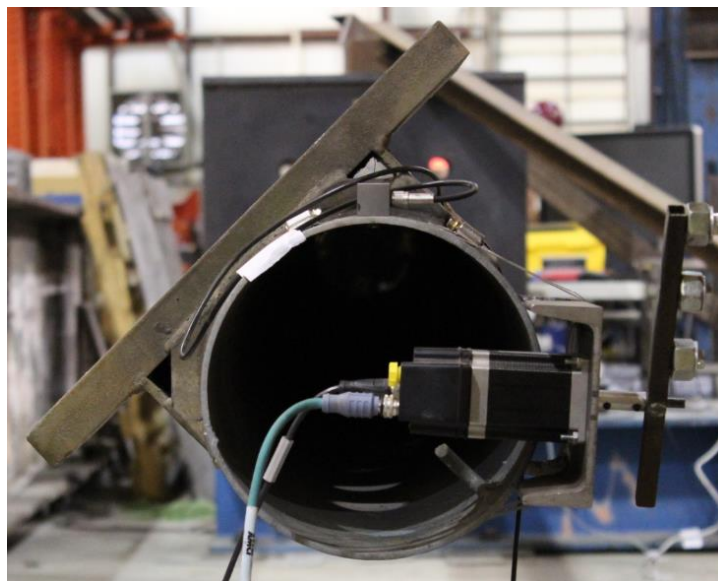
A variable frequency industrial stepper motor was used to induce vibrations in the pole. The motor had a maximum torque capacity of 1.25 ft-lbs (240 oz-in), and was connected to computer for data collection. The motor configuration settings, including the frequency, were input using the software interface on the computer. The motor with eccentric mass on a rotation arm was attached to the end of the pole, as shown in Figure 11. The unbalanced eccentric mass on the motor shaft produced a centripetal force large enough to create displacements or vibrations at the end of the pole.

**Figure 11. Variable frequency stepper motor attached to the free end of the pole**

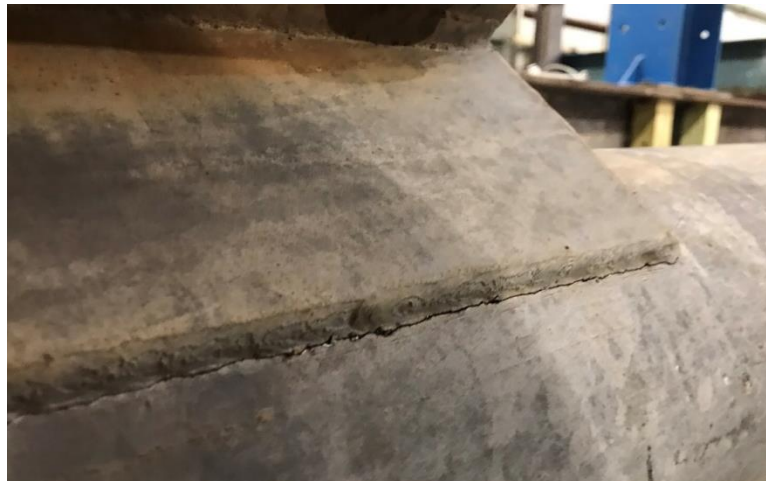
Fifteen resonance vibration tests were performed in total. The first test involved vibration testing on the traffic signal with a 15 ft mast-arm. The motor was attached to the mast-arm and the pole was vibrated in resonance in the second mode (fundamental mode of the mast-arm in out-of-plane direction). After the first test, some weld cracks at the box connection between mast-arm and straight pole were observed (see Figure 12). It was later decided to conduct the remainder of the resonance tests on the straight pole vibrating in its first natural mode shape.

**Figure 12. Fatigue weld crack at the box connection on the straight pole**

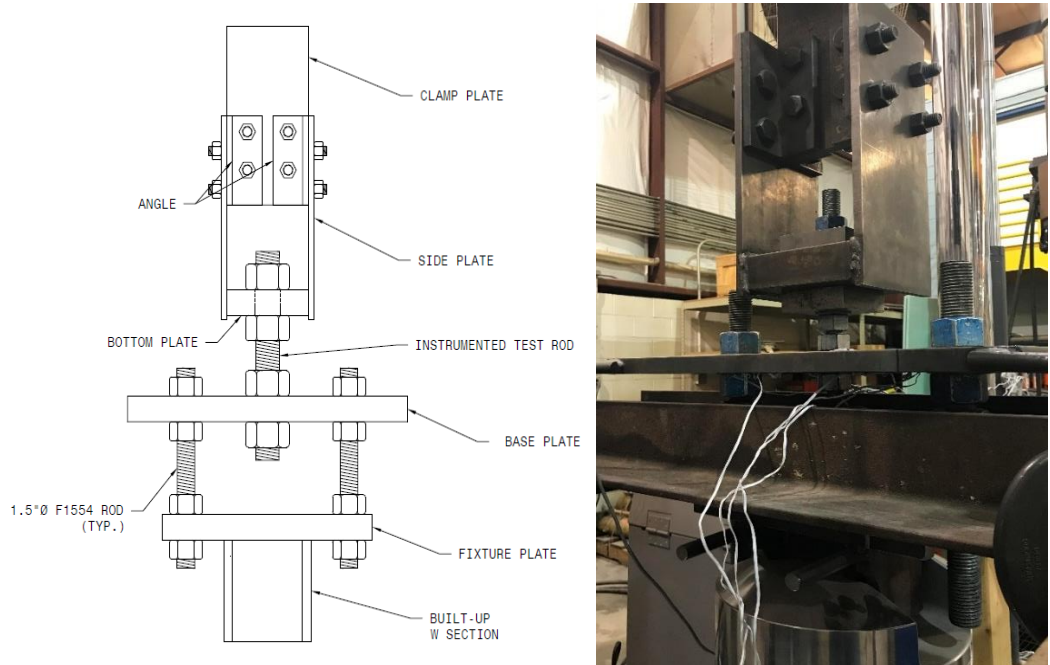
The anchor rod to be tested was fastened to a base plate in a double-nut moment connection. In order to produce axial vibrations in the connection, the top end of the rod was fastened to the top built-up fixture. Two other holes were drilled in the base plate such that two 1.5 in diameter threaded rods could be fastened to the base plate. The other ends of the 1.5 in diameter threaded rods were fastened to the bottom built-up plate fixture. Both the top and bottom built-up fixtures were clamped in the grips of the fatigue testing machine. Axial vibrations were simulated in the double-nut moment connection using the sinusoidal cyclic forces (alternating tension and compression) produced by the fatigue testing machine. The test-setup was also braced by angles to prevent any lateral movement. A schematic and photograph of the test-setup is shown in Figure 13.

**Figure 13. Small-scale test-setup – Schematic (left) and Photo (right)**

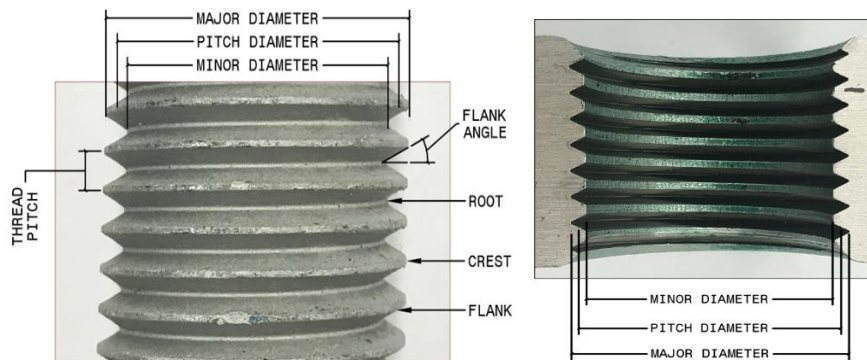
Threads are of two types – internal and external. The term ‘internal threads’ refers to the threads on the nuts whereas the term ‘external threads’ is often used for threads on a bolt, rod, or screw. Threads have a triangular profile with the top corner on the threads referred to as crest, whereas the bottom corner is referred to as the root of the threads. The root and the crest are connected by the surface called the flank. The distance measured parallel to the axis of the bolt or nut between the roots or the crests is known as the thread pitch. The distance measured radially between the adjacent root and crest is known as the thread height. The thread pitch and thread height vary with the diameter of the bolt or nut. Finally, the flank angle is the angle between a flank and the axis that is perpendicular to the bolt or nut axis. Thread profiles for a bolt and a nut along with external thread terminology and internal thread terminology can be seen in Figure 14.

**Figure 14. Thread terminology for a bolt (left – external threads) and a nut (right – internal threads)**

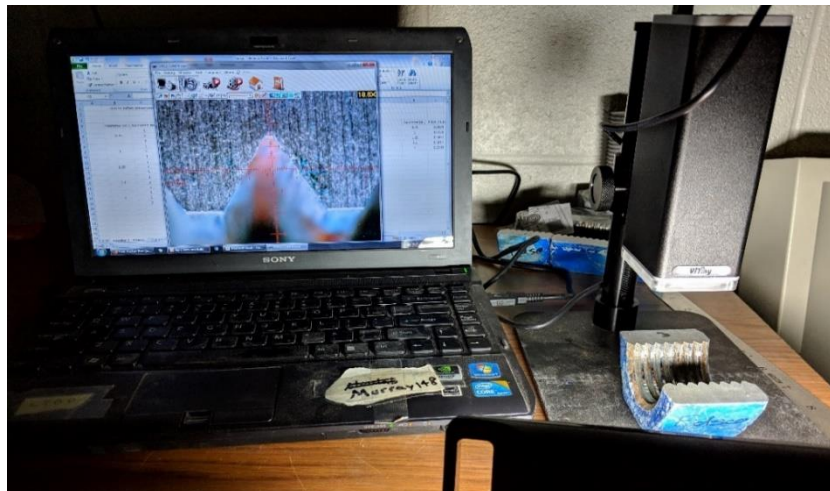
A digital microscope with measurement functions was used for measuring thread parameters on the anchor rods and nuts (see Figure 15). The microscope had a resolution of 0.1 mm or 0.004 in. The lights on the microscope and other external lighting were used to reduce reflection noise and to improve image clarity and edge detection. The major diameter of the rod and the minor diameter of the nut were measured using calipers due to the limited field of view as a result of the high magnifying power of the microscope. The rest of the thread parameters including thread pitch, thread height, and flank angle were measured using the digital microscope.

**Figure 15. Thread Parameters for a 2 in nut measured under the microscope**

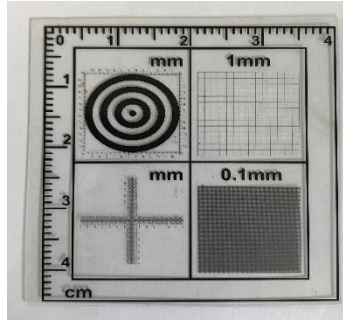
2. A digital microscope and lens were calibrated at the required height of the specimen using a target calibrator (see Figure 16).

**Figure 16. Target Calibrator**

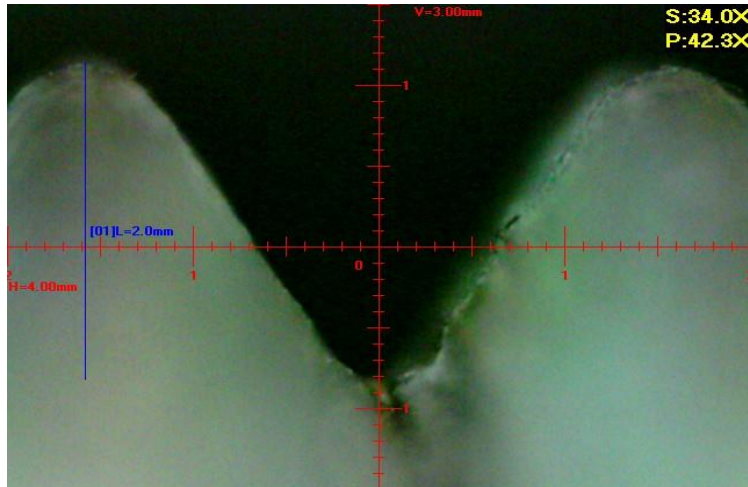
3. Once the digital microscope lens was calibrated to the mid-height of the anchor rod, the measurement function was used to measure the thread height, thread pitch, and flank angle of the anchor rod (Figure 17).

**Figure 17. Measurement of the thread height of a specimen under the microscope**

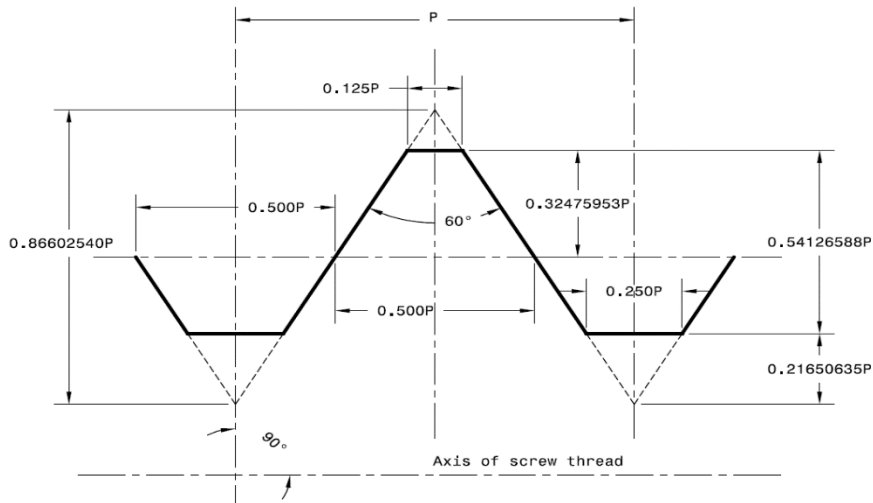
4. The pitch diameter was further calculated using the major diameter and the thread pitch calculated previously (see Figure 18). The expression for pitch diameter in terms of the major diameter and the pitch is given in ASME B1.1 (Equation 1) (ASME, 2003). Equation 1 uses simple trigonometric relations and assumes that the flank angle is equal to  $30^\circ$ . The flank angle measurements during the study were found to be within  $\pm 0.25^\circ$  and, hence, would have a negligible effect on the final pitch diameter.

**Figure 18. Basic thread profile for unified coarse (UNC) threads (ASME, 2003)**

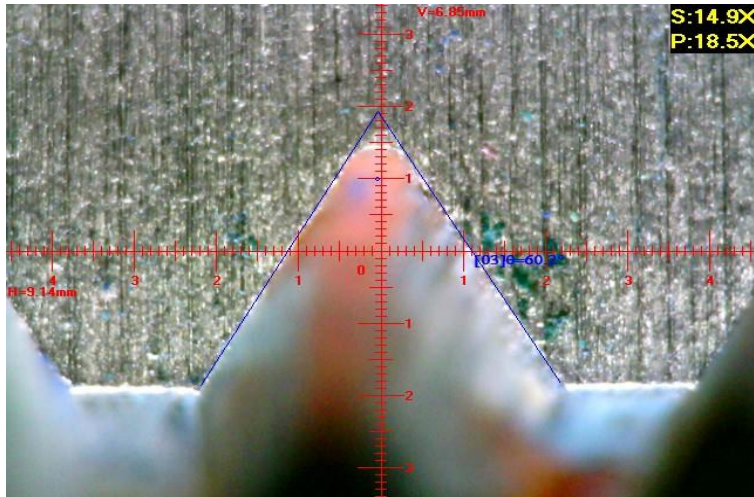
1. The minor diameter of the half cut anchor nut was measured at a particular location along the length using the inside jaws of the calipers.
2. Steps 2 to 3 of the anchor rod procedure involving calibration and measurement of thread height, pitch, and flank angle were performed (see Figure 19).

**Figure 19. Measurement of the flank angle of a specimen under the microscope**

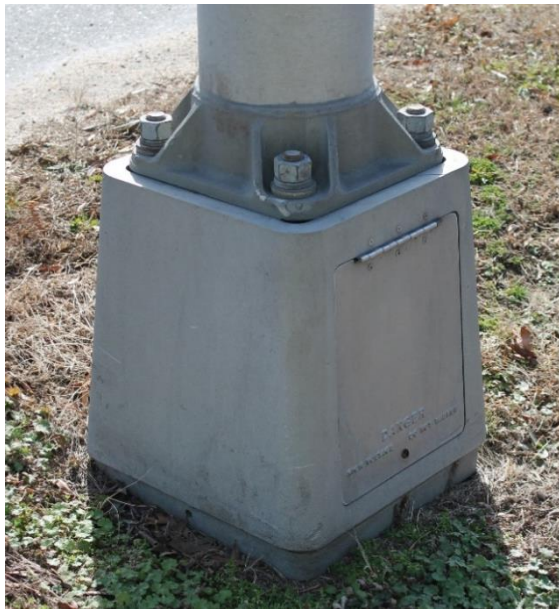
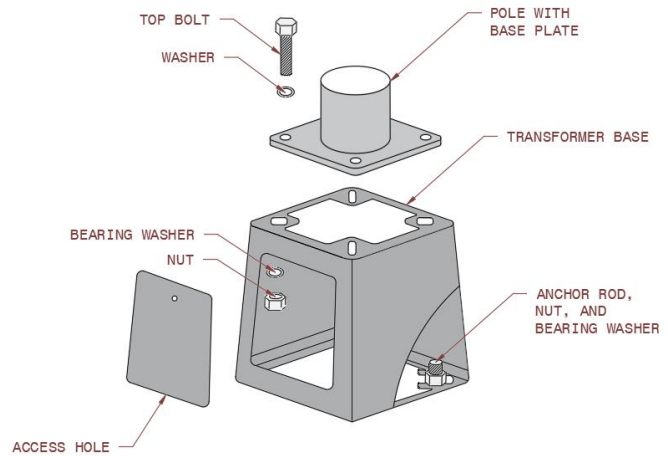
T-base poles and most aluminum ancillary structures use single-nut anchor rod connections at the base. T-base poles are commonly used for aluminum luminaires. An aluminum pole is welded to a cast-aluminum shoe base and the shoe base is fastened to the T-base using structural bolts. A typical connection for a pole with T-base is shown in Figure 20. There are no prescribed separate guidelines for tightening single-nut anchor rod connections on ancillary structures. At present, NCHRP 469 recommends tightening single-nut anchor rod connections to the same pretension as double-nut moment connections (Dexter and Ricker, 2002). In contrast, AASHTO recommends tightening single nut anchor rod connections on ancillary structures to half of the nut rotations recommended for double nut connections (AASHTO, 2015). There is no guidance regarding tightening of single-nut connections provided in the VDOT Road and Bridge Specifications (VDOT 2016a).

**Figure 20. A luminaire with a T-base connection (left) and components including anchor rods (or bolts) inside a T-base (right)**

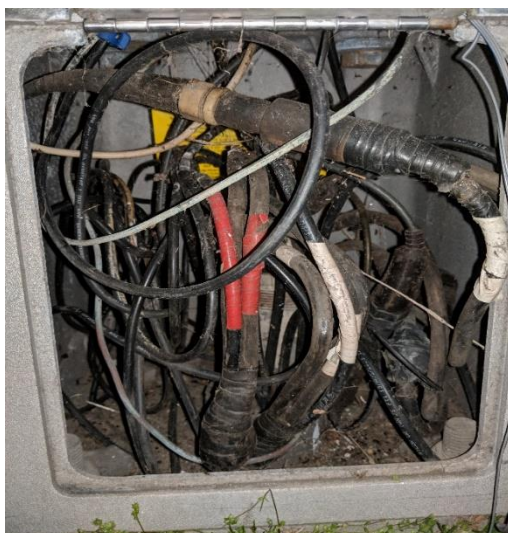
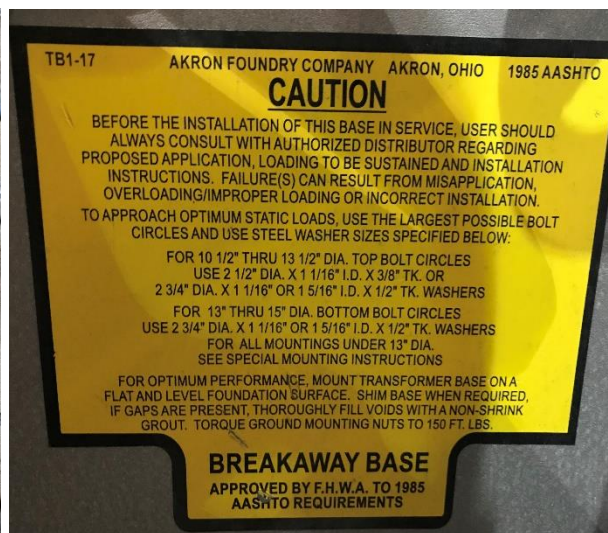
Breakaway aluminum transformer bases are designed so that they “break away” from the rest of the unit when hit with a certain amount of vehicular force. Breakaway T-bases generally come with manufacturer’s instructions for installation. Most of the breakaway T-bases require the anchor rods to be torqued to 150-200 ft-lbs instead of using the turn-of-the-nut procedure (see Figure 21). As seen in Figure 21, it can be challenging to tighten anchor nuts using a hydraulic wrench or torque wrench inside the transformer base due to limited access and electrical wiring. The structural bolts connecting the pole/shoe base to the T-base may be required to be tightened using turn-of-the-nut method as per the shop drawings.

**Figure 21. Electrical wiring (left) and manufacturer’s instructions for installation (right) inside T-base**

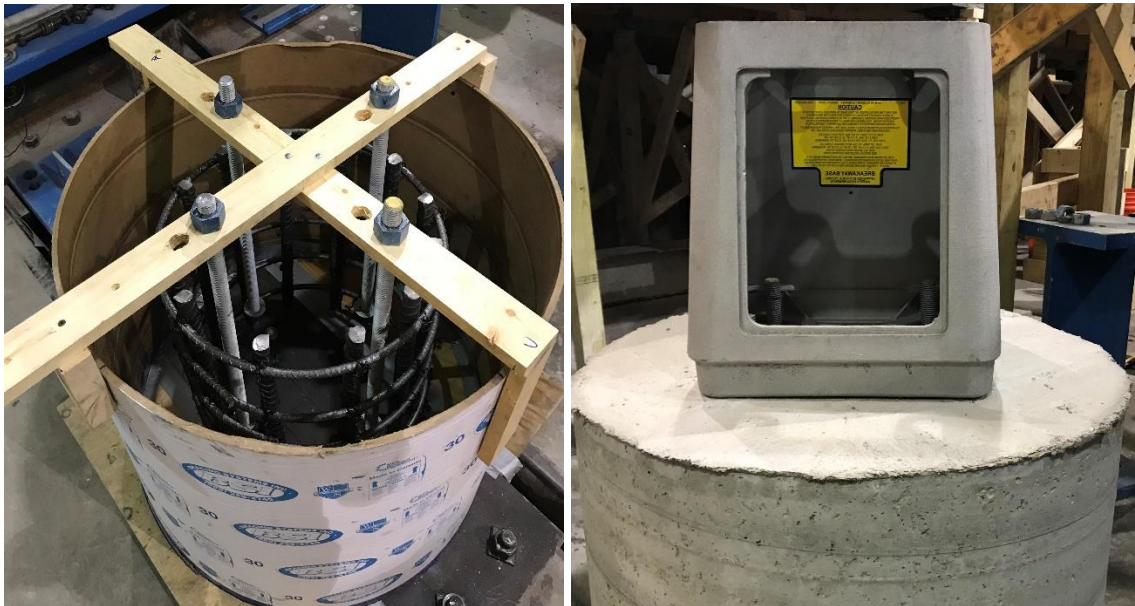
Four 1 in grade 55 anchor rods were cast inside a 30 in diameter, 24 in deep concrete foundation. The typical detailing given in the VDOT 2016 Road and Bridge Standards was followed (VDOT 2016b). The anchor rods were surrounded by a rebar cage consisting of 12-#8 vertical rebar and 5-#4 rebar ties at 4.5 in on center. The concrete foundation was connected to a 1 in thick A36 grade steel plate using four 0.75 in diameter steel stud anchors. The plate was further fastened to the strong floor of the laboratory. The formwork before placing of concrete and the final test-setup is shown in Figure 22.

Figure 22. Formwork for the concrete foundation (left) and T-base with the casted foundation (right)

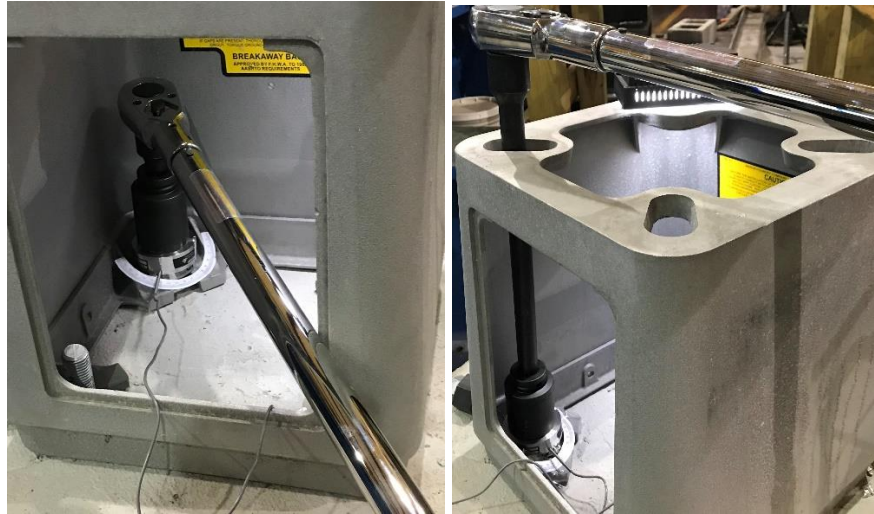
Each of the four anchor rods was tightened five times in total. Two tightening techniques were used. The first technique involved tightening the anchor rod using a 3 in deep socket from the access hole of the T-base (see Figure 23). The second technique involved tightening the anchor rod using the 3 in deep socket along with a 16 in long extension. The extension was passed through the upper holes for structural bolts for the ease of tightening (see Figure 23).

Figure 23. Tightening through the access hole (left) and tightening using the extension from the top (right)

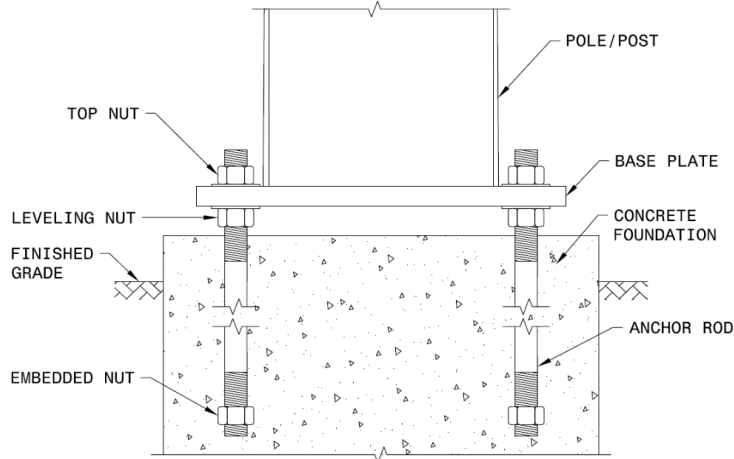
**Figure 24. A typical double-nut moment connection on ancillary structures**

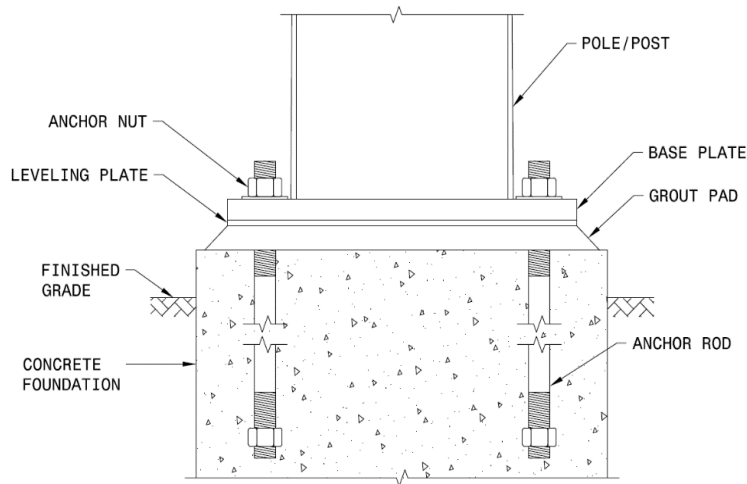
**Figure 25. A typical single-nut connection on ancillary structures**

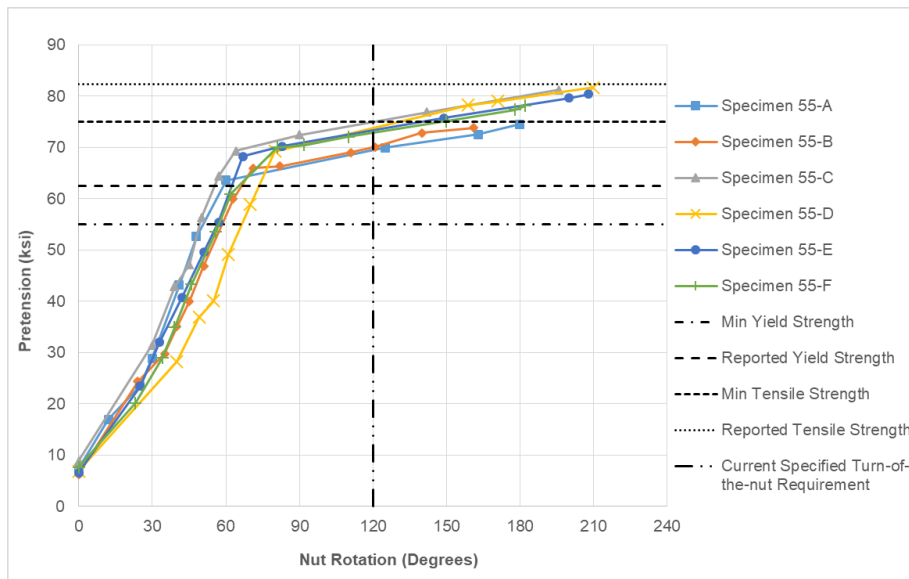
rotation, pretension, and applied torque were recorded during the turn-of-the-nut tightening procedure. The top nut was tightened incrementally beyond the snug-tight condition until there was a minimal change in pretension corresponding to large change in nut rotation, which indicated yielding of the rod. The pretension vs. nut rotation curve for all six rods is shown in Figure 26 and indicates relatively linear behavior until 70°, after which the change in slope indicates yielding of the rods. All the rods yielded around 62.5 ksi (see Figure 26). However, the mean nut rotation corresponding to the specified yield strength of 55 ksi was found to be approximately 60°. Additionally, the mean nut rotation corresponding to minimum installation pretension of  $0.6 F_u$  or 80% of  $F_y$  (45 ksi) was found to be 49° as opposed to currently specified turn-of-the-nut requirement of 120° in the FHWA guidelines (Garlich and Thorkildsen 2005) and AASHTO specifications (AASHTO 2015).

**Figure 26. Pretension vs. Nut Rotation curve for grade 55 – 1 in anchor rods on steel base plate**

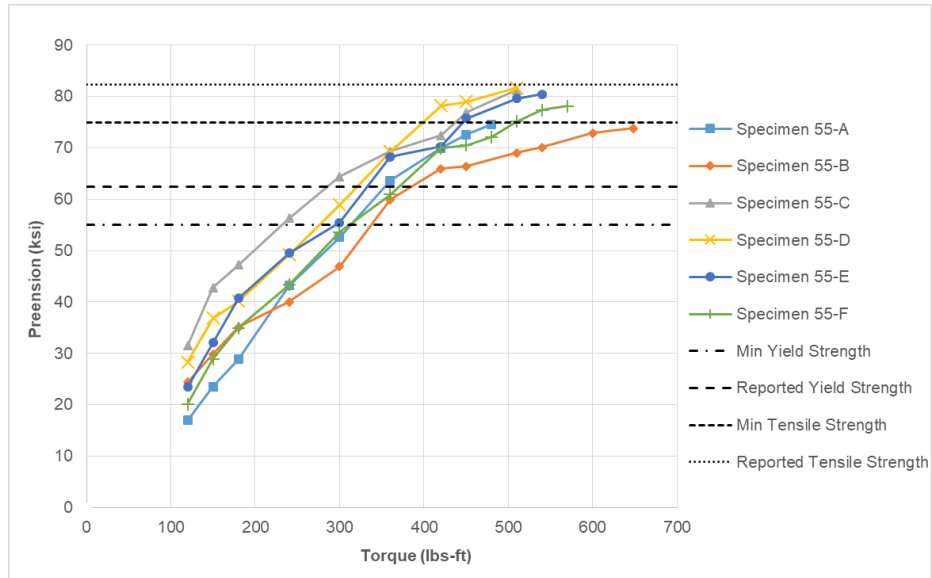
The relationship between pretension in the rod and applied torque was also analyzed. The overall relationship between pretension and torque was similar to the relationship between pretension and nut rotation. The behavior was linear until the rods reached their maximum reported yield strength of 62.5 ksi (see Figure 27). There was more scatter observed in the pretension vs. torque curve as compared to the pretension vs. nut rotation curve. This was due to the dependency of the applied torque on lubrication and friction between the components. The snug-torque for each of the anchor rods was applied using a manual torque wrench and, hence, its values were not plotted in Figure 27.

**Figure 27. Pretension vs. torque for grade 55 – 1 in anchor rods on steel base plate**

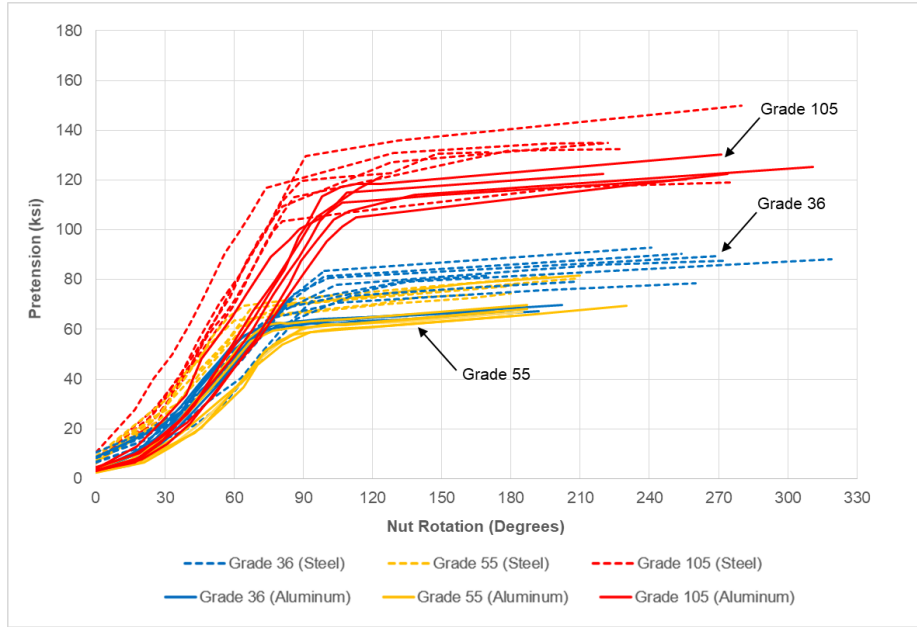
One in. diameter anchor rods were tightened on both steel and aluminum base plates. This was done to analyze the effect of base plate material on the tightening procedures and nut rotations during tightening. The pretension vs. nut rotation curve for all of the 1 in diameter anchor rods tested is shown in Figure 28. All of the tested rods behaved similarly (approximately same initial slope) until their respective yields. However, all the anchor rods tightened on the aluminum plates produced relatively smaller pretension values as compared to the ones tightened on steel base plates. This difference could be explained due to the small differences in the calibration slopes of steel plate and aluminum plate. However, the observed difference between the behaviors of anchor rods tightened on the two base plate material was small and would not have a significant impact on the overall results. Hence, it can be concluded that the turn-of-the-nut tightening procedures are independent of the material of the base plate. It was also observed that grade 36 and 55 behaved similarly to each other, which is indicated by the overlapping curves in Figure 28.

**Figure 28. Pretension vs. nut rotation curve for 1 in diameter anchor rods**

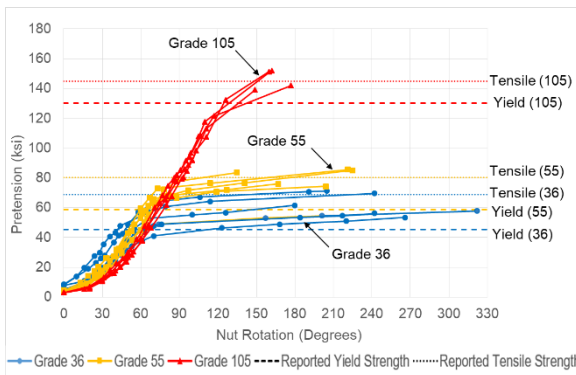
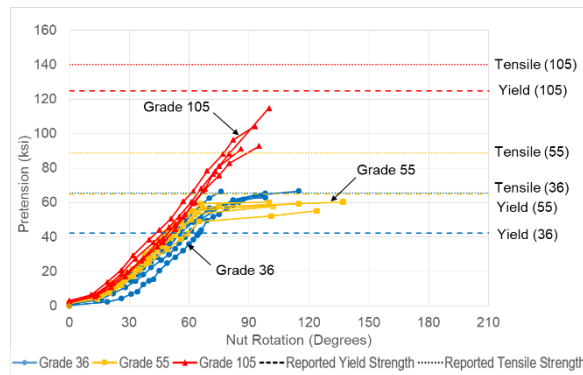
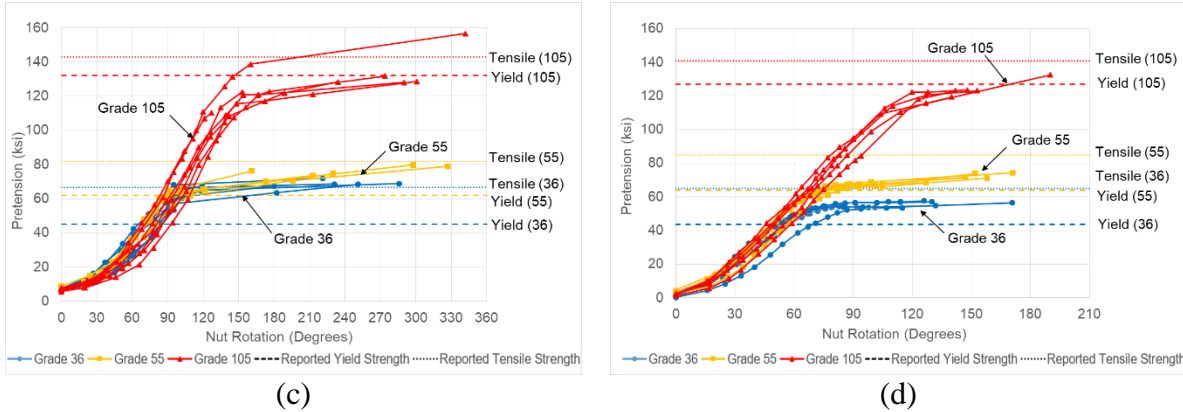
Four other combinations of anchor rods and base plate were tested: 1.5 in diameter anchor rod on steel base plate, 2 in diameter anchor rod on steel base plate, 0.75 in diameter anchor rod on aluminum base plate, and 1.25 in diameter anchor rod on aluminum base plate. The pretension vs. nut rotation curves for all the four combinations are shown in Figure 29. The curves for anchor rods of all steel grades remained linear until their respective yield strengths for each combination. The bilinear behavior of grade 36 and 55 anchor rods was very similar. Grade 105 – 2 in diameter anchor rods did not yield due to the large amount of tension required for yielding (Figure 29 (b)). Some local yielding around the aluminum base plate holes was observed during tightening. This behavior is unlikely to occur during the installation as the rods should only be tightened to a percentage of yield strength, rather than the extreme loading applied during the test.

**Figure 29. Pretension vs. nut rotation curves for (a) 1.5 in diameter rods on steel base plate (b) 2 in diameter rods on steel base plate (c) 0.75 in diameter rods on aluminum base plate (d) 1.25 in diameter rods on aluminum base plate**

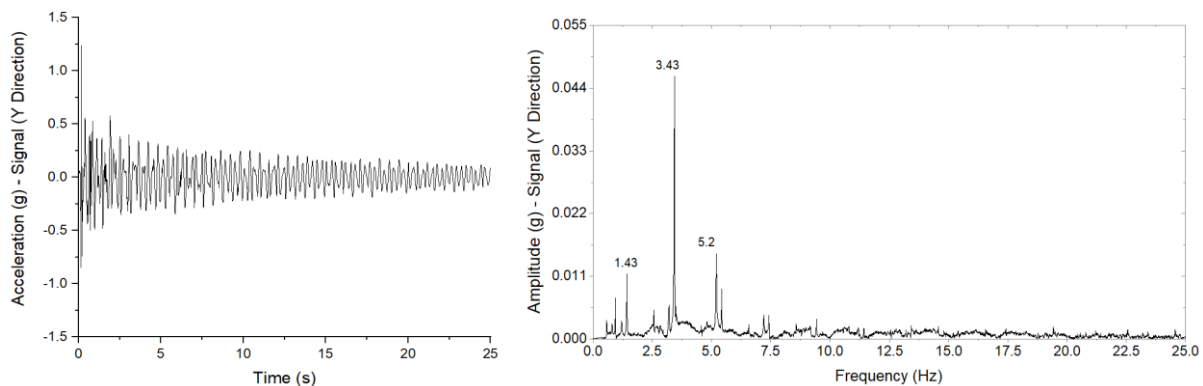
**Figure 30. Acceleration time history (Left) and frequency spectrum (Right) for the pluck test 1 performed on traffic signal in Y direction**

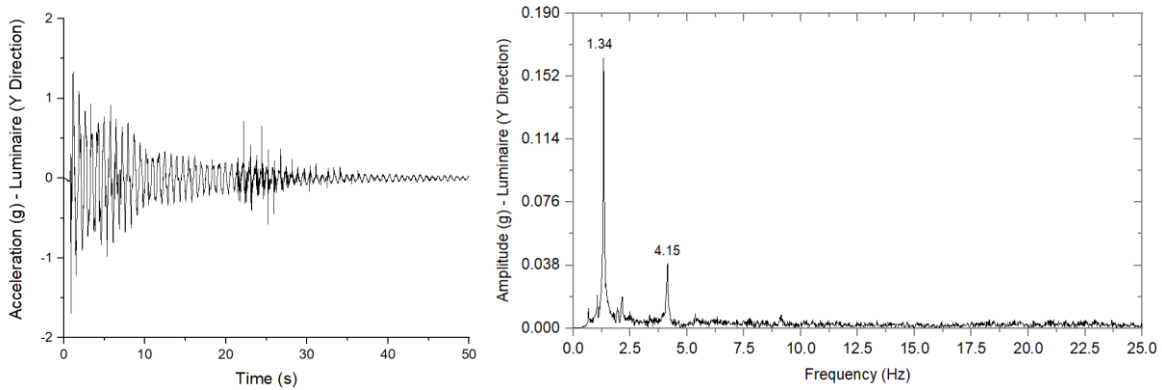
**Figure 31. Acceleration time history (Left) and frequency spectrum (Right) for the pluck test 1 performed on luminaire in Y direction**

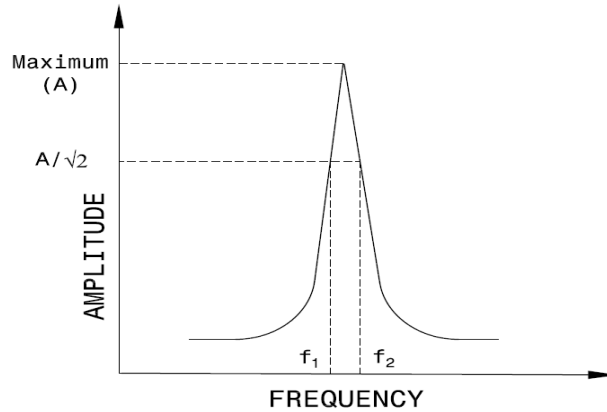
**Figure 32. Half-power Bandwidth method**

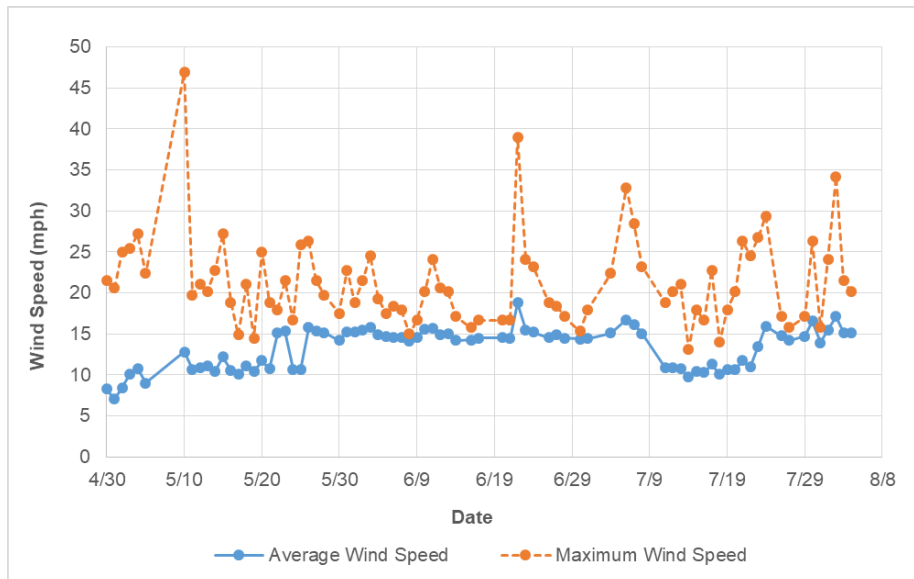
**Figure 33. Average and maximum wind speed variation at the location of instrumented poles**

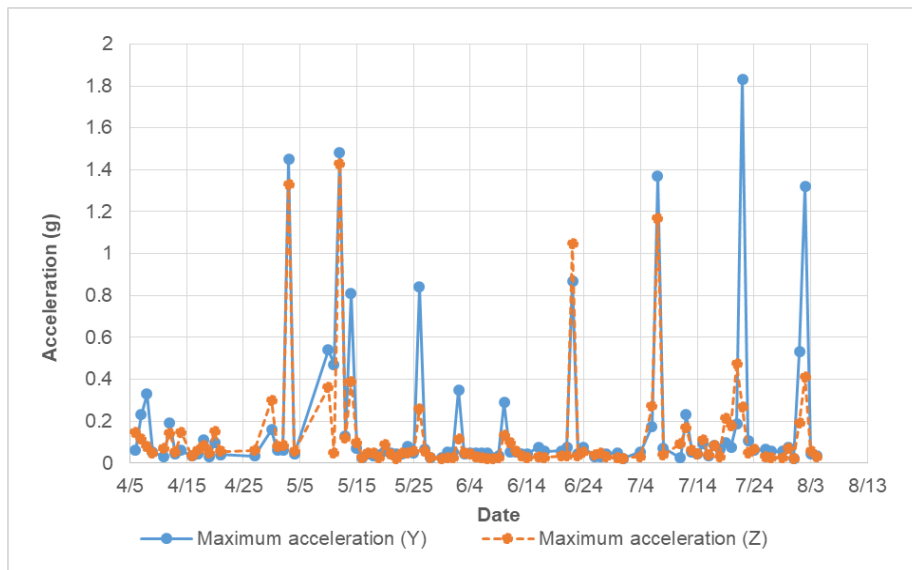
**Figure 34. Maximum daily acceleration for the traffic signal**

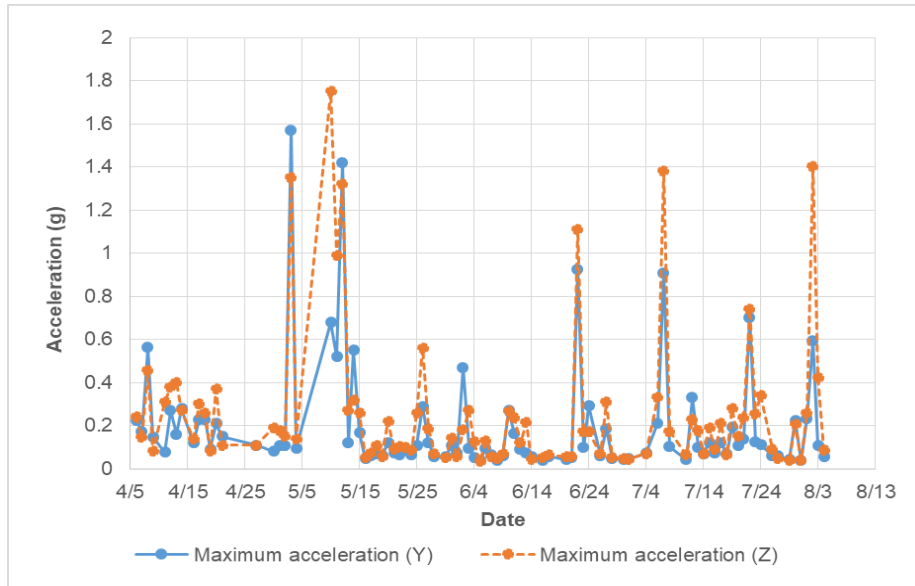
**Figure 35. Maximum daily acceleration for the luminaire**

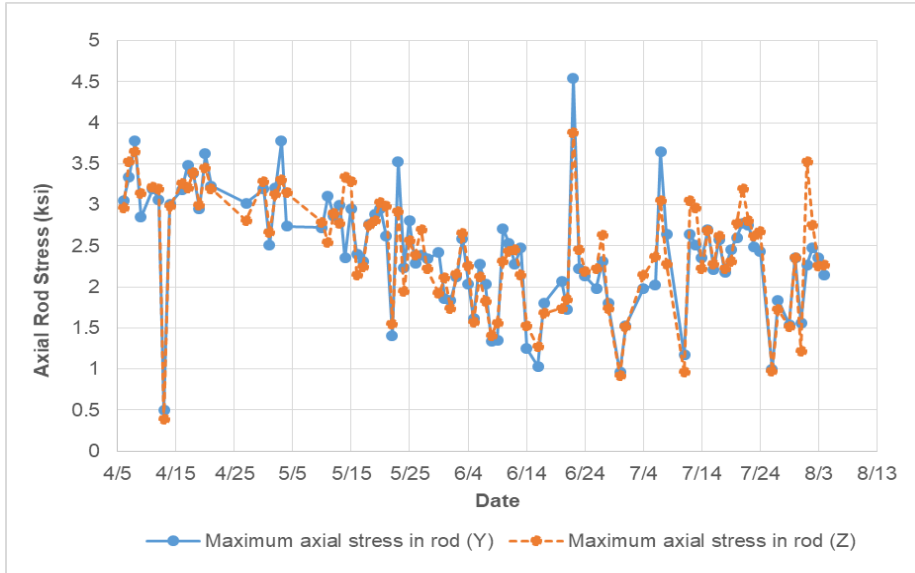
**Figure 36. Maximum daily axial rod stress for the traffic signal**

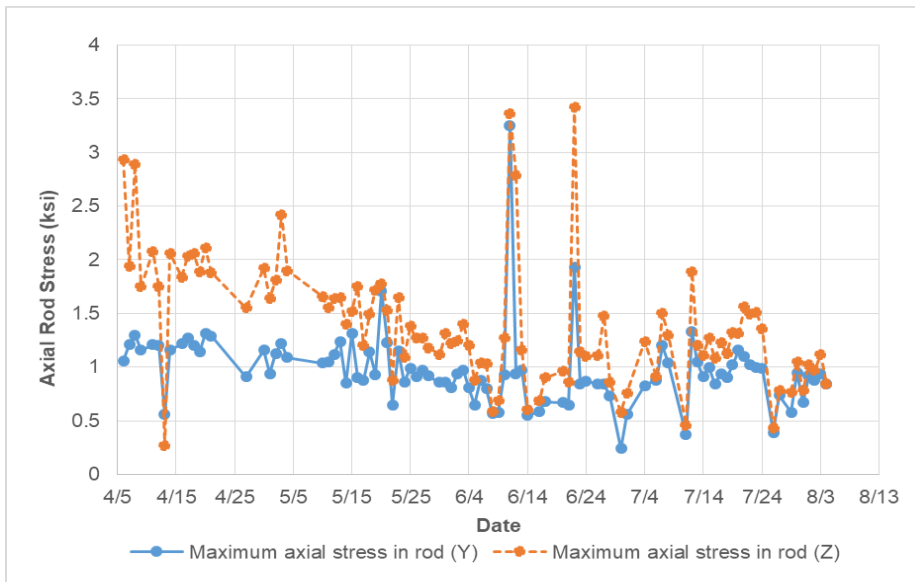
**Figure 37. Maximum daily axial rod stress for the luminaire**
