# Methods to Ensure Appropriate Installation and Prevent Loosening of Anchor Nuts on Ancillary Highway Structures

**MATTHEW H. HEBDON, Ph.D., P.E.**  
Assistant Professor

Final Report VTRC 20-R30

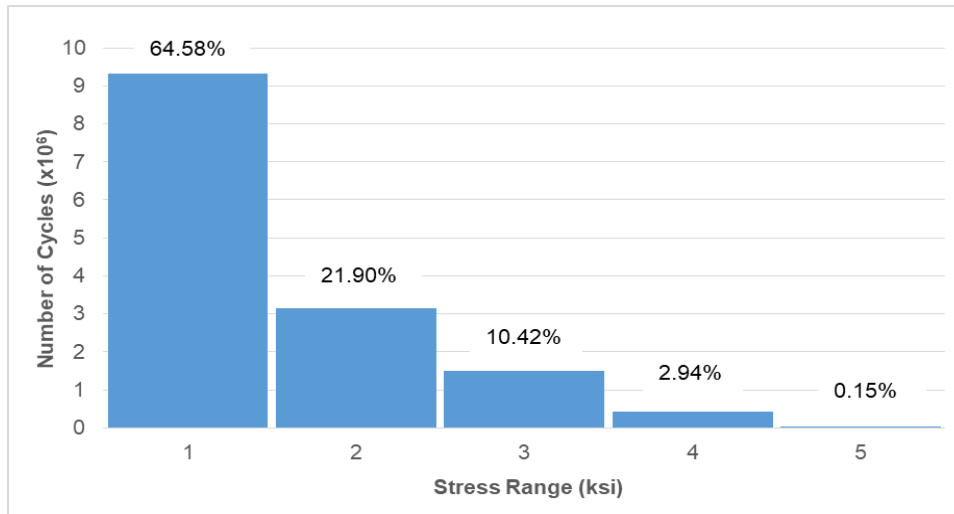
both the traffic signal and the luminaire in the Z direction are shown in Figure 38 and Figure 39, respectively.

**Figure 38. Rod axial stress range histogram for traffic signal in Z direction**

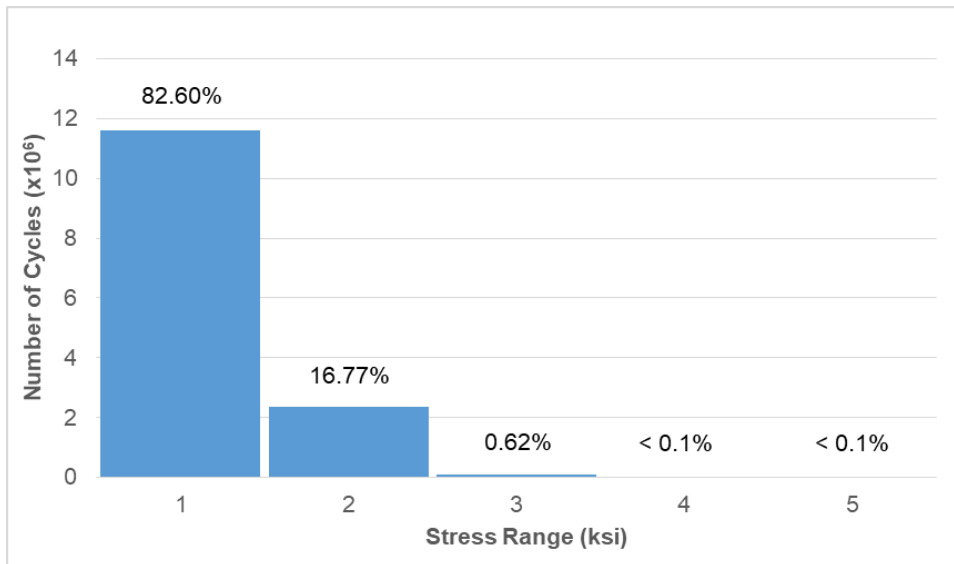
**Figure 39. Rod axial stress range histogram for luminaire in Z direction**

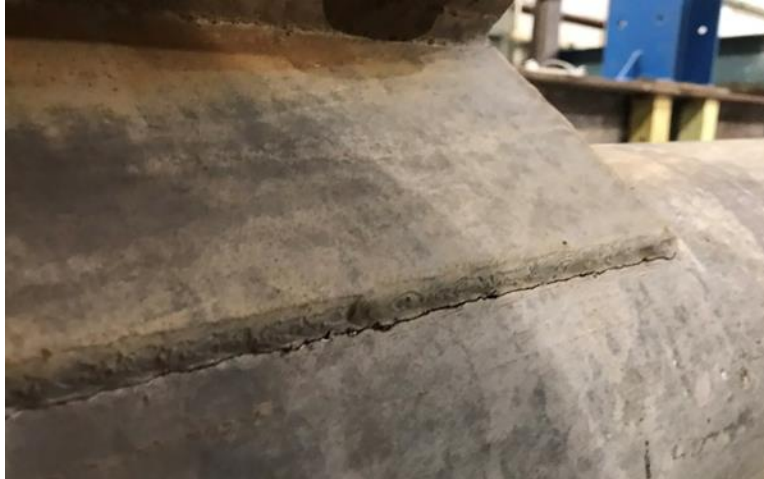
**Figure 40. Fatigue crack in welded connection between reaction box and straight pole**

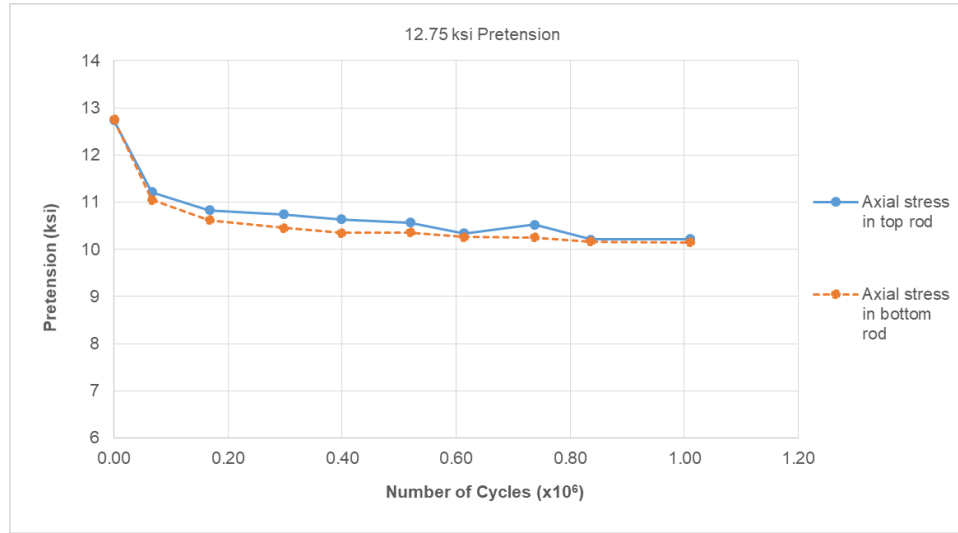
**Figure 41. Pretension loss curve for test 4 (12.75 ksi pretension)**

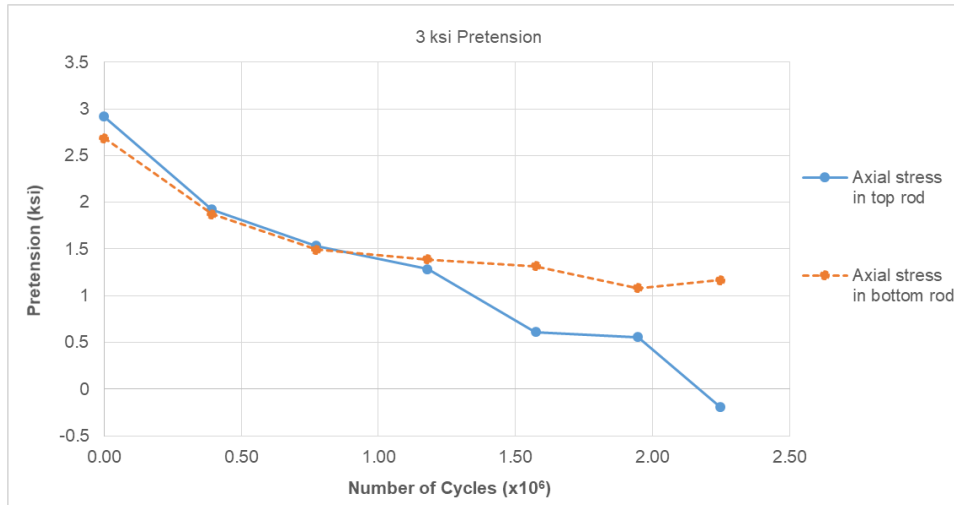
**Figure 42. Pretension loss curve for test 8 (3 ksi initial pretension)**

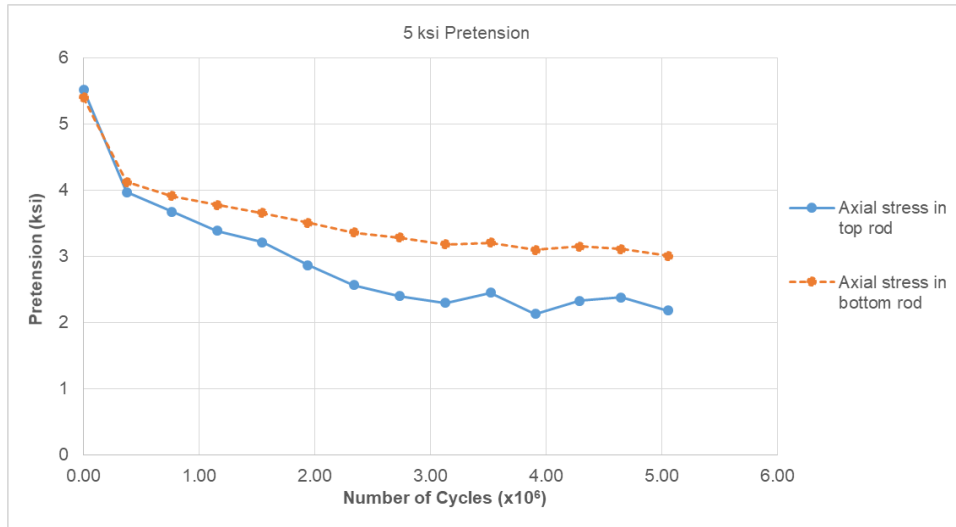
**Figure 43. Pretension loss curve for test 11 (5 ksi initial pretension)**

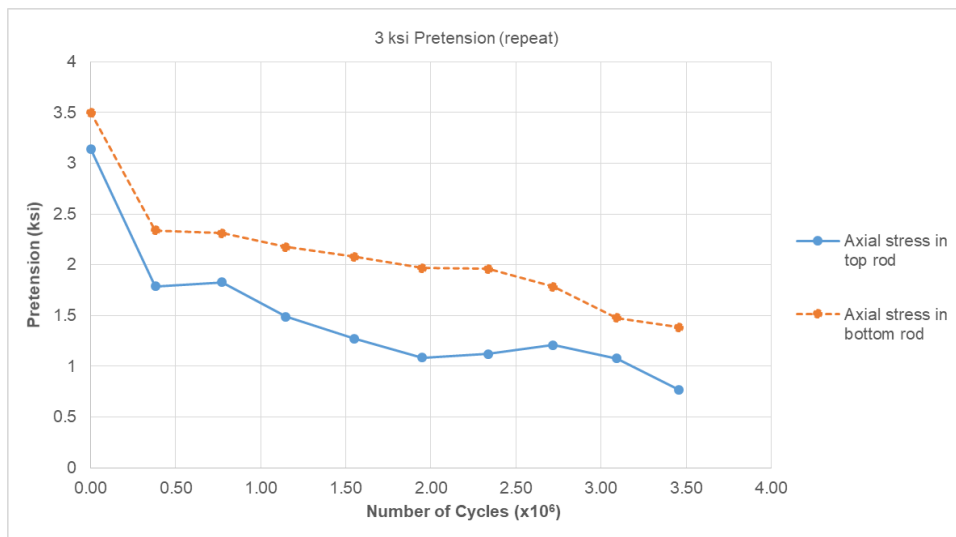
**Figure 44. Pretension loss curve for test 13 (3 ksi initial pretension repeat)**

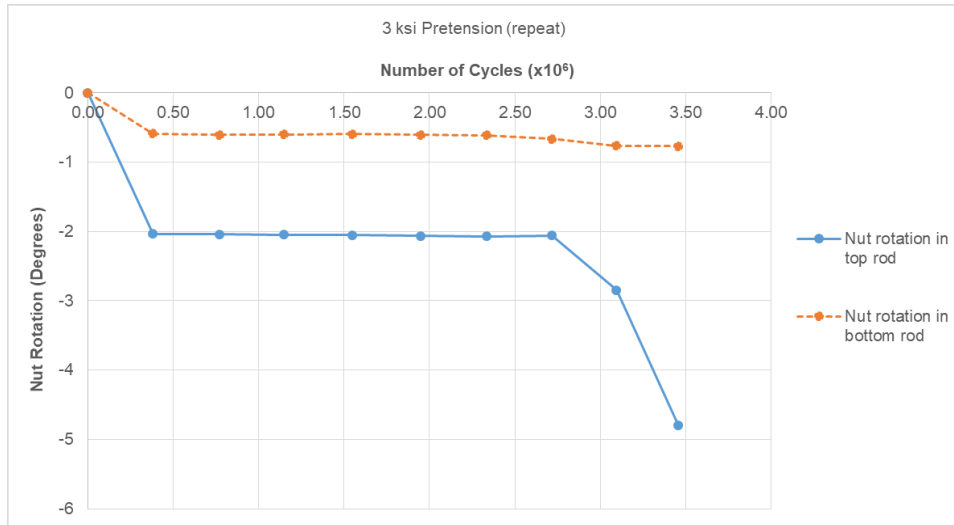
**Figure 45. Curve for change in nut rotation during test 13 (3 ksi initial pretension repeat)**

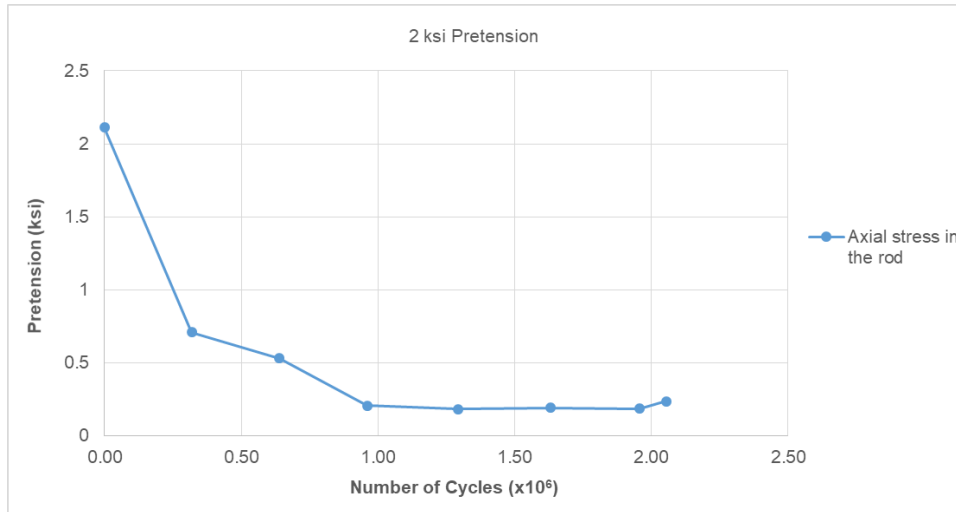
**Figure 46. Vibrational loosening curve for test 2 (2 ksi pretension)**

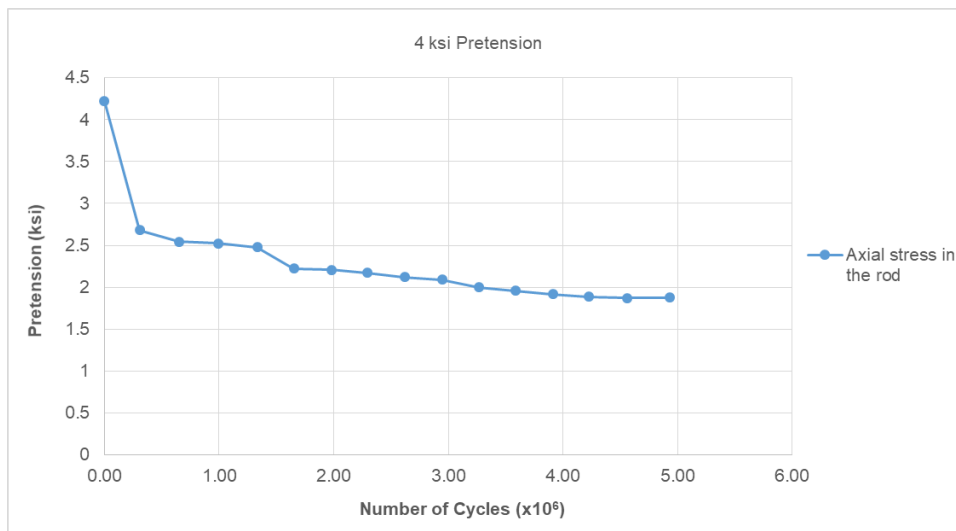
**Figure 47. Vibrational loosening curve for test 3 (4 ksi pretension)**

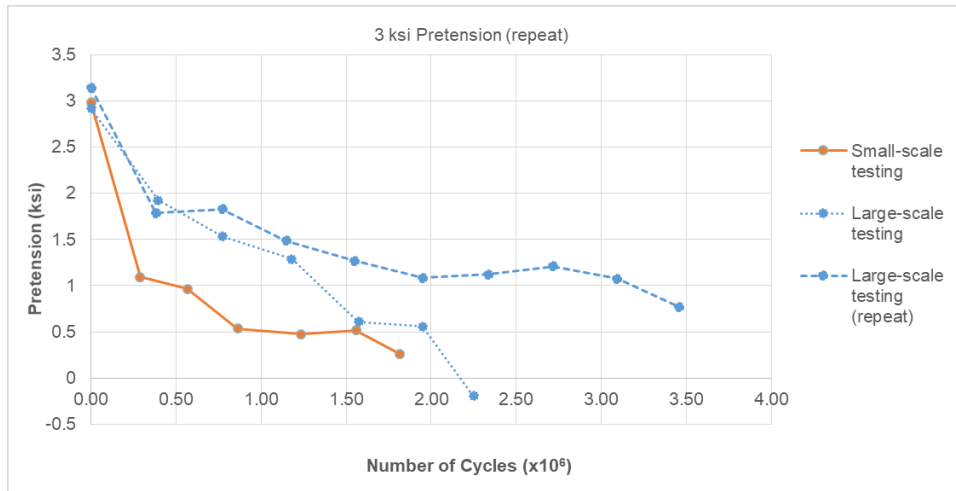
**Figure 48. Comparison of pretension loosening curves at 3 ksi initial pretension**

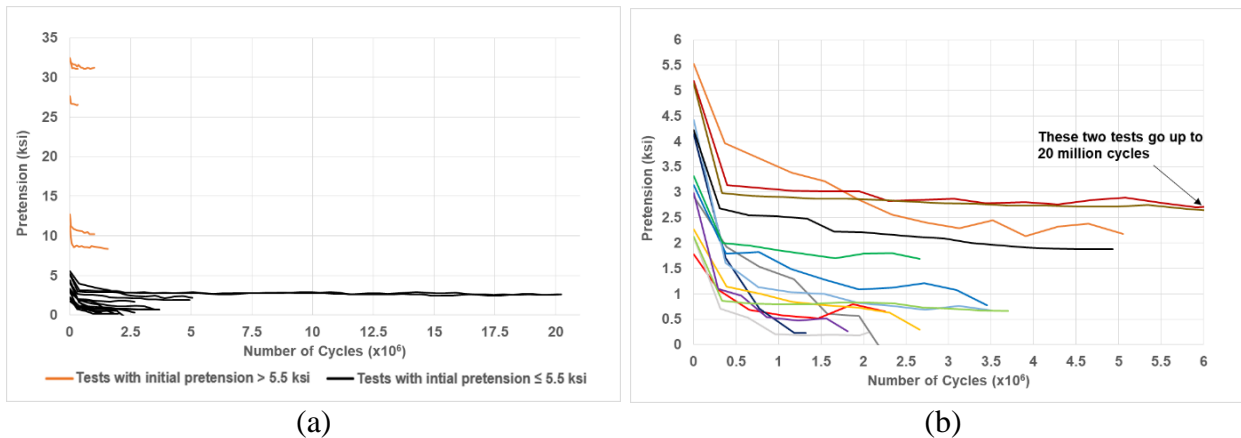
**Figure 49. Initial pretension vs. number of cycles for (a) all vibration tests and (b) tests with initial pretension less than or equal to 5.5 ksi**

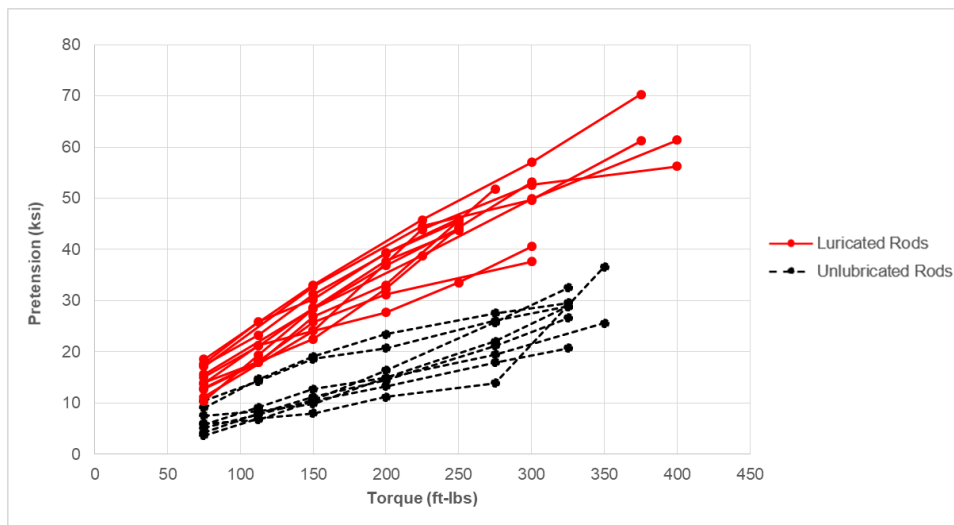
Figure 51. Comparison of pretension vs. torque relationship between lubricated and unlubricated rods

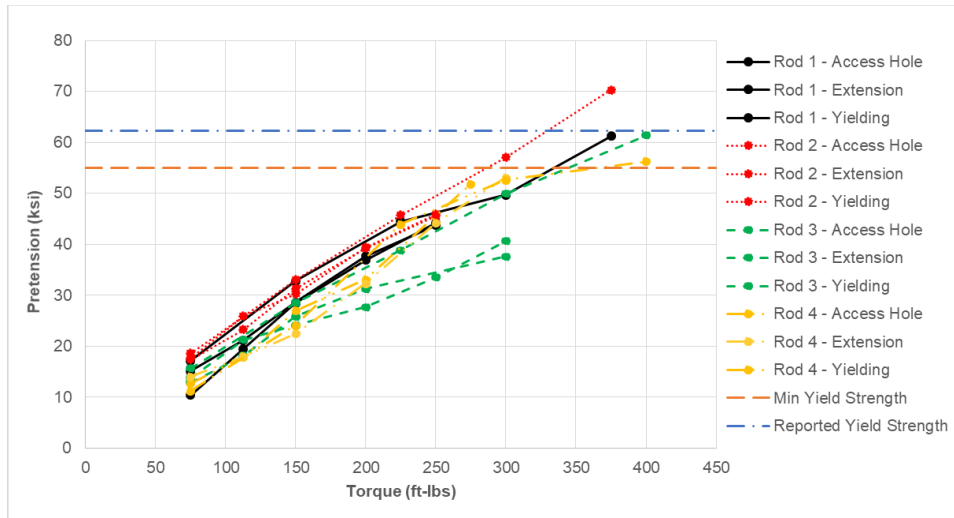
**Figure 52. Pretension vs. torque curve for lubricated rods**

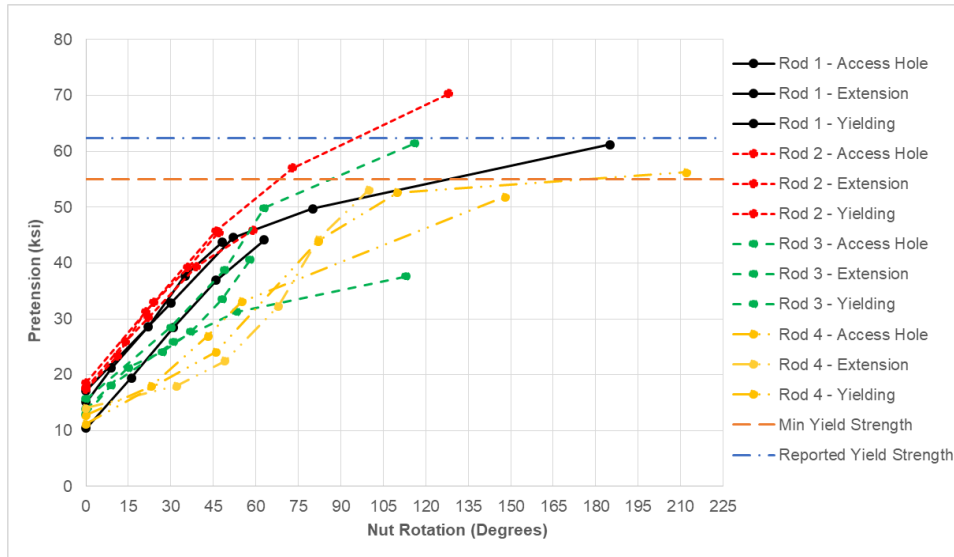
**Figure 53. Pretension vs. nut rotation curve for lubricated rods**

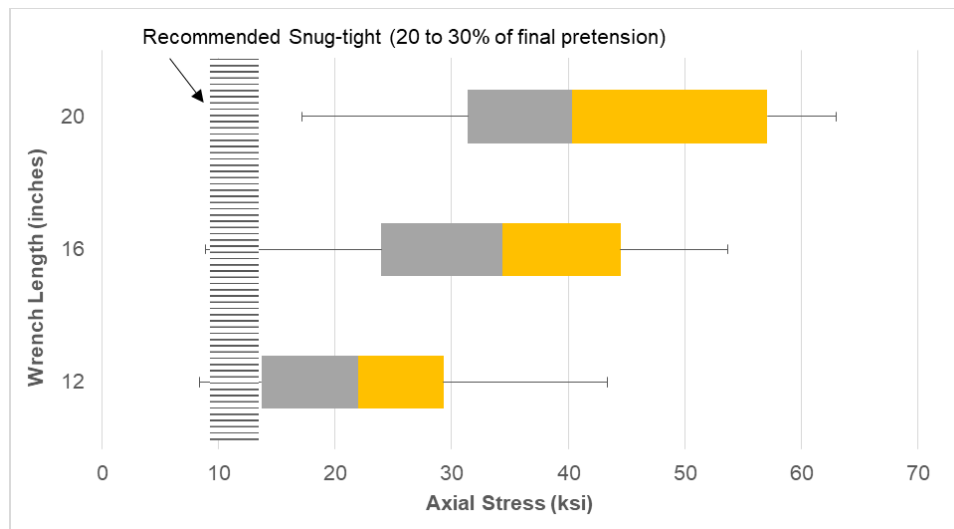
Figure 54. Axial stress distribution for snug-tight pretension in a 1 in anchor rod

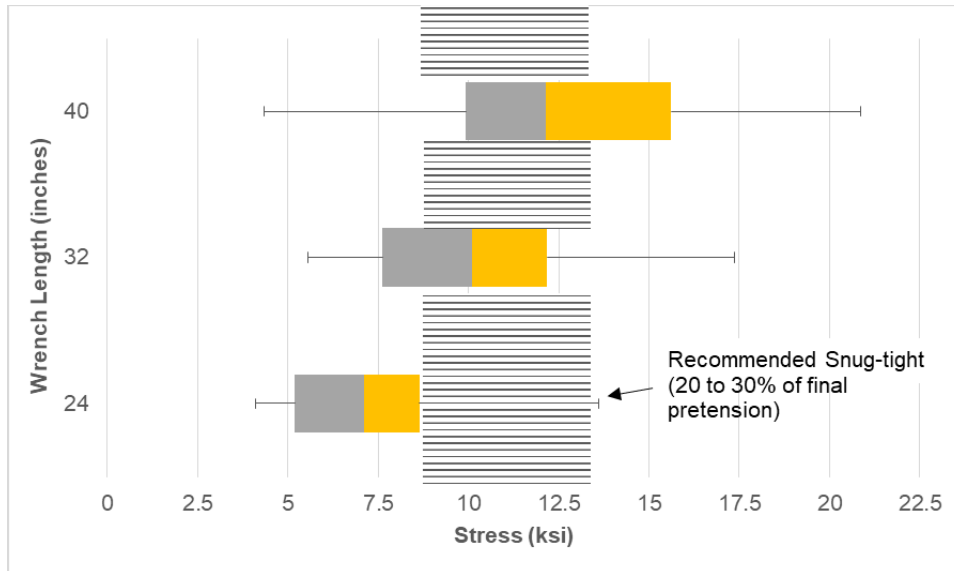
Figure 55. Axial stress distribution for snug-tight pretension in a 2 in anchor rod
