FIELD INVESTIGATION OF BROKEN CUT SPIKES ON ELASTIC FASTENERS USING INSTRUMENTED SPIKES

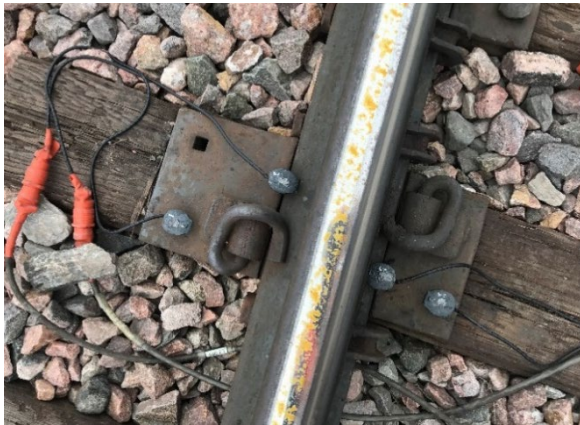
Figure 1. Instrumented spikes in a tie plate

In 2019, the Federal Railroad Administration (FRA) and Transportation Technology Center, Inc. (TTCI) conducted field experiments to investigate the spike failure mechanism found on elastic fastener tie plates. These experiments took place at the Facility for Accelerated Service Testing (FAST) in Pueblo, CO and at a revenue service site. The specific test locations were chosen from curves where broken spikes were common. To evaluate the real-time bending behavior of cut spikes, researchers developed and installed instrumented spikes in wood crossties (Figure 1). Rail force circuits measured the forces passing trains applied to the rails.

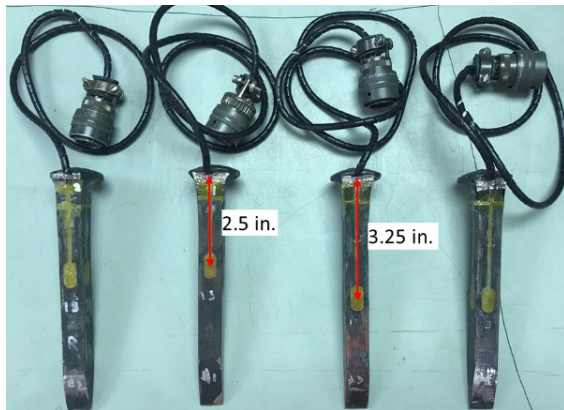
Figure 2. Instrumented locations of strain gages

TTCI developed the instrumented spikes used in this study. All four surfaces of the spike shaft were instrumented with strain gages to measure the vertical, longitudinal, and lateral strains. Based on the varying thickness of a tie plate at different spike locations and the likelihood of spikes to break 1 to 1.5 inches below the tie surface, strain gages were placed at two distinct locations as shown in Figure 2 to differentiate between a rail spike and an anchor spike. The instrument calibration showed the strain gage layout successfully separated the lateral and longitudinal bending strains.

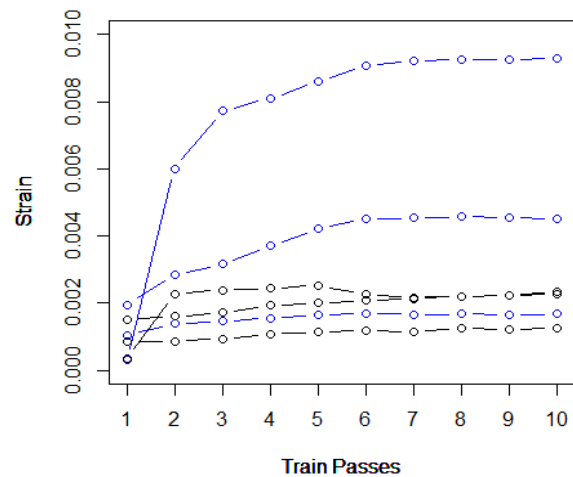
Figure 5. Maximum lateral bending strain for spikes on the same tie at FAST. High-rail spikes are shown in blue while low-rail spikes are shown in black.

The research team found the loads applied to each of the spikes in the same tie were not the same. Figure 5 shows the maximum lateral bending strain for all 6 spikes on the same tie after 10 train passes at FAST. The high-rail spikes (blue) carried a higher bending load than the low-rail spikes (black). In addition, the bending strains found in the high-rail spikes were not as evenly distributed as those in the low-rail spikes. The bending strain observed in one high-rail spike was substantially higher than that in the other two high-rail spikes. Other plates in the tests exhibited the same pattern of one or two spikes carrying a higher bending load.

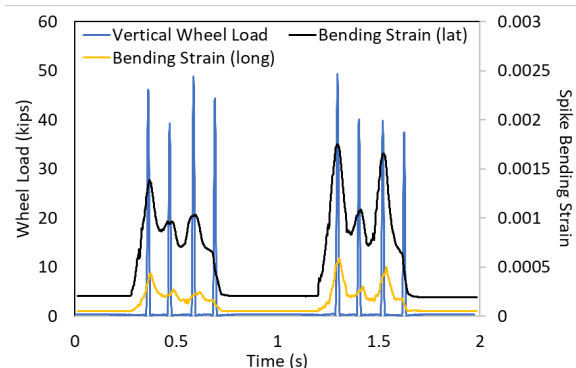
Figure 6. Wheel loads aligned with spike bending strains

The rail strain gage circuits measured the vertical, lateral, and longitudinal forces applied to the rails by passing trains. Figure 6 shows the spikes experienced the largest bending load when a wheel load was directly over that plate. The peaks in the spike bending strains were synced and aligned with the peaks of wheel loads. This indicates that vehicle body forces mainly caused the spike failures rather than train-induced track vibration.
