*Midwest Pooled Fund Program
Fiscal Years 2018-2021 (Year 28)
Research Project Number TPF-5(193) Supplement #118
NDOT Sponsoring Agency Code RFP-18-CABLE-1*

DESIGN AND EVALUATION OF SLEEVE NUT THROUGH TENSILE TESTING

MwRSF Research Report No. TRP-03-412-19

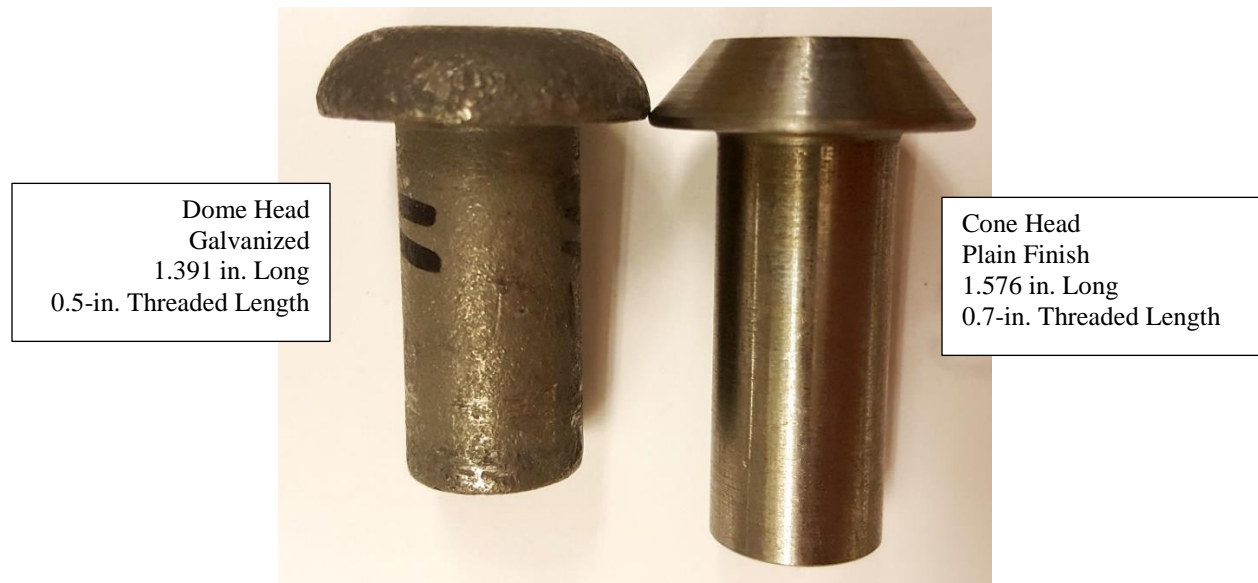
Figure 1. Illustration of Differences between Sleeve Nut Concepts

The two different head shapes were designed to be low profile in order to mitigate cable snag and reduce the possibility of floor pan tearing. Both sleeve nuts were designed to develop nominal yield and tensile forces of 5.2 kips and 6.0 kips (23.1 kN and 26.7 kN), respectively. These values are near the minimum nominal yield and tensile strength of the $\frac{5}{16}$ -in. (8-mm) diameter Grade 5 bolt, which are 92 ksi and 120 ksi (634.3 MPa and 827.4 MPa), respectively. This corresponds to a yield and tensile force capacity of 4.8 kips and 6.3 kips (21.4 kN and 28.0 kN), respectively, for the $\frac{5}{16}$ -in. (8-mm) diameter bolt. The bolted connection is necessary to maintain the fixity of the tabbed bracket, and provide positive engagement between the tab bracket and post.

All sleeve nuts were fabricated from AISI 1144 Class B Stressproof steel rod, with nominal yield and ultimate strengths of 100 ksi (689 MPa) and 115 ksi (792 MPa), respectively. Two different overall lengths, head shapes, and threaded lengths were investigated. The inner and outer diameters were the same for all sleeve nuts and measured $\frac{5}{16}$ in. (8 mm) and 0.563 in. (14 mm), respectively. The effects of plain and corrosion-resistant finishes were also investigated. Examples of the different parameters are shown in Figure 1. The test matrix is shown in Table 1. Detailed drawings are shown in Appendix A.

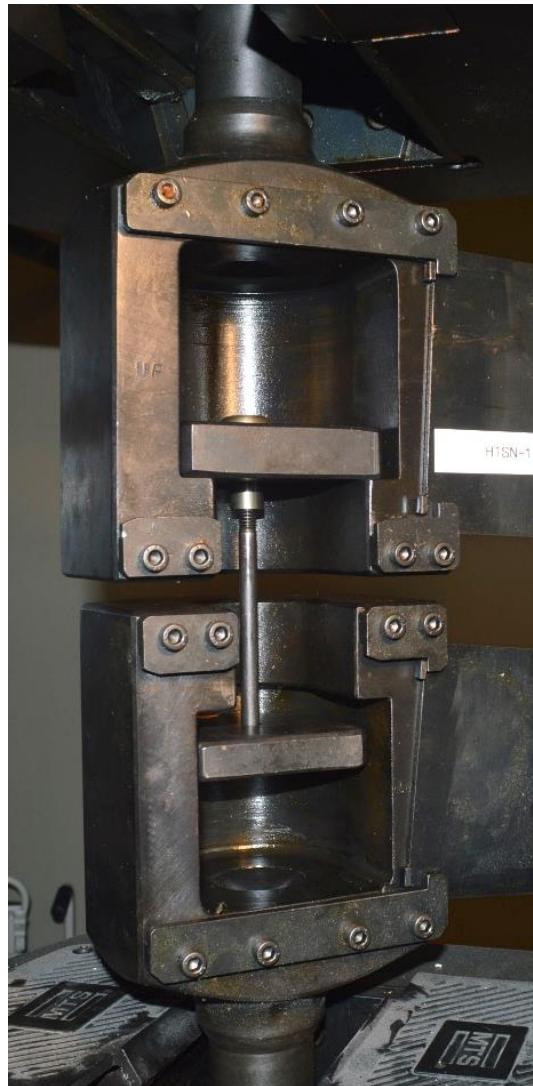
Figure 2. Tensile Test Setup

For each test, a $5/16$ -in. (8-mm) diameter Grade 5 bolt was threaded into the sleeve nut until it was snug. Typically, engagement of three threads between a bolt and nut will develop between 75 and 90 percent of the bolt strength. Therefore, one full bolt diameter deep into the sleeve nut should develop the full strength of the bolt. Each test used either a plain or a corrosion-resistant finish, as shown Table 1. The bolt and nut combinations were attached to test jigs mounted between grips of an MTS Criterion Series 60 – Model 64.106 machine, as shown in Figure 2. Pre-test photographs of the nuts and bolts are shown in Figures 3 through 6. A quasi-static tension test was conducted by slowly separating the grips of the tensile testing machine, thus creating a tensile force in the bolt and nut, until failure occurred. A total of fourteen static component tests were conducted, as shown in Table 1.

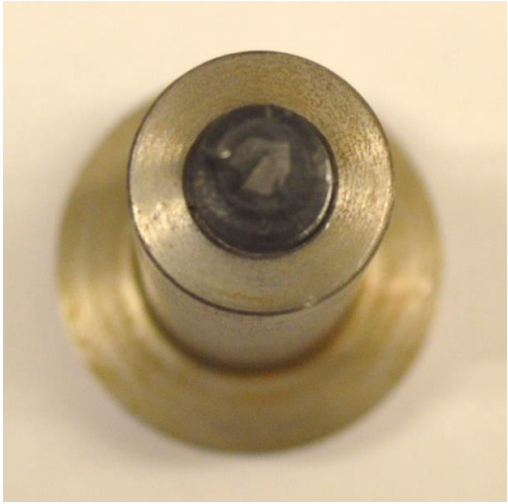
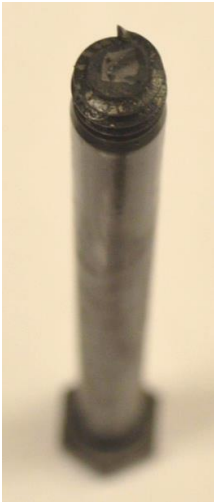
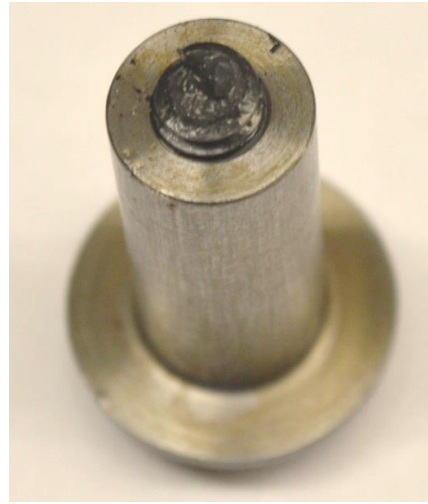
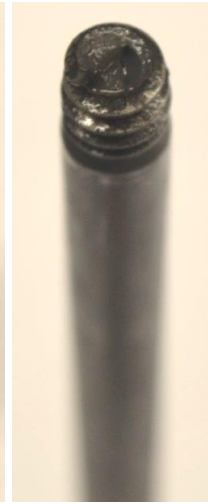
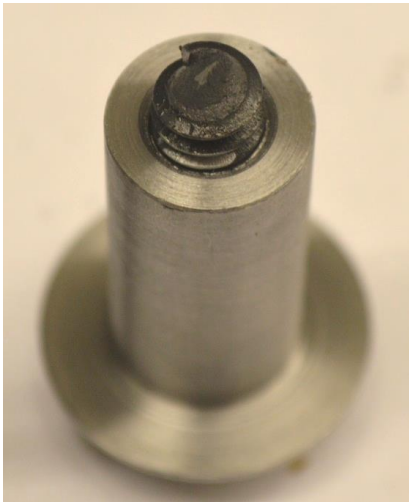
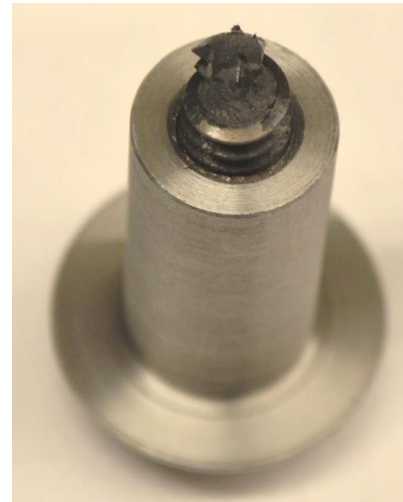
Figure 8. Post-Test Bolts and Nuts, Test Nos. HTSN-3 through HTSN-6

The variables in each test, test nos. HTSN-1 through HTSN-14, were the parameters of the bolts and nuts, as shown in Table 1. In every test, the $\frac{5}{16}$ -in. (8-mm) diameter Grade 5 bolt failed before the sleeve nut. Photographs of the bolt and nut damage for each test are shown in Figures 7 through 10.

During the initial round of testing (test nos. HTSN-1 through HTSN-6), the sleeve nut length, threaded depth, and head shape were investigated. The longer sleeve nut and deeper thread length did not make a difference in the test results. In addition, the two different head shapes did not make a difference. Therefore, all remaining tests were conducted on the shorter sleeve nut with shallower thread length. However due to the availability of head shapes of the existing sleeve nuts, both the dome and cone heads continued to be evaluated.

After each test, the sleeve nuts were inspected for damage, markings, or permanent deformation. For each test condition, the sleeve nuts and threads remained undamaged. The fractured portion of the bolt remaining in the sleeve nut could be easily removed without any plastic damage to the threads. No differences in test results were observed based on nut galvanization or head shape.

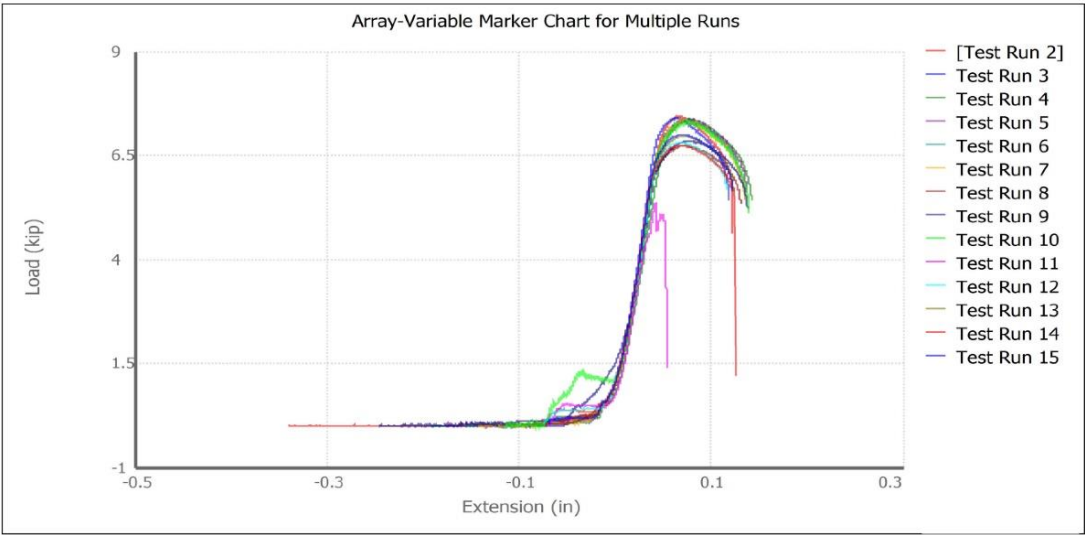
Figure C-1. MTS Test Results Summary

Name	Tagged	Load at Tensile Strength (kip)	Tensile Strength (kip/in ²)	Test ID
Test Run 2	No	7.433	141.8	HTSN-1
Test Run 3	No	7.401	141.2	HTSN-2
Test Run 4	No	7.374	140.7	HTSN-3
Test Run 5	No	7.392	141.1	HTSN-4
Test Run 6	No	7.396	141.2	HTSN-5
Test Run 7	No	7.382	140.9	HTSN-6
Test Run 8	No	6.736	128.5	HTSN-7
Test Run 9	No	6.855	130.8	HTSN-8
Test Run 10	No	7.338	140.0	HTSN-9
Test Run 11	No	5.368	102.4	HTSN-10
Test Run 12	No	6.813	130.0	HTSN-11
Test Run 13	No	6.965	132.9	HTSN-12
Test Run 14	No	6.740	128.6	HTSN-13
Test Run 15	No	7.001	133.6	HTSN-14
	Mean	7.014	133.9	
	Standard D	0.549	10.5

All nut and bolt combinations developed strength beyond the expected bolt strength, as shown in Figure C-1. The pre-loading in the sample shown in Figure C-2 was due to tension in the locking mechanism of the MTS Criterion that was meant to hold the sample in place for the test.

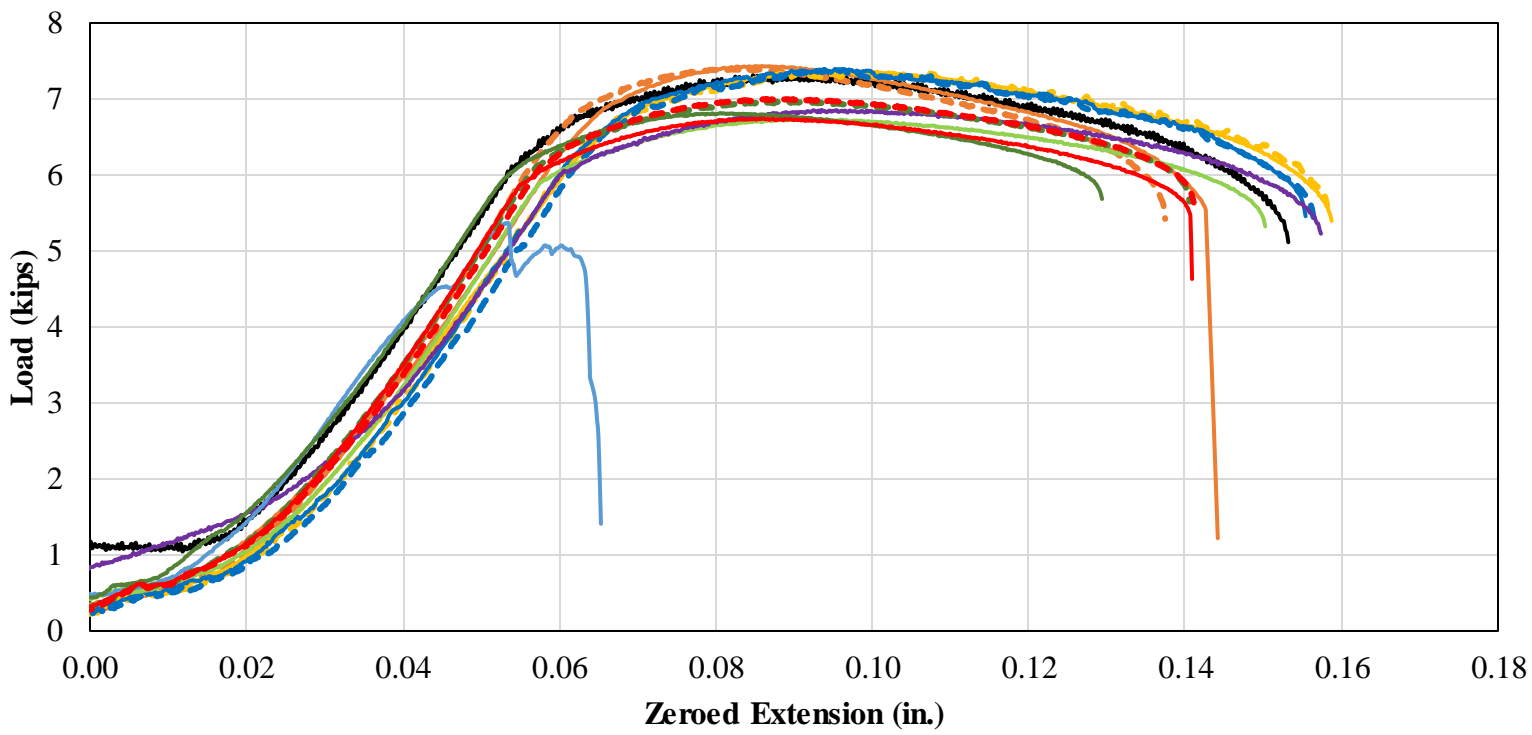
- HTSN-9 (baseline) — HTSN-1 - - - HTSN-2 — HTSN-3
- - - HTSN-4 — HTSN-5 - - - HTSN-6 — HTSN-7
- HTSN-8 — HTSN-10 — HTSN-11 - - - HTSN-12
- HTSN-13 - - - HTSN-14
