MEASURING THE IMPACT OF A LANDSLIDE ON TRANSPORTATION INFRASTRUCTURE TO IMPROVE MOBILITY AND SAFETY

FINAL PROJECT REPORT

Margaret M. Darrow, Ph.D., P.E. and Jaimy Schwarber, E.I.T.
University of Alaska Fairbanks

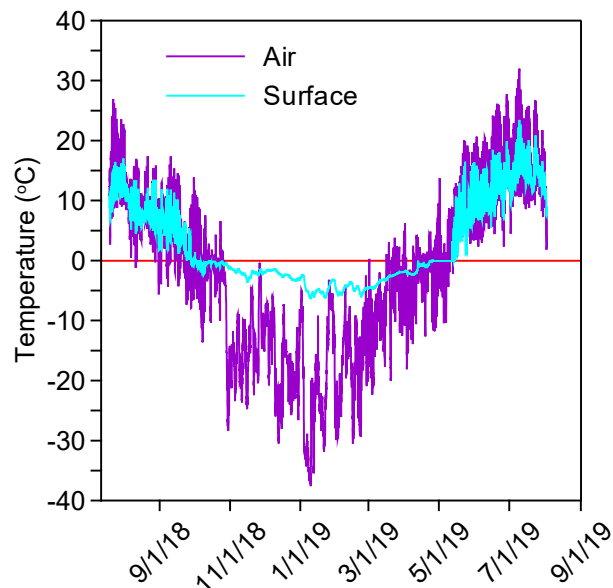
Figure 3.1. Air and surface temperatures measured at the toe of FDL-A from July 19, 2018 until August 2, 2019.

Figure 3.1 contains plots of the air and surface temperatures recorded at the Dalton MP219 ADAS from July 2018 until early August 2019. The average annual air temperature for the period of record was -2.16°C , with a minimum and maximum of -37.61°C and 32.00°C , respectively. The average soil surface temperature was 2.46°C , with a minimum and maximum of -6.31°C and 23.47°C , respectively. We calculated the n factors for the period of record using the air freezing and thawing indices and the surface freezing and thawing indices (Andersland and Ladanyi 2004). The final results were 0.83 for n -thaw and 0.21 for n -freeze. The low value for n -freeze can be explained in part by the significant snowfall recorded in the Brooks Range during the 2018-19 winter (e.g., 1.9 m in Coldfoot, Alaska (Snoflo 2019)).

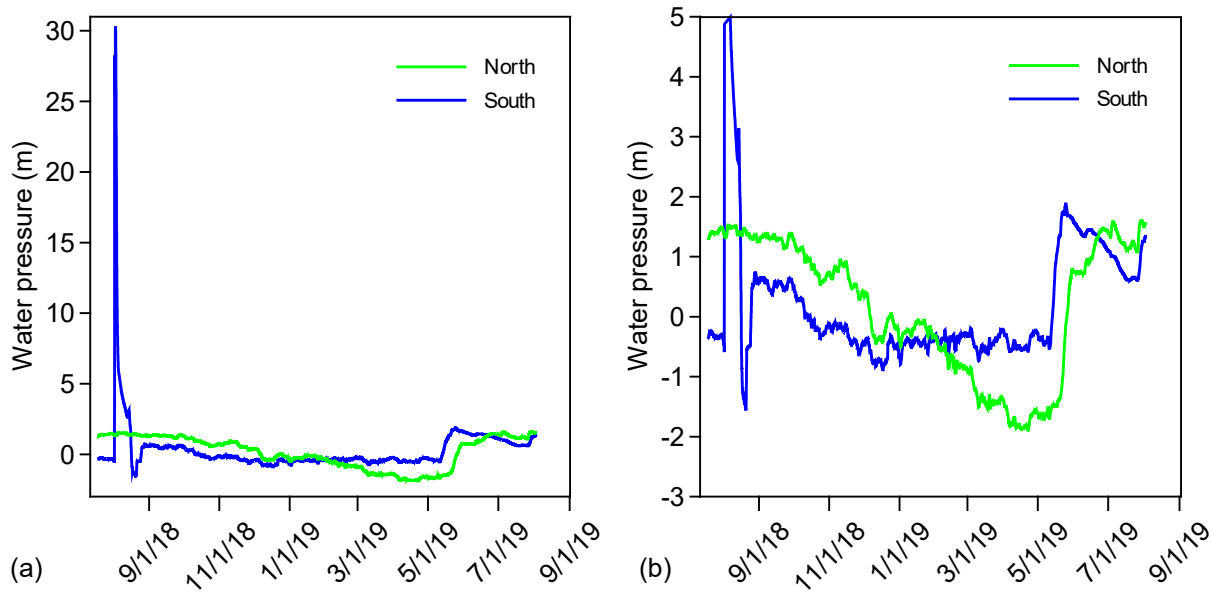
Figure 3.4. Water pressure measured near the toe of FDL-A: (a) includes all data, whereas in (b), the vertical scale has been restricted to illustrate the probable range in water pressure.

Figure 3.4 contains graphs of water pressure from both installations. In the days following its installation, the south piezometer spiked to indicate ~30 m of water pressure (figure 3.4a). It is unclear whether this spike was due to the curing of the cement-bentonite grout or some other anomaly; given the fact that this spike was not recorded in the north installation, we suspect that it was an artifact of the installation and did not represent actual conditions. In figure 3.4b, the vertical axis range is limited to illustrate the data trends. Both installations measured negative pressures during the winter months, which may indicate tension due to subfreezing conditions. Both piezometers also reported a spike in water pressure during the spring snow melt period, occurring on May 7, 2019, at the south installation, and on May 18, 2019, at the north installation.

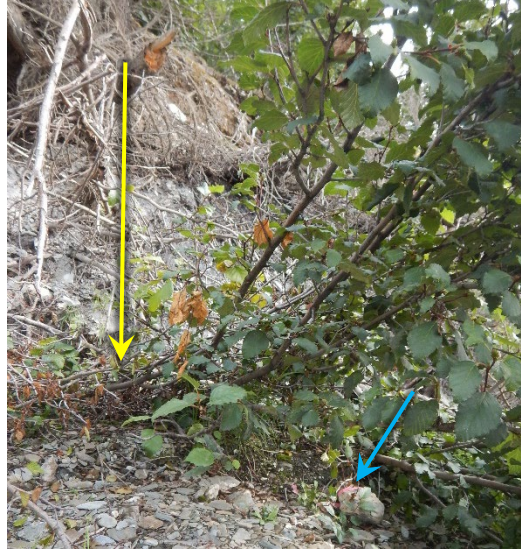
Figure 3.6. Proximity of FDL-A’s toe to the north installation on July 31, 2019. Yellow arrow indicates FDL-A toe, and blue arrow indicates position of north installation.

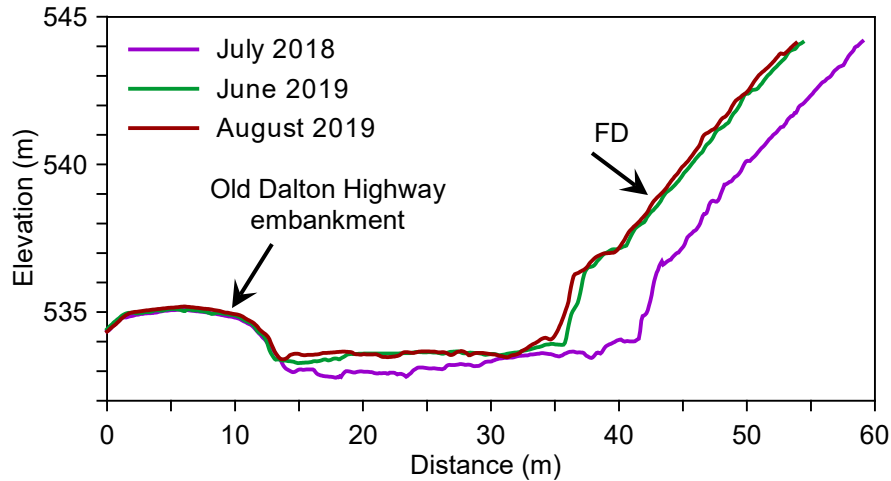
Figure 3.8. Longitudinal profiles of the toe of FDL-A generated from LiDAR DEMs from 2018 and 2019.

Figure 3.8 consists of three longitudinal profiles of the toe of FDL-A constructed along the double arrow black line indicated in figure 3.7b, and derived from the three different DEMs produced with the backpack-mounted LiDAR. The yearly change between July 2018 and August 2019 is most noticeable, with the forward motion of FDL-A resulting in a reduction in distance to the old Dalton Highway embankment. The seasonal change from June to August 2019 is not as significant, although the forward motion is still evident at the bottom of the slope. Another change that is notable is the increase in elevation of the ground surface between the FDL toe and the highway embankment between 2018 and 2019. This is due to sediment deposition along a creek that drains FDL-A and crosses under the highway embankment through several culverts.

slope angle remained similar (figure 3.8). The seasonal changes also indicated that the area of sedimentation in front of the culvert experienced some settlement during the summer (see yellow arrow in figure 3.9b). The settlement was visually evident in the field, as manifested by tension cracks, ponding, and holes (figure 3.10c). This settlement may have been due in part to the melting of the ice that formed during the preceding winter and was subsequently buried by sediment.
