Evaluation of Maintenance Procedures for Bridge Spalling on Parapet Walls

The Ohio Department of Transportation
Office of Statewide Planning & Research

February 2020

Phase II – Final Report

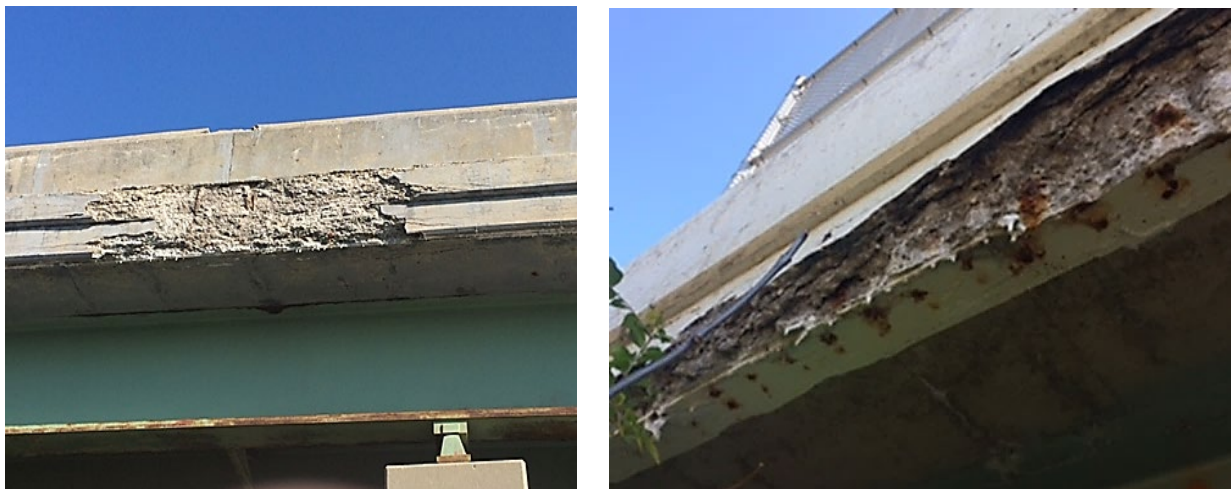
Figure 1: Example of the condition of a damaged parapet in District 6

Figure 1 shows examples of parapet walls in ODOT District 6 where unsound concrete has been removed. Presently, District 6 uses pneumatic handheld chipping hammers (**Figure 2**) to remove spalled concrete. Crew workers remove loose concrete generally up to the steel reinforcement, because the workers are typically unable to determine when they reach the sound concrete. After reaching the reinforcement, nothing else is done. The steel is left exposed, and no patching takes place. The combination of the inability to determine if all unsound concrete has been removed,

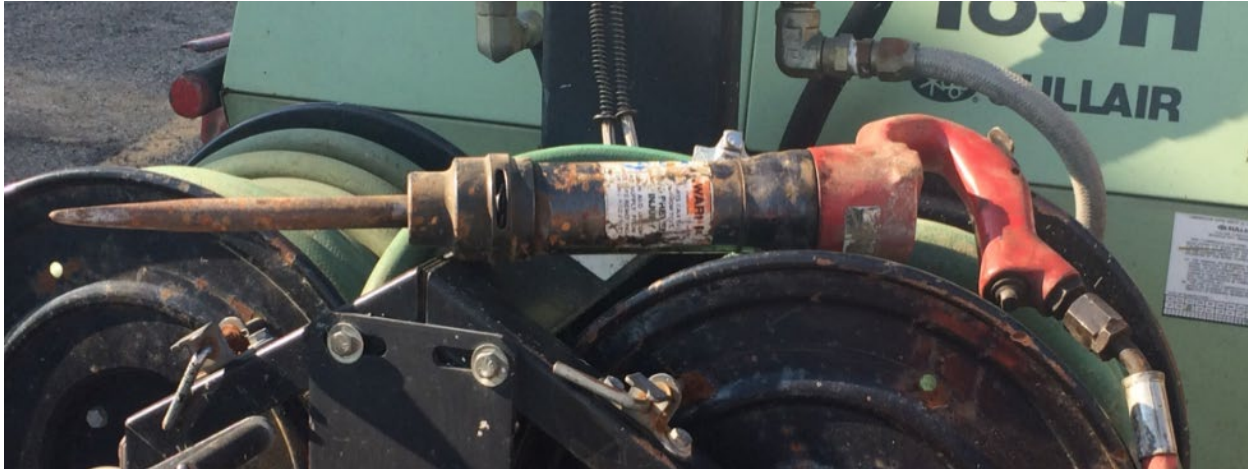
Figure 2: Pneumatic handheld chipping hammer

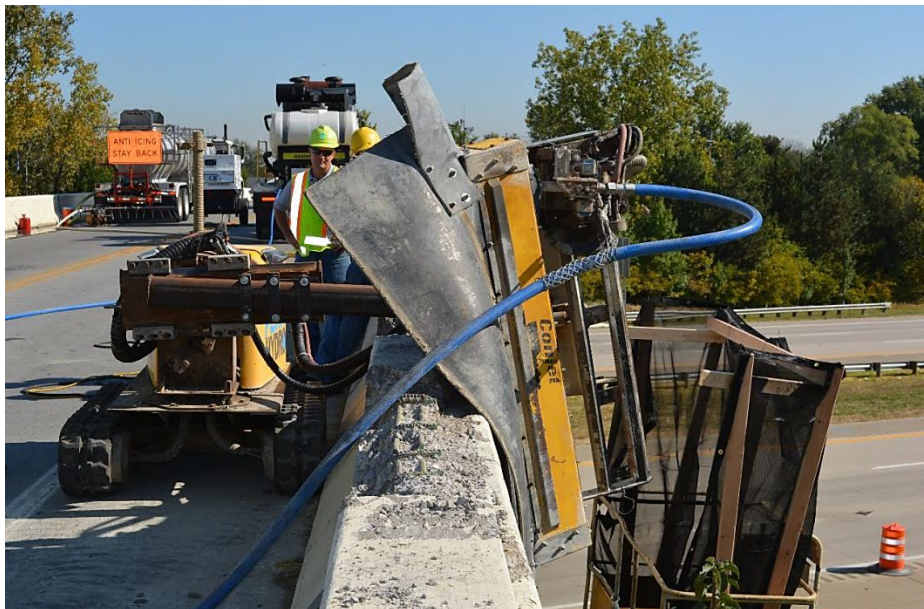
Figure 4: Hydrodemolition robot with articulated head for vertical surfaces

Phase I identified hydrodemolition as potentially the most efficient and safest alternative to pneumatic handheld chipping hammers for concrete removal. The main difficulty in using hydrodemolition is that the method is normally used on horizontal surfaces and most hydrodemolition equipment is designed for a horizontal surface. Equipment for vertical surfaces has a limited ability to reach high places, meaning platforms would be needed for bridges; an impractical situation when the bridge is over traffic. The hydrodemolition robot selected for field tests has a head on an articulated arm capable of performing hydrodemolition on both the inside and outside vertical surfaces of the parapet wall as well as on horizontal surfaces (**Figure 4**). In cases of a vandal fence, the robot is light enough to put on a lift to reach outside surfaces.

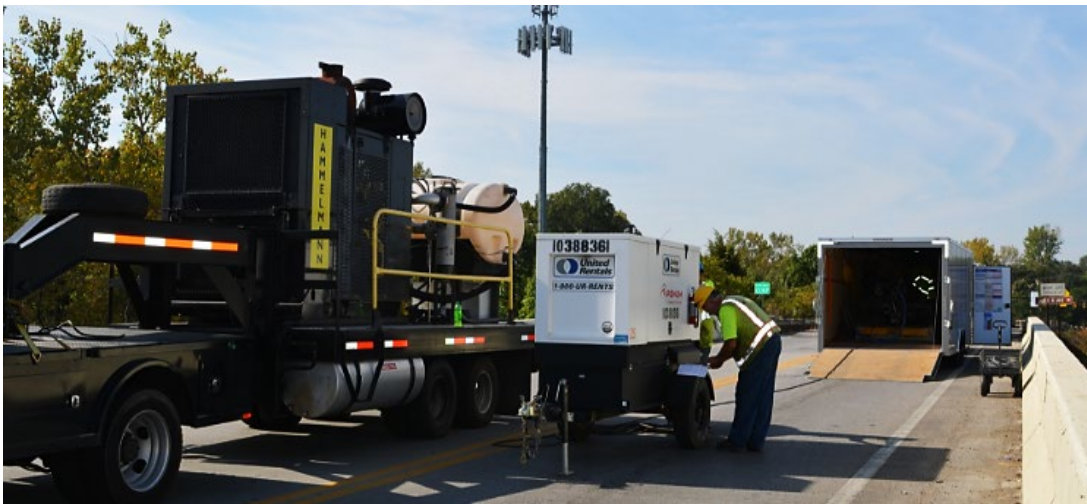
Figure 6: Hydrodemolition equipment setup

2. Set up equipment. The general contractor and ODOT arrived on-site with the equipment **Figure 6**. Set-up took approximately **one hour** and consisted of the following:

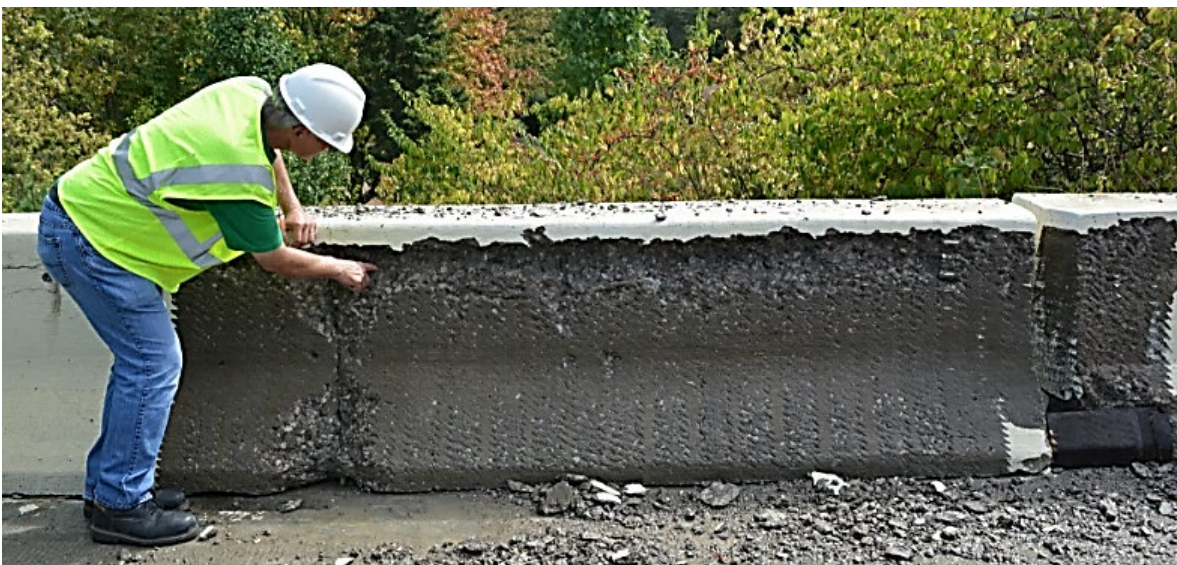
Figure 11: Interior parapet wall profile after hydrodemolition using the spray nozzle

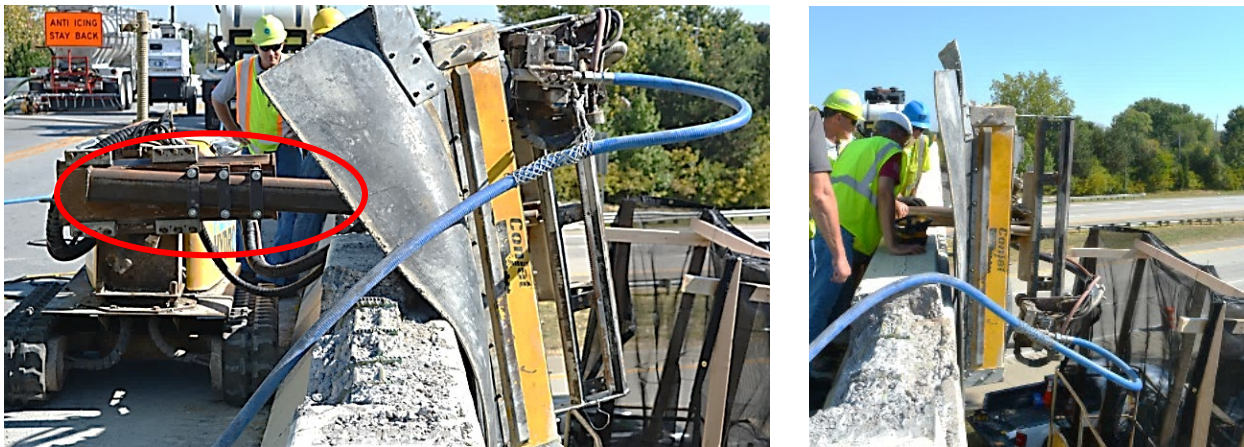
Figure 12: Exterior parapet wall hydrodemolition set-up

On September 26th, the hydrodemolition robot was modified to remove unsound concrete on the outer face of the parapet wall, see **Figure 12**. The modification added an extension to the articulated arm of the machine (red circle). Unfortunately, this modification did not allow the hydrodemolition head to reach the bottom of the parapet wall and tended to cause the robot to tip slightly on account of the weight of the beam added to the arm. In areas where the arm was able to reach, it was able to remove concrete effectively and efficiently. Subsequent discussions with the manufacturer revealed that other models of the robot have arms with sufficient reach for the proposed situation.

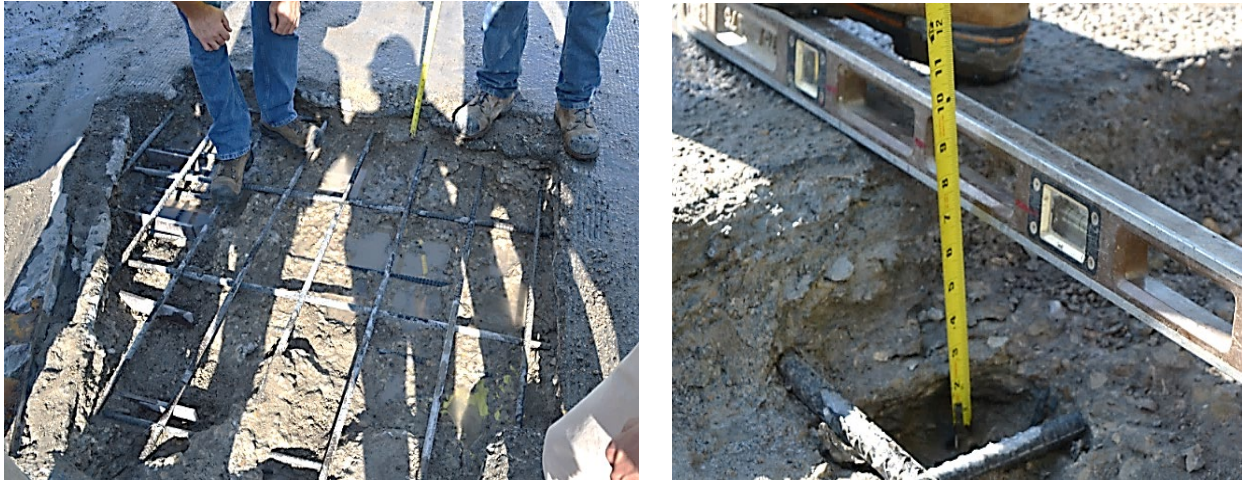
Figure 16: Hydrodemolition on the Gantz Rd. concrete bridge deck

As can be seen in **Figure 16** below, none of the reinforcing bar were damaged during the hydrodemolition process for bridge deck repair.

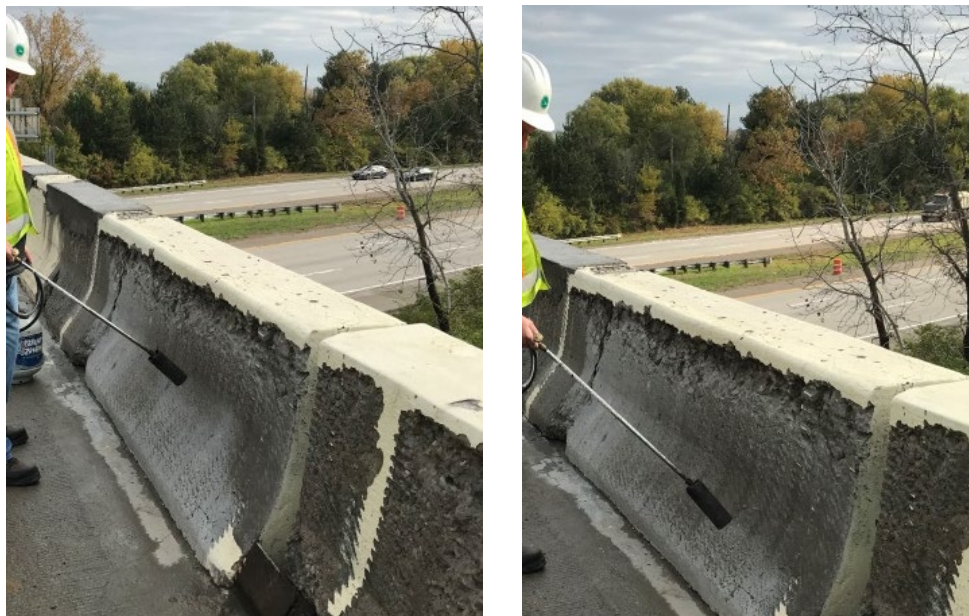
Figure 28: Drying the surface of the parapet walls

Figure 28 shows how a torch was used in order to get moisture content below 5% for application, because the parapet surfaces were wet from rain the day before and earlier in the day.

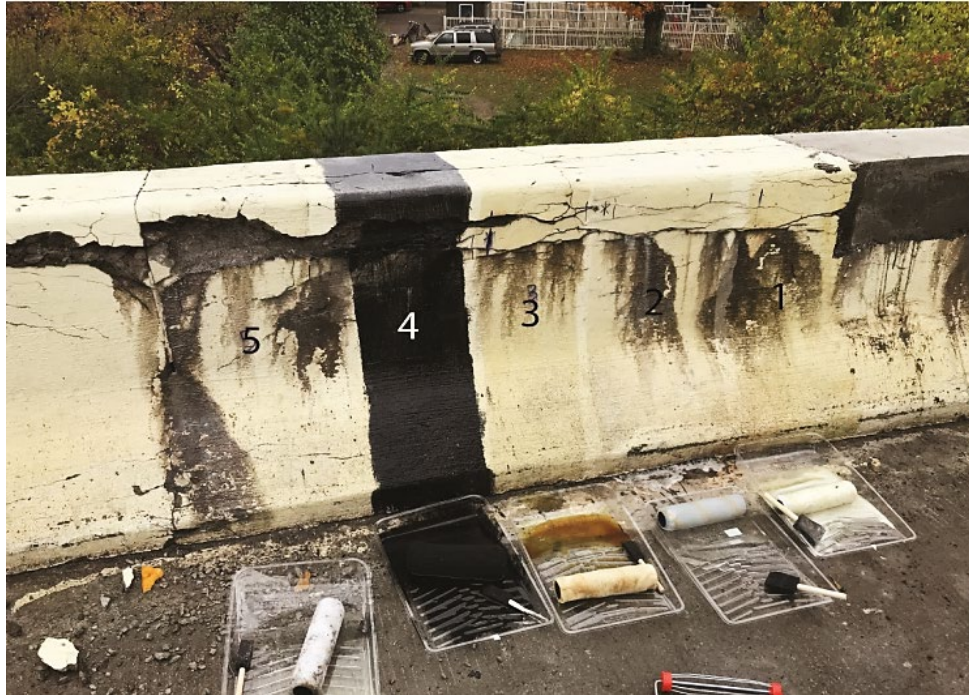
Figure 34: Application No. 2 of polyaspartic primer coatings

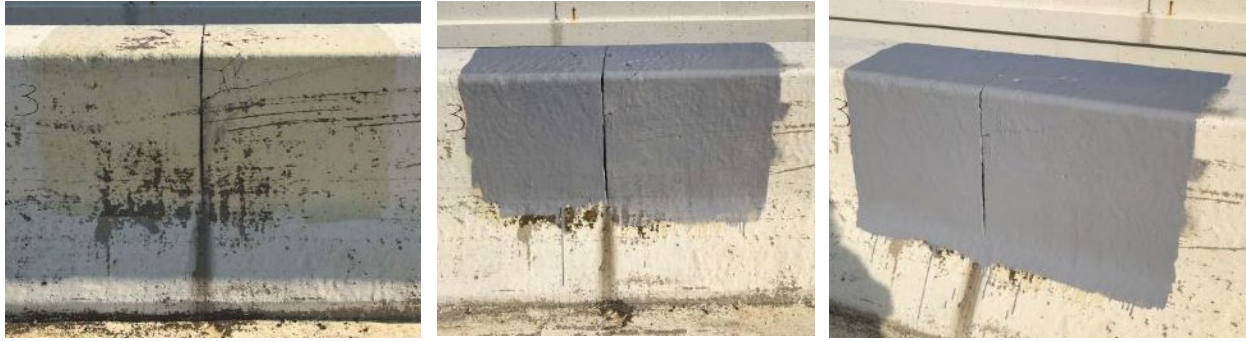
e) Product 3: Primer $\xrightarrow{\hspace{10em}}$ Top Coat
Figure 38: Photos of polyaspartic primer and top coat applications on SR142

After application the ODOT workers noted that application was easy, but suggested an air sprayer. They did not want to bend over to coat the parapets. They appreciated the products with tints, because they could easily coat over any graffiti. Additionally, after the second application tiny air bubbles appeared in the coatings (**Figure 39**). This is known as outgassing. Outgassing refers to the action of air or gas releasing from the concrete which causes pinhole bubbles (Lux, 2014). This condition is typically temporary, but usually occurs if the concrete has excessive air, or when moisture is leaving the surface, and/or the air is moving in and out of the slab as a result of temperature changes (Lux, 2014). This is why the manufacturers typically require moisture content in the concrete at a level below 5%.

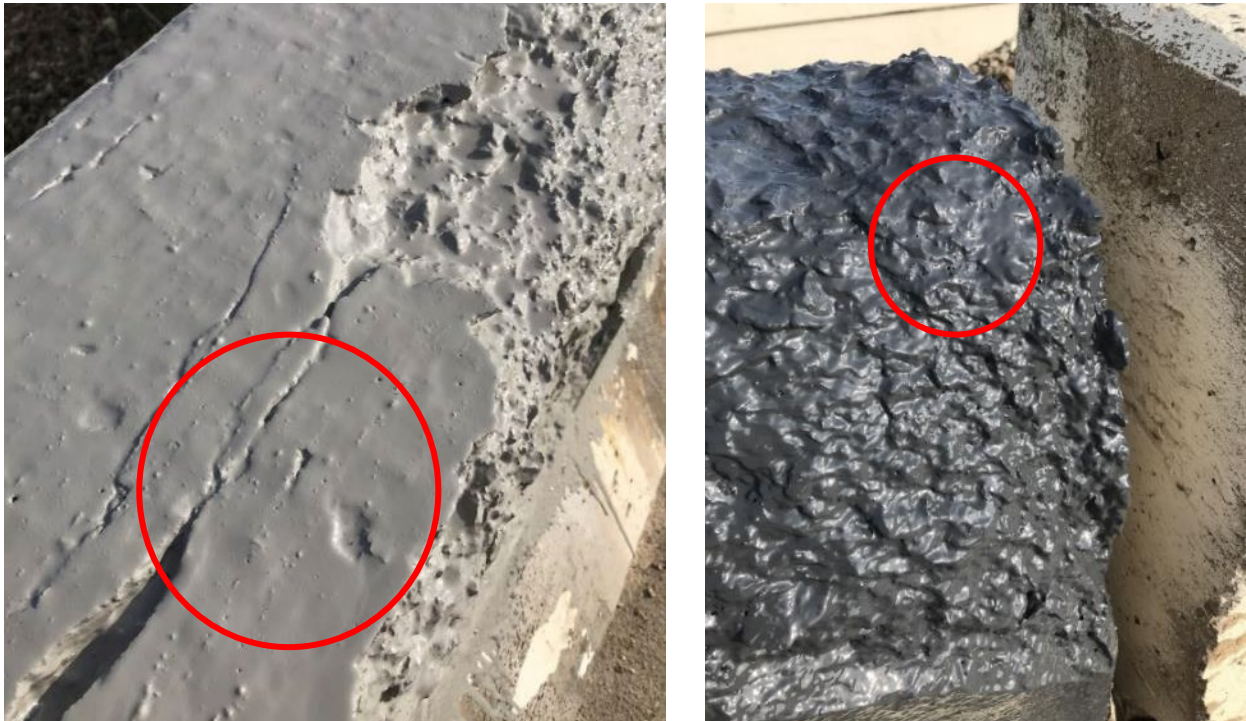
Figure 39: Air bubbles found in product 1 and product 4 after Application No. 1 on SR142

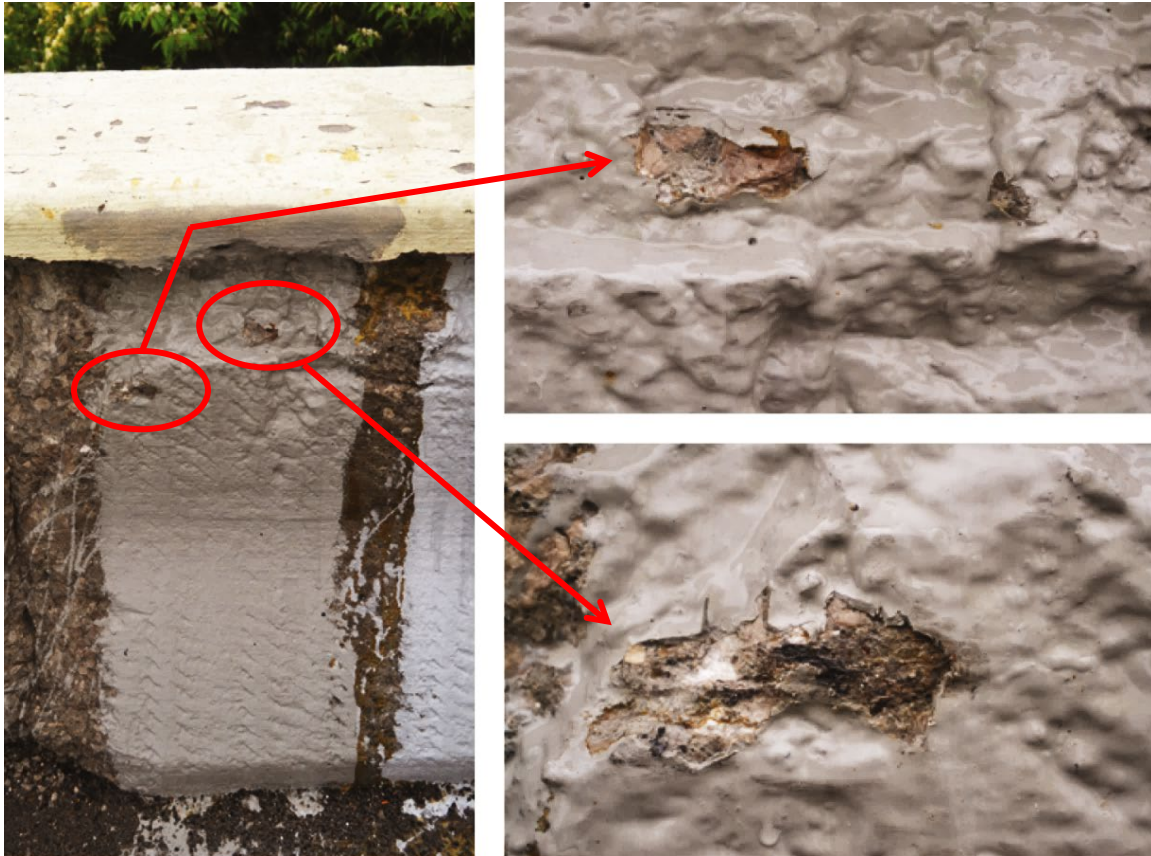
Figure 46: Product 1 substrate and polyaspartic coating failure

An additional note regarding product 1, chunks of the polyaspartic coating appeared to be missing from the parapet wall. The failure of the coating appeared to be a substrate failure. It was hoped that the coating would restrain any pieces of concrete that had come loose and prevent them from falling. This did not appear to be the case.

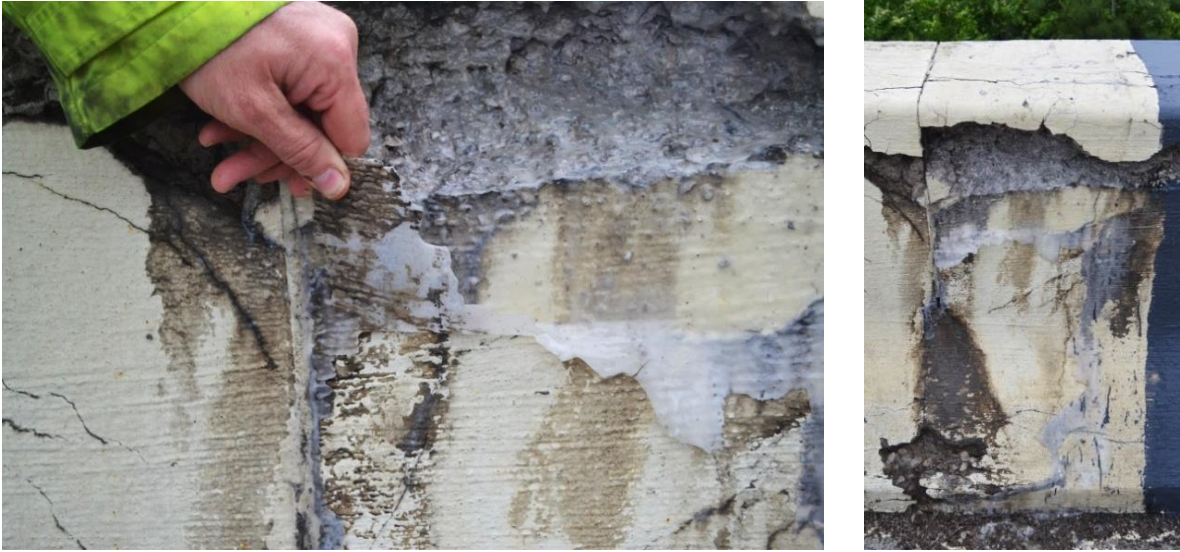
Figure 47: Failed product 5 of Application No. 2 on Gantz Rd. Bridge

The first observation is that proper preparation is important. During application back in November, a second coat was applied to product number 5 before the primer was tacky and the coating came off onto the paint roller instead of sticking to the concrete surface. This likely led to a failure of the coating. As shown the photos below, the polyaspartic polyurea was missing from most of the parapet wall after one winter. It appeared as if the coating had just flaked off as shown in **Figure 47**. This could be a result of the problems with the application of product 5, the cold/wet weather or that the product just does not adhere well to unprepared concrete surfaces.

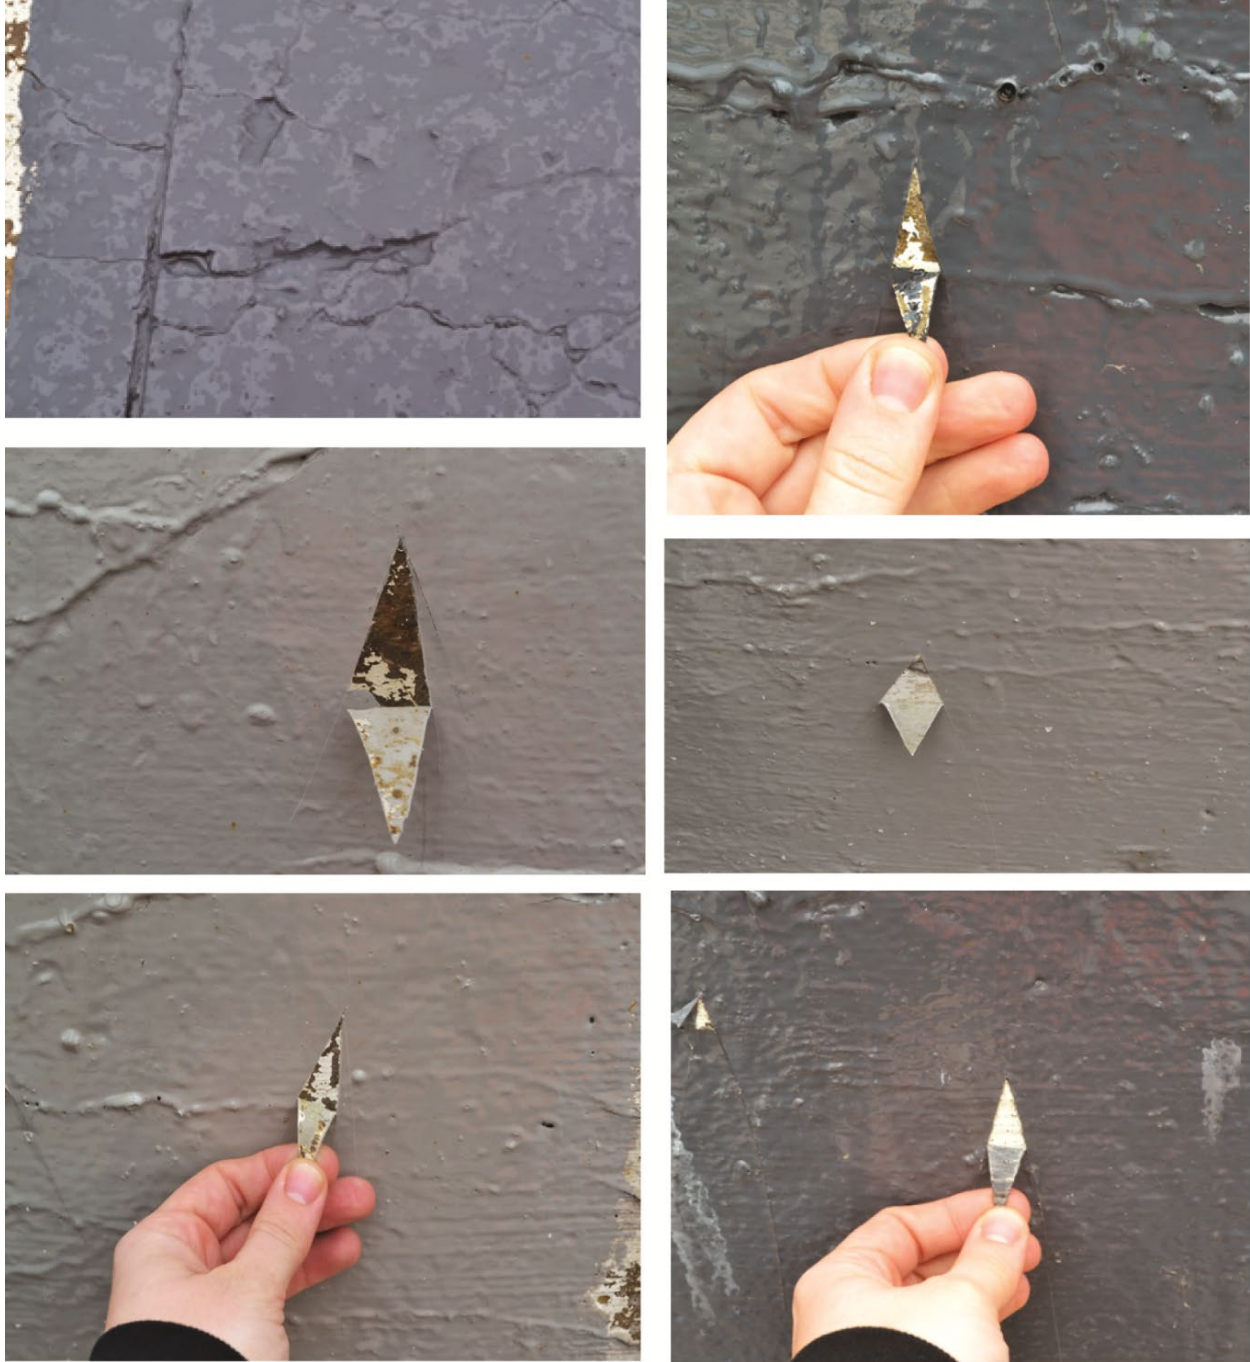
Figure 49: V-notch test on unprepped parapets with existing epoxy from Application No. 2 on Gantz Rd. Bridge

For the four coatings which did appear to bond to the epoxy, the notch test was used. Here the coating pulled off the existing epoxy surface, but it was observed that the epoxy came off with the polyaspartic. The polyaspartic appeared to bond very well to the epoxy and the failure was in the bond of the epoxy to the concrete. It was noted that if there were any reasonably large gaps in the epoxy, the polyaspartic bonded well to the concrete beneath. Therefore, the prior application of the epoxy did not appear to affect the bond of the polyaspartic in areas where the epoxy had come off. The polyaspartic applied over the epoxy seemed to stay intact. It was not separated until it was pulled off with the notch test. This may still provide a protective coating, but is likely to be a short term solution. The polyaspartic may provide protection for a year or two until a permanent repair is made.

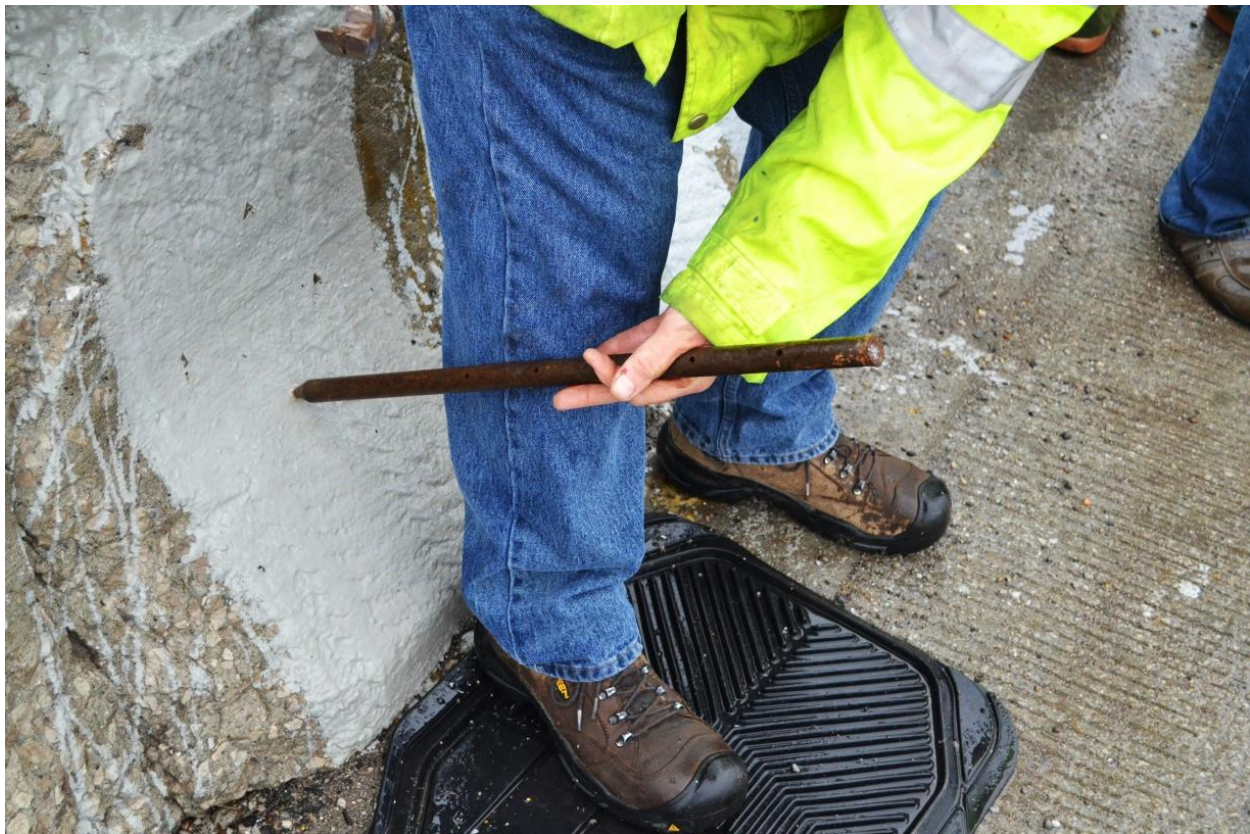
Figure 50: Impact test on parapets with stake and hammer

The impact test consisted of using a stake and hammer to impact the sides of the parapet (**Figure 50**). The intent of striking the parapets with the stake was to dislodge some concrete see if the coating would hold loose pieces of concrete after impact. The photo below displays how a stake and hammer was used to impact the coated parapet walls. For some of the walls, the stake was struck five times. For others, the stake was intentionally placed in areas and struck until a chunk of the concrete parapet became detached. However, the detached chunks were held to the parapet wall by the coating itself.

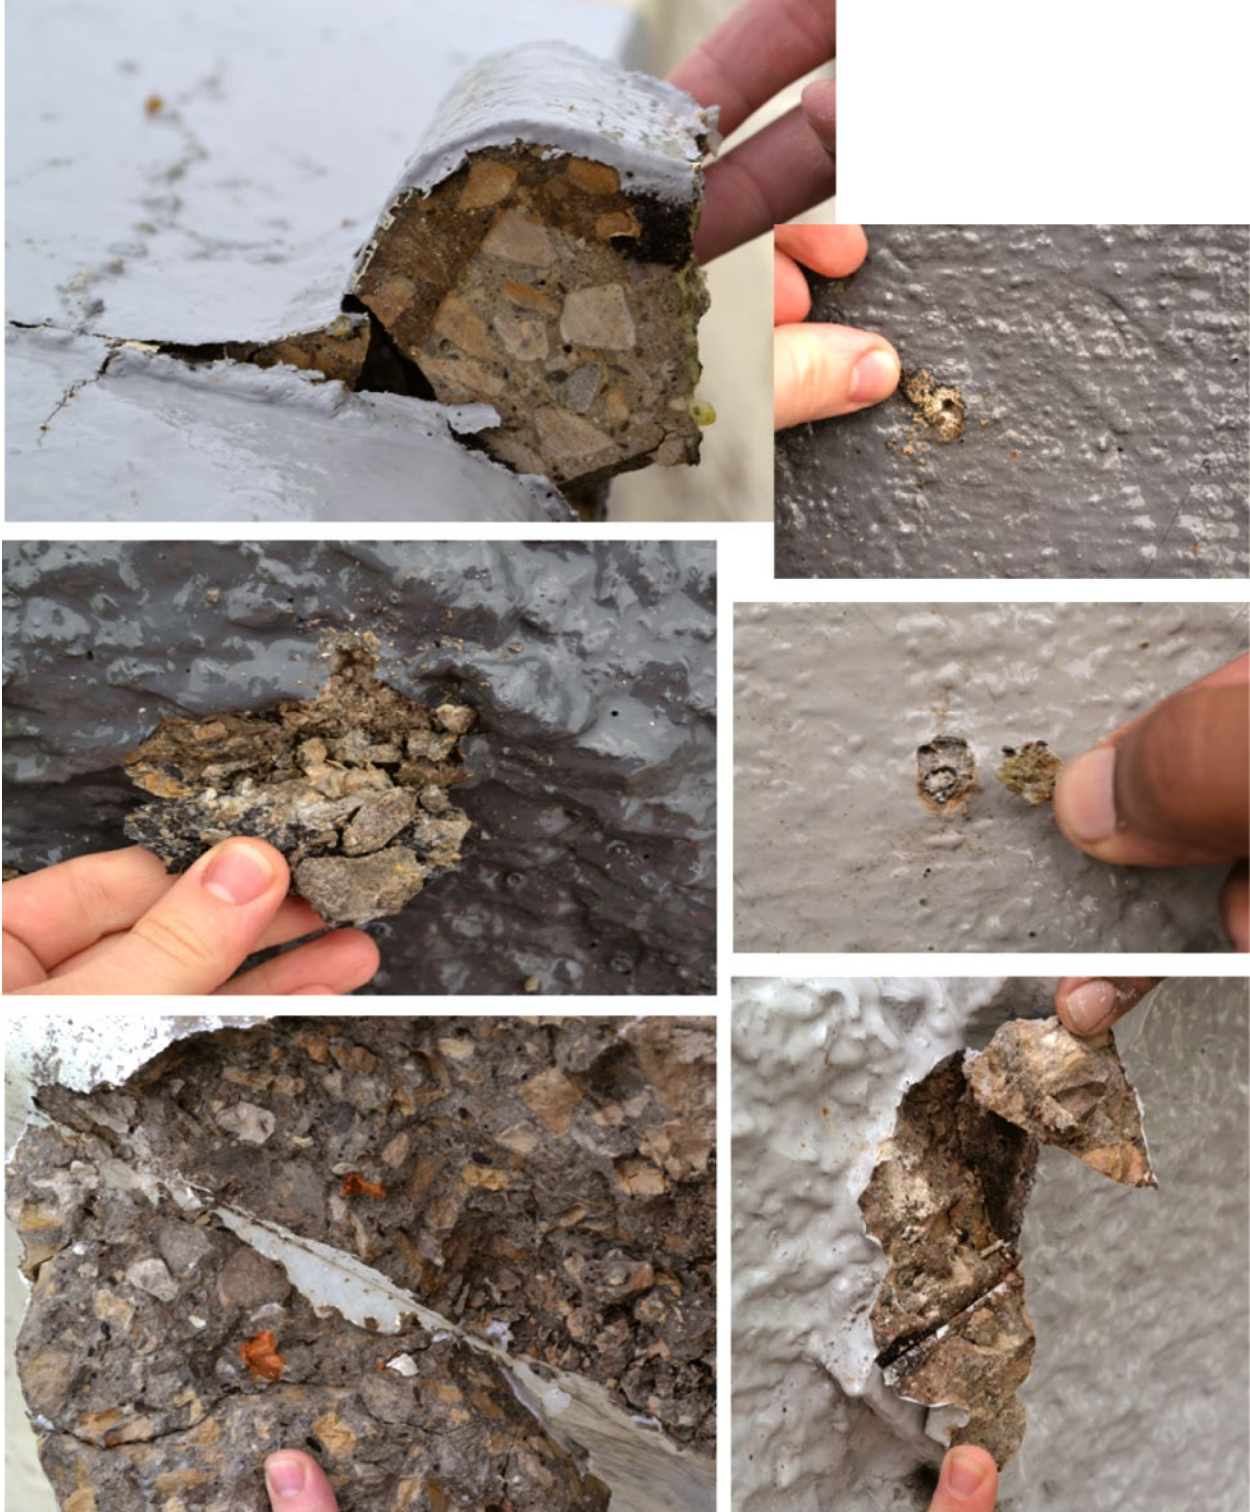
Figure 51: Impact test on parapets with existing epoxy from Application No. 1 on SR142 Bridge over I-70

After completing this test in the field, it was observed that the polyaspartic does in fact hold the loose concrete pieces to the parapet wall after impact, see **Figure 51**.

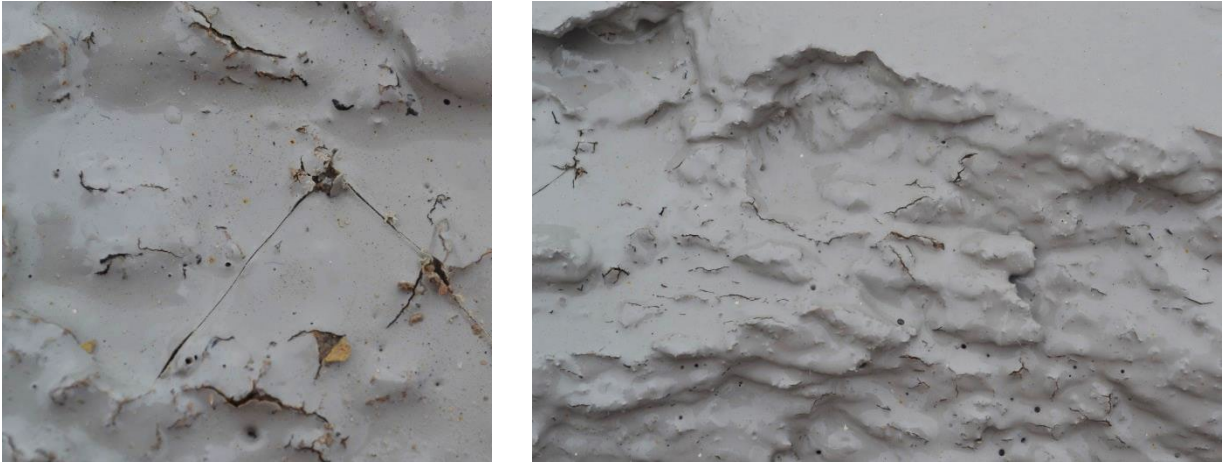
Figure 52: Small cracks observed in rough aggregate areas of the coated parapet walls

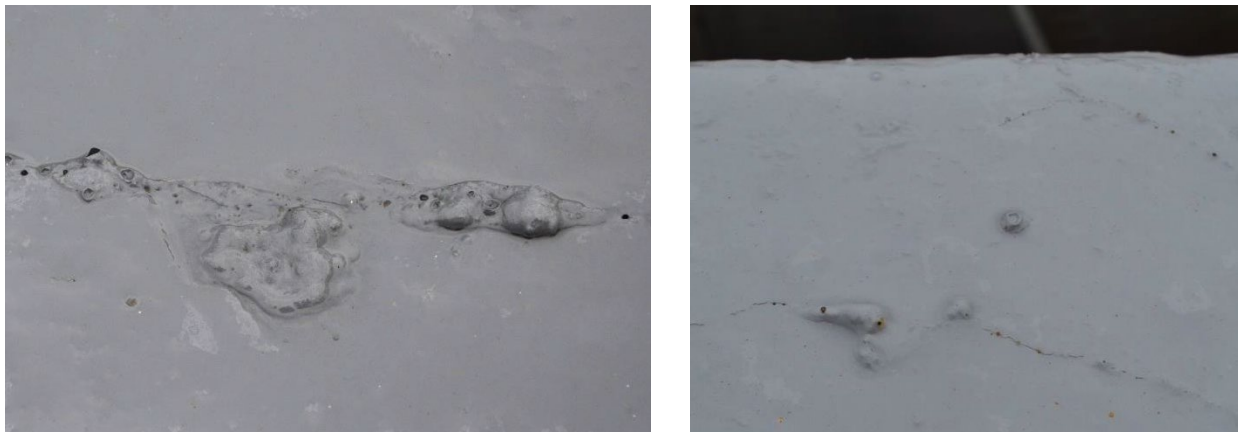
Figure 53: Bubbled polyaspartic product observed after one winter

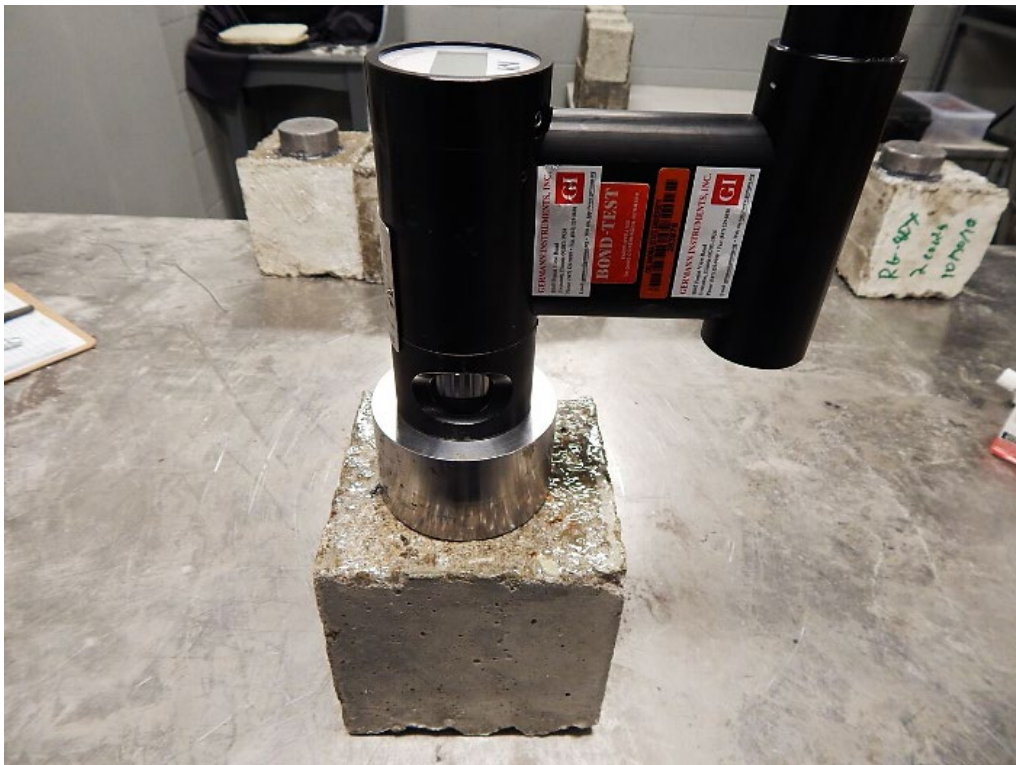
Figure 54: Example of Pull-off Testing

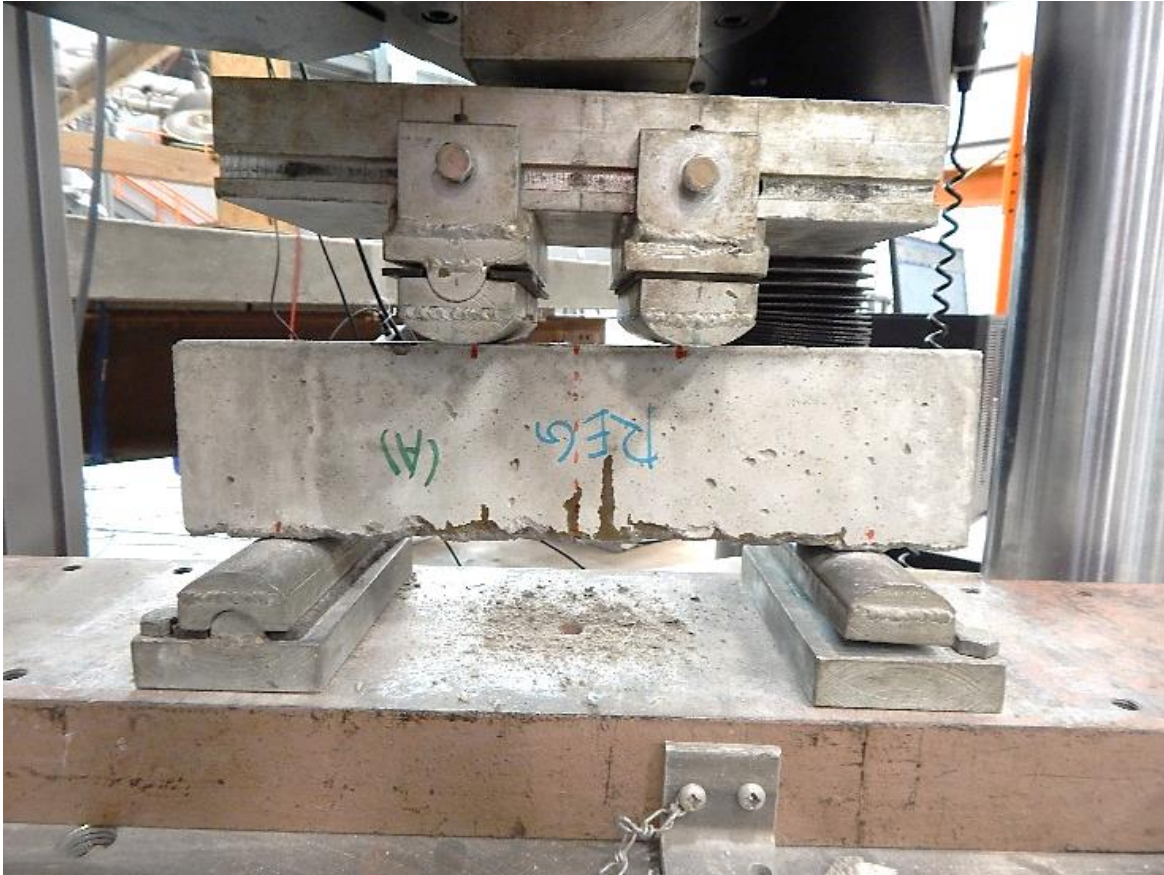
Figure 55: Flexural test setup

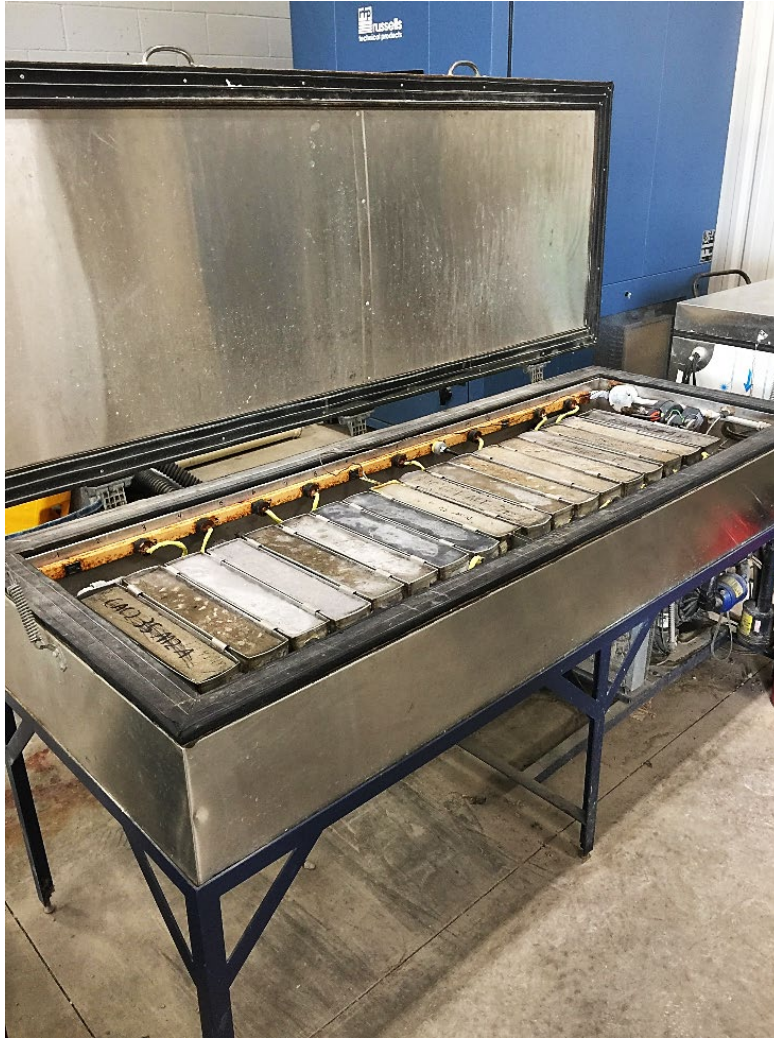
Figure 56: Freeze-thaw chamber with sample beams

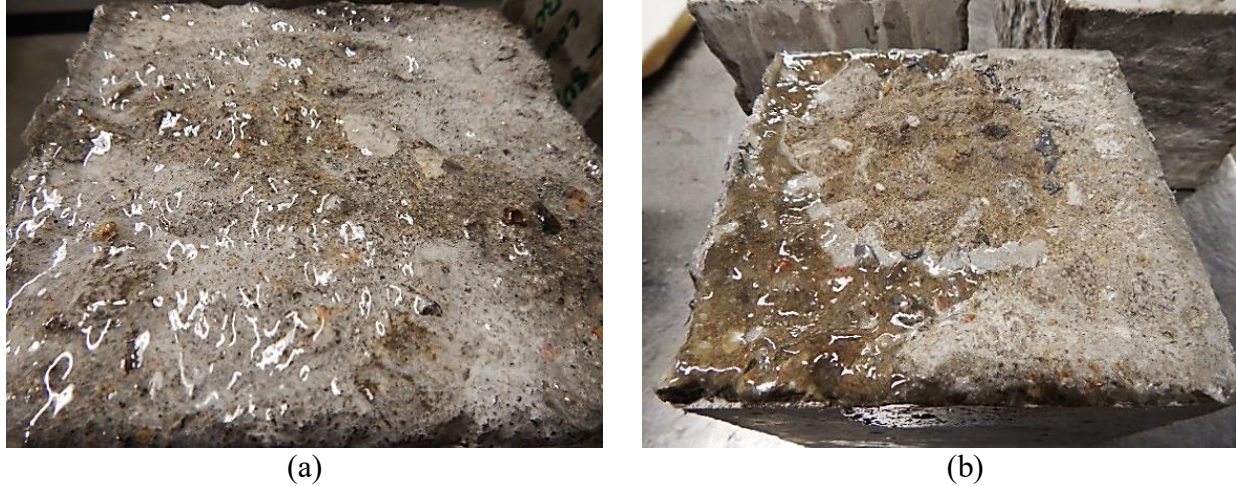
Figure 57: (a) Rust-Oleum RG-80X disbondment prior to testing flaking and (b) VersaFlex Clear Seal flaking from surface

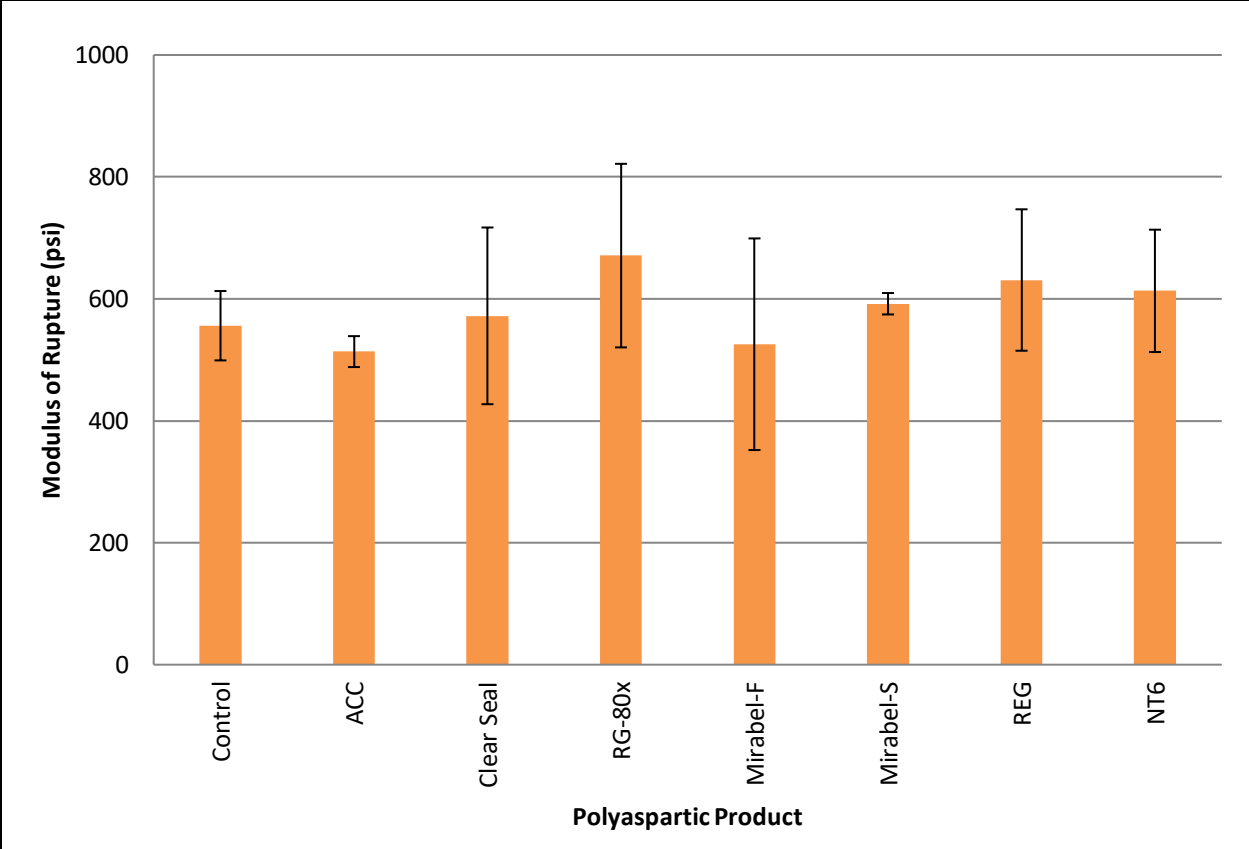
Figure 80: Flexural test results comparison (modulus of rupture) for scaled standard beams, all products

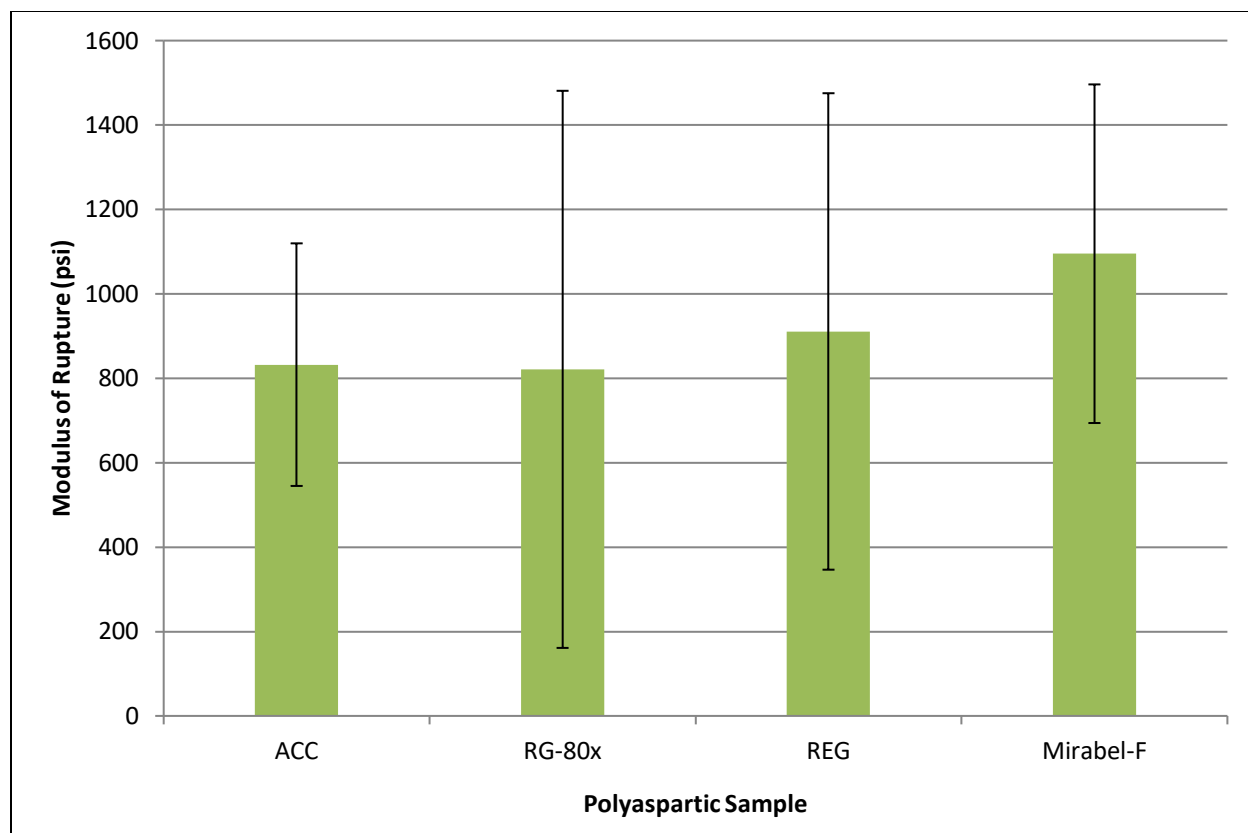
Figure 81: Flexural test results (modulus of rupture) comparison for standard beams, all products

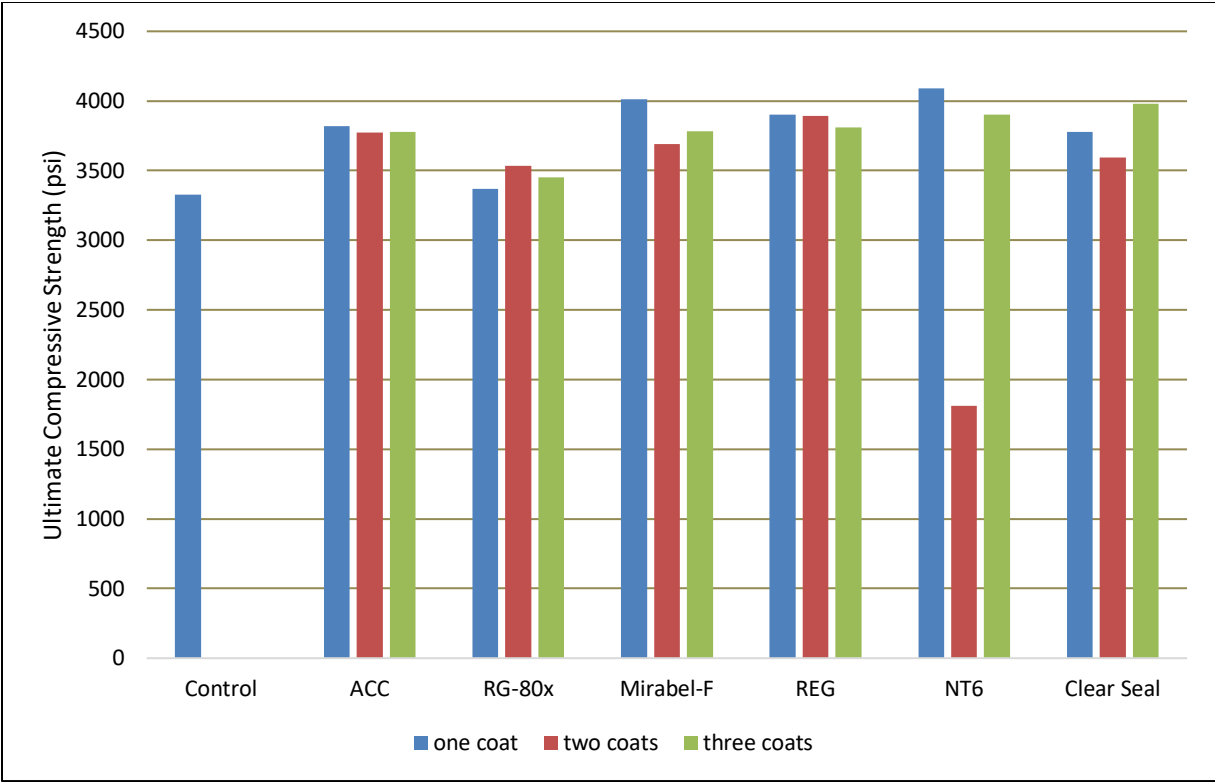
Figure 84: Compression test results comparison for all products: one, two and three coats samples.
