Evaluation of Maintenance Procedures for Bridge Spalling on Parapet Walls

The Ohio Department of Transportation
Office of Statewide Planning & Research

February 2020

Phase II – Final Report

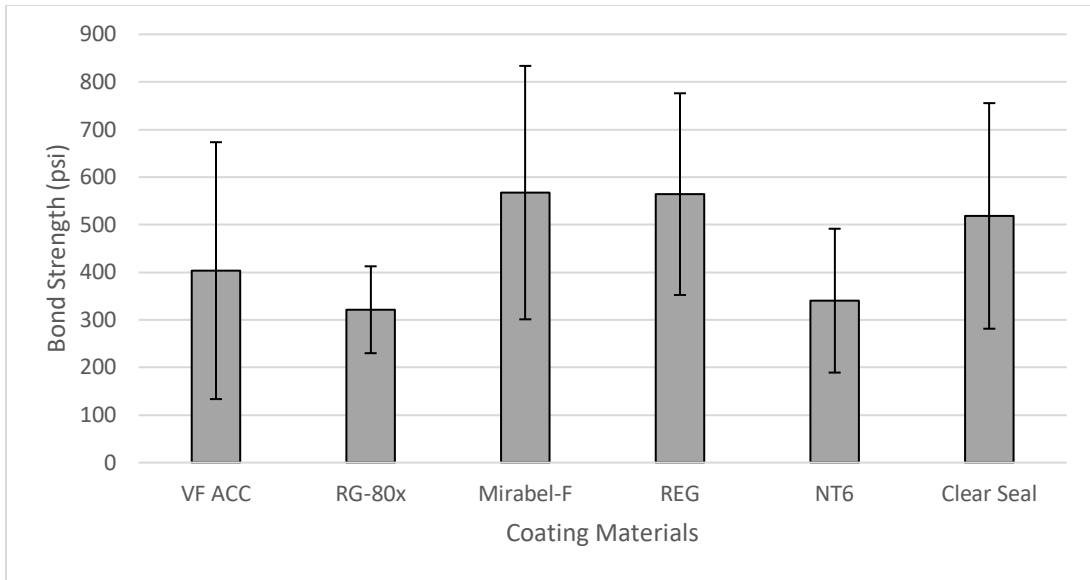
Figure 101: Pull-off test results comparison for all products, salt solution ponding samples
