# **CRASH TEST EVALUATION OF A PROTOTYPE ZIG-ZAG BOX BEAM END TERMINAL: MASH TEST DESIGNATION NO. 3-31**

## **MIDWEST ROADSIDE SAFETY FACILITY**

## **NEW YORK STATE DEPARTMENT OF TRANSPORTATION**

MwRSF Research Report No. TRP-03-391-20

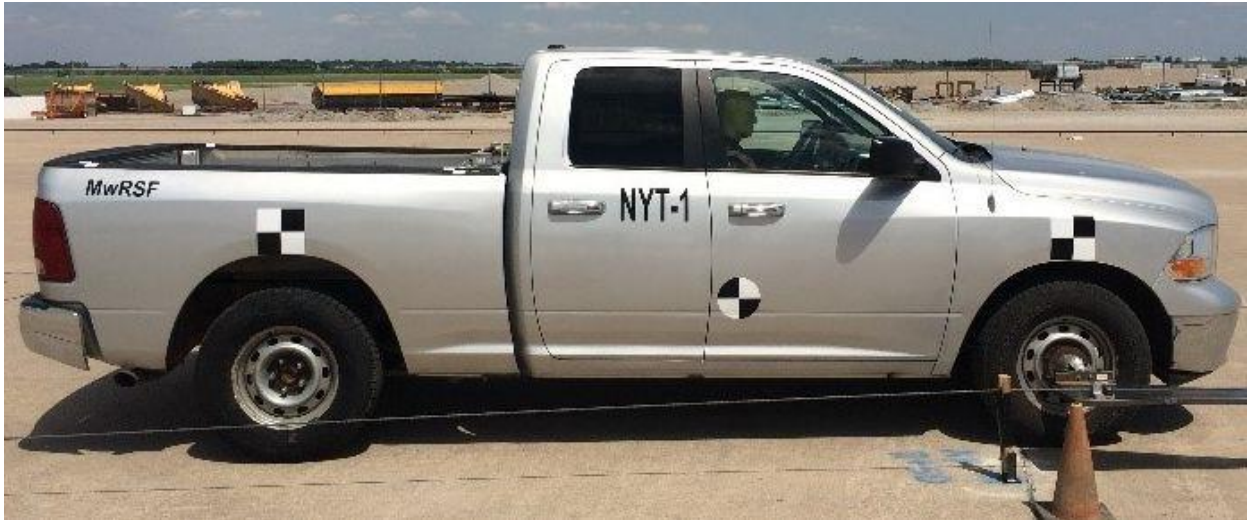
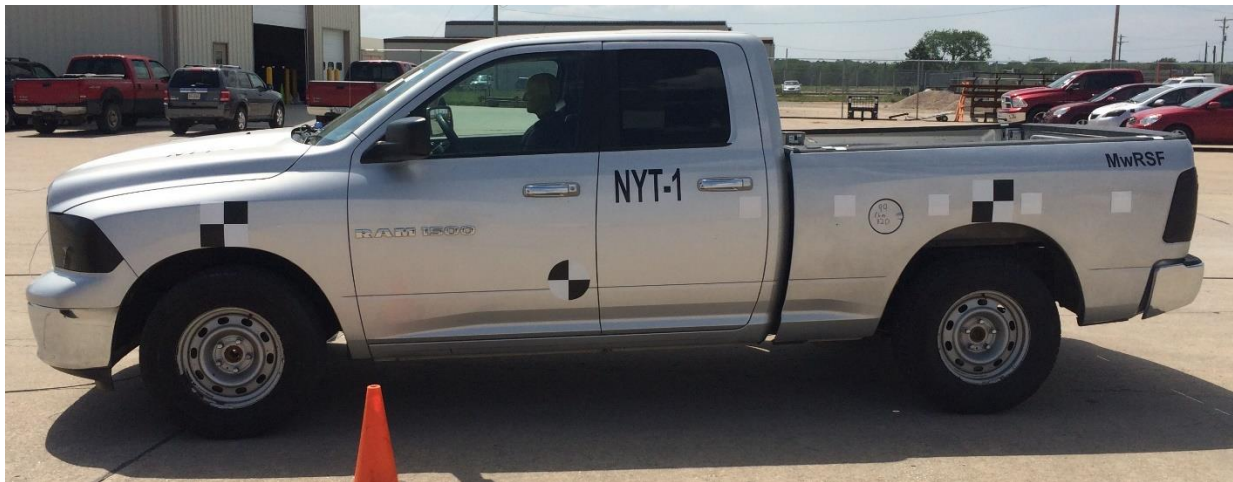
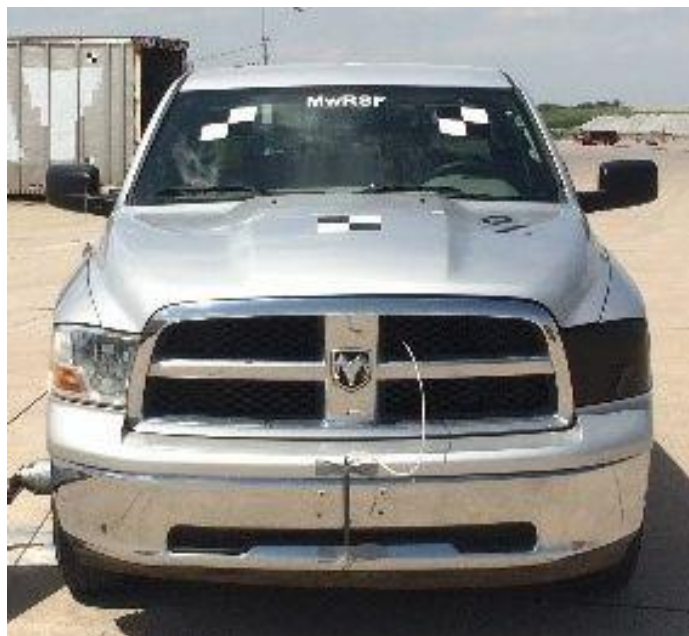
Figure 39. Test Vehicle, Test No. NYT-1

For test no. NYT-1, a 2011 Dodge Ram 1500 quad cab pickup truck was used as the test vehicle. The curb, test inertial, and gross static vehicle weights were 5,071 lb (2,300 kg), 5,000 lb (2,268 kg), and 5,158 lb (2,340 kg), respectively. The test vehicle is shown in Figures 39 and 40, and vehicle dimensions are shown in Figure 41. Pre-test photographs of the vehicle's undercarriage were unavailable.

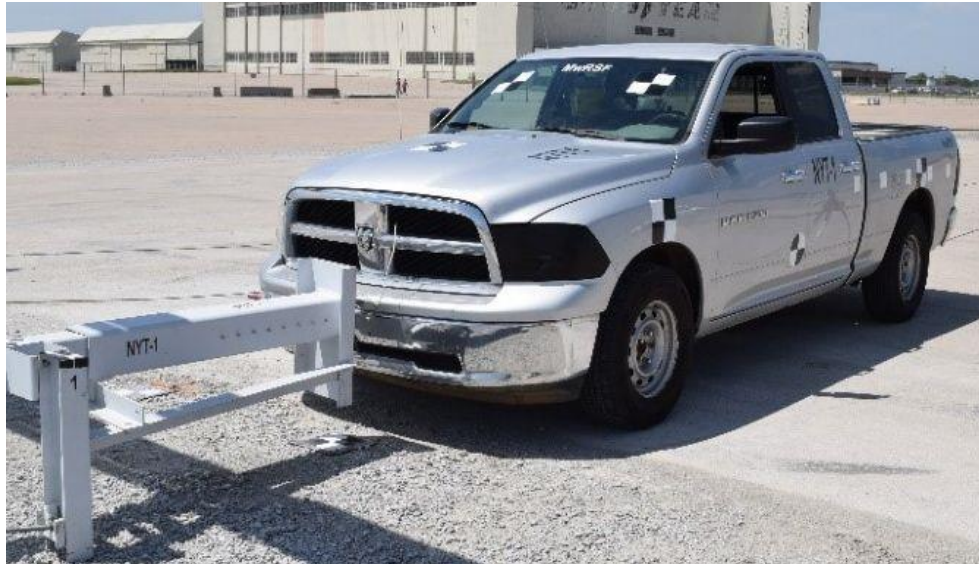
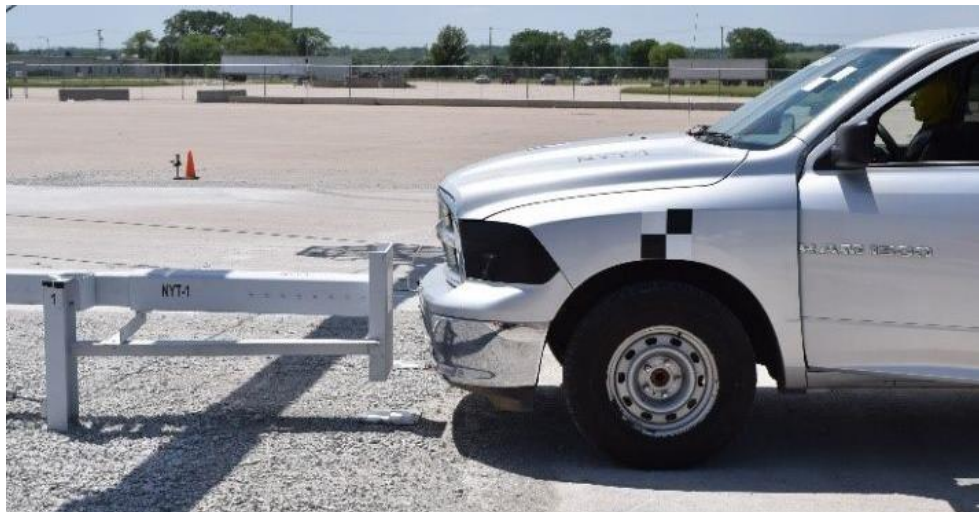
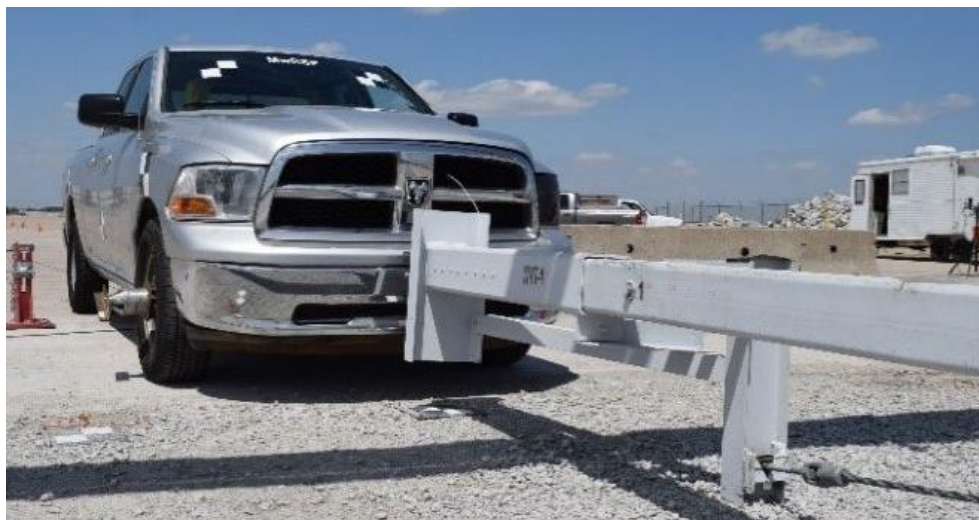
Figure 44. Impact Location, Test No. NYT-1

Initial vehicle impact was to occur at the upstream face of the terminal, as shown in Figure 44, which was selected using Table 2-3 of MASH 2016. The 5,000-lb (2,268-kg) quad cab pickup truck impacted the New York zig-zag box-beam terminal at a speed of 62.7 mph (101 km/h) and at an angle of 0.1 degrees. The actual point of impact was on the upstream end of the terminal. The vehicle came to rest 80 ft – 3 in. (24.5 m) downstream from the impact point and 6 in. (152 mm) from the back of the system, facing the system.

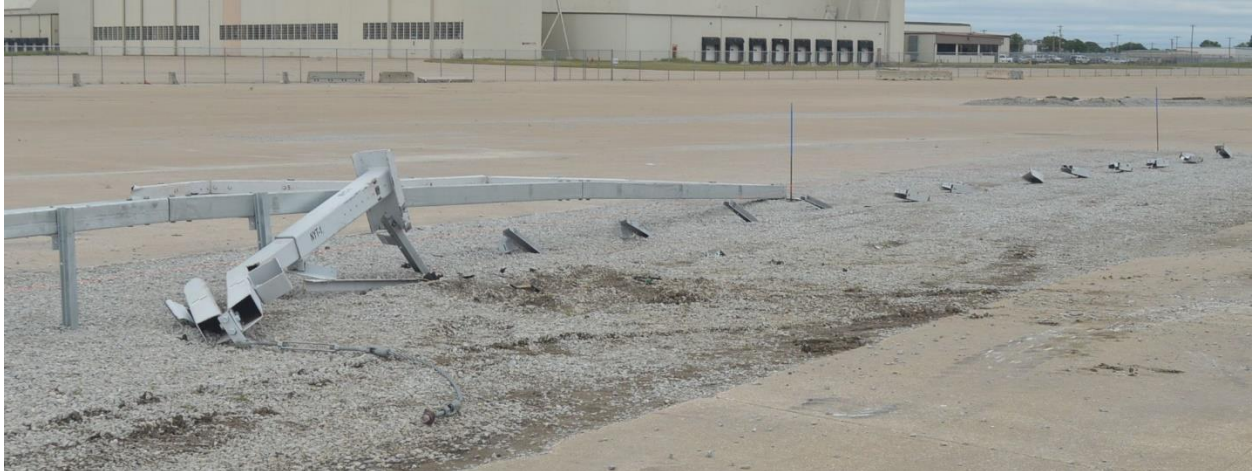
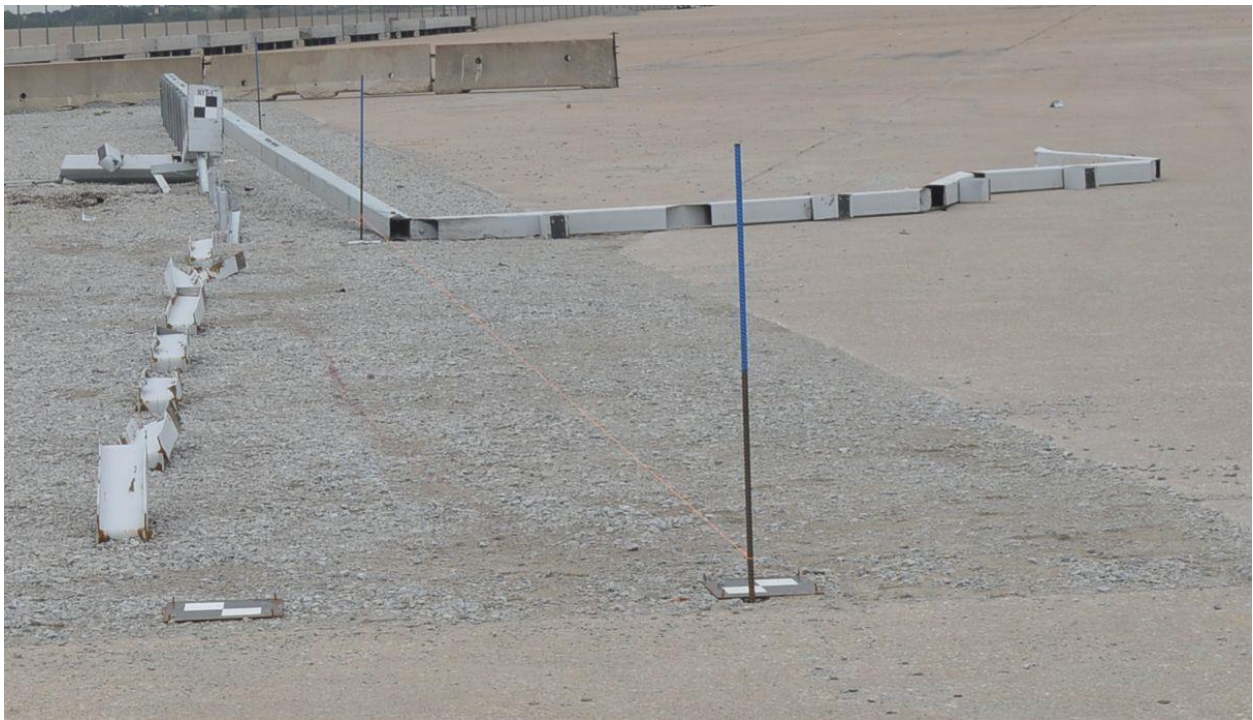
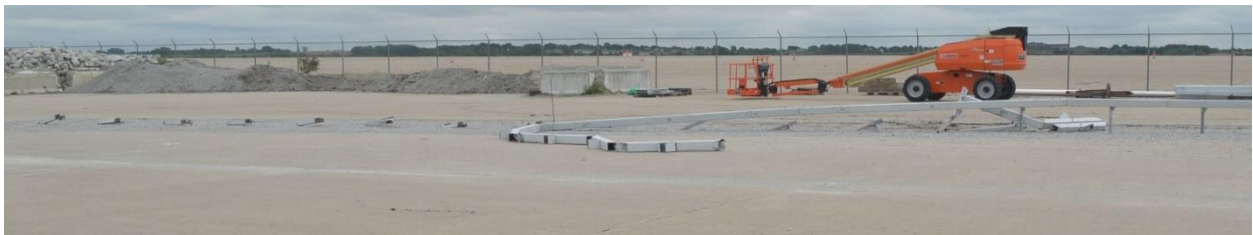
Figure 50. System Damage Overview, Test No. NYT-1

Damage to the barrier was moderate, as shown in Figures 50 through 57. Barrier damage consisted of contact marks on the impact head and box beam, vertical tears at the V-shaped sections, deformations to the box beam, and deflection of the posts. The length of vehicle contact along the barrier was approximately 80 ft – 3 in. (24.5 m) beginning at the front of the impact head.

The maximum lateral permanent set of the barrier system was 266 in. (6,756 mm) which occurred at the rail initially attached to post no. 4, as measured in the field. The maximum lateral dynamic barrier deflection was 326.7 in. (8,299 mm) which occurred at the rail initially attached to post no. 4, as determined from high-speed digital video analysis.

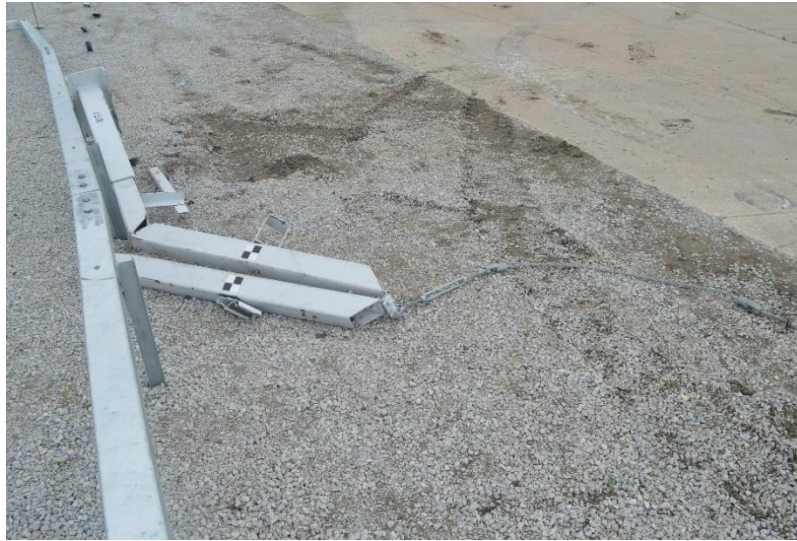
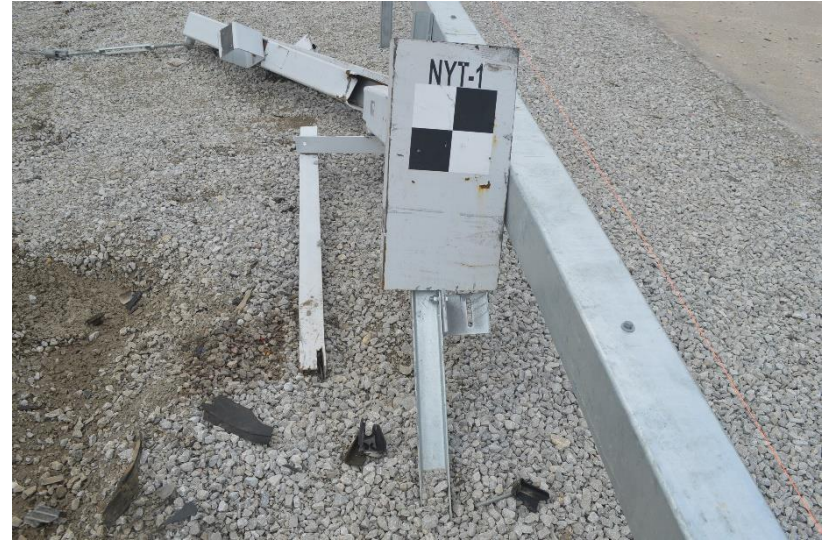
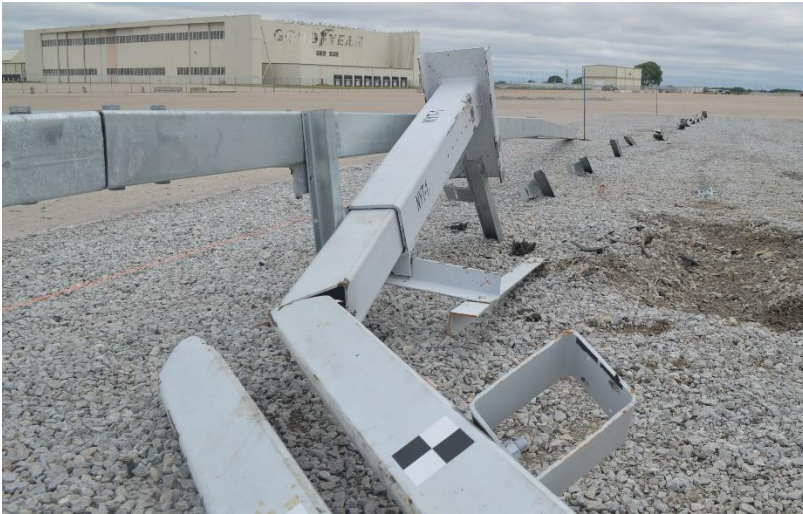
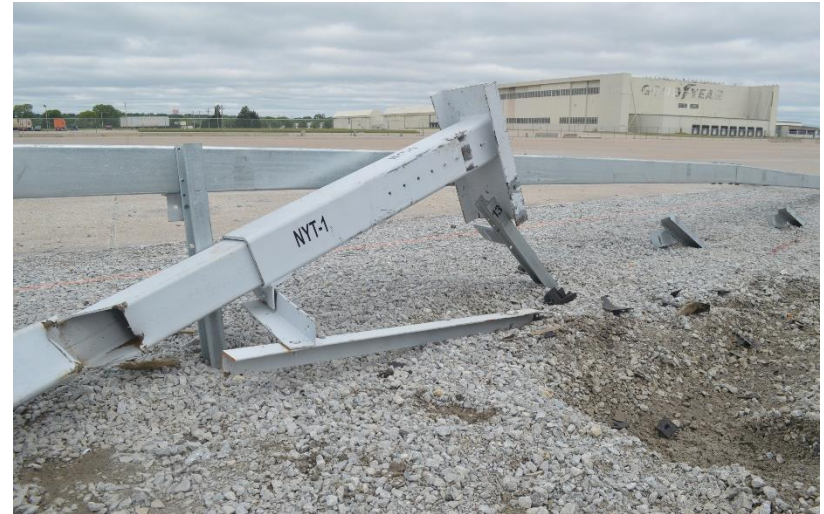
Figure 51. End Terminal Damage, Test No. NYT-1

Contact marks found on the front of the impact head measured 35 in. (889 mm), 24 in. (610 mm), and 23 in. (584 mm). An 8-in. high by 3-in. wide (203-mm by 76-mm) contact mark was found at the bottom of the back face of the impact head. A 2½-in. (64-mm) dent was visible on the front face of the impact head box beam. A 4½-in. (114-mm) bend was located at the downstream corner of the vertical plate, which bent ¾ in. (19 mm) backward. Dents were found on the V-shaped section on the rail between post nos. 6 and 7. A 7-in. (178 mm) tear was found on the V-shaped section on the rail between post nos. 6 and 7. Smaller contact marks, bends, tears, and dents were located on the impact head, V-shaped sections, and box beam.

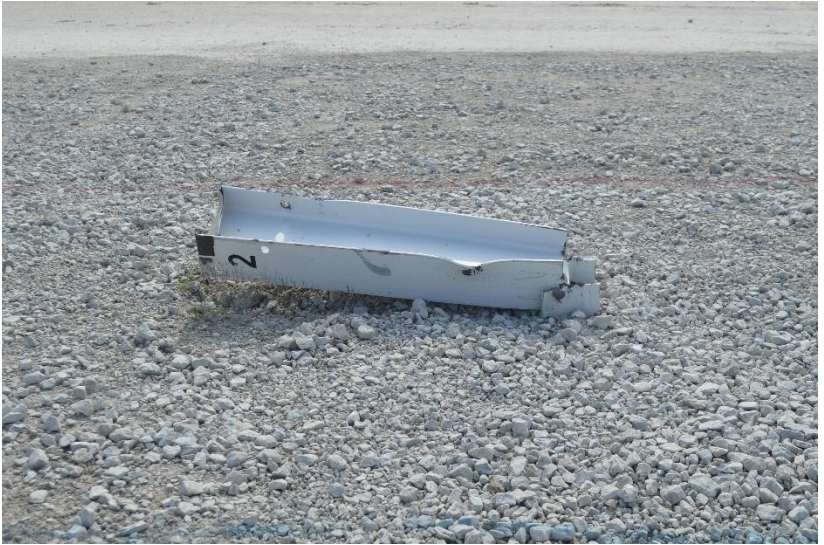
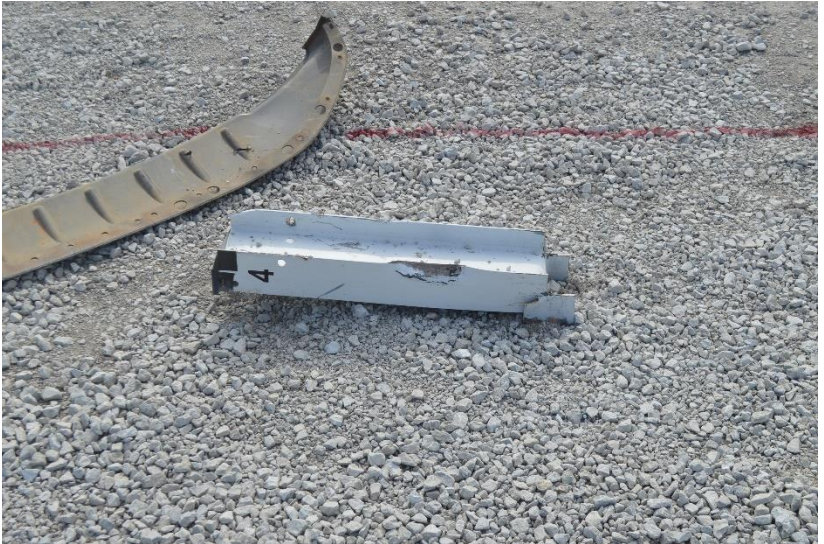
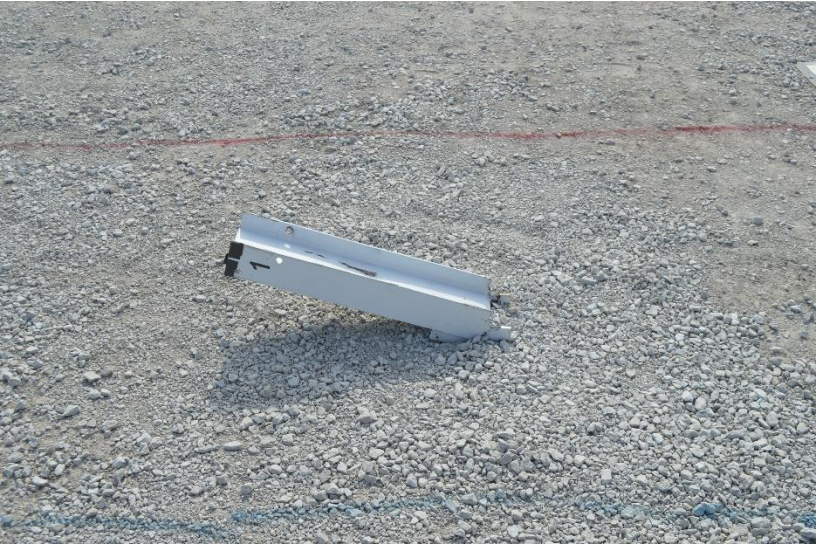
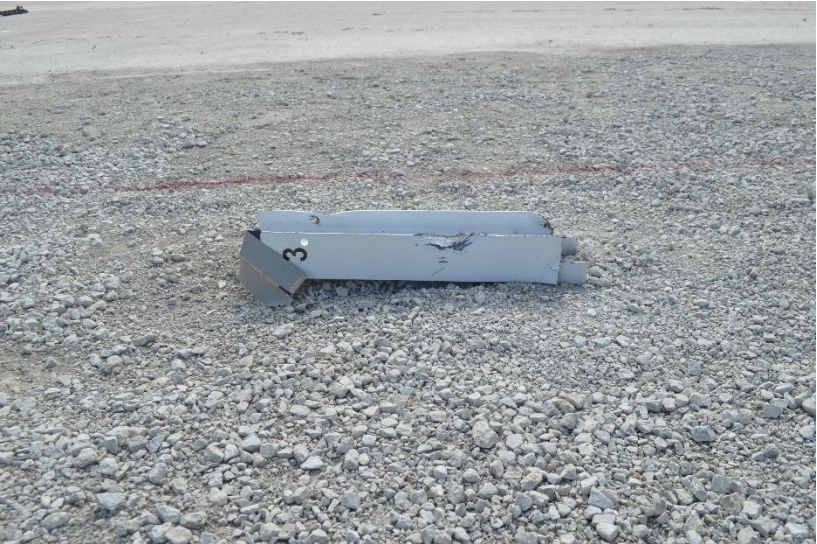
Figure 52. System Damage, Post Nos. 1 through 4, Test No. NYT-1

Soil heaves formed at the bases of post nos. 7, 9, and 11 through 13, and soil craters were found at the bases of post nos. 8 through 10, 13, and 15. Post nos. 1 through 13 were bent downstream at the ground line. For post nos. 1 through 8, four 1-in (25-mm) tears were found at the saw cuts, two on the upstream flange and two on the downstream flange. Dents, gouges, and contact marks were found on post nos. 1 through 14. The box beam disengaged from post nos. 12 and 13. All blockouts from post nos. 2 through 8 disconnected from their respective posts but stayed connected to the box beam. The blockout from post no. 1 disengaged from both the post and the box beam, and was displaced 32 ft – 6 in. (9,906 mm) laterally behind and 152 ft – 7 in. (46,507) downstream from its original position. The blockouts from post nos. 3, 4, and 7 were deformed. The rail-to-post L-brackets remained attached to post nos. 12 through 26. The L-bracket of post no. 14 rotated, but the L-bracket remained intact and fastened to both the post and the box-beam rail. The L-brackets from post nos. 11 through 13 disengaged from the box beam but stayed attached to their respective posts. The L-brackets from post nos. 9 and 10 disengaged from both the box beam and their respective posts. The remaining posts, nos. 15 through 26, appeared to be undamaged.

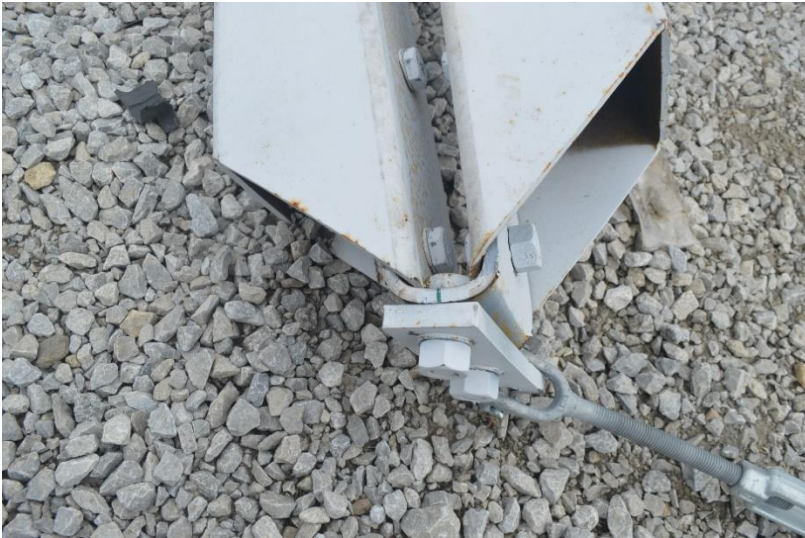
Splice 2-3

Figure 57. Splice Damage, Test No. NYT-1

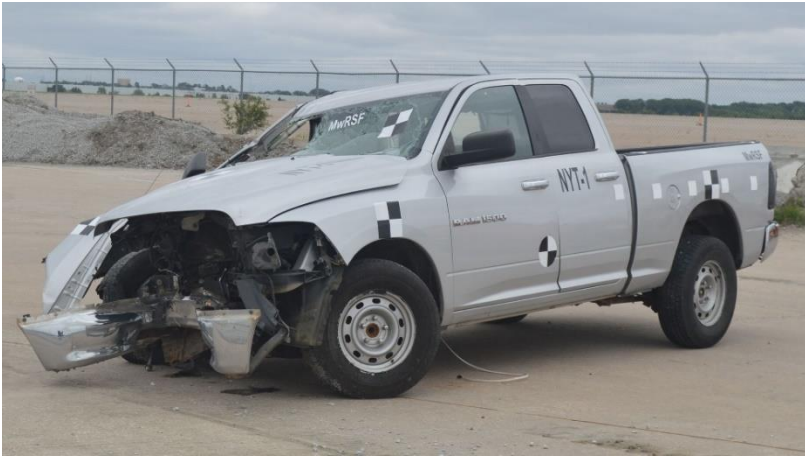
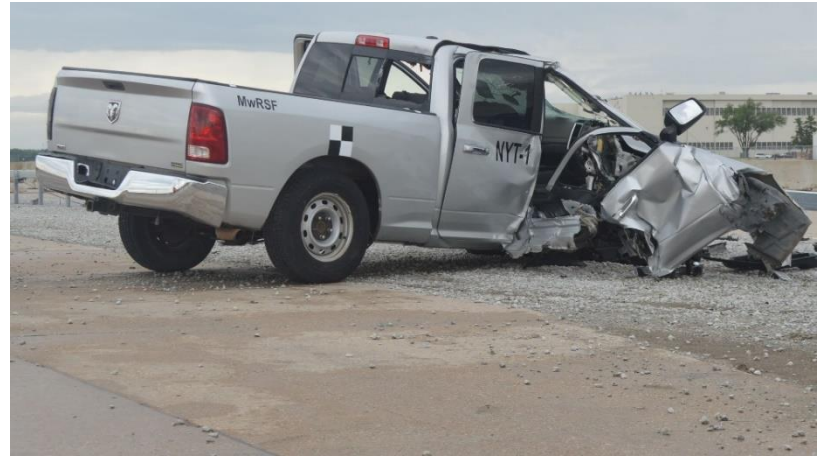
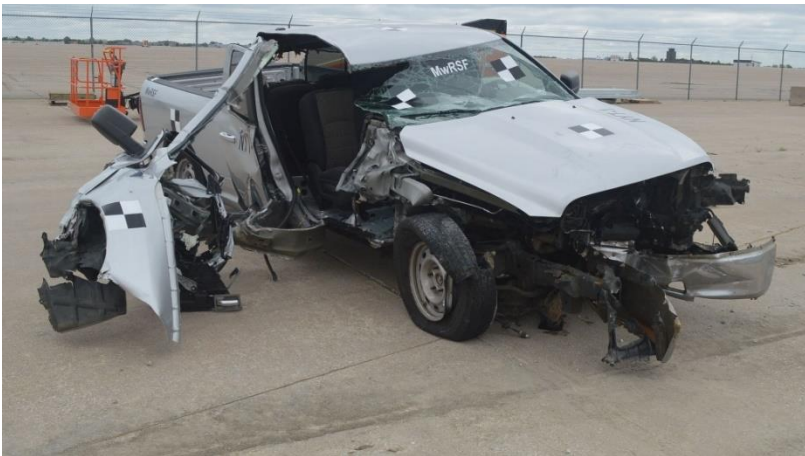
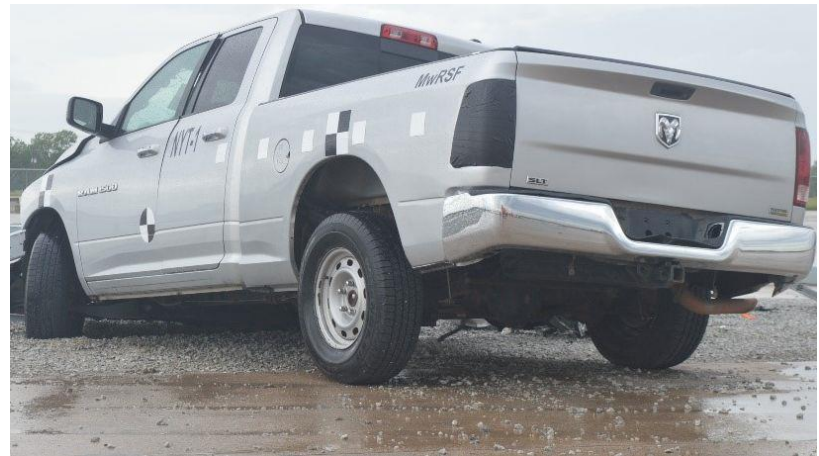
Figure 58. Vehicle Damage, Test No. NYT-1

Majority of the damage was concentrated on the right-front corner and right side of the vehicle, where 'right' is determined from the rear of the vehicle. The front bumper, headlights, radiator, and grille disengaged from the vehicle. The right-front fender and right-front door were separated from the vehicle's frame, consequently shattering the right-front side window. The right-front wheel assembly deformed and counterclockwise, and the tire tore. Denting and scraping were observed along the vehicle's entire right side. The entire windshield fractured and the top-right corner of the windshield tore from the roof where it was attached. The roof bent downward and buckled.

The vehicle anti-roll bar was dented near the middle-rear. The right-side steering knuckle disengaged from the vehicle. The right-side upper-control arm was severely bent, and the ball joint deflected approximately 3 in. (76 mm) toward the rear of the vehicle. The right-front mounting bracket and lower control arm bent backward. The right-side inner tire rod disengaged. The left-side suspension appeared undamaged. The left-side frame horn bent backward toward the left-side doors, and the right-side frame horn bent inward toward the left side. The first left-side cab mount disengaged from the vehicle while the second left-side cab mount bent inward. The left-front brake line was fractured at the caliper.

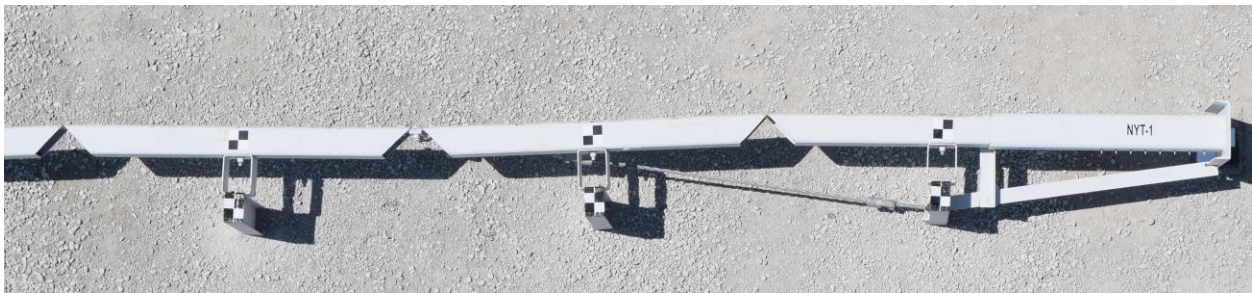
Figure 64. Plan View of NYSDOT “Zig Zag” Box Beam End Terminal

The NYSDOT “zig zag” box beam end terminal consisted of box beam segments offset from S3x5.7 posts with tubular steel blockouts. The system had a continuous traffic-side face, and the box beam was cut at 45-degree angles toward the backside, as shown in Figures 64 and 65. Each pair of 45-degree cuts were considered a joint, such that the rail was to deflect, rotate, and bend about those cuts. Splices were used when joints occurred at the box beam ends to form a continuous front face. The impact head consisted of a tubular plate steel box, which fit over the end of the last box beam segment such that the box beam slid inside of the terminal head before the system engaged. A series of bolts were placed in the box beam head. When the terminal head moved down the rail, the upstream end of the box beam would fracture the bolts in double shear before it bottomed out on the terminal head.
