DETECTION OF FLAWS IN ASPHALT OVERLAID CONCRETE BRIDGE DECKS USING ULTRASONIC GUIDED WAVES

**F
I
N
A
L

**Nebraska Department of Transportation and U.S.
Department of Transportation Federal Highway
Administration**

December 2020

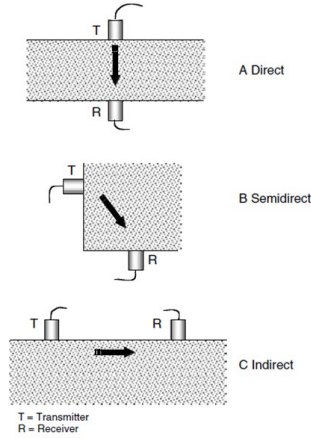
The typical and standardized layout for UPV is the “direct measurement technique” shown in Figure 1. The distance traveled, L , refers to the thickness of concrete in this setup. Other setups (semidirect and indirect) in Figure 1 are also referenced by ASTM C597, with the caveats that the results will be different than the direct measurements and they will likely be indicative only of surface layers. The standard acknowledges that in the case of indirect measurements, there is uncertainty in determining the actual length of the travel paths of the pulses and that the use of Equation 1 will be difficult or lead to errors. However, use of an array of sensors equally spaced to compare to one another is offered as a solution and this approach is utilized for Specimen B in this study.

Figure 1. Transmitter and Receiver arrangements in UPV

Figures 15 and 16 present the results for Specimen A1 and A2, respectively. It should be noted that when there is no rebar and the transmitter is placed on asphalt for Specimen A1, the test method becomes indirect UPV testing (Figure 1) and there is one less receiver in the array. When the data from the first testing point are compared UPV gives an order of magnitude weaker response (0.0014 versus a 0.016) than that of the UGWL method. As such, with amplitudes 10 times higher, this once again proves, in general, that UGWL method provides higher sensitivity in measurements.

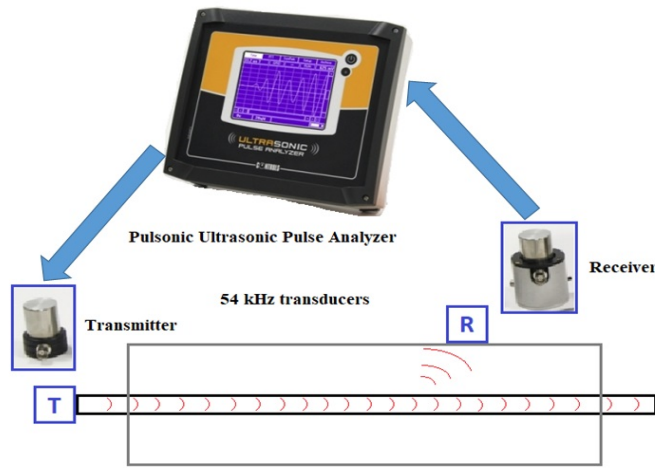
Figure 2 illustrates the UGWL method previously developed by the first author and her team (Garcia et al. 2017; Garcia et al., 2019; and Erdogmus et al., 2020) for assessment of condition of the rebar, rebar-concrete interface, and concrete. In the UGWL experimental set-up, a transmitter (T) is placed at the end of a steel rebar sending the energy directly and longitudinally into the wave guide (rebar). A receiver (R) is placed on the external top surface. The receiver is moved along the length of the specimen right above the rebar in 6-inch intervals in order to plot the attenuation of the energy across the system's length and to record any deviations from the expected attenuation in the amplitudes of energy leaked into the surrounding material. The longitudinal waves travel through the wave guide and some of the energy leaks into the surrounding medium, depending on the bond between the rebar and the medium as well as existence of other anomalies.

Figure 2. Experimental Setup

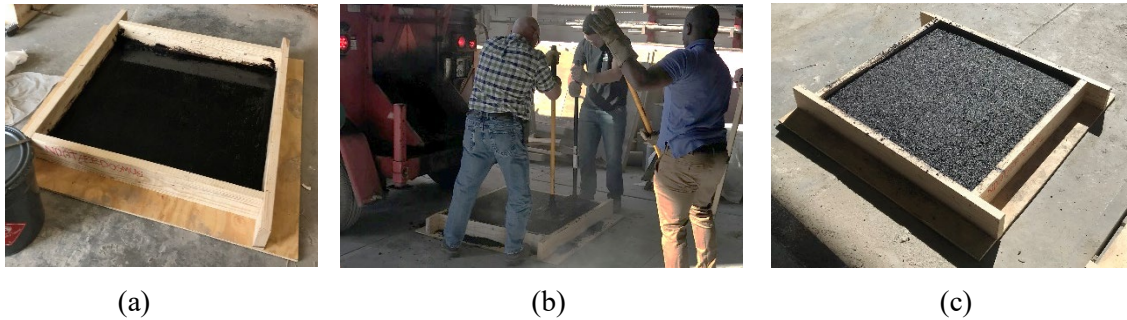
Two asphalt specimens measuring 3 ft x 3 ft x 4 in. constitute Specimen Set A. Specimen A1, shown in Figure 3 is composed entirely of asphalt and its purpose is to isolate the wave propagation properties of asphalt with indirect UPV measurements. Specimen A2 includes a #4 rebar in the center to be utilized as the wave-guide (Figure 4). The purpose of Specimen A2 is to compare the UGWL method's application in asphalt to previous findings with reinforced concrete specimens. A primer (Polyguard 650 RC Liquid Adhesive solution) was applied on the surface of the bottom plywood (Figures 3a and 4a) as well as the Polyguard 665 Membrane (Figure 4b) before the hot asphalt mix was placed and hand-compacted (Figure 3b). After the casting, the asphalt is left inside the formwork to maintain its integrity throughout the data collection process (Figures 3c and 4c).

Figure 3. Specimen A1 (Asphalt only): (a) Primer Application, (b) Compaction, (c) Cast Specimen

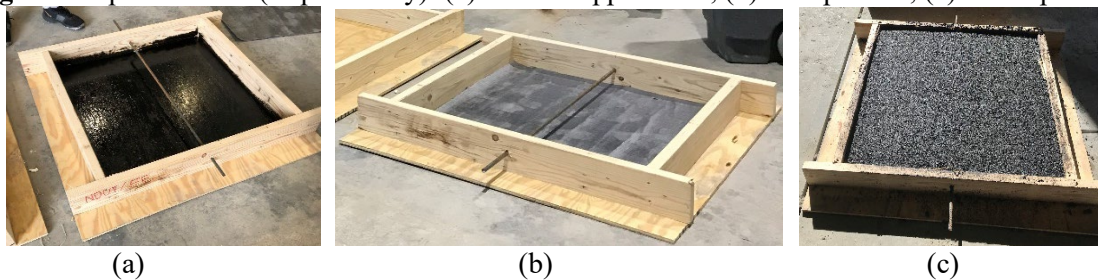
Figure 4. Specimen A2 (Asphalt with rebar): (a): Primer, (b) Membrane, (c): Cast Specimen
Specimen Set B: Embedded Flaws at the Membrane Level

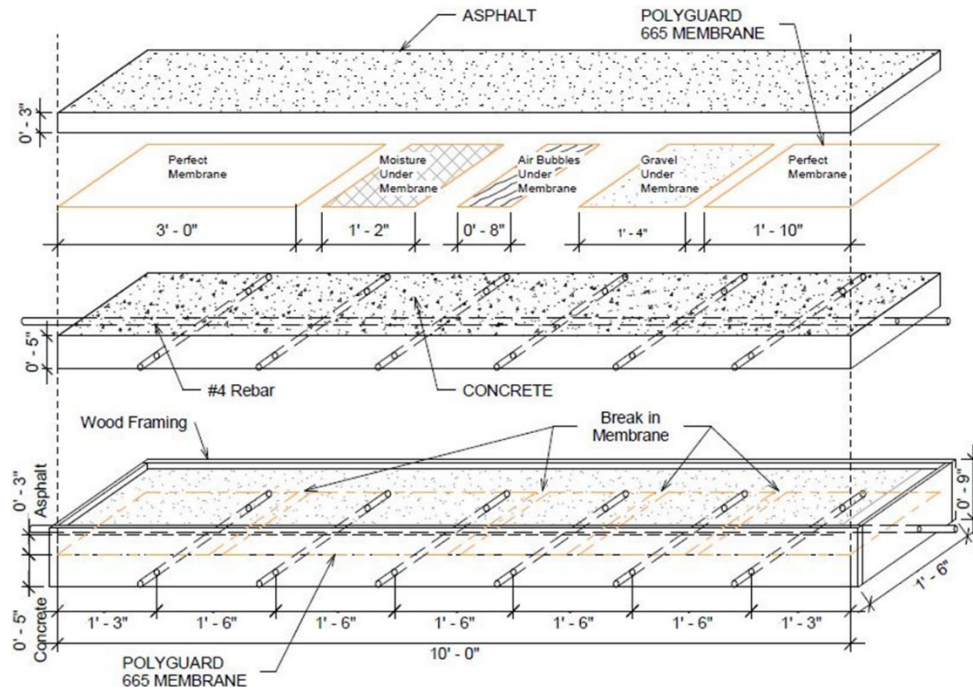
This set includes a single specimen with various flaws embedded at the membrane level (immediately underneath the membrane). A blown-up image of Specimen B is shown in Figure 5. For this specimen, first a concrete slab is cast with a single longitudinal reinforcement and six transverse rebars. After curing the concrete slab for 28 days, the primer, membrane, and the asphalt are placed. The membrane is divided into five areas (B1-B5). The first segments from both ends (B1 and B5) are considered “perfect membrane”, where care is taken to place the membrane according to NDOT and manufacturers’ specifications. Three middle segments (going from right to left on Figure 5) include different flaws embedded underneath the membrane, as shown in Figure 6:

- *B2- Gravel under the membrane:* To simulate a typical construction flaw, gravel was dispersed under the membrane in this segment.
- *B3- Air bubbles under the membrane:* This potential construction flaw was simulated by placing a bubble wrap under the membrane. It was considered that the wrap might melt during the hot asphalt casting but the air bubbles would remain.
- *B4- Moisture trapped under the membrane:* This potential construction flaw was simulated by wetting a thick paper towel and placing under the membrane.

Figure 5. Blown-up Illustration of Specimen B: Various Flaws Embedded at the Membrane Level (Note that the data is collected starting from the right end, therefore Segment B1 is the right-most segment, and B5 is the left-most in the following discussions.)

As can be seen in Figures 5 and 6, Specimen B includes six transverse bars and they are numbered 2-7, counting the longitudinal bar as number 1. UGWL data was collected by using each of these bars as the wave guide and taking a single reading in the center, at 9 inches from edges, as shown in Figure 23. Data representing each type of segment denoted by bars 3-7 are plotted in Figure 24. It can be seen that there is significant difference in the amplitude of the leaked waves between a completely intact membrane (bars 6 and 7) and those that experience physical separation due to anomalies: bars 3, 4, 5 for (gravel, bubbles, or paper towel).

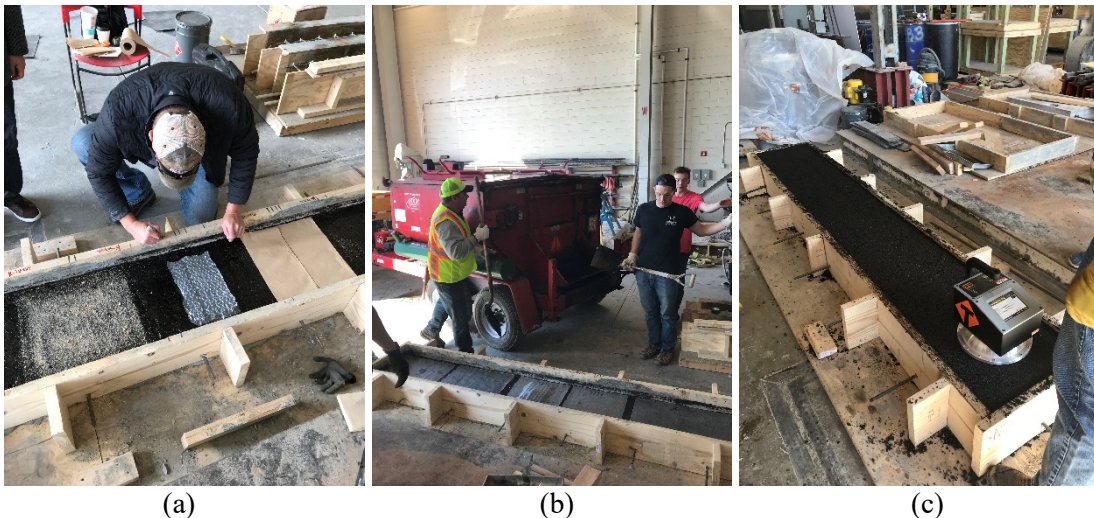
Figure 6. (Casting of Specimen B: (a) Placement of gravel (B2), bubble wrap (B3), and paper towel (B4) between primer and membrane; (b) Image after membranes are placed; (c) *In-situ* Density measurements

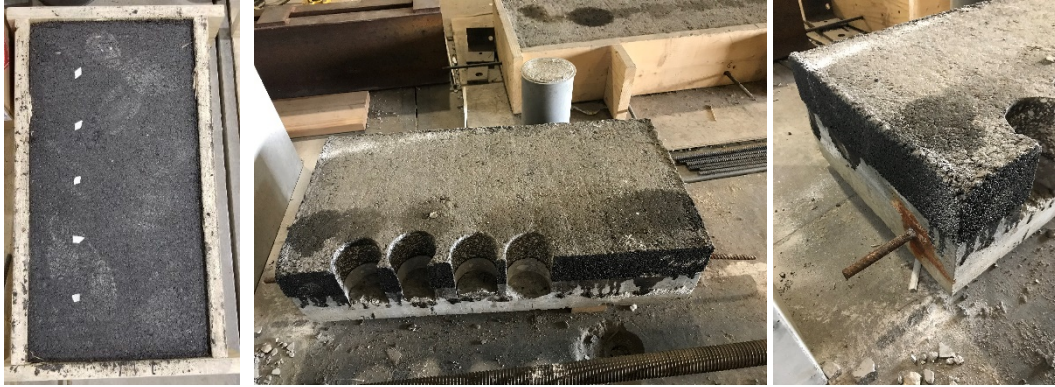
- *C1 (0-degree bar end and corroded rebar):* Rebar's end was left as is (0-degree) for UGWL measurements (Figure 7). This specimen was soaked in NaCl solution for a period of six months and the bar was corroded. After this period, the asphalt was added (Figure 7a) and ultrasonic testing was performed. Once all testing was done, chloride testing was performed on the concrete

Figure 7. Images of Specimen C1: (a) After asphalt is cast, points show where receivers were placed in testing, (b) After the formwork is stripped and chloride testing is performed (cite paper), (c) Close-up of the corroded blunt-end (0-degree) rebar.

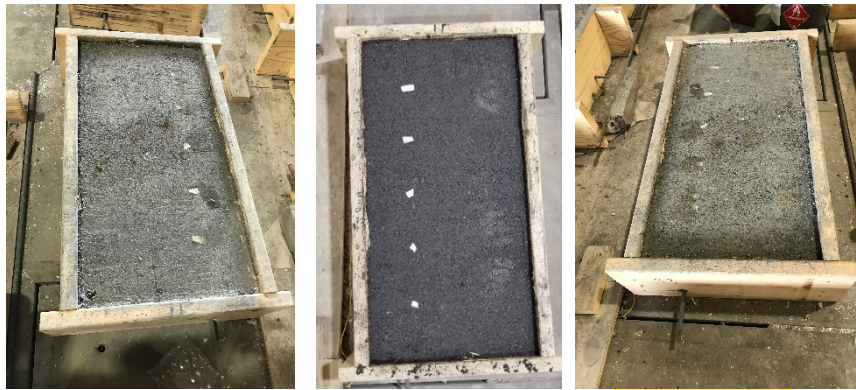
- *C2 (33-degree bar end and clean rebar)*:: Rebar's end was cut to 33-degrees to study the impact of the angle of emitted ultrasonic waves and the rebar is not exposed to any corrosion-accelerators (i.e. clean bar) as shown in Figure 8.
- *C3 (45-degree bar end and clean rebar)*: Similar to C2 except the rebar's end was cut to 45-degrees (Figure 9).

Figure 8. Images of Specimen C2 (33-degree **end clean rebar**)

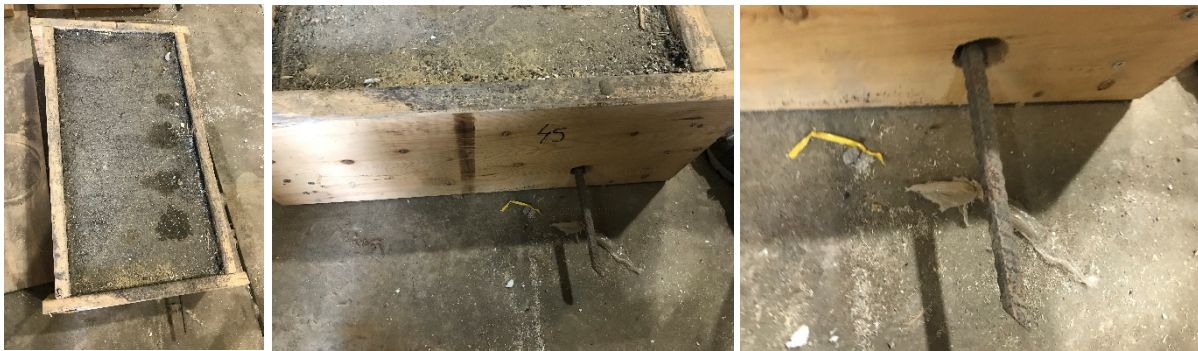
Figure 9. Images of Specimen C3 (45-degree end clan rebar)

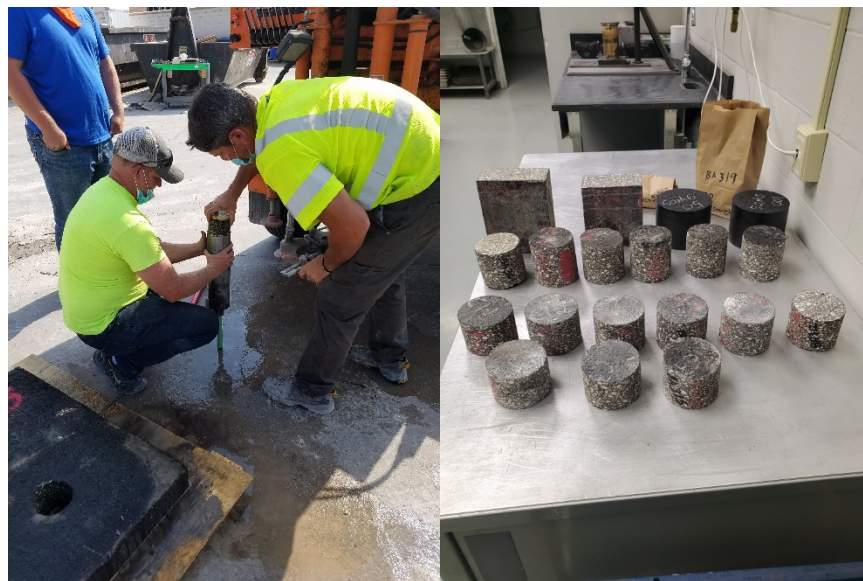
Figure 10. Coring (left) and all density test specimens (right)

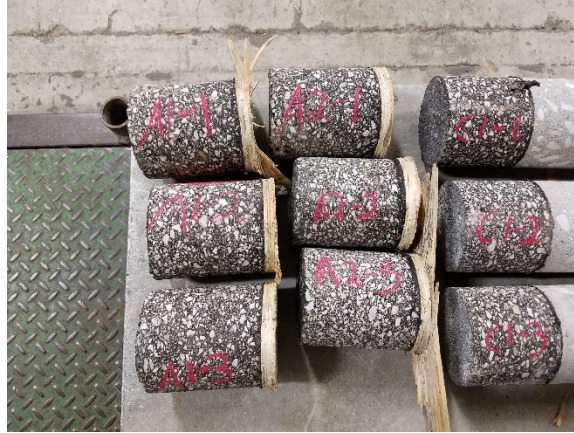
Figure 11. Density Test Cores for A Specimens

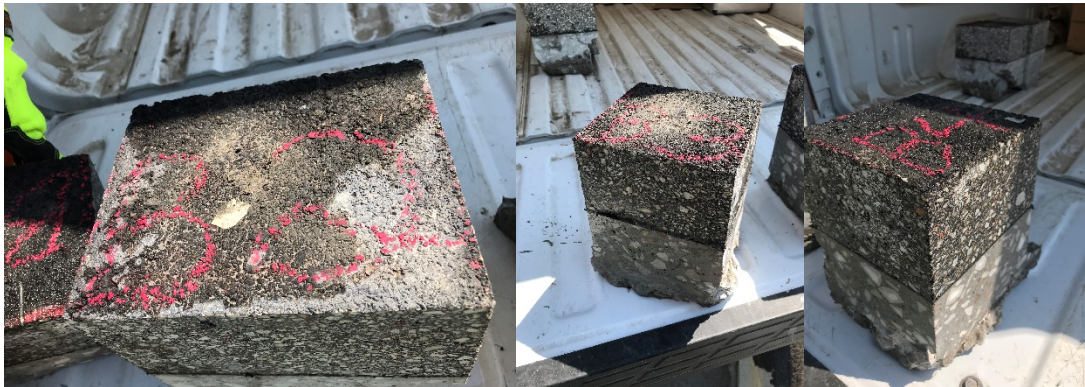
Figure 12. Density test was conducted on the sliced segments of Specimen B

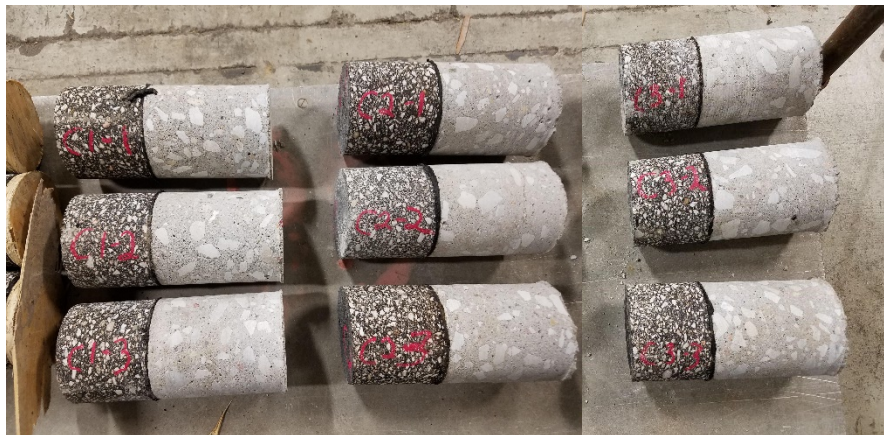
Figure 13. Density Test Cores for C Specimens

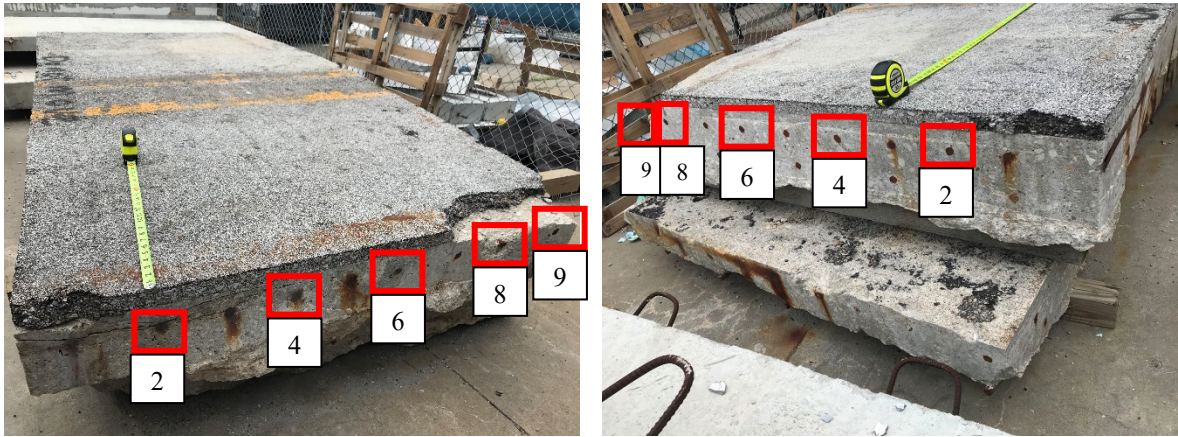
A segment cut from of an asphalt-overlaid reinforced concrete bridge deck was brought to the lab for another NDOT project by UNL faculty Dr. Jingying Zhu (Figure 14). With permission, one of these field specimens was tested in order to investigate if the visually identified condition differences between rebars can also be detected using the UGWL approach. This segment has 9 rebars on the top layer and based on the inspection from the two sides they are all in various levels of deterioration, which will be

discussed in more detail along with the test results, later in this paper. Out of the 9 bars, 5 of them were tested (2, 4, 6, 8, and 9) both from the north end and south end.

Figure 14. Old Bridge Deck Specimen, Left: North End, Right: South End

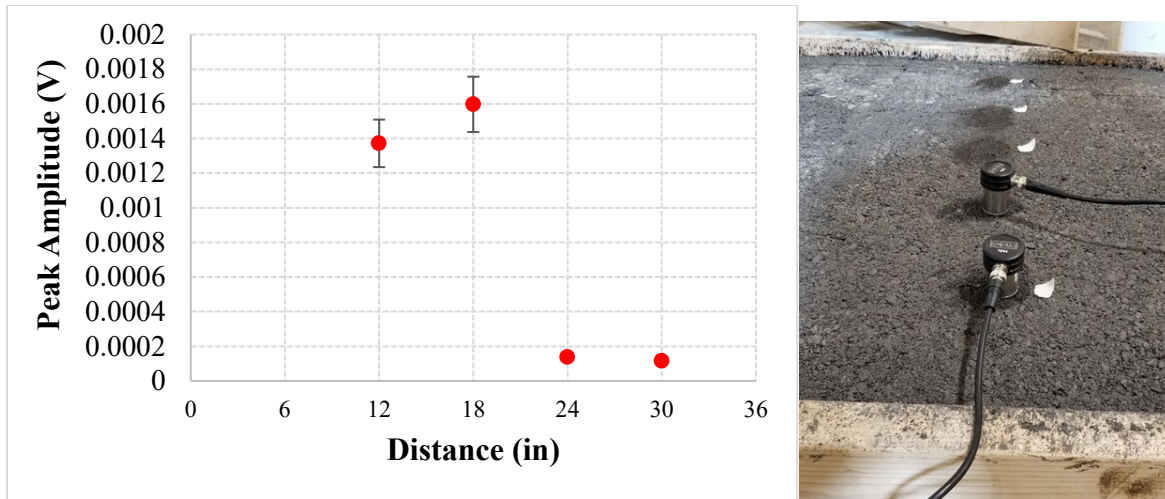
There are two reasons for the energy loss between Specimen A1 and A2. First is the difference in methodology. With Specimen A2, UGWL could be applied where the rebar is used as the wave-guide. In the UGWL method, powerful longitudinal waves are generated due to the direction of the transmitter parallel to the direction of propagation. As the wave propagates through the bound element, i.e. the steel rebar (wave guide), the leakage into the surrounding asphalt is measured from the surface of the specimen. The attenuation curve in Figure 16 has a defined exponential decay and confirms that UGWL method can be successfully applied to asphalt if there is a bound element, like steel rebar, in the asphalt.

Figure 15. Specimen A1 Results (Asphalt only) and Test Setup (Indirect UPV)

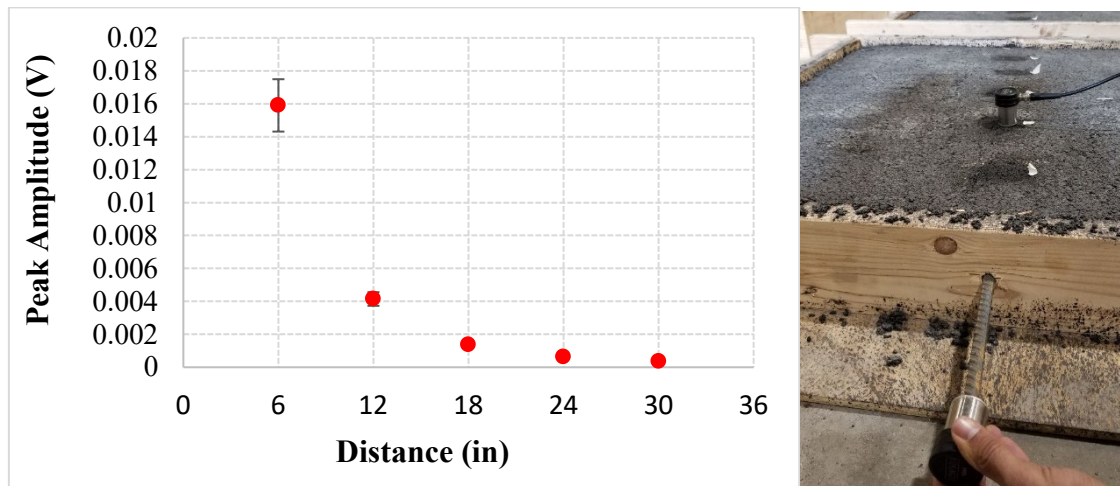
Figure 16. Specimen A2 Results (Asphalt and rebar) and Test Setup (UGWL)

The second reason of the difference is the difference in material properties between asphalt and concrete. Figure 17 shows the UGWL wave attenuation in a reinforced concrete slab. When this is compared to Specimen A2 in Figure 16, it can be seen that there is nearly an order of magnitude difference overall due to the difference in material properties between concrete and asphalt. The faster attenuation in asphalt due to its relevant material properties (see Equation 2) has also been reported by others (Pahlavan et. al, 2016).

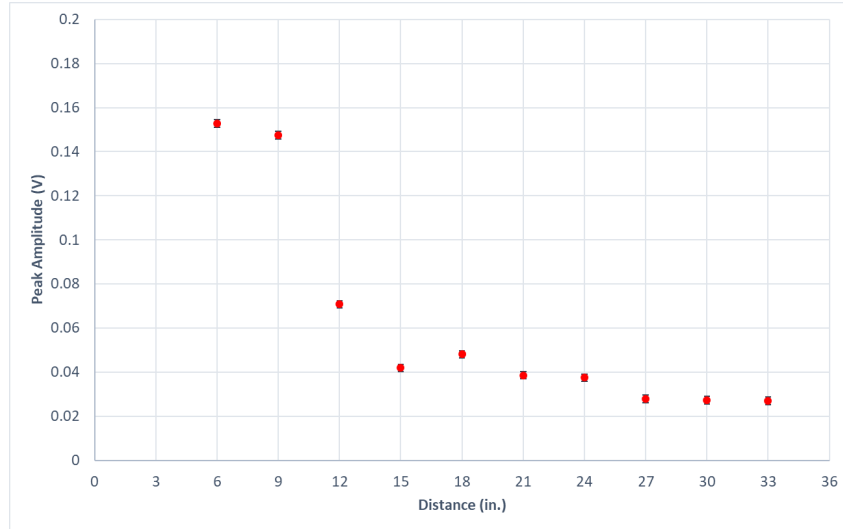
Figure 17. Results from a previous reinforced concrete specimen for comparison to Figure 16. Attenuation in Concrete when the waves are emitted through the rebar in the center of the specimen

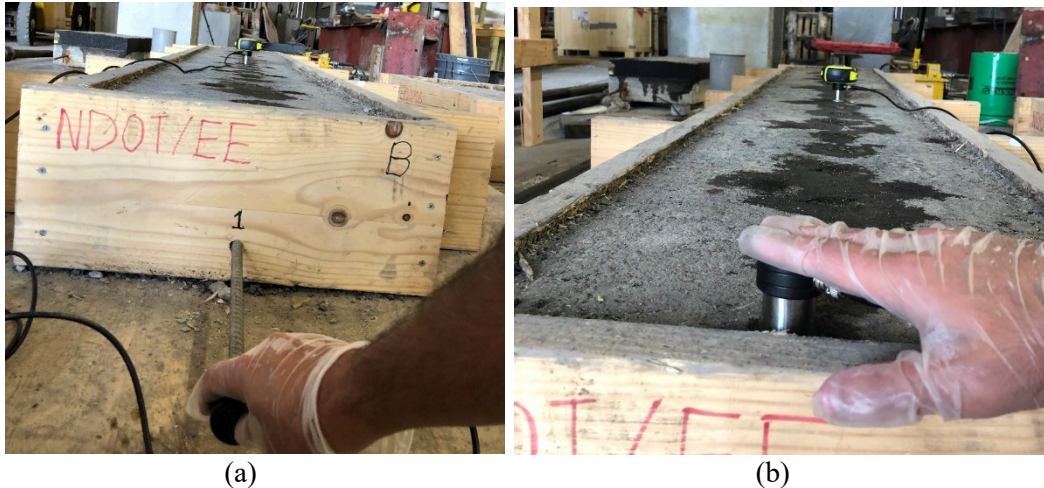
Figure 18 shows the two continuous tests performed in the long direction first with the transmitter placed on the rebar end (UGWL method) and then the transmitter placed on the asphalt surface roughly 2 inches from the end (Indirect UPV method). The resulting data are presented in Figures 19-21.

Figure 18. Two longitudinal continuous test setups: (a) UGWL Method application. Transmitter on the end of rebar and receivers along the middle line on the asphalt surface (*Results in Figure 19*). (b) Indirect UPV Application. Transmitter on the asphalt surface 2 inches from the edge and receivers along the middle line on the asphalt surface (*Results in Figures 20-21*).

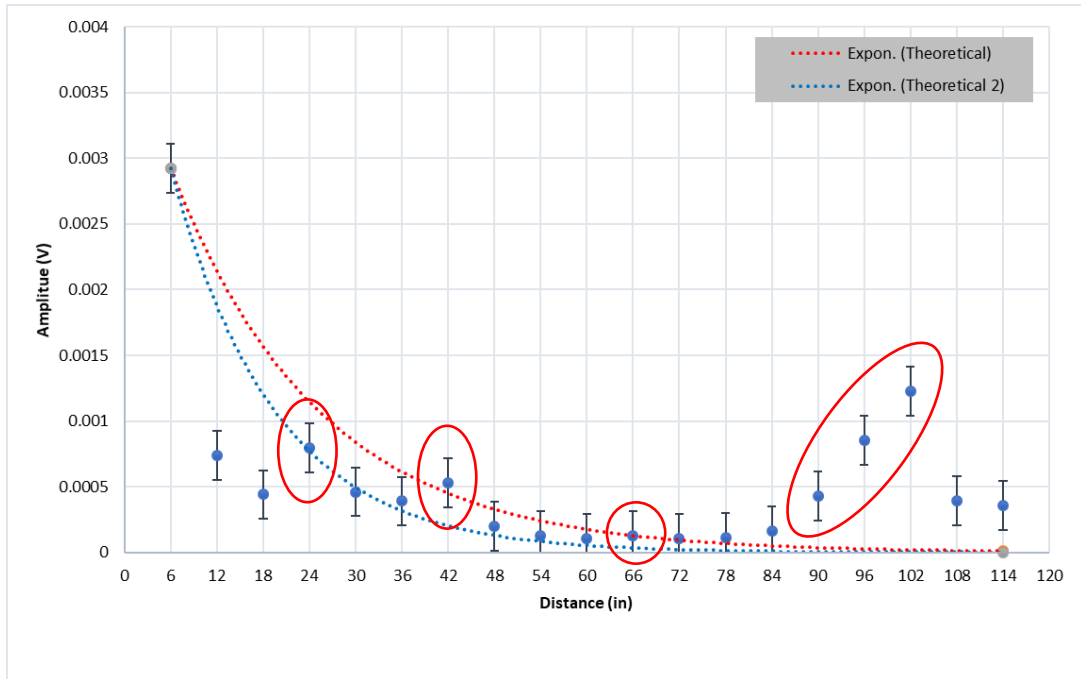
Figure 19. Specimen B- UGWL Results: Transmitter on the rebar end, continuous measurements from the surface of the asphalt

- Plots in Figures 19 and 24 are collected using UGWL method. Given this method send the energy through the rebar and measured the energy leaked into the surrounding medium, delaminations register as lower amplitudes and stronger bonds register as higher magnitudes.

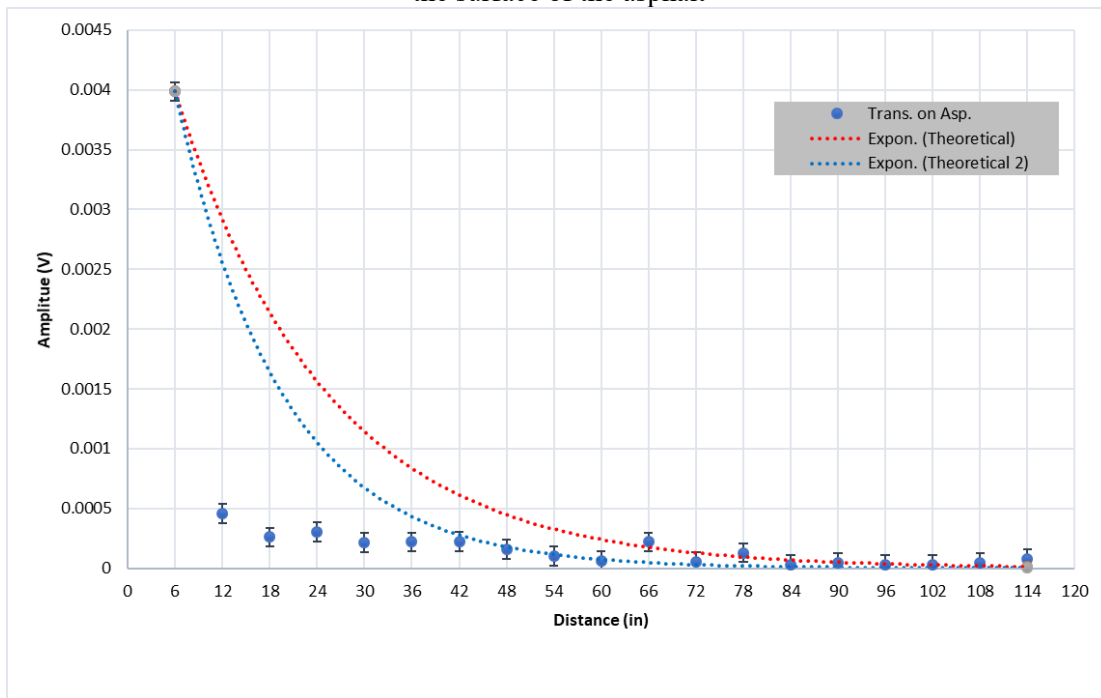
When the indirect UPV method is applied and the full spectrum is plotted as shown in Figure 20, the attenuation from the first data point to the second is so large that it is difficult to make meaningful observations. However, when the first data point is eliminated (therefore zooming into the rest of the data) as shown in Figure 21, not only the amplitudes become similar to those of UGWL, but also fluctuations indicative of anomalies can be observed at the following locations: at 24 in., 36-42 in., at 66 in., at 90 in., and 108-114 in. Therefore, both methods indicate potential of anomalies at similar locations. The corresponding anomalies in these locations are discussed further in conjunction with the segment-by-segment analysis of Specimen B.

Figure 20. Specimen B -Indirect UPV Results: Transmitter on the asphalt, continuous measurements from the surface of the asphalt

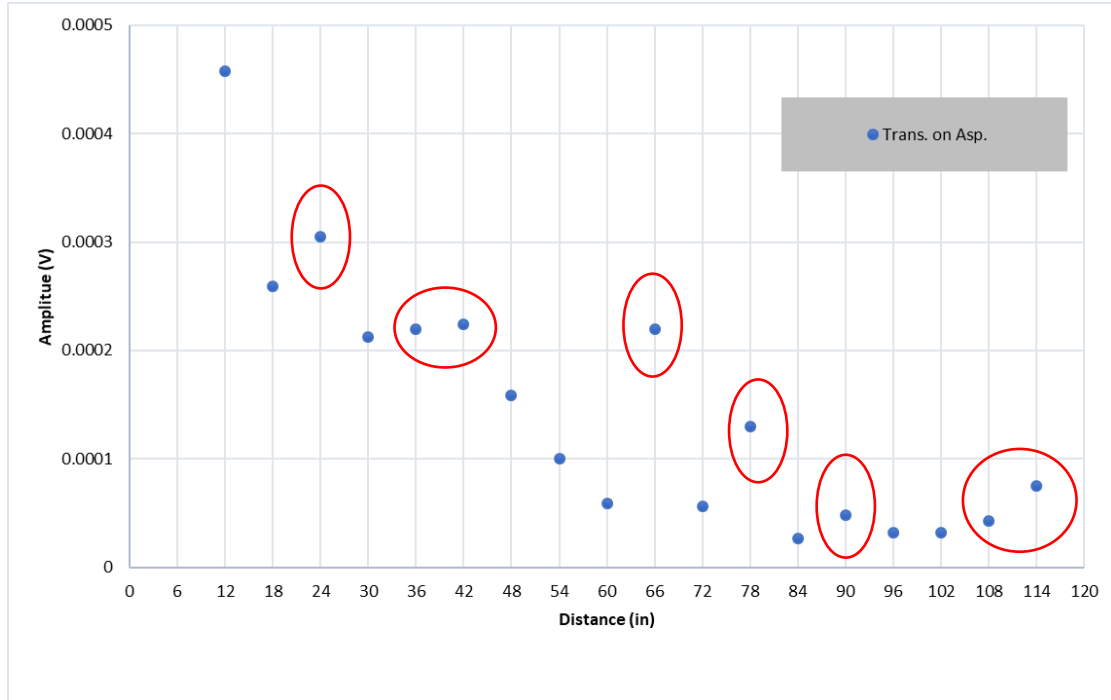
Figure 21. Specimen B- Indirect UPV Results without the first (high amplitude) point data at 6 inches

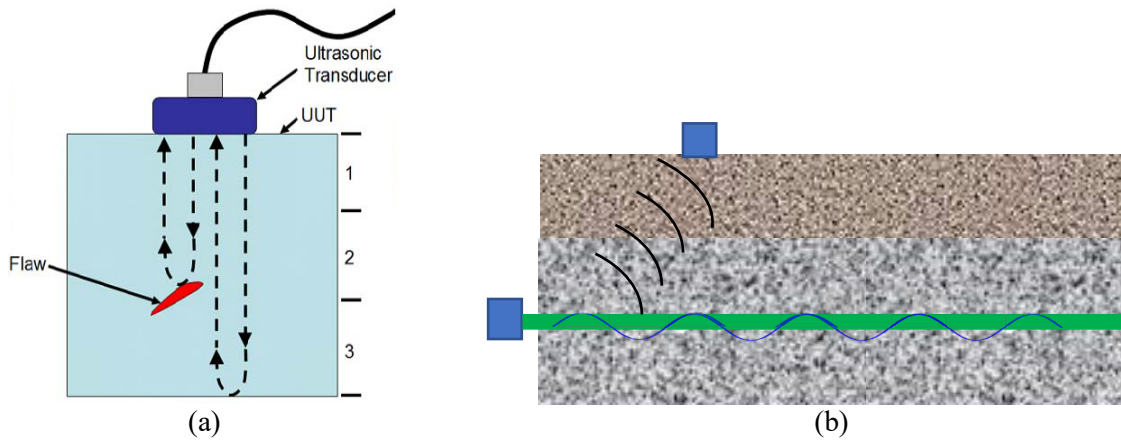
It must be reiterated that the significant difference in the first amplitudes of these two tests is due to the fundamental difference in the application of the ultrasonic waves, which is illustrated in Figure 22.

Figure 22. Left: Traditional Ultrasonic Pulse Velocity Method, Right: Proposed UGWL Method

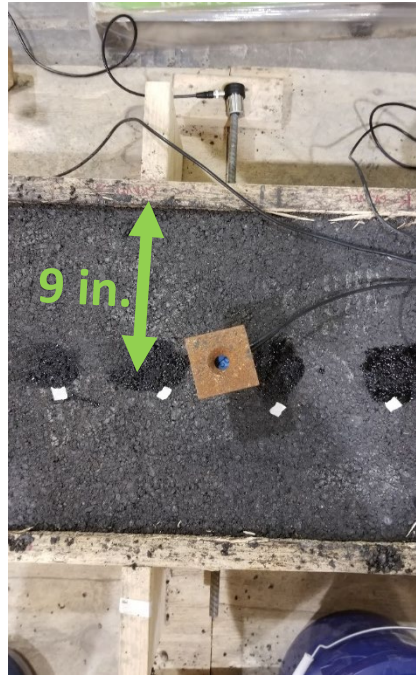
Figure 23. Transverse Bar UGWL Test Setup

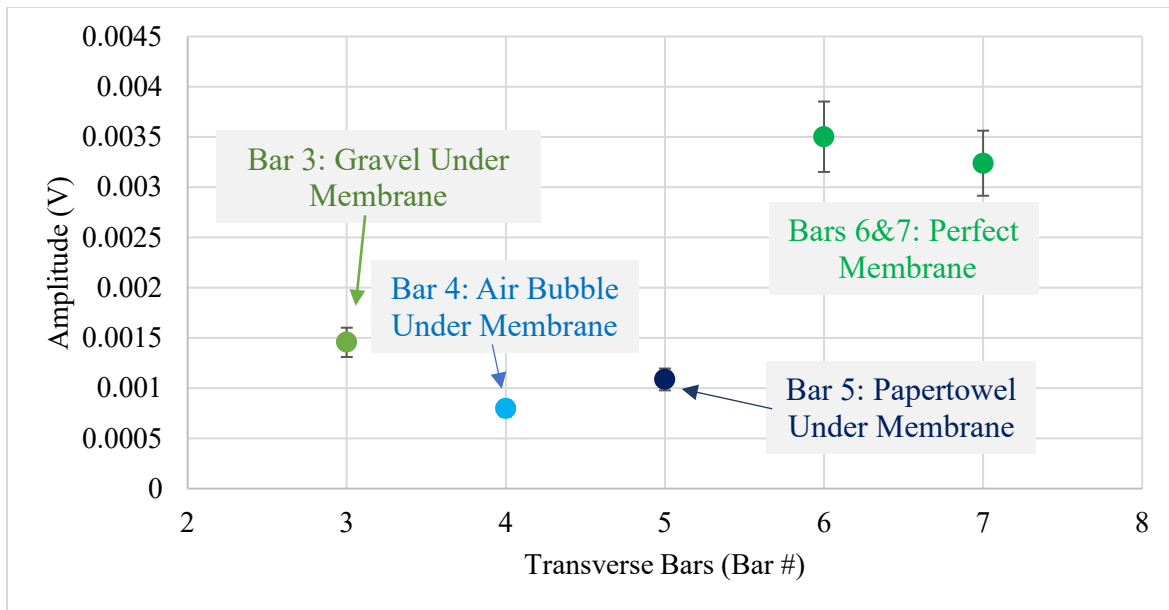
Figure 24. Transverse Bar UGWL reading results

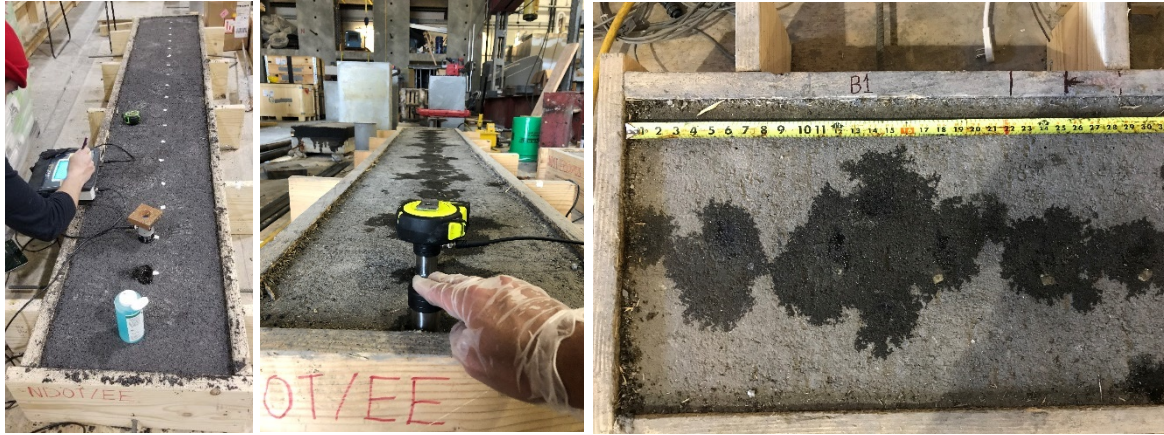
Figure 25. Segment by Segment Indirect UPV Testing of Specimen B

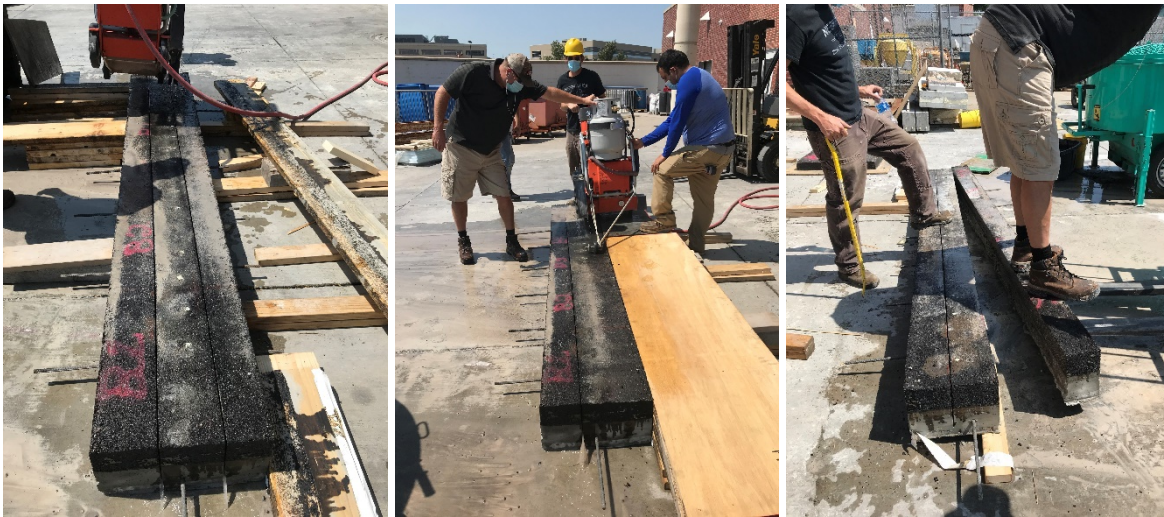
Figure 26. Dissecting Specimen B to evaluate the asphalt-membrane-concrete interface

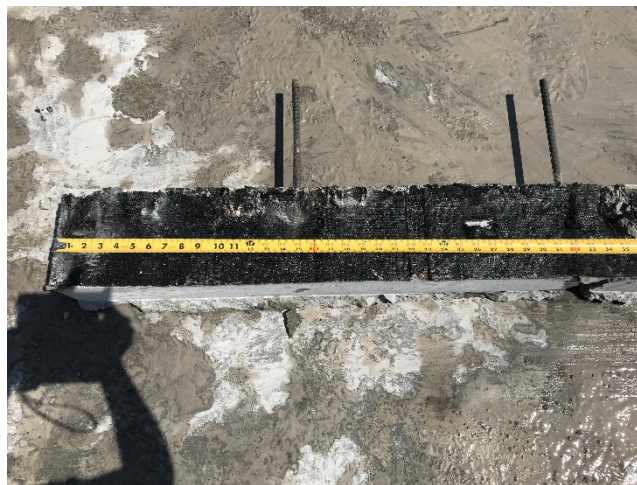
Segment B1 is one of the two “perfect membrane” sections in that there are no intentional flaws embedded in this area, which is 22 inches long (Table 3). Figure 27 shows the state of this membrane after the top asphalt layer is removed and the specimen is sliced.

Figure 27. Segment B1: Perfect Membrane 0-22” and 2” Gap 22-23”.

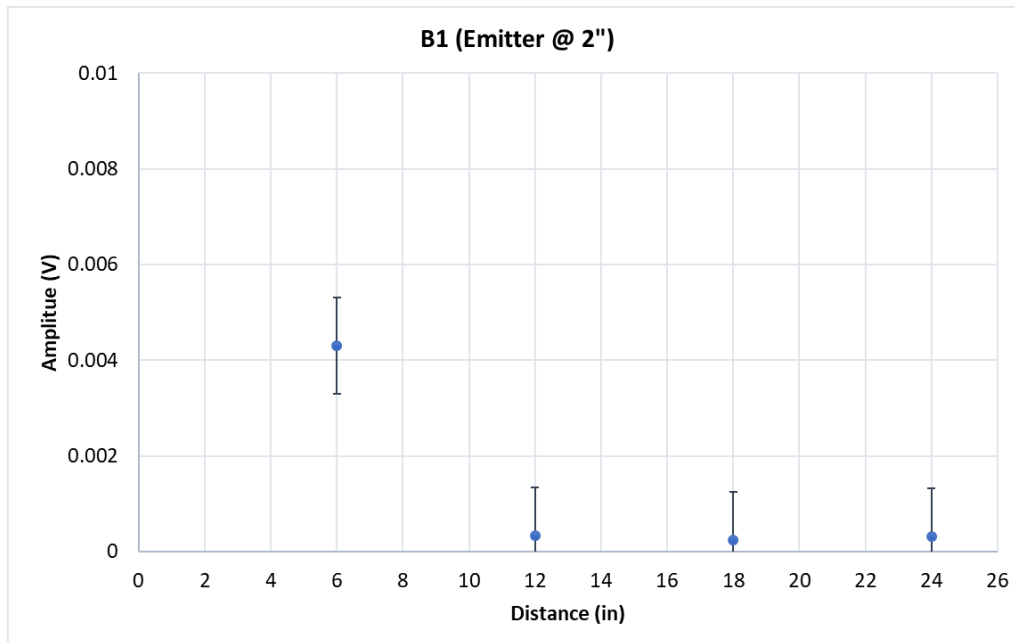
Figure 28 shows the indirect UPV data from this section, which shows a typical attenuation and no abnormal increases/drops in the amplitudes.

Figure 28. Segment B1 Indirect UPV results. Data attenuates as expected.

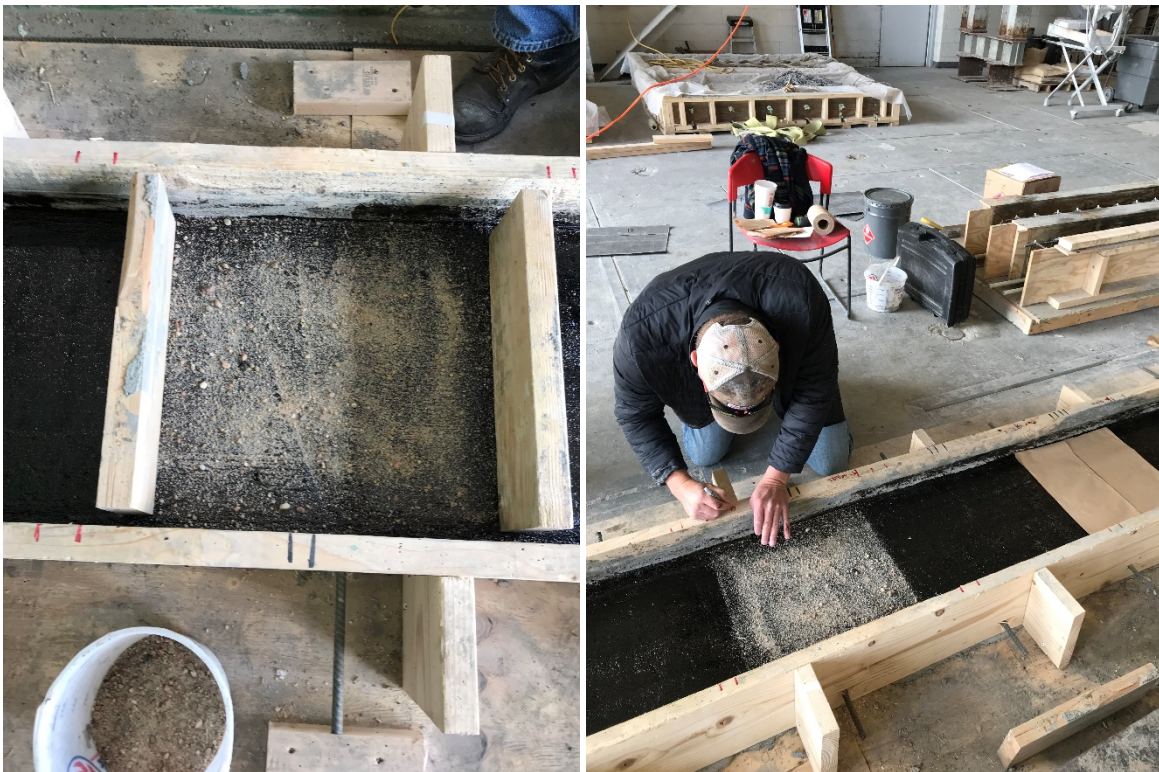
Segment B2 starts at 23 inches from the left end and it is where gravel was placed under the membrane (Table 3). Figure 29 shows the placement of the gravel under the membrane and Figure 30 shows the status of this area after the specimen was dissected.

Figure 29. Segment B2: Placement of the gravel under the membrane

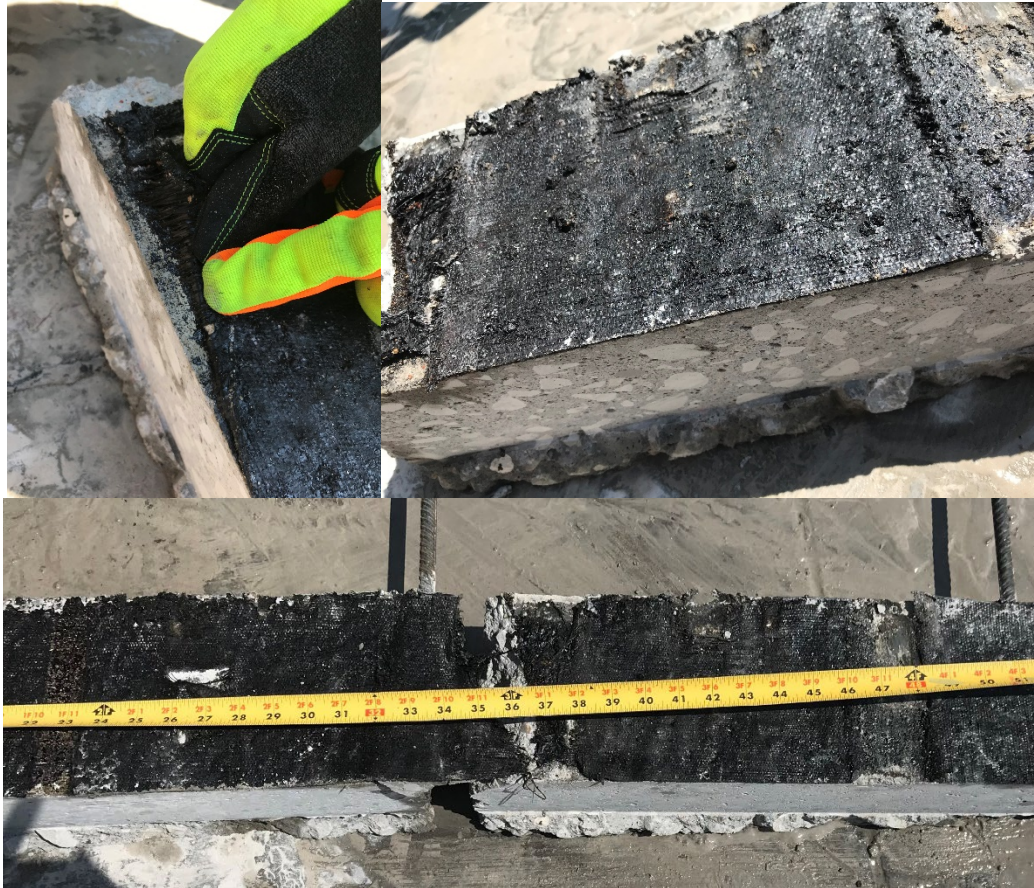
Figure 30. Segment B2: Status of Membrane After Testing

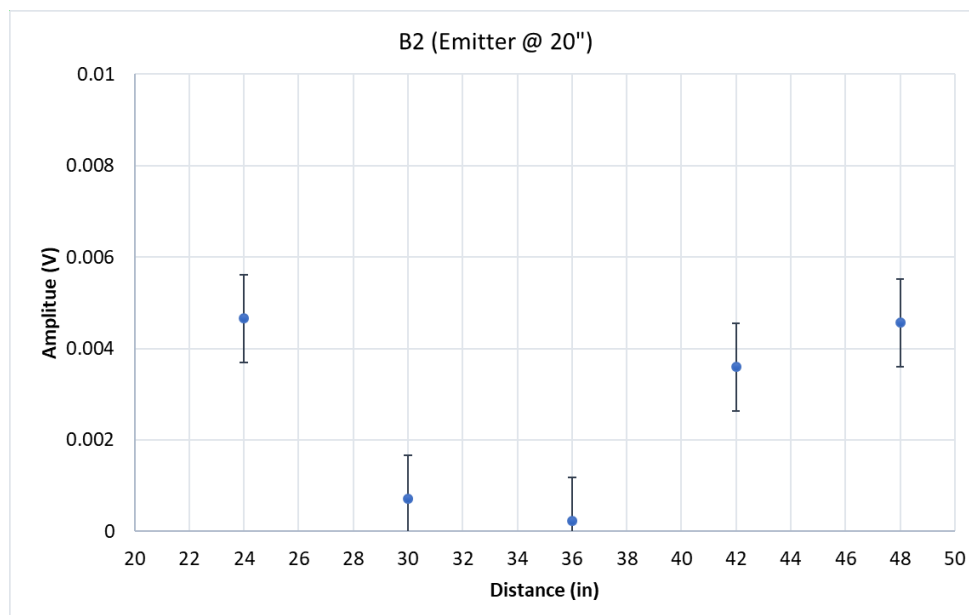
Figure 31. UPV test results on Segment B2.

Figure 31 shows the results of the UPV test on Segment B2 with the gravel under the membrane. As can be seen, the energy initially attenuates as expected, however, there is an increase in the amplitude at 42 inches from the left end of the specimen. The closeup photos of the studied specimen (Figure 30) shows that the membrane and primer bonded to the concrete strongly despite the gravel in most areas, but there are spots of delamination including one at 42 inches.

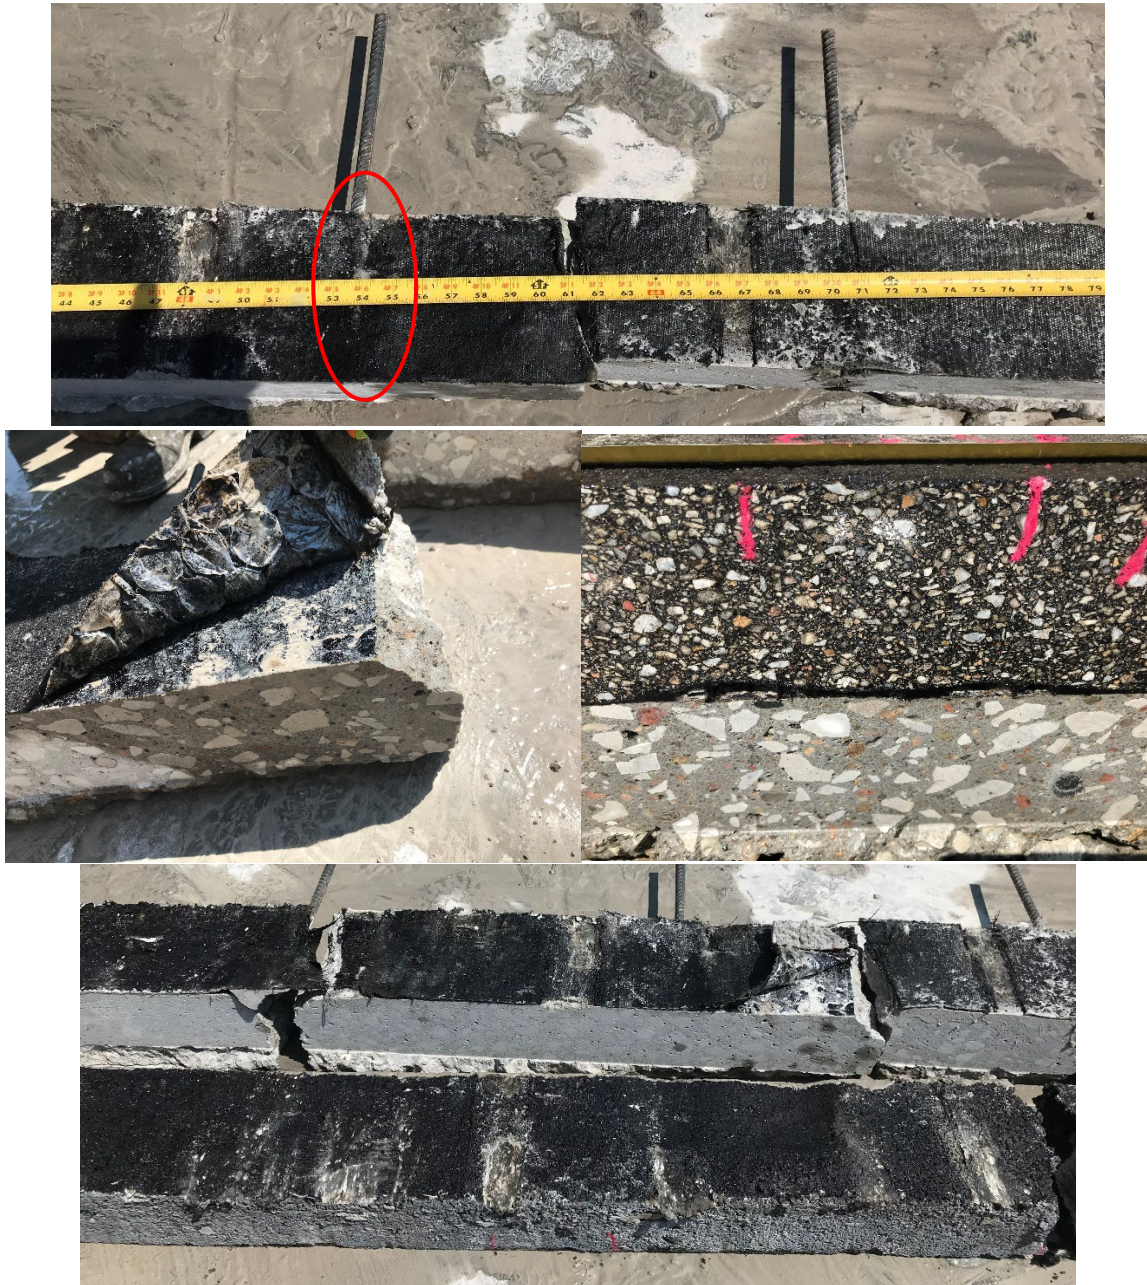
Segment B3 is where a bubble wrap was placed under the membrane. It was expected that the plastic would melt under the high heat of the asphalt and what will remain is the air bubbles. However, the dissection after the testing revealed otherwise: the bubble wrap was intact and created a physical separation between the membrane and the primer/concrete as can be seen in Figure 32.

Figure 32. Segment B3: Status of Membrane After Testing

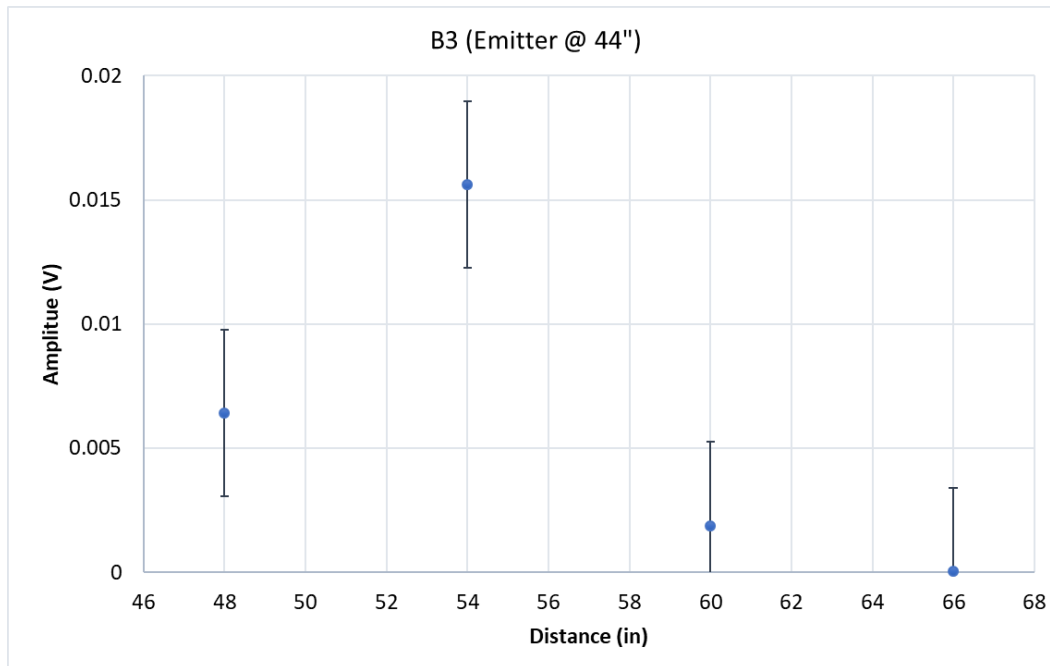
Figure 33. UPV test results on Segment B3.

Figure 33 shows the results for Segment B3. The spots of larger delamination results in much higher amplitudes, because the distance for the ultrasonic waves to travel became much shorter, spanning only the asphalt layer until the physical air gap. It should be noted that when Figure 32 and 33 are compared, the amplitudes are generally larger with the bubble wrap compared to the gravel area, once again confirming a continuous delamination with the bubble wrap insertion.

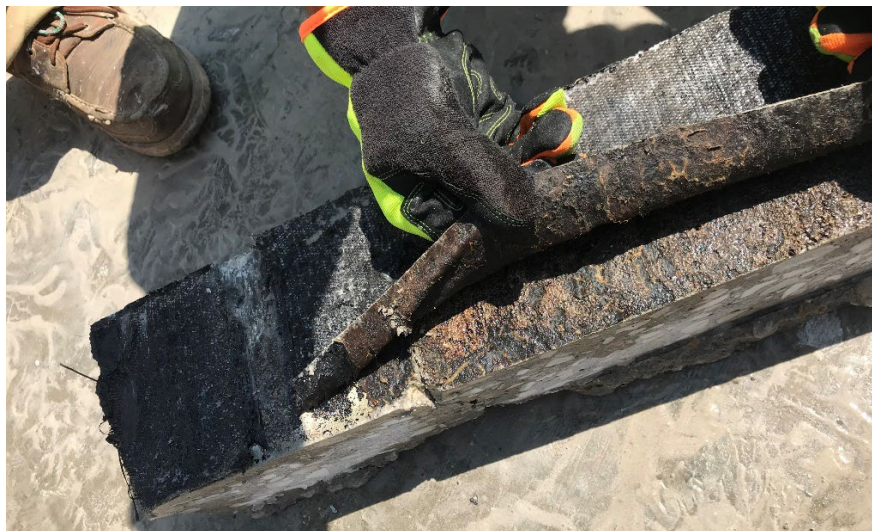
Segment B4 is where a moist paper towel was placed under the membrane. This insertion was intended to trap moisture under the membrane. While there is no direct evidence of moisture affecting membrane bond, the paper towel fibers appear to be embedded into the primer as shown in Figure 34. The results of this segment shown in Figure 35 indicate that this area does not necessarily register as an anomaly with the UPV tests and compared to Segment B3 amplitudes are generally lower.

Figure 34. Segment B4: Status of Membrane After Testing
