DETECTION OF FLAWS IN ASPHALT OVERLAID CONCRETE BRIDGE DECKS USING ULTRASONIC GUIDED WAVES

**F
I
N
A
L

**Nebraska Department of Transportation and U.S.
Department of Transportation Federal Highway
Administration**

December 2020

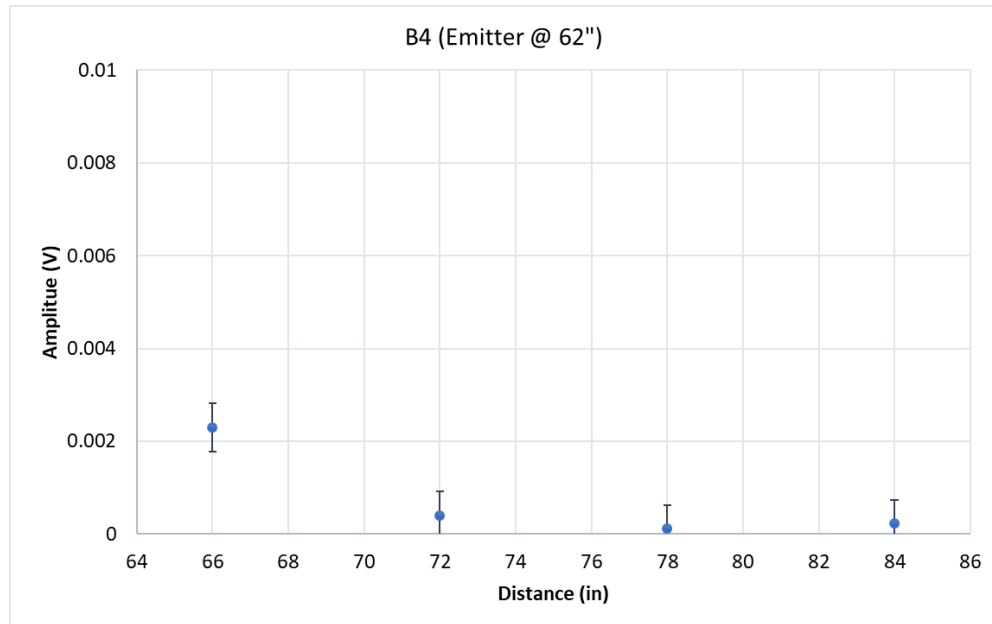
Segment B4 is where a moist paper towel was placed under the membrane. This insertion was intended to trap moisture under the membrane. While there is no direct evidence of moisture affecting membrane bond, the paper towel fibers appear to be embedded into the primer as shown in Figure 34. The results of this segment shown in Figure 35 indicate that this area does not necessarily register as an anomaly with the UPV tests and compared to Segment B3 amplitudes are generally lower.

Figure 35. UPV test results on Segment B4.

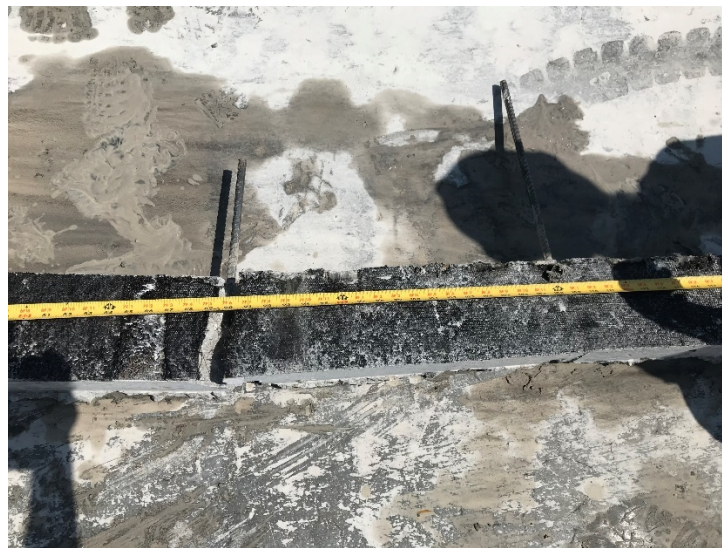
Segment B5 is another perfect membrane segment with no intentional flaws embedded under (Figure 36). Results are expected that no abrupt increases or decreased in the data amplitudes are detected and the amplitudes are generally lower indicating a longer continuous path for the ultrasonic waves.

Figure 36. Segment B5: Status of Membrane After Testing

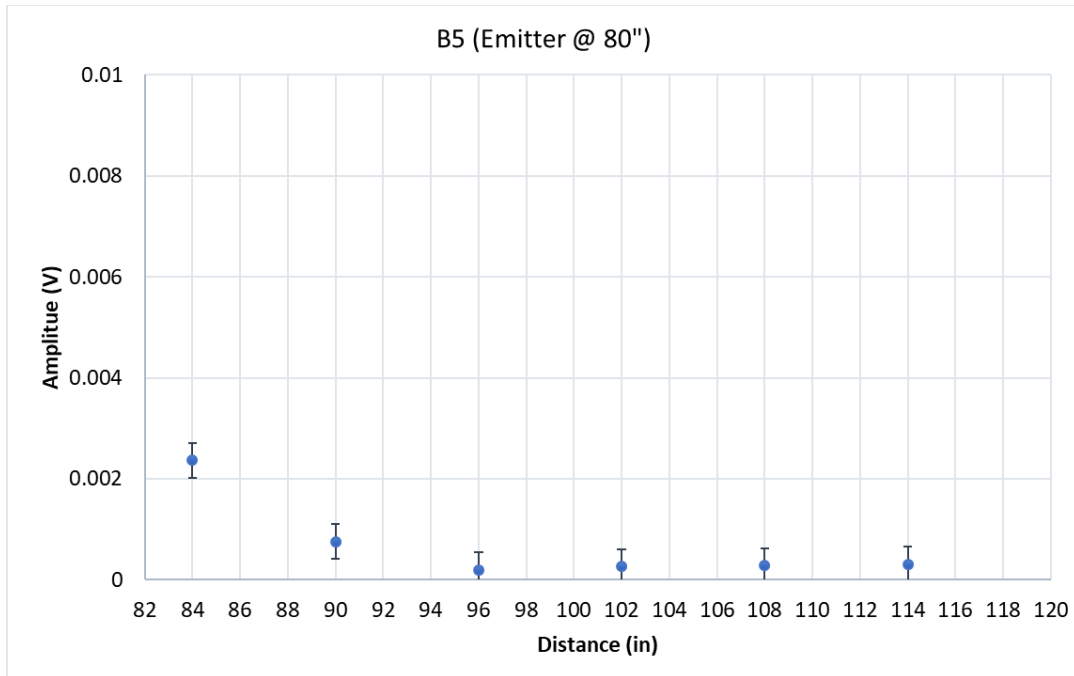
Figure 37. UPV test results on Segment B5.

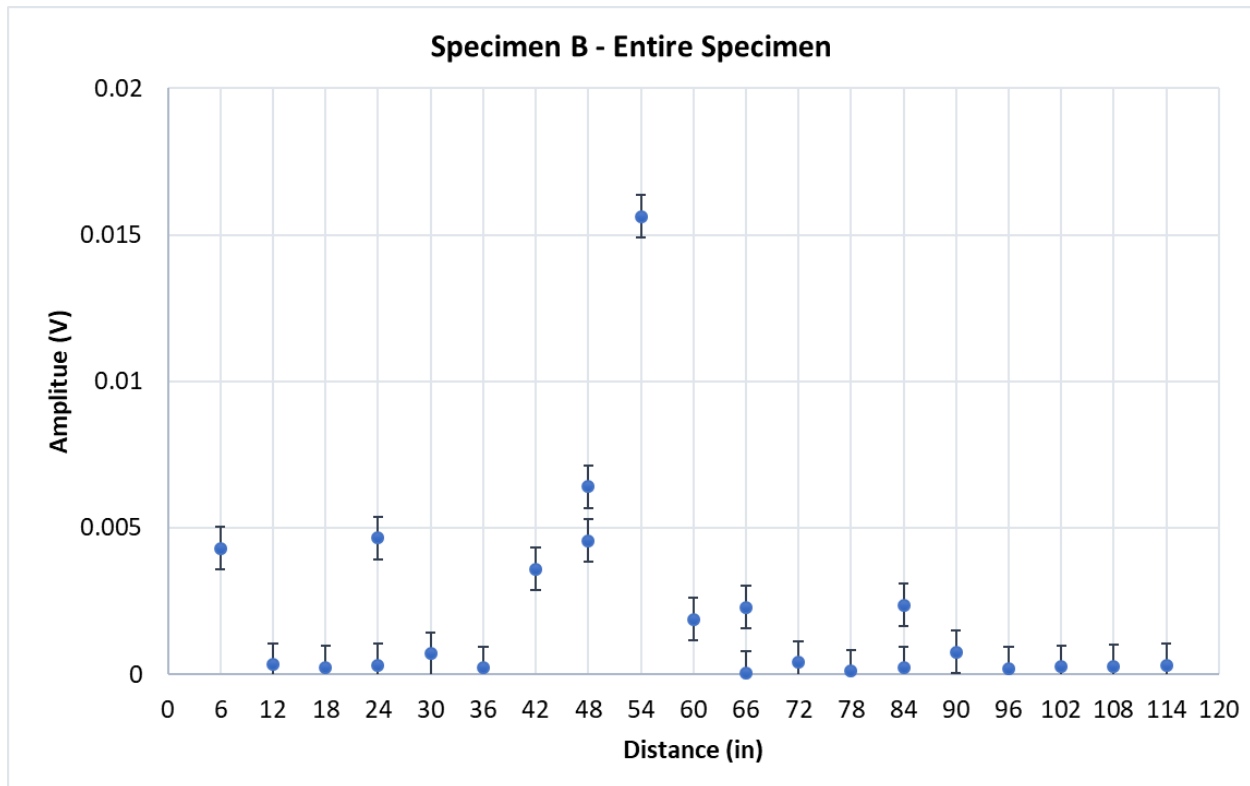
Figure 38 presents these segment by segment analyses plotted together. Double points indicate the last read from a segment coinciding with the first reading of the next segment. This plot shows that the most obvious issues are at 42-66 inches, which spans the transition from the gravel to the bubble wrap areas.

Figure 38. Segment by Segment Scans Plotted Together

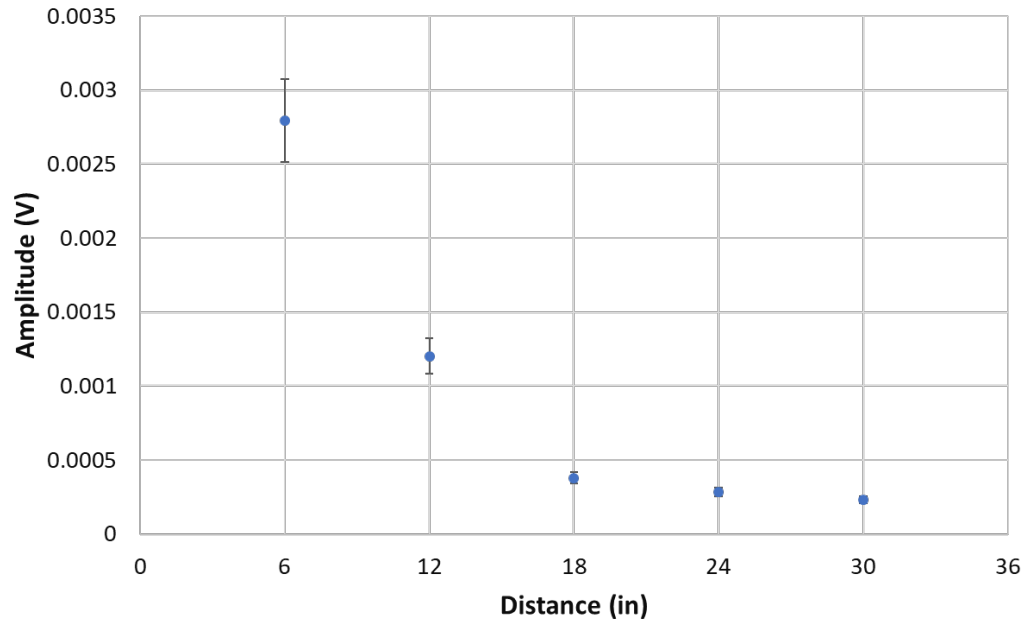
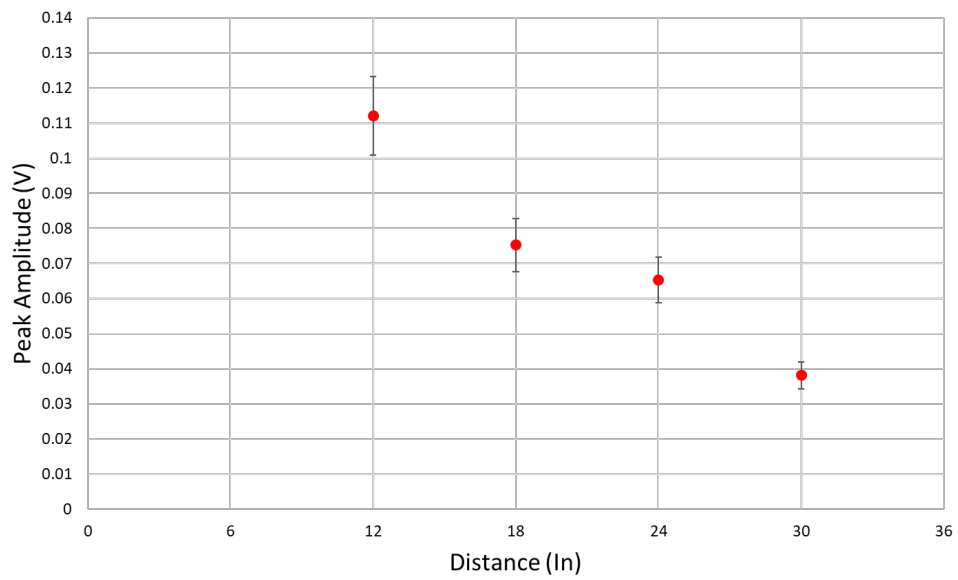
Figure 39 presents the UGWL test results for Specimen C1 where the transmitter is placed on the rebar and receivers are on the surface of the asphalt. The attenuation curve is as expected, indicative of a successful application of the UGWL method. However, when compared to UGWL results from before the asphalt was overlaid (Figure 39-bottom), as expected, the magnitudes are much lower. The peak amplitude for concrete-only readings is 0.11 versus 0.0025 because the leaked energy travels a much longer distance and through multiple layers (concrete, membrane, and asphalt).

Figure 39. Top: UGWL Test Results on Specimen C1 After Asphalt Overlay: Conditioned rebar with blunt (0-degree end); Bottom: UGWL Test Results on Specimen C1 before Asphalt Overlay: Conditioned rebar with blunt (0-degree end)

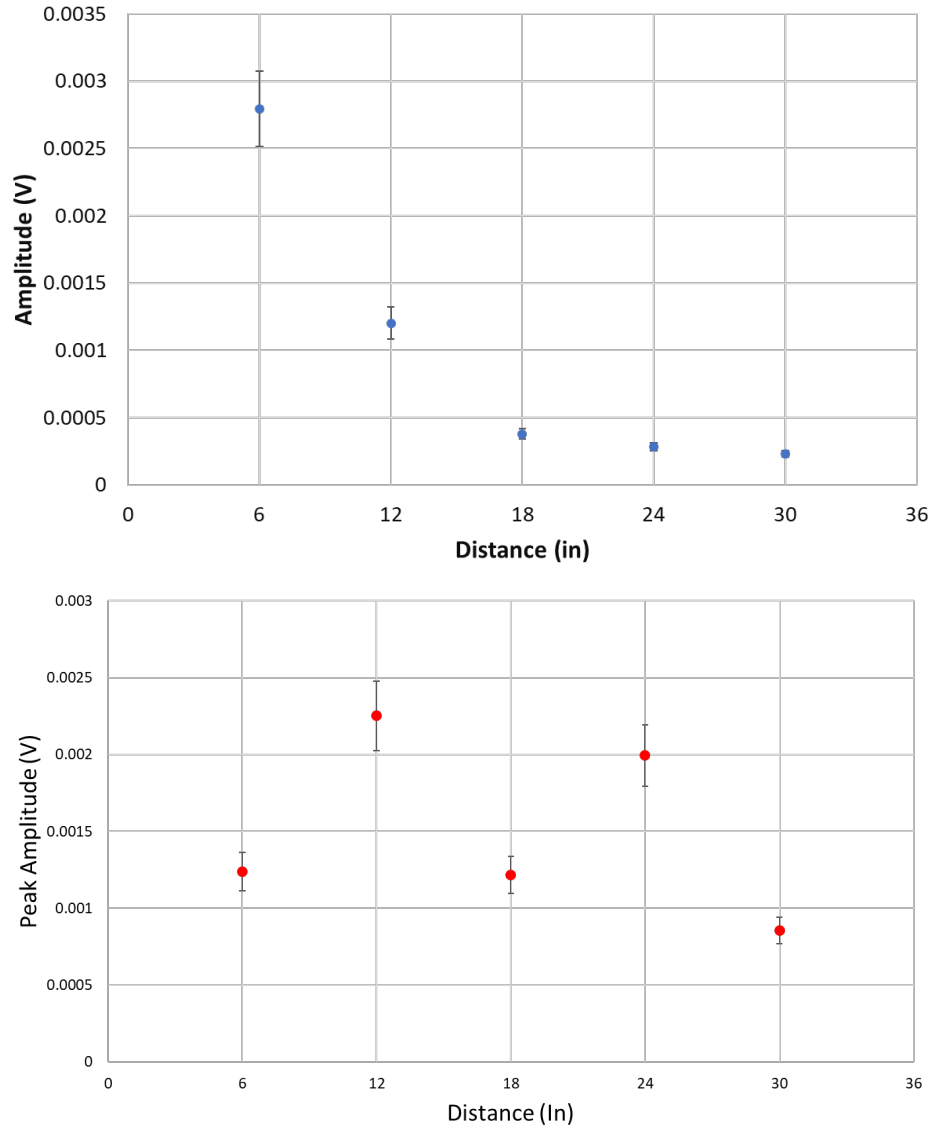
Figure 40. Left: Specimen C1 corroded rebar with 0-degree end, Right: Specimen C2 with clean rebar and 33-degree end.

Figure 40 compares the UGWL results from Specimen C1 with the corroded rebar at 0-degree-end (left) and Specimen C2 with the clean rebar at 33-degree end (right) after asphalt is overlaid on both specimens. The initial amplitudes for the corroded bar specimen are higher than the clean bar condition. This is expected from the UGWL method as reported previously (Erdogmus et al., 2020, M086 report). The early corrosion condition of Specimen C1 causes an increase in the leaked amplitudes due to the temporarily increased bonds between concrete and rebar. On the other hand, the data from Specimen C2 is more scattered and this is due to the bar end angle and deviations from the ideal UGWL method application (signals sent parallel to the bar).

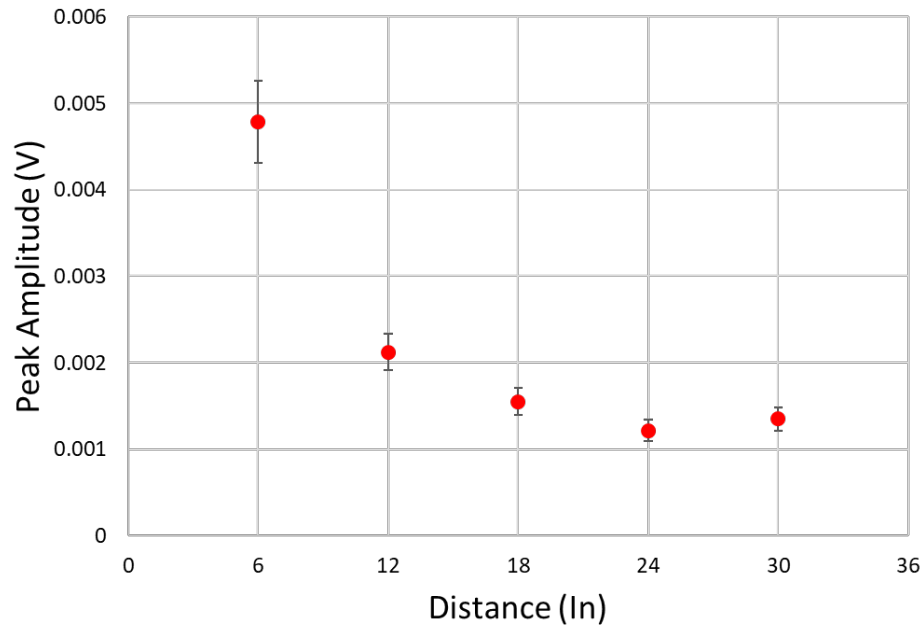
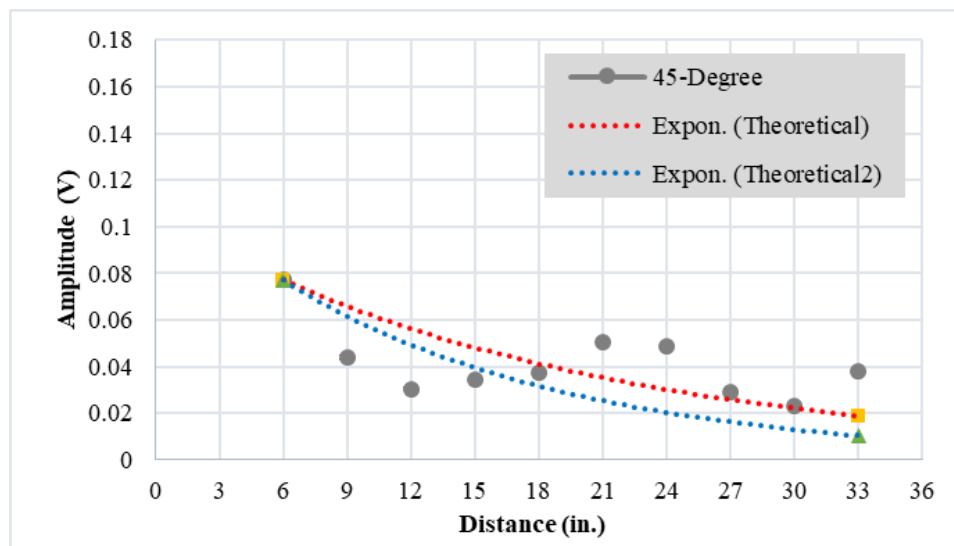
Figure 41. Top: UGWL Test Results on Specimen C3 After Asphalt Overlay. Bottom: UGWL Test Results on Specimen C3 before Asphalt Overlay

Figure 41 shows the results for Specimen C3. Once again, the method is applicable when the asphalt is added; however, the amplitudes are an order of magnitude smaller due to increased travel distance for the leaked waves and passing through three layers of materials.

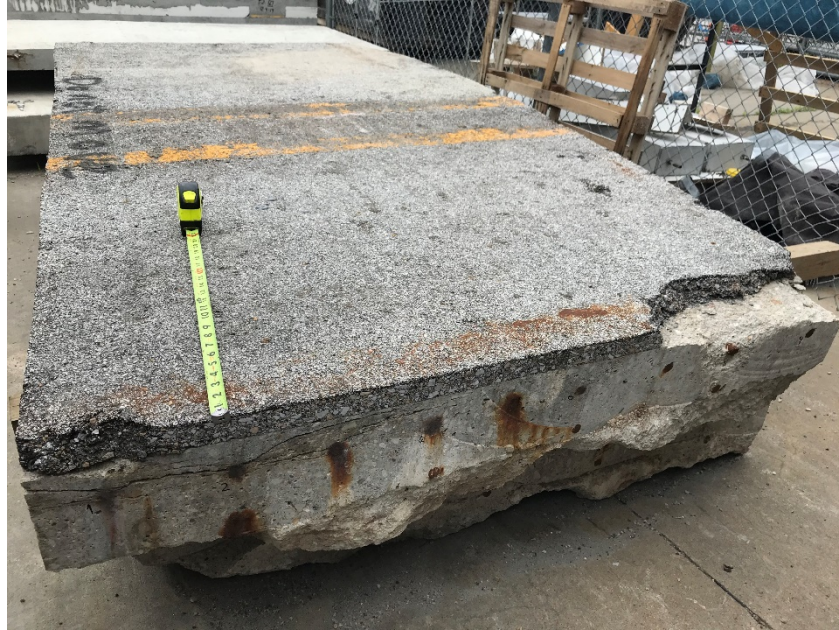
Figure 42 shows a view of the Field Specimen from the north end, and Figures 43 and 44 show the results when the waves are transmitted from of the Field Specimen for Rebars 2,4, 6, 8 and 9.

Figure 42. Field Specimen. View from North End showing the nine rebars

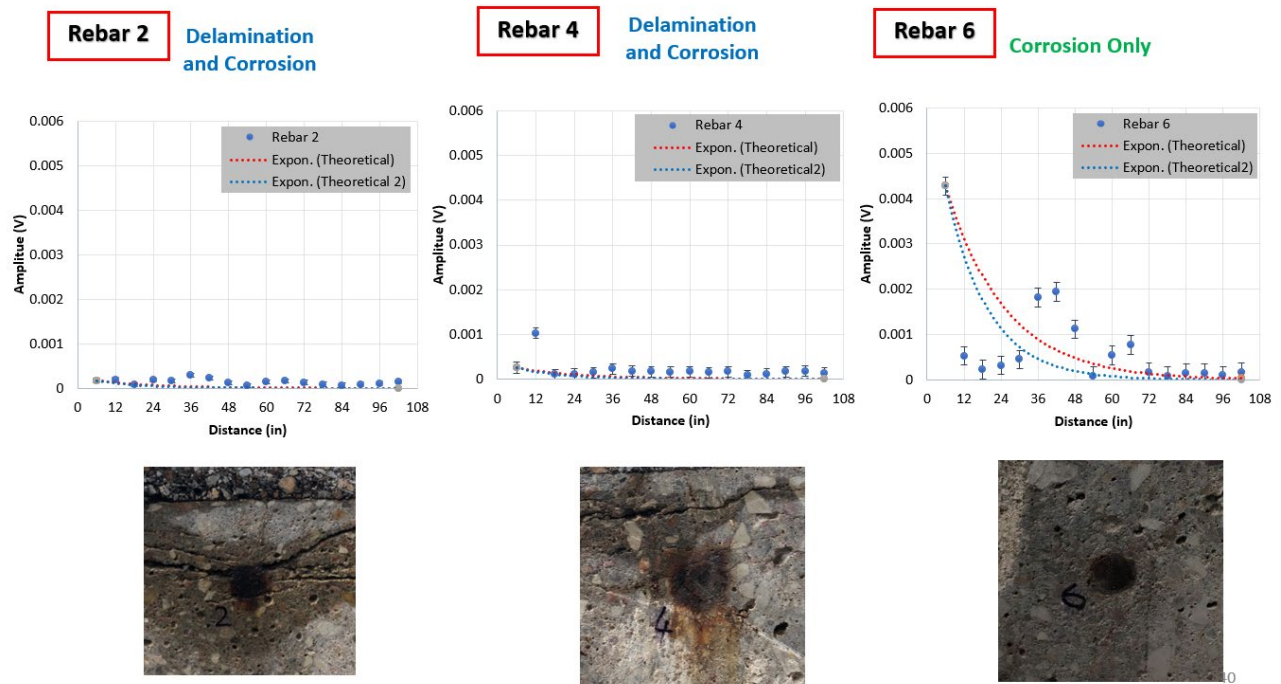
Figure 43. Field Specimen Results for Rebars 2, 4 and 6 from North End

It can be seen in Figure 43 that when there is a large and visually discernible delamination between the rebar and concrete or within concrete, as in the case of Rebars 2 and 4, the starting amplitudes are relatively low. In contrast, when there is no visible delamination but corrosion, as in the case of Rebar 6 and 9, the starting amplitudes are 93-96% higher than rebars 2 and 4. In Figure 44, rebar 8 presents a different case where some of the concrete is spalled due to corrosion for the first half inch, but then it appears well-bonded to the concrete after that. The initial magnitude for this rebar is closer to those with the corrosion only bars, but 49-57% smaller.

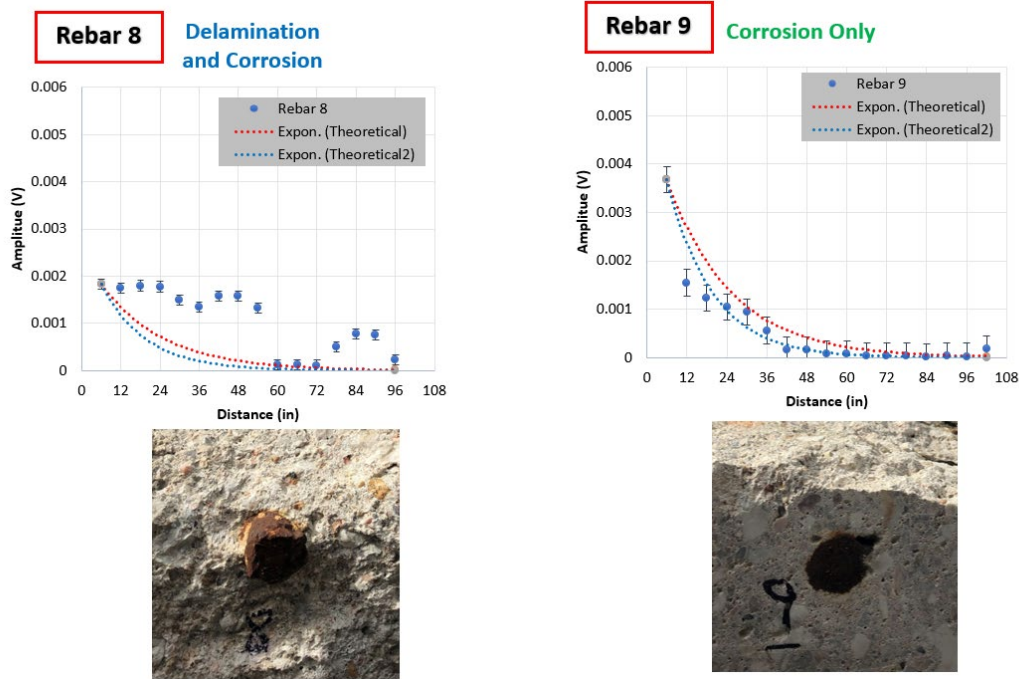
Figure 44. Field Specimen Results for Rebars 8 and 9 from North End

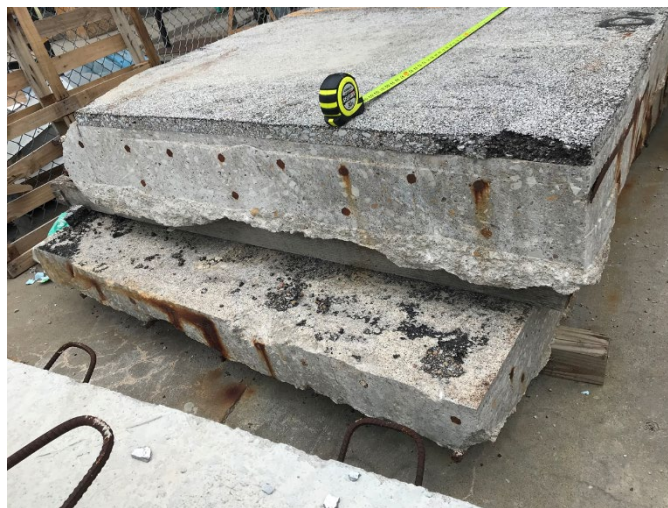
Figure 45 shows a view of the Field Specimen from the north end, and Figures 42 and 43 show the results when the waves are transmitted from

Figure 45. Field Specimen. View from South End showing the nine rebars

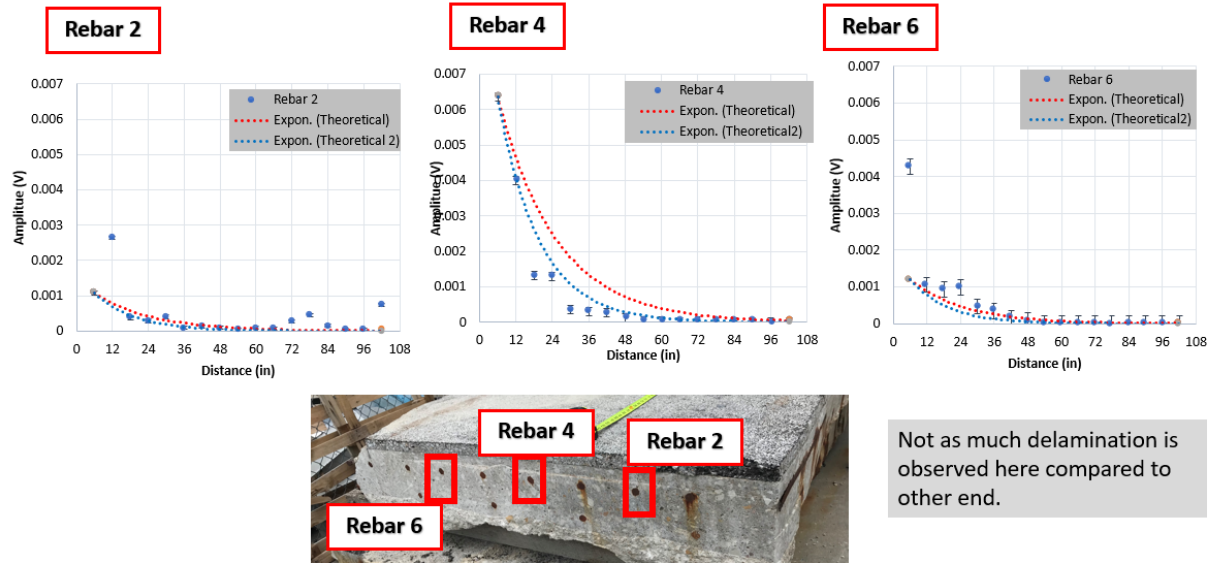
Figure 46. Field Specimen Results for Rebars 2, 4, 6 from South End

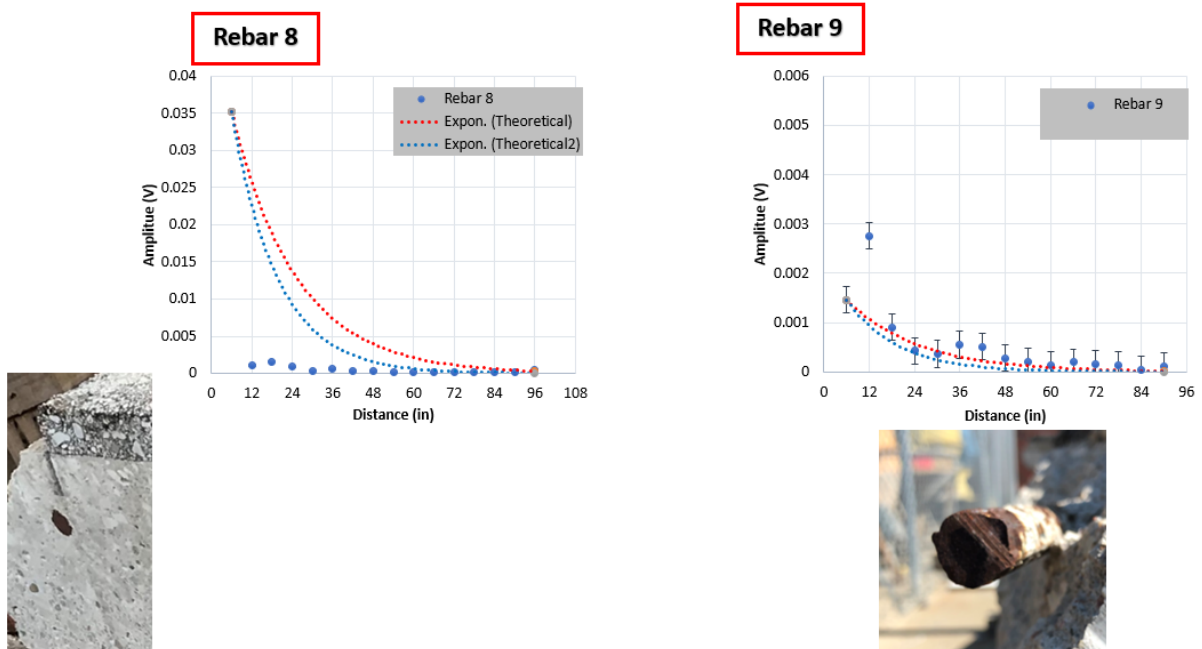
Figure 47. Field Specimen Results for Rebars 8 and 9 from South End
