Final Report WY-20/04F

Field Testing and Long-Term Monitoring of Selected High-Mast Lighting Towers

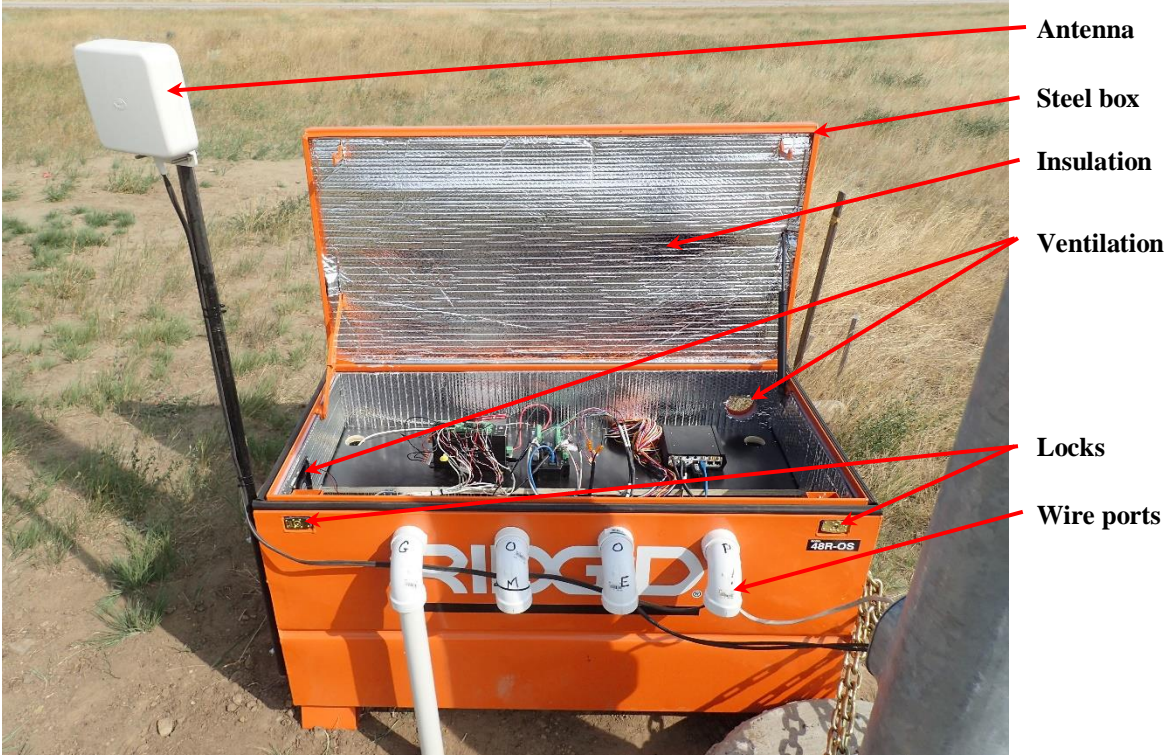
Figure 11. Equipment box

HMLT, as seen in Figure 12. The equipment box was fitted with a gasket around the lid to further seal against dust and moisture intrusion, dual locks to prevent unauthorized access, and each was chained to either the HMLT or anemometer pole. Finally, the Research Team placed ant bait and moth balls inside each box in order to mitigate pest intrusion and sealed the lock ports against rain water infiltration.

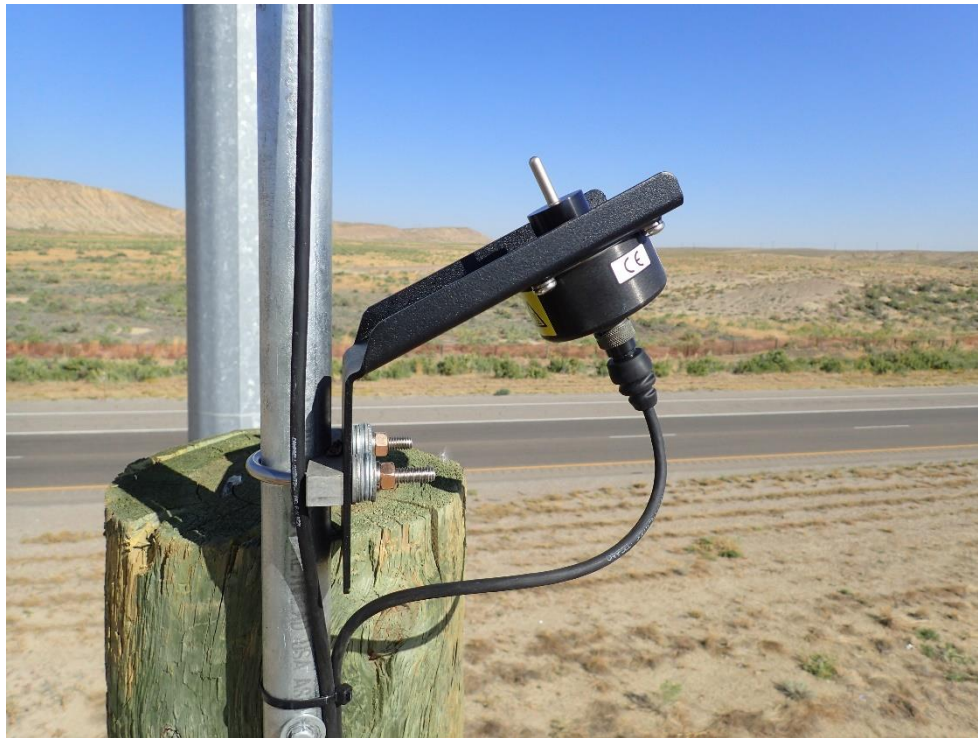
Figure 16. Freezing rain sensor and mounting kit

The freezing rain sensor is made by Rosemount Aerospace, Inc., Model 0871LH1. It detects the presence of icing conditions, or ice accumulation. The installation location can be seen in Figure 15, showing it mounted at the top of the temporary pole, below the anemometer, on the manufacturer-provided mounting bracket. The ice sensor operates using resonant frequencies of a nickel alloy probe. As ice collects on the probe, the added mass causes the resonant frequency to decrease. When the frequency decreases to about 130 Hz (resulting from a layer of ice of about 0.02 inches), the data logger logs an ice event and the ice sensor automatically defrosts the probe, and begins the process again.

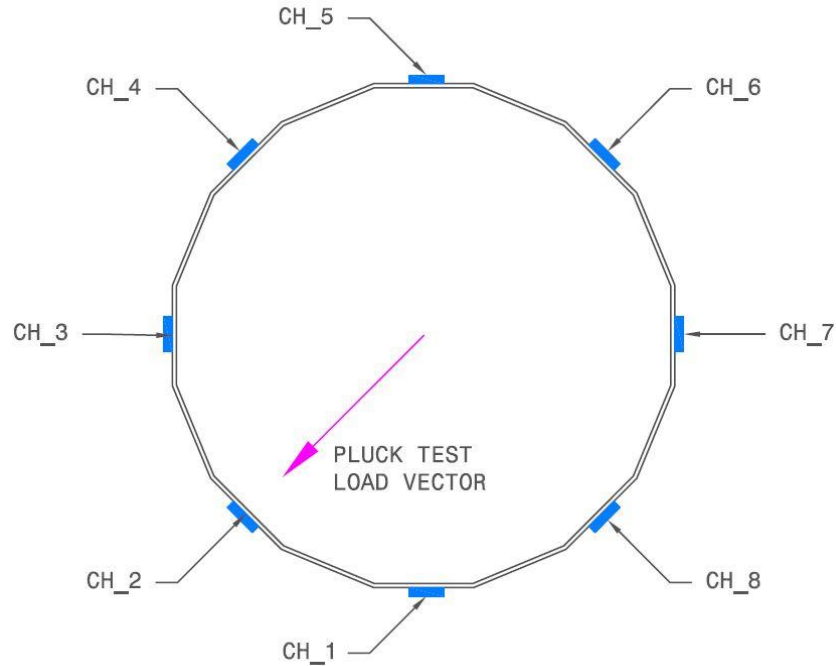
Figure 18. Sketch showing installation of strain gages on tube wall cross-section

All strain gages were installed seven feet above the top surface of the base plate, providing a distance from the hand hole slightly greater than one and half times the diameter of the HMLT. A single gage was installed on every other tube wall flat, providing nominal stress measurement along all the major axes with a redundant gage for each. Having the measured nominal stress range at a known height on the pole allows the Research Team to validate statics and extrapolate the nominal stresses at the base of the tube near the base plate weld. Figure 18 shows the typical installation of the gages, and Appendix A contains the detailed instrumentation plans for each location monitored. Channel, or gage, 1 was always installed on the flat facing magnetic south.

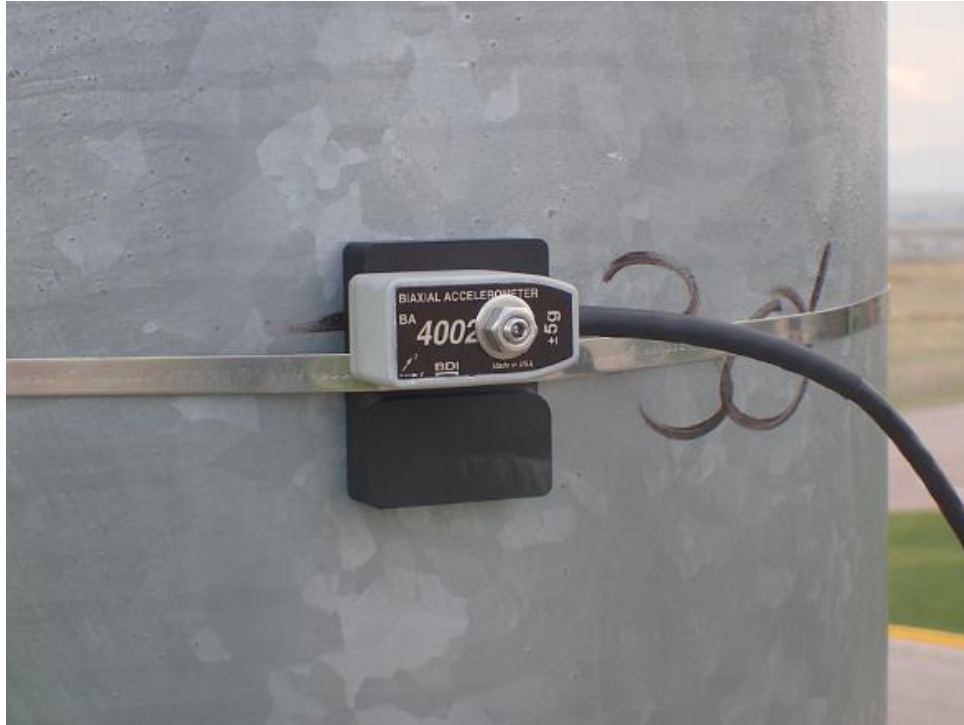
Figure 19. Bi-axial accelerometer

Accelerations were measured during the pluck tests using a bi-axial accelerometer produced by Bridge Diagnostics, Inc., Model BA1521-005, with an excitation voltage of 5 volts. This accelerometer has an acceleration range of $\pm 5g$. The accelerometer can be seen in Figure 19 attached to the HMLT using the manufacture-recommended mounting block and stainless steel strapping. The sensors were installed at 30-ft above the top surface of the base plate, facing south, as shown in the instrumentation plans in Appendix A.

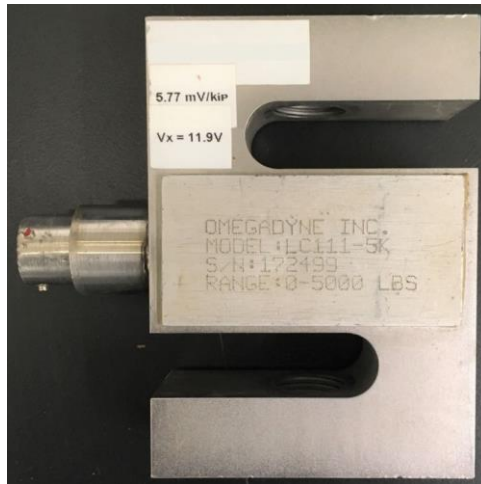
Figure 20. Omega Dyne Model LC111-5k Stainless S-Beam Load Cell

An Omega Dyne Model LC111-5k Stainless S-Beam Load Cell was used in line with the plucking strap for the pluck tests. The load cell was calibrated in tension prior to being deployed to the field. A voltage to load unit force multiplier was obtained during the calibration, which was plugged into the data logger program such that real time output on the computer during the testing was pounds.

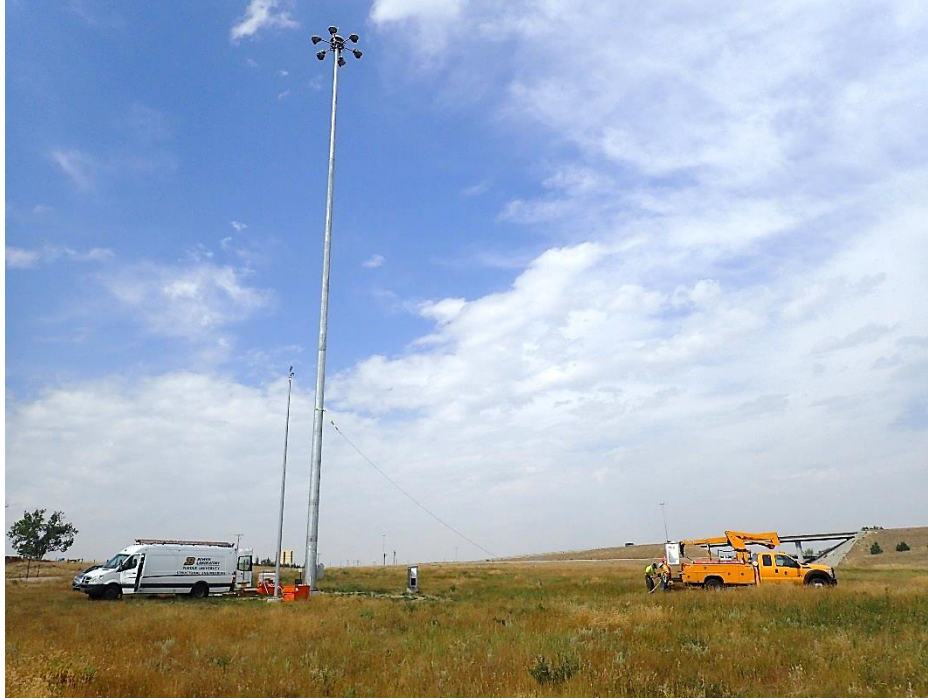
Figure 21. Pluck testing the HMLT at Buffalo Tri-Level

Figure 21 demonstrates an example of the setup for the pluck test, showing the test at the Buffalo Tri-Level. This reflects the same basic setup used at all testing locations. In this photograph it can be seen that the HMLT has been rigged with a strap. The strap was connected to the HMLT 32 ft. above the top surface of the base plate. In line with the strap were the S-beam load cell, a ratchet strap (come-along), and a quick release. With the strap anchored near the ground, either to a truck or aerial lift, the ratchet strap was used to apply a load to the HMLT between 1,000 – 2,000 pounds. The Research Team used a measuring tape and a laser distance measuring device to measure the horizontal leg of the loading triangle created by the setup. This way the load could be resolved into vertical and horizontal components and the measurements in the strain gages could be checked against theoretical calculations as another check for accuracy. The load vector was along the out-of-plane axis aligned with strain gage 2, pulling about 225 degrees off magnetic north for all of the sites except Vedauwoo, which due to the location of a fence, the load vector was moved to 315 degrees off magnetic north aligned with gage 4.

Once the strap was pulled to between 1,000 and 2,000 lbs, the quick release was triggered exciting a dynamic oscillation in the HMLT as it elastically rebound. Due to the load being applied relatively low on the HMLT, the dynamic response was primarily second or third mode vibrations rather than a large amplitude mode I sway. The magnitude of the load also ensured that the stresses in the HMLT tube wall remained far below yield capacity, generally with peak stress at the strain gage location of the pole being around 2 ksi. Data from the biaxial accelerometer were collected and analyzed to determine dynamic properties of each pole. This is explained further in the following section.

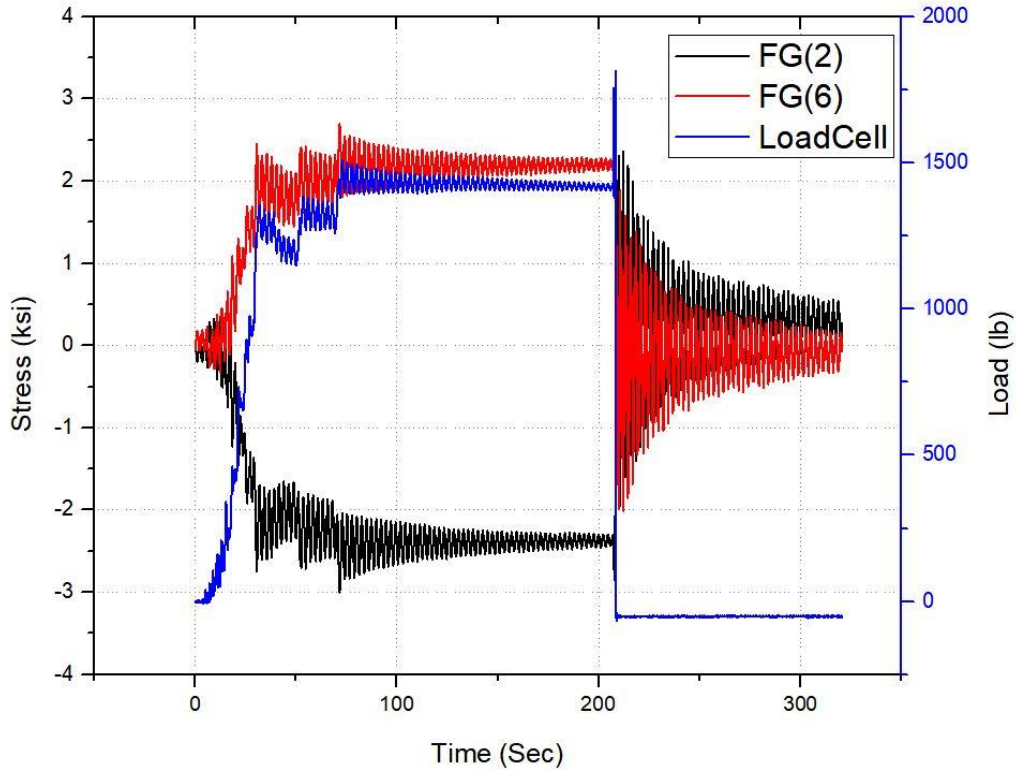
Figure 22. Sample pluck test data captured for the Baxter Interchange HMLT.

A sample of pluck test data is plotted in Figure 22. The strain measured by strain gages 2 and 6 has been converted to units of stress, ksi, using a calibrated multiplier. The double-y axis chart plots stress along the left vertical axis and load along the right vertical axis. These are plotted relative to time along the horizontal axis. It can be observed that as load increased, approximately equal and opposite stresses developed in the pole at the location of the two strain gages shown. These gages were installed opposite each other on the pole at a position of maximum bending stress. Thus, it would be expected that due to symmetry of the pole the stresses would be approximately equal with opposing signs. In this case, and the case of all stress data collected during this project, a negative sign indicates compression and a positive sign indicates tension. Figure 22 shows that load, and consequently stress, are shown to increase with distinct steps. This is due to the functionality of the ratchet strap used to apply load. Considering this figure again, it can be seen that at just past 200 seconds, the load is quickly released and stress oscillations are seen in the figure dampening out toward zero. Prior to releasing the load,

the HMLT was allowed to dampen to minimize the measured effect of the vibration from the ratcheting process.

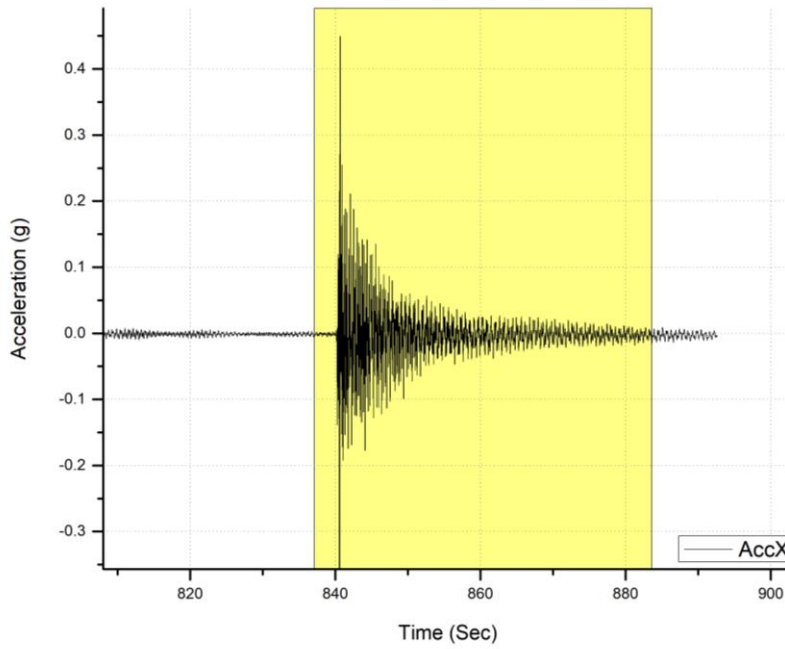
Figure 23. Sample of pluck data from Dwyer Junction

Figure 23 shows two Subfigures; Subfigure A is a sample of acceleration data collected during the Dwyer Junction pluck test. The vertical axis is acceleration in units of gravitational acceleration, g , and the horizontal axis is time in units of seconds. The maximum acceleration occurs at the time of load release and then dampens out toward zero. This section of the data has been highlighted in a yellow box. The data captured within the yellow box was used to perform a Fast Fourier's Transform calculation, the results of which are plotted in Subfigure B in the frequency domain. Along the vertical axis is amplitude and along the horizontal axis is frequency in units of hertz. Peak selecting was used from Subfigure B to identify the modal frequencies of each HMLT. This process was repeated using stress data for each location, as well, with natural frequencies identified up to and including mode 4. Table 2 summarizes the results of the modal frequency analysis. The results were consistent with data for other WYDOT HMLTs reported in NCHRP Report 718 (Connor et al., 2012).

A. Subfigure example of accelerometer data used to perform the FFT plotted in Subfigure B.

B. Subfigure example of FFT method applied to the data shown in Subfigure A.

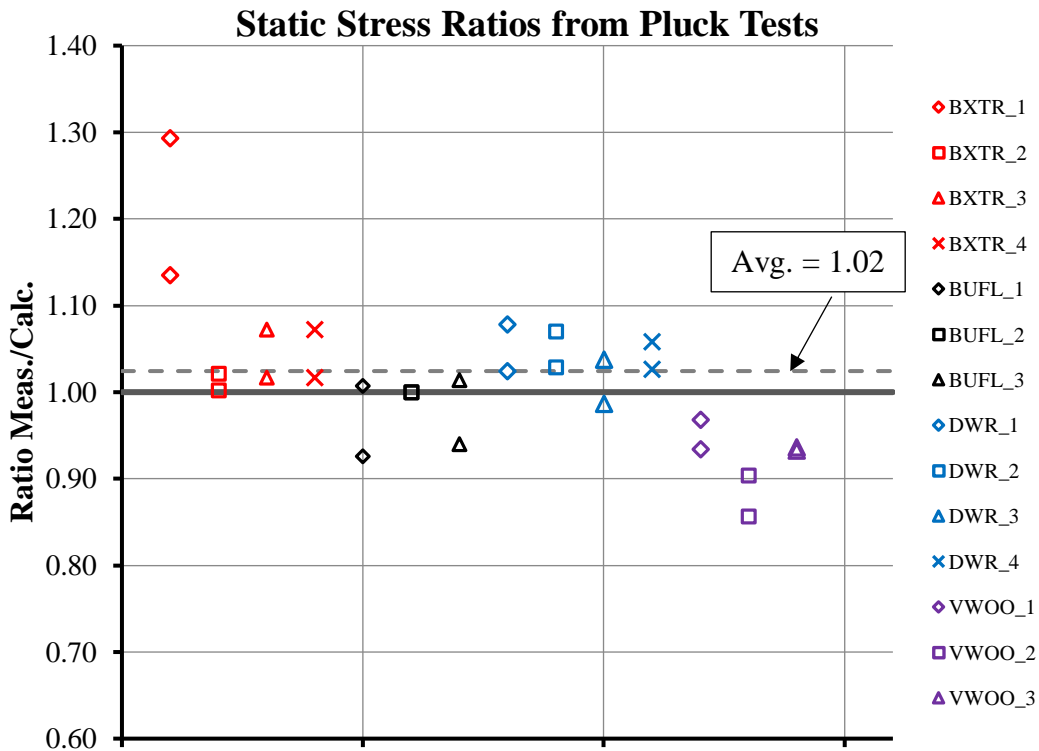
Figure 24. Summaries of Ratios of Measured to Calculated Static Stress

The pluck test data were also compared to hand calculations to further validate accuracy of the stress measurements and verify that the DAQ system was working as needed moving into the long-term monitoring program. Figure 24 plots the results of that comparison in ratios of measured to calculated stress. The hand calculation resolved the applied load into horizontal and vertical components, and accounted for the vertical portion of the load through axial stress and the horizontal portion through bending stress. Multiple pluck tests were performed for each site to ensure consistent, repeatable data. This is reflected in the figure. For each pluck test Figure 24 plots two data points. These measurements are taken from the two strain gages located at positions of maximum bending stress on opposing sides of the pole. The average ratio is

represented by the dashed line, which was 1.02. The standard deviation was 0.1 and the median value was 1.01. A possible reason for discrepancy indicated by a resulting ratio might be the assumption in the hand calculation that the load vector is truly perpendicular to the tube wall flat, when it likely was not exact despite best efforts to do so. This would change the flexural response of the pole and cause some minimal error.

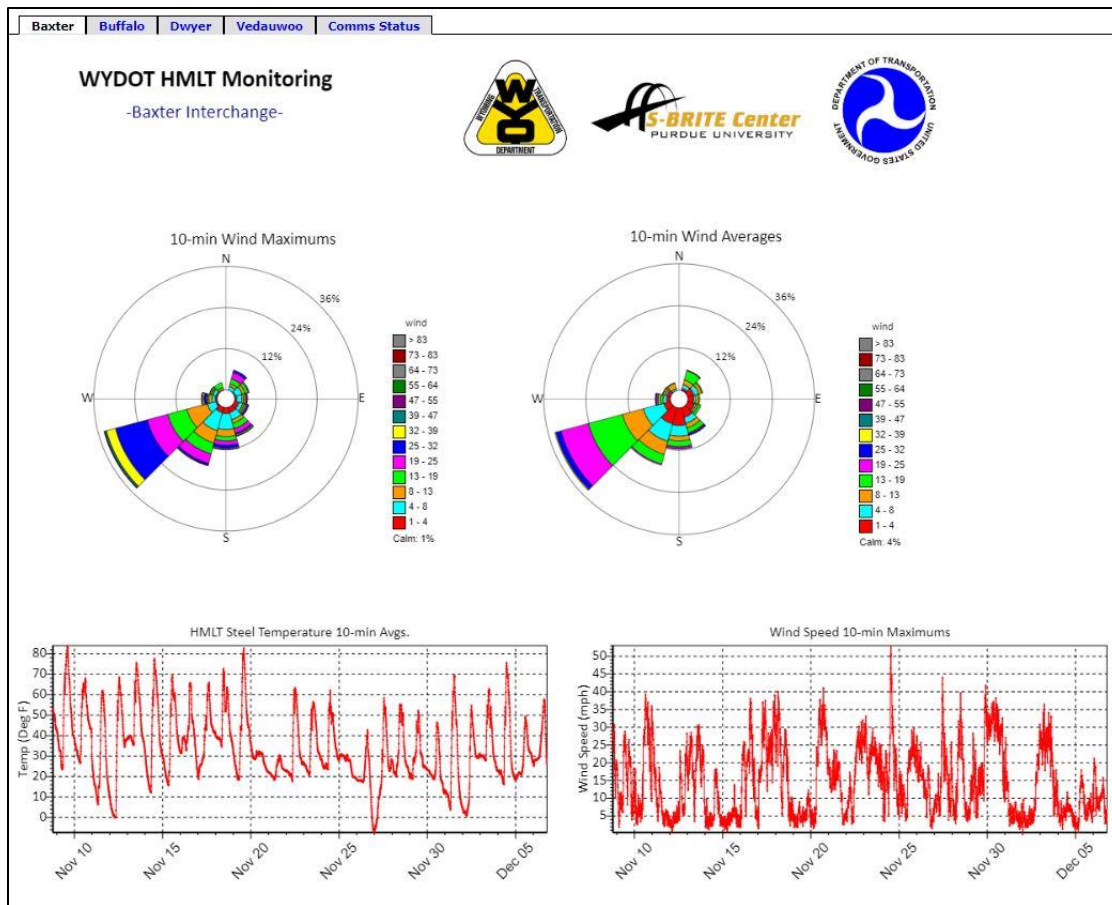
Figure 25. Web-based real time data display

In addition, the data logger was constantly monitoring output from the ice sensor. These data were sampled and stored independently of the wind and stress trigger events, but following post processing of data the Research Team was able to correlate recorded icy conditions present with the different trigger events through a synchronized time stamp, thereby enabling the team to determine any potential relationship between presence of ice and large-amplitude vibration.

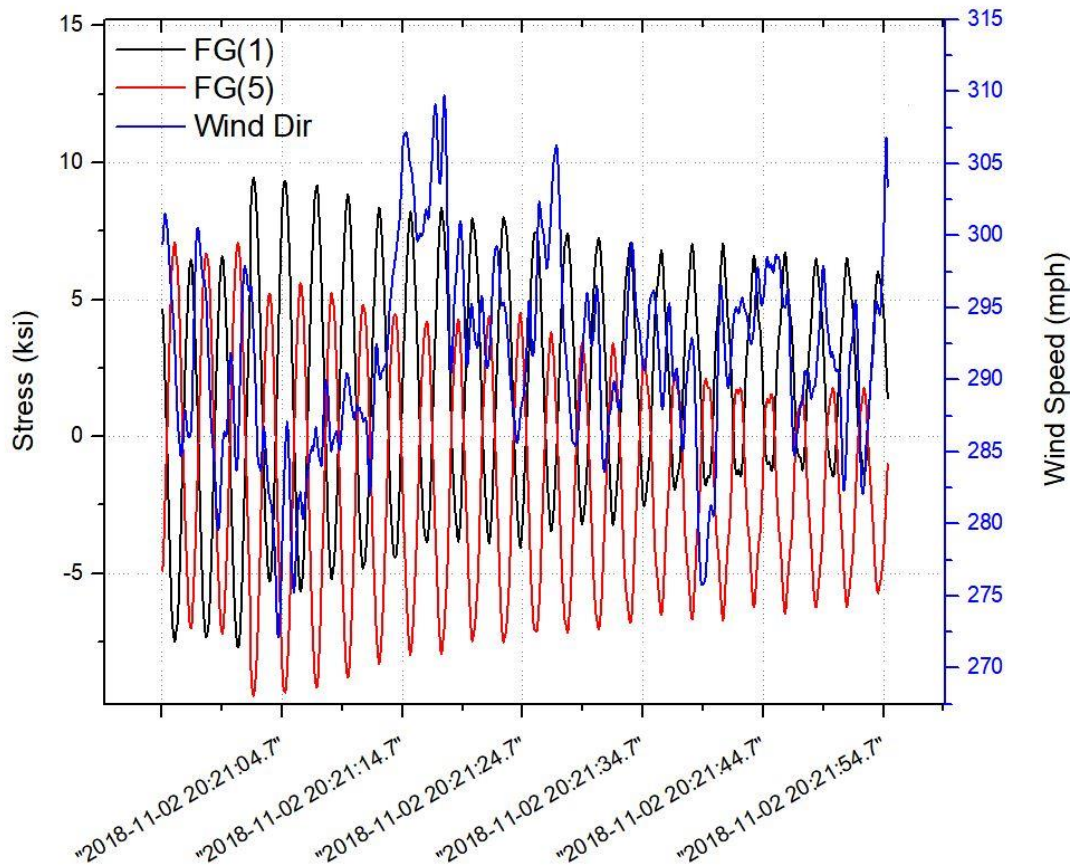
Figure 28. Data set from Vedauwoo Interchange captured on a Stress-5 trigger

In addition to wind-based triggers, two stress-based triggers were programmed, as discussed above; one for ± 5 ksi and the other for ± 10 ksi. This was done to ensure that large stress range events would be recorded if the wind speeds which caused it were less than 30 mph (or later in testing, less than 40 mph). Figure 28 shows a Stress-5 trigger event, meaning at least one of the strain gages measured a stress of greater than 5 ksi or less than -5 ksi. The event occurred at the Vedauwoo Interchange HMLT. This figure is a double-y plot with stress plotted along the vertical left axis and wind speed along the vertical right axis. Both are plotted against the data time stamps on the horizontal axis. The data from two foil resistance strain gages are shown, representing the largest stress ranges measured in the pole during this event. FG(1) and FG(5) were located opposite each other centered on the flats that face approximately magnetic north and south, respectively. Wind speed varied 12 mph between the low of 23 mph and high of 37 mph. The average wind speed over this period of time was 31 mph and the average direction was about 290 degrees, or heading east-southeast.

The peak stress range measured during this event was 17 ksi. There was no ice reported at that time. Direction of oscillation was across-wind. The vibration frequency was close to 4 cycles over 10 seconds, or approximately 0.4 Hz. This frequency corresponded well with the calculated

mode I resonant frequency for Vedauwoo, found to be 0.39 Hz, as reported in Table 2. As can be seen on the figure, the oscillations resulted in complete stress reversal indicating smooth, large-amplitude tip displacements. A calculation of tip displacement for the 17 ksi stress range is approximately ± 24 inches (or a full range of motion of 48 inches). The event was recorded on a trigger that recorded 10 seconds of data prior to the trigger, which is why the large stress cycles appear to abruptly start. Most likely there were several cycles building up to what is shown in the figure.

The event plotted in Figure 28 had similar wind characteristics to the event shown in Figure 29. Both events occurred at the Vedauwoo Interchange HMLT. In the case shown in Figure 29, the wind speed varied slightly more, 20 mph, between a low of 25 mph and high of 45 mph. The average wind speed over this period of time was 33 mph and the average direction was also 290 degrees, or heading east-southeast. However, the response of the HMLT is noticeably different, particularly in the magnitude of the stress ranges. The frequency of vibration was again the mode I resonant frequency of about 0.4 Hz and the motion was across-wind. There was no ice reported for the day of the event plotted in Figure 29, which would not necessarily be expected for August. The aerodynamic response was typical to most wind events for all of the monitored HMLTs throughout the two years of testing. Why the response plotted in Figure 28 was more significant in terms of amplitude of stress and tip displacement is inconclusive. It could be as simple as the characteristics of the wind flow were just different enough to excite lock-in phenomena in the November event (Figure 28). The presence of ice on the HMLT is also a possible explanation, particularly because the measured wind characteristics between the two events were remarkably similar.

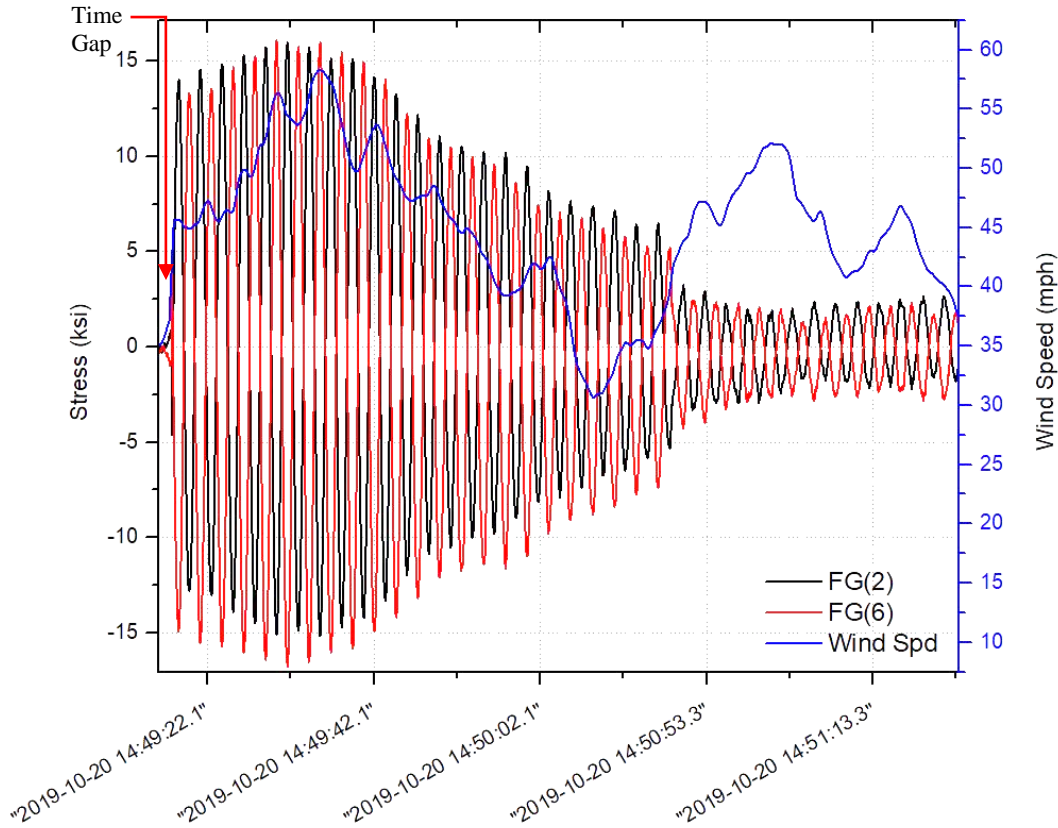
Figure 30. Large oscillation data set from Dwyer Junction captured on a Wind-50 trigger

Two additional large-amplitude events were recorded in the two years of monitoring. Both of them occurred at the Dwyer Junction location. The first event was initiated on a Wind-50 trigger, and is plotted in Figure 30. This figure is a double-y plot with stress plotted along the vertical left axis and wind speed along the vertical right axis. Both are plotted against the data time stamps on the horizontal axis. The data from two foil resistance strain gages are shown, representing the largest stress ranges measured in the pole during this event. FG(2) and FG(6) were located opposite each other centered on the flats that face approximately magnetic north-northeast and south-southwest, respectively. Wind speed varied 27 mph between the low of 31 mph and high of 58 mph. The average wind speed over this period of time was 37 mph and the average direction was about 280 degrees, or effectively heading east. The vibration was across-wind motion with approximately 4 cycles over 10 seconds, or 0.4 Hz. This frequency matches the calculated mode I resonant frequency for Dwyer Junction., found to be 0.4 Hz, as reported in Table 2. A calculation of tip displacement for the 32 ksi peak stress range is approximately ± 41 inches (or a full range of motion of 82 inches).

The large amplitude cycles appear to abruptly initiate at about 1:49 p.m. It's important to keep in mind that the data logger records each event in chronological sequence, such that the data file appears to be continuous when plotted. However, a closer review of the time stamp reveals that there is a gap in time that occurs between the small stress measurements appearing at the beginning of the plot, and the large stress cycles. The large-amplitude event was captured by a Wind-50 trigger that, once the wind speed exceeded 50 mph, data for 10 sec prior to the trigger were recorded. In this case it most likely missed a few initial cycles that would have shown a buildup of stress range magnitude. The largest of the stress cycles lasted a little over 10 seconds before beginning to dampen. The entire recorded event lasted about 1 minute and 20 seconds. Note, ice was reported at 1:40 p.m., or approximately 9 minutes prior to the beginning of the recorded event, suggesting that ice was likely accumulated on the HMLT when the trigger event occurred.

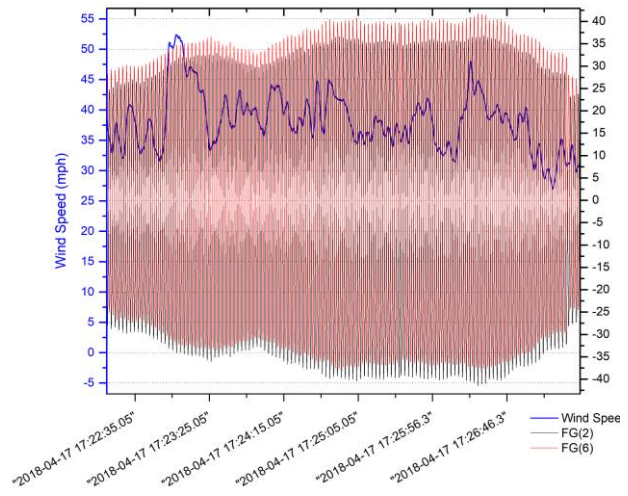
Figure 34. Data set with wind speed for large oscillation event at Dwyer Junction

A. Subfigure showing point when ice was reported before large-amplitude event, initial cycles, and data between 4:55PM and 5:21PM

B. Subfigure continuing the stress and wind speed time-histories from 5:22PM to 5:26PM

C. Subfigure continuing the stress and wind speed time histories from 5:27PM to 5:32PM

D. Subfigure continuing the stress and wind speed time histories from 5:33PM to 5:38PM

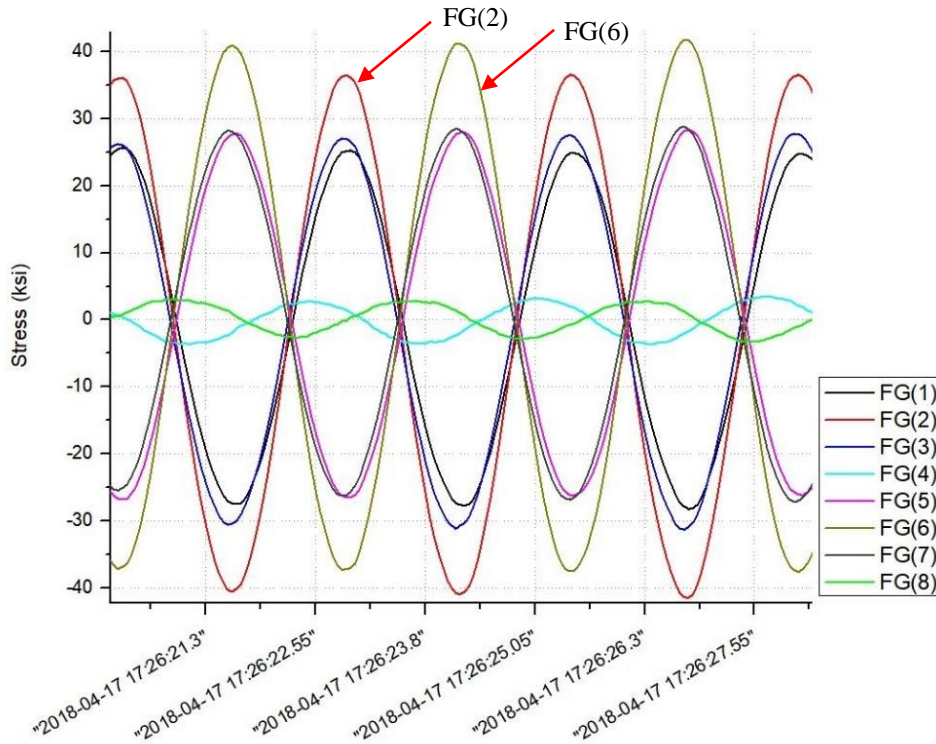
Figure 36. Close view of lock-in phenomena recorded for Dwyer Junction

Figure 36 is provided to show further detail of the observed stress measurements, adding all eight strain gages to the plot. This is a single y-axis plot with stress in units of ksi plotted along the vertical axis and data timestamps plotted along the horizontal axis. Two primary observations to be made here are that FG(2) and FG(6) measured the largest of the stress range measurements, reflecting symmetric equal-and-opposite behavior in the pole. The other supports the first, which is that gages FG(4) and FG(8) were measuring stress near zero, indicating their position would have been relatively close to the neutral axis of bending in the HMLT. The peak stress ranges observed were about 78 ksi during this period of time plotted here. FG(4) and FG(8) measured ± 3 ksi. Furthermore, it can be noted that when FG(2) measured compressive stress, FG(6) measured equal magnitude and opposite sign tensile stress, and vice versa. These two strain gages were installed on the HMLT at opposite flats. This can be seen in Figure 37, where a cross section of the HMLT is provided indicating the location of each strain gage and the gage ID. In this case, “CH_2” signifies “Channel 2”, or FG(2). The same symmetry can be seen for all gages positioned opposite each other.

Since the peak stress range measurements observed during the event were consistently seen for FG(2) and FG(6), it can be said that the direction of displacement did not vary significantly. It also indicates that the pole was displacing along the approximate axis between these two strain

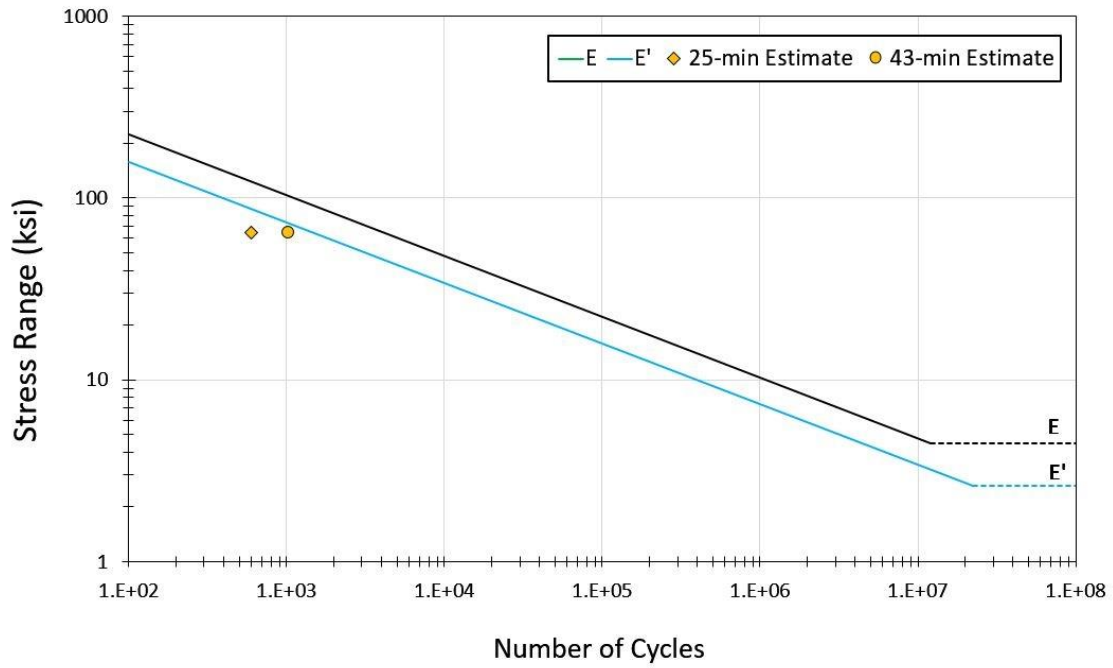
Figure 38. SN curve showing fatigue life consumed by the April 2018 large-amplitude event at Dwyer Junction

Truncation				0.75 ksi		
Location	Gage ID	N_{f_Design} (Cycles)	N_{f_Mean} (Cycles)	S_{reff}	% Exceedance	Remaining Life
Dwyer Jct	FG(6)	1,474	2,800	64.2	99.8	0
