# IMPROVEMENT OF MATERIAL CRITERIA FOR HIGHWAY EMBANKMENT CONSTRUCTION

NCDOT Project 2015-05

FHWA/NC/2015-05

March 2019

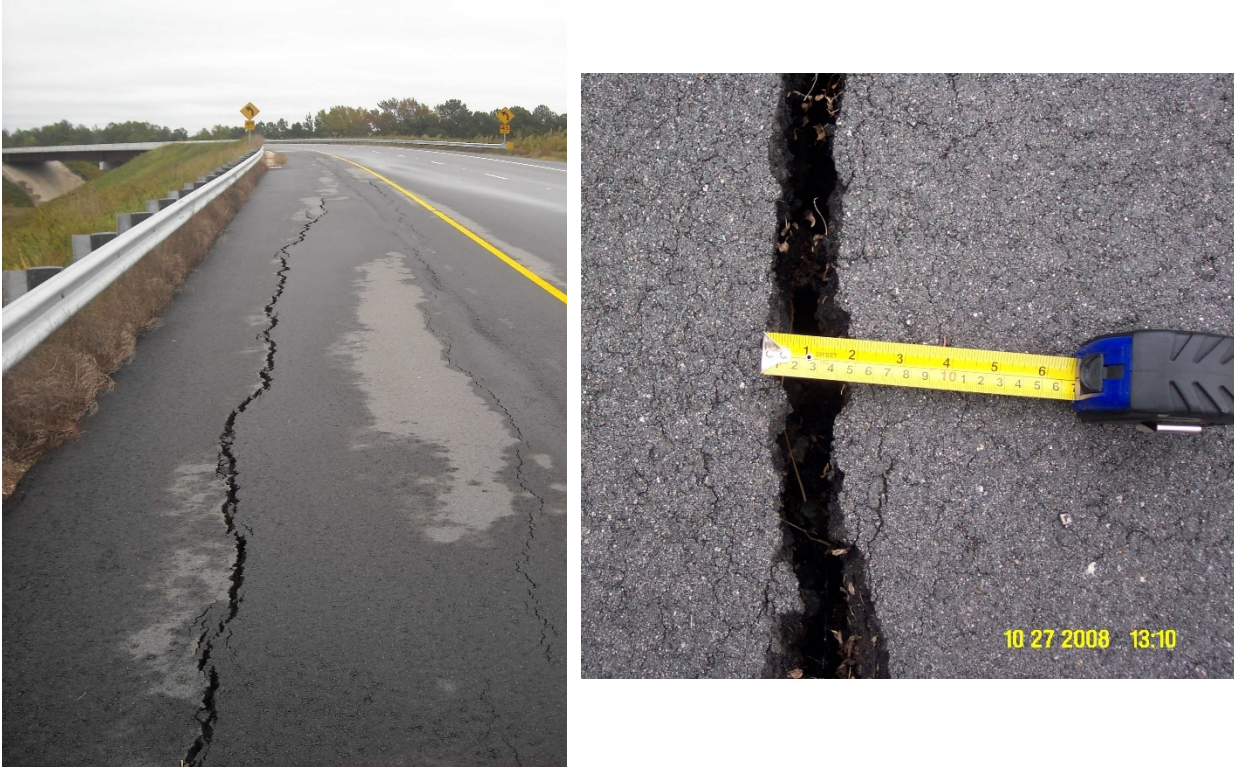
Figure 2.5. Longitudinal cracking caused by strength loss after wetting-drying cycles, NC I-540 @ Davis Drive (source: “Geotextile for Pavement Stabilization” presentation by NCDOT office)

Figure 2.5 shows an example of longitudinal cracking caused due to strength loss after wetting-drying cycles, on NC I-540 at Davis Drive. According to the local reports, this crack is caused by presence of moisture and “collapse” of embankment soil happening after cycles of wetting and drying. Site soil is attributed to be similar to the Soil 2 Lee of the current project, a highly plastic silt with LL= 58 and PI= 21.

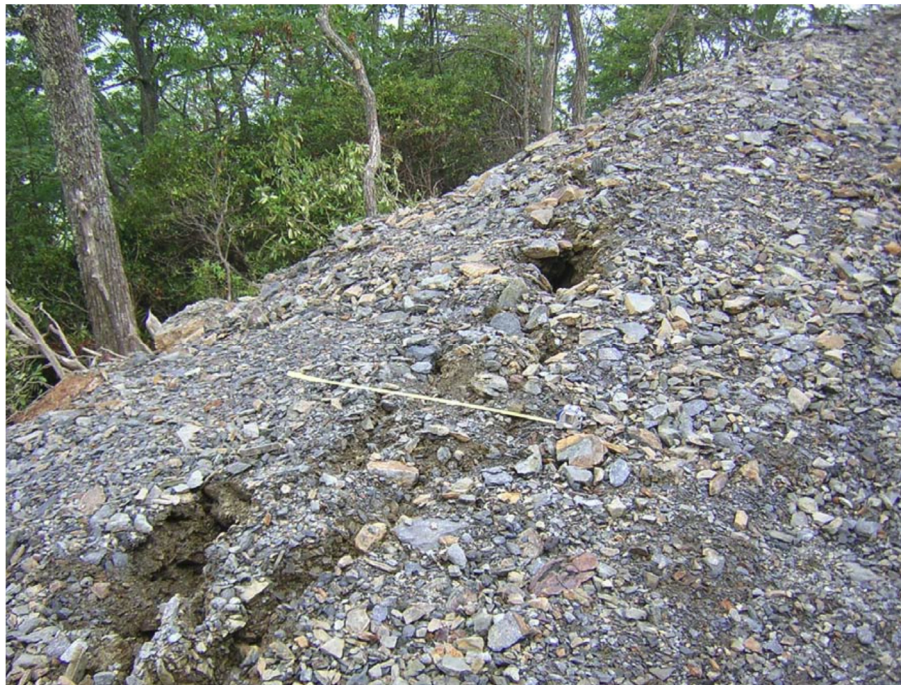
Figure 2.6. View of cracks in embankment, Haywood County, North Carolina  
(source: North Carolina Geological Survey 2006)

The bedrock beneath embankment is a graphitic-sulfidic bedrock which seems has been excavated by blasting to construct the road prism. It should be noted that the graphitic-sulfidic

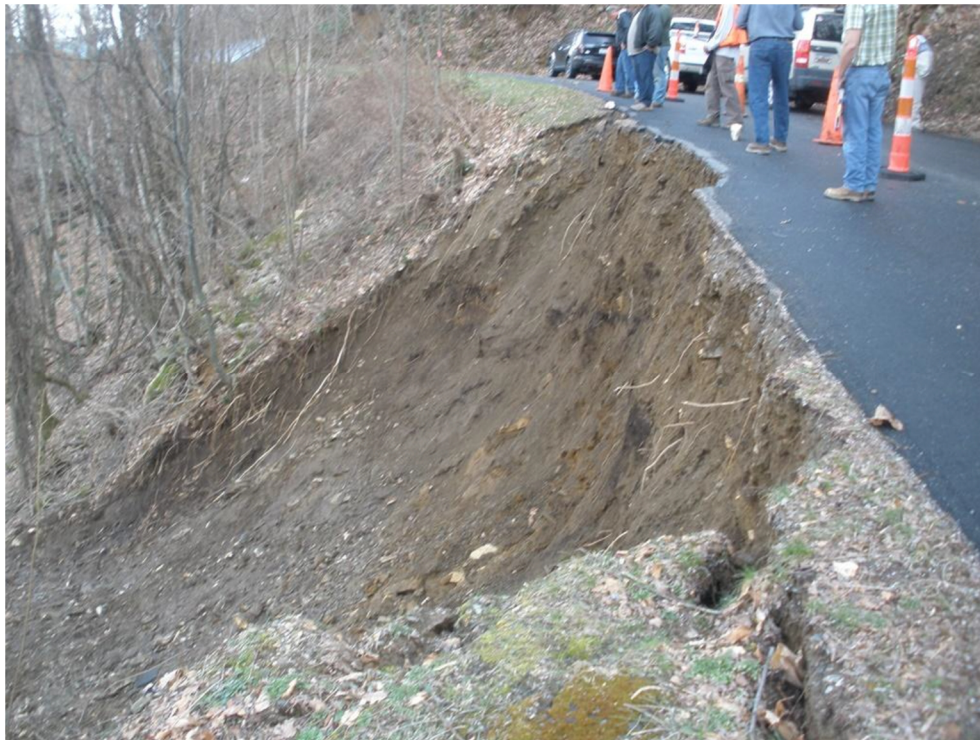
Figure 2.7. Embankment failure from the shoulder of roadway (Appalachian Landslide Consultants 2013)

According to a report by Appalachian Landslide Consultants which was prepared for the Jackson County Planning Department (Appalachian Landslide Consultants 2013), the most common type of road embankment failure seen in western North Carolina is slope failures from the shoulders of the road, as Figure 2.7 illustrates. These are the areas often compacted improperly. Sometimes utilities are buried in the outside shoulders and refilled without enough compaction. In such cases, uncompacted soil provides a pathway for water to flow along the utilities or between the more compacted soil of the road bed and the less compacted soil of the shoulder.

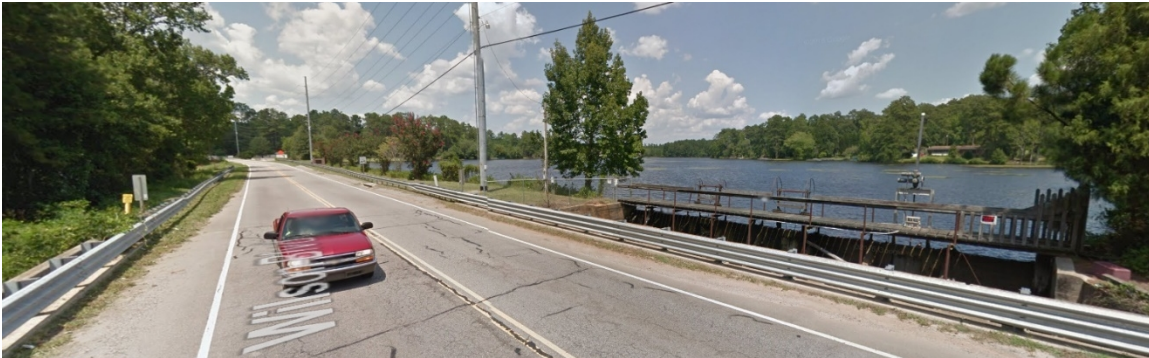
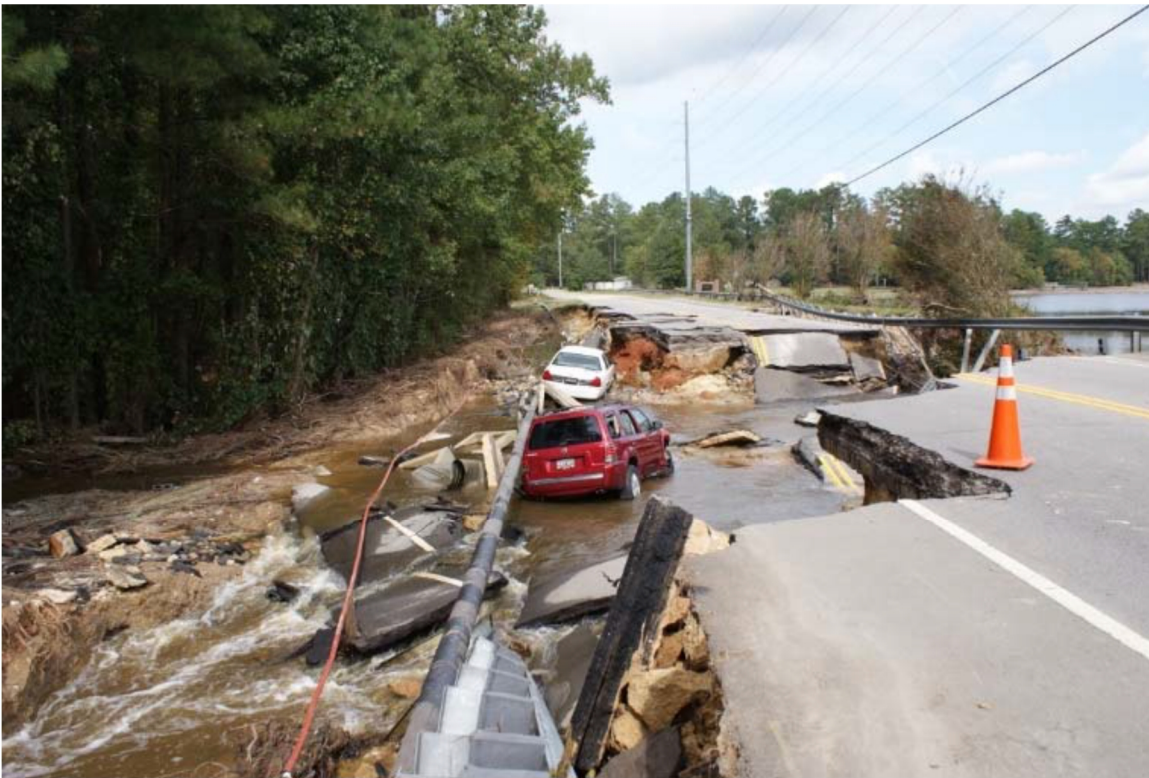
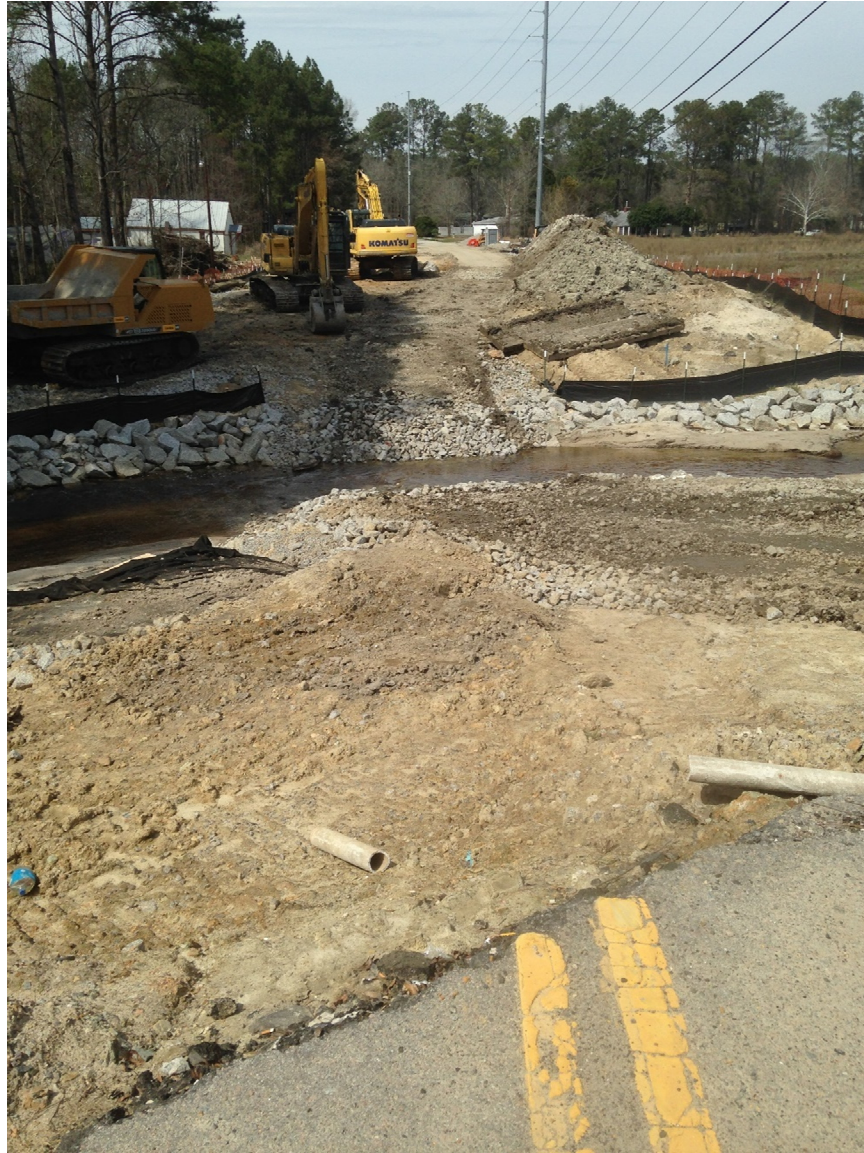
Figure 2.8. Lake Elizabeth Dam, (a) before flooding failure, (b) shortly after failure, (c) long time after failure on March 2018

From October 2-5 in 2015, Hurricane Joaquin resulted in extensive rainfall of more than 50 cm in most parts of the midlands of South Carolina, which was more than 1000-year design rainfall. The flooding resulted in more than 40 embankment failures across the state and caused 19 fatalities (Tabrizi et al. 2017). One of the failed embankments is the Lake Elizabeth Dam located in Richland county, a lake with its spillway gates located along the Wilson roadway in Columbia. The failure of this dam was reported on October 6, 2015, which matches with local reports stating that the failure of the road embankment happened 1.5 day after the rainfall. Figure 2.8 shows Lake Elizabeth Dam before failure, right after failure and long time after failure.

For this dam, the height of crest overtopping is reported equal to 1 m; this value is in fact the difference between maximum head above breach invert and breach depth (Tabrizi et al. 2017). For this case as a roadway embankment, it seems this number means at the time of failure the height of water on top of pavement was 1 m. Field investigation and sampling classified the lake soil as SC (clayey sand) with 70.9% of sand and 24% of fine particles (silt and clay).

However, the author interpretation is that because of the fact that failure happened 1.5 day after the rainfall, the roll of water penetrating beneath/through the embankment body cannot be overemphasized. Having enough time, embankment soil becomes saturated and starts to lose shear strength. The lateral force of the large volume of water was also helping to push water through

upper levels of the embankment. Eventually, the embankment soil and its foundation that have lost strength initiate failure and this also helps to break the pavement system.

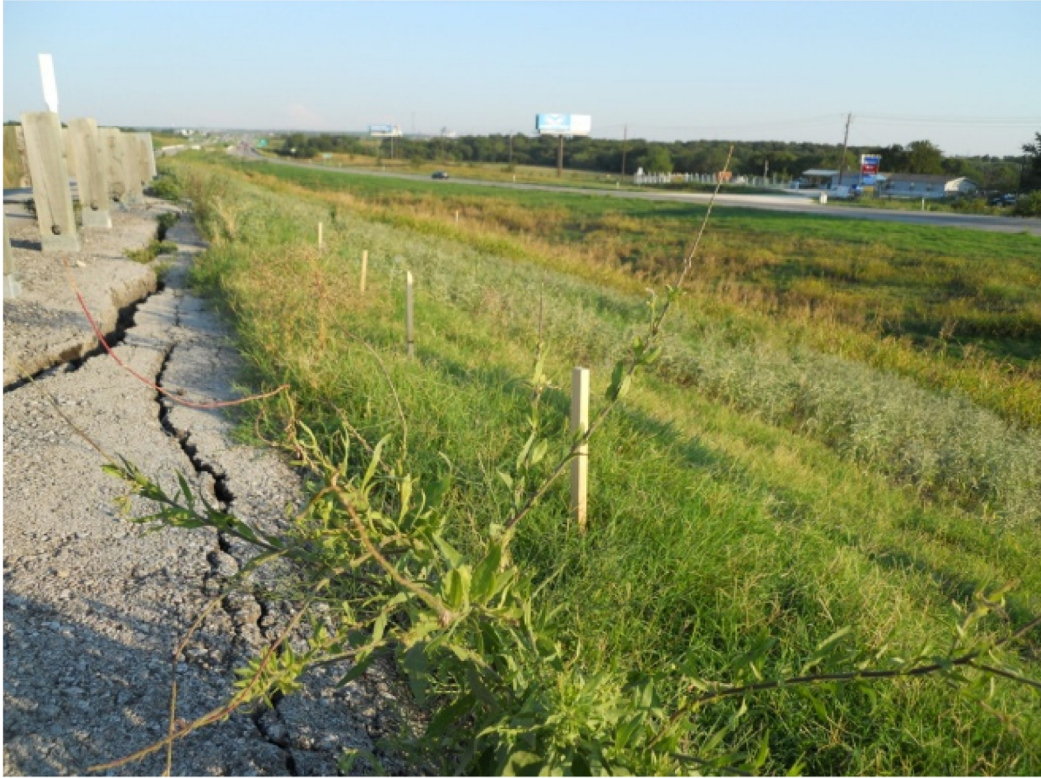
Figure 2.9. Surficial movement and cracked shoulder due to rainfall on U.S. Highway 287, Texas [photo credit: Khan et al. 2015]

However, the failure mechanism could be explained as follows. The highly plastic clay soil having montmorillonite, makes the soil highly susceptible to swelling and shrinkage during wetting and drying cycles. Wright (2005) states that fully softened strengths (which is lower than peak strength) may eventually develop in high-plastic clays, generally in field condition, after exposure to the wetting/drying cycles and provide the governing strength for first-time slides in both excavated and fill slopes. Moreover, it is well known that the cohesion of soil almost disappears in the fully softened state (Wright 2005; Duncan et al. 2014). The wetting and drying cycles may have caused the near-surface soil to soften, resulting in the movement of the slope and causing shoulder cracks. The cracks may have provided an easy path for water to intrude into the slope, which eventually saturated the soil near the crest during rainfall.

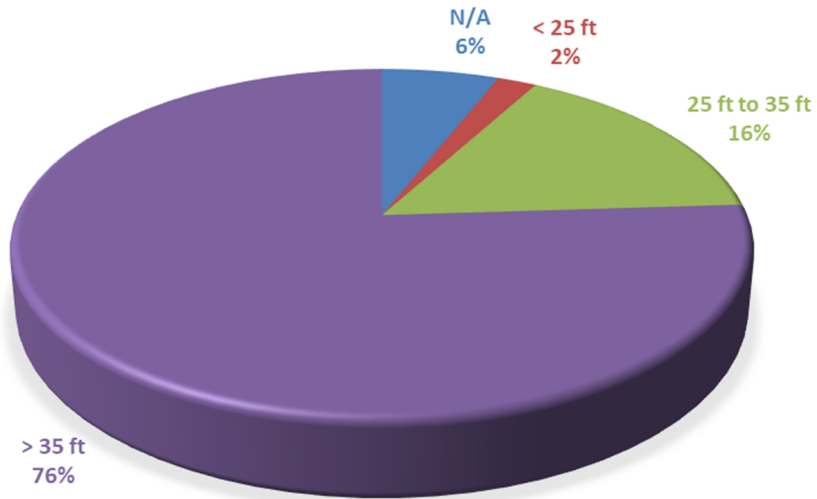
Figure 2.13. Shallow slope failure distribution with embankment height (feet)

presented in the summary table with respect to embankment height (feet), and embankment side slope (degrees) respectively. In these figures embankment height is in feet and embankment side slope is in degrees. It can be seen that big portion of failures have occurred in embankments higher than 35 ft.

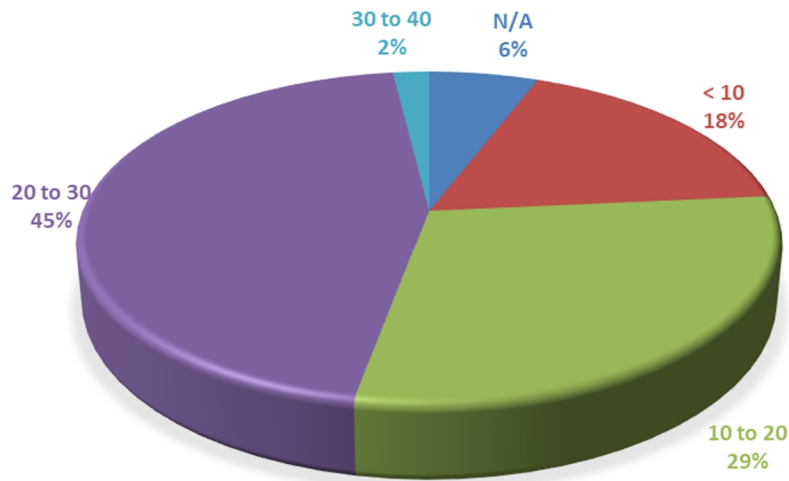
Figure 2.14. Shallow slope failure distribution with embankment side slope (degrees)

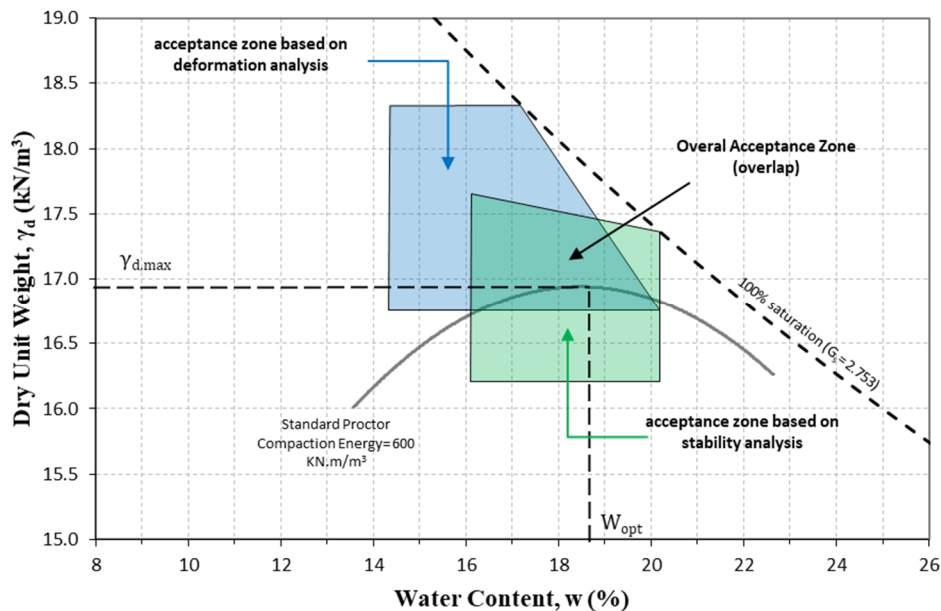
Figure 3.1. Schematic general research methodology used in the project

General research methodology used in this project consists of the idea that we will be striving to find out regions on the moisture content-dry unit weight domain which meet criterion for minimum factor of safety against sliding as well as criterion for allowable deformation of embankment. In other words, behavior of soil samples all over the moisture content-dry unit weight domain should be scrutinized. Figure 3.1 schematically illustrates general research methodology used in the project. This figure which is on the moisture content-dry unit weight domain, shows an acceptance zone based on slope stability analysis, an acceptance zone based on deformation analysis, and an overall acceptance zone. Shown in this figure is also the zero void air curve or saturation line, which represents location of saturated soil samples. This curve also serves as a limiting border on the moisture content-dry unit weight domain.

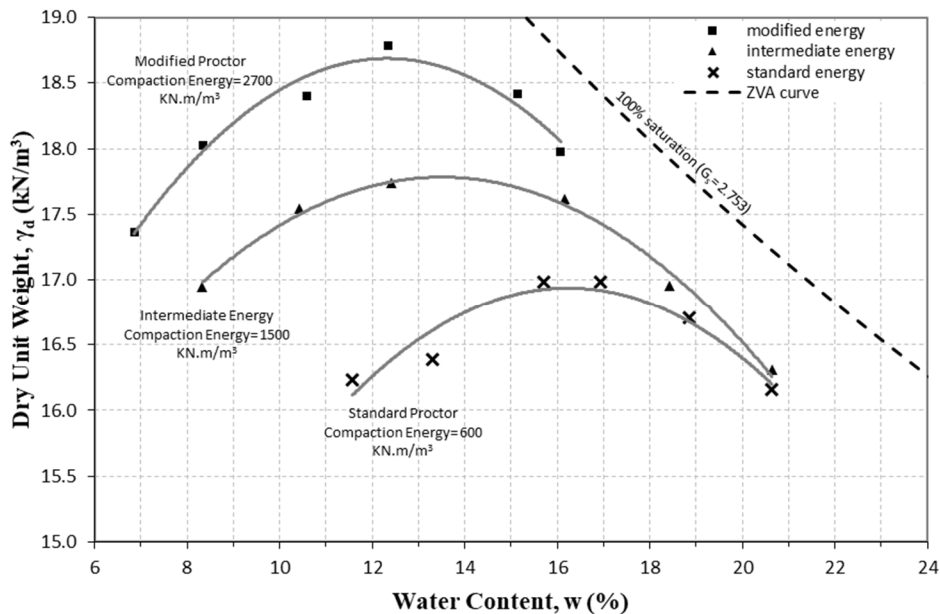
Figure 3.2. Schematic illustration of 15-points method; having enough data points around OMC at each compacting energy level

As stated earlier, performance of embankments could be attributed to two concerns; stability and deformation. In fact, factor of safety against instability, and deformation characteristics of embankments built with soil samples/data points shown in Figure 3.2 must be investigated.

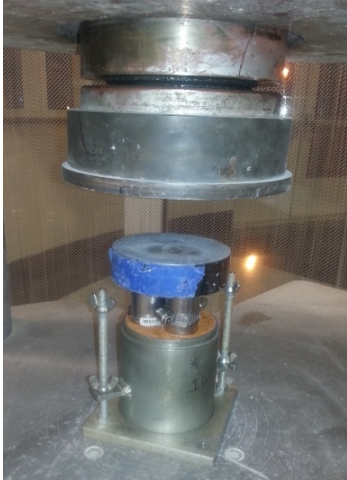
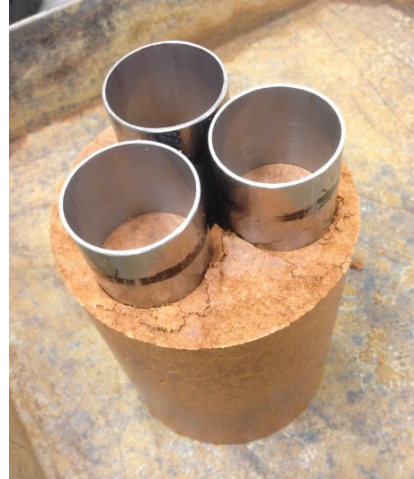
(a) pushing tubes into the soil sample

Friction angle and cohesion terms might be known as soon as Mohr-Coulomb failure envelop of the soil material is known. Obviously, for one to be able to draw the failure line, more than one triaxial test and the minimum of three is required. This necessitates creating minimum of three identical soil specimens for each particular point located on the moisture content-dry unit weight domain. Confining cell pressures ( $S_C$ ), or effective confining cell pressures ( $S'_C$ ) in the case of CU triaxial tests, will differ in the three consecutive tests and could be as 25kPa, 50 kPa and 100 kPa respectively. Figure 3.5 illustrates different steps needed to obtain three samples and to perform a triaxial test.

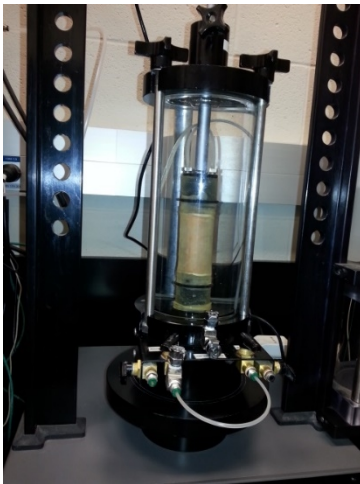
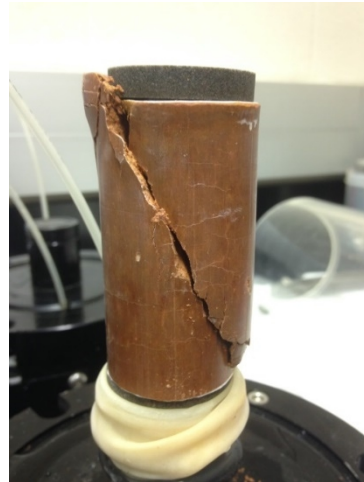
(b) UU triaxial test

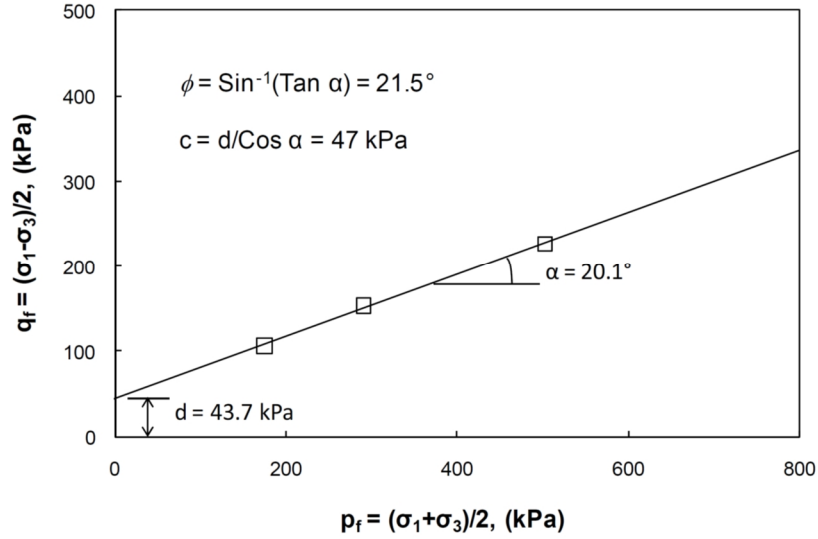
Figure 3.6. Method to get strength parameters from failure line in p-q space (from Chen 2010)

It is expected that the shear strength envelop would exhibit linear behavior over the range of confining cell pressures that will be used for the laboratory UU and CU triaxial tests. It is noted that shear strength envelop is the tangent line over the Mohr Circles which are drawn in shear stress ( $t$ ) versus normal stress ( $S_n$ ) space. However, using the well-known method proposed by Duncan et al. (1980), we can get the strength parameters more easily by having the failure points on p-q space rather than  $S_n-t$  space, and by using the following set of equations. The concept is also illustrated in Figure 3.6, and equations are listed in equation (3-1).

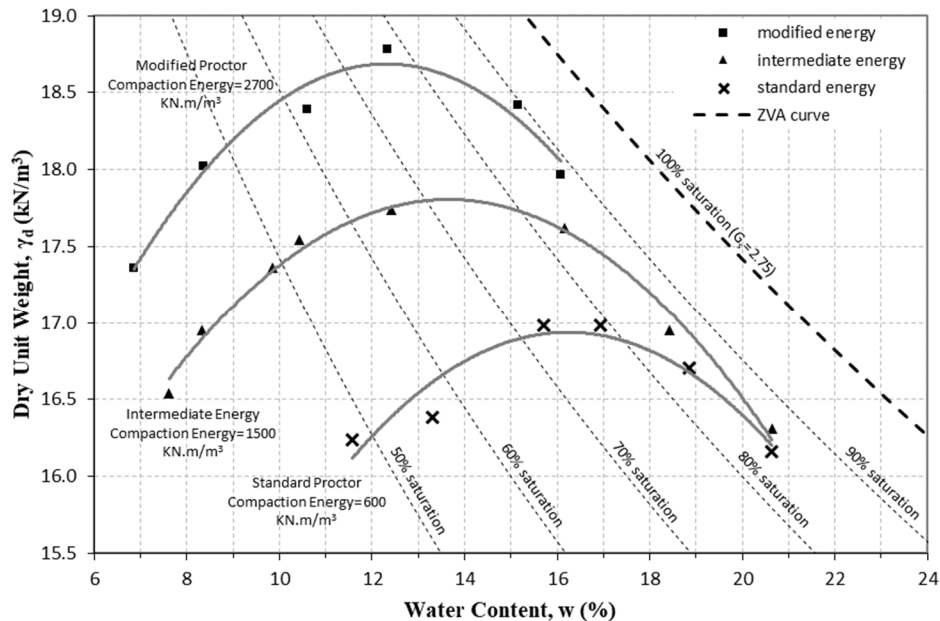
Figure 5.1. Compaction curves for Soil 1 Forsyth at three energy levels

Interestingly enough, in case of Soil 1 Forsyth optimum point at all energy levels is located relatively exactly on the 75% saturation curve.

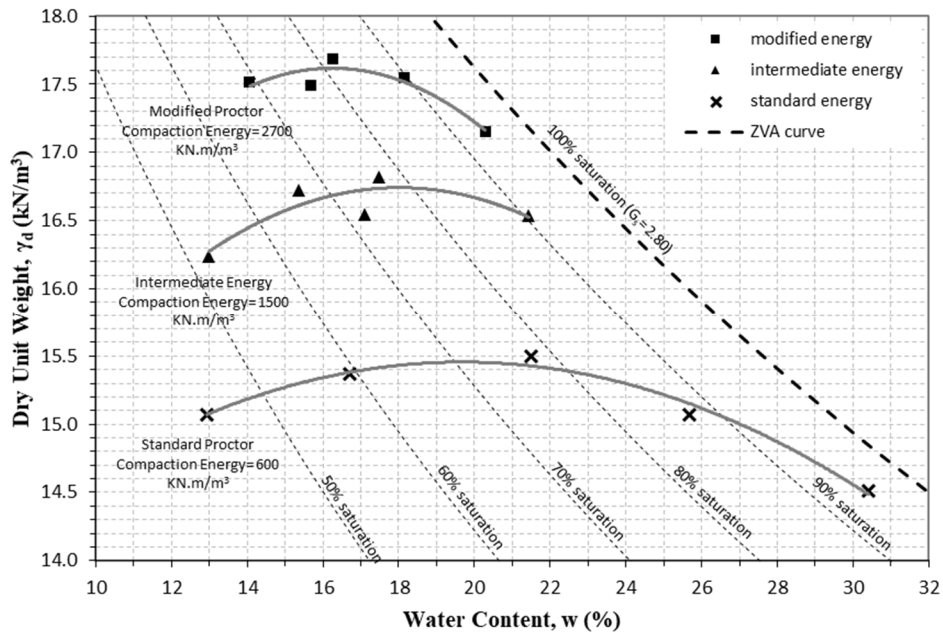
Figure 5.3. Compaction curves for Soil 2 Lee at three energy levels

It is noted that for Soil 2 Lee, optimum points fall within 70% to 80% of saturation.

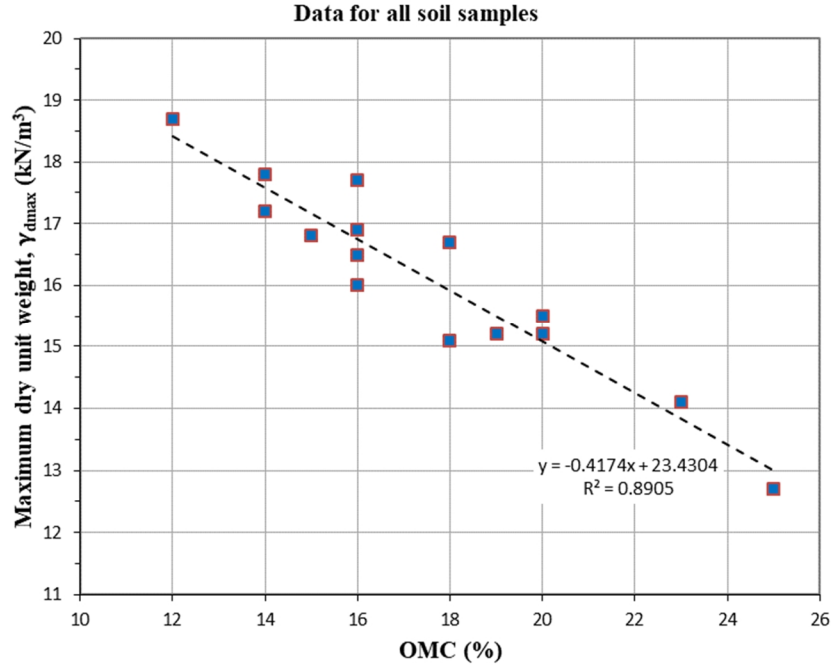
Figure 5.11. Maximum dry unit weight vs OMC for all soil samples

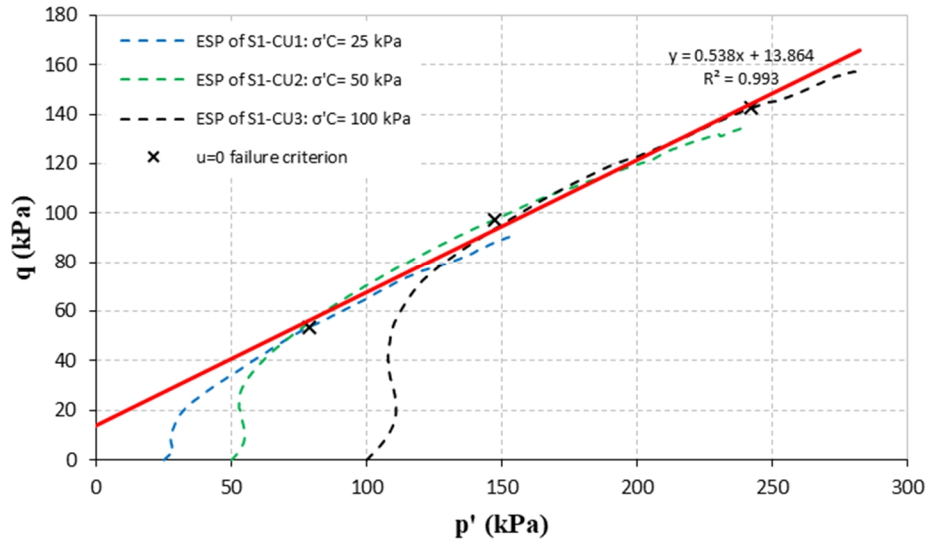
Figure 7.1. Typical effective stress paths and failure line for CU tests - samples of Soil 1 Forsyth compacted at standard energy

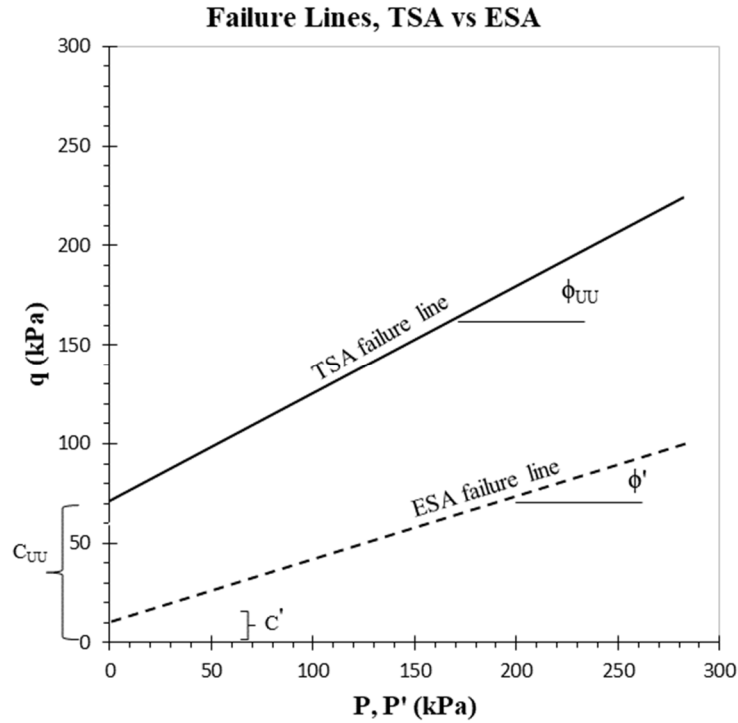
Figure 7.7. TSA failure line vs ESA failure line

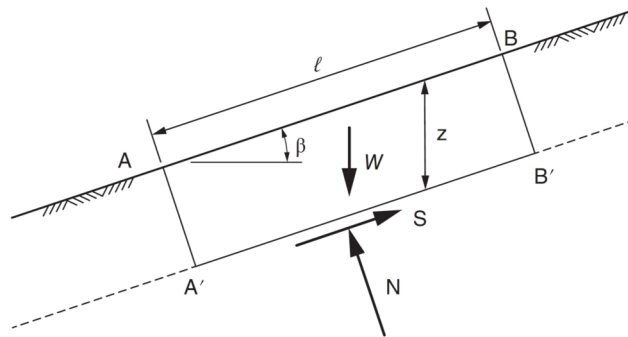
Figure 8.1. Infinite slope stability analysis (adopted from Duncan et al. 2014)

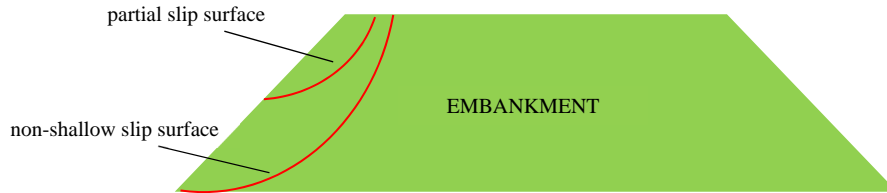
Figure 8.2. Schematic illustration of non-shallow slip surface and partial slip surface

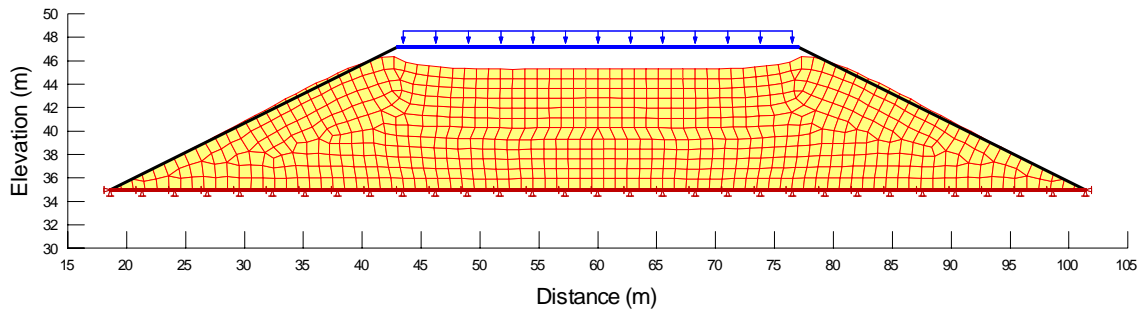
Figure 9.1. Schematic embankment deformed mesh due to traffic loading

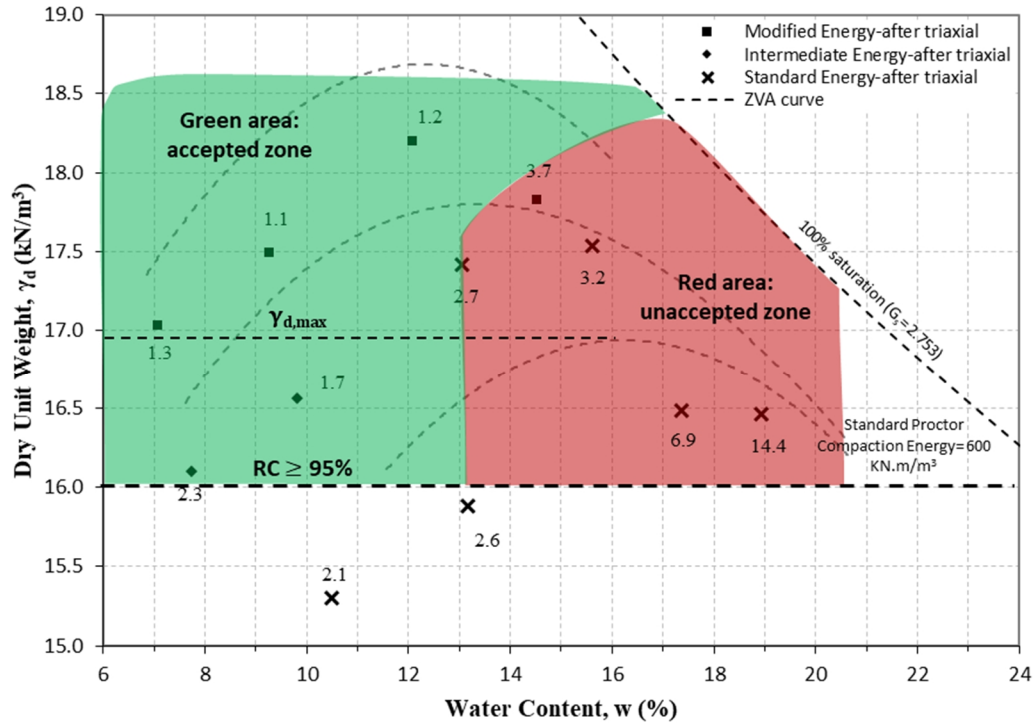
Figure 9.4. Acceptance zone and values of TSA crest deformation for embankment with H=40ft and 2H:1V side slope – Soil 1 Forsyth
