TECHNICAL REPORT 0-6752-1

Short-Term Skid Improvements by Light Texturing with a Milling Machine

Research Project 0-6752

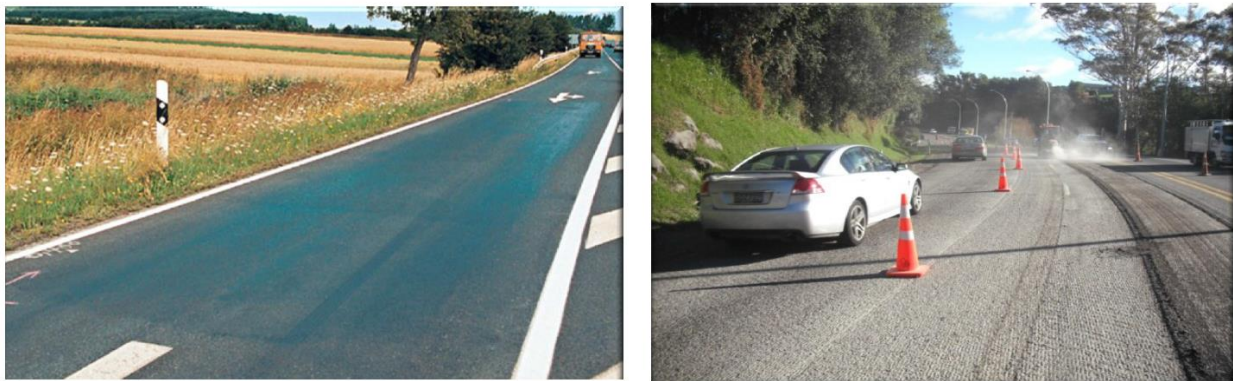
Figure 7. New Zealand Fine Milling Project: Before and After the Fine Milling

In 2006, 2010 and 2012, Higgins performed fine milling operations on three projects in New Zealand (18). It was reported that the cost of fine milling process is approximately 10-20% of the cost if resurfacing is performed. After the milling, the road is immediately cleaned, marked and reopened to traffic. In those projects, Wirtgen 130F Profiler was used and the drum width is 1300 mm. Figure 7 shows the pavement surface before and after the milling.

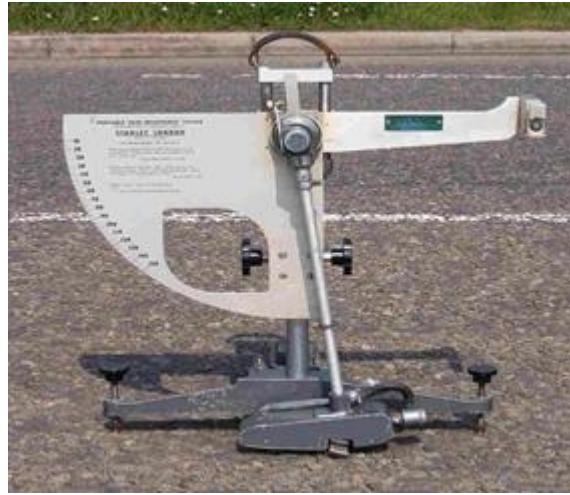
Figure 9. British Pendulum Tester

The test method is covered in ASTM E-303. The test result is reported as the British Pendulum Number (BPN). BPN is measured directly using a drag pointer. The greater the friction between the rubber slider and the test surface, the greater the BPN. The average slip speed decreases as the friction increases because the average velocity of the slider relative to the test surface is a function of the friction. Usually, the typical slip speed is assumed to be 6 mph (10 km/h) for the BPT. BPT is fitted with a scale that measures the recovered height in terms of the BPN over a range of 0 to 140. BPN mainly depends on the microtexture because the slip speed is

very low. The British Pendulum Number (BPN) is approximately 100 times the coefficient of friction (23).

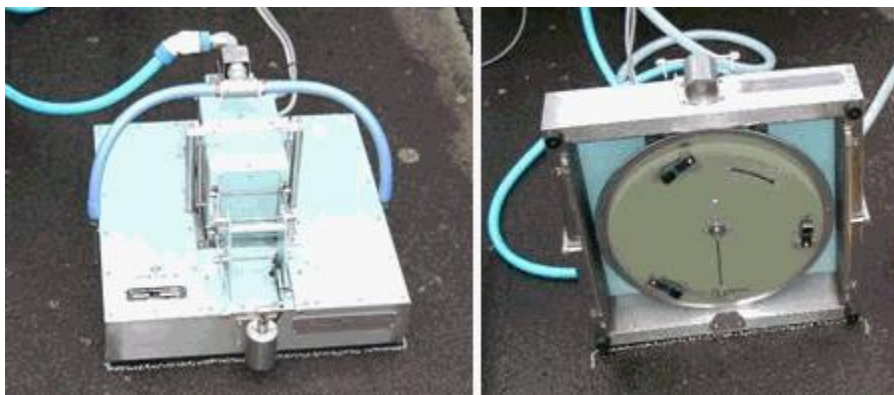
Figure 10. Dynamic Friction Tester

The dynamic friction tester (Figure 10), DFT, is a portable device for measuring friction. The test procedures are covered in ASTM E-1911. The fundamental principle is the Coulomb's friction law. This device consists of a horizontal spinning disk fitted with three spring-mounted rubber sliders. During testing, the disk is lowered so that the three sliders are in contact with the test surface under a constant force perpendicular to the test surface. The disk is driven by a motor and rotates at a tangential speed varying from 0 to 50 mph, which is determined from the rotary speed of the disk. Water is delivered to the test surface by a water supply unit. The horizontal force required to overcome the friction is measured by a transducer. The test result is reported as the coefficient of friction and is plotted against the speed. Like the British pendulum tester, use of the DFT in field pavement friction tests requires traffic control.

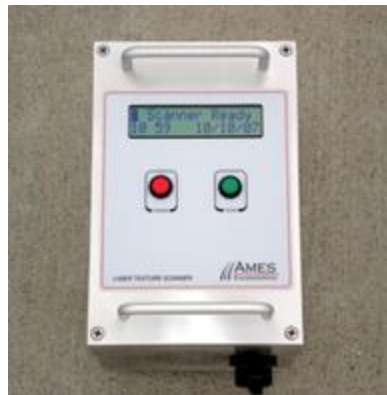
Figure 13. Laser Texture Scanner

The scanner is lightweight, portable and is powered using high cycle rechargeable batteries that can provide up to one hundred scans per charge.

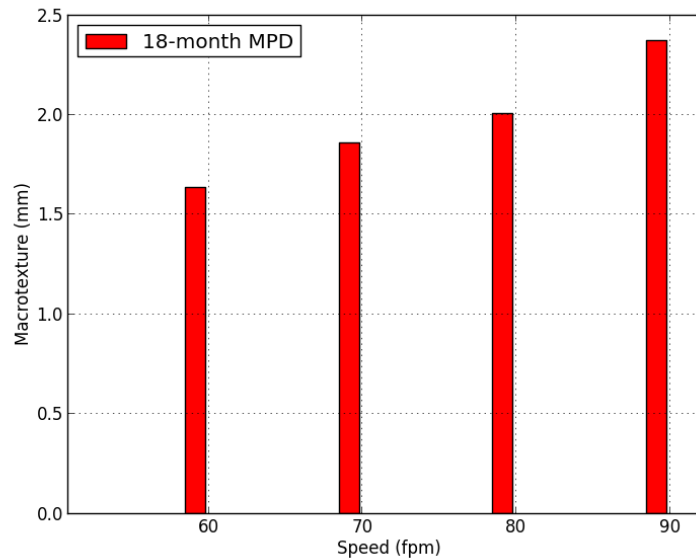
Figure 43. 18-month average MPD (HMA surface) of different forwarding speeds

For this analysis, test sections were grouped into categories according to the milling machine forwarding speed. The results are presented in Figure 43 through 46, which shows the macro-texture and friction values at the end of the research period. Average Mean Profile Depth (MPD) and Skid Number (SN) values for all the sections constituting each speed category were plotted sequentially. Although many factors (e.g., climate, traffic, and pavement condition prior to the milling) influence the results shown in these figures, some general trends regarding the macro-texture and friction performance over time can be seen. Test sections with milling speed equal or higher than 70 feet per minute (fpm) showed the highest texture and friction levels. Test sections with HMA surface showed an increase in SN when the machine speed increases. However, this trend is not observed in the sections with seal coat surface.

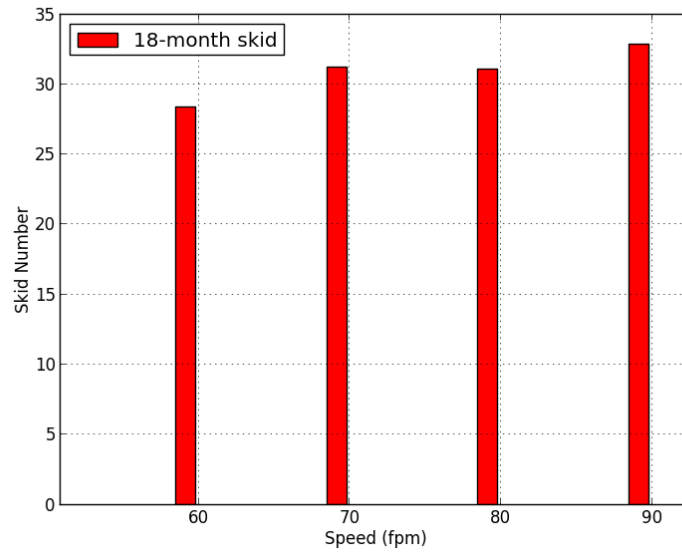
Figure 44. 18-month average skid number (HMA surface) of different forwarding speeds

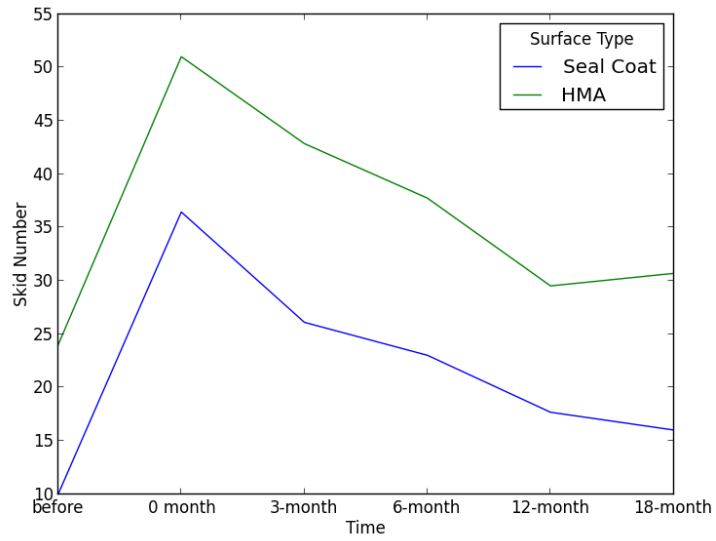
Figure 47. Skid number versus time for different surface types

Figures 47 through 54 provide an indication of the durability of macro-texture and skid number for the different locations, forwarding speeds, cutting depths and surface types based on the texture and friction values obtained during the 18-month research period. These figures illustrate the reduction in texture depth and friction for each test location over time. As Figure 47 and 48 show, the sections with HMA surface exhibited higher level of texture depth and friction than the sections with seal coat surface. The HMA surface sections experienced texture depth losses of 0.5 mm and skid number losses of 20 at the time of 18 months after the milling. The sections with seal coat surface exhibited texture depth losses of 1.5 mm and skid number losses of 20 during the same time period. Because of the very limited number of test sections of each climate type and surface type, the effect of climate on texture and friction loss could not be determined. The data also illustrate the importance of using forwarding speed to maintain high levels of friction over time.

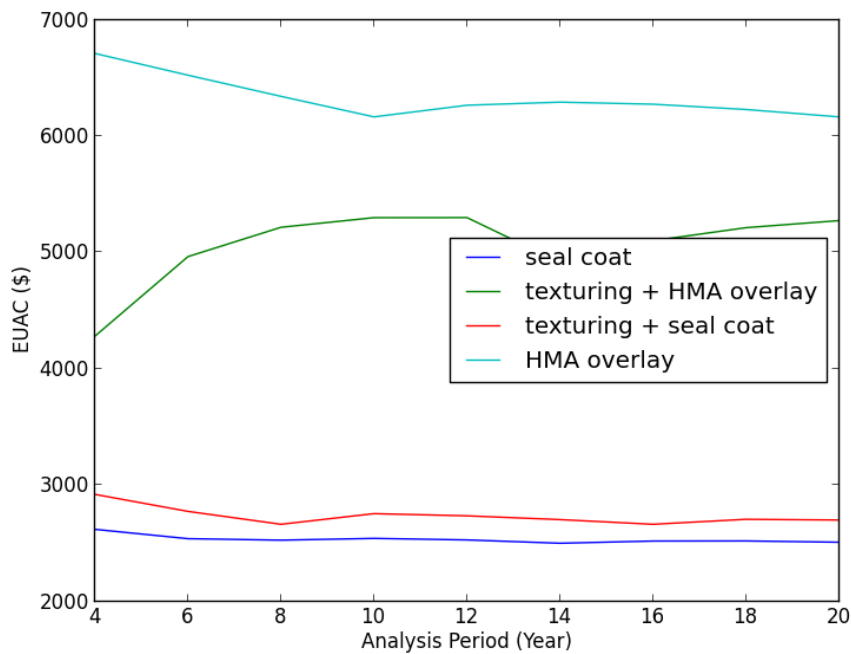
Figure 58. Life-cycle cost analysis using different analysis periods

A life-cycle cost analysis based on TxDOT historical cost was carried out on the four strategies discussed above. With the discount rate being 4%, the cost analysis showed that the first strategy with overlay of an estimated life of 10 years has an equivalent uniform annual cost (EUAC) of approximately \$6,165 per lane mile. The second strategy of seal coat with estimated life of 7 years has EUAC of \$2,508 per lane mile. The strategy of combining light texturing and overlay together has an EUAC of \$5,272 and the last strategy has an EUAC of \$2,699. This implies that applying light texturing to delay a HMA overlay project would cost about 15% less than placing the overlay directly. As shown in Figures 57 and 58, the difference between strategies 2 and 4 is small with the fourth strategy performing slightly better than the second strategy. Overall, the analysis suggests that delaying overlay placement for a few years with a light texturing can keep the skid resistance at a reasonable level and save money at the same time. The light texturing method, therefore, appears to be cost effective as a short term correction technique for pavement with skid problems. This would be particularly useful in situations where there are many competing lane miles for limited resources. It would also alleviate an immediate concern while a more permanent solution is planned.
