# Accelerated Repair and Replacement of Expansion Joints

**Final Report**  
**April 2020**

**Sponsored by**  
Accelerated Bridge Construction  
University Transportation Center

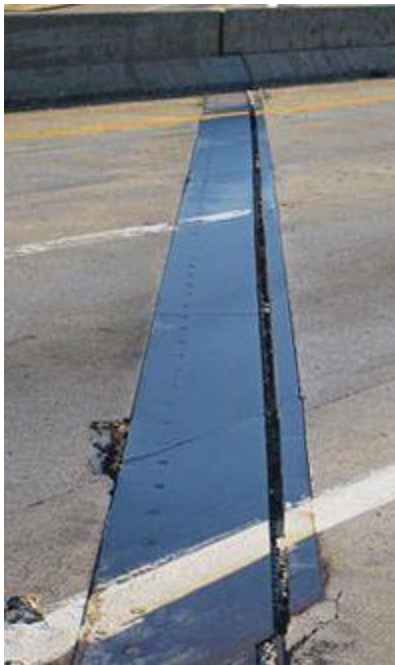
Sliding plate joints consist of one steel plate freely sliding over another steel plate embedded in the bridge deck. When the bridge expands and contracts, these plates are able to slide over one another to accommodate the movement. A typical sliding plate joint is shown in Figure 2.1.

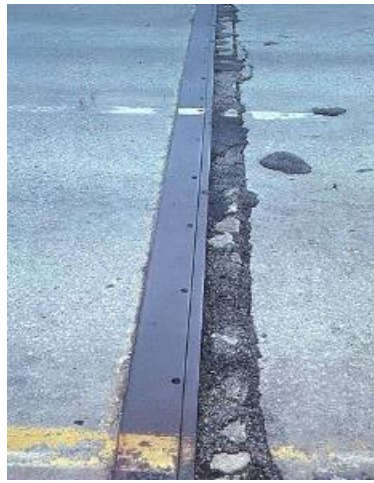
**Figure 2.2. Sliding plate fused and separated from abutment**

This can lead to the plates separating from their attachments and the joints cracking (see Figure 2.2 and Figure 2.3).

Sliding plate joints are no longer used by the Iowa DOT in replacements or new construction, but some older bridges still have these joints in place. Sliding plate joints are not watertight. Over time, these joints can experience severe failure to the steel plates. Rust formation can cause the two plates to fuse together, preventing any movement to occur and reducing the strength.

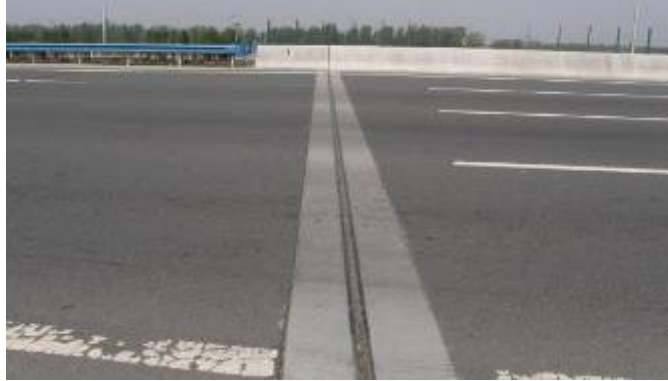
Strip seal joints consist of two steel extrusions embedded in the approach slab and bridge deck. A neoprene gland is then placed in the gap, attached to the steel extrusions. This gland provides a water barrier to protect the structural components below the joint, and the flexible nature of the material allows it to move with the expansion and contraction of the bridge. A typical strip seal joint is shown in Figure 2.4.

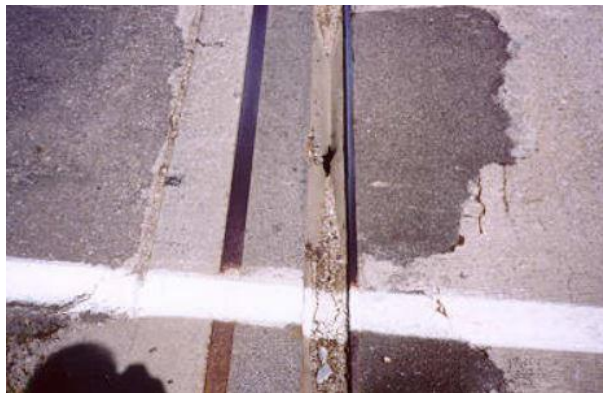
Strip seals are becoming the most common joint used in expansion joint replacements for the Iowa DOT. The neoprene gland is usually the first part of the joint to fail after about 15 years (see Figure 2.5).

These glands can be removed and replaced with relative ease and do not compromise the structural integrity of the joint. A strip seal joint typically only needs full replacement if damage has occurred to the steel extrusion due to rust or snowplow damage, or if there is severe spalling of the concrete header surrounding the joint.

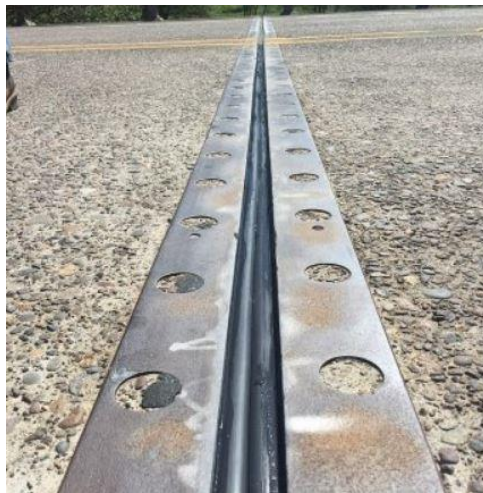
**Figure 2.7. EMSEAL BEJS retrofit installed**

In the recent past, a strip seal retrofit designed by EMSEAL Joint Systems, Ltd. has become increasingly popular as an option with midwest DOTs. The EMSEAL bridge expansion joint system (BEJS) utilizes a compression seal that can be installed against the flat surface of the joint. This system is ideal for when a steel extrusion fails but there is no major damage to the surrounding concrete. The system can be installed with minimal, if any, demolition and bypasses the need for a steel extrusion. A typical profile of the EMSEAL BEJS is shown in Figure 2.6 and Figure 2.7

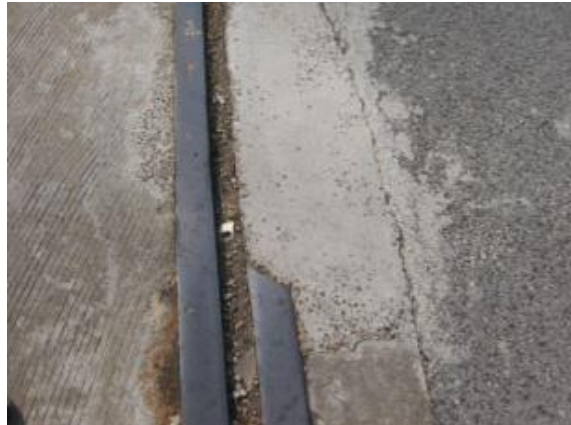
**Figure 2.9. Compression joint with broken anchor**

Although compression joints are being phased out of use by the Iowa DOT, many bridges in Iowa still use them. Compression joints have failure patterns similar to those of strip seal joints. The compression seal is typically the first thing to fail after about 10 years of service. With compression joints, it is optional to include steel armor with the joint. If the steel armor is included, it typically fails due to rust or the cyclic loading of traffic (see Figure 2.9).

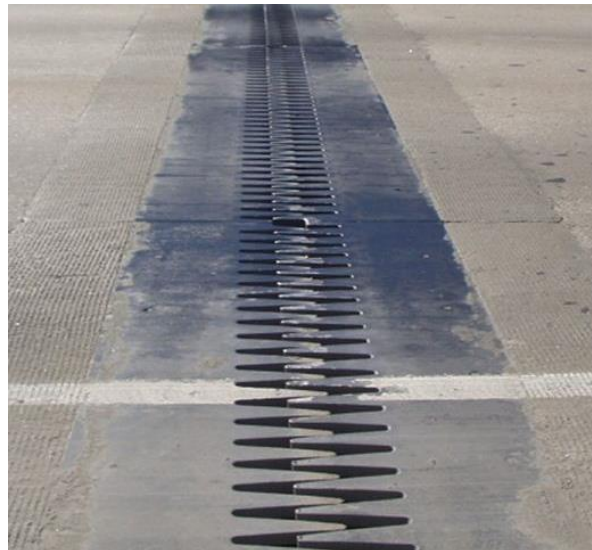
**Figure 2.10. Typical finger joint**

Finger joints and modular joints are typically used for larger bridges that require movement of more than 5 inches. Finger joints are comprised of interlocking “fingers,” while modular joints are a series of connected strip seals. Typical views of these two joints can be seen in Figure 2.10 and Figure 2.11.

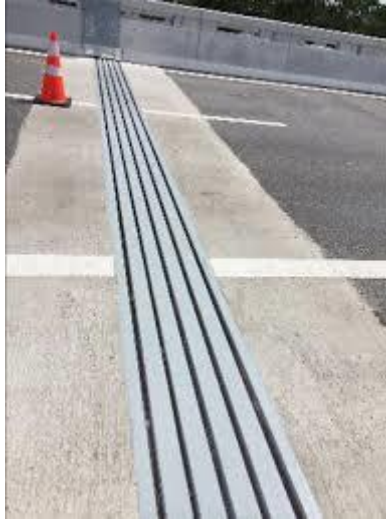
**Figure 2.11. Typical modular joint**

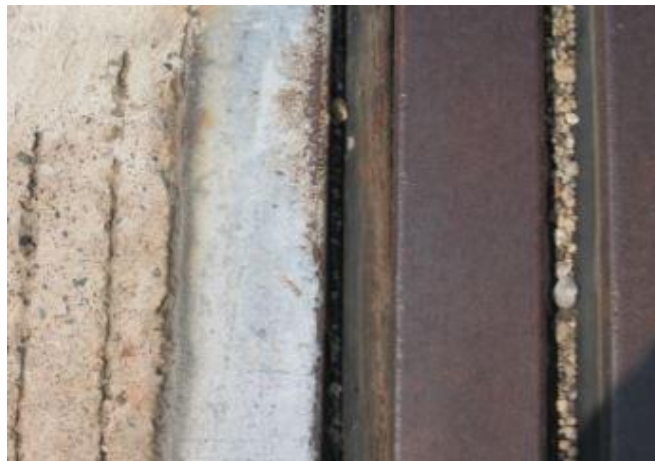
Both of these joints are very effective for longer bridges. When a component of either joint is damaged, it can simply be replaced without affecting the rest of the joint system. Finger joints are not watertight, however, which can lead to erosion of the soil below and/or damage to substructure elements. Modular joints fail similarly to strip seals (see Figure 2.12) and can be repaired in a similar manner.

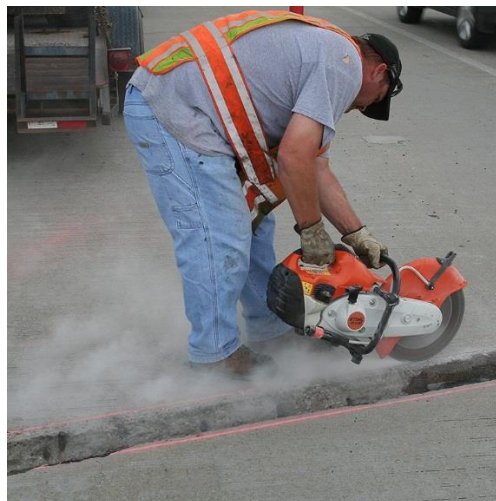
Saw cutting is the process of using a diamond-segmented blade to cut the concrete (see Figure 2.13).

Saw cutting leaves a smooth surface on the remaining concrete. This has the risk of creating a poor bond with the new concrete and would likely need to be roughened before the placement of replacement concrete. This also means a potential loss of the existing reinforcing steel, requiring dowels to be installed. Saw cutting also requires a larger workforce and creates potential overcuts that need to be filled (Phares and Cronin 2015).

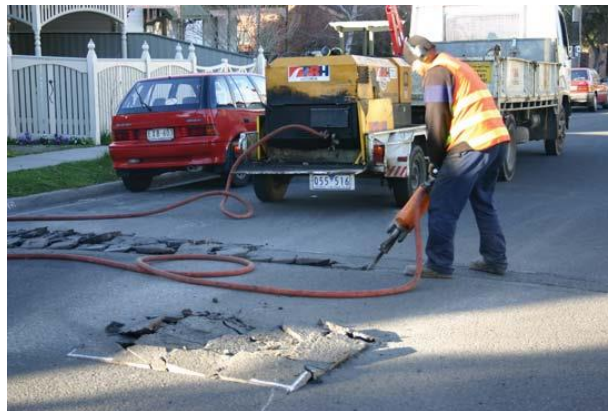
Pneumatic breakers are handheld machines that come in a variety of weights and sizes. They have a narrow cutting edge that hammers out the concrete that needs removal. A typical pneumatic breaker can be seen in Figure 2.14.

The largest drawbacks to pneumatic breakers for accelerated removal is the larger workforce and the amount of time needed to complete demolition. The time needed is significantly longer than it is with the other two demolition methods evaluated in this study. There is also some risk associated with the chiseling action of the pneumatic breaker. This mode of demolition can potentially cause micro-fracturing in the remaining concrete and damage the existing reinforcing steel.

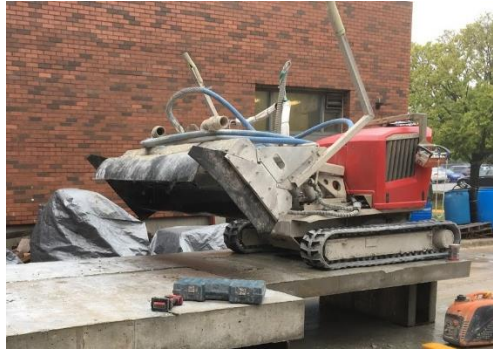
Hydrodemolition is the process of directing pressurized water to demolish concrete. Generally, the hydrodemolition unit is programmed and controlled by a walk-behind operator (see Figure 2.15).

The operator controls the rate of the water pressure, speed of the nozzle as it performs passes, and width of the demolition area. With the semi-automated equipment, a very small workforce is needed for hydrodemolition. Similar to pneumatic breakers, hydrodemolition leaves a rough surface that is likely good for concrete bonding. Unlike pneumatic breakers, though, hydrodemolition does no damage to the existing reinforcing steel (except perhaps to the epoxy coating) and results in minimal residual cracking in the remaining concrete. Hydrodemolition is also the fastest of the three demolition methods evaluated.

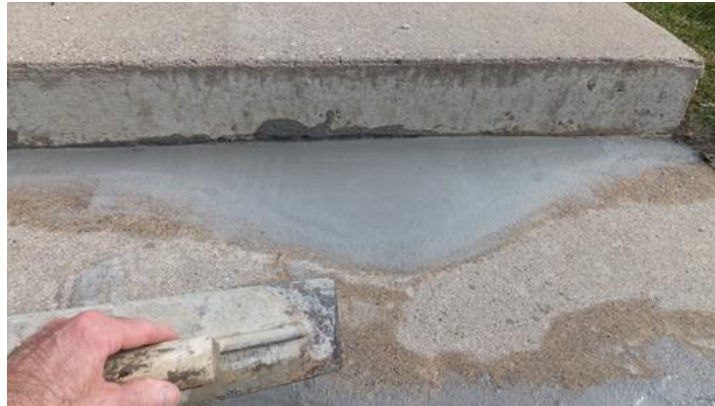
Historically, MPC has only been used for smaller patch jobs (see Figure 2.16).

**Figure 2.16. Magnesium phosphate cement being used for patching**

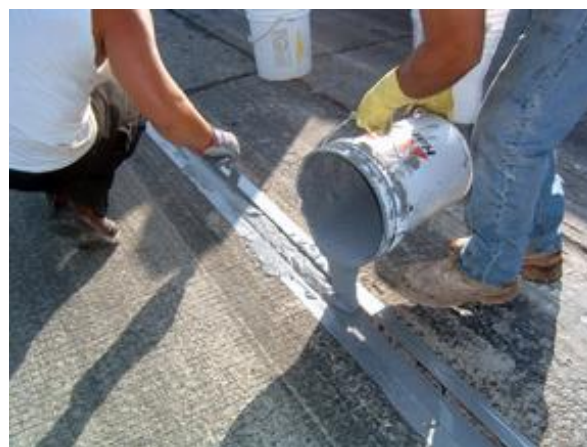
**Figure 2.17. Elastomeric concrete for expansion joint repair**

Elastomeric concrete is a mixture of a polymeric binder and aggregate that has been growing in popularity as an expansion joint repair material (see Figure 2.17).

Elastomeric concrete bonds well to concrete and steel and, unlike portland cement concrete (PCC), has a very low spalling risk. Elastomeric concrete can be placed within 4–5 hours and opened to traffic roughly 3 hours after it sets (Gergely et al. 2009). The service life of elastomeric concrete is approximately 25 years before it needs to be replaced.

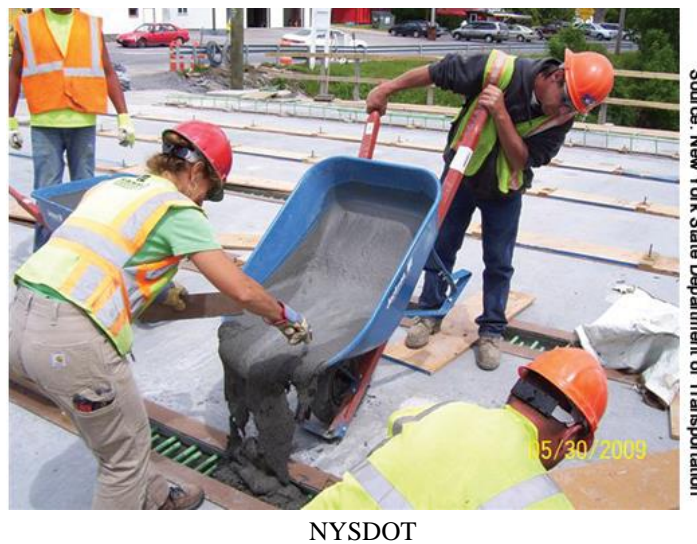
**Figure 2.18. UHPC being place into a joint**

UHPC is a relatively new class of fiber-reinforced, portland cement-based concrete. It utilizes a number of different admixtures to increase its strength and decrease its set time. According to the Federal Highway Administration (FHWA), UHPC is classified as having a minimum compressive strength of 21.6 ksi. UHPC has very low porosity, and, therefore, is very durable to chlorides and other de-icing chemicals, and it resists freeze-thaw cycles well (see Figure 2.18).

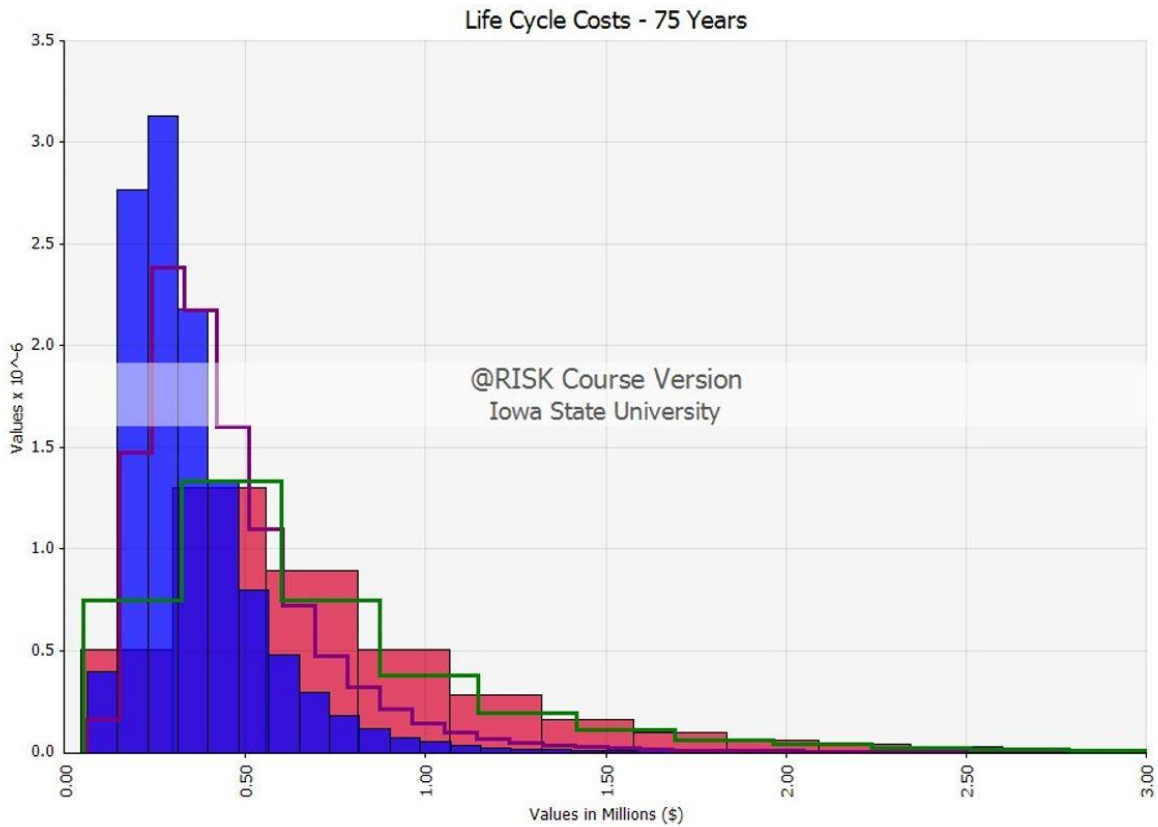
Figure 4.5. Cost distribution for 44-ft bridge, 75-year bridge life

For a 44-ft bridge with a 75-year life, the proposed replacement (scenario 2) surpassed scenario 3 for the lowest estimated life-cycle costs, like the 30-ft bridge costs (Figure 4.5 and Table 4.11).

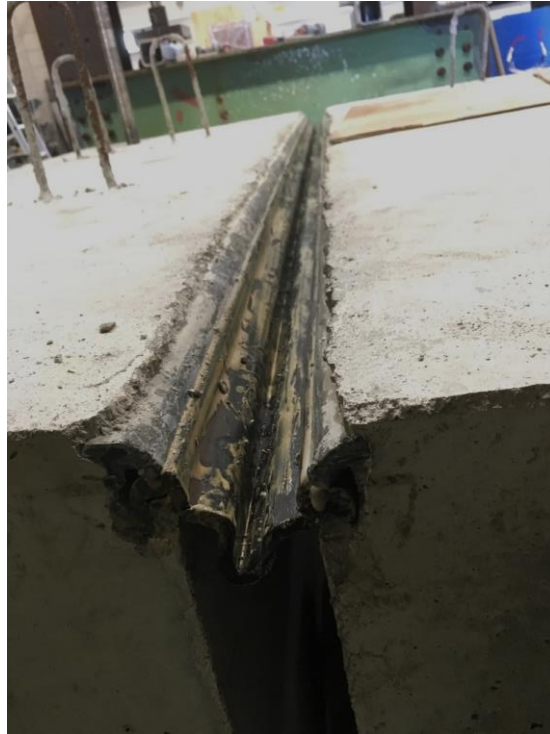
The following sections outline the specific geometry, boundary conditions, steel reinforcing, concrete, and instrumentation used for the test specimen (see Figure 5.1). Each of these are described separately and holistically.

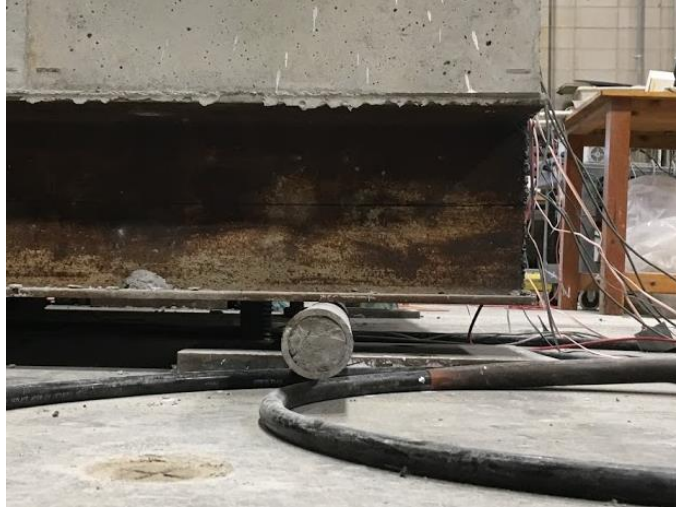
The end of the existing bridge deck near the joint was sitting on 3 in. bearing pads. The other end of the existing bridge deck was supported by a steel pipe/roller filled with concrete. This filled pipe acted as a roller, allowing the specimen to move freely horizontally. The roller was supported by a steel section to maintain a level surface on the specimen (Figure 5.4).

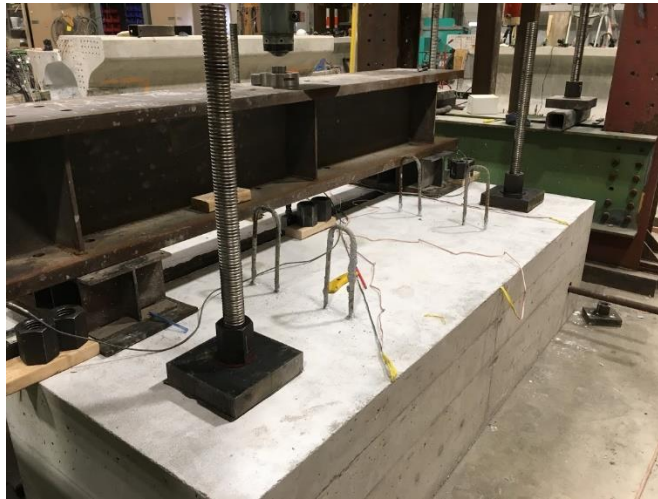
The backwall section of the specimen sat directly on the floor. The end of this section was tied to the strong floor of the laboratory, allowing it to act as a fixed support (Figure 5.5).

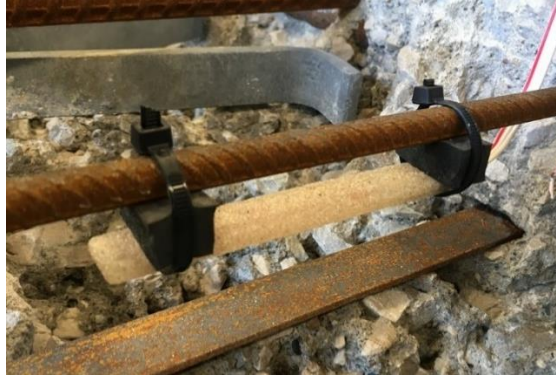
The gauges were placed one-third and two-thirds the length of the joint. Six embedded concrete gauges strain (SG5-10) were used (Figure 5.7).

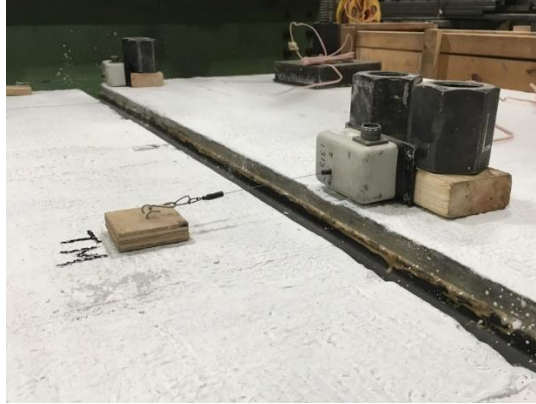
String potentiometers (Figure 5.9) were used to measure any displacement that occurred during testing.

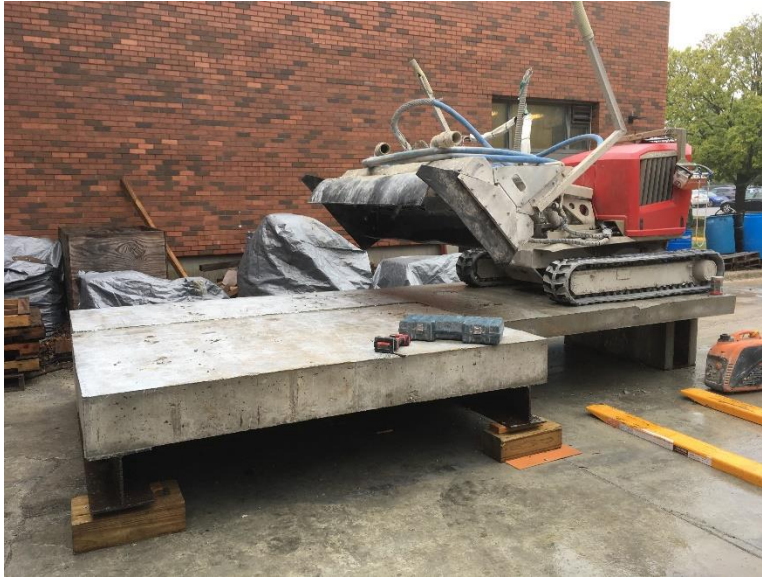
Hydrodemolition was used to remove the necessary concrete for the expansion joint replacement. CLC Hydro Services was contracted to perform the demolition. To accommodate for the water runoff and the hydrodemolition equipment, the demolition took place outside in the loading dock area of the laboratory. CLC Hydro Services used an Aquajet Systems Aqua Cutter 710H (Figure 5.13) to perform the demolition.

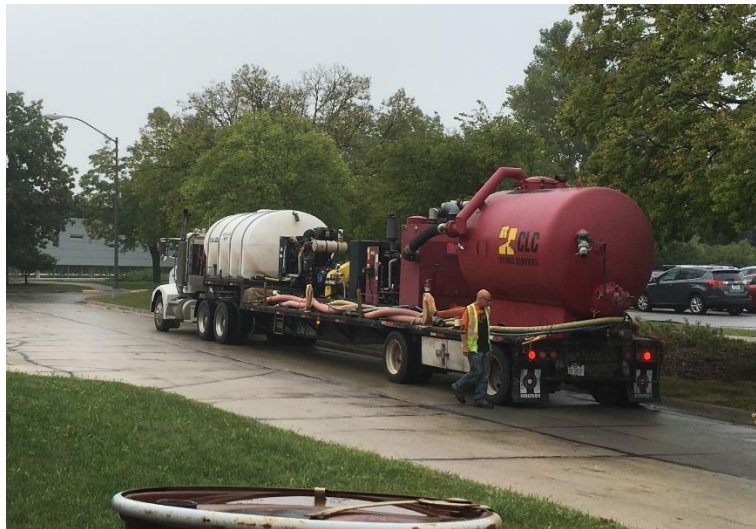
The Aqua Cutter was supplied with water from a water tank truck that CLC Hydro Services provided (Figure 5.14).

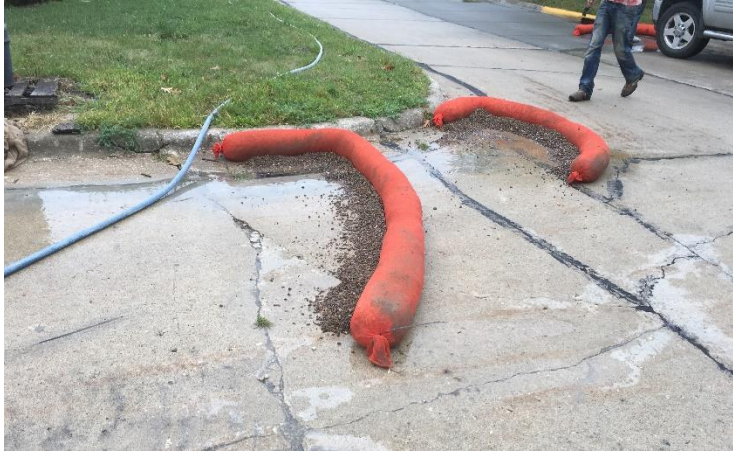
The mobilization for the hydrodemolition took about 3 hours. This included filling the water tank from the fire hydrant, positioning the Aqua Cutter onto the test specimen, hooking up the Aqua Cutter to the water tank, and setting up the wastewater filtering systems. For this project, a series of filter socks and pea gravel was used to filter the concrete particulates out of the water before it entered the storm drain (Figure 5.15).

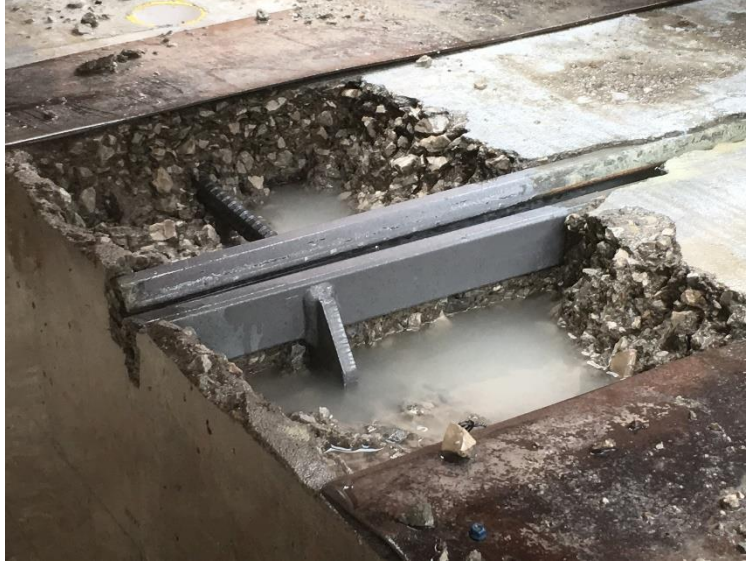
Through the trial-and-error process, it was determined that five passes of the water jet were necessary to reach the depth of 7 in. This was then programmed into the equipment, and the Aqua Cutter automatically moved down the joint when five passes were complete at one section. It took the Aqua Cutter about 10 minutes to complete 1 ft of demolition. Periodically, CLC Hydro Services would pause the Aqua Cutter to check on the progress of the demolition and make sure no unwanted damage was occurring (Figure 5.16).

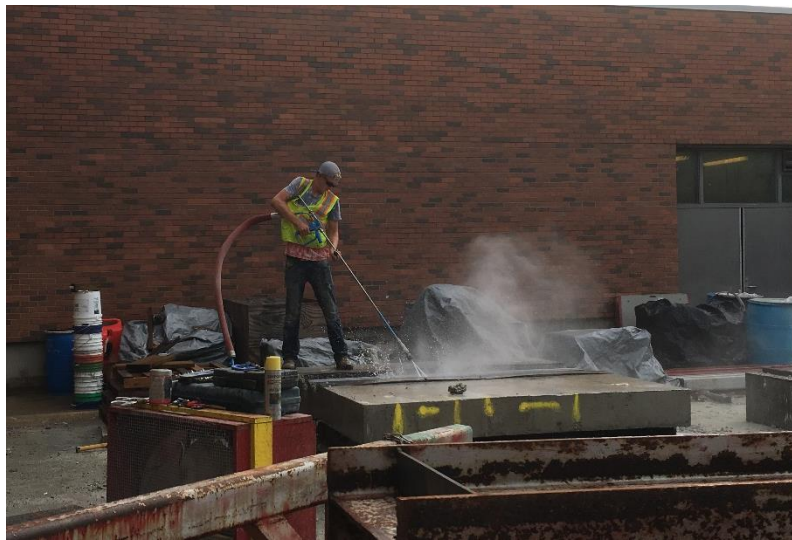
**Figure 5.17. Cleaning the joint after hydrodemolition**

The demolition took about two hours from the start of the trial-and-error process to the completion of demolition. When the Aqua Cutter completed the demolition of the expansion joint, CLC Hydro Services cleaned the demolition area and removed the excess water from the joint (Figure 5.17 and Figure 5.18).

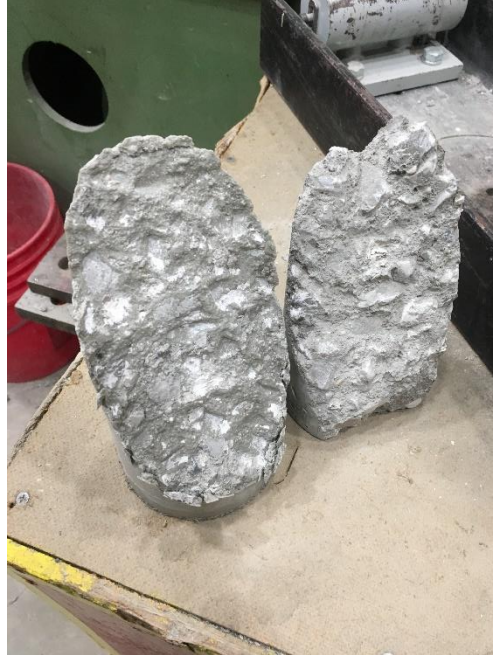
**Figure 5.20. Cylinder 1 slant shear failure**

The shear strength of cylinder 1 does not meet the acceptable strength as specified. However, the average value of shear strength does meet this requirement. All three cylinders experienced failure along the bonding interface, along with fractures in the PCC substrate (Figure 5.20 through Figure 5.22).

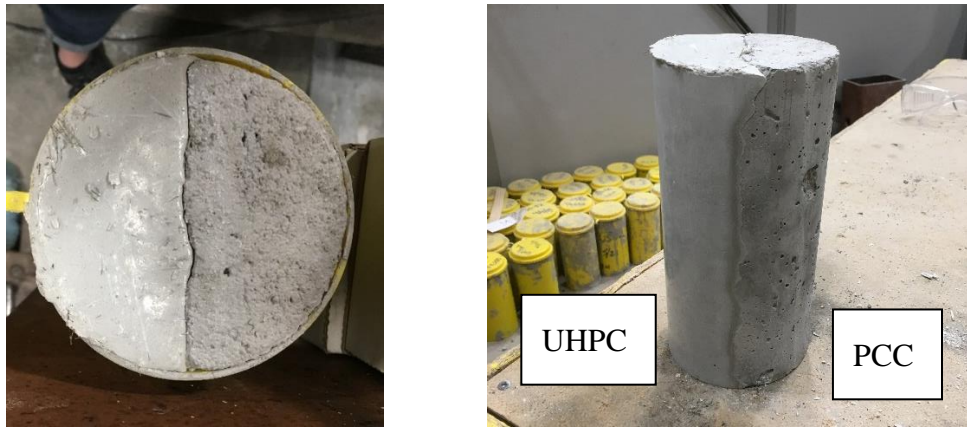
The split cylinder test utilized three cylinders made with half UHPC and half conventional concrete. The two materials were joined down the center of the cylinders vertically (Figure 5.23).

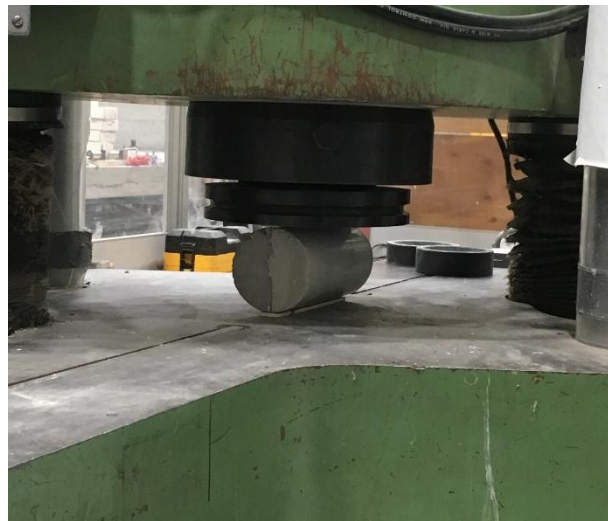
The cylinders were then tested on their sides to determine the indirect tensile strength of the bond (Figure 5.24).

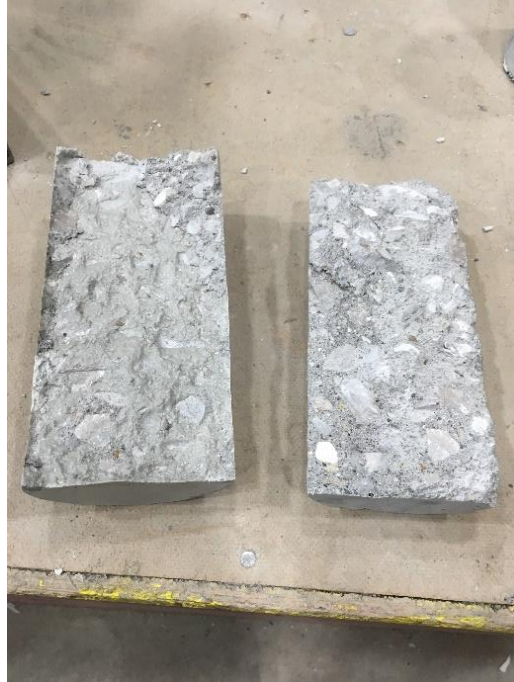
Cylinder 1 experienced a primary failure along the bonding interface with some failure in the PCC (Figure 5.25).

**Figure 5.25. Cylinder 1 split cylinder failure**

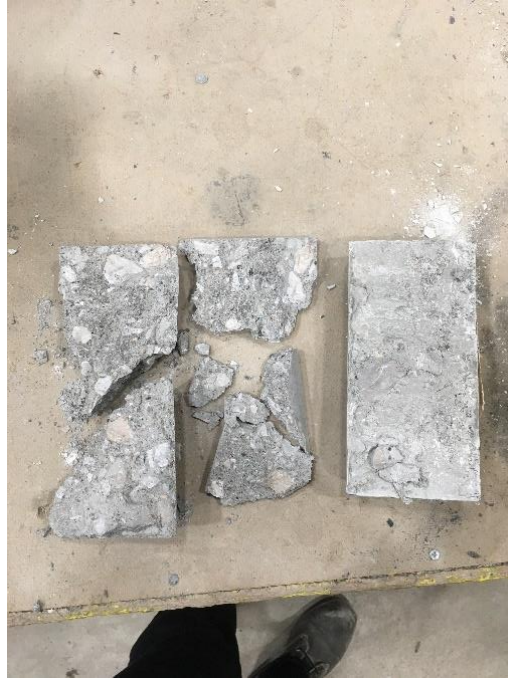
Cylinders 2 and 3 both experienced failure in the PCC substrate (Figure 5.26 and Figure 5.27).

**Figure 5.27. Cylinder 3 split cylinder failure**

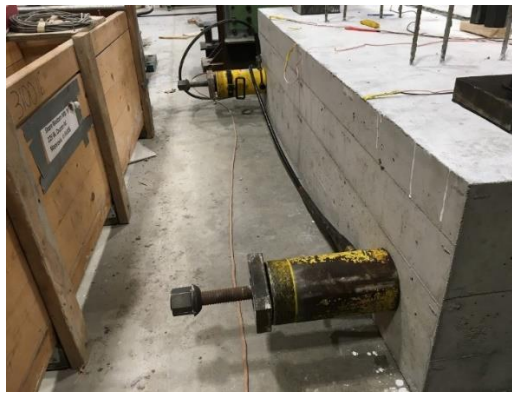
Thermal loading was applied to the original and replacement specimens to compare the performance of the two joints under thermal expansion and contraction. To mimic thermal loading, actuators were used to expand and contract the expansion joint gap in the specimens (Figure 5.29).

**Figure 5.29. Actuators used to mimic thermal loading**

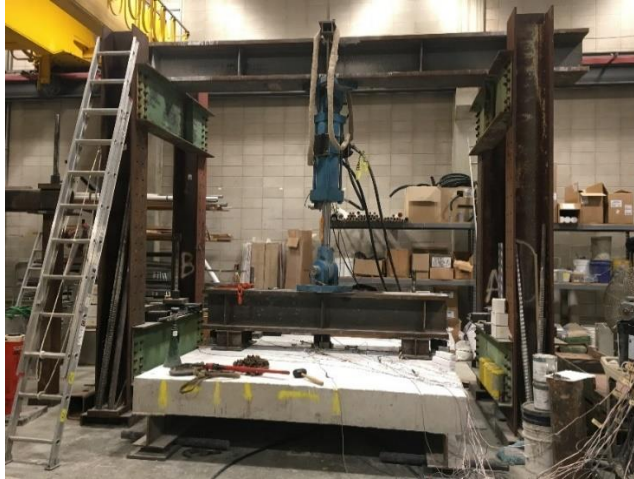
After all static testing was completed, the UHPC replacement joint underwent fatigue testing (Figure 5.32).

**Figure 5.32. Fatigue loading setup**

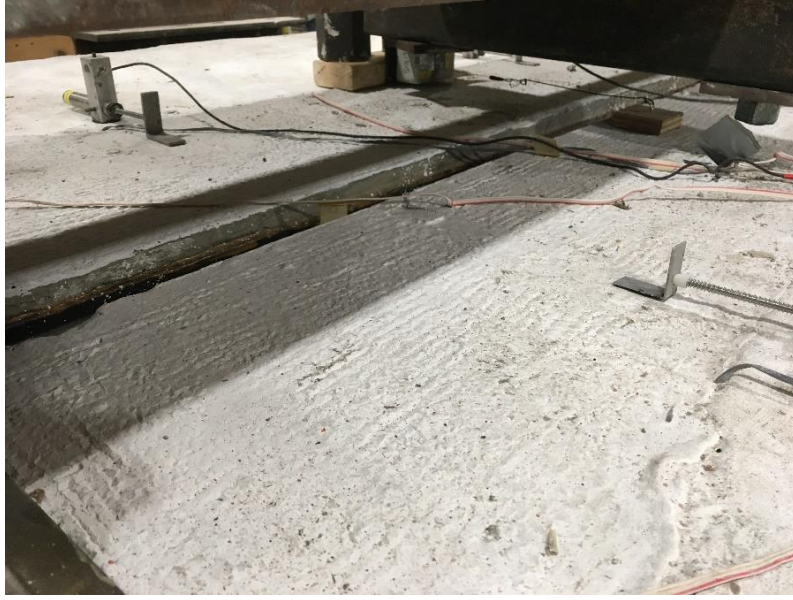
The strain in both the concrete and reinforcing varied very little throughout the test. Visual inspection of the specimen showed no signs of cracking or wear (Figure 5.34 and Figure 5.35).

**Figure 5.34. Visual inspection of specimen**

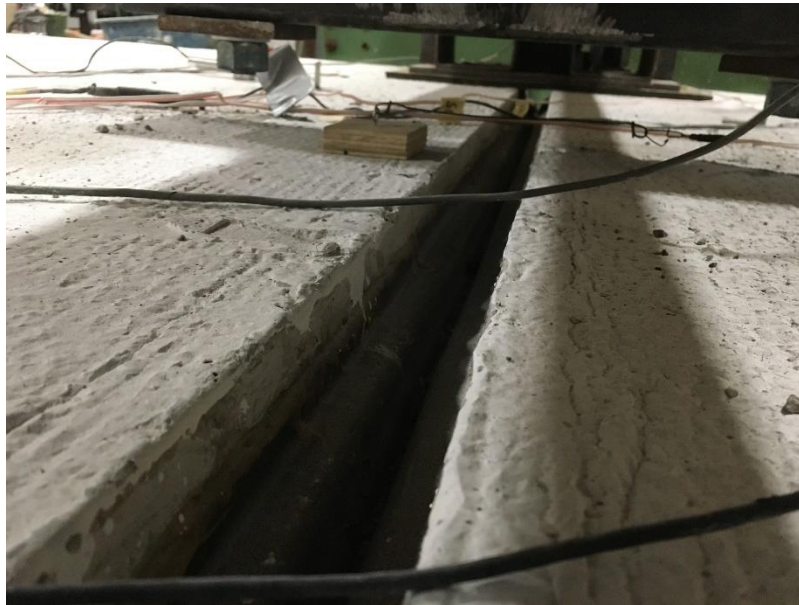
**Figure 5.35. Visual inspection of joint**
