FINAL REPORT

Pipeline Defense with Combined Vibration, Earth Movement, and Current Sensing

PHMSA Agreement Number: DTPH56-16-T-00020

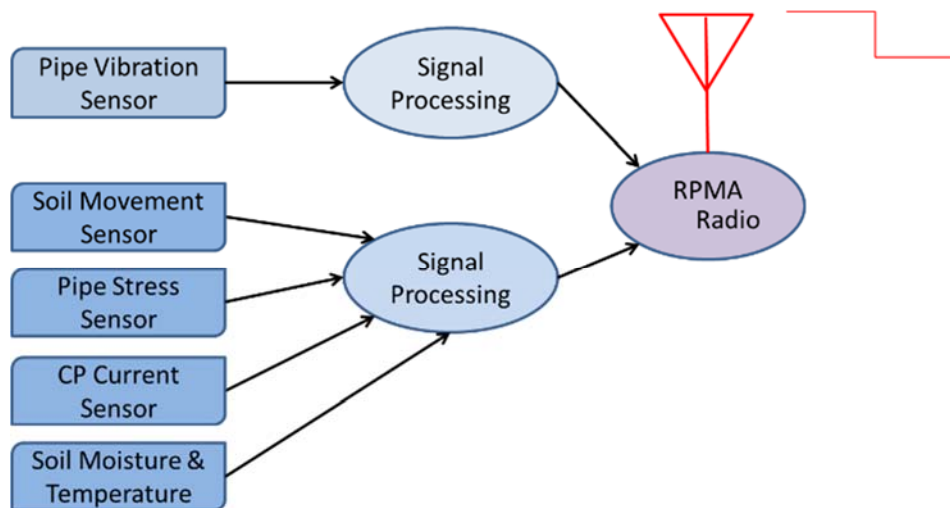
Figure 3 – Individual Sensor Node Block Diagram

During the 2nd quarter of 2016 the overall system architecture was more fully defined. Figure 3 shows the overall block diagram of one individual sensor node to be placed on a pipeline. The vibration sensor and its associated signal processing will be provided by Acellent technologies. The other sensors and support electronics will be provided by GTI. Figure 4 (provided by Acellent) depicts their concept for the installation of vibration sensors in the ROW. The data streams from all sensors is passed to a wireless link that provides connection to a cloud hosted repository.

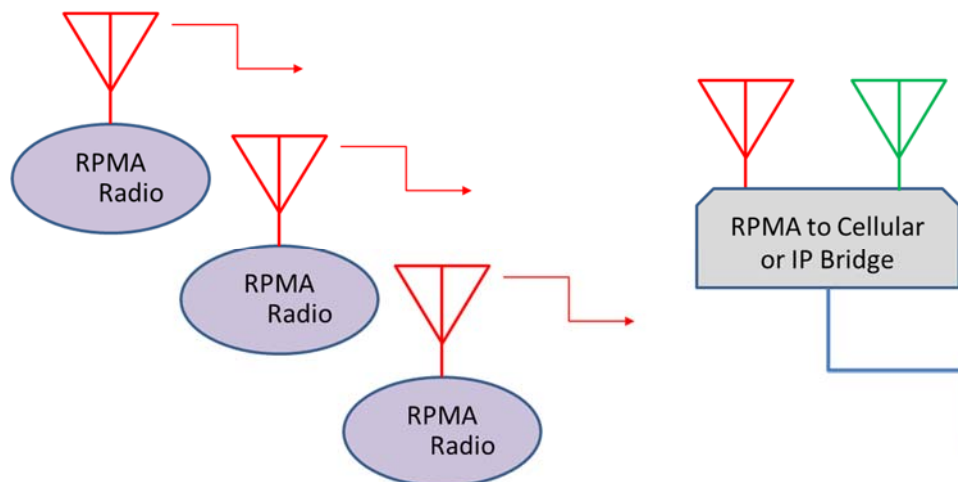
Figure 5 – Sensor Network Block Diagram

Figure 5 shows the block diagram of the proposed network architecture. Several RPMA radios feed data to a single access point; the access point provides an internet gateway to a central data repository. Figure 6 and Figure 7, provided by Leidos, show typical end-point and access point installations in the field.

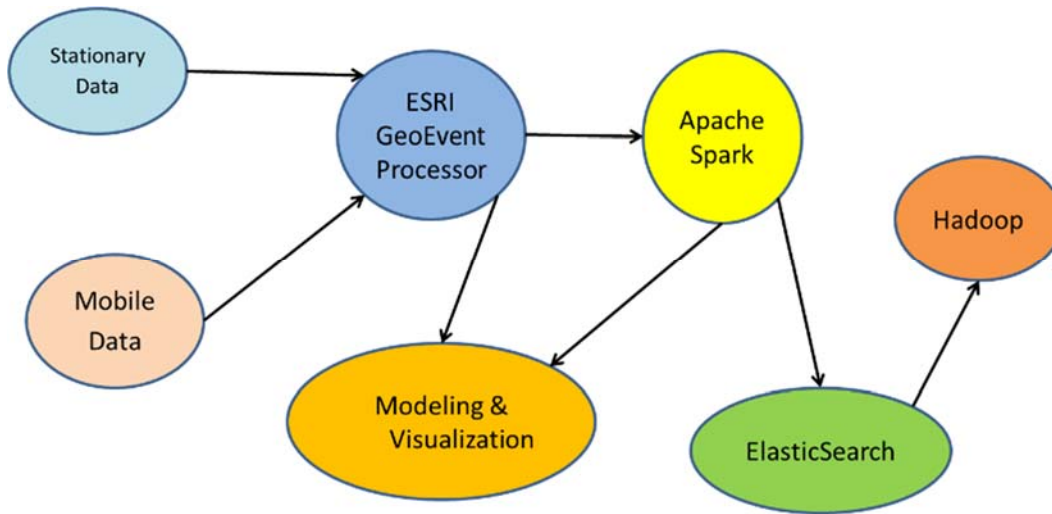
Figure 8 – Proposed Data Flow Architecture

Figure 8 shows the proposed data flow for the storage, analysis, and display portion of the system. Please note that this figure shows feeds from both stationary and mobile sensors. While this project deals specifically with stationary sensors on the pipe, the CEC partner project also includes mobile sensors on excavation equipment. Figure 9 shows an operations dashboard that can be used by an operator to visualize data from the repository. The data architecture also includes packages that can be used to analyze the data for the extraction of features of interest. This last item is crucial to project in that events that require attention must be separated from the background noise.

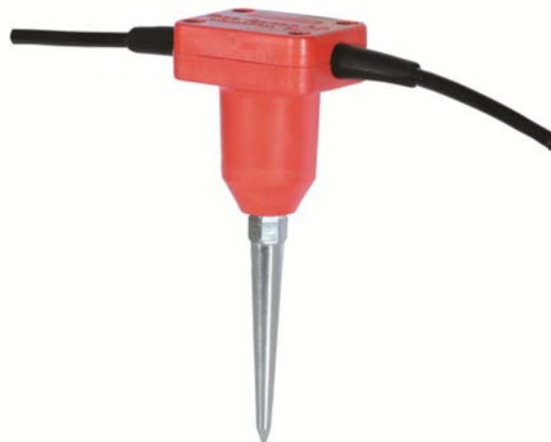
Figure 14. GS-30CT Geophone Soil Seismic Movement Sensor

During 4th quarter of 2017 it was determined that Acellent would also accept the signals from the geophone used to detect soil motion (Figure 14). This decision was based on the bandwidth of the analog inputs of the Campbell Scientific CR800 datalogger selected. The frequency content of the geophone signal is much higher than the other sensors attached to the CR800. The geophone would use most of the processing resources of the CR800 at the expense of the other sensors. The Acellent hardware will capture the data from their piezoelectric sensors and the geophone. Compressed vibration data will then be transferred to the CR800 datalogger over a serial link using the MODBUS protocol.

- Vibration sensors on the pipe for impact and proximity sensing
 - Acellent Technologies piezoelectric contact sensor and processor
- Strain sensors mounted on the pipe to determine tensile stress
 - Micro Measurements Strain Gauge CEA-06-125UW-350
- Pipe current sensor to determine AC and DC currents on the pipe
 - M.C Miller AC Corrosion Coupon
- Combined soil moisture and temperature sensor alongside the pipe
 - Campbell Scientific CS655
- Seismic soil motion sensors alongside the pipe to measure background noise
 - Geospace Technologies GS-30CT geophone

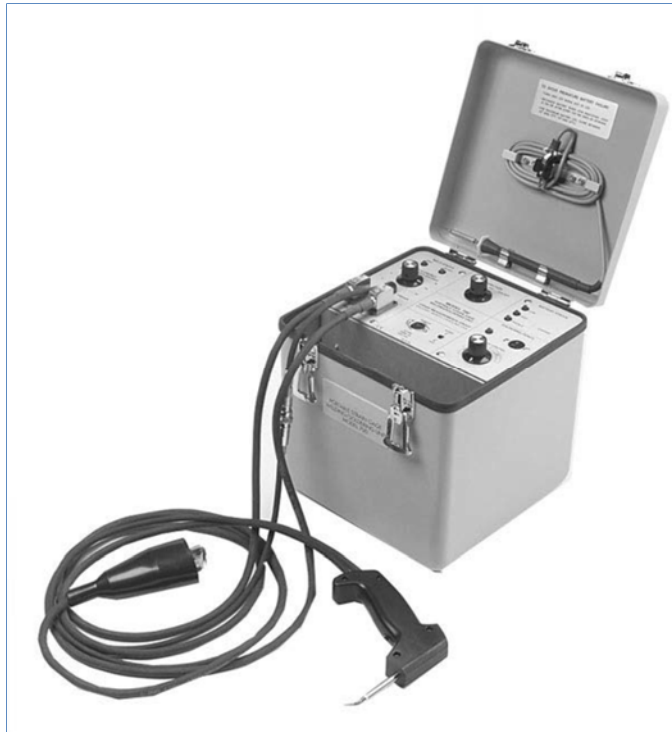
Figure 15 – Field Portable Resistance Welder

The proposal to the utilities hosting test sites was to use resistance welding to apply prefabricated sensors to the pipe wall. This is a method that has been used with strain gauges in structural health monitoring applications for decades. The strain gauge is adhesive bonded to a small metal shim under factory-controlled conditions. Wire leads are also attached in advance to create a prefabricated sensor. The sensor is then attached to item being monitored using a resistance welder (Figure 15) that uses a current pulse to “tack” a small area of the shim to the metal surface. The tacking process is repeated around the circumference of the sensor until it is securely in place.

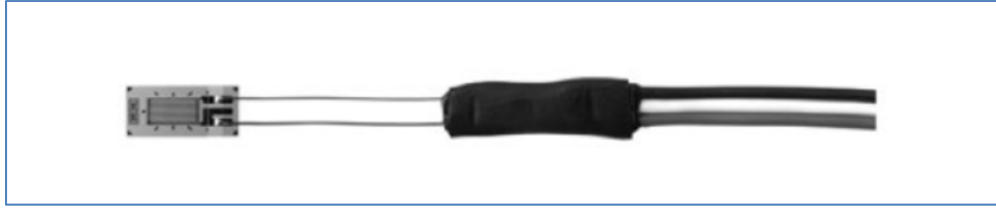
Figure 17. Adhesive Bonded Strain Gauge with Cable

GTI then investigated adhesive bonded strain gauges (Figure 17) to replace the welded types. It was also necessary to specify an adhesive that satisfies the volatile organic compound (VOC) emissions criteria for the state of California. Vishay Micro Measurements, the provider of the strain gauges, also provides several varieties of adhesives. One of the utilities was familiar with the gauges and adhesives from prior work and indicated that the AE-10 type epoxy is acceptable.

There are disadvantages to adhesive bonding versus resistance welding. More stringent pipe surface preparation must be achieved under field conditions. The epoxy must also be allowed to cure for several hours. GTI performed sample installation in-house to get a handle on how much time this will add. To facilitate this testing, the utilities provided GTI with several quarter-round sections of typical pipeline. This also allowed testing of the CR800 datalogger with samples of the actual gauge to be used in the field.

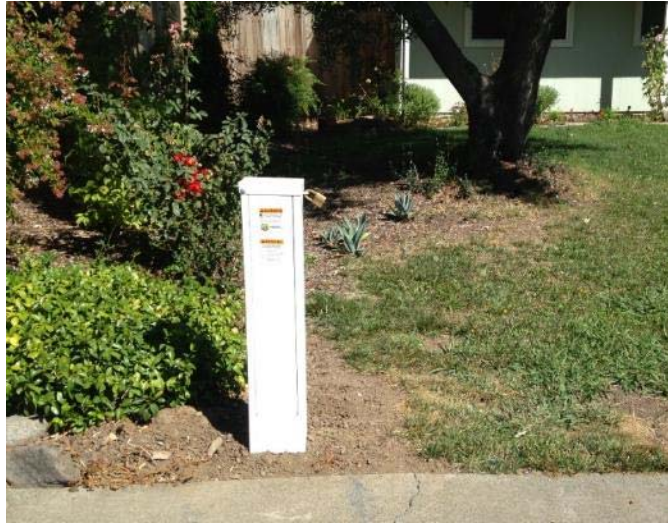
Figure 20. Rectifier Instrument Box

The alternative PG&E test sites considered were new cathodic protection rectifier installations. These sites had many desirable attributes: they require that the pipe be exposed and coating removed for the attachment of wires. Rectifiers must have a source of electrical power to function so no additional work was required for that aspect. Also, the enclosures (Figure 20)

typically used for rectifiers can be used for the instrumentation. Standard rectifiers can be housed in either pole-mounted or ground-based enclosures.

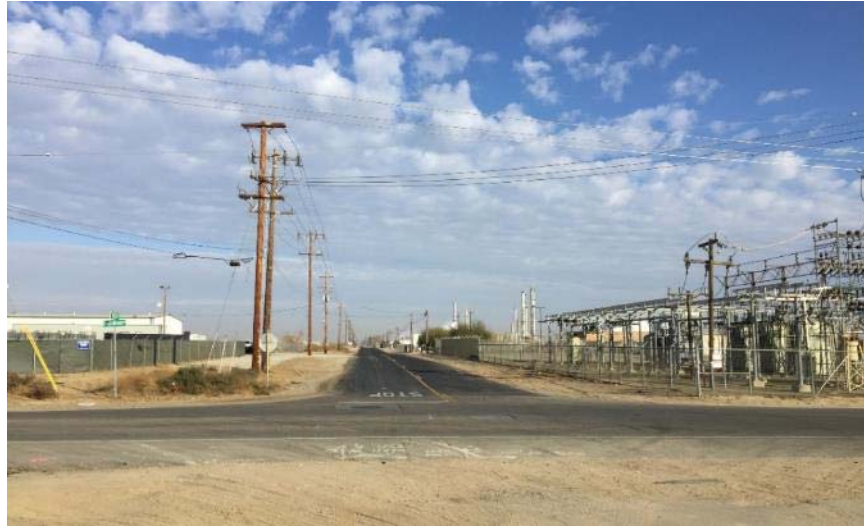
Figure 21. View of Utility Test Site

During the 4th quarter of 2017, the field site at SoCal Gas was identified; a site visit by GTI, Leidos, and Acellent took place. The site in question (Figure 21) involved a line relocation requiring several thousand feet of new pipe. Three stationary sensor test points were planned for placement on the new line with approximate spacing of 1000' between the first two test points and 2000' to the last test point. Construction was expected to begin in February of 2018. The goal was to have the sensors in place in time so that the hydro-testing of the line can be recorded. If the RPMA wireless network was not functioning at that time, the fallback plan was for the data to be recorded on the CR800 loggers and extracted manually.

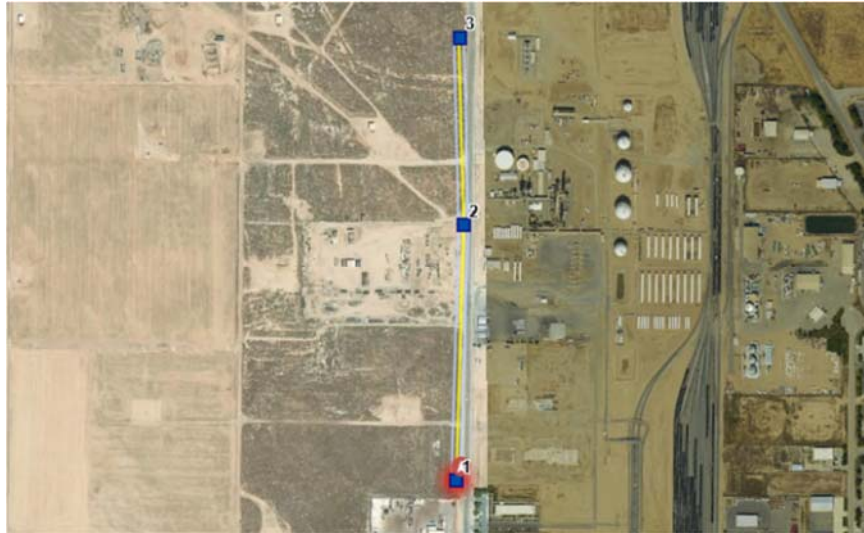
Figure 23. General Site Layout from User Dashboard

This task consisted of testing the hardware and analytics on the utility provided test site (Figure 23). Representative test site data that has been captured under field conditions will be presented and discussed. Three test stations were deployed along a newly installed pipeline on the test site. The design, selection, and installation of the equipment has been detailed in other reports from this project.

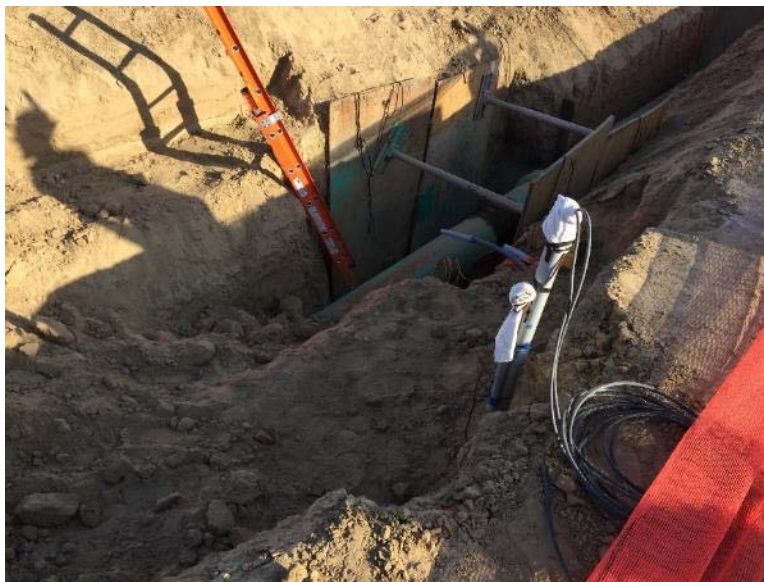
Figure 25. Excavation for Sensor Installation

- 1.1. Create a properly shored excavation that provides 360-degree access to the pipe.
- 1.2. Trench should be at least 4' wide and 8' long as seen in Figure 25. Safe access to the excavation must be provided.
- 1.3. Conduits to bring sensor cables to the surface can be placed in advance.
- 1.4. Keep excavation free of water; pump if necessary. Have heaters on hand to bring pipe surface to about 74 F. The pipe surface must be dry. The temperature effects the curing time for the epoxy used to attach sensors.

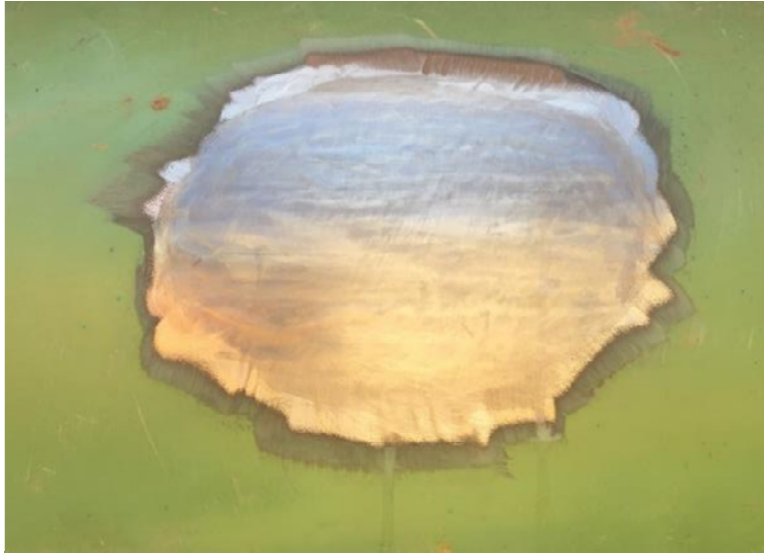
Figure 26. Cleaned Pipe Surface

Hand polish the pipe surface with 320 grit then 400 grit paper to further improve finish (Figure 26a).

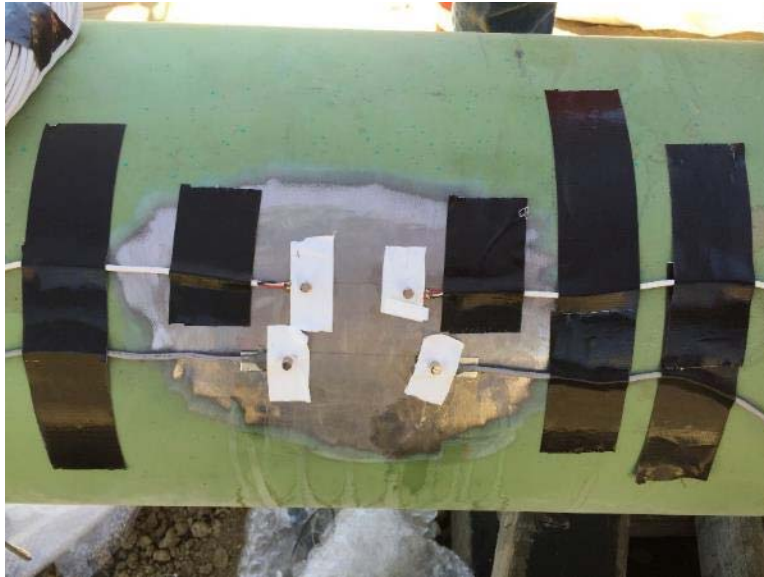
Figure 27. Sensors During Epoxy Cure

- 3.6. Wait for epoxy to cure based on ambient temperature: roughly four hours at 74 degrees F. Supplemental heat may be needed during cold weather. Care must be taken to exclude water from the sensor area during the cure time.

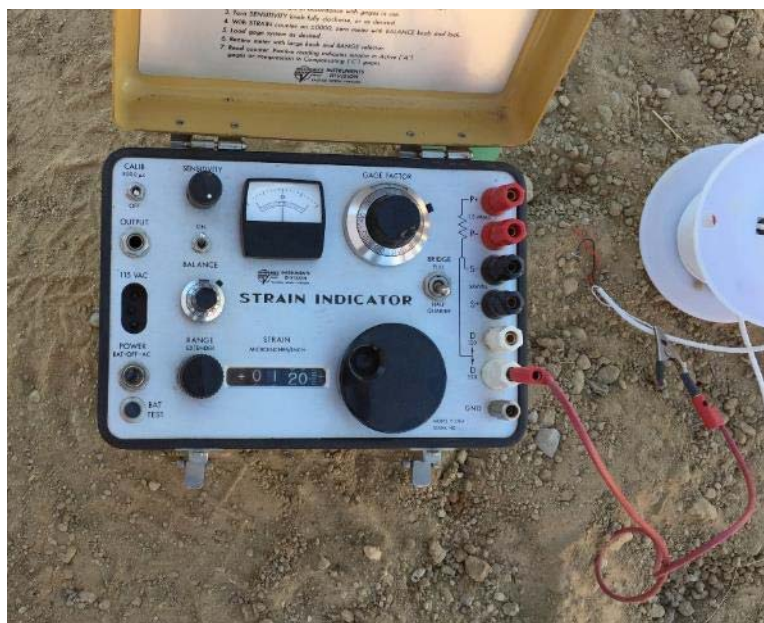
Figure 28. Vishay Micro Measurements Strain Indicator

4. Test and cover
 - 4.1. Remove magnets and Teflon tape from sensors. Test strain gauges with Vishay instrument (Figure 28) or ohm meter. Test vibration sensors with Acellent instrument or oscilloscope.
 - 4.2. If a sensor installation is found to be questionable it should be removed and/or replaced. If a “spare” sensor was installed, the best practice is to cut the cable from the suspect sensor to prevent later confusion.

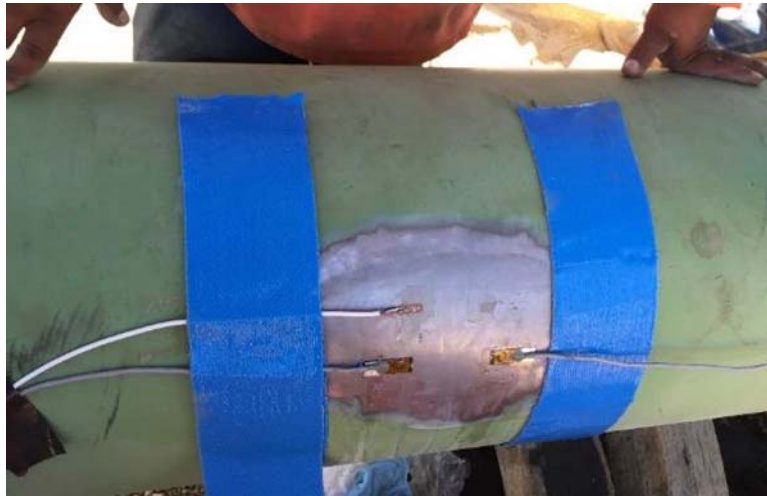
Figure 29. Form Protective Patch over Sensor Area

Viscotag and sandwich with additional strip (Figure 29). Cover over sensor area with additional strips perpendicular to the border strips to form a patch.

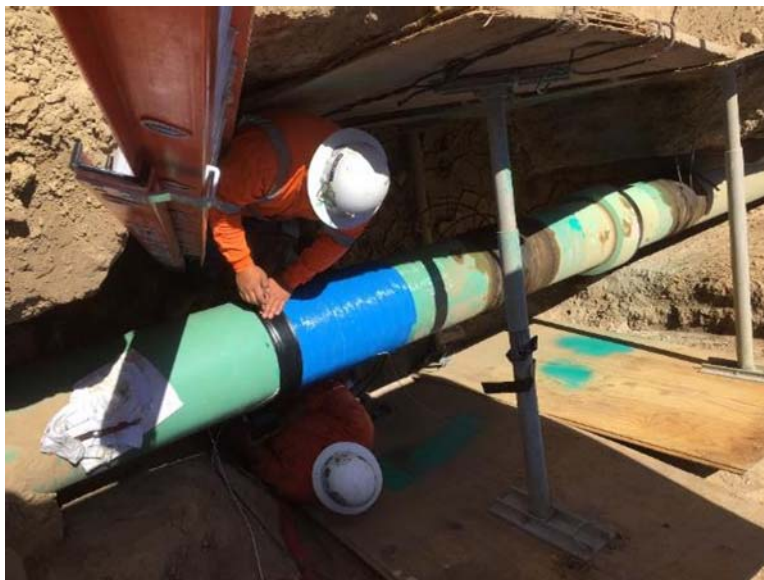
Figure 30. PVC Tape Wrap being applied over Viscotag Wrap

- 4.4. Over the sensor protection patch, perform a spiral wrap of the pipe with Viscotag as per manufacturer instructions. Start wrap at least 6” before sensor area; continue wrap to 6” beyond sensor area. Counter wrap the pipe with protective PVC tape over the top of the Viscotag (Figure 30).
- 4.5. Test all sensors again prior to backfill.

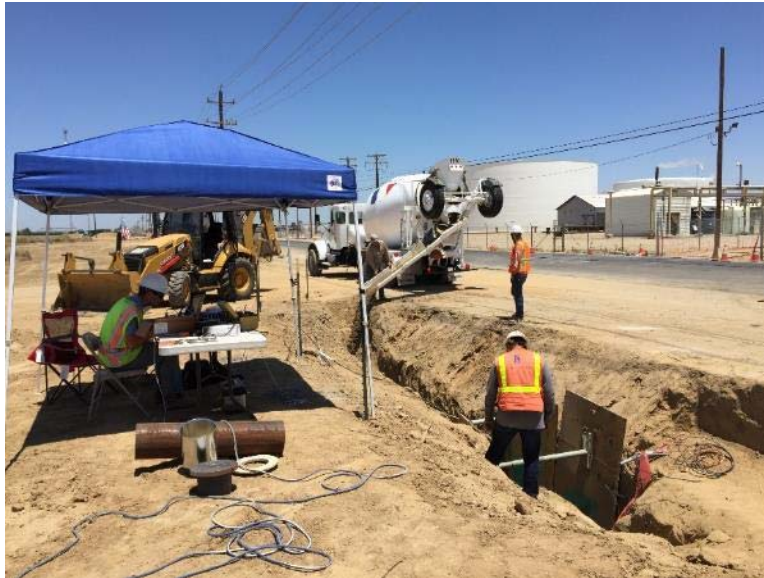
Figure 31. Monitoring Back Fill

5. Initial Backfill and Soil Sensor Installation
 - 5.1. Position excess sensor cable near the edge of excavation and on the bank. If the data logging equipment is available, it can be hooked up to record the back-fill process (Figure 31 and Figure 32). The change in pipe strain level during fill indicates the gauges is working correctly.

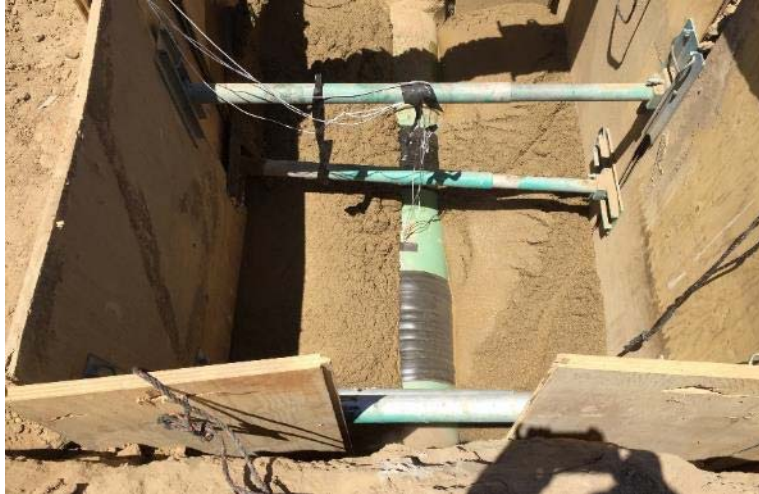
Figure 33. Excavation Partially Filled over Sensor Area

5.3. Flow fill from alternate sides of the sensor area to achieve a fill level to roughly 18” above the pipe crown line (Figure 33). When the fill level has been achieved, allow the fill to set for 1-2 hours until the surface becomes firm enough to walk on.

Slurry fill was poured into the trench up to a level roughly 18” above the top of the pipe (Figure 38). The slurry was allowed to set for about two hours until it was firm enough to walk on. Personnel hand dug a small pit in the slurry next to the pipe and installed the soil sensors: the current coupon, the geophone, and the soil moisture/temperature sensor. The soils sensors were then covered by hand. Because of construction schedules, the slurry process was performed at two locations in June and the third in August. The excavations were all topped up with normal backfill to bring them up to grade.

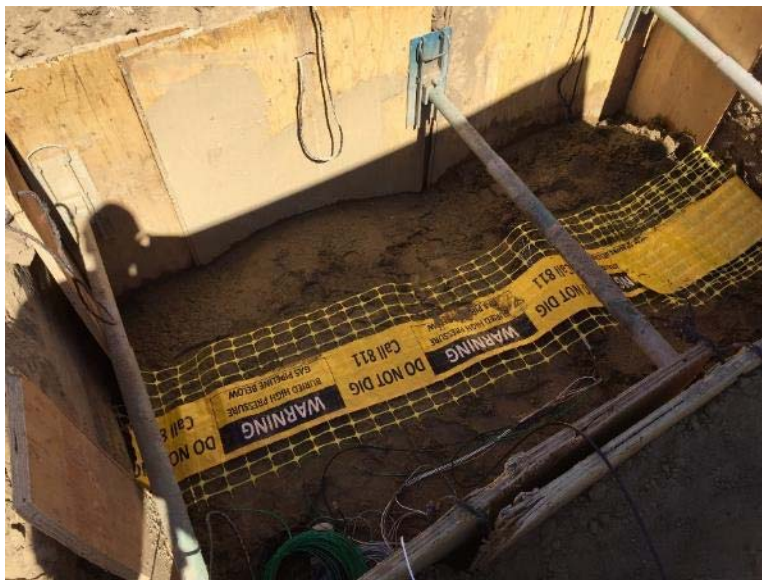
Figure 34. Sensors Installed

- 5.4. After the fill has set sufficiently, make a roughly 12” by 18” excavation by hand to the side of the pipeline near the bank. Insert the soil sensors into this excavation with the geophone in the center. Place the soil moisture and current coupon sensors at opposite ends of the hand excavation. Taking care to place the soil sensor cables on the bank, fill the excavation by hand (Figure 34).
- 5.5. After all sensors are installed under flowable fill, repeat tests using datalogging equipment and/or testers to verify that all sensors are working.

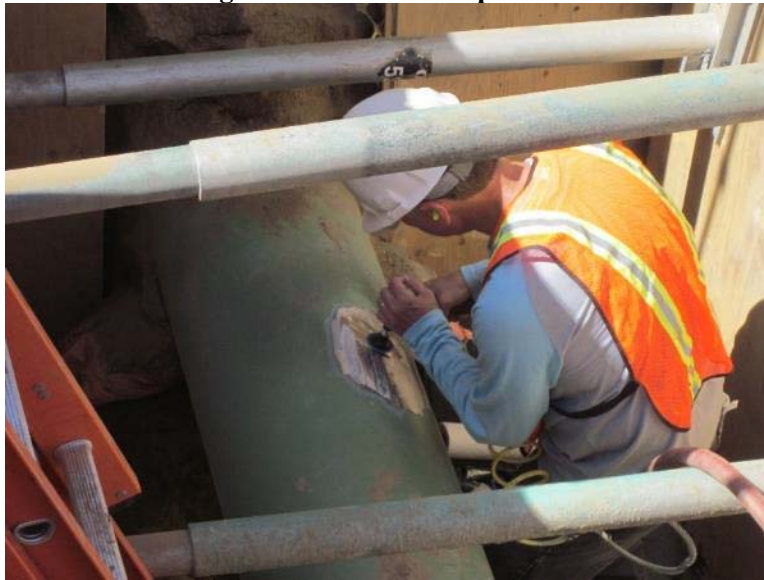
Figure 35: Surface Preparation

As noted previously, installation of the sensors on the site began in June of 2018. This is the first step in the deployment process and must be accomplished while pipe is exposed in open trenches. The trenches were constructed to provide adequate and safe access for the installations to take place. Those sensors attached directly to the pipe surface (strain, vibration, and current) required removal of the coating and surface preparation (Figure 35). Once the surface was prepared, strain and vibration sensors were immediately applied (Figure 36) using a two-part epoxy. The current sensor wire was installed by thermite welding. These steps were repeated at all three locations.

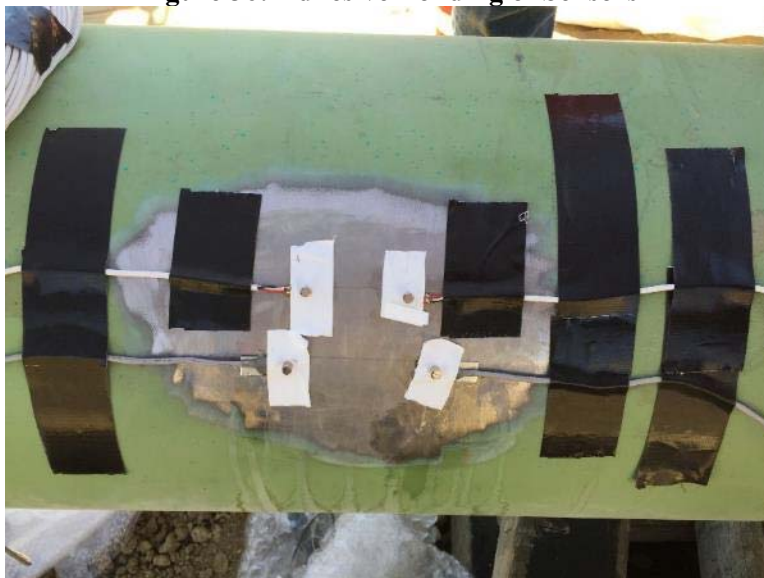
Figure 36: Adhesive Bonding of Sensors

Adequate time was allowed for the epoxy to cure. Given the hot, dry conditions at the test site, four hours was needed. The sensors were tested for continuity and functionality prior to sealing them up. A tape wrap product (Figure 37) was applied over the sensors and both over and under

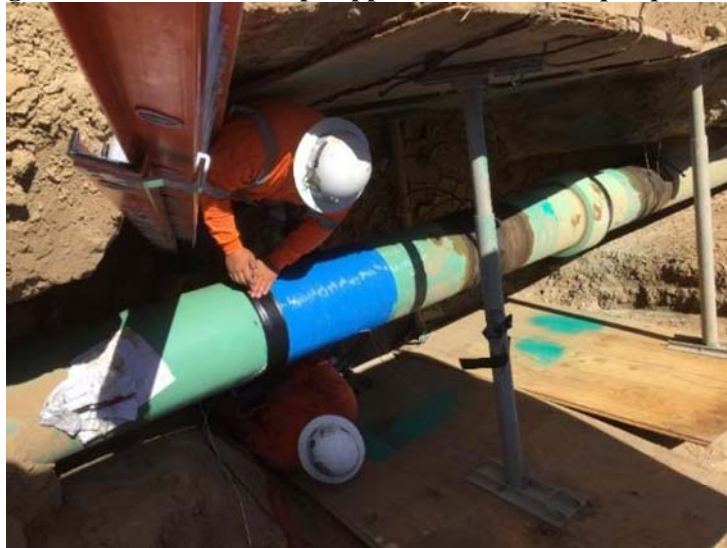
Figure 37: Black PVC Tape applied over Viscotaq Tape Wrap

their wiring to provide a long-term seal against moisture. The sensor cables were temporarily secured to the cross braces.

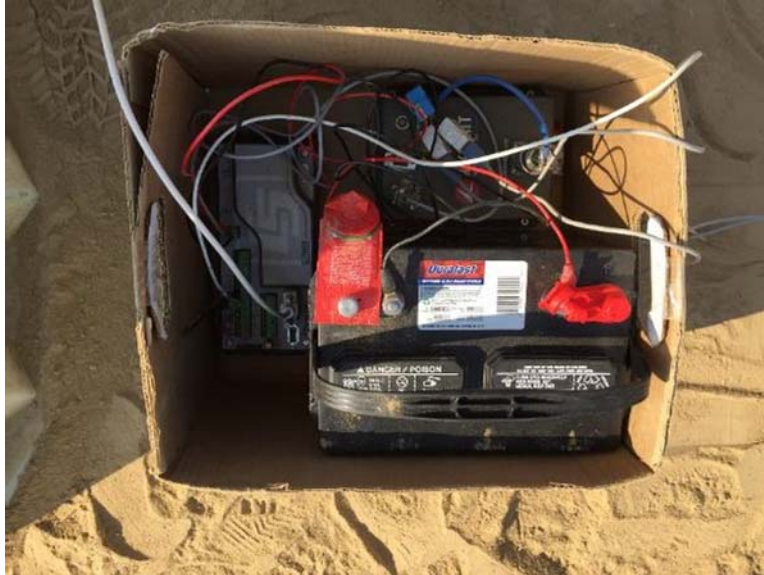
Figure 39: Instrumentation Running on Battery Power

The pipeline was hydro-tested in early July. The permanent instrument enclosures were not complete at the time of the hydro-test. The instrumentation temporarily deployed (Figure 39) for a three-day period to capture this data. This provided test data for some of the major systems. There was no cathodic protection in place during the hydro-test preventing

testing of the current coupon. The instrumentation was run from a combination of batteries and/or generators. The RPMA radios were not available making it necessary to recover the test data by directly connecting (Figure 40) to a laptop.

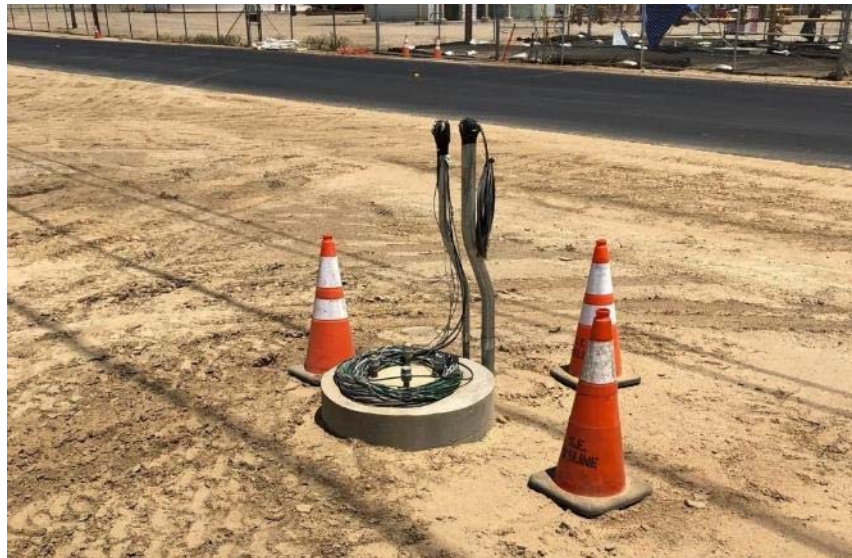
Figure 44: Footing and Conduit in Place

After the hydro-test was complete, the instrumentation was removed to a safe storage area in the construction yard until the permanent enclosures could be completed. The sensor cables were pulled through conduits and brought above ground. Footings (Figure 44) were poured at two locations to support the pole for the instrumentation cabinet during July. The remainder of the soil backfill was put in place on top of the slurry fill covering the pipe.

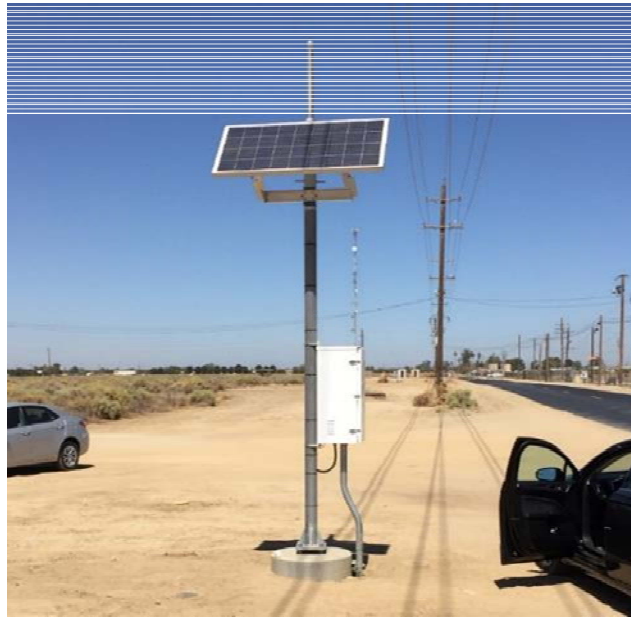
Figure 45: Solar Powered Enclosure in Place

The poles were put in place and the permanent enclosures with their solar power system (Figure 45) installed in early September. The CR800 dataloggers and associated sensors were installed and wired by SoCal personnel and contractors using the installation drawings developed by GTI. The Acellent vibration processors and RPMA radios will be installed in the future. Space has been left at the top of the 15' pole for the radio enclosure. This installation is typical for 2 of the 3 locations on this site.

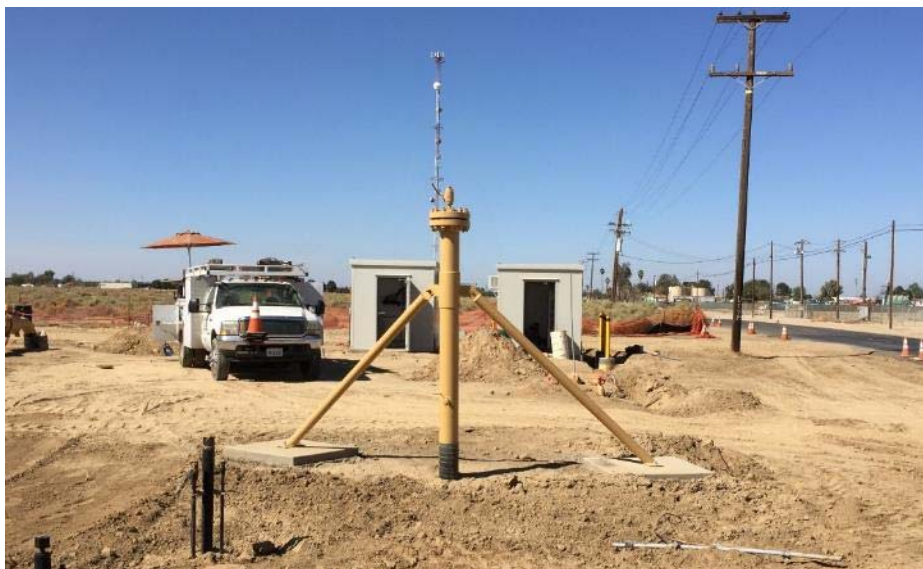
Figure 46: Equipment Sheds at Location 3 under Construction

The third location on this site to house instrumentation will be inside the fence of a permanent station being constructed by SoCal. The array of sensors is the same as the other locations, but the instrumentation will reside in an equipment shed (Figure 46) that is supplied with AC mains power. A 15' mast will be provided for the RPMA radio equipment. This location was completed near the end of September and has not been tested yet.

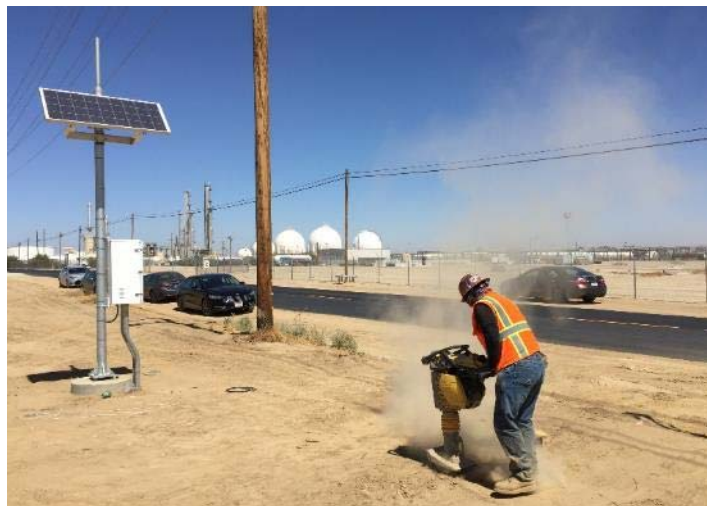
Figure 48: Compactor Testing

The purpose of the compactor testing was to put repeatable vibrations into the ground at known locations between station 1 and station 2. This would provide data on the sensitivity of the vibration sensors mounted on the pipe and on the attenuation of the soil-pipe system. The compactor testing (Figure 48) began 50' south of location 1 and proceeded continuously over the pipeline to a point 50' to the north. The testing continued proceeding north toward location 2 (Figure 49) with the compactor being moved to discrete points rather than run continuously. These points were 100', 200', 400', 600', 800', and 1000' north of location 1. The compactor was run for roughly 2 minutes at each point. The last point in this series was roughly 43' south of location 2. To complete the series the compactor was run continuously from this point to on 50' to the north of location 2.

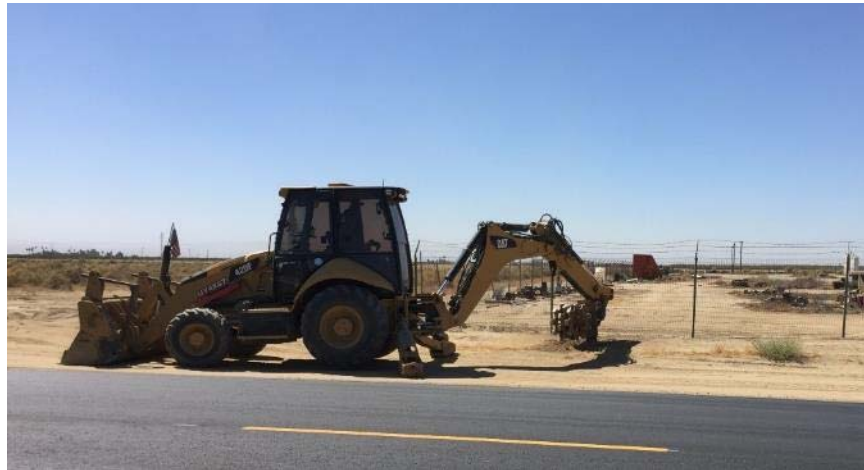
Figure 50: Excavator Testing

The excavator testing was carried out at the same set of discrete points as the compactor but in reverse order. The excavator started at a point 50' to the north of location 2 and proceeded to a point 50' to the south of location 1. At each point the excavator removed a small amount of soil, impacted the arm onto the ground several times, and then replaced the soil. At no time was more than 12" of soil removed or was there any hazard to the pipeline.

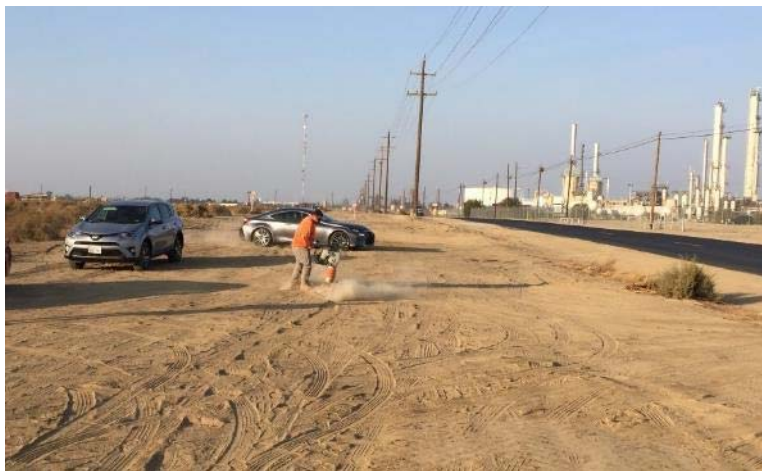
Figure 53. Vibration Test with Compactor

For the second round of vibration testing a soil compactor was operated near the buried sensors at Station 1. The first test occurred on top of the sensor location. For the second test, the compactor (Figure 53) was moved to a location 75' from the sensors. The compactor was operated for 2 minutes continuously in both locations.

The raw data was recorded internally by the Acellent Technologies vibration monitor (ATVM) and a processed version of the data was passed to the Campbell datalogger (CR800) for storage. The radio system was not active the day of the vibration test; storage in the web hosted system was not available.

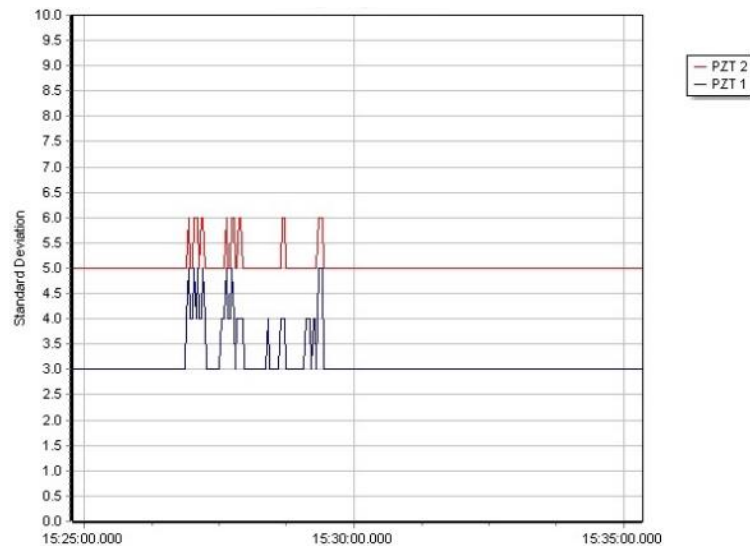
Figure 58: Standard Deviation for PZT Sensors Only

When looking at only the response (Figure 58) of the piezoelectric sensors, there is indication that they were able to detect the closer of the two vibration tests. It is unclear why the response of the PZT sensors is so low. In other condition monitoring applications, the manufacturer claims that the PZT sensors produce several volts of signal with no additional amplification. It is possible that attachment to a massive pipeline and layers of coating over the sensors are the cause. In this application a preamplifier might improve the results.

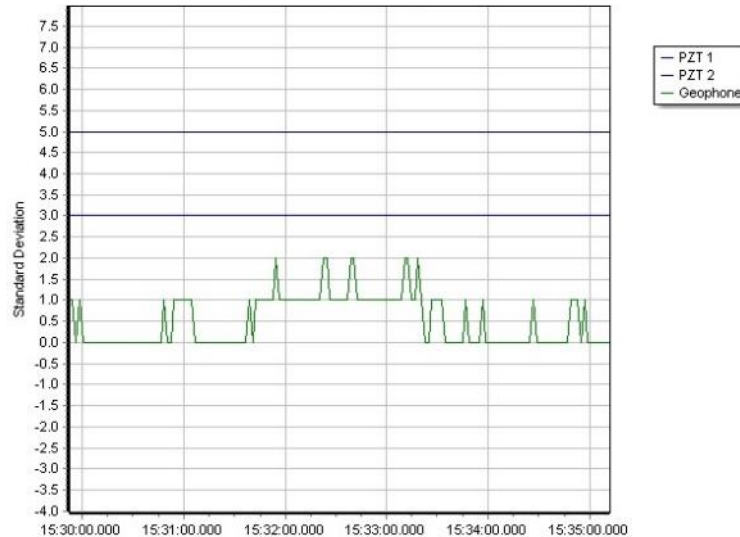
Figure 59: Signal Standard Deviations for Far Test

Figure 59), with the compactor 75' from the sensors, the geophone still shows a small response to the excitation. The two piezoelectric sensors do not show any deviation from their baseline values whatsoever. This observation reinforces the argument that the PZT sensors require some form of amplification to be effective in this application.

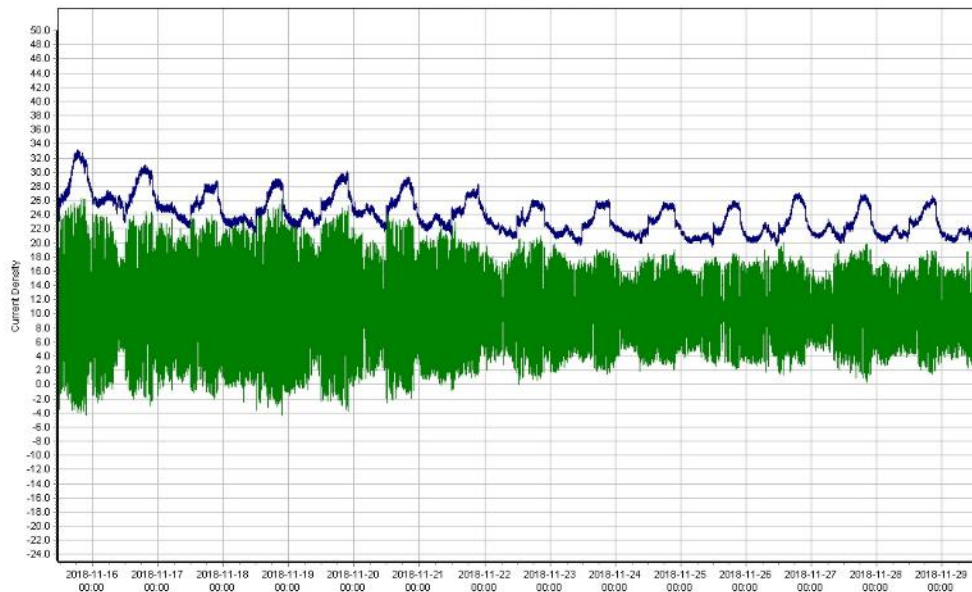
What causes the periodic structure in the RMS current? When one expands the RMS feature for closer examination (Figure 72), clearly the period is 24 hours. There is a set of nearby AC power lines that run parallel with the pipeline. The effect being observed is an AC current induced in the pipeline proportional to the power line current. Looking at the time stamps, the highest values mirror the highest demand for electricity between noon and midnight. There is a corresponding drop in demand after midnight; the cycle repeats daily. This is a reasonable result that has been observed in many other cathodic protection studies.

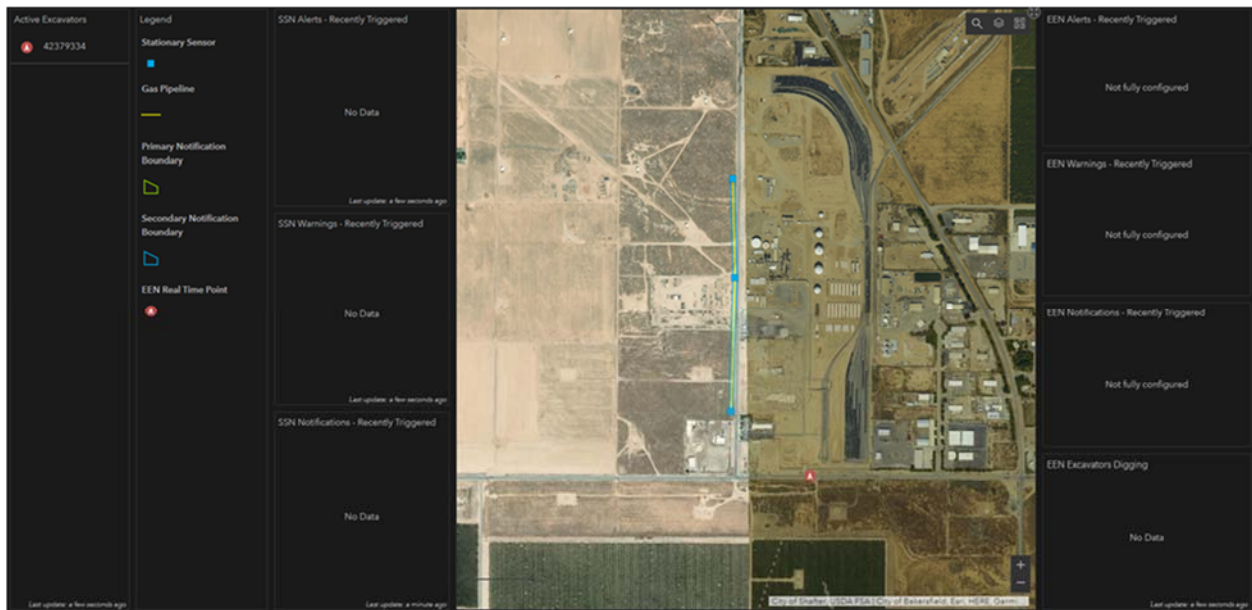
Figure 74: Mockup of Operator Data Dashboard

The purpose of the web-hosted user interface is to provide a single portal to view data from both Stationary Sensor Nodes (SSN) and Excavation Encroachment Notification (EEN) devices. The user interface is based on Esri Operations Dashboard (Figure 74) for the presentation layer and on Esri GeoEvent Processor for the underlying logic.

The demonstration was a simulation based on data recorded on the actual site. At the time of this demonstration wireless connectivity is not in place. Data captured during the hydro-test and during vibration testing was used to populate the model. The simulation can be run faster than “real time” for testing and demonstration. At this writing, real-time wireless data is available for the sensor stations and analytic development is proceeding with live data.

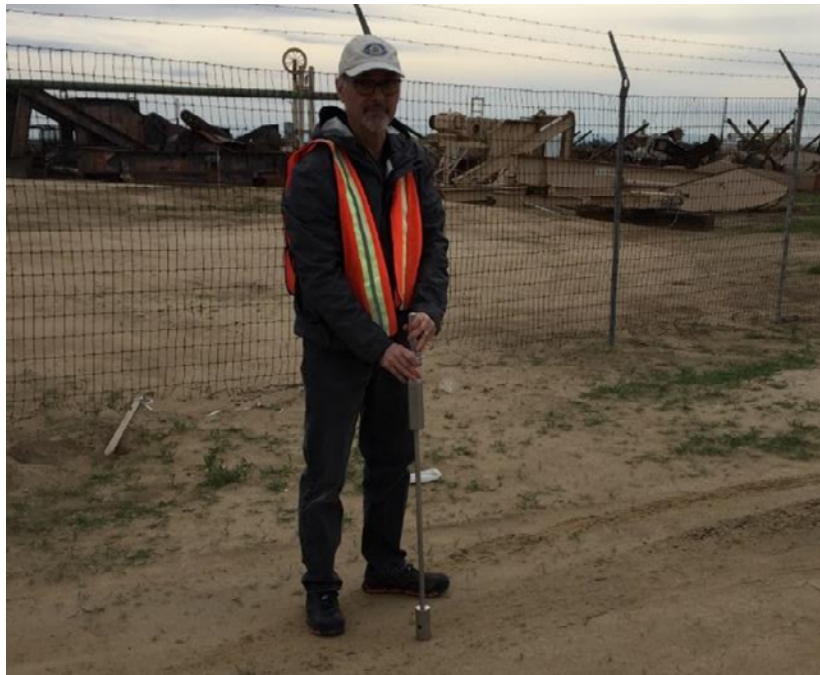
Figure 82. DCP to Generate Impact Signal

For this round of vibration testing a dynamic cone penetrometer (DCP) was used to generate the signal in the soil. This is a hand-held, manual device that consists of a drop weight on a rod that is raised a fixed distance above the ground and then released (Figure 82). The DCP is normally

used as a means of testing soil compaction density repeatedly driving a pointed tip into the ground and recording the number of hits required to advance a certain distance.

For this test, the pointed tip was removed, and the blunt face of the DCP put in contact with the soil. The drop was raised and released 5 times at each location. The test was carried out a series of locations along the pipe with a spacing of 10' between locations. One of the locations was directly over the sensors on the pipe. For this given drop weight and travel distance the impact energy was just over 12 Joules per impact. This is a much smaller signal than that generated by a backhoe or compactor. It is GTI's judgement that sensitivity must be sufficient for small impact (at least close to the sensors) must be detectable for this technology to be successful.
