## Wayside Worker Protection Technology—TrackSafe Phase II *Research & Demonstration Report*

FTA Report No. 0194  
Federal Transit Administration

14. ABSTRACT This report outlines research and demonstration of a roadway worker protection (RWP) warning technology developed by Bombardier Rail called TrackSafe. The system was installed at the Metropolitan Atlanta Rapid Transit Authority (MARTA) and was designed to reduce the hazards of working within a transit rail right-of-way (ROW). The report details the proof of concept, design, construction, commissioning, and operation of the technology, shares issues experienced during the project, and provides a qualitative assessment supported by lessons learned. Sharing these experiences should further enhance RWP technologies for more reliable systems in the future, ultimately creating a safer work environment for ROW workers at rail transit agencies.

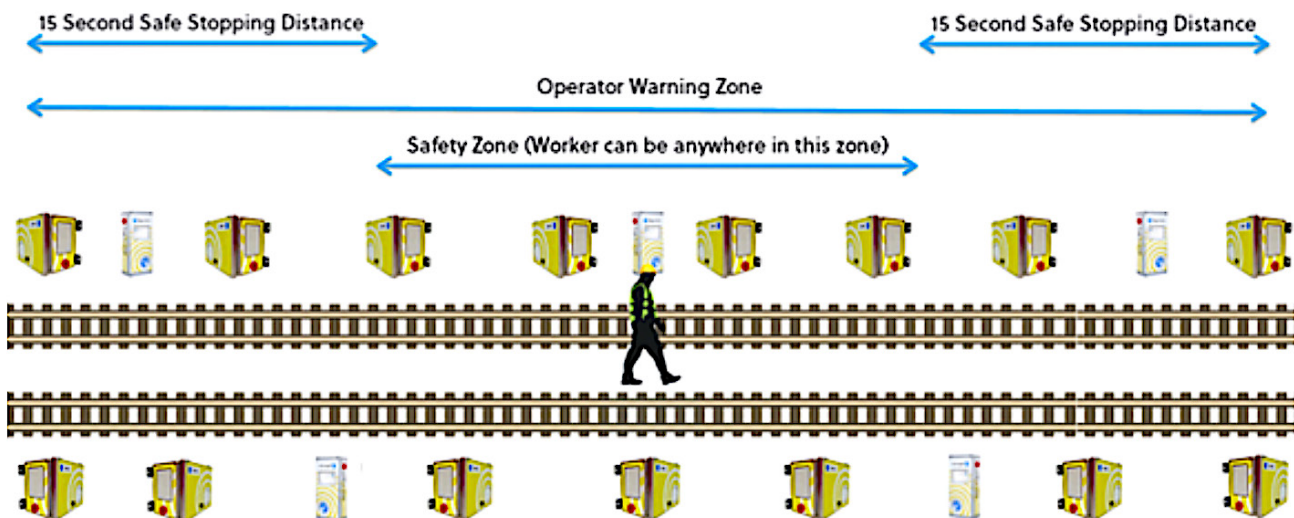
**Figure 2-1**

Figure 2-1 shows the OWZ and SZ zones and the need for a 15-second warning notice on either side of the workers. This is configurable based on track conditions on individual transit property requirements.

*TrackSafe concept*

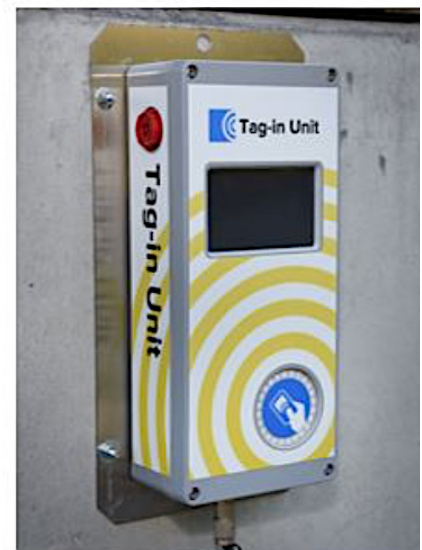
**Figure 2-2**

In general, TIUs are installed every 500–1,000 feet depending on factors such as the configuration of the track, ROW worker and train operator line of sight, allowable train speeds, and environmental noise conditions. For example, TIUs are installed closer together in curved track sections where the line of sight is shortened when compared to straight track.

*TIU exploded view and installed unit*

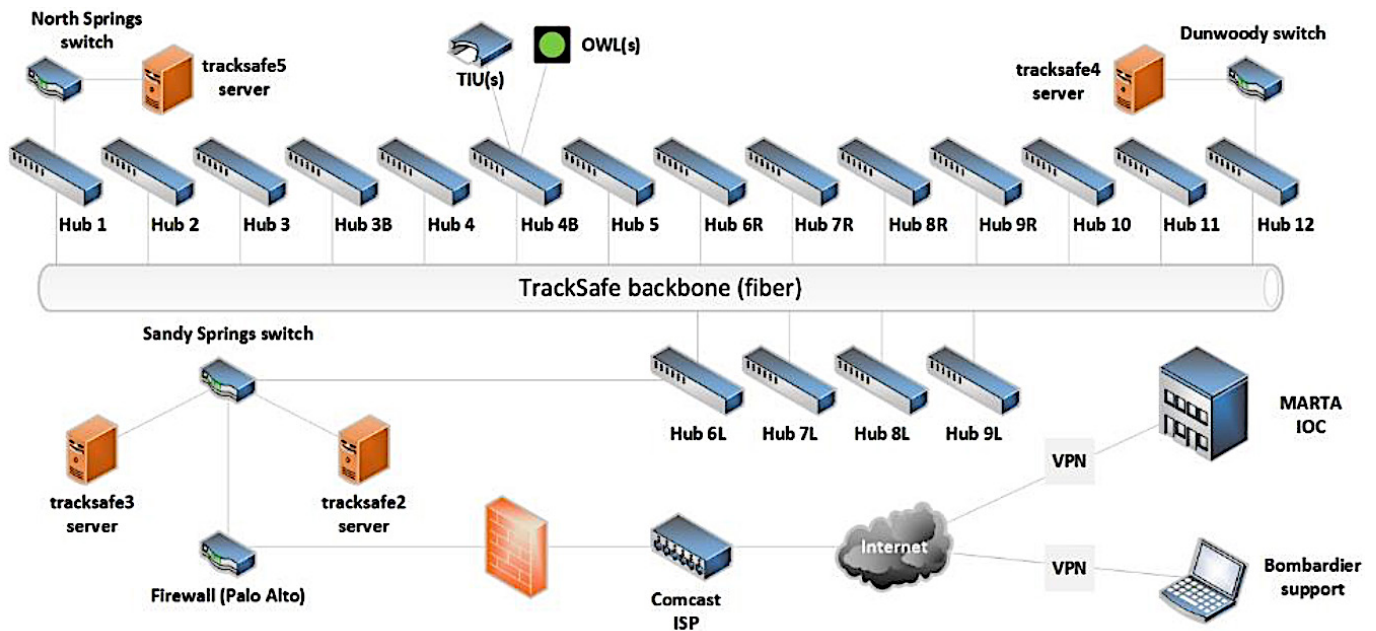
**Figure 3-4**

At the core of the network is the TrackSafe fiber backbone, where all devices on the network communicate between each other using the backbone. The backbone is deployed using a ring topology to allow for redundancy and act as a backup in case of single link failure.

*Overview of network topology*

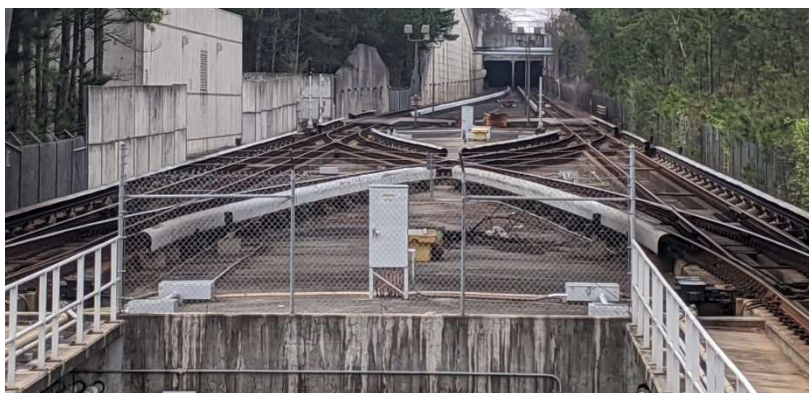
*Figure 1: Entry to Right-of-Way at North Springs Station*

**On the morning of March 11, 2020**, the TRA team split into two subsets for field observations of MARTA personnel working under TrackSafe. At North Springs Station, three TRA team members who were certified for MARTA wayside access surveyed a focus group of MARTA track inspectors who had worked under TrackSafe in the course of their day-to-day duties. After the conclusion of the focus group, the three TRA

members, plus one representative from Bombardier, joined the MARTA track inspectors on a track walk from North Springs to Dunwoody Stations, with the MARTA track inspectors interacting with the TrackSafe system. The TRA team observed the MARTA track inspectors’ interactions with TrackSafe and also noted observations about the configuration and functionality of the system. TRA team personnel also asked questions of the MARTA track inspectors on their experiences in interacting with TrackSafe and also posed questions to the Bombardier representative about TrackSafe’s design, configuration, and functionality.

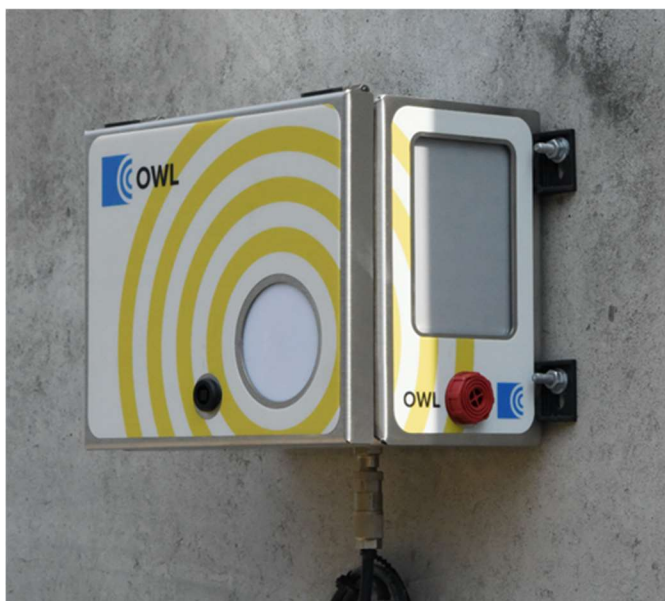
Figure 3 - Operator Warning Light (OWL)

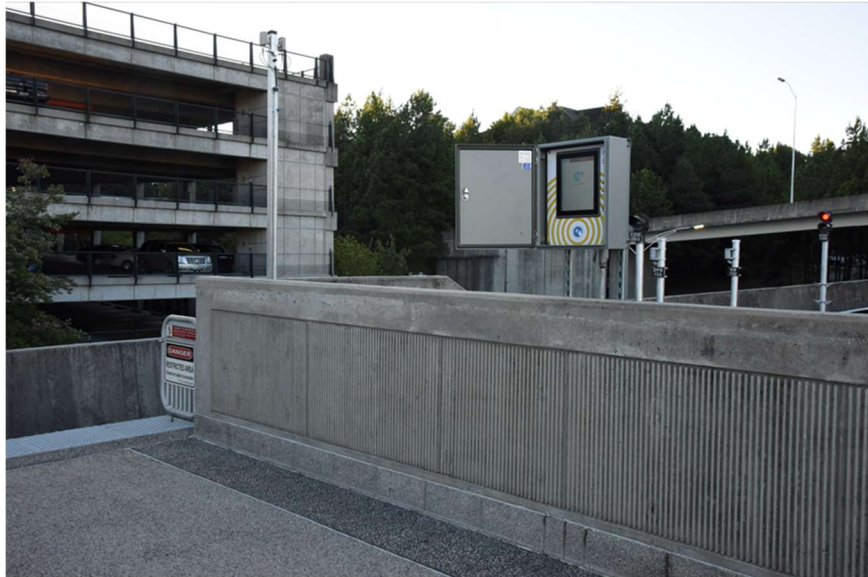
*Figure 4 - Wayside Access Unit (WAU) at North Springs Station platform*

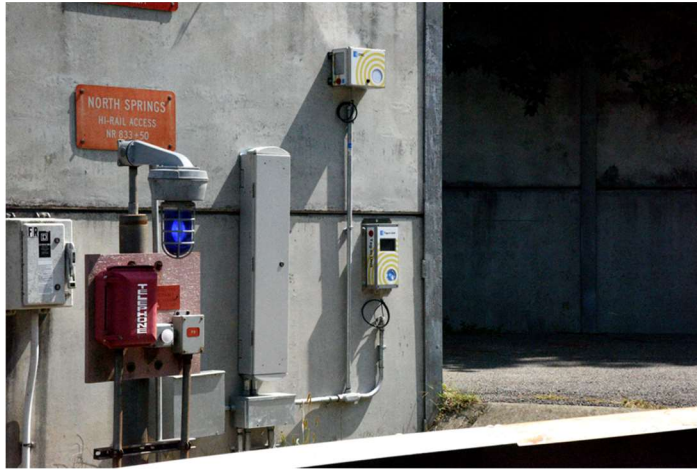
During the inspection, the inspectors tagged into all passed, operable TrackSafe TIUs. The TRA team noted delayed TIU responses when the inspectors tagged in at some of the TIUs along the right-of-way. While some TIUs immediately recognized wayside worker identification (ID) cards, others took several attempts or longer periods of time to register the cards. The Bombardier representative that accompanied the TRA team track inspection observation reported that the delays in TIU recognition were likely due to communications fiber or power issues rather than unit failures.

Figure 5 - Tag-In Unit (TIU) at North Springs Hi-Rail Access point

Additionally, the TIUs were often installed in locations that were difficult for the inspection team to access. For example, in the portals, TIUs were installed just above the walking surface of the safety walkways, so that personnel in the track area could reach them. However, in most, if not all, cases, the lookout engaged the TIUs from the walkway. This resulted in the lookout taking both inspectors' cards and bending down to utilize the TIU at foot level. It is vital that all TIUs are installed in locations that do not pose additional hazards for users, such as losing sight of oncoming trains, fouling the dynamic envelope of the train, or crossing
