MDOT State Study 286 - Performance Evaluation of Highway Slopes on Yazoo Clay

FINAL REPORT

June 30, 2020

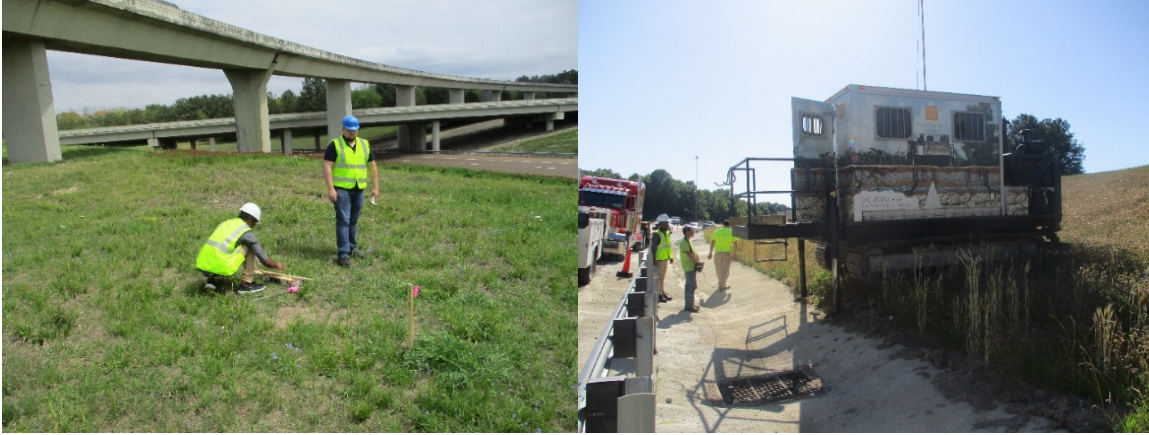
Figure 3.3 Conducting CPT test at Slope 1

Figure 3.3 shows the site investigation photo using CPT testing at Slope 1. Figure 3.4 shows the CPT results at the crest of the slope at the failed section. Figure 3.4 presents the tip resistance (q_t), sleeve friction (f_s), pore pressure (u_2 & u_0), and friction ratio (R_f). The complete CPT results are available in Appendix A.

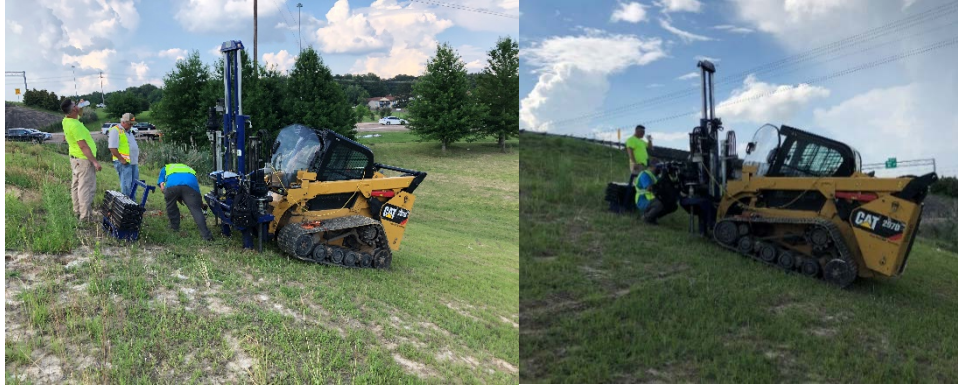
Figure 3.11 Field Activity of CPT test at Slope 2

Six CPT tests were conducted at both repaired and at as-built sections of the slope at the crest, middle, and toe of the slope. The depth of the CPT test at the crest, middle, and toe of the slope was 30 ft., 25 ft., and 20 ft., respectively. Thompson Engineering conducted the CPT testing at the slope. The CPT was performed using standard 10 cm² piezocone at the specified project locations, as presented in Figure 3.10. The CPT test photo at Slope 2 is presented in Figure 3.11. The tip resistance (q_t), sleeve friction (f_s), pore pressure (u_2 & u_0), and friction ratio (R_f) of the test location CPT 1 at the repaired area of the crest of the slope is presented in Figure 3.12. Other CPT test results from this slope are available in Appendix A.

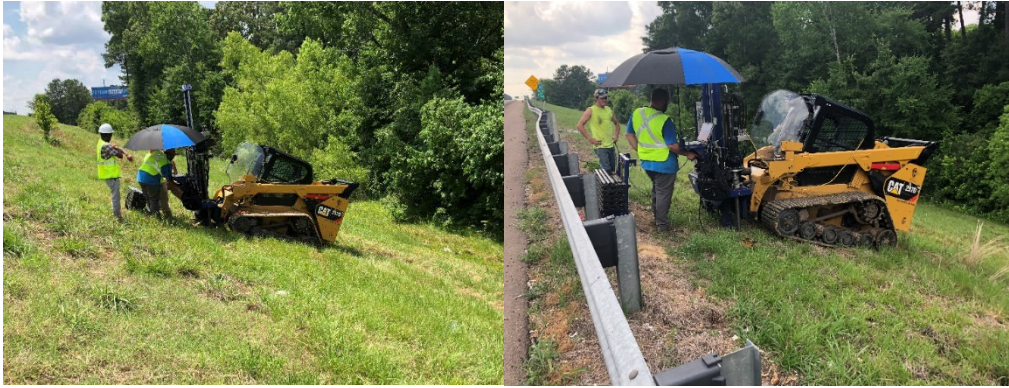
Figure 3.26 Field activity of CPT at Slope 4

Thompson Engineering conducted six CPT tests at the highland drive slope at the crest, middle, and toe of the slope. The depth of CPT at the crest, middle, and toe of the slope was 30 ft., 25 ft., and 20 ft.; respectively. The field activity of the CPT at the site is presented in Figure 3.26. The CPT was performed

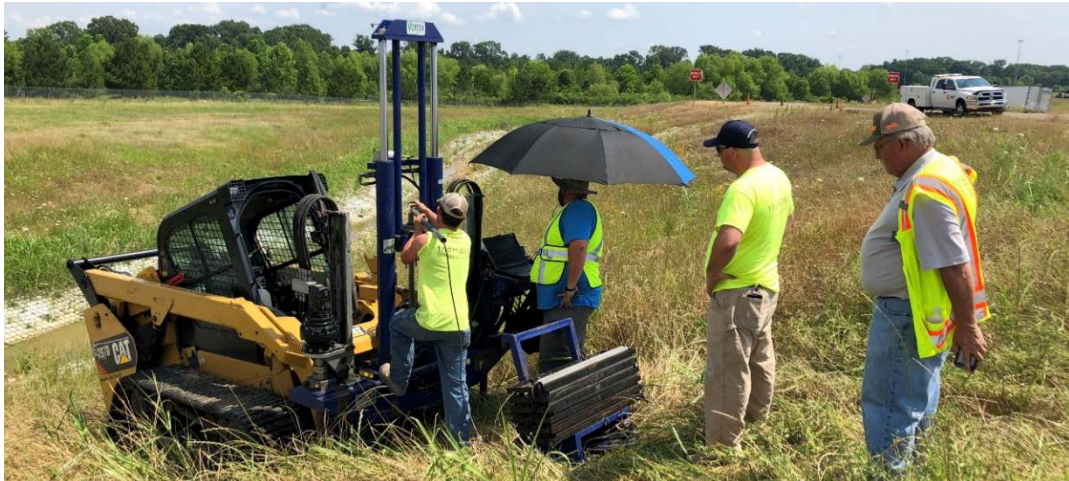
(a)

Thompson Engineering conducted six CPT tests at the crest, middle, and toe of the slope. The depth of the CPT at the crest, middle, and toe of the slope was 30 ft., 25 ft., and 20 ft.; respectively. A field activity photo of the CPT at Slope 5 and CPT test results at location C1 is presented in Figure 3.34. The CPT performed using standard 10 cm² Type 1 Piezocone, suitable for this location. The CPT results at other locations of Slope 5 are included in Appendix A.

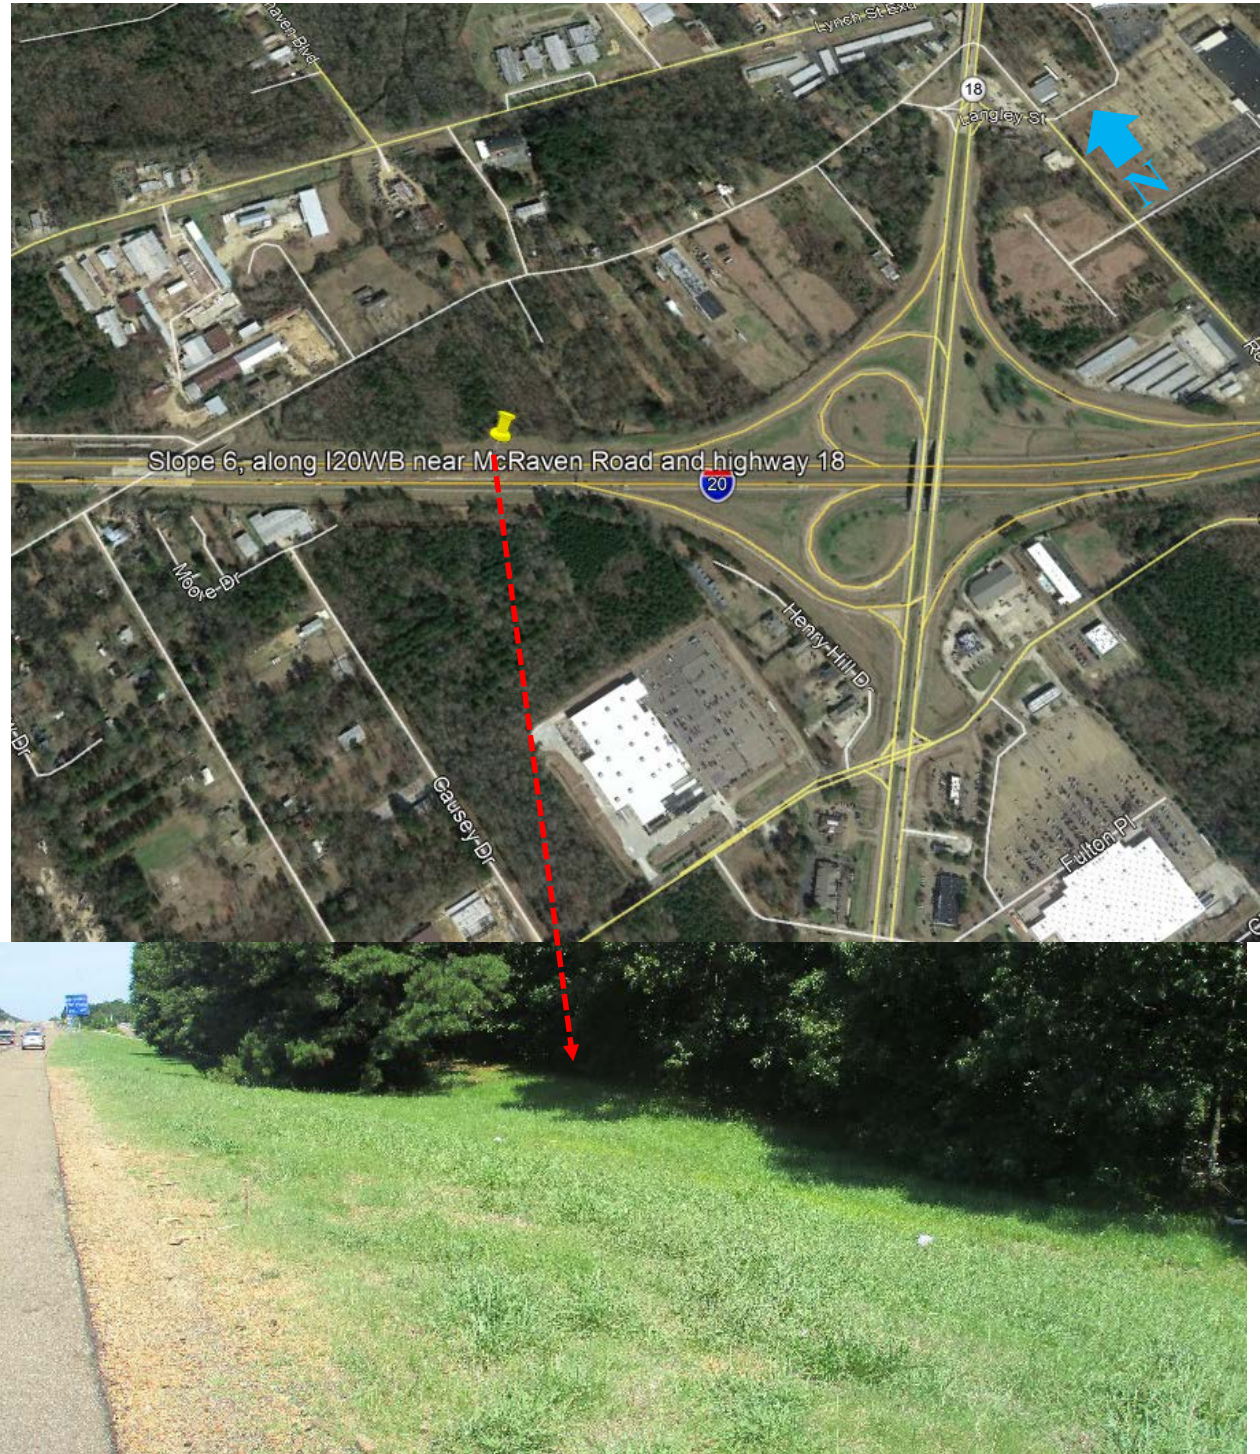
Figure 3.39 Location of Slope 6

Slope 6 is located on along I20E near McRaven road. The location of the slope and site photo is presented in Figure 3.39. It is a 4H: 1V slope with a height of 15 ft. Some part of the slope has shown prior movement, which was re-built, re-graded and the drainage structure of the slope was reestablished. Both the repaired section and the as-built section were considered for this study.

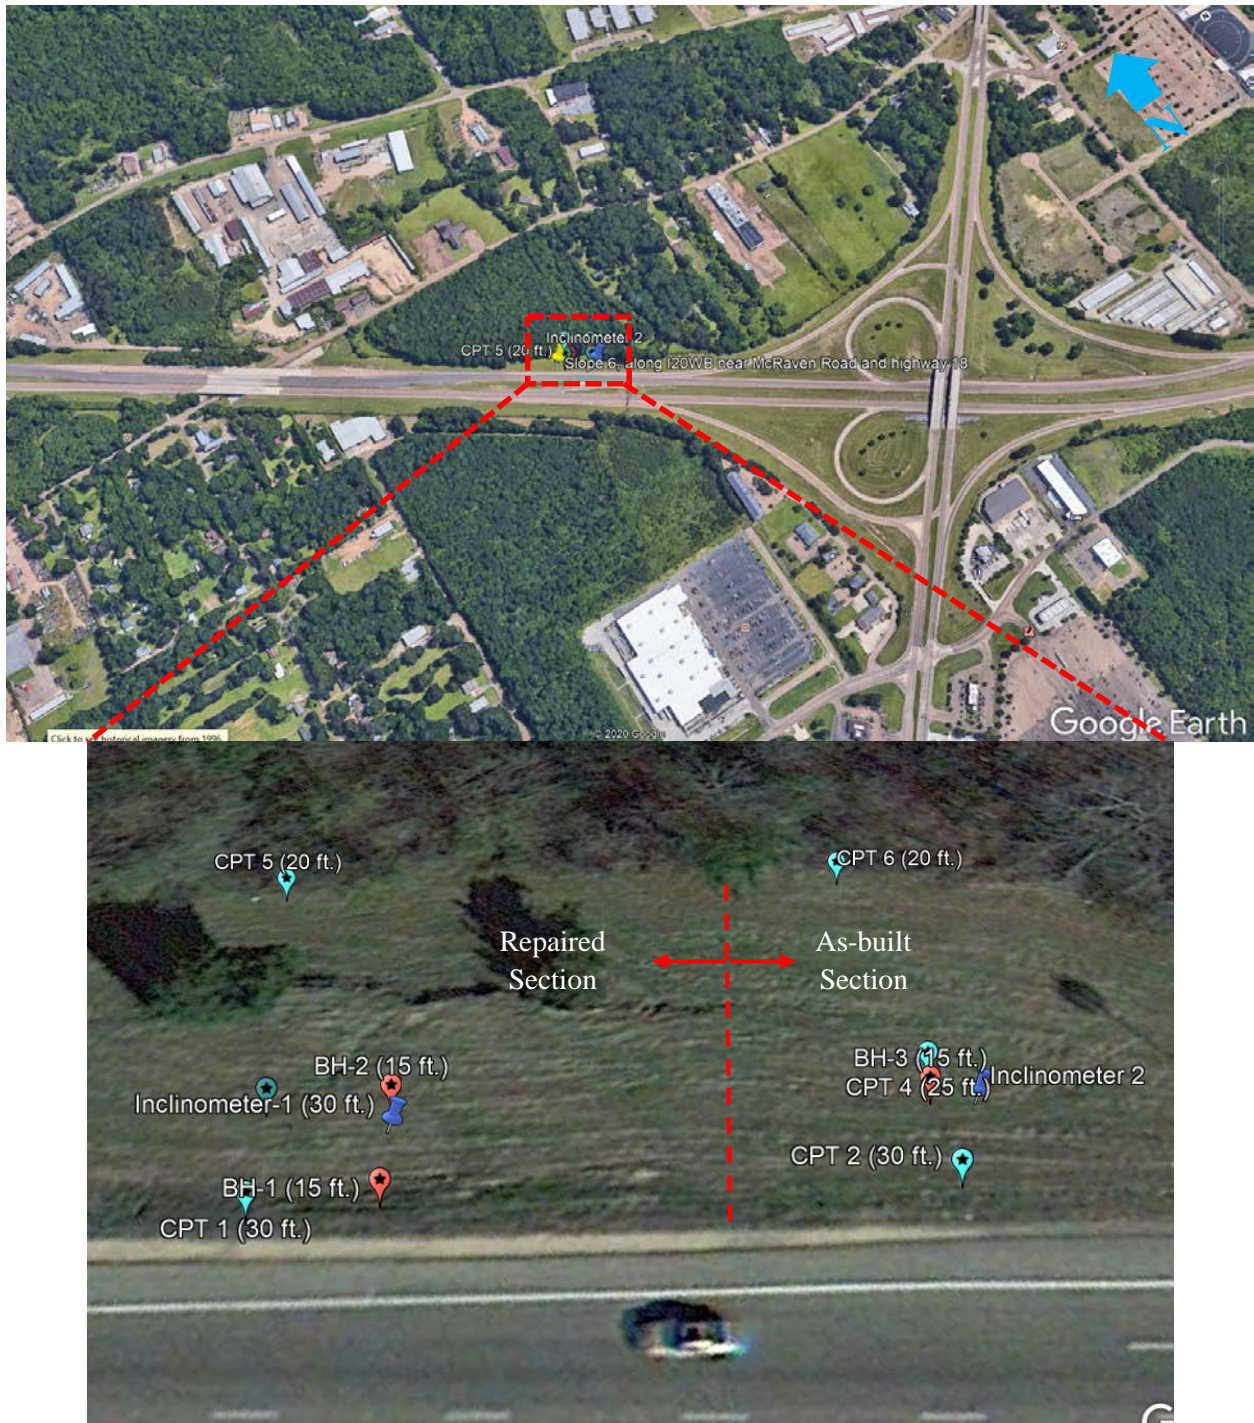
Figure 3.40 Location of CPT at Slope 6

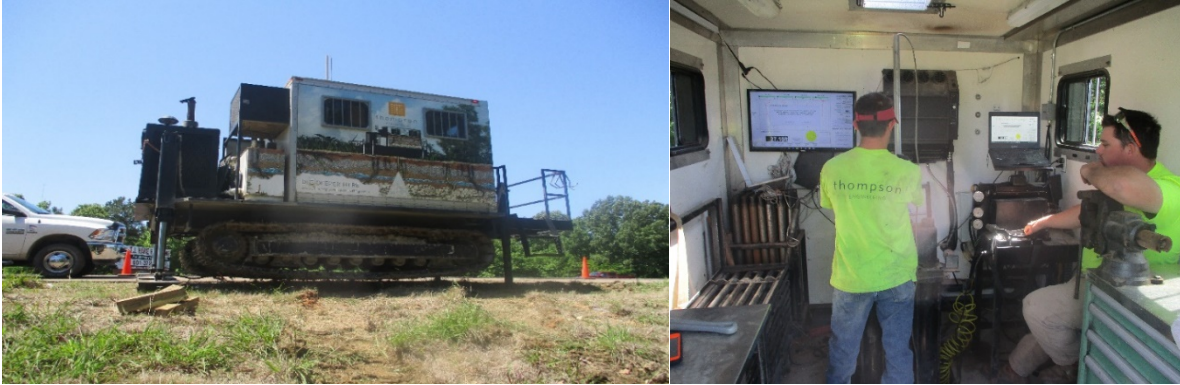
Figure 3.41 CPT test at Slope 6

Thompson Engineering conducted six CPT tests at slope 6. A field activity photo of the CPT at Slope 6 e is presented in Figure 3.41. The depth of the CPT at the crest, middle, and toe of the slope was 30 ft., 25 ft., and 20 ft.; respectively. The CPT performed using standard 15 cm² Type 1 Piezocone. The CPT results at location C1 is presented in Figure 3.42. The other CPT results are included in Appendix A.

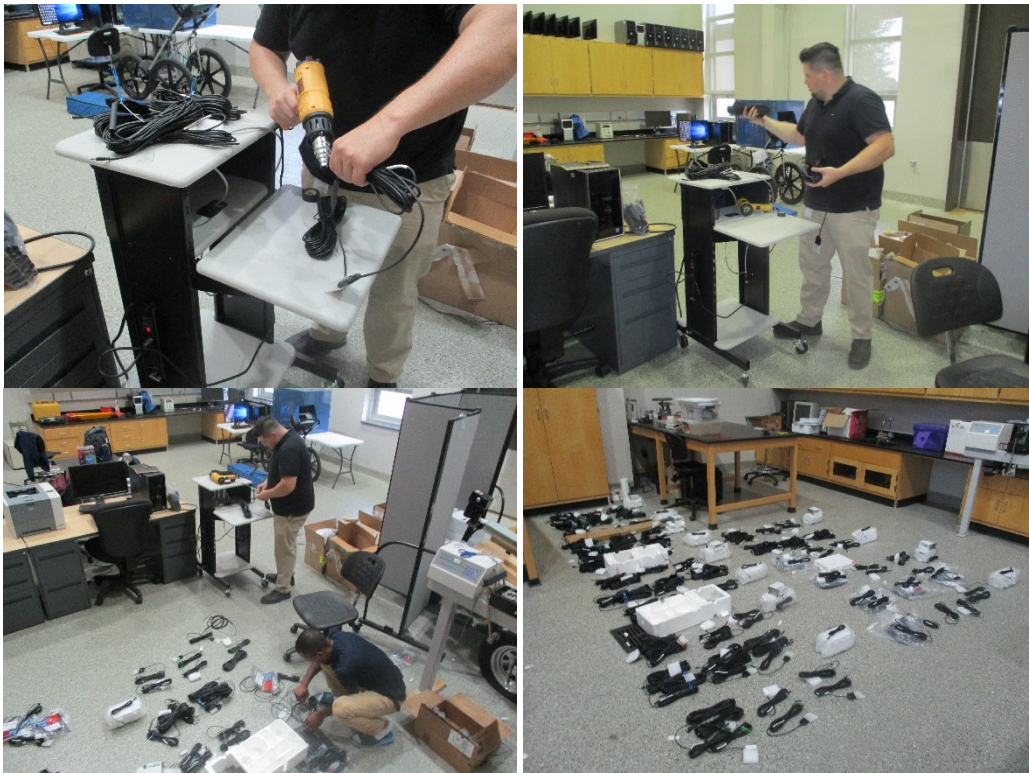
Figure 4.2 Field sensor preparation

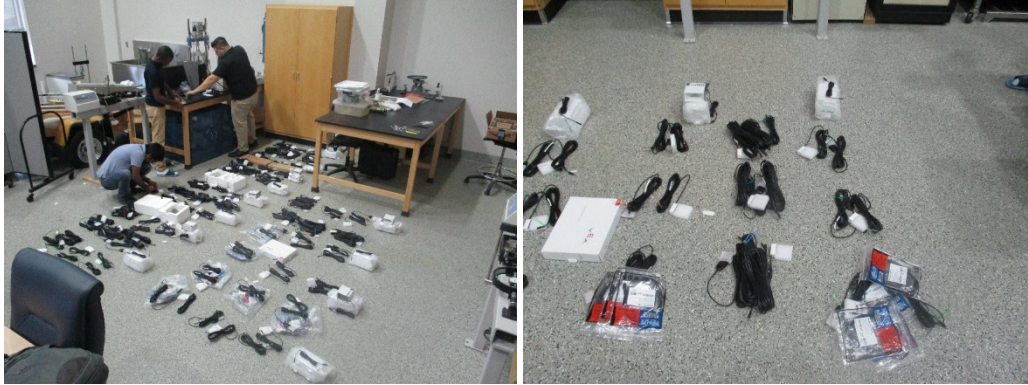
Figure 4.3 Field sensor color-coding set up

In each of the slopes investigated, twenty sensors and two inclinometer castings were installed. Figure 4.2 and Figure 4.3 present the process of sensors assemblage and color-coding. About 150 ft. long cables were used for the installation of the sensors. Each of the sensors is connected with a 3.5 mm stereo audio extension cable with the data loggers to record a continuous reading of in situ measurements.

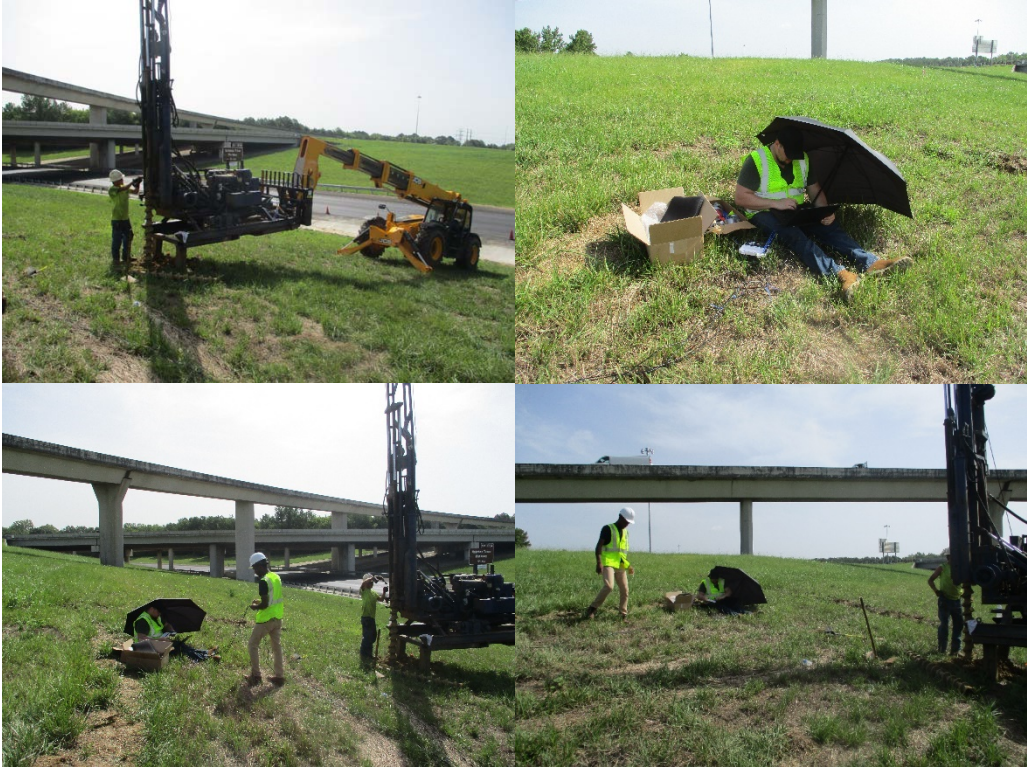
Figure 4.5 Slope 1 sensor installation

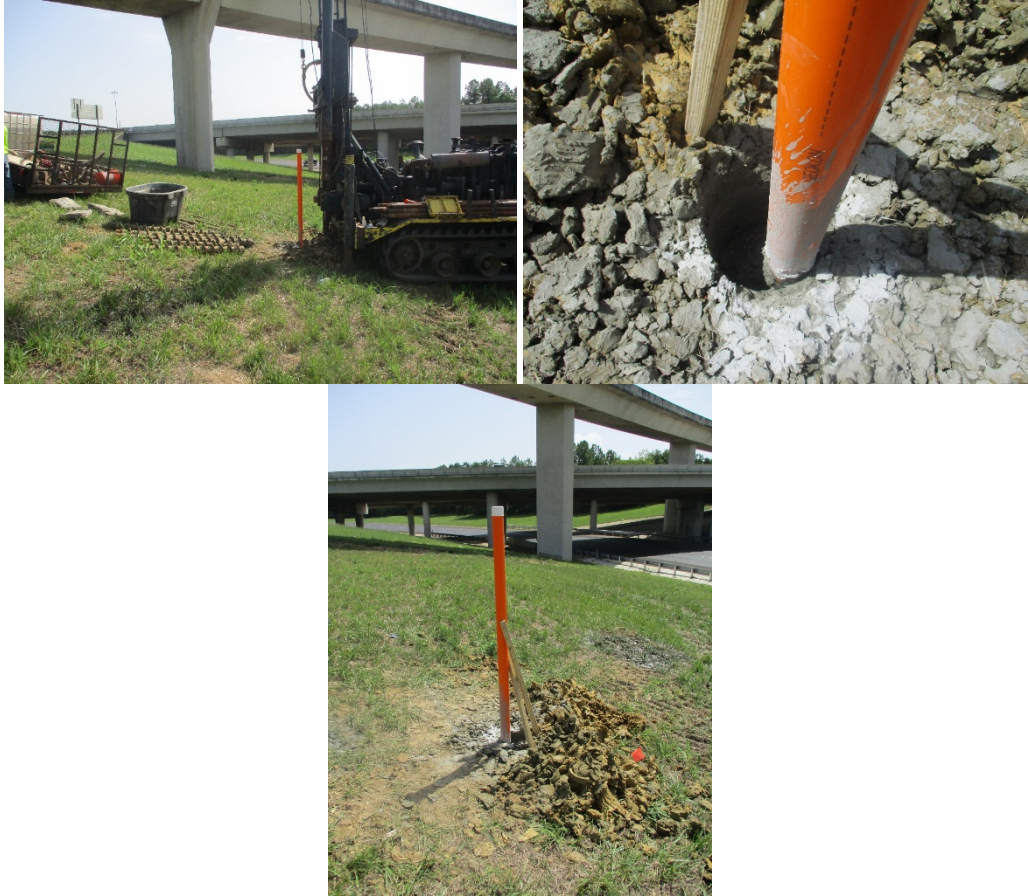
Figure 4.6 Slope 1 slope inclinometer installation

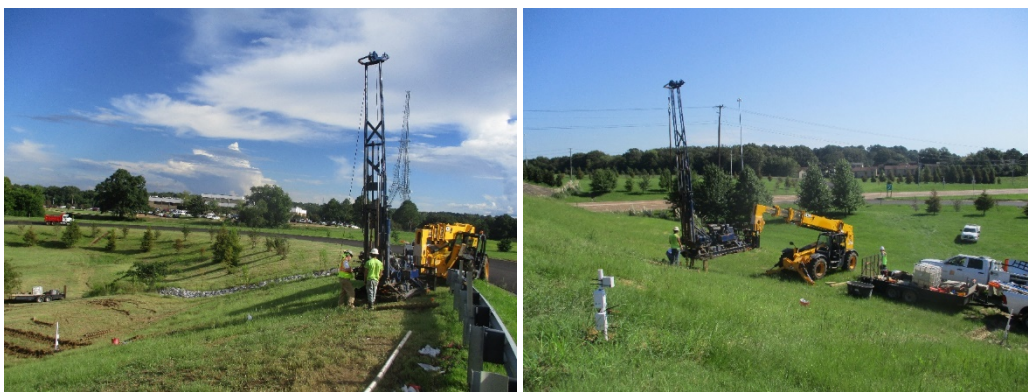
Figure 4.16 Field Activities photo at Slope 2.

In each of the Instrumentation locations, at 5 ft (1.5 m), 10 ft (3 m), and 15 ft (5 m) depths, a moisture sensor, and a water potential sensor were installed. Additionally, a rain gauge and air temperature were installed at instrumentation 1 at Slope 2. The sensor installations photos are presented in Figure 4.16.

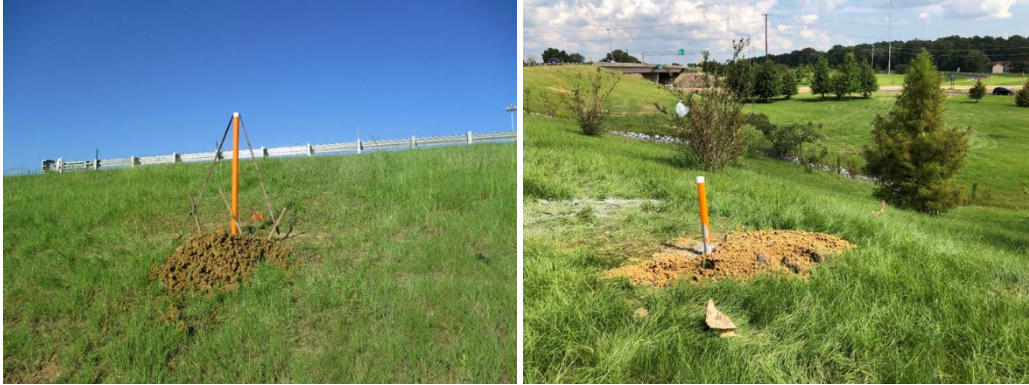
Figure 4.17 Inclinometer casing at Slope 2

The slope inclinometer installation photos are presented in Figure 4.17. The inclinometer 1 is installed at the reinforced section, whereas the inclinometer 2 is installed at the as-built section. Each of the inclinometers were installed in the middle of the slopes.

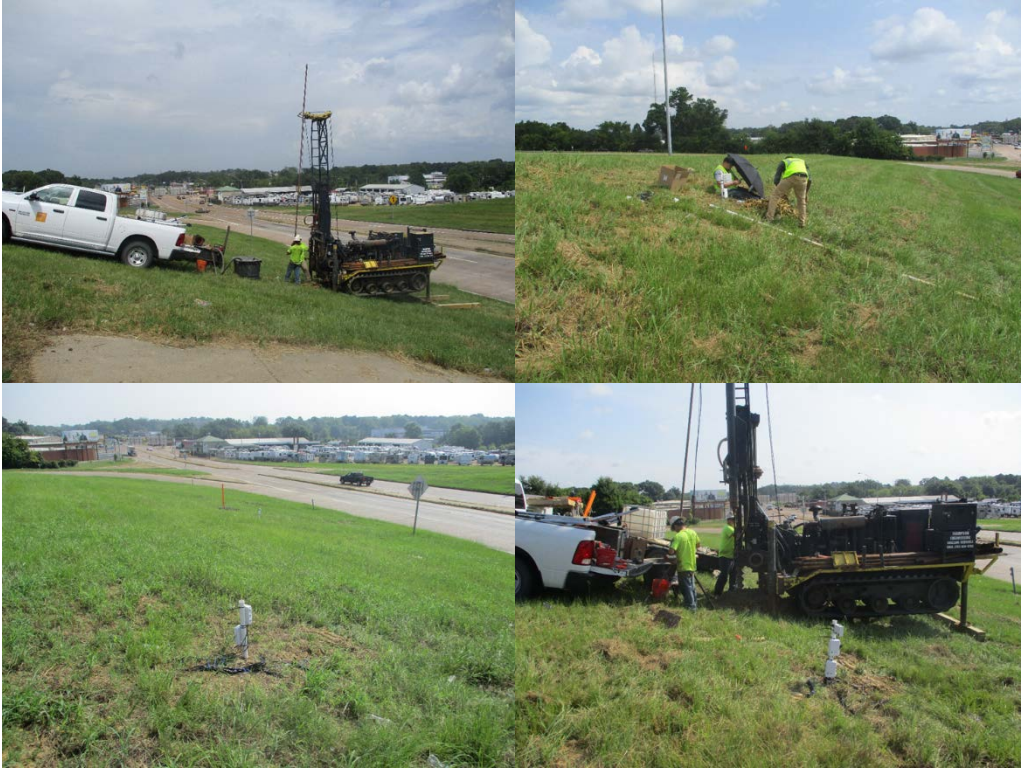
Figure 4.27 Field Instrumentation Activities at Slope 3

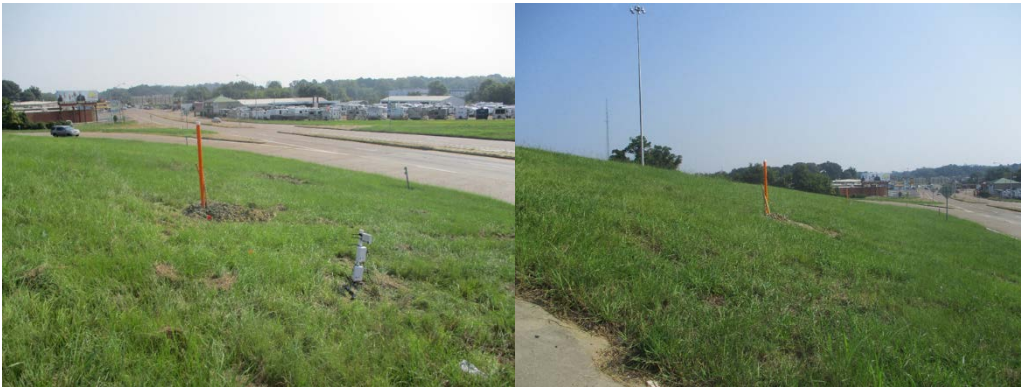
Figure 4.28 Inclinometer casting at Slope 3

The slope inclinometer installations are presented in Figure 4.28. The 30 ft slope inclinometer 1 was installed at the as-built section, whereas, Inclinometer 2 was installed at the repaired section of Slope 3.

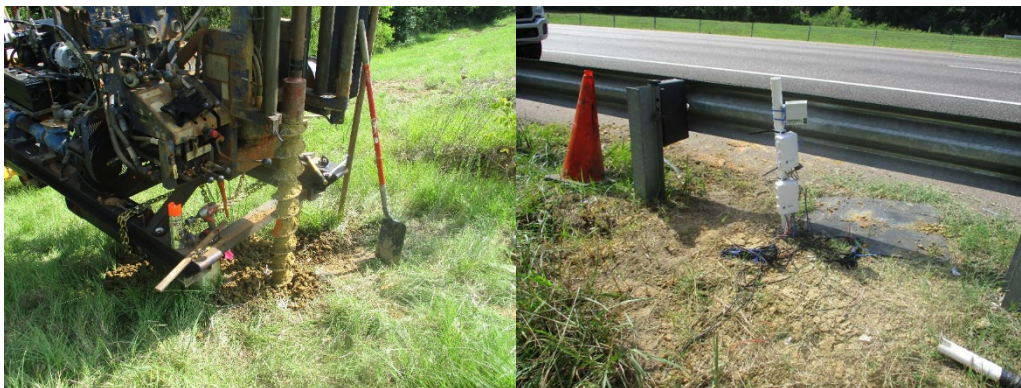
Figure 4.38 Field installation of the sensors at Slope 4

In each of the Instrumentation locations, at 5 ft (1.5 m), 10 ft (3 m), and 15 ft (5 m) depths, a moisture sensor, and a water potential sensor were installed. Additionally, a rain gauge and air temperature were installed near instrumentation 1 at Slope 4. The sensor installations photos are presented in Figure 4.38. The inclinometer installation photos are presented in Figure 4.39. An inclinometer 30 ft. deep was installed at the middle of the slope.

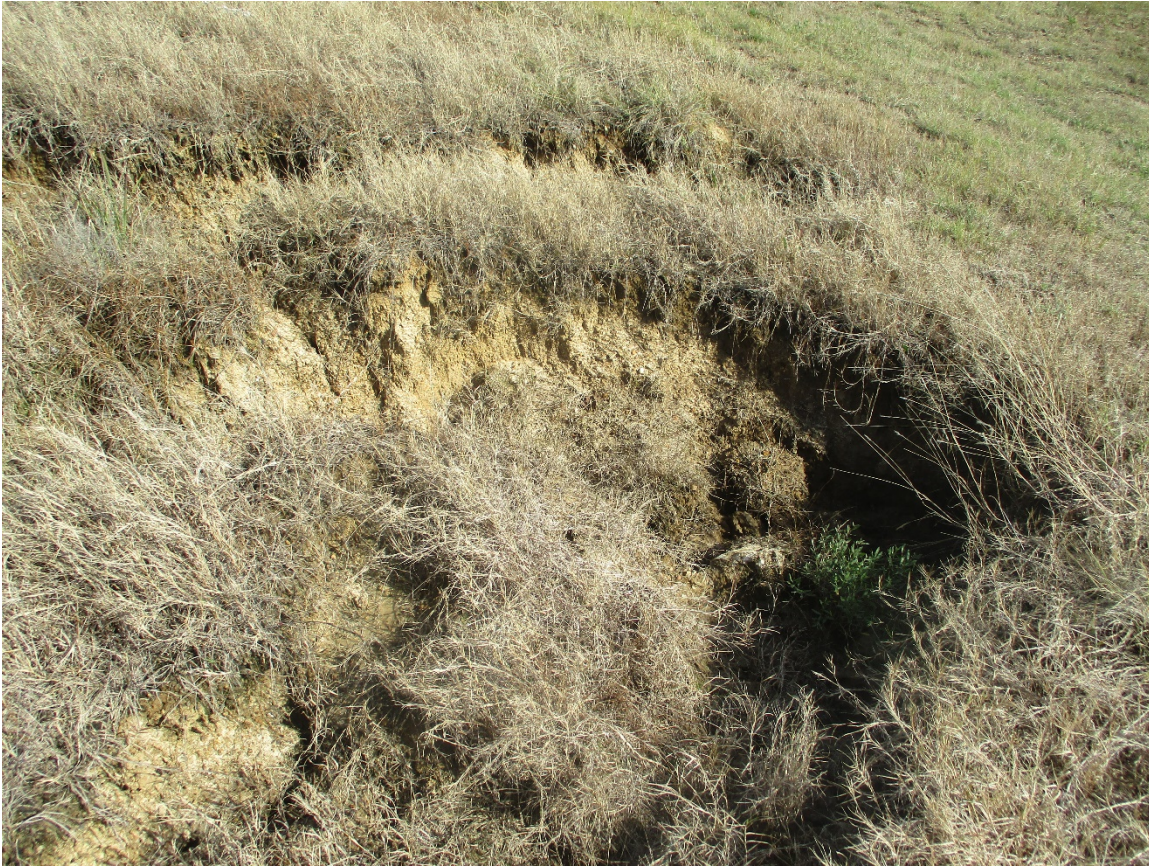
Figure 4.42 Soil Erosion at the slope surface at Slope 4

The horizontal movement data from the slope was observed using slope inclinometer measurements collected at every 2 ft. spacing along the slope inclinometer pipe. The collected inclinometer data was analyzed to determine the slope movement. The horizontal movement data from Inclinometer 1 and time-dependent movement at the surface of the slope is presented in Figures 4.40 and Figure 4.41 respectively. No significant movement was observed that depicts any landslides. However, some movement was observed within the slope from 5 ft. to 10 ft. depth. During the field visit, formation of a void was observed near the inclinometer 1 due to erosion of the slope surface, as presented in Figure 4.42. Some measures are recommended, such as backfill the void with lean clay fill materials.

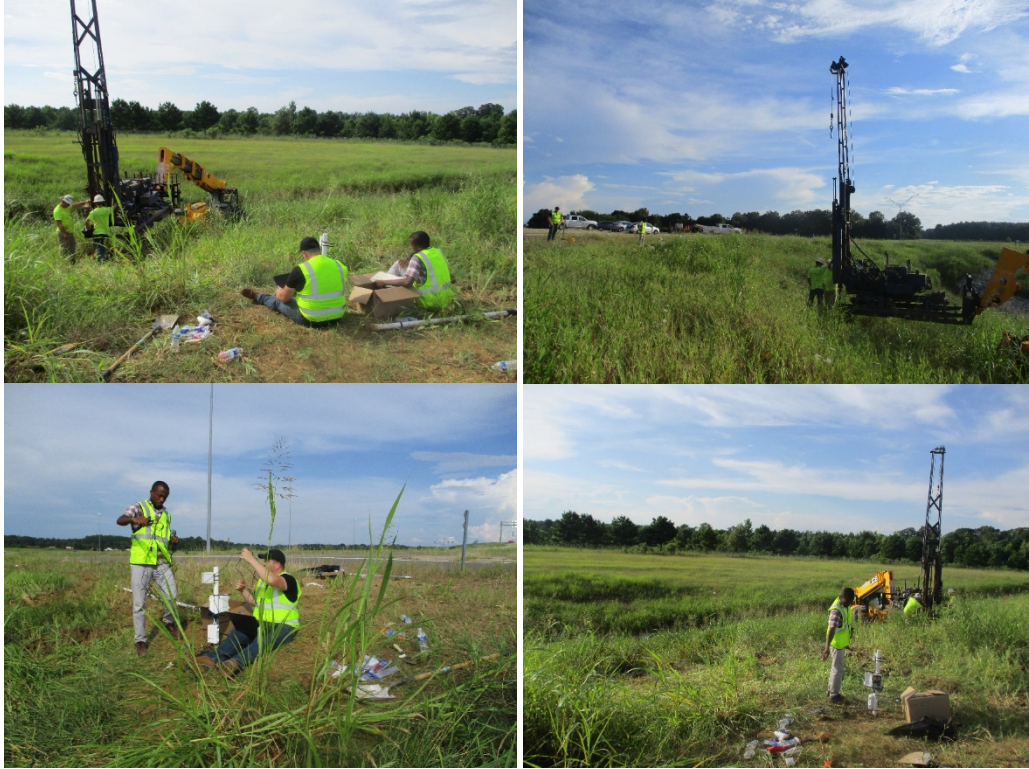
Figure 4.48 Installation of sensors at Slope 5

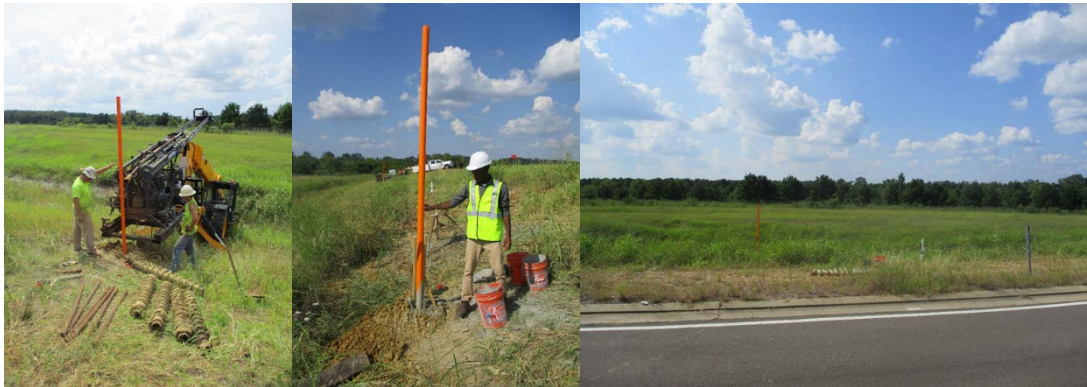
Figure 4.49 Slope 5 slope inclinometer installation

The slope inclinometer installations are presented in Figure 4.49. The inclinometer 1 is installed at the as-built section, whereas the inclinometer 2 is installed at the repair sections. Each of the inclinometer is 30 ft. deep and installed at the middle of the slope.

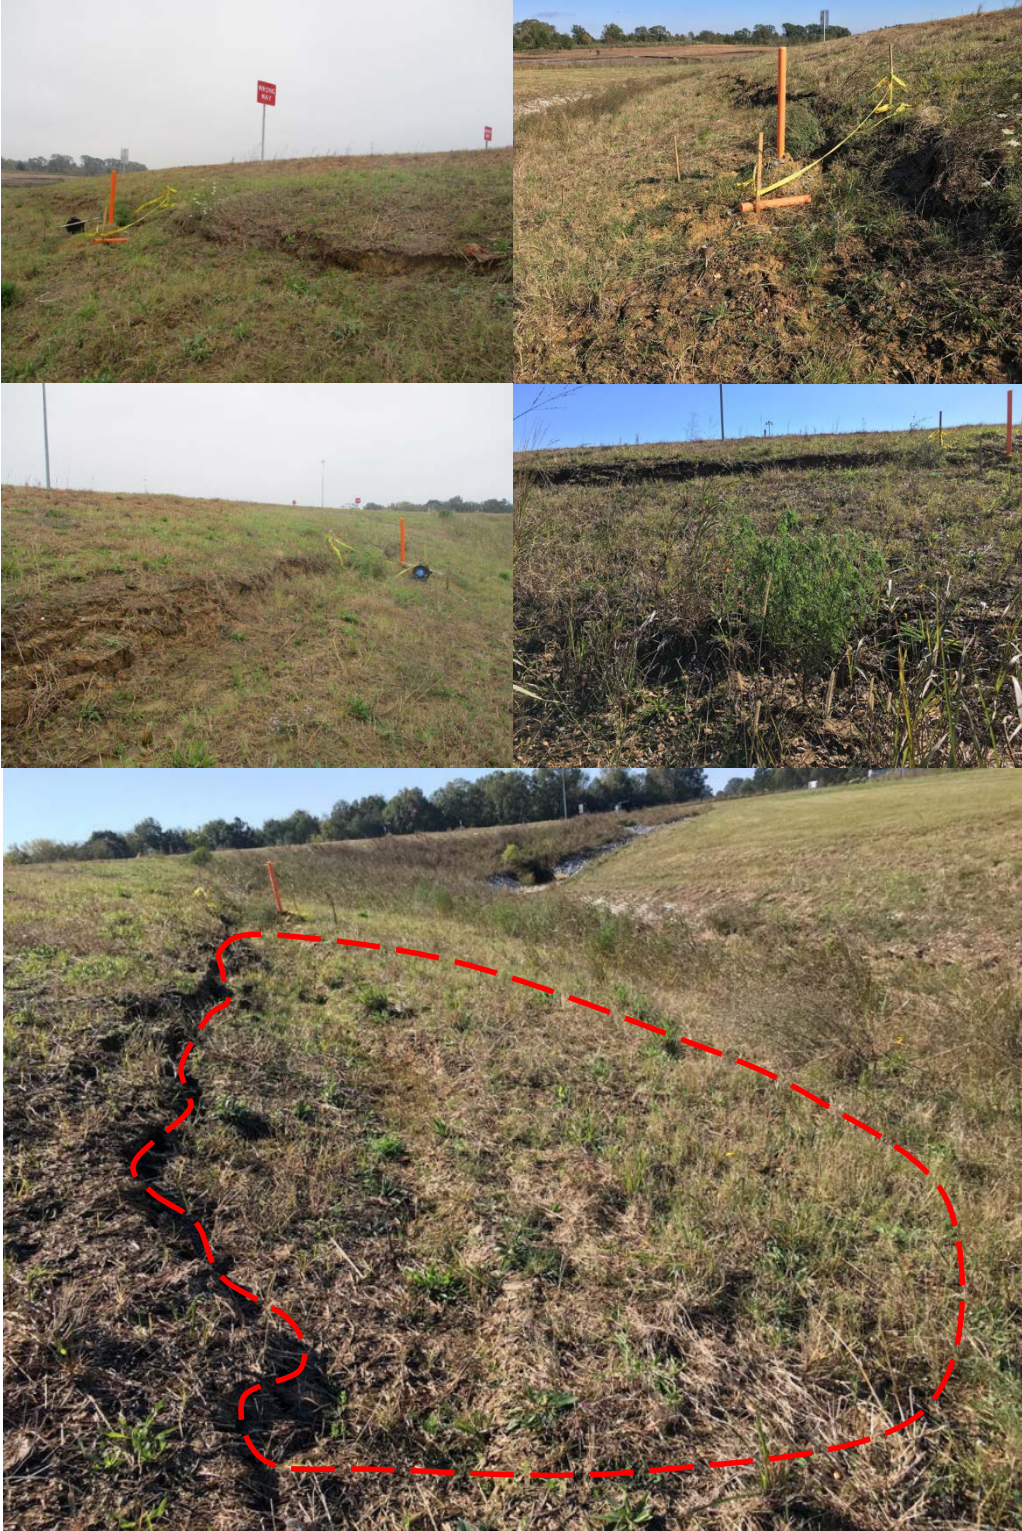
Figure 4.53 Landslides at Slope 5

The horizontal displacement of inclinometer 2 at the repaired section is presented in Figure 4.52. Based on the inclinometer data, a 14 ft. (4.3 m) deep sliding movement was observed during November 2018. The failure photo of the slope is presented in Figure 4.53. It should be noted that the slope was repaired using 30 ft. long HP 14x73 at 3 ft. center to center spacing in the middle of the slope. The HP 14x73 has provided enough resistance at the active part of the slope and resisted any movement of the upper pavement ramp. However, the bottom part of the slope was unreinforced, which experienced the landslides. A detailed analysis of the slope failure was conducted in Finite Element Analysis, which is presented in Chapter 5.

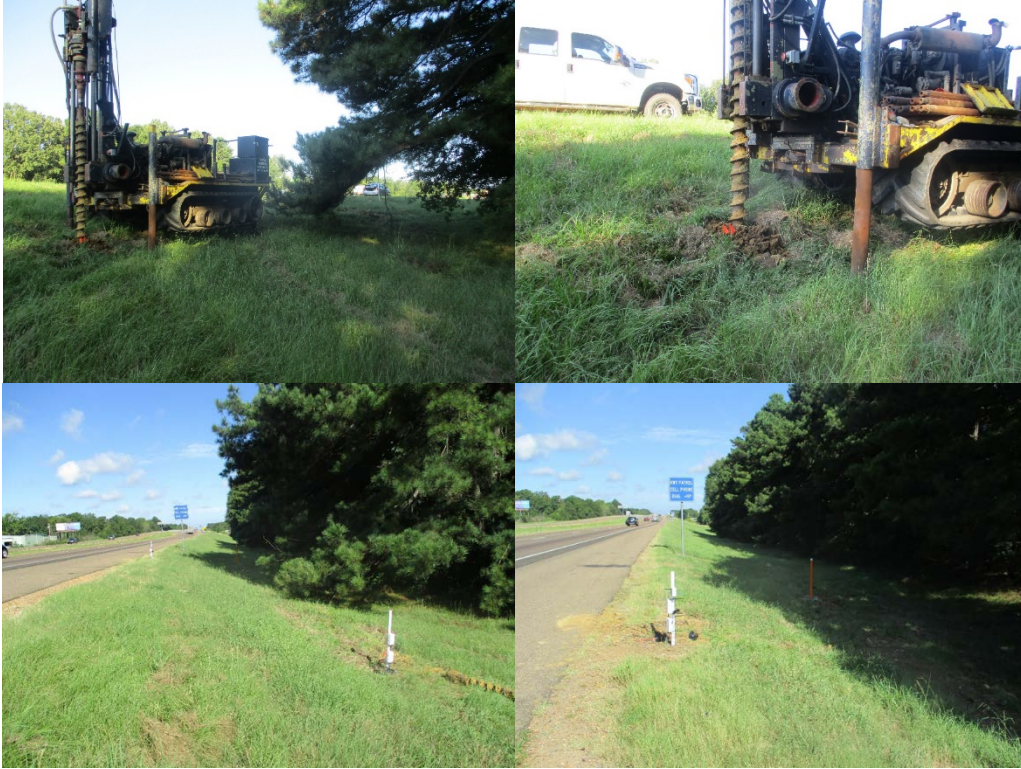
Figure 4.59 Slope 6 sensor installation

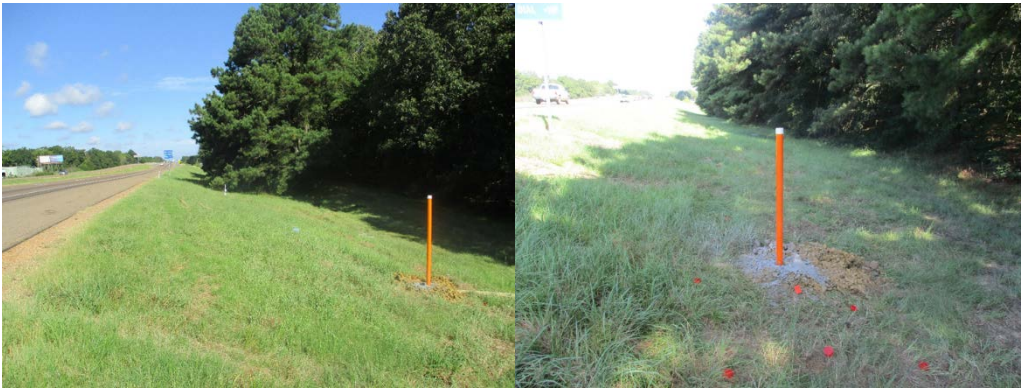
Figure 4.60 Slope 6 slope inclinometer installation

The slope inclinometer installations are presented in Figure 4.60. The 30 ft slope inclinometer 1 was installed at the repaired section, whereas, Inclinometer 2 was installed at the as-built section of Slope 6.
