# ***Louisiana Transportation Research Center***

Final Report 611

## **Evaluating the Effectiveness of Regulatory and Warning Signs on Driver Behavior near Highway/Rail Crossings**

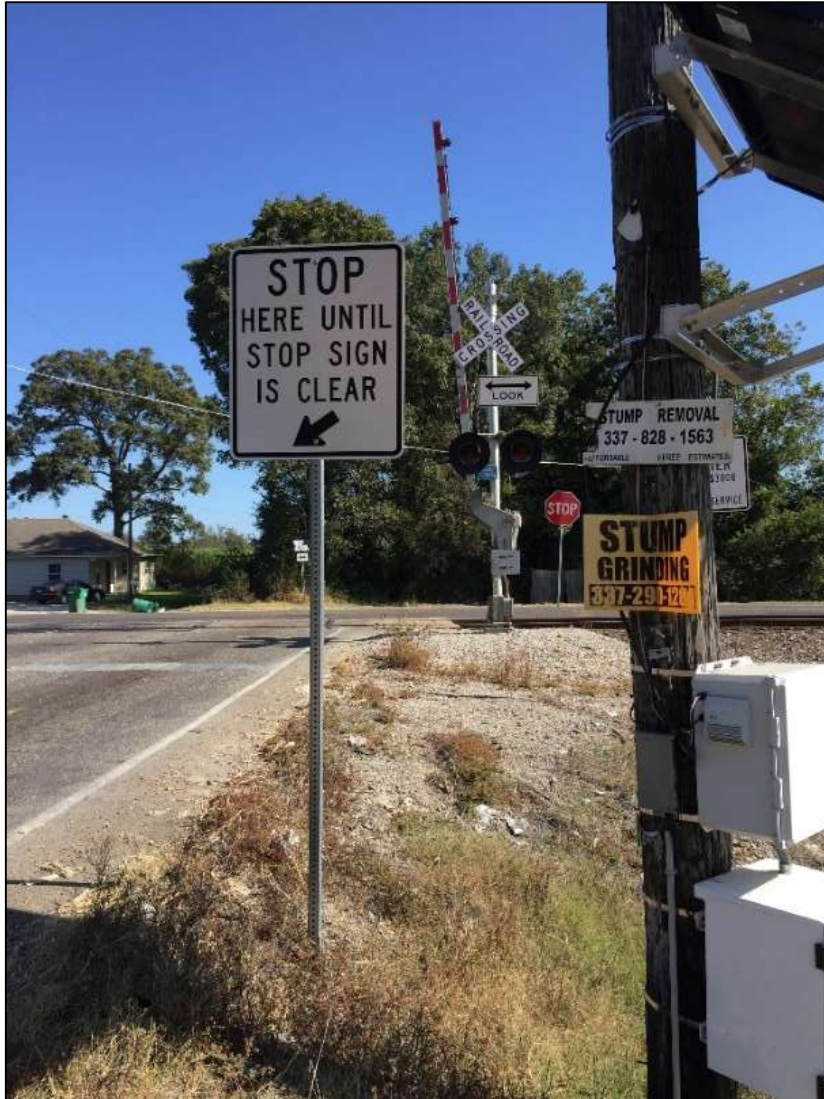
**Figure 2**  
**Regulatory signage installed at Site A**

In July 2016, the DOTD District 3 office conducted a Road Safety Assessment on Site A which involved an extensive study of the site including crash analysis and alternative solutions for reducing the amount of crashes at the grade crossing [16]. This site experienced several fatalities and was subject to legal issues. The study resulted in the recommendation of additional regulatory signage. It was therefore equipped with the R15-8 “Look” sign attached to the gate as well as the less conventional variant of the R8-8, “STOP HERE UNTIL STOP SIGN IS CLEAR” as seen in Figure 2.

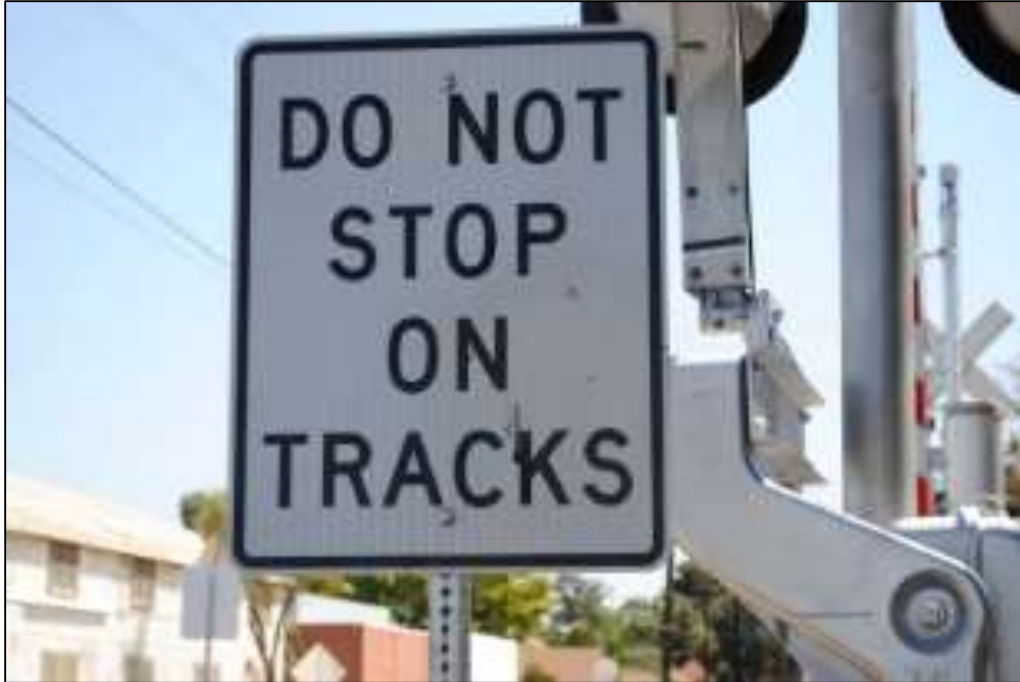
**Figure 3**  
**Regulatory signage installed at Sites B-H**

Sites B to H were equipped with the standard R8-8, “DO NOT STOP ON TRACKS” sign as seen in Figure 3, in both directions of the approaches to the railroad. All sites were initially without any signage.

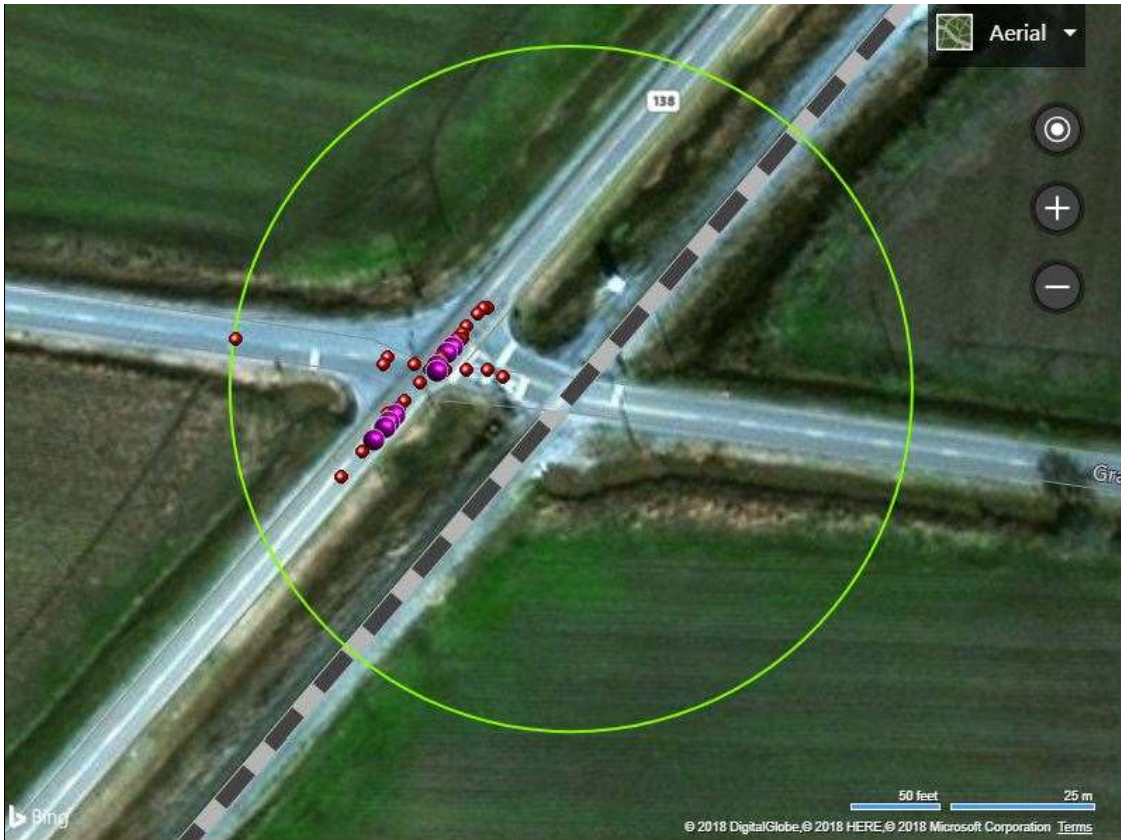
Figure 9  
Aerial view and crashes at Site F

Table 6  
Site F characteristics

Locality	Functional Classification of Roadway (Parallel)	Functional Classification of Roadway (Intersecting)	Angle of Roadway (Degrees)	Number of Tracks	Railroad Company
Rural Four-way Junction (Stop Sign)	Major Collector	Major Collector	62	1	Union Pacific

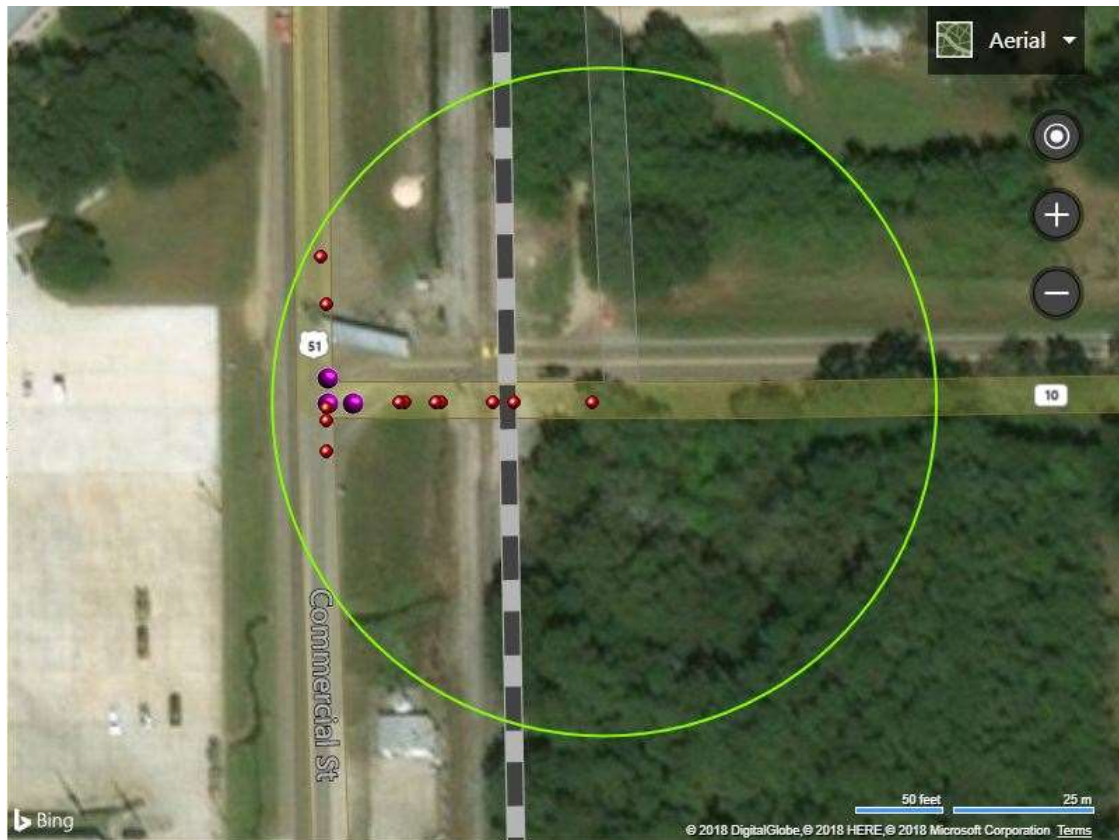
Figure 10  
Aerial view and crashes at Site G

Site G Roseland

Table 7  
Site G characteristics

Locality	Functional Classification of Roadway (Parallel)	Functional Classification of Roadway (Intersecting)	Angle of Roadway (Degrees)	Number of Tracks	Railroad Company
Rural Three-way Junction (Stop Sign)	Minor Arterial	Major Collector	88	1	Canadian National

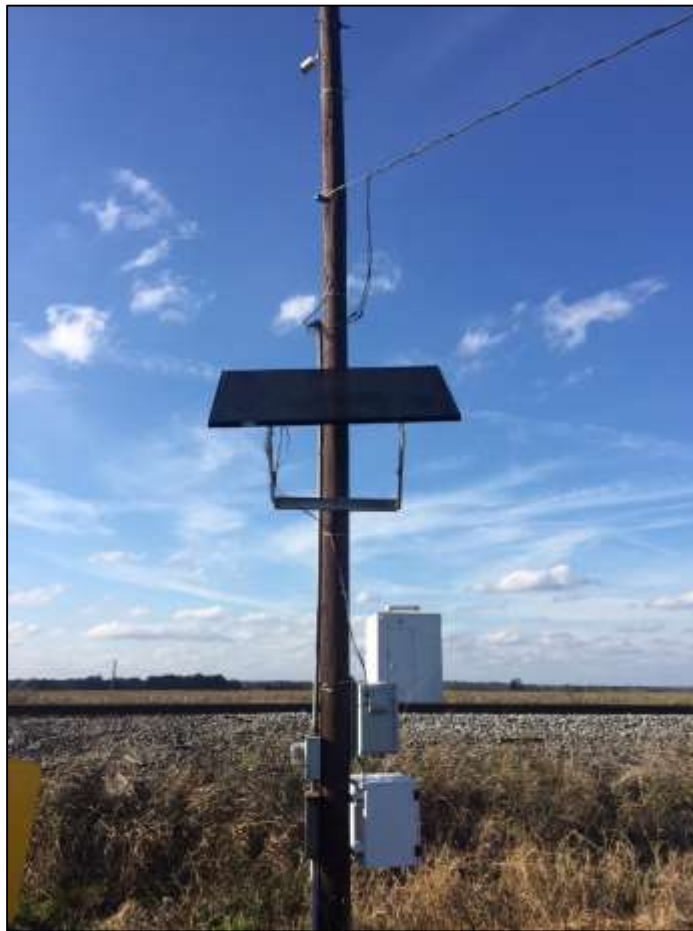
**Figure 12**  
**DETEL apparatus**

Collectively, DETEL Computer Solutions and DETEL Communications is a Louisiana-based company that provides technological products and services for a wide range of businesses [17]. The camera systems from DETEL are typically used for security purposes and this was the first time that the company's products were used for a traffic study as specific as this one. As a result, the system required extra work for adaptation to continuous filming and traffic monitoring. Installation required DOTD district personnel and effort by professionals, including an electrician with an elevated bucket. The camera system is powered by a 200 W solar panel. Figure 12 shows the equipment used for the system, which was attached to a nearby utility pole.

The camera is a 2 megapixels (MP) Starlight IP Intelligent Bullet Camera that can record in both daytime and nighttime conditions. The footage is recorded in a high resolution and compatible with image processing software. Hardware storage requires more space due to

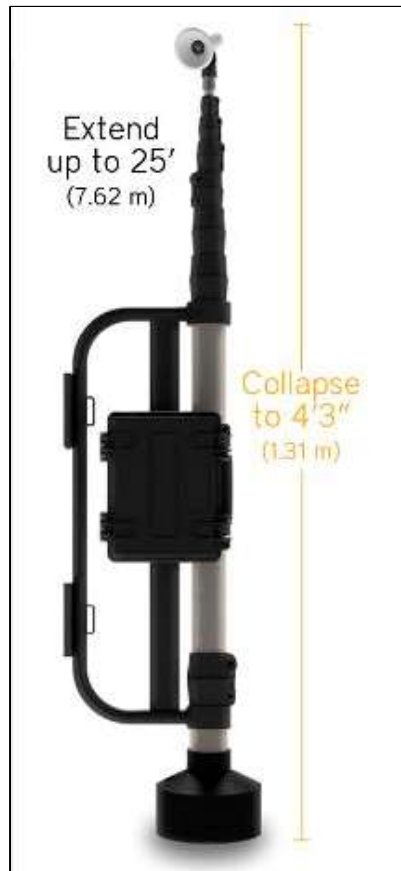
**Figure 13**  
**Miovision apparatus**

Miovision is a well-known Canadian company in transportation engineering that focuses on traffic operations, traffic data, and smart cities solutions [18]. The installation for the system is easy and does not require professional installation or special software to review the footage. Minimal space is necessary to store the equipment shown in Figure 13.

The system utilizes the Scout camera which records at 30 fps and at a 720 x 480 resolution. The video footage is saved in MP4 format and can be viewed in most media players such as Windows Media Player or VLC. The camera stores two SD cards (max of 64 gigabytes (GB) each) worth of data and the battery lasts up to seven days. The system requires minimal

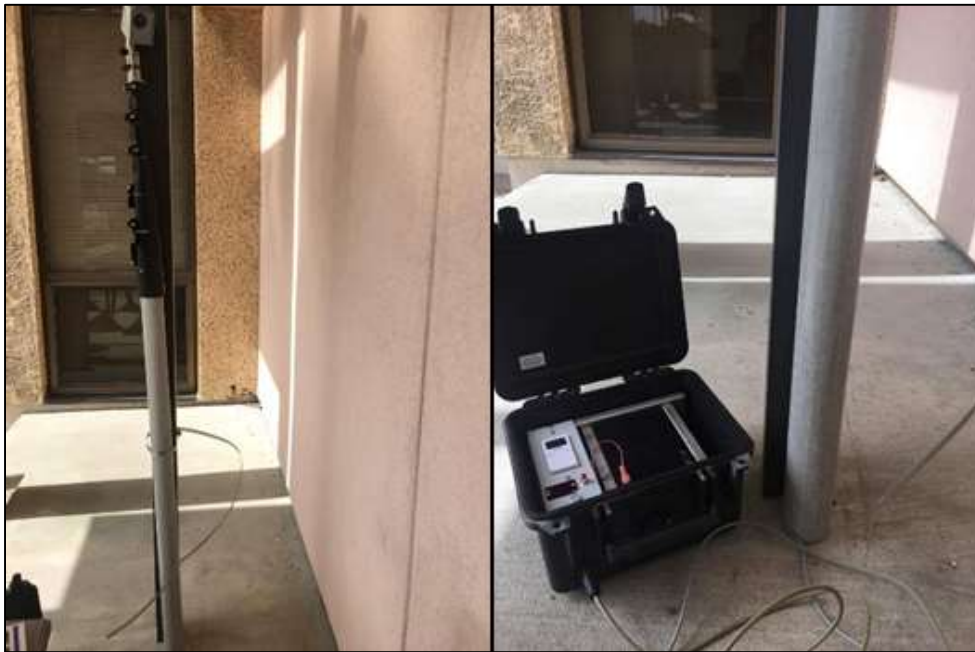
**Figure 14**  
**Jamar Technologies apparatus**

JAMAR Technologies, Inc. offers a large selection of products for traffic data collection [19]. The JAMAR Portable Video Camera System installation does not require professional effort and can be set up with two workers at most. The camera has built in Wi-Fi for remote setup and viewing wirelessly. The system, shown in Figure 14, also includes the TDC-Ultra, a turning movement counter, and the companion data processing software PetraPro.

The system has a 64GB memory capacity for each filming period and can capture approximately two days of continuous footage with a standard resolution of 640 x 480 pixels and four to nine hours with highest resolution at 1920 x 1080 pixels. The footage is saved in an MP4 format onto a micro SD card (max 64 GB), making data transfer easy. The PetraPro allows for exporting data into an excel format along with a number of other formats. Minimal space is needed for storage and minimal maintenance is required. The camera is battery operated with the option to add an external battery for increased recording time. A battery and a 64 GB SD card will last two days at most when continuously filming with a standard resolution. This system also includes settings for a filming schedule to prolong the battery life.

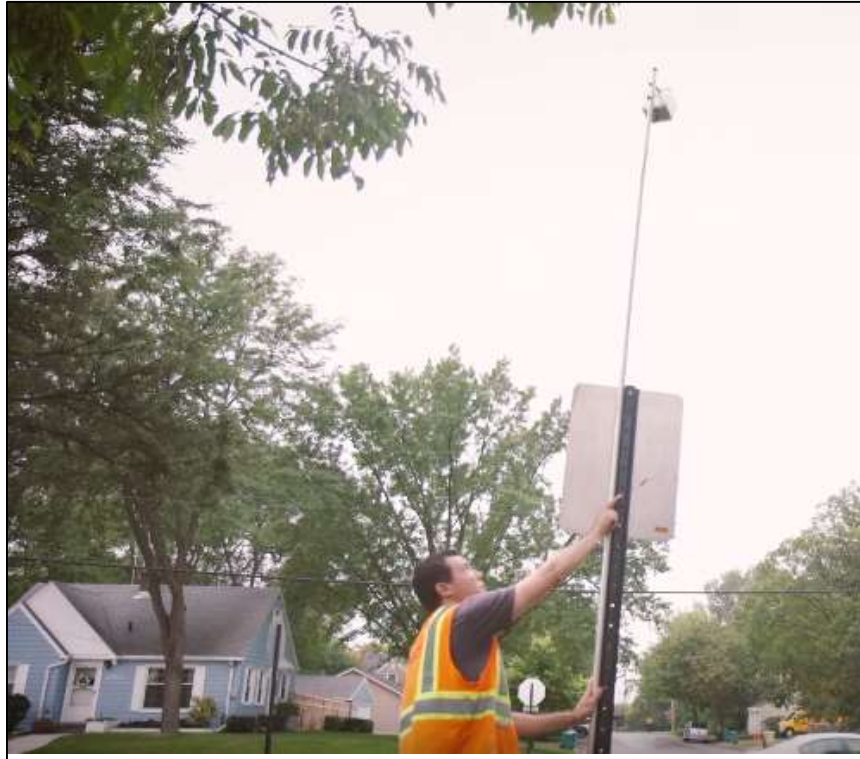
**Figure 15**  
**Counting Cars apparatus**

Counting Cars is an American manufacturer and maintains an online store for transportation data collection equipment [20]. Installation is easy, but does require some tools and hardware. As shown in Figure 15, the camera angle and footage can be viewed on site. In addition, the system uses a 64 GB SD card which makes data transferring the data efficient.

The quality of footage is a lower compared to the other systems in terms of standard resolution, which is 640 x 480 pixels, and might not be compatible with image processing data. “COUNTpro” software exports data directly to Excel and Petra Pro file formats and generates its own detailed PDF reports. “COUNTpad2” allows for easy interaction with footage. Minimal parts make storage easy and the maintenance involves storage and battery exchange approximately every 12 days.

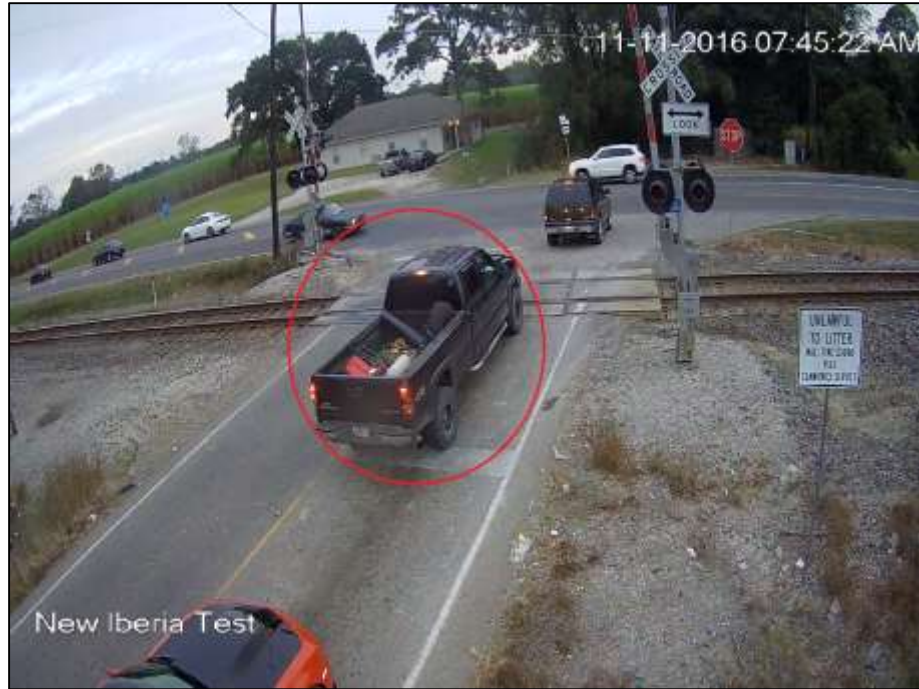
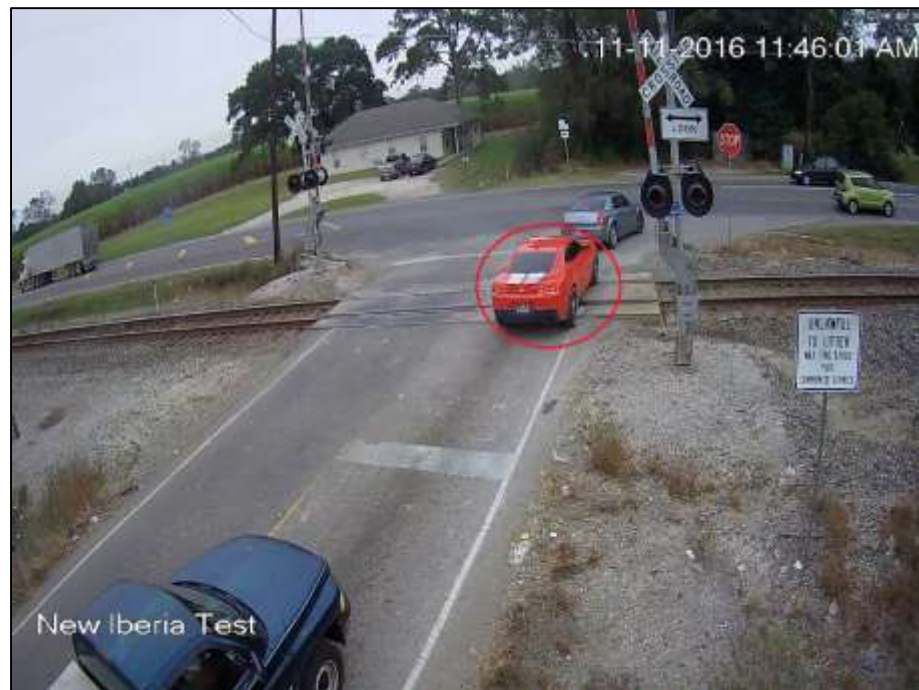
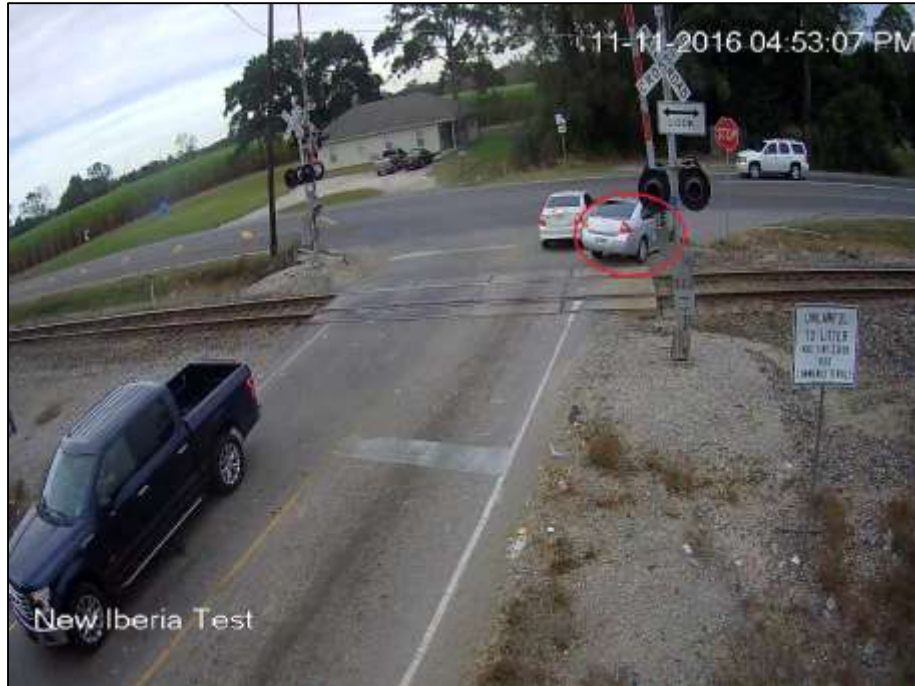
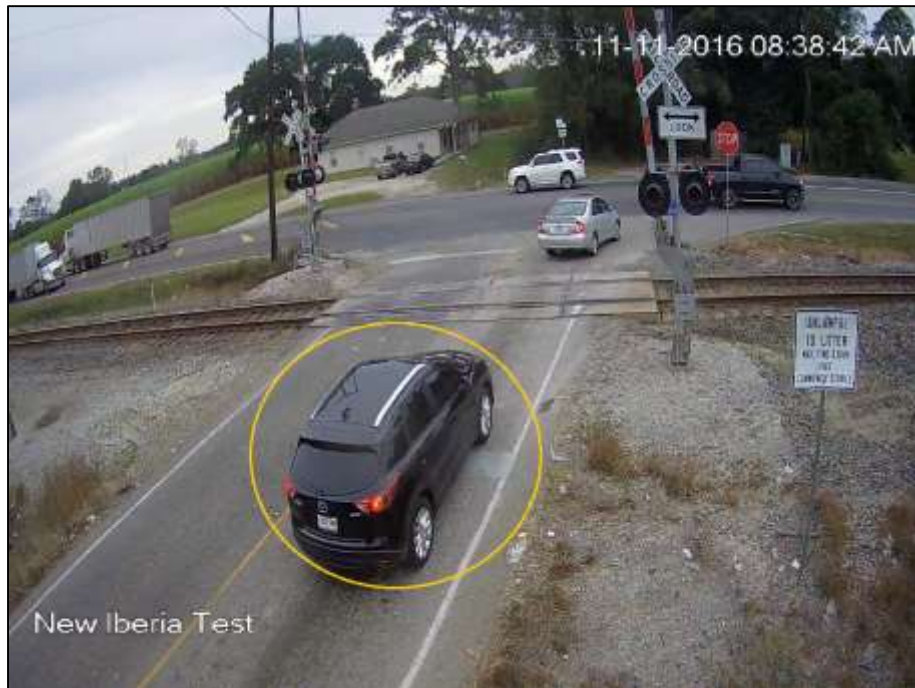
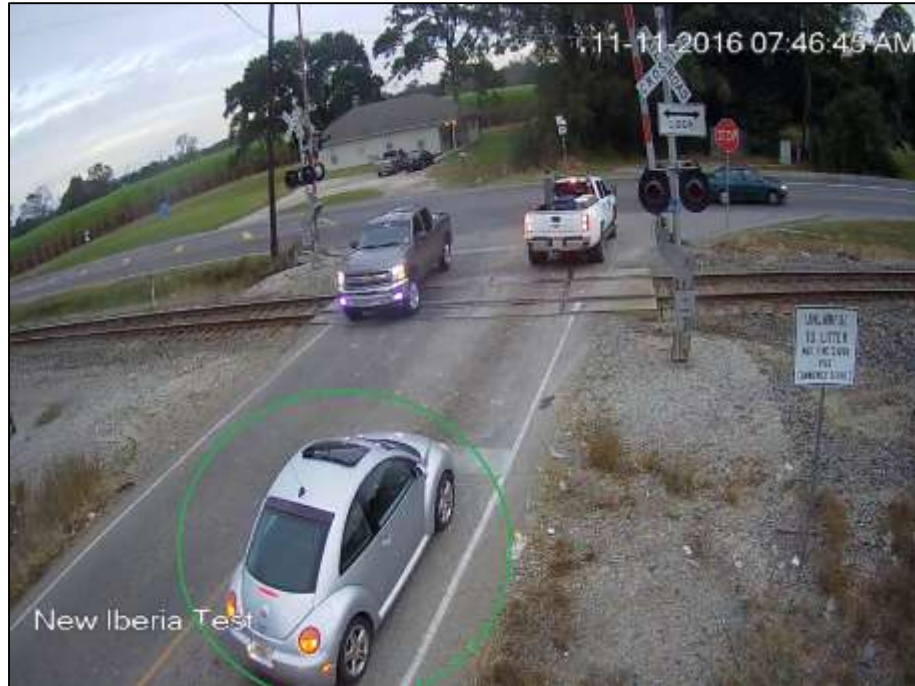
categories for defining LOC, including two violations and safe maneuver that were observed and documented as undertaken in several previous studies [5], [11], [13]. Any form of stopping within the DEZ was considered to be a major violation and observed as “Prior to Tracks,” “On Tracks,” or “After Tracks.” Minor violations occurred if a vehicle did not stop at the stop line or performed a rolling stop with the presence of a vehicle queue. The driver behavior at the stop line was observed as “Stop,” “Doesn’t Stop,” and “Rolling Stop.” Table 12 summarizes each category of the LOC parameter and Figures 18 to 22 show visual examples of each LOC category. A safe maneuver occurred when the vehicle stopped before the stop line with a queue and waited for the area between the intersection and the tracks to become clear. If there were no queue present then it was not necessary for the vehicle to stop at the stop line, therefore a “Doesn’t Stop” or “Rolling Stop” with no vehicle queue was observed as a safe maneuver. The following section discusses the parameters that were used for the analysis of factors that correlate to unsafe driver behavior and to better understand the sites that experienced an increase in unsafe driving behavior.

<b>Category</b>	<b>Description</b>	
<b>Major Violation</b>	Vehicle stops completely within the DEZ.	Before Tracks
		On Tracks
		After Tracks
<b>Minor Violation</b>	Vehicle does not stop within the DEZ, or does not stop at the stop line, or performs a rolling stop with a vehicle queue.	Stop
		Doesn’t Stop
		Rolling Stop
<b>Safe Maneuver</b>	Vehicle stops before the stop line with a queue and waits for the area between the intersection and the tracks to become clear. (If there was no queue present then it was not necessary for the vehicle to stop at the stop line, therefore a “Doesn’t Stop” or “Rolling Stop” with no vehicle queue was observed as a safe maneuver)

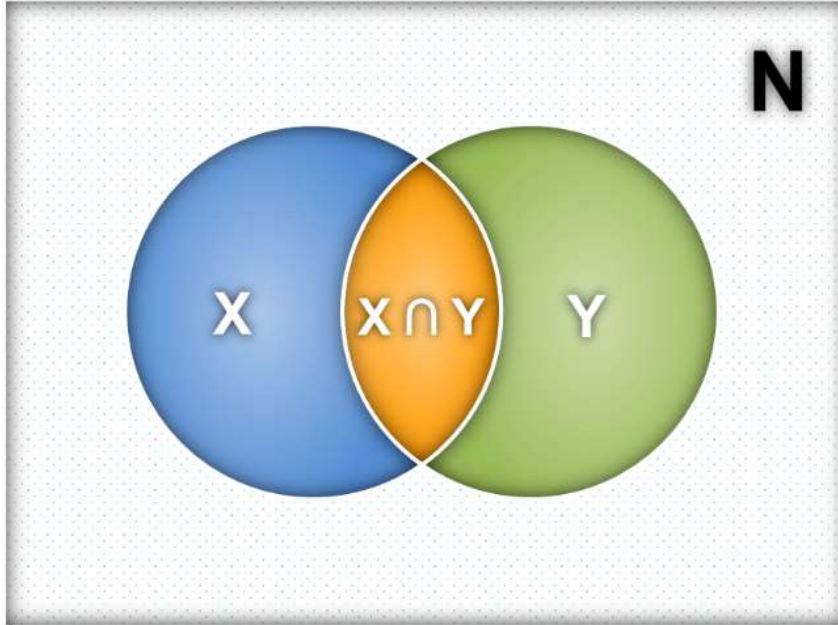
**Figure 23**  
**Venn-diagram representing MBA metrics**

As the dimensionality or number of variables in data increases, tracking associations between parameters using contingency tables becomes overwhelmingly tedious and inefficient. The MBA extracts rules that identify associations among a set of variables within given data and is a more generalized tool for looking through all the possible associations in order to identify those that are meaningful. Marketers normally use this type of analysis for identifying the items or set of goods a customer prefers to buy jointly and more frequently through the investigation of transactions. The “A Priori” algorithm is most commonly used for this analysis and comes from the concept that the frequency of subsets of any item set is dependent on the frequency of that set [22]. The algorithm implements this concept in the form of a pruning technique that trims the exponential search space for candidate rules. In general, the MBA implements three metrics to evaluate the item sets of extracted rules, namely, the “Support,” “Confidence,” and “Lift.” These metrics are presented in the Venn diagram illustrated in Figure 23, where the area of the rectangle N is the set of all observations.

The three metrics represent the frequency, strength, and interest of a particular association rule. A rule of length two is defined as “ $X \rightarrow Y$ ” consisting of an antecedent (LHS) and a consequent (RHS). The length of the rule can also be three or more, as in “ $X_1, X_2, X_i \rightarrow Y$ .” It is important to note that the MBA does not indicate a cause and effect relationship, but simply investigates associations between specific parameters or combinations of parameters. Accordingly, the rule “ $X \rightarrow Y$ ” is assumed to have the same meaning in reversed order [23]. Since the MBA does not suggest this type of relationship, both rules including parameter “X” in the LHS or the RHS are useful. Therefore, many useful rules are repeated with reversed LHS and RHS.

The Support represents how frequently an association rule occurs. It is determined by taking the number observations of parameters X and Y occurring together and dividing that value by the number of total observations. It essentially represents the percentage of a specific rule occurring and is represented as the orange area in Figure 23 divided by the area of the rectangle. The higher the support value, the more frequently a rule of the LHS and RHS occurs. The following equation defines the Support:

The Confidence acts as the strength or reliability measure of a specific association rule by representing its conditional probability. As seen in Figure 23, the Confidence of a rule is represented as the percentage of summing both the blue and orange areas. It determines how often a rule occurs when parameter X occurs. The Confidence is calculated by equation (5):
