**Quantifying Pile Rebound with Deflection Measuring Systems  
Best Suited for Florida Soils**

**FDOT Contract BDV-28 977-07  
Final Report**

*May 15, 2020*

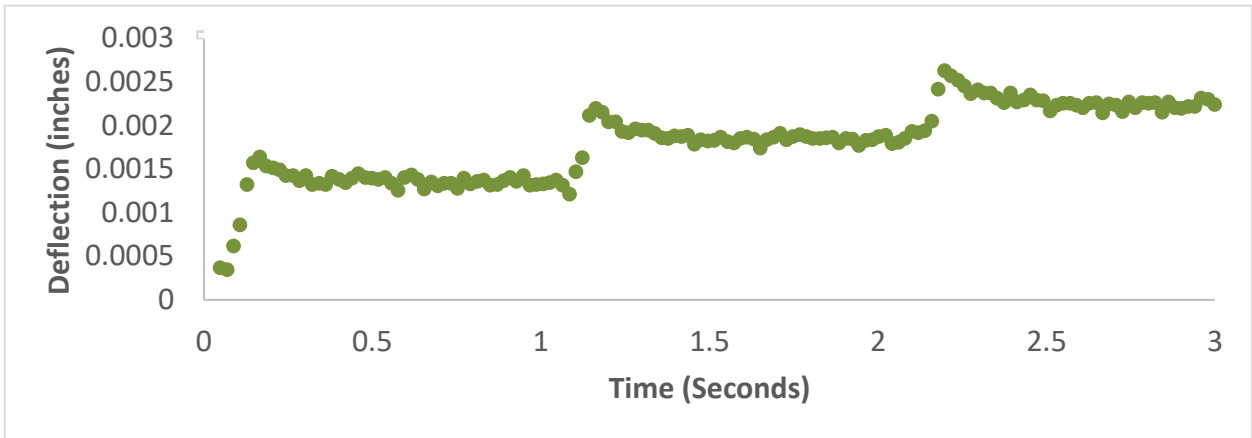
During BDV-28-977-01, 30 sets of cyclic triaxial tests were conducted with 1000 cycles at eight stress levels ranging from 10% to 80% of the static failure stress. The following figures depict cyclic results. Both Figure 1-4 and Figure 1-5 show deflection versus time data while Figure 1-6 shows load versus time data that corresponds to both deflection-time plots. The data in Figure 1-4 is from a site with excessive rebound and the data in Figure 1-5 is from a site without rebound. Note that the Figure 1-4 rebound data shows an increase in deflection as the load is applied, followed by a decrease that does not return to near the original value. For the non-rebound site (Figure 1-5), the deflections increase as the load is applied then decrease to nearly the original deflection. The small, or more properly slow, decrease in deflection following loading for the rebound (i.e., viscoelastic) Florida soil corresponded to rebounds in excess of  $\frac{3}{4}$ -inch, while the large or faster decrease in deflection corresponds to minimal rebound.

Figure 1-4 Three Deflection versus Time Cycles: Ramsey Branch at 63 feet

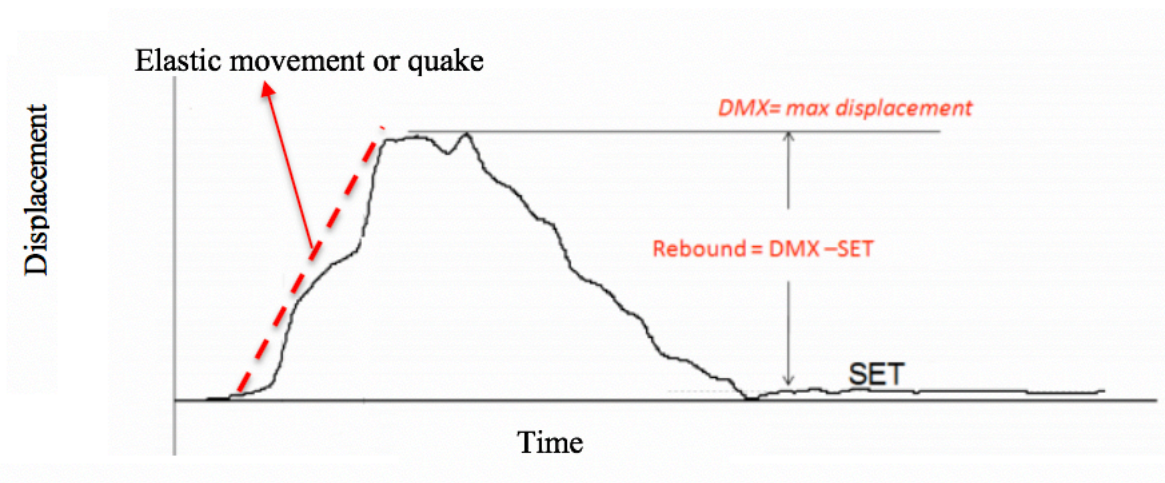
A displacement versus time signal from a PDA test pile experiencing rebound is shown in Figure 2-1. Rebound is obtained by subtracting the set from the maximum pile top displacement (DMX), as illustrated in Figure 2-1 (Cosentino et al., 2010). Note that the initial slope, which is when the hammer contacts the pile, shows a relatively fast displacement-time movement, which from an engineering viewpoint would be considered elastic. However, the displacement-time slope after impact is slower, indicating a more time-dependent or visco-elastic response.

Figure 2-1 Pile Rebound from PDA Displacement-Time Data (Cosentino et al., 2010; Courtesy of GRL Engineers, Inc., adapted)

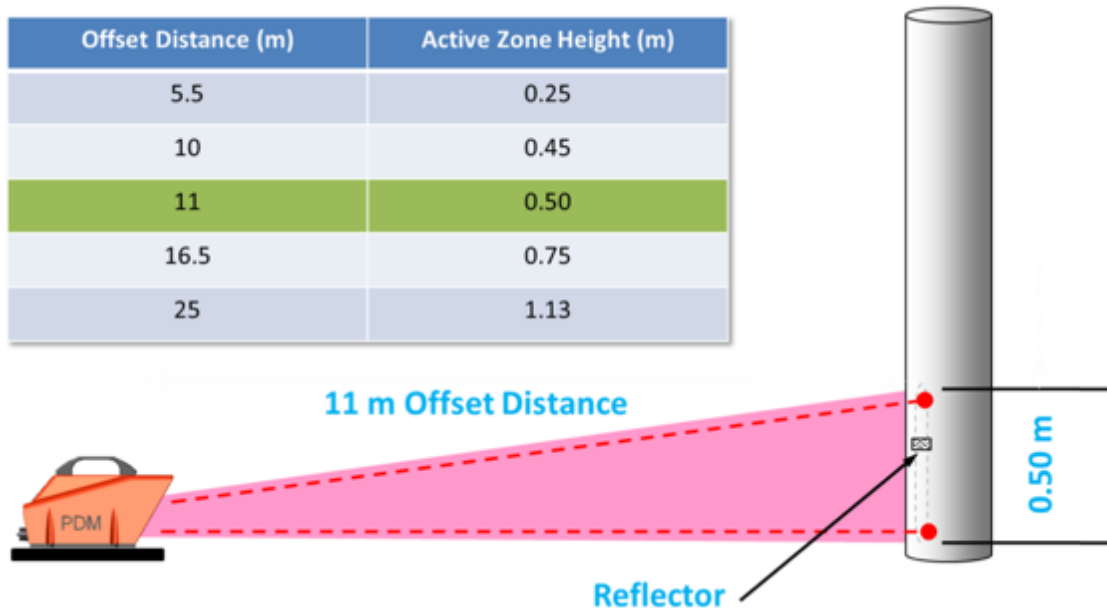
The Inopile Pile Driving Monitor (PDM) uses LED opto-electronic technology to measure pile set and temporary compression as well as calculate peak pile velocity (Look et. al 2015a). PDM measurements involve placing a reflector on the pile (Look et. al 2015b). The PDM is recommended for placement about 30 to 45 feet (10-15 m) from the pile. It allows for a greater degree of safety than other methods as operators can conduct measurements from a safe distance away from the pile driving hammer that avoids the risk of being hit by falling parts, broken cushions or spalling concrete above (Look and Seidel, 2015). The PDM has a vertical field of view of 1.5 ft (0.45 m) at 32 ft (10 m) range. This field of view varies marginally with range as illustrated in Figure 2-7 (Look et. al, 2015a). PDM sampling at 240Hz (Look et. al 2015b) yields an accuracy of 0.004-inch (0.1mm) at 32 ft (10m) (Look and Seidel, 2015).

Figure 2-7: Illustration of the relationship between offset distance and active zone height for PDM (reprinted from Look et. al, 2015a)

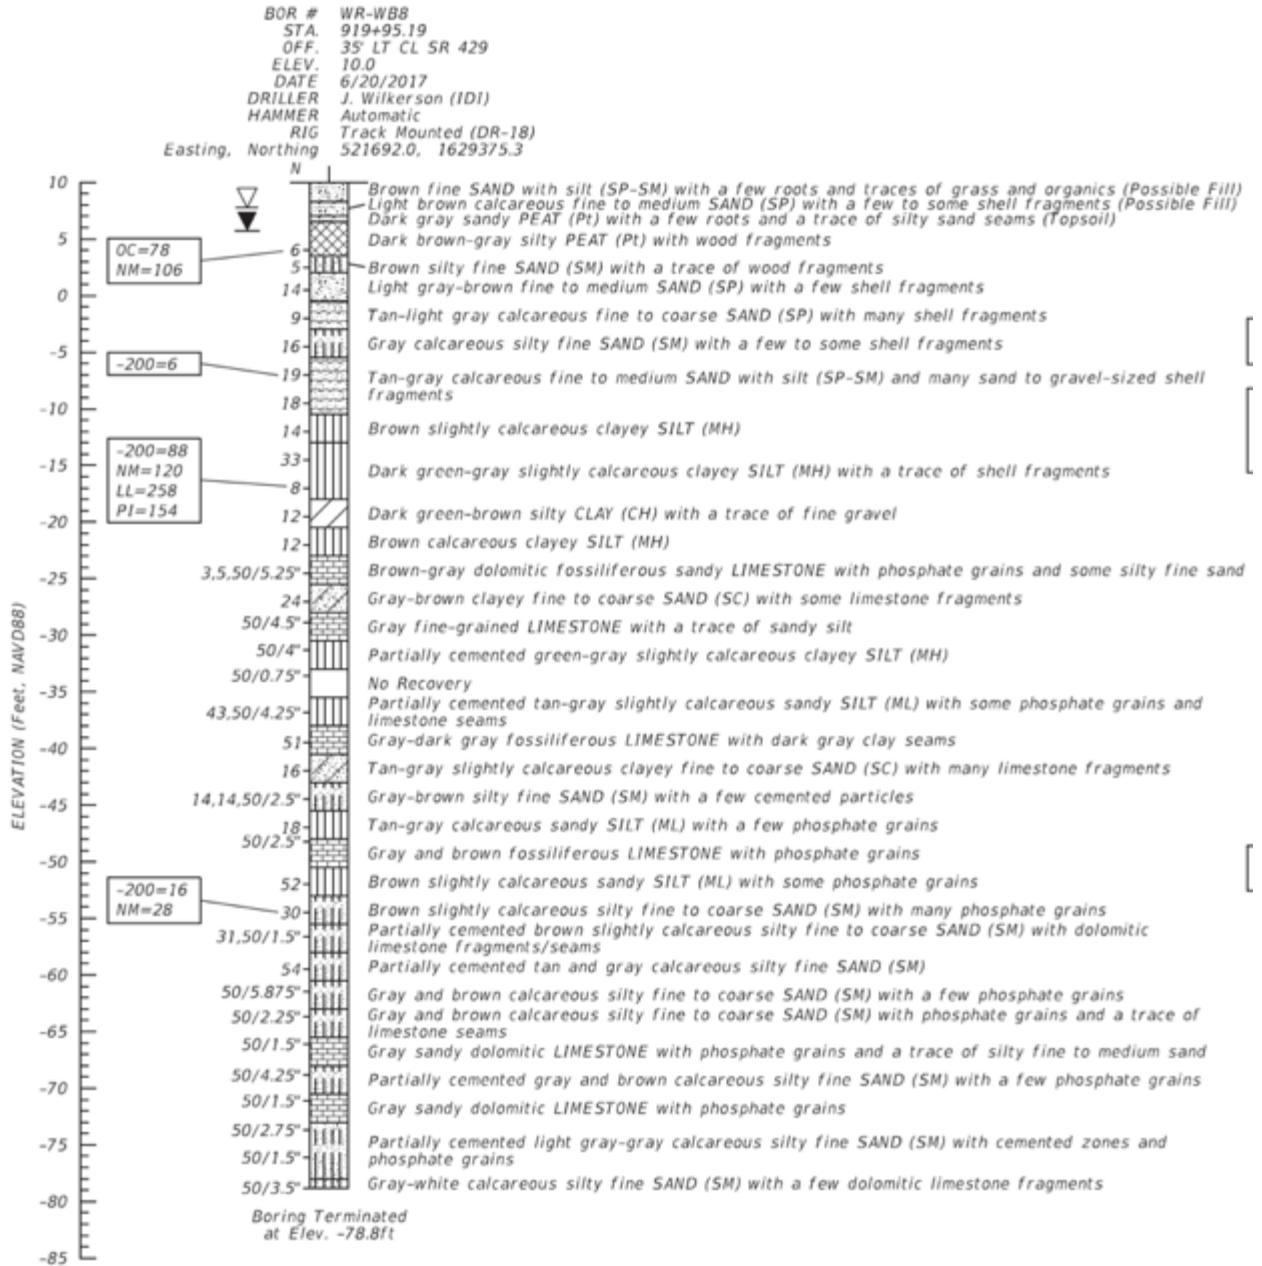
Figure 3-24 Wekiva Bridge 110118 Test Boring WR-WB8 at Station 919+95.19

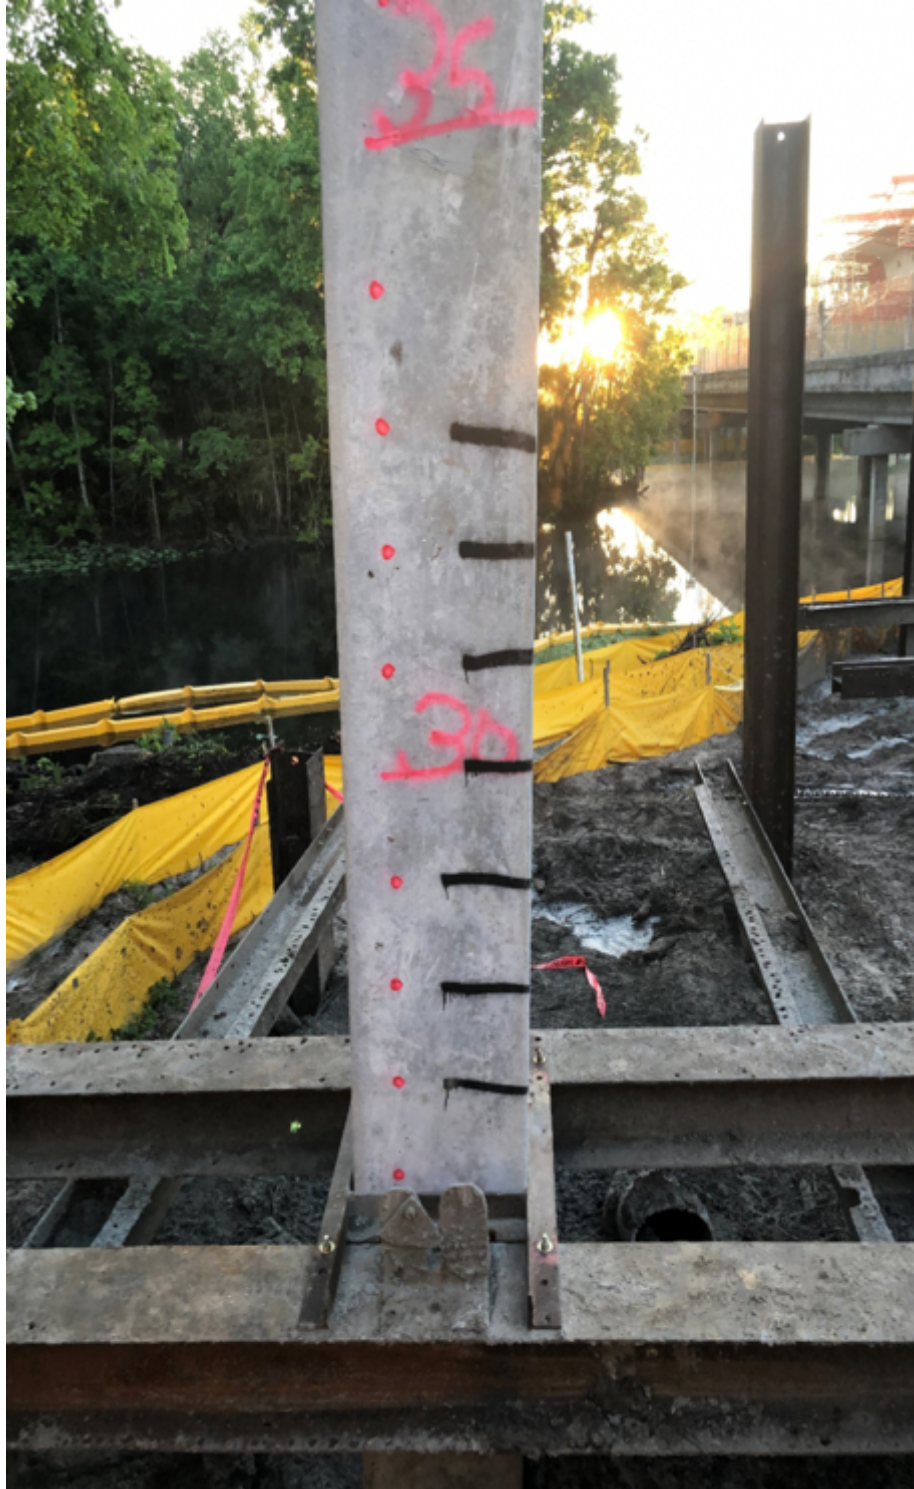
Figure 3-25 Photo of Wekiva Bridge 110118 Pier 8, Test Pile 1 with black paint for CMS Evaluation

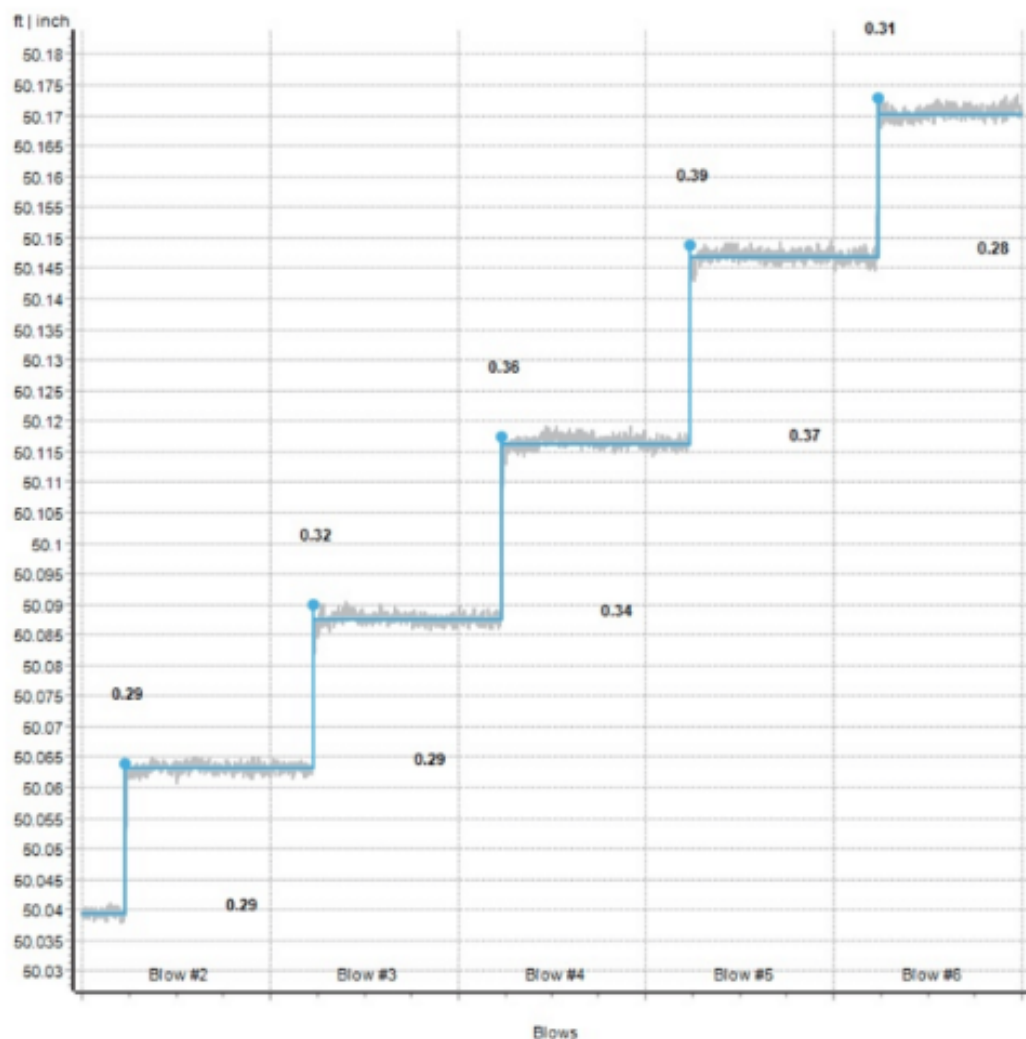
Figure 4-7 Example of High-quality PDM Data

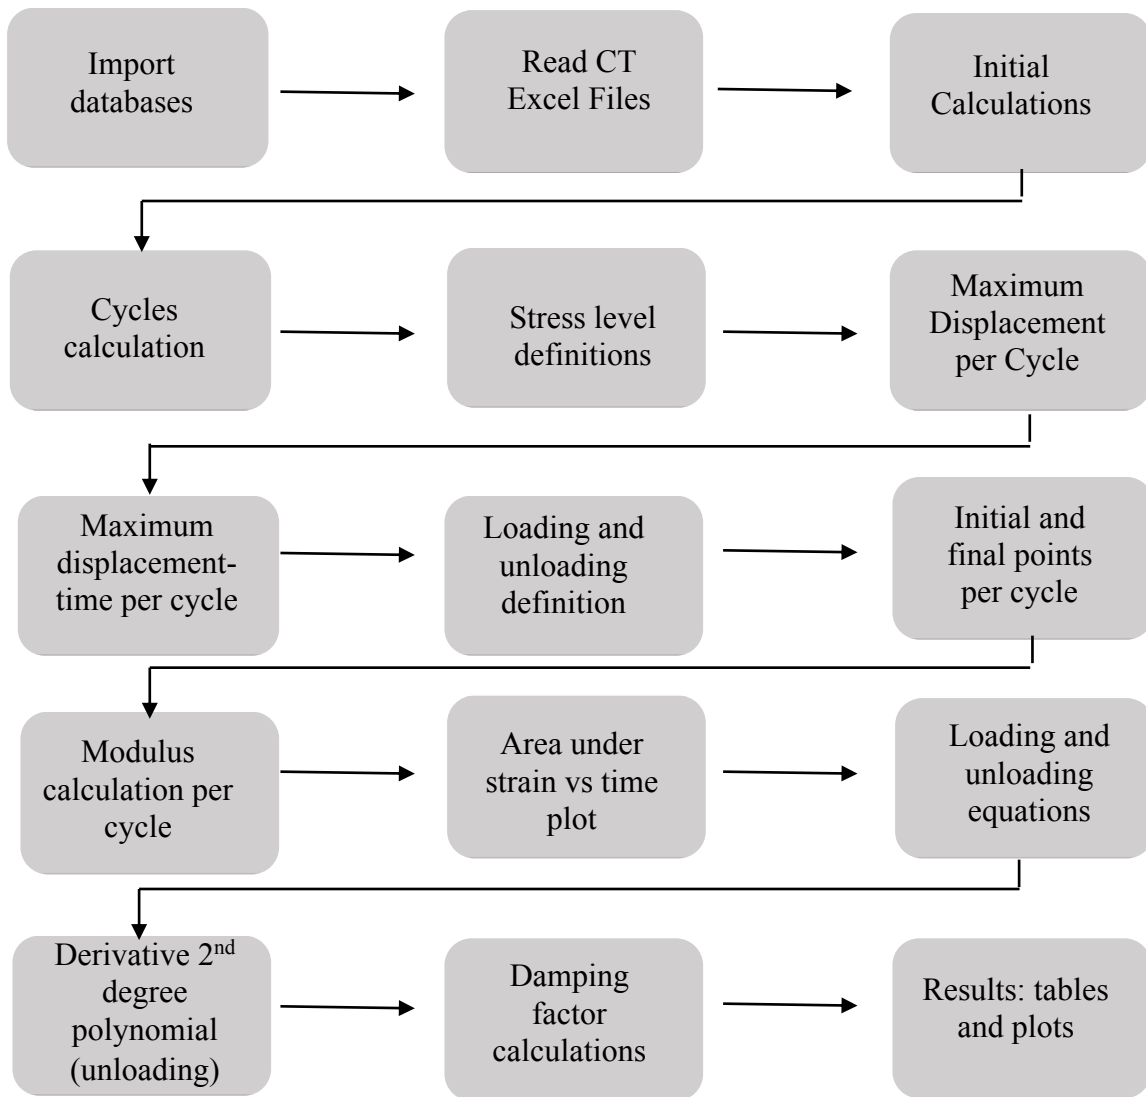
Figure 5-1 Python™ CT Data Analysis Programming Flow Chart

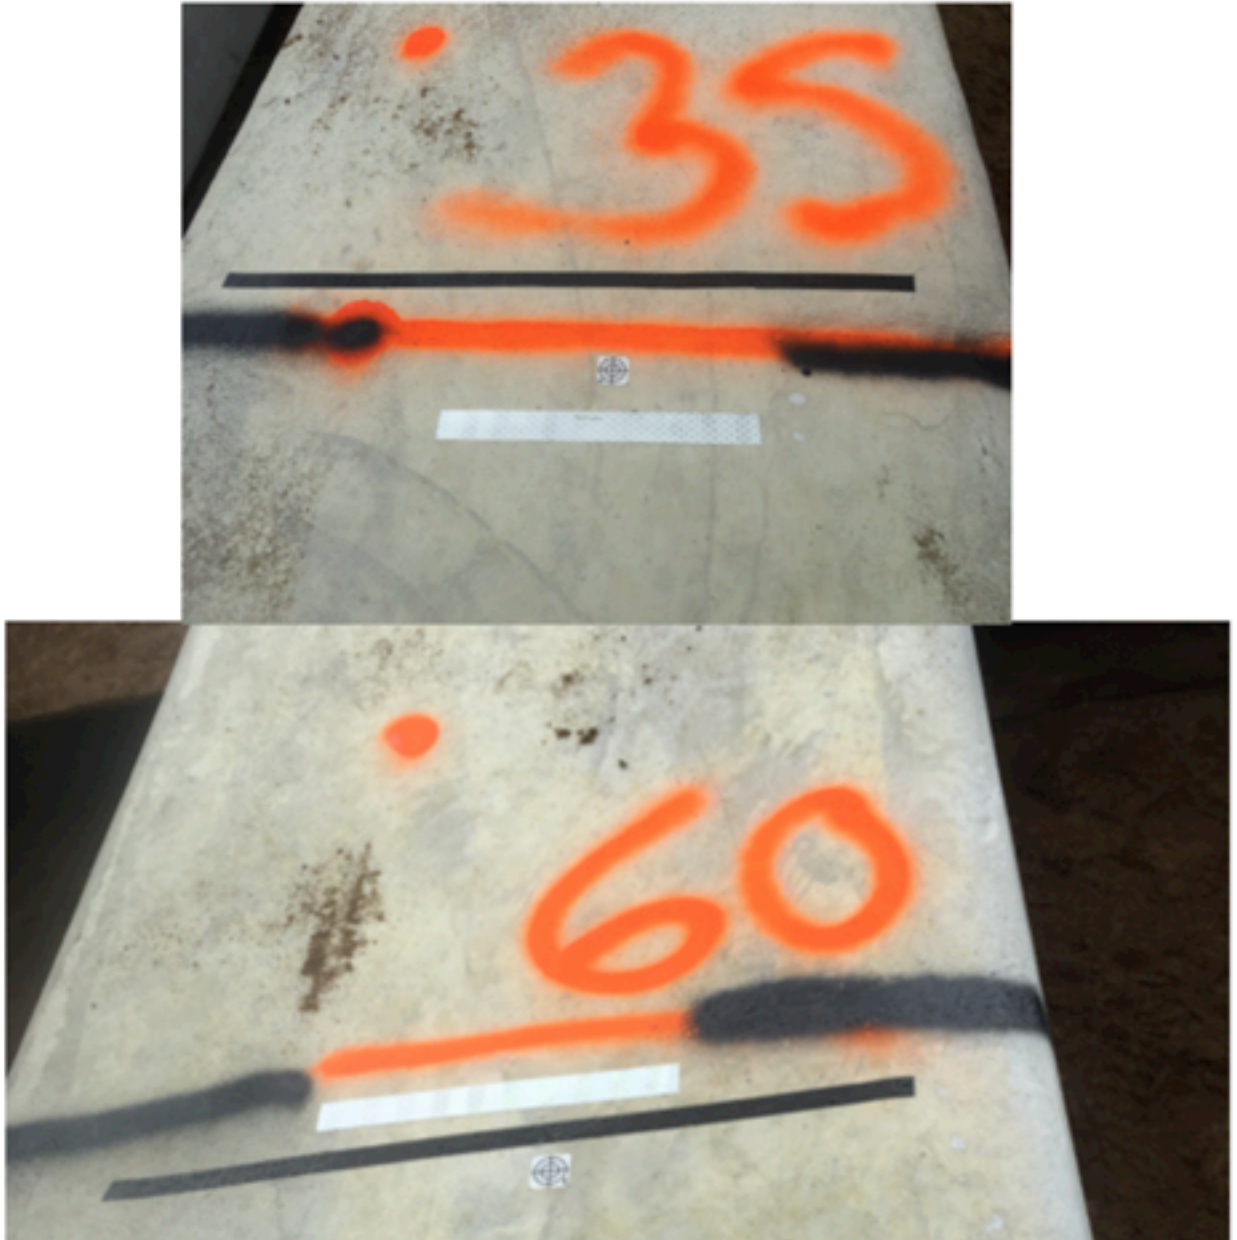
The setup was mostly executed as specified in the methods described in Chapter 4. The reflective tape placed on the pile was the Original tape provided by Inopiles. It was spaced at 5-foot intervals that matched the 5-foot markings on the pile (Figure 6-4).

Figure 6-4 Baldwin Bypass PDM and CMS 5-foot spacing pile markings

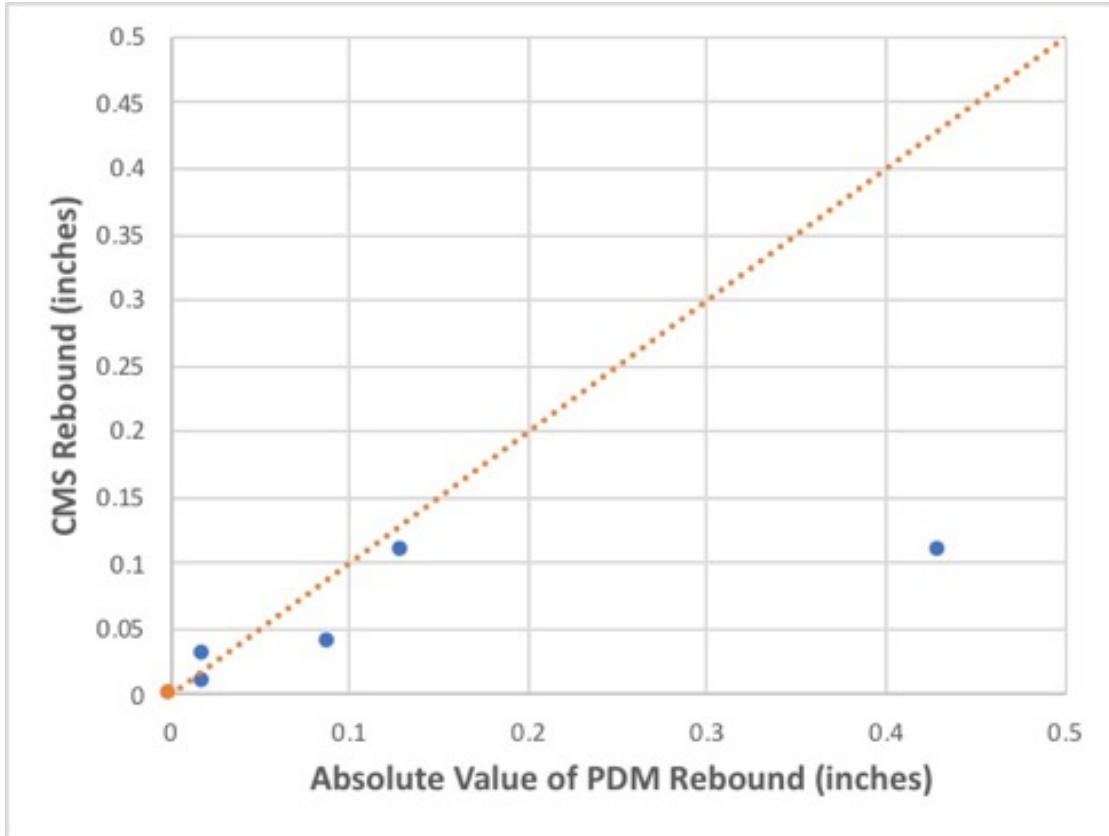
Figure 6-19 PDM Rebound versus CMS Rebound from 39.859 to 40.696 feet at Dunns Creek SPT-1

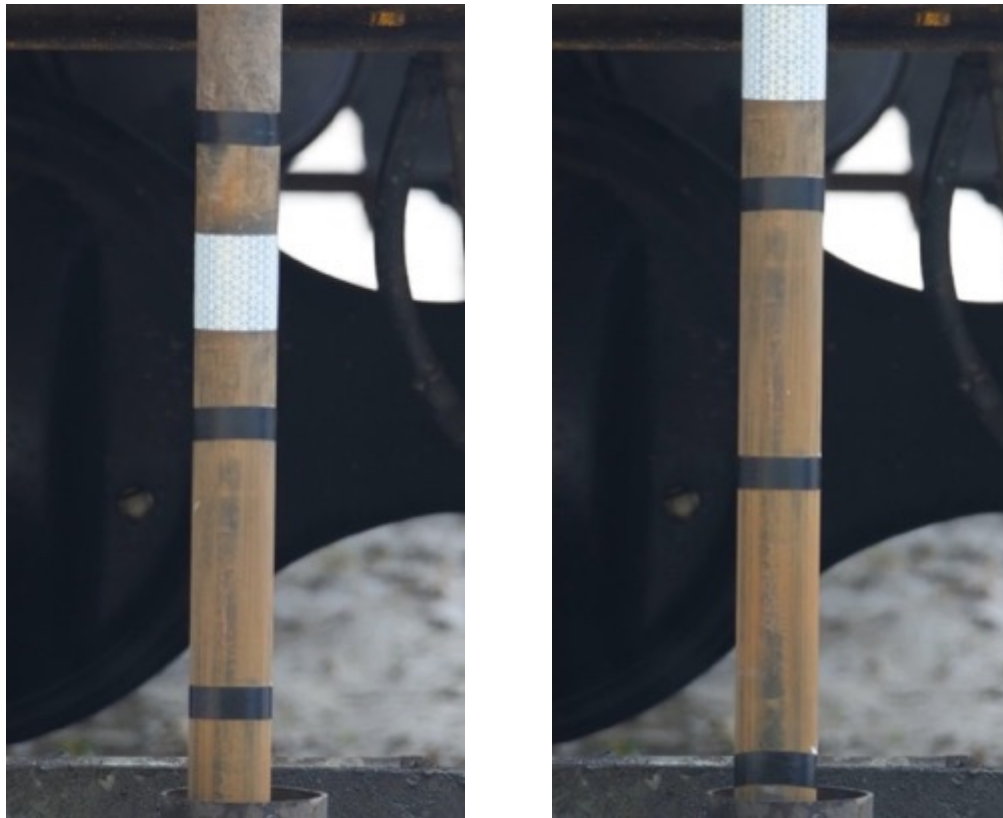
Figure 6-32 Dunns Creek SPT Rods with White PDM Reflective Tape and Black CMS Tape

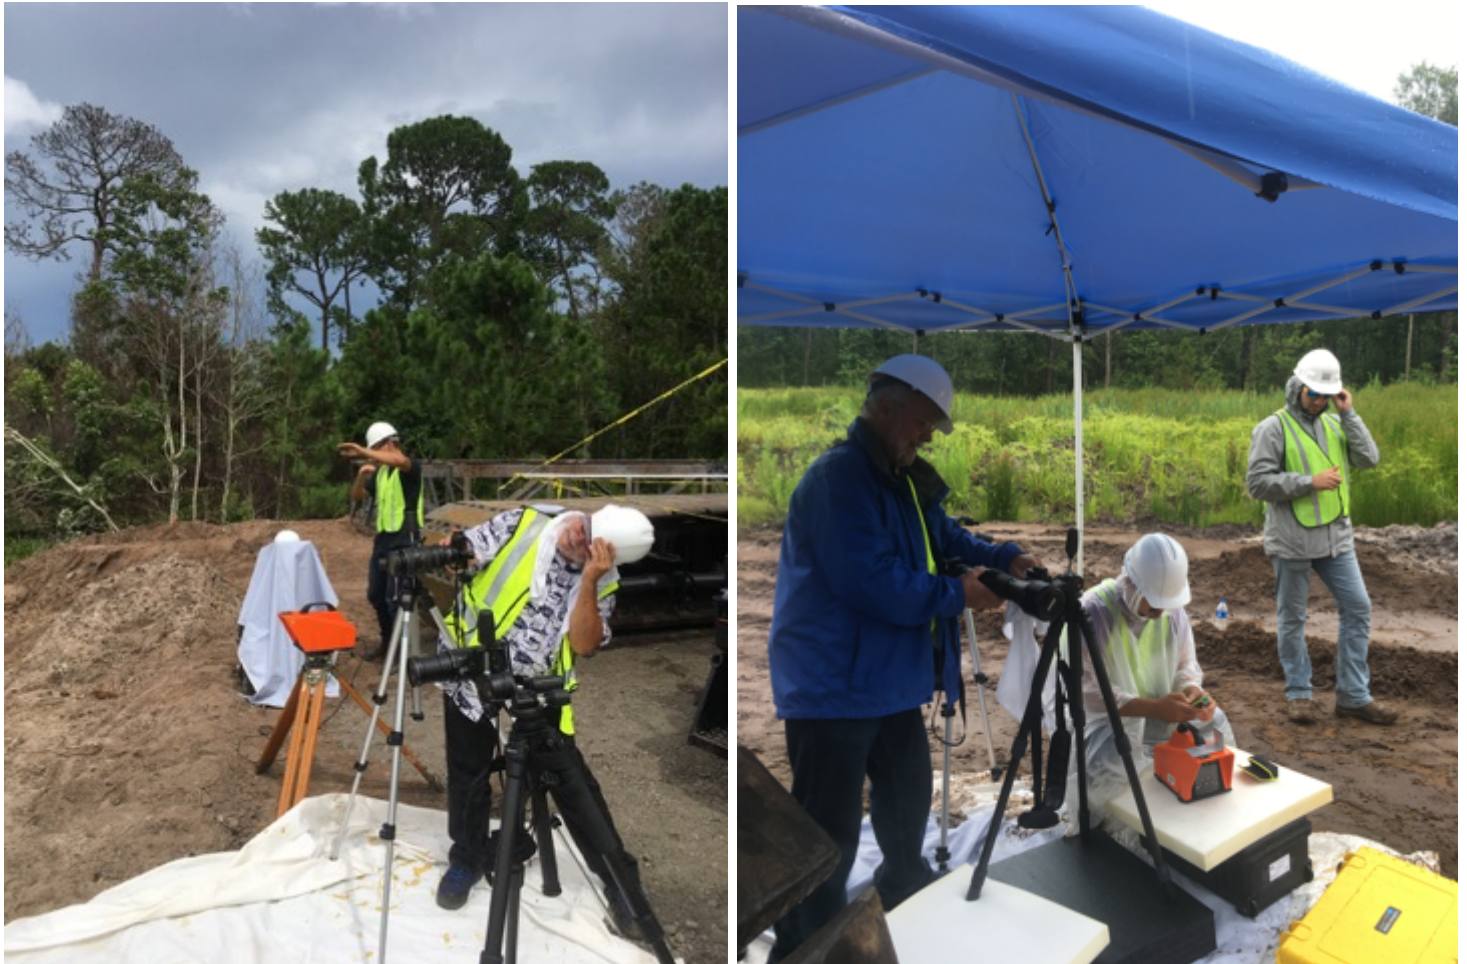
Figure D-2 Typical Camera Setups

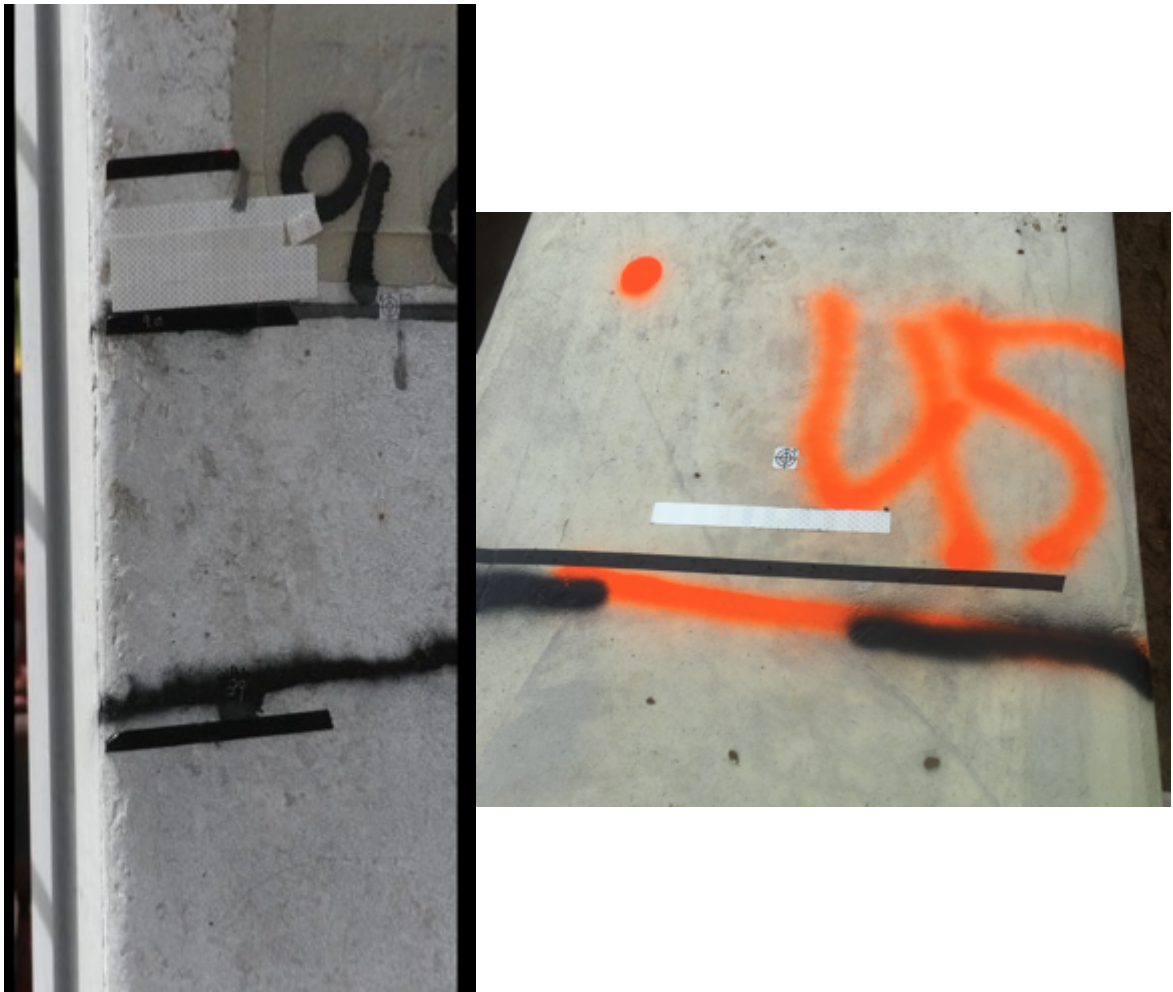
Figure D-3 Typical Pile plus PDM Markings

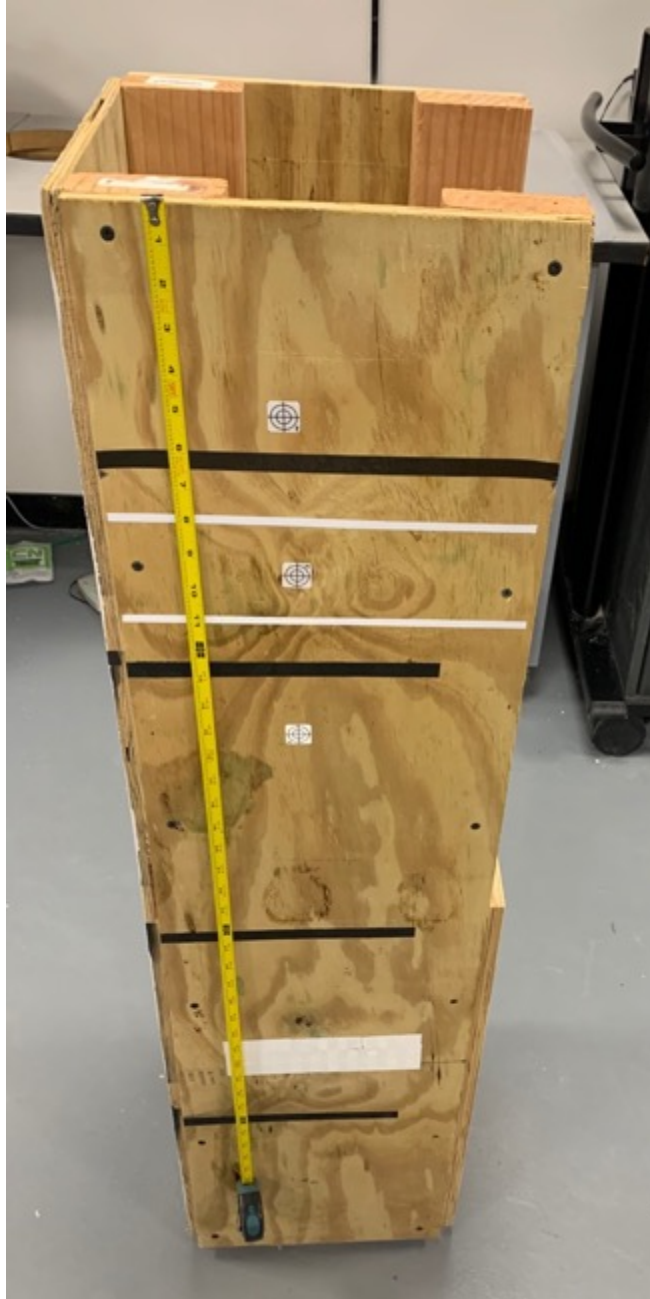
Figure D-7 Laboratory wooden simulated pile with PDM and CMS markings

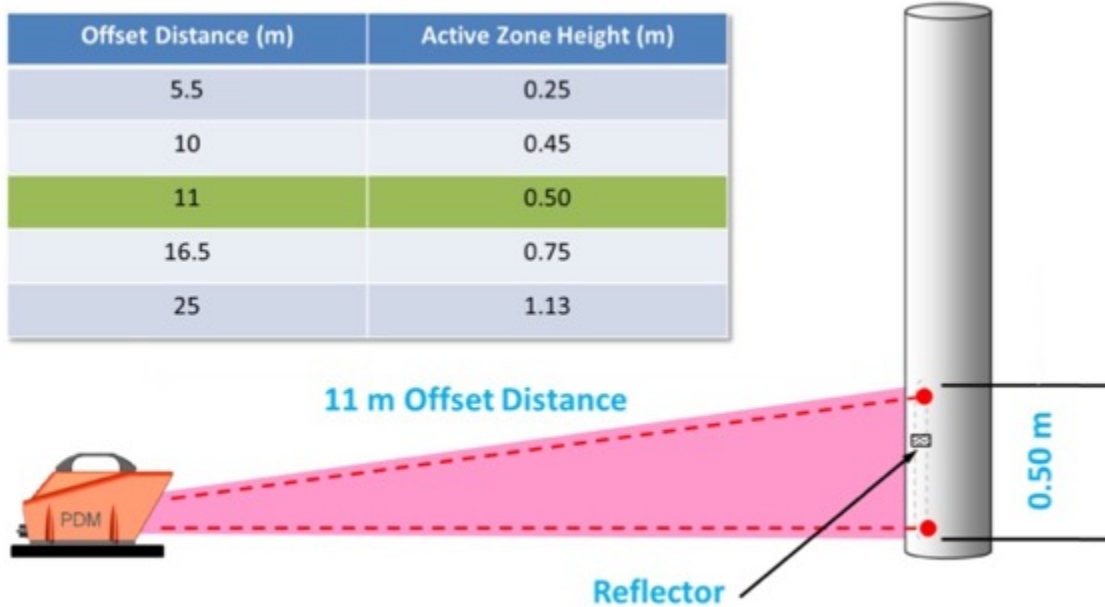
Figure H-1 Schematic of Inopiles Operation within Active Zone

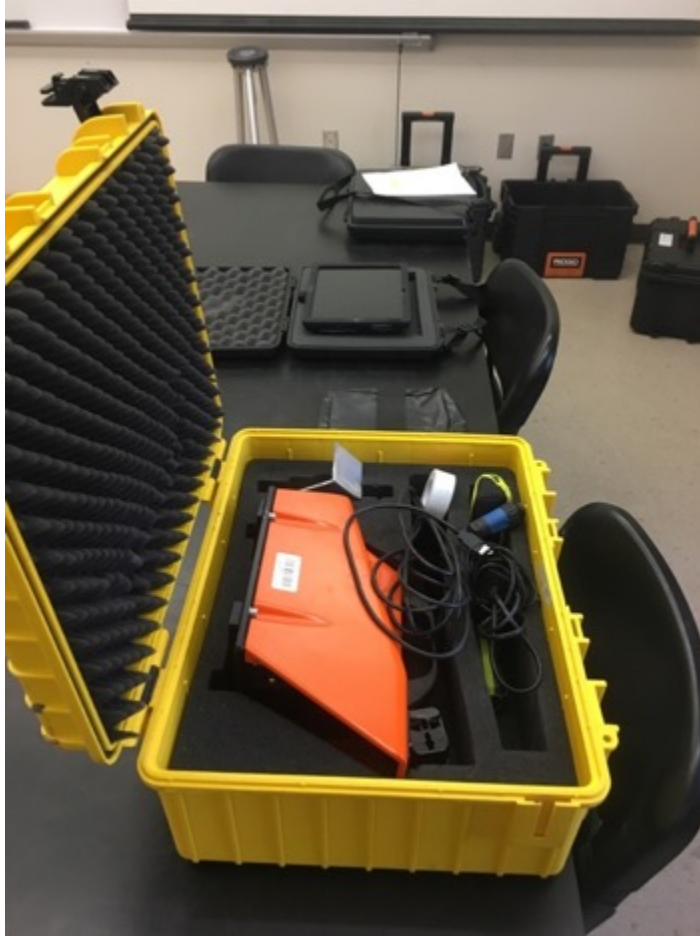
Figure H-2 Inopiles PDM in Case, leveling bag and Surface Pro<sup>®</sup>
