**Research Project Number:**

# **FINAL REPORT**

## **Autonomous Truck Mounted Attenuator (ATMA) Pilot**

University of Tennessee Center for Transportation Research

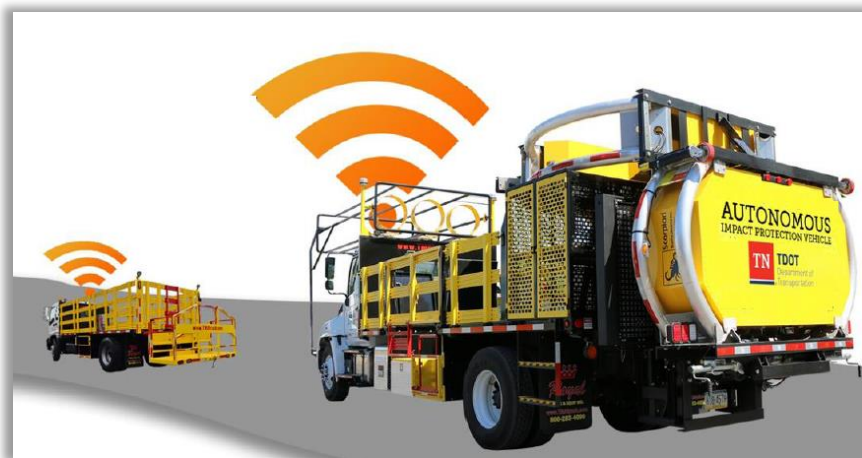
*Figure 1 - ATMA's Leader Follower Concept*

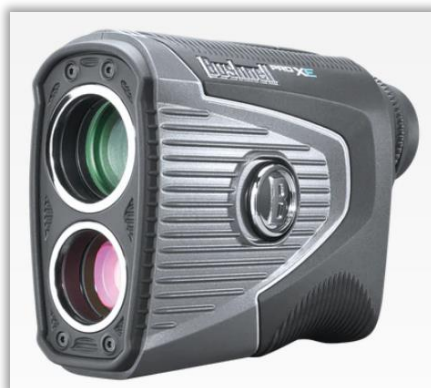
Based on this information, the research team recommends TDOT to explore the use of rangefinders with laser technology (Figure 4). This device would allow a TMA operator to better estimate and maintain the follow and roll ahead distance between a TMA and a service vehicle. Currently available laser technology allows for precise distance measurements up to 500 yards.

These devices can compensate for slope and weather conditions (temperature and barometric pressure) at an estimated cost of less than \$750 per unit.

Figure 4 - Rangefinder

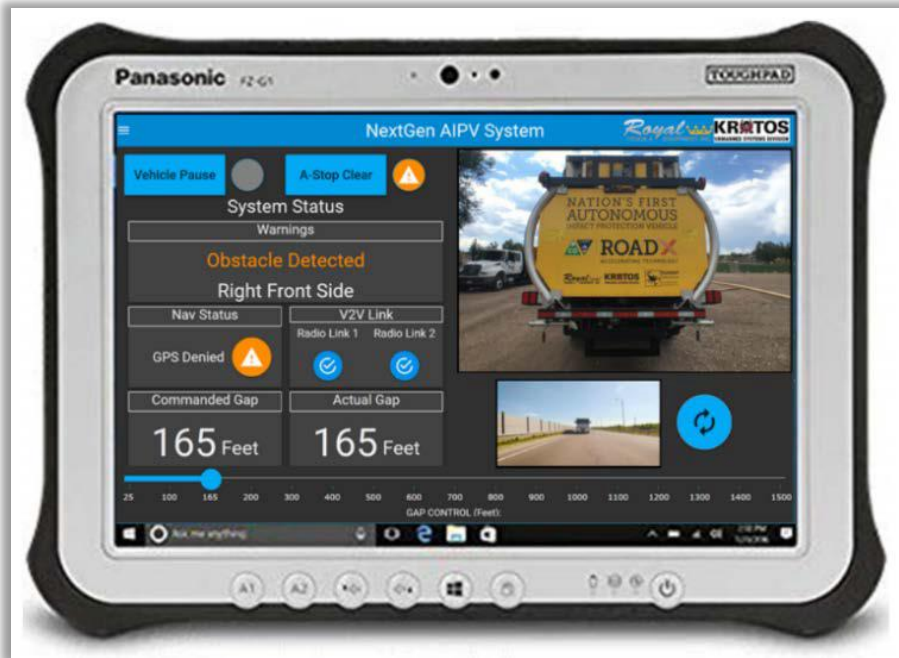
touchscreen tablet computer in the LV with Graphical User Interface (GUI) software. The display provides clear images in all lighting conditions. The GUI enables the operator in the LV to remotely set the Gap (Follow) Distance between the LV and ATMA to prescribed distances using a slider-bar touchscreen control.

Figure 9 - Graphic User Interface (GUI) device located on Leader Vehicle

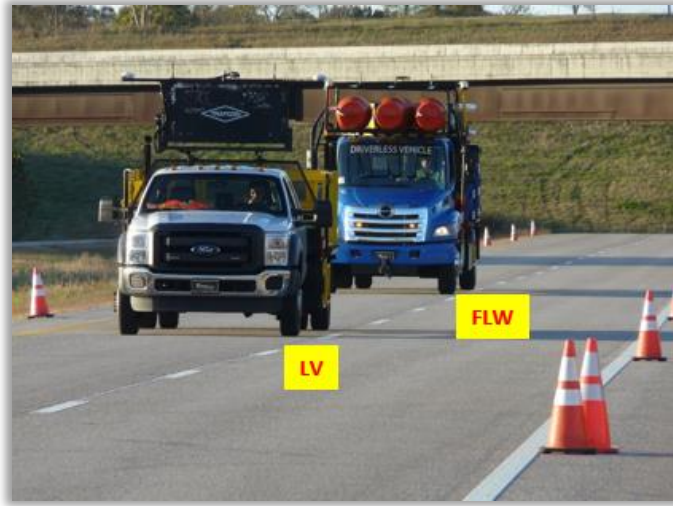
A Ford F550 was used as the leader vehicle (LV). Dimensions are 25'L x 8'6"W and the GPS units were located 11'4" from the front. A HINO 268 truck was used as the follower vehicle (FLW). Dimensions are 32'5"L x 8'9"W and the GPS units were located 9'9" from the front. The AIPV was equipped with a Scorpion truck mounted attenuator that measured 15'2" when deployed. Figure 10 presents the LV and the FLW (AIPV). For the purpose of this report, AIPV (Autonomous Impact Protection Vehicle) is used to denote the follower vehicle and the term ATMA system is used to denote the LV plus the AIPV.

Figure 10 - Leader (LV) and Follower (FLW/AIPV) Vehicles

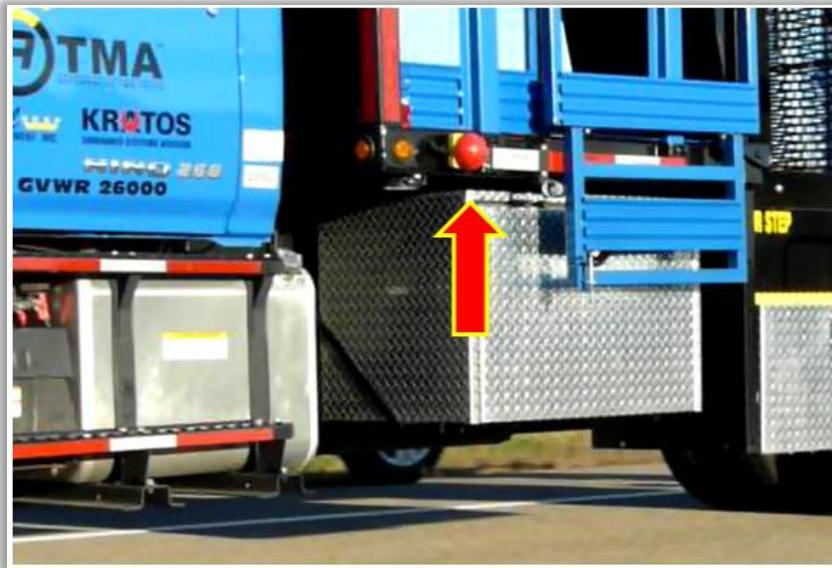
Figure 12 presents the equipment installed outside of the AIPV that controls the manually activated Emergency Stop (E-Stop). There are two large red buttons, one on each side of the AIPV.

*Figure 12 - AIPV External E-Stop Button*

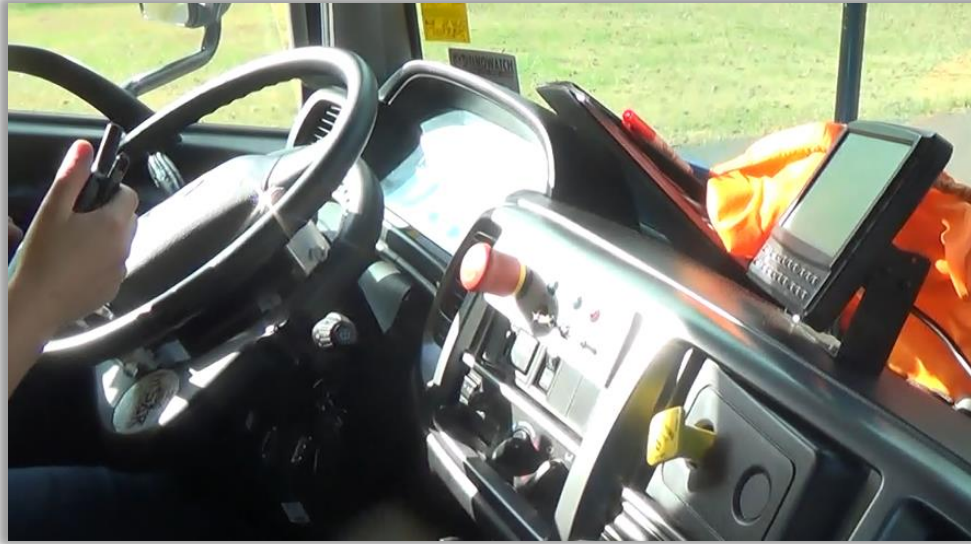
The AIPV also has an OCU controlling the IDLE or GO mode of operation, with a red E-Stop button that can be manually activated (Figure 13). The applicability of the internal E-Stop on the AIPV may be considered limited but the equipment worked as expected as demonstrated in a testing scenario (detailed in Chapter 6). The yellow button is used for the parking brakes.

*Figure 13 - AIPV Internal E-Stop Button*

Figure 13 also shows the equipment installed below the steering wheel that is used to control the vehicle autonomously, the Multi-Platform Appliqué Kit or M-PAK™ Steering Wheel Actuator / Smartmotor Assembly. The research team noticed it as a potential inconvenience, since it limits the space available for sitting. The ATMA system developer discourages users of the system to remove the steering wheel actuator on the AIPV, to prevent damage, misalignment and improper installation. The research team was informed that, in response to user feedback, the steering wheel actuator design has been modified after the testing procedures took place, to allow greater flexibility, during the installation process, and to increase clearance for the driver when the vehicle is being manually operated.

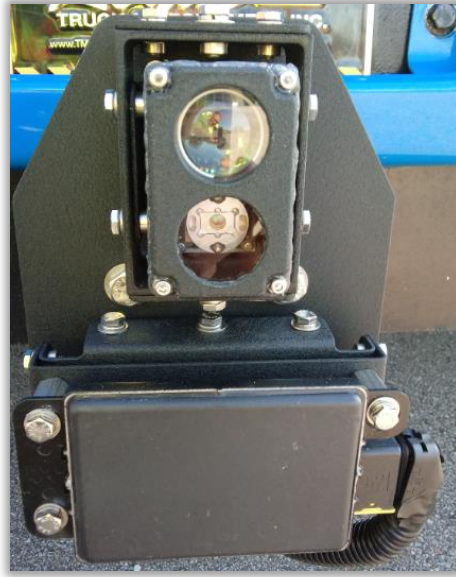
The forward-looking obstacle detection sensors mentioned in *Section 5.1.1* are installed in the AIPV. Light and radar is used for obstacle detection. The top sensor in Figure 16 is a Lidar unit and the bottom sensor is a Delphi ESR (Electronic Scanning Radar).

Figure 16 - Forward-looking Obstacle Detection Sensors

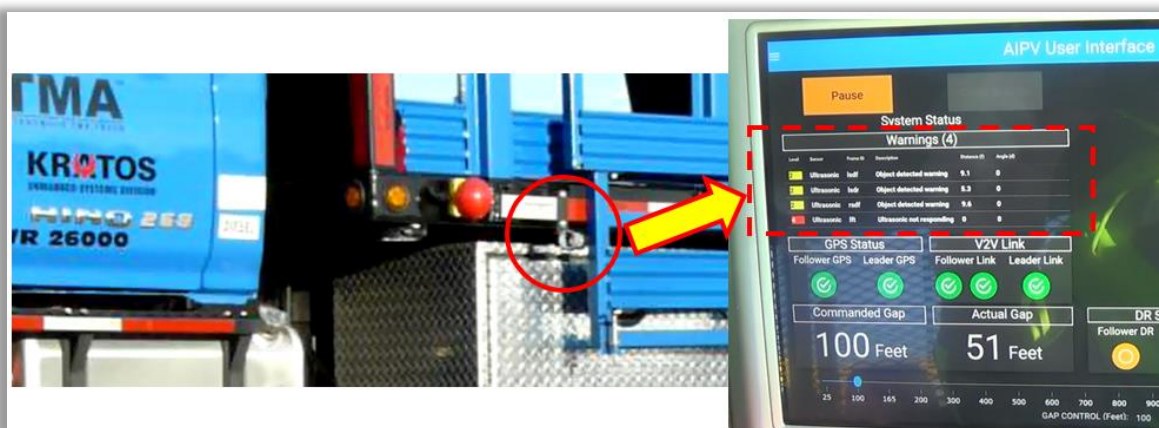
Ultrasonic sensors mentioned in *Section 5.1.1* were installed in the front and on both sides of the AIPV (Figure 17). These sensors enhanced the forward looking obstacle detection system and provide side-view obstacle detection further enhancing the operational safety of the system. When the sensors detected an obstacle, the system notified the operator by flashing a warning on the GUI (Figure 17).

Figure 17 – Side-view Obstacle Detection Sensors

the vehicle. The sensors were extremely sensitive. They occasionally relayed false object-detected warnings to the GUI. This issue was noticeable in all test scenarios. The equipment failed to work as expected.

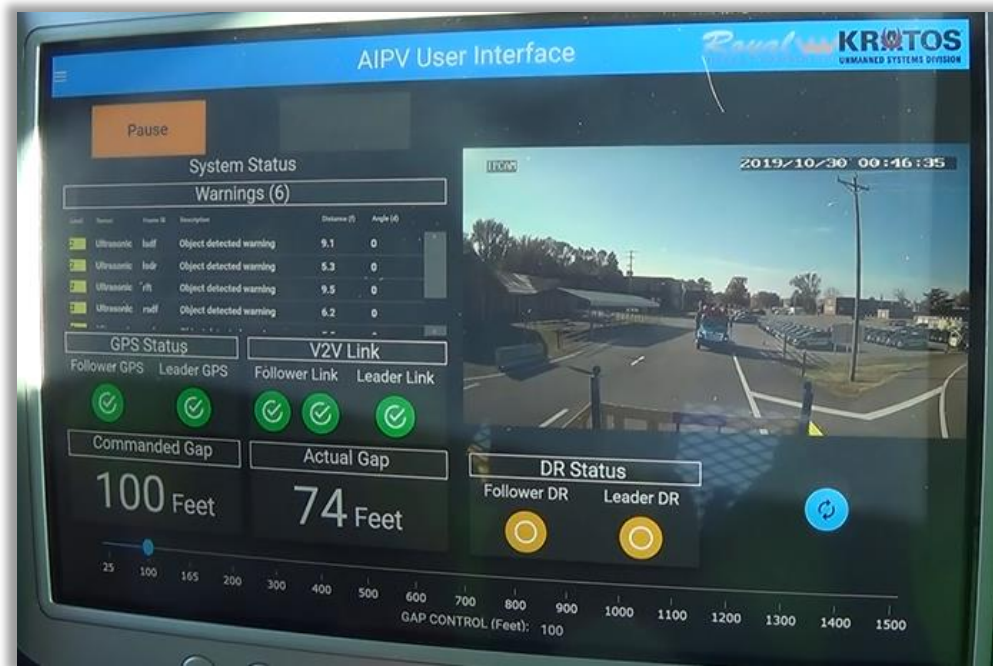
The GUI described in *Section 5.1.4* was mounted in the LV on the passenger side, not interfering with the driver ability to control the vehicle but within easy reach. The screen was easily readable at all light conditions. The process to disconnect and reconnect the GUI to its bracket and communications cables was not cumbersome and took less than 3 minutes. A video of the procedure can be found here: [https://youtu.be/G\\_Fxtkbuezw](https://youtu.be/G_Fxtkbuezw). Figure 18 presents a screenshot of the GUI.

Specific warning messages pop up at the top of the screen and promptly warn the driver of a system malfunction. An example of an E-crumb error (where the AIPV was not able to locate the LV next data point position) can be found here: <https://youtu.be/Tbiy2FyXiNg>. It is necessary to note that the Gap Control slide bar does not accommodate for all potential following distances required by TDOT's Work Zone Field Manual for Maintenance Operations (eg.:175 feet, 225 feet). No other GUI issues were noticed during the testing procedures.

Figure 18 – Graphic User Interface (GUI) Panel

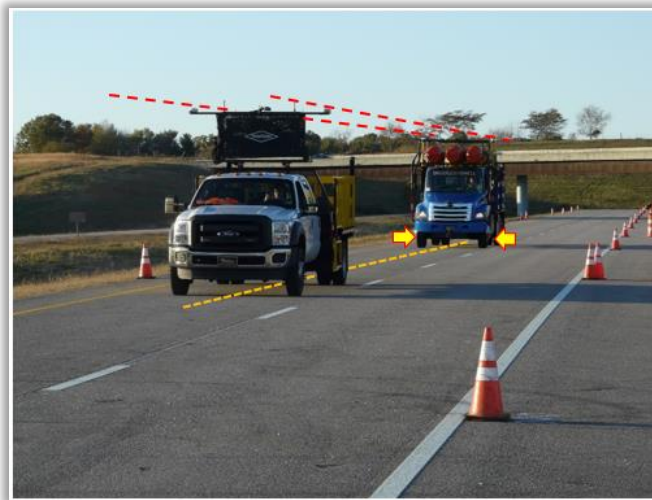
Figure 20 – LV and AIPV during Line-up Procedure

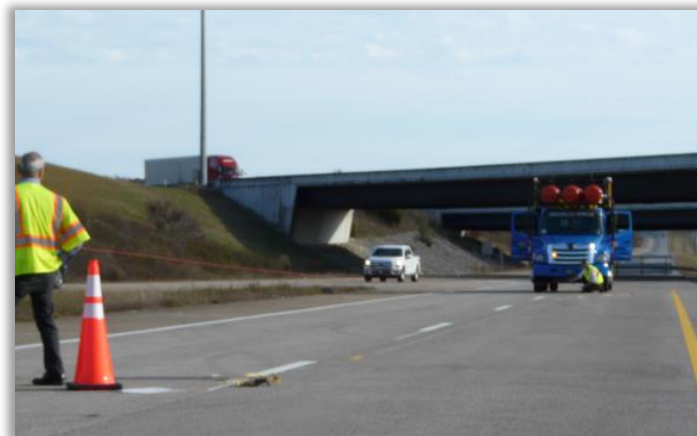
Also, the ATMA system was not operating normally during the initial testing procedures, according to the system operator personnel present in the testing site. A recalibration process of the system was performed (Figure 21). A system relay was exchanged and after the lengthy testing delay, the system was deemed ready for testing. The testing schedule was affected.

Figure 21 – ATMA System Recalibration Process

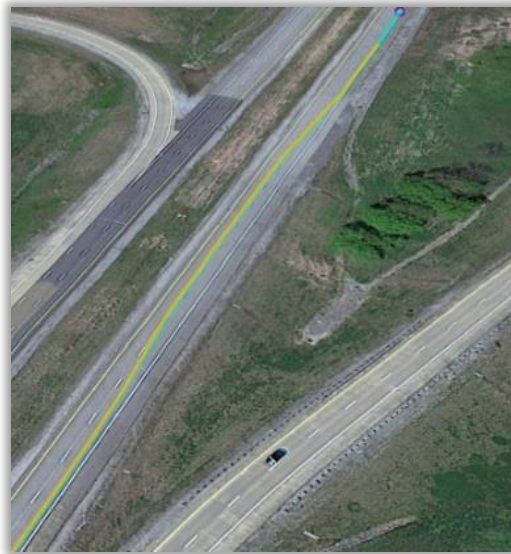
Test procedure: Using the 2 lanes of I-840, the right side lane was tapered from the shoulder to the left most lane, between 200 feet and 400 feet. After a 100 feet straight segment another taper was created from the left most lane back to the shoulder, between 500 feet to 700 feet. The command gap was set to 100 feet on the GUI. The LV and the AIPV were activated. The LV operator was asked to drive at a target speed of 10 mph, navigating the lane change described above. The test was repeated at a target speed of 15 mph. Data was collected for a total of four runs. Figure 30 presents the plotted path of the test, with the orange line representing the LV and the blue line representing the AIPV.

Figure 30 – Test Path – Following Accuracy on Lane Change Test

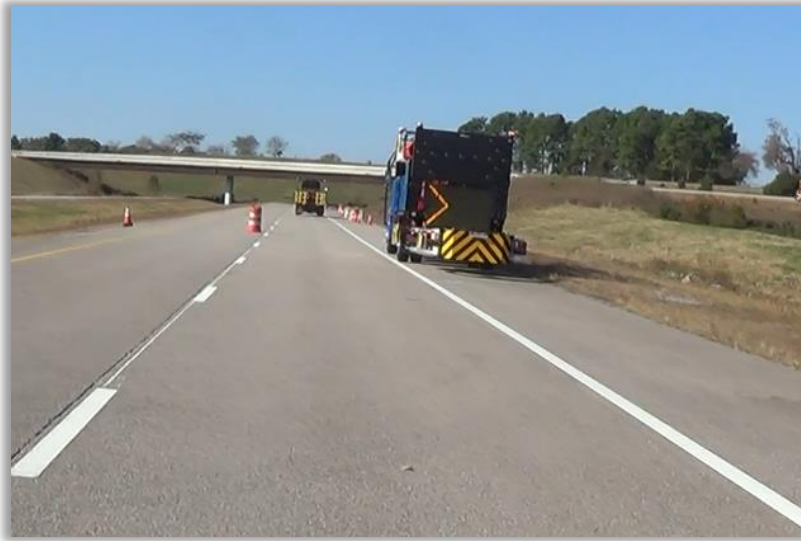
Results: As mentioned in *Chapter 5*, when in operation, the LV transmits its position, speed, and heading to the AIPV vehicle in a sequential series of Vehicle-to-Vehicle (V2V) “e-Crumbs” messages. The AIPV then maneuvers from one e-Crumb to the next following the path of the LV at a user-defined vehicle-gap. Figure 42 presents the moment the service vehicle (LV) encroached in the adjacent lane during the testing. From that point, for the next 19 seconds, the AIPV was unable to shadow the service vehicle as required. The AIPV simply continued to follow the e-Crumbs laid out by the LV on the shoulder. While the LV returned to the shoulder, the AIPV followed the e-Crumbs laid out by the LV on the adjacent lane. The ATMA system was not capable of continuously shadow/protect the service vehicle (LV).

Figure 42 – Unprotected Service Vehicle – Herbicide Application Test

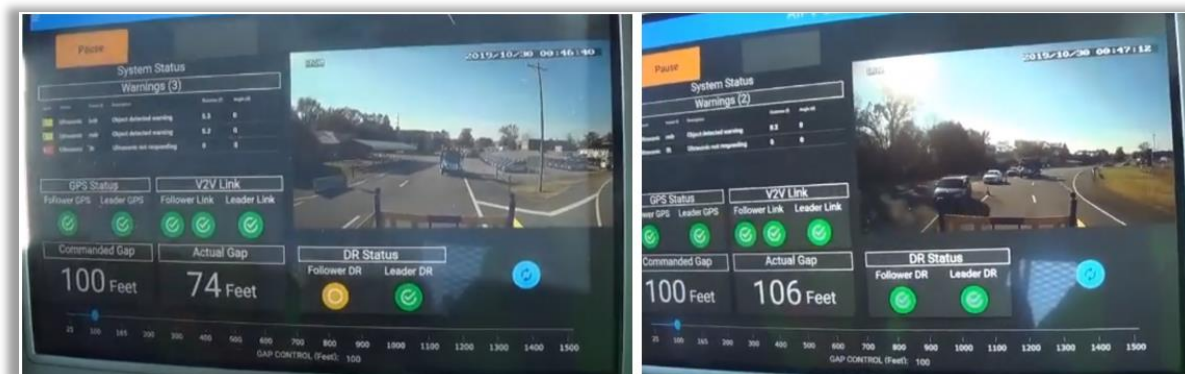
**Results:** The ATMA system was not able to consistently detect and recognize the parked vehicles. The ATMA system did not execute an A-Stop.

Figure 51 – GUI Display during Object Recognition Test
