BEST PRACTICES TO ADDRESS ISSUES OF EXCESS AGGREGATE DUST IN NEBRASKA

F
I
N
A
L

R
E
P
O
R
T

December 31, 2020

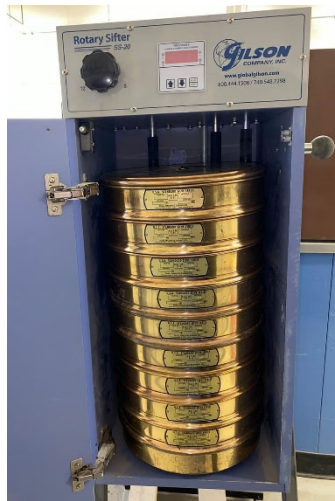
Figure 4. Aggregate sieve analysis setup.

The particle size distribution of obtained coarse and fine aggregates was determined by sieve analysis following ASTM C136 (Standard Test Method for Sieve Analysis of Fine and Coarse Aggregates) (ASTM 2014). A representative aggregate sample of a required testing size was dried to a constant mass at a temperature of $110\pm 5^{\circ}\text{C}$ prior to sieving in a mechanical sieve shaker, as shown in Figure 4.

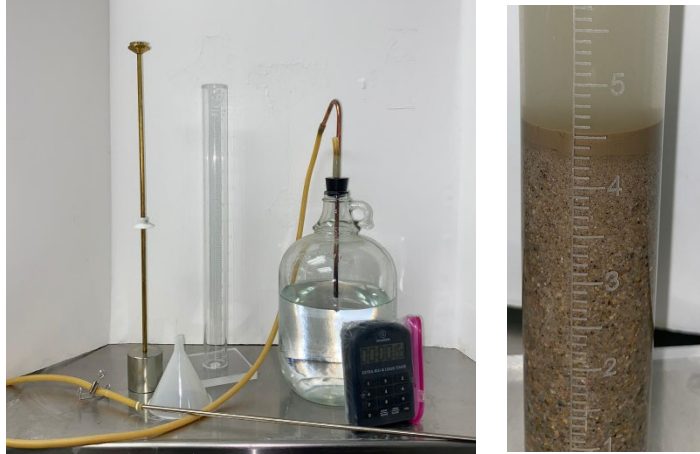
Figure 6. Sand Equivalent test apparatus and example of test result.

Another relatively quick and common test to identify aggregate dust or claylike materials content in a given set of fine aggregates is AASHTO T176 - Standard Method of Test for Plastic Fines in Graded Aggregates and Soils by Use of the Sand Equivalent Test (AASHTO, 2017). An oven-dry sample of fine aggregate was sieved through No. 4 sieve, moisturized to approximately saturated surface dry (SSD) condition, and sampled by quartering method. As shown in Figure 6, an obtained test sample was then oven-dried and put into a plastic cylinder, where it was thoroughly mixed with a calcium chloride solution. The process resulted in layers' separation of clay and sand that was further used to calculate the sand equivalent value, which quantifies relative proportions of sand versus clay in a given sample (i.e., a higher sand equivalent value indicates that there is less clay-like microfines content).

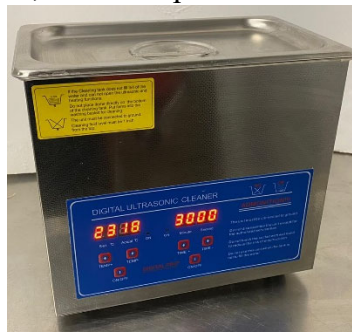
Figure 8. Ultrasonic cleaner machine.

An approximately 1000g sample of washed aggregate was dried at a temperature of $110\pm 5^{\circ}\text{C}$ and immersed into an ultrasonic bath (Figure 8) filled with 1500 mL of deionized water. The sample was then sonicated for 30 minutes at a normal (23°C) temperature. The rinse water then was sieved through a No.200 sieve, dried off, and a sample of microfines was collected (Figure 9).

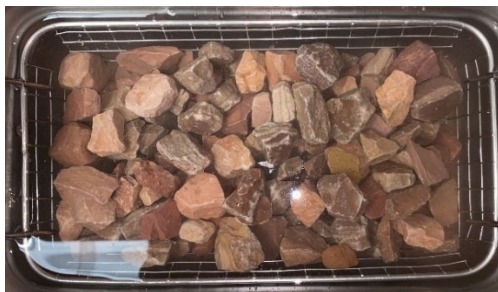
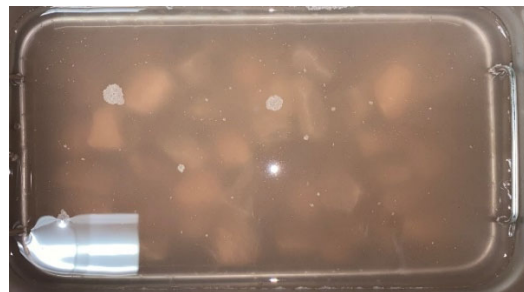
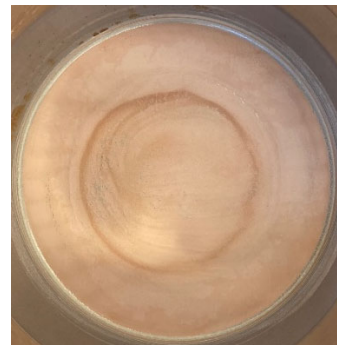
Figure 9. Example of step-by-step ultrasonic cleaning procedure.

a) Aggregate immersed in an ultrasonic bath with clean deionized water

b) Aggregate after ultrasonic cleaning

d) Dried off microfines

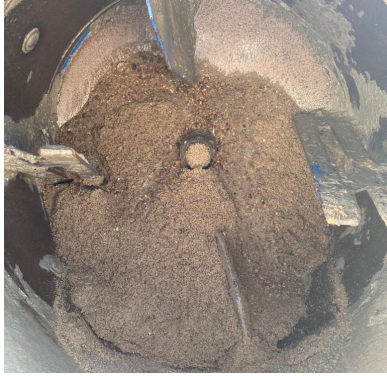
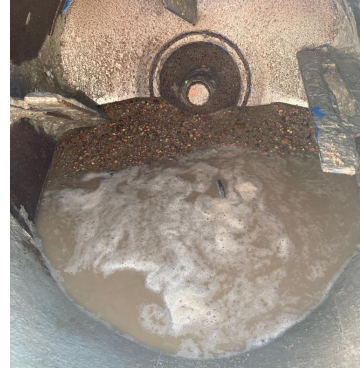
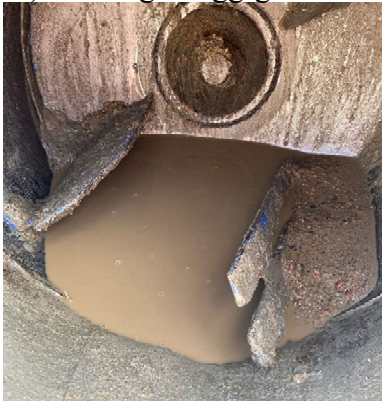
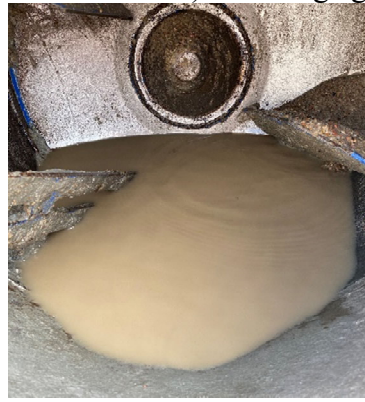
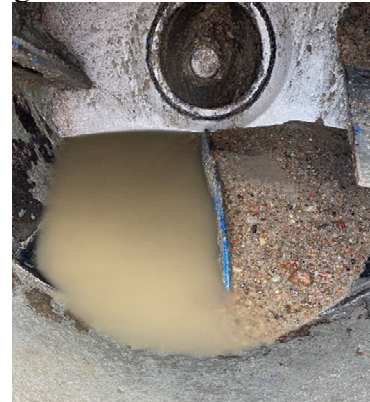
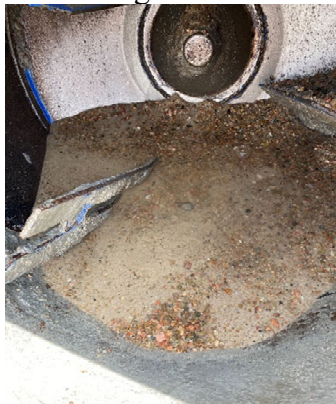
Figure 10. Step by step sand and gravel washing.

- i. Mix for 5 minutes, drain the wash water over the No.16 and 200 sieves, introduce clean water
- ii. Run a few revolutions, drain the wash water over No.16 and 200 sieves, introduce clean water (repeat five times)
- iii. Return the material retained on the sieves back into the mixer

An example of the step-by-step washing process is shown in Figure 10. The procedure was to be repeated three times, and by the end of the washing procedure, the rinse water should appear transparent.

a) Loading of aggregate in the mixer

b) Covering aggregate with clean water

c) After 1st round of 5-min washing

d) After 2nd round of 5-min washing

e) After 3rd round of 5-min washing

f) Clean aggregate covered with water

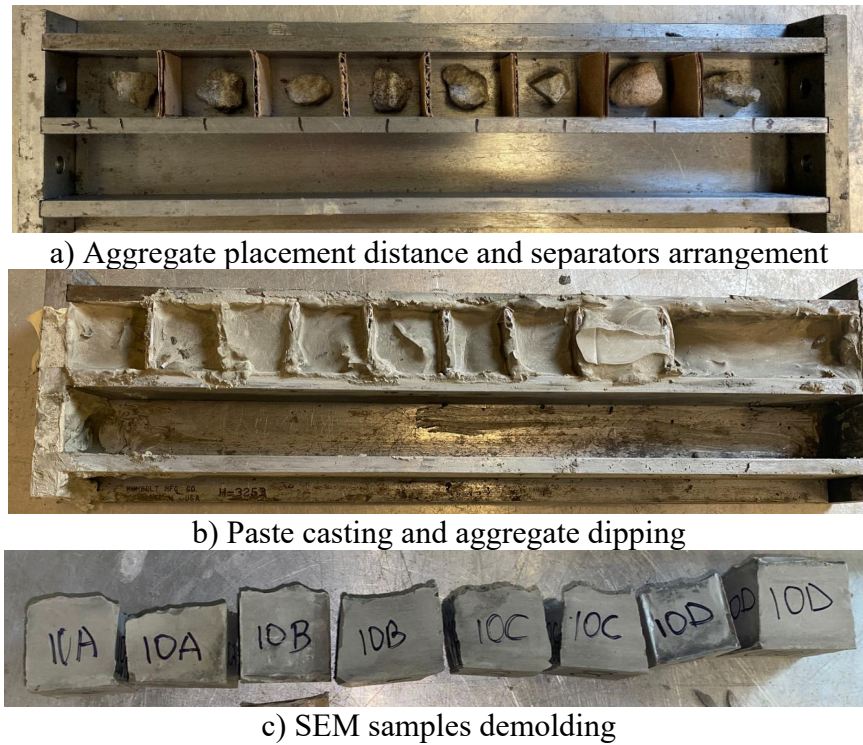
Figure 12. SEM samples casting procedure.

Step 3. Cast the cement paste in 1x1x11 inch prisms, dip eight aggregate pieces at a sufficient distance, and place tape-covered cardboard separators (Figure 12).

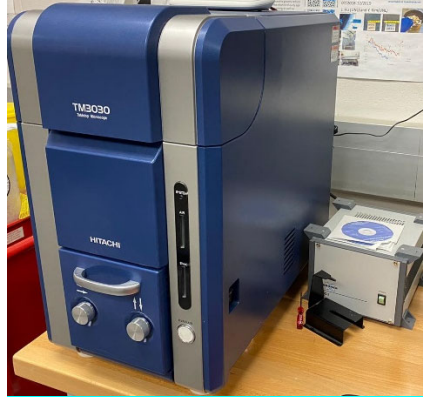
Figure 14. Hitachi TM3030 SEM and Quantax EDS unit.

A Hitachi TM3030 tabletop scanning electron microscope (SEM), as shown in Figure 14, was utilized to assess the effect of microfiners on the aggregate-cement paste bonding.

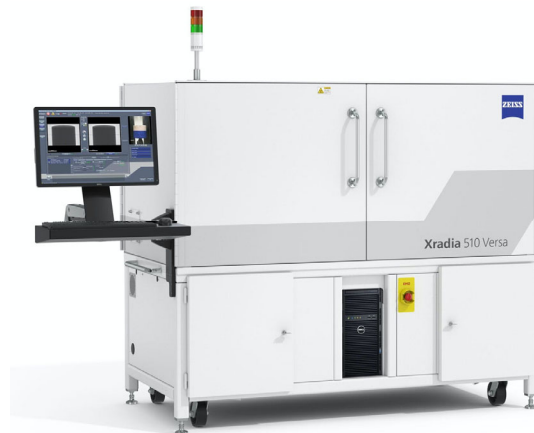
Figure 17. ZEISS Xradia 3D X-ray Microscopy and Computed Tomography.

X-ray micro computed tomography (CT), as shown in Figure 17, is a nondestructive technique for obtaining the three-dimensional internal microstructure of solid materials. X-ray beams are shot to the specimen by a high energy source (350 kV and 225 kV) for imaging of a wide range of materials with different densities and thicknesses. Low-density phases are typically represented by darker color contrasts, while high-density phases are represented by brighter color contrasts (Elseifi et al. 2011). In this study, more than 1,000 two-dimensional image slices were captured per specimen, and the aggregate-paste interphase was evaluated.

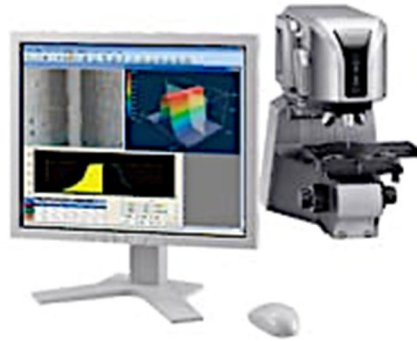
Figure 19. KEYENCE VK-9700K laser scanning confocal microscope (LSCM).

In this study, a Keyence® VK9700 laser scanning confocal microscope (LSCM), as shown in Figure 19, was used to obtain topography near the ITZ. LSCM is a type of optical microscope that uses two light sources: a white light for gathering color and a laser beam for scanning the surface and collecting detailed topography information. The result is a high-resolution, large depth-of-field, color image with nanometer-level height resolution for accurate profile and roughness measurements. In this study, LSCM was employed to obtain 3-D topography images from multiple locations over the aggregate-paste interface. 2-D profiles were also captured from one random location through a line scanning perpendicular to the interphase.

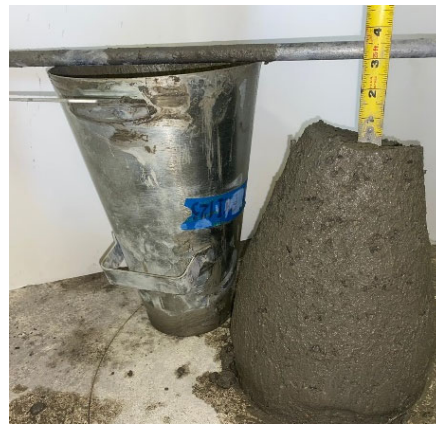
Figure 24. Slump test apparatus.

To assess workability and determine the consistency of fresh concrete, ASTM C143 (Standard Test Method for Slump of Hydraulic-Cement Concrete) was followed (ASTM, 2015). The complete test was performed within 2.5 minutes right after concrete mixing. A slump (see Figure 24) was measured to the nearest quarter inch.

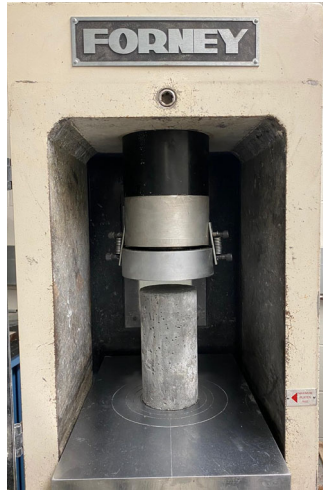
Figure 26. Compressive strength apparatus – Forney compression testing machine.

The compressive strength of hardened concrete was measured per ASTM C39 (Standard Test Method for Compressive Strength of Cylindrical Concrete Specimens) (ASTM, 2020). Cylindrical specimens at the dimensions of 4” diameter and 8” height were subjected to compression using the Forney compression testing machine (see Figure 26) at 7 and 28 days of age. At each testing age, three specimens were randomly selected for the test, and the average value and standard deviation were reported.

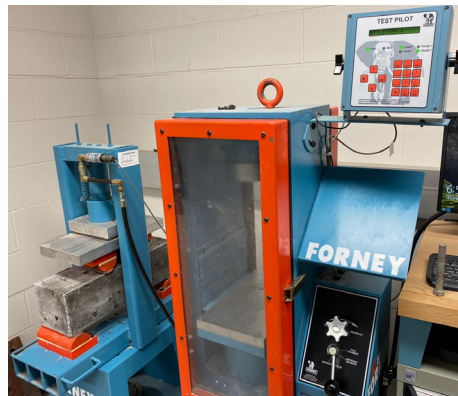
Figure 27. Flexural strength apparatus – Forney flexural testing machine.

The flexural strength of hardened concrete was evaluated based on the modulus of rupture value determined by ASTM C78 (Standard Test Method for Flexural Strength of Concrete (Using Simple Beam with Third-Point Loading)) (ASTM, 2018). Thus, a 28-d cured concrete beam specimen (prism of 6”×6”×20”) was subjected to third-point loading on Forney flexural testing machine (Figure 27).

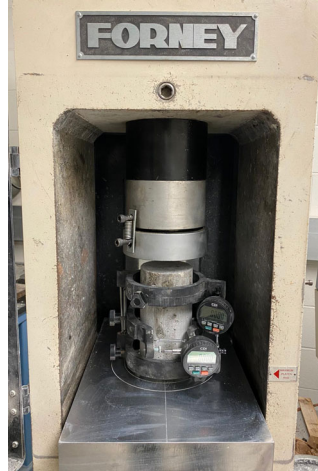
Figure 28. Modulus of Elasticity testing apparatus.

The static modulus of elasticity was measured per ASTM C469 (Standard Test Method for Static Modulus of Elasticity and Poisson’s Ratio of Concrete in Compression) (ASTM, 2014). 28-d cured cylindrical specimen was (4” radius and 8” height) was subjected to compression while axial and radial deformations were recorded (Figure 28). Three specimens were randomly selected for the test, and the average value and standard deviation were reported.

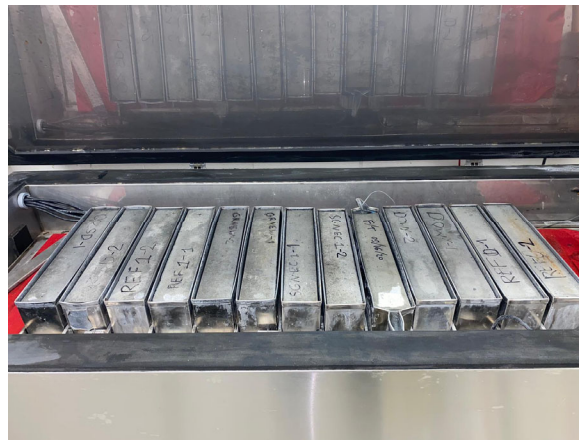
Figure 29. Freeze-thaw resistance testing apparatus.

Figure 29a). After every 30 cycles, the mass loss of the samples was measured.

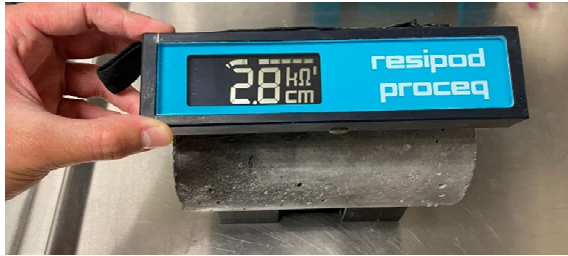
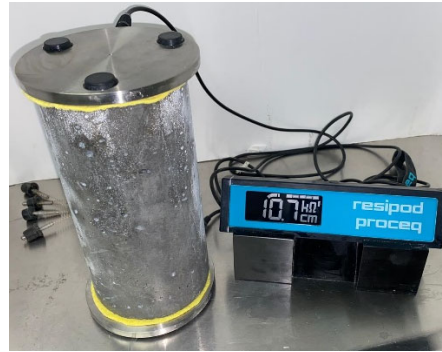
Figure 30. Concrete surface resistivity testing apparatus.

Concrete surface resistivity was measured per AASHTO TP 95-14 (Standard Method of Test for Surface Resistivity Indication of Concrete’s Ability to Resist Chloride Ion Penetration) (AASHTO, 2014). Two fully saturated and cured concrete cylindrical specimens (4” radius and 8” height) were tested for their electrical surface and bulk resistivity characteristics using Proceq

Resipod resistivity meter at the ages of 7, 14, 28, and 90 days (Figure 30). Bulk resistivity measures the resistivity of the whole cylinder instead of just the surface, as from the surface resistivity test.

a) Surface resistivity measurement

b) Bulk resistivity measurement

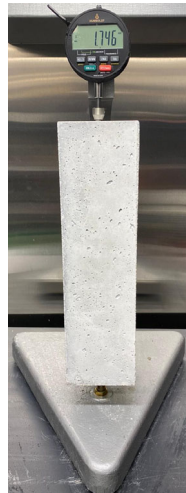
Figure 31. Free shrinkage test equipment setup.

The potential volumetric contraction of concrete was tested according to ASTM C157 (Standard Test Method for Length Change of Hardened Hydraulic-Cement Mortar and Concrete) (ASTM, 2017). After 28-d of lime-water curing, three concrete prisms of the dimension of 3”×3”×11.25” were placed in an environmental chamber with a temperature of 73.5±3.5°F (23.0±2.0°C) and relative humidity of 50±4.0%. The length change of bars was measured by length comparator after 4, 7, 14, 28 days, and after 8, 16, 32, 64 weeks of air storage (Figure 31).

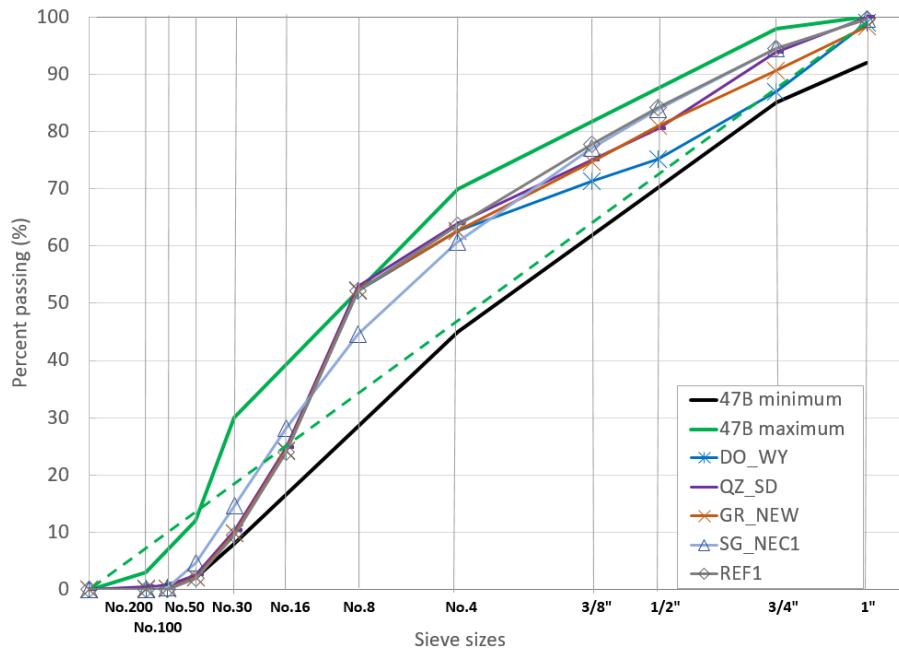
Figure 34. Combined gradation (0.45 Power chart).

The combination aggregate gradations of coarse and fine aggregates of DO_WY, QZ_SD, GR_NEW, SG_NEC1, and REF1, plotted in 0.45 Power curve, were also used to evaluate the gradation of the combined gradation.

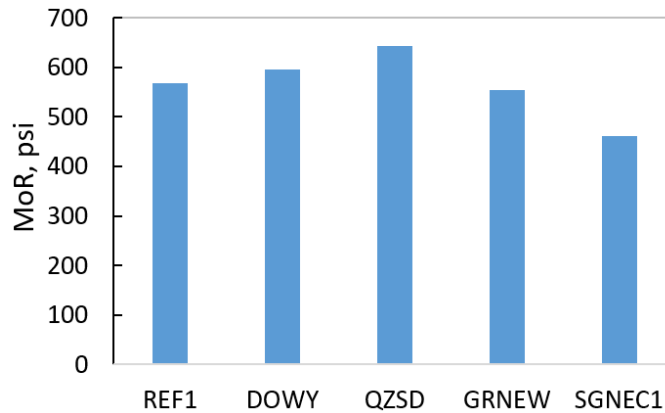
Figure 36. Effect of aggregate on mechanical properties of concrete.

c) Modulus of rupture

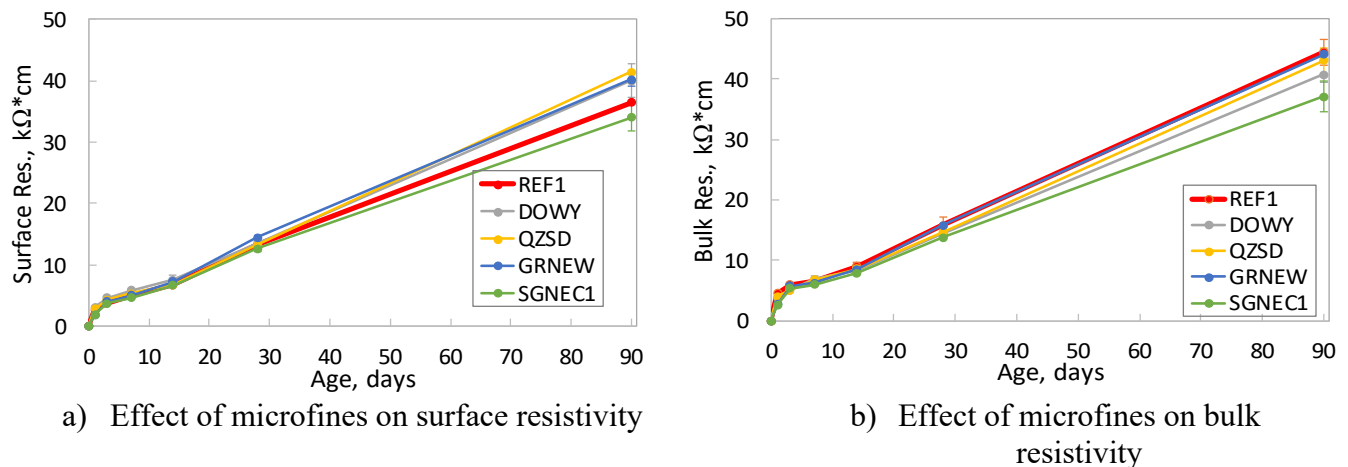
Figure 37. Effect of microfines on resistivity.

The results of the electrical resistivity per AASHTO TP95-14 and freeze/thaw resistance test per ASTM C666 are presented in Figure 37 and Figure 38, respectively. Results showed a steady growth of the resistivity of concrete specimens over time. At 90 days, the resistivity of the mixes were found to be between 30 and 40 $k\Omega \cdot cm$, which represents low to very low chloride ion penetrability, according to Layssi et al. (2015). Overall, no significant difference in concrete durability properties between the mixes was observed. However, it worthwhile to note that the previously questioned SG_NEC1 mix ended up with slightly lower surface and bulk resistivity values (Figure 37). Results from the bulk and surface resistivity tests followed a very similar trend, and no significant difference between the two tests was observed.

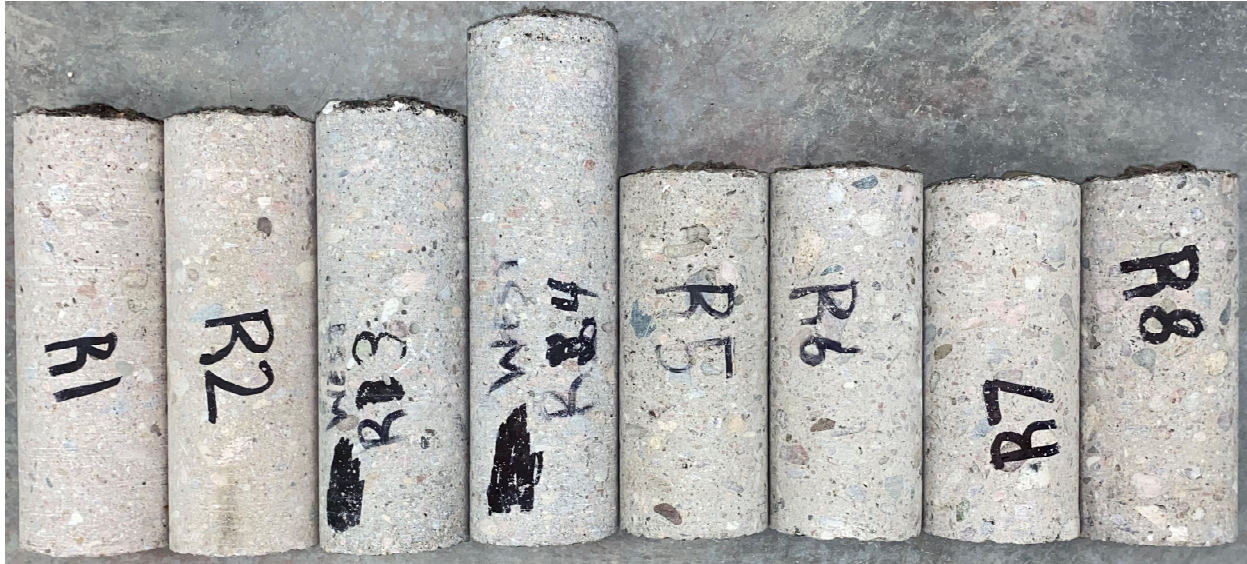
Figure 41. Core samples obtained from NDOT projects for inspection.

Eight concrete core samples were received from NDOT Materials Lab at the University of Nebraska-Lincoln (UNL) (Figure 41). The cores were approximately 4" in diameter and at different depths. A visual inspection of the cores showed no cracks or other visible surface deteriorations of each core, except core specimen R3 and R4 seems to have more air voids compared to other cores.

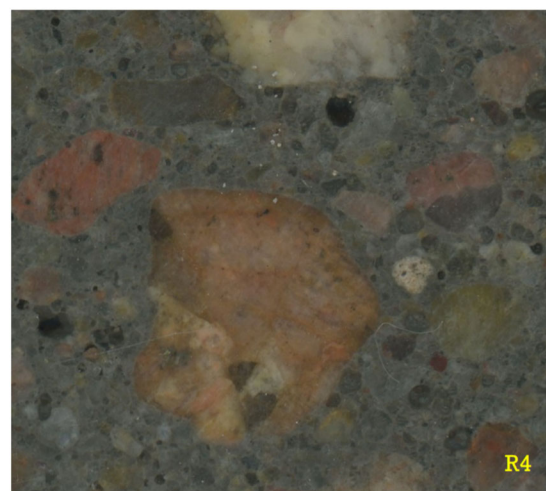
Figure 42. Microscope images of aggregate-cement paste bonding of core sample.

The main focus of the visual inspection was to indicate possible distress problems, due to dust coating from the aggregates, if any. The detailed results of the visual examination of each sample are shown in Table 27 in Appendix B-2. In addition, all samples were cut in a vertical plane in order to obtain a high-quality image of the cross-section of the sample to identify possible internal cracks, and assess the quality of aggregate-paste bonding. The results of the vertical cross-section of each of the obtained core specimens can be found in Appendix B-2. As can be seen from Figure 108, no apparent cracks or any other deteriorations were detected on the cross-section of each sample. An optical microscope was used to perform a more in-depth visual examination. As examples shown in Figure 42, the results of the core samples' visual examination revealed a possibility of aggregate dust coating appearance in sample R2, where no apparent dust coating was observed in sample R4.

b) Core sample R4

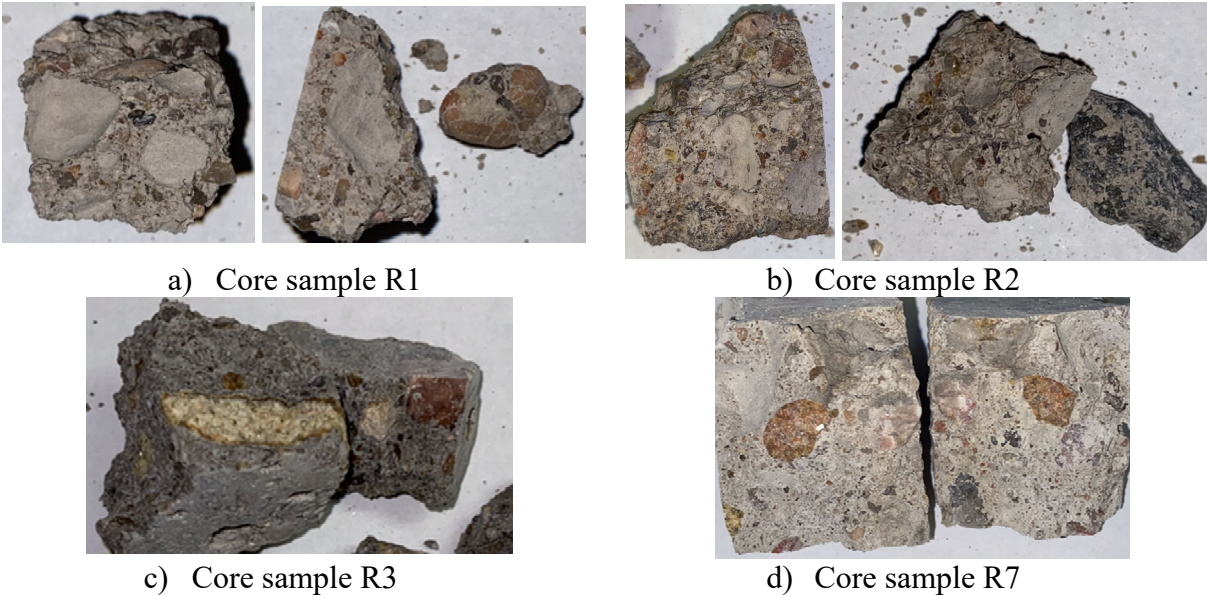
Figure 43. Examples of crushing patterns of core concrete specimens.

Further investigation by gently striking a portion of specimens with a hammer revealed that there might be some aggregate-cement paste bonding problems associated with samples R1 and R2, as the fracture mainly happened around aggregates particles. It was possible to separate aggregate pieces from cement paste with bare hands in core specimen R1 and R2, while the fracture of other samples (R3-R8) ended up breaking the aggregate pieces instead of the boundary (Figure 43).

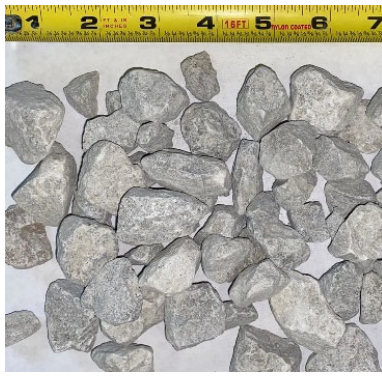
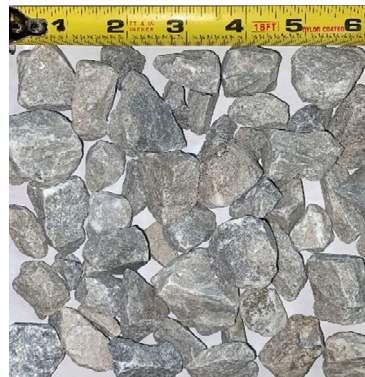
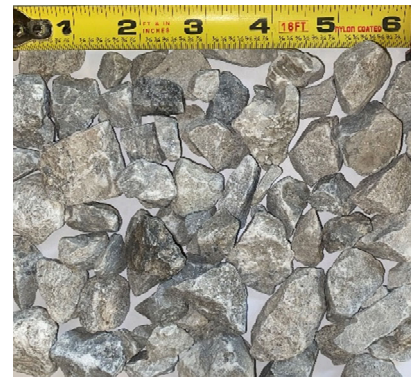
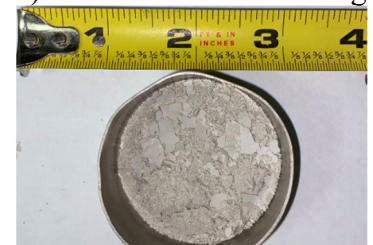
Figure 46. Limestone sample from Weeping Water, NE (LS_NEE1).

a) Before washing

b) After washing

c) After ultrasonic cleaning

f) Microfines collected after ultrasonic cleaning

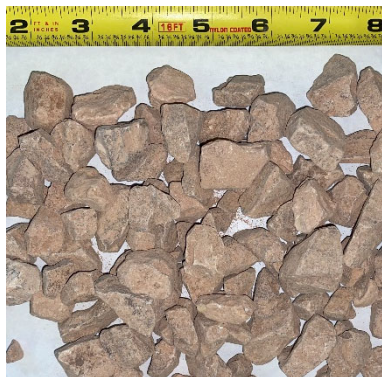
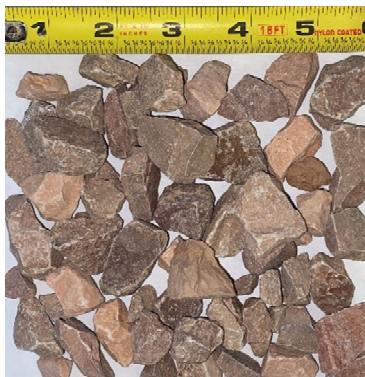
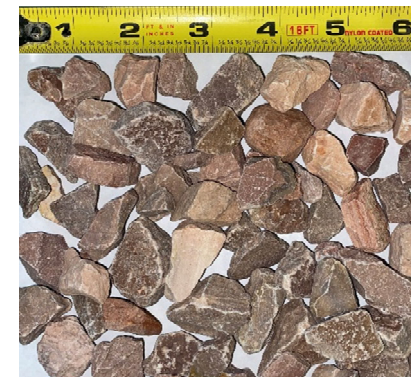
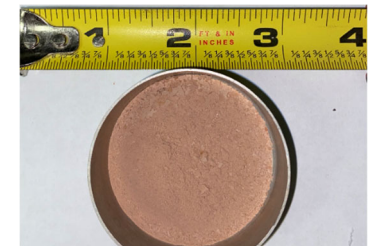
Figure 47. Quartzite sample from Rapid City, SD (QZ_SD).

a) Before washing

b) After washing

c) After ultrasonic cleaning

f) Microfines collected after ultrasonic cleaning

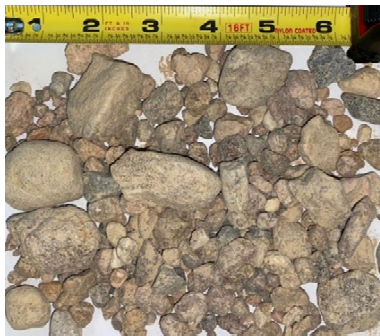
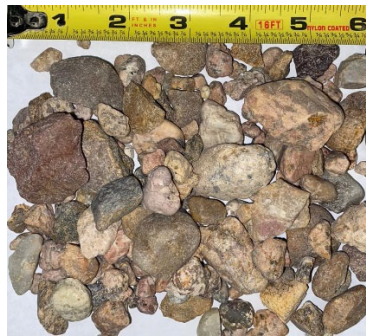
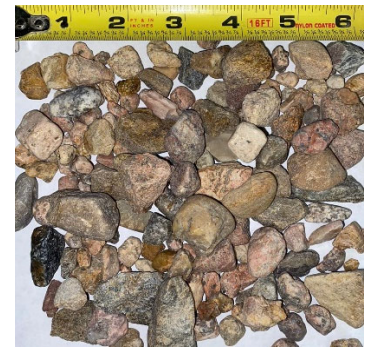
Figure 48. Gravel sample from Apex Dru Pit, Gering, NE (GR_NEW).

a) Before washing

b) After washing

c) After ultrasonic cleaning

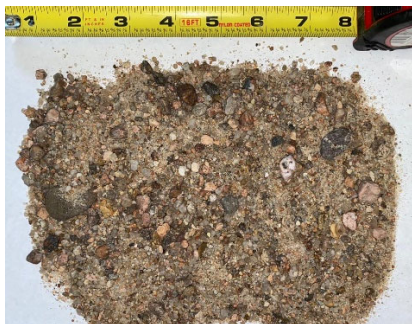
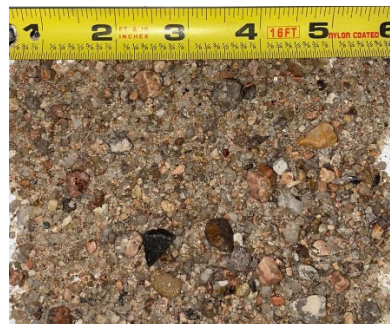
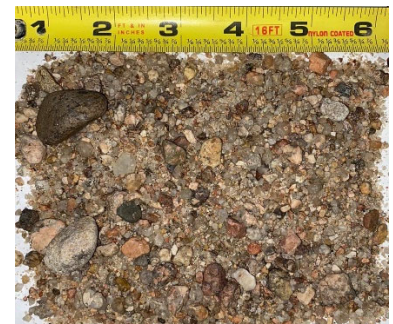
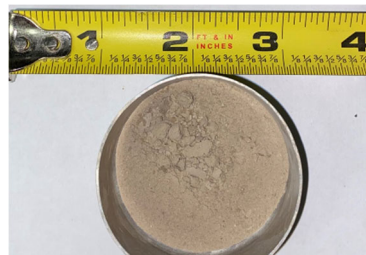
Figure 49. Sand and Gravel sample from Platte River Wet Pit, Platte River, NE (SG_NEC1).

a) Before washing

b) After washing

c) After ultrasonic cleaning

e) Microfines collected after washing

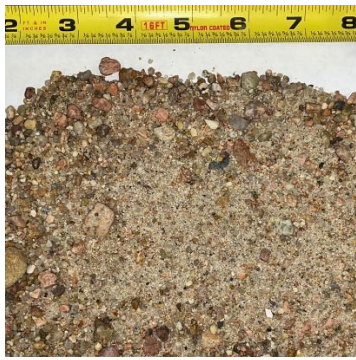
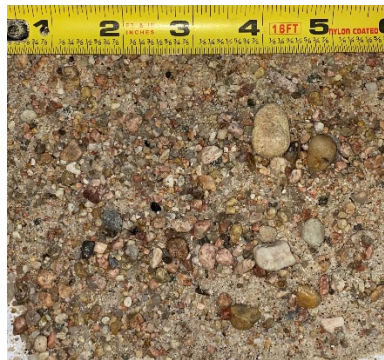
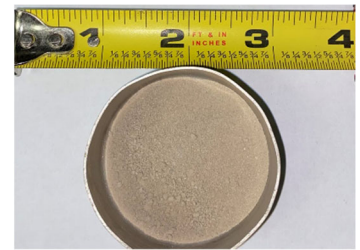
Figure 50. Sand and Gravel sample from Grant Island, NE (SG_NEC2).

a) Before washing

b) After washing

f) Microfines collected after ultrasonic cleaning

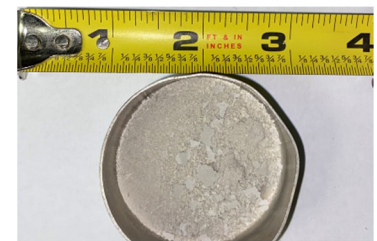
f) Microfines collected after ultrasonic cleaning

Figure 51. Limestone sample from East Nebraska (LS_NEE2).

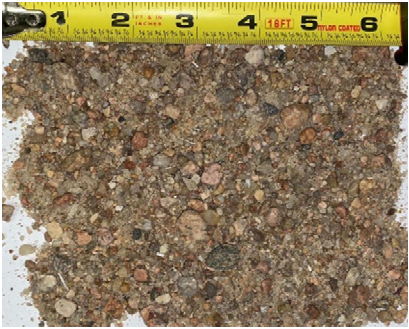
a) Before washing
SG_NEW_A

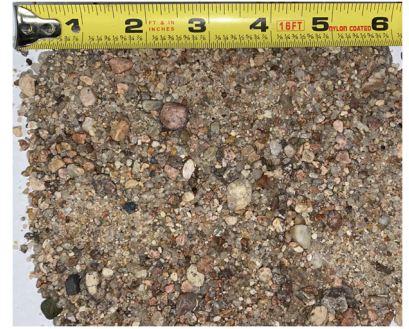
c) After ultrasonic cleaning
SG_NEW_D

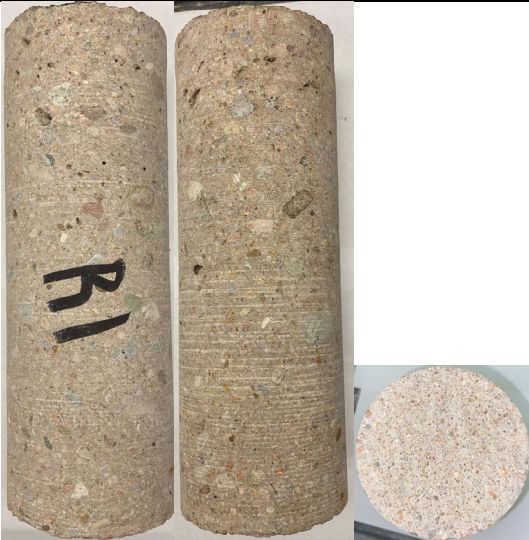
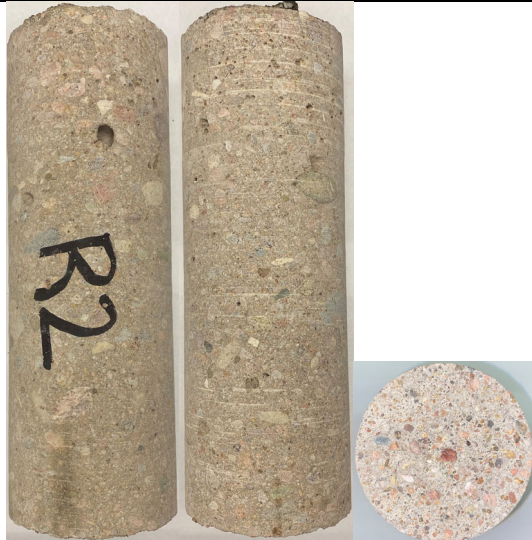
<p>R1 sample: Diameter: 4" Depth: 11" No apparent deterioration/soft substances</p>	<p>R2 sample: Diameter: 4" Depth: 11" No apparent deterioration/soft substances</p>

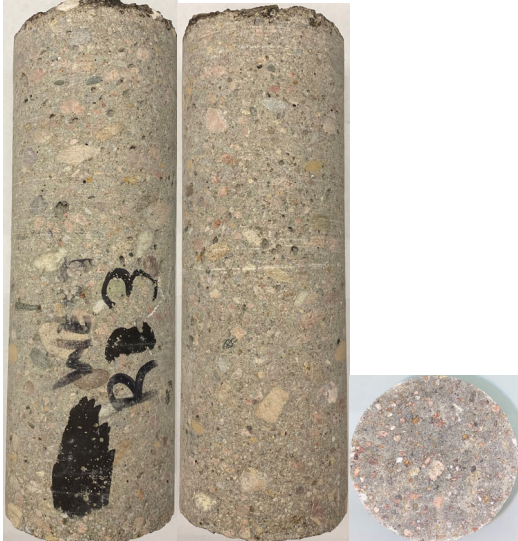
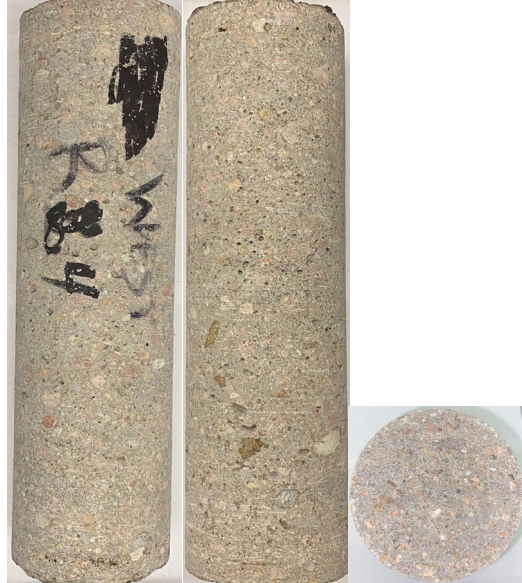
<p>R3 sample: Diameter: 4" Depth: 11" No apparent deterioration/soft substances</p>	<p>R4 sample: Diameter: 4" Depth: 13" No apparent deterioration/soft substances</p>

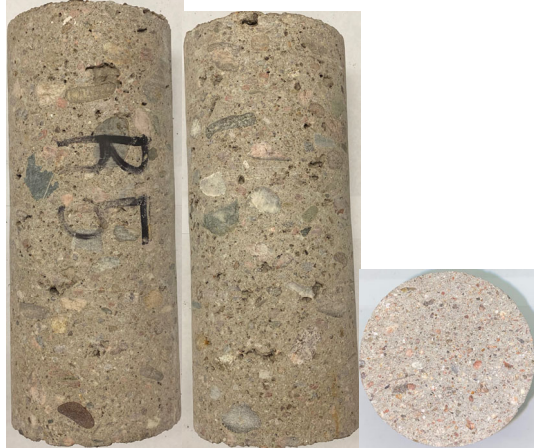
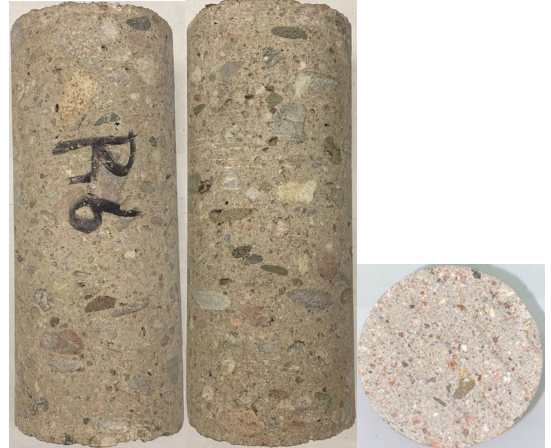
<p>R5 sample: Diameter: 4" Depth: 9" No apparent deterioration/soft substances A slight amount of voids/small cavities on the side surface</p>	<p>R6 sample: Diameter: 4" Depth: 9" No apparent deterioration/soft substances A slight amount of voids/small cavities on the side surface</p>

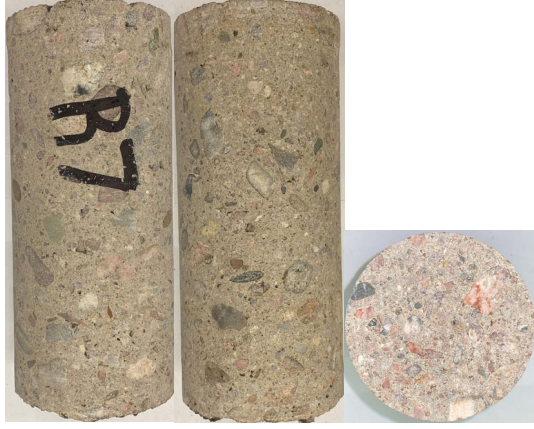
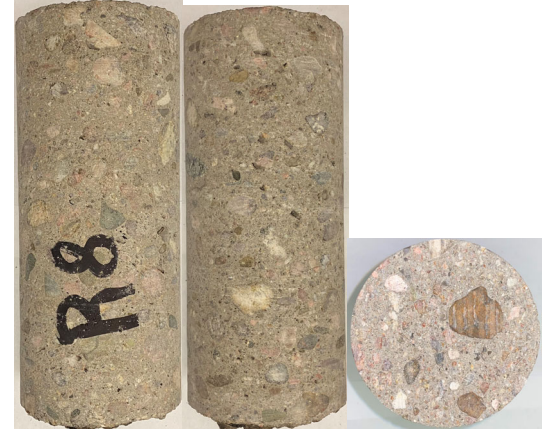
<p>R7 sample: Diameter: 4" Depth: 9" No apparent deterioration/soft substances A slight amount of voids/small cavities on the side surface</p>	<p>R8 sample: Diameter: 4" Depth: 9" No apparent deterioration/soft substances A slight amount of voids/small cavities on the side surface</p>
