JOINT TRANSPORTATION RESEARCH PROGRAM

Investigation of Durability and Performance of High Friction Surface Treatment

Wei, F., Wang, C., Tian, X., Li, S., & Shan, J. (2021). *Investigation of durability and performance of high friction surface treatment* (Joint Transportation Research Program Publication No. FHWA/IN/JTRP-2021/02). West Lafayette, IN: Purdue University. <https://doi.org/10.5703/1288284317281>

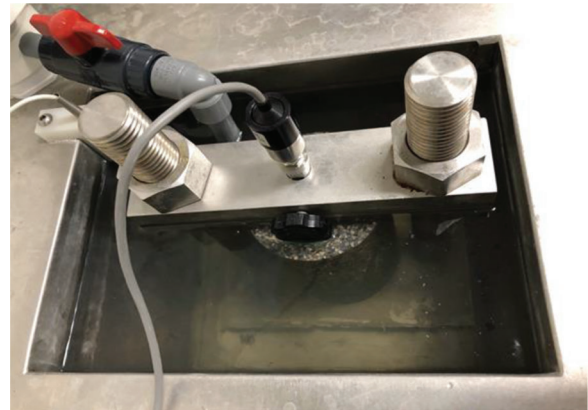
Figure 2.5 CTE test set-up.

demonstrated that the AASHTO T336 test method tends to yield lower CTE. The AASHTO T336 was utilized by the authors due to the test equipment available. Figure 2.5 shows the set-up of the transducer, i.e., linear variable differential transformer (LVDT) for measuring the CTE of HFST cylinder specimen. During the test, both calibration and verification tests were first conducted to ensure accuracy using metal specimens with a known CTE of $8.89 \times 10^{-6}/^{\circ}\text{F}$. The measured CTE was $9.06 \times 10^{-6}/^{\circ}\text{F}$, about 1.9% greater than the actual CTE value. This indicates that the test method and equipment were accurate.

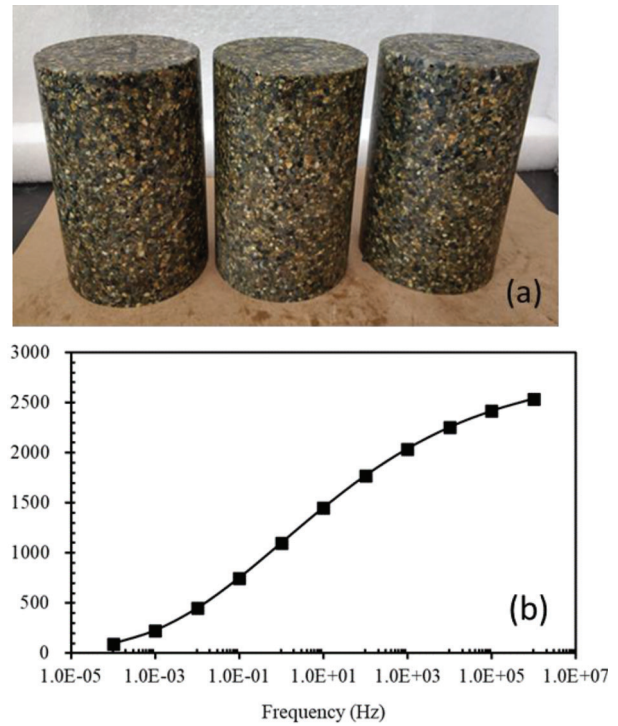
Figure 2.6 Dynamic modulus test: (a) cylinder specimens and (b) master curve.

10 Hz, 2 Hz, 1 Hz, 0.5 Hz, and 0.1 Hz) were used by the authors. Presented in Table 2.8 are the modulus test results for the epoxy-bauxite mortar. Phase angle is an ideal indicator to distinguish between the elastic and viscous properties of a typical material (Ferry, 1980). A phase angle of 0° represents a perfectly elastic material and a phase angle of 90° represents a perfectly viscous material. As shown in Table 2.8, both the dynamic modulus and phase angle did not experience any significant changes as the loading frequency increased from 0.1 Hz to 25 Hz at 14°F . The resultant phase angles are less than 3.12° , which indicates that the epoxy-bauxite mortar is essentially an elastic material at low temperatures. However, the effects of loading frequency and the phase angle increased as temperature increased. The phase angles at 99°F varied from 22° to 36° , depending on the loading frequency, a huge increase as compared to the phase angle at 14°F . Therefore, the epoxy-bauxite mortar is a viscoelastic material, particularly at a temperature of 70°F or higher.

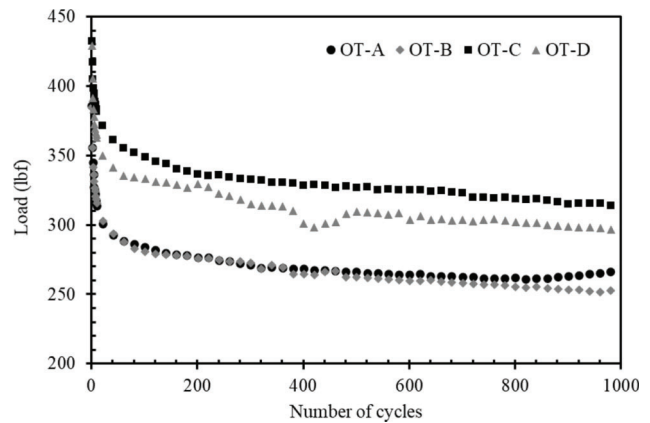
Figure 2.8 Load reduction curves.

maximum load ranging from 384 pounds to 432 pounds. As illustrated in Figure 2.8, the load reduction during the test was not significantly after 1,000 load cycles. Presented in Table 2.10 are the overlay test results for these four specimens. The average load reduction of HFST is about 31.62%, indicating that this type of material has very good cracking resistance. The crack progression rate (CPR), commonly used to assess the cracking property during the crack propagating (Garcia et al., 2017), was also calculated from the load reduction curves. The average CPR is 0.046, which indicates a very good anti-cracking performance for the tested HFST epoxy-bauxite mortar.

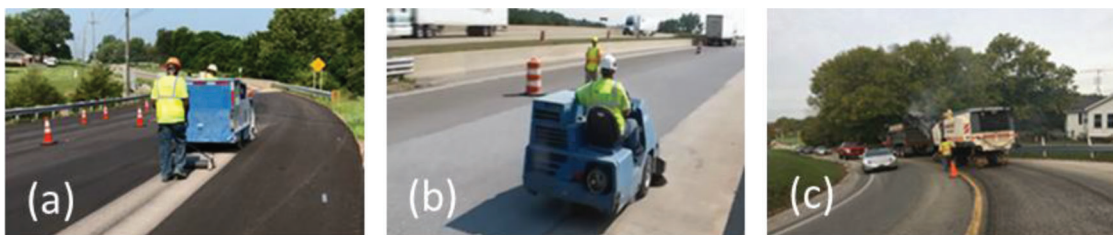
Figure 3.1 Photos of surface preparation operations: (a) shotblasting, (b) sweeping, and (c) scarification.

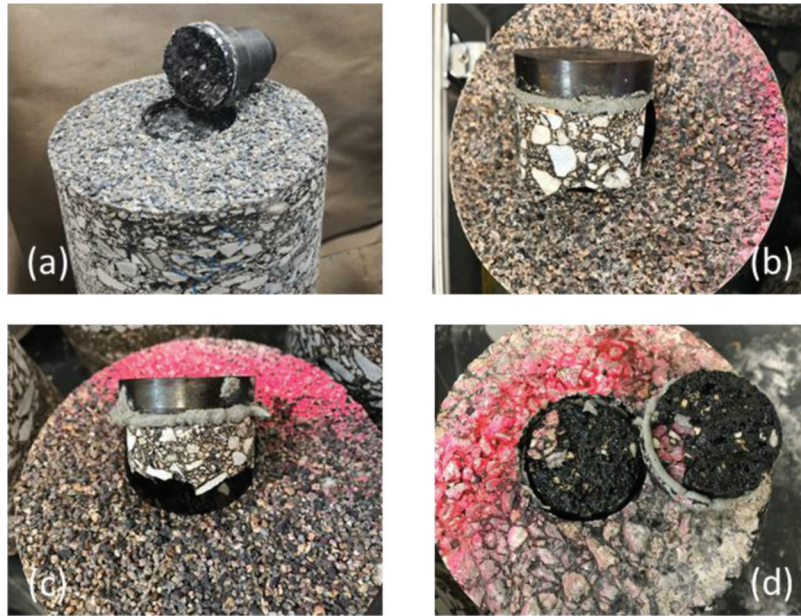
Figure 3.2 Photos of failed samples after pull-off testing: (a) HFST with scarification milling, (b) HFST with vacuum sweeping, (c) HFST with shot-blasting, and (d) chip seal pavement.

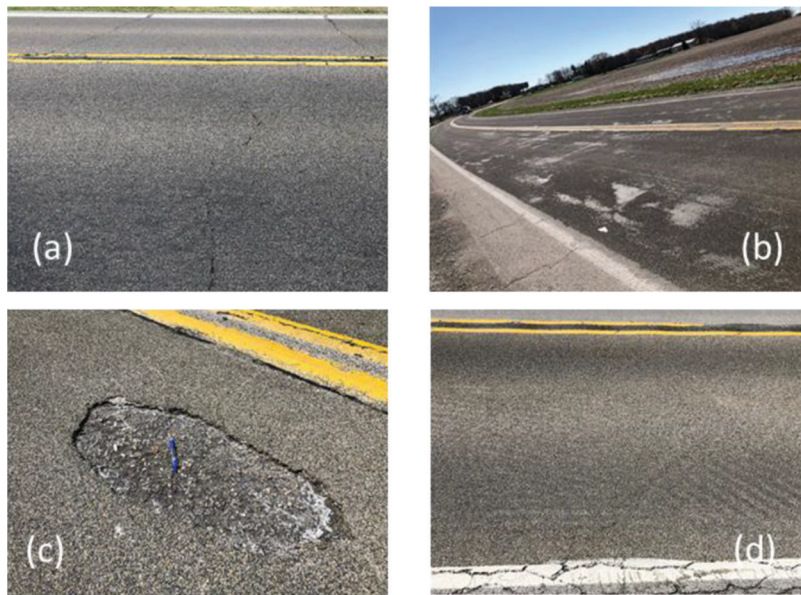
Figure 3.3 Most common early HFST distresses: (a) cracking, (b) aggregate loss, (c) delamination, and (d) surface wrinkling.

- *Most common early distresses in HFST.* The most common early HFST's distresses in Indiana are reflective cracking, aggregate loss, delamination at the interface of chip seal-HMA pavement beneath HFST, and surface wrinkling (slippage). Any discontinuities in the existing pavement surface, including cracks, pothole patches, and alligator repair patches, will reflect through HFST. The above may be extended to imply that there are tangible benefits to placing HFST on new pavements. Aggregate loss is likely to occur in an HFST when the existing pavement is pretreated by scarification milling due to insufficient epoxy binder, when the HFST is installed at low temperatures, or both. Delamination at the chip seal-HMA interface tends to occur when the chip seal surface is pretreated by scarification milling. Surface wrinkling tends to occur due to the combined effect of large traffic loads, low temperature installation, and steep superelevation.

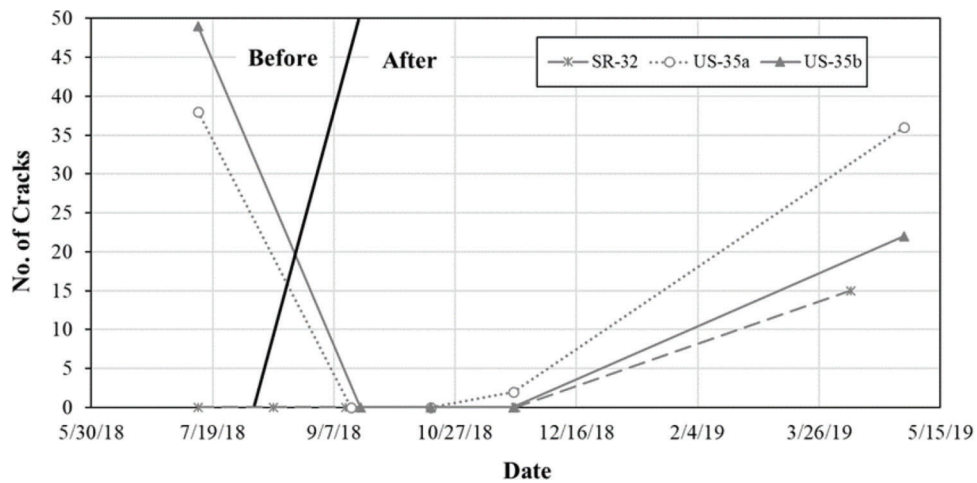
Figure 3.5 Illustration of cracking development trends.

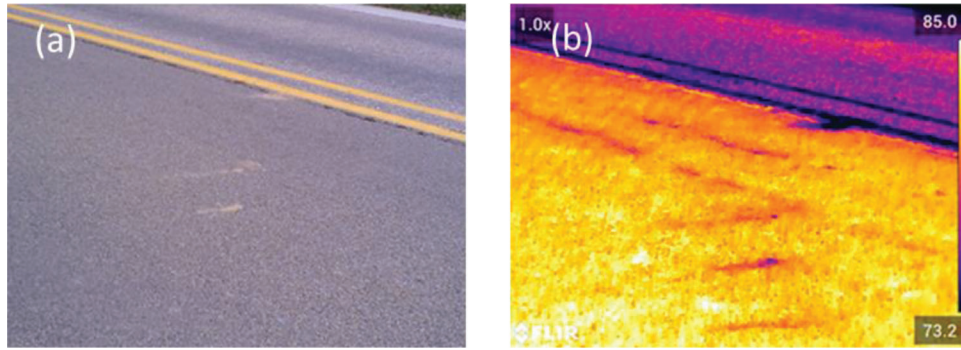
Figure 3.6 Photos of HFST cracks in the same area: (a) digital image and (b) infrared image.

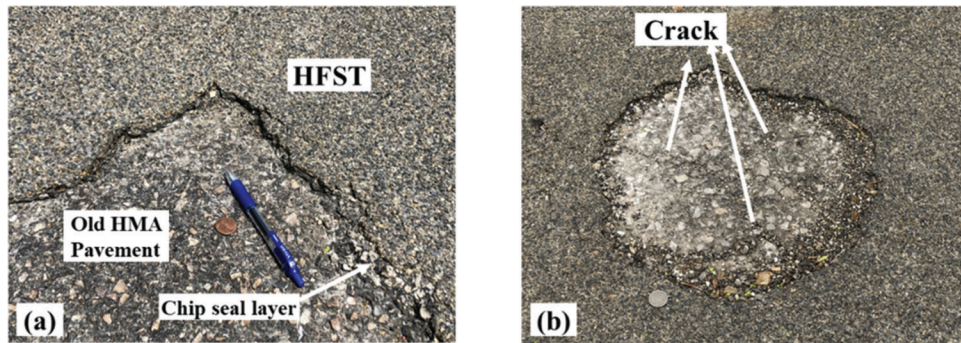
Figure 3.8 Photos of HFST surface delamination: (a) position of delamination and (b) cracks presented.

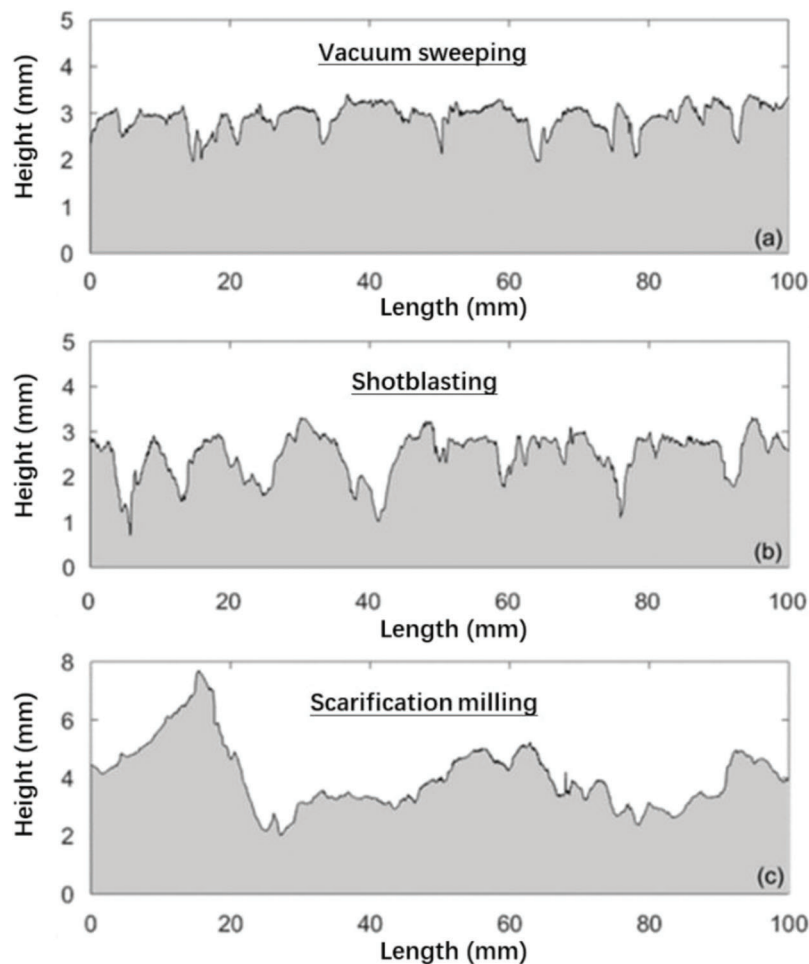
Figure 4.2 Macro-texture profiles on three pavement surfaces after different pretreatments.

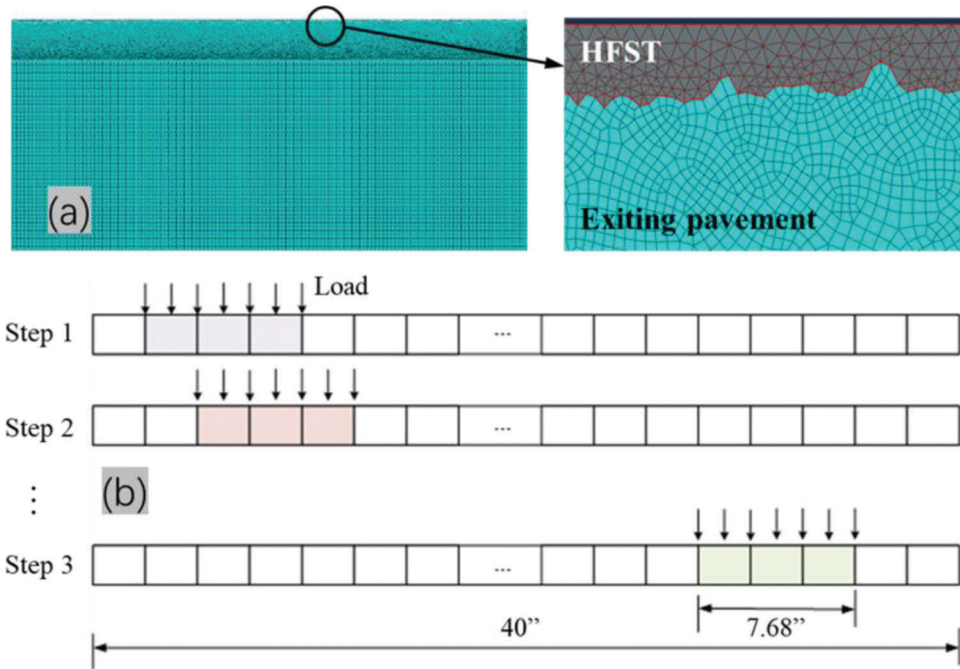
Figure 4.3 The FE model: (a) meshing and (b) moving load and steps.

Figure 4.3(a) demonstrates the meshing in the 2D FE model. The 3-node linear plane stress triangle (CPS3) finite elements with a mesh size of 0.04" were assigned

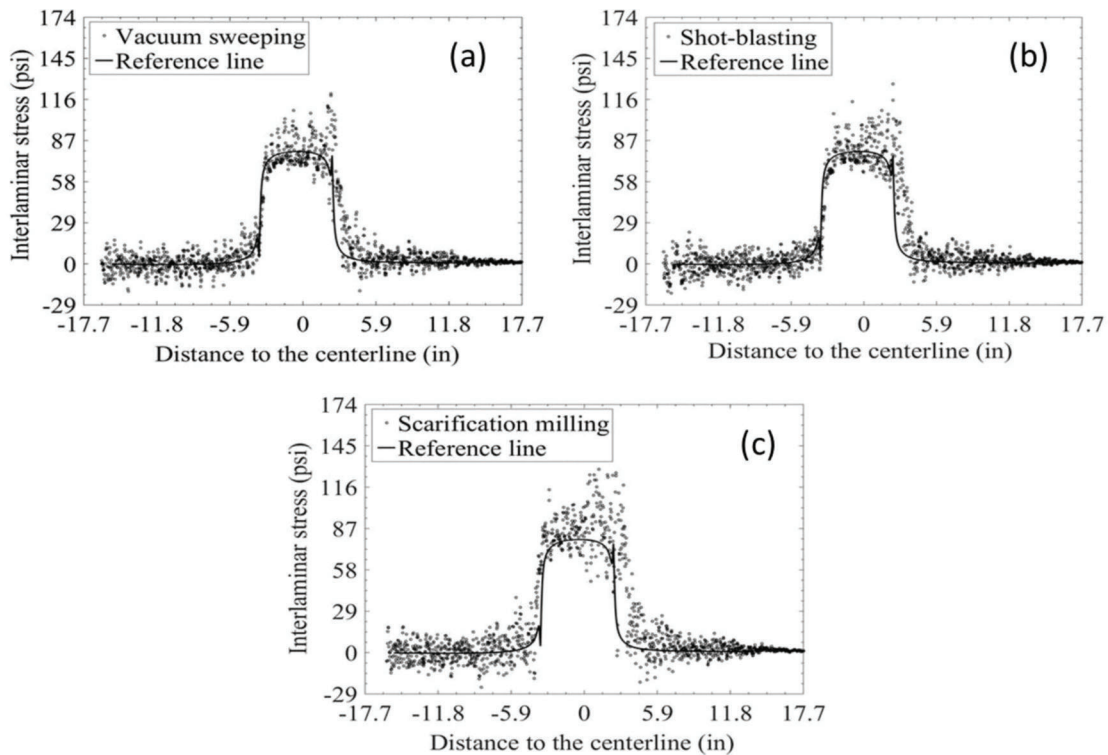
Figure 4.4 Interlaminar stress with different surface pretreatments: (a) no pretreatment, (b) shotblasting, and (c) scarification milling.

Presented in Figure 4.4 are the interlaminar stresses with different pretreatments when the vehicle load was applied at the center of the FE model. The maximum interlaminar stress in the reference model is equal to the braking force of 86 psi. When the surface texture was included in the FE model, however, noticeable stress concentrations occurred, depending on the texture characteristics of the pre-treated surfaces. The above confirms that comparing the interlaminar stresses is a reasonable way to determine the effect of pretreatment. The stress concentrations occurred along the entire

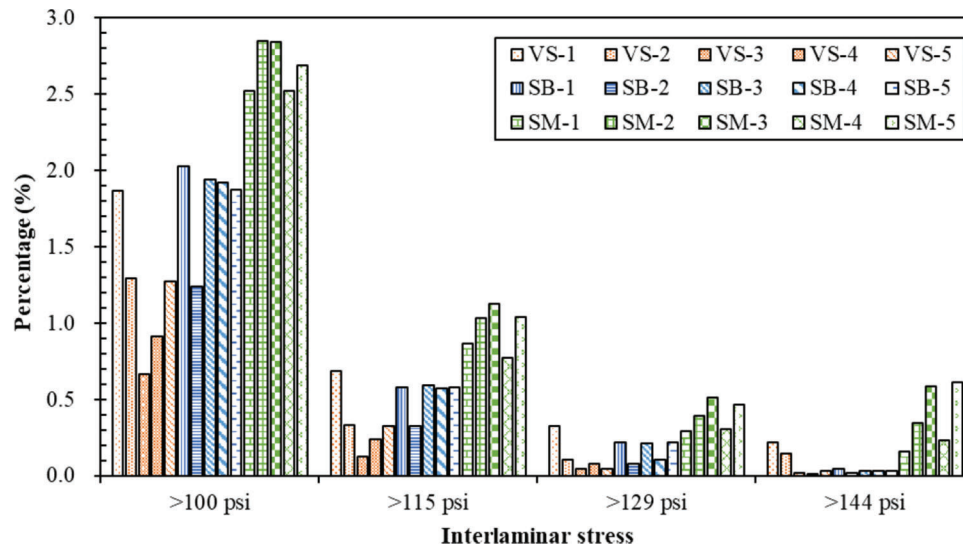
Figure 4.5 Percentage of interlaminar stress higher than threshold values.

To further examine the percentages of high interlaminar stresses with different pretreatments, Figure 4.5 shows the percentages of interlaminar stresses in four categories, i.e., greater than 100 psi, 115 psi, 129 psi, and 144 psi, respectively. The percentages of high stresses with scarification milling were always greater than those with either vacuum sweeping or shotblasting in all four categories. However, the percentages of high stresses with shotblasting were higher than those with vacuum sweeping in all categories except for the category greater than 144 psi. In the category greater than 144 psi, the percentages of high stresses with vacuum sweeping were

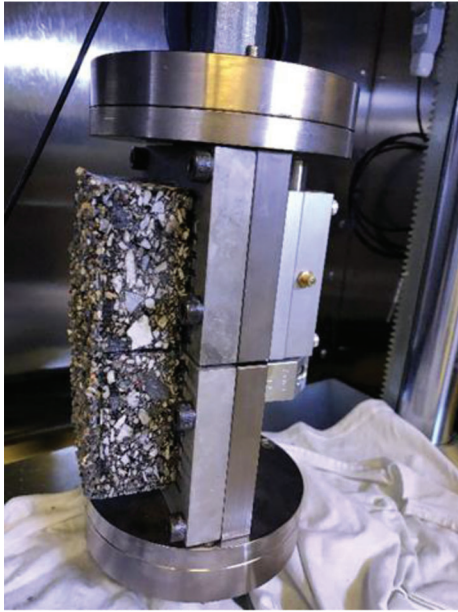
Figure 4.9 Setup of laboratory overlay test.

Reflective cracking is one of the main distresses in HFST, which affects the HFST's durability. Laboratory overlay test was used to investigate the causes and development of reflective cracking in HFST. Details about the overlay test can be found elsewhere (TxDOT, 2008). Figure 4.9 is the setup of the laboratory overlay test. The specimen was glued to the metal plates using epoxy binder. The test temperature was $77 \pm 1.0^\circ\text{F}$. The specimen was placed in a temperature chamber for a minimum of one hour before testing. Because a 93% reduction of the maximum load did not occur for all specimens during the tests, load conditionings were terminated after 1,000 loading cycles was reached. In addition, two parameters, including the maximum peak load (MPL) and maximum load reduction (MLR), were calculated at the end of test for each specimen. MPL has been used to evaluate the tensile strength of the specimens. The higher the MPL, the stiffer the specimen. The MLR has been used to assess the anti-reflective cracking ability. The lower the MLR, the higher the cracking resistance. To the authors' knowledge, for two

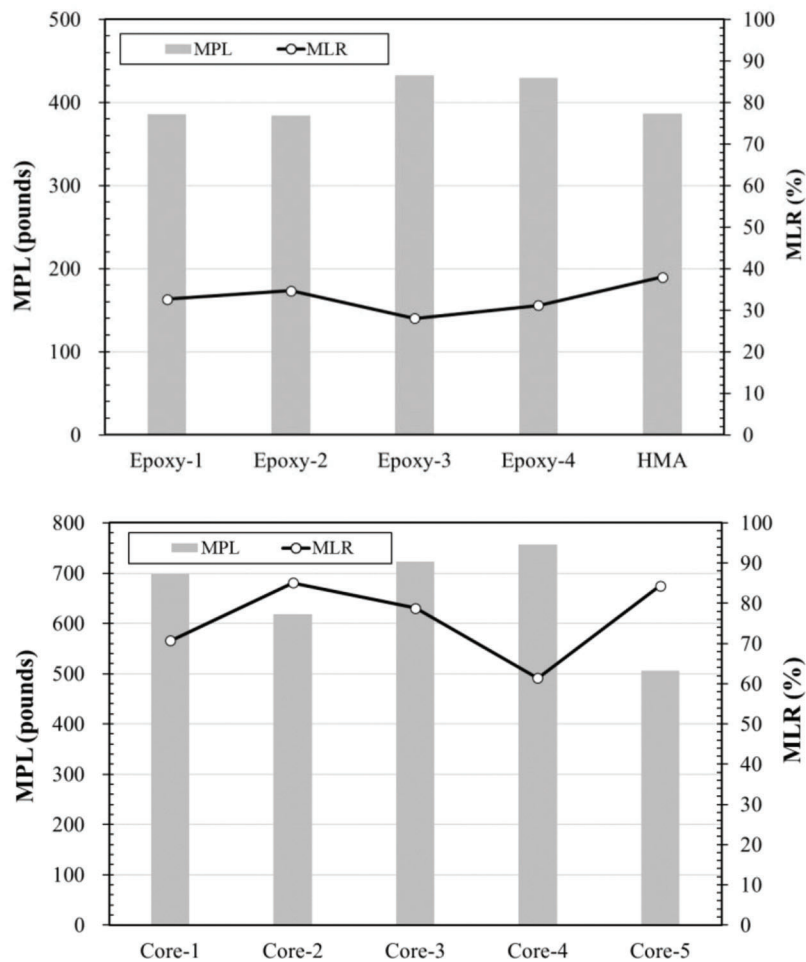
Figure 4.10 MPL and MLR for epoxy-bauxite mortar, HMA, and HFST-HMA.

Presented at the top of Figure 4.10 are both the MPL and MLR of epoxy-bauxite mortar and HMA specimens, respectively. It is shown that there is little difference in both the MPL and MLR between these two materials. The average MPL and MLR, respectively, are 407 pounds and 31.6% for epoxy-bauxite mortar. For the HMA specimen, its MPL is slightly lower and its MLR is slightly higher. Presented at the bottom of Figure 4.10 are the results from the laboratory overlay tests conducted on the HFST-HMA specimens made from field HFST cores. Each HFST-HMA specimen consisted of both an HFST layer and an HMA layer. It is shown that the average MPL is 661 pounds, significantly higher than that of both the epoxy-bauxite mortar and HMA specimens, which indicates that the HFST-pavement specimens were much stiffer. The average MLR of HFST-HMA is around 76.1%, which is expected.

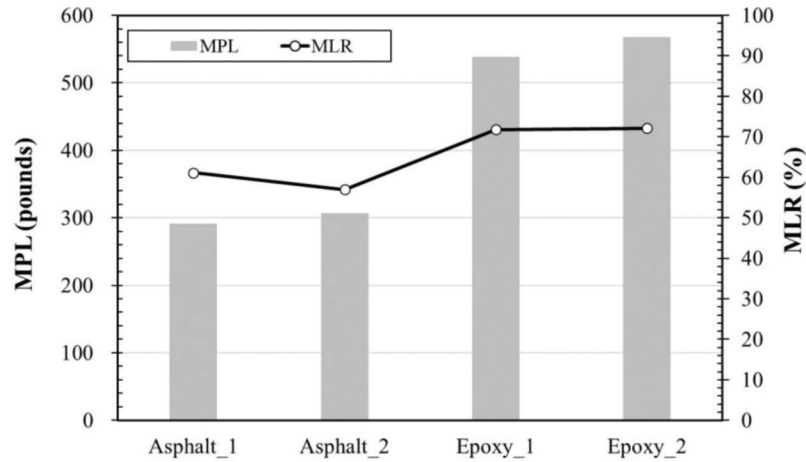
Figure 4.12 MPL and MLR for cracks treated with hot asphalt and epoxy binder.

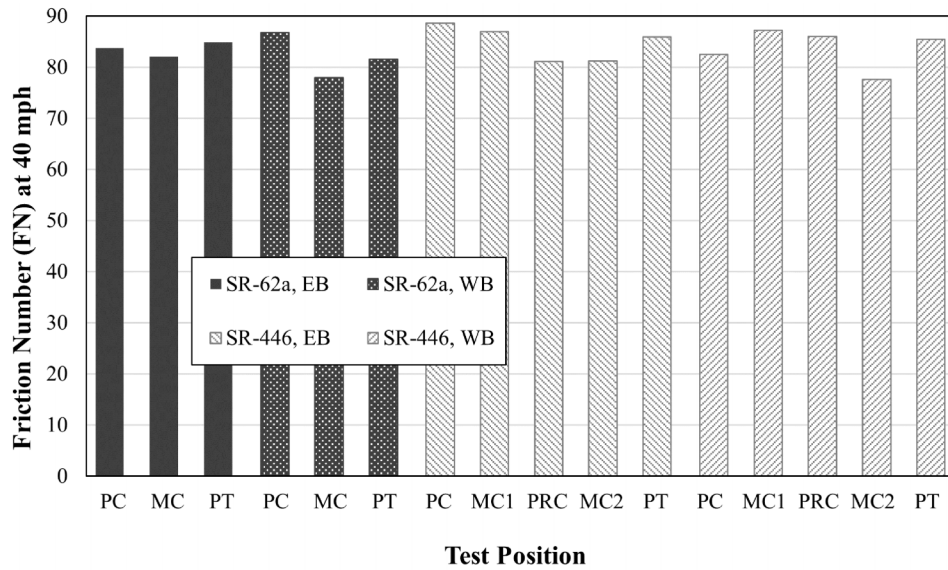
Figure 5.6 Friction measurements: (a) SR-62a (simple curve) and (b) SR-446 (reverse curve).

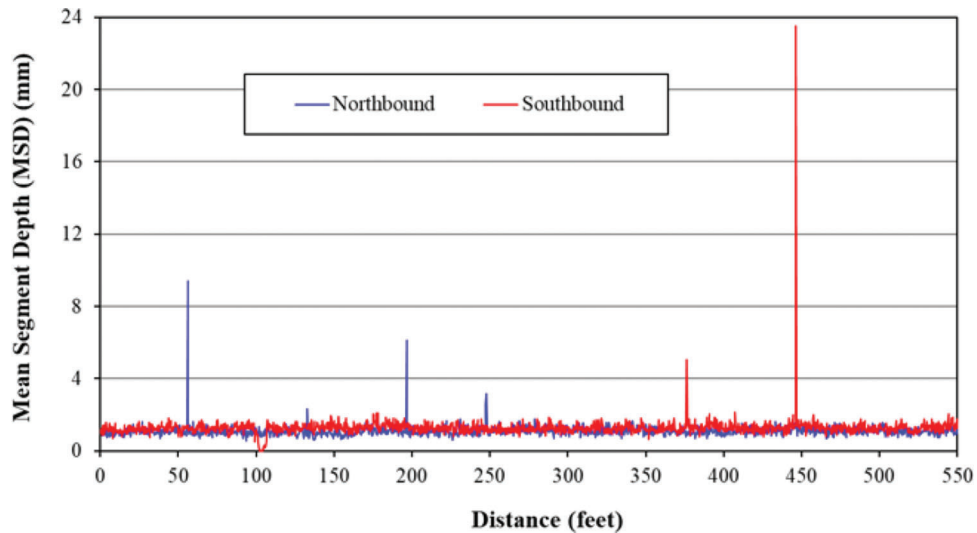
Figure 5.10 Mean segment depth (MSD) measurements of HFST at SR-43.

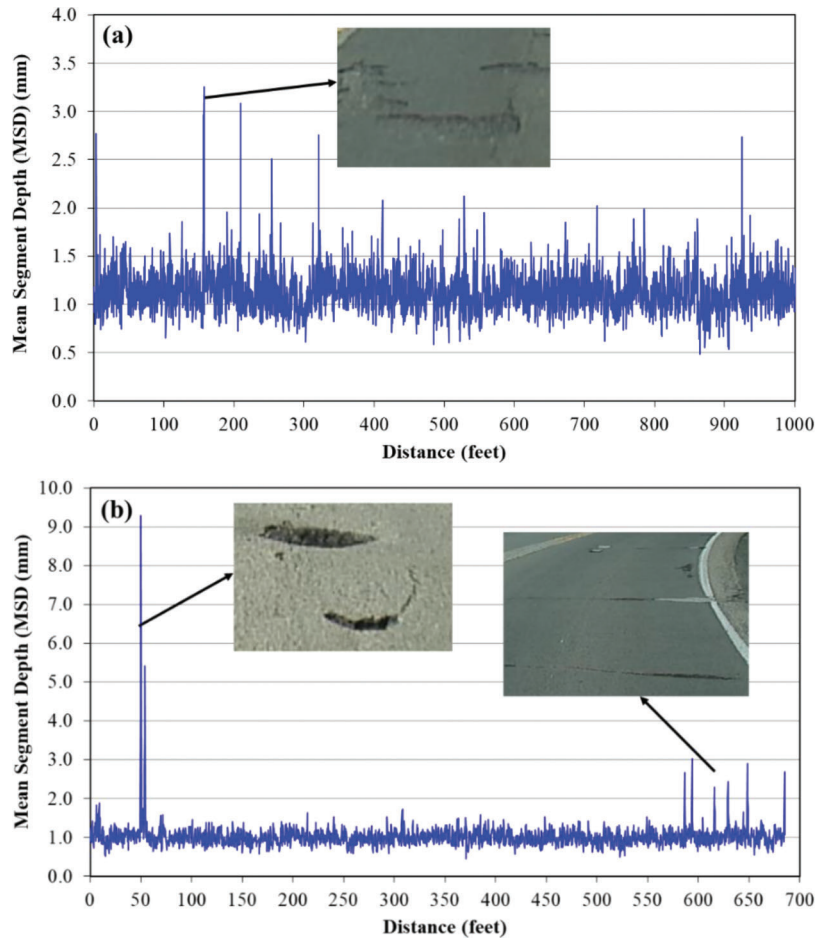
Figure 5.11 Causes for spikes in mean segment depth (MSD) measurements: (a) delamination, US-24b and (b) crack spalling, SR-23.
