Traffic Control Device Analysis, Testing, and Evaluation Program: FY2019 Activities

Technical Report 0-6969-R2

TEXAS A&M TRANSPORTATION INSTITUTE
COLLEGE STATION, TEXAS

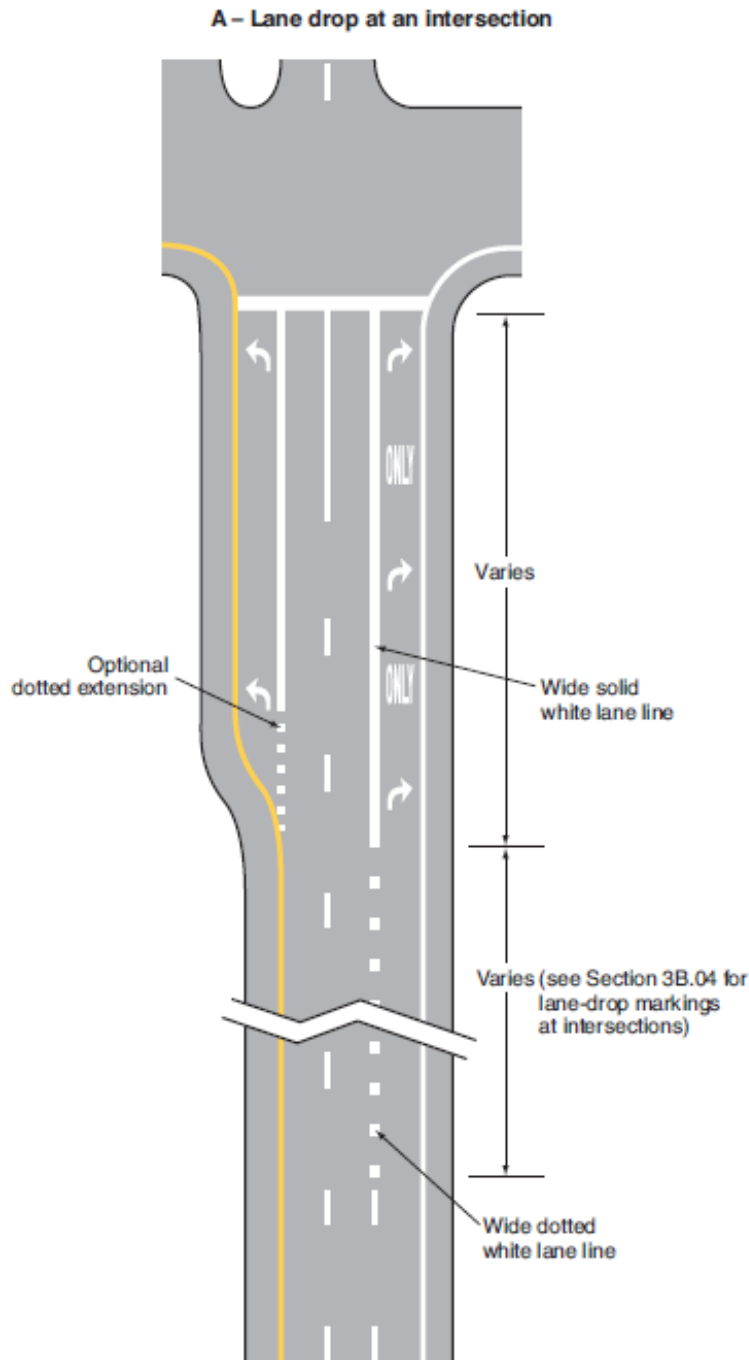
Figure 6. Texas MUTCD Figure 3B-11 Sheet 1 (5).

signs. For through lanes that change to turn-only lanes, the ONLY word markings (seen in both Figure 6 and Figure 7) should also accompany the lane-use arrow markings and the appropriate signs. The markings and signs should be placed well in advance of the turn and repeated as necessary to avoid being unseen during queues, as demonstrated in Figure 6.

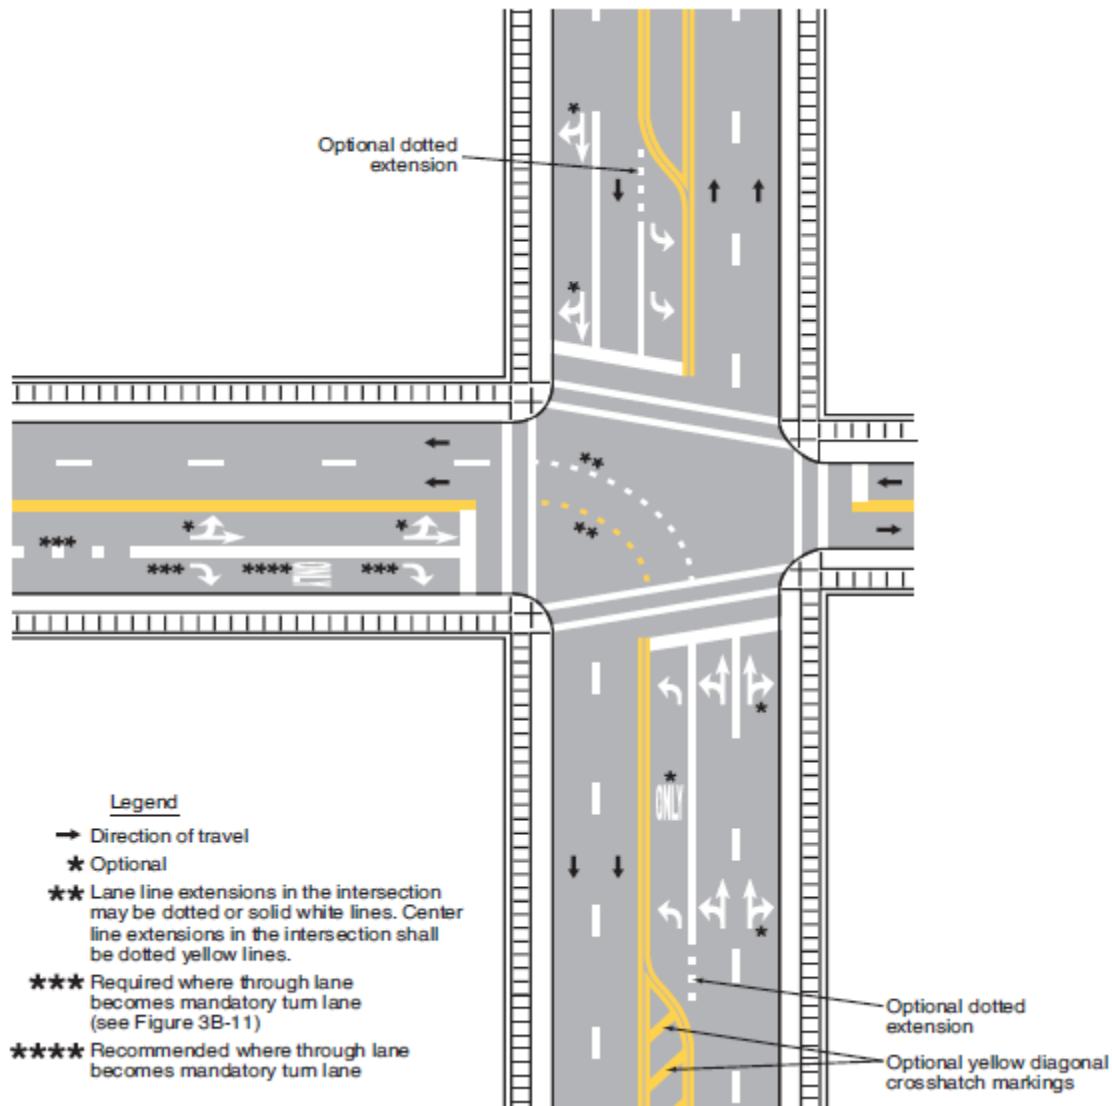
Figure 7. Texas MUTCD Figure 3B-27 (5).

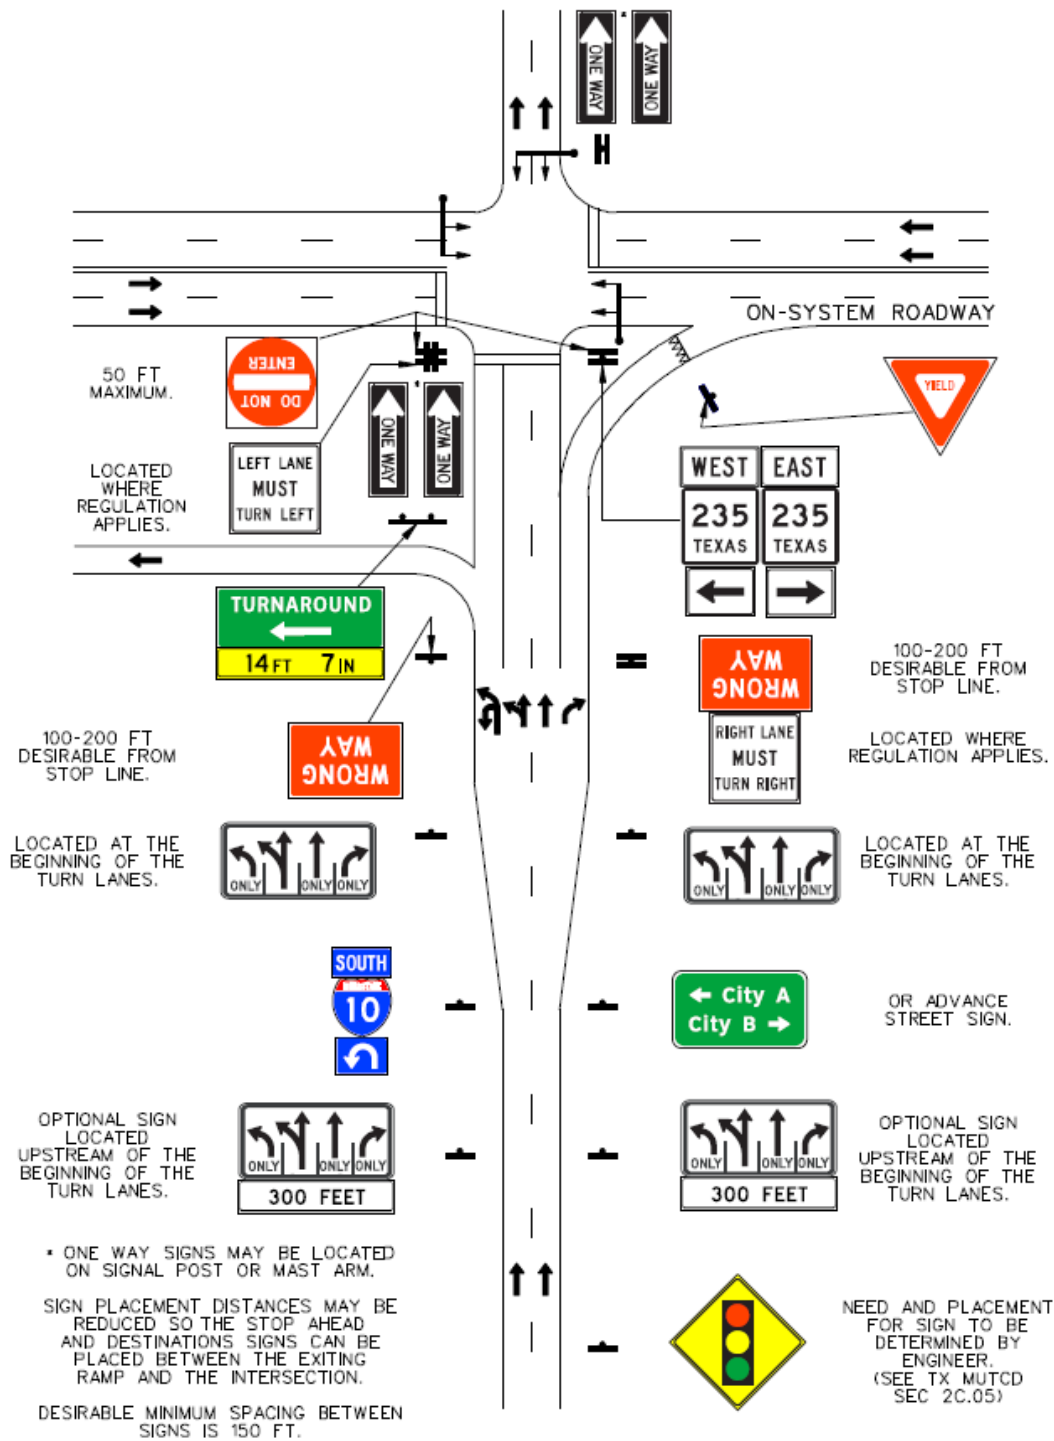
Figure 8. Frontage Road Approach Signing for a Two-Lane Approach with Left-Turn/Turnaround Bay, Right-Turn Bay, and Signal Control (6).

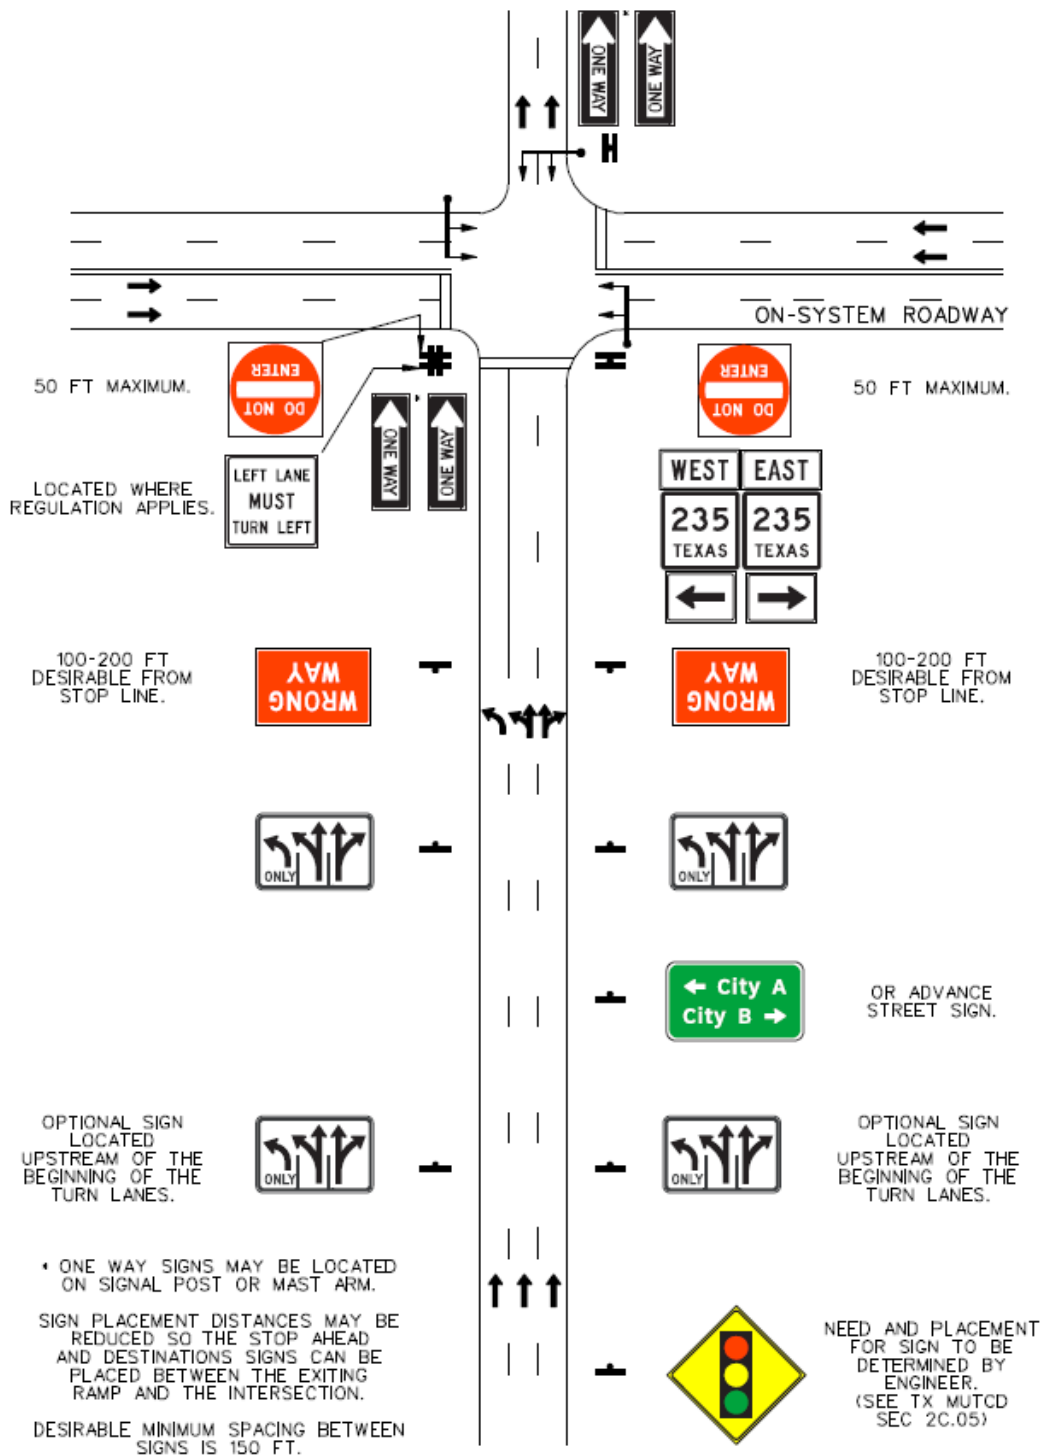
Figure 9. Frontage Road Approach Signing for a Three-Lane Approach with Left-Lane Drop and Signal Control (6).

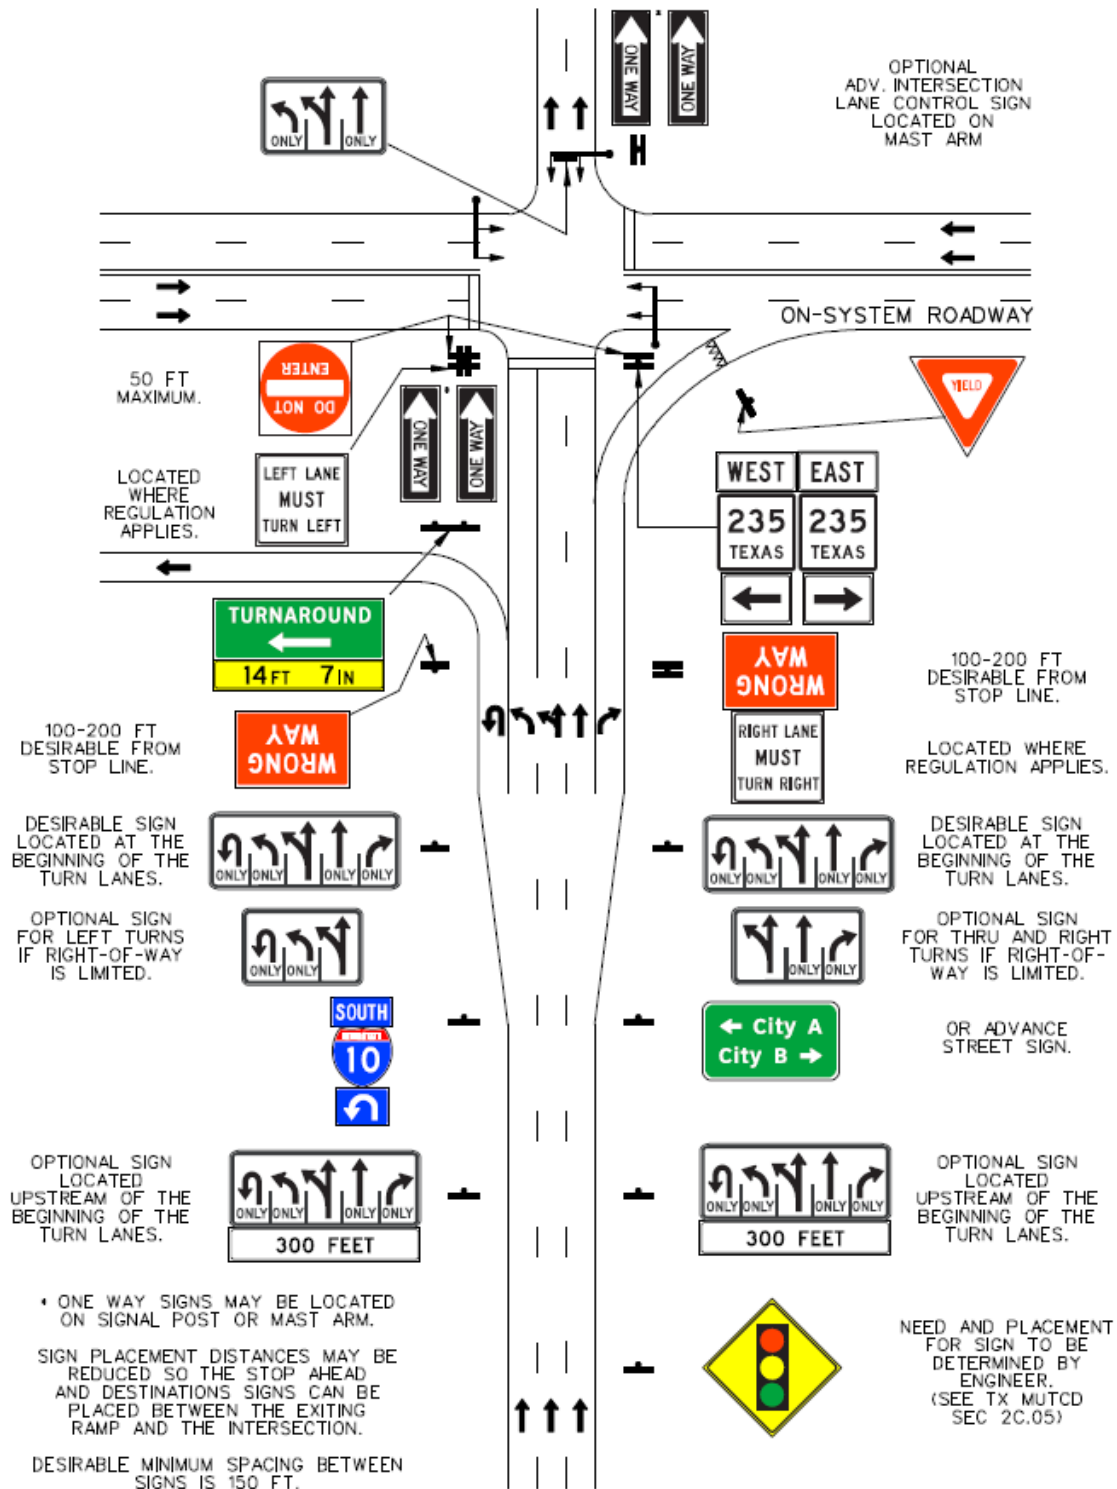
Figure 10. Frontage Road Approach Signing for a Three-Lane Approach with Turnaround Bay, Left-Lane Drop, Right-Turn Bay, and Signal Control (6).

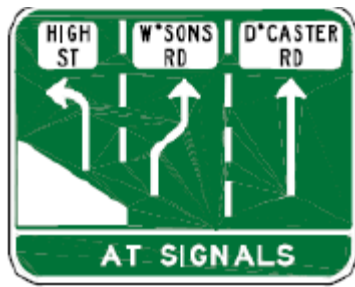
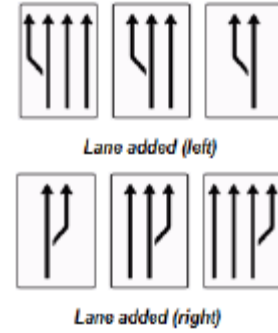
Figure 11. International Lane Assignment Signs for Flared Approaches (12).

In 2010, TTI completed a research project that investigated how best to sign approaches to diamond interchanges (12). Researchers identified international practices of lane assignment with signs and pavement markings from Australia, New Zealand, the United Kingdom, and Germany. Researchers found a common theme among several of the countries of using trap lane signs, which use arrows to illustrate through, shared, and turn-only movements for flared approaches. Figure 11 contains examples of international lane assignment signs.

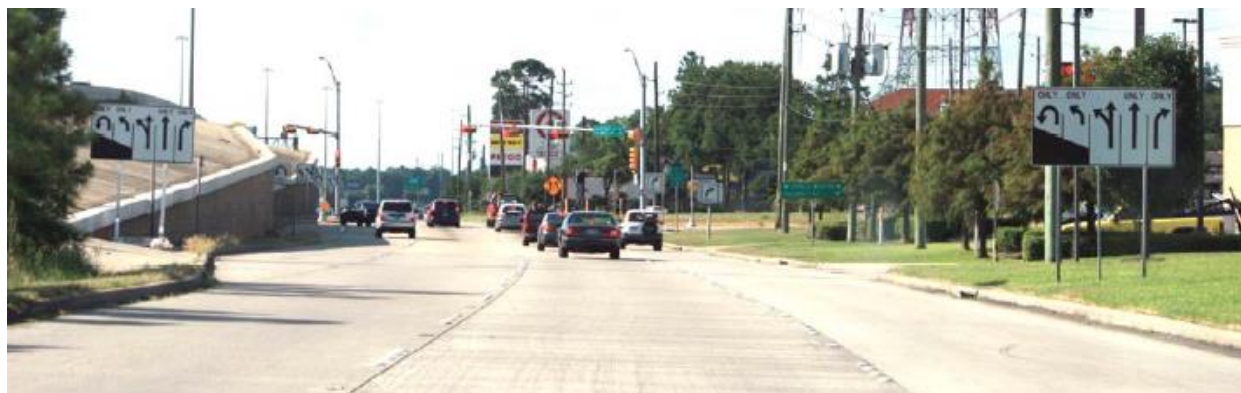
Figure 13. Set of Alternative Advanced Intersection Lane Control Signs at IH-45 Southbound at Cypresswood Drive in Houston (12).

Field study findings revealed only a slight reduction in the number of illegal movements at the intersection. In addition, the number of lane changes nearest the intersection remained relatively the same. However, the total number of lane changes in the entire area of interest (from the stop line at the intersection to 1635 ft upstream of the stop line) decreased, leading researchers to assume that drivers were making lane changes farther upstream (outside of the data collection area).

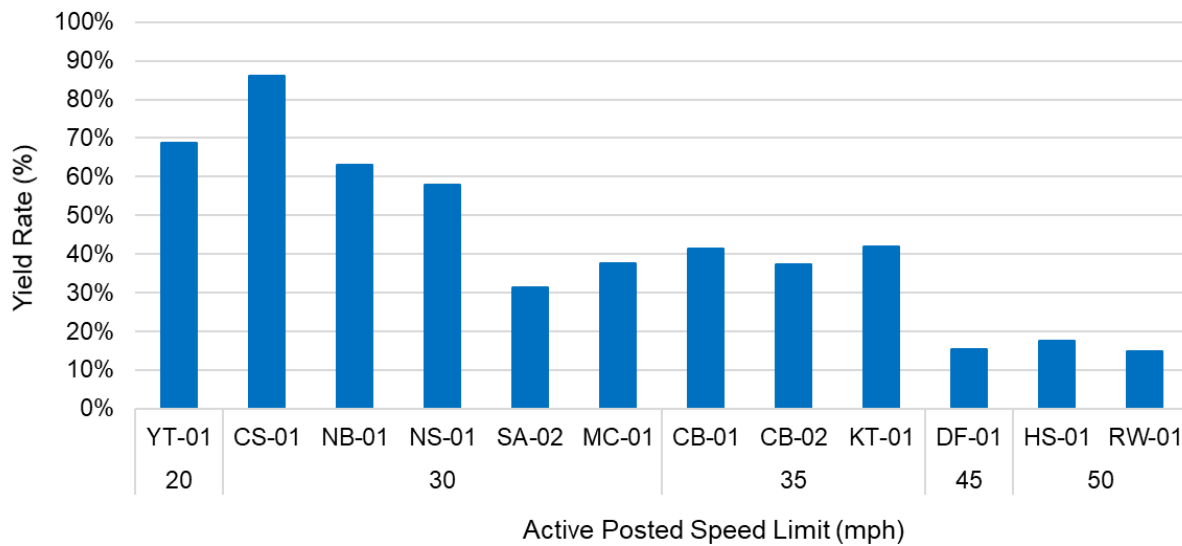
Figure 20. Driver Yield Rates by Active Posted Speed Limit for Staged Crossings

The graphs illustrate an inverse relationship between the yield rate percentage and speed. The main finding from this exploration is that seemingly, with higher operating speeds, the yield rates for the LED-Em signs decrease. Five of the sites had an active speed limit of 30 mph with a range of driver yielding between 86 and 31 percent, which implies that aside from speed, there are other factors contributing to the yield rate differences among sites.

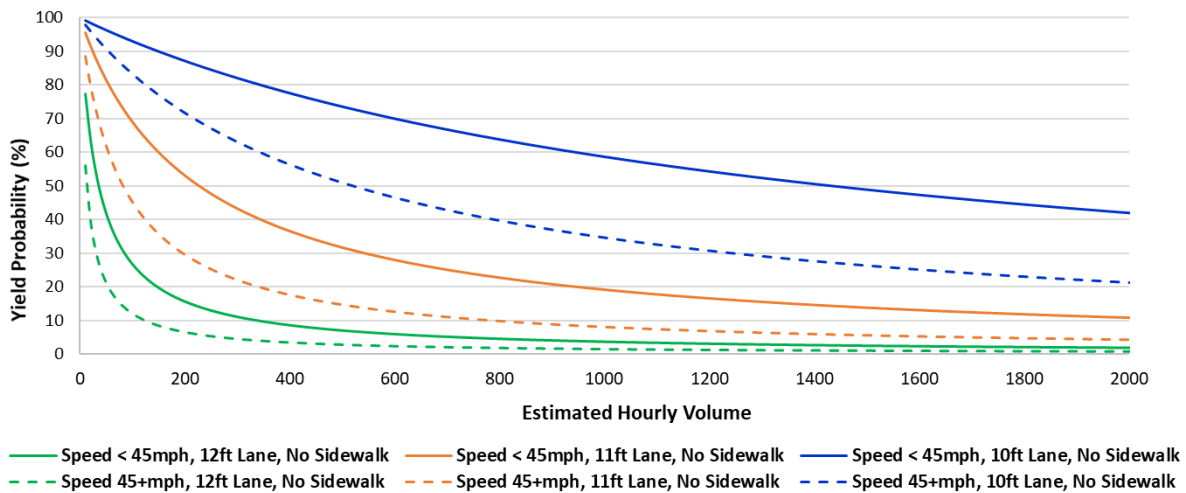
(a) Sidewalks

(b) No Sidewalks

Figure 21. Yield Probability for Driver Yielding Based on Hourly Volume, Operational (85th Percentile) Speed, Lane Width, and Sidewalk Presence.

starts to level out for volumes of greater than 600 vehicles per hour, especially in the case of a combination of no sidewalks, 12-ft lanes, and 85th percentile speeds of 45 mph or greater.

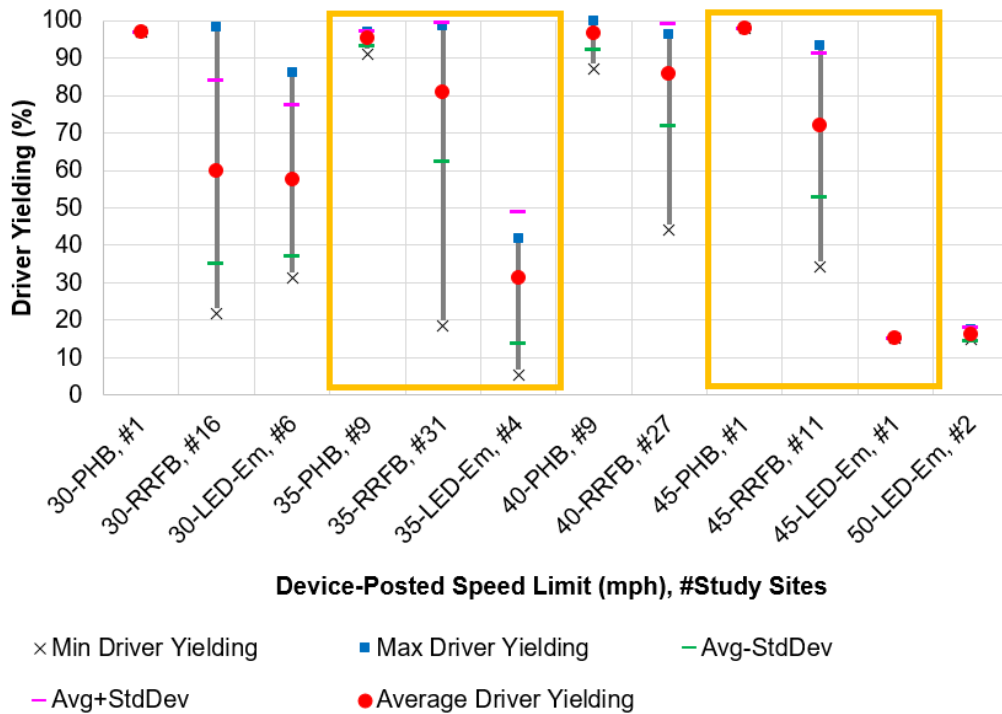
(a) Driver Yielding Statistics, Grouped by Type of Device

(b) Driver Yielding Statistics, Grouped by Posted Speed Limit

- A direct comparison is not possible for posted speed limits of 40 mph and 50 mph due to the lack of LED-Em sign sites with a posted speed limit of 40 mph and the lack of PHB and RRFB sites with a posted speed limit of 50 mph (see Figure 22b).

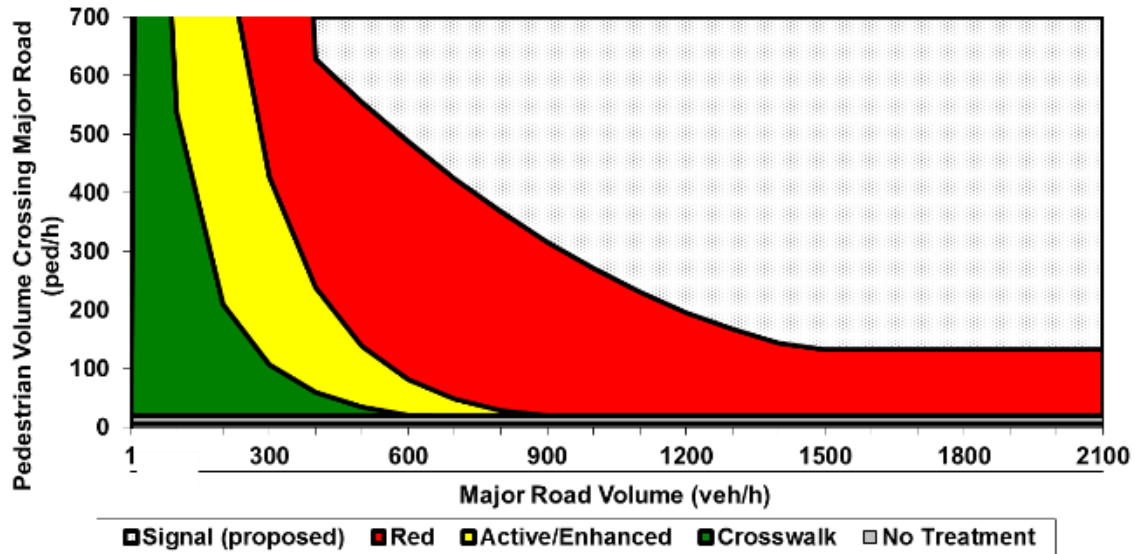
Figure 26. Example of Graph Generated from TCRP 112/NCHRP 562 Methodology (Function of Walking Speed, Crossing Distance, and Other Variables) That Could Be Used to Determine Pedestrian Treatment.

Figure 26 shows an illustration of a graph that can be generated from the NCHRP 562/TCRP 112 methodology using an assumed crossing distance and other variables. The user would then consider the major road volume and the pedestrian volume to determine the appropriate type of pedestrian treatment for the site. The graph in Figure 26 may be dated since the research was done prior to the 2009 MUTCD change in the pedestrian signal warrant, but the concept is applicable and has formed the basis of guidance included in other guidelines.

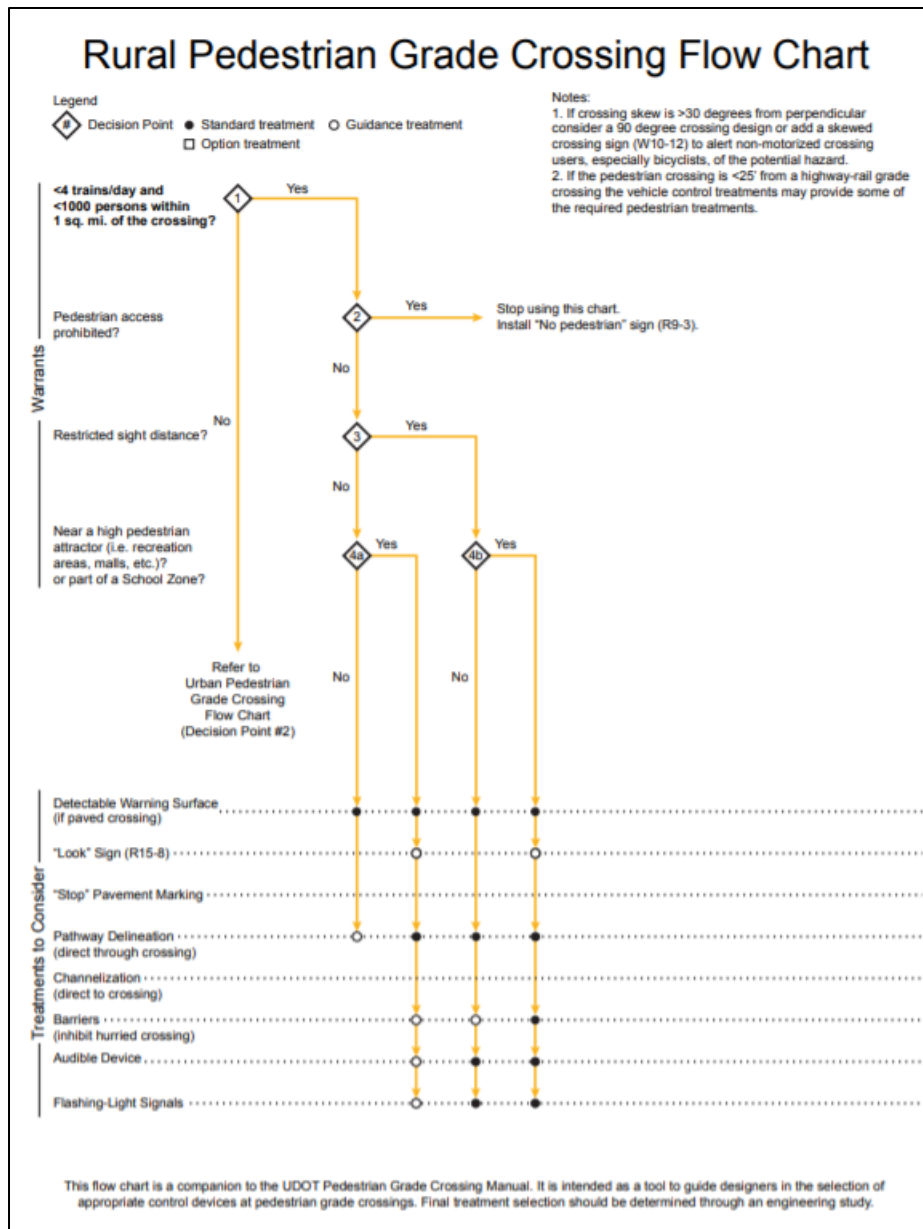
Figure 31. Utah DOT Flowchart for Rural Pedestrian Grade Crossing (70).

The Utah *Pedestrian Grade Crossing Manual (70)* discusses treatments for a railroad grade crossing, which has some fundamental differences with the design and appropriate treatments for a pedestrian crossing of a road. A feature of the document that may be of interest is the structure of the flowchart. On one page, the flowchart provides potential treatments along with conditions when those treatments are to be considered. An example is shown in Figure 31. Figure 27, Figure 28, and Figure 29 are other examples of decision tools that show specific potential treatments on a single page.

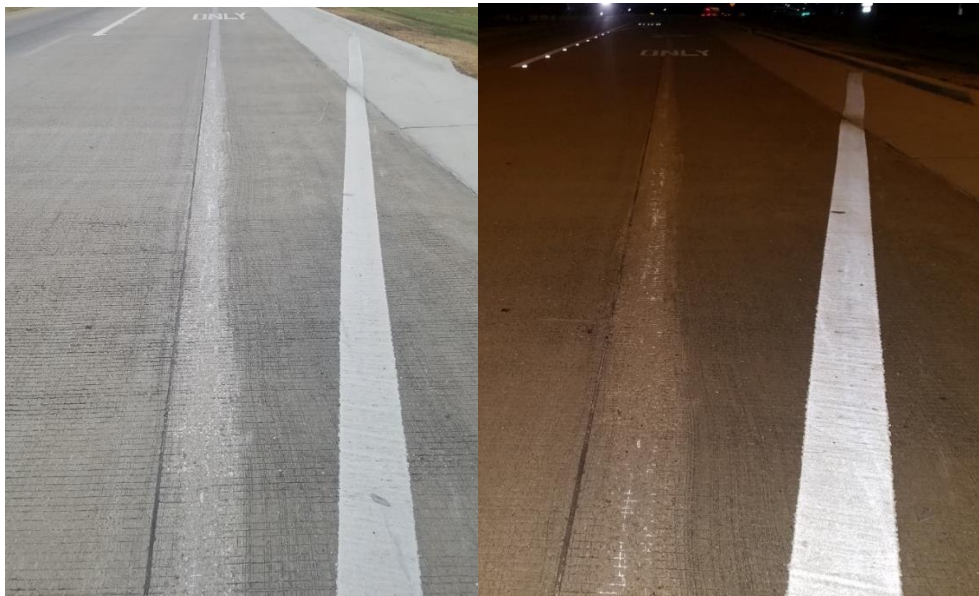
Figure 36. Flailing Removal of Edge Line on Grooved Concrete (Day and Night).

Figure 36 shows removal results near the same area as Figure 35 but focuses on where the original edge line was removed. Figure 36 shows minimal pavement damage but some discoloration and clear remnants of marking showing up at night. Actions could be taken to improve this removal area depending on the perceived confusion caused by the discoloration or visibility of the marking remnants at night. Cleaning of the adjacent concrete pavement with high-pressure water blasting would help alleviate the daytime color issues. The same high-pressure water blasting could be used to remove the marking remnants at the same time to improve the nighttime appearance.

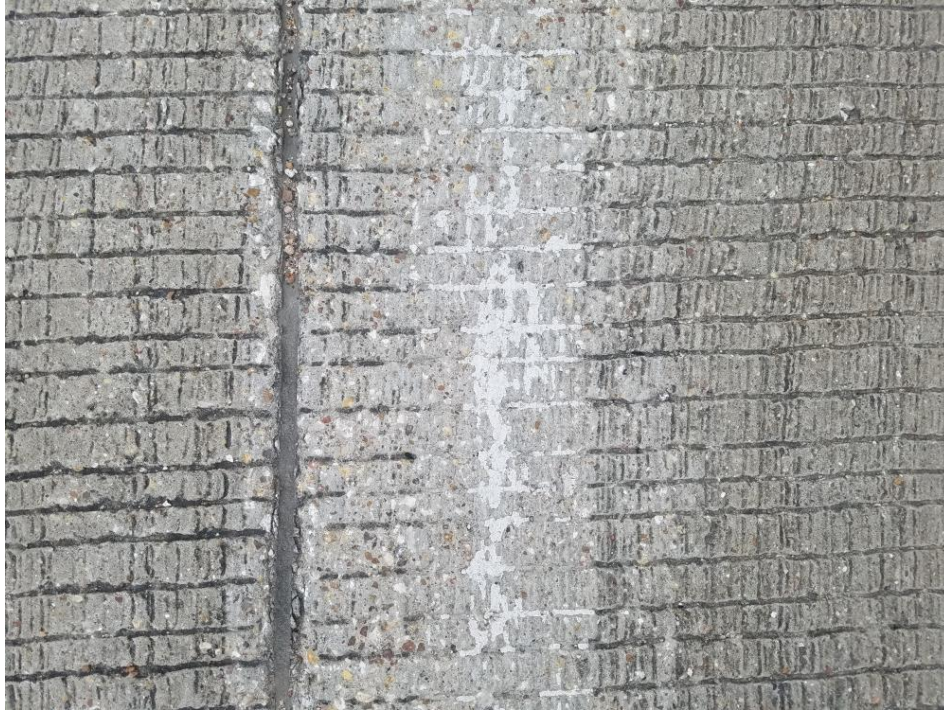
Figure 37. Flailing Removal on Grooved Concrete—Marking Remnants in Grooves.

Figure 37 shows an example of the marking remnants that were left in the groove and area below the top surface of the concrete pavement. A blasting technique would effectively remove these remaining pieces of marking with minimal road surface damage if full removal were needed. If the flailing technique were used to completely remove the marking, the pavement surface would have been damaged, and the color difference would have been more noticeable during the day.

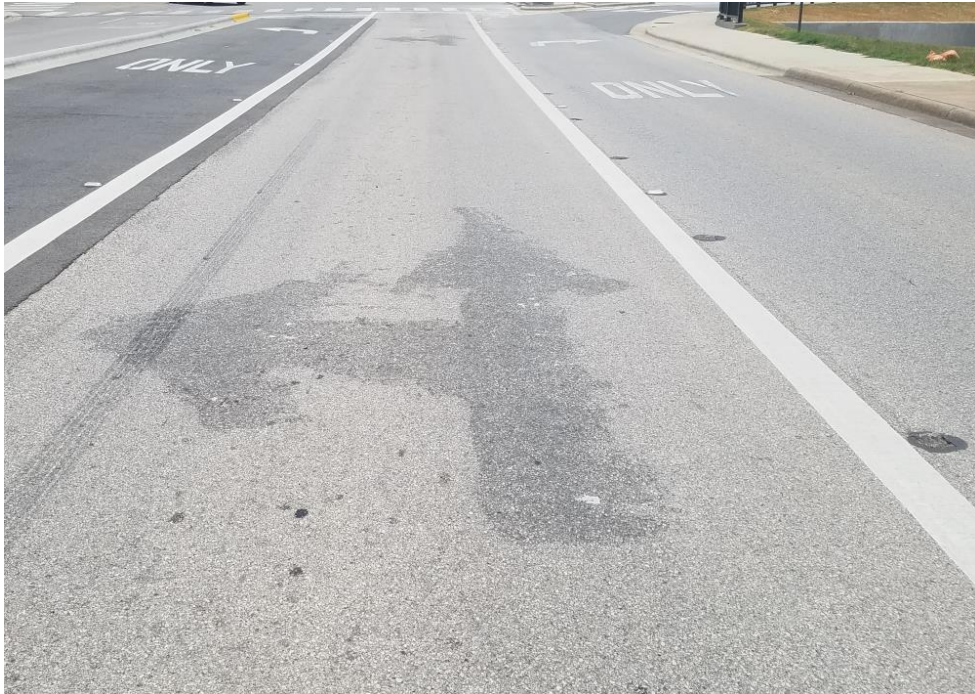
Figure 39. Hand-Operated Flailing Removal on Asphalt.

hole if the hole in the asphalt pavement is of concern for water intrusion and possible premature pavement failure.
