Corrosivity of Water-Soluble Sulfate Ions in Simulated Pore Water Solutions and Different Types of Grout Samples

PUBLICATION NO. FHWA-HRT-21-052

MAY 2021

U.S. Department of Transportation
Federal Highway Administration

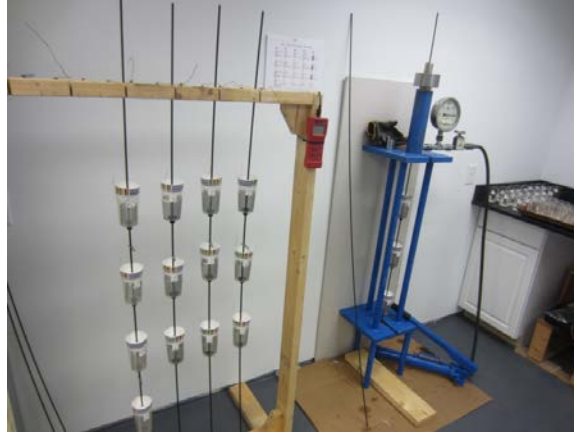
Figure 1. Photo. Ambient temperature test setup (77 °F) for Batch #1 with unstressed wires in the wooden frame and a stressed wire in the steel loading frame.

The stressed and unstressed center wires were vertically installed in the loading frames. Figure 1 through figure 3 show the experimental setups for Batch #1 at the ambient temperature, elevated temperature, and cold temperature, respectively. A heat lamp controlled by a digital thermometer ensured the elevated temperature remained at 104 °F.

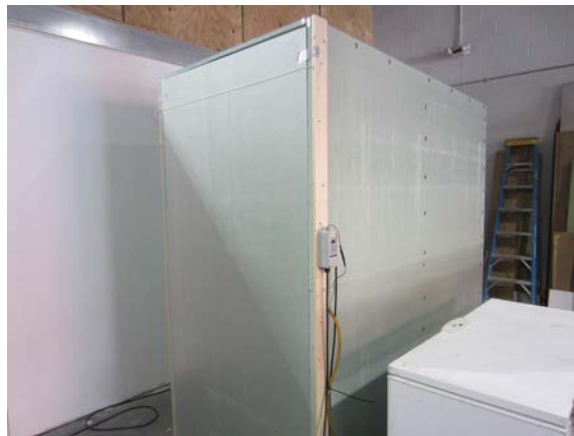
Figure 2. Photo. Elevated temperature test setup (104 °F) for Batch #1.

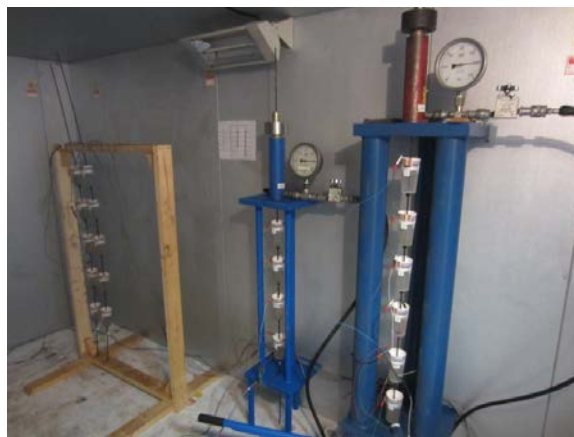
Figure 3. Photo. Cold temperature test setup (32 °F) for Batch #1 inside a walk-in environmental chamber.

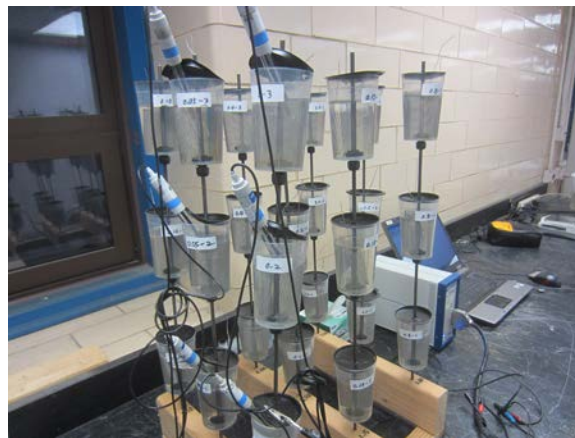
Figure 4. Photo. Ambient temperature test setup for Batch #2.

Unstressed, short center wires were placed vertically on the wooden platforms. The elevated temperature testing was conducted inside a commercial chest freezer. A heat lamp controlled by a digital thermometer maintained the temperature accurately at 104 °F.

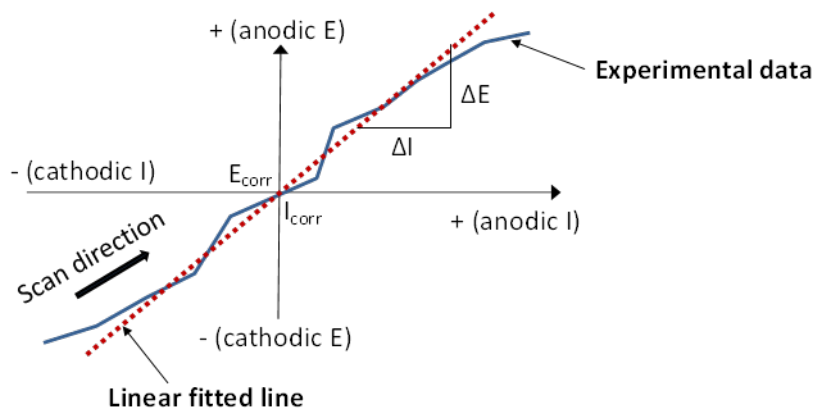
For each LPR measurement, a test cell was filled with 5.1 fl oz of a test solution. After approximately 24 h of initial conditioning without disturbances, a potentiostat applied a small increment of direct voltage between the WE and CE, from -15 mV with respect to the specimen's corrosion potential (E_{corr}) to $+15$ mV, at a scan rate of 0.5 mV/s and a sampling period of 2 s. This process is called polarization. The corresponding current output data in response to each polarized potential step were recorded. Subsequently, the slope of the linear region found between the potential and the current data points, as shown in figure 8, determined the polarization resistance (R) of the specimen by Ohm's law (figure 9).

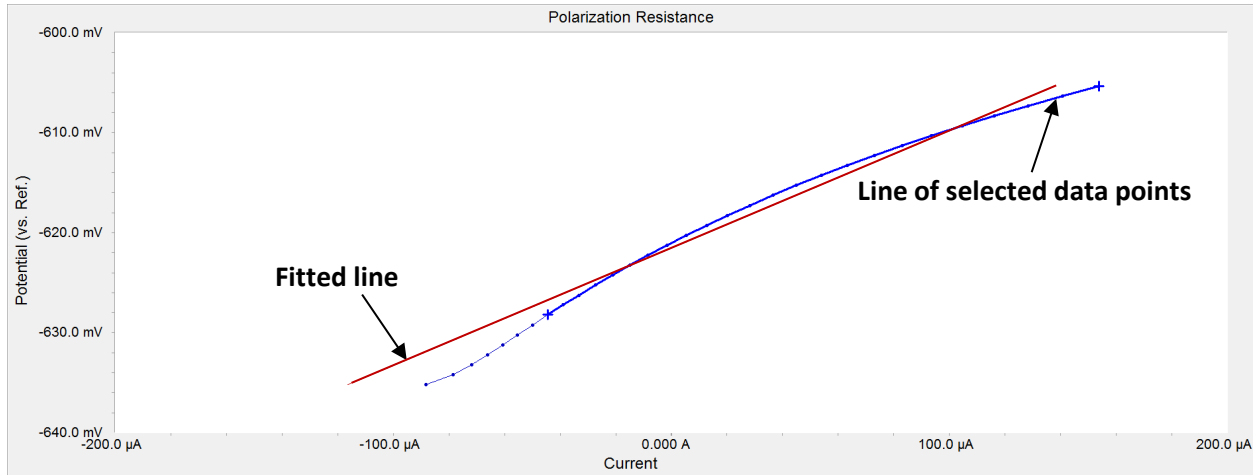
One problem encountered during this study was that most of the LPR measurements made at the elevated temperature yielded a concave curve instead of a straight line. Figure 10 presents one example of the problem.

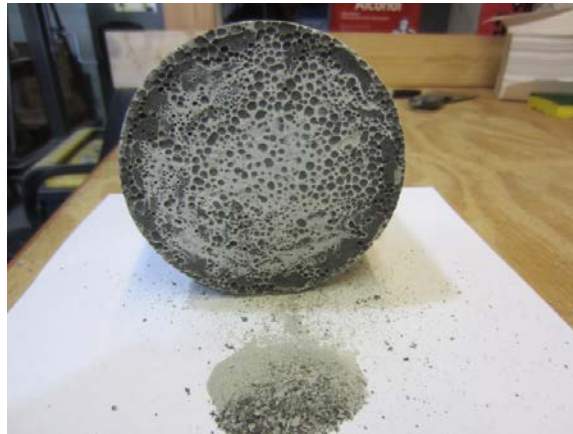
Figure 15. Photo. Grout sample scraped from the top layer of a cylindrical specimen of Product 3.

Once the specimens were cured and demolded, a grout sample was scraped off the top of each specimen and analyzed for free sulfate ions in the top layer. Figure 15 shows the top surface of a cylindrical specimen that has been scraped mechanically with a chisel and the collected grout sample.

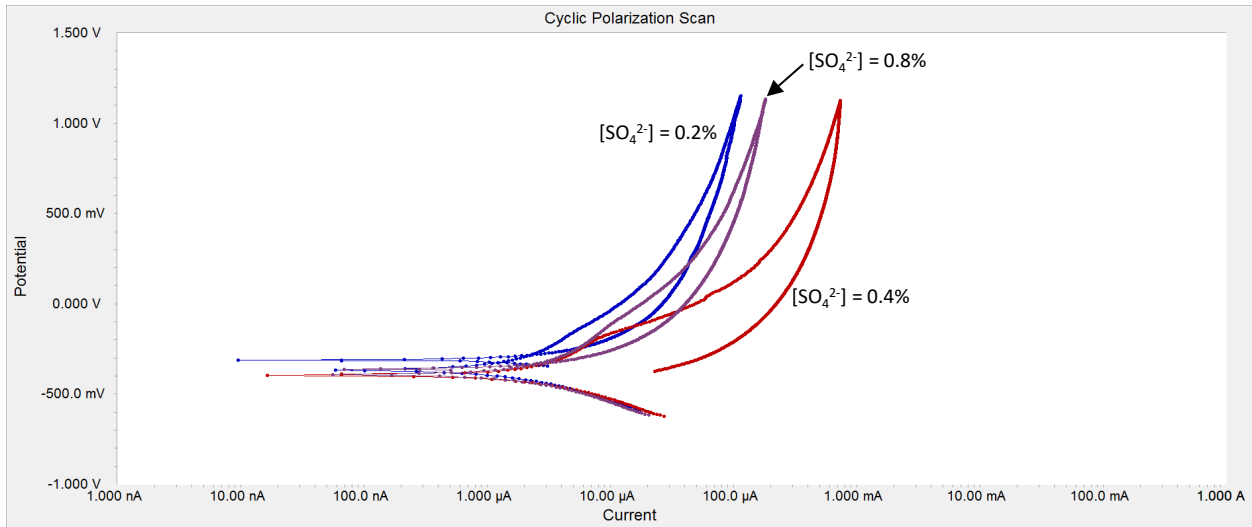
Figure 19. Graph. CPP data from unstressed wires exposed to three $[\text{SO}_4^{2-}]$ in pH 8.0 solutions.

Figure 19 through figure 26 present data from the CPP tests of unstressed wires collected at ambient temperature in four pH solutions (8.0, 10.0, 12.5, and 13.6). Each figure shows three CPP plots of data obtained from either three sulfate solutions ($[\text{SO}_4^{2-}] = 0.2, 0.4, \text{ and } 0.8$ percent) or three chloride solutions ($[\text{Cl}^-] = 0.08, 0.4, \text{ and } 0.8$ percent) at a given pH.

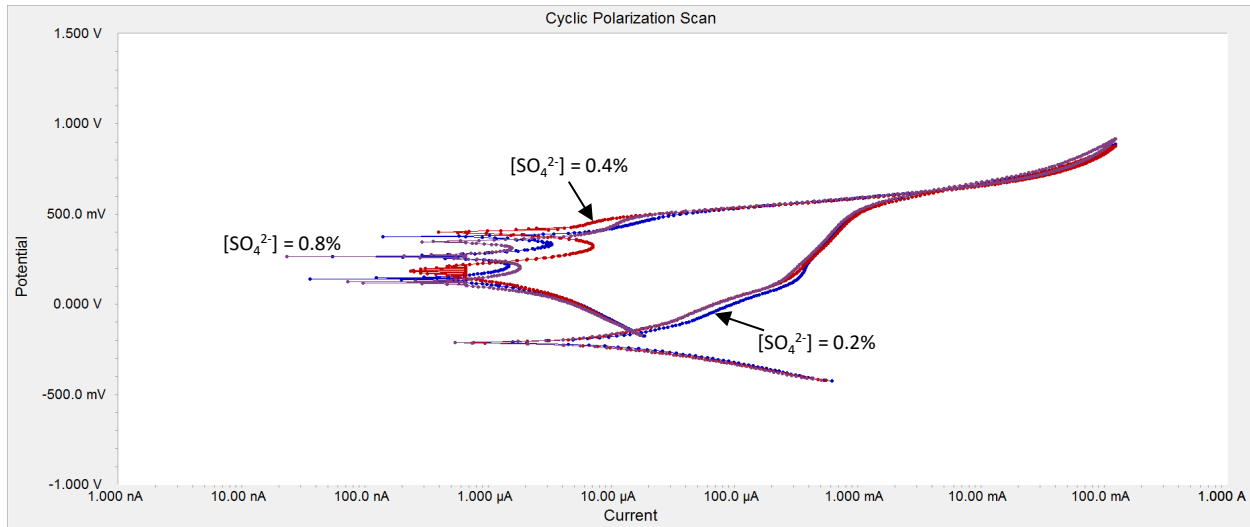
Figure 25. Graph. CPP data from unstressed wires exposed to three $[SO_4^{2-}]$ in pH 13.6 solutions.

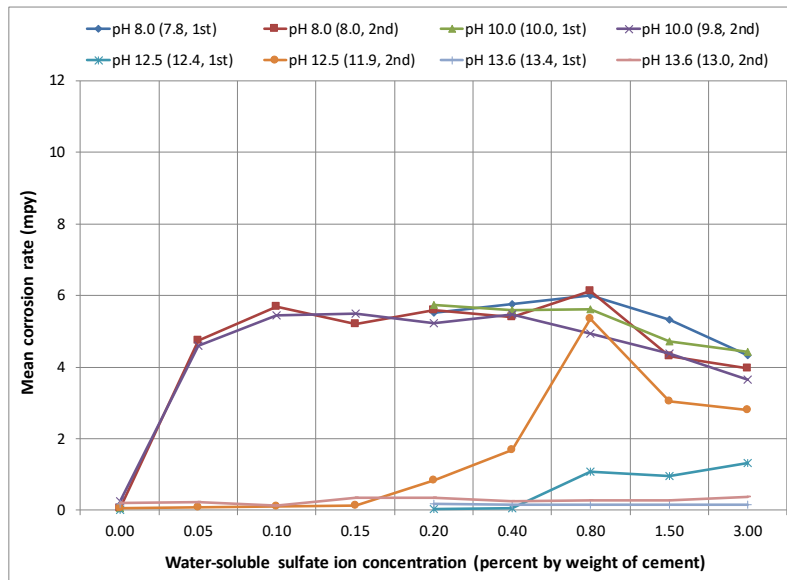
Figure 27. Graph. Mean corrosion rate data from Batch #1 and Batch #2 in [SO₄²⁻] solutions at 77 °F.

Figure 27 and figure 28 show mean corrosion rates of Batch #1 and Batch #2 versus pH plots for the wires exposed to eight sulfate concentrations and one sulfate-free solution at 77 and 104 °F, respectively. Each legend entry indicates nominal pH, actual pH, and batch number (Batch #1 designated as 1st and Batch #2 as 2nd).

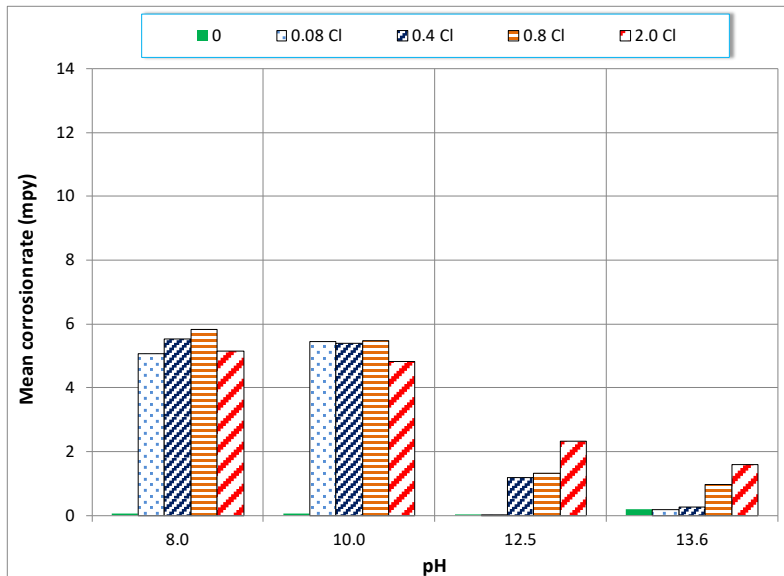
Figure 29. Graph. Mean corrosion rate data from Batch #1 in [Cl⁻] solutions at 77 °F.

Figure 29 and figure 30 show mean corrosion rates for five Batch #1 chloride concentrations in four different pH solutions at 77 and 104 °F, respectively.

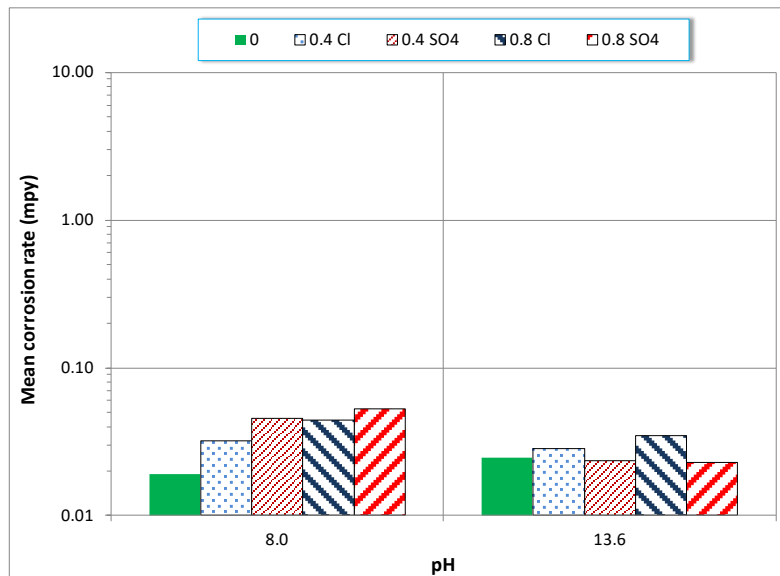
Figure 31 presents the mean corrosion rate data from Batch #1 measured at 32 °F in pH 8.0 and 13.6 solutions that contained three concentrations (0, 0.4, and 0.8 percent) of sulfate and chloride ions.

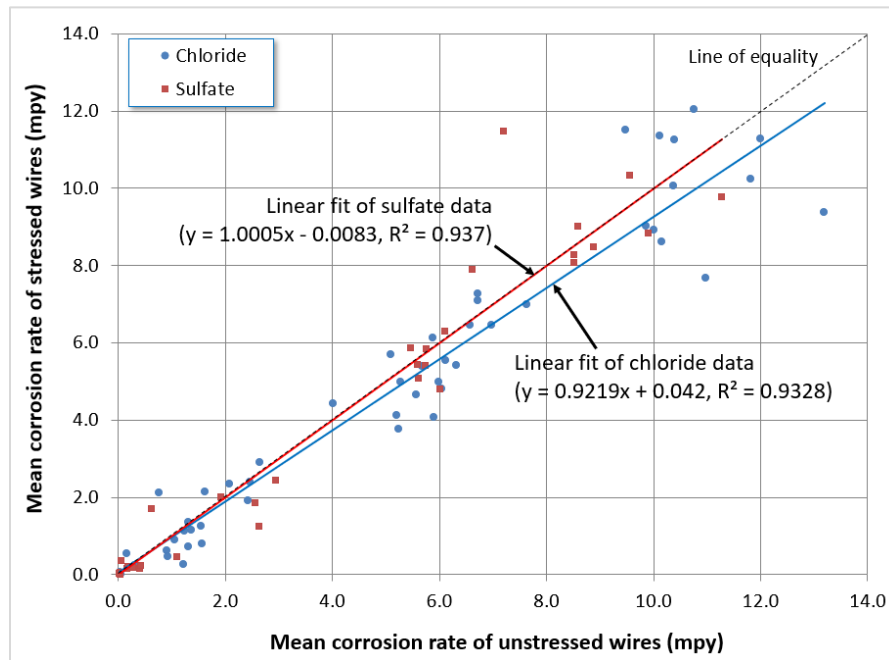
The effect of stress on the corrosion rate was also examined after regrouping Batch #1 data by unstressed versus stressed conditions. Figure 32 shows a scatter plot of mean corrosion rates for unstressed and stressed wires immersed in sulfate and chloride solutions.

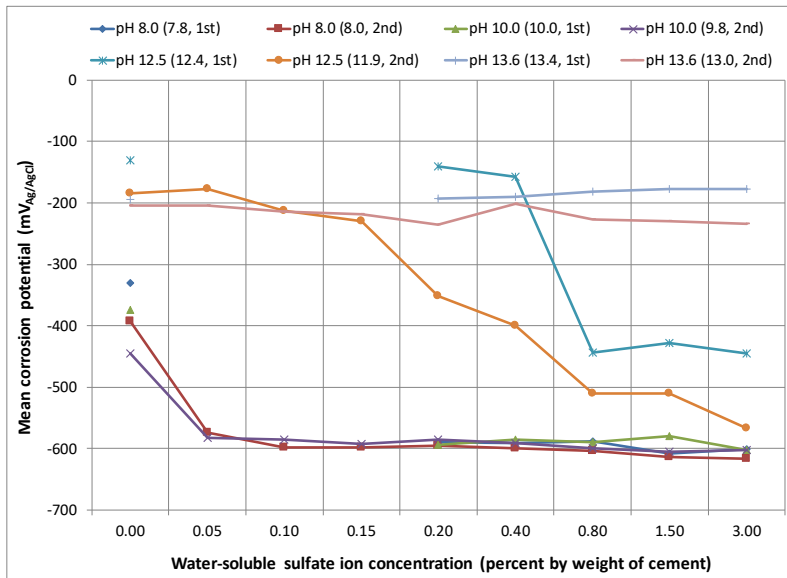
Figure 34. Graph. Mean corrosion potential data from Batch #1 and Batch #2 in [SO₄²⁻] solutions at 77 °F.

Figure 34 and figure 35 show mean corrosion potential data from Batch #1 and Batch #2 exposed to eight sulfate concentrations in eight pH solutions at 77 and 104 °F, respectively. Figure 36 and figure 37 show the same type of data in five chloride concentrations.

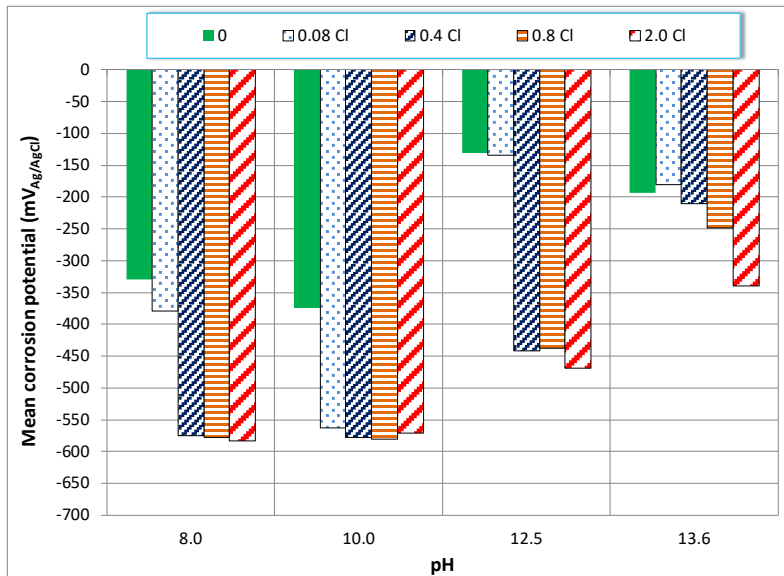
Figure 36. Graph. Mean corrosion potential data from Batch #1 in [Cl⁻] solutions at 77 °F.

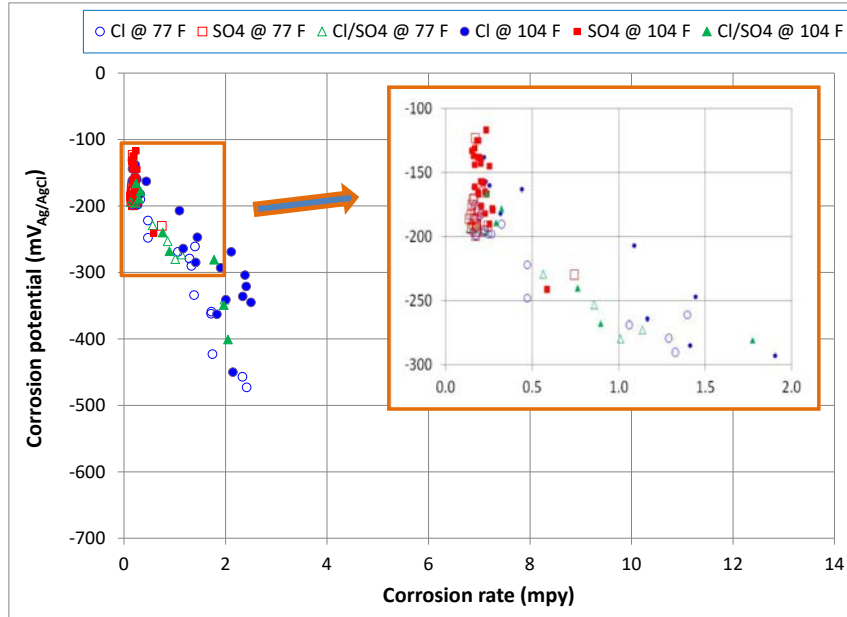
A similar plot for the pH 13.6 data is presented in figure 39.

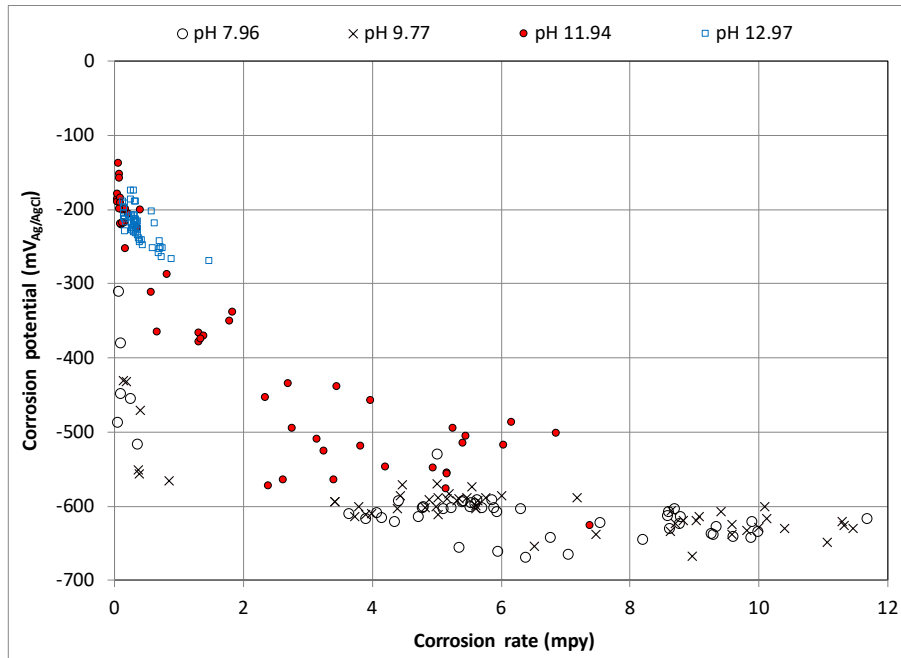
Figure 40 shows the relationship between individual corrosion rate data from Batch #2 and the corresponding corrosion potential data, grouped by the actual pH and all sulfate concentrations.

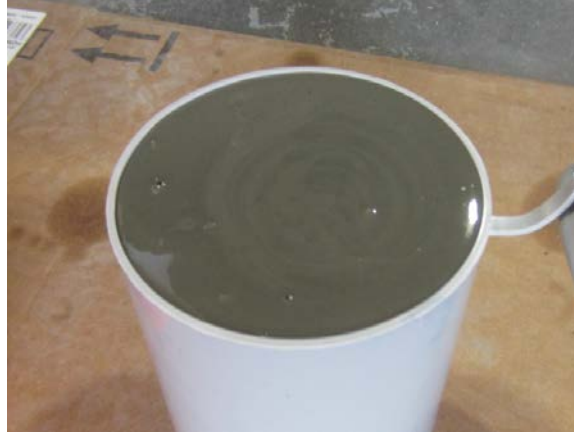
When Product 1 and Product 2 were mixed with their recommended amounts of water, the fresh mixes looked normal. A representative fresh grout mix of Product 1 is shown in figure 41.

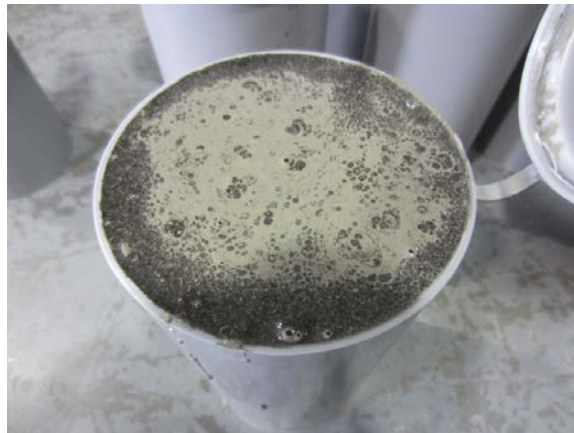
However, the fresh grout mix of #1 Old Product 3 exhibited an unusual appearance, even though the recommended water dosage was used. Soon after the mix was poured into the mold, unidentified black particles and many tiny air bubbles surfaced along the mold's rim. Petrographic examination later identified the floating black particles as silica-fume agglomerates. Figure 42 shows a fresh mix made with #1 Old Product 3.

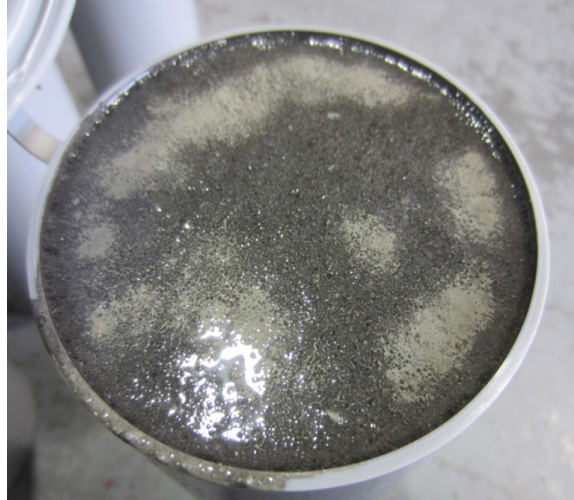
Figure 43 shows the worsened condition of the fresh mix shown in figure 42 after adding 0.5 lb of water.

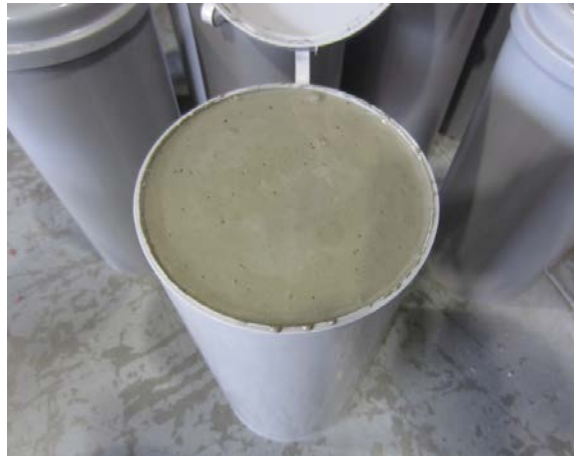
Figure 44. Photo. Fresh grout mix of a #2 Old Product 3 specimen made with the recommended water dosage.

Figure 44 and figure 45 show fresh mixes of the #2 Old Product 3 made with the recommended water content and with an extra 0.5 lb of water to the leftover fresh mix, respectively.

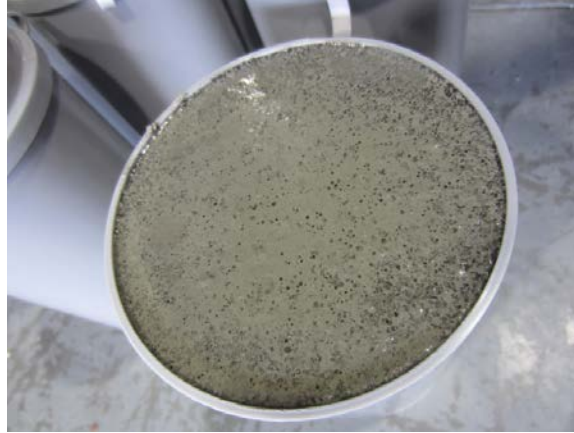
Figure 45. Photo. Fresh grout mix of another #2 Old Product 3 specimen after adding 0.5 lb of extra water to the fresh mix shown in figure 44.

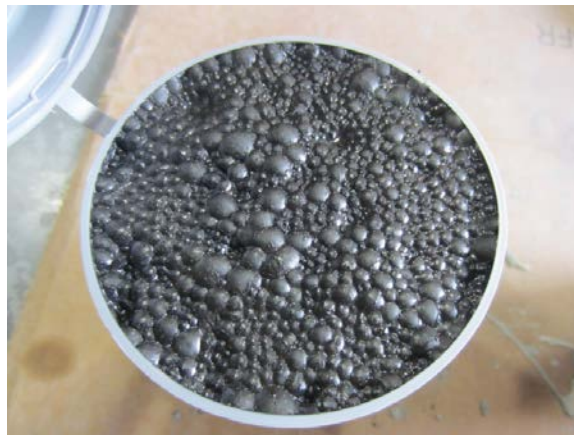
Figure 46. Photo. Fresh grout mix of a #2 Old Product 3 (opened bag) specimen made with the recommended water dosage.

Unlike #1 Old Product 3, #2 Old Product 3 did not exhibit excessive silica-fume particles. However, regardless of the amount of mixing water, the #2 Old Product 3 that had been kept in an opened bag produced the most significant amounts of silica-fume particles and air bubbles observed in this study. Figure 46 shows a fresh mix using the recommended water dosage, and figure 47 shows another fresh mix after adding an extra 0.5 lb of water to the leftover fresh mix shown in figure 46.

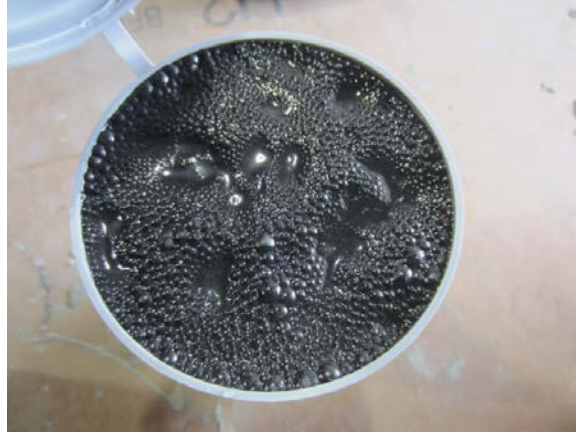
Figure 47. Photo. Fresh grout mix of another #2 Old Product 3 (opened bag) specimen after adding 0.5 lb of extra water to the fresh mix shown in figure 46.

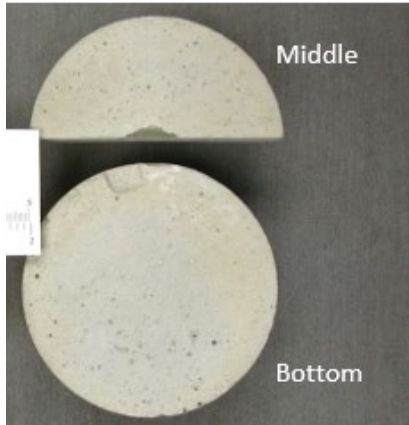
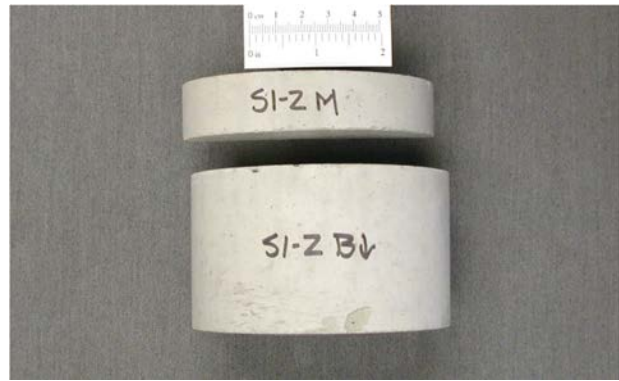
A. Top view.

B. Side view.

Figure 54. Photos. Middle and bottom slices from Sample #1 P3-2.

Samples #1 P3-2M and #1 P3-2B, shown in figure 54 through figure 58, consisted of two saw-cut sections of light gray grout that had been cast in a 4-inch diameter cylindrical mold. Sample #1 P3-2M, the smaller section, was a 0.8-inch-thick, saw-cut, half-slice sample cut from the middle of the larger sample. Sample #1 P3-2B, the larger section, was a 2.3-inch-thick, full-cylindrical sample cut from the bottom of the sample. The saw-cut surfaces of both samples were examined using a stereomicroscope to assess the distribution of constituents. Samples #1 P3-2M and #1 P3-2B were visually similar and appeared generally uniform. Both samples contained white carbonate aggregate particles up to 0.025 inch in diameter and black silica-fume agglomerates up to 0.015 inch in diameter. The saw-cut surfaces exhibited frequent air bubbles up to 0.09 inch in diameter. The interior surface of the air voids often had a thin, black lining. Optical characteristics of the black material were consistent with silica fume.

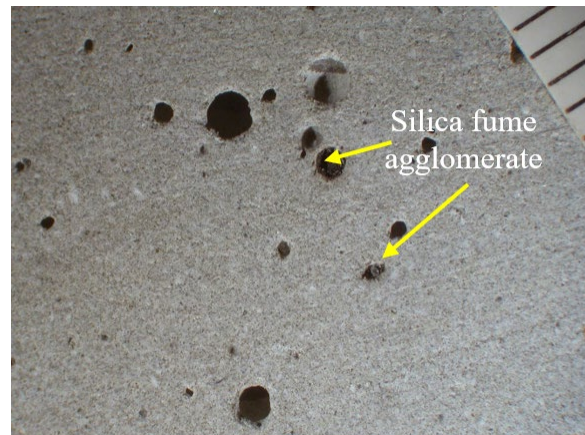
Figure 56. Photo. Stereomicroscope view (millimeter scale) of the saw-cut surface of Sample #1 P3-2M showing a thin film of black material in the air voids.

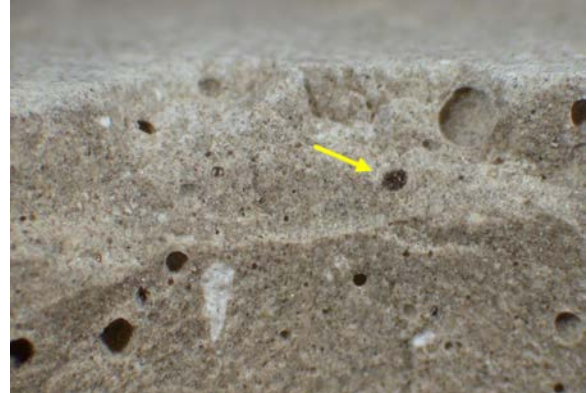
Figure 58. Photo. Sample #1 P3-2M at 15× magnification showing white particles and dark silica-fume agglomerates (arrow) on the fracture surface.

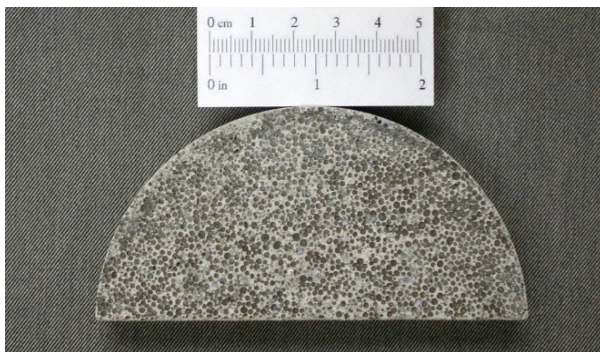
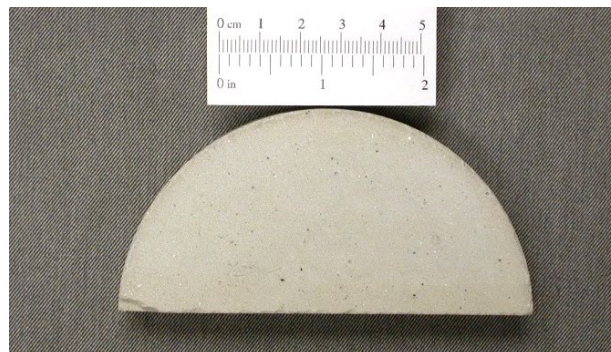
A. Top surface.

B. Saw-cut bottom surface.

Figure 59. Photos. Sample #1 P3-4 xtra T.

Sample #1 P3-4 xtra T, shown in figure 59 through figure 63, consisted of one-half of a 0.8-inch thick, transverse slice of light gray grout that had been saw-cut from the top of a 4-inch-diameter cylinder. The top surface was generally flat and was covered with small craters formed by burst air or gas bubbles and small gray to black silica-fume agglomerates. Crater floors were thinly coated with a black film similar to the black film observed in air voids in Sample #1 P3-2M. Patches of white, blue-white, and colorless alkali–silica reaction (ASR) gel were frequently observed in the craters, further suggesting that the black film is silica fume. The saw-cut transverse and vertical surfaces were examined using a stereomicroscope to assess the distribution of constituents. The surfaces were similar to the saw-cut surfaces described for both samples #1 P3-2M and #1 P3-2B.

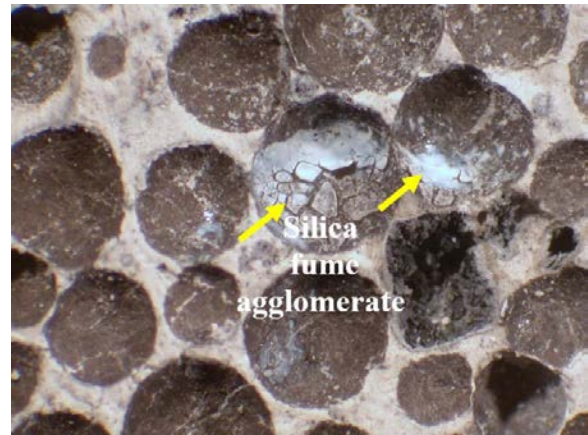
Figure 63. Photo. Sample #1 P3-4 xtra T at approximately 25× magnification showing ASR gel and silica-fume agglomerates in craters.

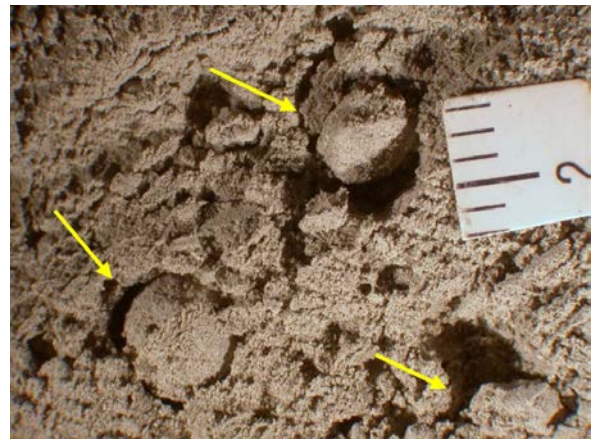
Figure 65. Photo. Stereomicroscope micrograph (millimeter scale) showing ovoid lumps in the raw grout sample.

The composition of the ovoid lumps was generally similar to that of the loose powder. The recognizable components of the lumps consisted of approximately 70 percent portland cement, 25 percent fragmental carbonate (interground limestone), 2 to 3 percent silica-fume agglomerates, and trace amounts of anhydrite, gypsum, and partially carbonated calcium hydroxide. Silica-fume agglomerates tended to be larger in the ovoid lumps, and a few were 30 to 50 μm in diameter. Many cement particles exhibited thin, partial films of hydration product where multiple particles were in contact. The appearance of the sample indicated it may have experienced limited hydration caused by exposure to ambient moisture.

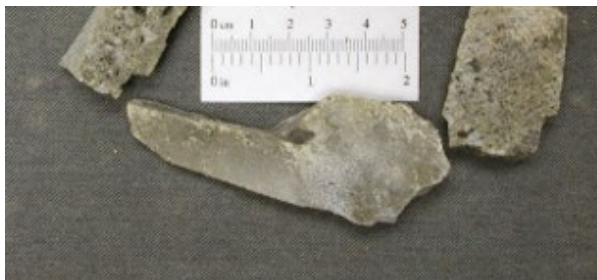
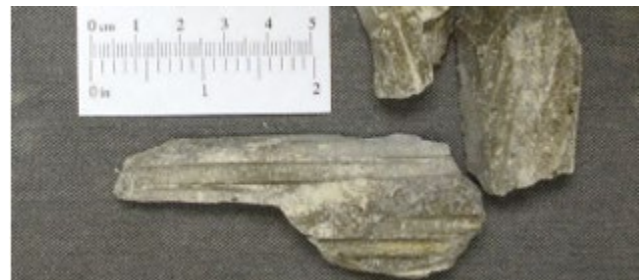
A. Surfaces in contact with the duct.

Figure 71. Photos. Hard fragments from the field sample.

The field sample, shown in figure 71 through figure 74, was provided in two bags: one bag contained three hard fragments of medium gray grout and the other contained smaller fragments of soft, moist grout. The hard fragments were approximately 1 inch wide and 1.5 to 3 inches long. The surface that had been in contact with the duct was curved, smooth, and exhibited small air-bubble craters. The surface that had been in contact with the strand was well consolidated, uniform in appearance, and free of corrosion deposits and other secondary deposits. The broken surfaces were uniform in appearance and the character of the fracture was subconchoidal (smooth and nearly shell-shaped). No macroscale cracks or unusual characteristics were observed. Silica-fume agglomerates were not observed.

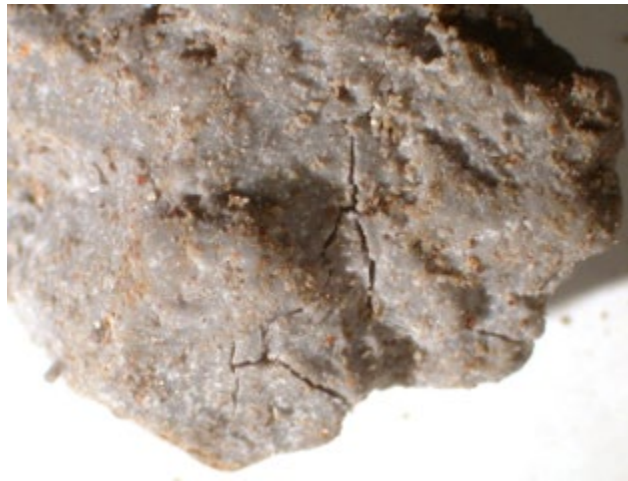
Figure 73. Photo. Field sample at approximately 10× magnification showing examples of desiccation cracks in air-dried soft grout.

The dark color of the soft material was caused by moisture retention. The fragments became lighter in color and developed desiccation cracks as the material air dried (figure 73). Patches of red-brown corrosion deposits were commonly observed and were typically associated with the white chalky and light gray, semitranslucent materials (indicated by yellow arrows in figure 72 and figure 74). The sample contained a small number of hard, light gray grout fragments. Silica-fume agglomerates were not visible at 5 to 50× magnifications.

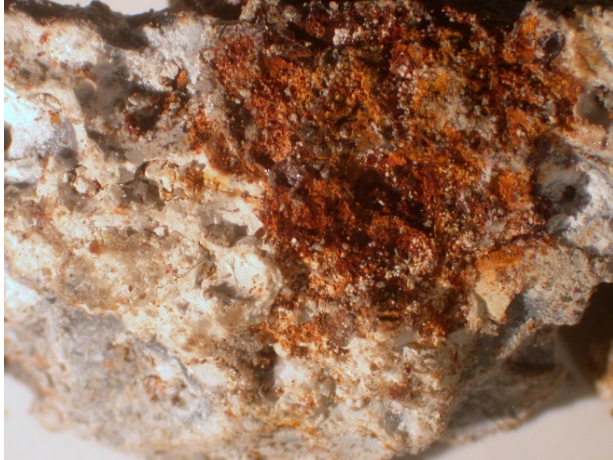
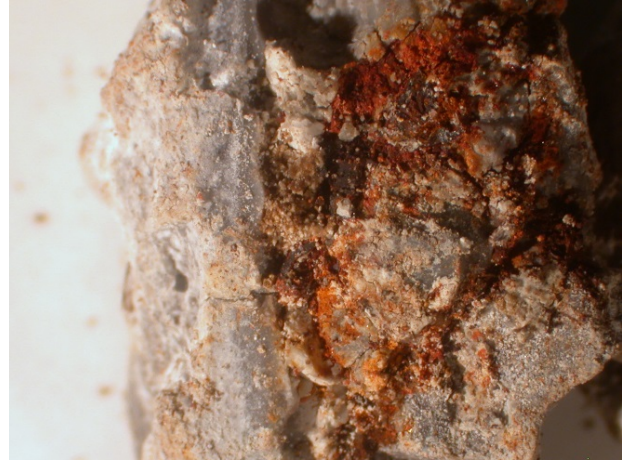
A. On chalky material.

B. On light gray, semitranslucent material.
