Evaluation of Penetrating Sealers Applied to Saw Cut Faces in Concrete Pavement Joints

Danny X. Xiao, Ph.D., P.E., ENV SP
Samuel Owusu-Ababio, Ph.D., P.E.
Robert Schmitt, Ph.D., P.E.
Department of Civil and Environmental Engineering
University of Wisconsin-Platteville

WisDOT ID no. 0092-18-01

March 2020

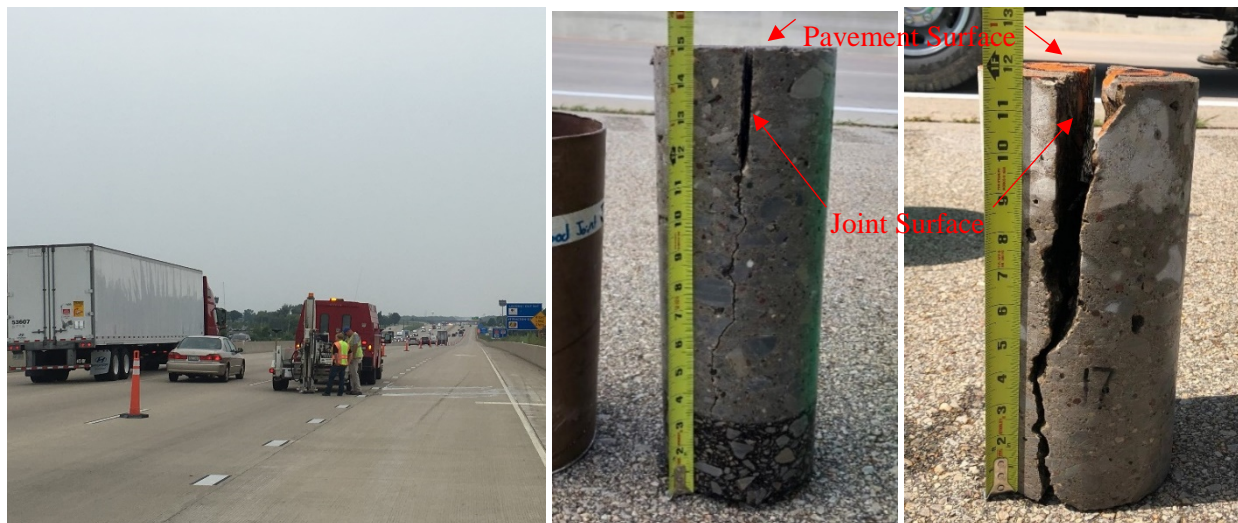
Figure 3.2 (a) Taking field cores (b) A core sample of good joint (c) A core sample of spalled joint

Core samples were then taken at three locations from each project: 2 cores from good performing joints, 2 cores from spalled joints, and 1 core from mid-slab as the control since penetrating sealer was only applied to joints. Figure 3.2 shows the field operation and example of core samples. All cores were taken from the main traffic lane where most trucks use except core #4,5,6 from the ramp of Exit 156 on I-39. A total of 17 cores were collected (Table 3.2).

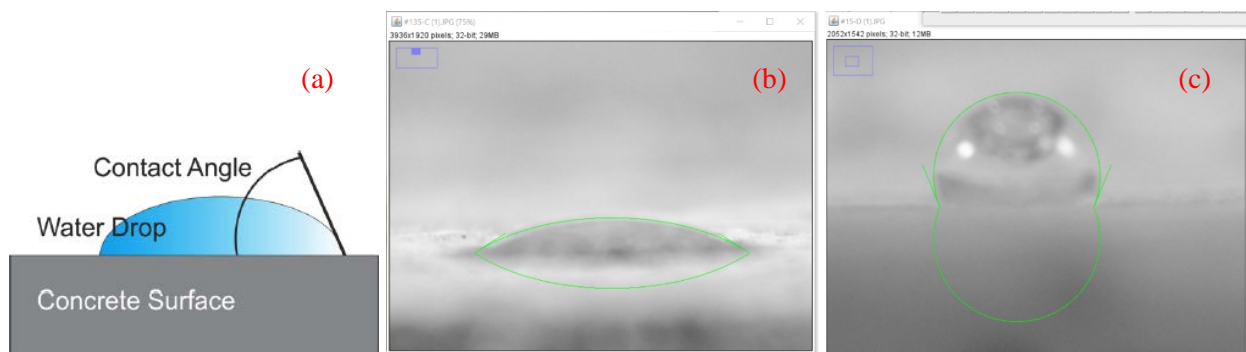
Figure 3.3 (a) Definition of contact angle (b) Contact angle=32.5° for core #135 (c) Contact angle =112.5° for core #15

Core samples were then subjected to a series of laboratory tests. Contact angle was measured on the joint surface of each sample. Two measurements were made for each sample, one on each side of the water droplet, and then averaged. Contact angle is a quantitative measure of the wetting of a solid by a liquid. It is defined as the angle formed between the liquid/solid and liquid/vapor interfaces. Therefore, a small contact angle means the surface is hydrophilic (water loving), and a large contact angle indicates the surface is hydrophobic (resistant to water). Figure 3.3 shows examples of different contact angle measured in this project. Since penetrating sealer is designed to help with moisture resistance, a larger contact angle is expected for core samples with sealers applied.

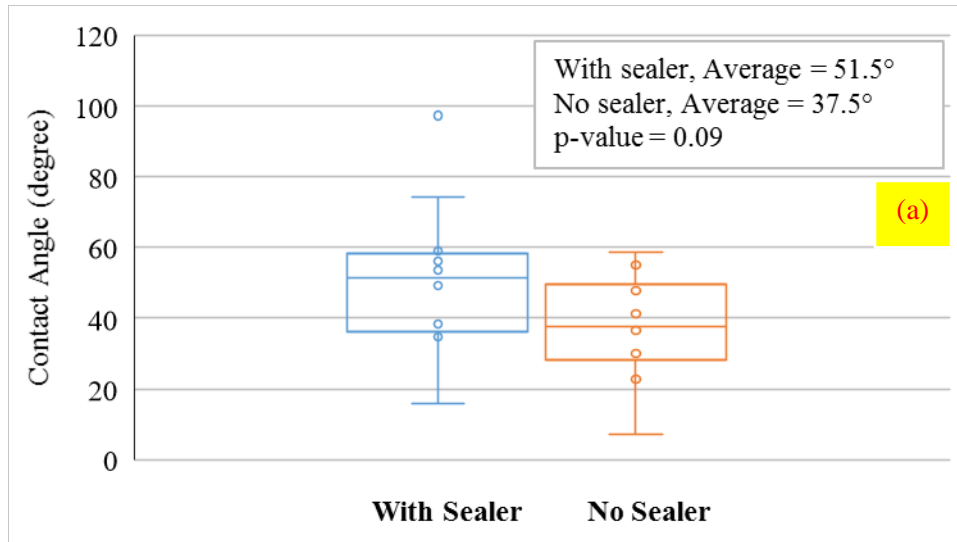
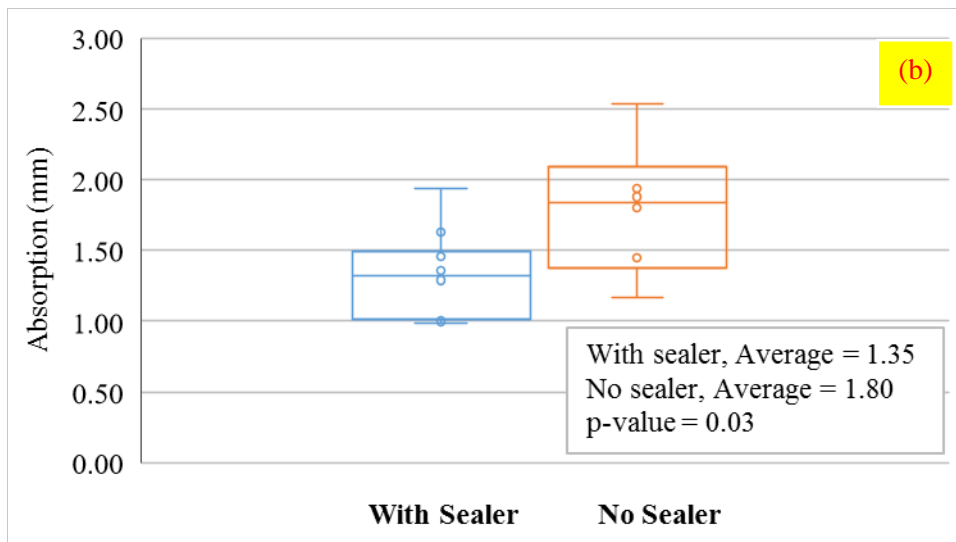
Figure 3.6 Presence of Sealer (a) Contact Angle, (b) Absorption, (c) Depth of Penetration

Figure 3.6(b) shows a clearer difference between samples with sealer and without sealer. At the end of 14-day test, the average absorption for samples with sealer is 1.35 mm and the average for samples with no sealer is 1.80, 34% more. This is confirmed with ANOVA analysis (p -value = 0.03). Penetrating sealer is designed to slow down the absorption of water and chemicals to concrete. Therefore, the absorption data proved that the sealer in the field is still functioning as intended.

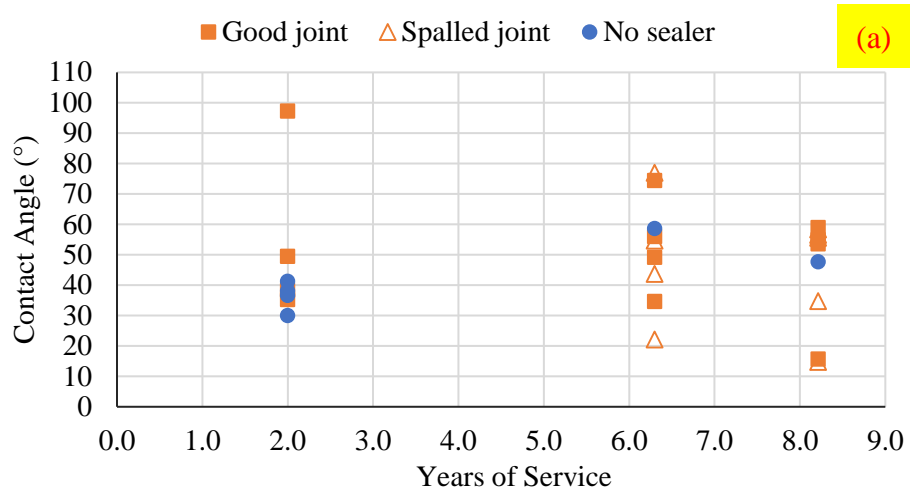
Figure 3.7 Service Life (a) Contact Angle, (b) Absorption, (c) Depth of Penetration

Test results in this study along service life are presented in Figure 3.7. A general trend is observed that, as service life increases, contact angle reduces and absorption increases. In other words, as time passes by, penetrating sealer slowly loses its effectiveness in resisting water ingress. However, when compared with the samples without sealer, more than half of the joints with sealer are still performing better in terms of contact angle and absorption after 8.2 years of service.

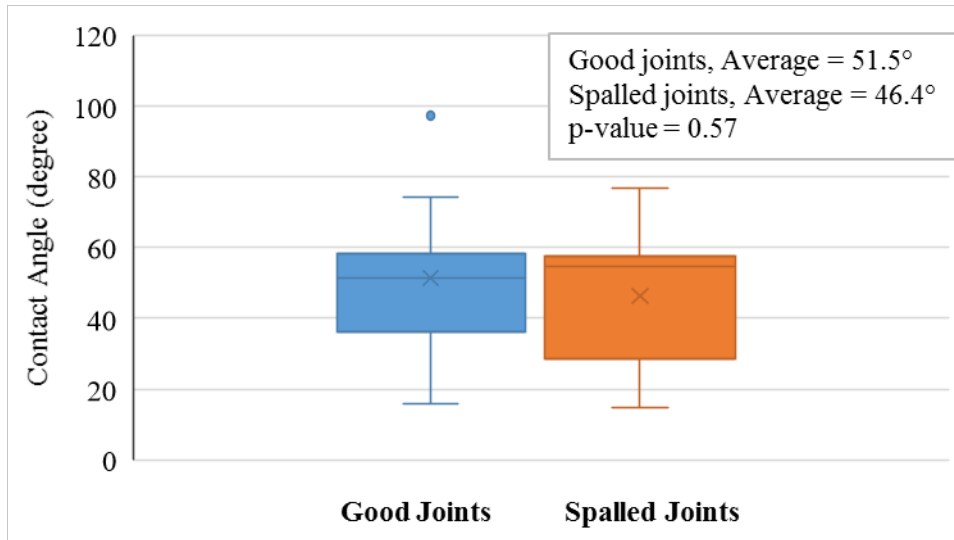
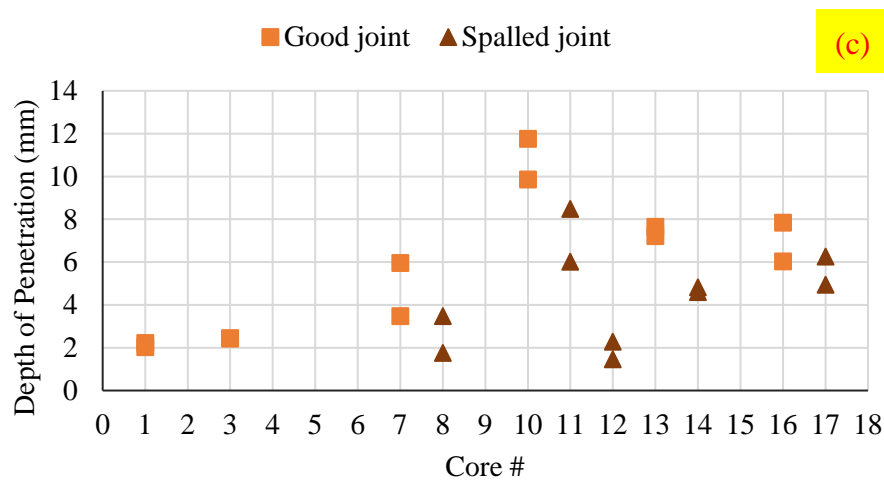
Figure 3.8 Good vs. Spalled Joints (a) Contact Angle, (b) Absorption, (c) Depth of Penetration

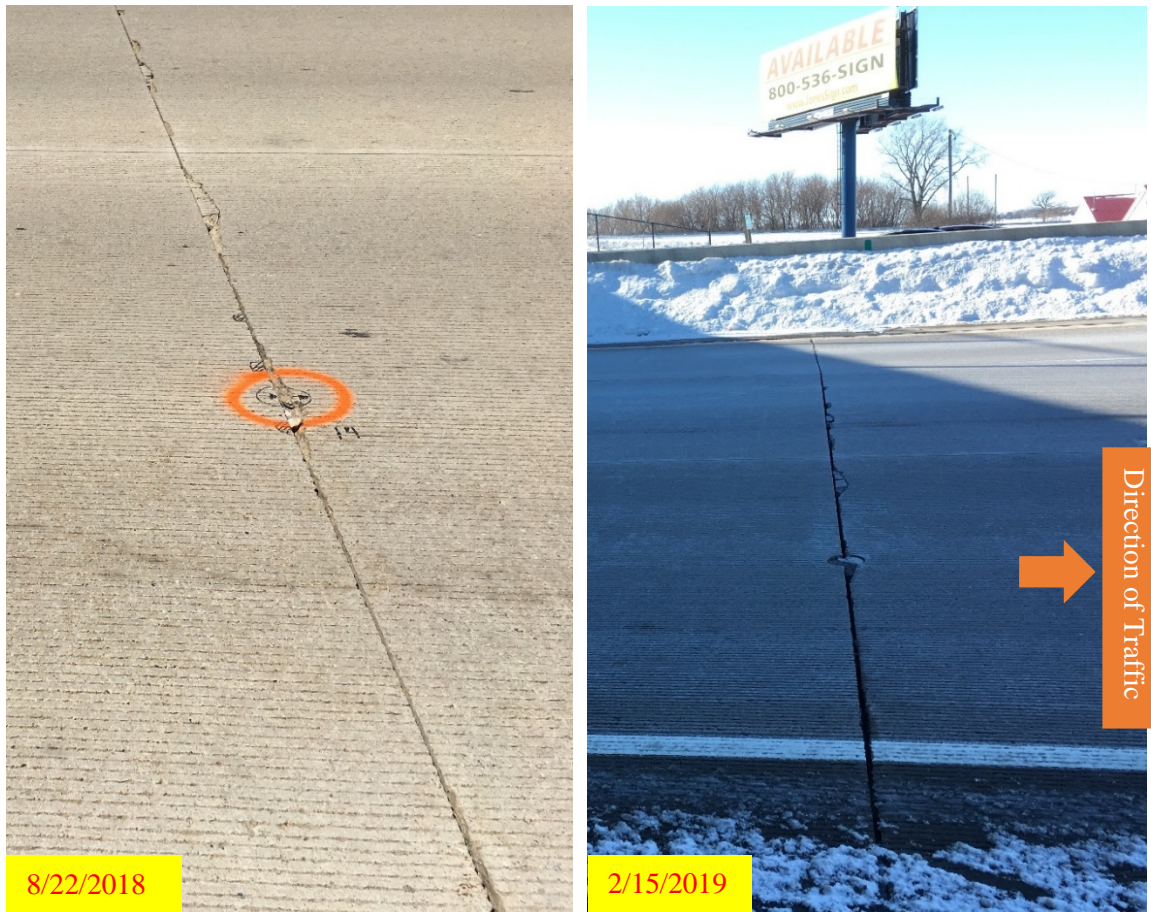
Figure 3.10 Picture Taken from Shoulder of Core #14 Joint on I-41

One such joint was identified and historical pavement images were retrieved from pavement management system. Core #14 is from a spalled joint on I-41. The nearby joint is in good condition. Several other similar joint spalling led to the suspicion that saw cutting could be the cause. As shown in Figure 3.9, the right side spalling started to occur in 2016 (the 4th year), and the left side spalling did not occur until 2018 (the 6th year). The spall is about one inch from the joint, which agrees with the phenomenon of incremental cracking (Taylor et al., 2012). The concrete between the crack and the free face is normally sound, as is the remaining concrete next to the crack. It is hypothesized that this distress is a result of the interfacial zone around coarse aggregate particles being exposed by the saw cut.

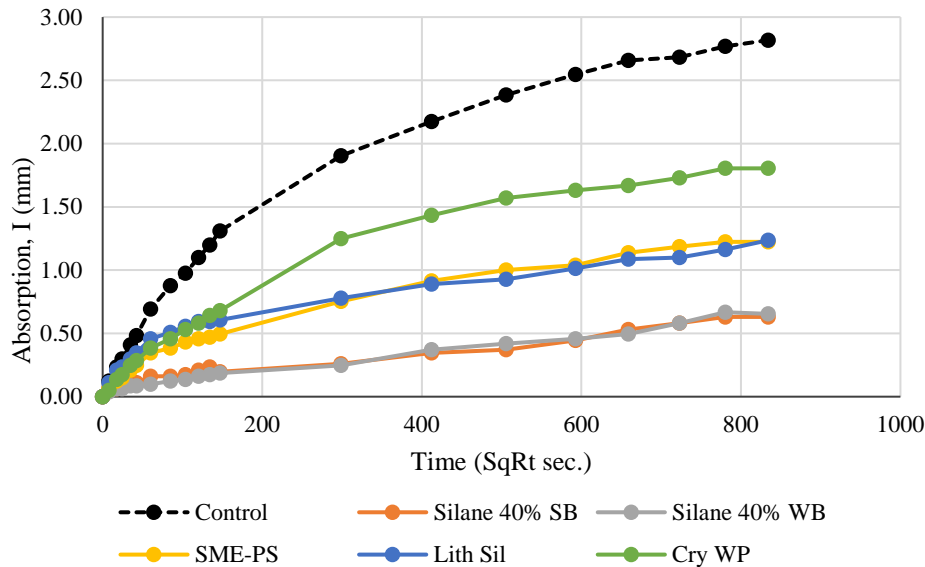
Figure 4.1 Absorption Results for Initial Penetrating Sealer Products

similar reductions in absorption (~56%). The crystalline waterproofing product resulted in a 36% reduction in absorption.

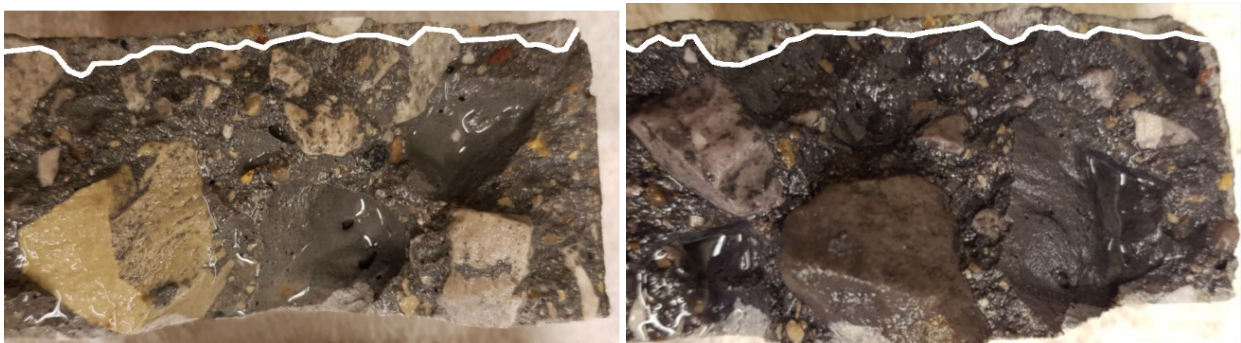
Figure 4.4 Example Depth of Penetration for SME-PS Specimen (Left: water, Right: blue fabric dye)

Depth of penetration was utilized as a method of indicating potential life span of a sealer. A deeper penetration would be assumed to provide protection for a greater length of time. ImageJ® analysis was used to determine an average depth of penetration for samples. As observed in Figure 4.3 and Figure 4.4, penetration depth was highly variable. Both water and powdered navy blue fabric dye were similarly effective in delineating water repellency.

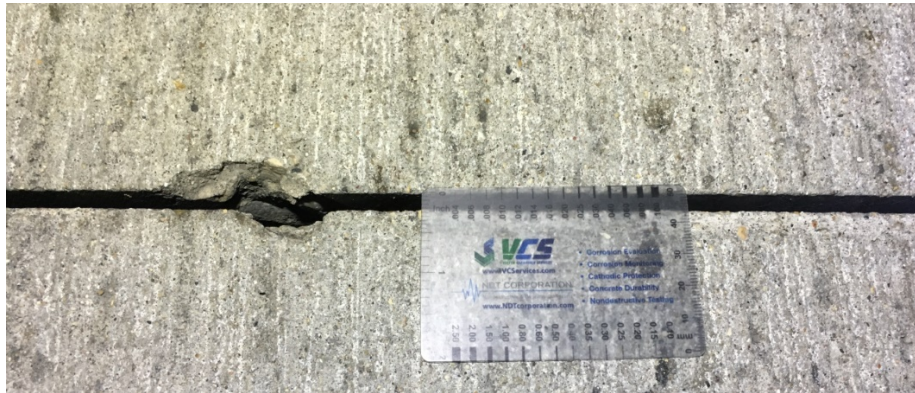
Figure 5.5 Close-up of small spalling at Joint #104

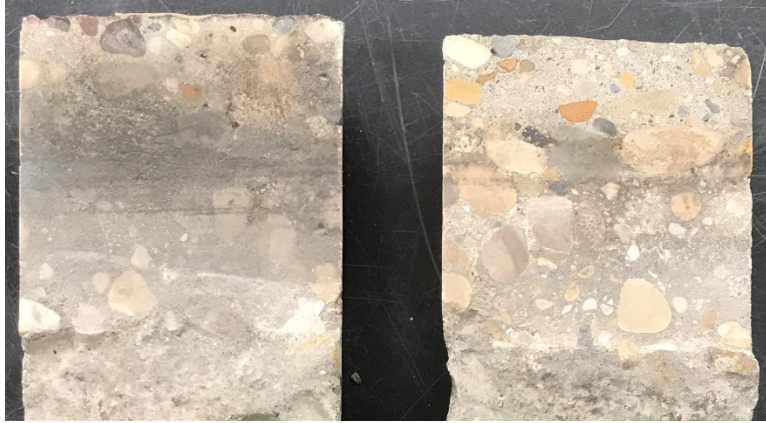
Figure 5.6 Untreated core samples (left) as received and (right) after cleaning

After one year in service, fifteen 4-inch-diameter core samples were removed from non-adjacent slabs and transported to the laboratory for testing. It was observed that all core samples were quite dirty with salt and tire residue. Figure 5.6 shows an untreated core in the as-received condition on the left and after cleaning in an ultrasonic bath on the right. All cores were visually similar in the as-received condition. After cleaning the core samples treated with silane (Figure 5.7) and SME-PS had less black residue than the siloxane mixture or lithium silicate mixture.

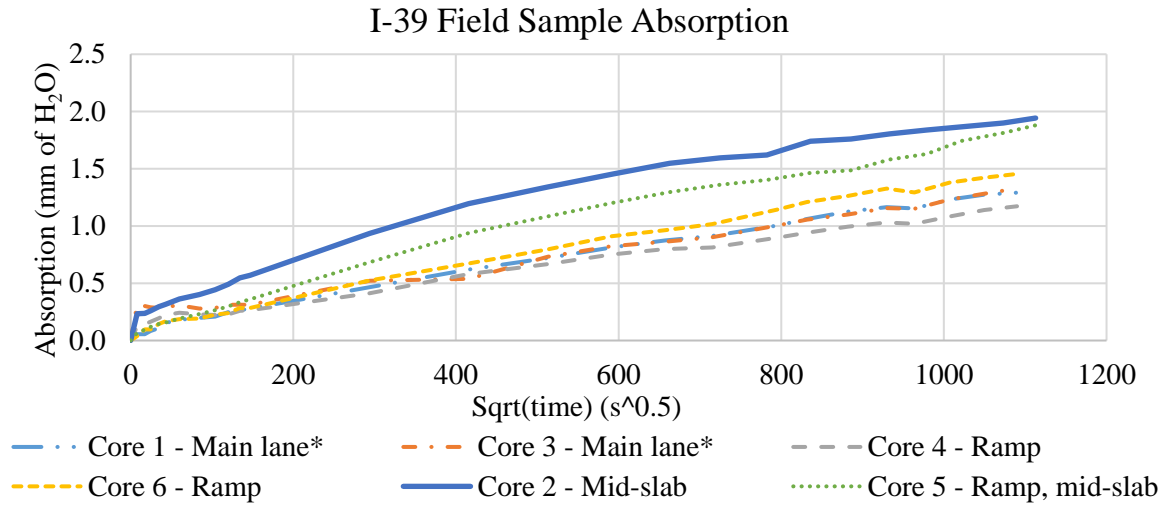
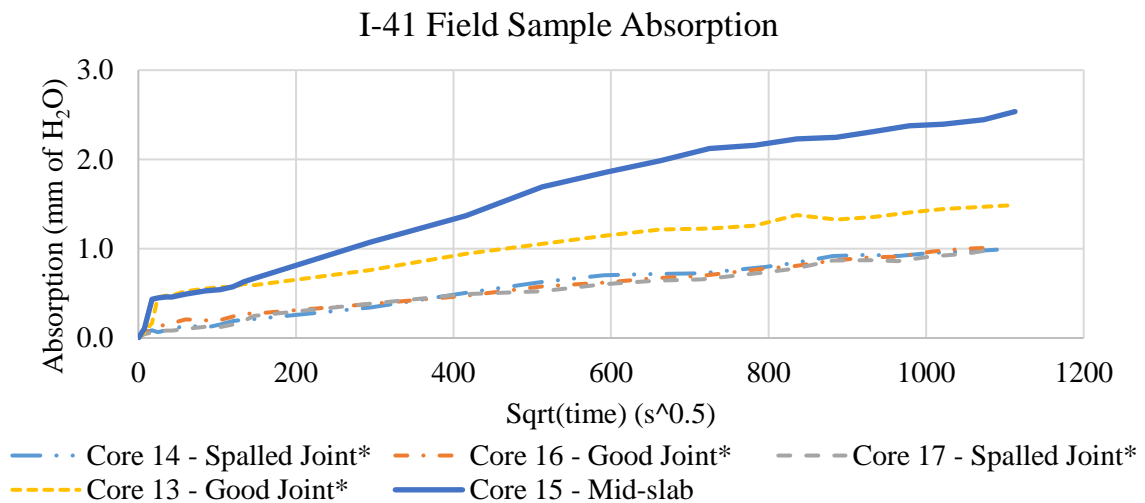
Figure A.1 Absorption of Core Samples from I-94, I-41, and I-39

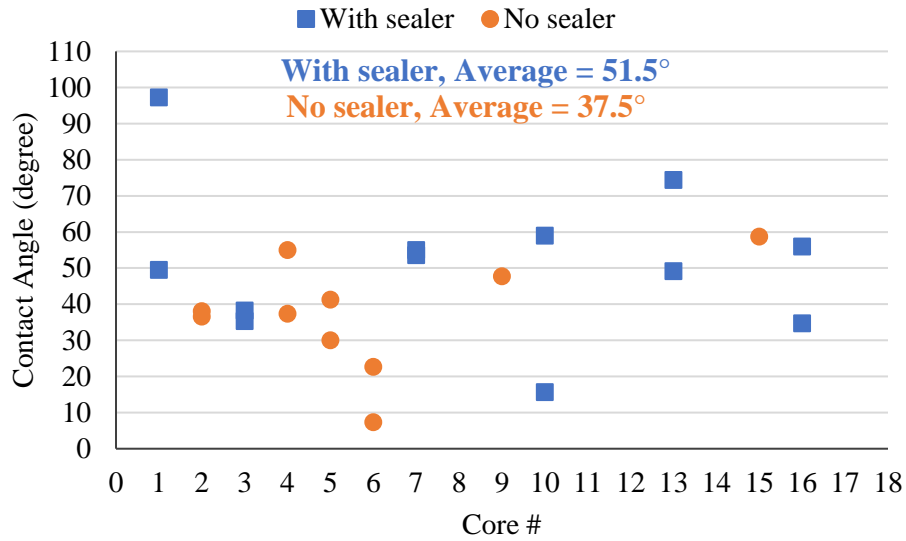
Figure A.2 Contact Angle of Core Samples from I-94, I-41, and I-39

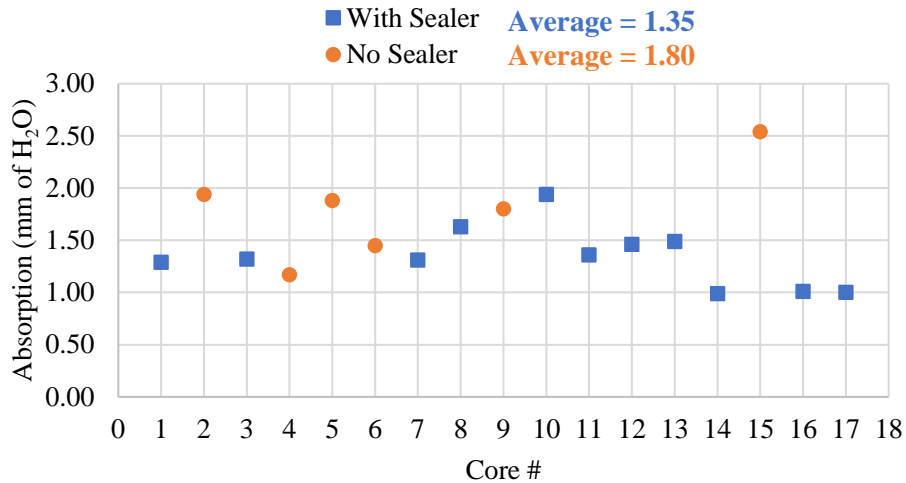
Figure A.3 Absorption of Core Samples from I-94, I-41, and I-39

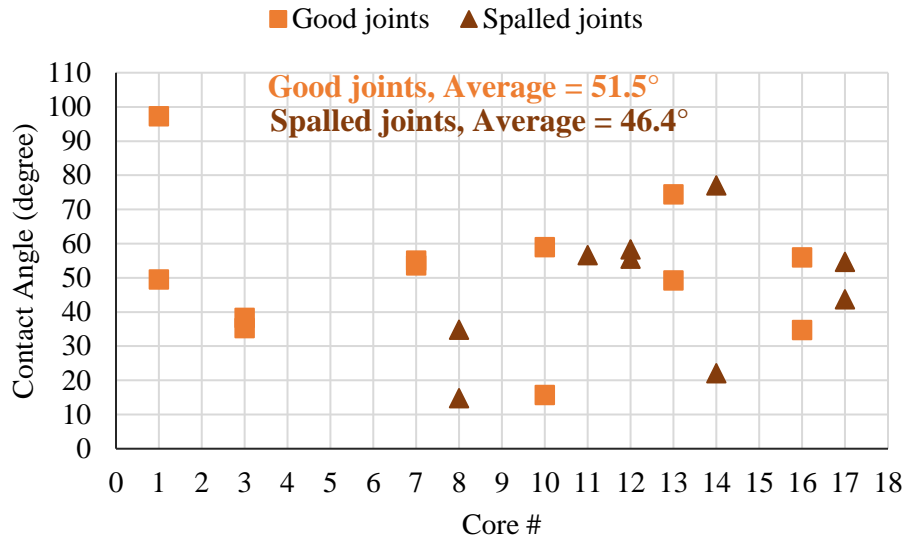
Figure A.4 Contact Angle of Good Joints and Spalled Joints from I-94, I-41, and I-39

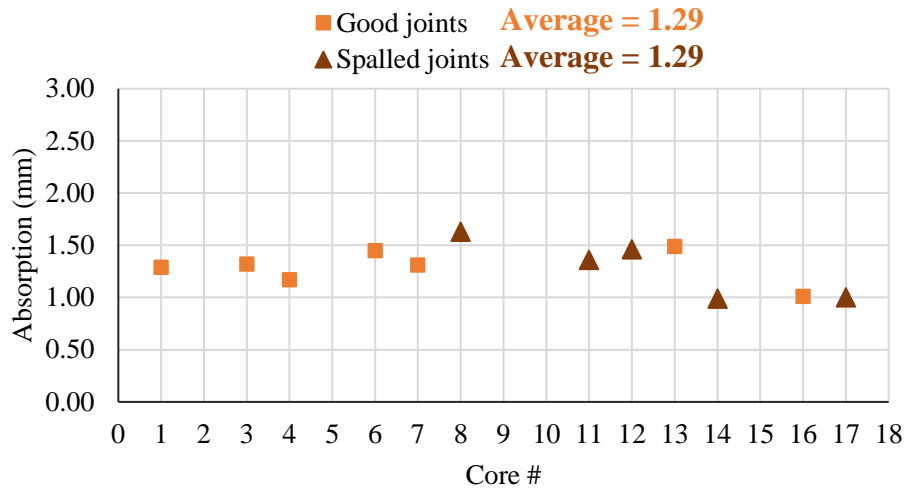
Figure A.5 Absorption of Good Joints and Spalled Joints from I-94, I-41, and I-39

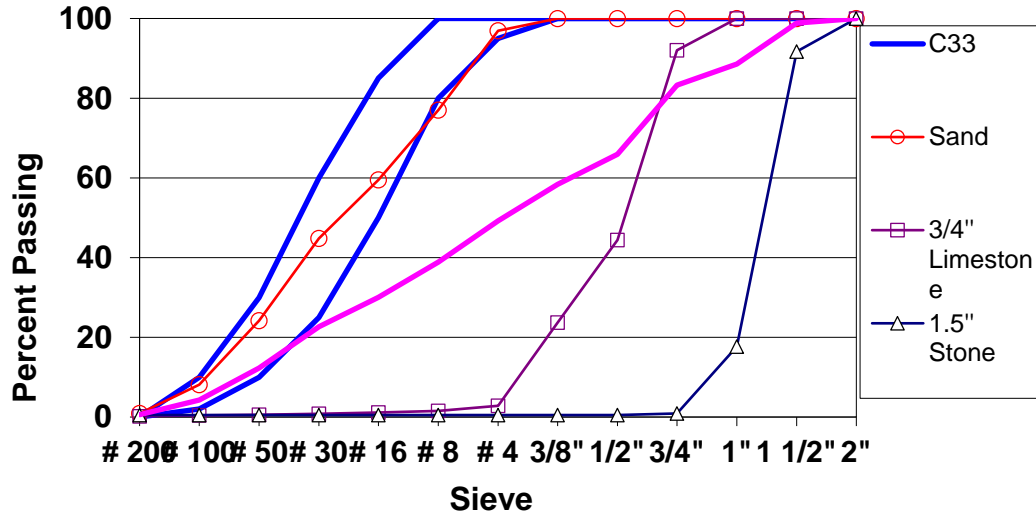
Figure B.1 Aggregate Gradations

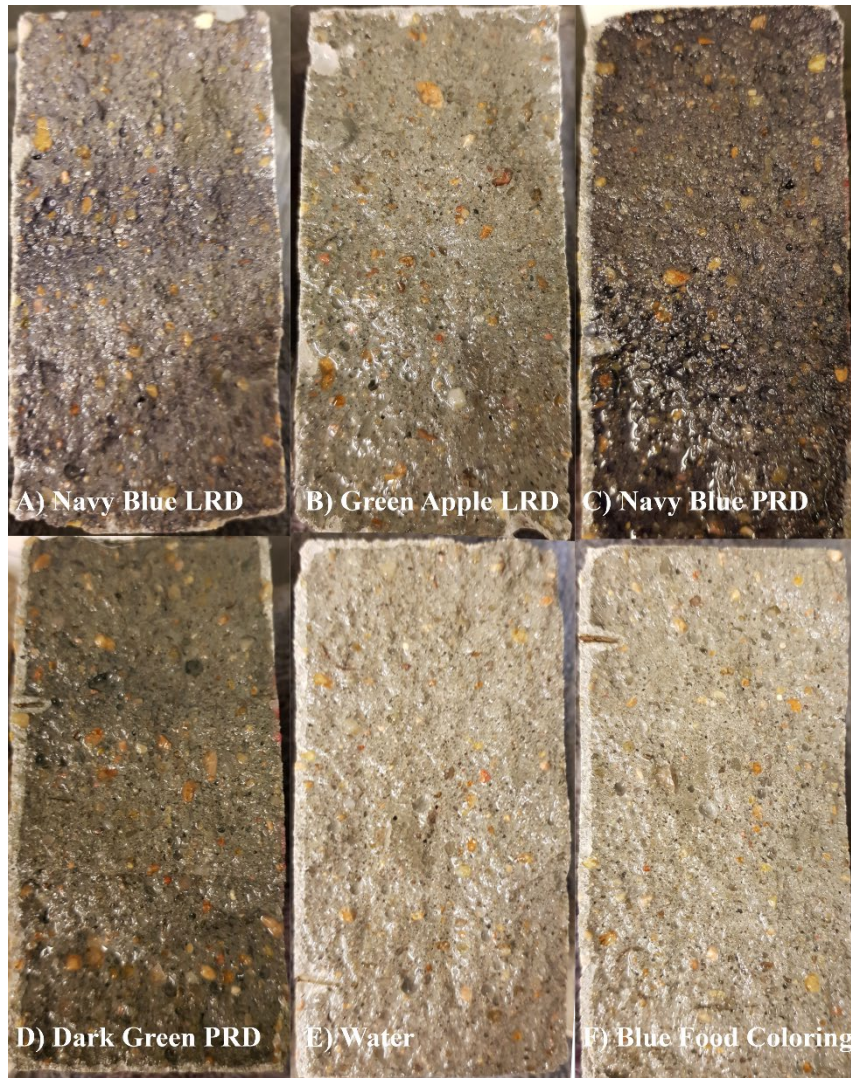
Figure C.3 Secondary Dye Testing for Depth of Penetration

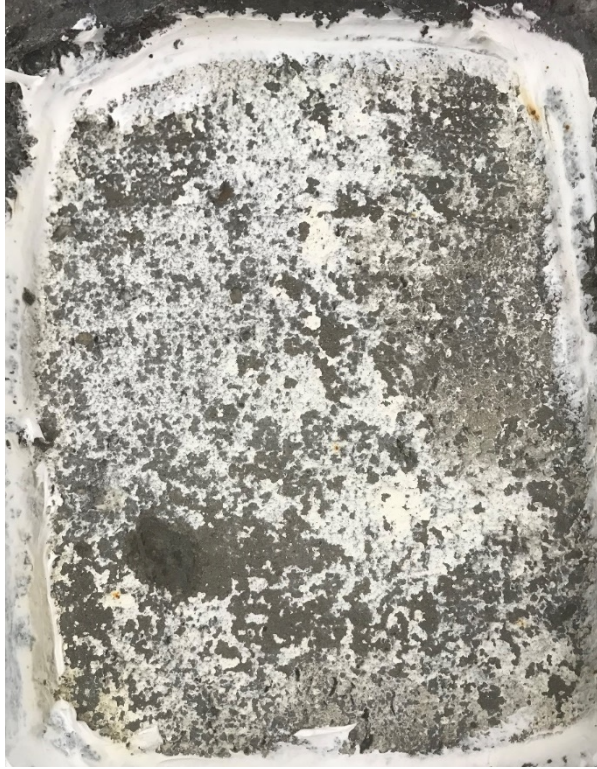
Figure C.4 FA Control after 50 Cycles

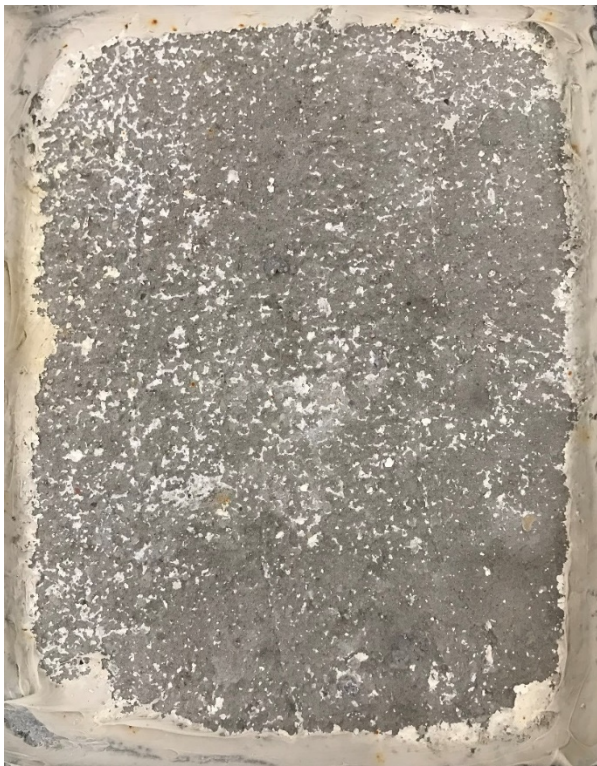
Figure C.5 FA Silane applied dry after 50 Cycles

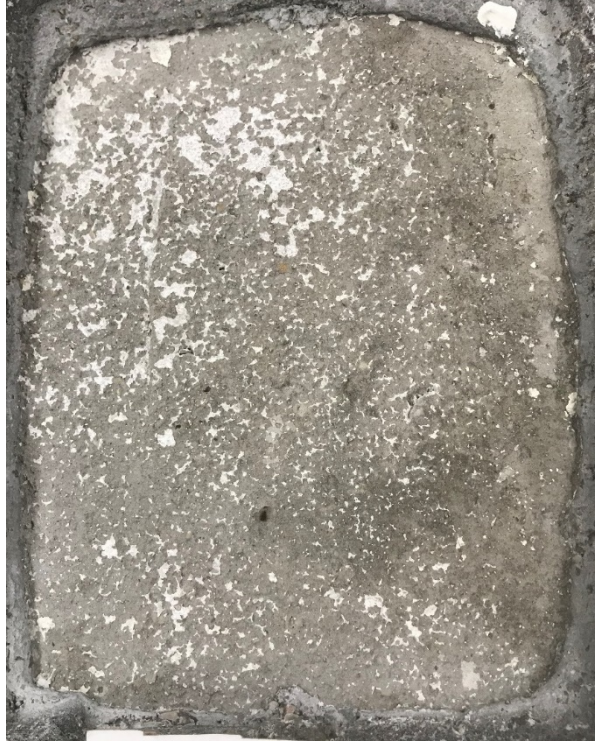
Figure C.6 FA Silane applied moist after 30 minutes after 50 Cycles

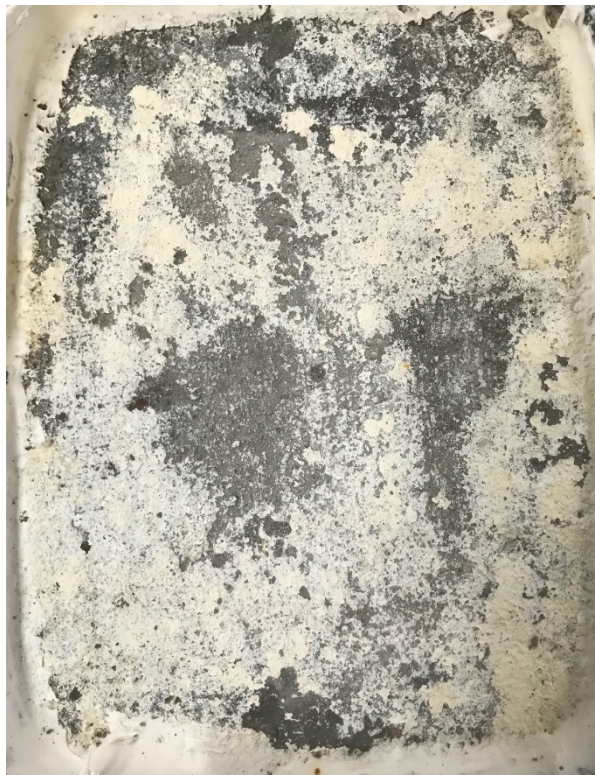
Figure C.7 FA SME-PS applied dry after 50 Cycles

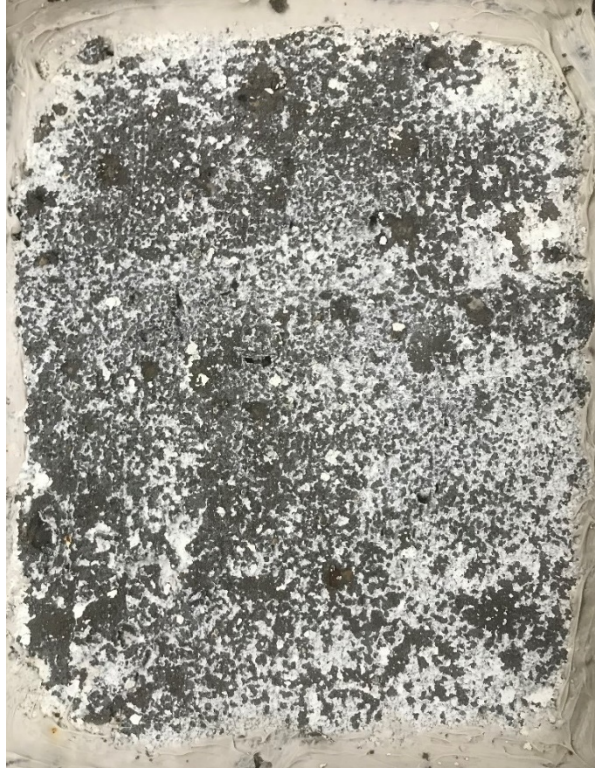
Figure C.8 FA Lithium Silicate mixture applied moist after 30 minutes after 50 Cycles

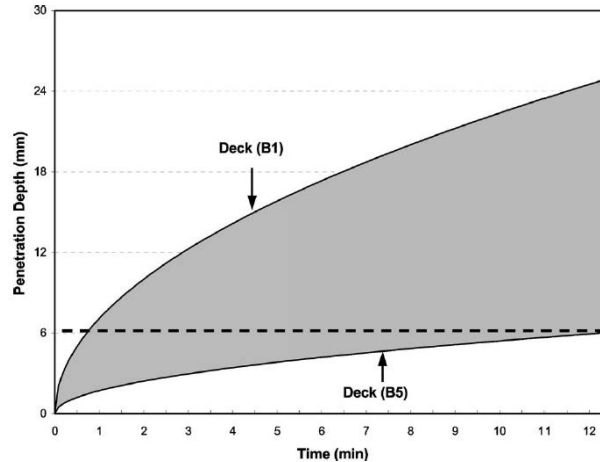
Fig. 4. Silane penetration depth against time
