# **Unmanned Aircraft Systems (UAS) - Metro District Bridge Inspection Implementation**

**Barritt Lovelace, Principal Investigator**  
Collins Engineers, Inc.

**MAY 2021**

Research Project  
Final Report 2021-13

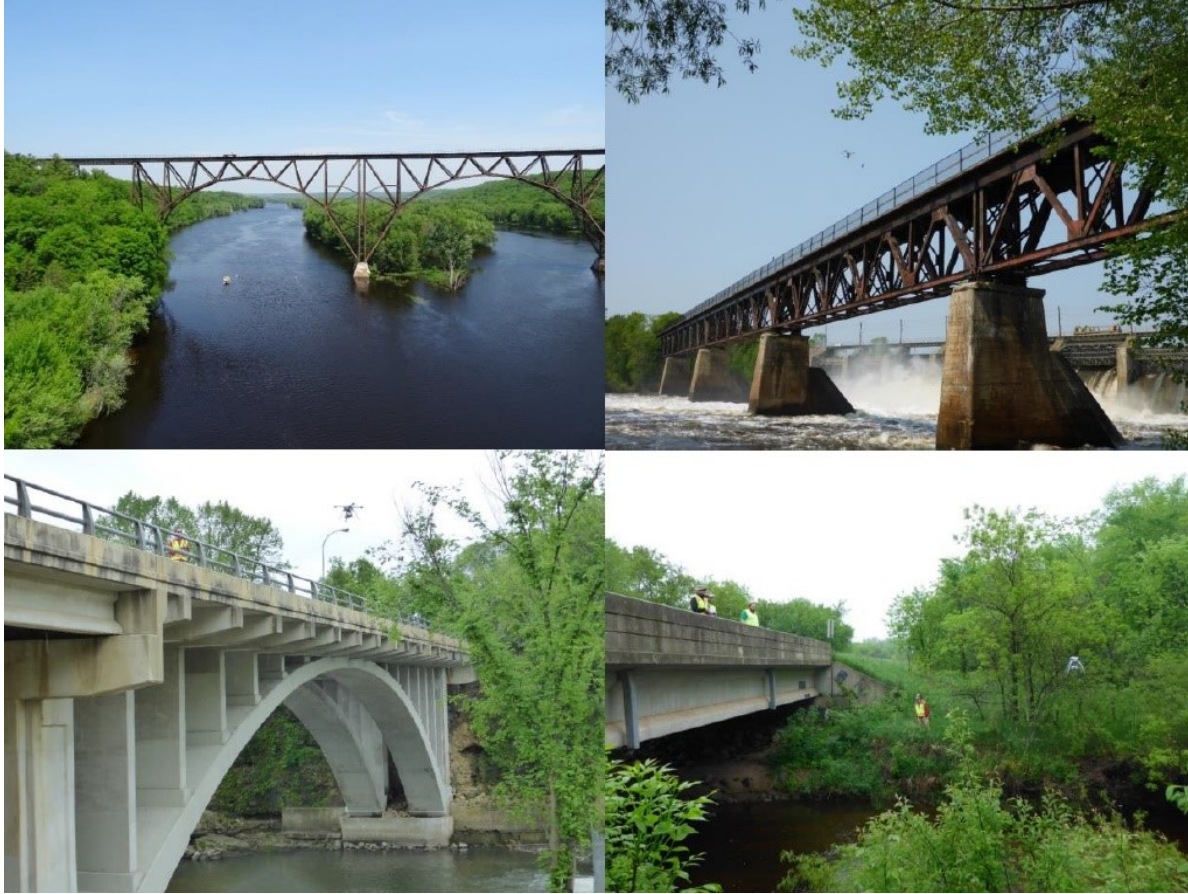
**Figure 1-1 Overall Photographs of Four Bridges Selected for Phase I UAS Inspection (Shown clockwise from upper right, Arcola Bridge, Morrison County Pedestrian Truss, Chisago County Bridge, Oronoco Concrete Arch)**

Investigators identified four bridges in Minnesota that represented a variety of bridge types and sizes: an 80-foot local bridge in Chisago County, a medium-sized concrete arch bridge in Oronoco, a large steel truss bridge in Morrison County, and a 2,682-foot long railroad bridge near Stillwater that rises 185 feet above the St. Croix River.

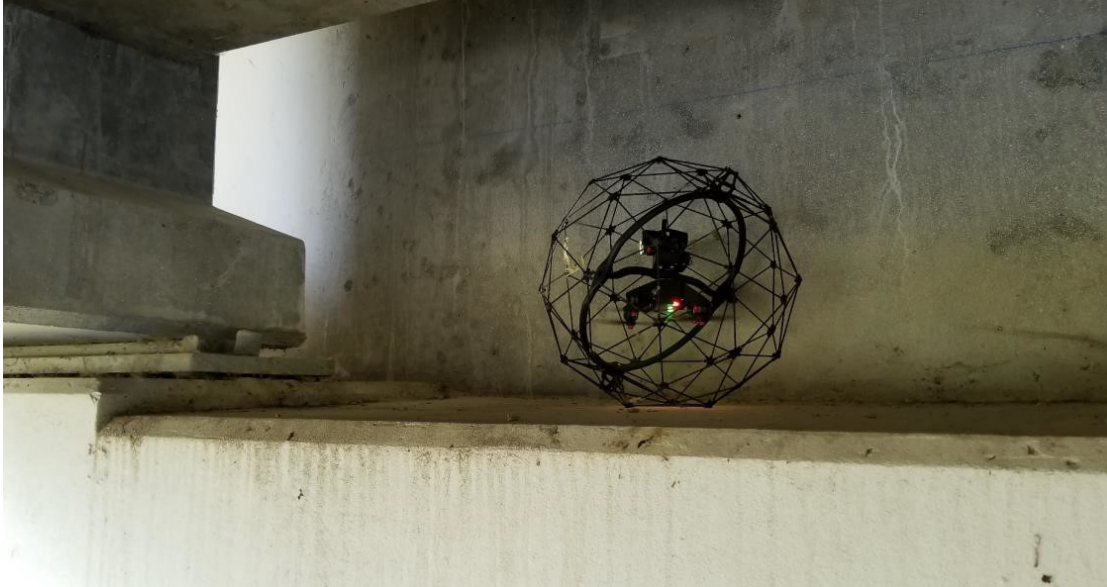
- Risk of damage is very low.
- Ability to navigate areas of a bridge that are difficult to access.
- Ability to roll: The protective frame can serve as a rolling device to better control the UAS, save battery life, and maintain a fixed distance from the face of an object. It was ideal for inspecting wide flange beams and concrete deck soffits by rolling the UAS along the top side of the bottom flanges.

**Figure 2-1 Elios Rolling Along an Abutment Bearing Seat.**

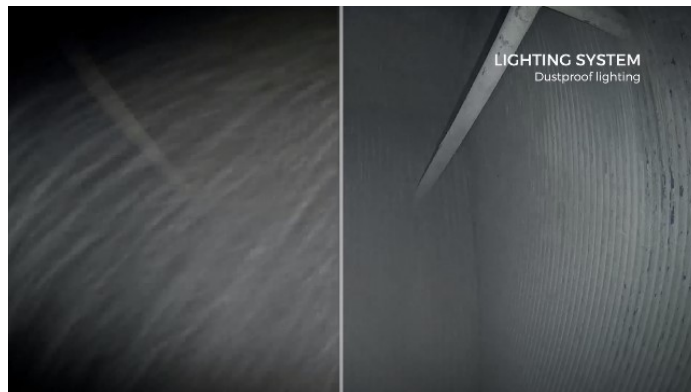
- Dust Proof Lighting: The Elios 2 contains a 10,000 lumen lighting package that is offset from the camera to help eliminate overexposing images with close proximity to dust and debris.

**Figure 2-3 Elios 2 Dust Proof Lighting Comparison**

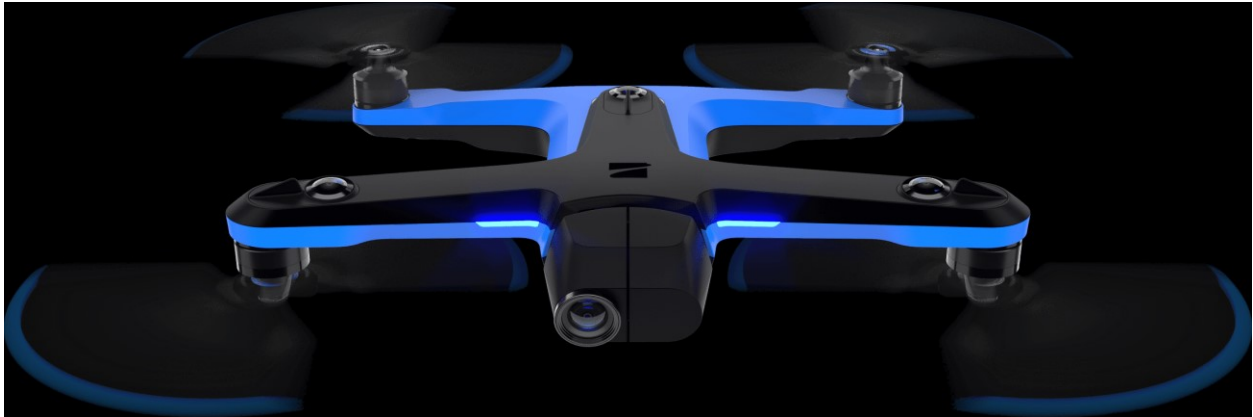
The Skydio 2 is manufactured by [Skydio](#) as displayed in the image below is the second UAS platform made produced by Skydio. The Skydio 2 was initially marketed to adventure enthusiasts for cinematic use but has also been developed with inspection specific enterprise features includes the ability to use obstacle avoidance with a shorter 1 foot range. The environment in which this UAS was created require autonomous flight through dense wooded areas and AI (Artificial Intelligence) capable of real-time

navigation around obstacles. To accomplish this, the Skydio has a state-of-the-art obstacle avoidance and object sensing technology. Skydio produces and develops UAS in the United States.

Figure 2-4 Skydio 2

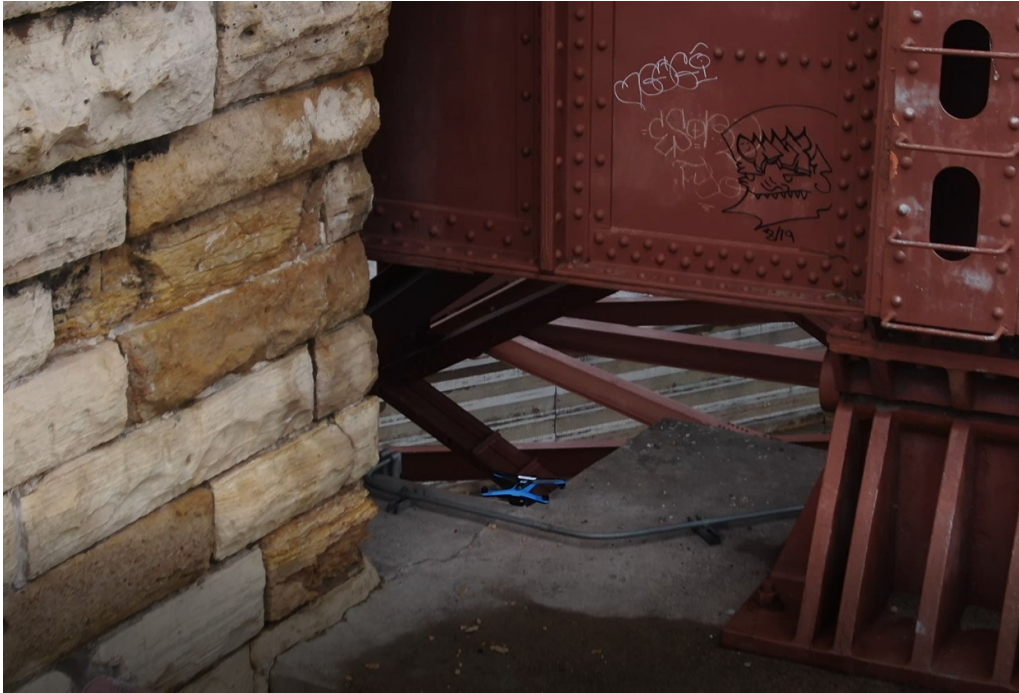
The Skydio's autonomy system and navigation camera system consist of a high-speed video processor and an on-board camera payload which create a real-time point cloud of the world around it. The onboard processor can create over 1 million points per second at a rate of 500 iterations per second. The camera payload for navigation consists of 6 cameras in a triangular configuration on the top and bottom. Each camera is a 4k Sony sensor with a super fisheye lens (200-degree field of view) creating a 360-degree coverage of the environment around the camera. The generation of a 3D real-time point cloud in conjunction with AI based autonomous flight makes the Skydio an ideal candidate for flying in close proximity to bridge members, confined space and through bridge trusses.

**Figure 2-6 Skydio 2 Flying in Tight Area Using Obstacle Avoidance**

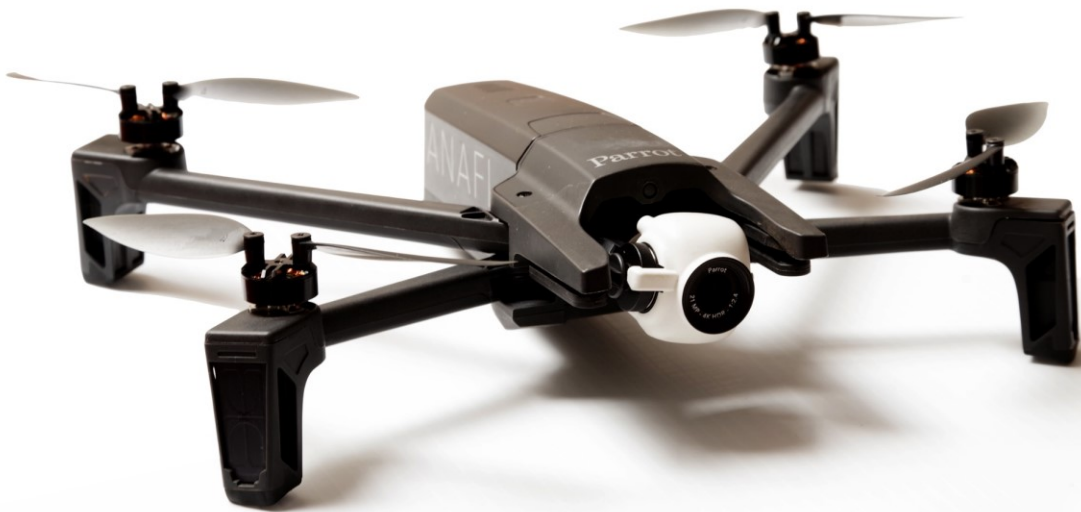
The Parrot Anafi folds up into a roughly 10in x3 in x3in block which makes it very portable. It can be flown from either a controller using a tablet or phone as the screen or flown from a phone or tablet directly. Several phone apps such as Pix4DCapture and Drone Deploy provide excellent on-site mission planning for near commercial-grade quality of aerial mapping and 3D modeling. The Anafi is not manufactured in China which makes it a candidate for use with government sectors such as military or the Department of Defense.

**Figure 2-9 Parrot Anafi**

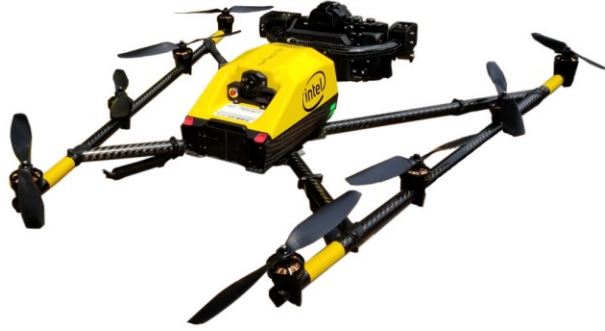
The Intel Falcon 8+ features carbon fiber frame construction consisting of 2 rail bars in a V-shape. Each rail houses 4 rotors. At the center of the V is the payload and processing housing. The configuration of rotors allows for flight in wind speeds in excess of 30 mph. Furthermore, the lightweight construction provides best in class weight to payload ratio for excellent flight time. The V-shape provides for an unobstructed field of view from vertical down, 180 degrees to vertical up. The onboard electronic and hardware system features triple redundant flight control with three redundant Internal Measurement Units for quick and reliable data processing of position, altitude and orientation for excellent responsiveness and stability. The 8 rotors, dual batteries, and multiple communication links also offer built-in redundancy for optimal safe operation.

**Figure 2-10 Intel Falcon 8+ Platform**

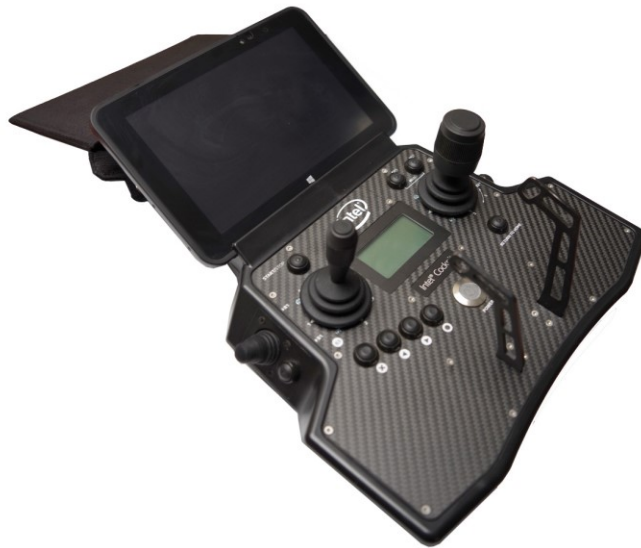
The cockpit controller is the main control interface with the Falcon 8+ platform. The controller features a built in 8-inch touch screen display for imaging and flight planning and a designated 2-inch system information display for system vitals. The controller has two main joysticks similar to traditional UAS platform controls. However, the right joystick has an additional rotational sensor which makes single hand flight control possible at a set altitude. Toggle switches built into the sides of the controller allow for image payload operation with a single hand. With the innovations of this controller, it is possible for a single pilot to flawlessly fly a manual mission at a given altitude while simultaneously operating and manipulating the imaging payload.

**Figure 2-11 Intel Falcon 8+ Cockpit Controller**

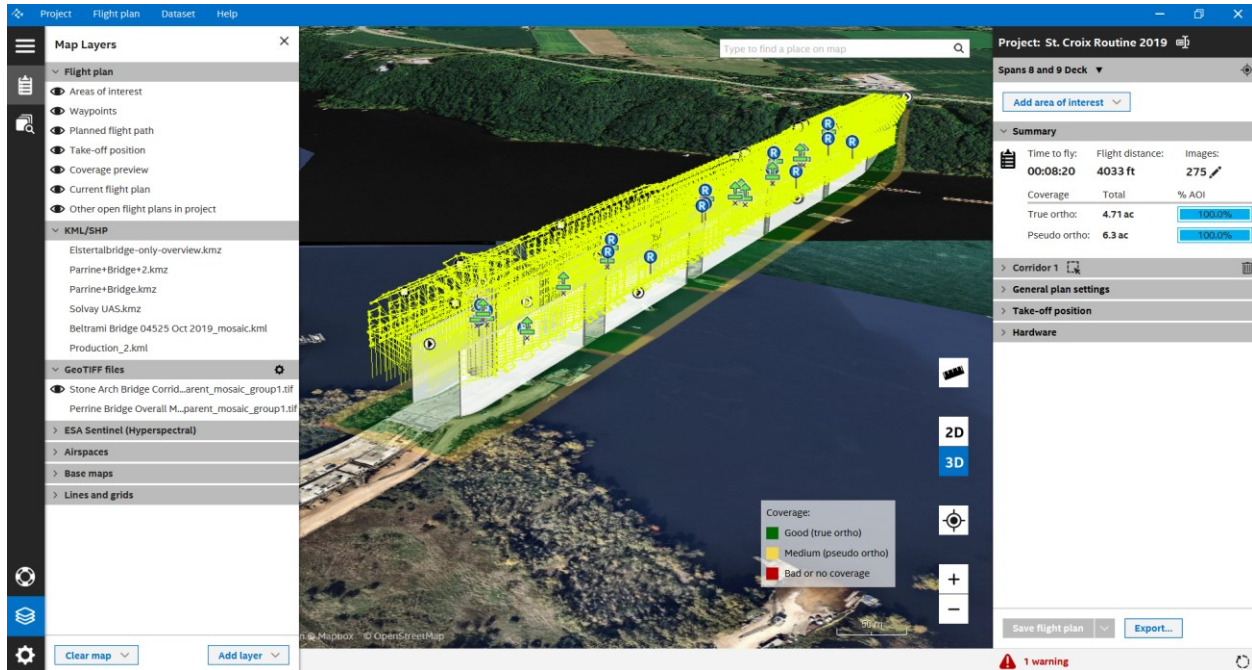
Intel Mission Control is a proprietary software suite created by Intel for mission planning for the Falcon 8+. The software features several mission types which can each be flown in series and edited to suit any flight condition. The software also allows for importing digital surface models created from higher altitude initial site flights. This provides a detailed background 3D image to plan flight missions.

**Figure 2-12 Intel Mission Control Flight Plan**

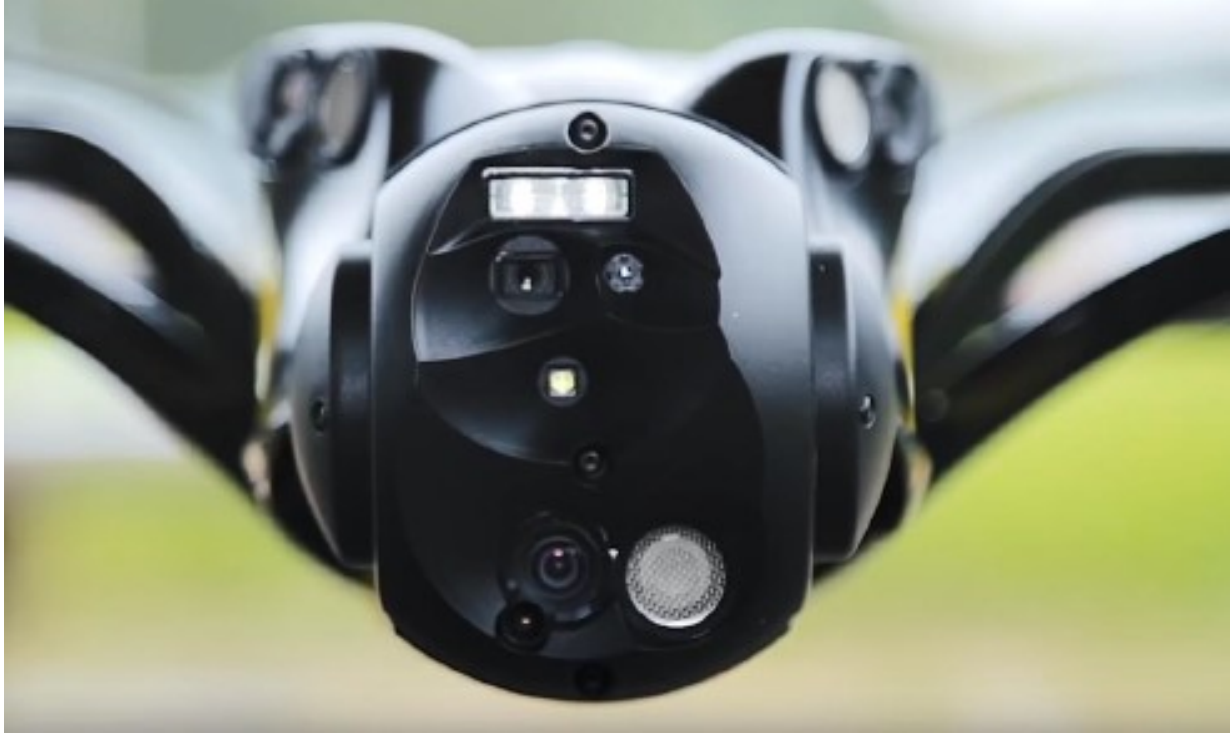
Many of the positive physical specifications and limitations of the Albris have been either duplicated or enhanced in the Parrot Anafi. However, the Albris retains its position in the commercial UAS due to the imaging payload which consists of a TripleView head containing a high-definition video camera, a 38 Mega-Pixel (MP) still camera, and an infrared camera. The 38MP camera is the primary data acquisition tool. The absolute horizontal/vertical accuracy of the UAS is reported at 3ft to 16ft without using ground control points and down to 0.04 in when using ground control points.

**Figure 2-13 Sensefly Albris TripleView Payload**

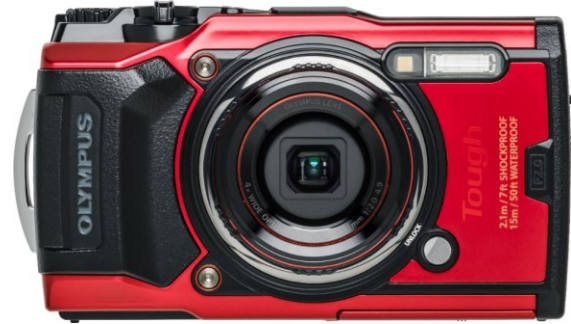
- HDR (High Dynamic Range) Still Imagery: HDR provides excellent photography in all lighting conditions. Often with terrestrial imagery, sky, sun or bridge backgrounds are captured while obscuring the focus on dark elements such as bearing or bridge soffits. HDR imagery assists in consistent image lighting, reducing instances of over or under exposure and saturation.

- Water / Dust / Impact Resistant: Inspection conditions are often in wet, dirty, and tough environments. Waterproof, shockproof, and dustproof camera features provide inspectors a durable and reliable platform with the potential use of underwater imagery for submerged element modeling.

**Figure 2-14 Point and Shoot Digital Camera for Photogrammetry**

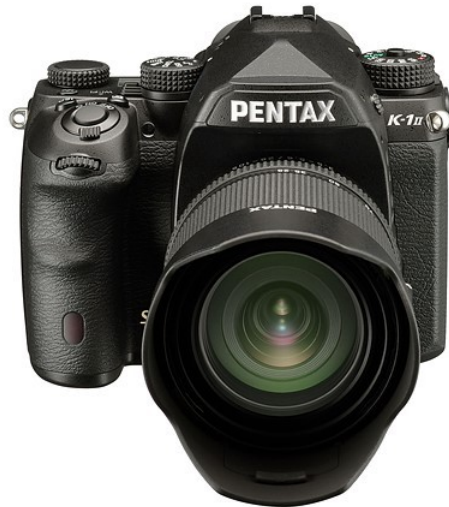
Less traditional to inspectors is DSLR (digital single-lens reflex) cameras. DSLR cameras are commercial grade, high resolution digital cameras. The benefits of these platforms are very high-resolution sensors, typically 36MP or more, which yields images that can display small defects from relatively far distances. The user input settings create better quality images in low light conditions or high-speed photography but requires the user to have a significant understanding of photography. GPS enabled feature are not as common in DSLR cameras and they are much less durable in wet or rough

Figure 2-15 DSLR Digital Camera for Photogrammetry

environments, which limits their use in inspections. A variety of aftermarket lenses such as wide angle or optical zoom options are available for these cameras, but not all are recognized by the post processing software. The use and type of a DSLR camera and lenses should be determined and vetted through post processing software prior to implementing in the field.

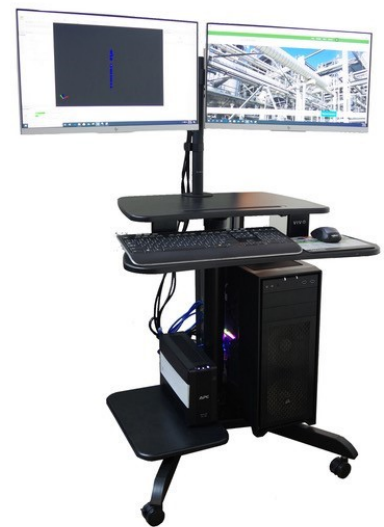
Throughout Phases II, III and again, in Phase IV, computing power was foreseen as an issue in processing 3D models efficiently while still delivering a quality product. In several cases where large bridges were imaged using a full frame DSLR camera using preplanned mission software, the raw data files were exceeding 100GB of imagery. On smaller bridges using manual photography and medium resolution cameras, data collected was still typically exceeding several gigabytes. It was quickly realized that to roll out a deliverable in an efficient timeframe, custom built computers would be required to process all the data. In addition to the computer processing being an issue, transfer of files over the internet or FTP sites became very tedious due to size of files and folder. Cloud-based technology and processing was implemented in Phases II through IV and is still a very efficient method of processing; however, from a security, ownership, and user input standpoint, it is still not capable of handling all jobs.

Figure 2-16 Custom Built Post Processing

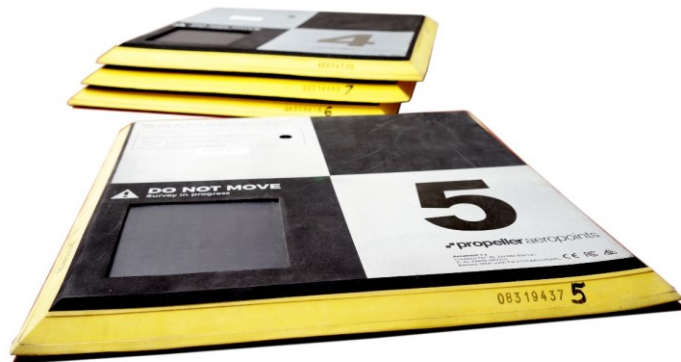
AeroPoints are drone specific aerial targets that record their own position using GPS, which is processed and corrected to ensure survey grade accuracy. Benefits of this technology is that inspectors do not need traditional base and rover surveyors to mark benchmarks prior to flying and these serve as both the GPS collector and the image target in one package. In Phase IV, our team used the Propeller AeroPoints with great success and reliability on inspections as large as 9-mile-long corridor surveys to one-mile long bridge inspection models. The use of these smart targets greatly increases the accuracy of your survey or model from +/- 3-foot accuracy to sub-inch accuracy.

Figure 2-20 Propeller AeroPoint UAS Survey Target

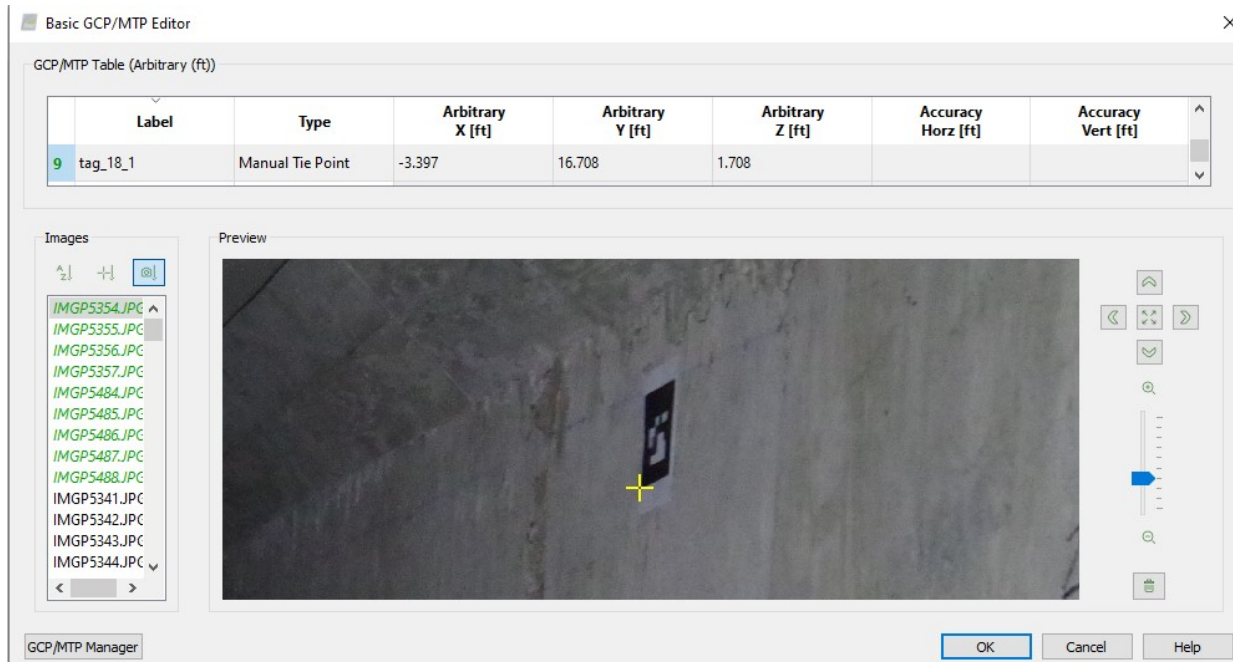
After placing the QR codes throughout the area to be imaged in conspicuous locations, the user can proceed as normal with acquiring UAS or Terrestrial Imagery for a model. The user will then import information from these QR codes into Pix4D as MTPs to aid in processing.

**Figure 2-24 Pix4D GCP/MTP Editor Screenshot Showing Points Automatically Inserted on a QR Code.**

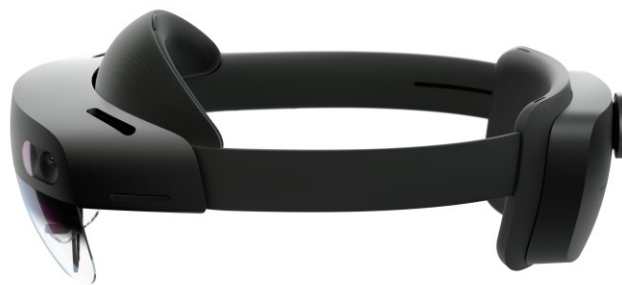
Collins Engineers has been working with Bentley in developing software for the Microsoft HoloLens 2 to be able to perform virtual inspections using mixed reality. A 3D reality model can be loaded on a HoloLens headset and the user can not only view the virtual bridge in a hologram but, can also make measurements, add notes, add and classify defects and denote elements. This data can then be integrated into the bridge inspection report database as condition codes and quantities. Utilizing mixed reality can allow users to populate or review inspection data from their office and allows for the sharing of bridge inspection data with experts in other locations.

**Figure 2-25 Microsoft Hololens 2**

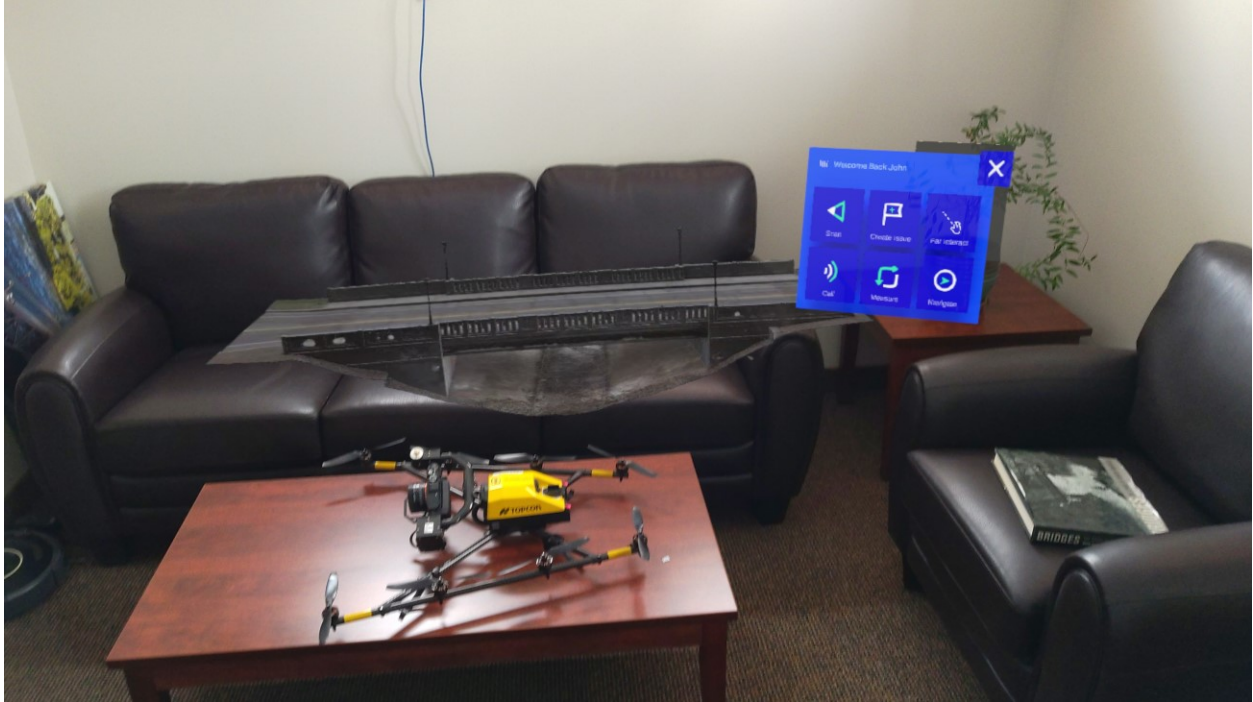
Figure 2-26 Holographic Overall Bridge View from HoloLens 2

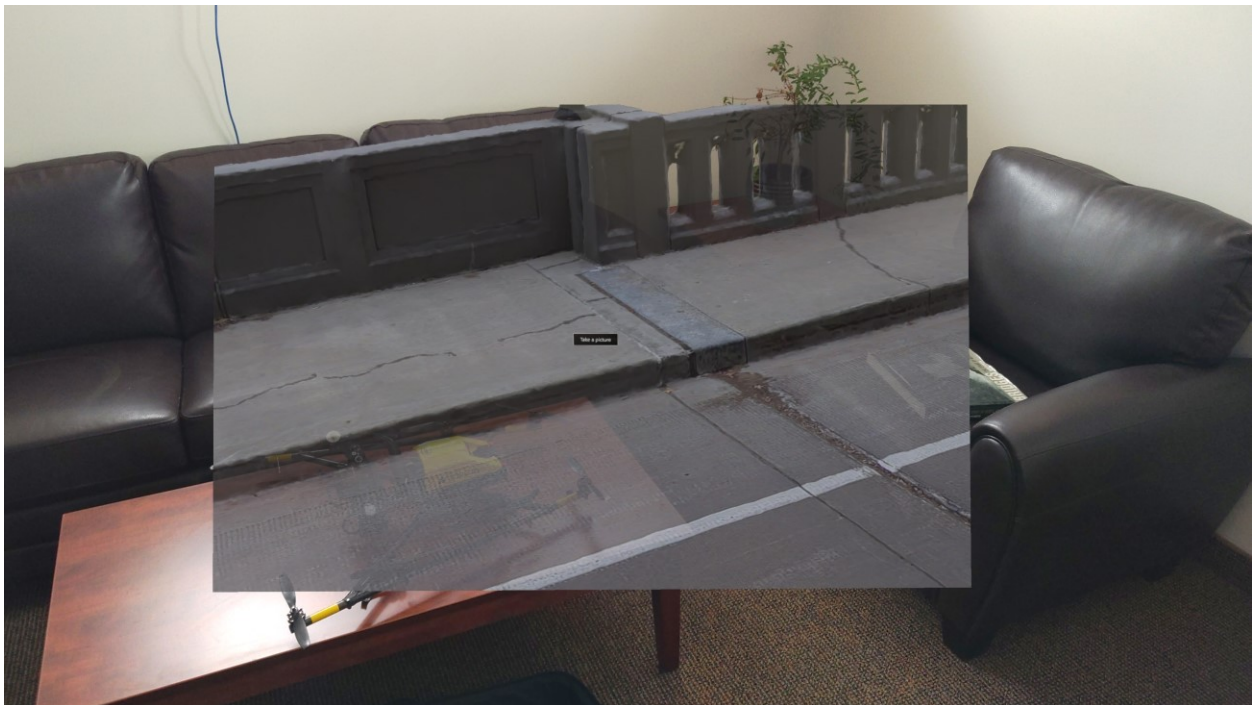
Figure 2-27 Holographic Close Up View of Bridge from HoloLens 2

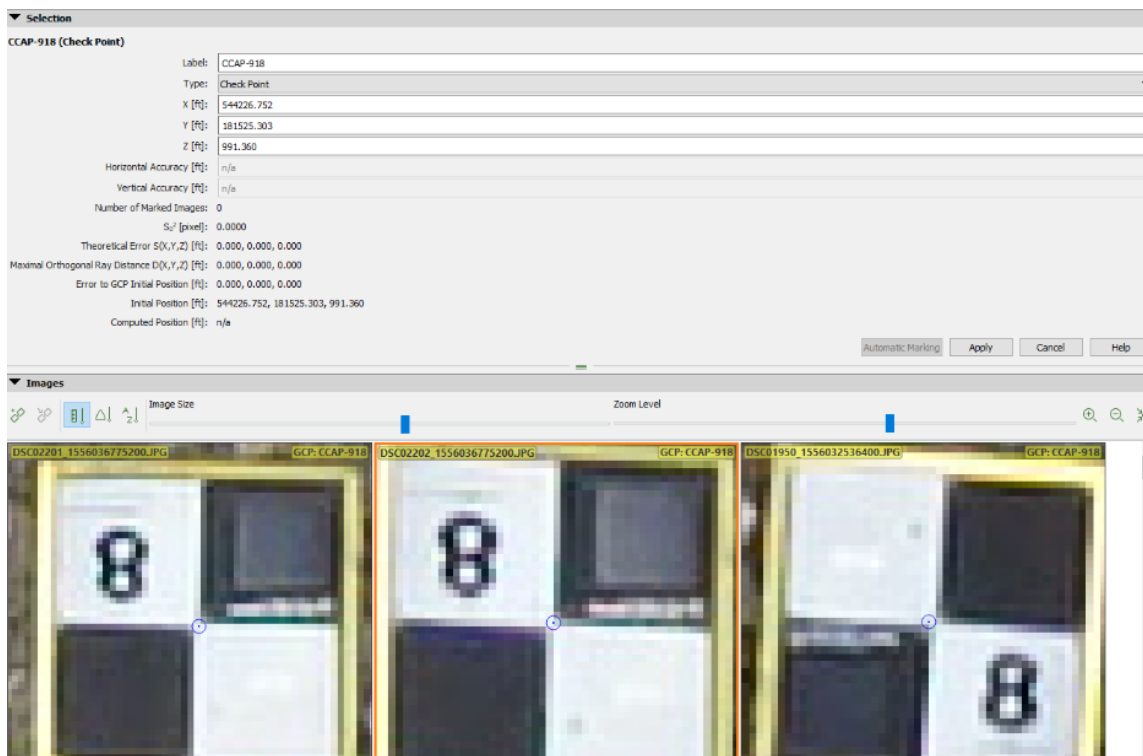
The use of AeroPoints, in conjunction with the Intel Falcon8+ UAS platform, was implemented as part of a 9-mile corridor survey for Carver County in Minnesota to obtain a terrain model. This survey technique proved to have many benefits. It provided additional data than a traditional ‘base and rover’ type survey and was much more efficient and economic than an LiDAR survey. To ensure accuracy and to prove proper calibration of the UAS system using AeroPoints, Carver County surveyors set out 21 Check Points surveyed with traditional base and rover methods. These points were then compared to the final model which utilized 234 individually placed AeroPoints as Ground Control Points. A report was generated which compared the model points to the check point locations and calculated error. These results concluded that with the use of AeroPoints, a UAS survey using a commercial UAS platform can achieve sub-centimeter accuracy of an entire terrain area.

Figure 2-28 Pix4D Ground Control Point Editor Showing a Propeller AeroPoint

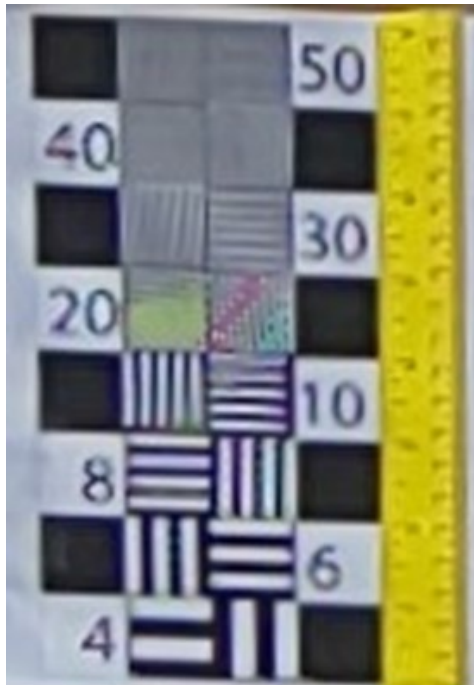
**Skydio 10 FT at 0 degrees**

The first comparison at 10 feet resulted with the Skydio is shown below. At all skew angles, 20 lines per square were blurry and could not be counted. The largest amount of lines still able to be legible was 10 lines per one inch. This correlated to being able to detect a crack width of 0.1" at 10 feet away at any angle up to 60 degrees.

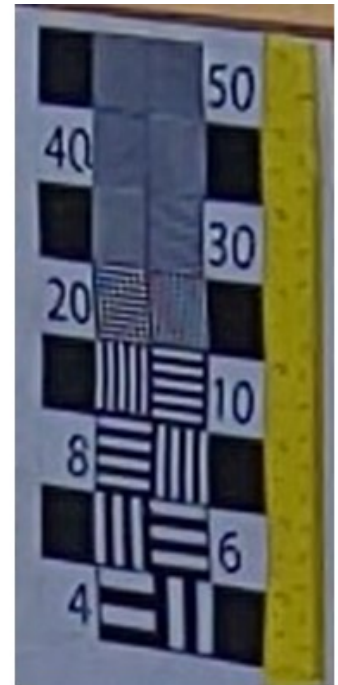
**Skydio 10 FT at 60 degrees**

**Figure 2-30 Skydio Resolution Test at Several Angles From 10'**

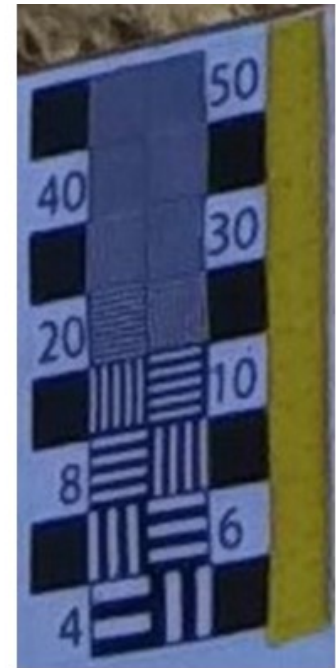
**Anafi 10 FT at 60 degrees**

**Figure 2-31 Anafi Resolution Test at Several Angles from 10'**

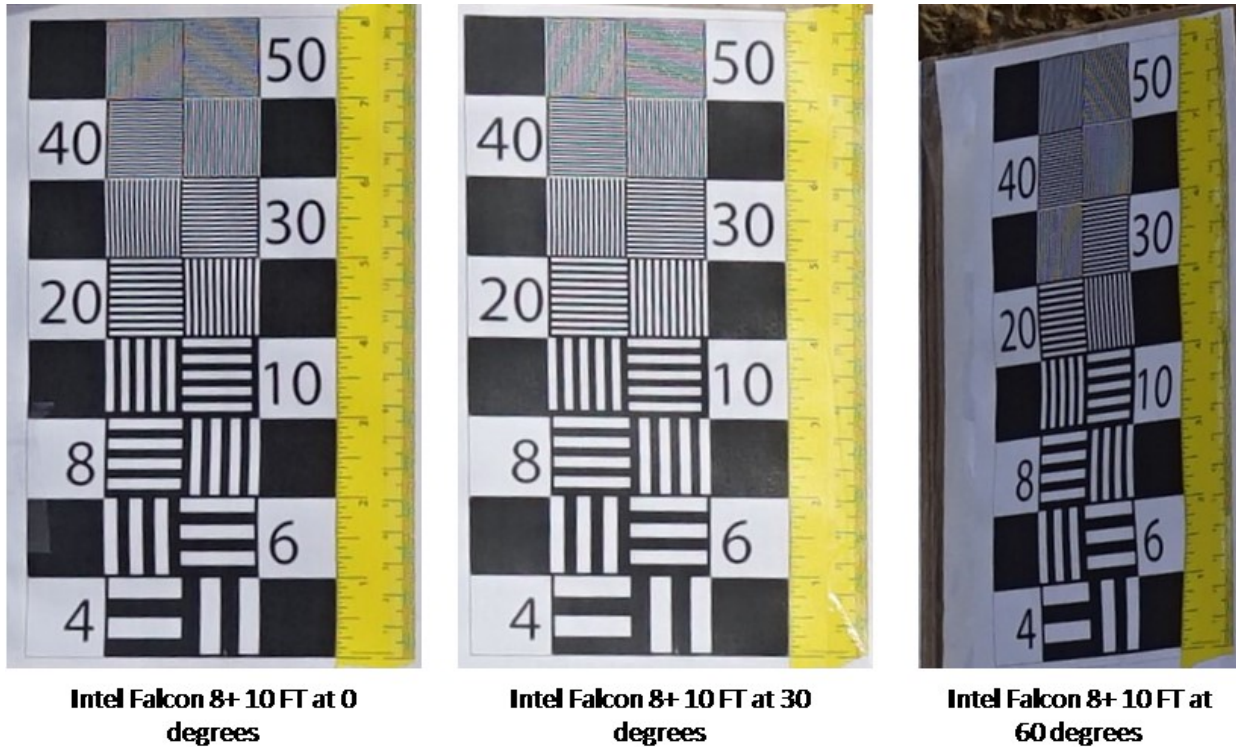
The last comparison at 10 feet was performed with the Intel Falcon 8+ which is shown below. At all skew angles, 50 lines per square were blurry and could not be counted. The largest amount of lines still able to be legible was 40 lines per one inch. This correlated to being able to detect most crack widths of 0.025" or larger at 10 feet away at any angle up to 30 degrees. At 60 degrees, horizontal lines were clear up to the 40 lines per inch with the vertical lines blurred above 40 lines per inch while vertical lines only started to be visible at 20 lines per inch. At a 60-degree skew, it would be understood that a horizontal crack of 0.025" or larger would be noticed while vertical cracks would need to be 0.05" or larger to be noticed.

Figure 2-32 Intel Falcon 8+ Resolution Test at Several Angles From 10'

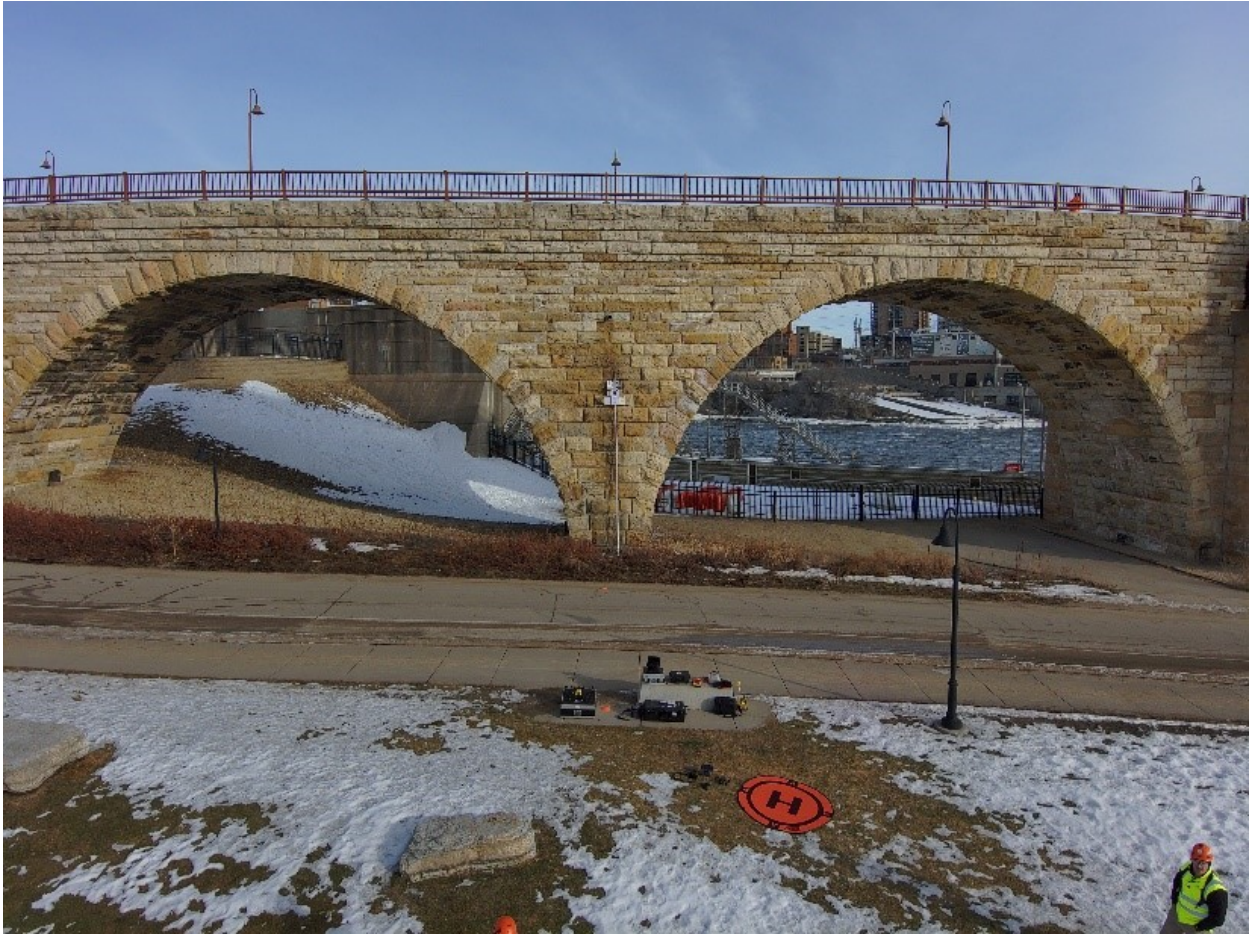
The Skydio image shown below has a relatively darker image when compared to the other two cameras. Of all three drones this had the widest shot which included more background and more of the adjacent piers to the target.

**Figure 2-33 Skydio's Full Image at 100 Feet From the Visual Test Board**

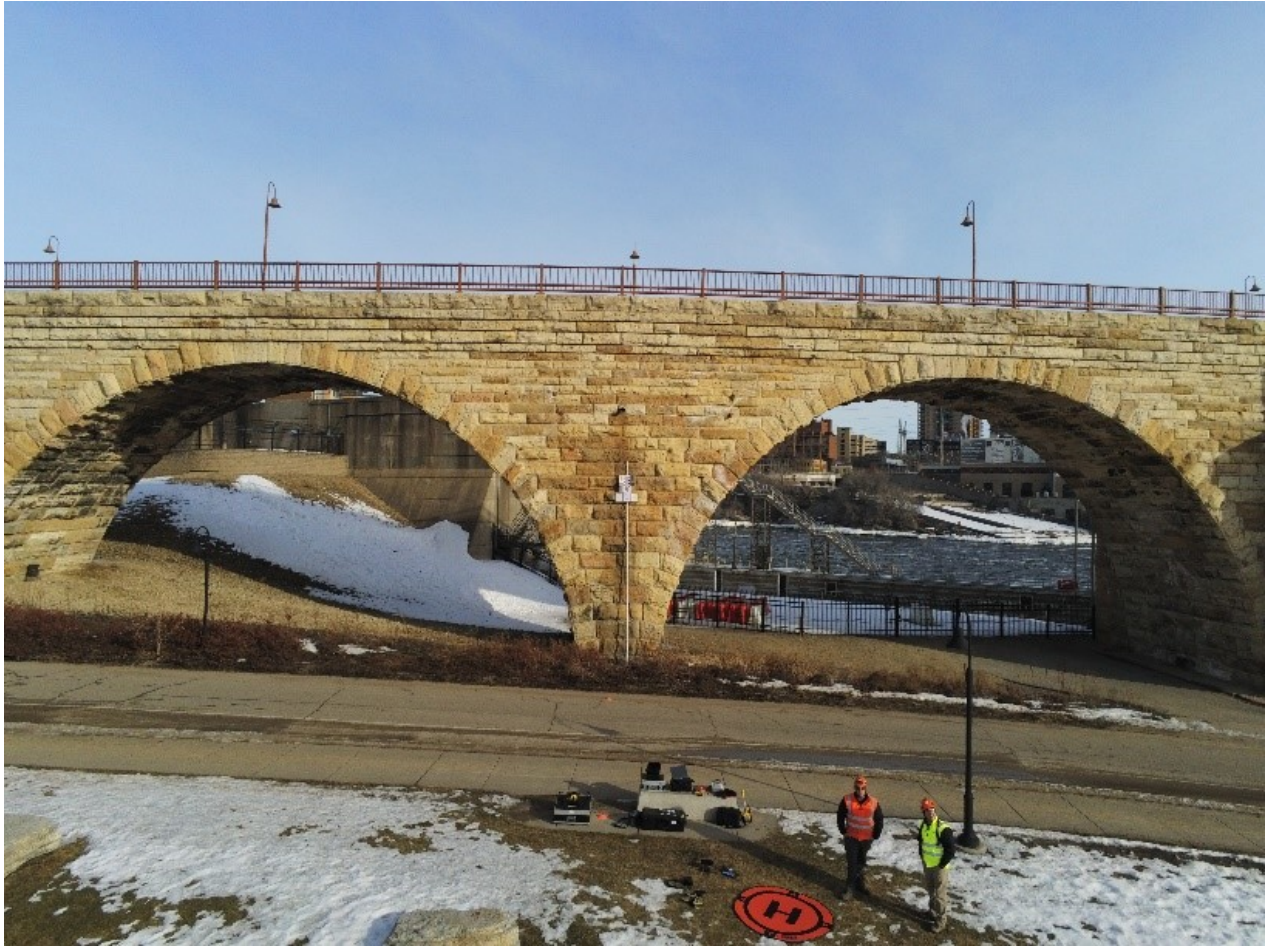
The Anafi Parrot also had a wider shot compared to the Intel and is shown below. Colors were the brightest on this camera. Detail was lost within the shadows when compared to the other images by the Intel and Skydio.

Figure 2-34 Anafi's Full Image at 100 Feet From the Visual Test Board

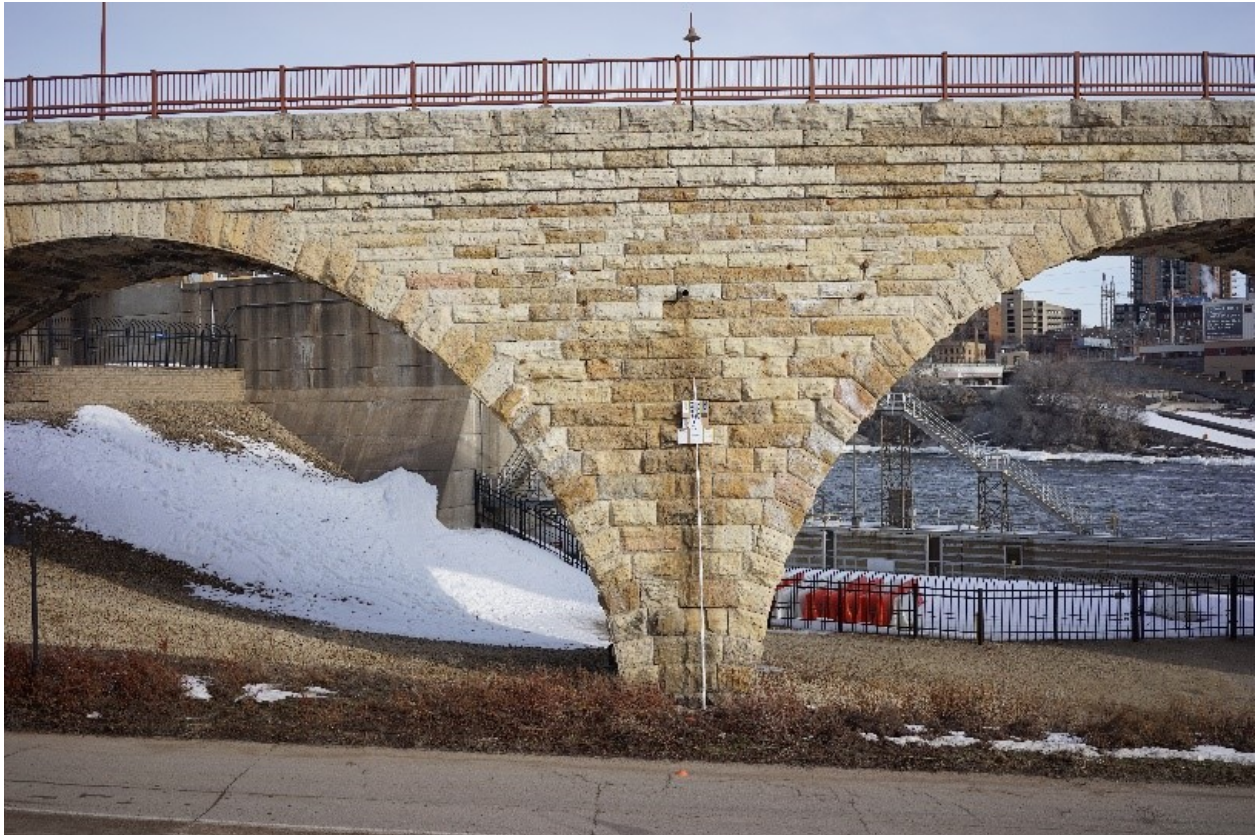
The Intel's camera is shown below, which had a noticeable narrower field of view. Also, colors observed in this were paler in contrast to the other camera images.

**Figure 2-35 Intel Falcon 8+'s Full Image at 100 feet From the Visual Test Board**

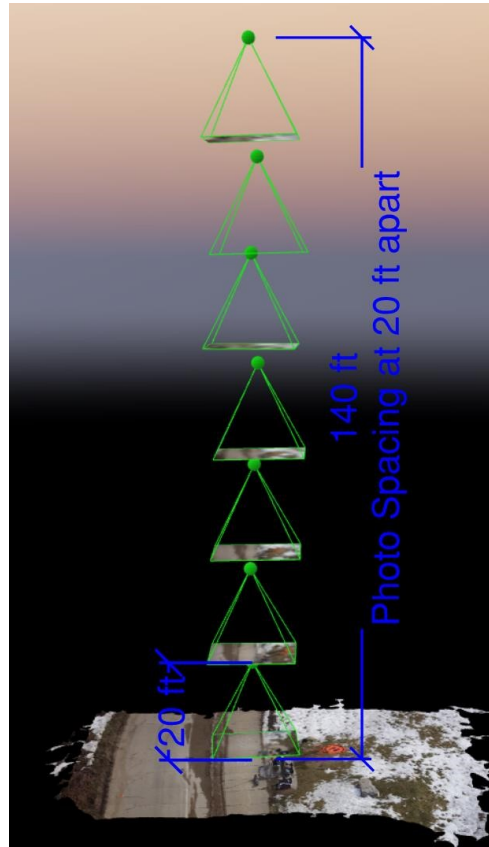
The flight plan of the Intel Falcon 8+ was to take a photo starting at an altitude of 20 feet directly over the QR codes and capturing a photo every additional 20 feet up to the altitude of 140 feet. The screenshot below showcases the flight. Each green point represents the location where a photo was taken.

Figure 2-36 Pix4D Screenshot with the Locations Of Each Shot Taken During the Test

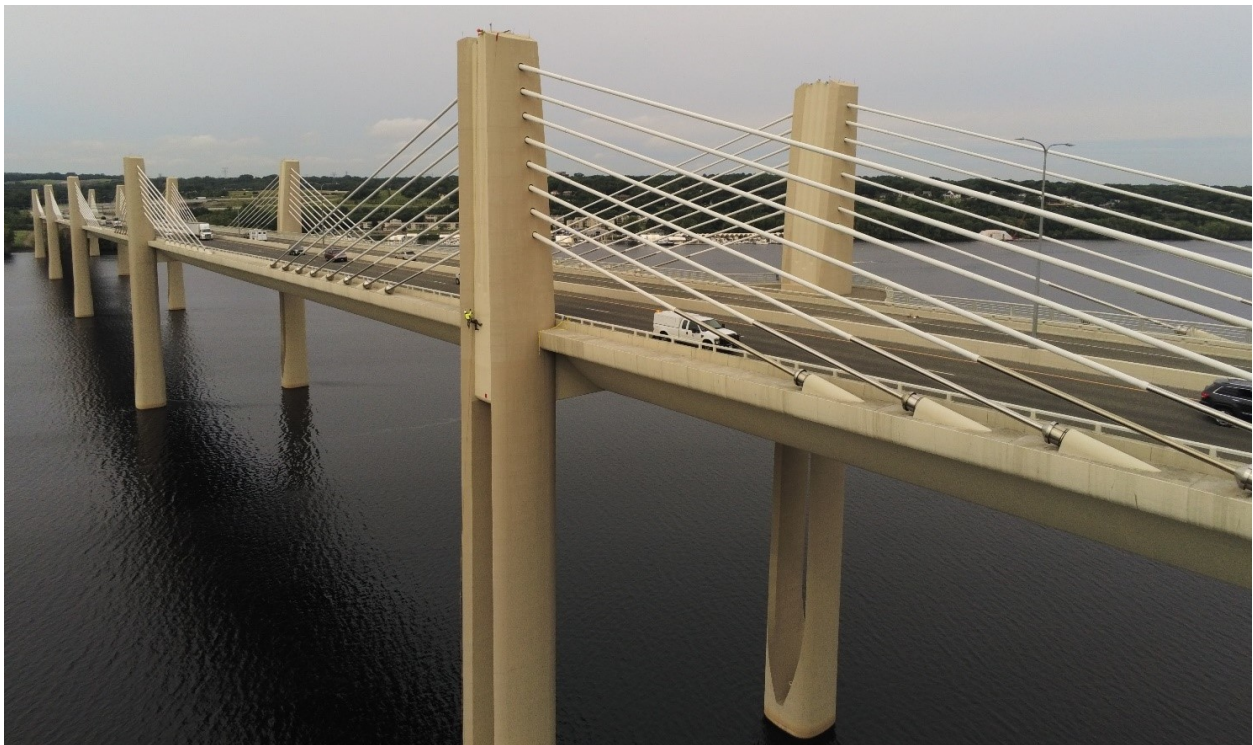
This case study consists of the results of an UAS bridge modeling and defect mapping of St. Croix Crossing bridge number 82045, TH 36 over St. Croix River in Oak Park Heights, Minnesota. The section of bridge modeled for this phase was unit 3. Unit 3 is a 6-span, extradosed cable-stayed, post-tensioned concrete box girder unit spanning a total length of 3,365 feet between Piers 7 and 13. The unit is comprised of parallel precast box girder segments and carries the two lanes and shoulders of west and eastbound TH 36 and a 12-foot wide barrier-separated trail on the north side of the bridge. Transverse post-tensioning is located at each deck level with cable-stay anchorage. Loads are transferred from the interior box girder webs to the cable-stays. A catwalk is present along the full length of the unit along the bridge centerline. The typical unit width is 98'-6" out-to-out with a depth of 18' throughout.

Figure 4-1 St. Croix Crossing Bridge

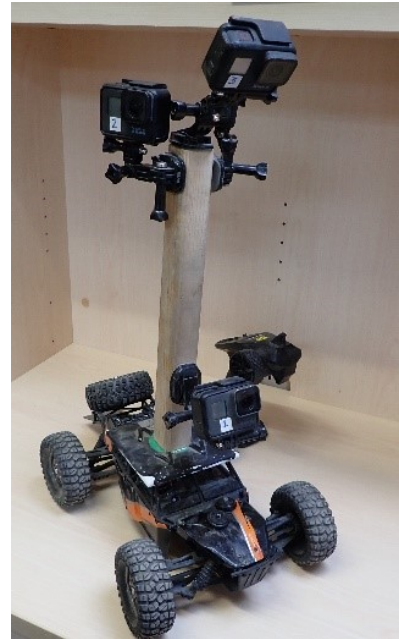
Several additional missions using terrestrial cameras mounted on a Remote Control (RC) platform were identified for this bridge to explore the potential of terrestrial photography to map concrete box girder interior defects. The target goal of the mission was to explore the difference in quality between UASs and terrestrial photography in confined spaces. The imaging of all boxes for bridge numbers 27831C and 27831D were selected for imaging using terrestrial means and cell DE1 from Bridge 27831C was selected for UAS means. The Flyability Elios was selected for the UAS method. The small confined space had limited effectiveness using the UAS due to the high dust levels. The terrestrial method utilized four GoPro Hero 7 High-Resolution Cameras mounted in a cluster on the RC device and orientated in different directions (up, down, left, and right). Images were taken simultaneously from all cameras at calibrated distances from the RC device. The cameras were equipped with a 12 Megapixel still camera and a fisheye lens. During the inspection, the driver worked with a mobile controller while the other crew members monitored hazards and maintained communication in the confined space for the occupant(s). The entirety of terrestrial imaging was conducted inside the box girder spans. The number of images ranged from 100-350 per box depending on the size of the individual cells.

**Figure 4-5 RC Imaging Platform with GoPro Camera Cluster**
