# **Unmanned Aircraft Systems (UAS) - Metro District Bridge Inspection Implementation**

**Barritt Lovelace, Principal Investigator**  
Collins Engineers, Inc.

**MAY 2021**

Research Project  
Final Report 2021-13

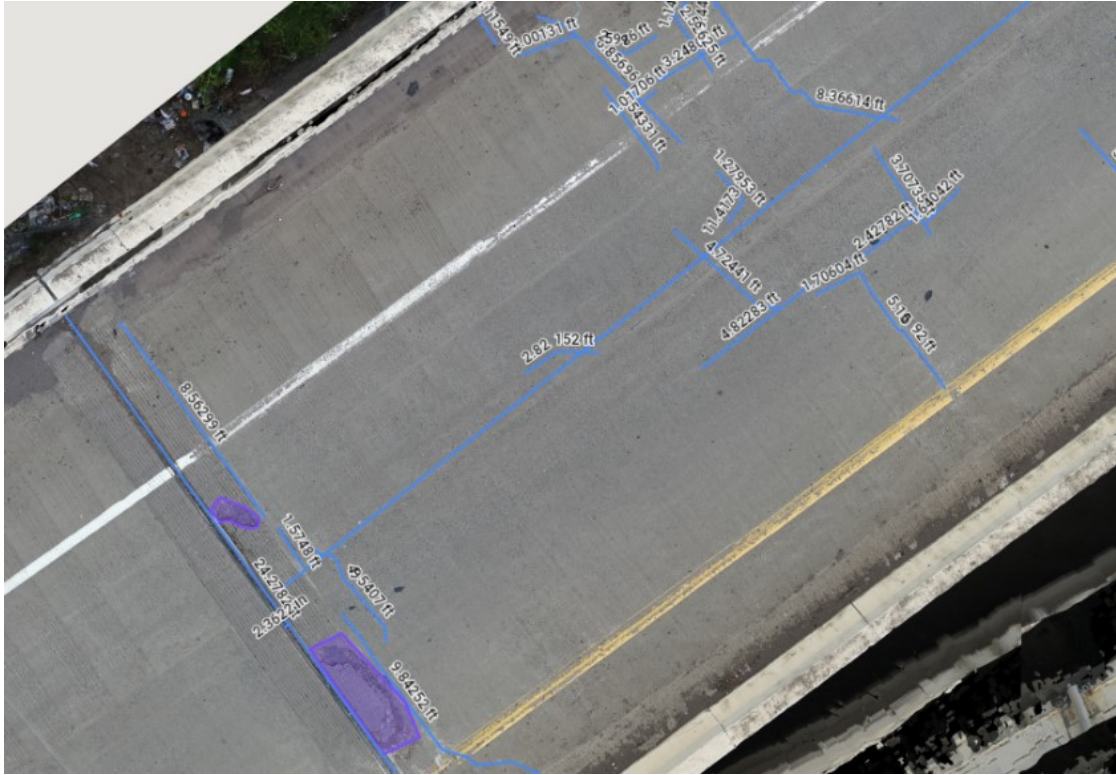
A second use of UASs provided inspectors the ability to produce an orthomosaic map of the deck with the Pix4D program. These models were uploaded to the cloud and the inspector placed annotations and measurements on any deficiencies found in the model. If there was a specific area of interest, the inspector could click the area, and the software would provide all the still images affiliated with its annotations showing the original pictures of the area of interest. Refer to Figure 4-7 and Figure 4-8 for an example of a deck with inspection notes and annotations.

Figure 4-7 Bridge 27831A Deck with Measurements in Pix4D Cloud

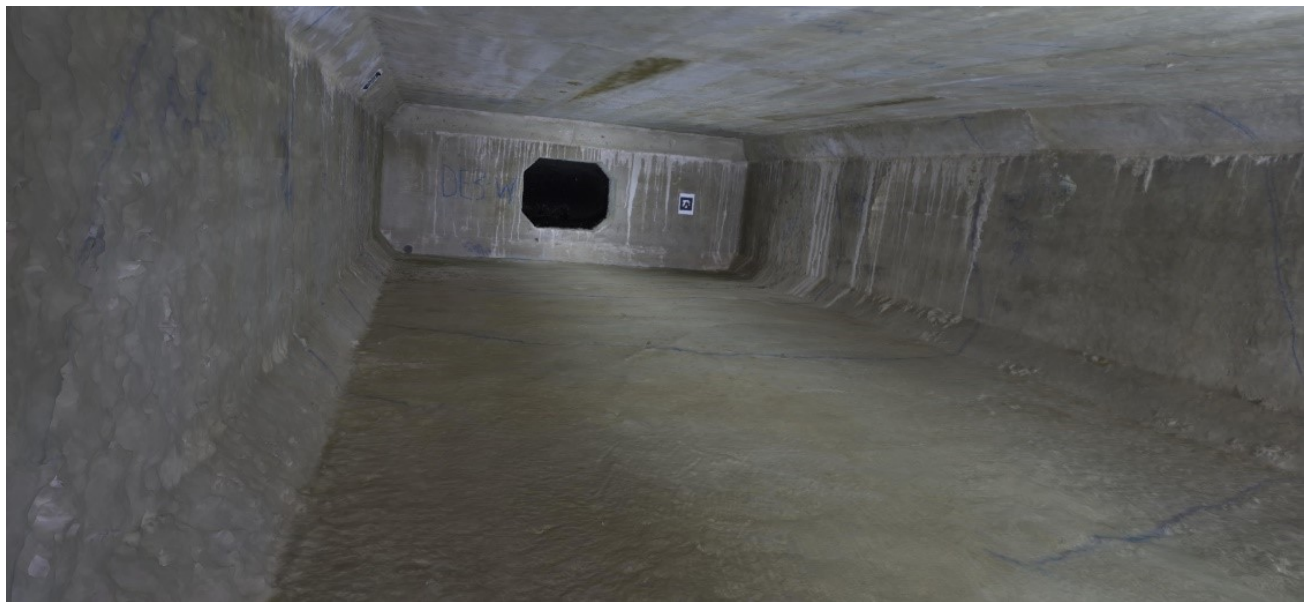
**Figure 4-10 3D Model of a Cell**

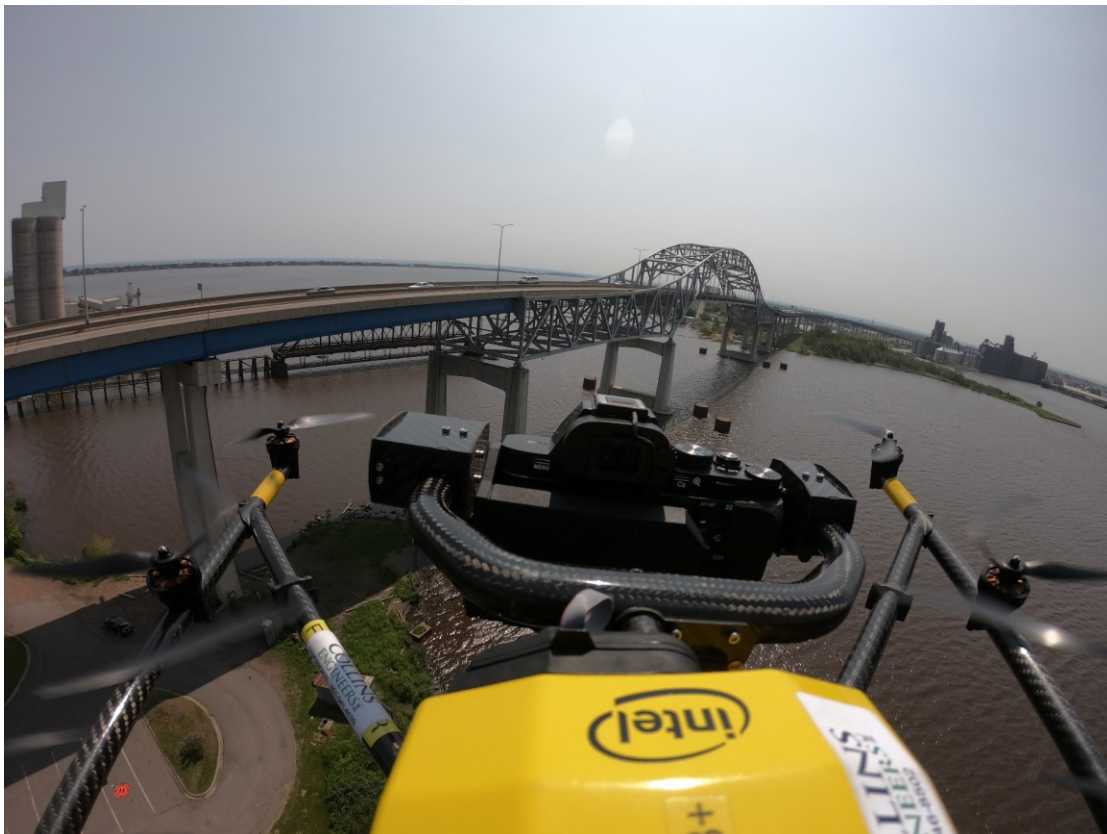
The UAS inspection was conducted using the Intel Falcon 8+ equipped with a Sony Alpha 7R camera. The missions were preplanned using Intel's Mission Control software. During the inspection, the pilot worked with a mobile controller and the other crew member-maintained line-of-sight with the UAS. In order to achieve a high-resolution 3D model of the bridge, flights were conducted manually using a pre-planned flight to allow for a more accurate overlap of each photo of approximately 85 percent. Flights were performed from the corners underneath the bridge. AeroPoint automatic ground control targets were placed on the bridge deck and on the piers near the waterline to geolocate the deliverables. The bottom of the bridge was covered by using a boat to drive patterns under the bridge while images were triggered manually. The entire data collection effort took less than 8 hours with a crew comprised of two bridge engineers.

Figure 4-14 Aerial View of the Intel Drone Collecting Data

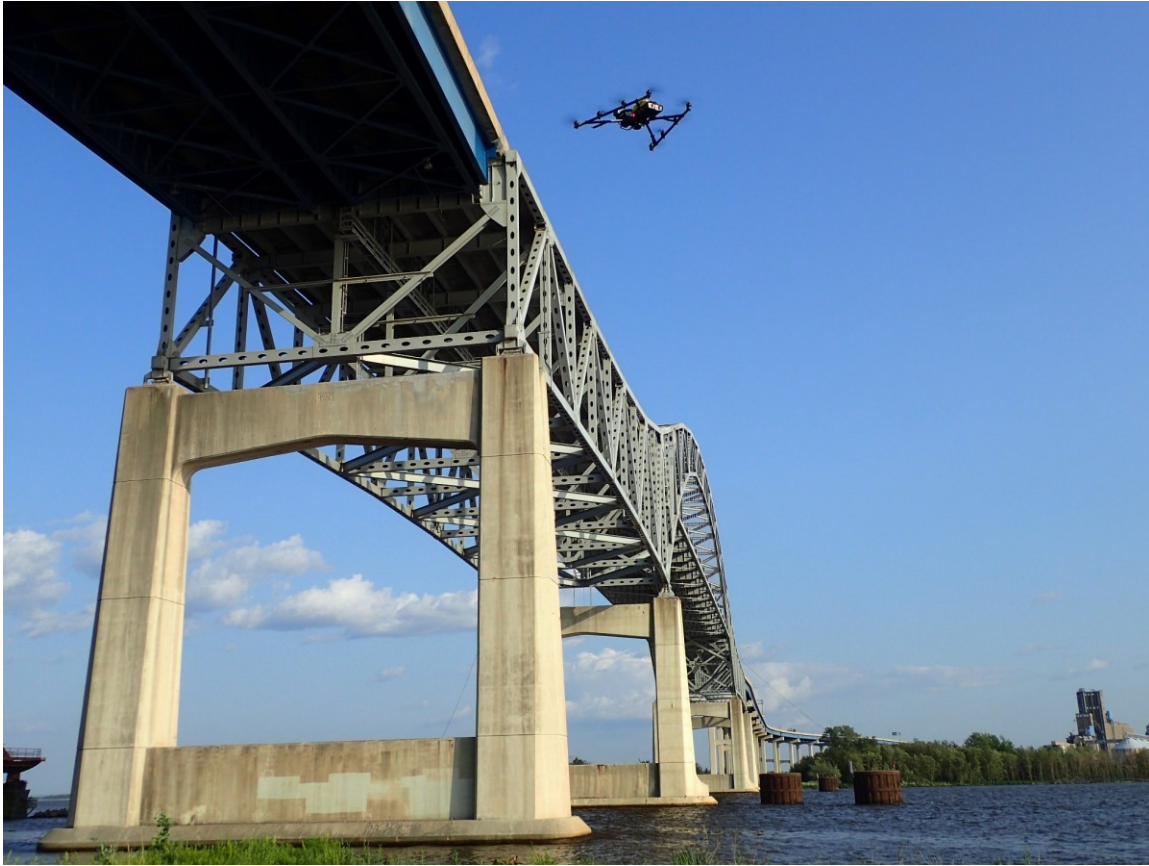
**Figure 4-15 Intel Drone Collecting Data**

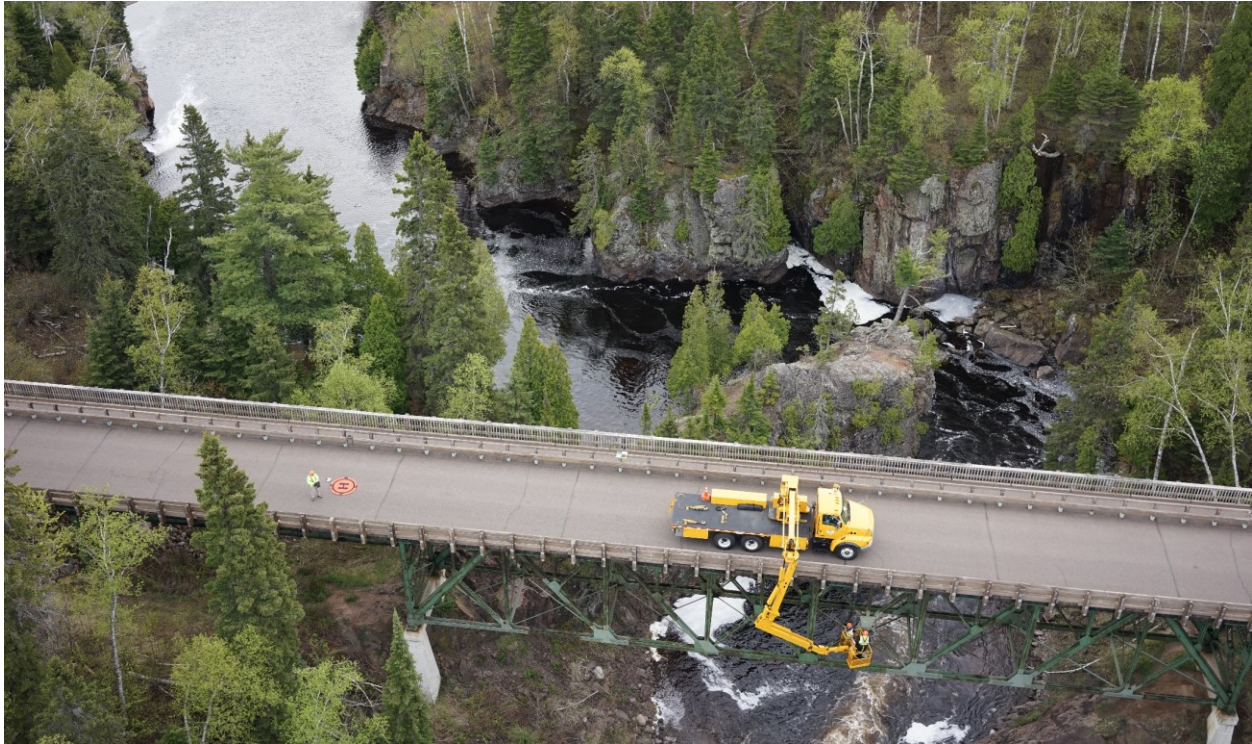
This case study consists of the results of an UAS bridge modeling and inspection of the Tettegouche State Park Bridge. This bridge is 383 feet long and includes a 140-foot steel deck truss main span over the Baptism River and 4 steel girder approach spans. The UAS inspection was performed in conjunction with a fracture critical inspection performed by MnDOT.

**Figure 4-20 Tettegouche Bridge**

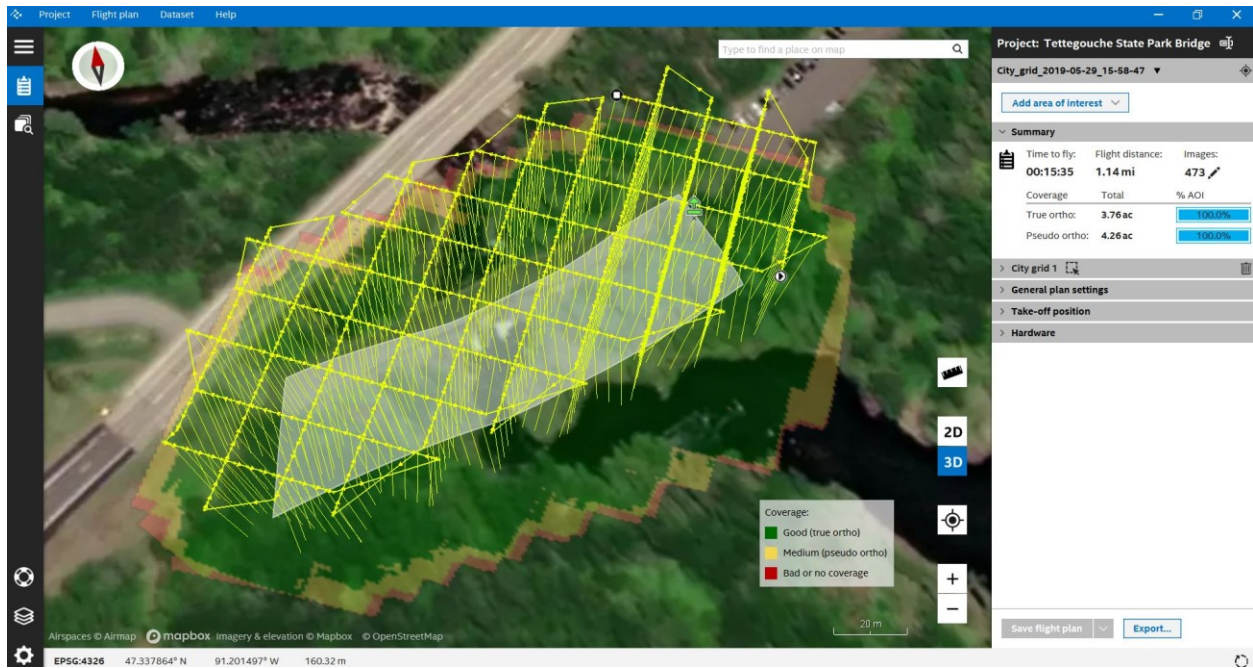
Figure 4-21 Tettegouche Bridge Flight Plan

A UAS was utilized to collect inspection information and to create a 3D reality model of the bridge to aid in organizing inspection results. The bridge was processed in both Pix4D and Context Capture to compare the quality of the models. The bridge was also uploaded to Pix4D cloud platform and bridge elements and defects were recorded directly on the model.

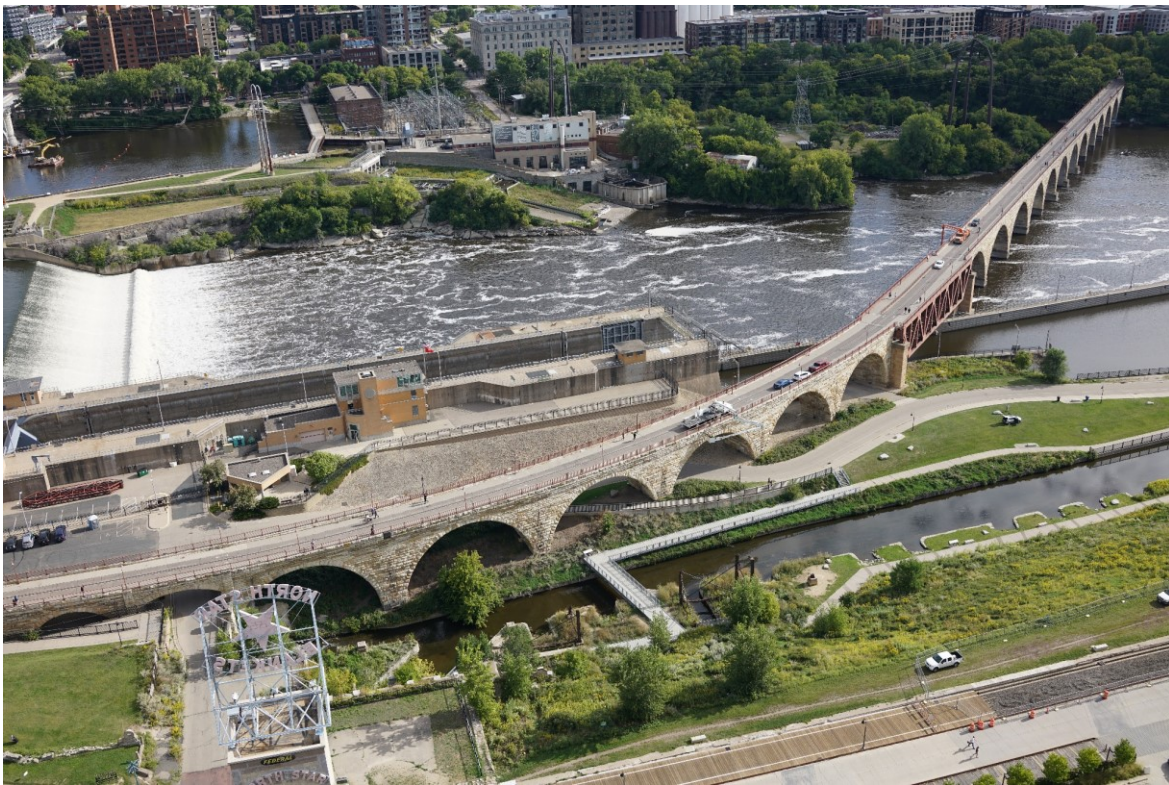
Figure 4-26 Overall Photo of the Stone Arch Bridge

The Stone Arch Bridge is located in downtown Minneapolis and crosses the Mississippi River. The bridge is a 2100-foot-long, 22 span masonry stone arch bridge built by James J. Hill for his Great Northern Railroad in 1883. The bridge served rail traffic until the early 1990's when it was converted to a pedestrian bridge. The Stone Arch Bridge is a historically significant bridge and is a landmark for the City of Minneapolis and the State of Minnesota.

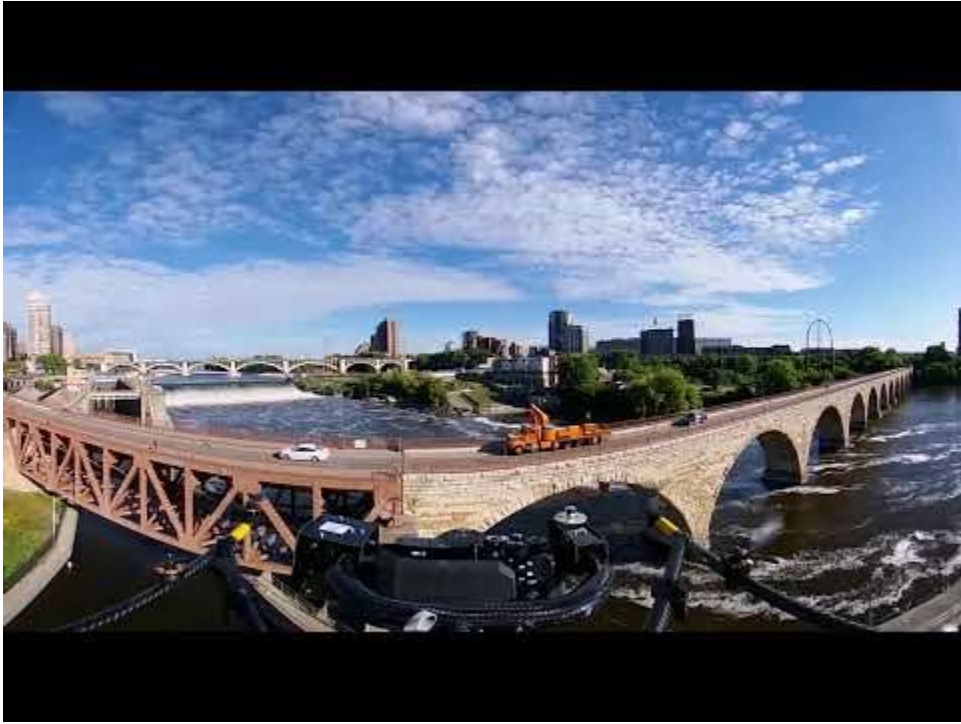
Figure 4-28 Video of Falcon 8+ Performing Inspection

The UAS inspection was conducted using the Intel Falcon 8+ equipped with a Sony RX1R camera. The missions were preplanned using Intel’s Mission Control software. During the inspection, the pilot operated the drone with the mobile cockpit controller and the other crew members maintained line-of-sight with the UAS. In order to achieve a high-resolution 3D model of the bridge, most flights were conducted autonomously using pre-planned flights to allow for a more accurate overlap of each photo of approximately 85 percent. Flights were performed from areas near the bottom of the bridge with some flight performed from the bridge deck. When flights were flown from the bridge deck additional team members were present to direct pedestrians for safety. AeroPoint automatic ground control targets were placed on the bridge deck and on the ground near the bottom of the bridge to geolocate the deliverables. The images of the underside of the arches was collected by using a boat to drive

patterns under the bridge while images were triggered manually. The entire data collection effort took less than 4 days with a crew comprised of two to three bridge engineers. A video of the drone in flight collecting data can be viewed [here](#):

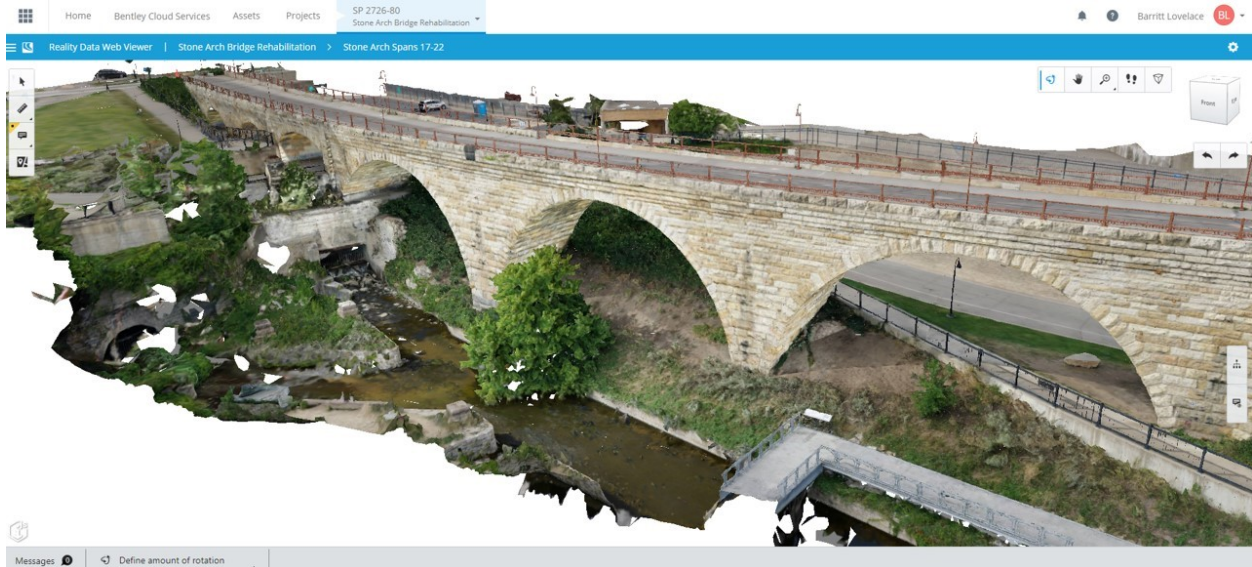
**Figure 4-31 Reality Model of Spans 17-22**

Before any inspection was performed, the bridge was flown in its entirety and reality models were created of sections of the bridge in anticipation of a hands-on field inspection. The models were created with Context Capture and were uploaded to Projectwise for cloud sharing and editing in the field. Bridge engineers used iPad tablet computers with an internet connection to view the models and input inspection notes directly on the model during the hands on inspection. This method, the reality model and digital access while in the field was found to be advantageous. It allowed for greater accuracy than traditional paper and pencil note taking, and efficiencies were gained from not having to locate each stone or determining which stone on the drawing the inspector was looking at as this information was easily and accurately accessible. With all notes going directly onto the model and there was no

confusion about what the correct stone is. Ideally, inspection information could be prepopulated in the office and verified in the field but, the project schedule did not allow that in this case.

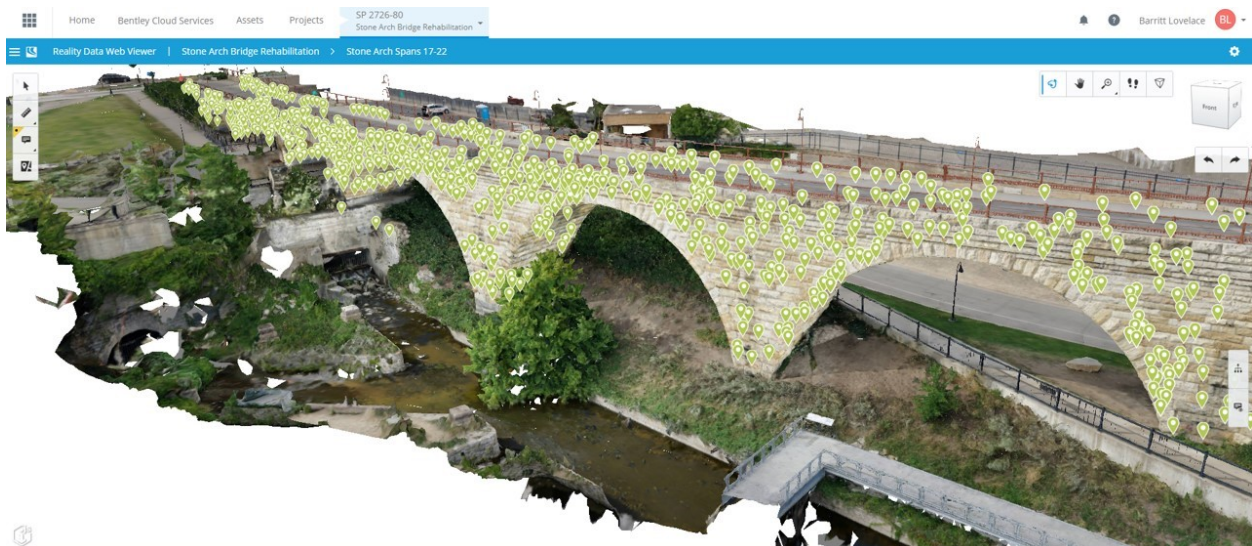
**Figure 4-32 Reality Model of Spans 17-22 With Inspection Notes**

Another advantage of creating and tying inspection notes to the reality model is that all of the data is available as a .json file and each note is geospatially located. The notes can be easily transferred to the construction drawings without having to manually copy notes into CAD, which is tedious and a timely process.

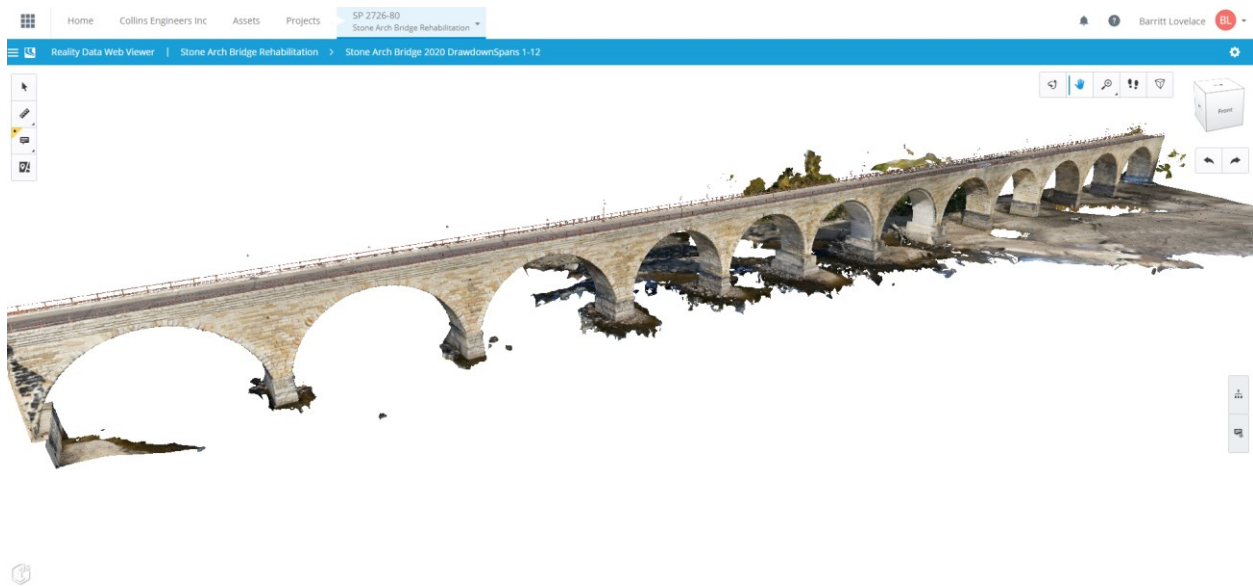
Figure 4-33 3D Reality Model of Stone Arch Bridge During River Drawdown

The following figure is a model of spans 1-12 that was created from the data collected during the river drawdown. This model represents a unique opportunity to capture data and display what the bridge looks like for the portions of the bridge that is normally underwater. The river basin is drawn down approximately every 12 years so, this data will be valuable for many years to come.

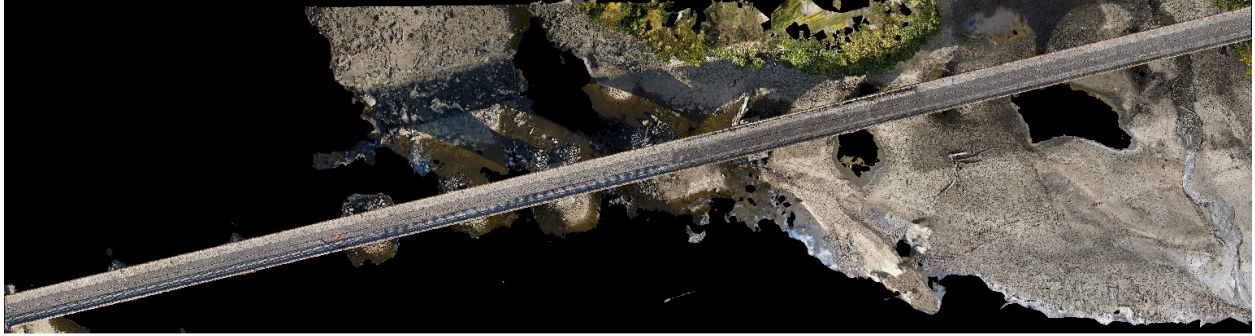
Figure 4-35 2D Orthomosaic Overall

3D Reality Models and 2D orthomosaics were generated in ContextCapture software as discussed previously. The models were generated locally on high-end desktop computers and uploaded to Projectwise. The models provided a way to communicate visually the current condition with a virtual interactive environment and provide means for future comparisons. The reality models are being used locally in Microstation to develop repair plans and are also available on Projectwise for all team member to view.

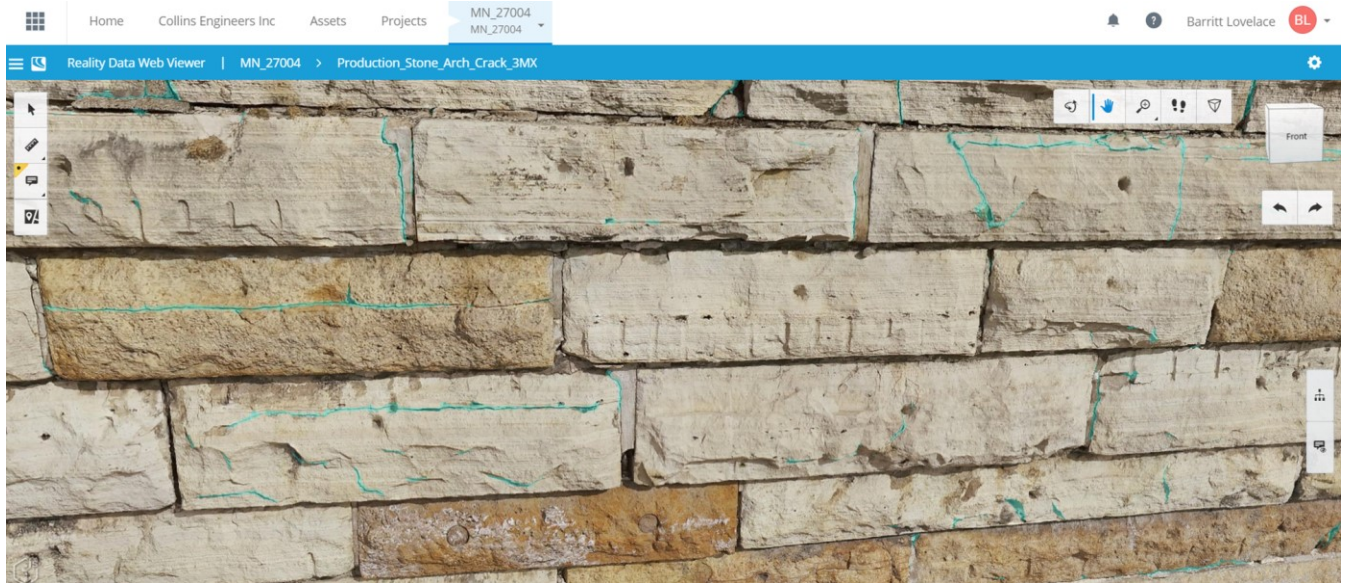
**Figure 4-38 ContextCapture Insights AI Crack Detection**

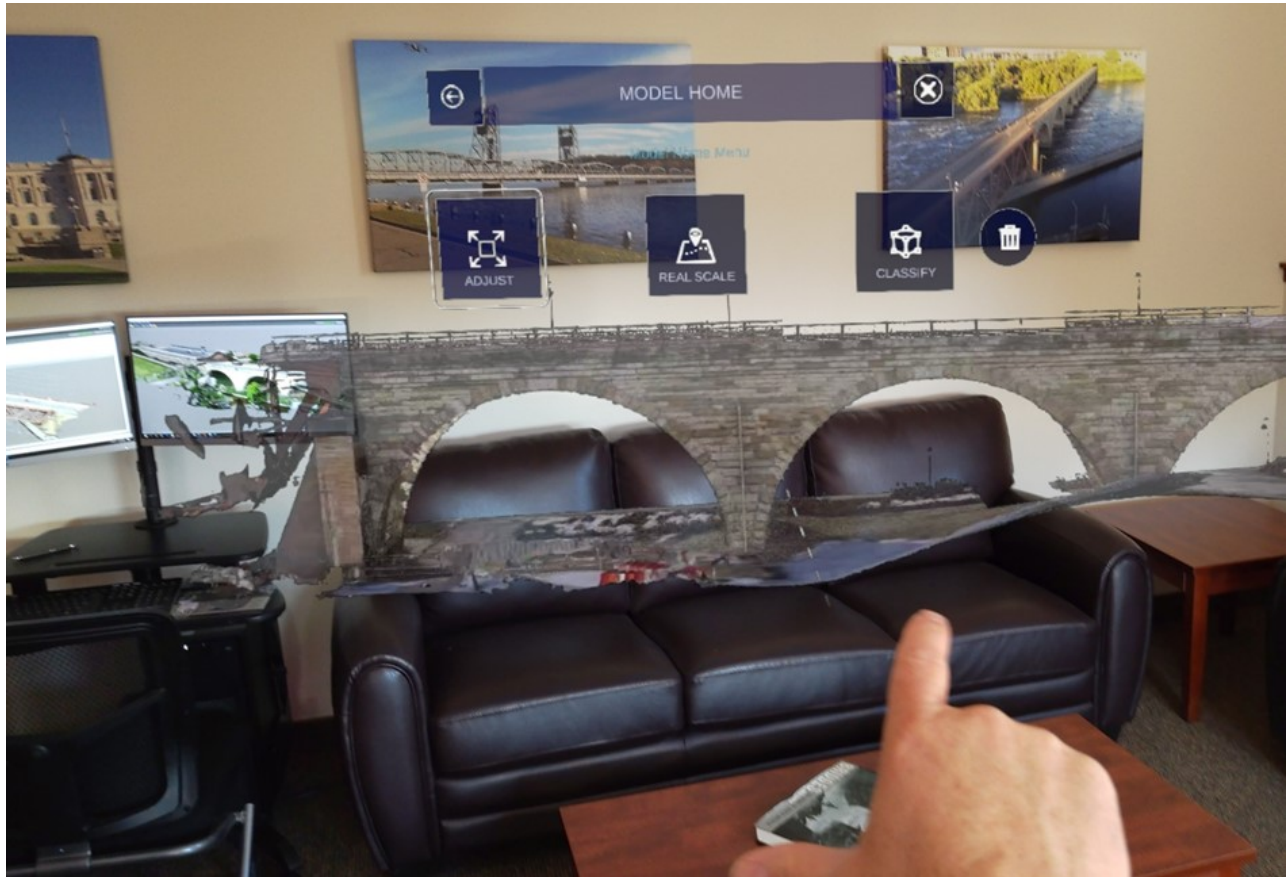
Figure 4-39 Virtual Inspection of Bridge Using Microsoft Hololens 2

Another deliverable that we created with Bentley Inc. is the ability to view and annotate the bridge model using the Microsoft Hololens 2. This unique method allows team members to perform virtual inspections of the bridge from their office.

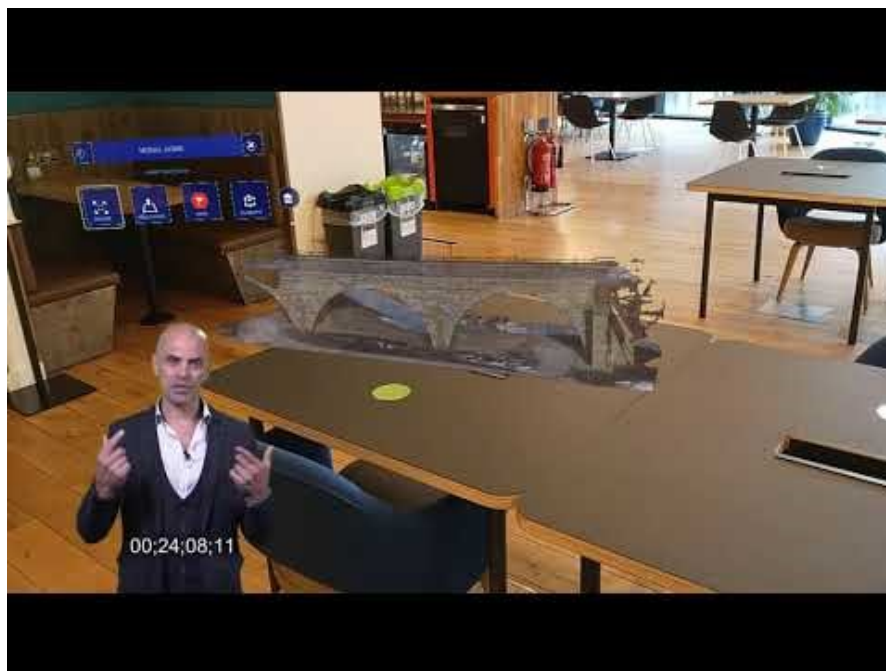
Figure 4-41 Hologram Virtual Inspection Process

More information on the holographic virtual inspection process can be found [here](#):

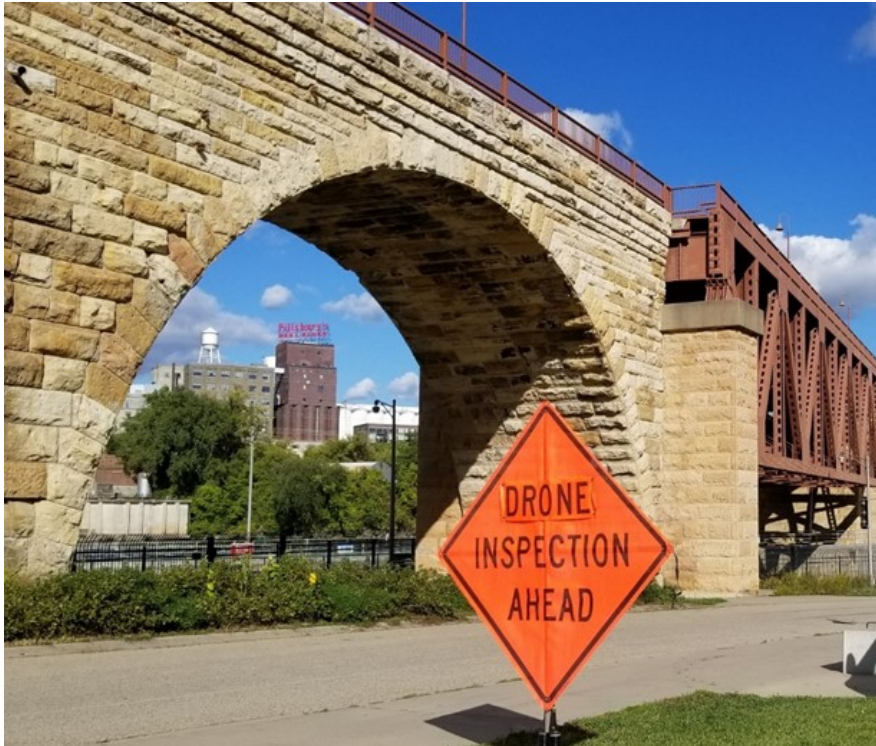
Figure 1- 3 Drone inspection ahead sign at the Stone Arch Bridge in Minneapolis.

Drone Inspection Ahead signage should be placed so drivers are not distracted by a UAS. An onsite safety briefing should be performed before work begins on the site each day

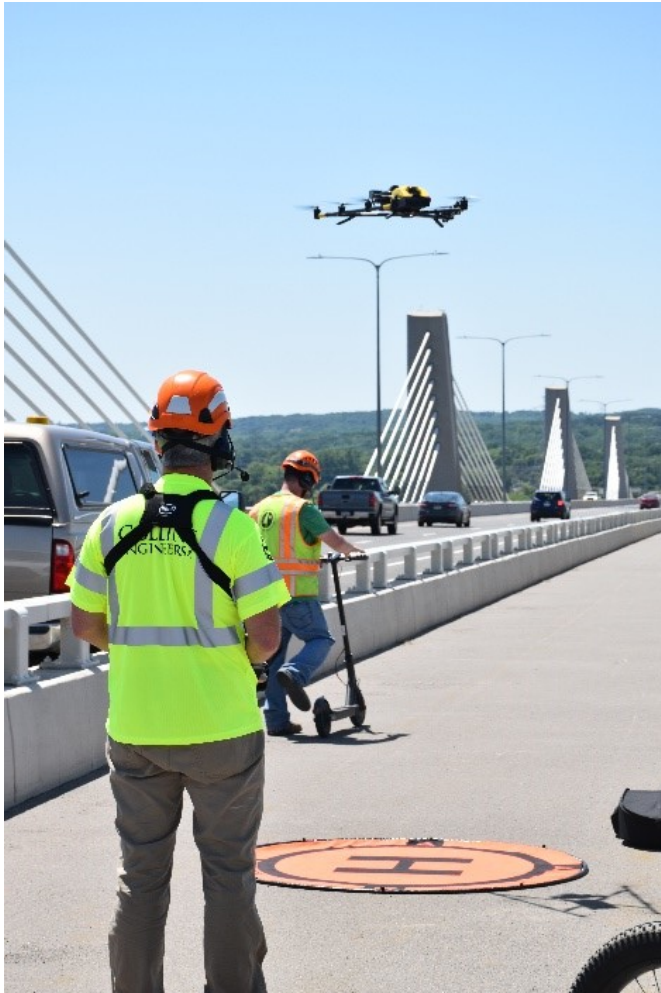
Figure 1- 4 UAS Inspection staff wearing PPE at the St. Croix Bridge.

Personal Protective Equipment should include the following as needed based on site conditions:

- Reflective Clothing or Vests
- Safety Glasses
- Cut Proof Gloves
- Hearing Protection
- Respirators or Masks
- Skin Protection

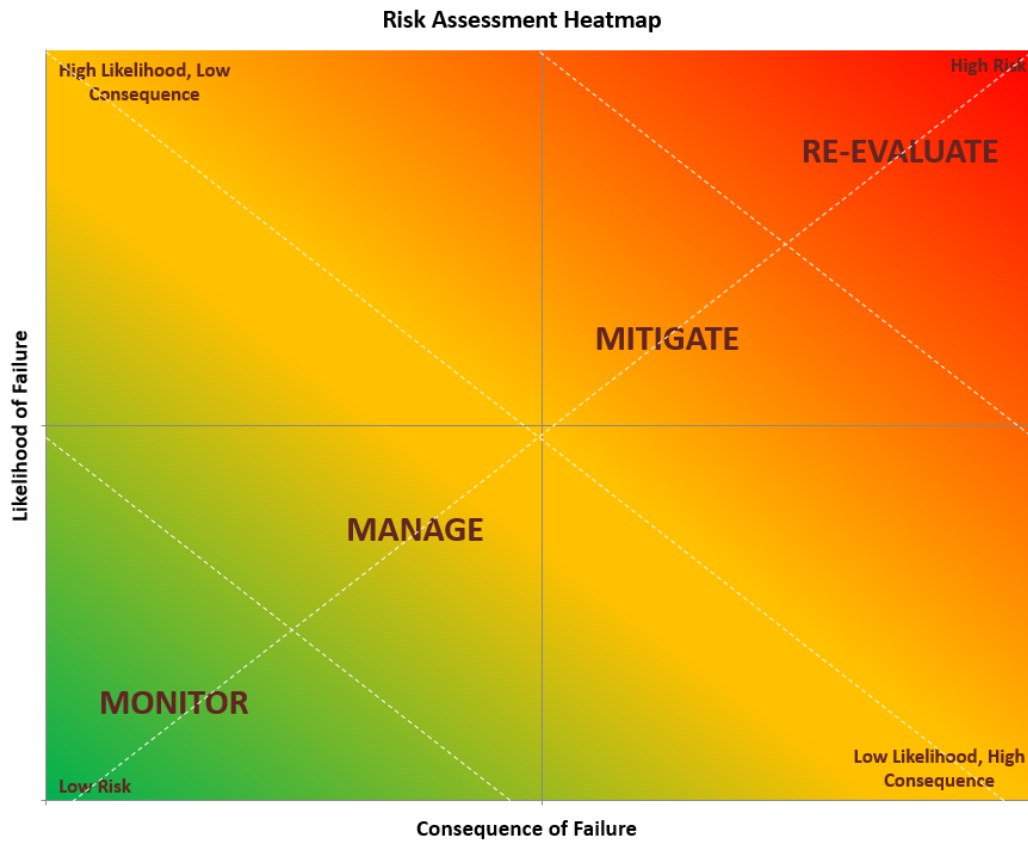
Figure 1- 5 Risk chart showing the likelihood of failure
