Performance of Interstate Rubblization in Illinois

Research Report No. FHWA-ICT-21-005

ICT PROJECT R27-193-2

Flexible Pavement Design

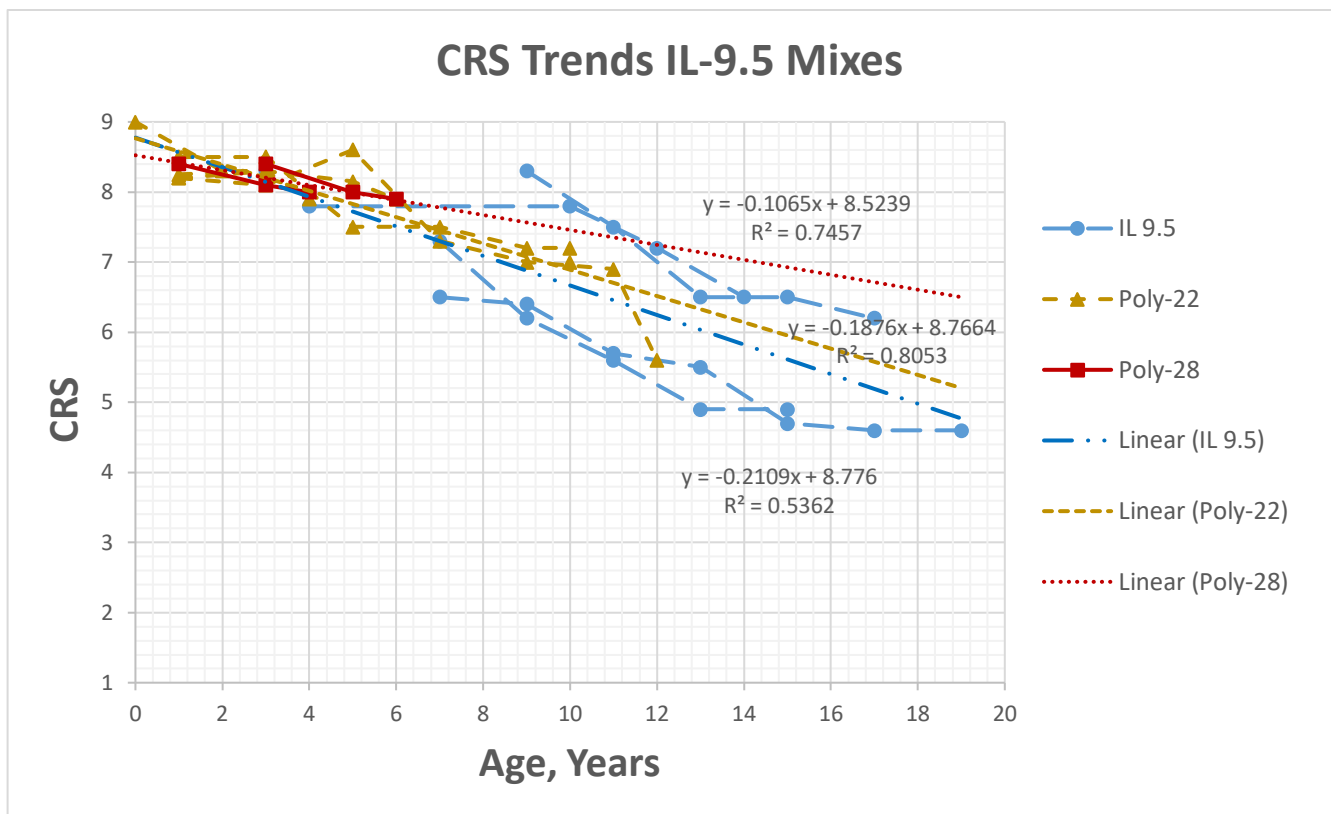
Figure 2. Graph. Data trends of IL-9.5 mixes.

Figure 2 presents the CRS trends for IL-9.5 mixes, and Figure 3 presents the CRS trends for SMA mixes using the various PG defined above with age from original construction.

Within the IL-9.5 mixes, the Poly PGXX-28 mixes are showing improved performance trends over other IL-9.5 mixes. In general, the SMA mixes are shown to have superior performance over IL-9.5 mixes. One SMA section is showing outstanding performance, namely the 30-year design section on I-70 (Contract 70059). While the calculated life to a terminal CRS of 5.5 is not realistic, the data shows outstanding performance over the 15-year dataset retaining an unprecedented CRS value of 8.0. There were several additional features included in this section that are unique and worth exploring for future rubblizing projects. These areas are as follows. The first is longitudinal joint priming. This feature was intended to address longitudinal joint deterioration by filling air voids in this area. The second is SMA with a PGXX-28 grade. This softer asphalt grade helps provide protection from thermal cracking, helps prevent block cracking, and reduces the impact of aging on the surface. The third is oversized section. While not economical, the full-depth use of polymer in a much thicker than typical section likely benefits the section’s performance. The biggest benefits to performance seem to be using a SMA surface mixture, using a PG76-28 asphalt grade, and priming the longitudinal joint (an improved longitudinal joint sealant has been adopted by IDOT), as block cracking and longitudinal joint deterioration are minimal on this project.

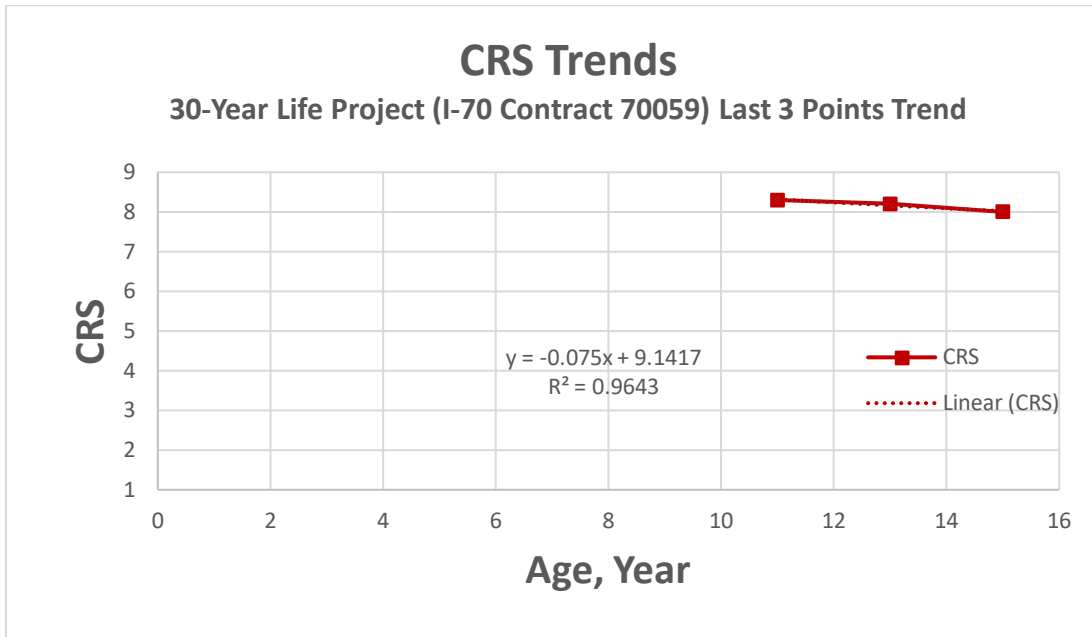
Figure 4. Graph. Last three data points trend of I-70 SMA with PG76-28—30-year life contract 70059.

Because the SMA-28 data trends are so flat over the early life of the pavement, the last three data points are likely a better predictor of future performance. For this reason, an additional trend line was determined using the last three data points, as presented in Figure 4.

To date, IDOT has not extensively used Poly PGXX-28 grades in SMA surfaces on rubblized projects. The outstanding performance to date using this combination would warrant additional construction of SMA and IL-9.5 mixes using Poly PGXX-28 in surface mixes. IDOT recently announced an effort to widely adopt both non-polymer and polymer PGXX-28 asphalt usage, which should make polymer PGXX-28 with SMA more the norm going forward (Trepanier, 2020).

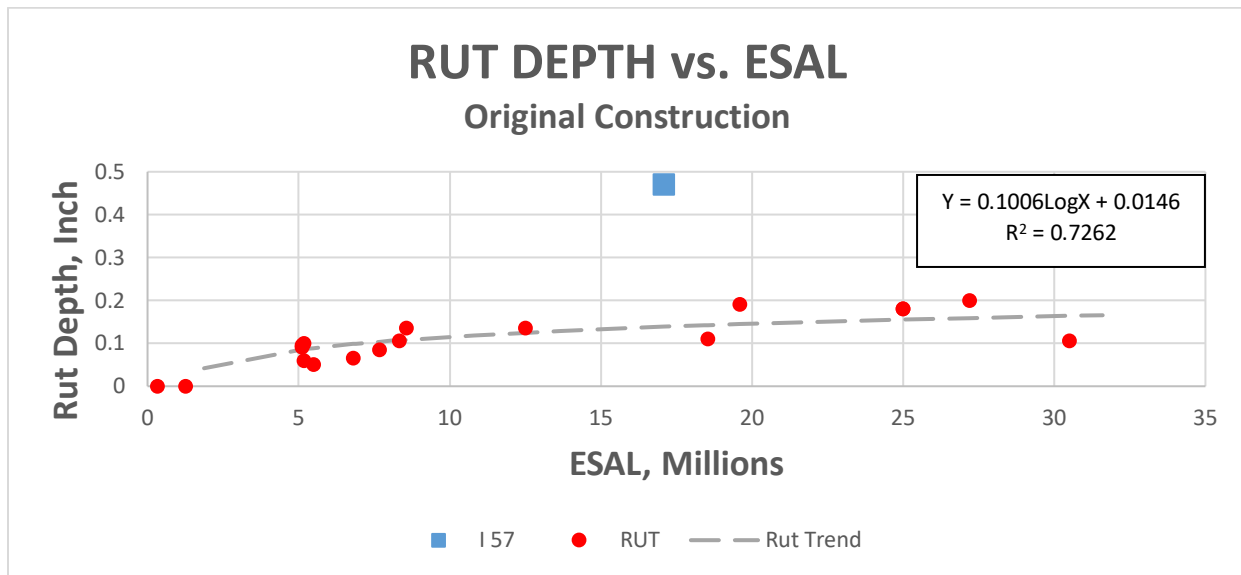
Figure 5. Graph. Rut depth trends of rubblized pavements.

For rutting trends, all available rutting data was utilized without separating surface mix types or asphalt PG usage. Traffic counts of passenger vehicles as well as single-unit and multiple-unit trucks were converted to 18,000 lb equivalent single axle loads (ESALs) for flexible pavement, as outlined in Chapter 54 of IDOT’s BDE Manual (IDOT 2013/2017). The result is presented in Figure 5 as rut depth versus ESAL. A logarithmic regression was developed through the dataset. Using the resulting trend line, a traffic value of 100 million ESAL would result in an average rut depth of 0.22 in. While this would be considered exceptional performance, such a projection far exceeds the dataset (currently 31.6 million ESAL). More data at higher traffic levels are needed to increase the reliability of such a projection.

The I-57 rubblizing project, constructed in 1997 as Contract 98387 in Union County, presented a rut depth of 0.47 in., which is considered excessive. Within two years of construction, this project was exhibiting excessive rutting to the point that a special investigation was warranted. Details and results

were documented at the time and showed that the root cause of the rutting was the use of a level binder (currently termed as a binder by IDOT) layer added to the cross-section to provide the full pavement thickness shown on the plans (Heckel, 2002). Debonding and slippage at the level binder layer resulted in the excessive rutting seen. Due to findings of the investigation, this project was removed from the regression analysis in Figure 5.

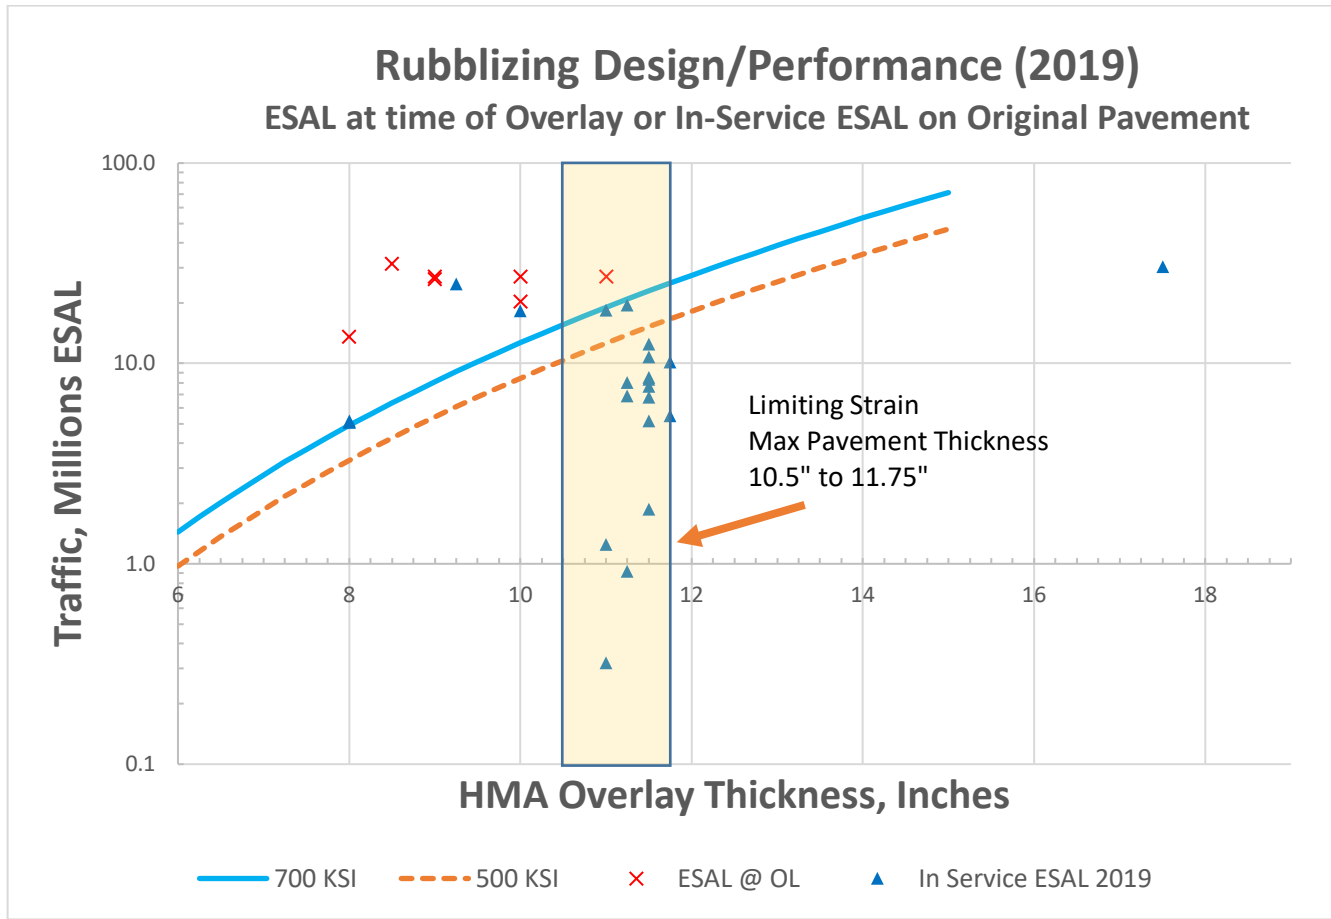
Figure 6. Graph. Terminal ESAL at overlay (failure) or ESAL to date of original rubblized pavement.

A simplistic approach was used to evaluate the adequacy of the structural design for rubblized pavement. A design graph was developed in Figure 6 that presents design ESAL vs pavement thickness for HMA modulus of 500 ksi (representing southern Illinois and/or softer PG binders) and 700 ksi (representing northern Illinois and/or stiffer PG binders). Plotted upon this figure are the original constructed pavement thickness vs. the ESAL count to date. The use of the upward pointing triangle is to indicate that the section is still in service and expected to move up the scale with time and additional loading. Pavement that has been overlaid (failed) are represented by an “X” to indicate the end life for that section. All X’s are above the design curves, which indicate that the design procedure is more than adequate from a structural aspect.

Note that for the 30-year design warranty project constructed on I-70 under Contract 70059, an early design procedure for rubblized pavements was used, resulting in a 17.5 in. HMA thickness. This project also included several additional features, as noted above, to increase the durability of the

pavement surface. From a structural viewpoint, the section was grossly oversized and precipitated a review of limiting strain criteria for incorporation into the design process that would result in a maximum pavement thickness regardless of the traffic loading. After this experience, the Bureau of Materials and Physical Research worked to provide limiting strain designs on a case-by-case basis. Limiting strain was incorporated into the design process in 2013 by an update to the BDE Manual (IDOT 2013/2017). To indicate this limitation, Figures 6 and 7 include a shaded box to indicate the maximum thicknesses where limited strain criteria is used to control the pavement thickness. Note that many of the rubblized pavement section designs are being controlled by the limiting strain criteria of the procedure.

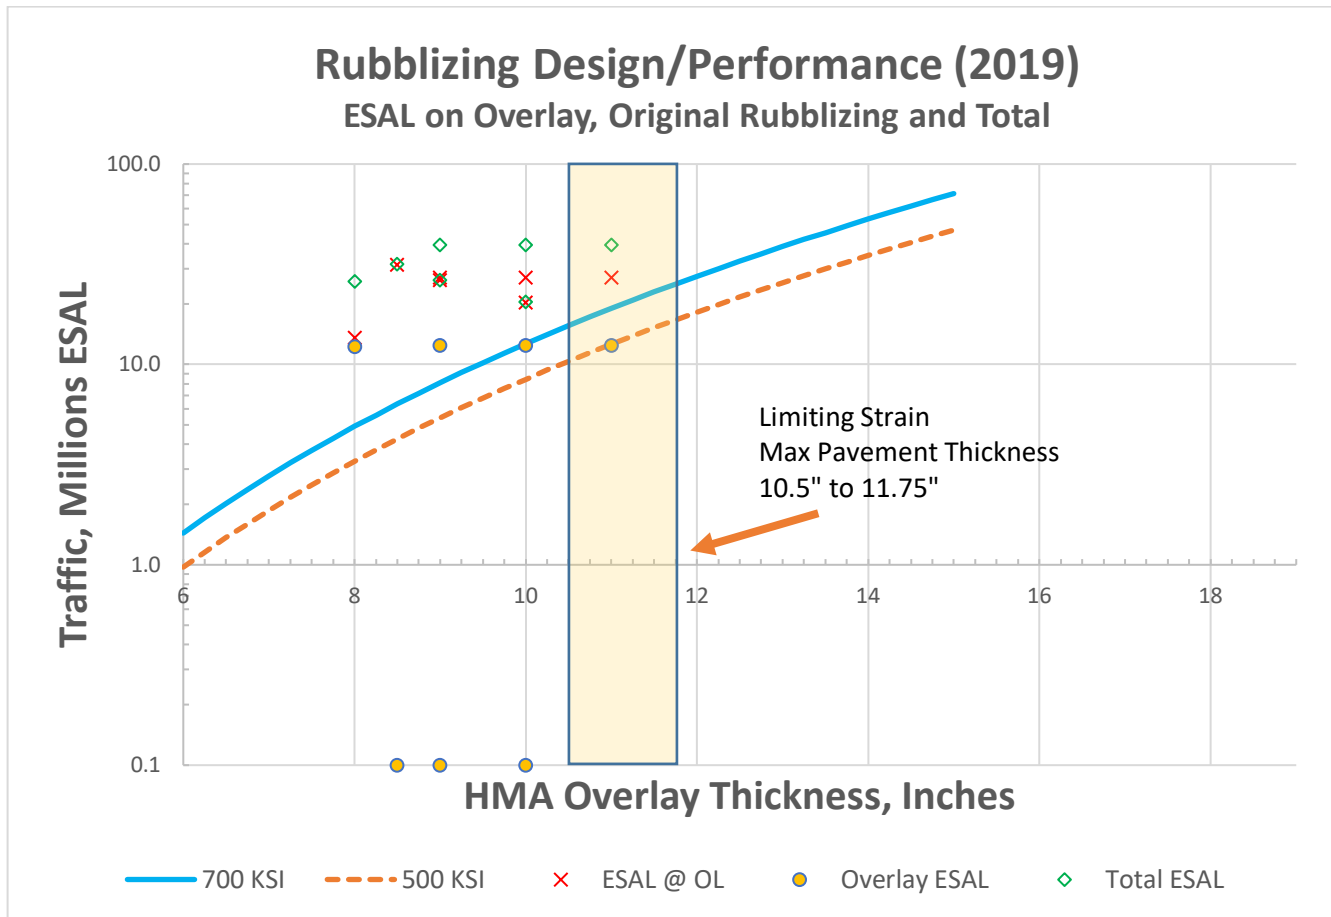
Figure 7. Graph. ESAL at time of overlay (failure), ESAL on overlay, and total ESAL to date.

Of the original 31 rubblizing projects with HMA pavement, five projects (seven sections) have been rehabilitated to date. For those that were rehabilitated, Figure 7 extends the simple evaluation used above on the original pavement to those that have received an overlay. Overlays were mill and fill types of rehabilitation in the 2 to 3 in. range except for one project, which was a micro-surfacing. Patching because of structural failures was not present or minimal on these sections. The analysis is similar to above using the design chart to compare to the actual traffic served by the specific project.

The figure presents the original constructed pavement thickness vs. the ESAL to date, as in Figure 6. Sections that have been overlaid are represented by an “X” for the thickness and ESAL to indicate the end life for the original section. The circles represent ESAL traffic upon the new overlay, and the diamond represents the total ESAL traffic on both the original construction and new overlay.

The performance of the overlay sections is very encouraging. The critical fatigue location is the bottom of the HMA layer. Because only the surface has been replaced, the bottom of the original pavement has experienced the expected design traffic plus the overlay traffic, which in some cases is two to six times that of the original predicted design. To date, these sections have served with little to no fatigue distress.

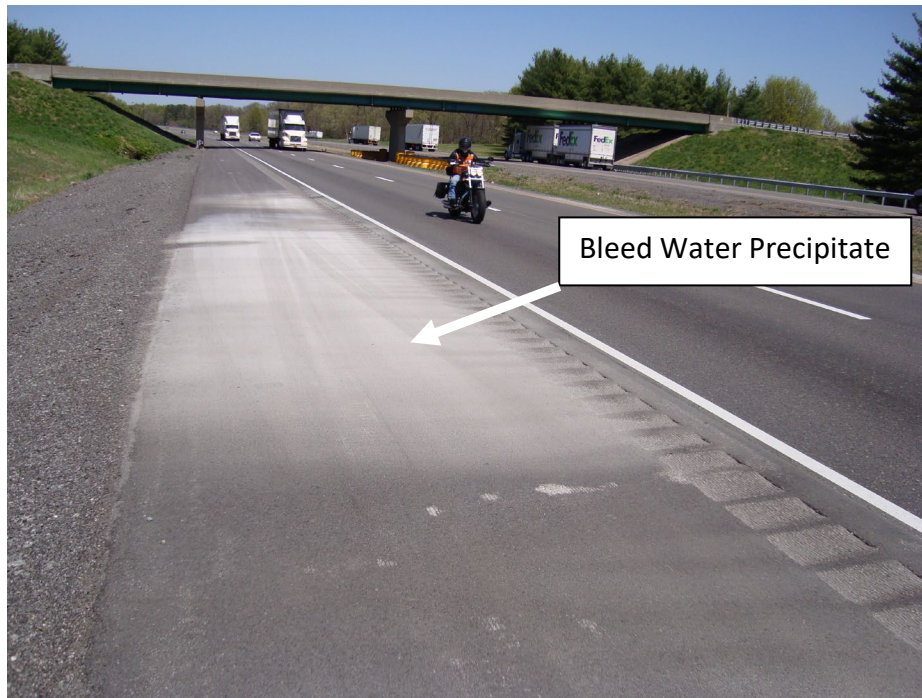
Figure 8. Photo. Bleed water precipitate—April 2010.

Another problem with underdrains on rubblizing projects is the effluent water is extremely high in dissolved calcium. As this water is exposed to air, a precipitate (calcium carbonate) forms and floats on the surface of any water ponding in the underdrain pipe after a rain. With the next rain, this calcium carbonate material or tufa is flushed out of the pipe as plate-like flakes. The process repeats with each rain. For newly rubblized sections, the result is clogging of the wire mesh rodent screens in the underdrain outlet. To ensure proper drainage, the outlets need to be maintained by removing/cleaning the screens and flushing the pipe to remove the built-up deposits. One state has taken the approach of eliminating the screen. The problem seems to clear up two to three years after construction.
