# Innovative Materials and Advanced Technologies for a Sustainable Pavement Infrastructure

**Jia-Liang Le, Principal Investigator**

Department of Civil, Environmental, and Geo- Engineering  
University of Minnesota

Research Project  
Final Report 2021-18

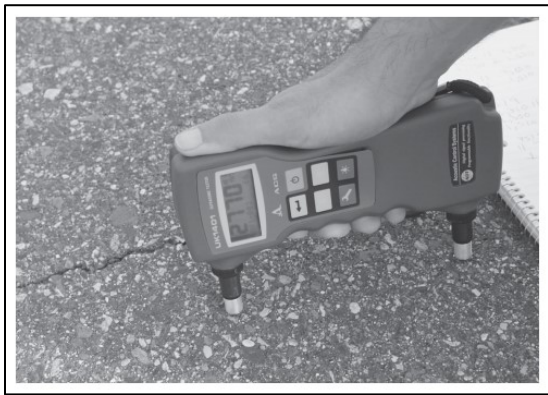
An ultrasonic technology that has been used successfully for many years to determine cracking in concrete structures, provided an evaluation of distresses in asphalt concrete pavements through a simple procedure. (Khazanovich *et. al.*, 2005) The ultrasonic tester, a UK1401 (Figure 2.1), is used to obtain crack measurements in two directions: along and across each crack.

**Figure 2.1: Ultrasonic tester UK1401. (Khazanovich *et. al.*, 2005)**

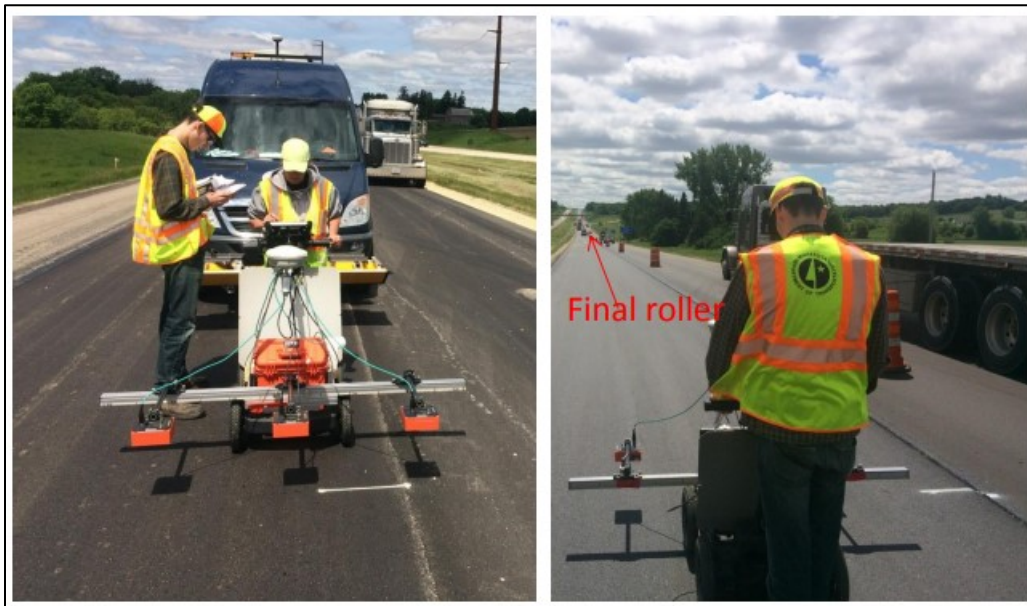
The Rolling Density Meter (RDM), which is a Ground-penetrating radar (GPR), provides a non-destructive alternative to evaluate asphalt pavement air voids. The RDM, shown in Figure 2.4, is a commercially available device recently developed under an SHRP2 study that can be used to assess relative compaction levels nondestructively. (Hoegh & Dai, 2017)

**Figure 2.4: Equipment and Data Collection before a 500 ft pass (left), and during data collection moving behind the final roller compactor (right). (Hoegh & Dai, 2017)**

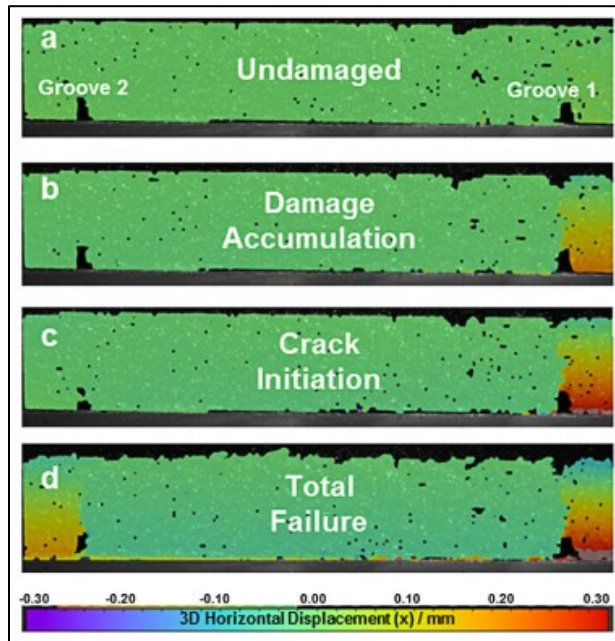
Using this procedure, researchers were able to detect damage accumulation and crack initiation before crack damage was visible, as shown in Figure 2.7. This was an important step since it indicated when to stop the test before damage reached an irreversible level.

Figure 2.7: Full-field strain maps during different damage stages. (Bueno & Arrigada, 2016)

The slabs were first damaged and then subjected to induction heating. To enhance the heating effect, cast iron particles were added to the slabs subjected to induction heating through an alternating electromagnetic field. The DIC system was able to monitor the accumulated damage and detect crack initiation. The system also monitored the healing of specimens. (Bueno & Arrigada, 2016)

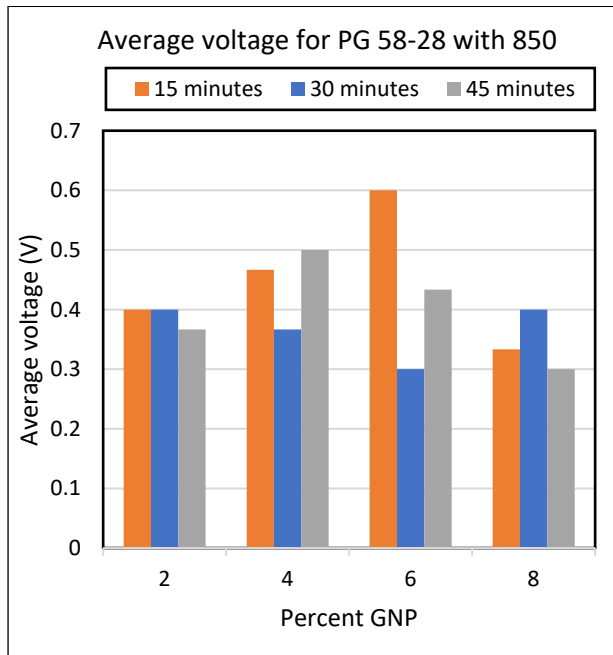
The potential difference and conductivity results are also summarized in Figures 3.3 and 3.4, respectively. The conductivity values have increased compared to the results from the previous experiments. However, these values are still very low, and, in some cases, the results are quite variable.

Figure 3.3: Average voltage for (a) PG 58-28 with 850 GNP and (b) PG 58-28 with 4827 GNP.

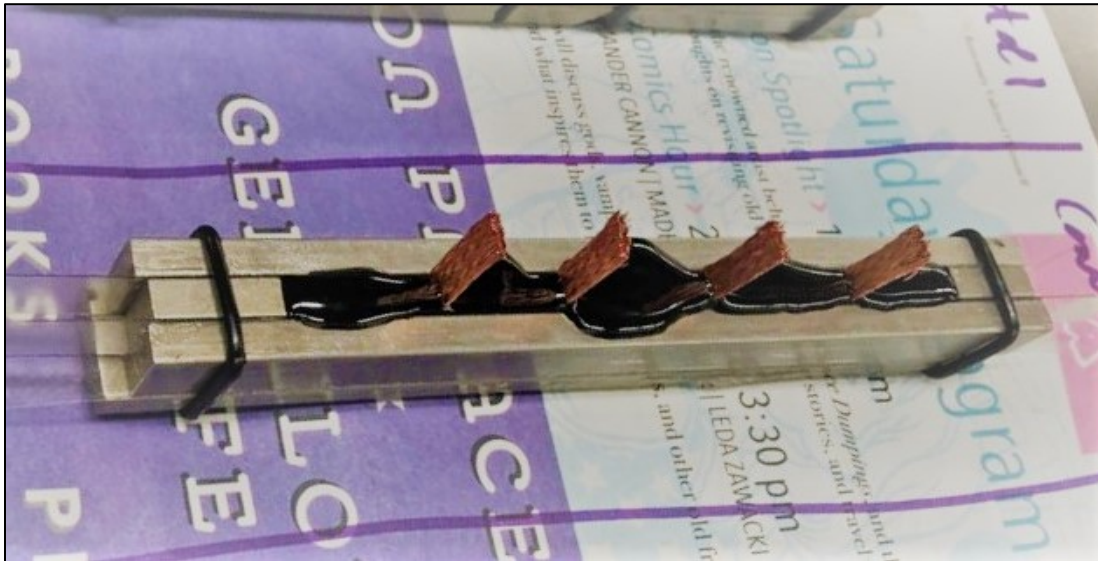
The GNP 4827 and heated binder were mixed by a high-velocity shear mixing device for one hour. Due to particle size, the taconite concentrate was mixed with the heated binder through hand stirring for about 5 minutes. The four samples were poured into the beam molds used for BBR experiments. Four electrodes made of copper were placed in the mold and the heated binder was poured, as shown in Figure 3.6. The beams were kept in the refrigerator for 19 days, after which they were tested. The electrical conductivity tests were performed on the four binder beams using the same method as before: the outer two probes were used to supply electrical current to the specimens, while the inner probes were used to measure the voltage.

**Figure 3.6: Sample with copper electrodes immediately after pouring.**

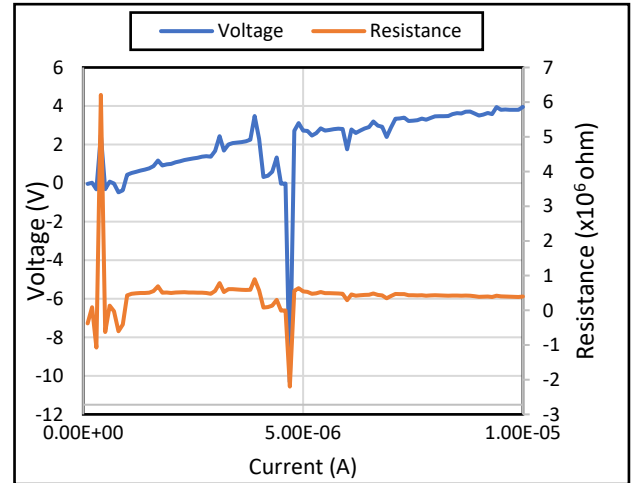
Figure 3.10: Applied current vs. voltage and resistance for sample number 3 from: (a) test 1; (b) test 2.

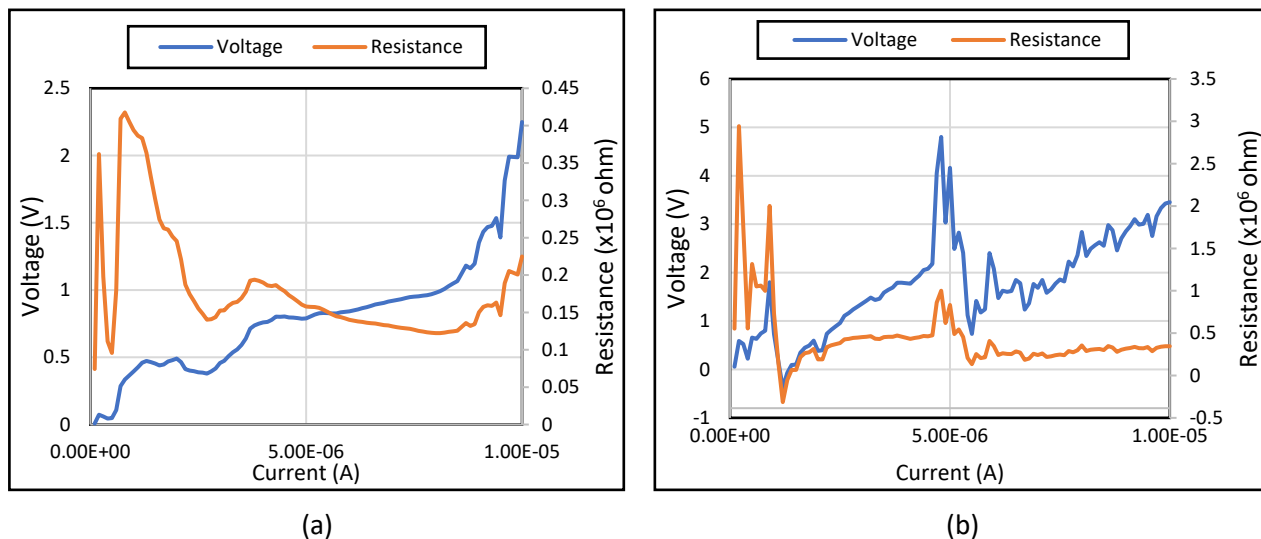
Figure 3.11: Applied current vs. voltage and resistance for sample number 4 from: (a) test 1; (b) test 2.

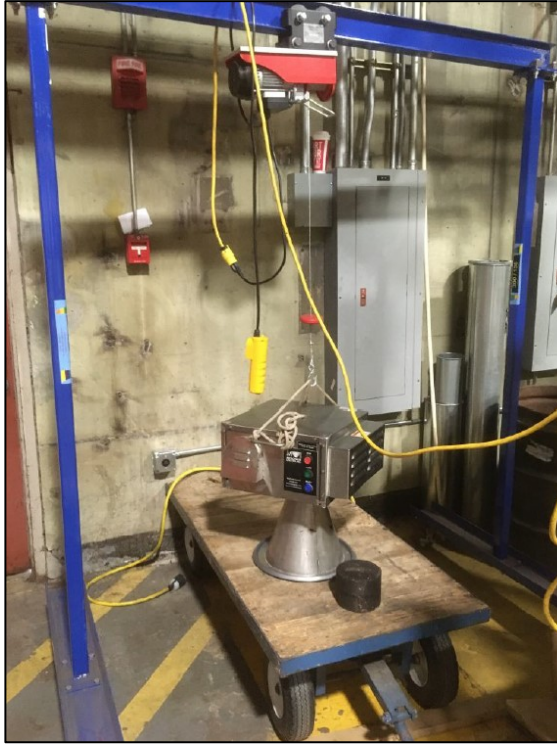
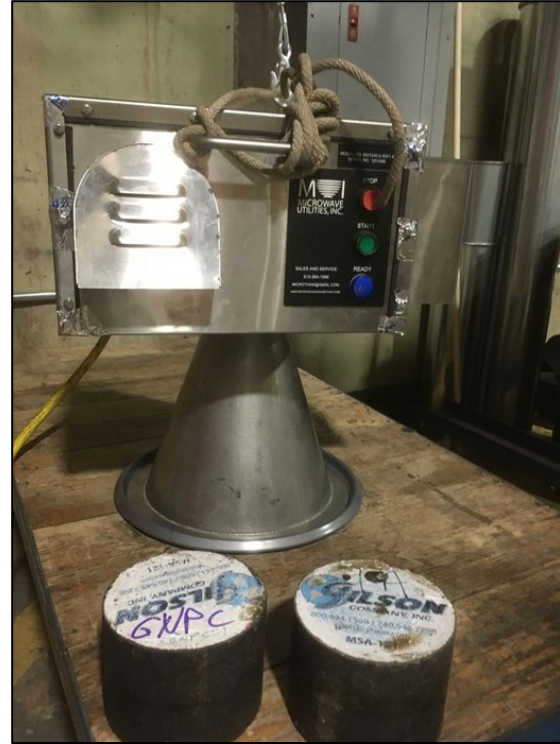
Figure 6.3: Microwave setup used to heat the GNPC specimens: (a) full setup and (b) close-up

Each GNPC specimen was placed on top of a metal sheet and under the cone of a custom-built 1kW, 2450MHz microwave device, as shown in Figure 6.3a-b. The metal sheet ensured that all of the microwave energy would be absorbed by the specimens and not by the material or substrate below the specimen. Test specimens are shown in front of the device. Each specimen was heated for 15 min until reaching a temperature of 55-65°C. A FLIR Systems InfraCAM™ thermal imaging camera borrowed from UMD's Department of Mechanical and Industrial Engineering was used to visually document the nature of the microwave heating and provide supplemental temperature information. An example of this can be seen in Figure 6.4. The starting and ending temperatures of the top and bottom of each specimen were recorded (Table 6.1). The specimens were numbered and transported back to UMN for tack coat bond shear strength testing.

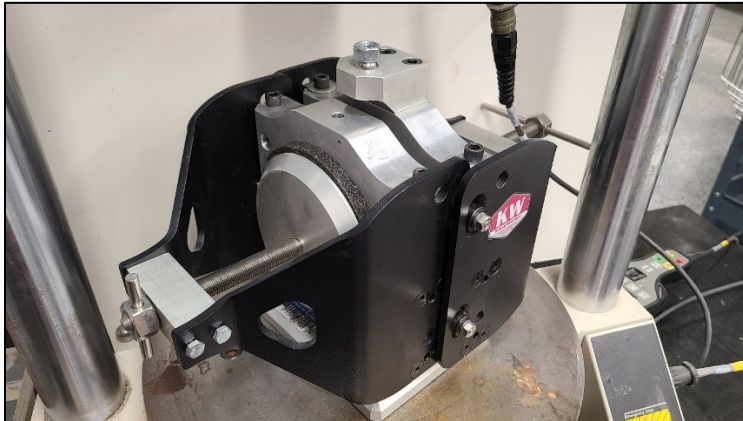
**Figure 6.5: MS-43 Asphalt Tack Bond Shear Strength Apparatus**

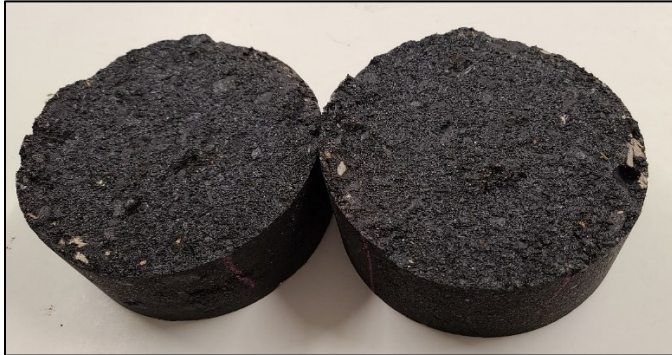
**Figure 6.6: A specimen that failed along the tack coat interface.**
