# Continued Monitoring of Stormwater Effluents from Filter Media in Two Bioslope Sites

Research Project  
Final Report 2021-15

# CONTINUED MONITORING OF STORMWATER EFFLUENTS FROM FILTER MEDIA IN TWO BIOSLOPE SITES

## FINAL REPORT

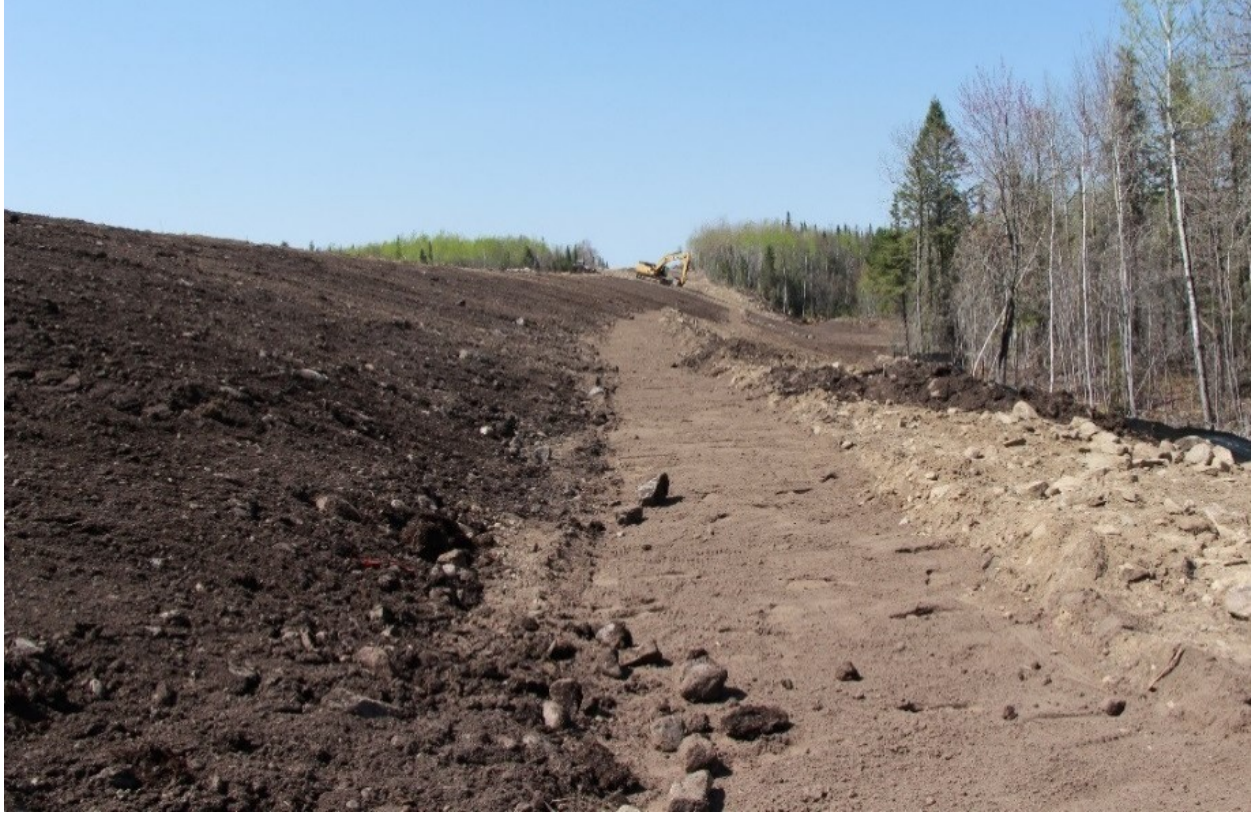
**Figure 2.3 Bioslope and bioswale construction on Eagle's Nest site in 2018.**

The Eagle's Nest site was constructed in 2018 during the Minnesota Department of Transportation (MnDOT) Highway 169 reconstruction project. This site contained biofilter amendments throughout the 5.7 miles of new road construction. Peat that was excavated from sections of the site, shown in Figure 2.3, was placed on slopes adjacent to roads at a depth of four inches and seeded. An infiltration bench was placed at the toe or cutoffs of sloped sections along the roadways. The swales contained an 80:10:10 by volume mixture of sand, peat, and compost. A perforated pipe underdrain system was also placed under the swale trench to promote drainage. The monitoring of soil moisture changes and the collection of water samples from bioslope and bioswale started from August 2018.

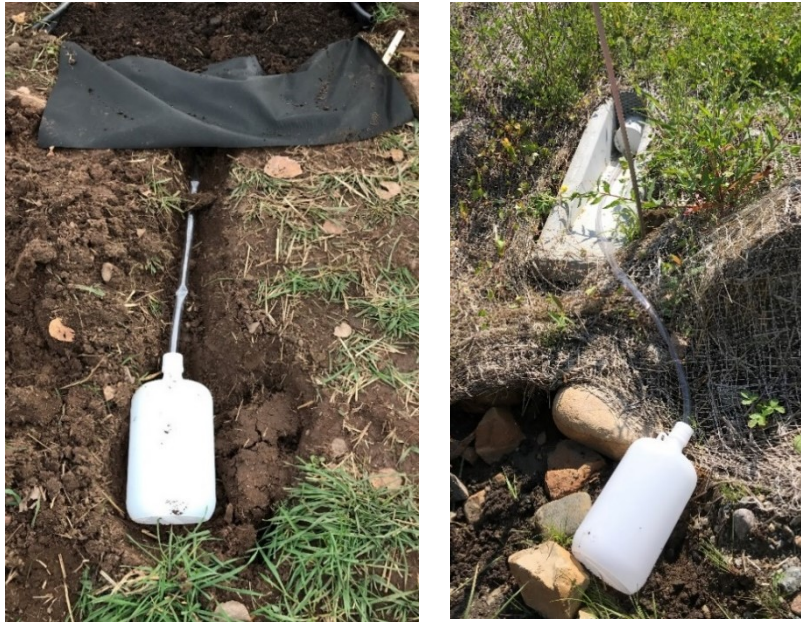
**Figure 2.6 Perforated pipe to collect water samples in the NRRI site (left) and Eagle's Nest trench site (right).**

Seven pipes to capture runoff were installed at the NRRI site and two were used at the Eagle's Nest trench (Figure 2.6). These pipes were installed when the experimental site was constructed in 2016 at the NRRI site and when Highway 169 was reconstructed in 2018. No additional construction was completed for this project. Water samples were collected from both the NRRI and Eagle's Nest sites by perforated pipe installed under modified soil media and are connected to the collectors.

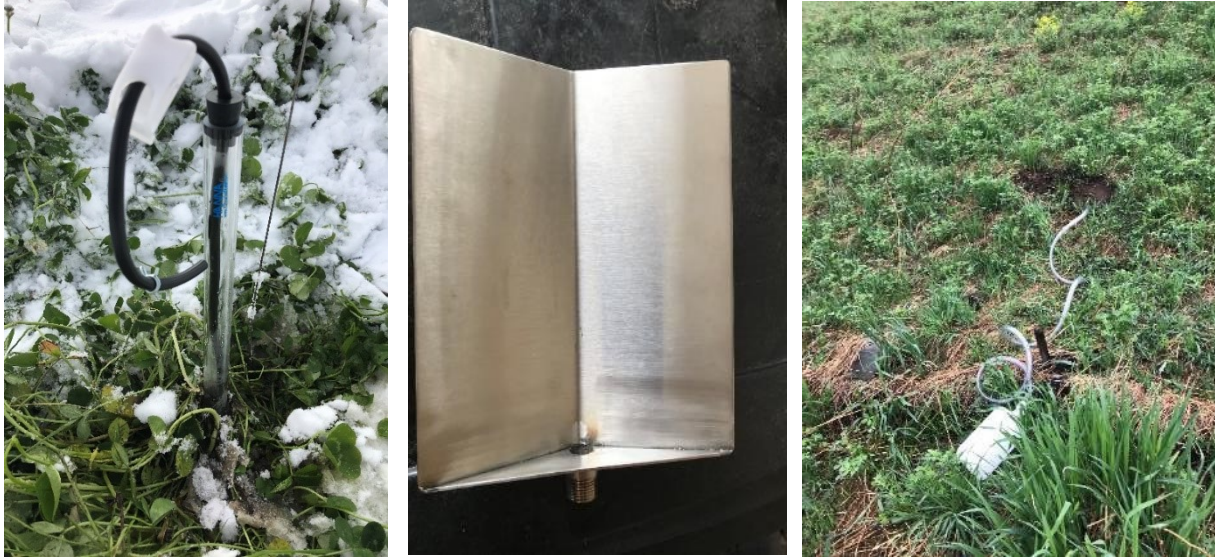
**Figure 2.7 The suction lysimeter (left) used in 2019 and the 1-ft pan lysimeter (middle and right) used in 2020 at the Eagle's Nest slope.**

For the bioslope at the Eagle's Nest site, water samples were collected by six suction lysimeters, which were installed after spring snow melted and removed after the first fall snow in 2019 (Figure 2.7). In 2020, water samples were collected by a stainless pan lysimeters, which were newly manufactured this year because the suction lysimeters used in 2019 were damaged by grass mowing and animal activities.

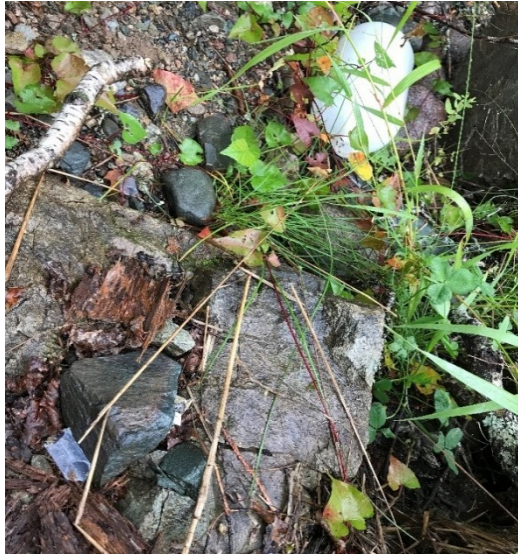
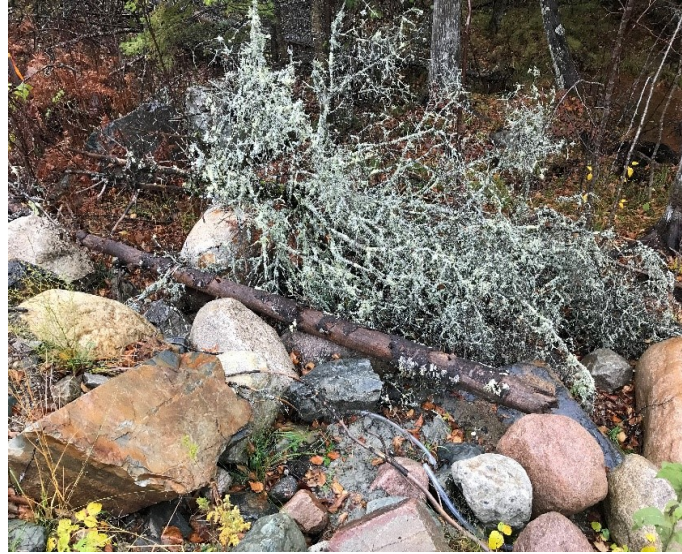
Figure 2.8 The same trench water collection point. The picture on the left was taken on September 10, 2019. The tube connection to the sample collection bottle was cut, probably by an animal. The same site was destroyed by fallen trees, as shown in the picture on the right taken on October 22, 2019.

In 2019, some field monitoring equipment on the Eagle's Nest site became non-functional by natural or human activities. In September, one trench pipe outlet was observed to be cut, possibly by an animal's chewing (Figure 2.8). The sample collection jar was pushed away from the site. The tube was reconnected at that time. However, a fallen tree, together with some rock debris, buried that site in October. Now the entire site and its equipment are completely destroyed and covered by the fallen tree.

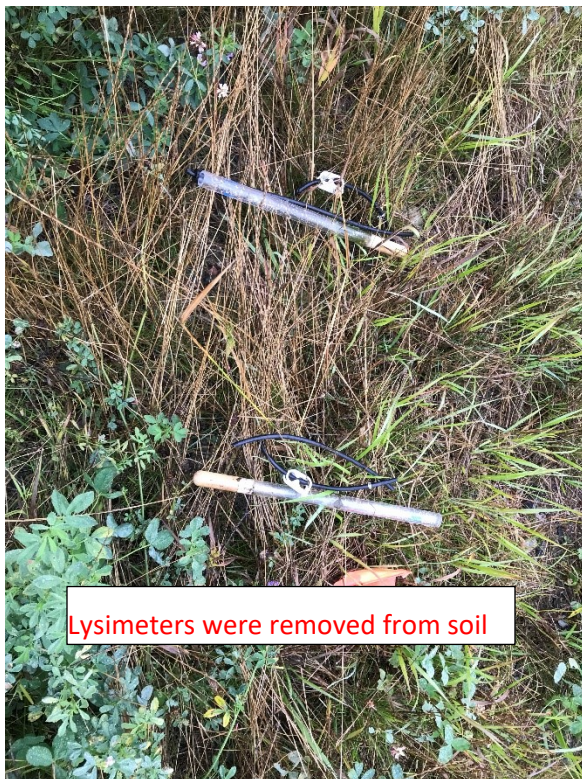
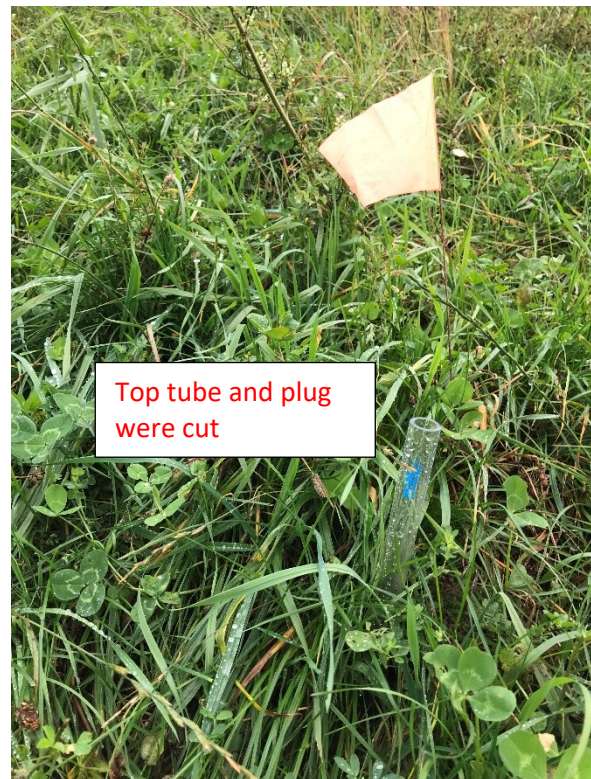
Figure 2.9 Pictures of destroyed lysimeters taken on October 11, 2019. The picture of a working lysimeter is shown on the left in Figure 2.7.

All six lysimeters on the Eagle's Nest slope were destroyed between September 13 and October 11, 2019 (Figure 2.9). These lysimeters may have been cut by grass mowing. Therefore, no sample was collected from the slope after September 13 in 2019.

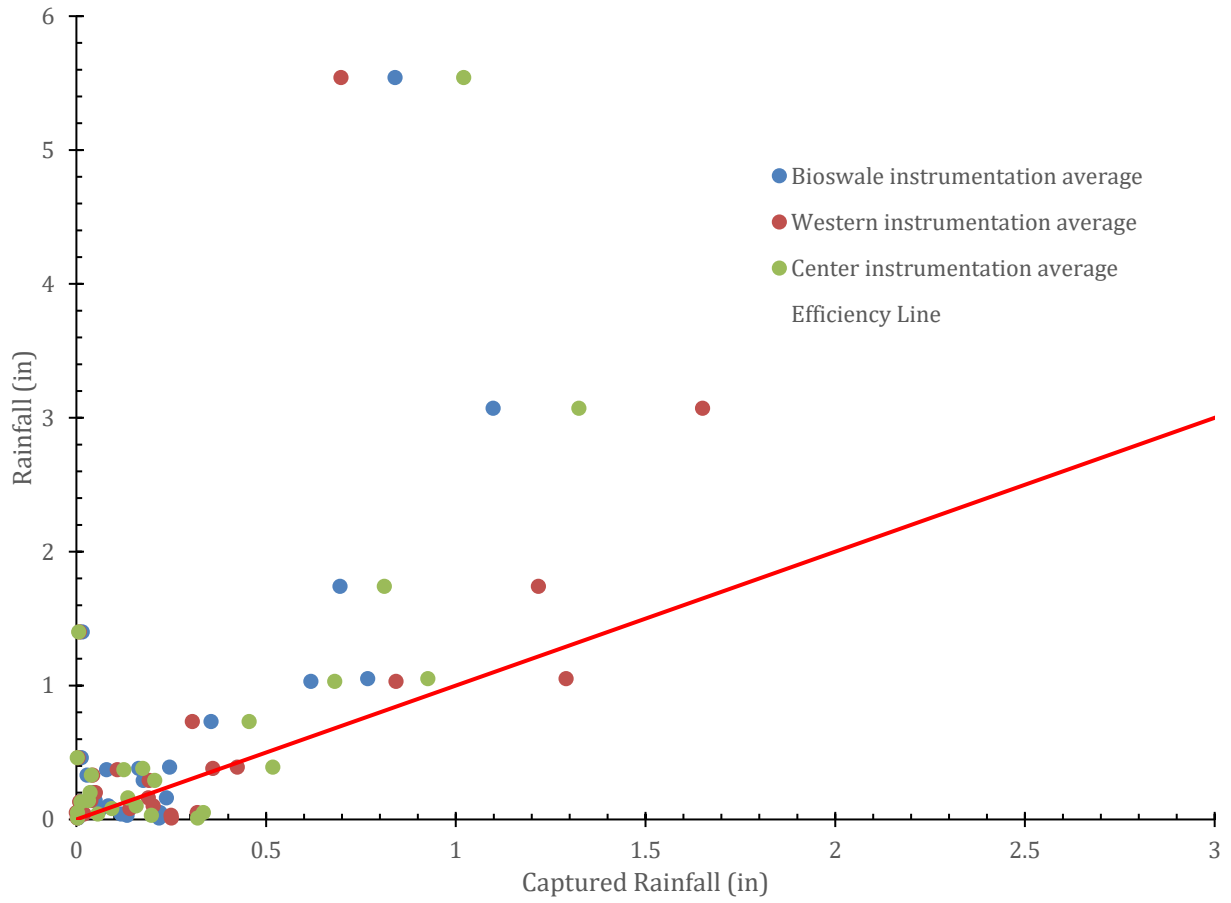
Figure 3.7. Historic rainfall vs. water captured by the biofilters at Eagle’s Nest after July 21, 2020.
