JOINT TRANSPORTATION RESEARCH PROGRAM

Repair and Strengthening of Bridges in Indiana Using Fiber Reinforced Polymer Systems: Volume 2—FRP Flexural Strengthening and End Region Repair Experimental Programs

**William B. Rich, Robert R. Jacobs,
Christopher S. Williams, Robert J. Frosch**

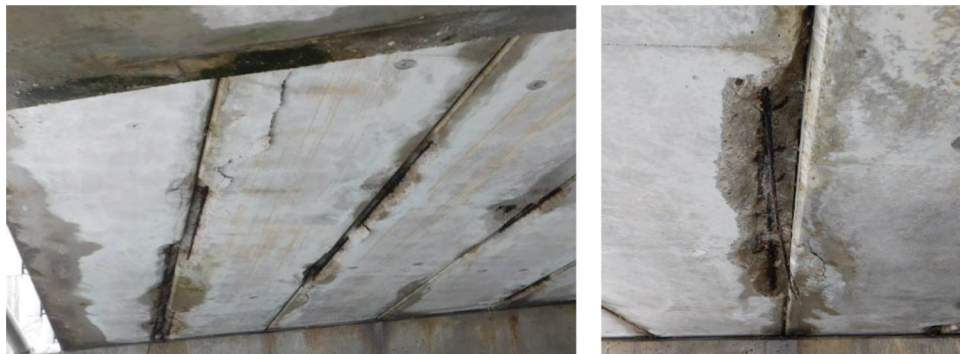
Figure 1.2 Common deterioration patterns (Elkhart, Indiana, Bridge No. 102 CR 35 over Little Elkhart River).

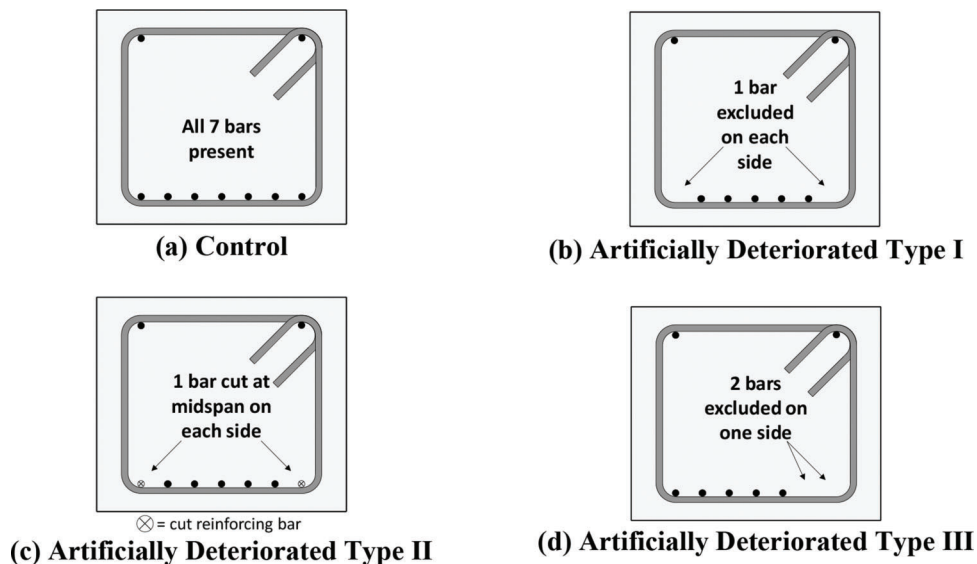
Figure 2.3 Simulated field conditions.

mens (see Figure 2.3(d)) were designed to simulate unsymmetrical deterioration of reinforcement to provide the means to evaluate the effects of the placement of NSM strips relative to the missing bars. The variation of the NSM strips relative to the missing bars is intended to simulate a field condition in which it would not be practical to place the NSM strips directly under the deteriorated reinforcement (i.e., insufficient concrete cover or excessive concrete spalling). The

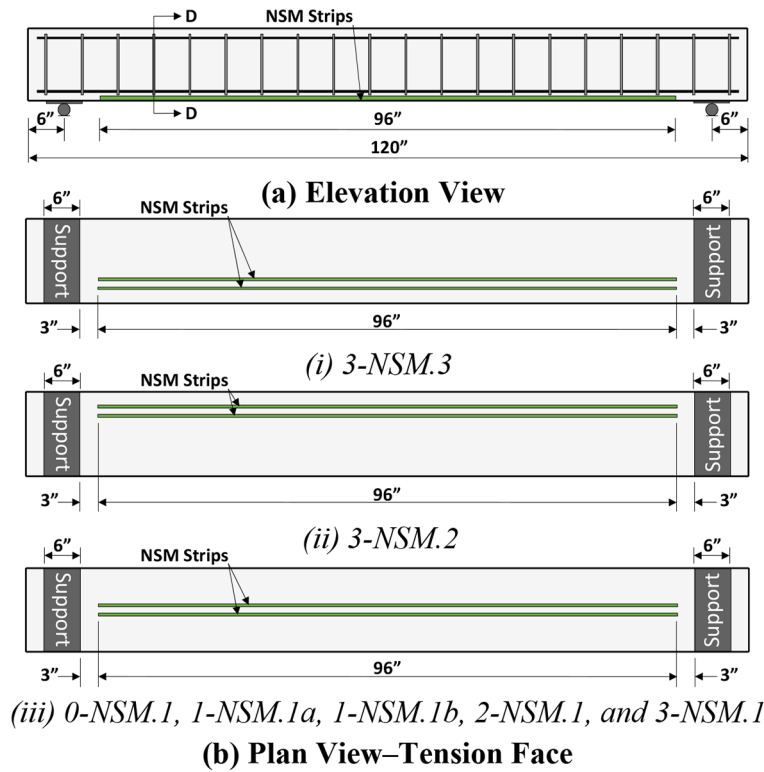
Figure 2.10 NSM strengthening system.

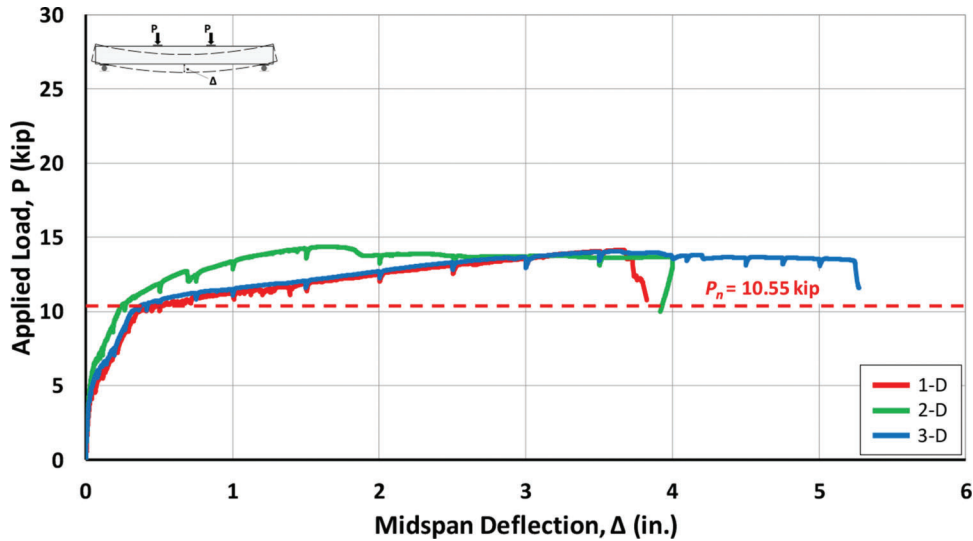
Figure 3.9 Applied load vs. midspan deflection for artificially deteriorated specimens.

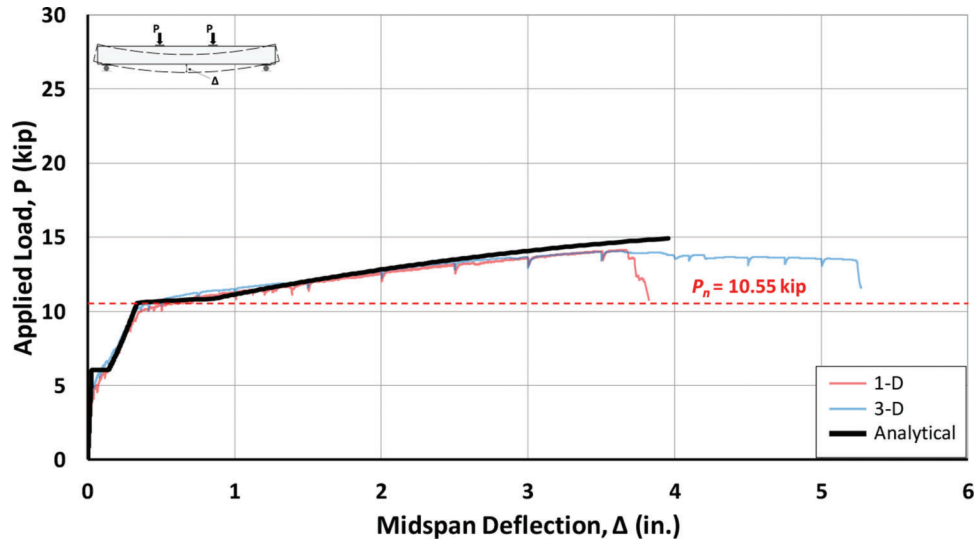
Figure 3.11 Comparison of theoretical and experimental responses for artificially deteriorated specimens.

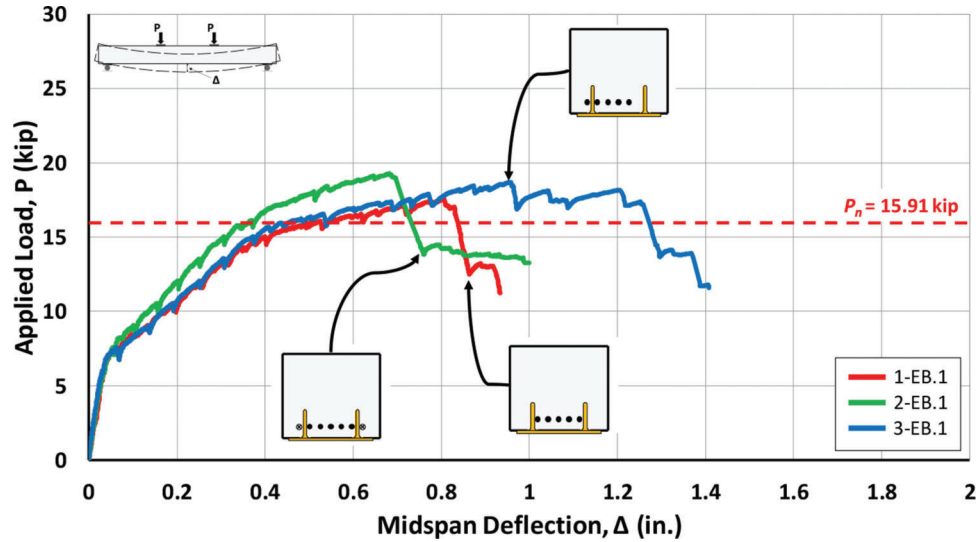
Figure 3.13 Applied load vs. midspan deflection for EB.1 specimen.

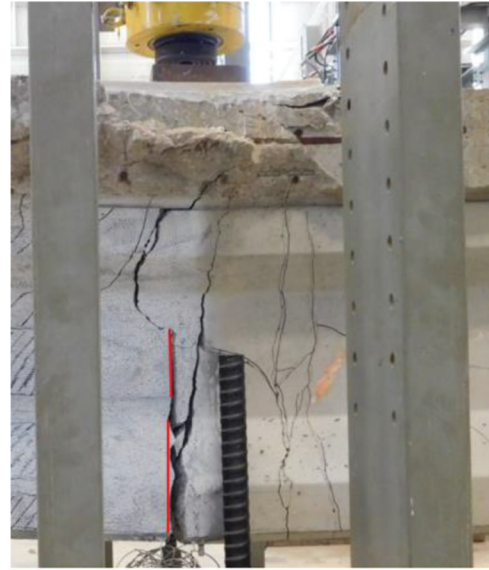
Figure 5.12 Critical flexural crack of externally bonded FRP specimen after failure.

termination of the FRP strips. The sudden loss in load-carrying capacity at a deflection of 1.39 in. is believed to coincide with strand fracture. The specimen continued to be loaded after this event and maintained a shear force of approximately 100 kips until another sudden drop in load-carrying capacity at a deflection of 2.35 in. Concrete crushing was observed in the deck beneath the load point. During the test, minor diagonal cracking was observed near the load point in the region not covered by FRP sheets. The crack was oriented at an angle of approximately 46° from the horizontal. The crack did not widen significantly after formation, however, and the propagation of the crack toward the support is unknown due to the presence of the FRP.

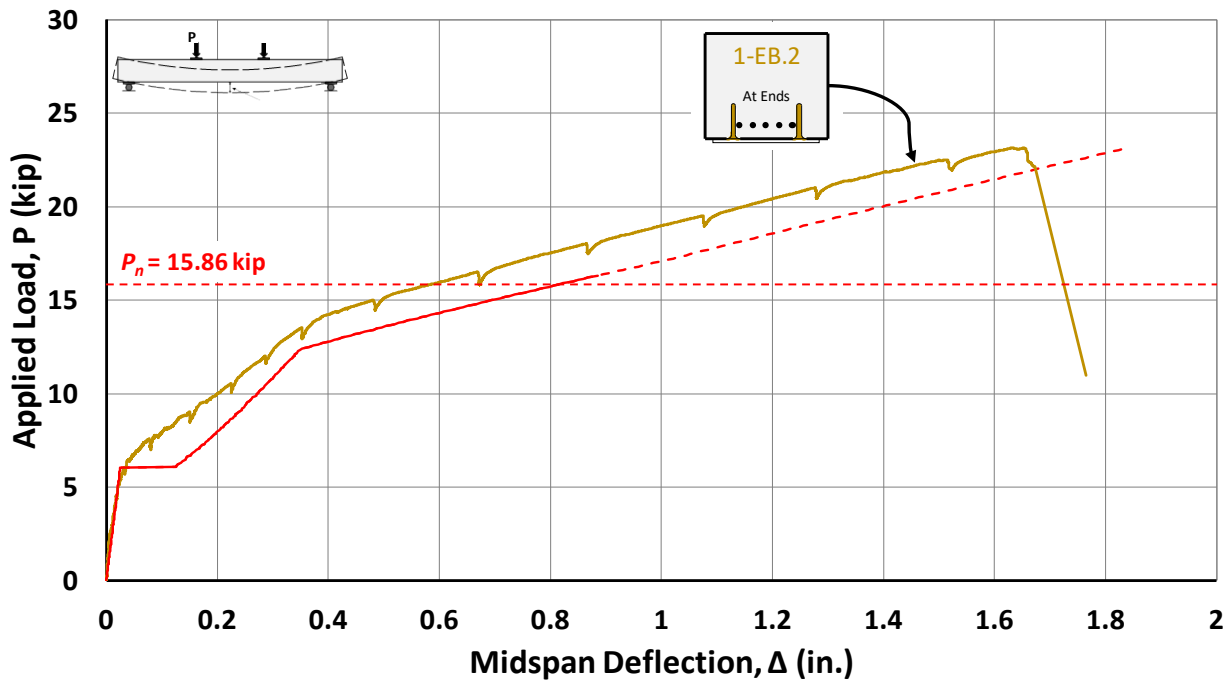
Figure B.6 Example of comparison of theoretical and experimental responses.

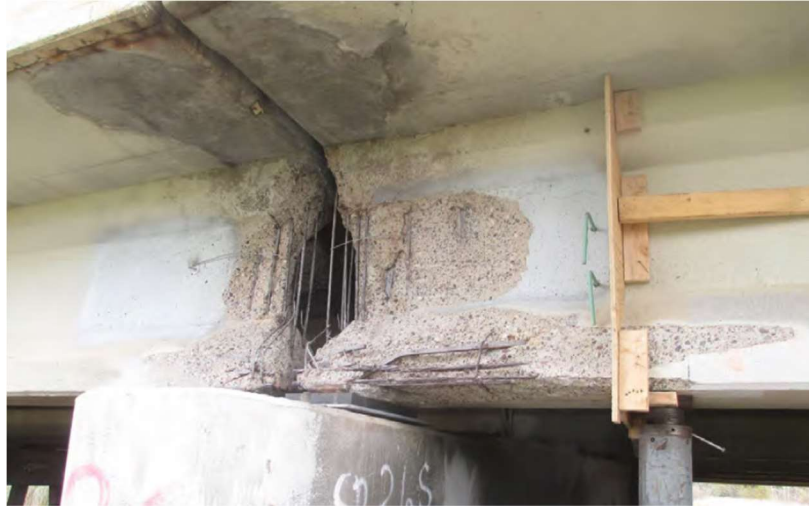
(a) Condition of the Girder Following Removal of Delaminated Concrete

Figure D.8 Girder condition prior to and following shotcrete repair (from Shield & Bergson, 2018).

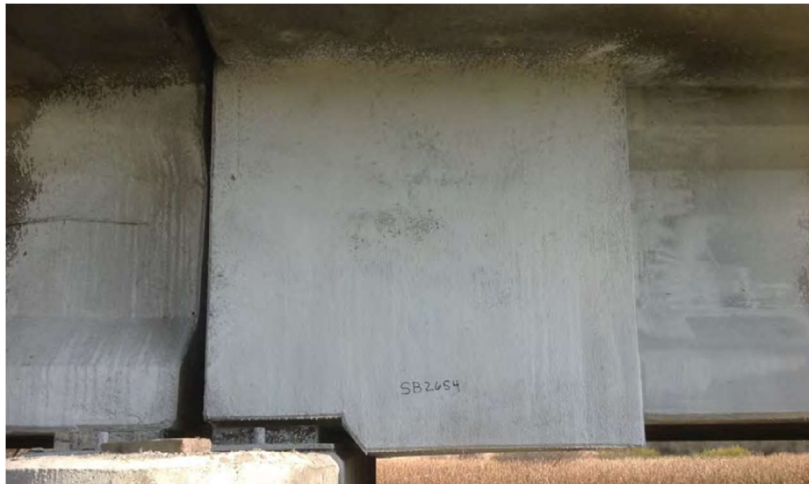
(b) Complete Shotcrete Repair

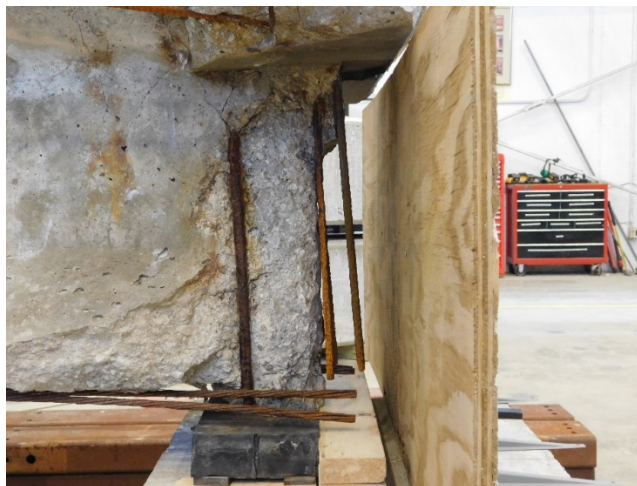
Figure E.9 Simulated mud wall and bearing pad location for externally bonded FRP specimen.

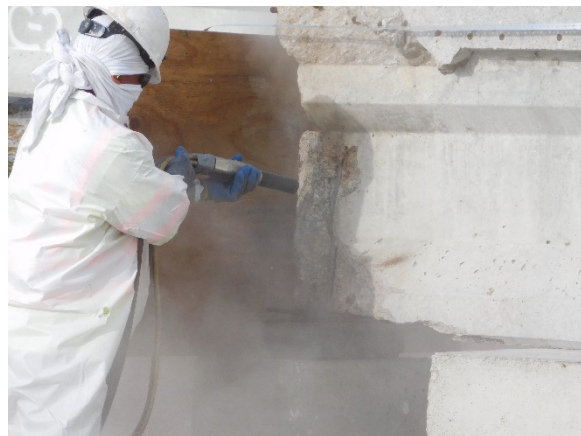
(b) Sandblasting to Remove Corrosion

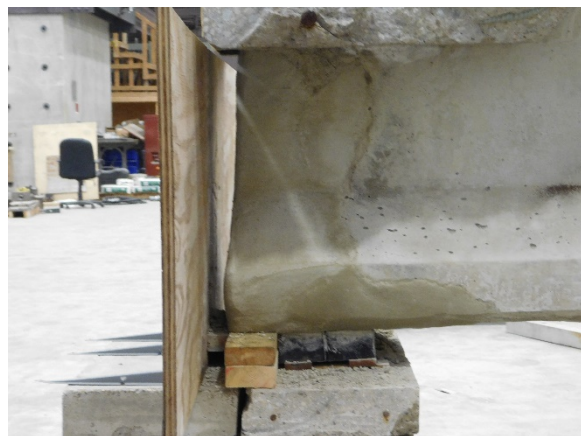
(d) Specimen After Mortar Repair

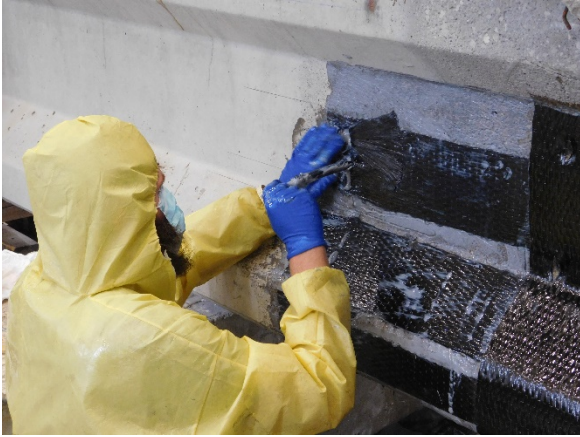
(c) Inserting Spike Anchor

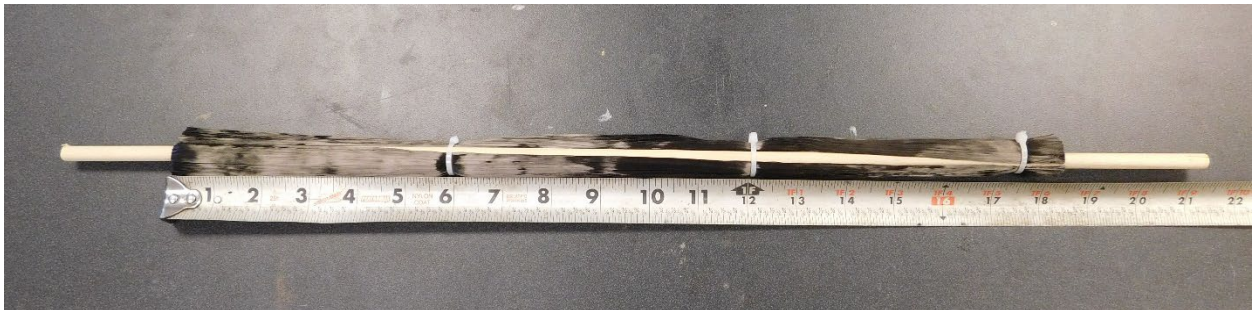
Figure E.13 Assembled FRP spike anchor for web installation.

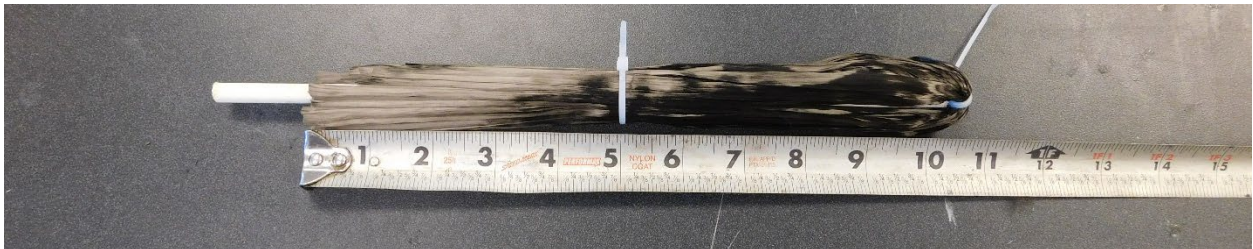
Figure E.14 Assembled FRP spike anchor for bottom flange installation.

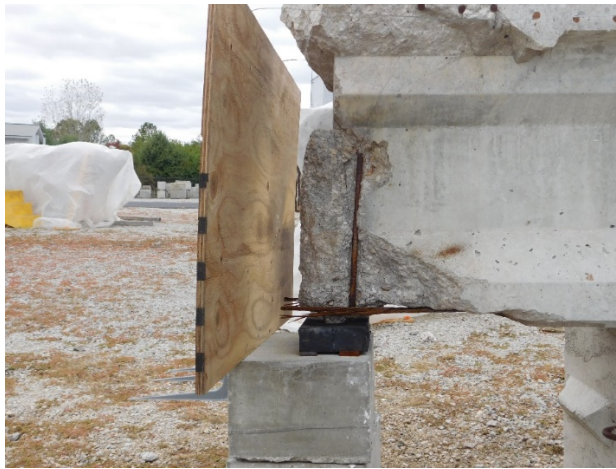
Figure E.15 Simulated mud wall and bearing pad location for NSM FRP specimen.

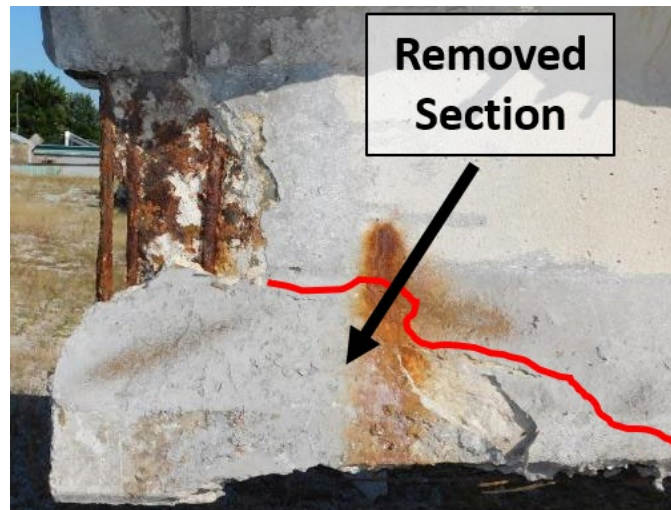
Figure E.18 Flange portion removed from supplemental diaphragm specimen.
