Test Report No. 612051-4 Test Report Date: March 2020

# MASH TL-3 FULL SCALE CRASH TESTING AND EVALUATION OF TRANSITION FROM 32-INCH TALL WEAK POST GUARDRAIL SYSTEM TO MGS STRONG POST SYSTEM

Test No.: 612051-03-1 & 612051-02-1 Test Date: 2019-10-07 & 2019-11-05

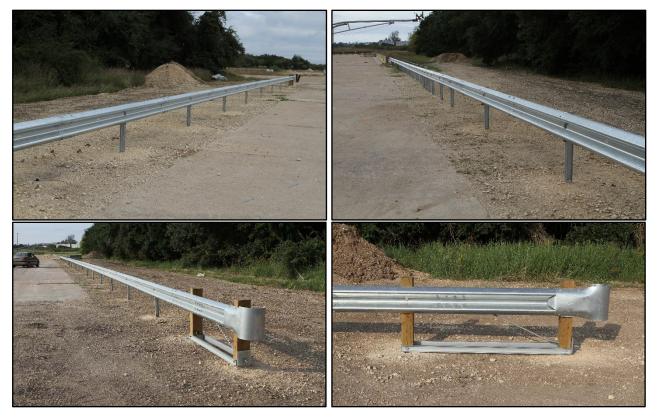
Figure 2.1. Details of Guardrail Transition from 32-inch Tall MGS Weak Post System to MGS Strong Post System.

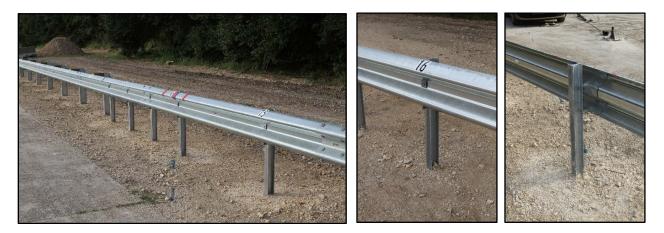
Figure 2.2. Guardrail Transition from 32-inch Tall MGS Weak Post System to MGS Strong Post System prior to Testing.

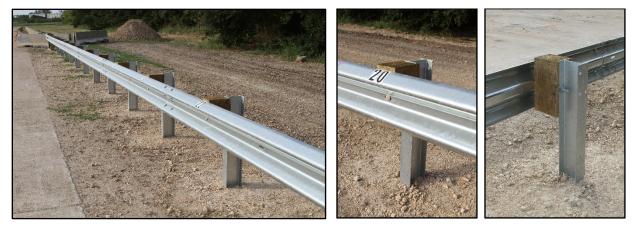
Figure 2.3. Transition prior to Testing.

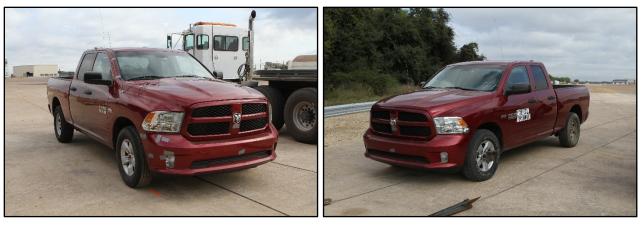
Figure 5.2 shows the 2014 RAM 1500 pickup truck used for the crash test. The vehicle's test inertia weight was 5005 lb, and its gross static weight was 5005 lb. The height to the lower edge of the vehicle bumper was 11.75 inches, and height to the upper edge of the bumper was 27.0 inches. The height to the vehicle's center of gravity was 28.1 inches. Tables D.1 and D.2 in Appendix D1 give additional dimensions and information on the vehicle. The vehicle was directed into the installation using a cable reverse tow and guidance system, and was released to be freewheeling and unrestrained just prior to impact.

Figure 5.2. Test Vehicle before Test No. 612051-02-1.

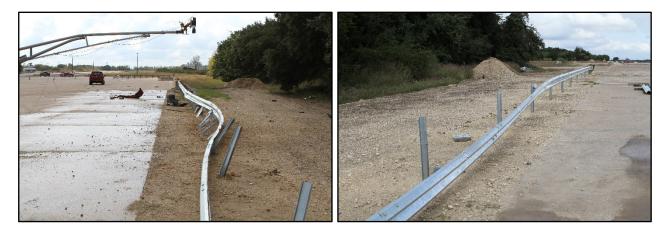
Figures 5.3 through 5.7 show the damage to the transition. There was a  $\frac{1}{2}$  inch gap in the soil at the upstream side of post 1 and the rail was pulled down 3 inches from its original height. The soil was disturbed around post 2 and the rail was released from the post. Posts 3 through 6 were leaning downstream  $87^{\circ}$  from vertical. Posts 7 and 8 were leaning downstream  $86^{\circ}$  from

vertical. Posts 9, 10, 11, and 12 were leaning 85° downstream from vertical. Post 13 was leaning at 77° downstream and 80° toward the field side from vertical. Post 14 was leaning 65° downstream and back toward the field side from vertical. Post 15 was leaning 56° downstream and rotated toward the field side from vertical. Posts 16 through 22 were leaning downstream and toward the field side at 24° from vertical. There was slight soil disturbance at post 34. The rail released from posts 10 through 23. The rail element had a partial tear on the field side of the splice between posts 20 and 21.

Working width\* was 65.5 inches, and height of working width was 54.2 inches. Maximum dynamic deflection during the test was 57.2 inches, and maximum permanent deformation was 31.0 inches.

Figure 5.3. Transition after Test No. 612051-02-1.

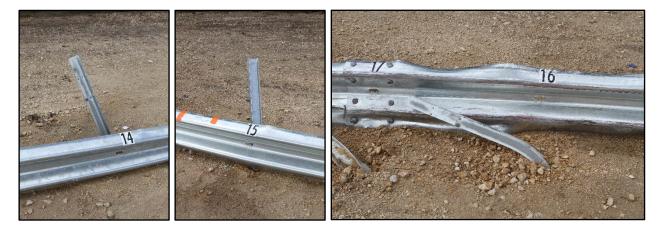
Figure 5.4. Posts 14 through 16 after Test No. 612051-02-1.

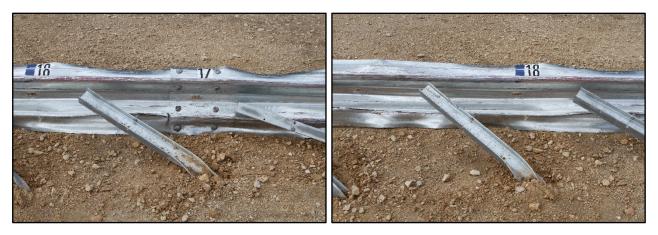
Figure 5.5. Posts 17 and 18 after Test No. 612051-02-1.

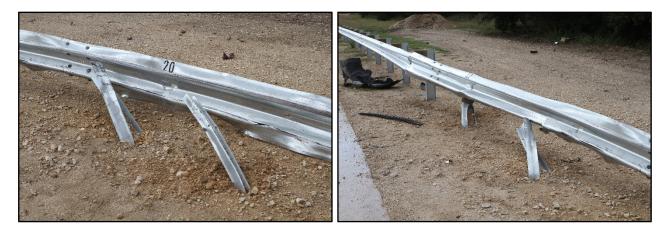
Figure 5.6. Posts 19 through 25 after Test No. 612051-02-1.

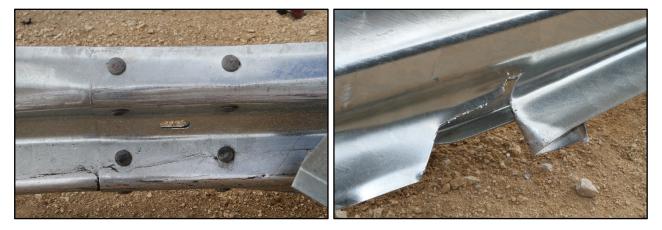
Figure 5.7. Partial Tear of Rail Element after Test No. 612051-02-1.

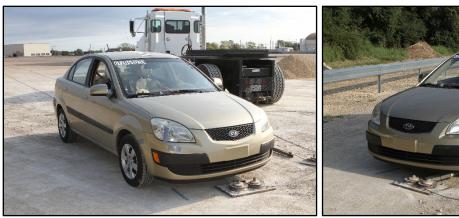
Figure 6.1 shows the 2009 Kia Rio used for the crash test. The vehicle's test inertia weight was 2426 lb, and its gross static weight was 2591 lb. The height to the lower edge of the vehicle bumper was 7.75 inches, and height to the upper edge of the bumper was 21.5 inches. Table E.1 in Appendix E1 gives additional dimensions and information on the vehicle. The vehicle was directed into the installation using a cable reverse tow and guidance system, and was released to be freewheeling and unrestrained just prior to impact.

Figure 6.2. Test Vehicle before Test No. 612051-03-1.

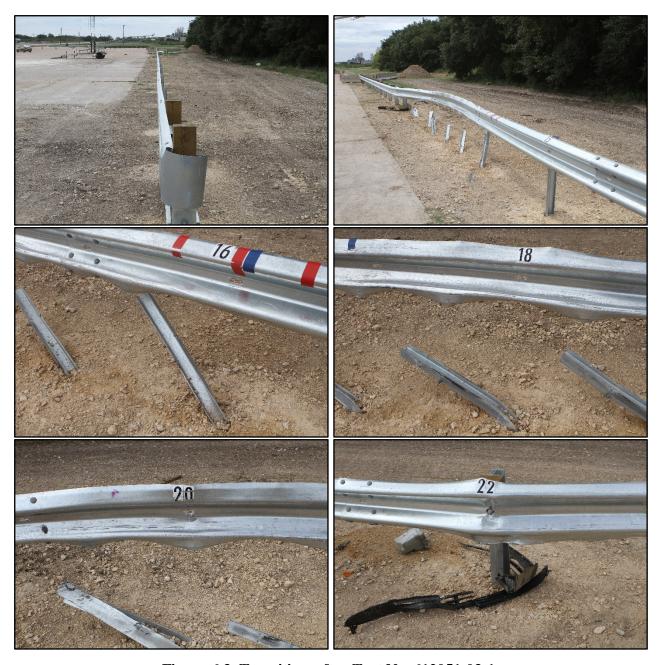
Figure 6.3 shows the damage to the transition. The soil was disturbed around post 1, and it was pulled downstream 0.125 inches at ground level. The rail sustained a partial tear at the bolt at post 2. The rail element released from posts 15 through 21, and the blockouts released from

posts 20 and 21. Posts 7 through 14 were leaning downstream between 86 and 88.6°. Post 15 was leaning toward the field side at 83.7°, posts 16 through 21 were leaning toward the field side at approximately 5° and downstream approximately 20°, and post 22 was leaning toward the downstream at 86.6°. Working width\* was 37.9 inches, and height of working width was 40.0 inches. Maximum dynamic deflection during the test was 34.9 inches, and maximum permanent deformation was 27.0 inches.

Figure 6.3. Transition after Test No. 612051-03-1.

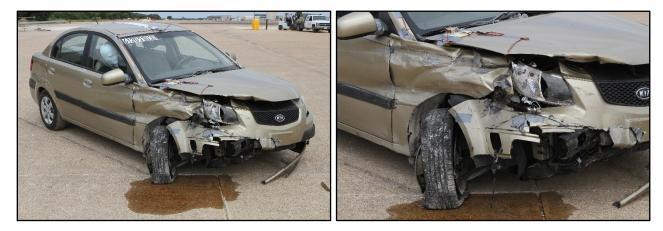
Figure 6.4 shows the damage sustained by the vehicle. The front bumper, radiator and support, right front tire and rim, right front floor pan, right front strut and tower, right front fender, right front and rear doors, and right rear quarter panel were damaged. No fuel tank damage was observed. Maximum exterior crush to the vehicle was 10.0 inches in the front plane at the right front corner at bumper height. Maximum occupant compartment deformation was 1.0 inch in the right front toe pan. Figure 6.5 shows the interior of the vehicle. Tables E.3 and E.4 in Appendix E1 provide exterior crush and occupant compartment measurements.

Figure 6.4. Test Vehicle after Test No. 612051-03-1.

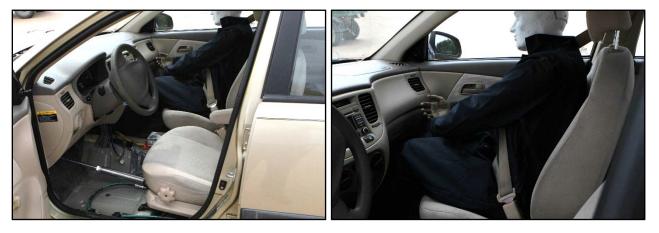
Figure 6.5. Interior of Test Vehicle after Test No. 612051-03-1.
