U.S. Department
of Transportation
**National Highway
Traffic Safety
Administration**

DOT HS 813 136

August 2021

Li-Ion Battery Pack Immersion Exploratory Investigation

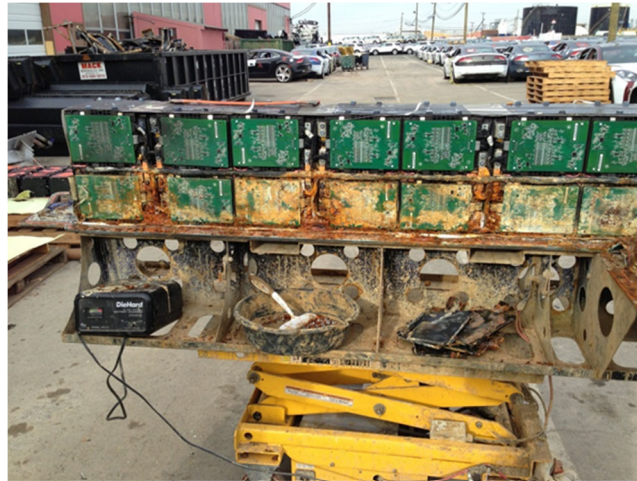
Figure 1. Fisker Karma Flooding – water intrusion of the entire pack

of damage observed across many of these packs, varying from water intrusion to clear indicators of high-energy discharge. Many of the damaged packs show significant BMS board and connector degradation while showing no issues with the individual cells. This again suggests that many of these failures are related to system-level loss of isolation as opposed to cell-initiated failure.

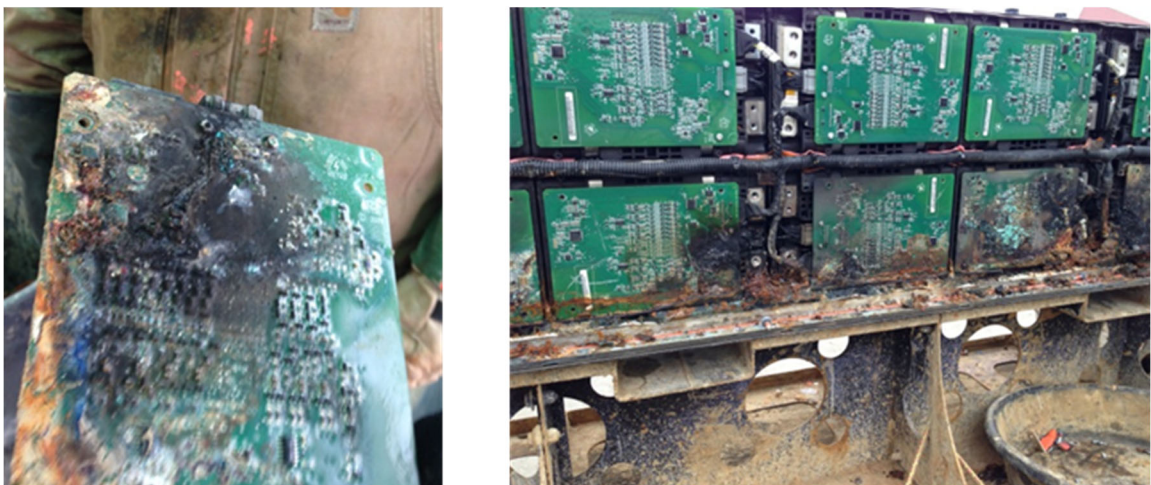
Figure 2. Fisker Karma Flooding – BMS and internal cabling damage and shorting

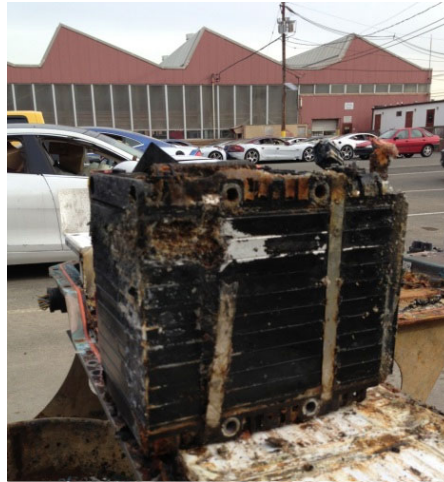
Figure 3. Fisker Karma – evidence of actual individual cell damage

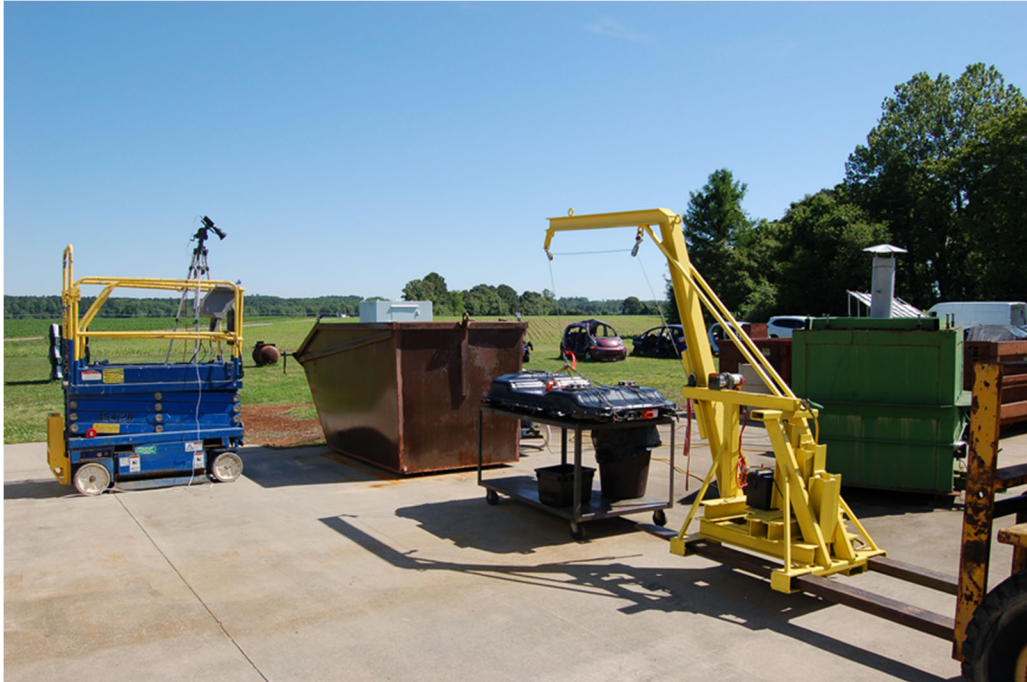
Figure 4. Test setup overview – observation station, lifting mechanism, and immersion tank

As discussed in the introduction, the testing in this project aimed at assessing the immersion of batteries during the initial and subsequent immersion as well as behaviors related to initial or long-term reactions following removal of the battery from the immersion conditions. To these ends, the testing equipment use for these experiments needed to provide a safe location for immersion, a means to lower and raise the device-under-test into and out of the immersion, and a means to observe the on-going experiments and monitor for any incidents. An overview of the key equipment is shown in Figure 4. The reader can see the immersion tank, a repurposed dumpster, as well as the lift mechanism to raise and lower the battery into the tank. The lift mechanism was placed on the forks of a fork-lift to provide the starting height from which the battery could be raised or lowered. Care was taken to ensure the lift has sufficient capability for the various batteries examined, as some were over 400kg. The lift could be operated remotely, allowing the battery to be re-lowered quickly and easily should any issue be encountered during observation above the tank. In contrast to a specific observation area, it was decided early on during experimental developments that the battery should be observed directly over the immersion tank, so if an incident was detected, the battery could quickly go back into the immersion, most likely stopping problem. A remote camera fixed to a lift was used as the primary video collection apparatus as it allowed for directly viewing into the immersion tank and during observation, while allowing test operators to stay a safe distance away in case any thermal issues arose during testing.

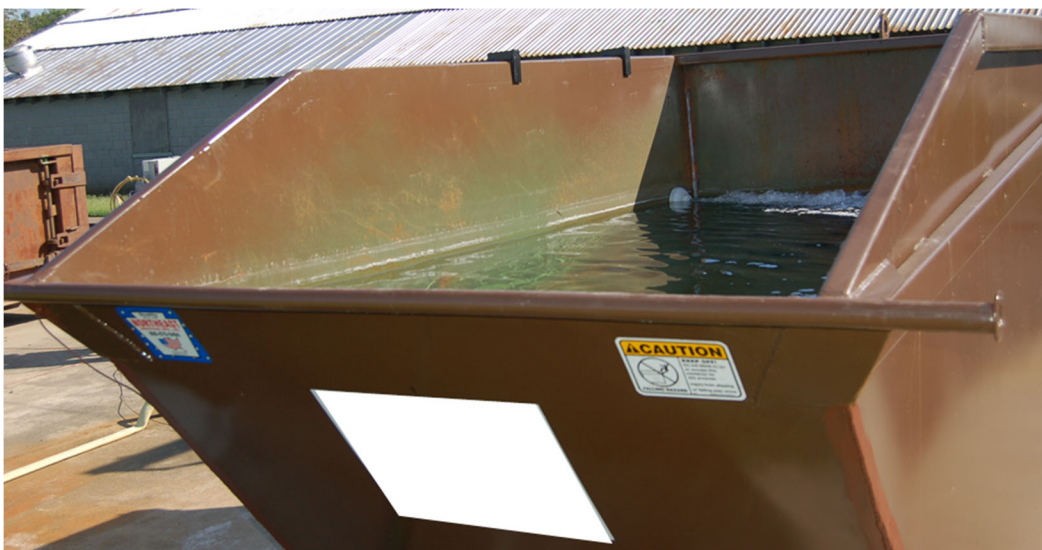
Figure 5. Dumpster used for immersion

The immersion tank for these experiments was a trash dumpster shown below in Figure 5. This provided a robust and cost-effective means to perform the immersion testing and is easily obtainable.

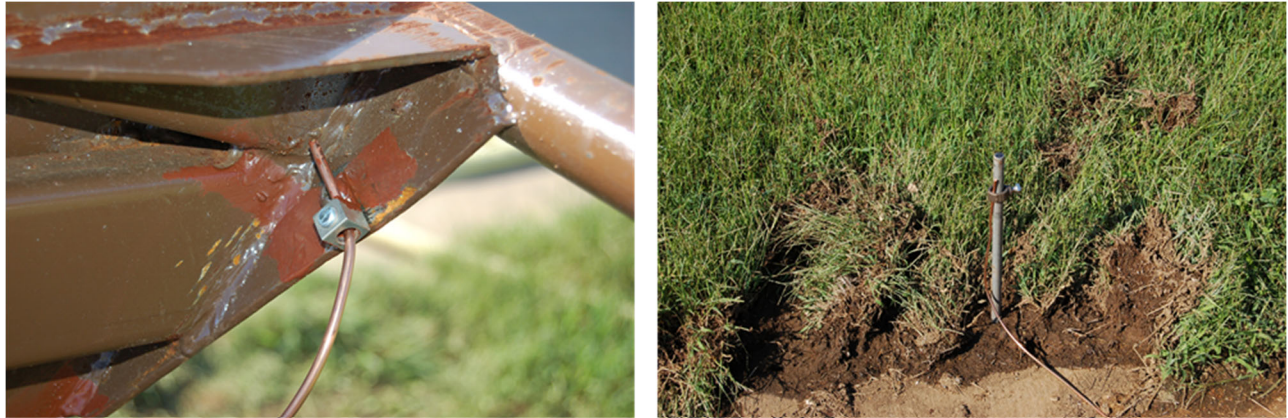
Figure 6. Immersion container grounding connections

As an additional safety precaution, shown in Figure 6, the dumpster was also grounded via welded lugs, large copper wire, and a grounding spike to ensure that the tank was itself grounded to avoid any possible complications during the immersion of the batteries.

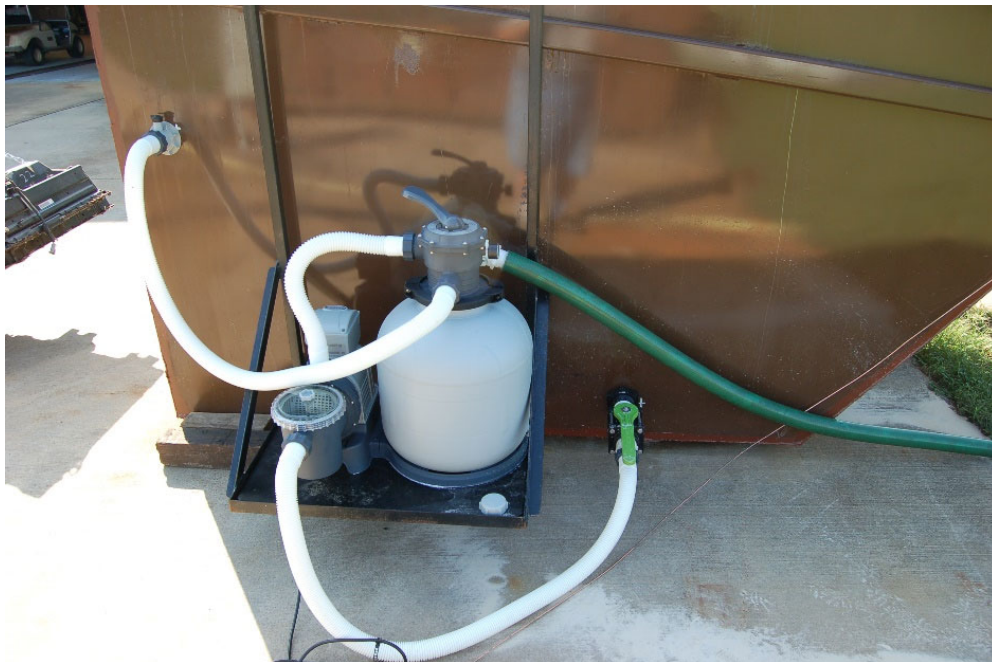
Figure 7. "Pool" filter system for immersion water circulation and filtering

In discussions with several test engineers and experimental facilities, it was found that immersion tanks quickly become cloudy and hard to observe even prior to the battery entering the tank. With this issue in mind, the immersion tank was retrofitted with a basic pool filtration system to ensure reasonable water conditions prior to the various tests since there was frequently time associated with preparing the batteries and immersion tank that could otherwise lead to undesirable water conditions. This system is illustrated in Figure 7.

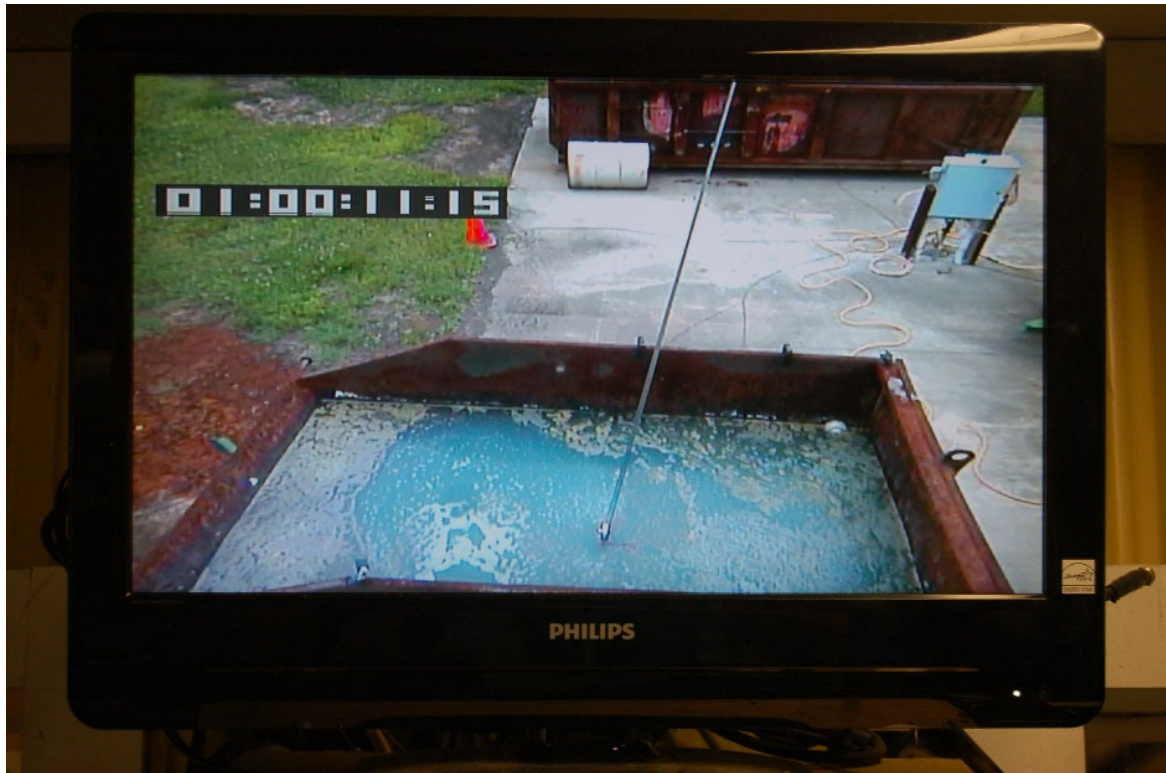
Figure 8. External "bird's-eye" camera view of immersion testing

As mentioned earlier, the primary camera for the experimental testing was a bird's-eye view remotely provided to a set of displays in the experimental control room. This allowed for safety observation during and post-immersion but was also found to provide the best vantage point during most of the experiments to get an overall feel of testing progress and the emergence of any possible issues during testing. An example of a typical view is shown in Figure 8, where the progress of the immersion (bubbles) can be easily viewed and recorded. Since the remote camera was also recording, the feed also displayed the elapsed time, which was helpful for keeping track of the duration of immersion and observation time as the experiments progressed.

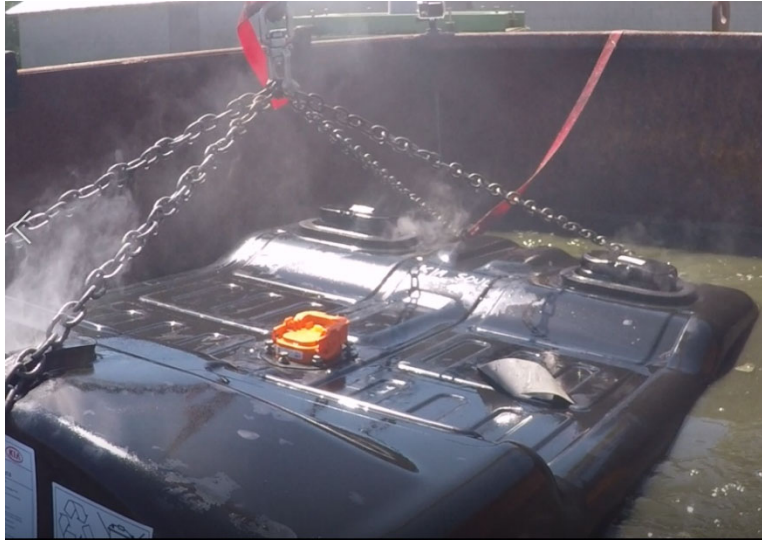
Figure 9. Waterline immersion tank camera view

Supplementing the birds-eye camera was a camera in the corner of the immersion tank near but above the water line of the tank. This camera was particularly helpful identifying the location and initiation of issues such as cell rupture and off-gassing. This camera offered an alternative view during the observation phase that was found to be the location of issues during the experiments as opposed to any issues during the immersion. Figure 9 shows an example view from this camera during a cell rupture event as evidenced by smoke rising from the battery's vents.

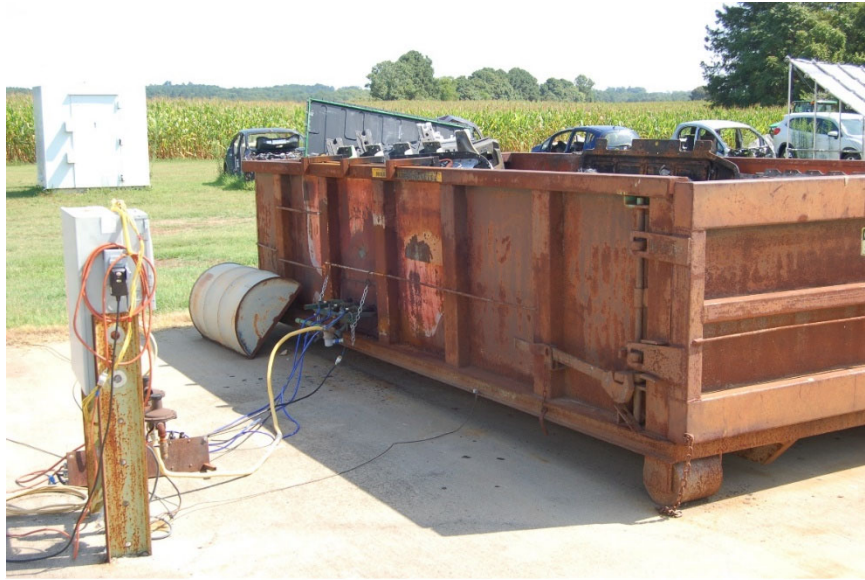
Figure 11. Secondary containment for long-term observation and final battery destruction

After the initial immersion and observation experiment was complete for a particular battery pack, the battery was then moved to a secondary location for longer-term observation, final inspection, and final destruction via incineration. The secondary location allowed for additional batteries to be evaluated in the immersion tank while providing a longer-term storage area in case delayed thermal incidents occurred. After the longer observation period, individual batteries were finally incinerated within the enclosure. The secondary enclosure used for this experiment was also a repurposed dumpster, but this time a much larger one to allow for adequate space to retain several packs for observation and examination. The exterior of the containment is shown in Figure 11, and the location of the direct flames used to initiate the final incineration of the battery is shown in Figure 12. Figure 13 shows sample images during and after the battery incineration.

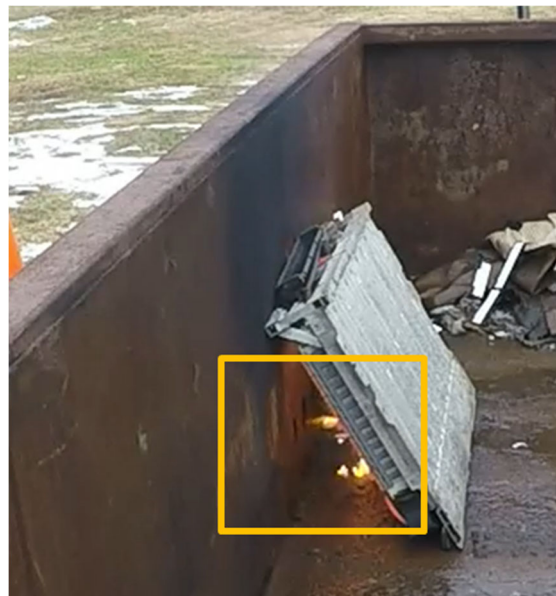
Figure 12. Location of direct flames for initiation of battery incineration

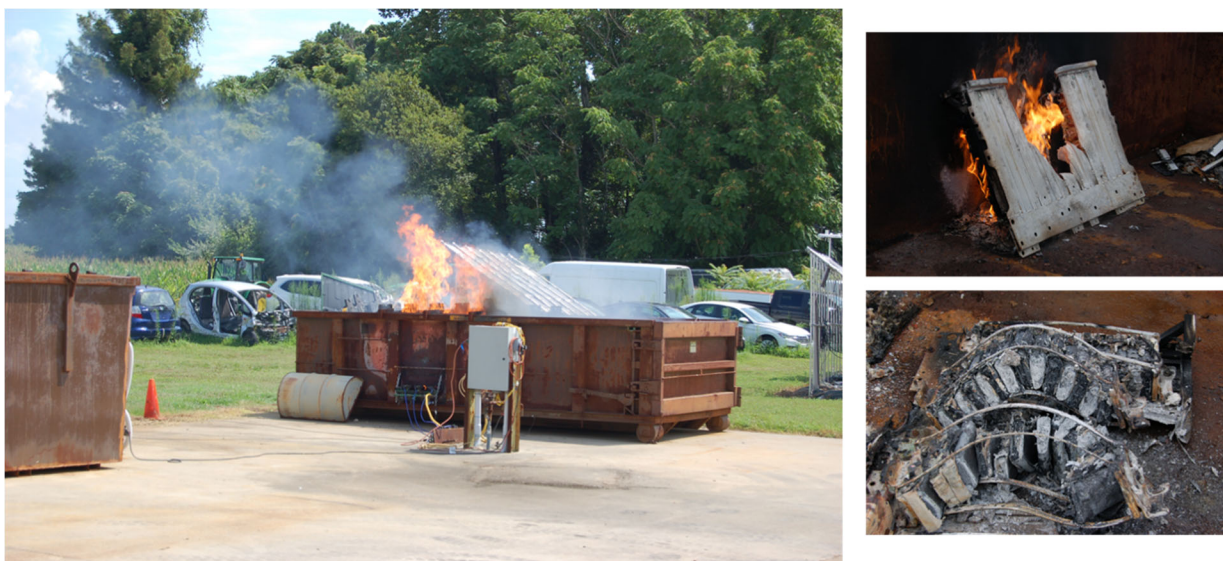
Figure 13. Battery destruction

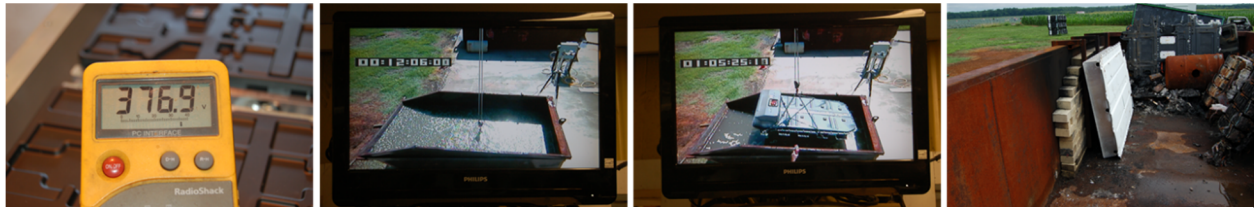
Figure 14. Overview of battery immersion testing process - Battery preparation, immersion, observation above immersion tank and extended observation

For certain experiments, the experimental immersion/observation steps would be repeated if working to assess the impacts of different immersion times with the same battery (i.e., initial short immersion and observation period followed by a longer immersion period). The long-term final immersion was done to ensure the battery was fully de-energized to the greatest extent possible and was typically done for 24+ hours beyond any of the experimental immersion done previously. This helped to ensure the battery was de-energized and thus less active for the final destruction phase of these efforts to collect information during battery incineration.

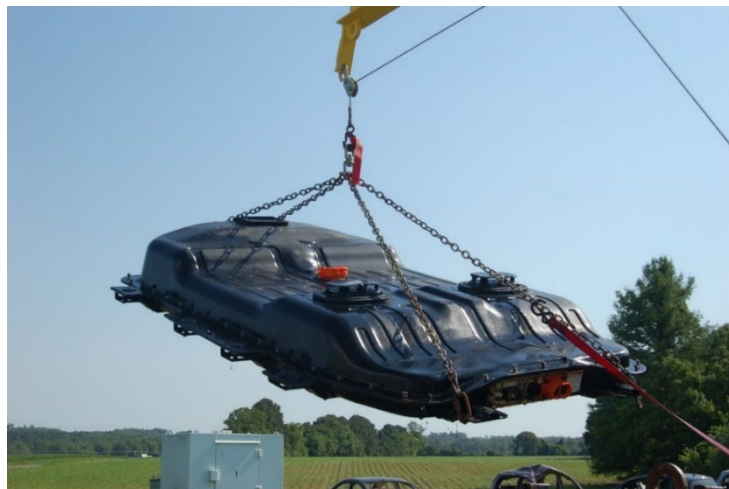
Figure 15. Angled battery prior to immersion (to avoid floating)

Parallel with the procedures in the introduction, the batteries were lowered into the immersion tank smoothly and rapidly, allowing the reactions to take place with the battery fully under water and without any major sloshing of the water within the battery. For this testing, the batteries were held at a slight angle (Figure 15) to avoid any air pockets from forming within the battery and possibly floating it to the top of the waterline unexpectedly. This technique appeared to work as all of the batteries remained underwater for the entire duration of their respective immersion tests.

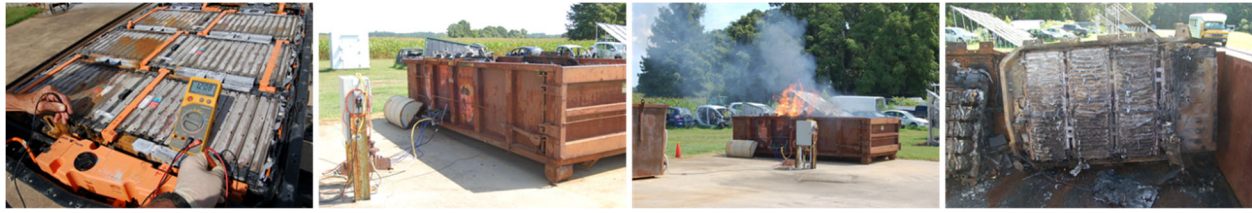
Figure 16. Overview of final battery destruction process

While not as detailed as the previous discussion, this section seeks to discuss the post-immersion observation and destruction phase of the testing. Following 24+ hours of observation, the battery overall pack voltage was again assessed, this time to ensure sufficient de-energizing from the extended immersion period and the ability to safely examine the pack. The battery covers were then removed to allow for visual inspection of the batteries for the extent of deterioration and damage from the immersion and subsequent removal. Once this stage was complete, the batteries were then incinerated by initiating a fire with an open flame provided by a starter integrated into the secondary container. Once the incineration was initiated externally, the batteries continued to burn until they were nearly completely incinerated. During the incineration, a camera recorded

the event. Once destroyed, the batteries were removed from the container to make room for additional test batteries from the immersion. Examples of the process steps are shown in Figure 16.

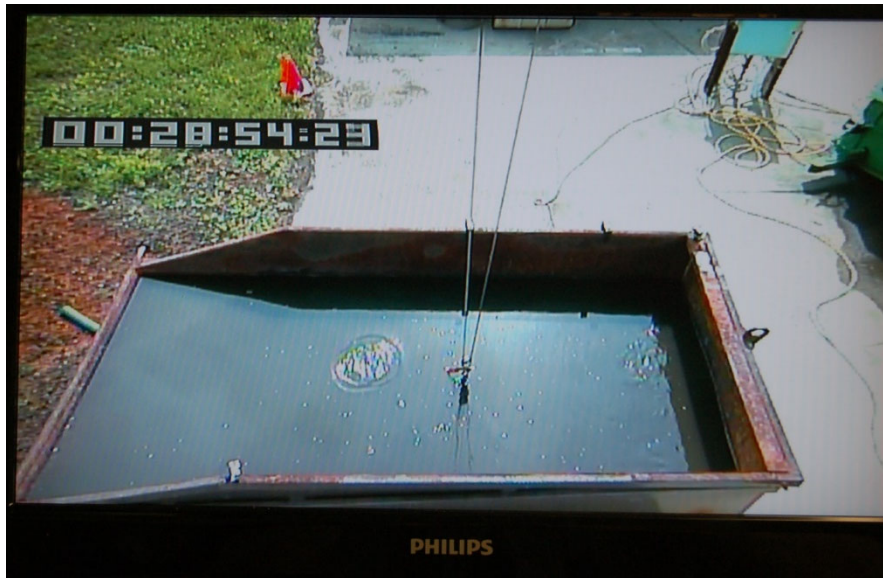
Figure 18. Example image of immersion behavior (bubbling)

For all batteries tested, no issues were observed during the actual immersion phase of testing. While in the past, some batteries have exhibited arcing and even underwater fires while in the immersion, no behaviors of this type were observed for any of the batteries tested. The overall process of immersion for the various batteries followed a very similar series of events. Directly after immersion, remaining air in the pack was released as evidenced by large bubbles escaping the pack from various openings and vents. After this initial release of air bubbles has subsided, battery degradation and electrolysis of the batteries was indicated by smaller bubbles rising to the surface in one-or-two primary locations. Figure 18 shows an example image of a battery during immersion with bubbling clearly visible on the surface. Depending on the size of the battery, the primary reactions during immersion appeared to last between roughly 30 minutes and 1 hour, with larger batteries having a longer reaction duration compared to the smaller batteries tested in this work. While informative, these observed durations should be treated as approximate numbers, since it is not particularly easy to identify when reactions have “stopped” since the appearance of a few small bubbles is somewhat difficult to detect. With these observations and behaviors in mind, the 2-hour immersion time highlighted in the earlier relevant procedure discussion is likely a reasonable testing parameter for most immersion testing scenarios, although a shorter immersion time could possibly provide similar results for most batteries except for those that are very large or where water will have difficulty penetrating. Given no adverse reactions were observed during the immersion itself for any of the test objects, a focus on post-immersion behavior in addition to “during immersion” for a given immersion scenario is strongly suggested (similar to the ISO 6469 post-immersion observation period).

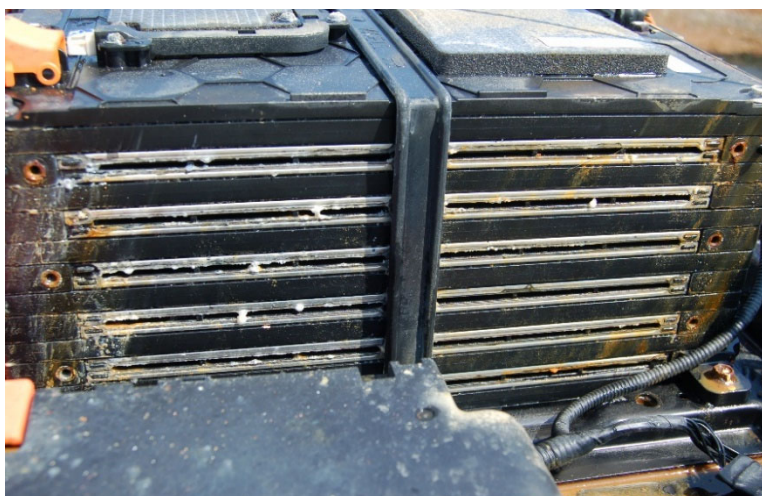
Figure 19. Evidence of battery cell and module degradation

As would likely be expected from batteries experiencing a relatively long period of immersion, all the batteries tested showed significant signs of degradation due to water intrusion across all major components. Despite having their protective cases installed, water was found to easily enter the packs during immersion as the tank selected was sufficiently deep to fully immerse the batteries with a significant amount of water above them. The following figures highlight some of the observed degradation across the various test subjects, which was consistent across the different immersion scenarios. Figure 19 highlights a common set of battery cell and module degradation observed across all of the immersion tests in that a significant amount of battery cell leakage and corrosion can be seen for multiple cells. In addition to the cells themselves, significant corrosion can also be seen for the module enclosure and metal mounting surfaces of the battery.

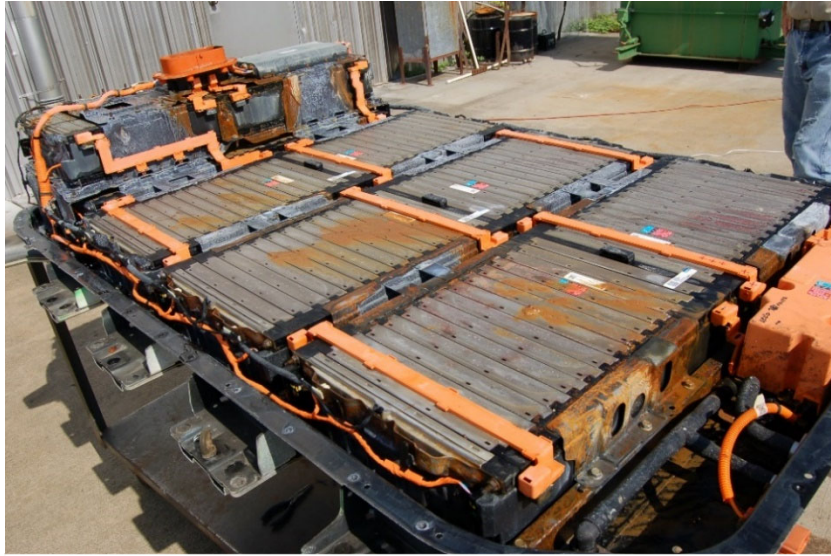
Figure 20. Example pack-level view of battery degradation due to immersion

Figure 20 shows an example view of immersion related degradation across an entire pack. Again, cell and module level degradation can easily be seen, but also connectors and other metallic surfaces contained within the pack are also severely degraded. Recalling the examples of in-field immersion discussed in the introduction, very similar observations can be made regarding the types and level of degradation observed from the immersion scenarios described in these efforts.

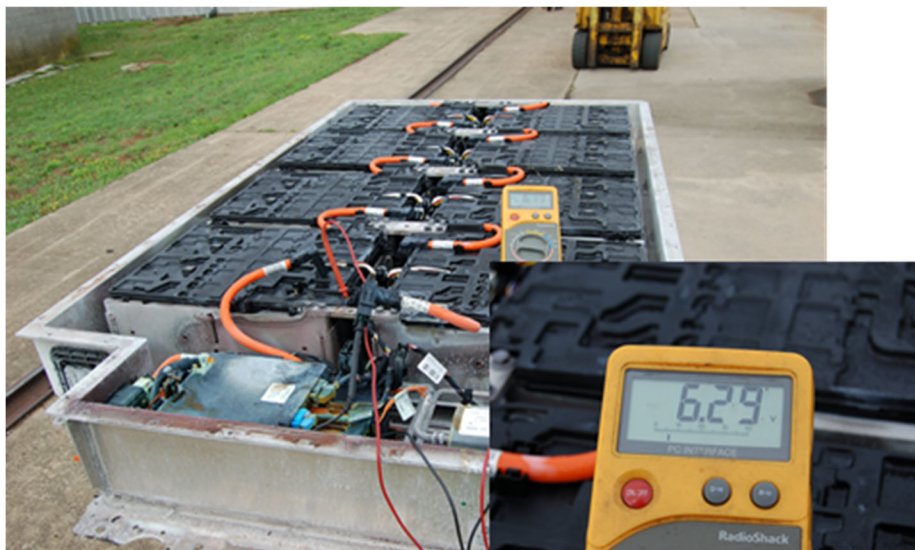
Figure 22. Example confirmation of <50V remaining battery voltage following long-term immersion

As discussed in the process overview, once the initial immersion testing and observation was complete, batteries remained in the immersion for an extended period with the aim of de-energizing the packs. For every battery tested, this method of de-energizing was successful since all batteries examined post-immersion showed well under 50V, typically on the order of 5V–10V

overall. While not necessarily the primary focus of this work, these findings continue to support the generally accepted process of saltwater immersion as a means of de-energizing a battery. Figure 22 highlights this observation, showing a specific pack and voltage-probe result following immersion and before more detailed examination.

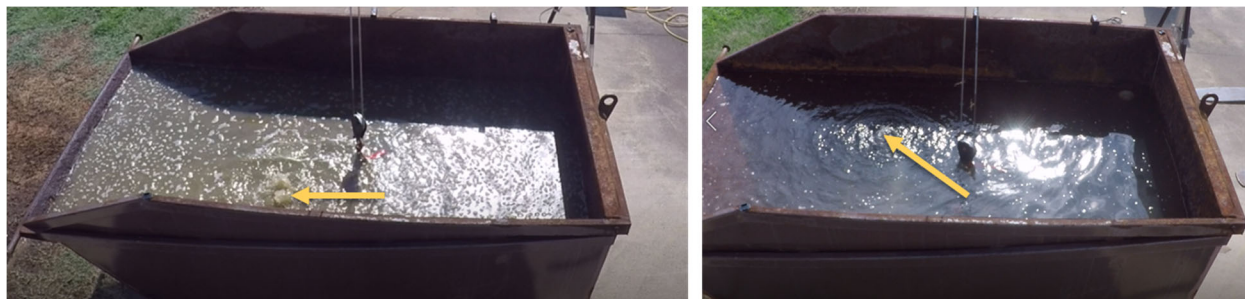
Figure 23. Battery reactions after 5 minutes of immersion in seawater (left) and brackish water (right)

For the same battery configuration tested across both salinity levels, the results were relatively similar, but the reactions could be observed to be taking place more slowly in the lower salinity water as would be expected. Figure 23 attempts to illustrate this point, showing an image of both salinity level tests at a point five minutes into the immersion process. The arrows highlight the primary location of bubbling (indicating the degree of reactions) for the two cases. The seawater image shows more vigorous bubbling versus the more muted bubbling observed in the brackish water case. These slower reactions suggest that an immersion test done in brackish water would likely be less aggressive from an initial battery abuse testing standpoint, but might lead to a higher energy state during the observation period, which in turn may be more aggressive from a delayed thermal incident perspective. Ultimately, it is a topic of research relative to the expected salinity as well as immersion time for various battery scenarios, so this work primarily highlights that the expected differences can be observed during testing. Despite the slow reactions for the

brackish conditions, in both salinity cases, the majority of reactions appeared to be concluded by the 2-hour immersion time used for these tests, as indicated by little to no observed bubbling.

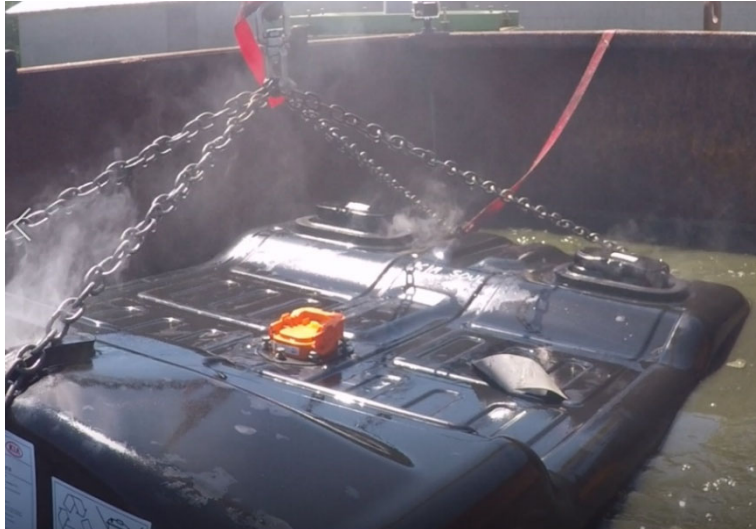
Figure 24. BEV (Test #3) battery showing smoke during observation period

The first battery that exhibited an issue was removed from the immersion after roughly 20 minutes in the seawater tank. Reactions were still clearly taking place as would be expected from such a short initial immersion. When held above the water, smoke/venting could be easily observed coming from the vehicle, as highlighted in the image shown in Figure 24. After the initial 20-minute immersion and subsequent re-immersion, this battery was again removed from the immersion for observation roughly 15 minutes into the re-immersion to see if any issues would occur following the second immersion. Interestingly, during this second observation period, smoke was again observed suggesting that a longer, 30-minute immersion time could still lead to a possible issue as evidenced by continued smoking. While the volume of smoking was significantly reduced, it was still present, indicating possible issues. As discussed in the

introduction, it appears, in this case, that a shortened immersion period may be a possible means to induce an issue in the battery, thus highlighting the value of not only longer-term immersion, but also shorter immersion as a possibly accelerated means to investigate battery failures — subject to real-world judgment related to the duration of possible in-field events.

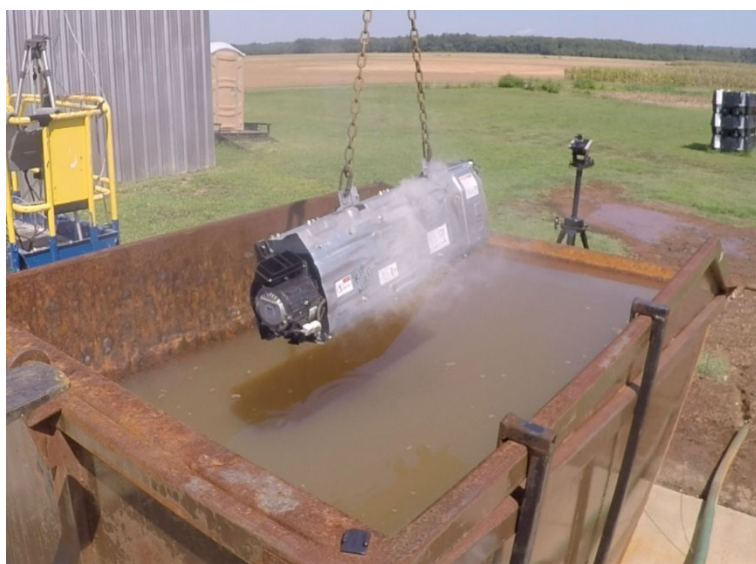
Figure 25. PHEV (Test #7) battery showing smoke during observation period

A second battery tested during these efforts also showed similar behavior, with observable smoke/venting during the observation period following an initial 15-minute immersion. Interestingly, this battery was tested using a brackish water immersion, thus providing evidence for further study as one battery at each salinity level experience a possible issue and was observed to be smoking following removal from the immersion. Figure 25 shows an image of the observed smoke during the observation period.
