1. Report No. FHWA/NC/2008-15	2. Government Accession No.	3. Recipient's Catalog No.	
4. Title and Subtitle Asset Management Inventory and Data Collection		5. Report Date October 2009

ASSET MANAGEMENT INVENTORY AND DATA COLLECTION

FINAL REPORT **(Report No. FHWA/NC/2008-15)**

To North Carolina Department of Transportation
(Research Project No. HWY-2008-15)

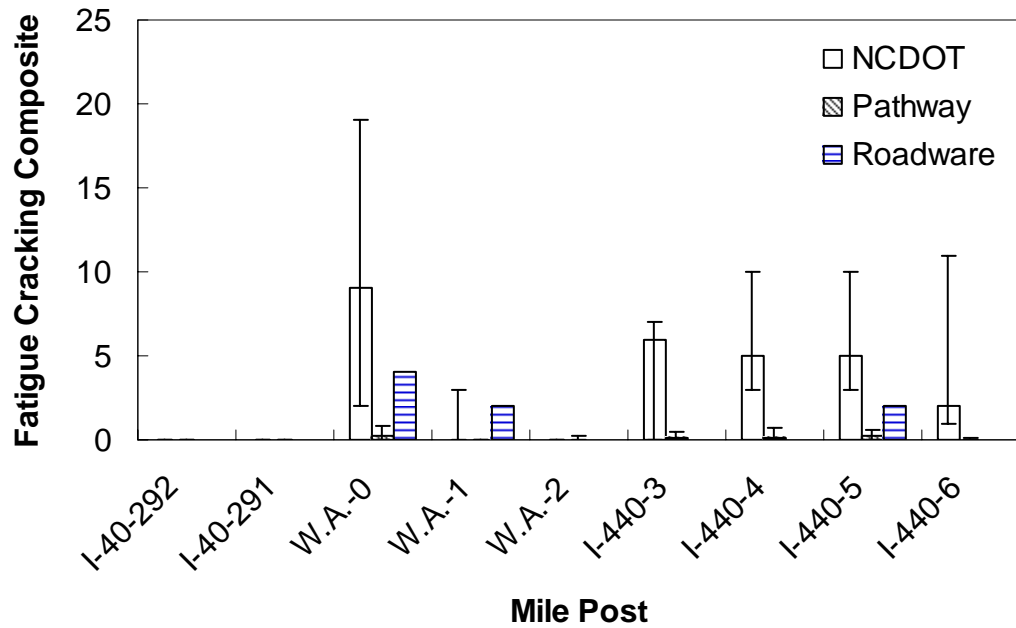
Figure 3.2. Fatigue cracking composite index for I-40, Wade Avenue, and I-440 sections.

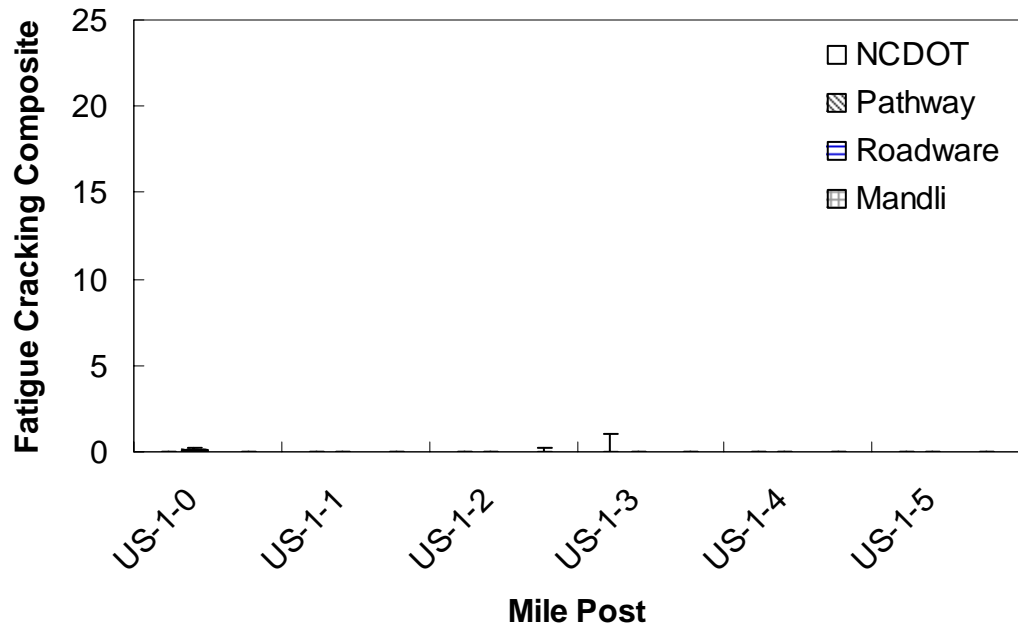
Figure 3.8. Fatigue cracking composite index for US-1 sections.

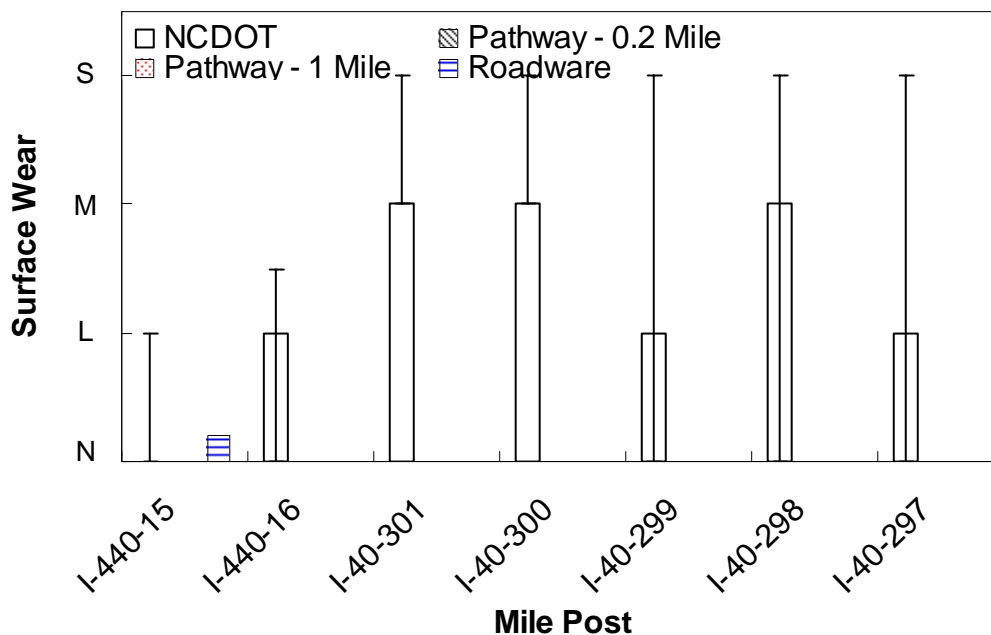
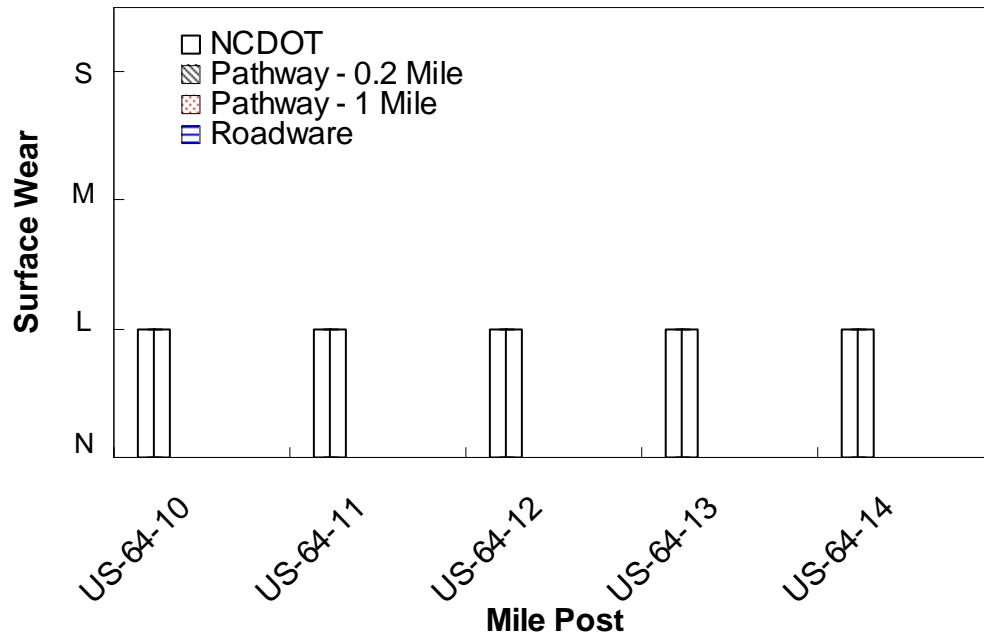
Figure 3.54. Surface wear for I-440/I-40 (1) sections.

Figure 3.55. Surface wear for I-440/I-40 (2) sections.

Figure 3.56. Surface wear for US-64 (1) sections.

Figure 3.57. Surface wear for US-64 (2) sections.

The surface wear results are shown in Figure 3.54 through Figure 3.57. Since most sections were dominated by a single severity level the individual percentages are not shown in these figures. Instead the qualitative ranking is shown. For sections which were rated approximately equally with two severity levels, the data are shown between the two nearest qualitative levels. For example, if a section were 50% light severity and 50% moderate severity then the bar for that section would be between the *L* and *M* levels in Figure 3.54 through Figure 3.57.

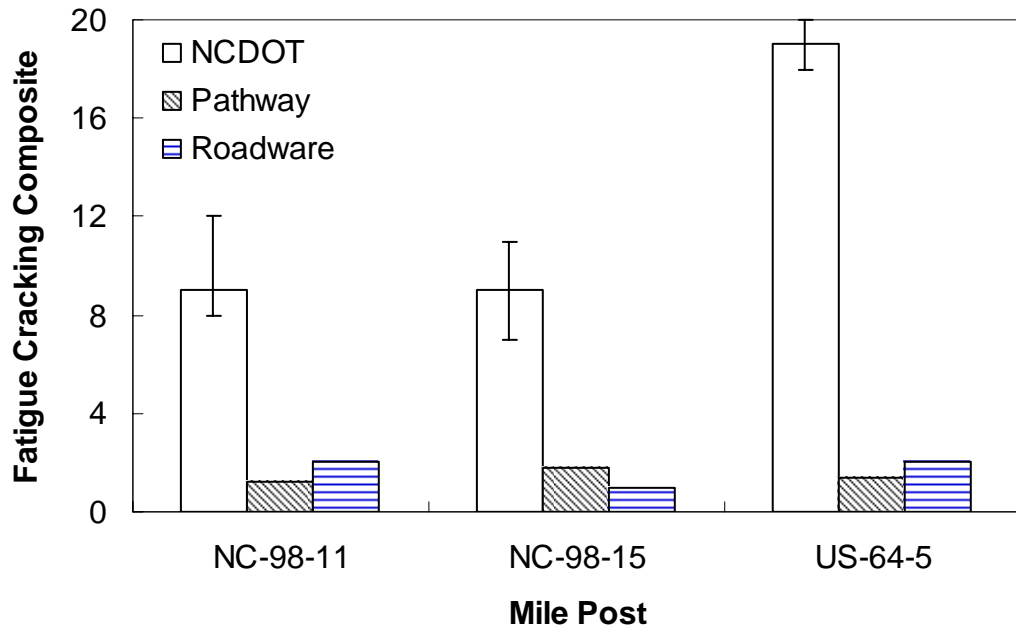
Figure 3.99. Fatigue cracking results for *original analysis* of resubmitted sections; (a) none rating, (b) light rating, (c) moderate rating, and (d) severe rating.

Figure 3.100. Fatigue cracking composite index for *original analysis* of resubmitted sections.

The results from the original analysis are shown for these three sections in Figure 3.99 and Figure 3.100 using the same plotting rules as were used before. Results from the reanalysis of these three sections are shown in Figure 3.101 and Figure 3.102. From these figures it is clear that the process of even a single iteration has resulted in a better match of the automated and reference surveys. There still appears to be an issue with sensitivity, but the second survey has moved in the right direction.

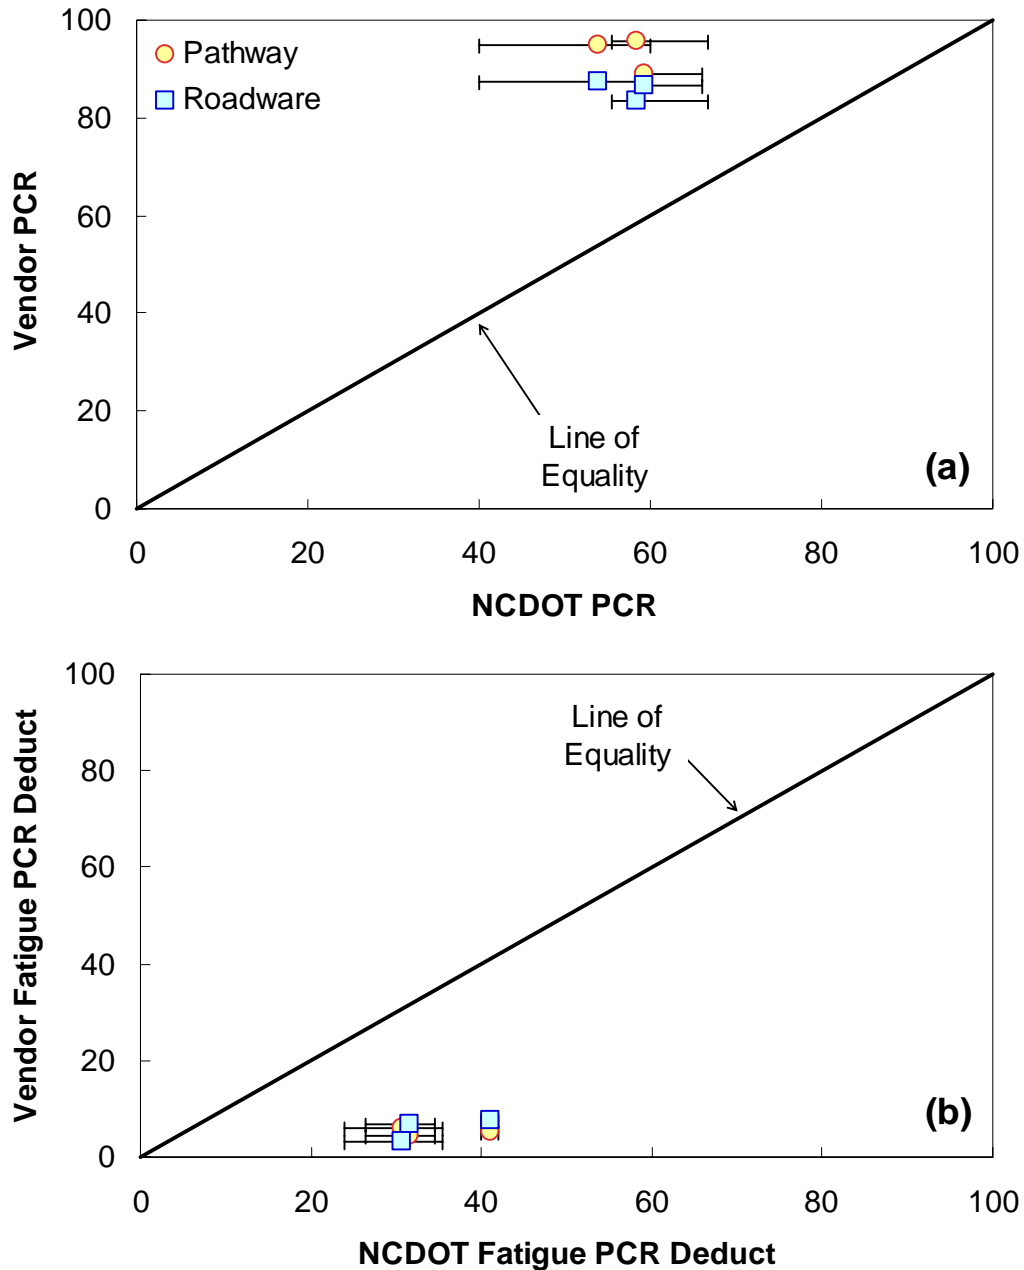
(b) plot shows only the PCR deduct values for the fatigue cracking components, e.g., Equation (3.3). In both plots the horizontal error bars represent the variability from the NCDOT reference survey. Comparing the original and reanalyzed data submissions it is clear that the calibration process has greatly improved the agreement of PCR values between the automated and reference surveys. Particular improvement is made with the fatigue cracking deduct values indicating an improvement in the sensitivity of the vendor detection of fatigue cracking.

Figure 3.108. PCR for *original analysis* of resubmitted sections; (a) full PCR computation and (b) comparison of only fatigue deduct values.

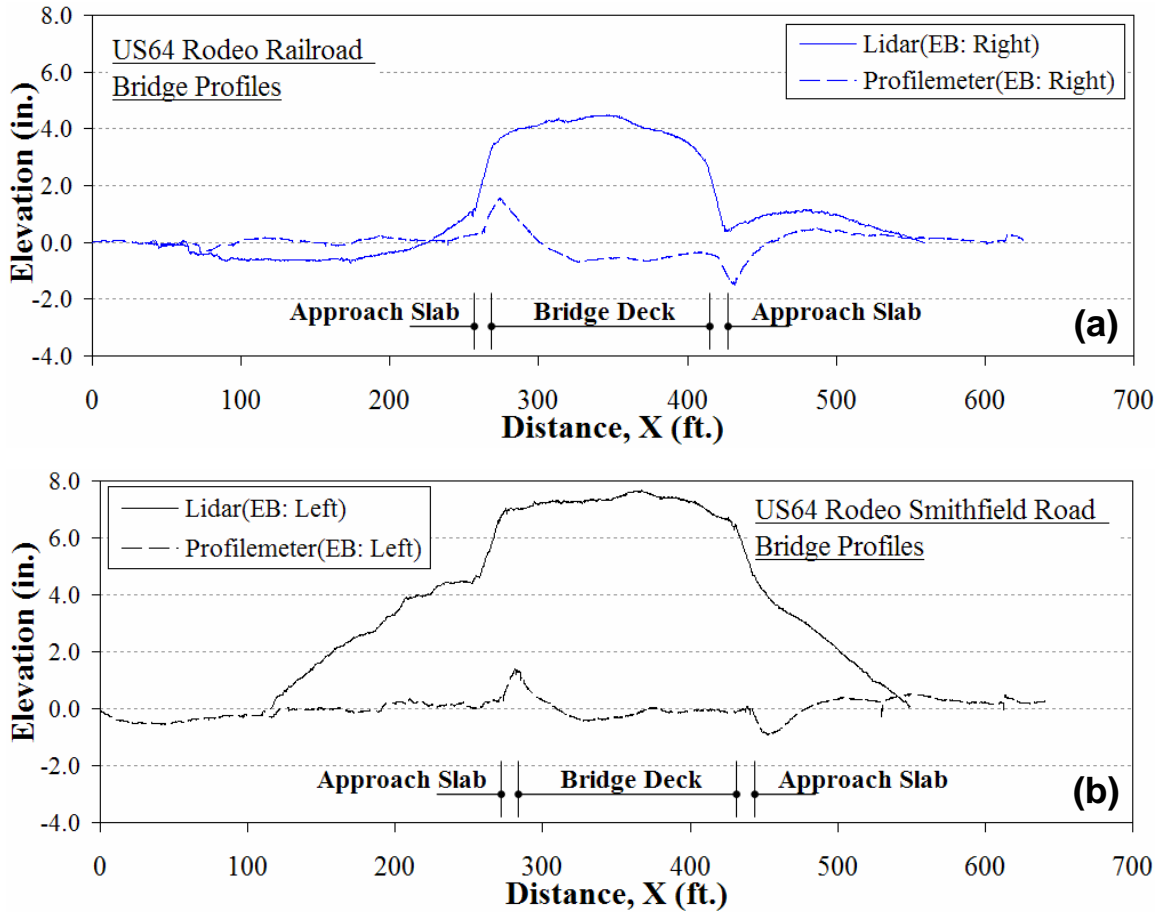
Figure 5.7. Longitudinal bridge profiles by LIDAR and Profilemeter: (a) US 64 over railroad and (b) US 64 over Smithfield road.

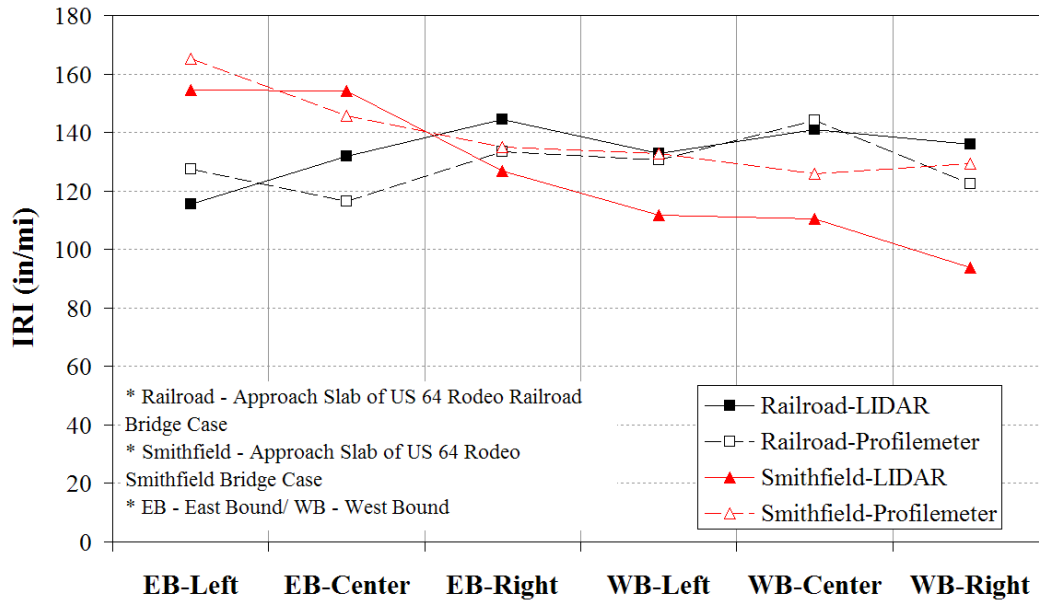
Figure 5.9. IRI variation for the selected cases.
