JOINT TRANSPORTATION RESEARCH PROGRAM

Evaluating Reserve Strength of Girder Bridges Due to Bridge Rail Load Shedding

Yao Wang, Mirela D. Tumbeva, Ashley P. Thrall

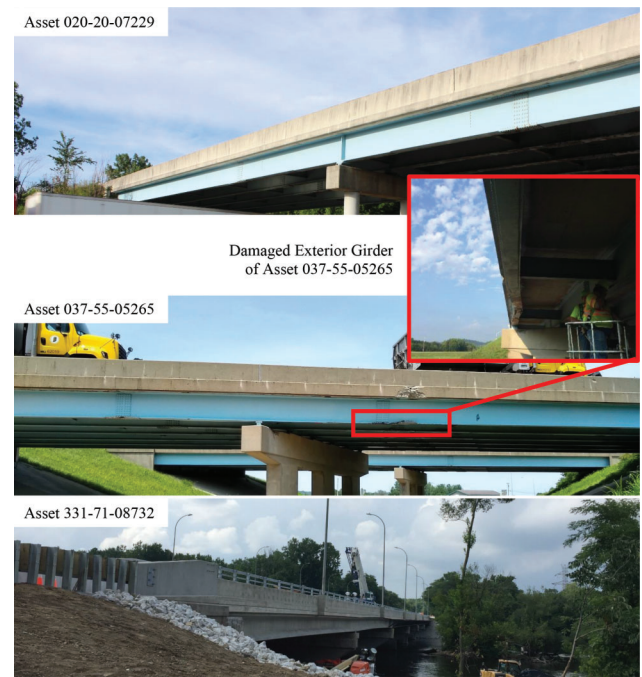
Figure 1.1 Monitored bridges.

continuous), one steel girder bridge damaged by vehicular collision (two-span continuous), and one prestressed concrete girder bridge (six-span continuous), as shown in Figure 1.1. The study was limited to intact, reinforced concrete bridge rails that are integral to the deck. Specifically, the behavior of four integral, reinforced concrete INDOT rail types was considered (INDOT, 2020): FC, FT, PS-1, and PS-2 (Figure 1.2). Research culminates in *Recommendations for Evaluating the Reserve Strength of Girder Bridges due to Rail Participation* (Appendix A). Based on findings from this study, as well as findings from SPR-4119: *Assessment of Bridges Subjected to Vehicular Collision*

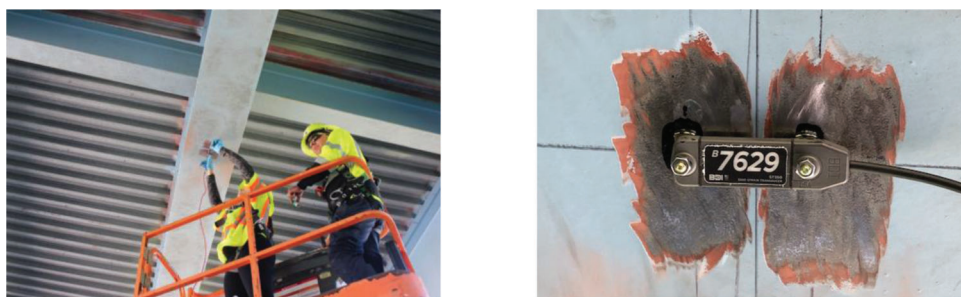
Figure 3.2 Researchers adhering a strain gauge to the bottom flange of Asset 020-20-07229 (left) and an adhered gauge (right).

The behavior of the girders and rail in each bridge was monitored using an array of ST350 strain transducers (BDI, 2018) with the STS4 data acquisition system (BDI, 2014) provided by BDI. The ST350 strain transducers have a gauge length of 3 in. The gauge length was extended to 1 ft. to monitor the surface strains on the rail in Asset 020-20-07229 and Asset 037-55-05265. The strain transducers were adhered to the bridge components by Loctite 410 epoxy and were removed when testing was completed. Figure 3.2 shows the researchers adhering a gauge to the bottom flange of a steel girder in Asset 020-20-07229. For the steel girder bridges, the paint was removed prior to adhering the gauge. All gauges were aligned to measure longitudinal strains.

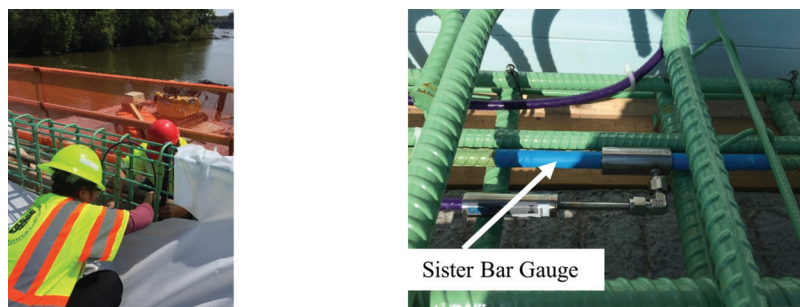
Figure 3.3 Researchers installing a sister bar gauge in Asset 331-71-08732 (left) and the installed gauge (right).

As Asset 331-71-08732 was new construction, four model 3911 resistance type rebar strain meters (sister bar, Geokon, 2019) were inserted in the deck and the rail to monitor the internal strains in these components. Figure 3.3 shows researchers installing a sister bar

gauge in Asset 331-71-08732 by attaching it to rebar via zip ties prior to concrete casting.

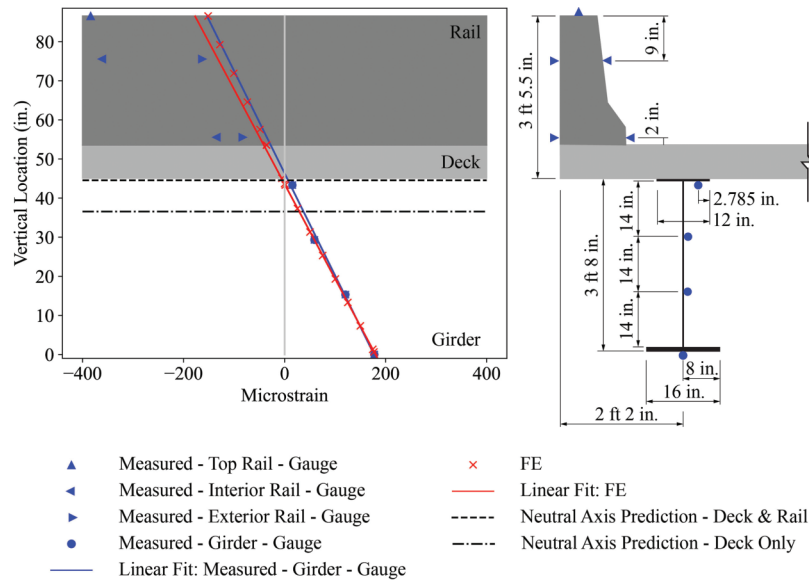
Figure 3.11 Asset 020-20-07229 Location M1: measured and predicted strains under the static load of two trucks positioned to induce peak positive moment.

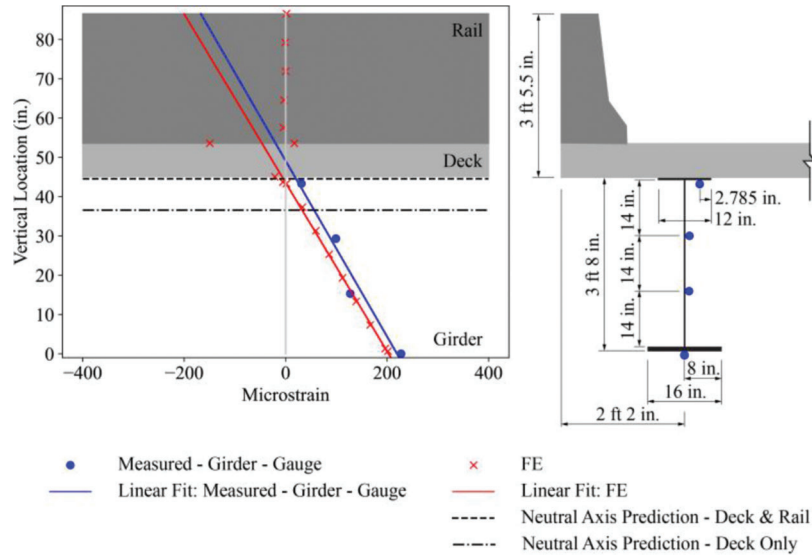
Figure 3.12 Asset 020-20-07229 Location N1: measured and predicted strains under the static load of two trucks positioned to induce peak positive moment.

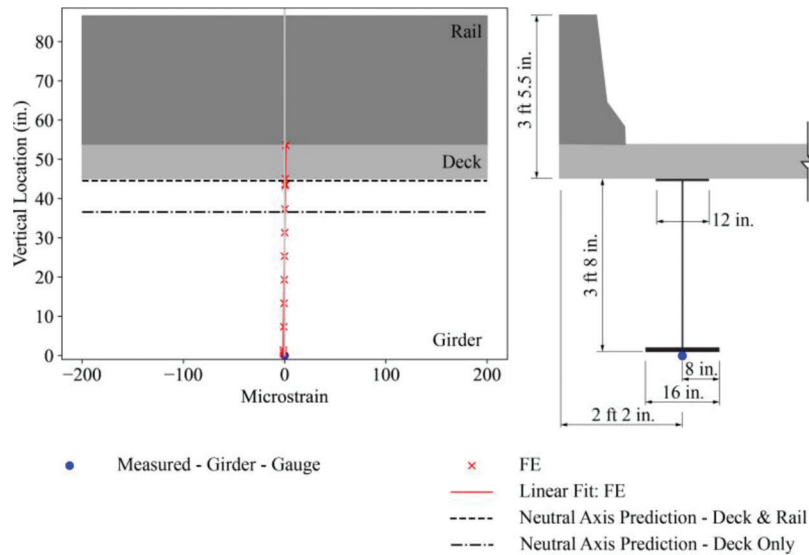
Figure 3.16 Asset 020-20-07229 Location M5: measured and predicted strains under the static load of two trucks positioned to induce peak positive moment.

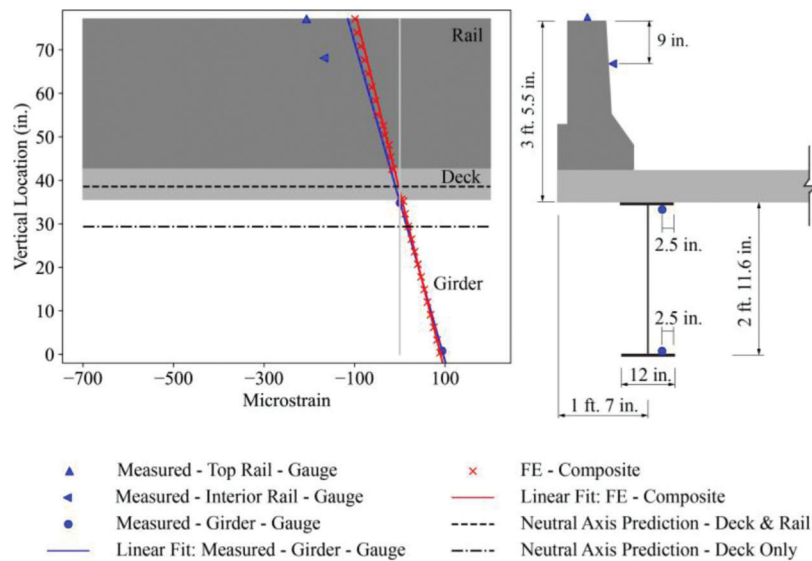
Figure 3.21 Asset 037-55-05265 Location D1: measured and predicted strains under the static load of two trucks positioned to induce peak positive moment.

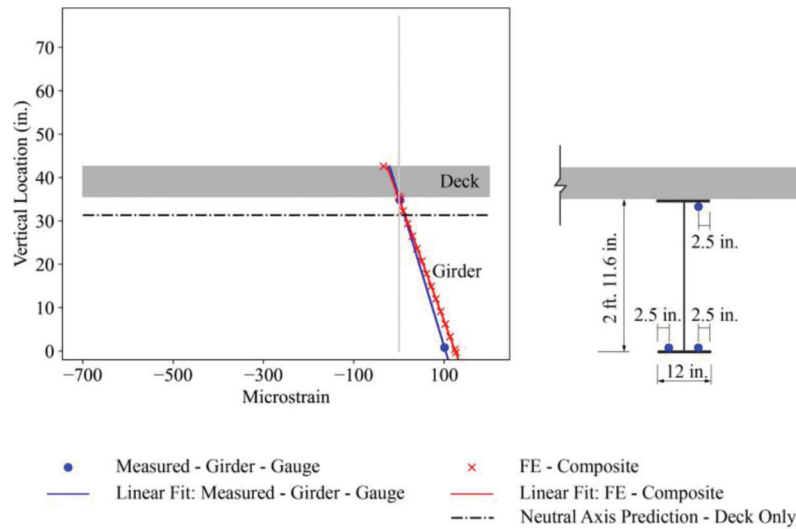
Figure 3.22 Asset 037-55-05265 Location M2: measured and predicted strains under the static load of two trucks positioned to induce peak positive moment.

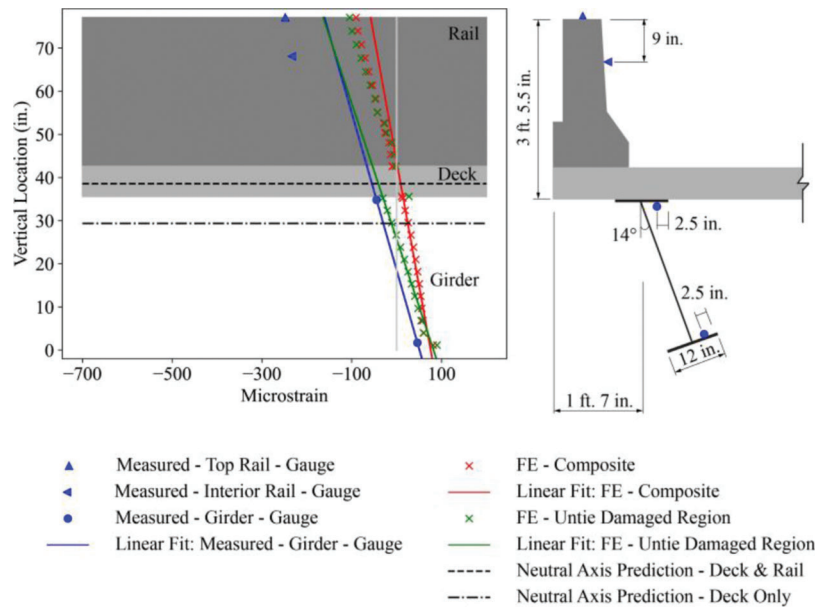
Figure 3.23 Asset 037-55-05265 Location D6: measured and predicted strains under the static load of two trucks positioned to induce peak positive moment.

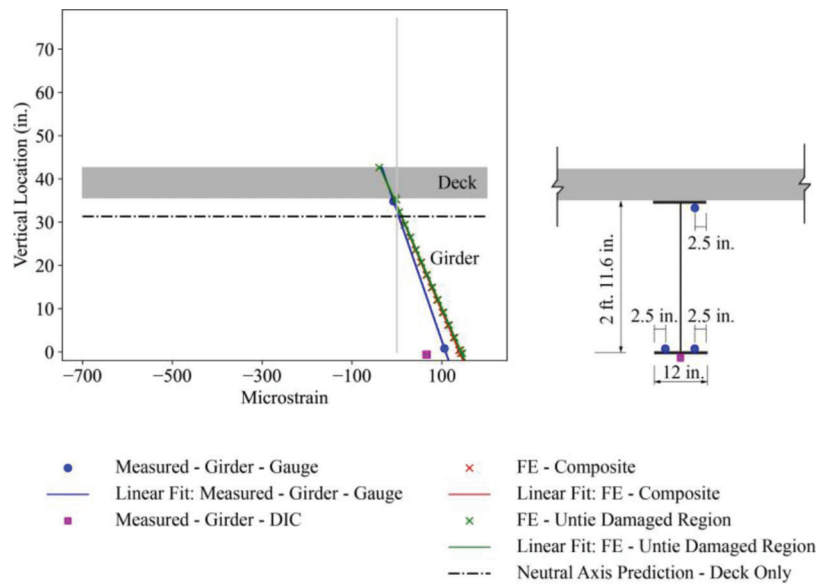
Figure 3.25 Asset 037-55-05265 Location M5: measured and predicted strains under the static load of two trucks positioned to induce peak positive moment.

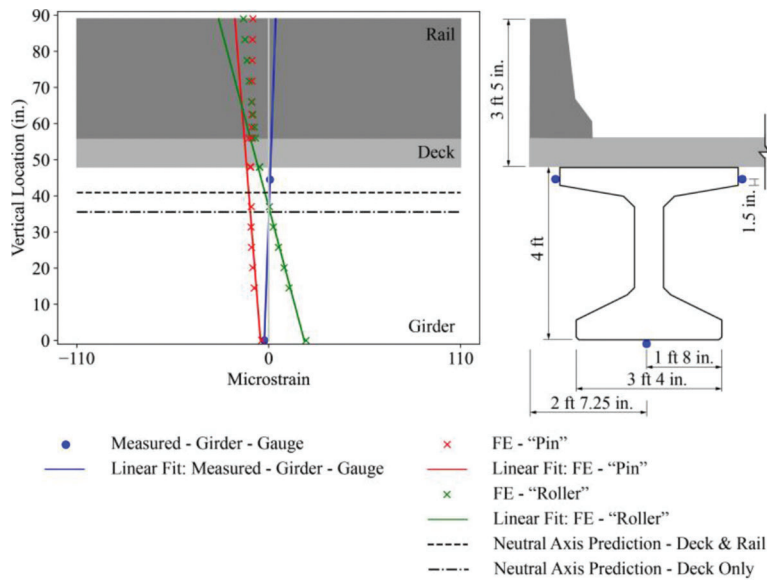
Figure 3.28 Asset 331-71-08732 Location E1: measured and predicted strains under the static load of two trucks positioned to induce peak positive moment.

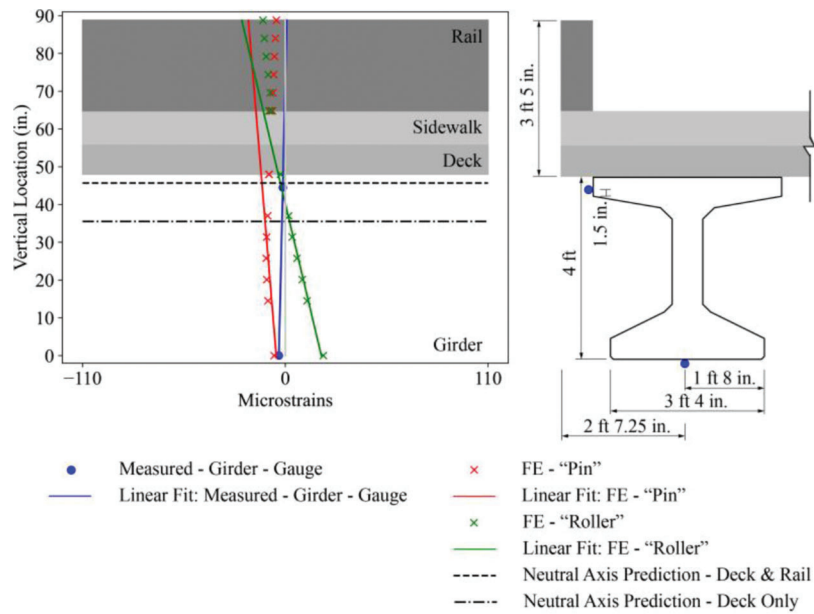
Figure 3.31 Asset 331-71-08732 Location E4: measured and predicted strains under the static load of two trucks positioned to induce peak positive moment.

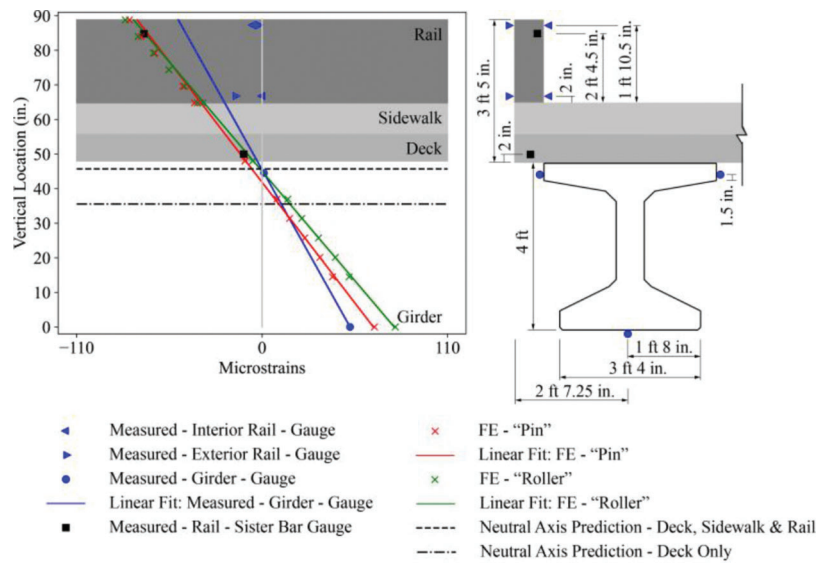
Figure 3.32 Asset 331-71-08732 Location M4: measured and predicted strains under the static load of two trucks positioned to induce peak positive moment.

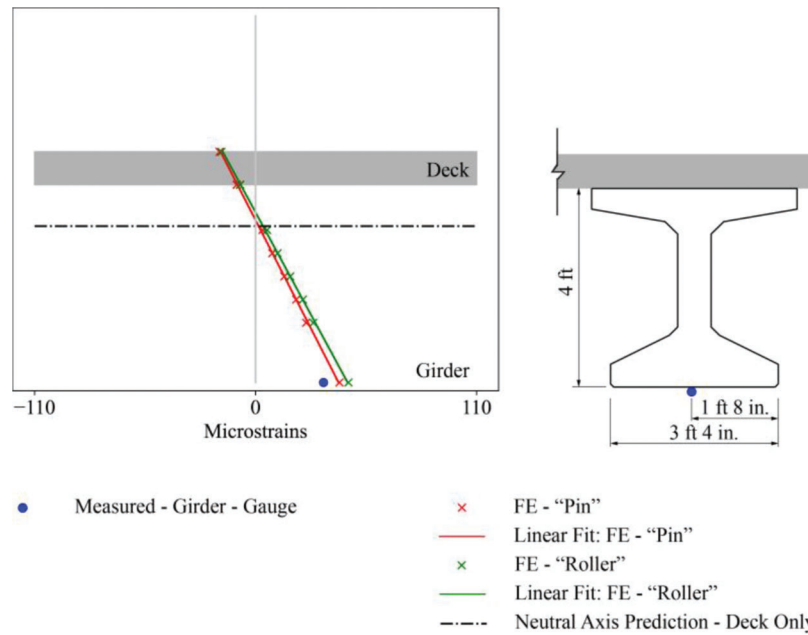
Figure 3.33 Asset 331-71-08732 Location M3: measured and predicted strains under the static load of two trucks positioned to induce peak positive moment.
