FINAL REPORT ~ FHWA-OK-21-03

EVALUATION OF ULTRA-HIGH-PERFORMANCE CONCRETE FOR USE IN BRIDGE CONNECTIONS AND REPAIR

School of Civil Engineering and Environmental Science
The University of Oklahoma
Norman, Oklahoma

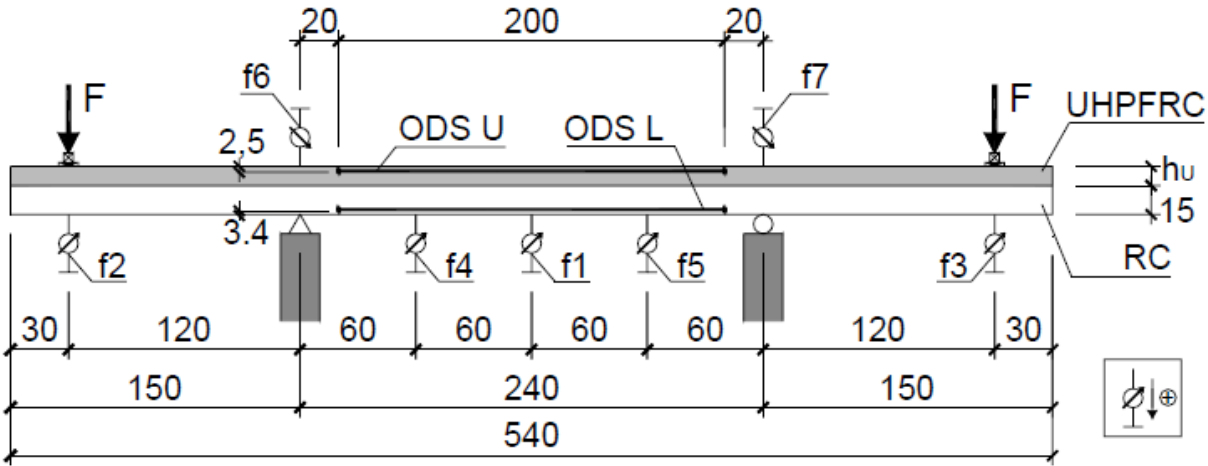
Figure 9. Four-point loading system for Habel et al. (2004) experiments. Notations f1-f7 are LVDT locations, and dimensions are given in cm.

Habel et al. (2004) also performed testing on a UHPC composite overlay configuration to determine the bending behavior of the composite element. The study used a four-point loading system, seen in Figure 9. Three different types of overlays were studied (each having different depths and rebar configurations), and the following conclusions were made: (1) the enhanced mechanical properties of UHPC contribute to improved structural response of composite elements due to its strain-hardening behavior under uniaxial tension (2) the stiffness of the composite elements was increased under service loads, and no large cracks formed until the maximum force was reached, and (3) the addition of tensile reinforcement in the UHPC layer increased resistance and stiffness of the composite elements and delayed localized macrocracks (Habel et al., 2004).

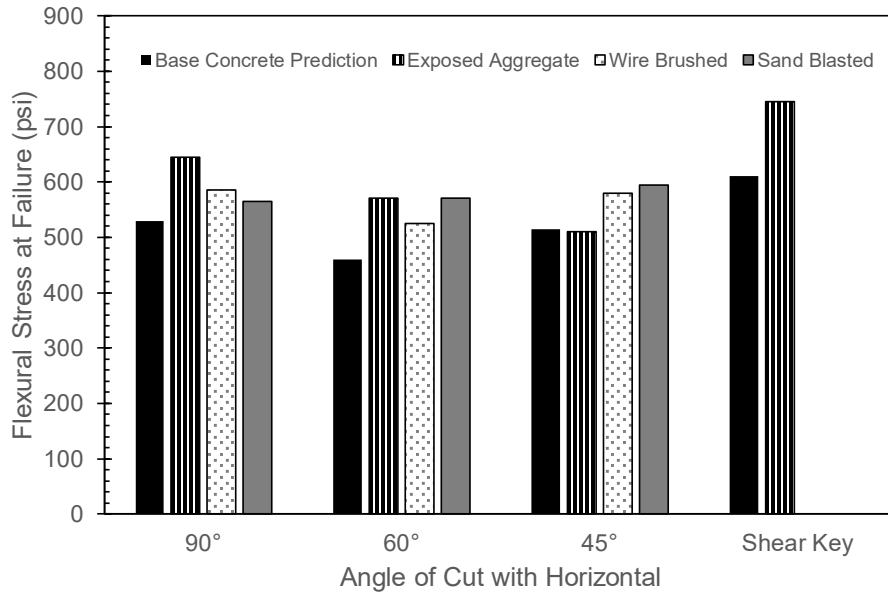
Figure 56. Summary of small-scale specimen testing results

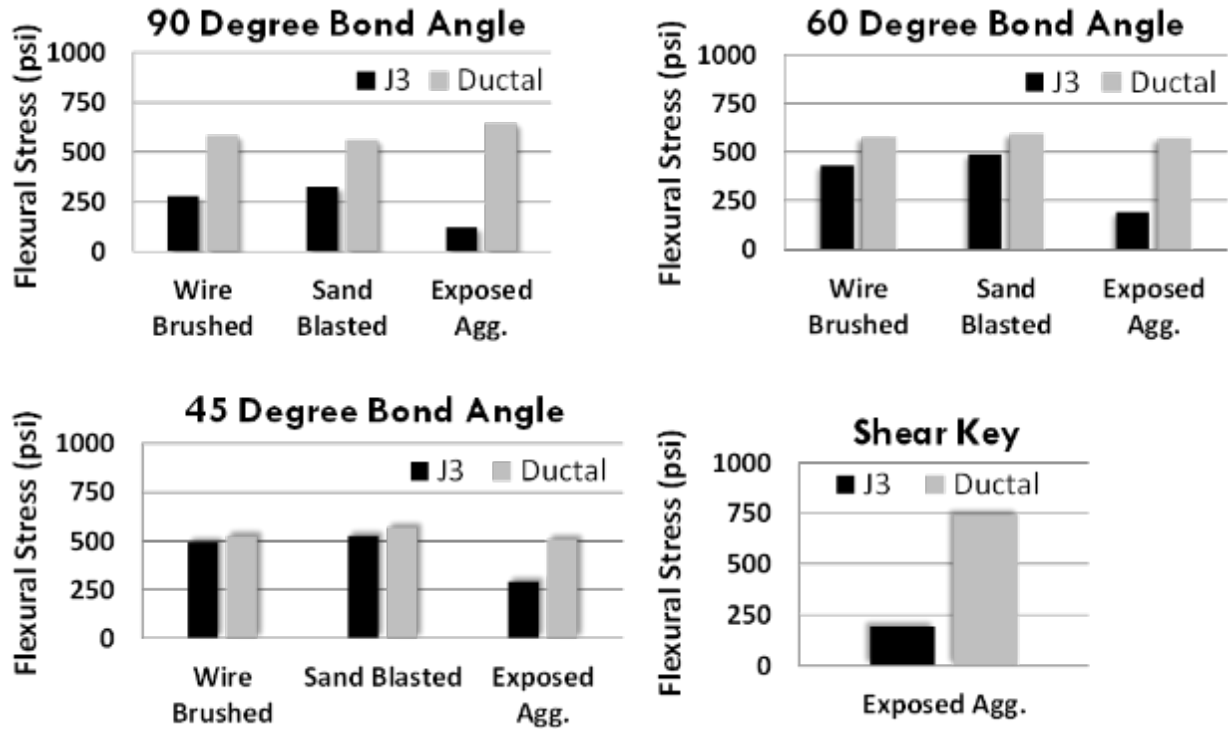
Figure 58. Comparison of the composite MOR specimen test results

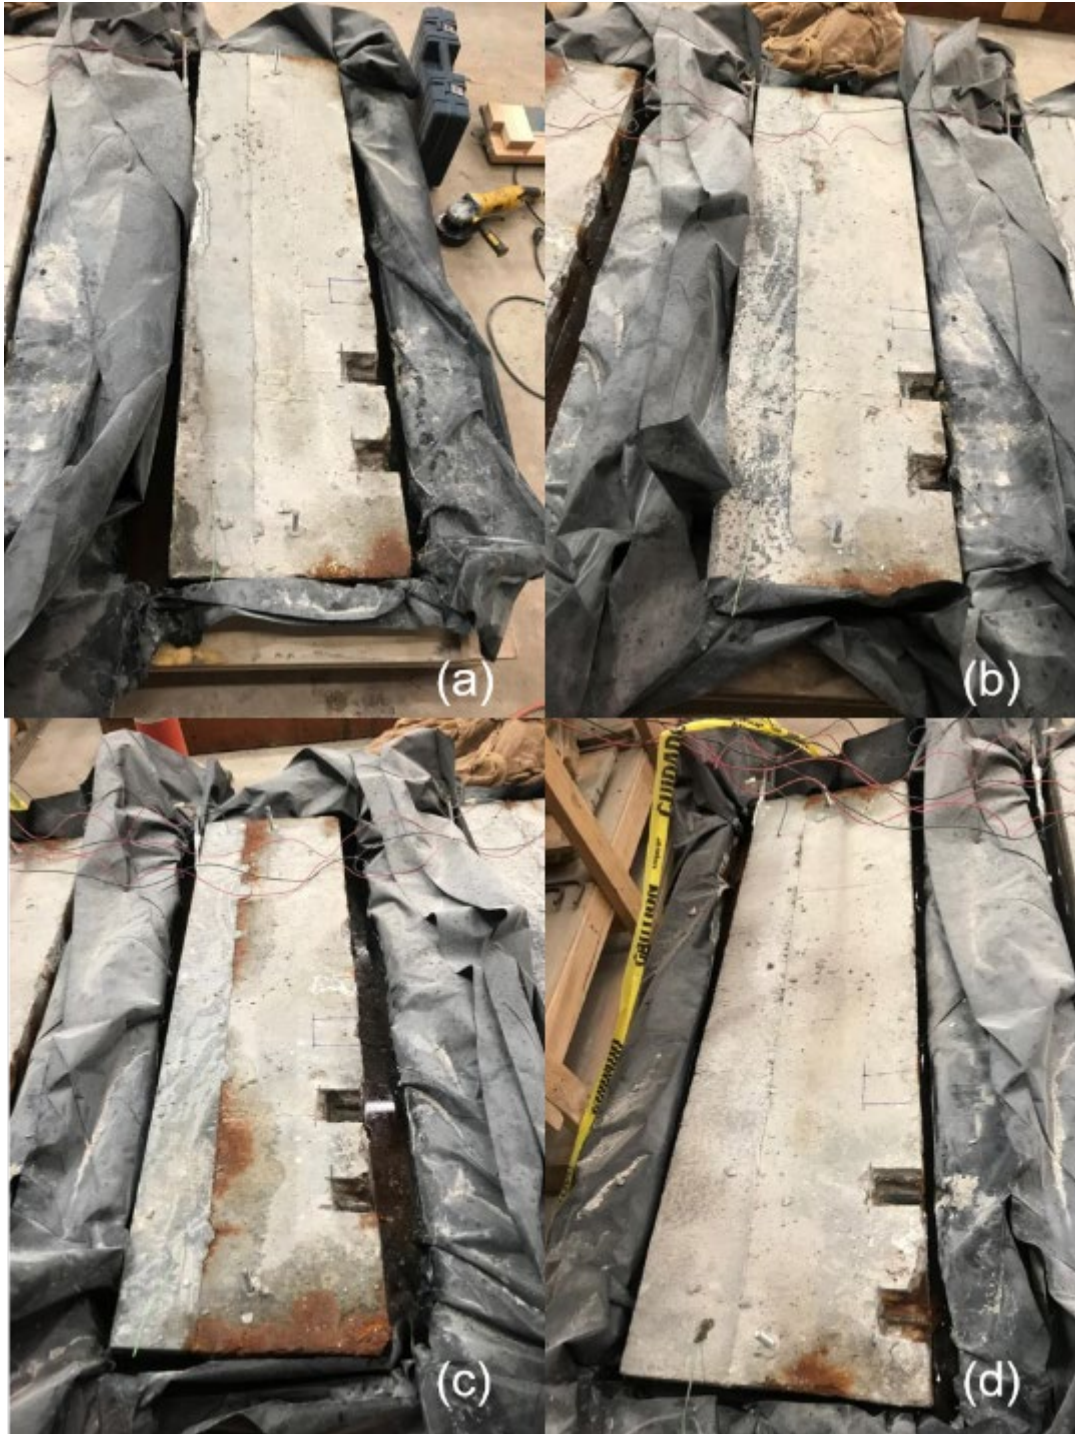
Figure 315. Week 6 update for large-scale corrosion specimens using (a) ODOT AA, (b) J3, (c) Ductal®, and (d) Phoscrete
